## **Bridge M0493 Inspection Report**

US 371- 05 - 25.44 over CREEK

Location: 3.11 MI NO OF COLUMBIA CO

Team Lead: Jared Kegley Inspection Date: 02/12/2024

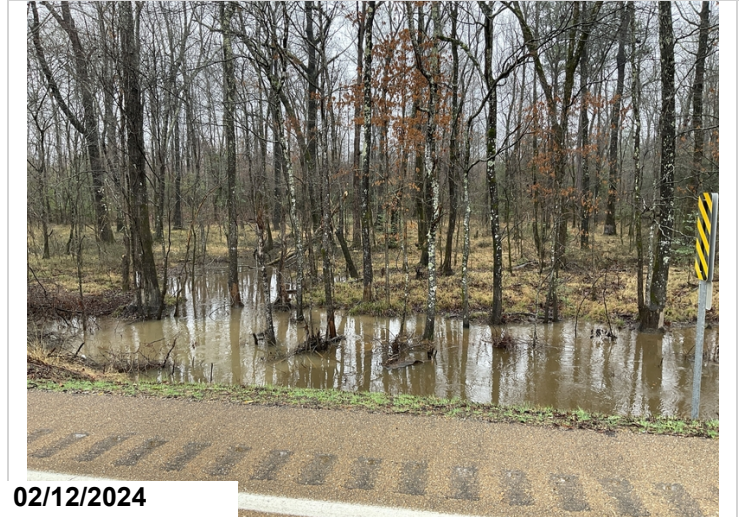
**61 - Channel/Channel Protection** (6 - Bank is beginning to slump. River control devices and embankment protection have widespread minor damage. There is minor stream bed movement evident. Debris is restricting the channel slightly.) Channel rating is a 6 this inspection due to streambank damage located in various locations both upstream and downstream sides of the box culvert.

Upstream channel

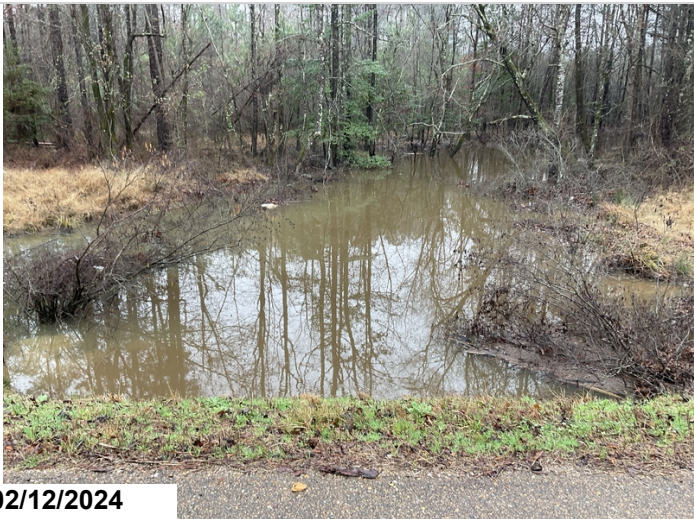
Downstream channel
