Bridge M0494 Inspection Report

Asset #M0494(Routine)

US 371- 05- 24.60 over CREEK

Team Lead: Jared Kegley Inspection Date: 02/12/2024

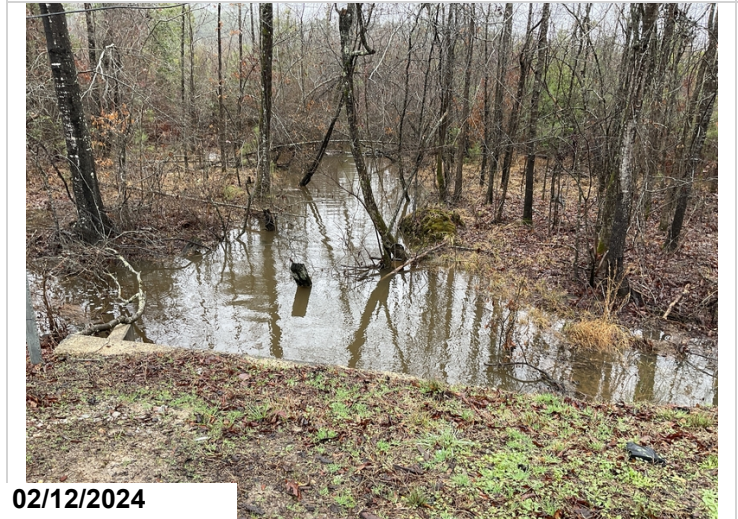
61 - Channel/Channel Protection (6 - Bank is beginning to slump. River control devices and embankment protection have widespread minor damage. There is minor stream bed movement evident. Debris is restricting the channel slightly.) Channel rating is a 6 this inspection due to poor alignment on upstream side, channel is on a skew coming into box. Some debris is in channel on upstream side.

Channel upstream

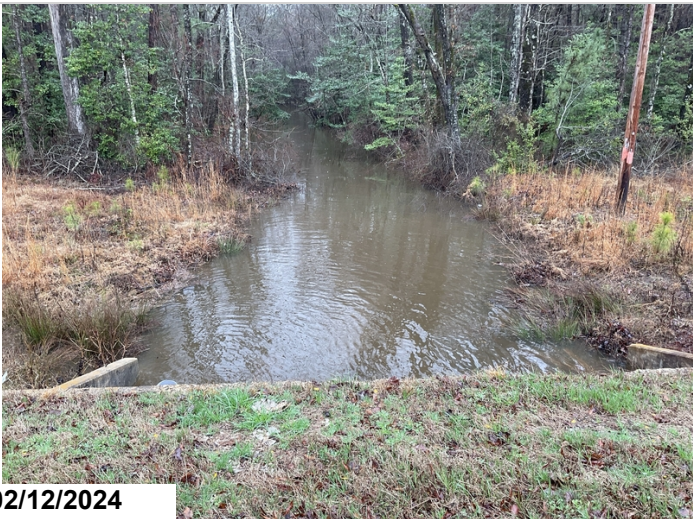
Channel downstream

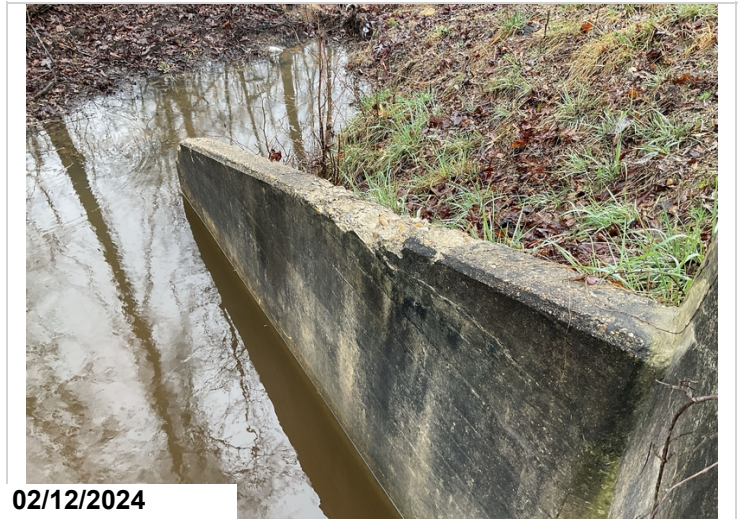
Salt damage barrel 2 LT side wingwall, approx. 3' long.

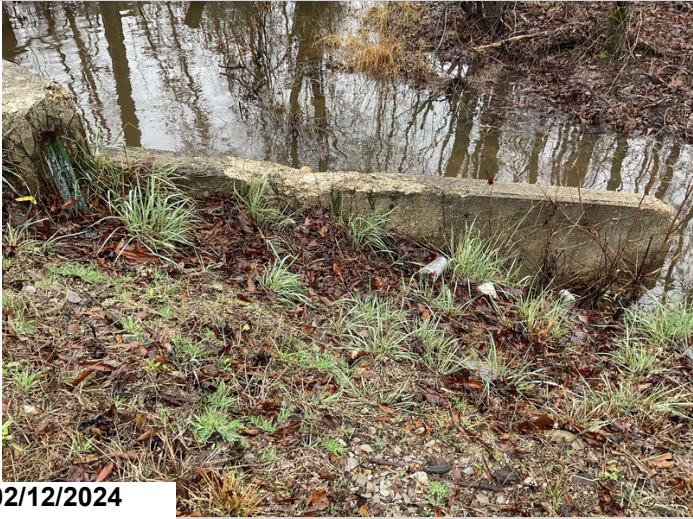
Scour rating is a 7 this inspection due to minor erosion behind inlet and outlet end wingwalls and minor scour at edges of box aprons on inlet and outlet ends.

10' x 2' x 3' deep minor erosion starting behind barrel 2 inlet end wingwall, no MN at this time

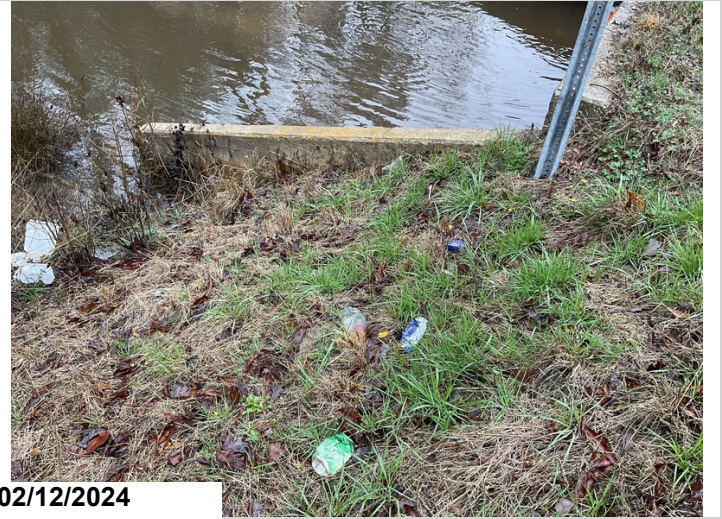
10' x 2' x 3' deep minor erosion starting behind barrel 2 inlet end wingwall, no MN at this time

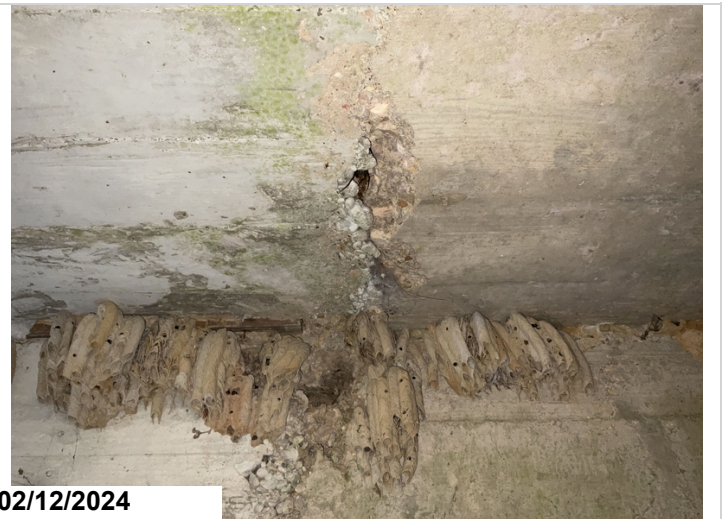
Spalling to add on section to barrel 2 outlet end, 1 LF CS2

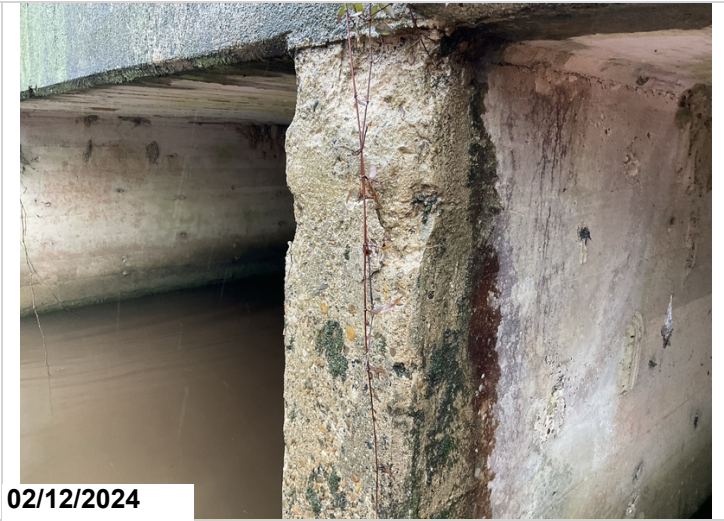
Spalling on inlet end divider wall. CS2

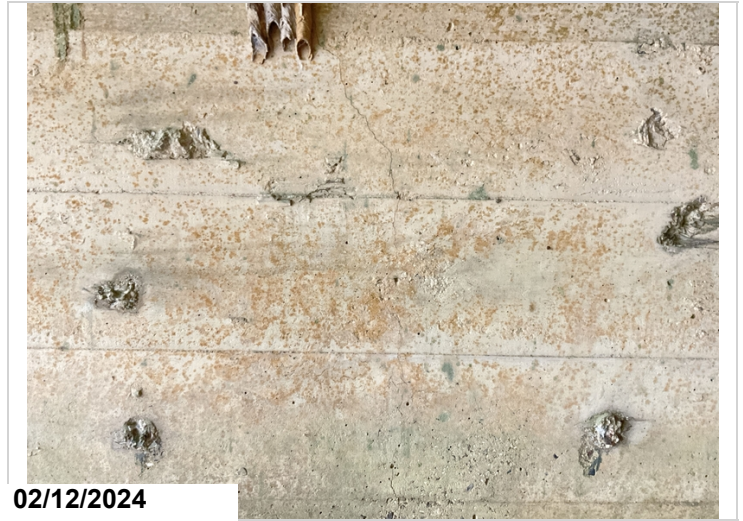
Cracking throughout both barrels 1 & 2. CS2

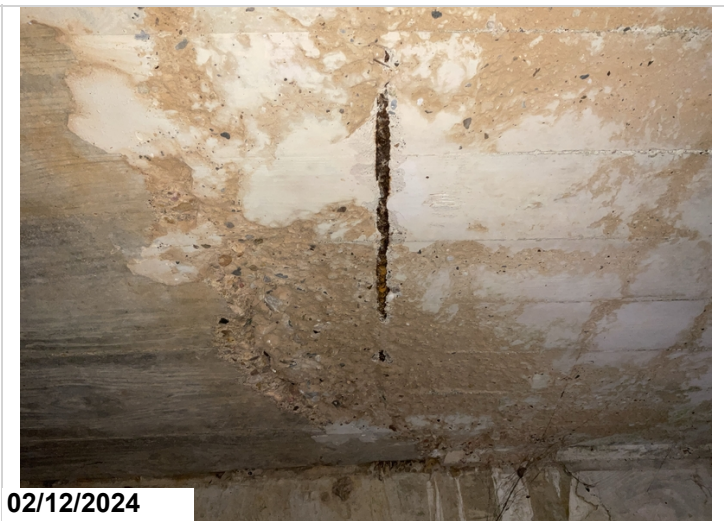
Exposed rebar to top of barrel 1 near inlet end, 2 LF no section loss CS2.

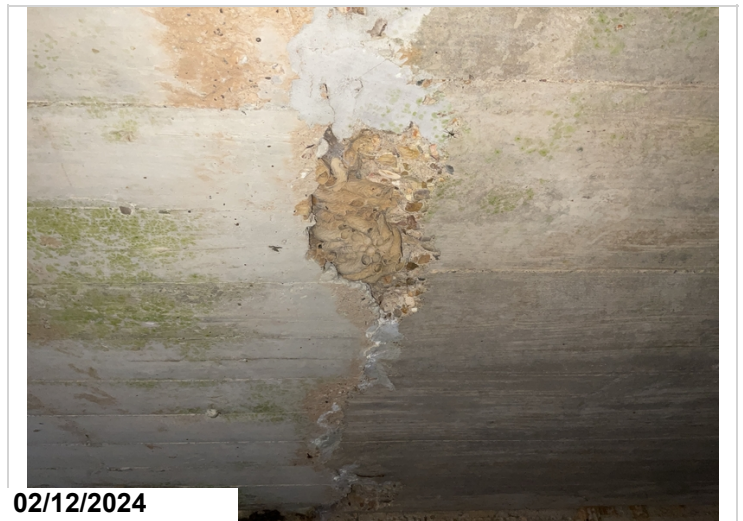
Spalling to barrel 1 ceiling, 1 LF CS2.

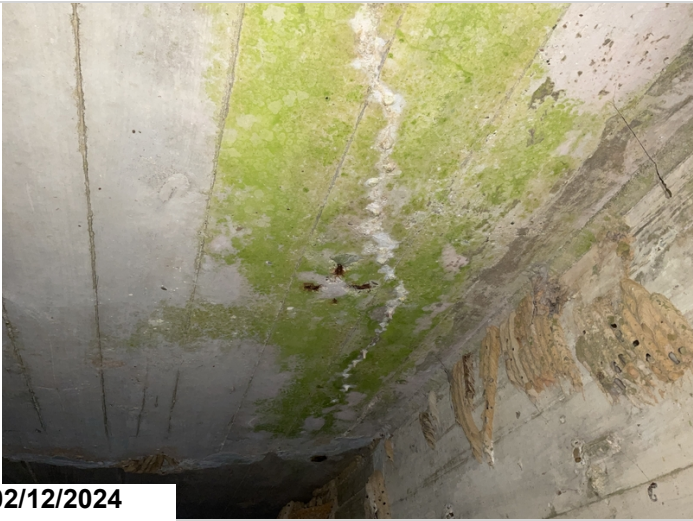
Barrel 1 efflorescence. CS2

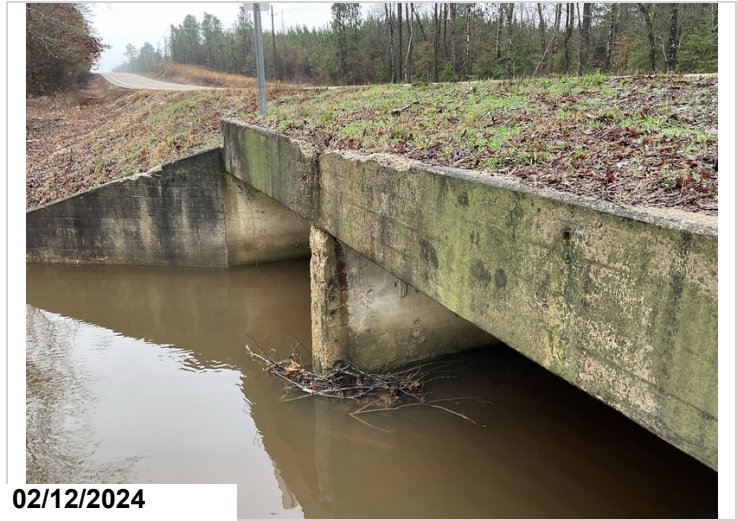
LT side upstream headwall spalling, 5 LF CS2

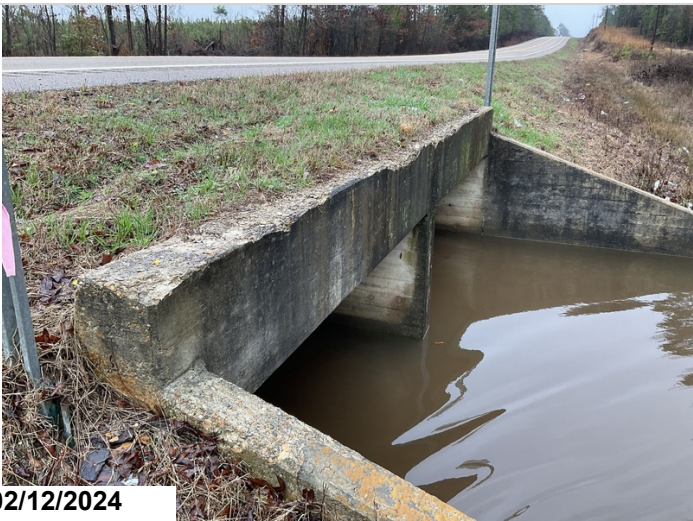
Outlet end headwall spalling, 5 LF CS2
