## **Bridge M0495 Inspection Report**

Asset #M0495(Routine)

US 371 - 05- 24.40 over CREEK

Team Lead: Jared Kegley Inspection Date: 02/12/2024

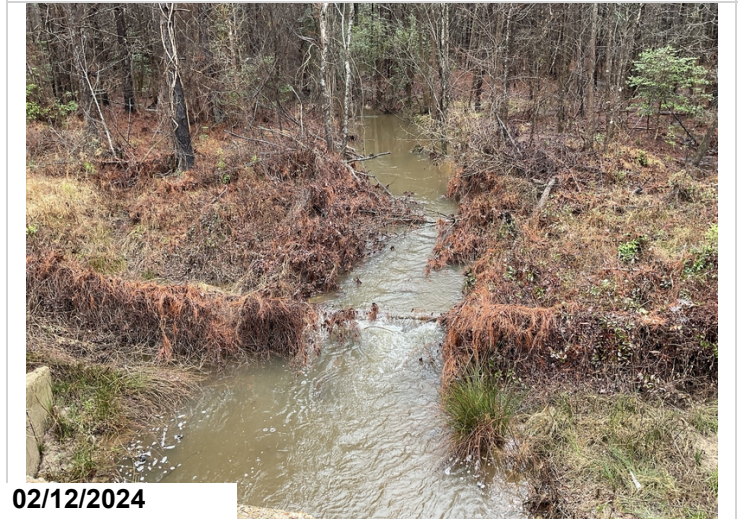
**61 - Channel/Channel Protection** (6 - Bank is beginning to slump. River control devices and embankment protection have widespread minor damage. There is minor stream bed movement evident. Debris is restricting the channel slightly.) Channel rating is a 6 this inspection due to streambank damage located in various locations both upstream and downstream sides of the box culvert.

Upstream channel

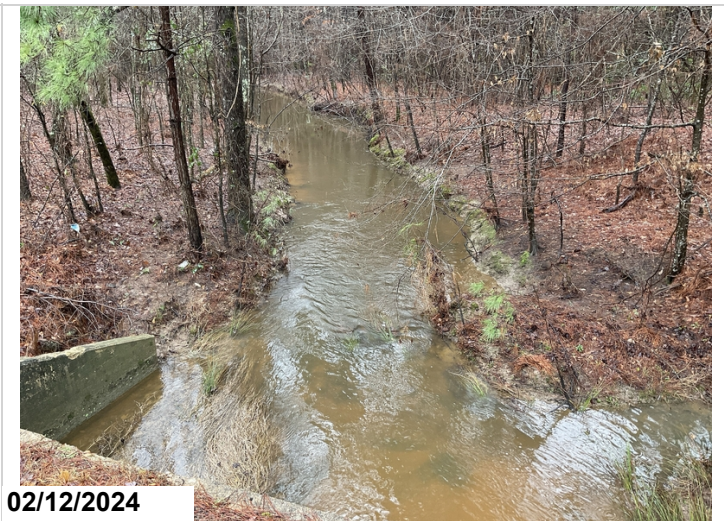
Downstream channel

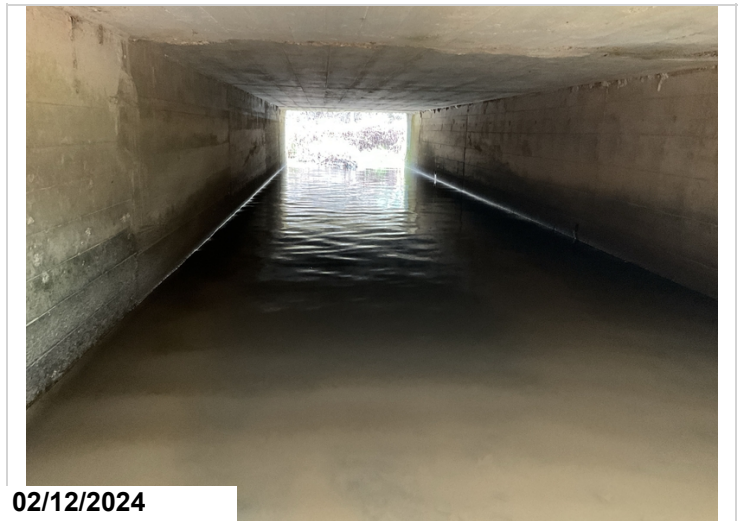
Typical through shot of culvert

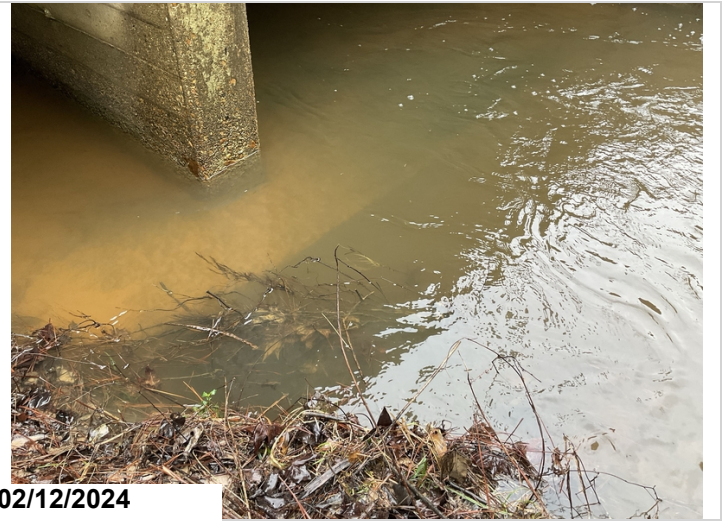
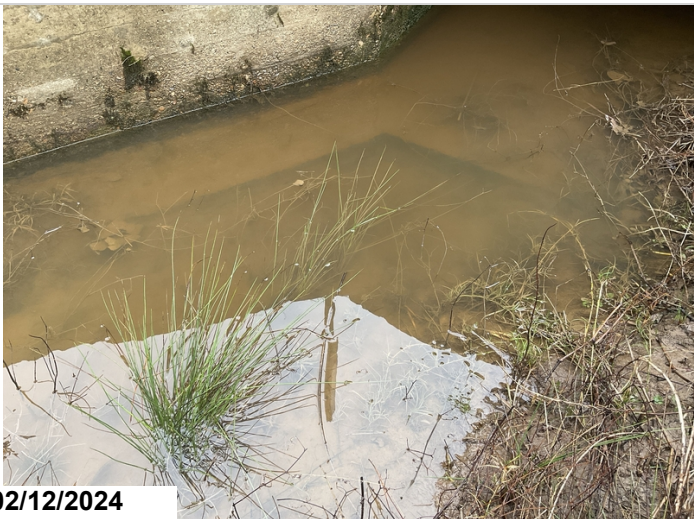
**A-B.C.11 - B.C.11 Scour Condition Rating (New NBIS)** (6 - Widespread minor or isolated moderate scour.) Scour rating is a 6 this inspection due to isolated moderate scour around both inlet and outlet ends of barrels 1 & 2.

Scour around inlet end footing at both barrels 1 & 2.

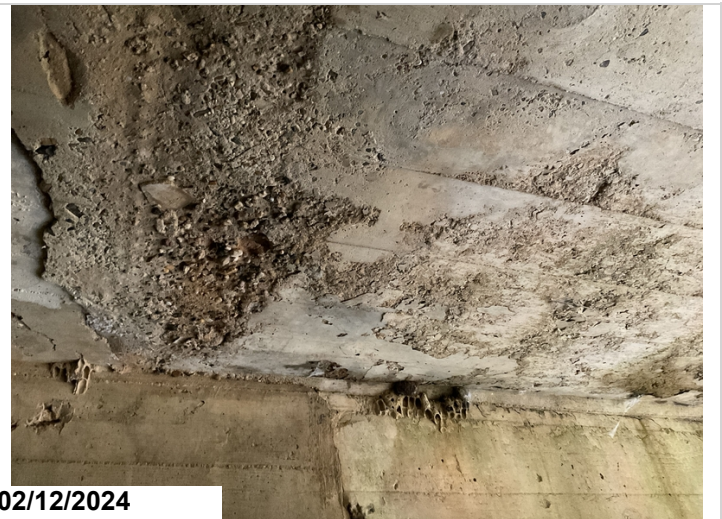
Honey coming to barrel 2

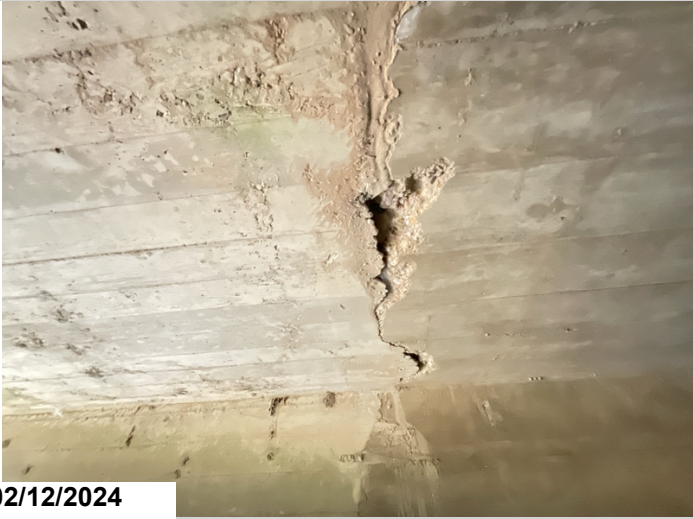
**62 - Culverts** (6 - Deterioration or initial disintegration, minor chloride contamination, cracking with some leaching, or spalls on concrete or masonry walls and slabs. Local minor scouring at curtain walls, wingwalls or pipes. Metal culverts have a smooth curvature, non-symmetrical shape, significant corrosion or moderate pitting.) Dropped culvert rating to a 6 this inspection due to spalling, exposed rebar, cracking, as well as abrasion being found in various locations throughout both barrels 1 & 2.

Barrel 2 spalling

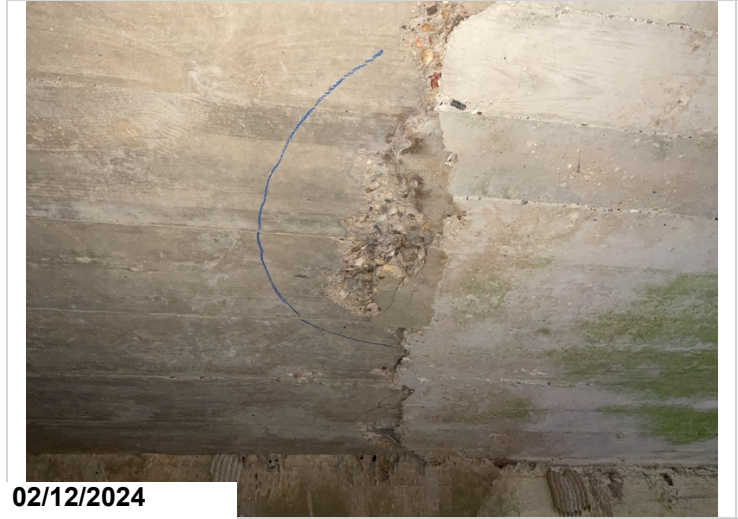
Spalling in barrel 2. CS3

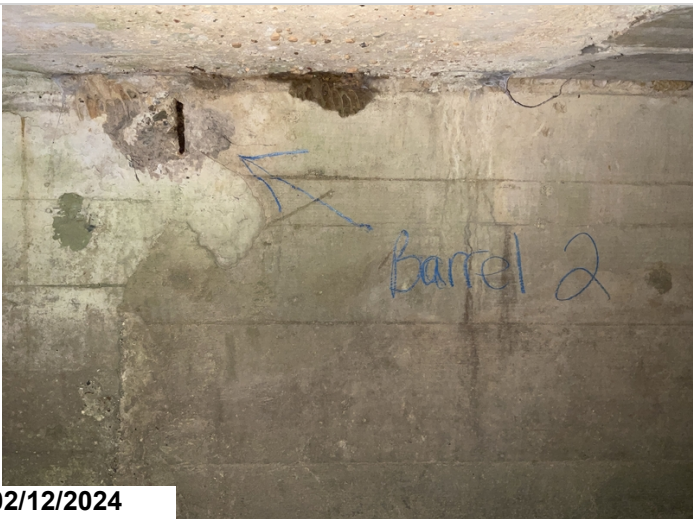
Barrel 2 exposed rebar. CS2

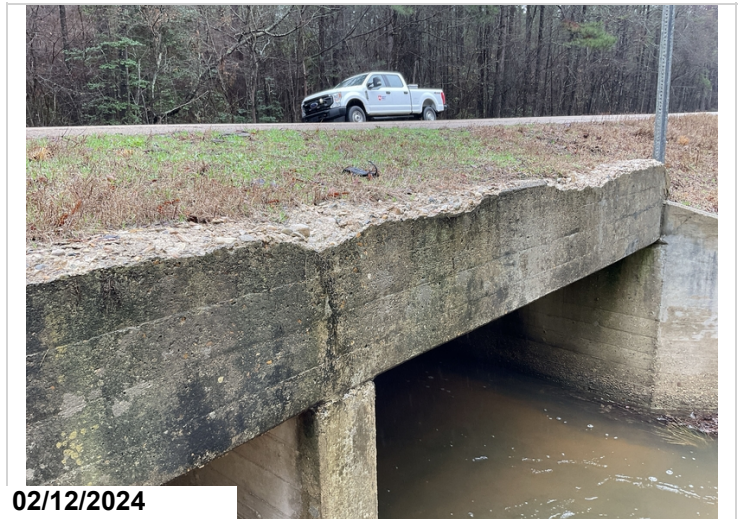
Spalling to inlet end headwall. CS2

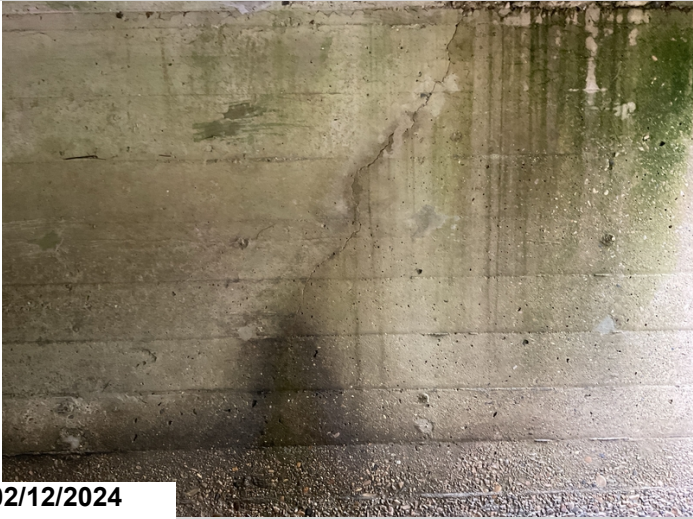
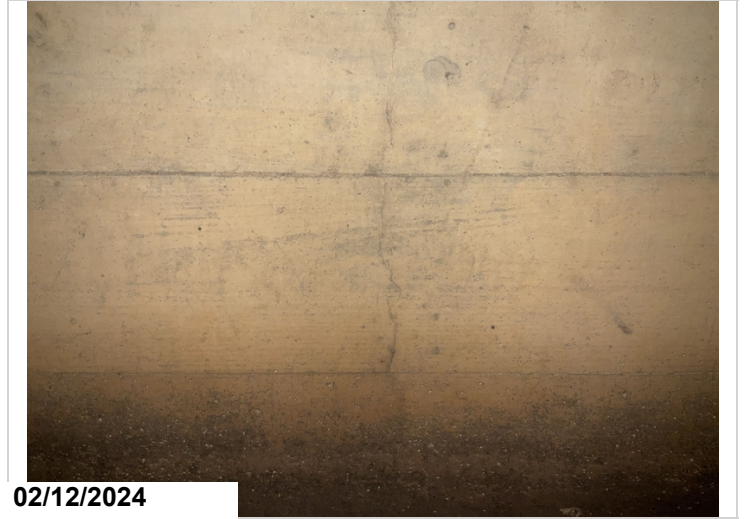
Typical cracking throughout both barrels. CS2

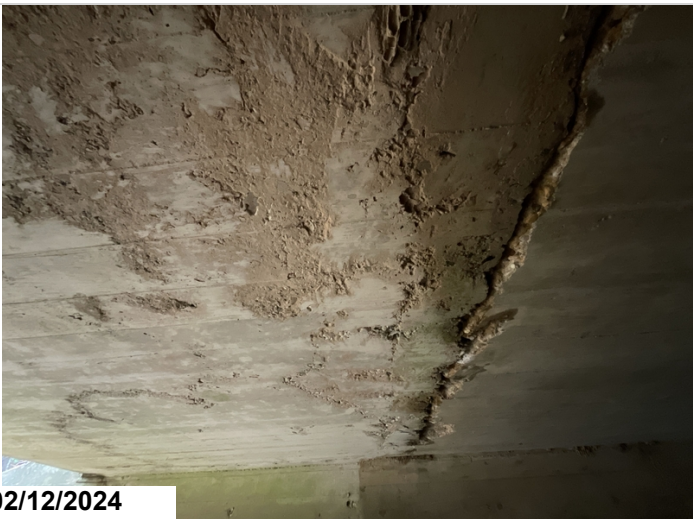
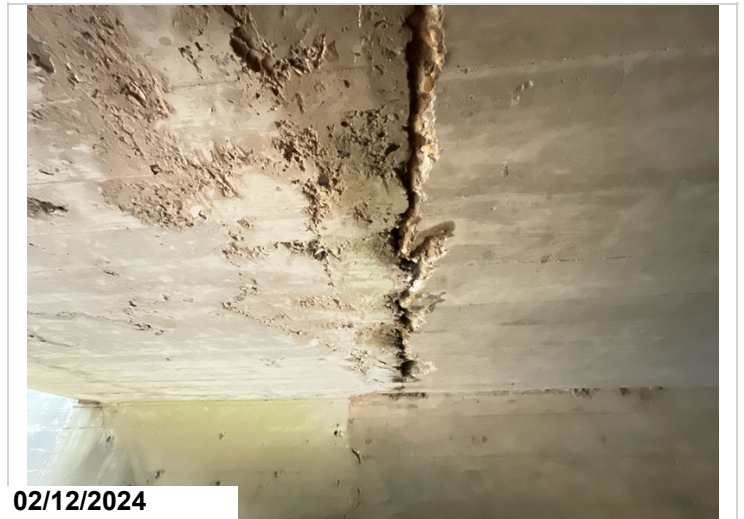
ELEMENTS	DESCRIPTION	UNITS	TOTAL	CS1	CS2	CS3	CS4
241	Reinforced Concrete Culvert	LF	96	42	53	1	0
1080	Delamination/Spall/Patched Area	LF	12	0	11	1	0
1090	Exposed Rebar	LF	2	0	2	0	0
1130	Cracking (RC and Other)	LF	10	0	10	0	0
1190	Abrasion/Wear (PSC/RC)	LF	30	0	30	0	0
(241) Spalling is found throughout both barrels 1 & 2 as well as in various location of inlet and outlet end headwalls. CS2 & CS3 Exposed rebar is found in both barrels 1 & 2. CS2 Minor cracking is found in various locations in both barrels 1 & 2. CS2 Abrasion is found near the bottom of both barrels 1 & 2 as well as in various locations of both headwalls at inlet and outlet ends. Abrasion is also found at the top of barrels 1 & 2 where the add on section has been added. CS2

Barrel 1 add on section, honeycombing and spalling. CS2

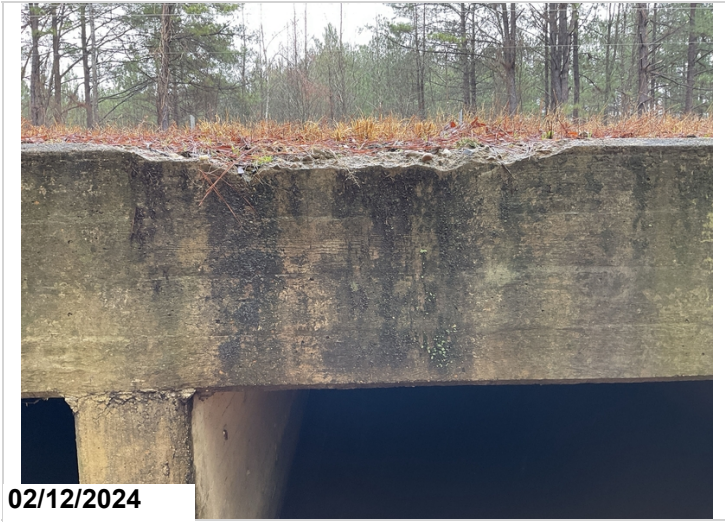
Spalling to headwall on outlet end above barrel 2. CS2
