Bridge M0496 Inspection Report

Asset #M0496(Routine)

US 371- 05 - 22.65 over CREEK

Team Lead: Jared Kegley Inspection Date: 02/12/2024

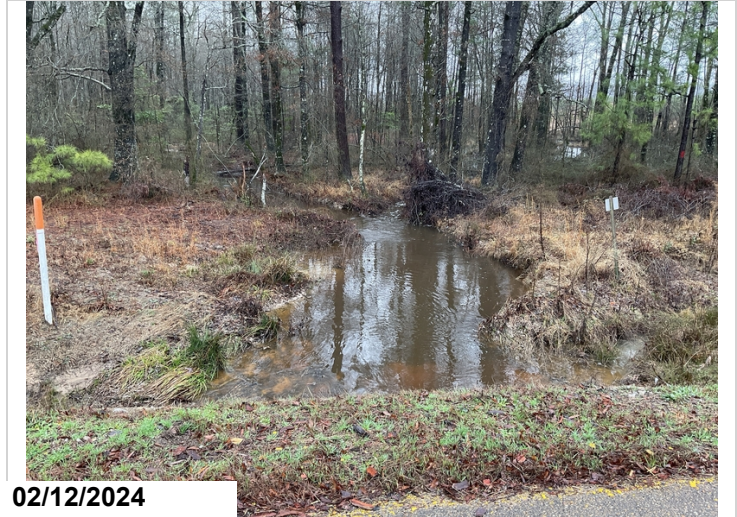
61 - Channel/Channel Protection (7 - Bank protection is in need of minor repairs. River control devices and embankment protection have a little minor damage. Banks and/or channel have minor amounts of drift.)
Channel rating is a 7 this inspection due to minor streambank damage in various locations both upstream and downstream sides of the box culvert.

Channel upstream

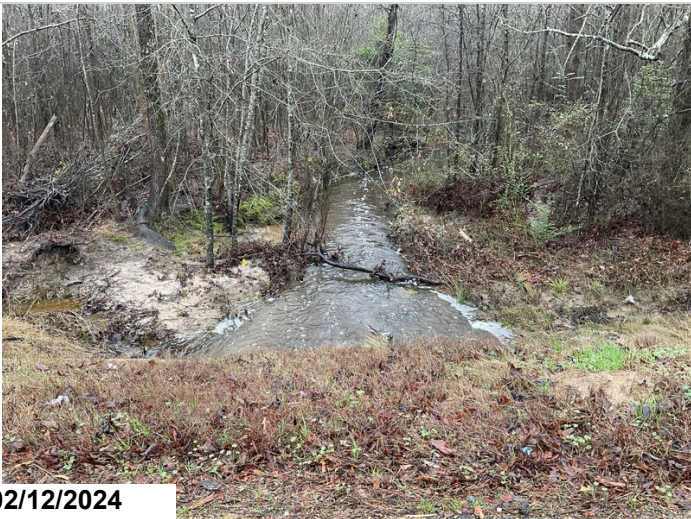
Channel downstream

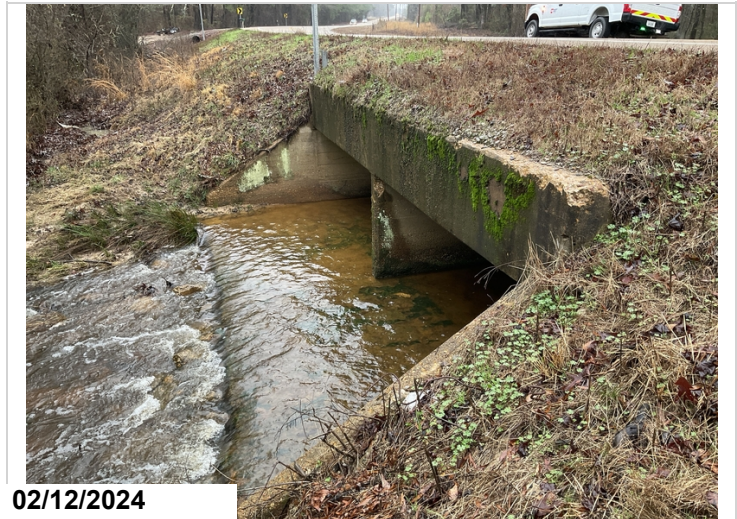
Scour rating is a 7 this inspection due to minor scour at the inlet and outlet ends of box culvert. There have been repairs made to fix scour at the outlet end prior to this inspection.

Culvert outlet end

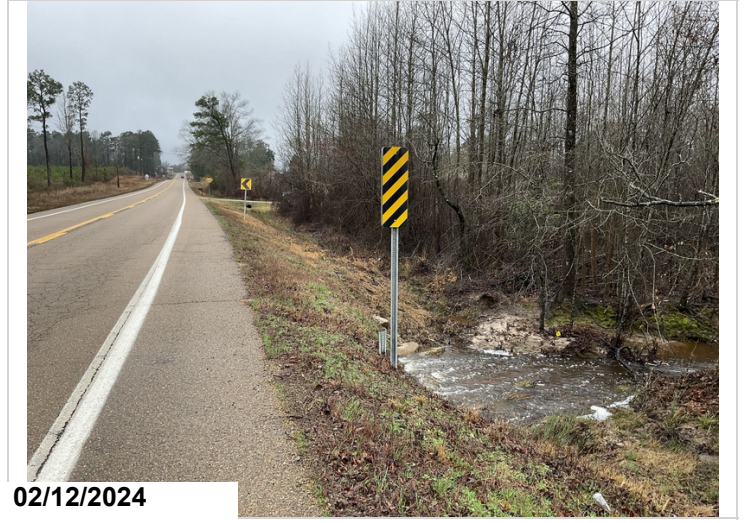
Log mile sign missing on + end.

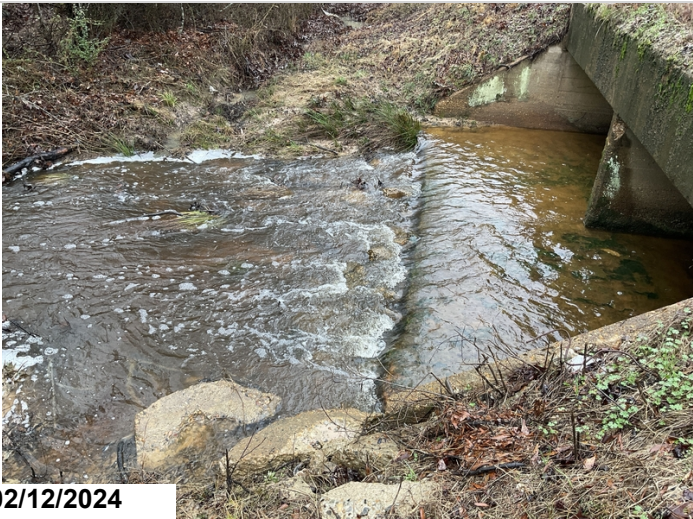
Minor scour repaired in past

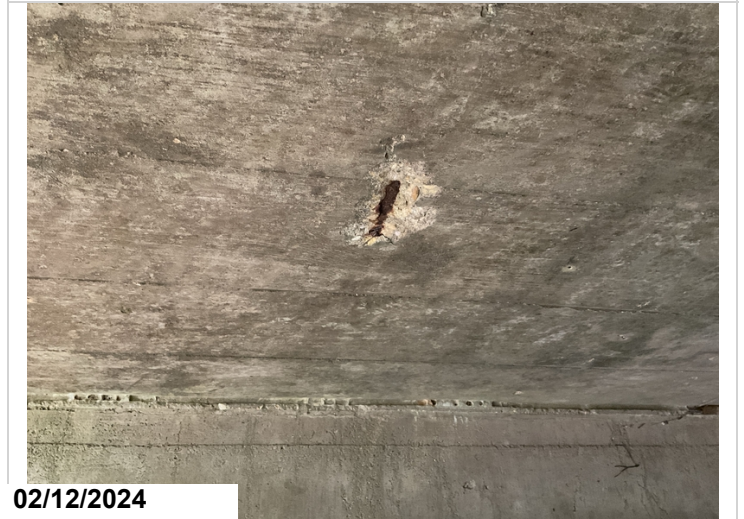
ELEMENTS		DESCRIPTION	UNITS	TOTAL	CS1	CS2	CS3	CS4
241	Reinforced Concrete Culvert	LF	88	76	12	0	0	
1080	Delamination/Spall/Patched Area	LF	3	0	3	0	0	
1090	Exposed Rebar	LF	1	0	1	0	0	
1130	Cracking (RC and Other)	LF	8	0	8	0	0	
(241) Spalling is found to various locations to both barrels 1 & 2 as well as the inlet end headwalls. CS2 Exposed rebar to the ceiling of barrel 2 near the outlet end. CS2 Minor CS2 cracking throughout barrels 1 & 2.

Barrel 2 near outlet end. CS2

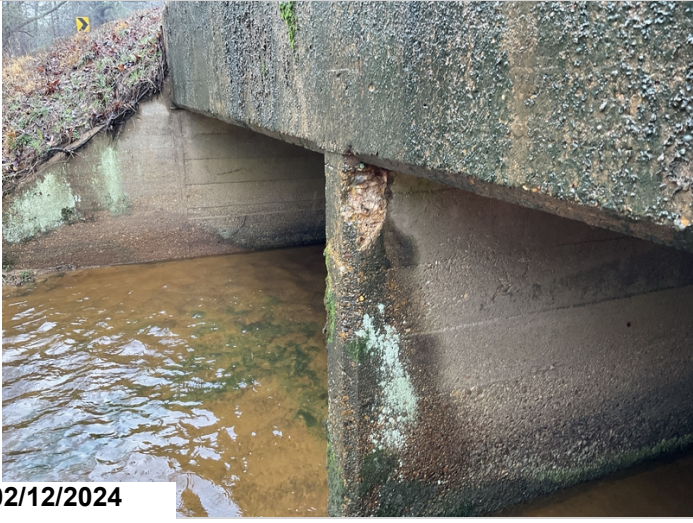
Spall at top of divider wall on outlet end. CS2

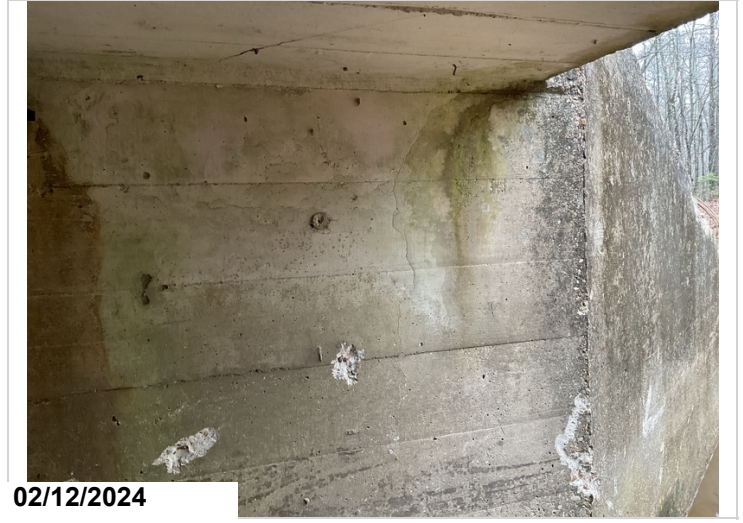
Cracking in barrel 1. CS2

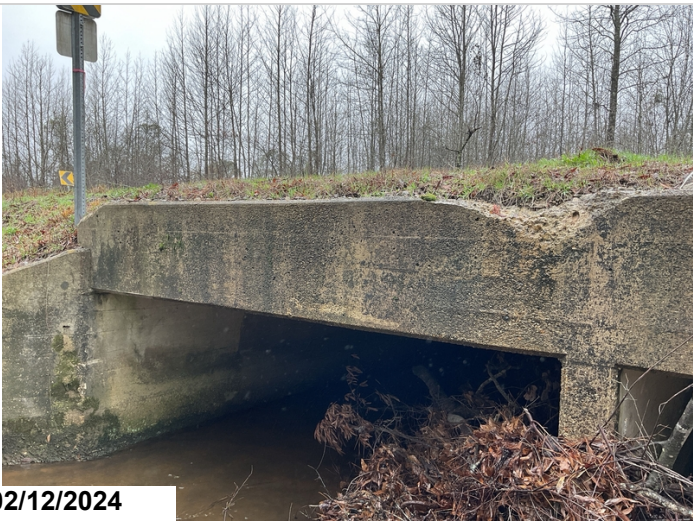
Large spalls on inlet end headwall. CS2

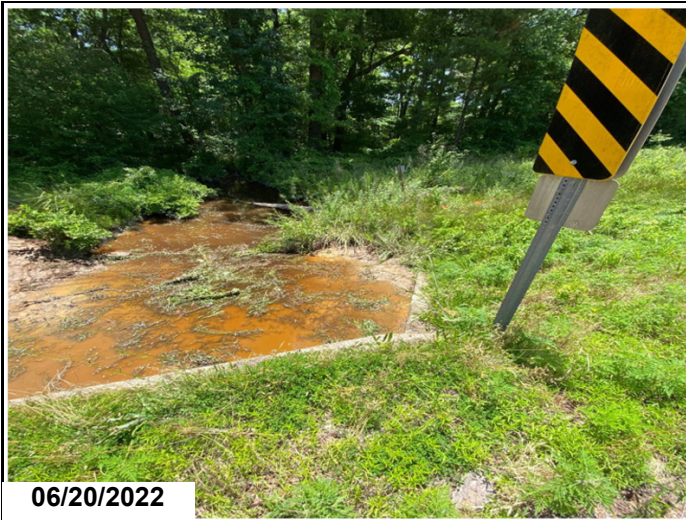
6/20/2022... Repaired

6/20/2022... Cleaned out per AMS Carl Jensen

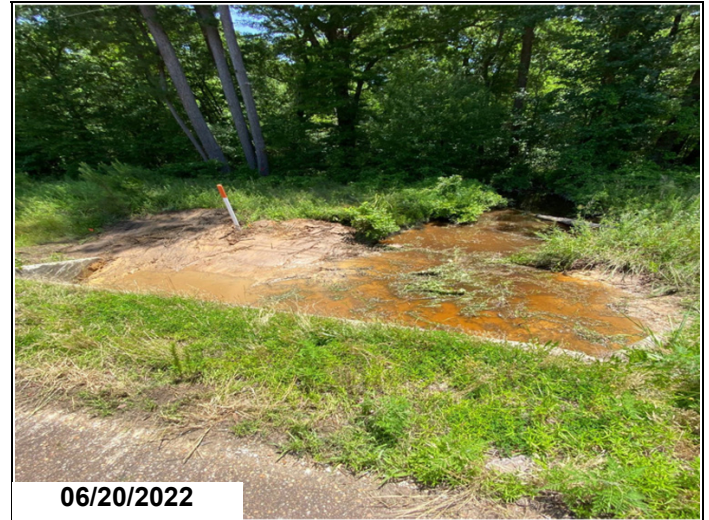
6/20/2022... Repaired

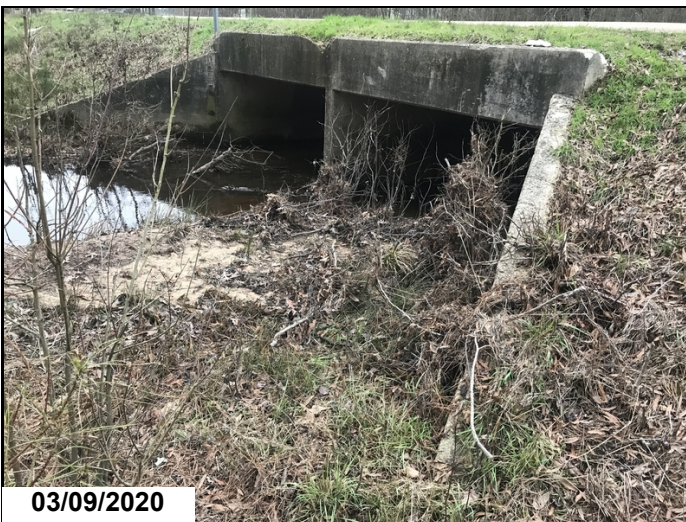
DEBRIS AND SEDIMENT AT INLET OF BOX 1

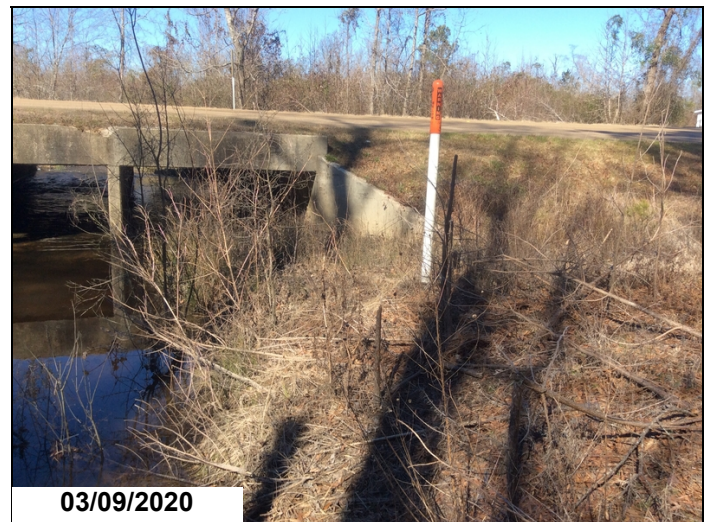
DEBRIS AND SEDIMENT AT INLET AND OUTLET
ENDS OF BOX 1

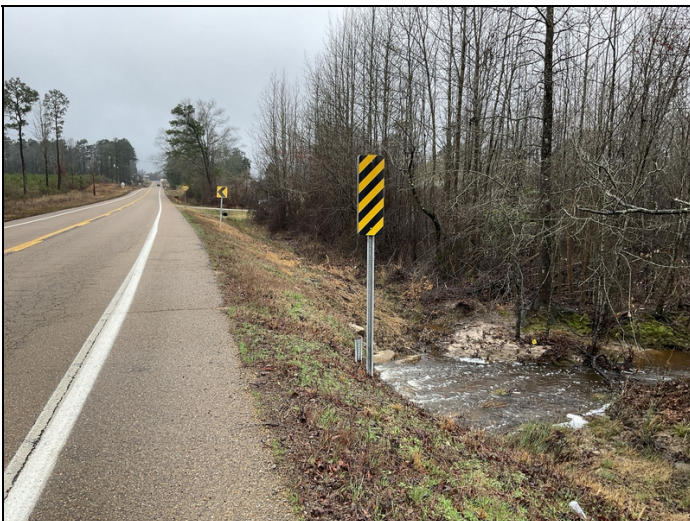
Log mile sign missing on + end.
