Bridge M0497 Inspection Report

Asset #M0497(Routine)

US 371 - 05 -18.70 over CREEK

Team Lead: John King Inspection Date: 05/01/2024

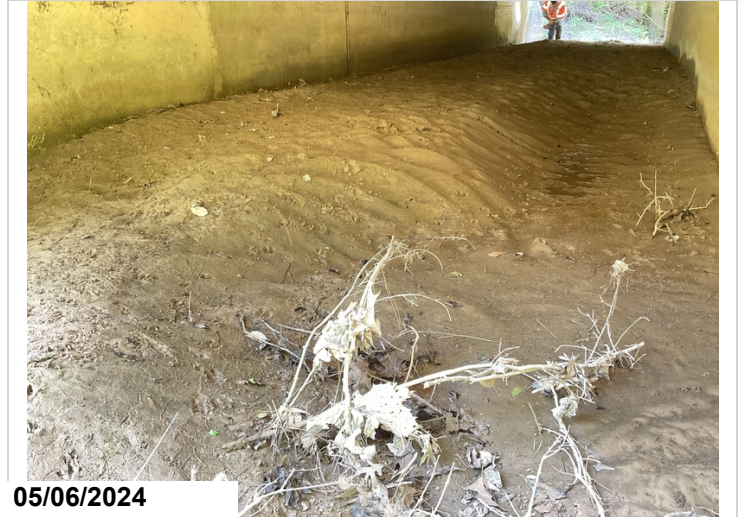
61 - Channel/Channel Protection (6 - Bank is beginning to slump. River control devices and embankment protection have widespread minor damage. There is minor stream bed movement evident. Debris is restricting the channel slightly.) Channel rating is a 6 this inspection due to various locations of widespread streambank damage located to both the up and downstream sides of the box. There is also sediment buildup that is present throughout the entire length of barrel 1 that is slightly restricting the channel flow this inspection.

Sediment buildup throughout the entire length of barrel 1 that slightly restricts the channel flow

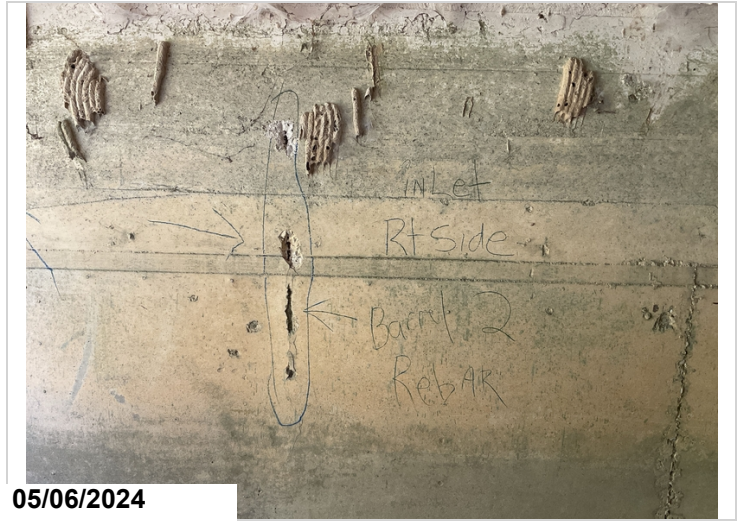
62 - Culverts (6 - Deterioration or initial disintegration, minor chloride contamination, cracking with some leaching, or spalls on concrete or masonry walls and slabs. Local minor scouring at curtain walls, wingwalls or pipes. Metal culverts have a smooth curvature, non-symmetrical shape, significant corrosion or moderate pitting.) Culvert rating is a 6 this inspection due to various locations of cracking, efflorescence, exposed rebar, and spalling throughout barrels 1 & 2. The efflorescence throughout both barrels is showing signs of rust staining in various locations and the exposed rebar that is found has no section loss at this time.

Barrel 2, Divider wall. Exposed rebar with no section loss, CS2.

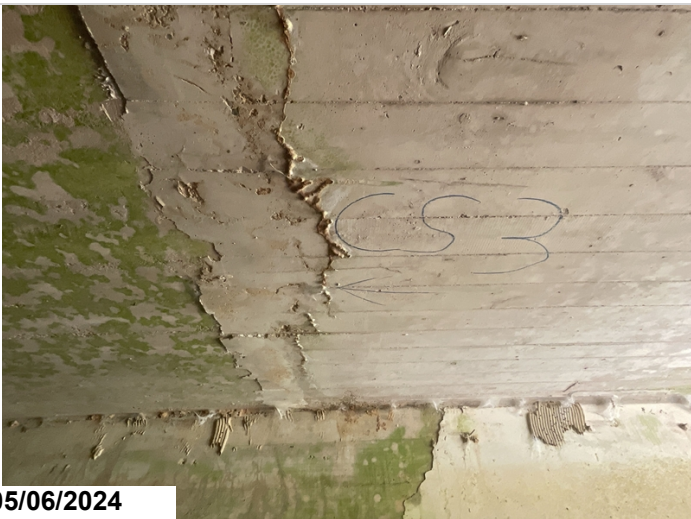
Barrel 2, Efflorescence with rust staining, CS3.

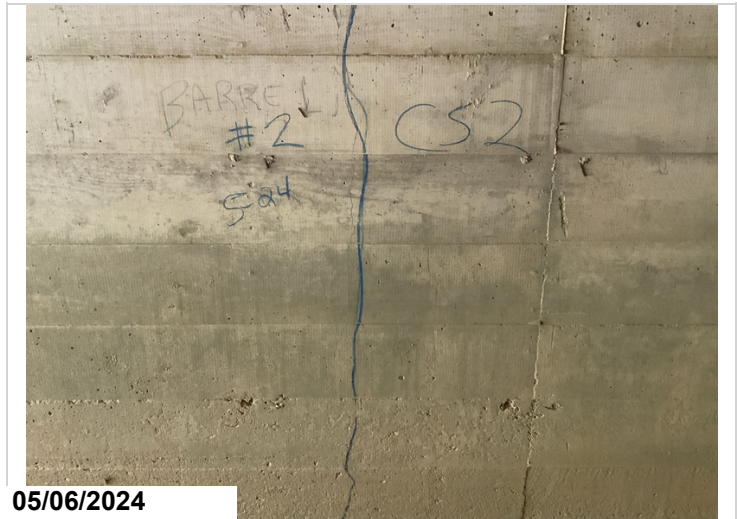
Barrel 2, Cracking, CS2.

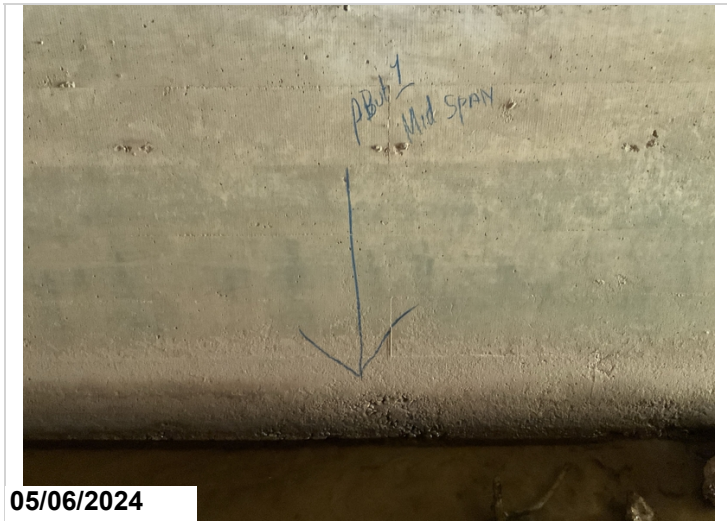
Barrel 2, Abrasion on abutment wall near mid span, CS2.

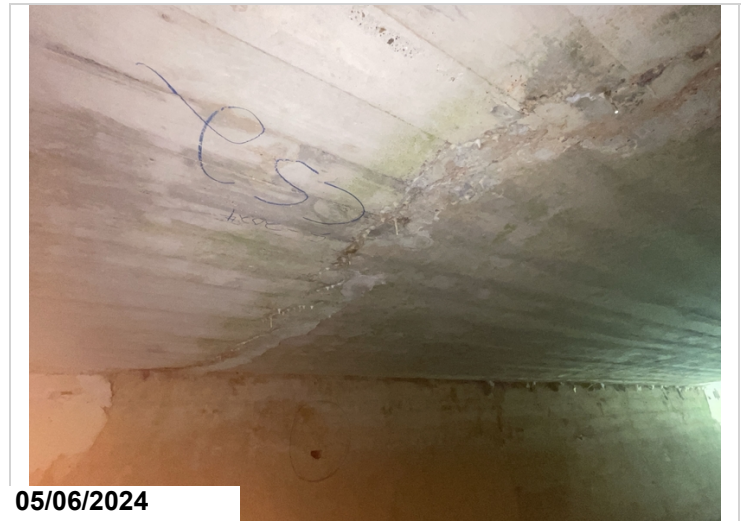
Barrel 2, Efflorescence, CS2.

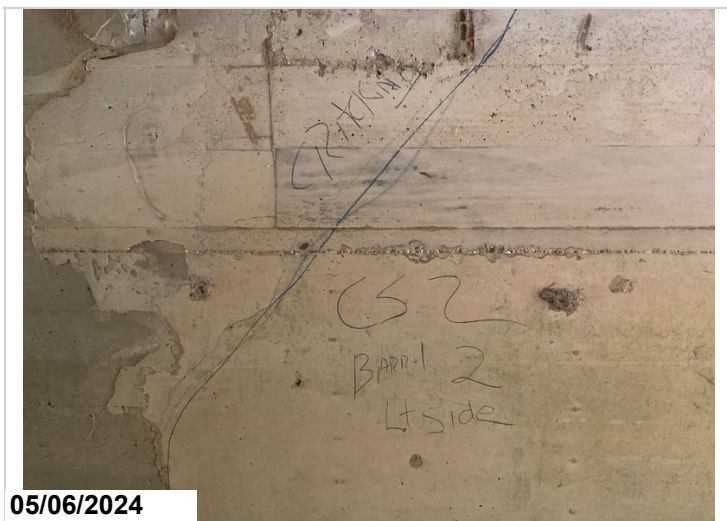
Barrel 2, Cracking, CS2.

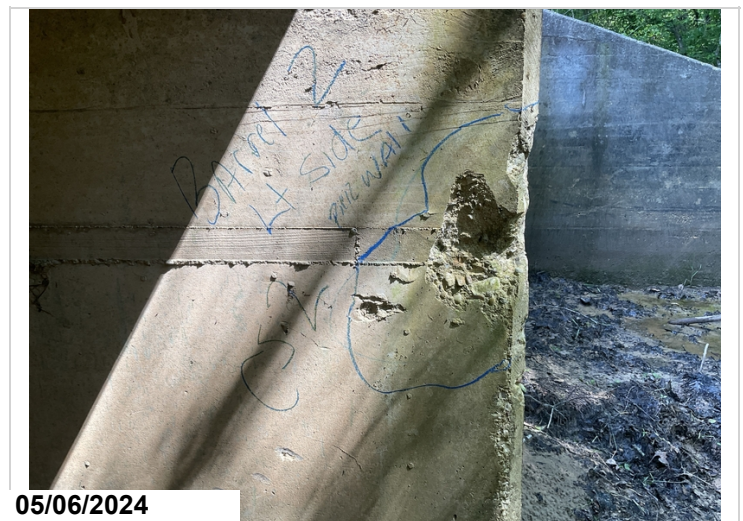
Divider wall, Outlet end, Spalling between barrels 1 & 2. CS2

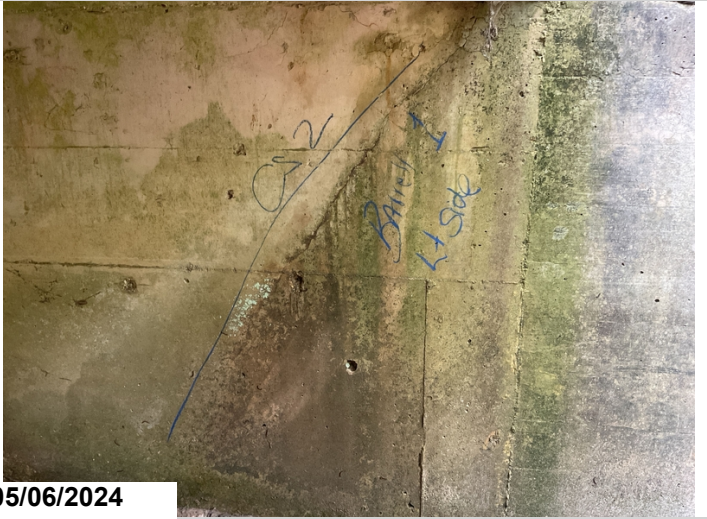
Barrel 1, Outlet end, Cracking, CS2.

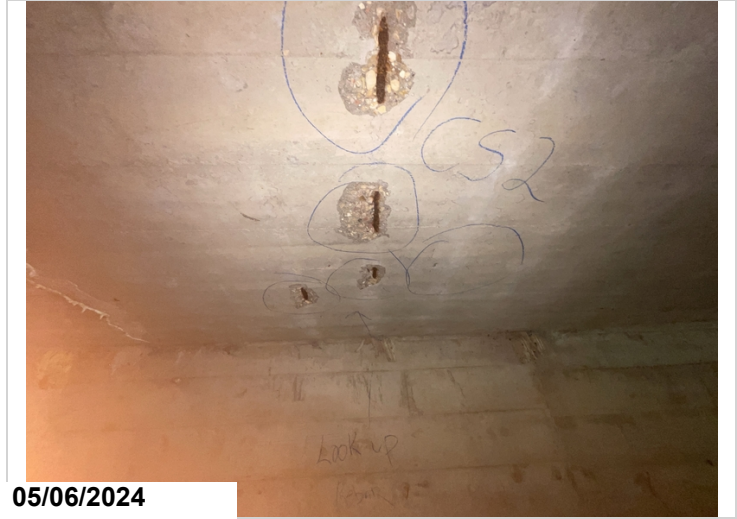
Barrel 1, Exposed rebar with no section loss and delamination, CS2.

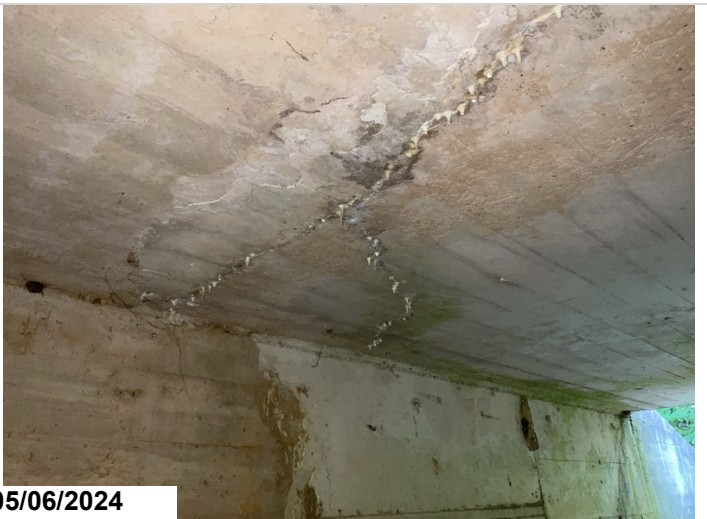
Barrel 1, Efflorescence, CS2.

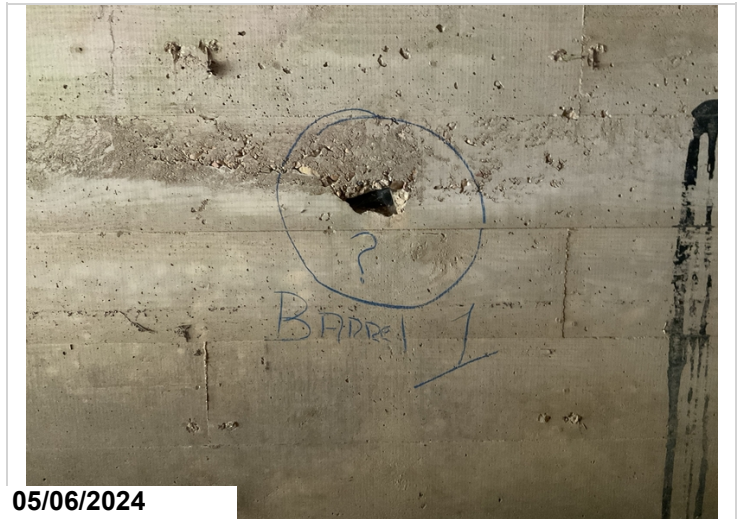
Barrel 1, Lt side spall, CS2.

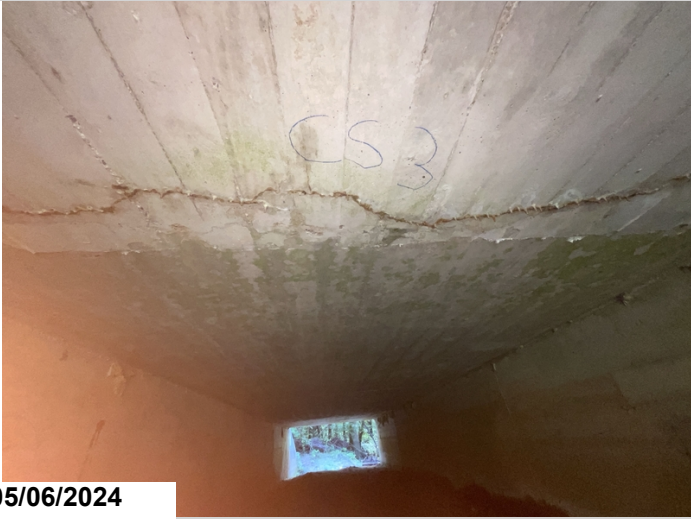
Barrel 1, Efflorescence with rust staining, CS3.

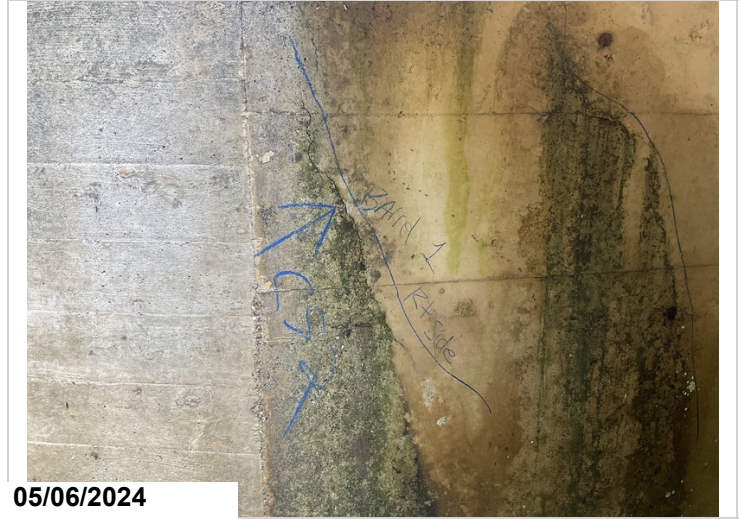
Barrel 1, Rt side, Inlet end, Cracking, CS2.

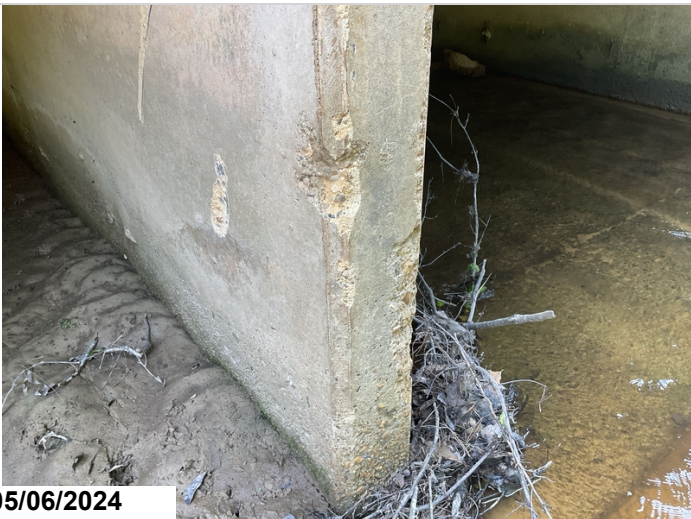
Divider wall, Inlet end, Spalling between barrels 1 & 2. CS2
