Bridge 06653 Inspection Report

Asset #06653(Routine)

SH 27 - 05 - 7.32 over E FORK PRAIRIE CREEK

Team Lead: Jared Kegley Inspection Date: 07/23/2024

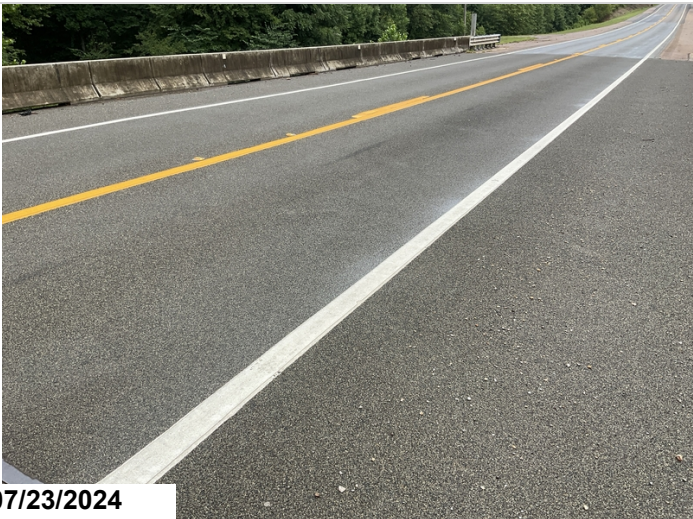
Deck, new polymer overlay

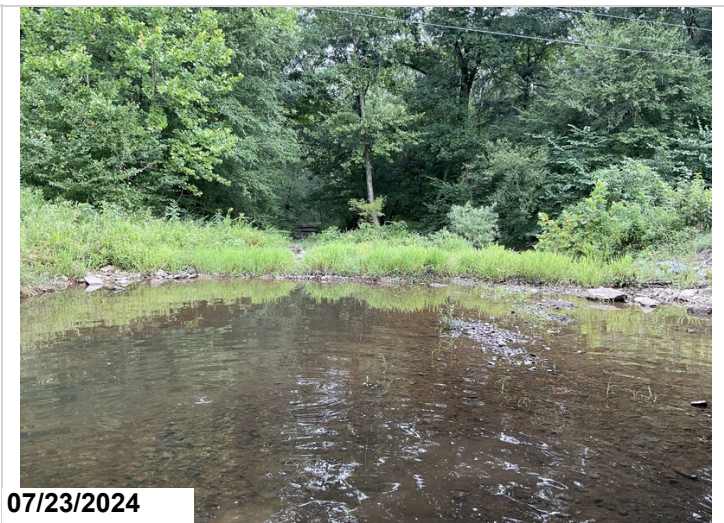
Channel was dropped to a 7 this inspection due to some sediment and debris buildup on downstream side, streambanks are well vegetated.

Downstream channel

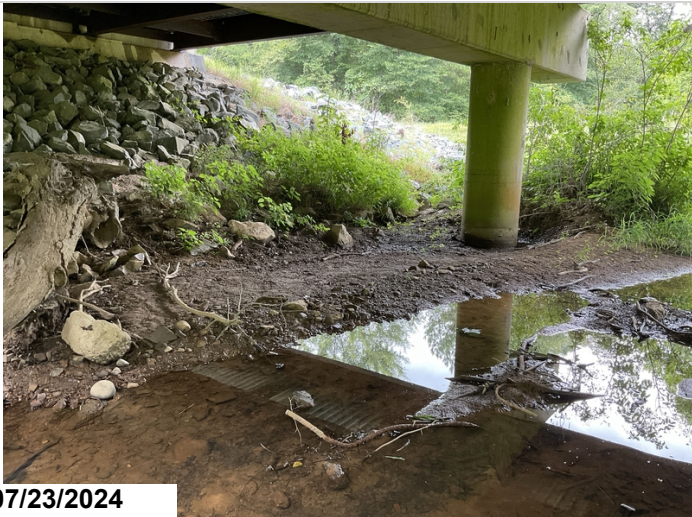
Scour is rated an 8 due to insignificant scour.

Insignificant scour

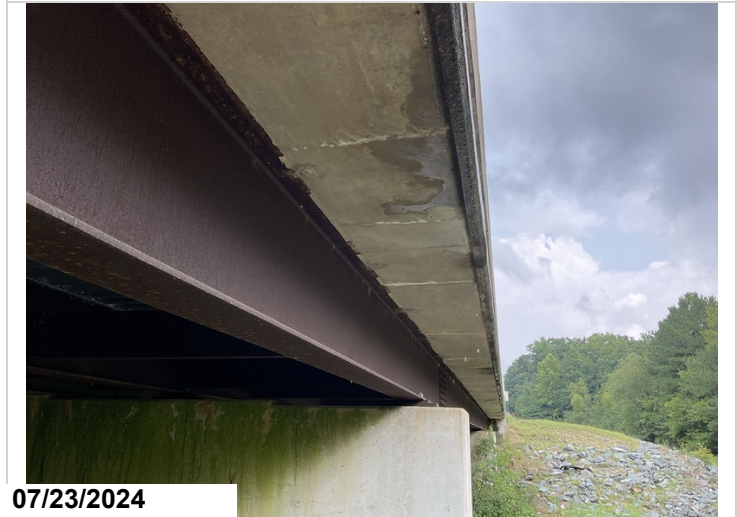
Deck is rated a 7 this inspection due to cracking with efflorescence in both concrete deck overhangs. Cracking in top side of deck has been sealed by new polymer overlay.

(12) Various locations, Concrete deck overhangs, cracking with efflorescence, 100' total, CS2. New polymer overlay has sealed all cracks. (1120-12) 07/22 efflorescence 50ft undersides of deck left and right side overhang. (510-12) Polymer overlay has been added to top of bridge deck.							
107	Steel Open Girder/Beam	LF	630	630	0	0	0
515	Steel Protective Coating	SF	41344	41344	0	0	0

Various locations, Concrete deck overhangs, cracking with efflorescence, CS2.

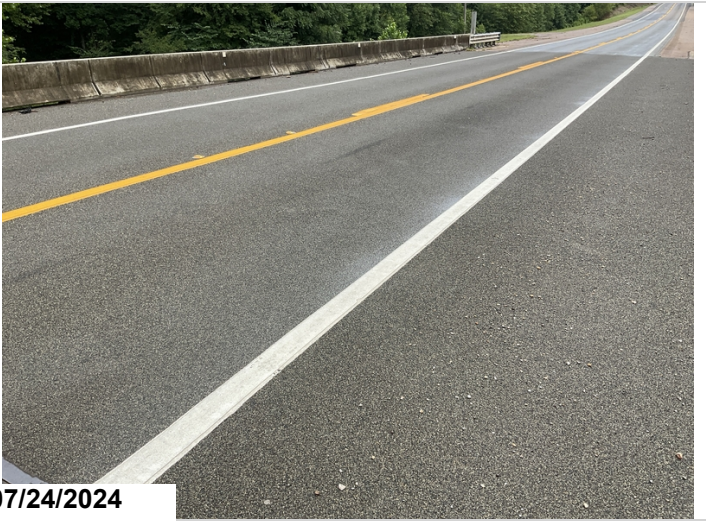
Deck, new polymer overlay

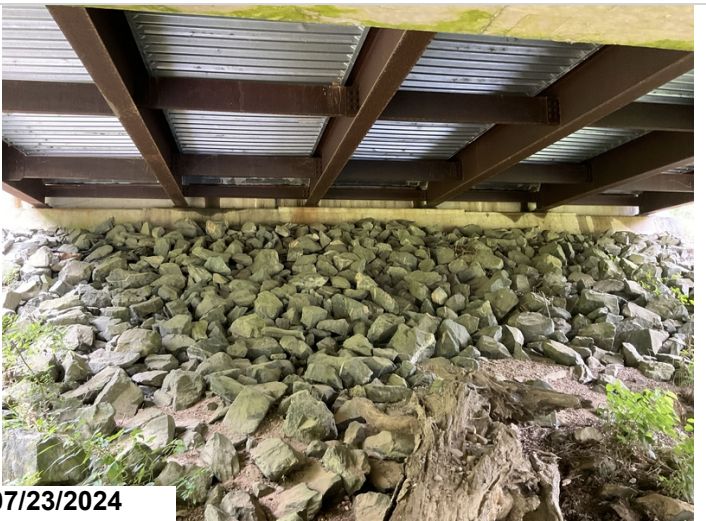
Dropped substructure a 7 due to cracking with efflorescence in both abutments.

(215) Bent 1 abutment, cracking with efflorescence, 4', CS2. Bent 4 abutment, cracking with efflorescence, 3', CS2.							
234	Reinforced Concrete Pier Cap	LF	82	82	0	0	0
301	Pourable Joint Seal	LF	80	80	0	0	0
313	Fixed Bearing	EA	24	24	0	0	0

Bent 4 abutment, cracking with efflorescence, 3', CS2.

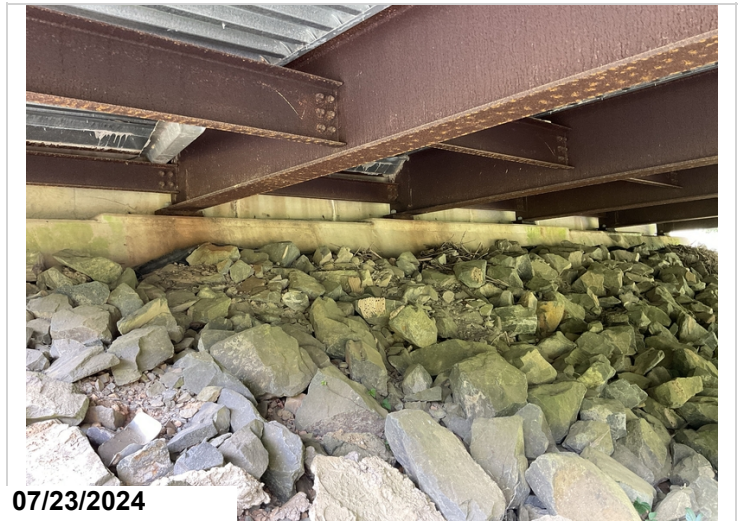
Bent 1 abutment, cracking with efflorescence, 4', CS2.
