Asset #02450(Routine, Underwater type 2)

SH 29 - 01- 7.98 over DOOLEY CREEK

Location: 2.0 MI N OF BRADLEY

Team Lead: Jared Kegley Inspection Date: 09/09/2024

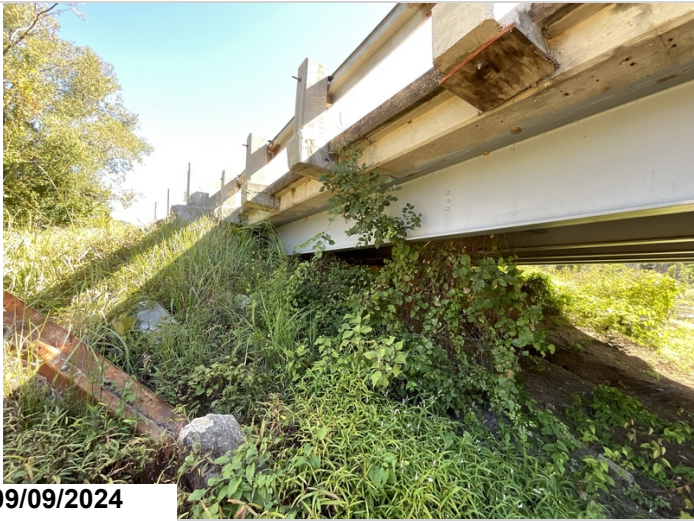
Vegetation growth on the left side at the end of the bridge.

**A-64 - Vegetation Removal Requested** (Y)

Vegetation growing along both sides of bridge.

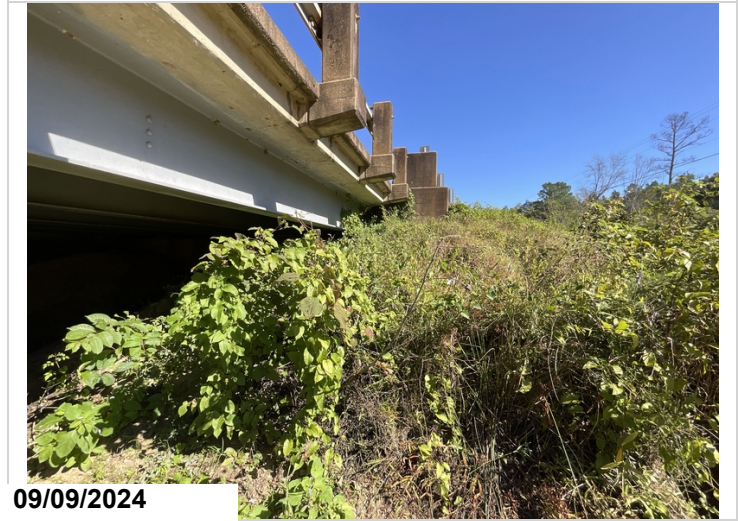
Vegetation growth on the right side at the end of the bridge.

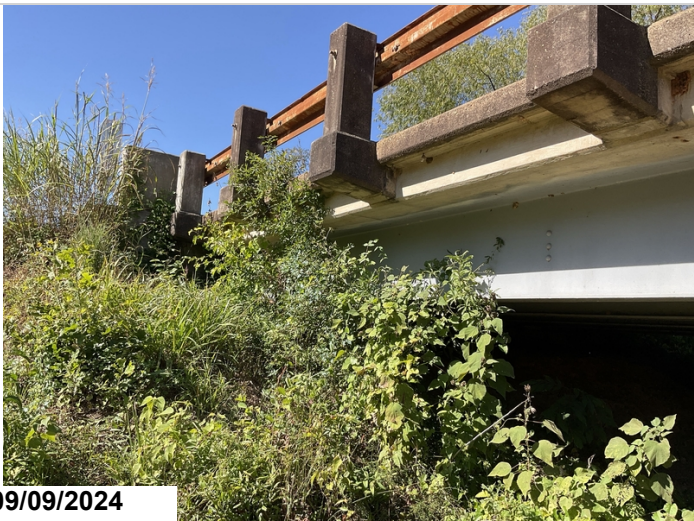
Vegetation on the right side at the beginning of the bridge.

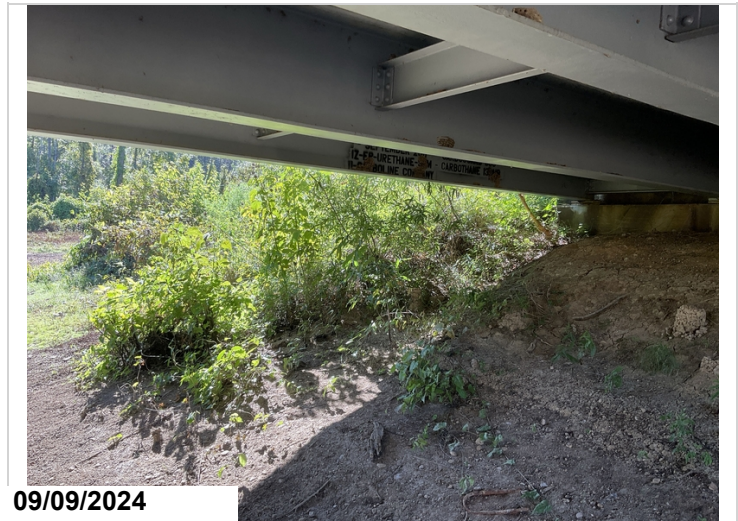
Vegetation on the right side at the beginning of the bridge.

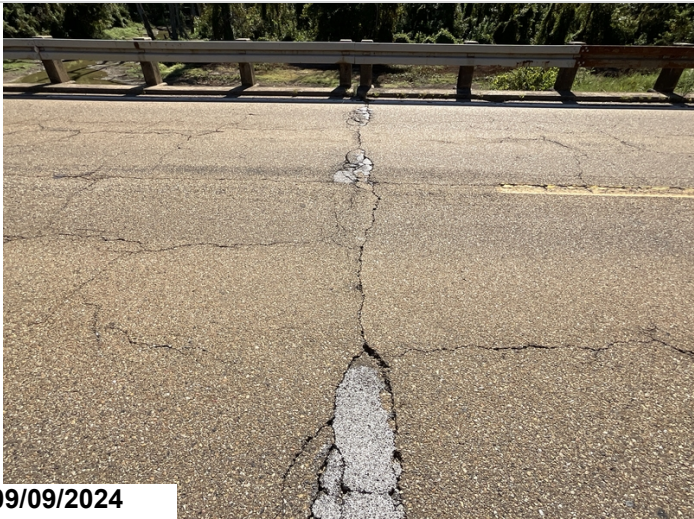
Joints are covered by an asphalt overlay.

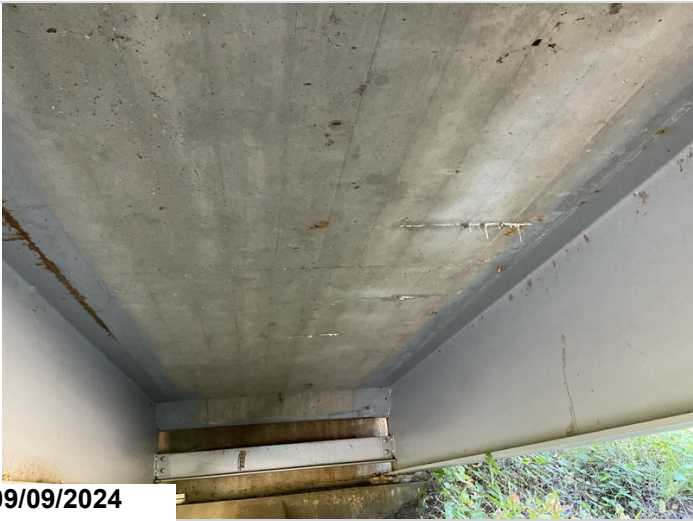
Deck is rated a 6 this inspection due to cracking with efflorescence on bottom side of deck in various locations. Note: Top side of deck has an asphalt overlay.

Span 1, between beams 1 & 2, 2' of cracking with efflorescence, CS2.

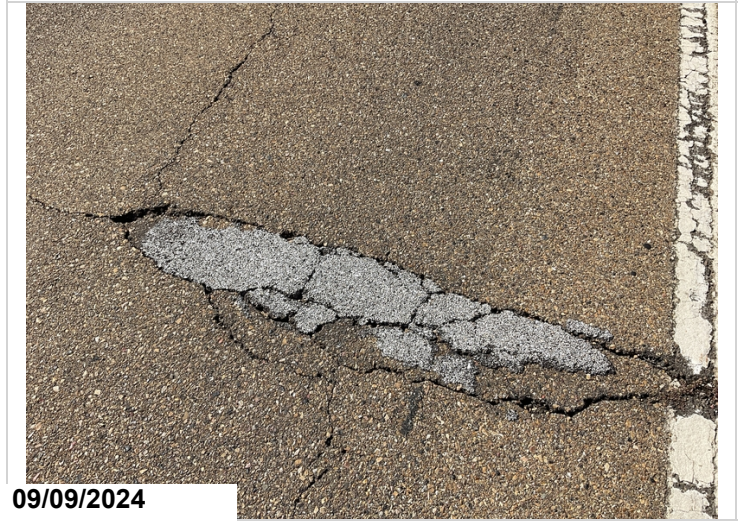
8' total of spalling in the wearing surface in various locations, CS2.

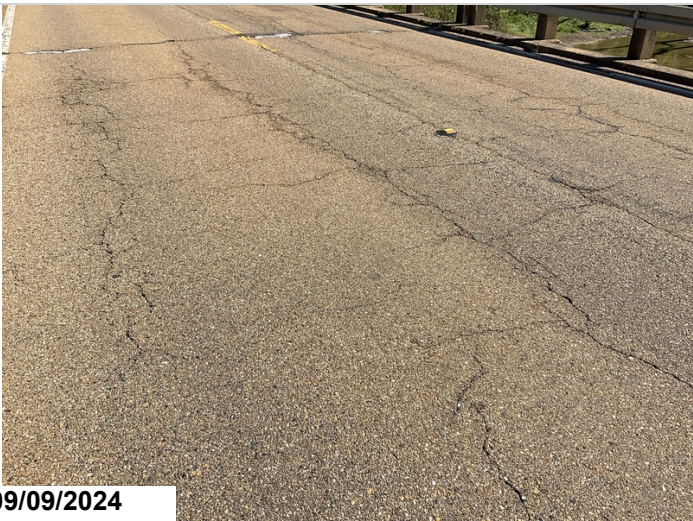
Cracking in all spans of the wearing surface, CS2.

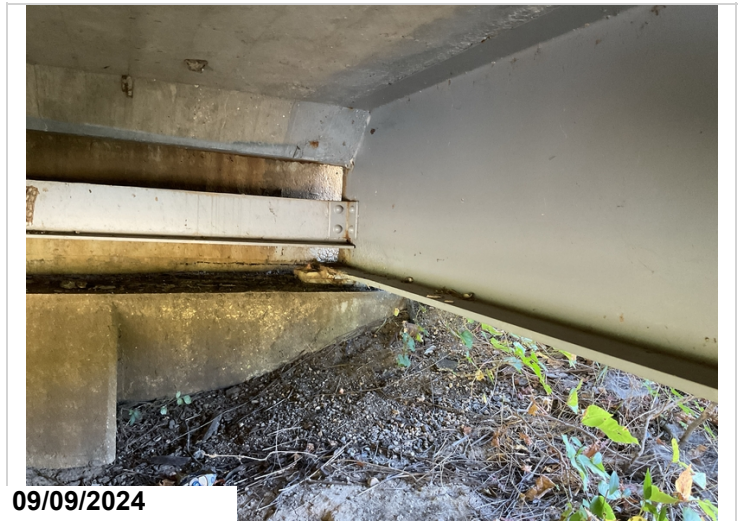
The superstructure is rated a 6 this inspection due to minor and moderate corrosion with minor section loss in various locations of the beam ends.

Bent 1, beam 1, left side, 1' of section loss, CS3.

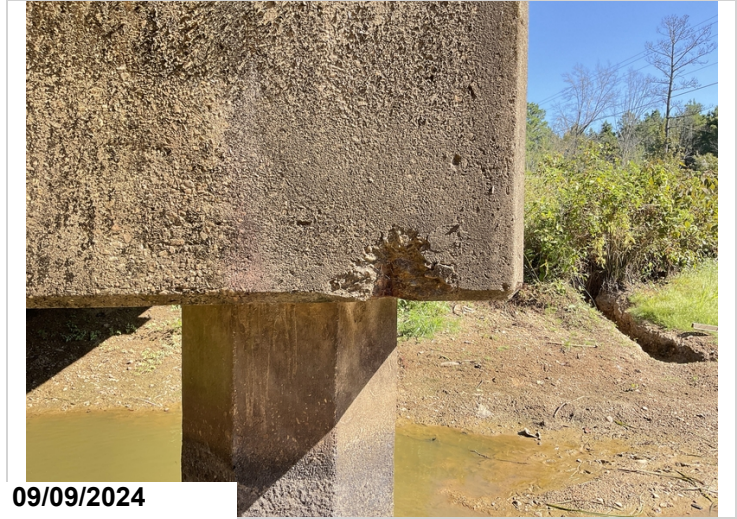
The substructure is rated a 7 this inspection due to there being a minor delam and exposed rebar on concrete pier cap.

Bent 3, span 2 side, right side, 1' of exposed rebar, CS2.

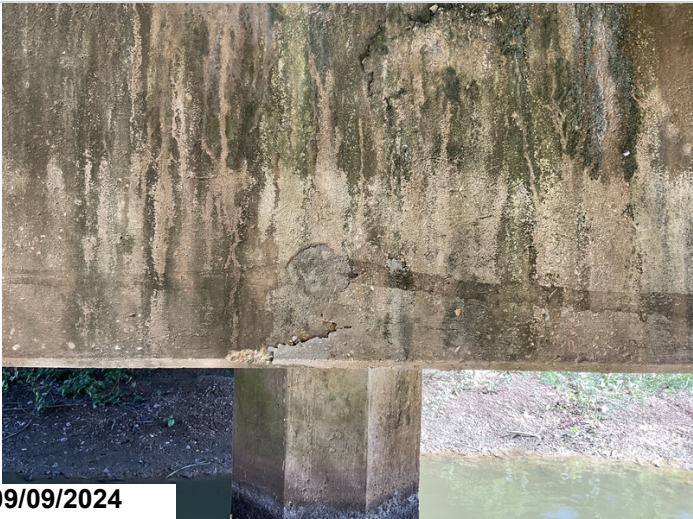
Bent 3, span 2 side, 1' of Delam, CS2.

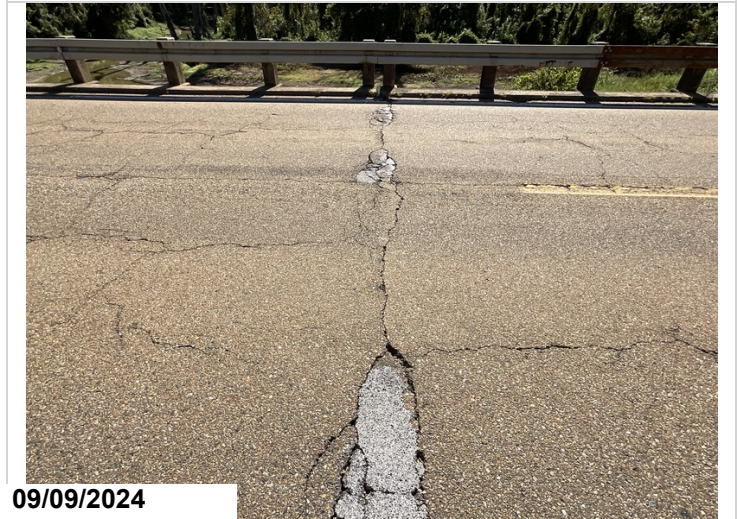
Joints are covered by an asphalt overlay, CS4.

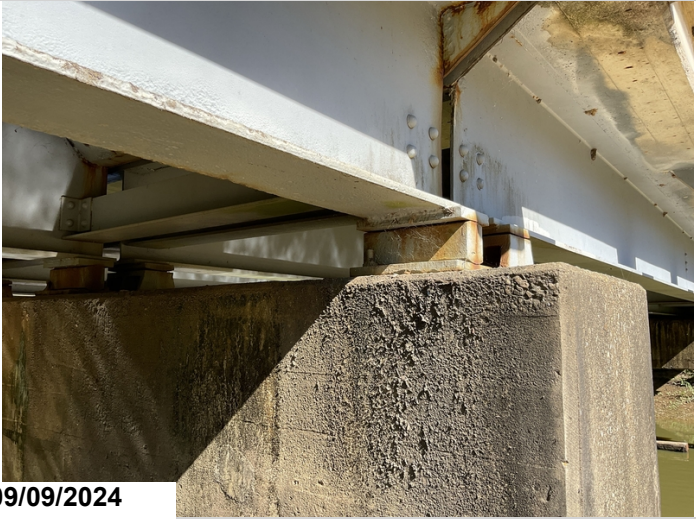
All movable bearings have minor to moderate corrosion, CS3.

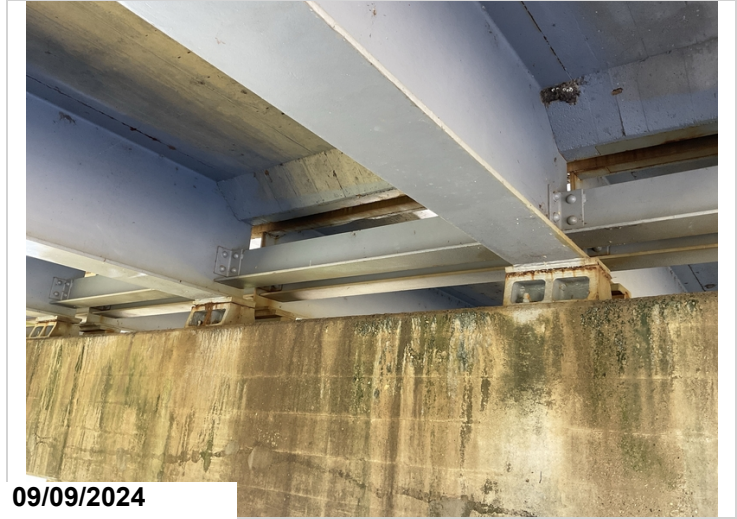
All fixed bearings have minor to moderate corrosion, CS3.

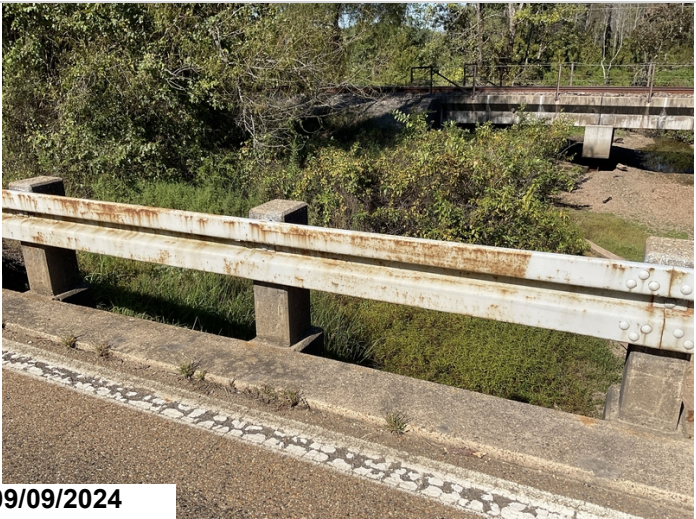
The left and right side of the metal bridge railing has corrosion, CS2.

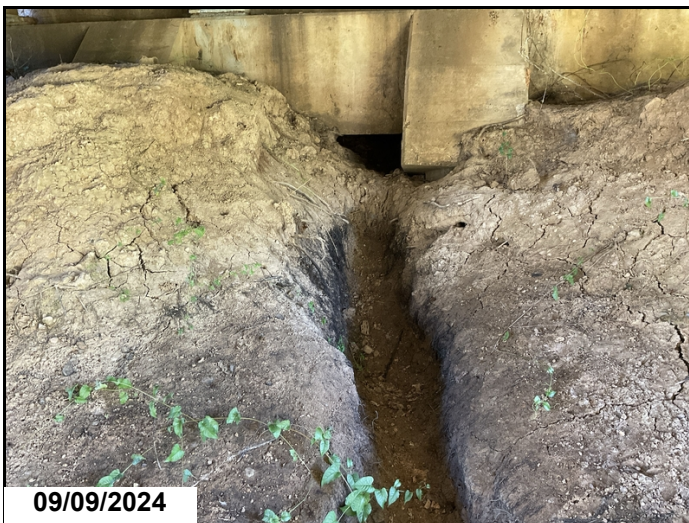
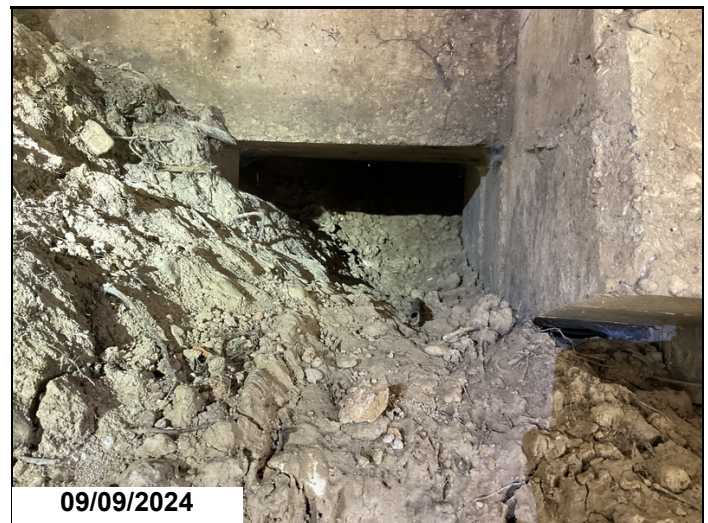
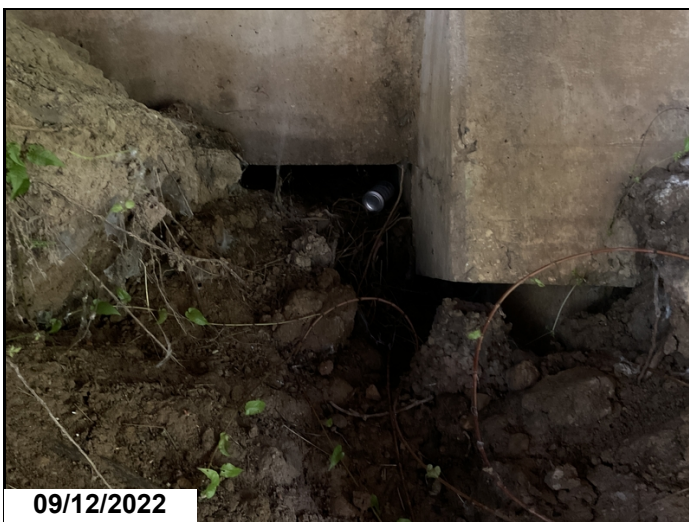
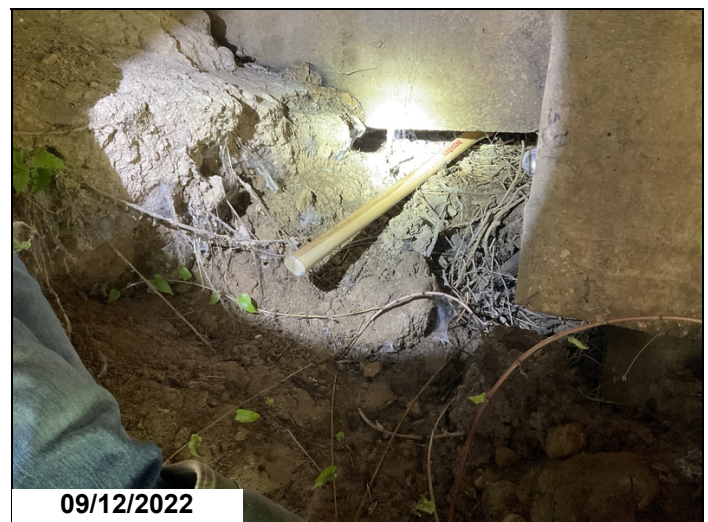
The scour is rated a 6 this inspection due to isolated moderate scour under bent 4 abutment.

Moderate erosion under abutment 4 exposing various concrete pile.

9/12/2024 - Reopened MN and moved to a "B" priority due to worsening condition, see photos.

Scour hole leading under abutment 4 9/24

Type of Work: Repair (General)

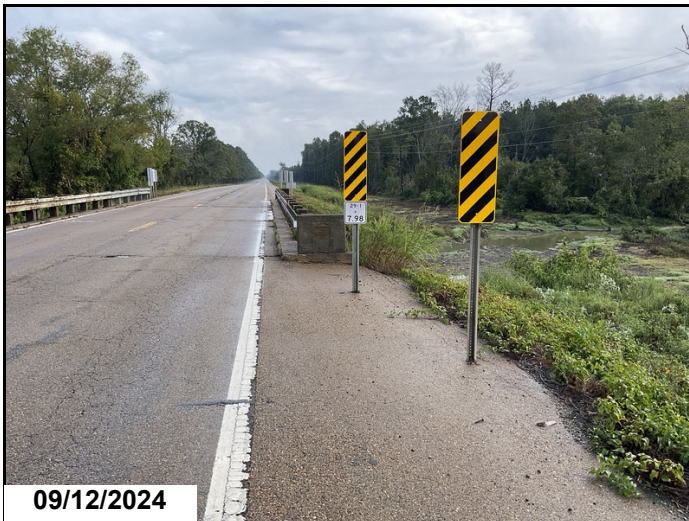
Log mile sign and flare board needs replaced Rt side beginning of bridge. 29-1 7.98

Repaired

9/12/2024 - The log mile sign and flare board has been replaced per 9/24 inspection.

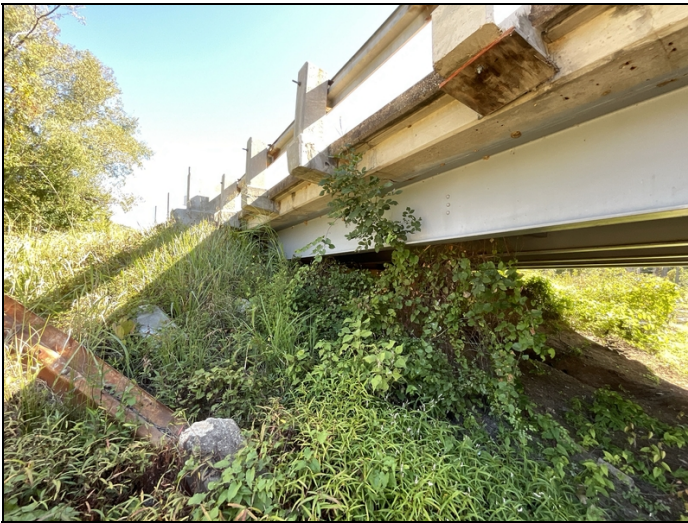
Vegetation growth on the left side at the end of the bridge.

**A-64 - Vegetation Removal Requested (Yes)**

Vegetation growing along both sides of bridge.

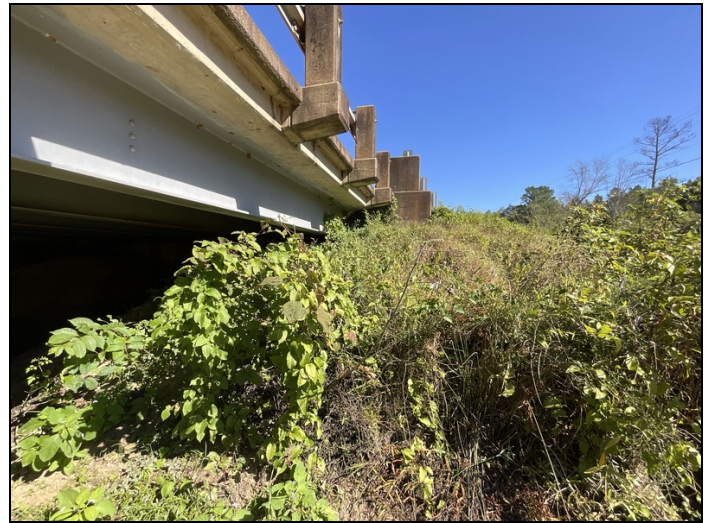
Vegetation growth on the right side at the end of the bridge.

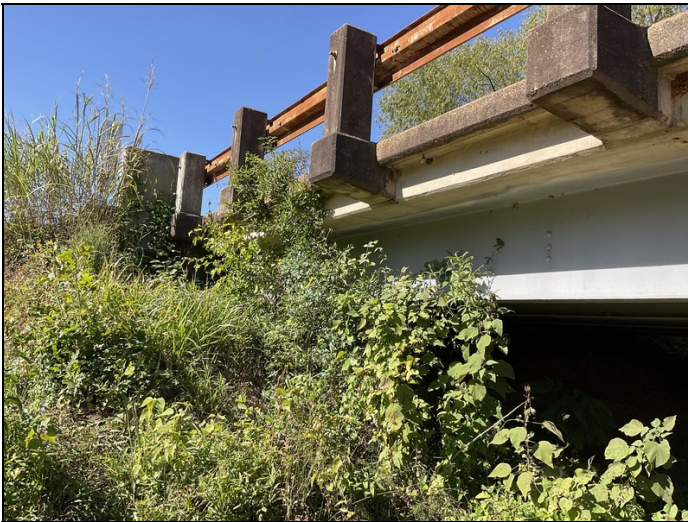
Vegetation on the right side at the beginning of the bridge.

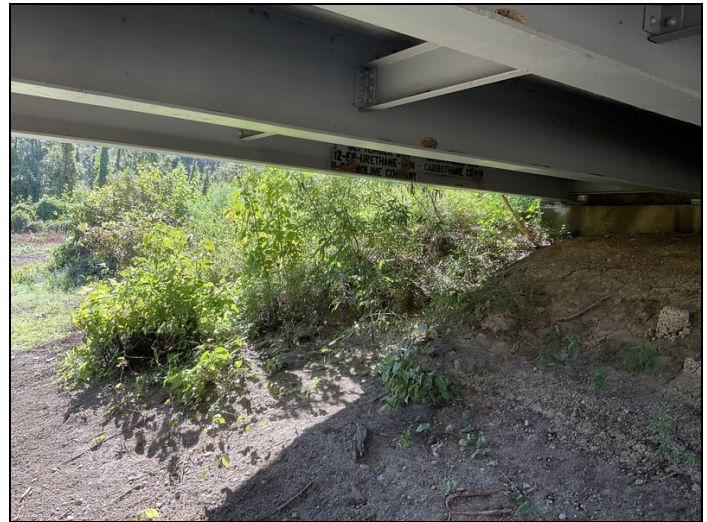
Vegetation on the right side at the beginning of the bridge.
