Asset #03749(Routine)

SH 160 SEC.02-9.00 over BODCAW CREEK

Location: 1.0 MI W JCT SH 160 & 53

Team Lead: John King Inspection Date: 05/15/2023

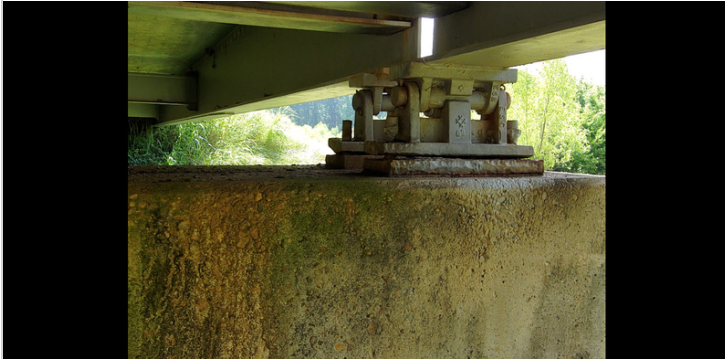
2023 drone photo bent 10

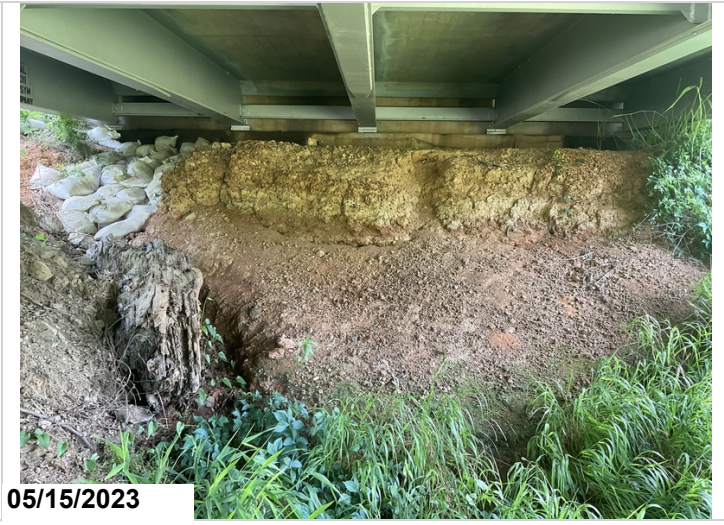
Erosions at bent 1&11.

Erosion bent 11

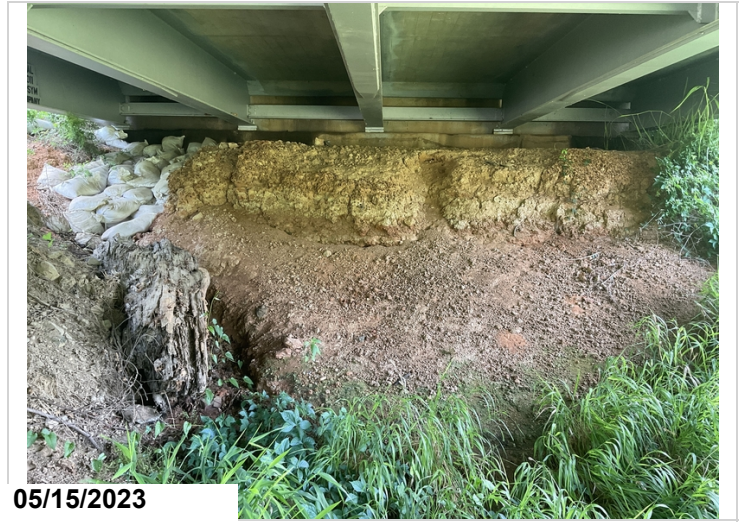
Erosion bent 11

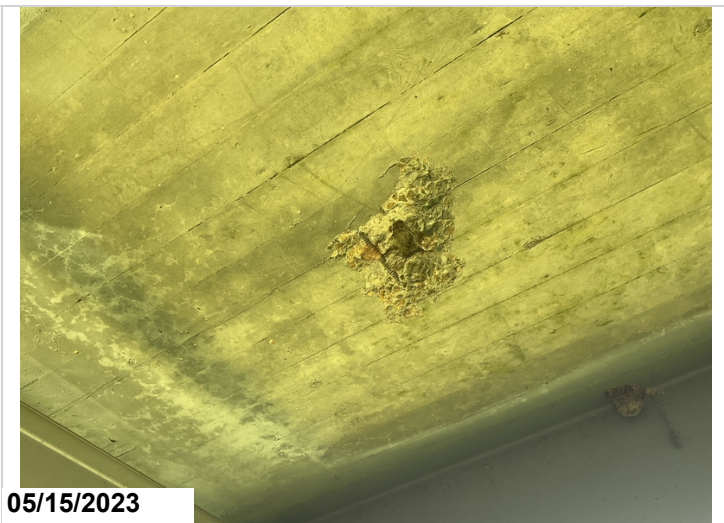
Rebar exposed span 10 bay 4

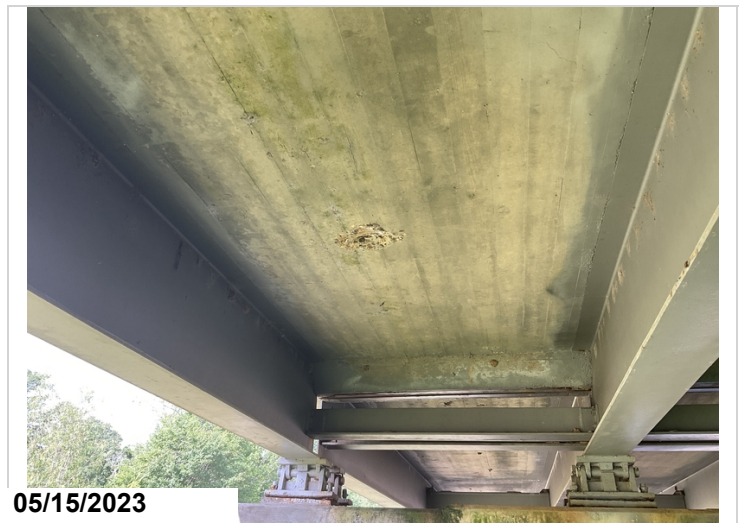
Rebar exposed span 10 bay 4

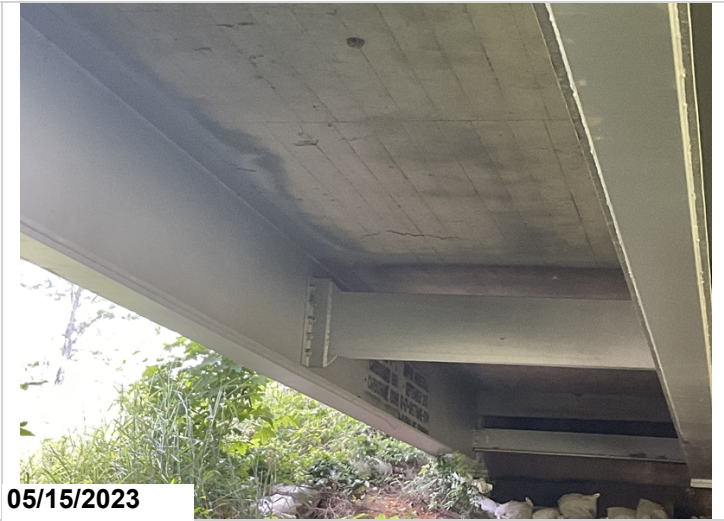
Delam span 10 bay 1

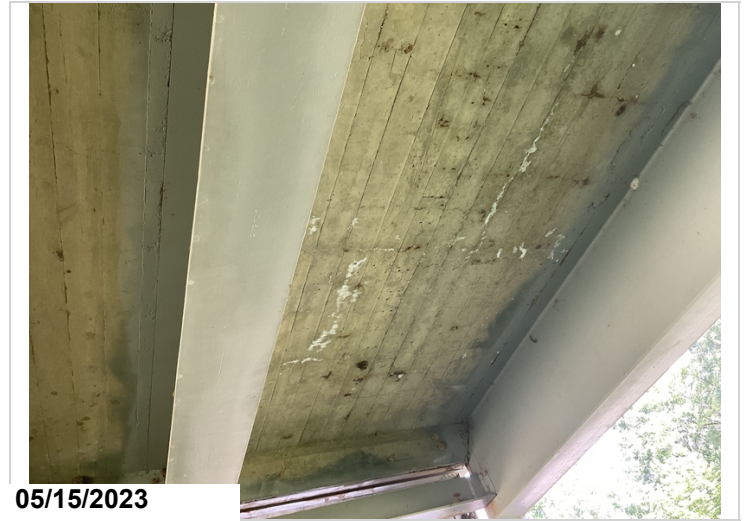
Efflorescence span 10 bay 1

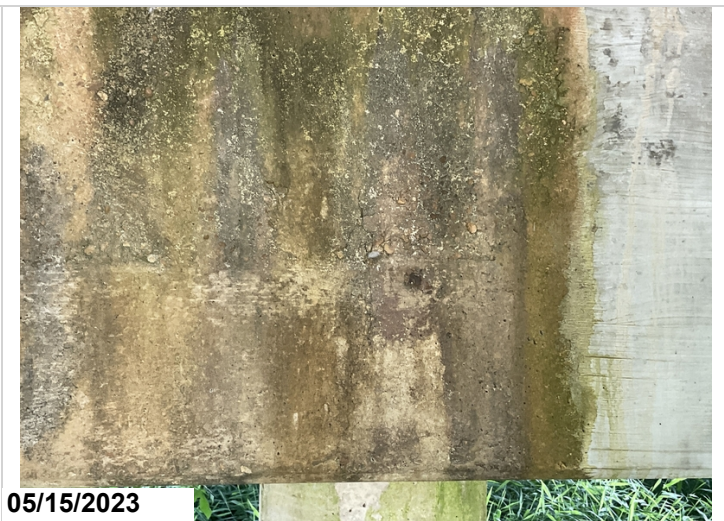
Map like cracking bent 10 span 9 side

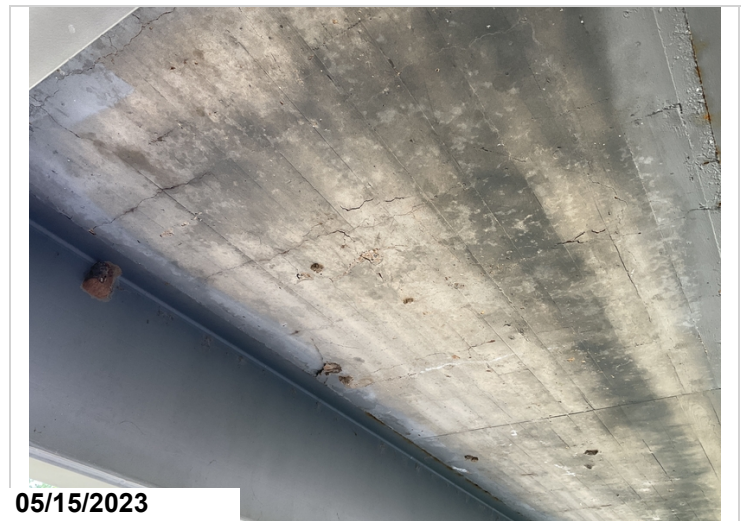
Delam span 9 bay 4

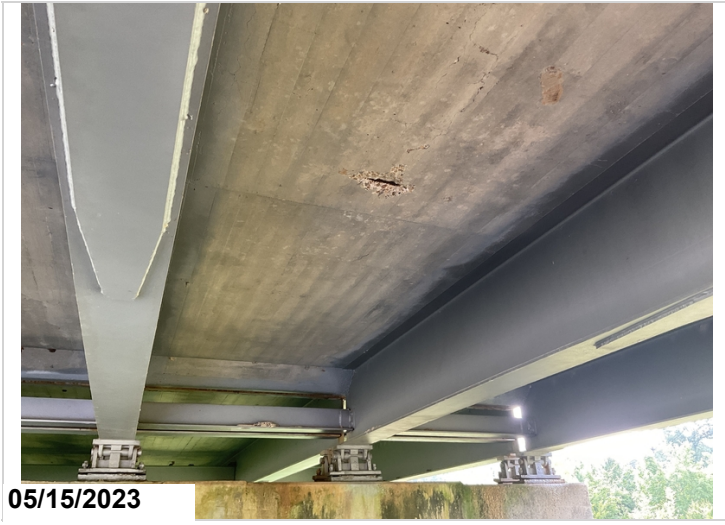
Rebar exposed span 9 bay 3

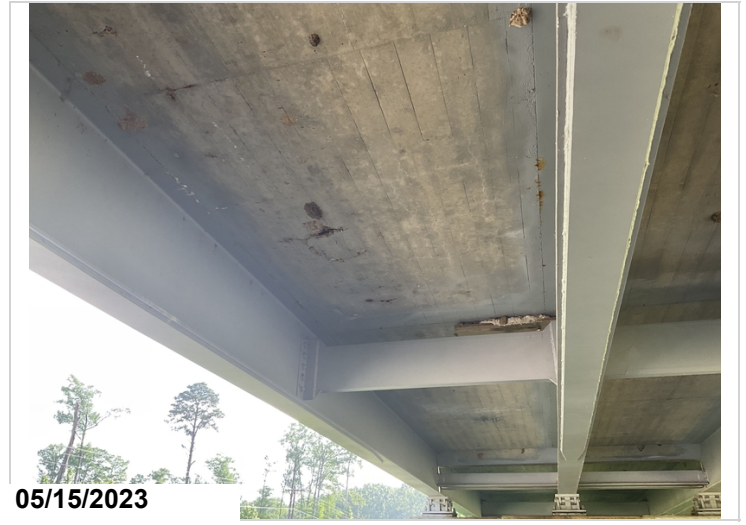
Rebar exposed span 9 bay 1

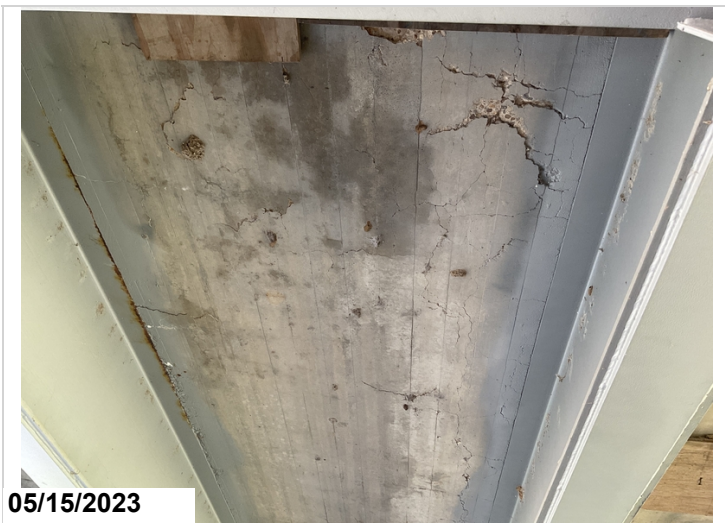
Delam span 9 bay 2

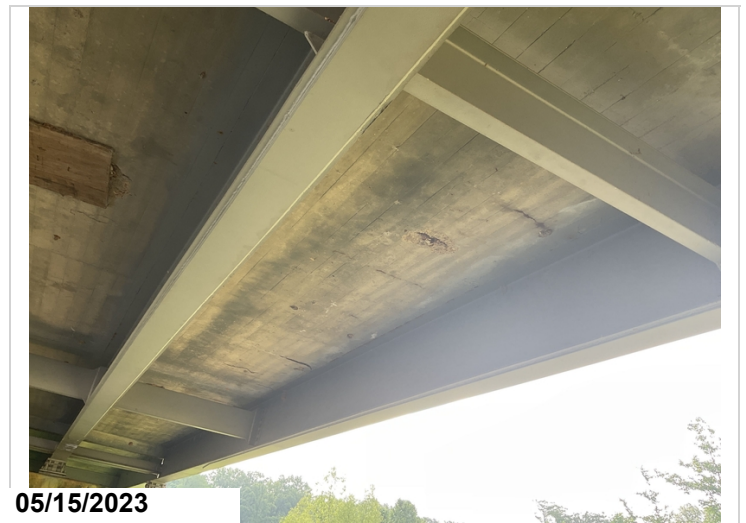
Rebar exposed and delams span 9 bays 3&4

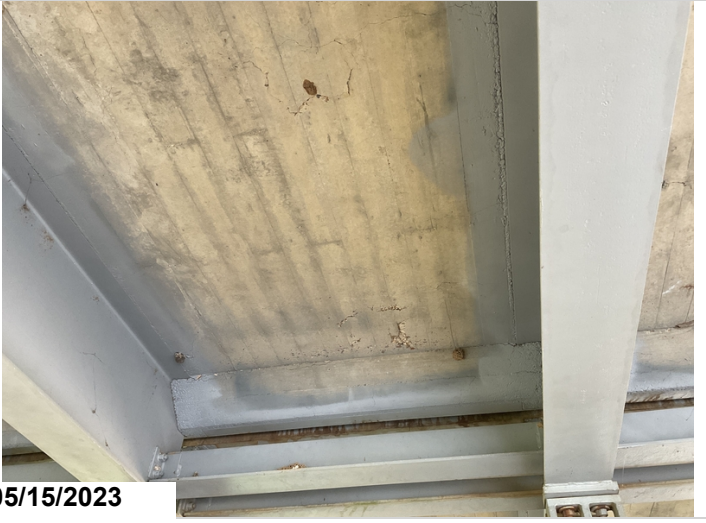
Delam span 9 bay 2

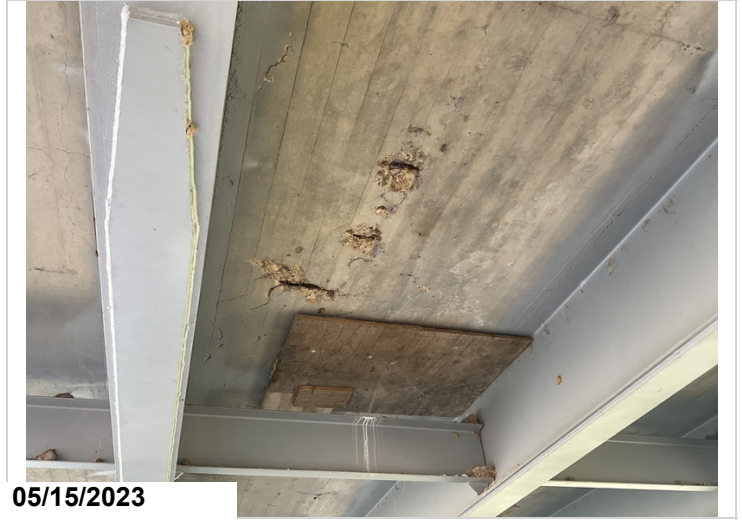
Rebar exposed span 9 bay 2

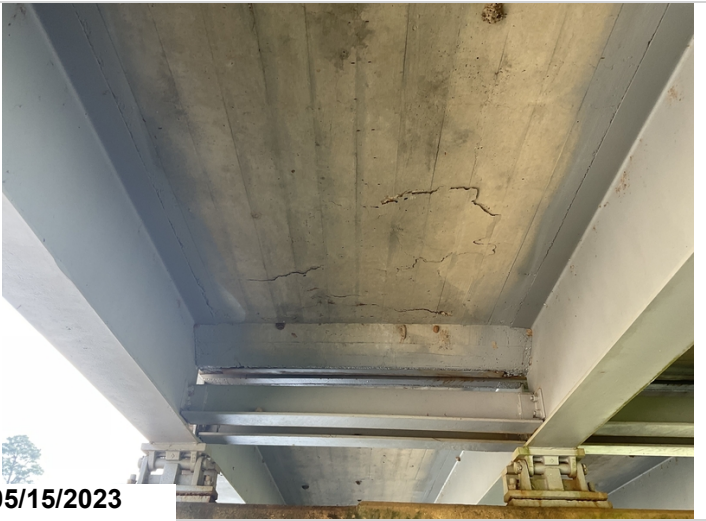
Delam span 8 bay 1

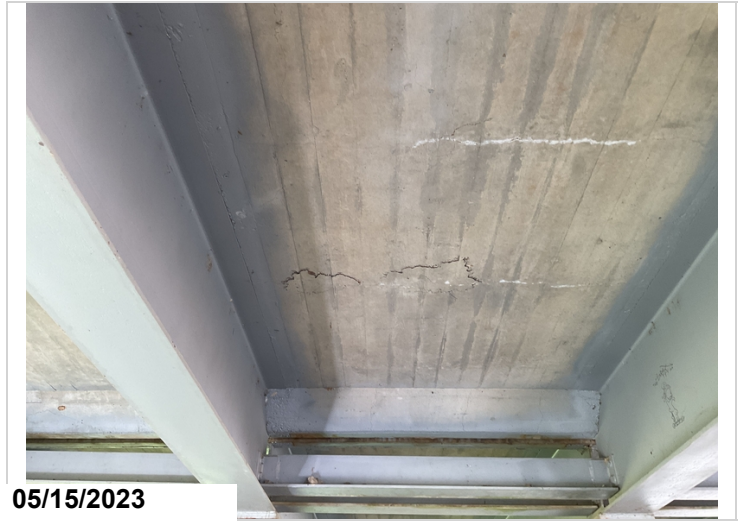
Delam span 8 bay 3

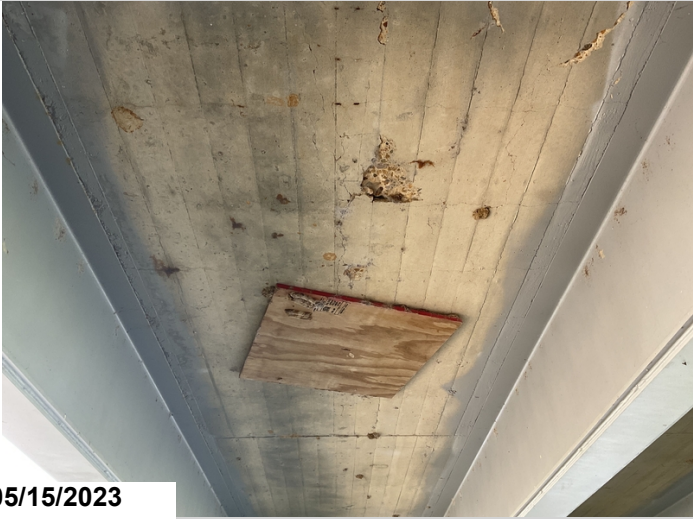
Spall and old patch span 8 bay 1

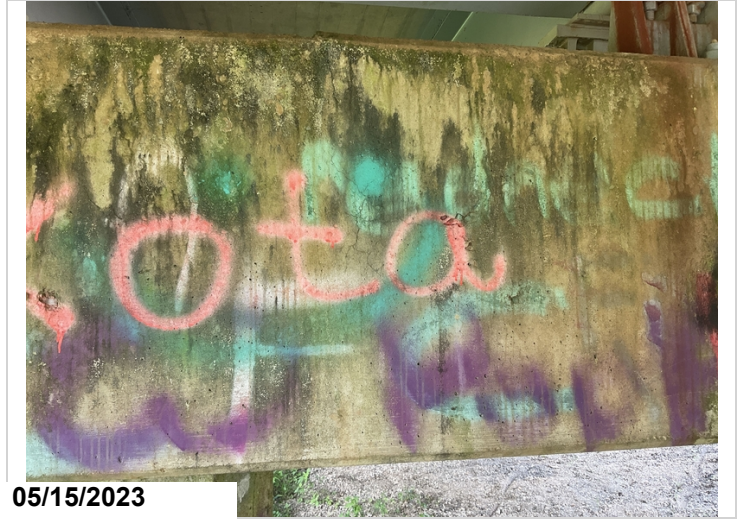
Map like cracking in bent 8 cap span 8 side

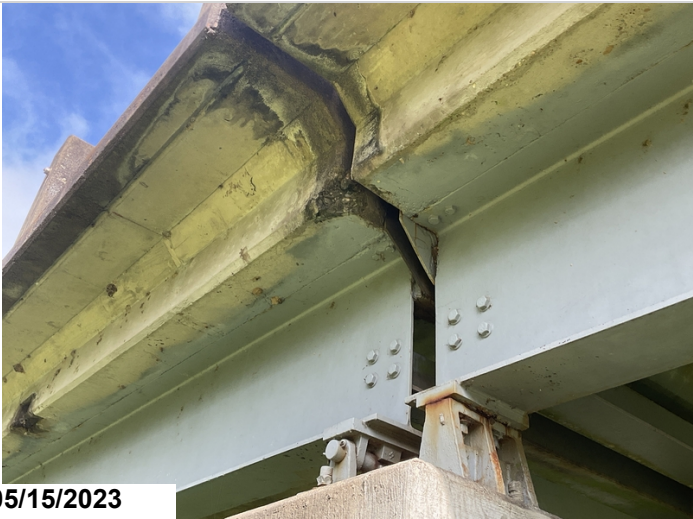
Delam above bent 7 right side

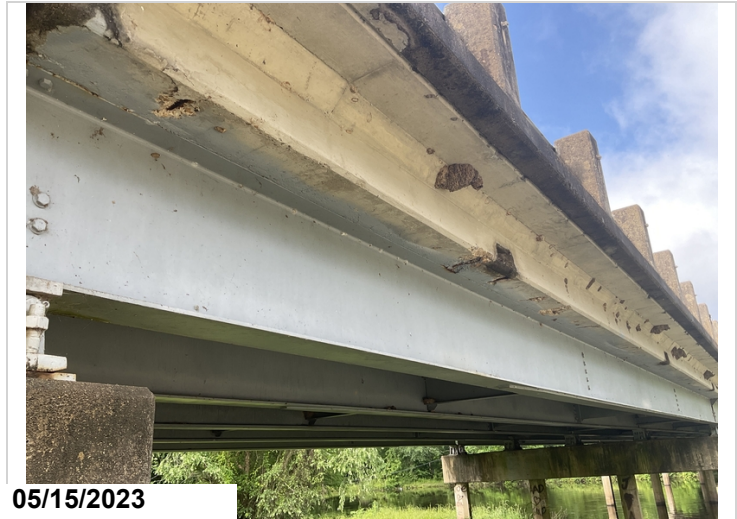
Rebar exposed span 6 left side

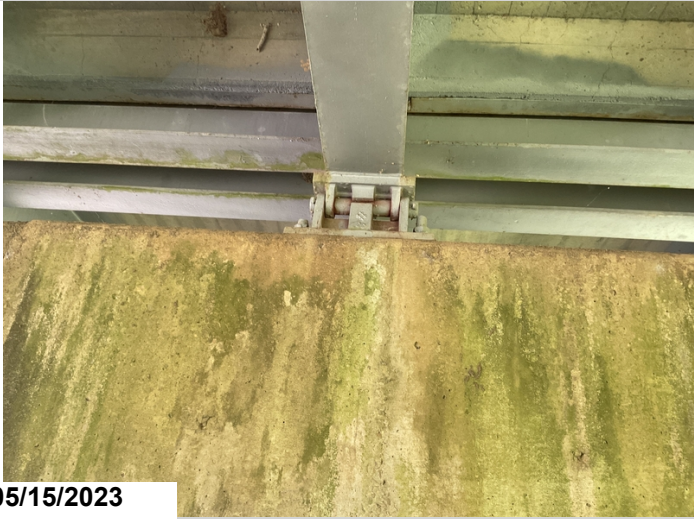
Movable bearing are beginning to corrode

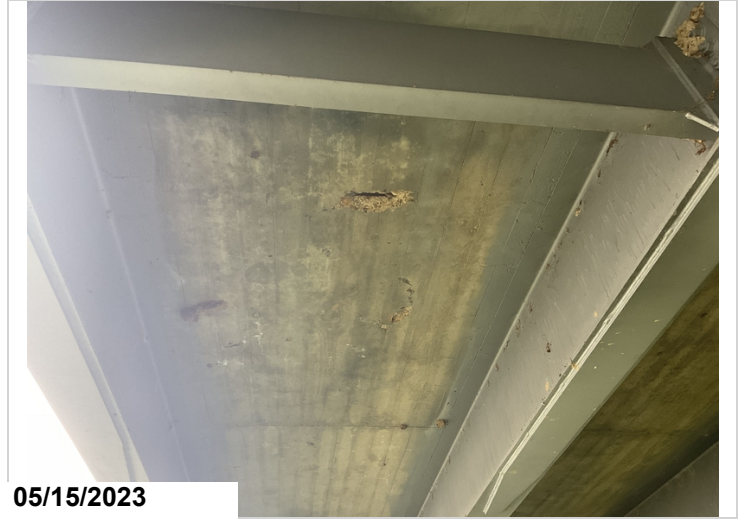
Rebar exposed and delam span 6 bay 1

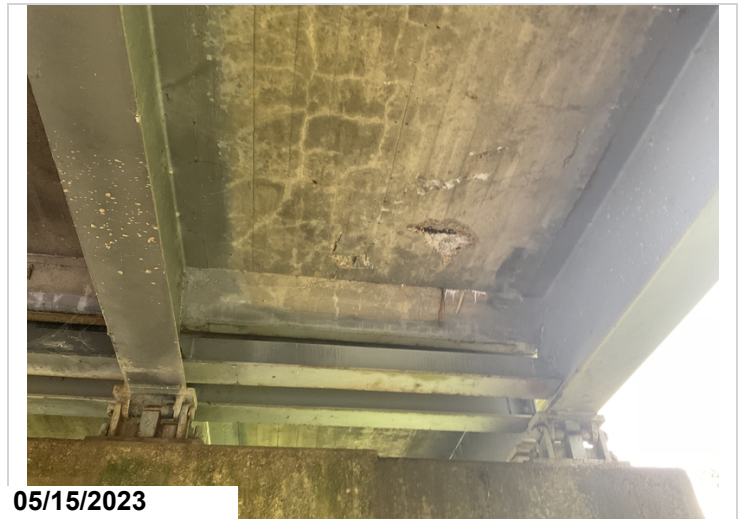
Span 5 bay 4 rebar exposed and delam

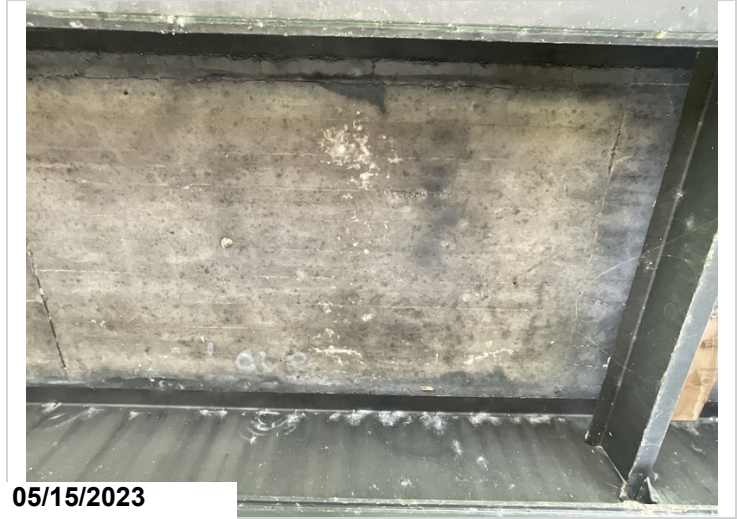
Span 5 bay 2 efflorescence

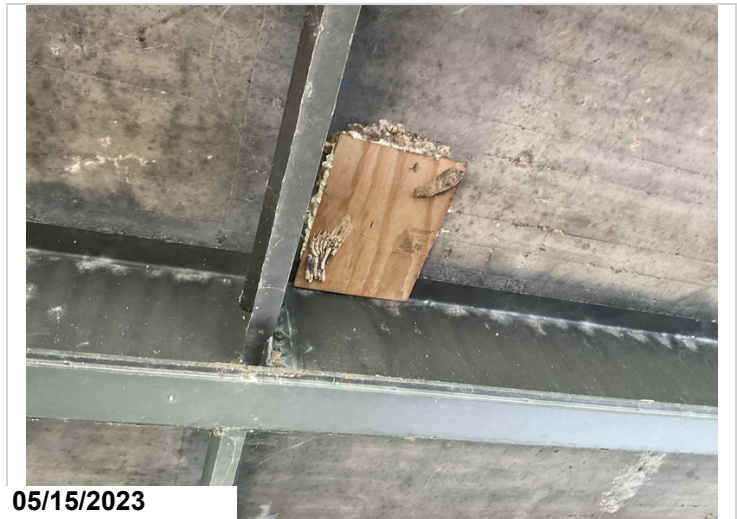
Span 5 bay 2 old patch

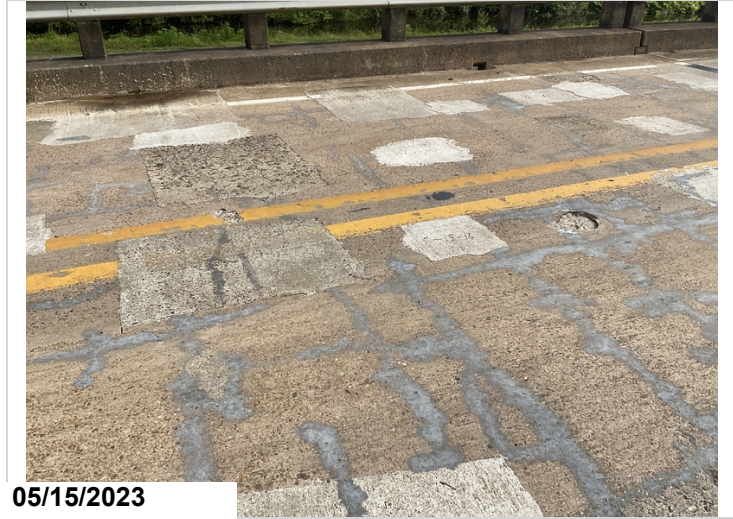
New pop out spall span 9 by yellow line

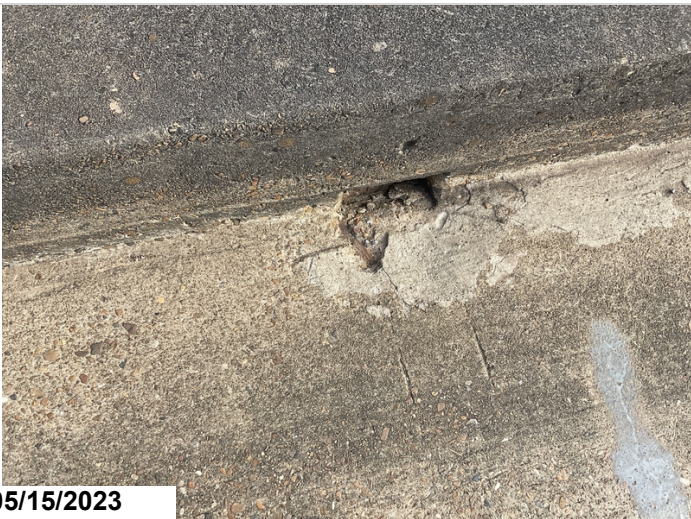
Beginning of span 7 left side drain hole has rebar exposed

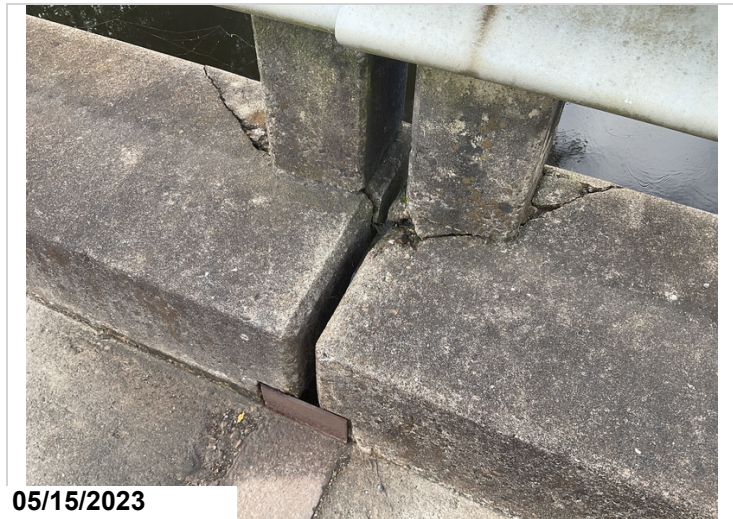
End of span 4 right side guard rail posts are cracked severely

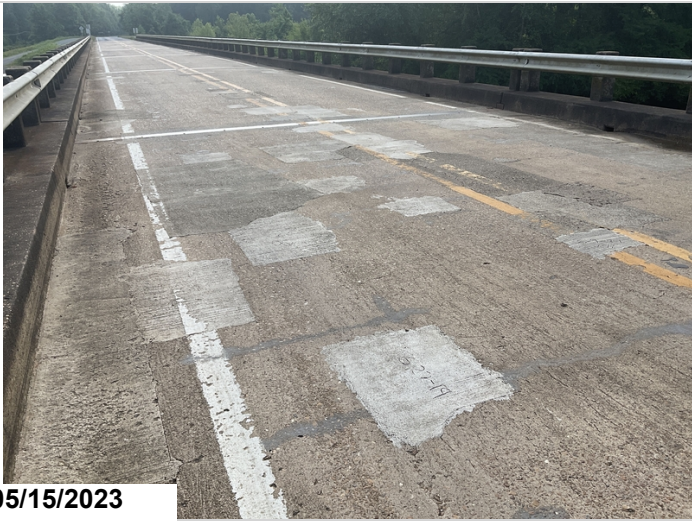
Old patches all across deck surfaces spanning all spans in various locations and sizes

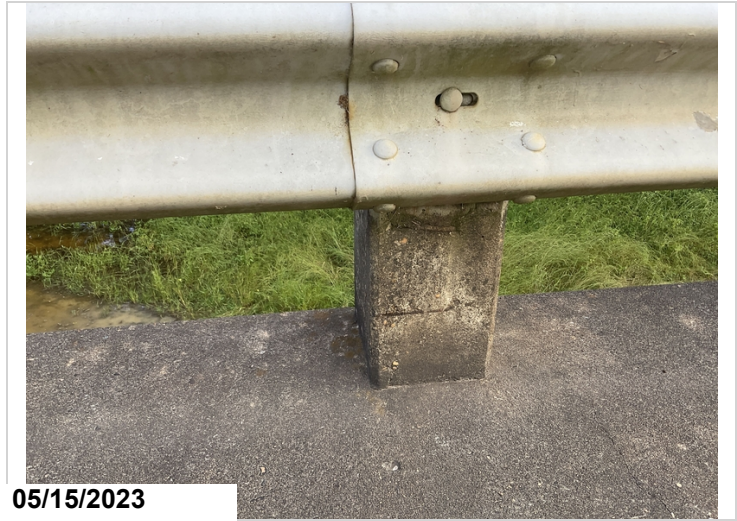
Middle of span 2 left side post has rebar exposed

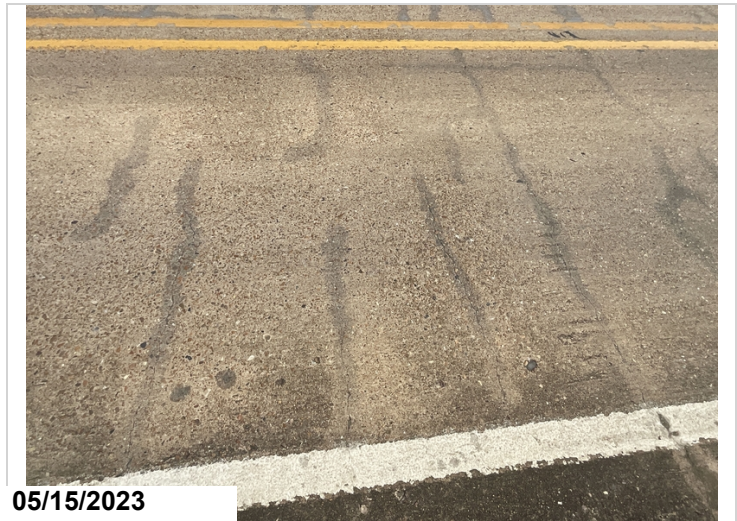
Large amounts of cracking in all spans on bridge deck in various locations some sealed some not sealed.

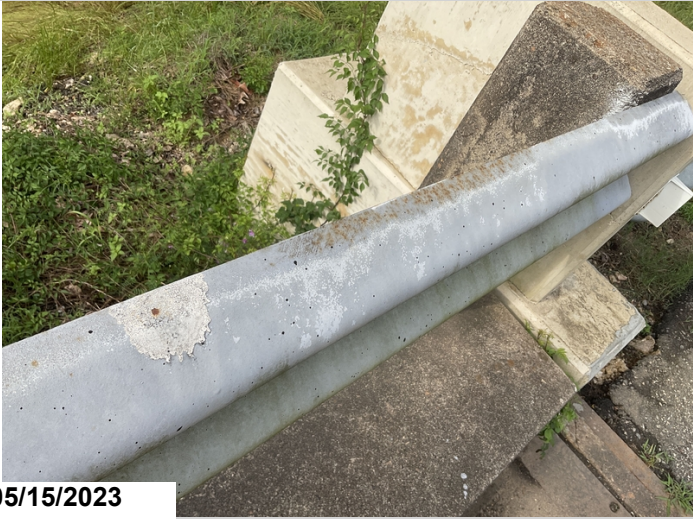
Minor amount of corrosion on guard rail in various locations

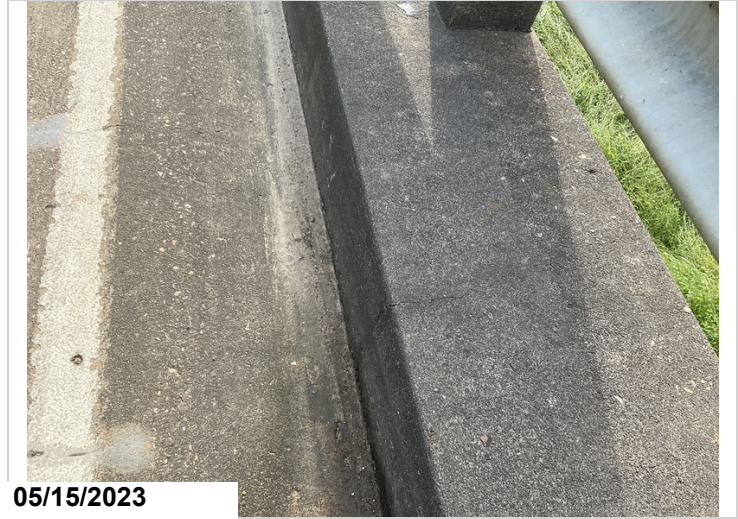
Cracking in concrete guard rail various locations

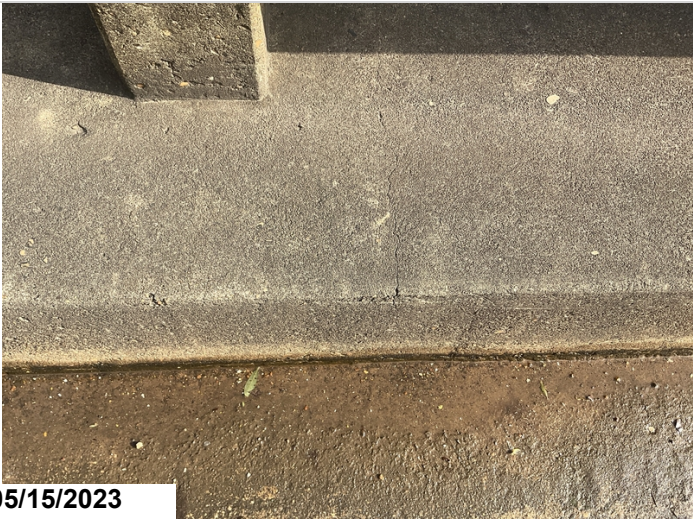
Cracking in concrete guard rail various locations

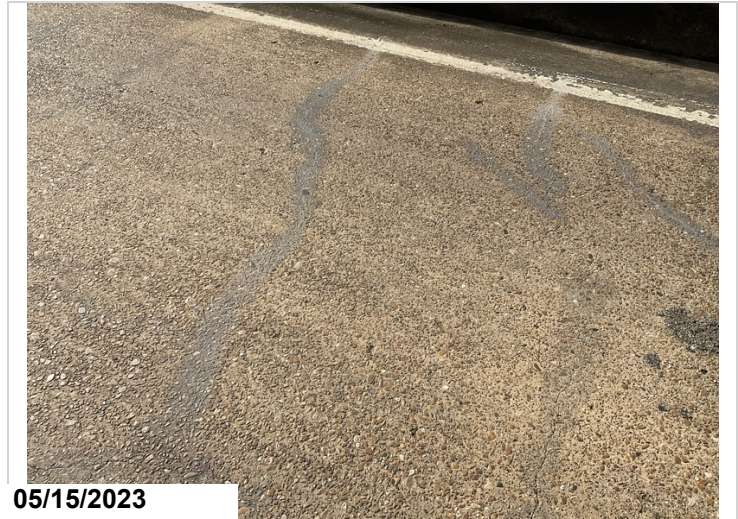
Deck cracking in various locations some sealed some not

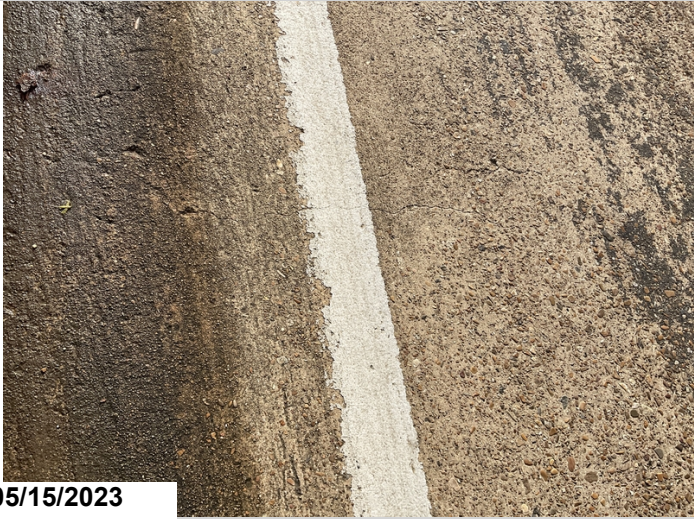
Deck cracking in various locations some sealed some not

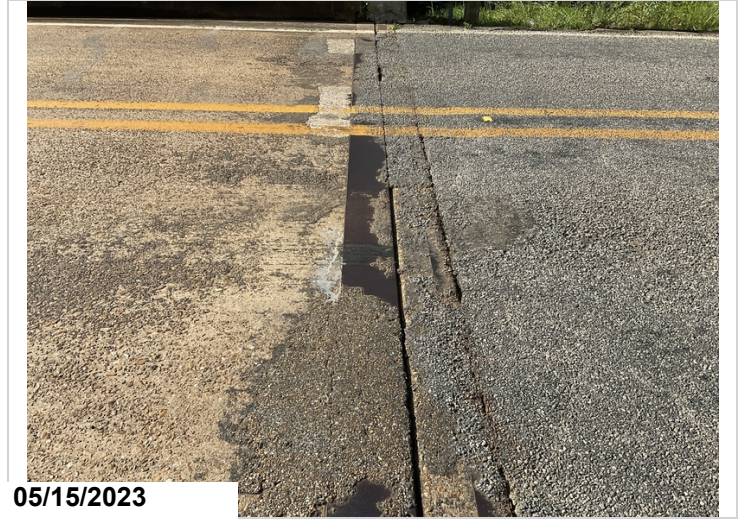
Beginning of bridge debris impaction

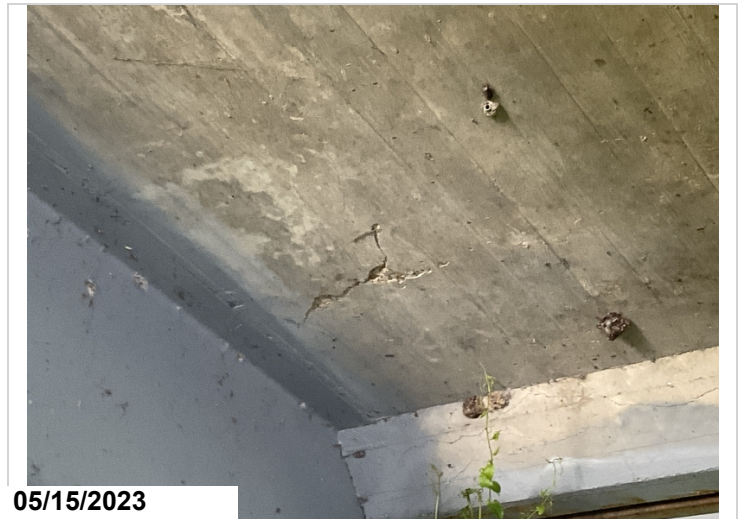
Delam span 3 bay 4

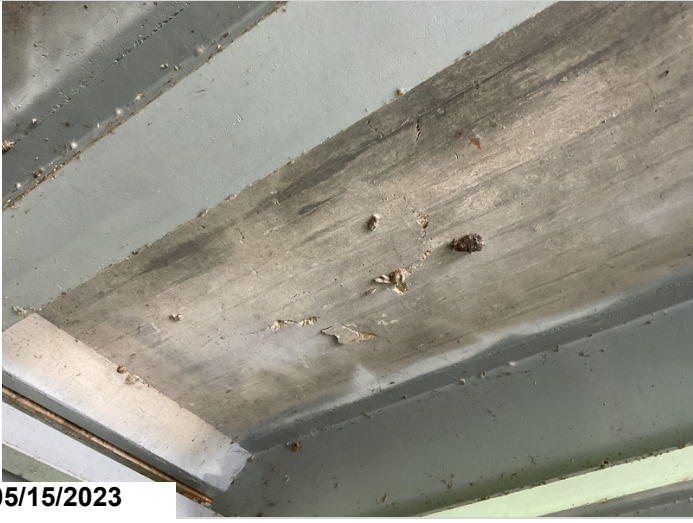
Delam span 3 bay 2

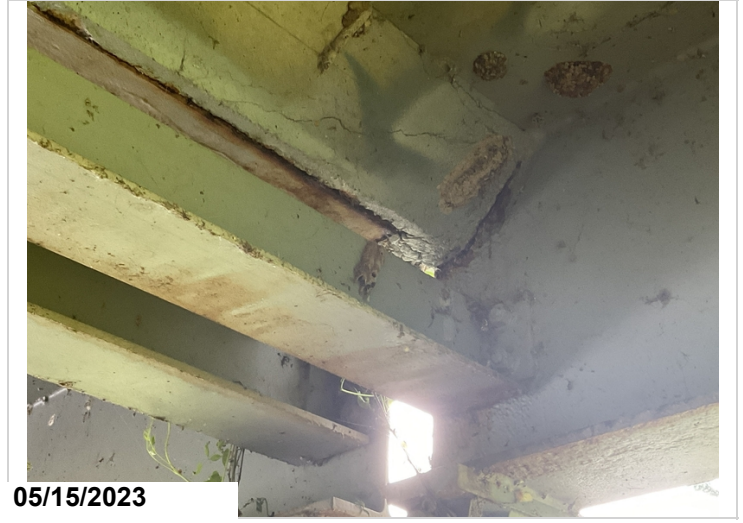
Section loss first 8 in of beam span 2 above bent 3 beam 5

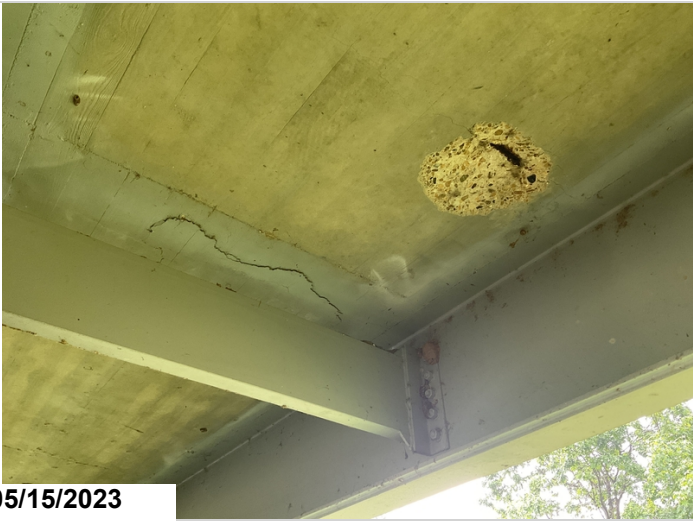
Rebar exposed and delam span 2 bay 4

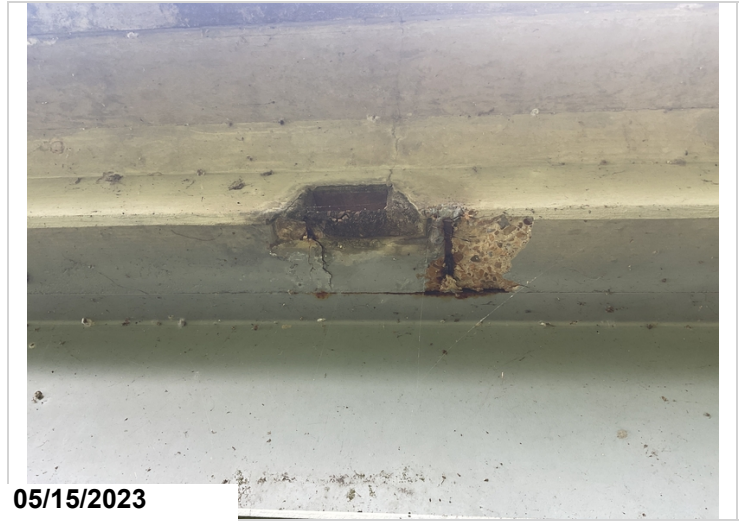
Rebar exposed span 2 left side by drain hole

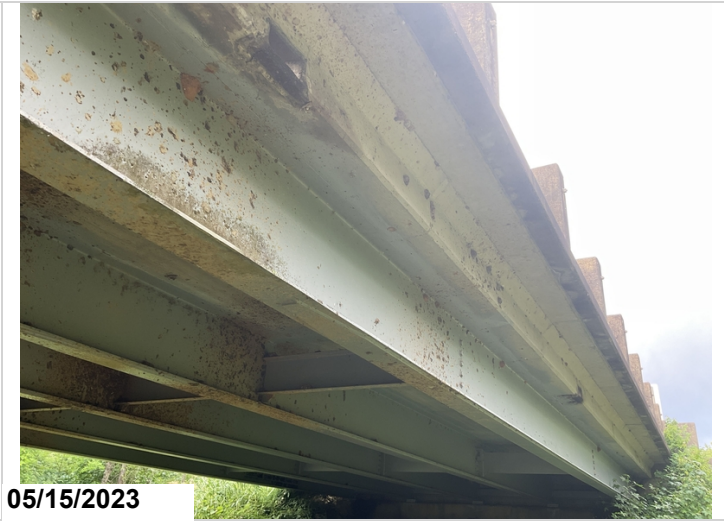
Cracking around both drain holes span 1 left side

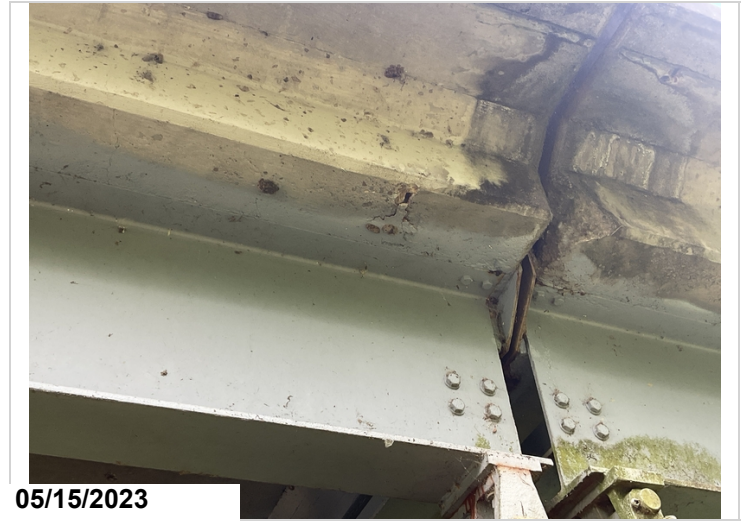
Rebar exposed span 2 left side above bent 2

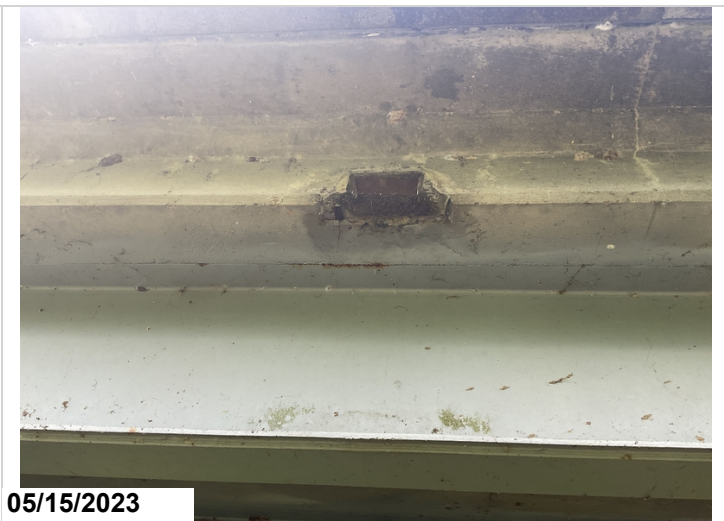
Rebar exposed left side span 2 by drain hole

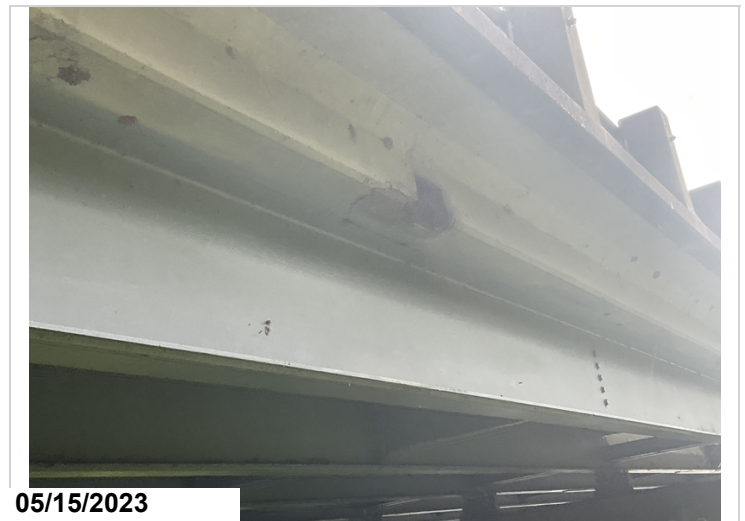
Delam span 2 Rt side by drain hole

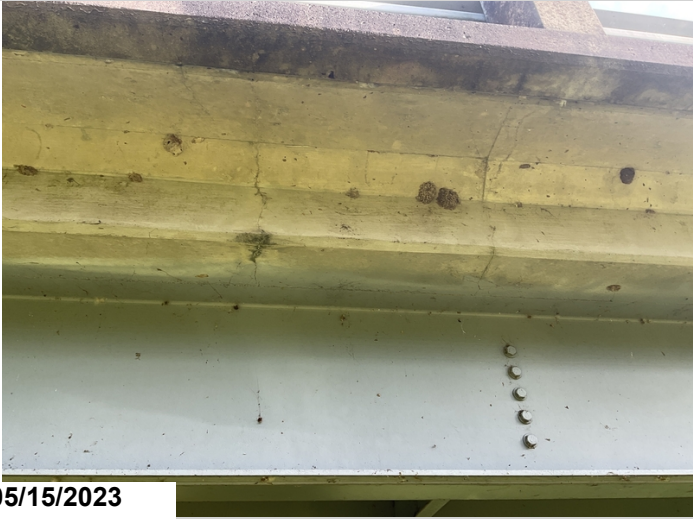
Cracking in deck various locations

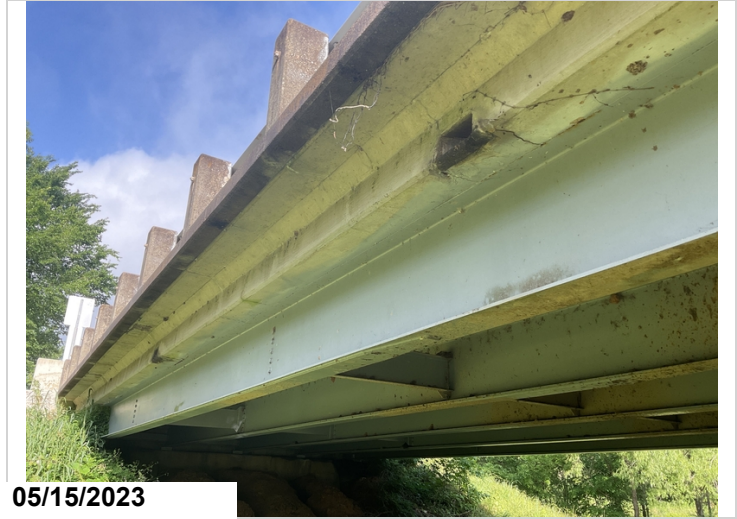
Cracking at both drain holes span 1 Rt side

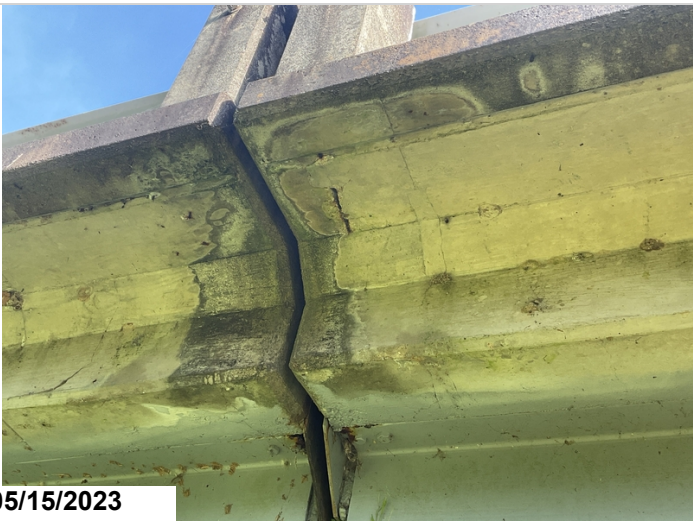
Rebar exposed above bent 2 Rt side span 2

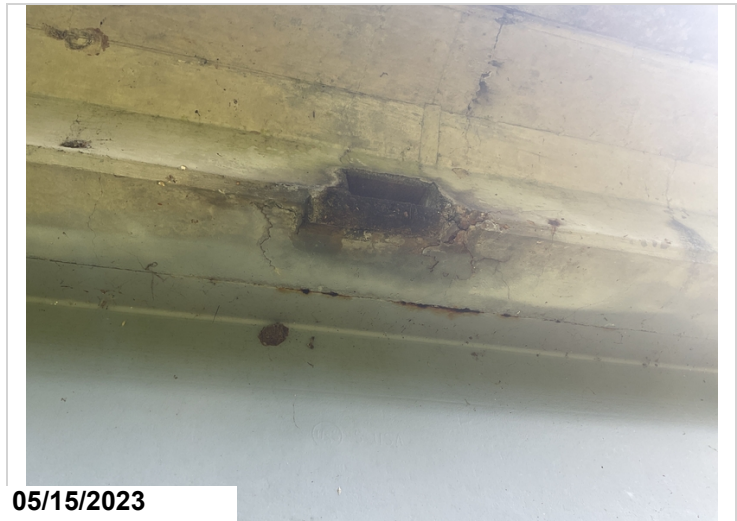
Delam right side span 2 drain hole

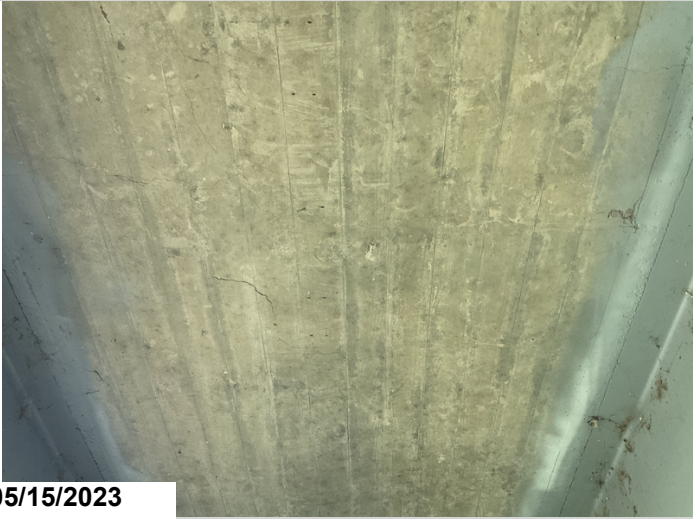
Cracking in deck span 2

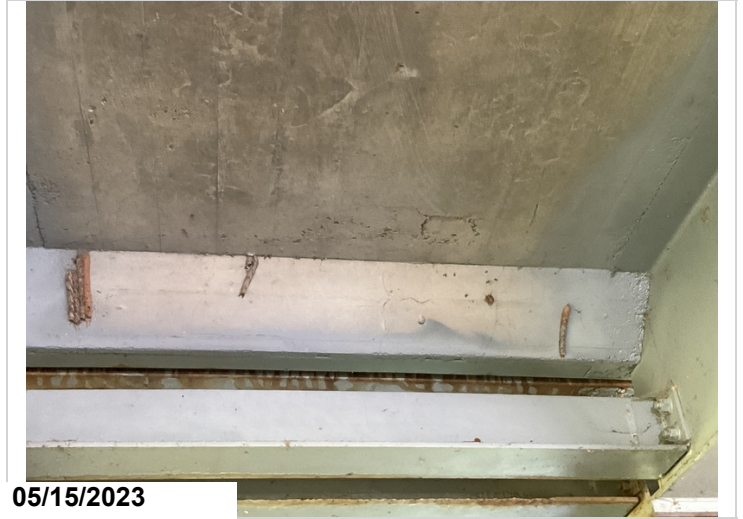
Delam span 2 bay 2

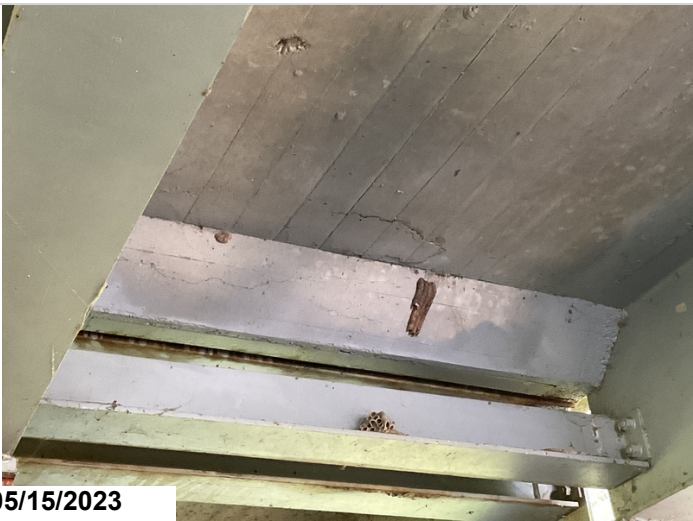
Delam span 2 bay 1

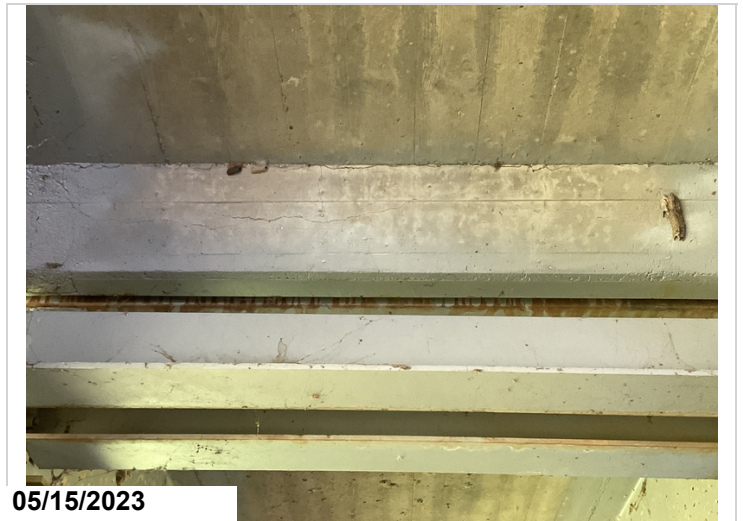
Cracking in various haunch areas no element for this

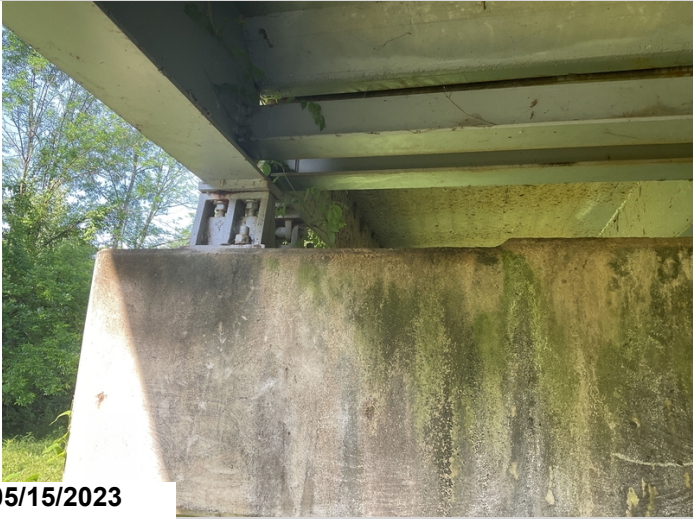
Corrosion beginning on fixed bearings various locations.

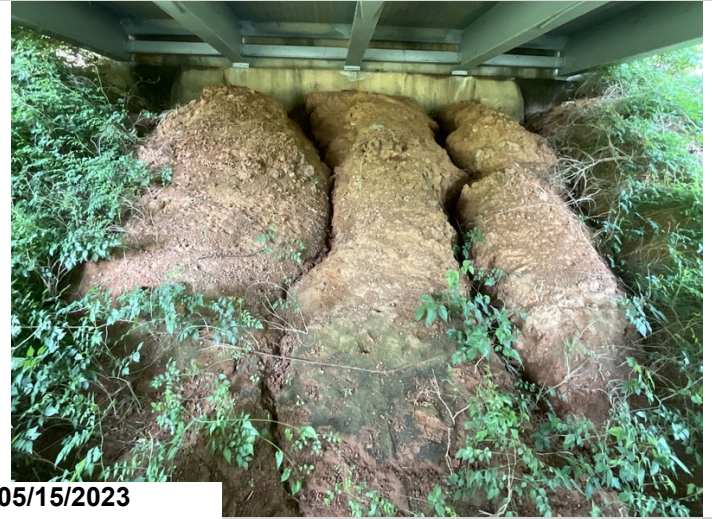
Erosion at bent 1

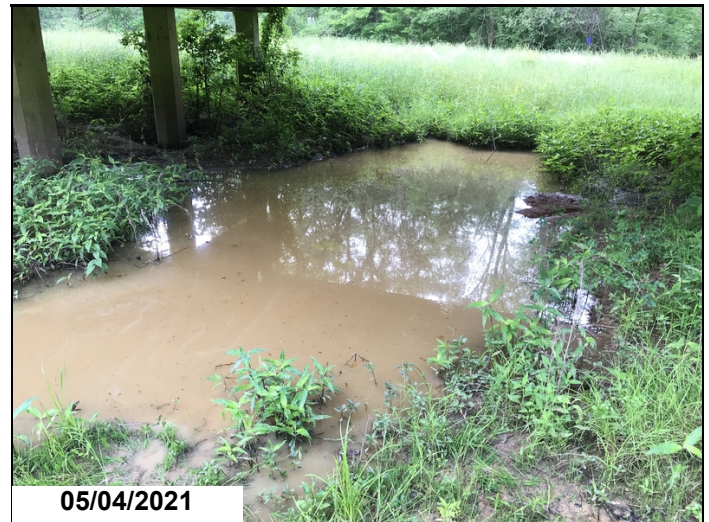
Span 1 bottom of slope
