Asset #06007(Routine)

SH 160 - 02 - 7.79 over POLK CR. & LAKE ERLING

Location: 7.8 MI E BRADLEY

Team Lead: Jared Kegley Inspection Date: 09/05/2024

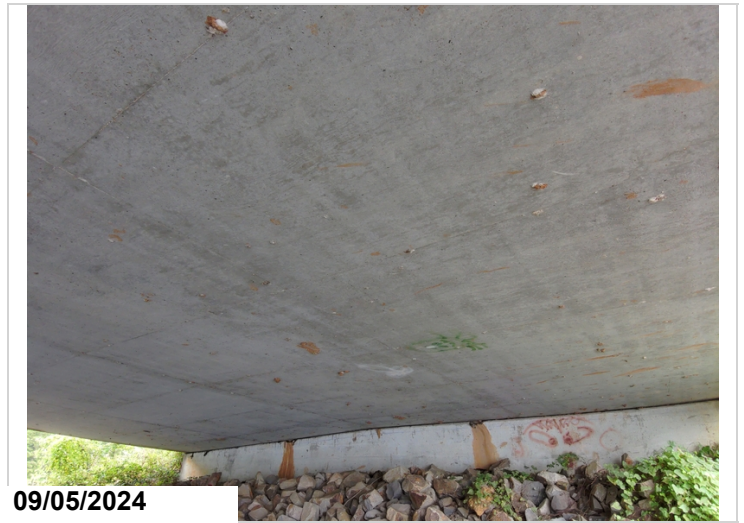
Typical photo of the under surface.

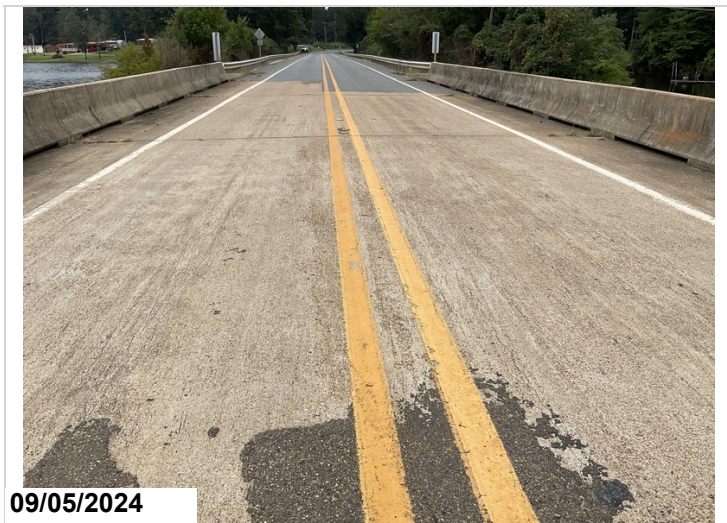
Typical photo of the topside of the deck.

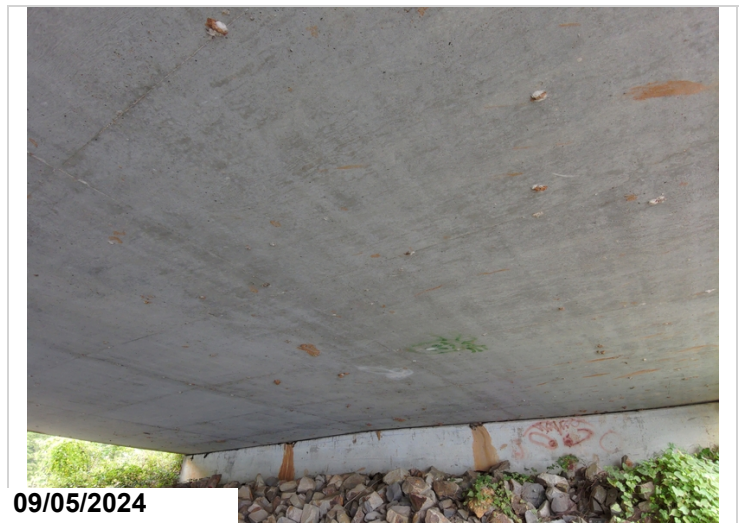
Typical photo of the superstructure.

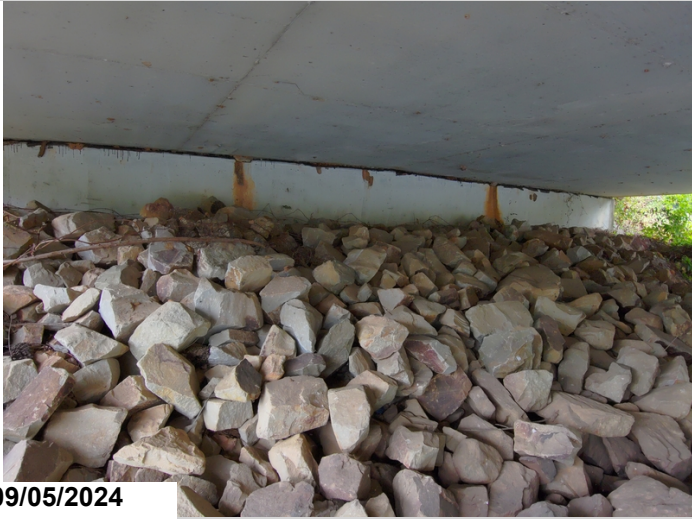
Typical photo of bent 1 abutment.

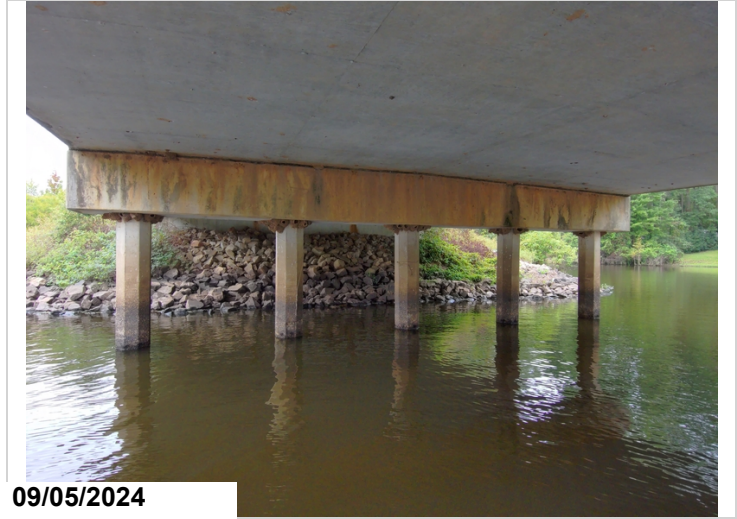
Typical photo of the substructure.

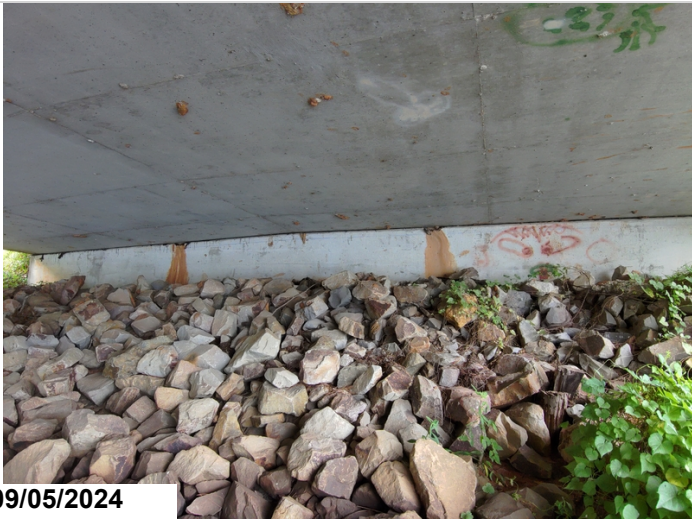
Typical photo of bent 4 abutment.

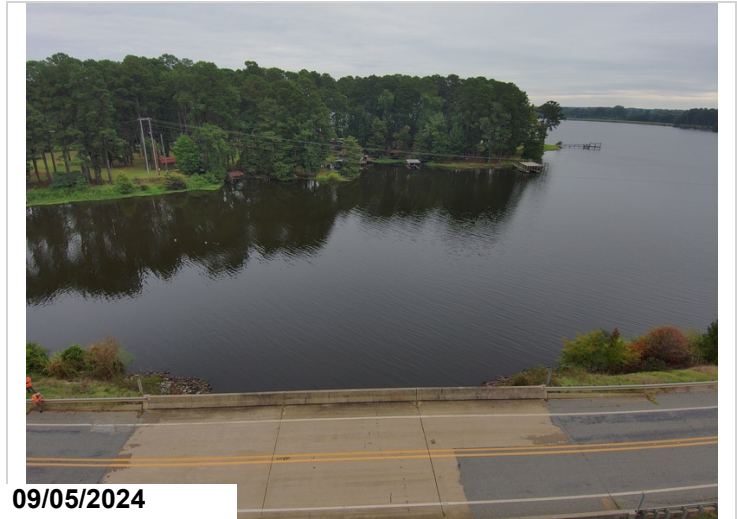
Upstream Channel.

The channel is rated a 8 this inspection due to the upstream and downstream channel being well vegetated.

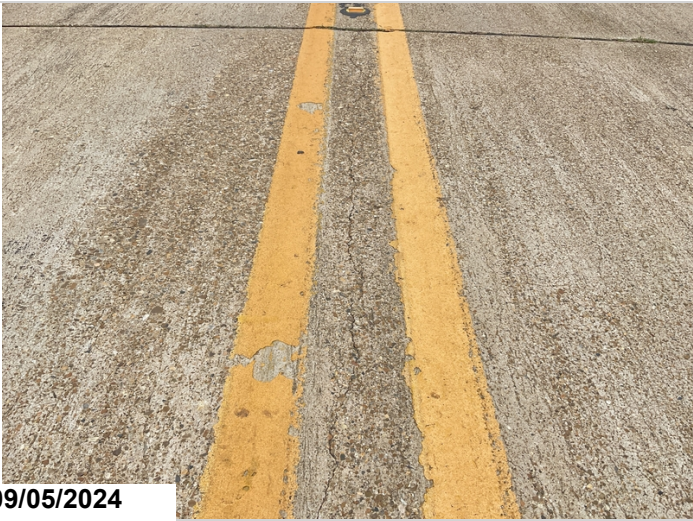
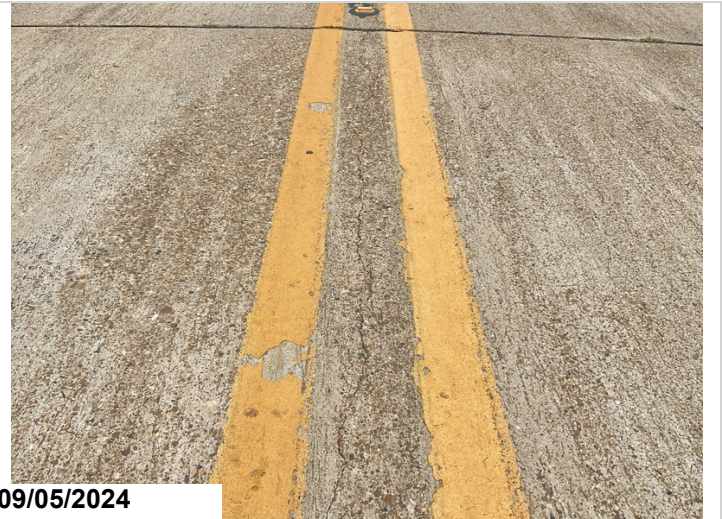
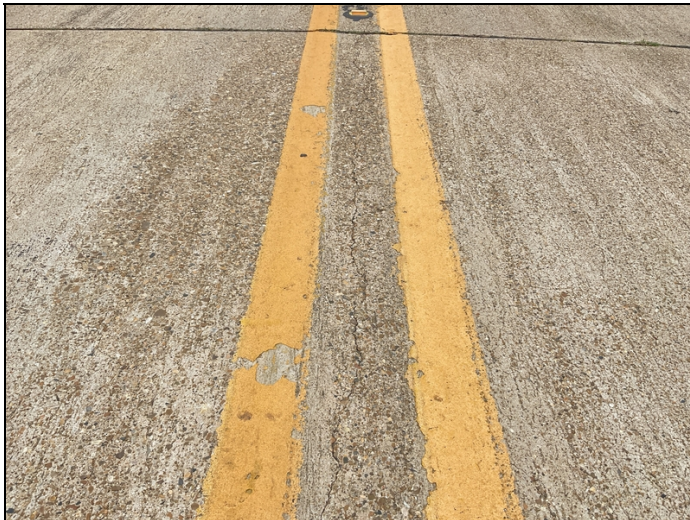
Deck was dropped to a 6 this inspection due to cracking on the top side of the deck and cracking with efflorescence on the sides of the slab in various locations.

Superstructure was dropped to a 6 this inspection due to cracking on the top side of the deck and cracking with efflorescence on the sides of the slab in various locations.

Span 1, centerline, 15' of large cracking.

Span 1, centerline, 15' of large cracking, CS3.

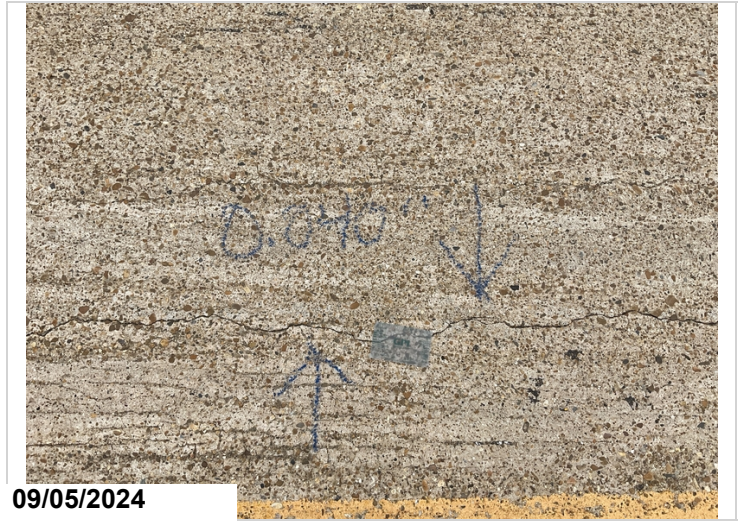
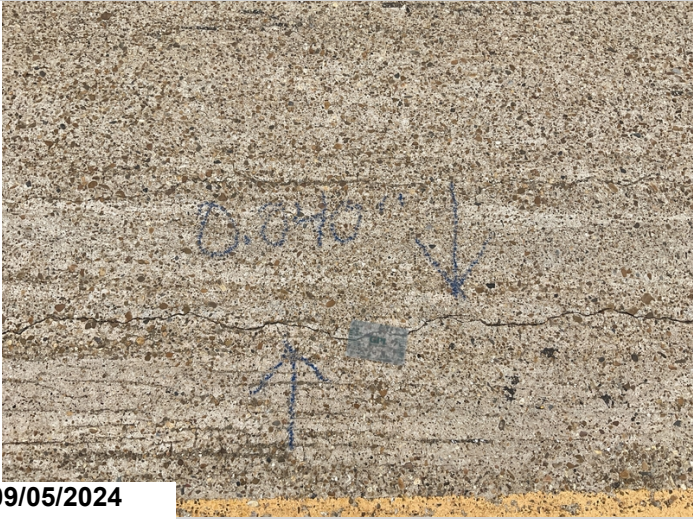
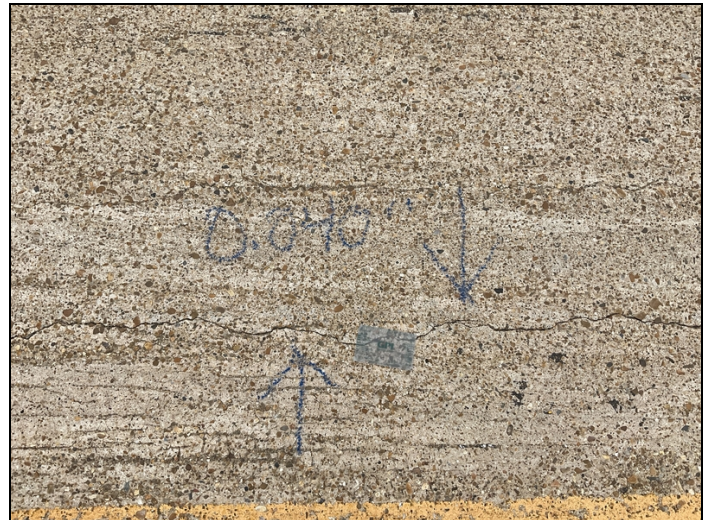
Numerous cracks in various locations of all spans.

Numerous cracks in various locations of all spans, CS2.

Numerous cracks in various locations of all spans.

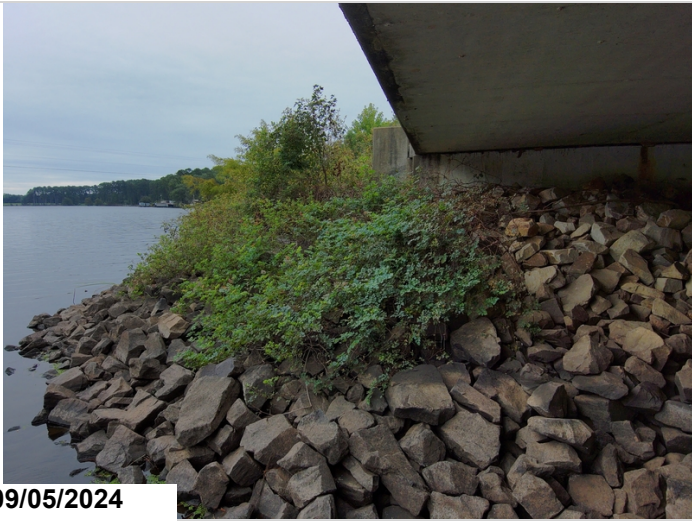
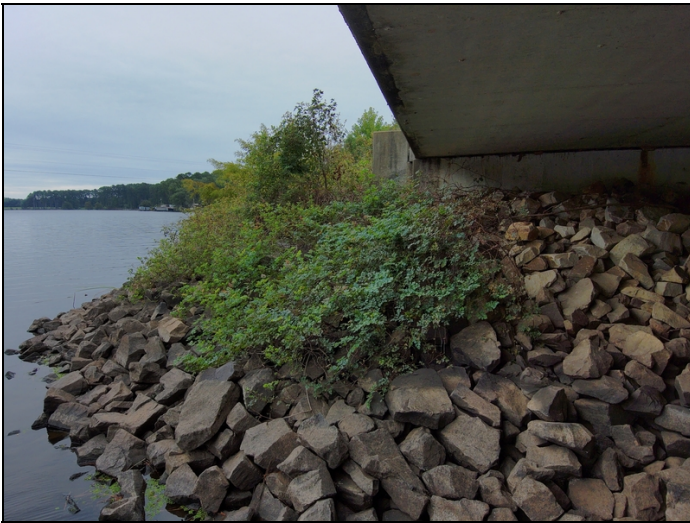
There is heavy vegetation on the left and right side at the beginning and end of the bridge.

heavy vegetation on the left side at the end of the bridge.

There is heavy vegetation on the left and right side at the beginning and end of the bridge.

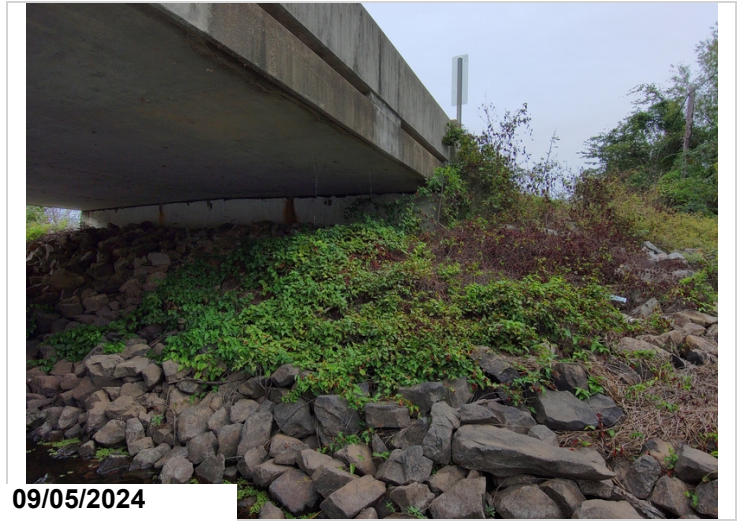
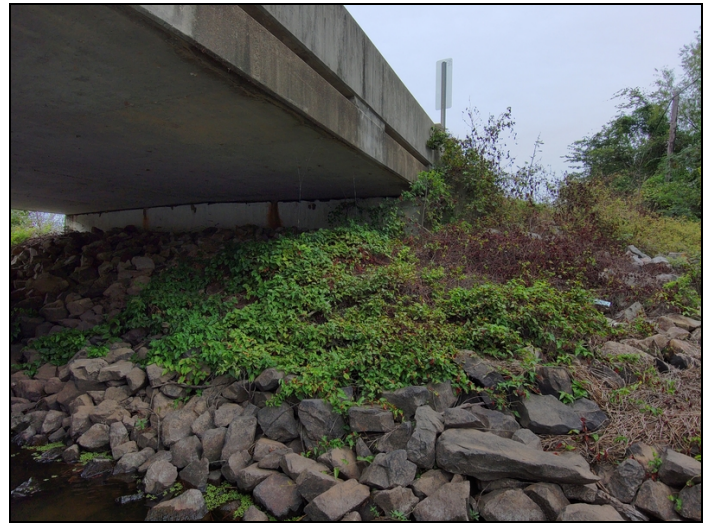
heavy vegetation on the right side at the end of the bridge.

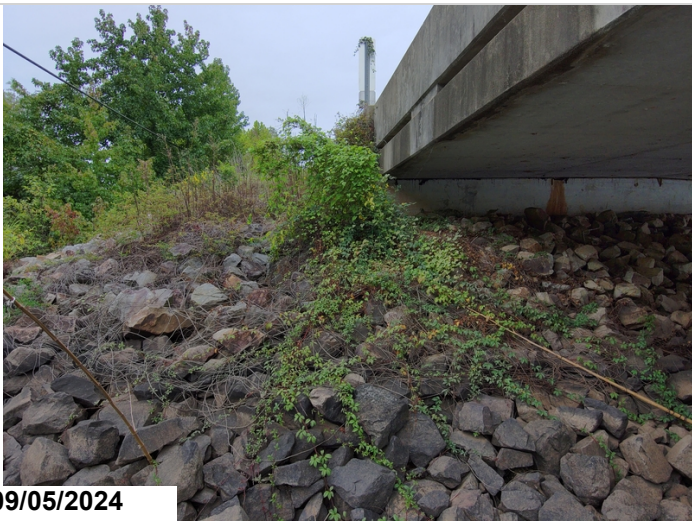
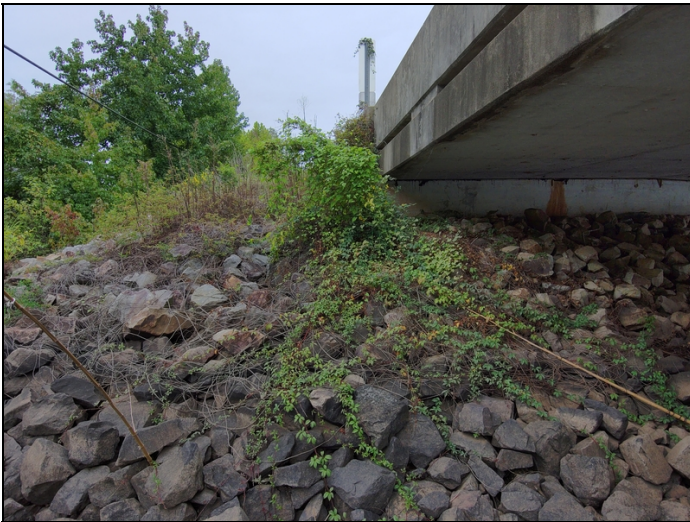
heavy vegetation on the right side at the beginning of the bridge.

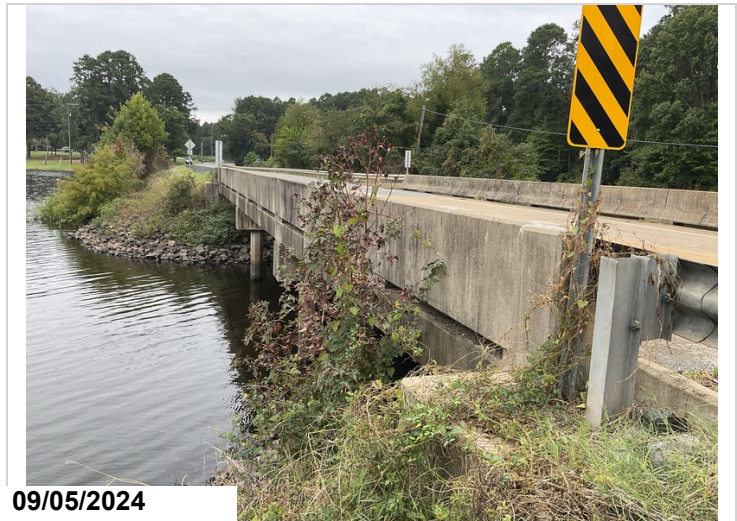
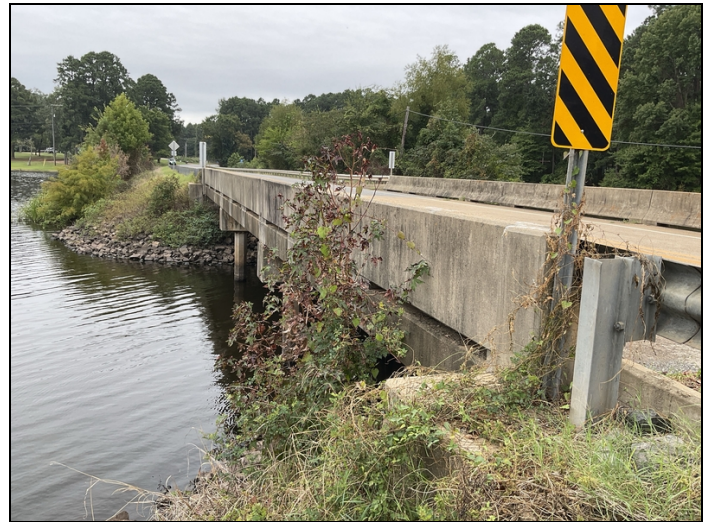
Vegetation on the left side at the beginning of the bridge is growing above the bridge.

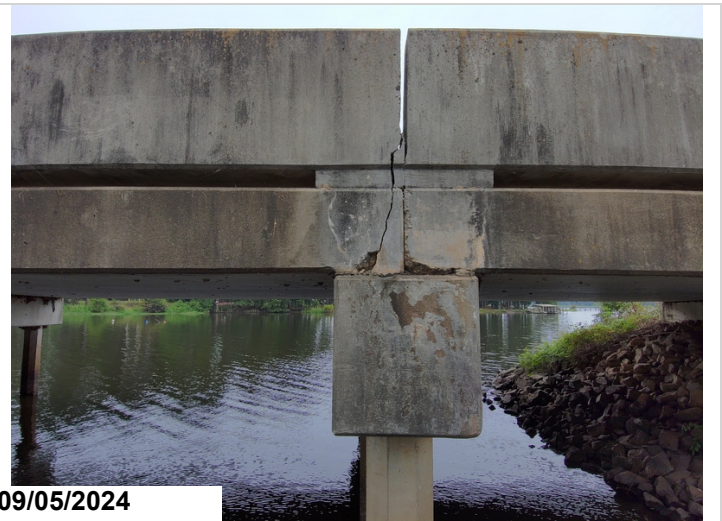
bent 3, right side, 1' of large delam, CS3

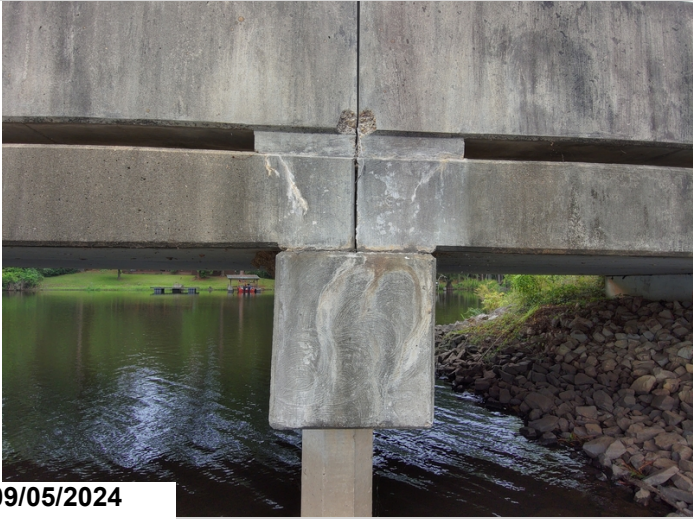
Bent 3, Right side, 2' of cracking with efflorescence, CS2.

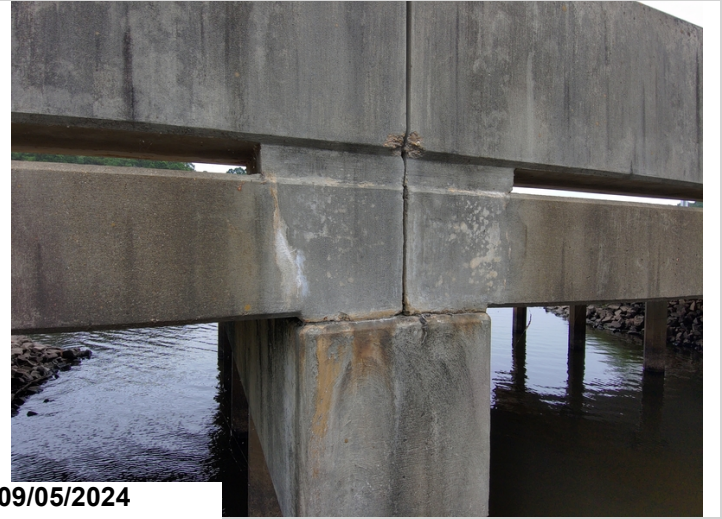
Bent 2, right side, 1' of cracking with efflorescence, CS2.

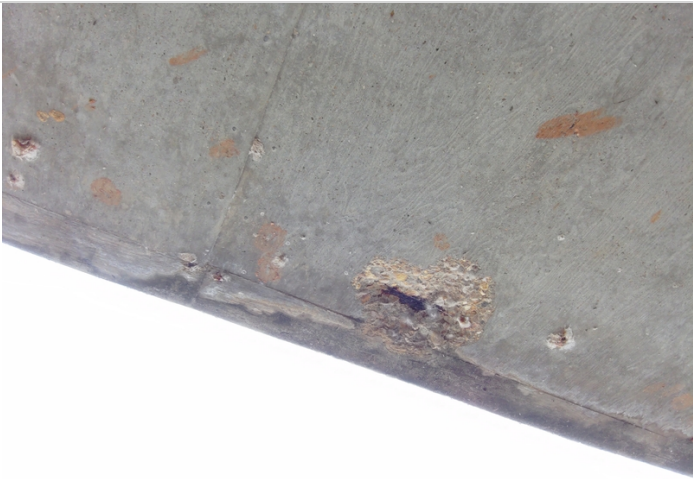
Span 1, Left side, 1' of exposed rebar, CS2.

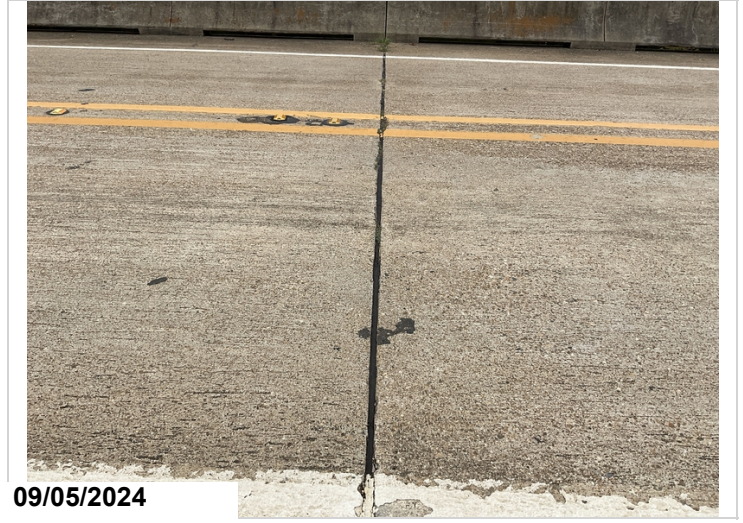
All joints have leakage and debris impaction.

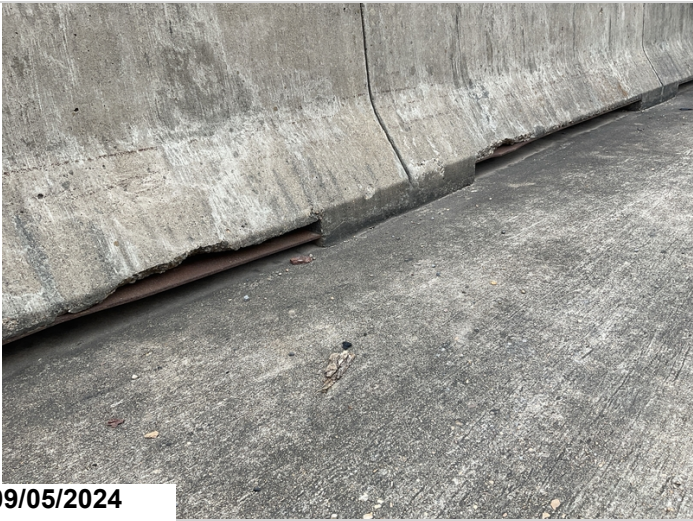
The beginning of the bridge on the left side has minor spalling. Note: The metal plate is loose on the bottom of the parapet wall.
