Bridge 06861 Inspection Report

Asset #06861 (Routine)

RAMP NW OF I 49 over LINE FERRY ROAD

Team Lead: Jared Kegley Inspection Date: 12/19/2023

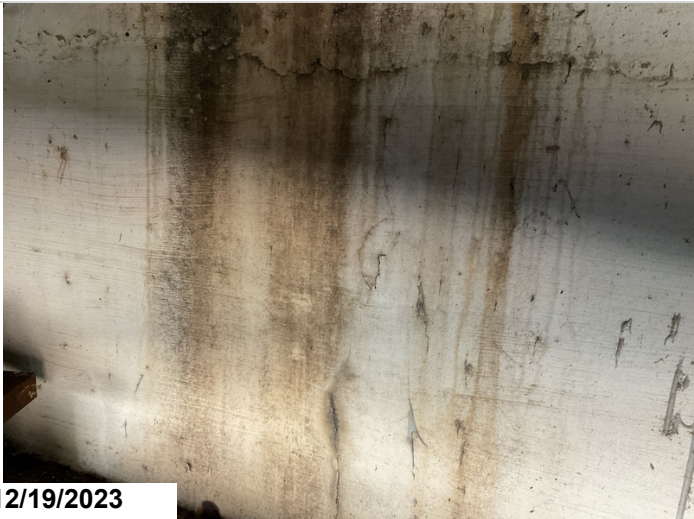
Substructure was dropped to a 7 this inspection due to cracking in bent 1 abutment.

(215) 2' of CS2 cracking in bent 1 abutment							
234	Reinforced Concrete Pier Cap	LF	170	170	0	0	0
302	Compression Joint Seal	LF	84	75	0	0	9
2330	Seal Damage	LF	9	0	0	0	9

Bent 1 abutment cracking

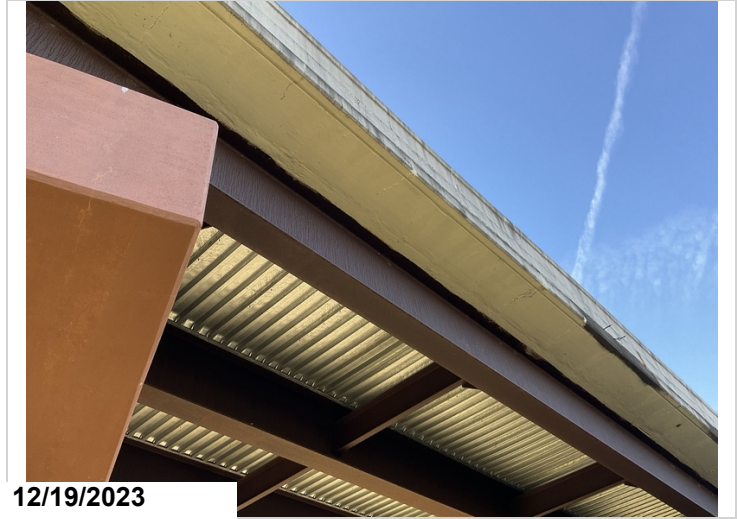
(12) Various locations of patched areas from removed plowable pavement markers prior to this inspection. Cracking with efflorescence is present on both right and left overhangs throughout all spans. Deck cracking is present in various locations of the concrete bridge deck throughout all spans.							
107	Steel Open Girder/Beam	LF	1074	1074	0	0	0
515	Steel Protective Coating	SF	7876	7876	0	0	0
(515-107) Weathering steel is in good condition							
205	Reinforced Concrete Column	EA	4	4	0	0	0
215	Reinforced Concrete Abutment	LF	130	128	2	0	0
1130	Cracking (RC and Other)	LF	2	0	2	0	0

Cracking with efflorescence in deck overhangs

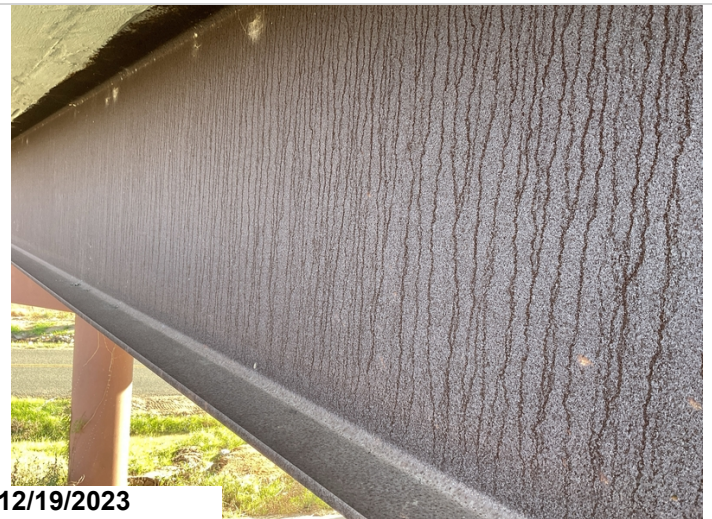
Weathering steel is in good condition

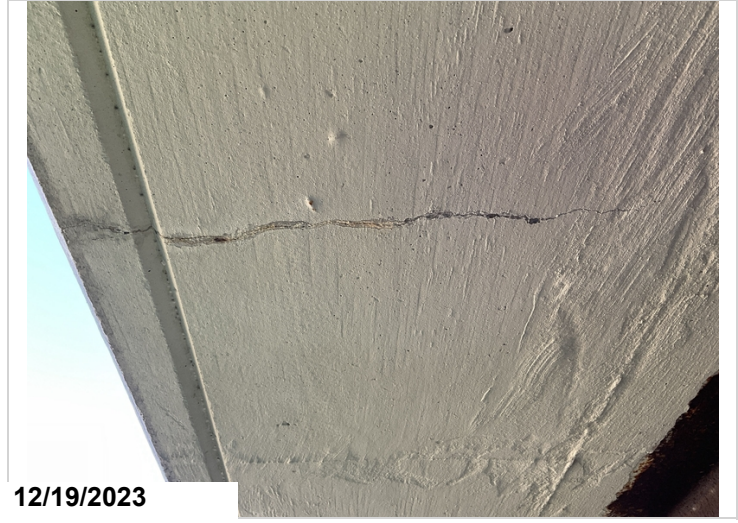
Cracking in deck overhangs

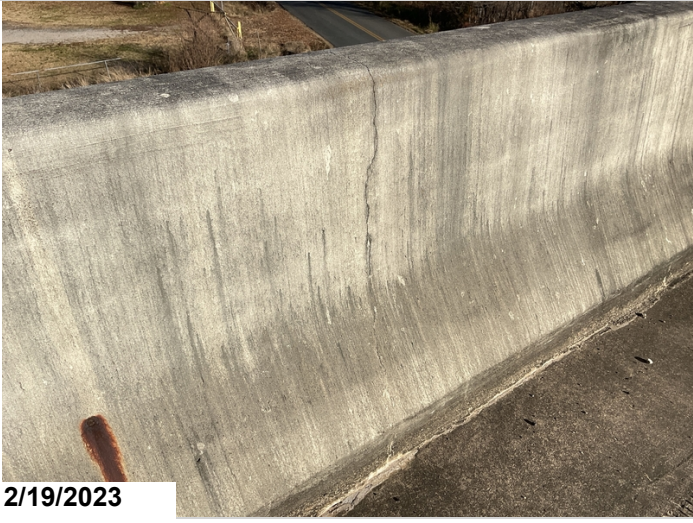
(331) Cracking is present in various locations along both right and left concrete bridge railing.

Cracking in bridge railing

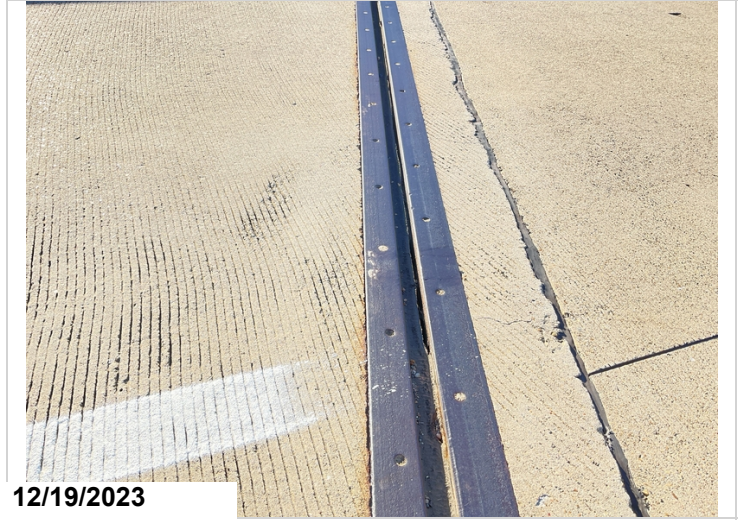
6' of joint material damage at end of bridge

(302) 3' of CS4 tears in bent 1 joint seal							
6' of CS4 tears in bent 4 joint seal							
310	Elastomeric Bearing	EA	24	24	0	0	0
321	Reinforced Concrete Approach Slab	SF	1728	1727	1	0	0
1080	Delamination/Spall/Patched Area	SF	1	0	1	0	0

6' of seal damage at end of bridge joint

A-59 - Joint Repair Needed (Yes)

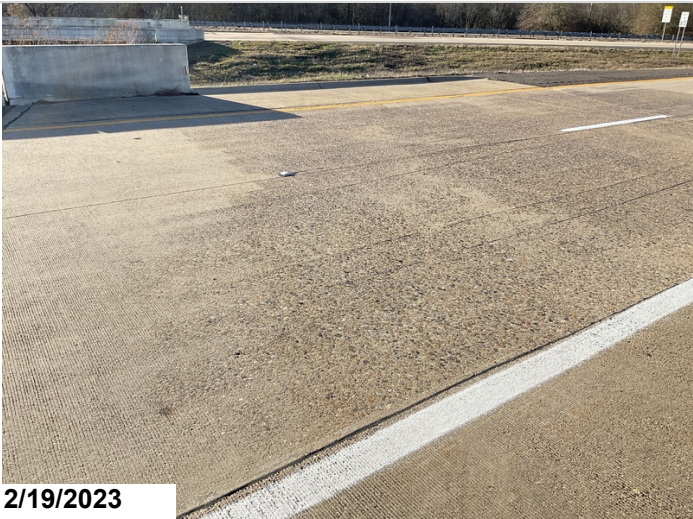
(321) Patched area from removed plowable pavement markers prior to this inspection at the end of bridge approach slab.							
331	Reinforced Concrete Bridge Railing	LF	358	292	66	0	0
1130	Cracking (RC and Other)	LF	66	0	66	0	0

Approach slab at end of bridge

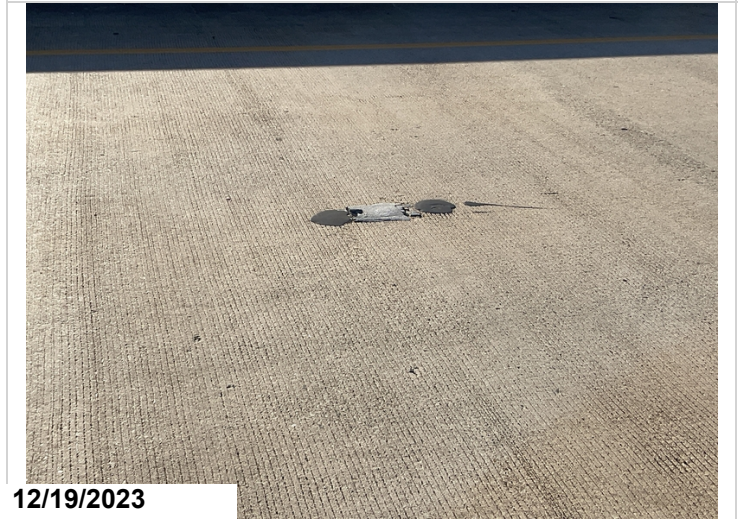
Deck is rated a 7 this inspection due to cracking in all spans, 2 sq ft of patched area on top of deck where old raised pavement markers were pulled out, cracking and cracking with efflorescence in overhangs.

Deck patching from previous RPM removal

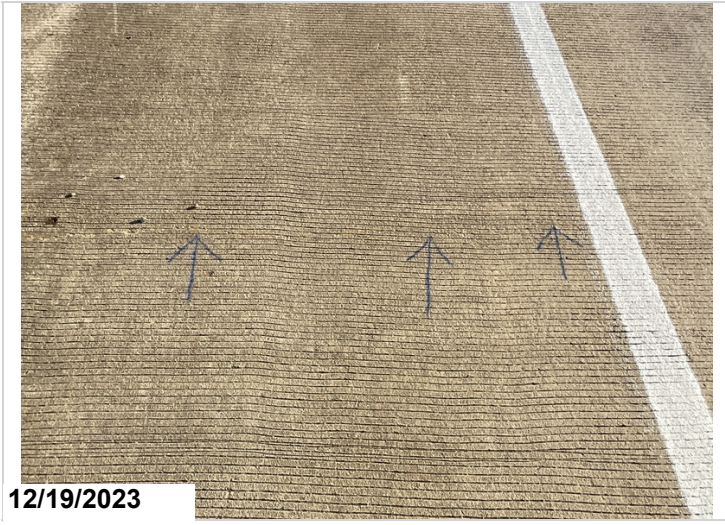
Sealable deck cracking is present throughout all spans.

Deck cracking in various locations of deck

A-54 - Sealable Deck Cracks (Yes)

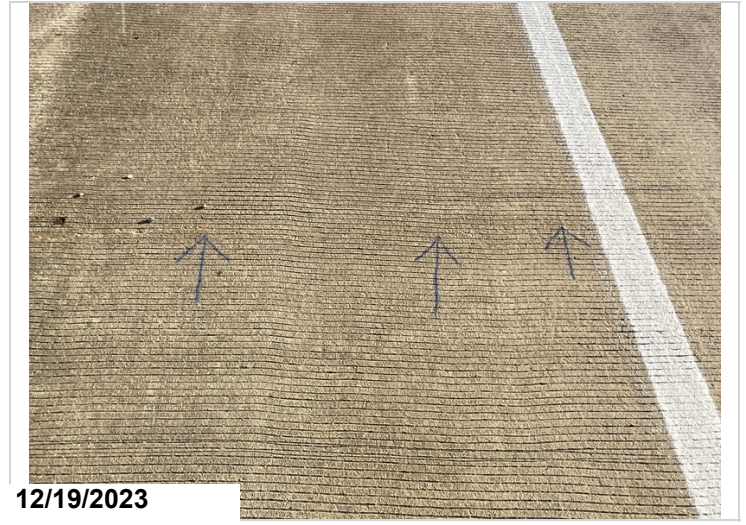
Deck cracking in various locations of deck

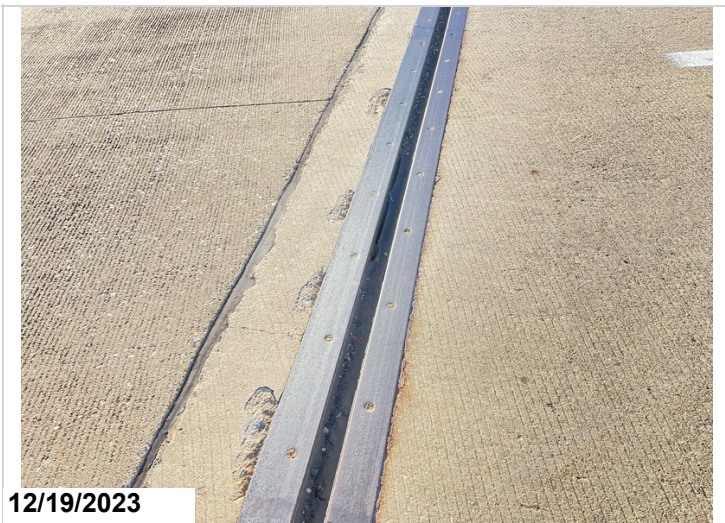
3' of joint material damage at beginning of bridge

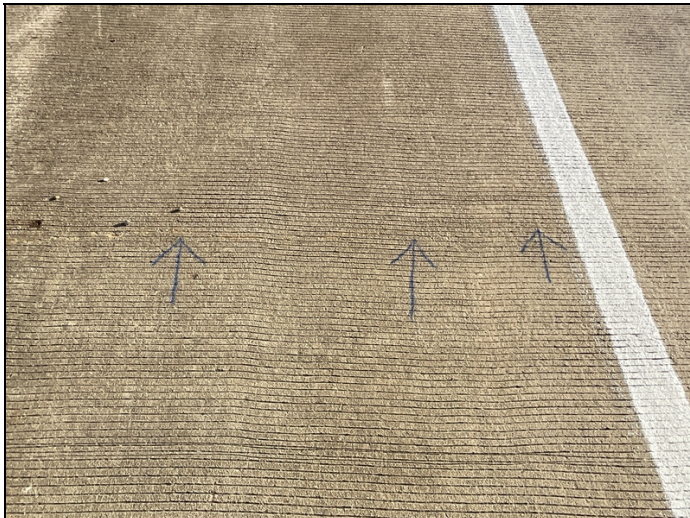
Sealable deck cracking is present throughout all spans.

Deck cracking in various locations of deck

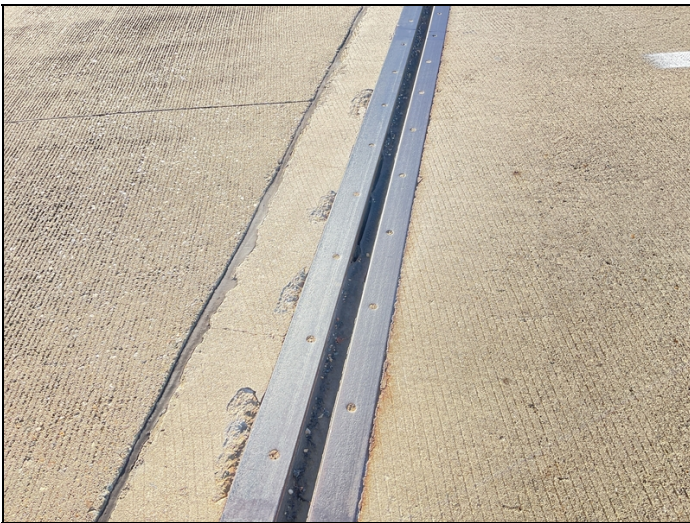
Joint material damage is present at both beginning and end of bridge.

3' of joint material damage at beginning of bridge
