Bridge A6816 Inspection Report

Asset #A6816(Routine)

S.H.151 S.BND-0.95 over LINE FERRY RD.

Team Lead: Jared Kegley Inspection Date: 08/14/2024

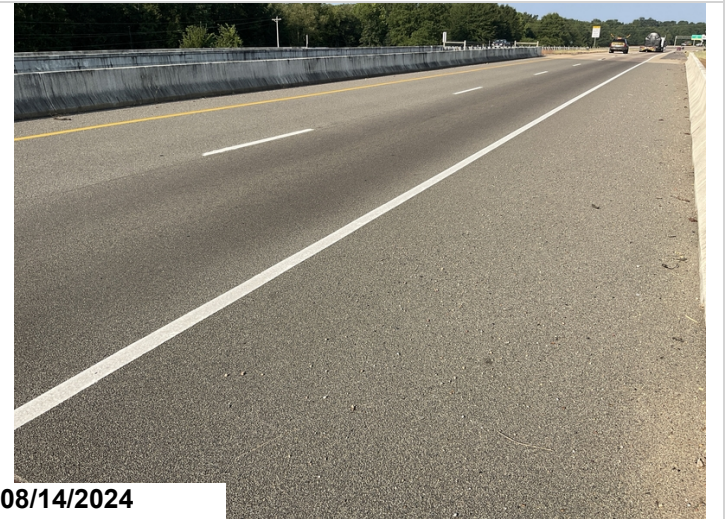
Deck is rated a 7 this inspection due to deck cracking that is located on the driving surface of the bridge deck has been sealed with a polymer overlay prior to this inspection, but both the right and left overhangs throughout all spans have various locations of cracking with efflorescence.

Deck photo, Driving surface

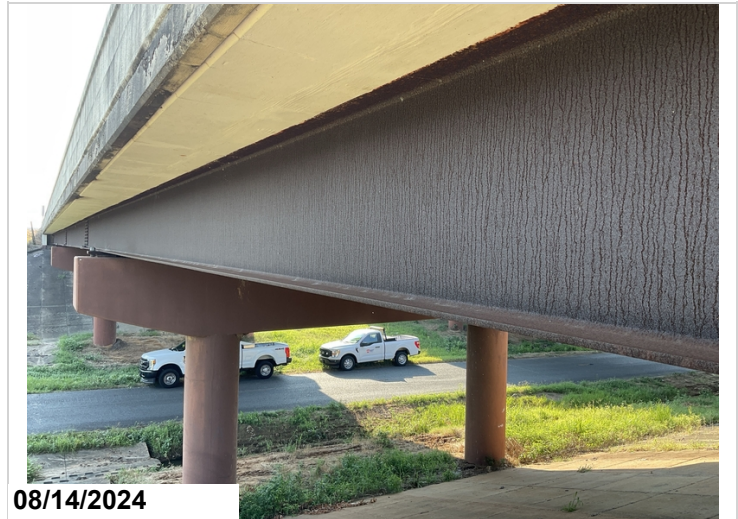
The superstructure rating is an 8 this inspection due to no noteworthy defects being located to superstructure elements. The weathering steel beams are weathering properly per this inspection.

Steel beam photo

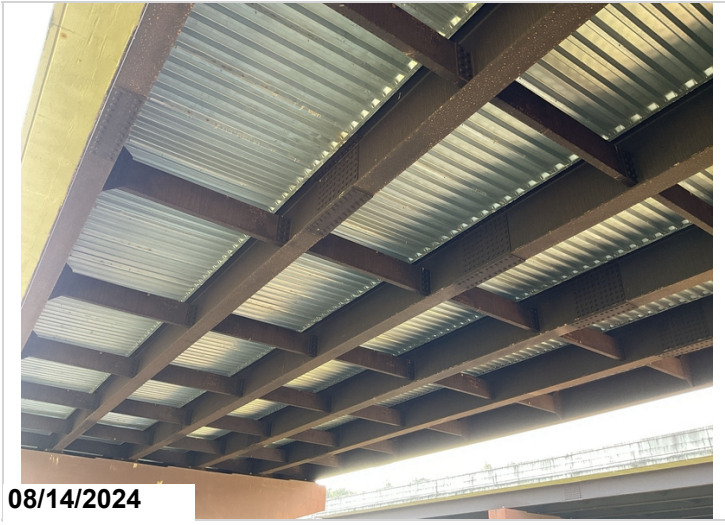
Steel beam photo

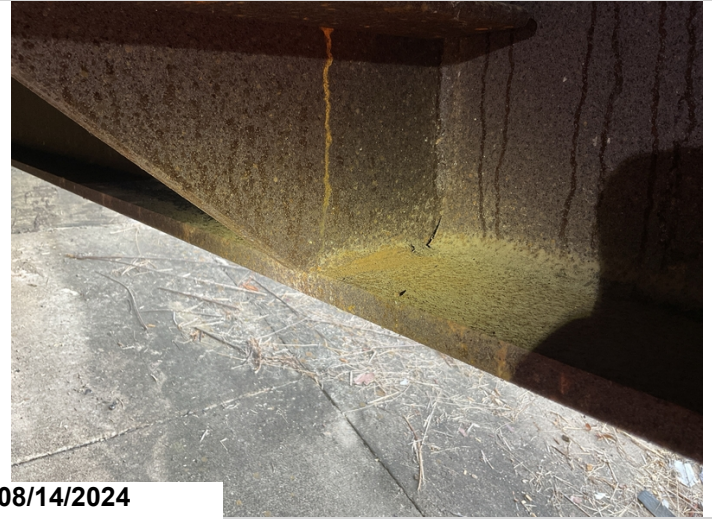
Both outside steel beams have welded connections on diaphragms.

Both outside steel beams, Welded connections on diaphragms

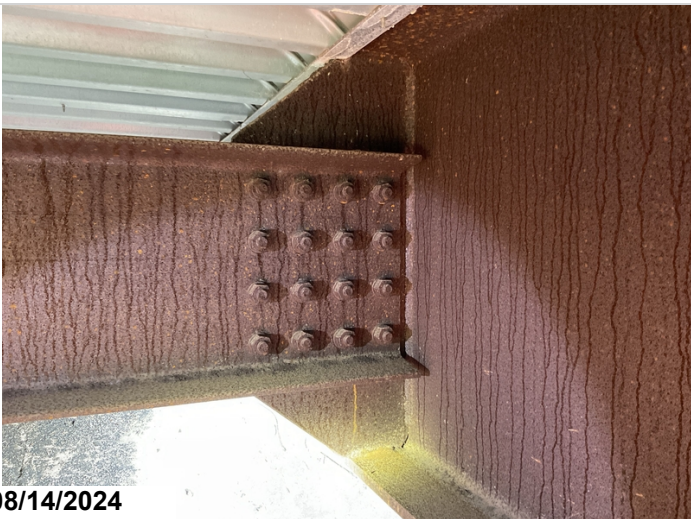
Both outside steel beams, Welded connections on diaphragms

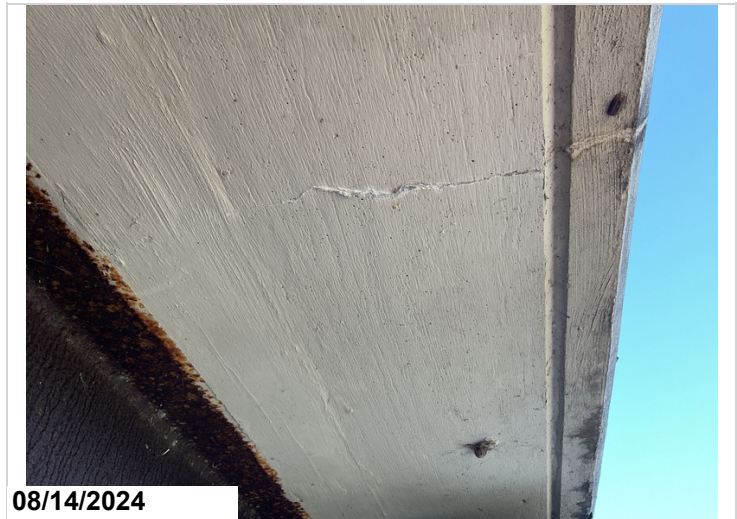
(12) Concrete bridge deck, Undersurface, Both right & left overhangs, Cracking with Efflorescence, CS2, 35 SF.							
Concrete bridge deck, Driving surface, Cracking has been sealed per polymer overlay added per this inspection.							
(1130-12) 08/22 Small to mid size cracking in deck Various locations							
(510-12) Concrete bridge deck, Driving surface, Cracking has been sealed per polymer overlay added per this inspection.							
107	Steel Open Girder/Beam	LF	1082	1082	0	0	0
515	Steel Protective Coating	SF	9113	9113	0	0	0
205	Reinforced Concrete Column	EA	4	4	0	0	0
215	Reinforced Concrete Abutment	LF	124	119	5	0	0
1130	Cracking (RC and Other)	LF	5	0	5	0	0

Deck, Undersurface, Efflorescence is found in various locations on both right and left overhangs, CS2

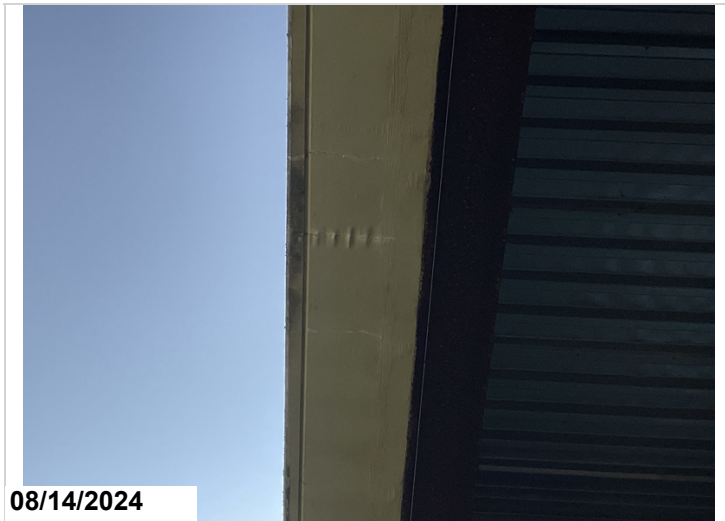
Deck, Undersurface, Efflorescence is found in various locations on both right and left overhangs, CS2

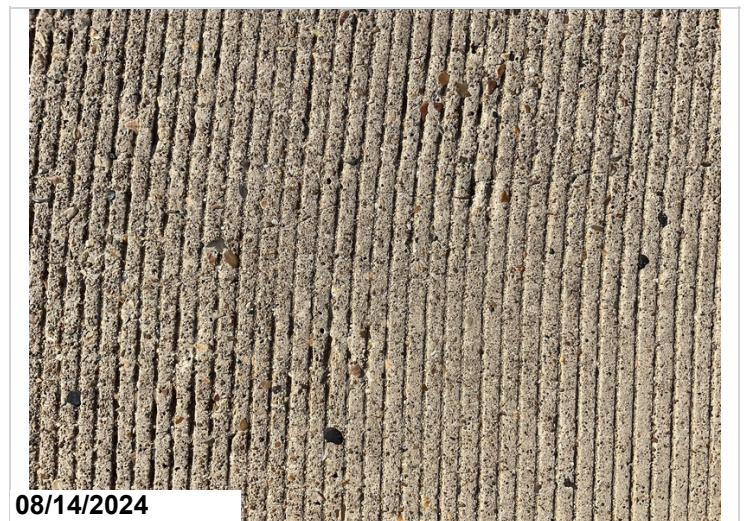
(321) Concrete approach slab, Both beginning & end of bridge, Cracking is located in various locations, CS2, 35 SF.							
Concrete approach slab, Beginning of bridge, Patched area where plowable pavement marking was located, CS2, 1 SF.							
331	Reinforced Concrete Bridge Railing	LF	365	325	40	0	0
1130	Cracking (RC and Other)	LF	40	0	40	0	0

End of bridge, Cracking in approach slab, CS2

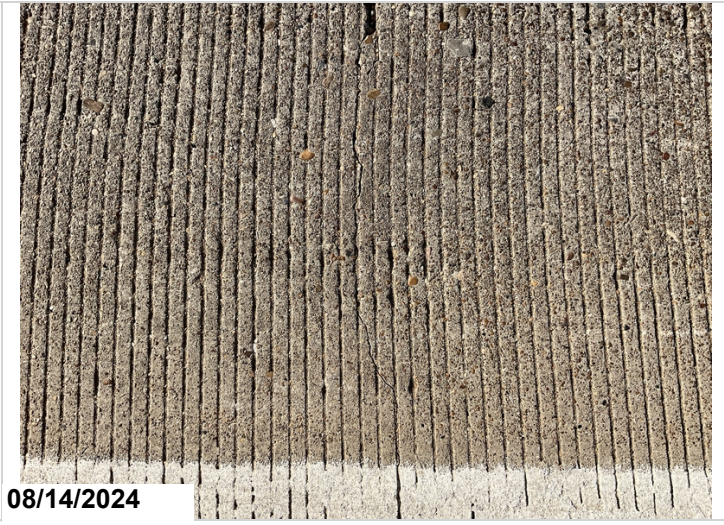
Beginning of bridge, Cracking in approach slab, CS2

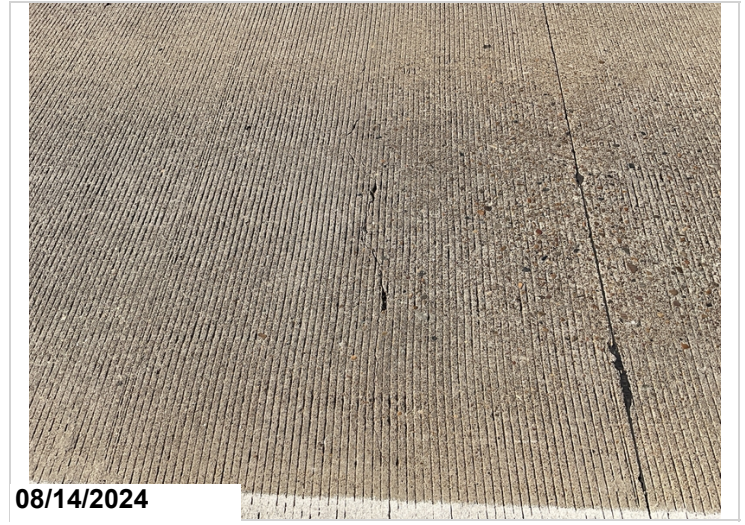
Beginning of bridge, Cracking in approach slab, CS2

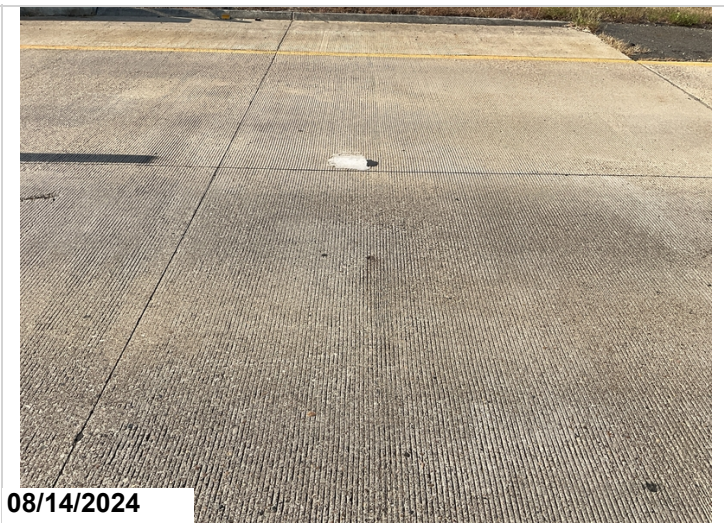
Beginning of bridge, Patched area, CS2

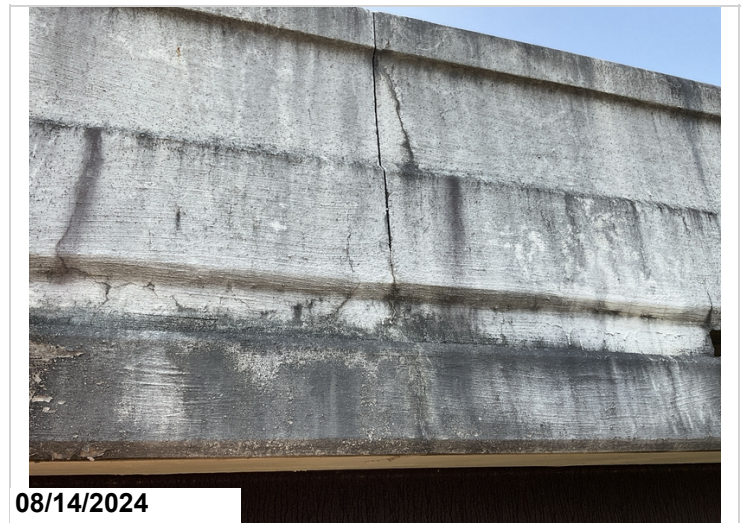
(331) Concrete bridge railing, Both right & left sides throughout all spans, Cracking, CS2, 40 LF

Concrete bridge railing, Both right and left sides, Cracking, CS2
