Bridge B6816 Inspection Report

Team Lead: Jared Kegley, Inspection Date: 08/14/2024

S.H.151 N.BND-0.95 over LINE FERRY RD.

Location: 1.01 MI.E. OF TEX.ST.LINE

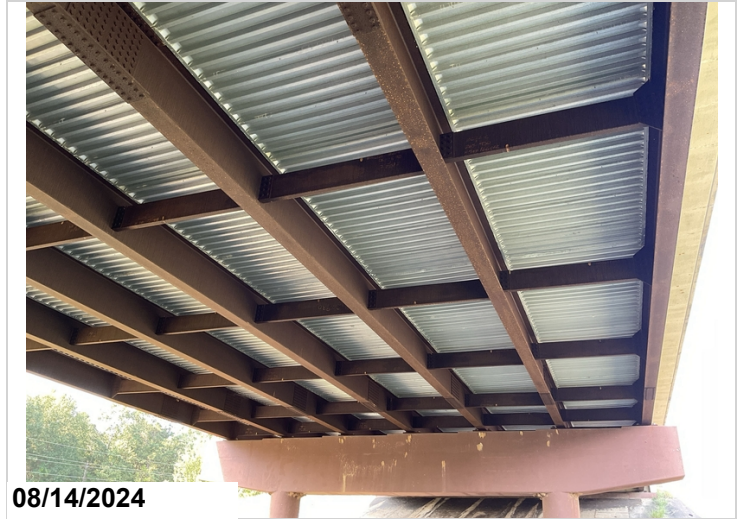
Steel beam photo

The superstructure rating is an 8 this inspection due to no noteworthy defects being located to superstructure elements. The weathering steel beams are weathering properly per this inspection.

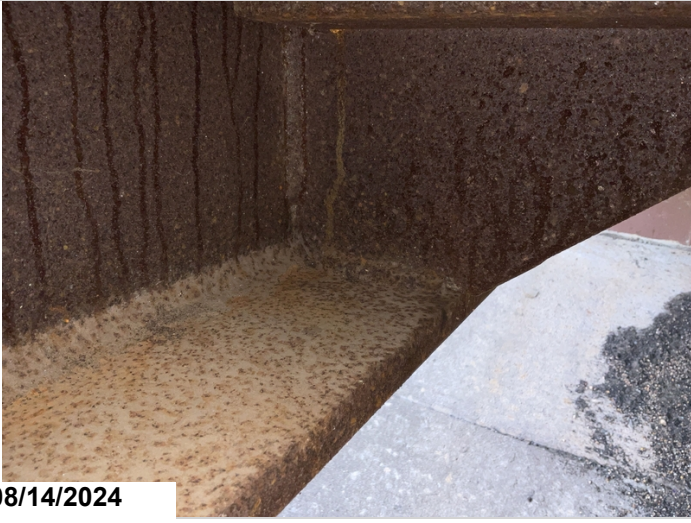
Both outside beams have welded connections at diaphragms.

Both outside beams, Welded connections at diaphragms

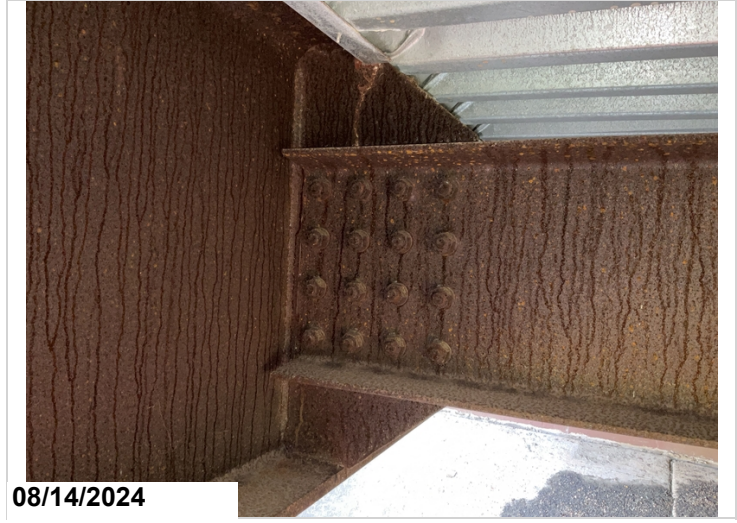
Both outside beams, Welded connections at diaphragms

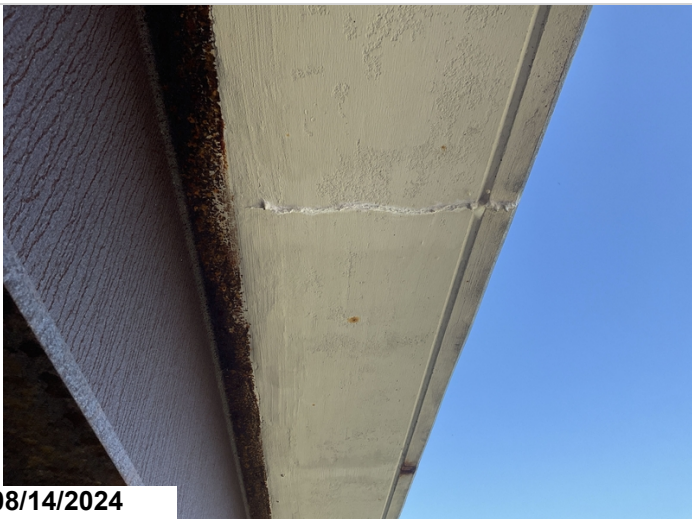
The deck rating is a 7 this inspection due to minor problems being present on the driving surface as well as the overhangs. The deck cracking that is located on the driving surface of the bridge deck has been sealed with a polymer overlay prior to this inspection. Both the right and left overhangs throughout all spans have various locations of minor efflorescence.

(12) Concrete bridge deck, Undersurface, Both right & left overhangs, Efflorescence, CS2, 40 Sq Ft							
(510-12) Concrete bridge deck, Driving surface, Cracking has been sealed per polymer overlay added per this inspection.							
107	Steel Open Girder/Beam	LF	1263	1263	0	0	0
515	Steel Protective Coating	SF	10632	10632	0	0	0

Deck, Undersurface, Efflorescence is present in various locations on both right and left overhangs, CS2

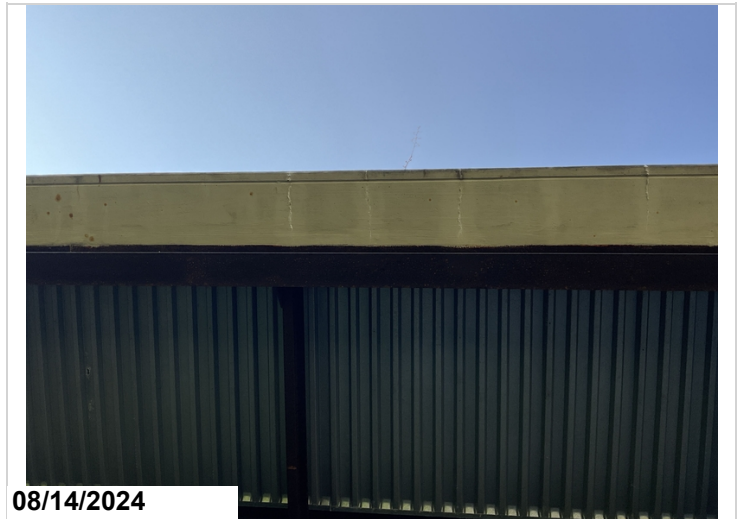
Deck, Undersurface, Efflorescence is present in various locations on both right and left overhangs, CS2

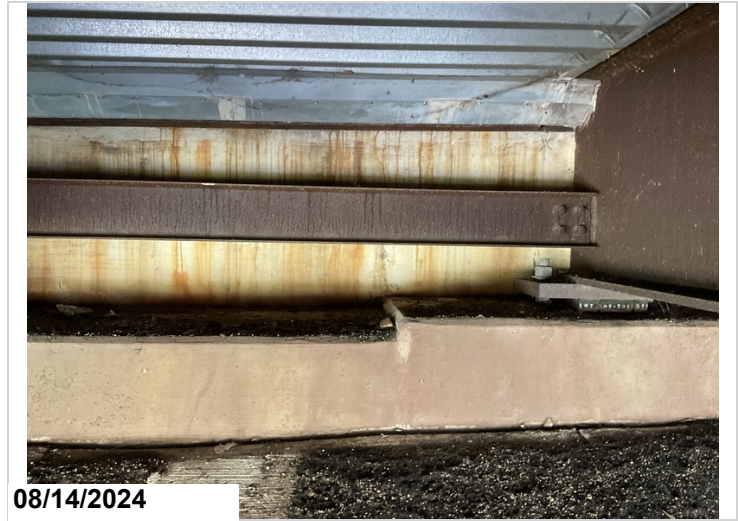
The substructure rating is a 7 this inspection due to various locations of cracking found throughout both the bents 1 & 4 abutments as well as throughout the concrete pier caps at intermediate bents 2 & 3.

(215) Bent 1 abutment, Cracking is located throughout various locations of the backwall, CS2, 2 LF							
Bent 4 abutment, Cracking is located throughout various locations of the backwall, CS2, 5 LF							
234	Reinforced Concrete Pier Cap	LF	108	105	3	0	0
1130	Cracking (RC and Other)	LF	3	0	3	0	0

Bent 1 abutment, Cracking in backwall, CS2

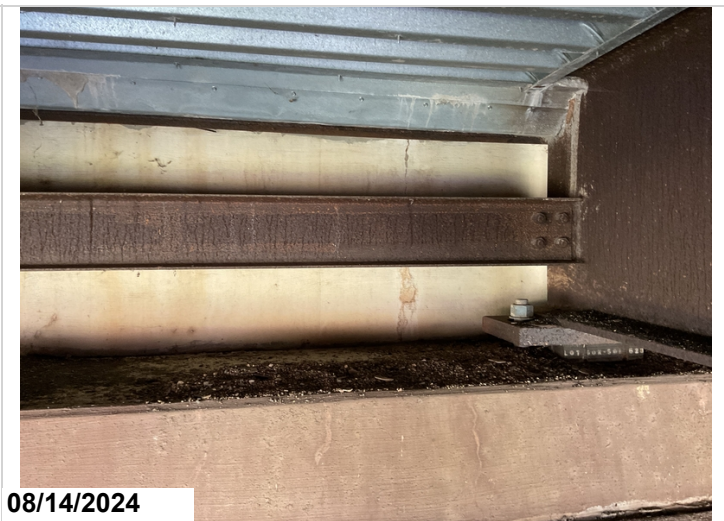
Bent 4 abutment, Cracking in backwall, CS2

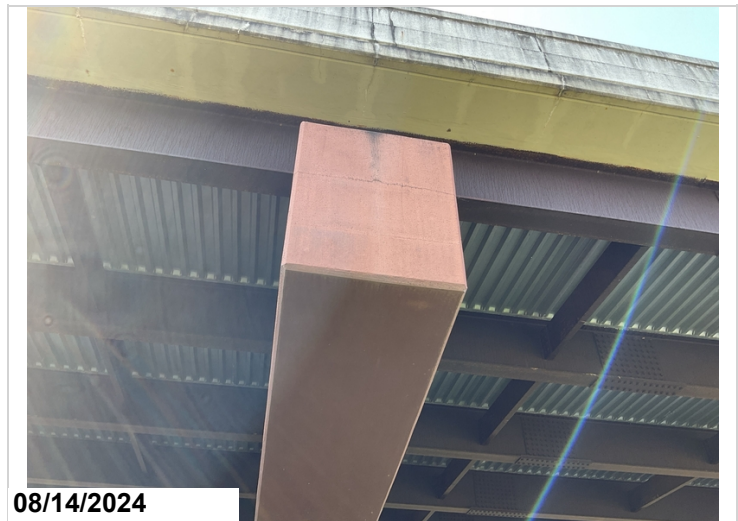
(234) Concrete pier caps, Bents 2 & 3, Various locations of cracking, CS2, 3 LF							
302	Compression Joint Seal	LF	108.5	106.5	0	2	0
2330	Seal Damage	LF	2	0	0	2	0

Bents 2 and 3 caps, Various locations of cracking, CS2

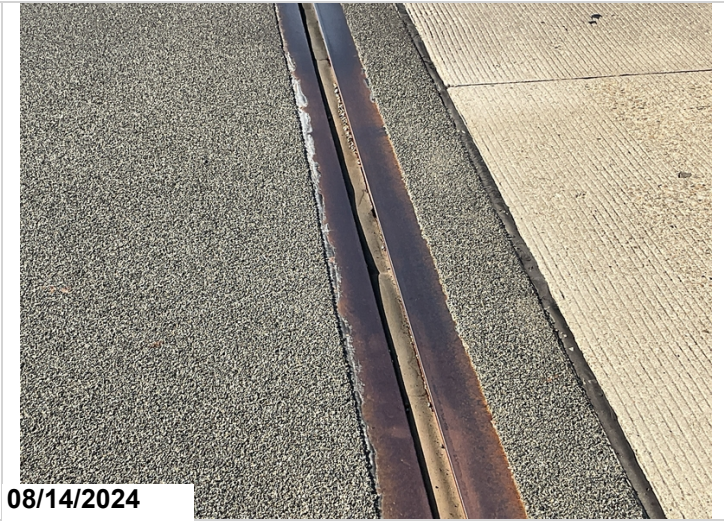
(302) Compression joint seal, Beginning of bridge, Various locations of joint damage, CS3, 2 LF							
310	Elastomeric Bearing	EA	28	28	0	0	0
(310) 8/22 bearings are in good shape							
321	Reinforced Concrete Approach Slab	SF	3500	3499	1	0	0
1080	Delamination/Spall/Patched Area	SF	1	0	1	0	0

Beginning of bridge, Joint damage, CS3

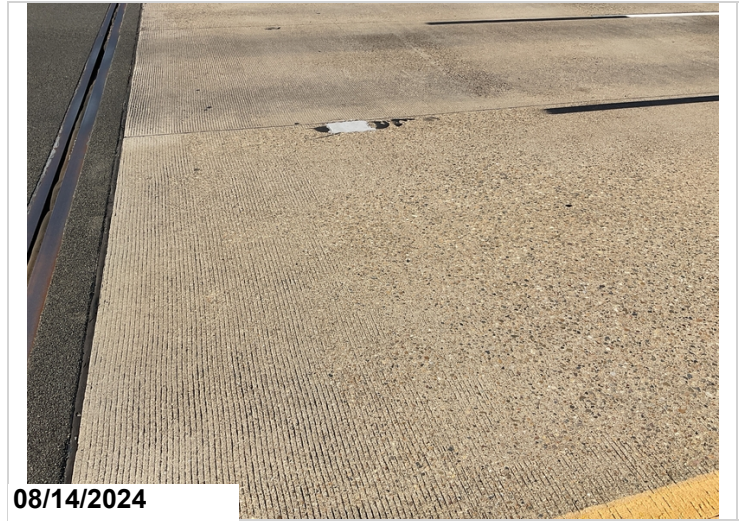
(321) Concrete approach slab, Beginning of bridge, Patched area where plowable pavement marking was located, CS2, 1 Sq Ft							
331	Reinforced Concrete Bridge Railing	LF	365	335	0	30	0
1130	Cracking (RC and Other)	LF	30	0	0	30	0

Beginning of bridge approach slab, Patched area, CS2

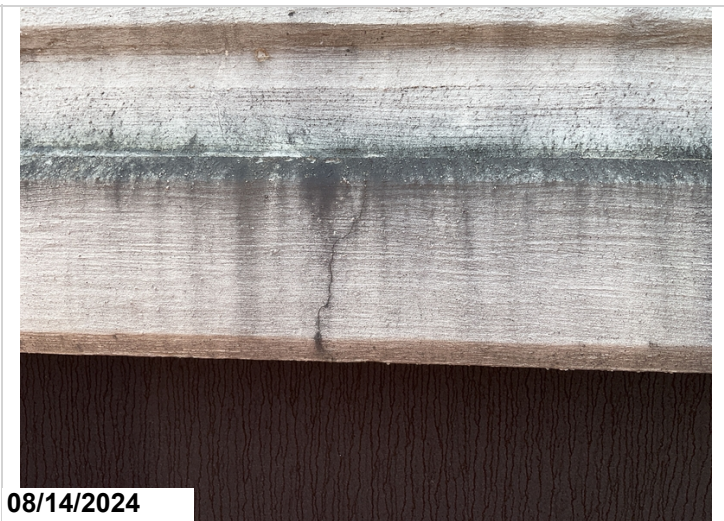
(331) Concrete bridge railing, Both right & left sides throughout all spans, Cracking, CS2, 30 LF

Concrete bridge railing, Cracking on both right and left sides,
CS2
