Bridge Inspection Report

05430
SH 59-Crawford Co.
over
Ar. & Mo. Railroad

02/21/2018 - EJW, JRT & TML - Routine Inspection conducted on this date. Underclearance verified at this inspection.

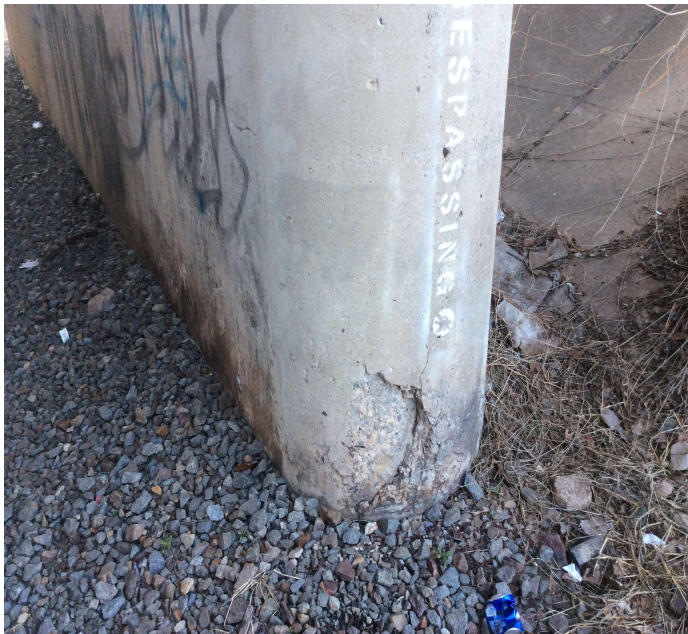
Substructure. The Base of Bent # 2 columns.

The base of Bent # 2 Columns # 1 & 3 have spalling and delaminated concrete that does not expose reinforcing steel.

PHOTO 1 Description Spalling at the East column base is approx. 2" deep and 12" tall. Sounding indicates that there is 12" of additional delamination of concrete above the spall.

Work Code: Repair

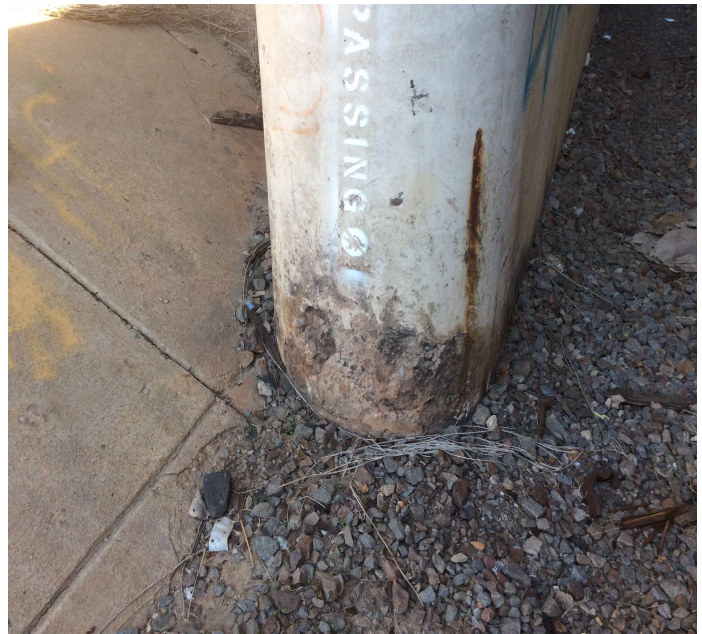
PHOTO 2 Description Spalling at the West column base is approx. 1" deep and 14" tall.

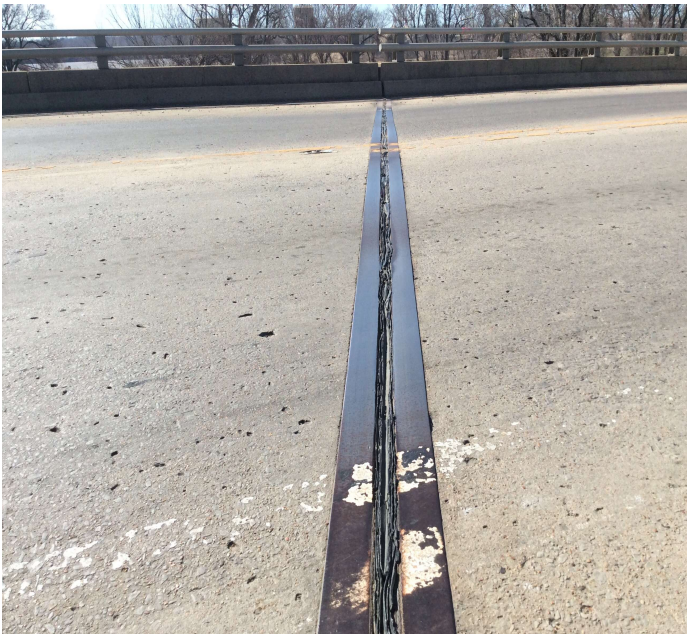
The compression deck joint seals have rips, tears and leak water and debris on the bent caps.

PHOTO 1 Description The compression deck joint seals have rips, tears and leak on the bent caps.

Work Code: Replace

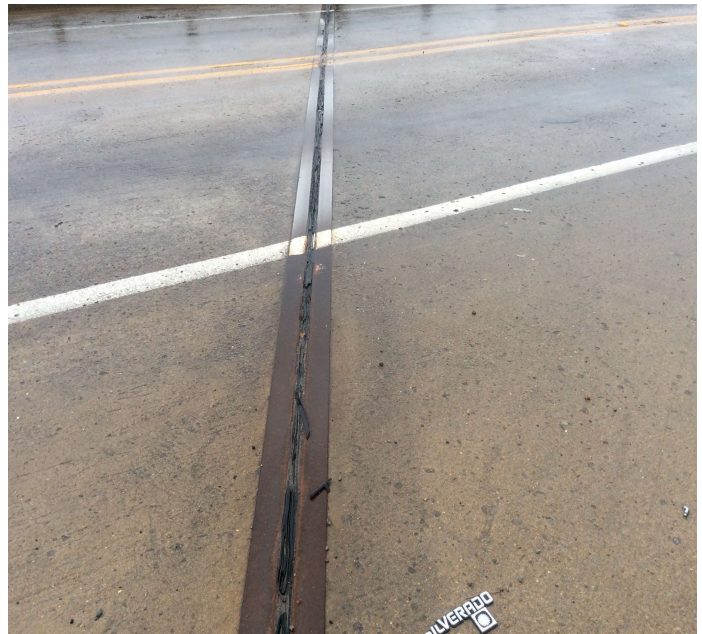
PHOTO 2 Description Typical compression joint seals.

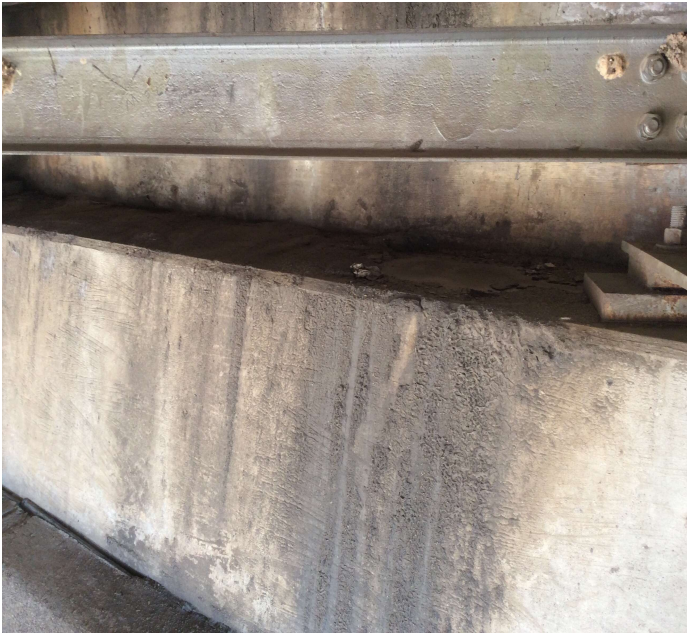
PHOTO 1 Description Dirt accumulation on Bents # 1 & 4 cap.

Work Code: Clean

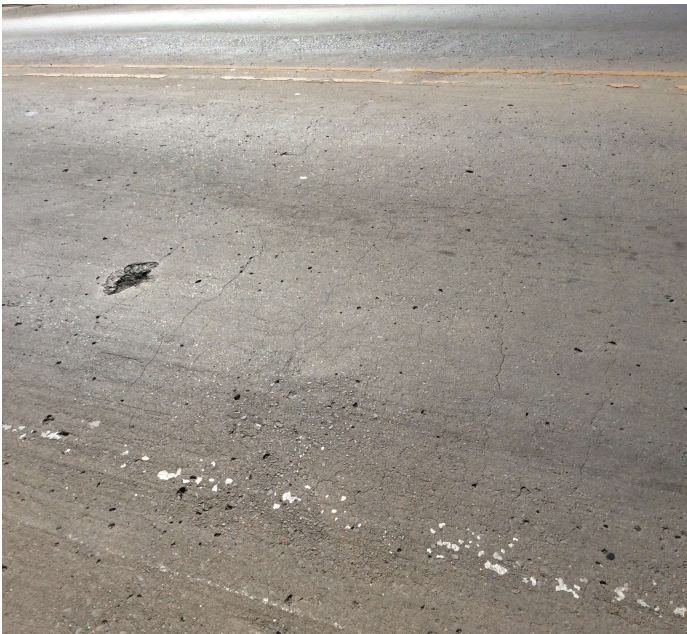
PHOTO 1 Description Minor sealable cracks on the driving surface of the deck.

Work Code: Repair

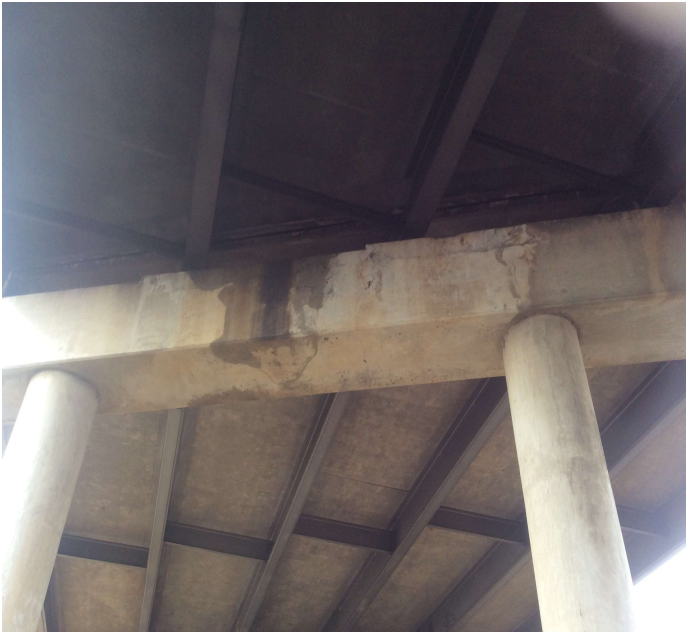
Bent # 2 cap has delaminated concrete and spalling that exposes reinforcing steel on the right end of the cap.

PHOTO 1	Description	Concrete delamination with exposed reinforcing steel on the caps
---------	-------------	--

Work Code: Repair
