Bridge Inspection Report

05879
SH 373-02- LM 3.64
over
DITCH NO 1

Structure Number: 05879

Facility Carried: SH 373-02- LM 3.64

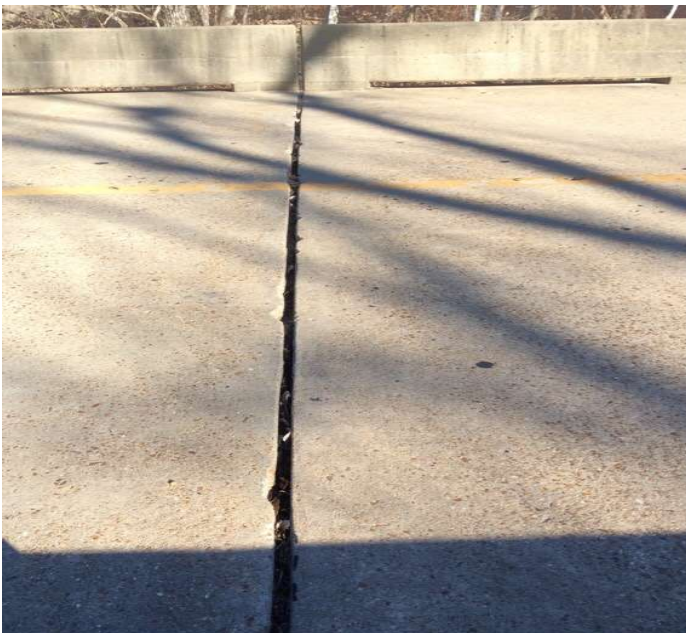
PHOTO 1 Description

Poured joints are separated and/or missing at all spans.

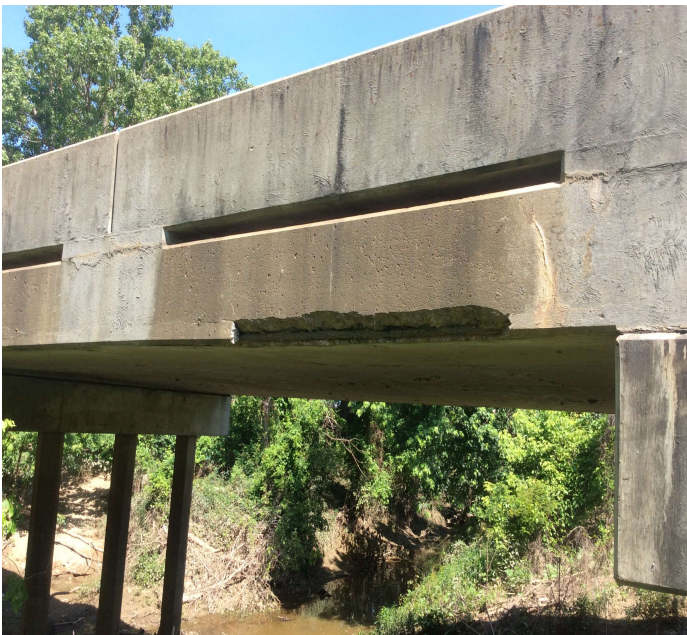
PHOTO 1 Description

Slab soffit has delaminated areas and/or spalls with rebar exposed along Lt and Rt edges.
