Bridge #05360(Routine, Underwater type 2)

State Highway 255 over Sewer Outlet

Location: JCT SH 55 & P STREET

Team Lead: Jeff Jones Inspection Date: April 06, 2022

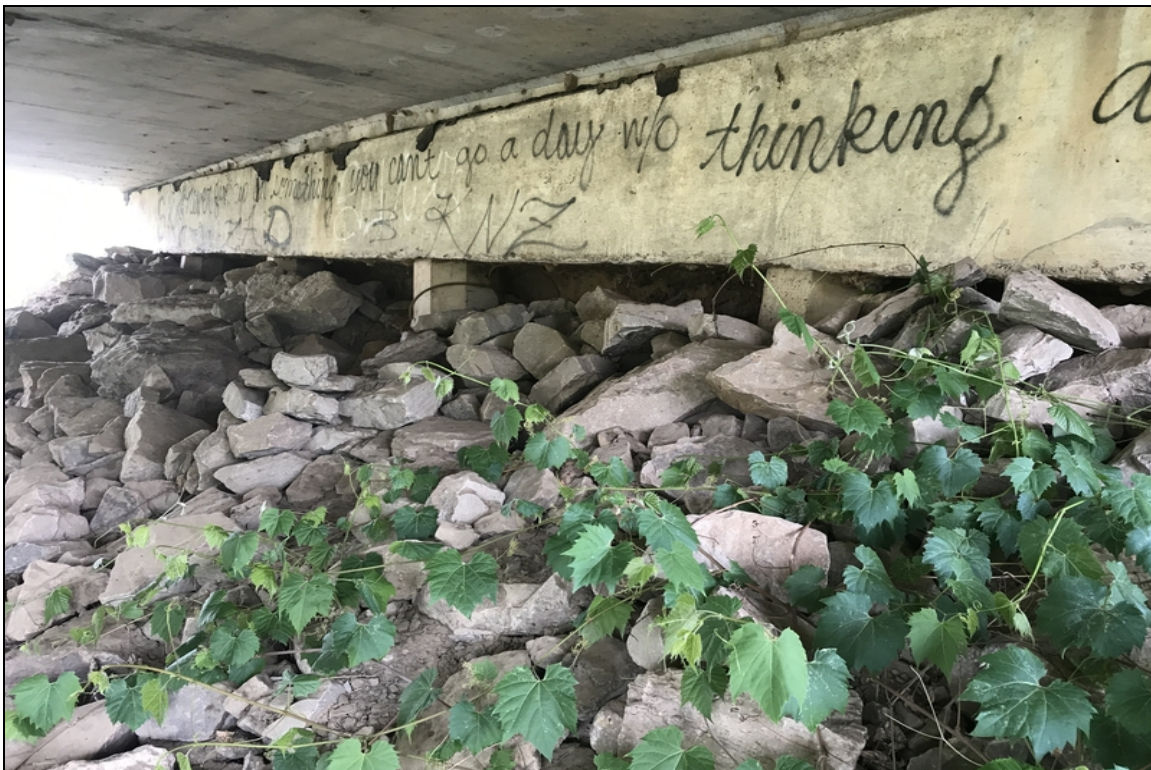
Bent # 1 approach roadway settlement.

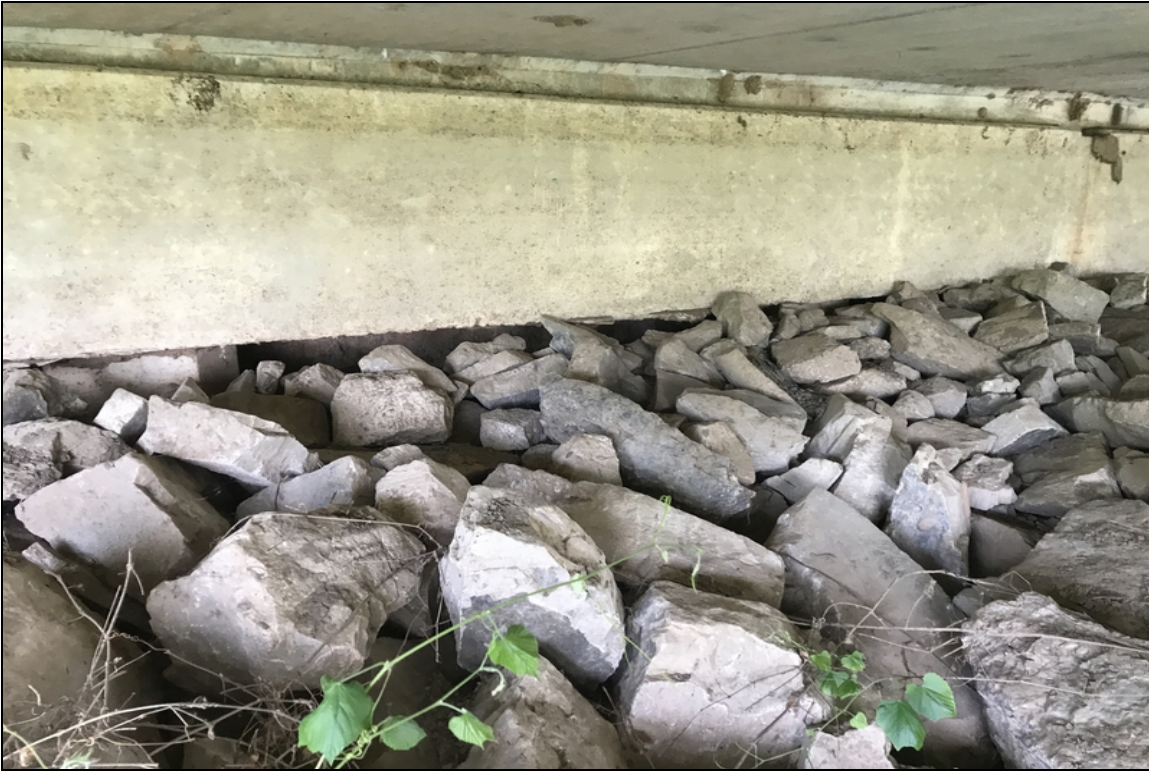
Bent # 4 earth settlement under the abutment cap.

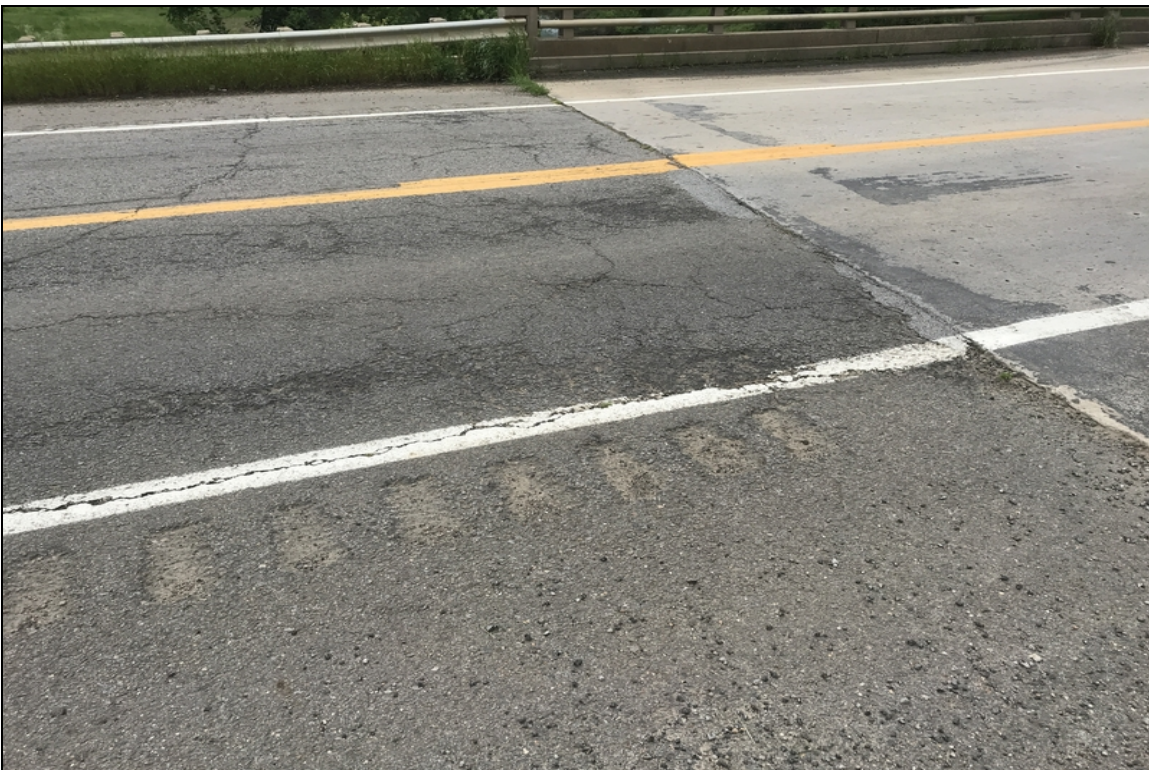
Bent # 1 asphalt settlement.

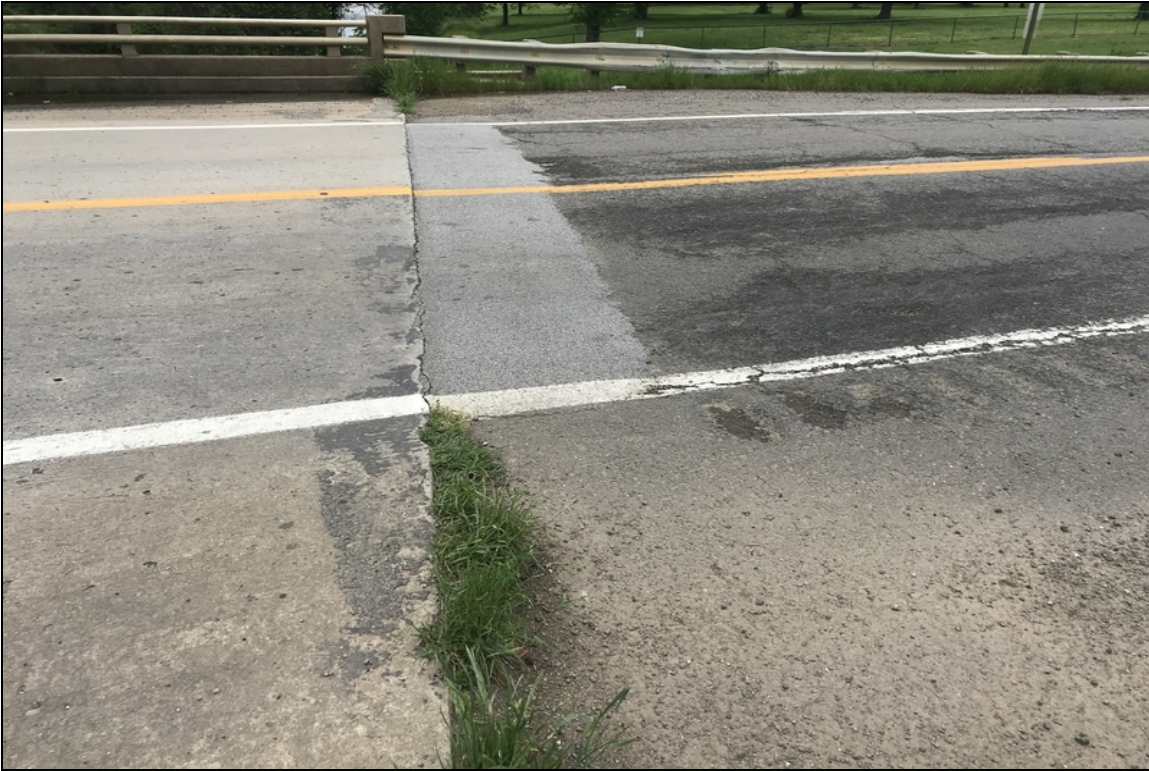
North approach settlement..

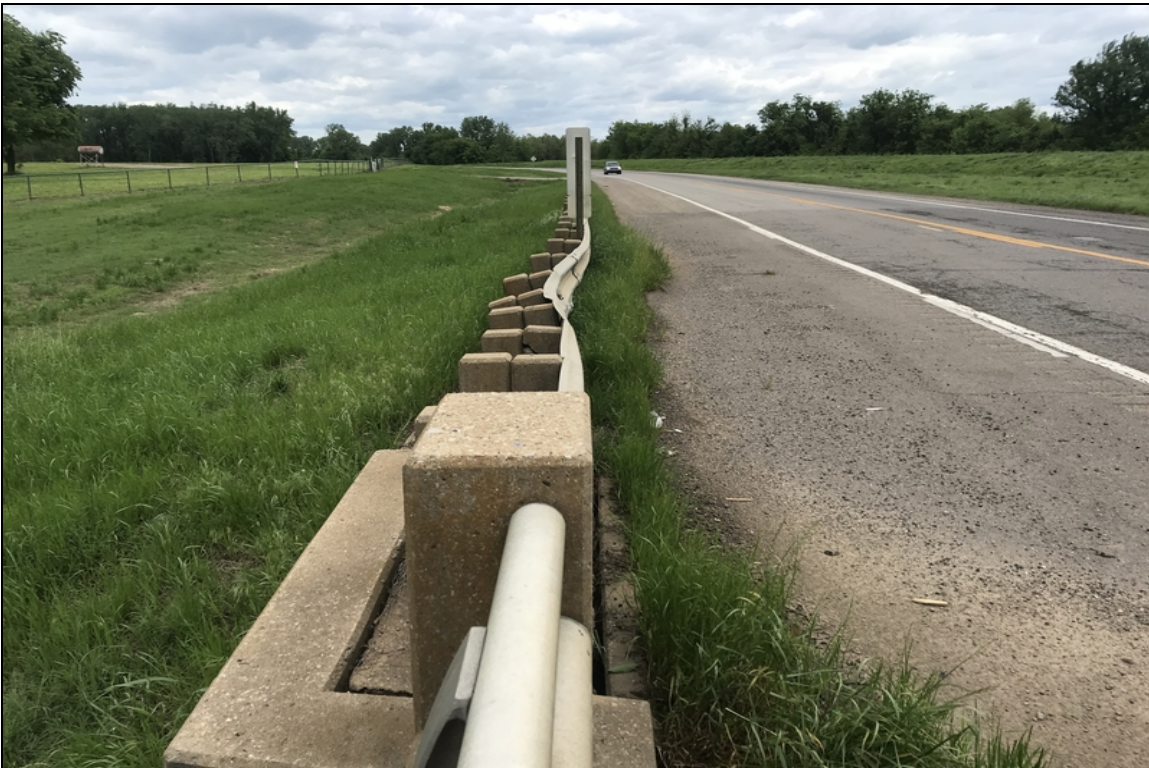
Northwest approach guardrail damage.

The Northwest approach railing has collision damage that has created a "pocket" in the railing and fractured 5 of the concrete posts at the base.

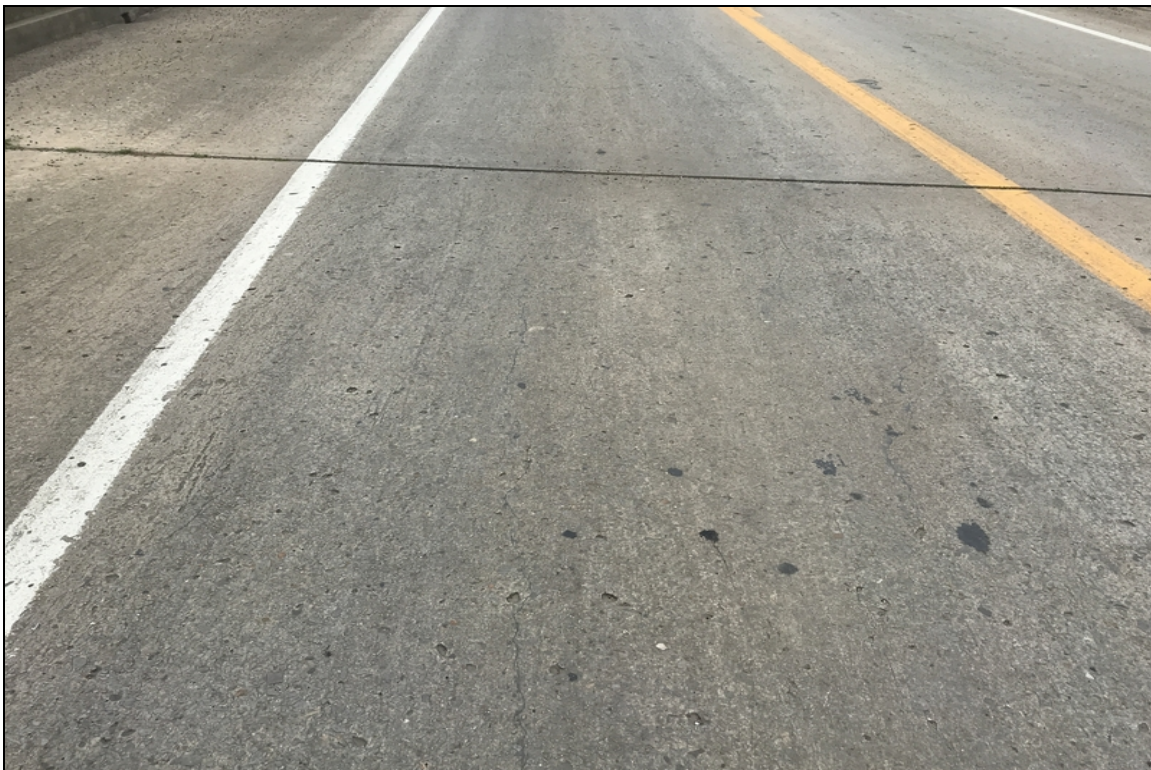
Longitudinal cracking that has been sealed in the past.

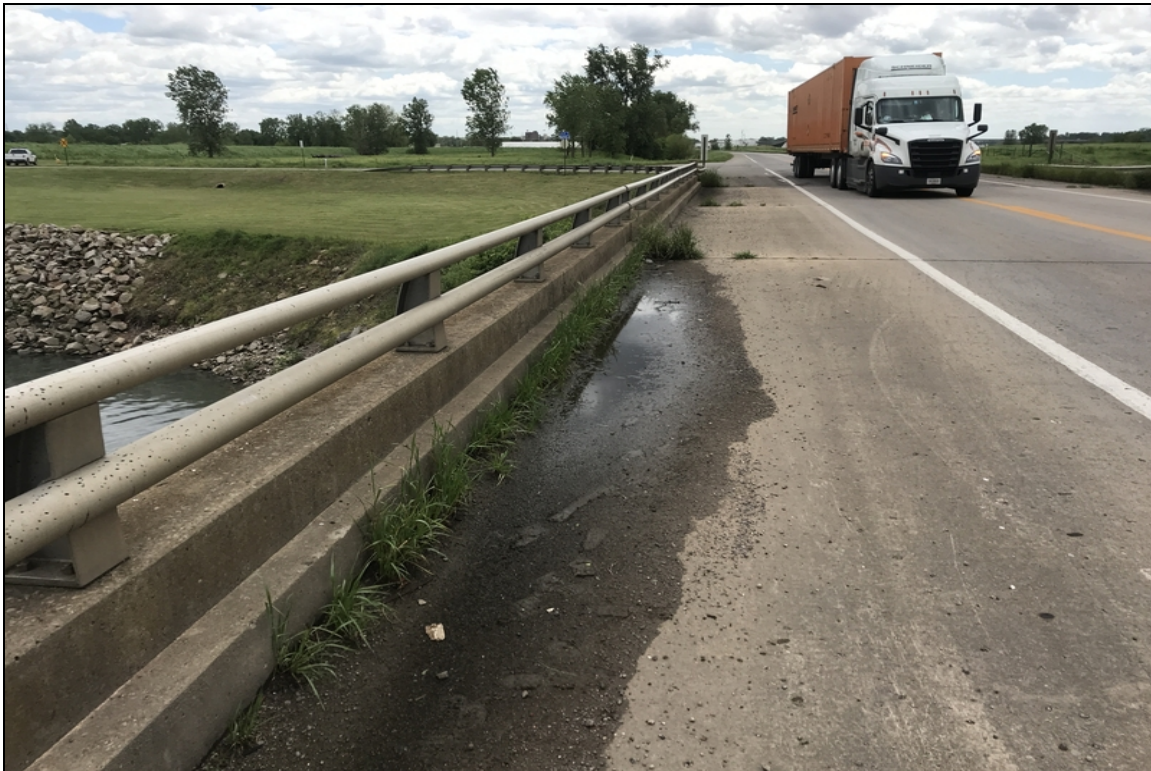
Dirt and debris accumulation in the gutters.

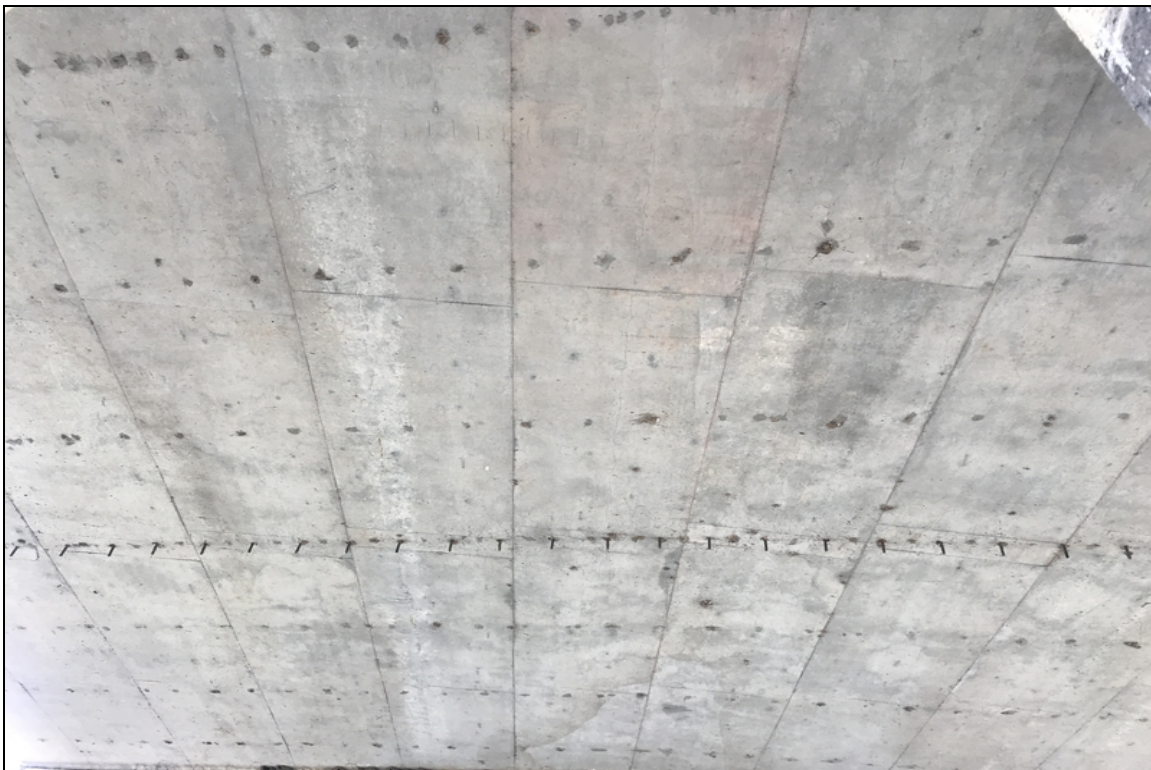
Span # 2 longitudinal cracking visible on the undersurface of the slab.

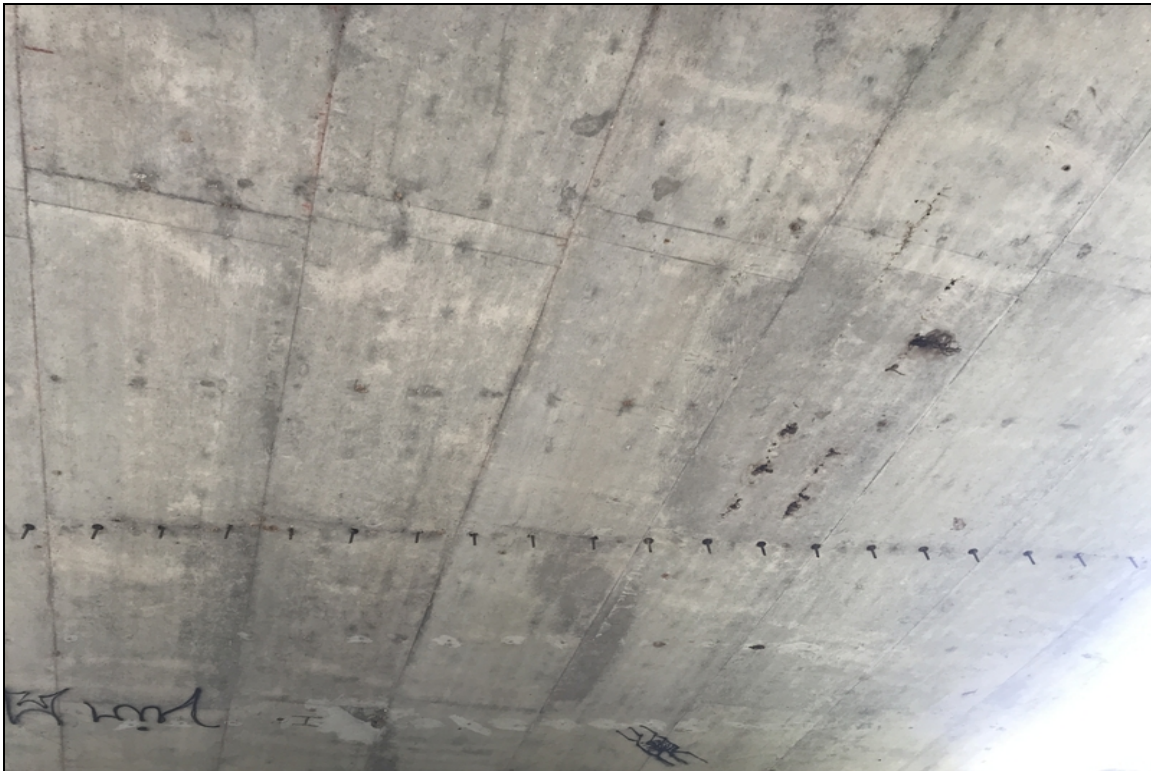
Span # 1 longitudinal cracking with leakage visible from the undersurface of the slab.

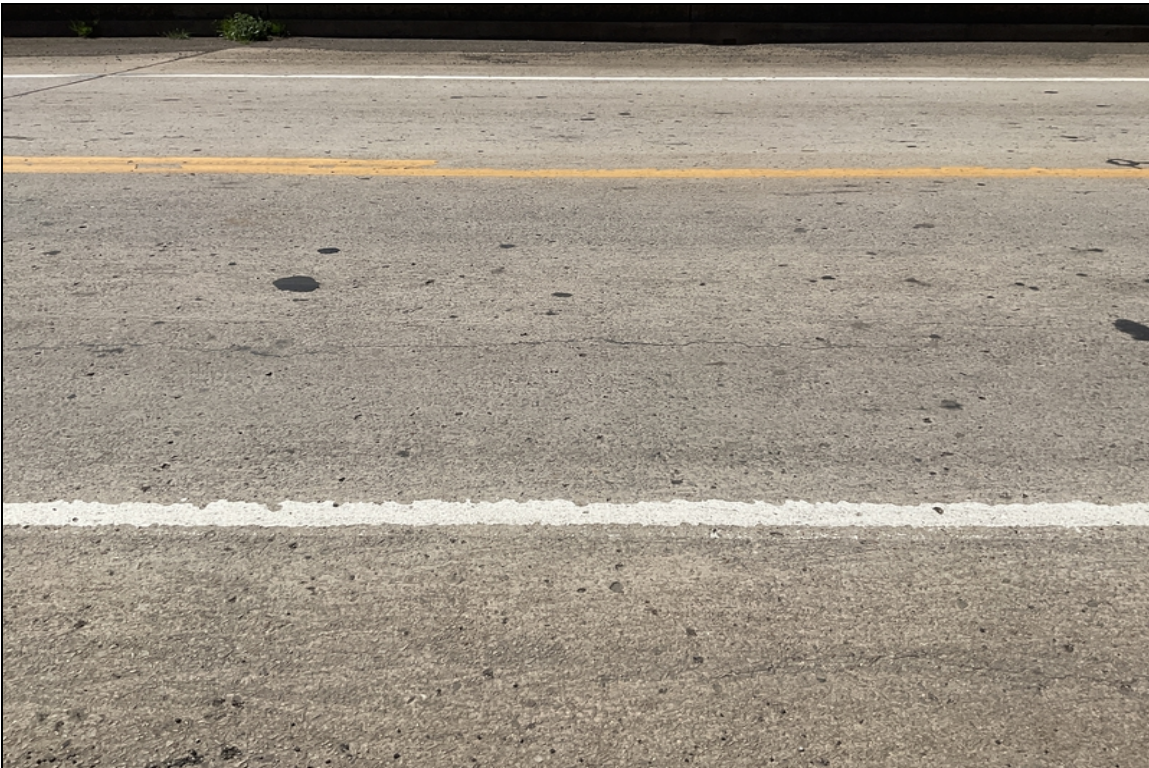
Longitudinal cracking in the deck of Span # 2.

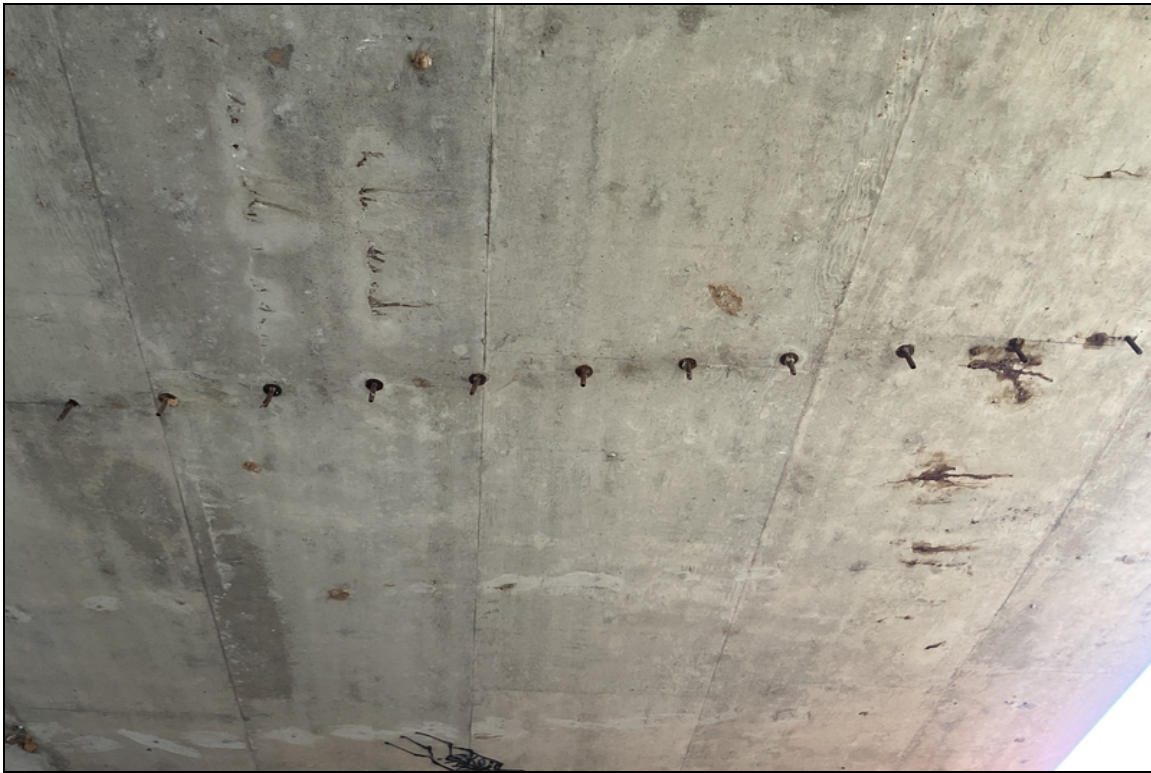
Span # 1 slab soffit has cracking with rust stains.

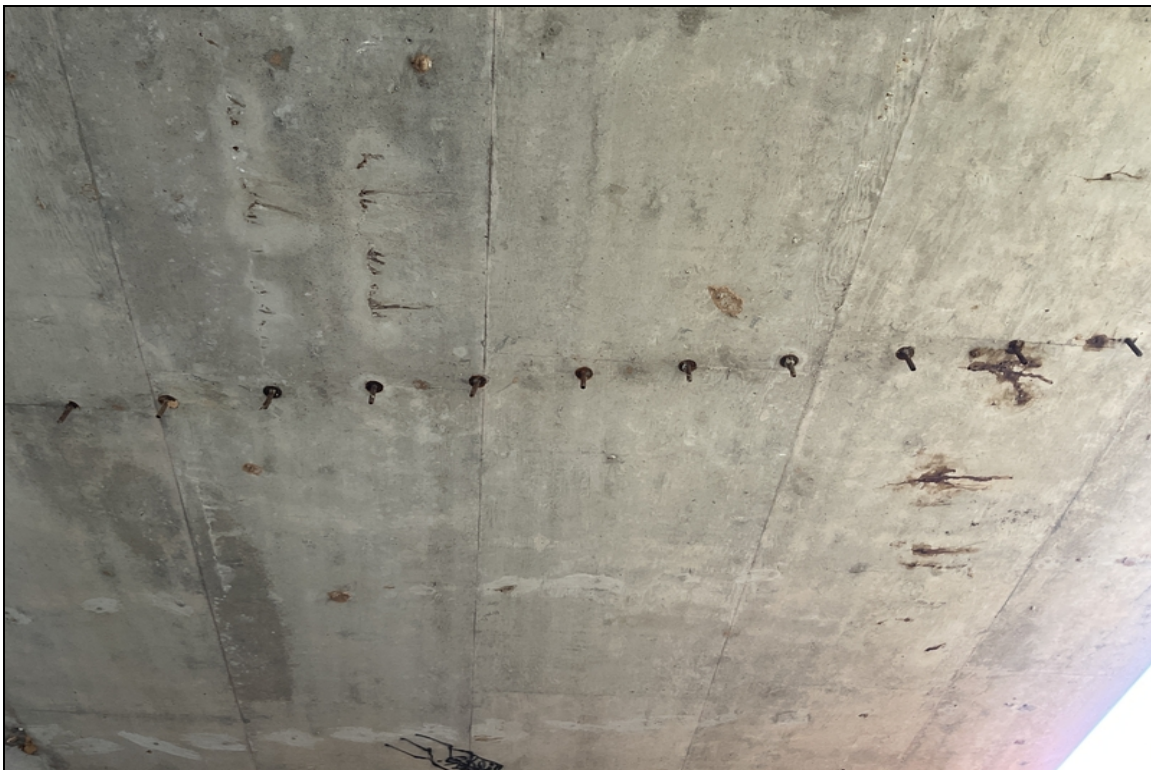
Span # 1 slab soffit has cracking with rust stains.

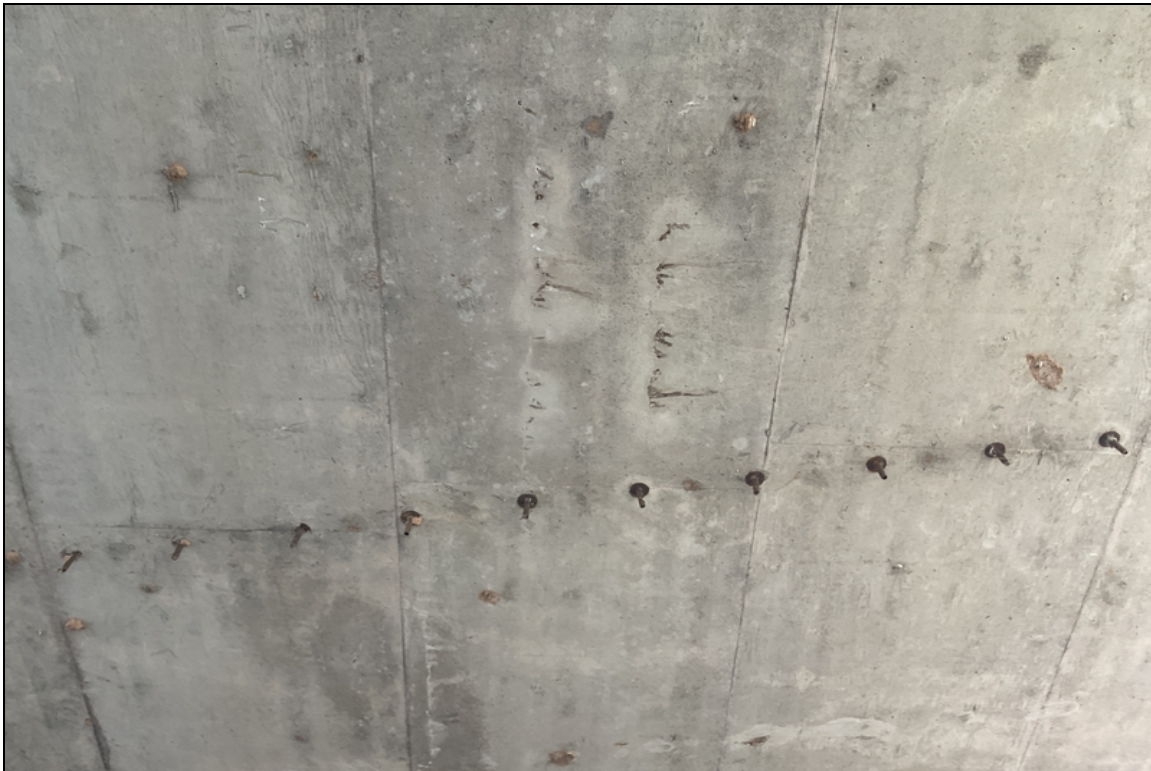
Span # 1 slab soffit with longitudinal cracks and rust stains.

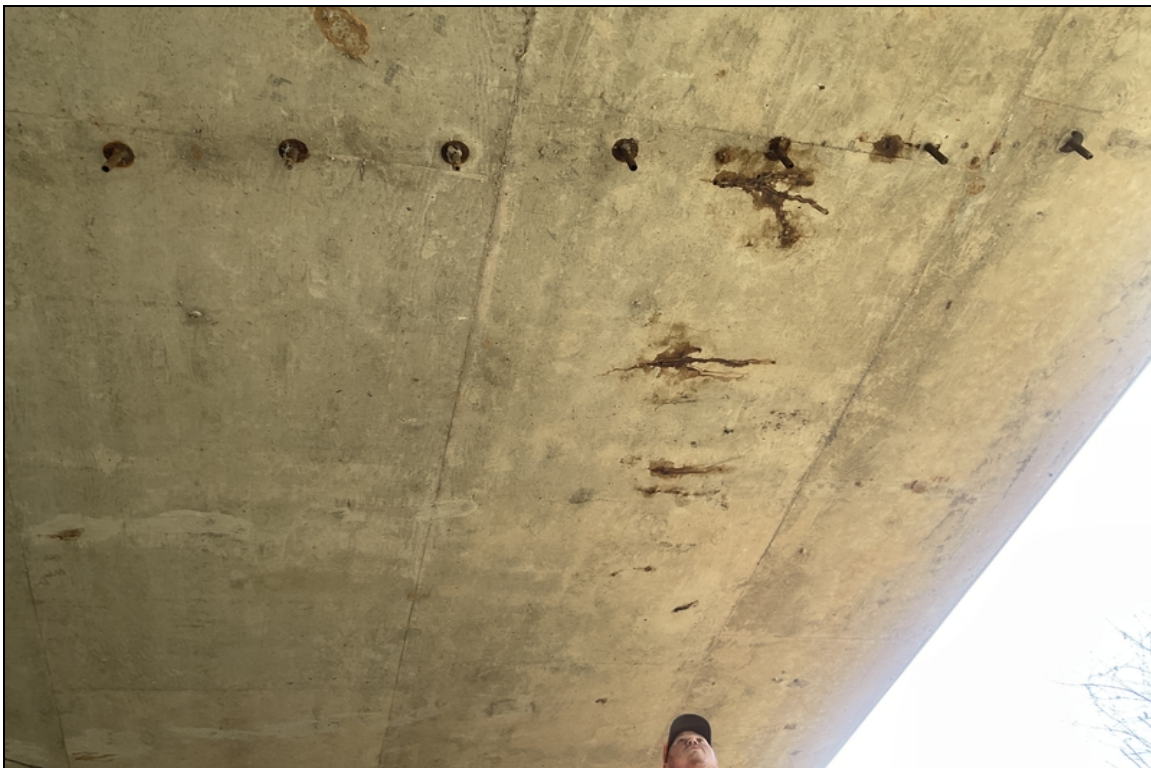
Span # 1 slab soffit with transverse cracks with rust stains.

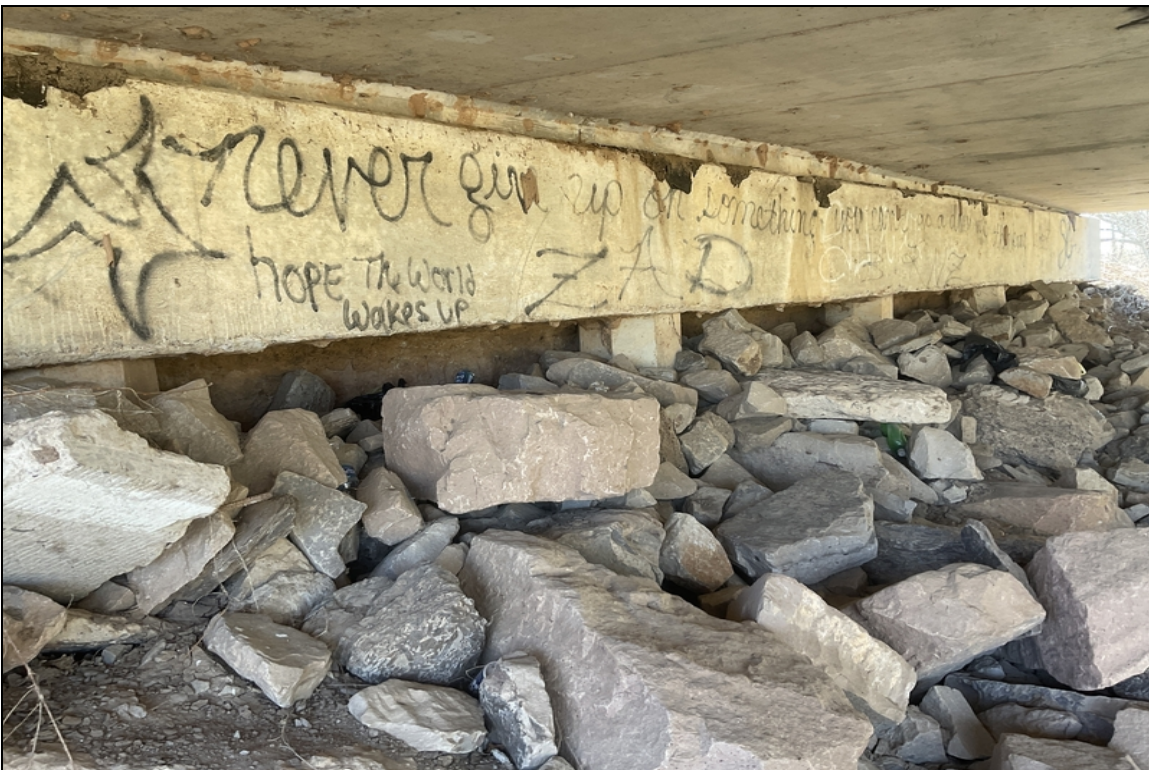
Earth settlement under the South abutment.

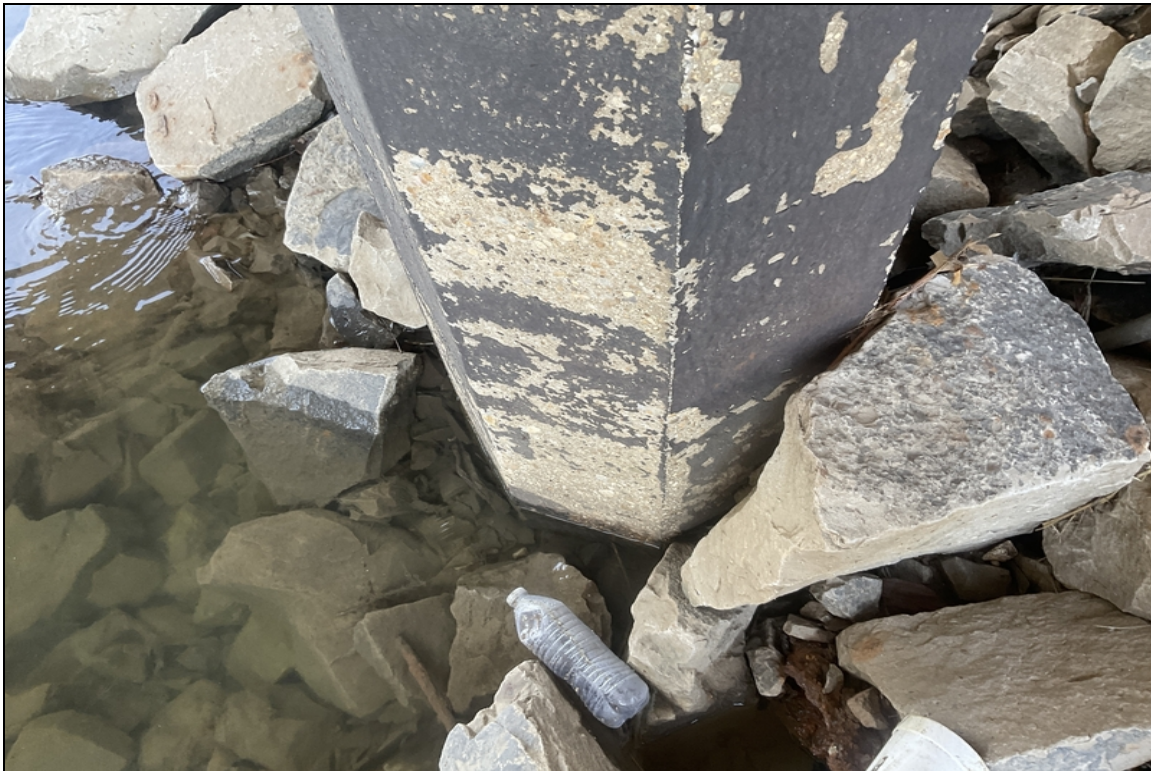
Bent # 3. Piling # 5 typical. -Minor areas with missing tar at the base of the columns.

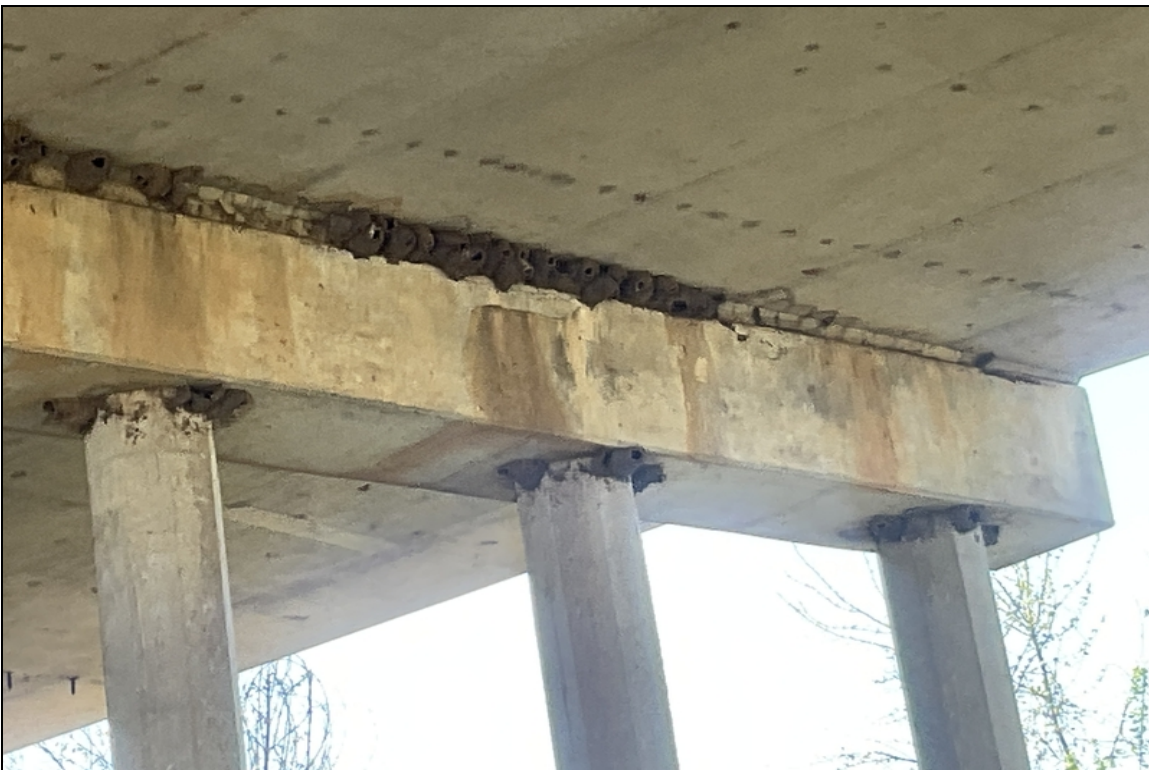
-The ahead side of Bent # 2 cap has two delaminated areas approximately 16" long adjacent to Pile # 2.

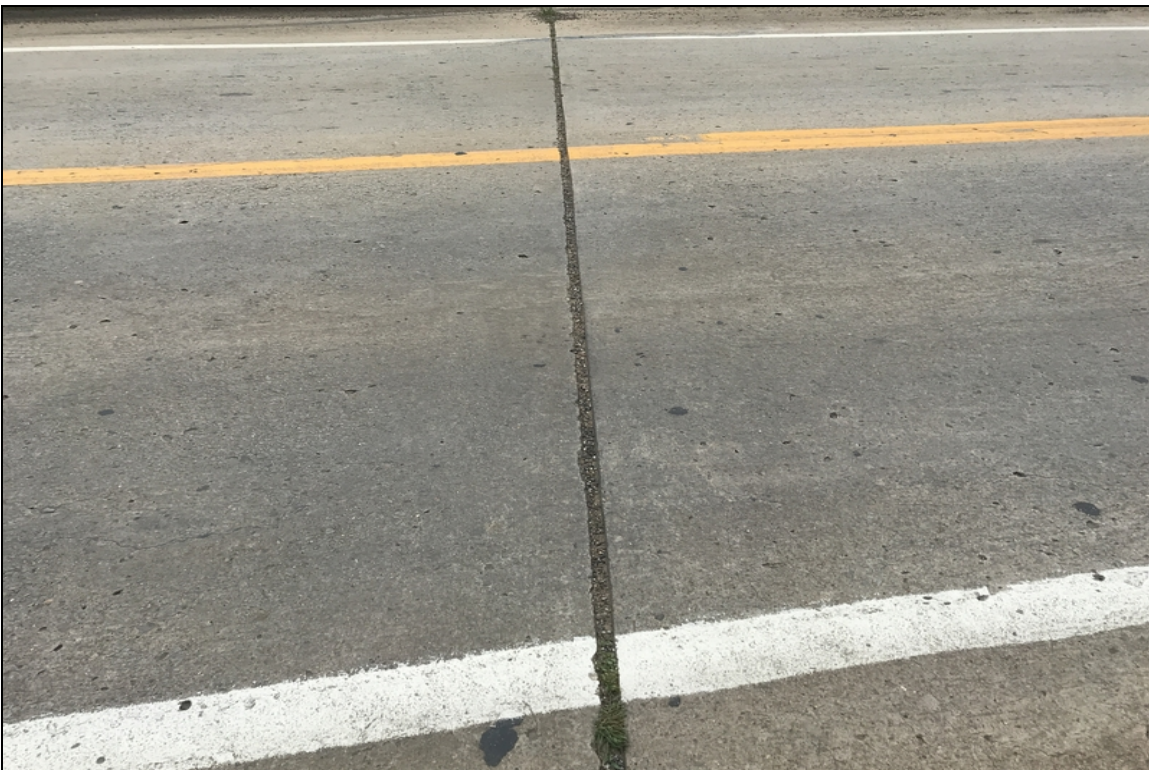
Bent # 2 debris impact in the joint seal.

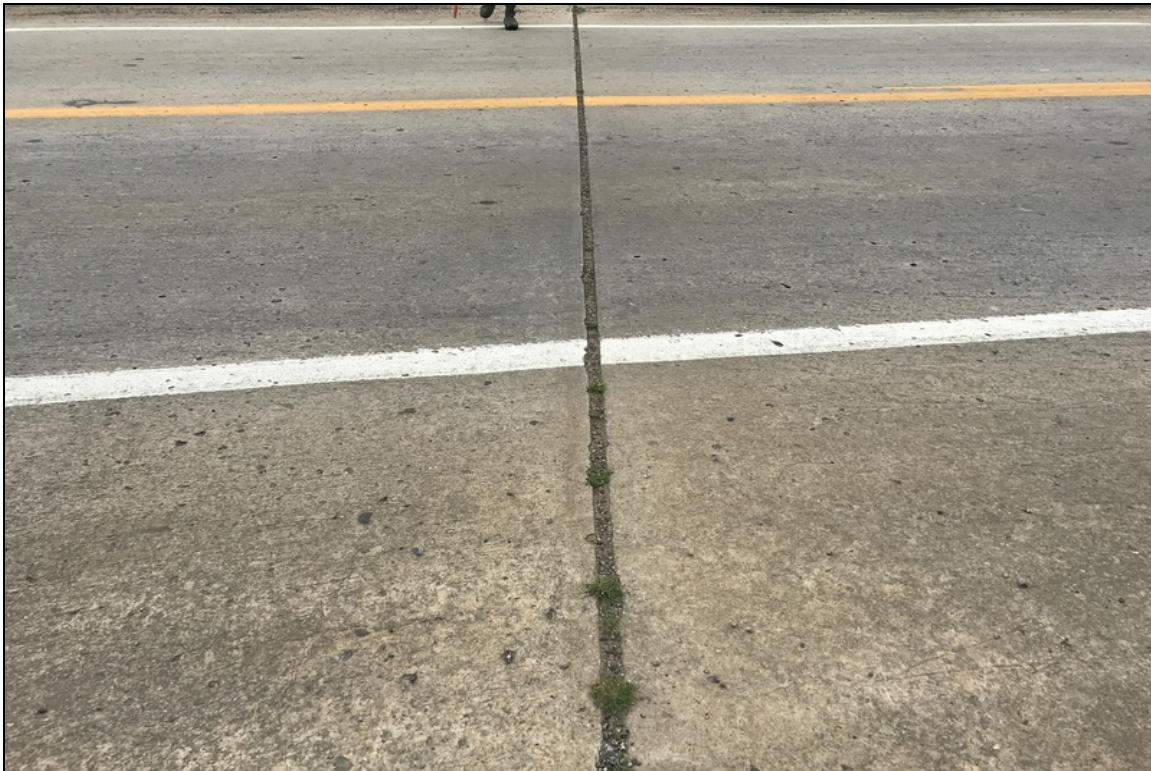
Bent # 3 debris impact in the joint seal.

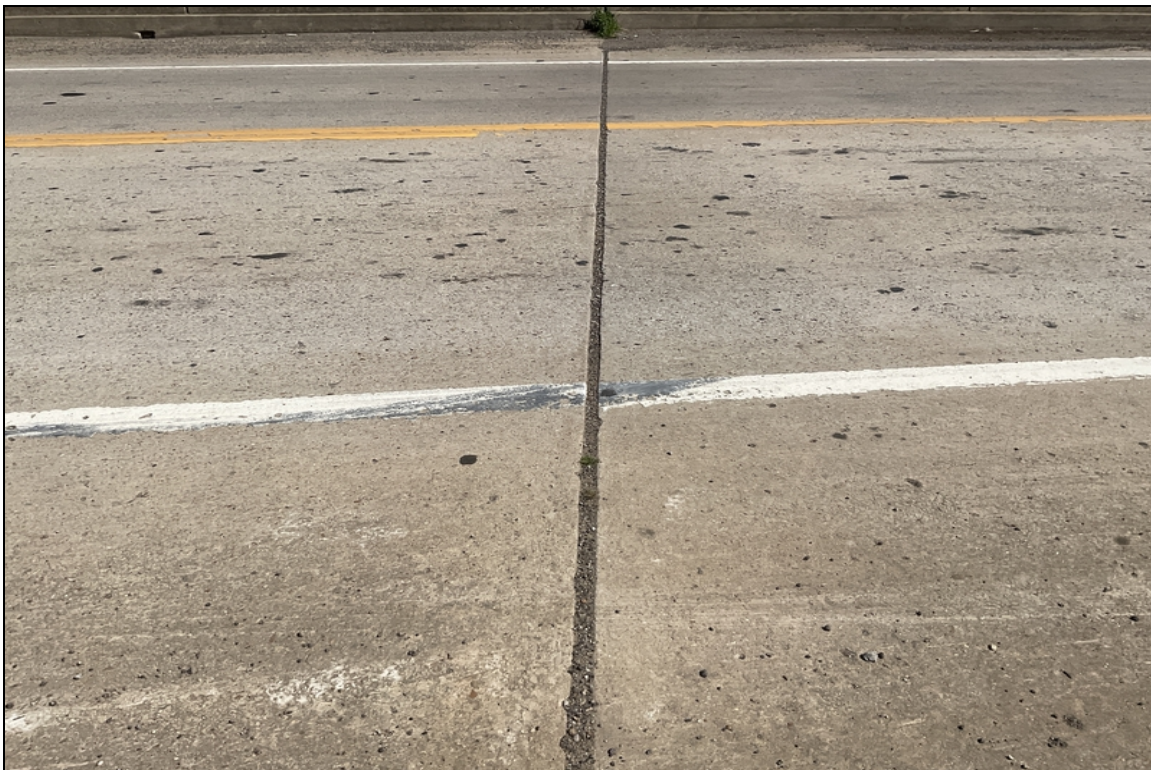
Expansion joint over Bent # 2. Debris impact.

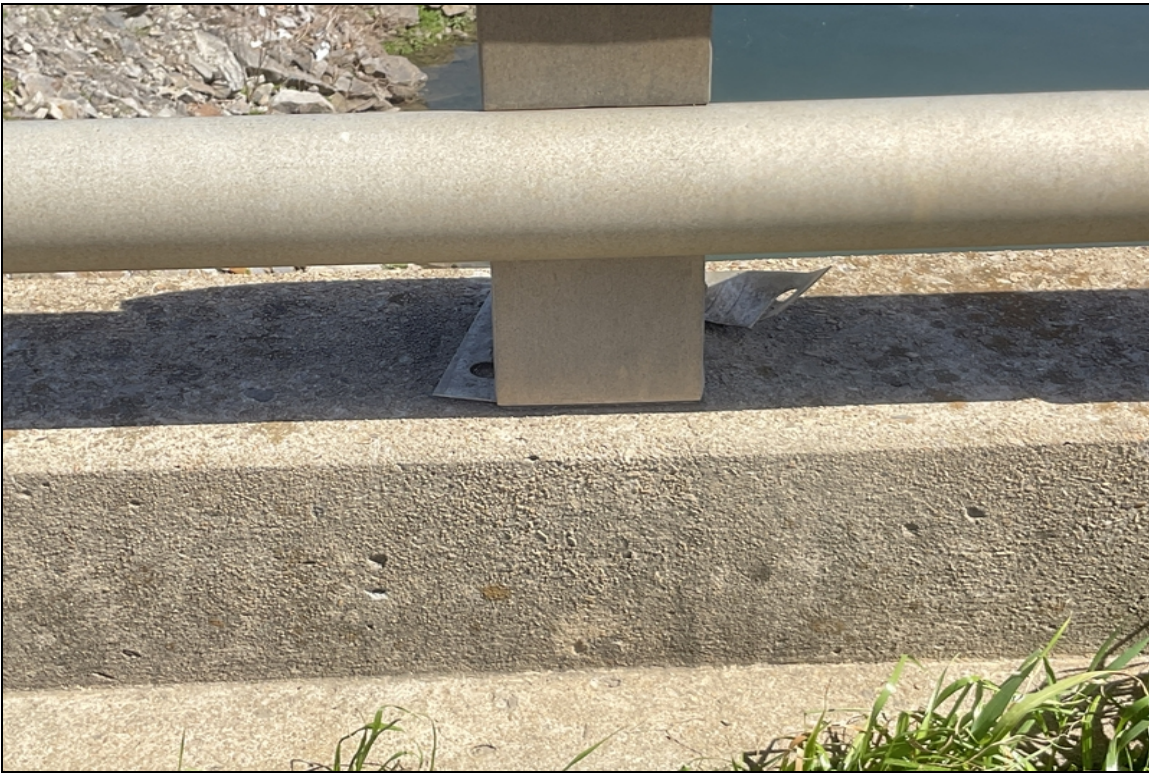
The Right bridge railing post over Bent # 3 has loose anchor bolts.

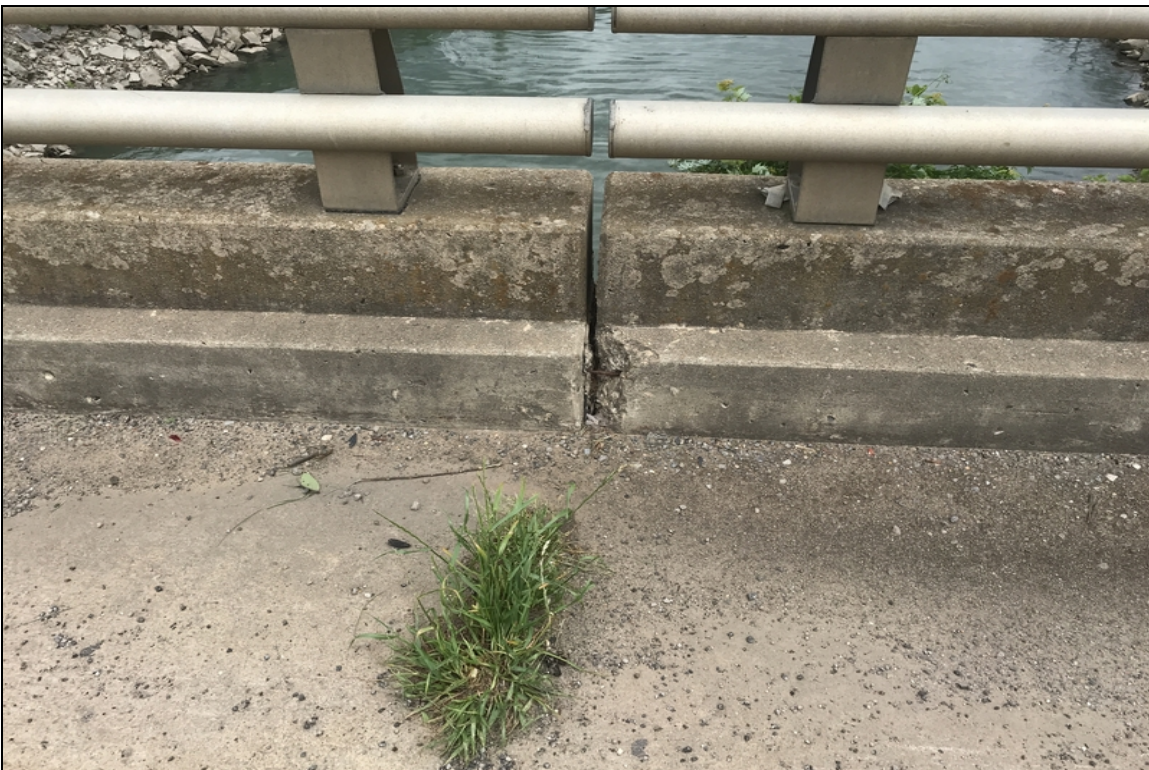
331	Reinforced Concrete Bridge Railing	LF	210	188	18	4	0
1080	Delamination/Spall/Patched Area	LF	1	0	0	1	0
1090	Exposed Rebar	LF	3	0	0	3	0
1130 (331)	Cracking (RC and Other)	LF	18	0	18	0	0
-The concrete portion of bridge railing has spalling with exposed reinforcing steel on the Left and Right sides over Bent # 2 and along the base of railing on left side of Span # 3.

Span # 1, Bent # 2 Rt spalling with exposed reinforcing steel in the base of the bridge rail.

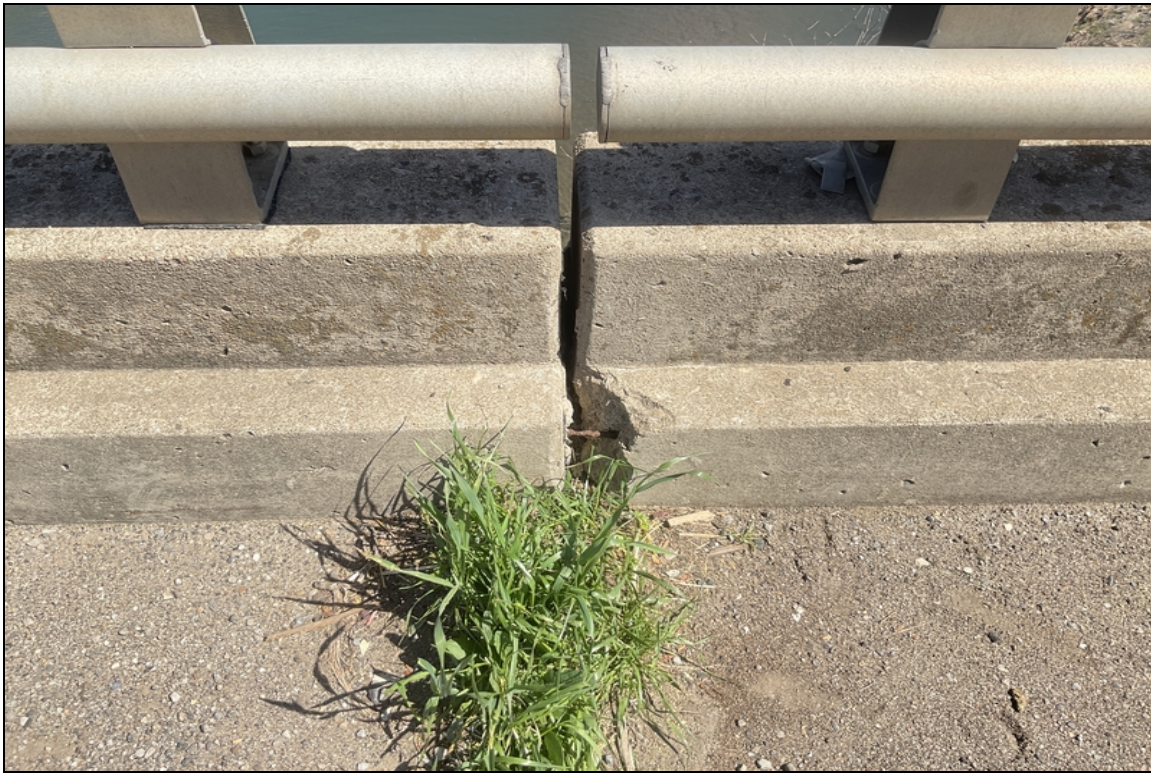
Spall with exposed reinforcing steel in the Right curb over Bent # 2.

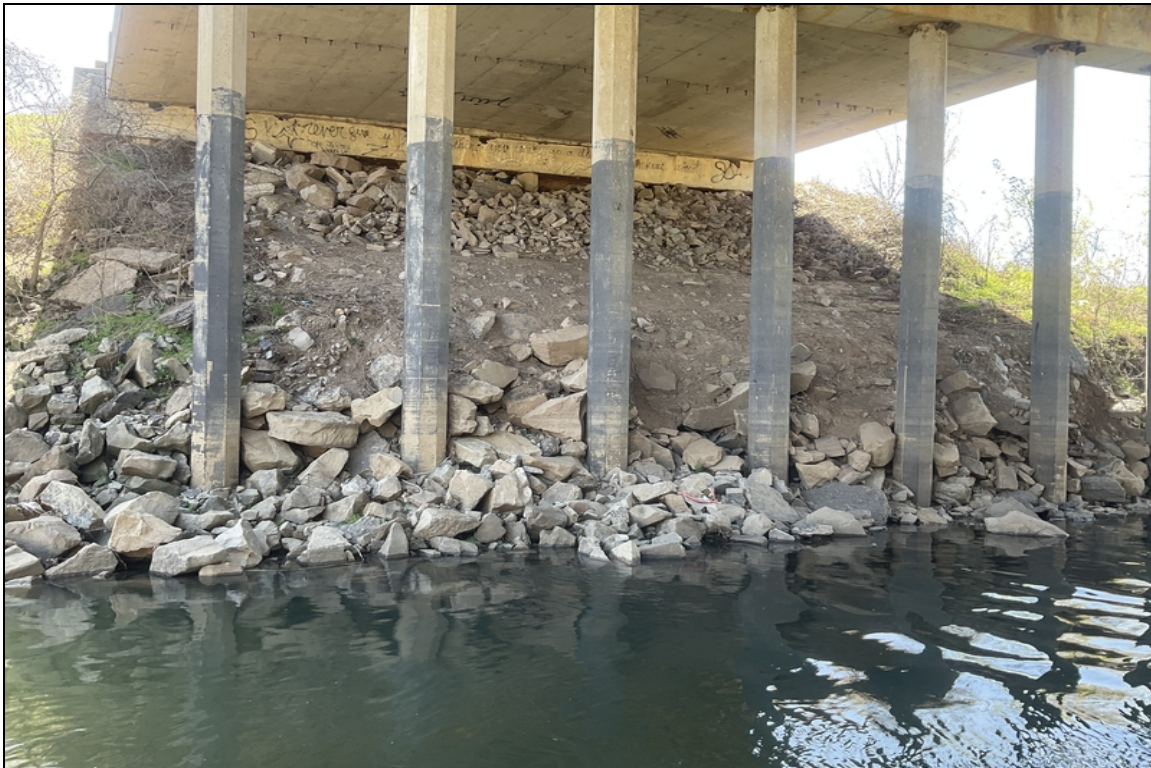
There is embankment erosion and rip rap displacement along both sides of the channel. Photo of South embankment.

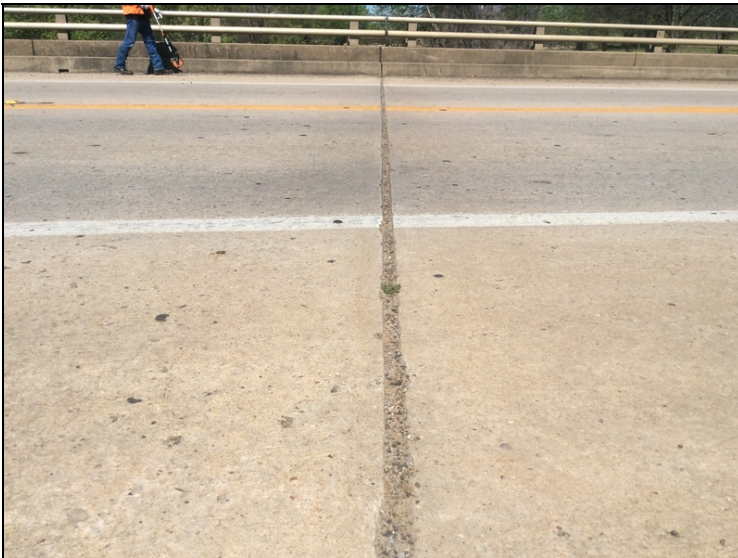
The poured type expansion joint sealant has deteriorated and is missing in several locations over bents # 2 and # 3 allowing incompressible materials to enter the joints and appears to be forcing spans # 1 and # 3 away from the channel.
(See attached maintenance memorandum)

Bent # 3 expansion joint-Debris impaction.

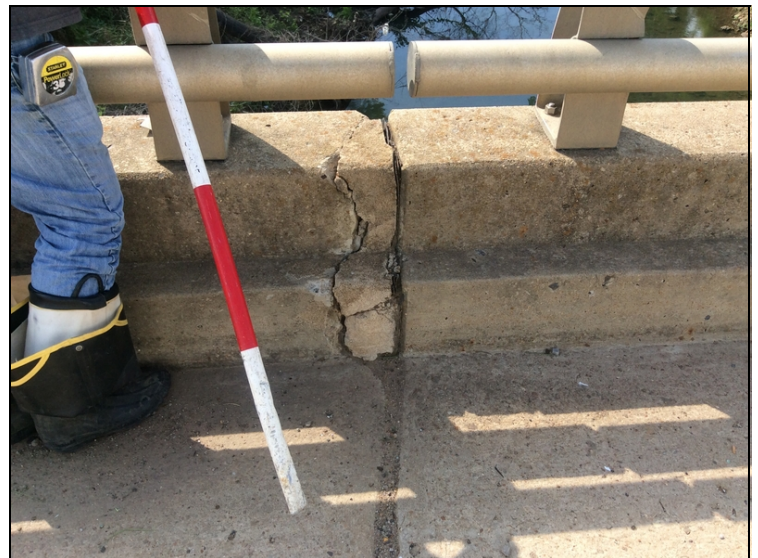
Left side over Bent # 2.

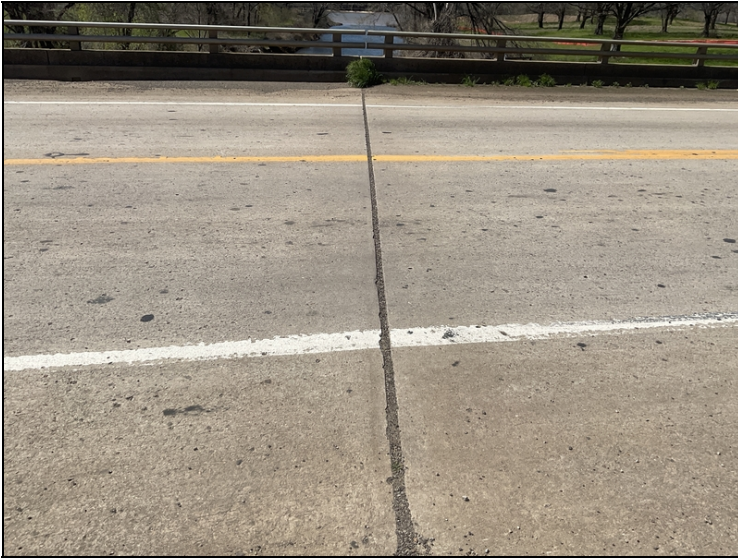
Expansion joint over Bent # 3. Debris impaction.
