Bridge #05360(Routine, Underwater type 2)

State Highway 255 over Sewer Outlet

Location: JCT SH 55 & P STREET

Team Lead: Jeff Jones Inspection Date: April 06, 2022

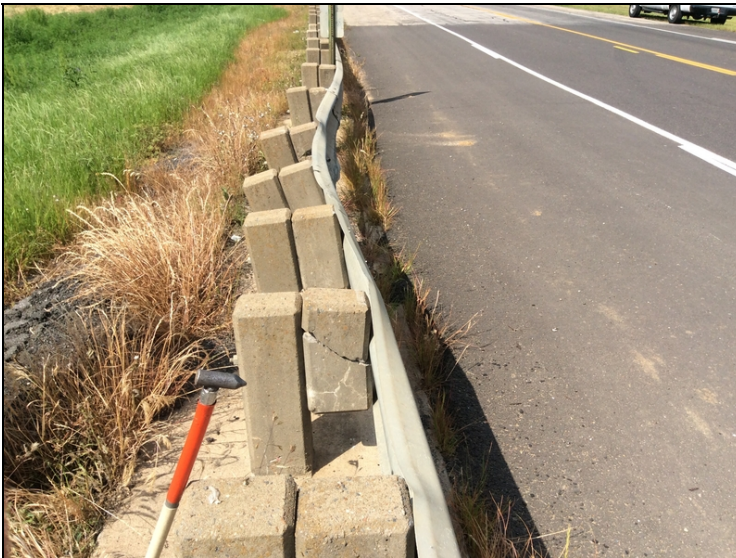
The Northwest approach railing has collision damage that has created a "pocket" in the railing and fractured 5 of the concrete posts at the base.

Northwest approach guardrail.

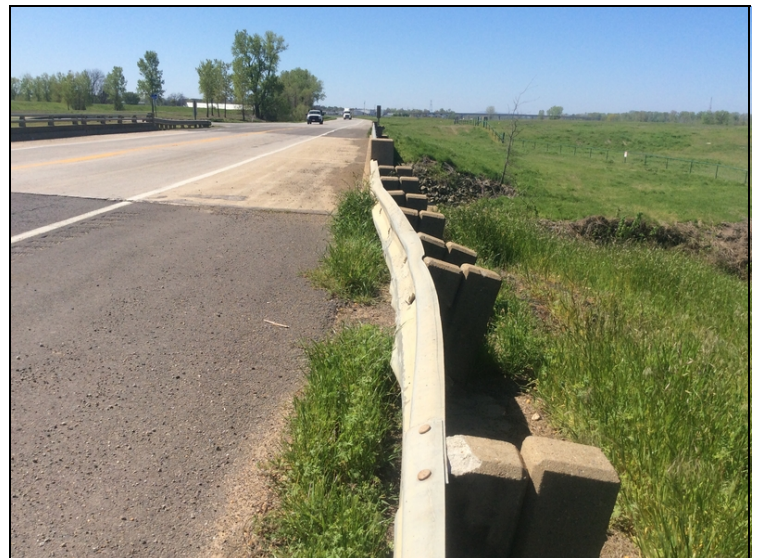
Northwest approach railing-Collision damage.

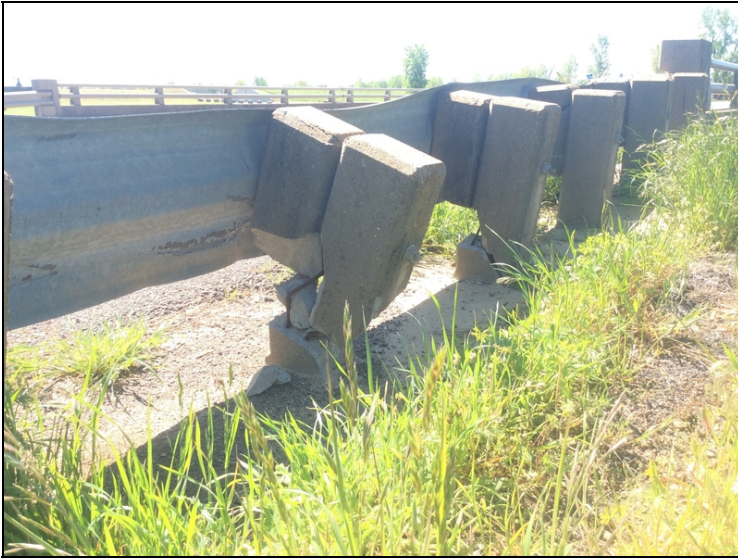
Northwest approach railing-Fractured posts.

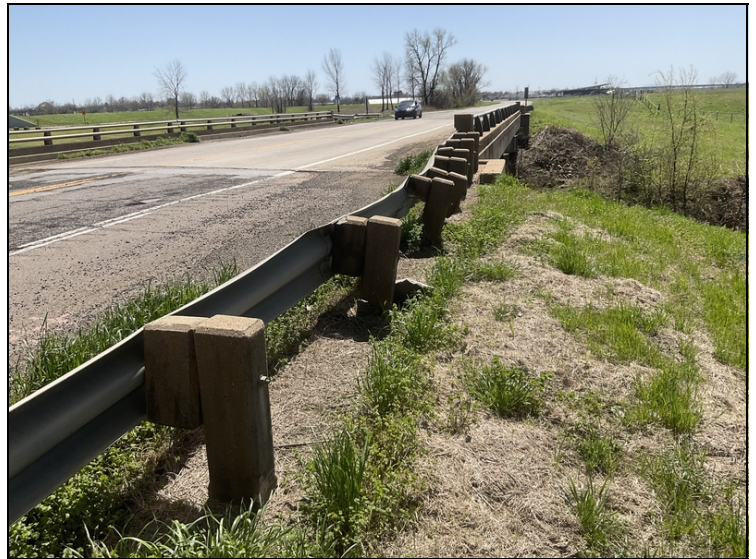
Northwest approach guardrail has collision damage.

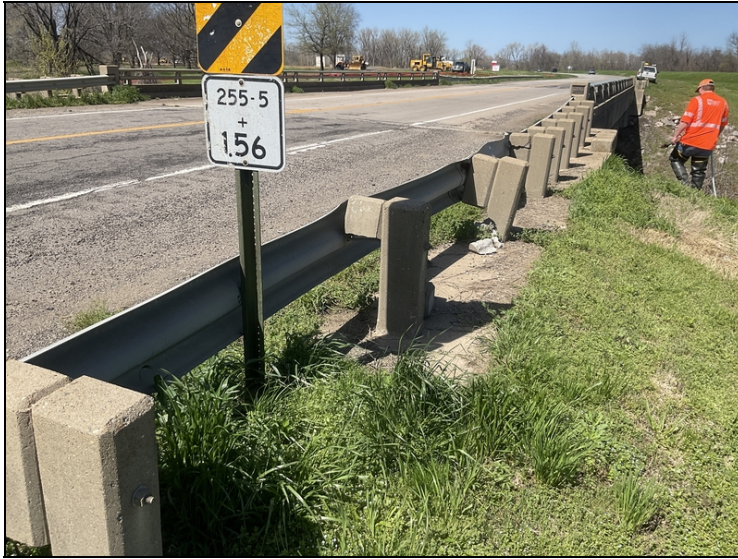
The Southeast approach guardrail has collision damage with several fractured concrete posts and spacer blocks.

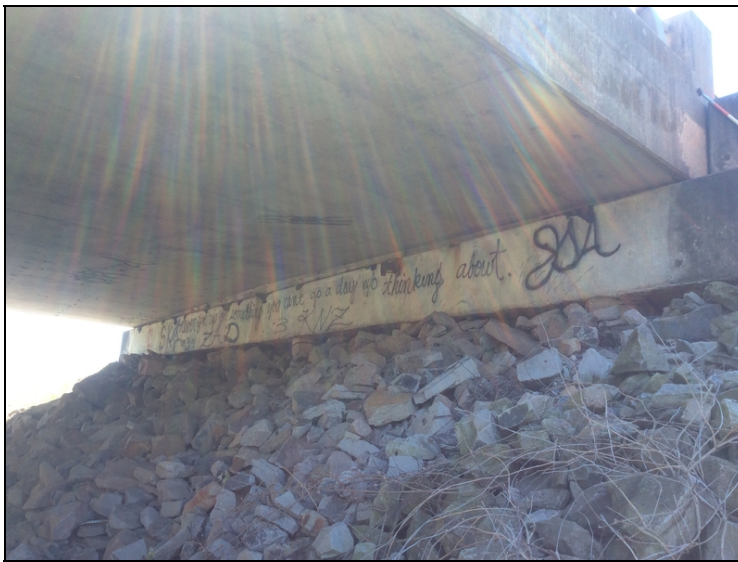
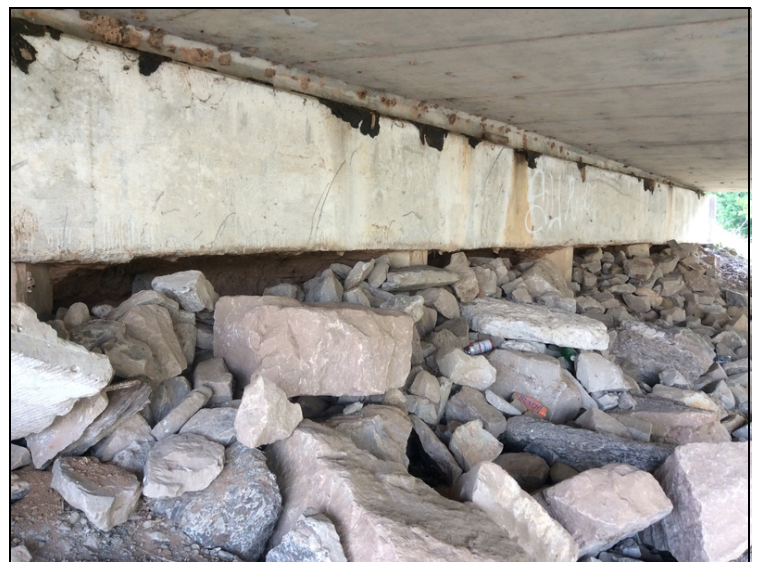
There are voids under the approach gutters adjacent to the abutments. There is earth settlement under the abutment caps.

Abutment # 1
-Minor settlement of embankment.

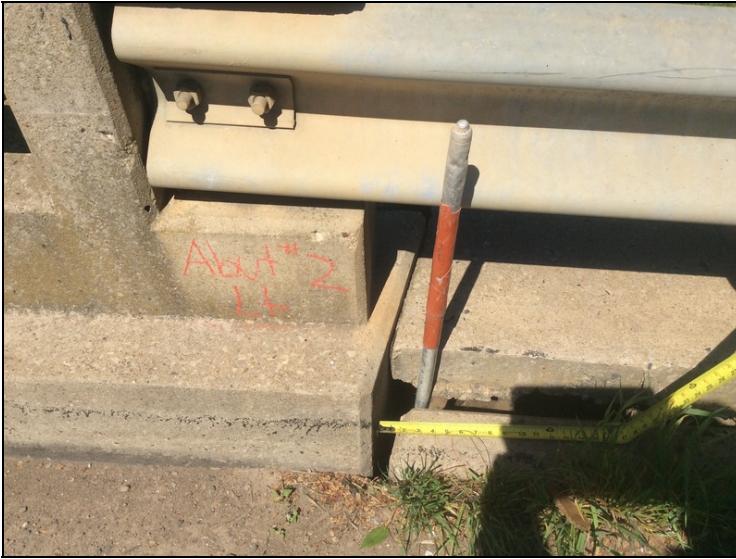
Abutment # 2, left side. Void.

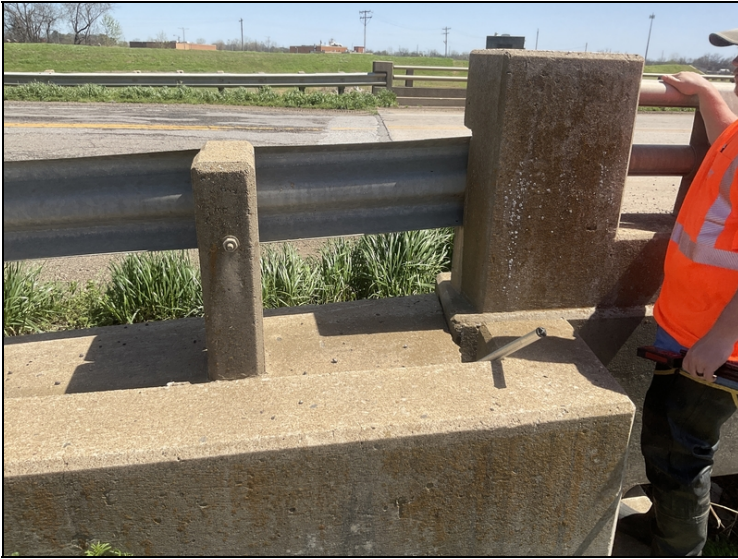
Void under the North approach gutters.

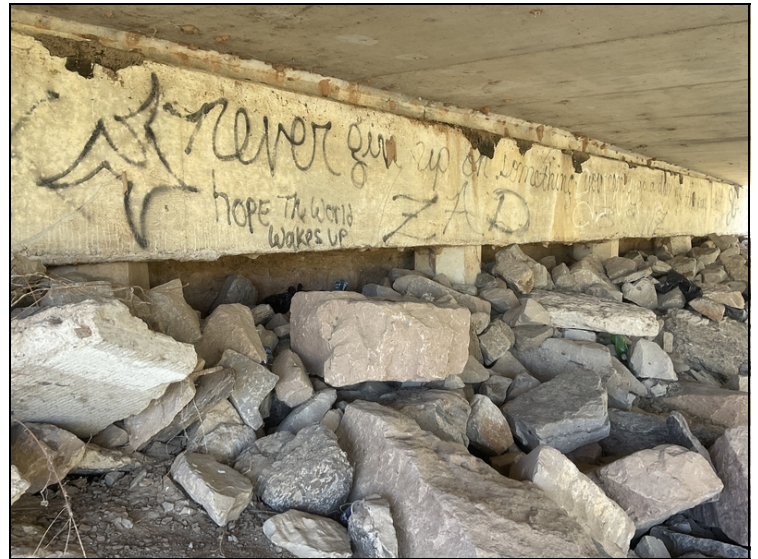
Earth settlement under the South abutment cap.

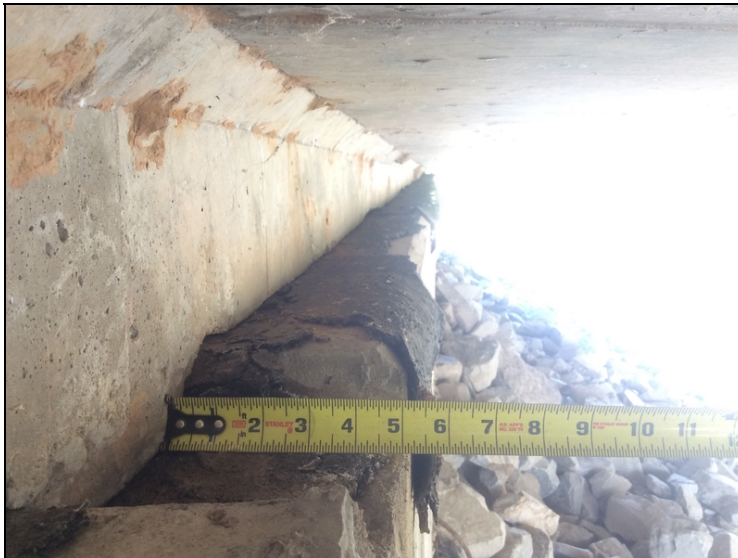
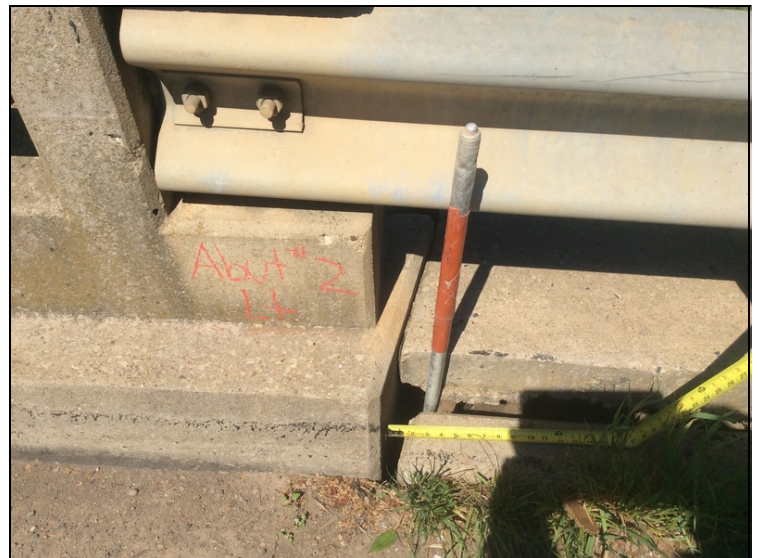
Substructure - Actual field measurements indicate that the abutments have 5/8" of additional movement on the Left side and 1/8" additional movement on the Right side since the 04/26/2016 inspection. See documentation attached to this report for additional information.

Plan dimension is 101.00'

Actual field measurement Left side - 100.25'

Actual field measurement Right side - 100.19'

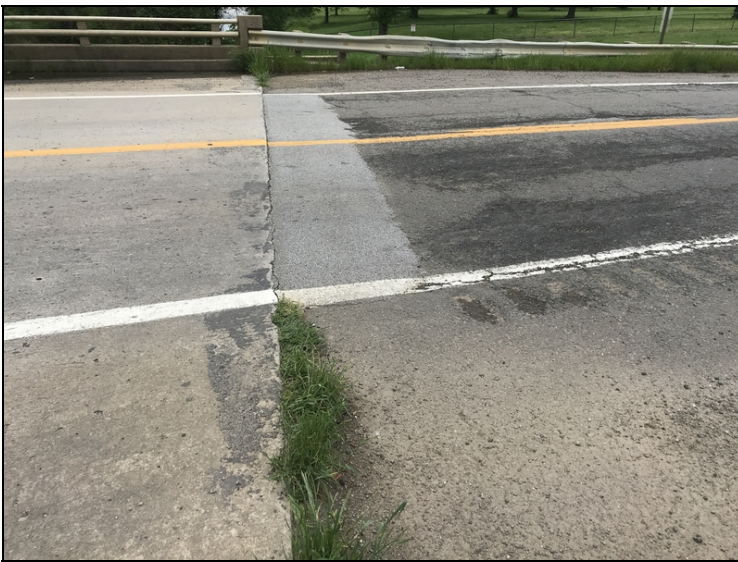
The approach roadway has settlement that is causing additional impact to the slab spans.

North approach settlement.

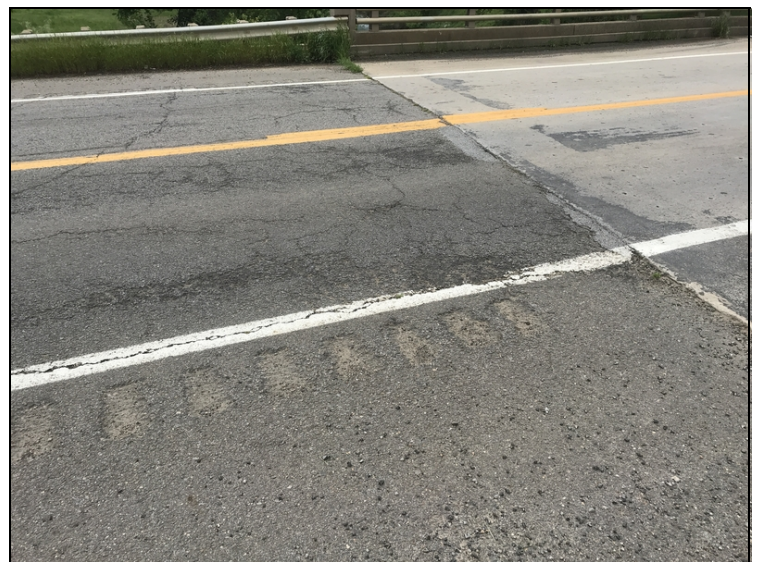
Bent # 1 asphalt settlement.

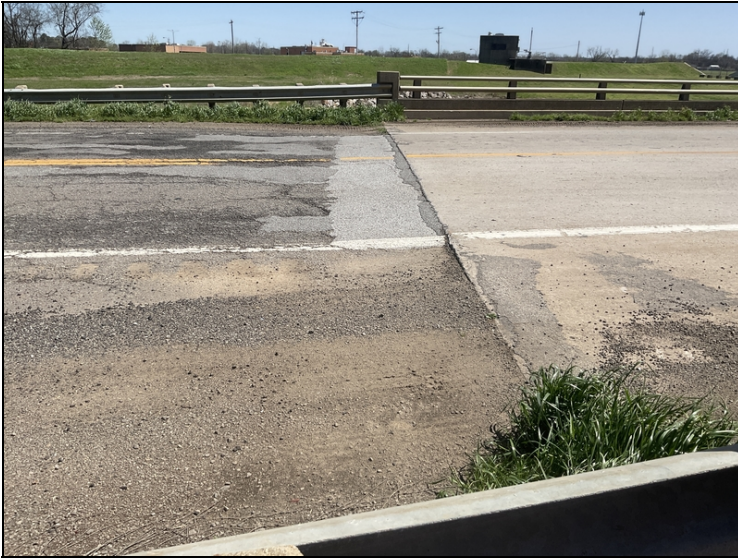
Settlement at the North approach slab adjacent to
Bent # 4.

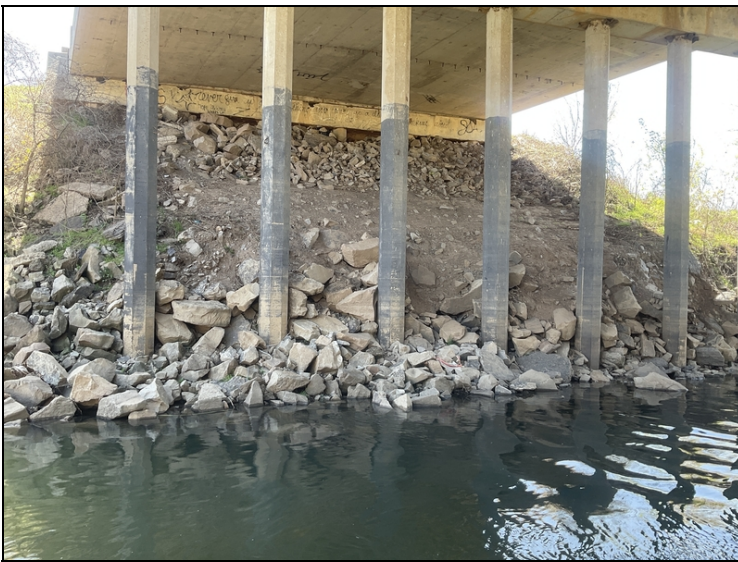
There is embankment erosion and rip rap displacement along both sides of the channel.
Photo of South embankment.

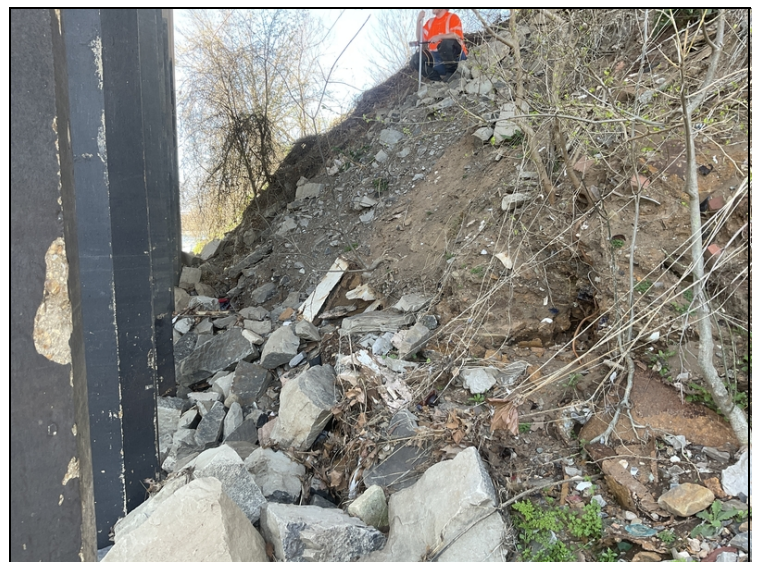
There is embankment erosion and rip rap displacement along both sides of the channel.
Photo of North embankment.

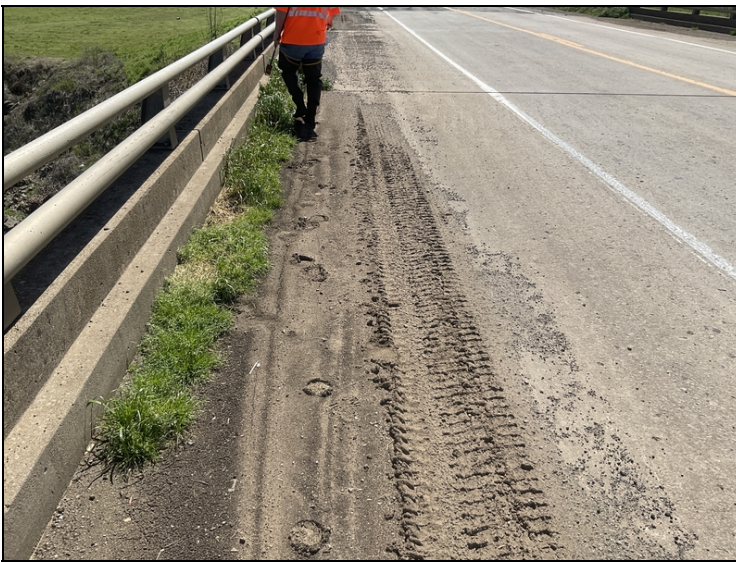
There is dirt accumulation in the gutters.

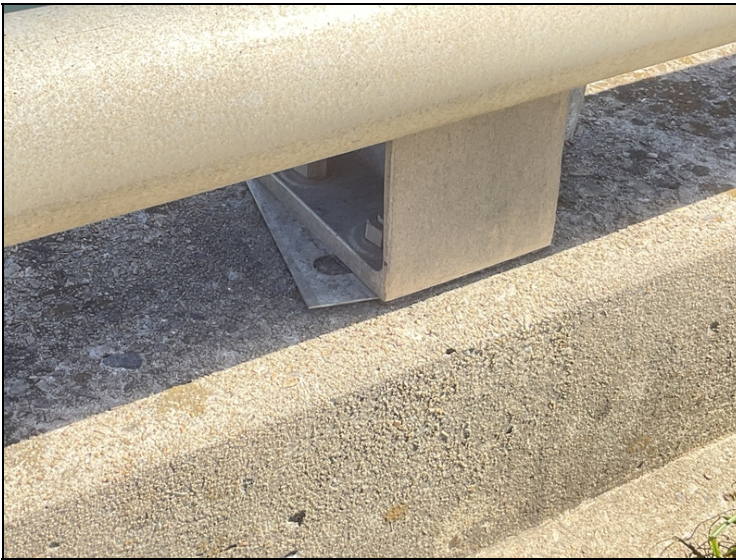
The right bridge railing post over Bent # 3 has loose anchor bolts.

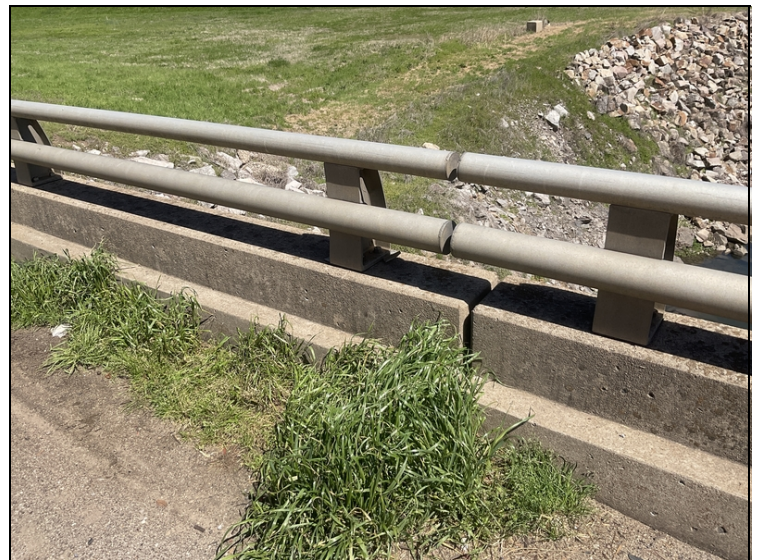
The right bridge railing post over Bent # 3 has loose anchor bolts.
