**Bridge #01196(Routine)**  
**US 71 B-Washington over Spring Creek**  
**Location: 0.89 MI S OF BENTON CO LN**

**Team Lead: Jacob Turner Inspection Date: September 30, 2021**

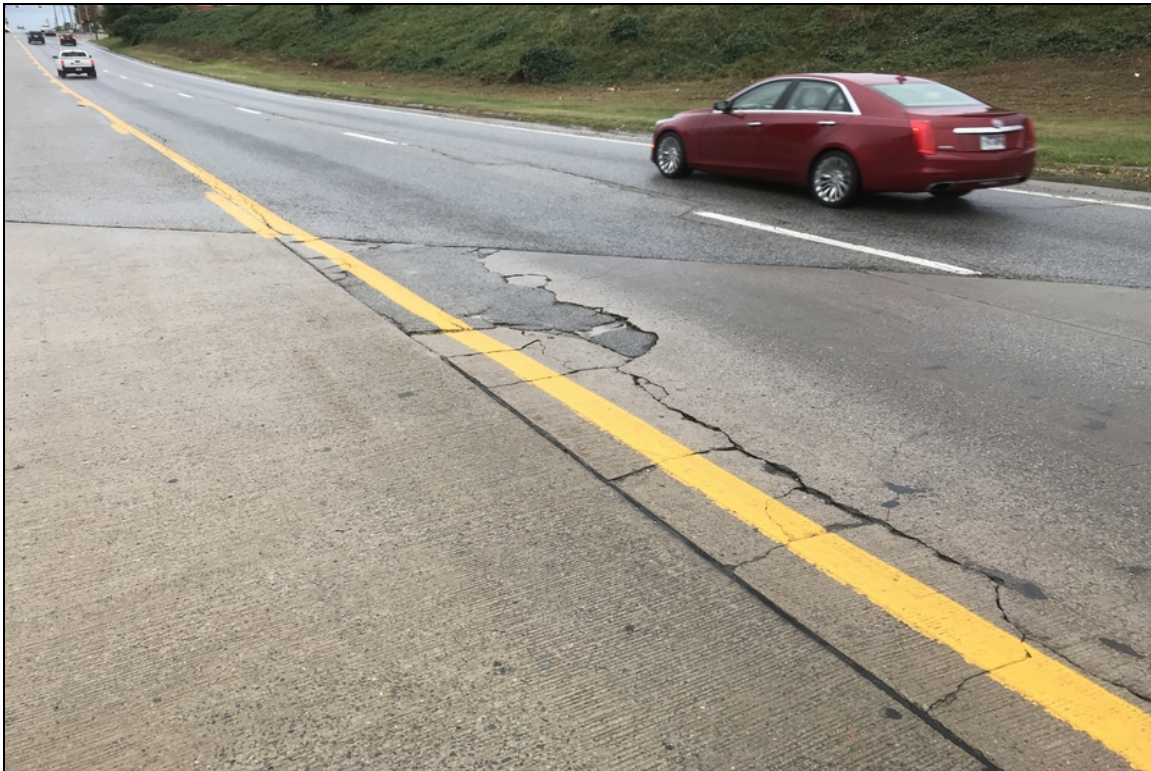
Span 1 spalling in wheel path

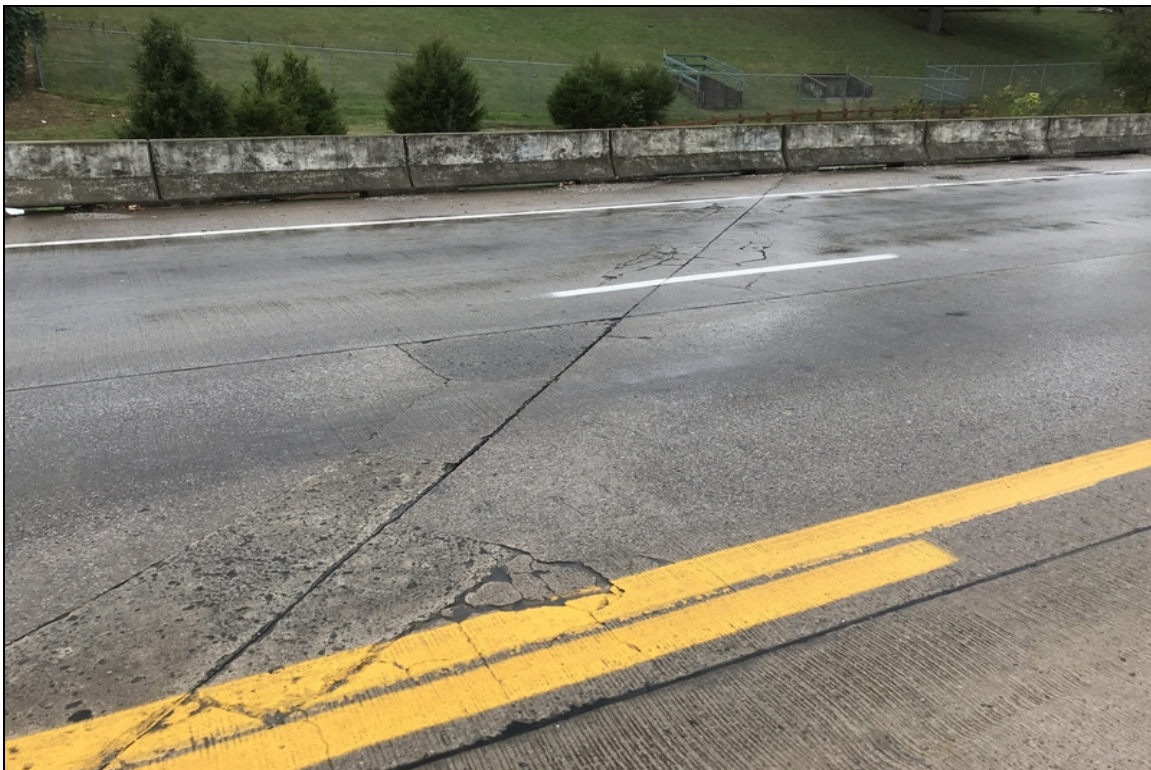
Span 2 spalling in wheel path

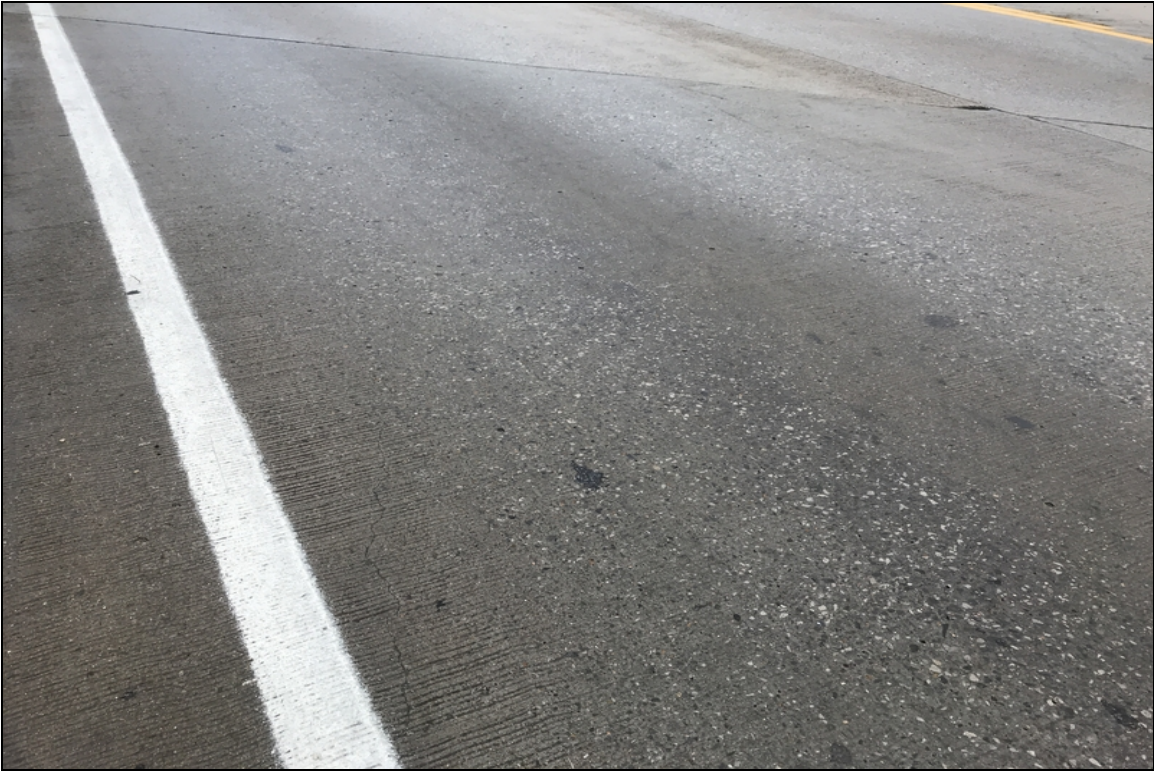
Abrasion in wheel paths typical

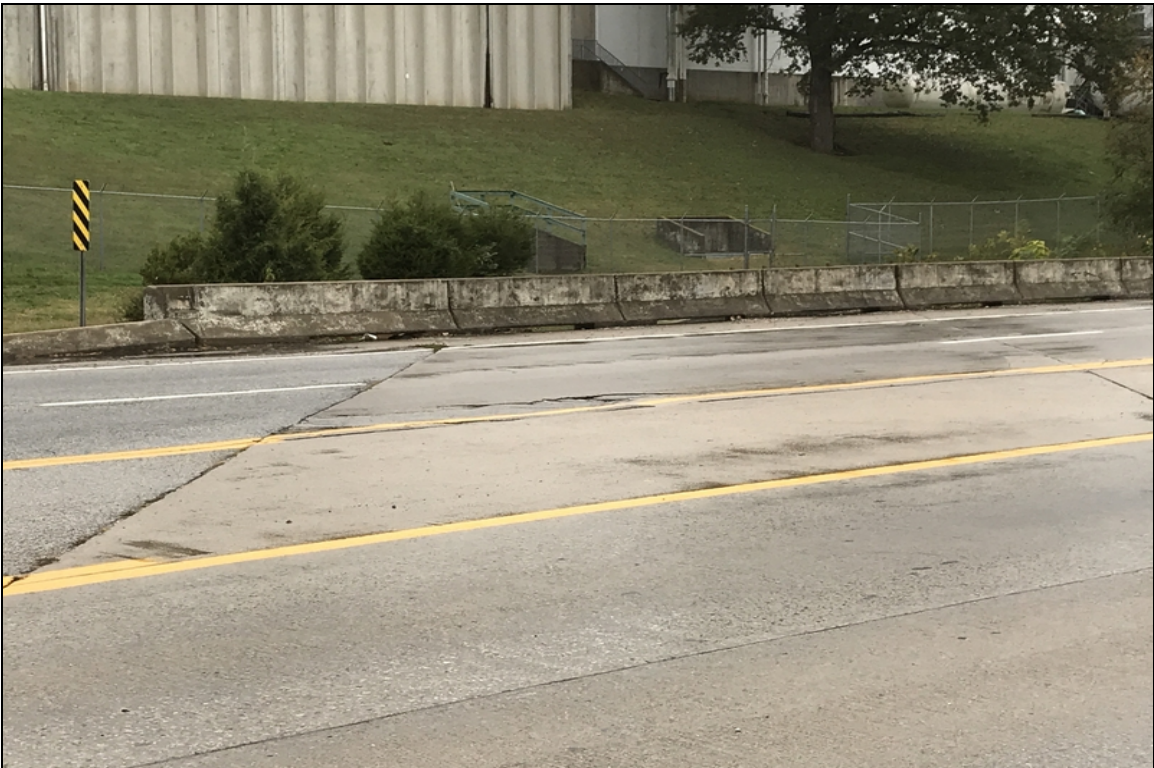
Span 1 spalling on inside southbound lane in wheel path

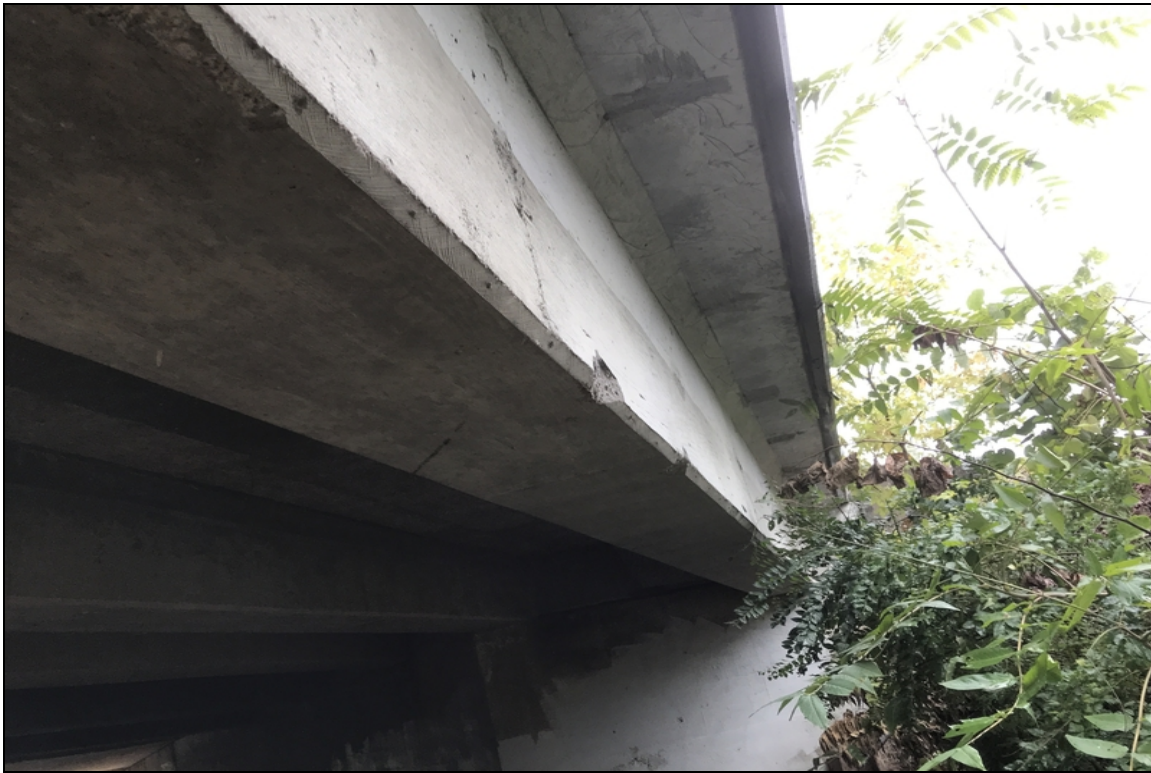
Span 3 girder 7 spall

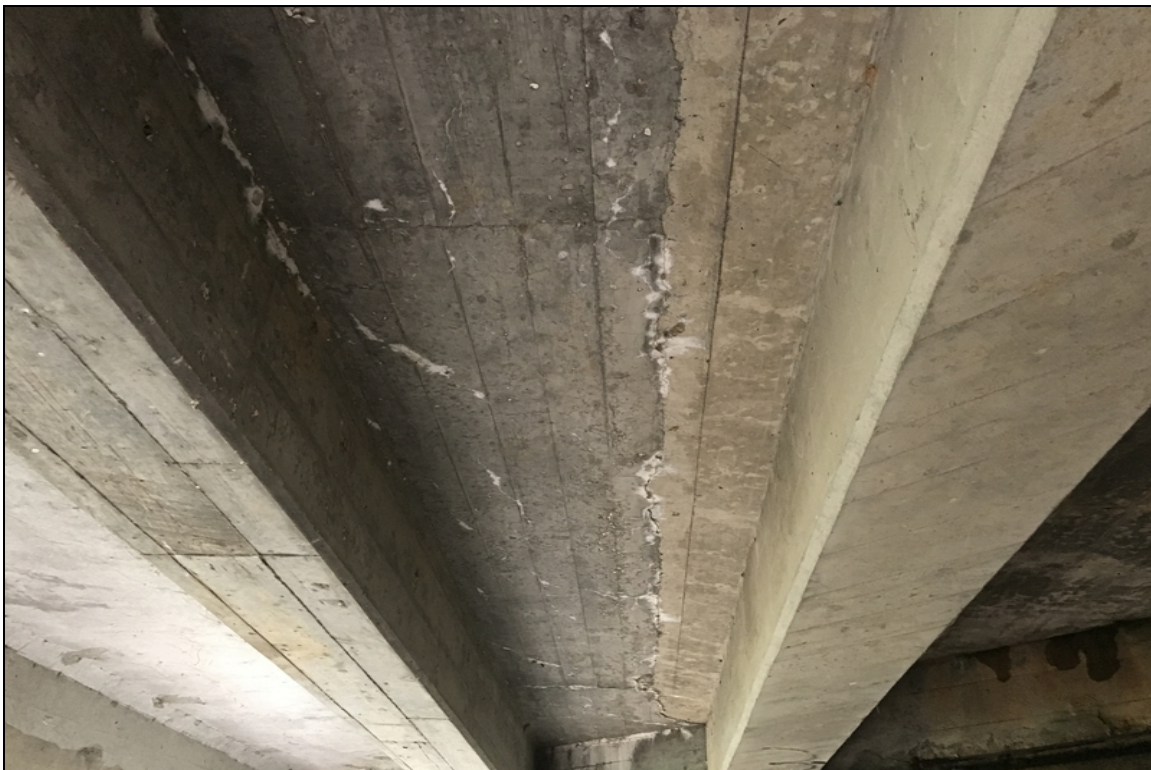
Span 3 under surface cracking with efflorescence

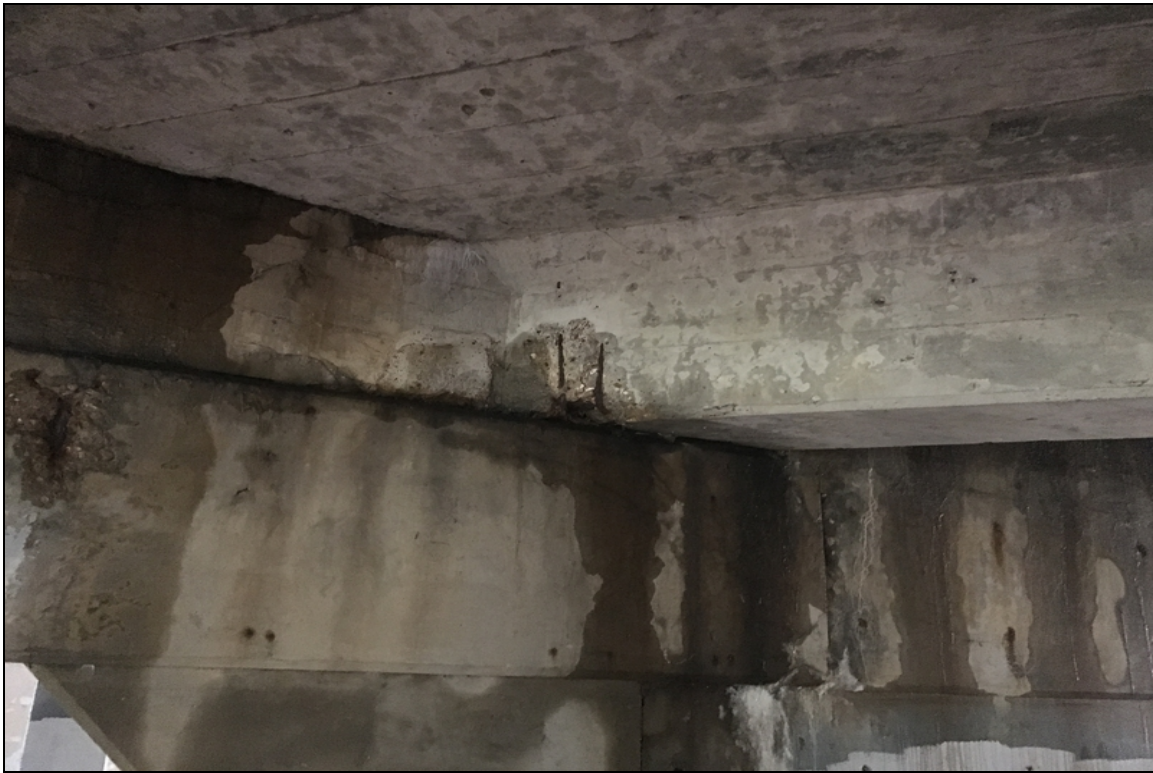
Span 3 girder 3 bent 3 spalling with exposed reinforcing steel

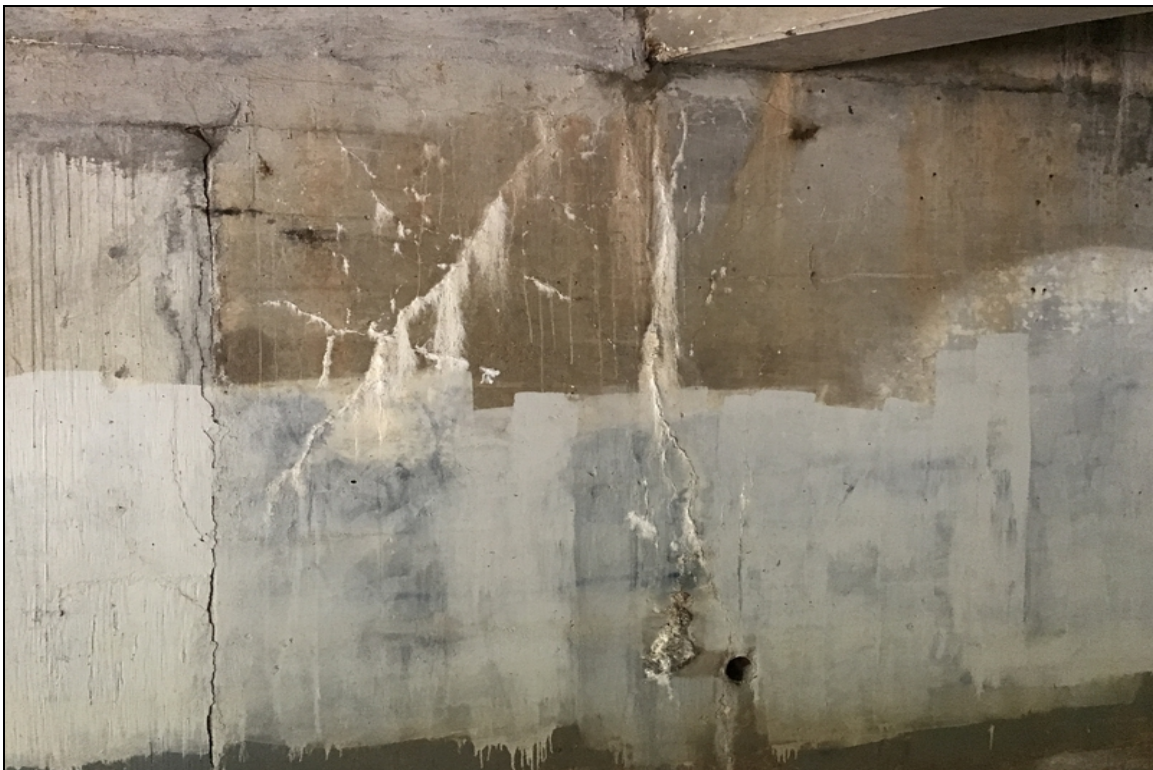
Bent 4 cracking with efflorescence

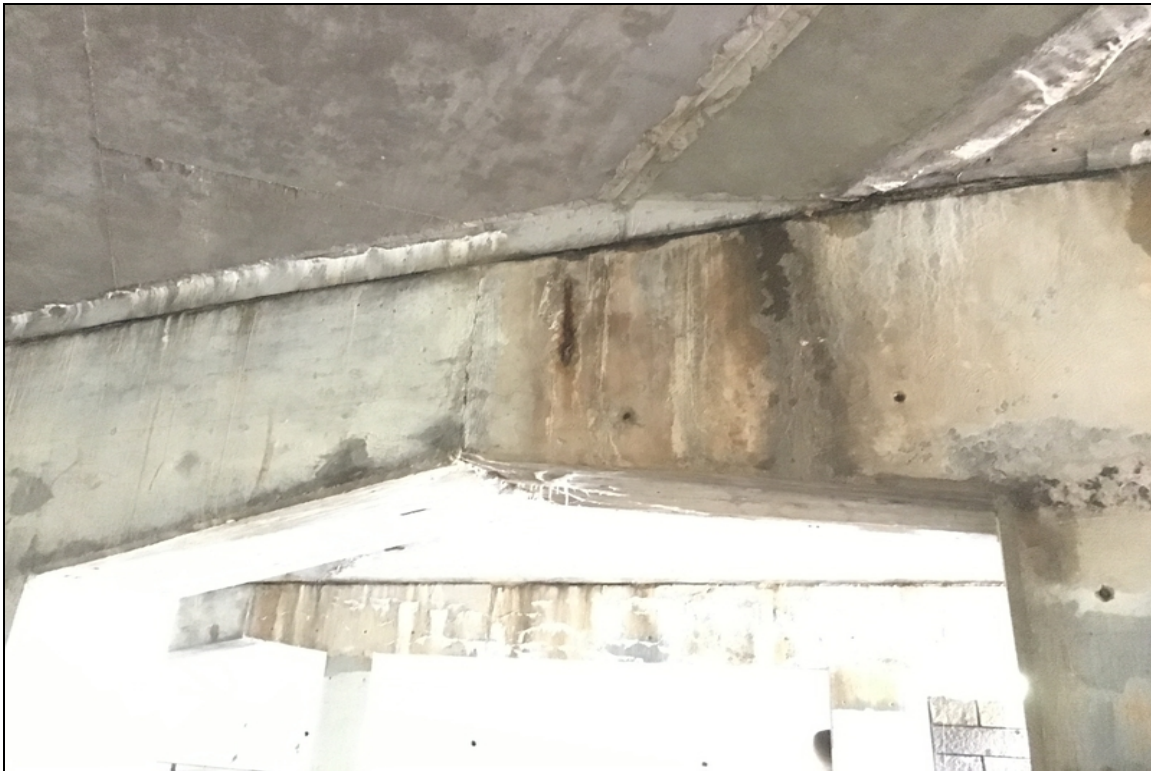
Bent 3 spalling with exposed reinforcing steel

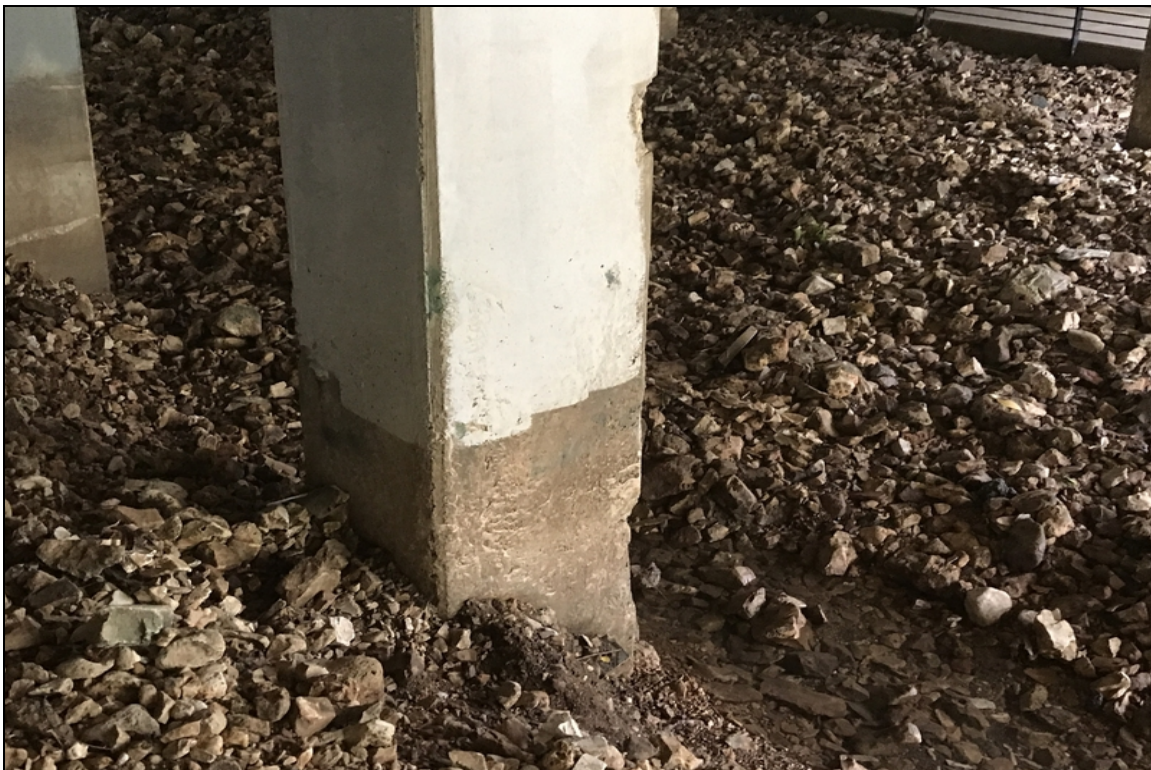
Bent 3 column 4 spalling

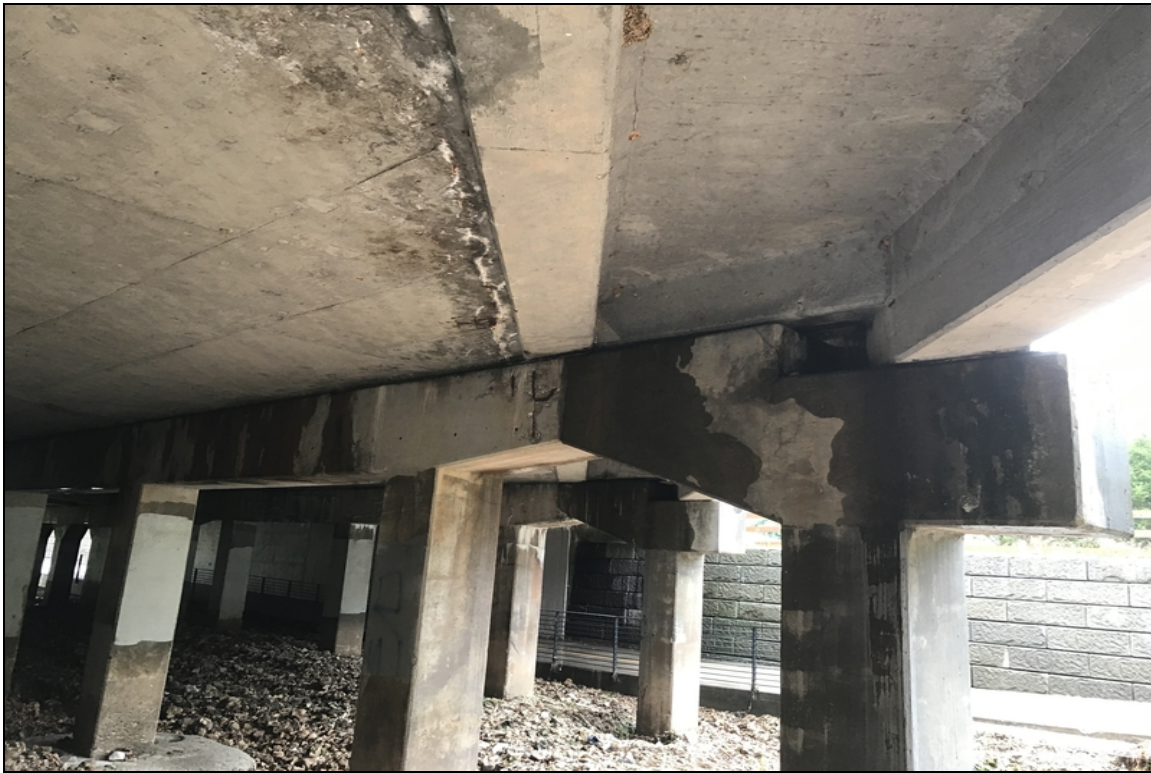
Bent 3 spalling with exposed reinforcing steel (both sides)

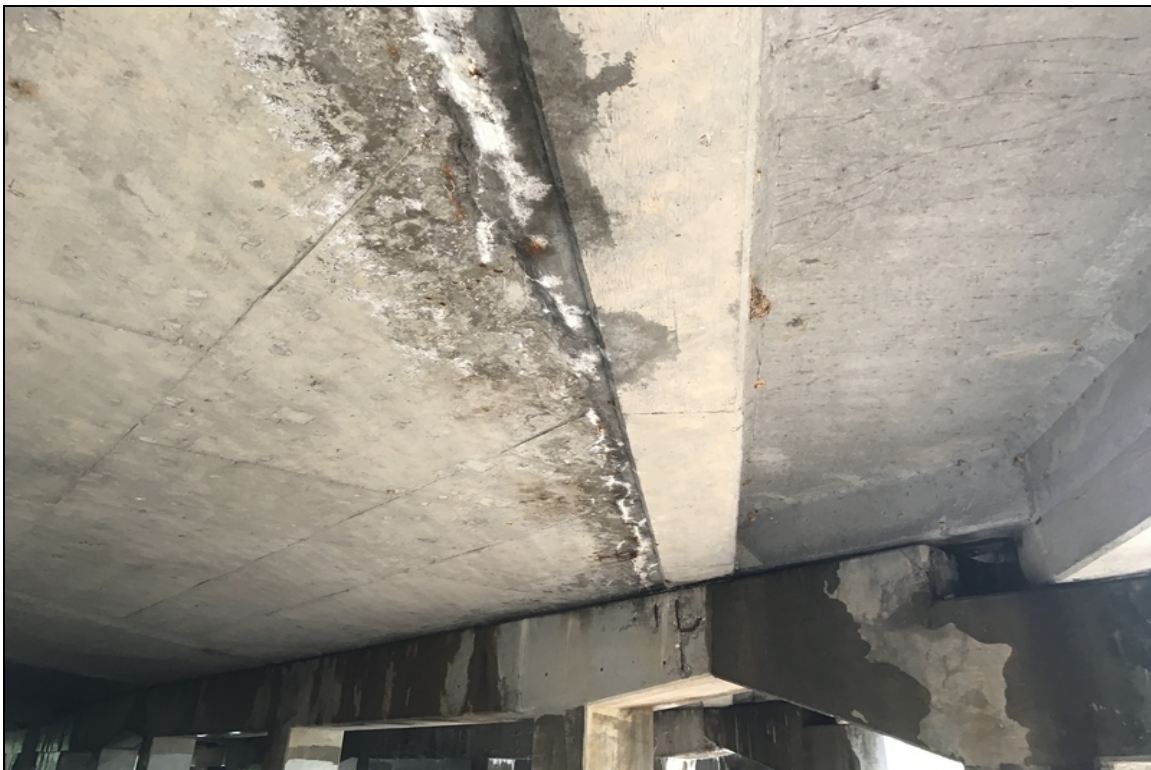
Span 3 construction joint cracking with efflorescence

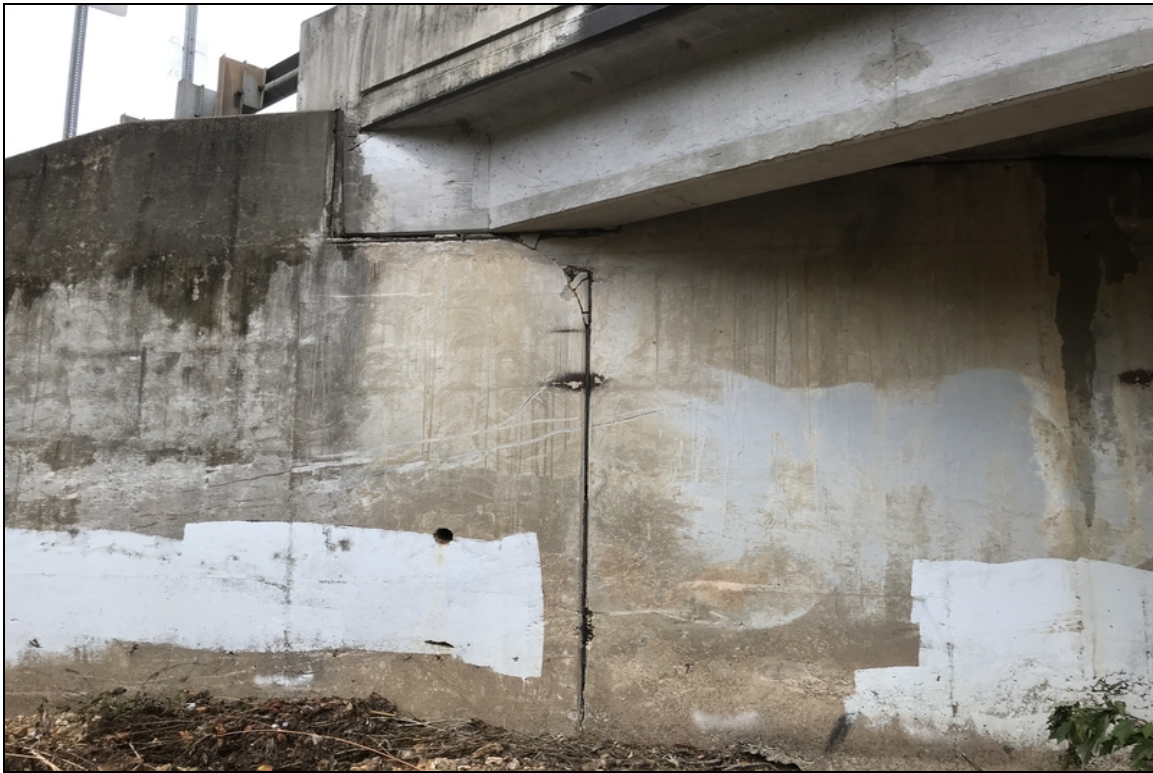
Bent 4 spalling with exposed reinforcing steel at construction joint

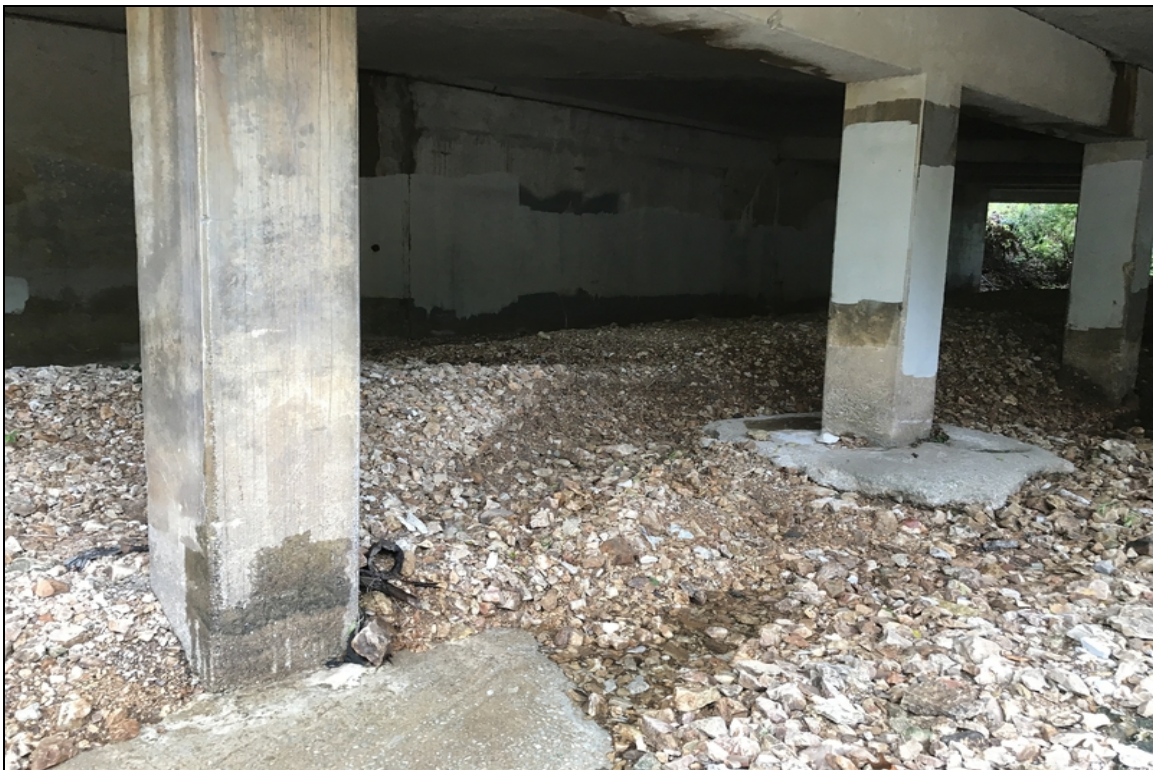
Bents 2 & 3 columns have abrasion

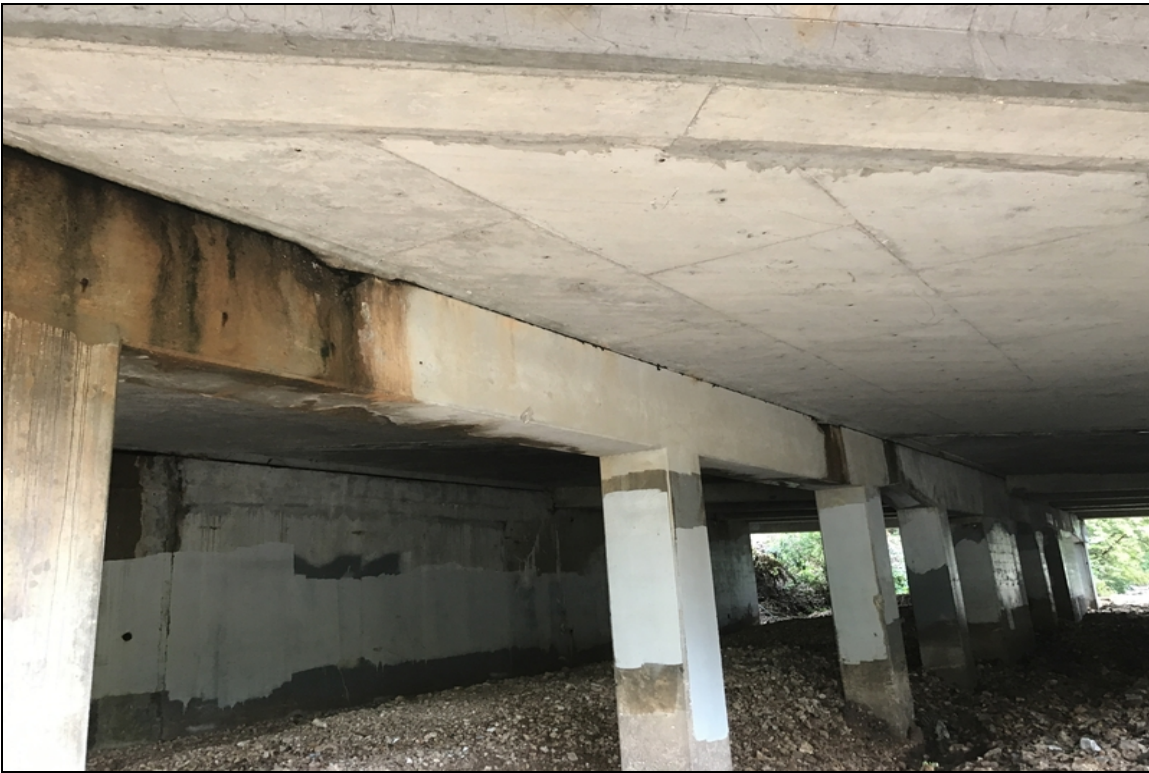
Bent 3 has 2 spalls (bk)

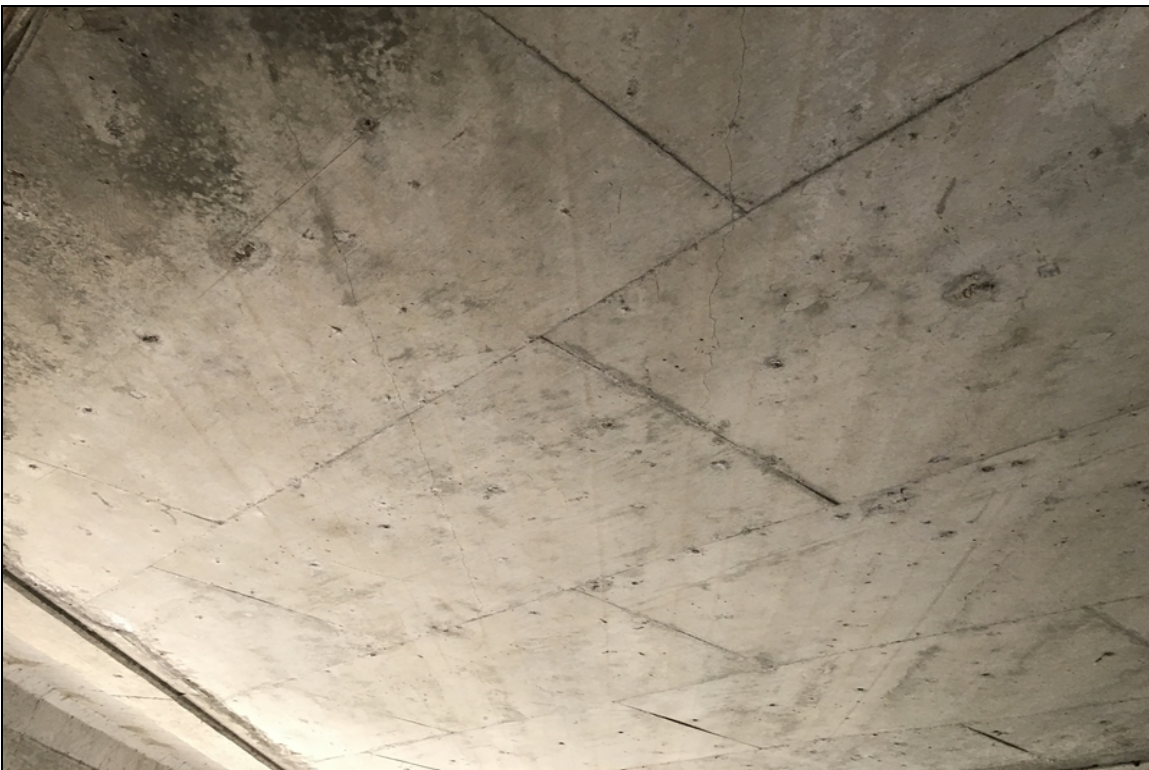
Span 2 longitudinal cracking

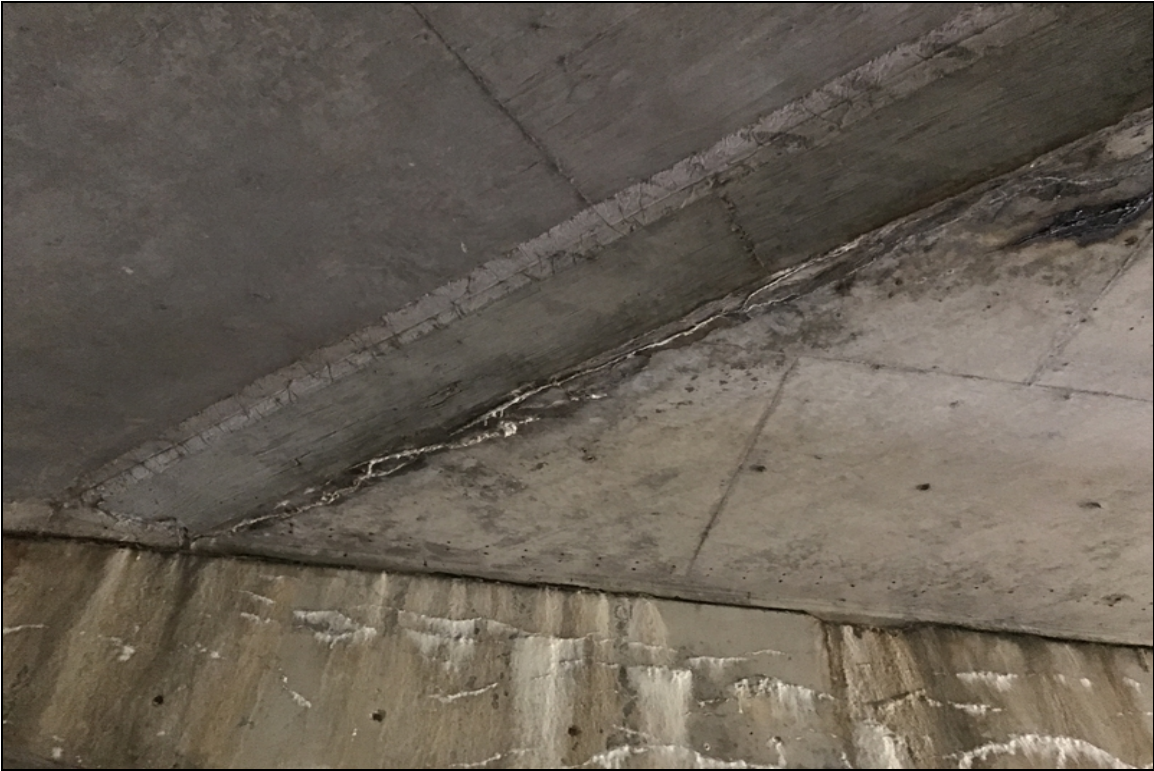
Span 2 slab construction joint cracking with efflorescence

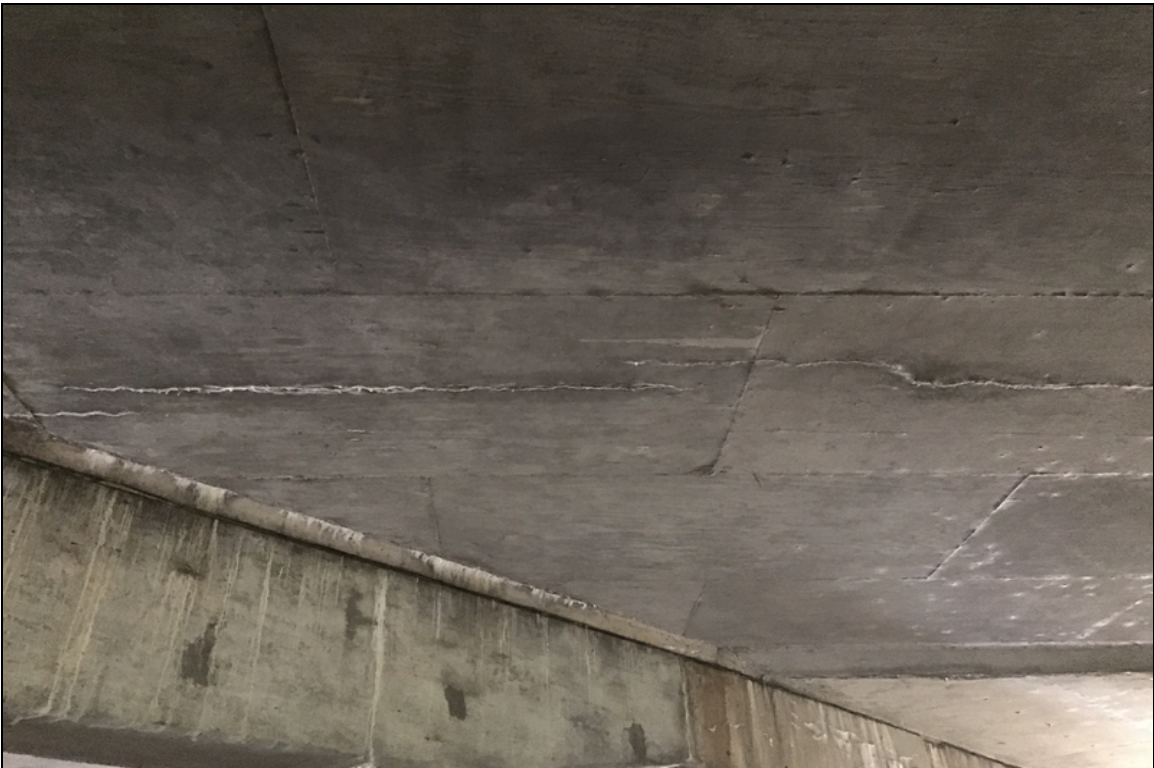
Span 2 slab cracking with efflorescence

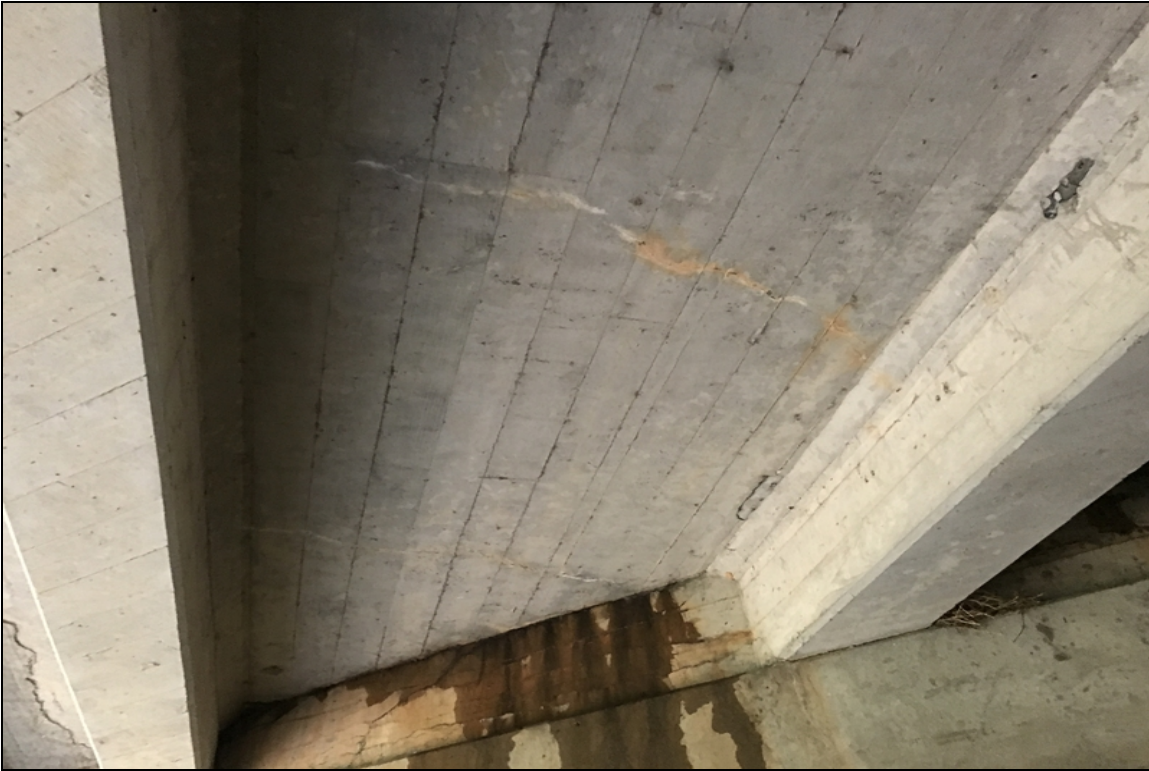
Span 2 under surface cracking with efflorescence

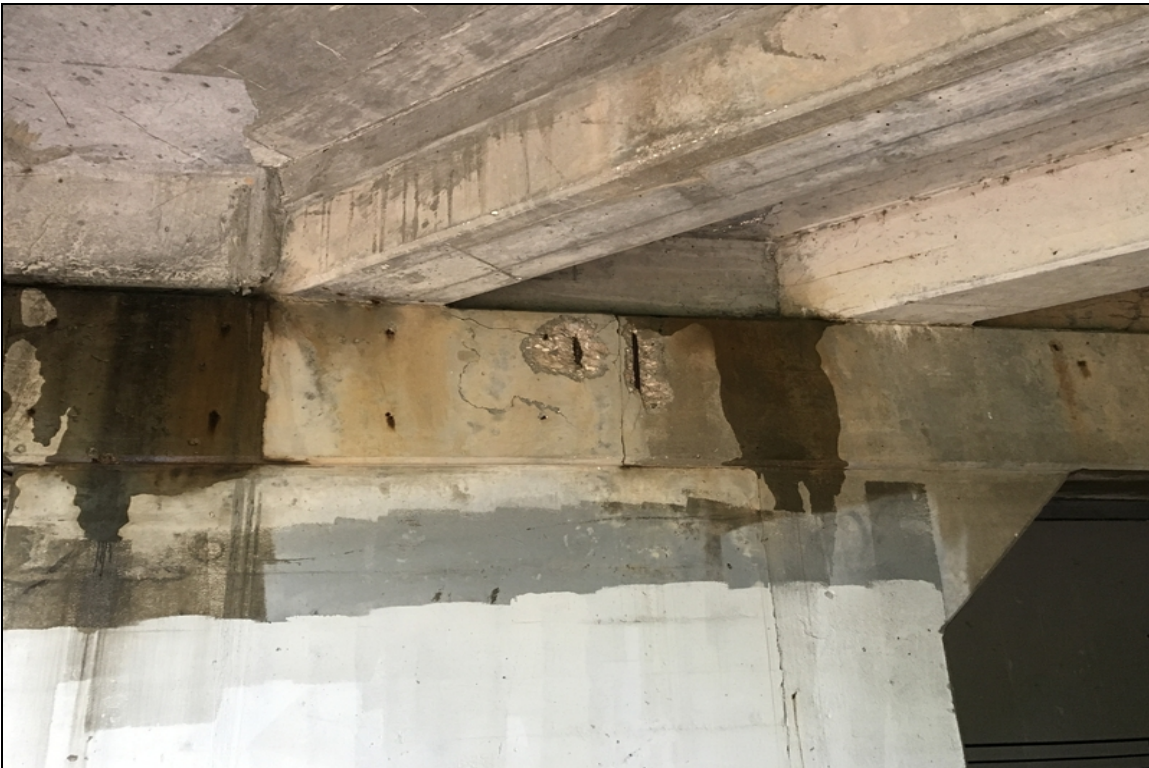
Bent 2 cap (ahd) spalling with exposed reinforcing steel

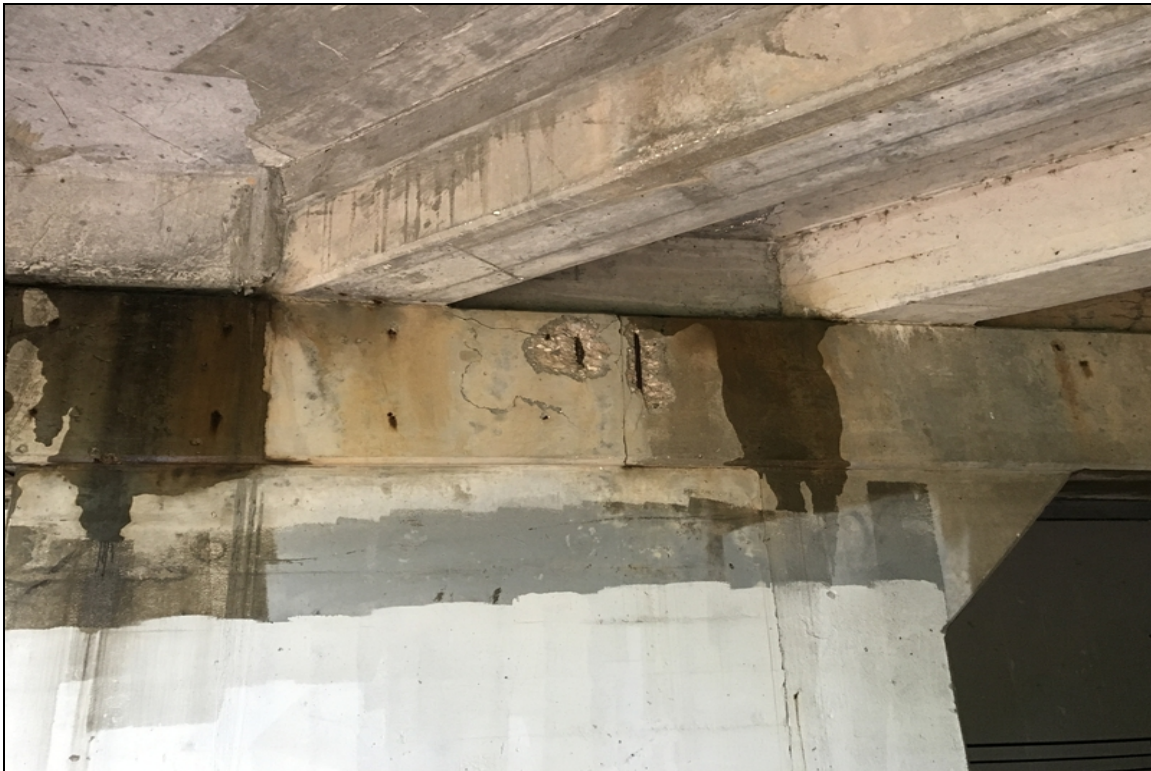
Bent 2 cap (ahd) spalling with exposed reinforcing steel

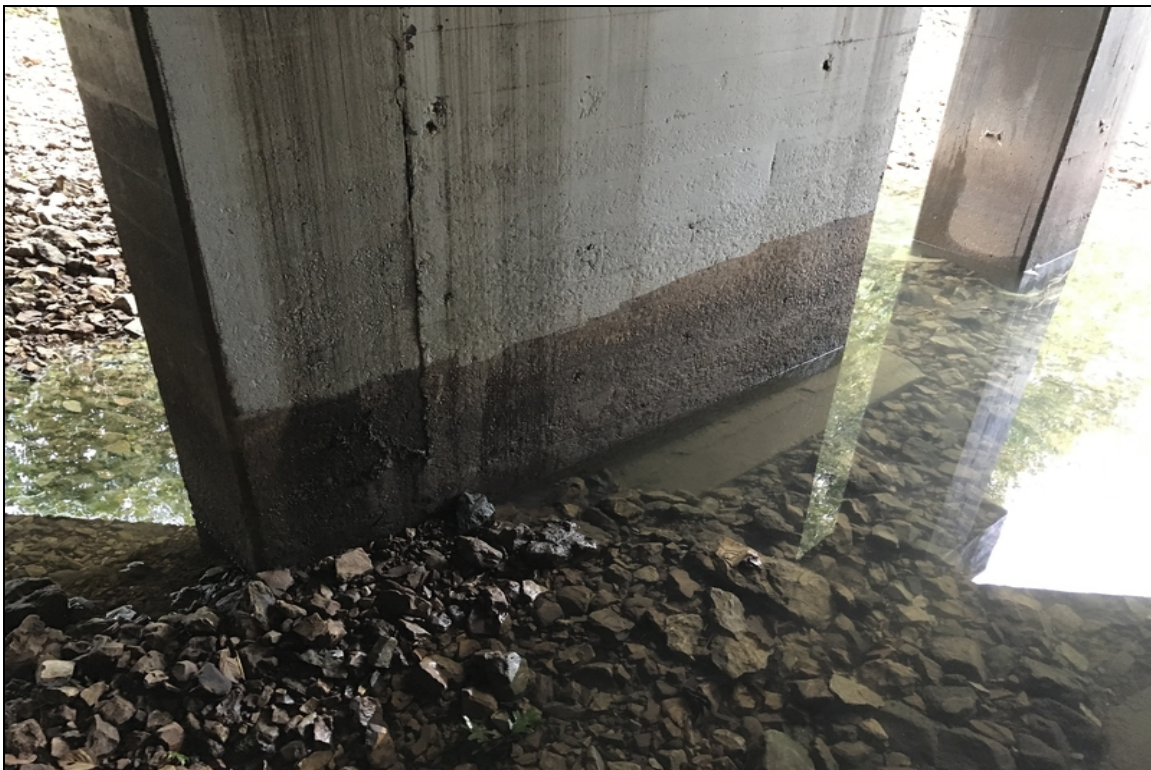
Bent 2 pier wall abrasion

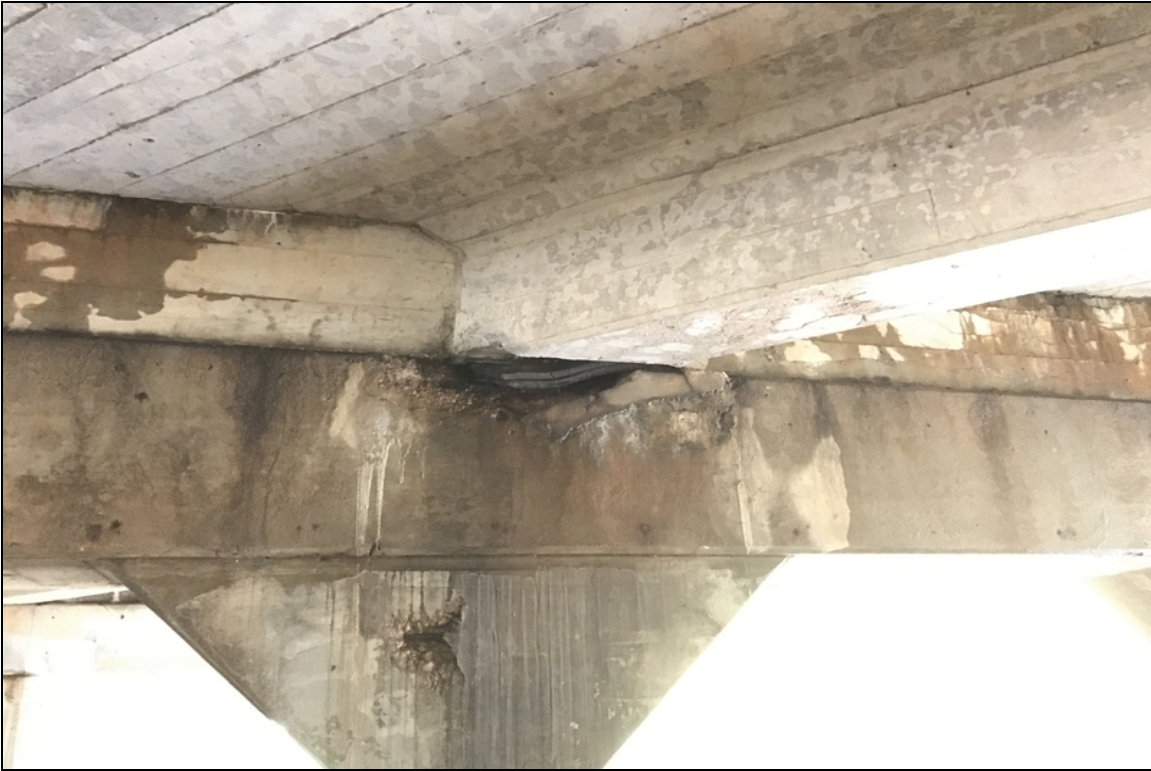
Bent 2 spalling at bearing area adj to girder 4 (Bk)

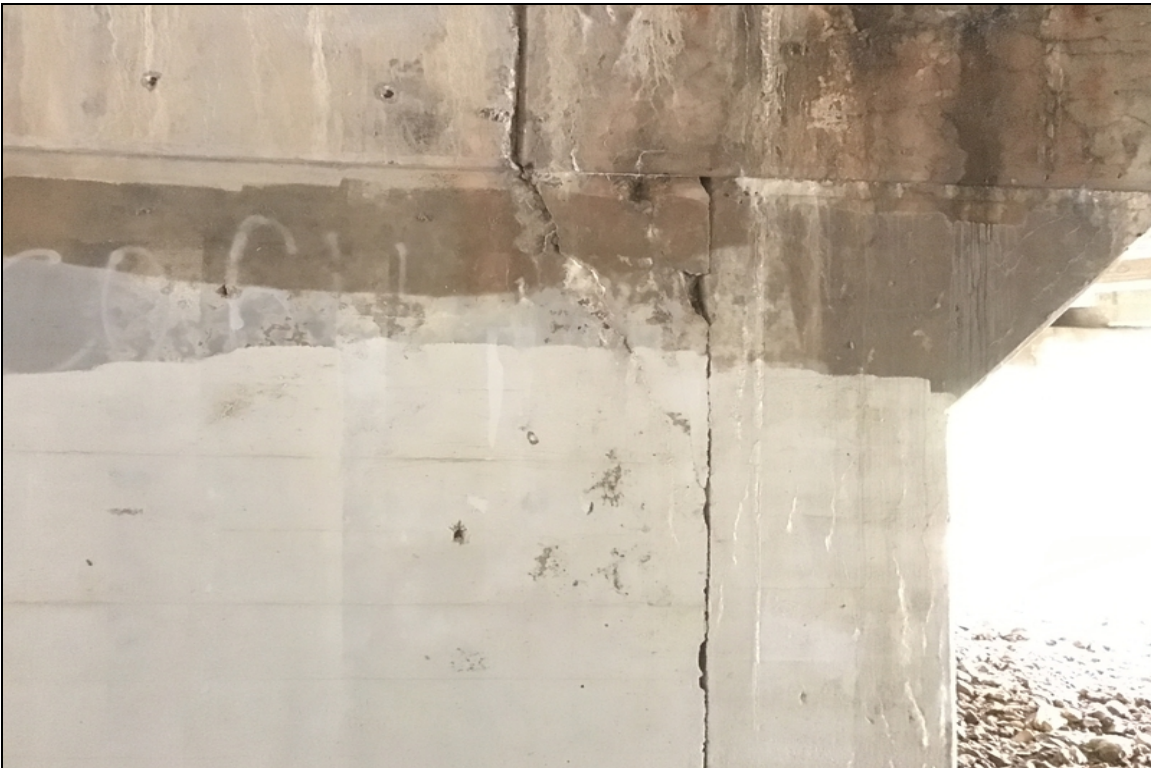
Bent 2 pier wall cracking with efflorescence

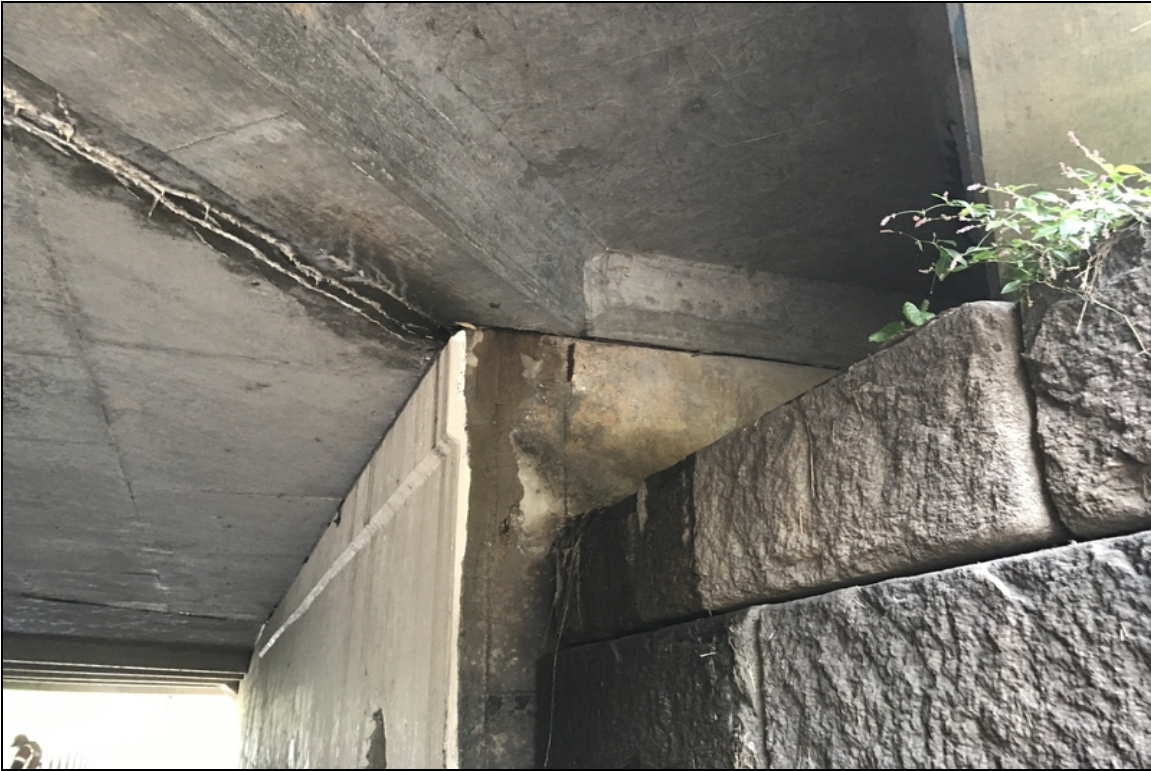
Bent 1 adjacent to girder 2 spalling with exposed reinforcing steel

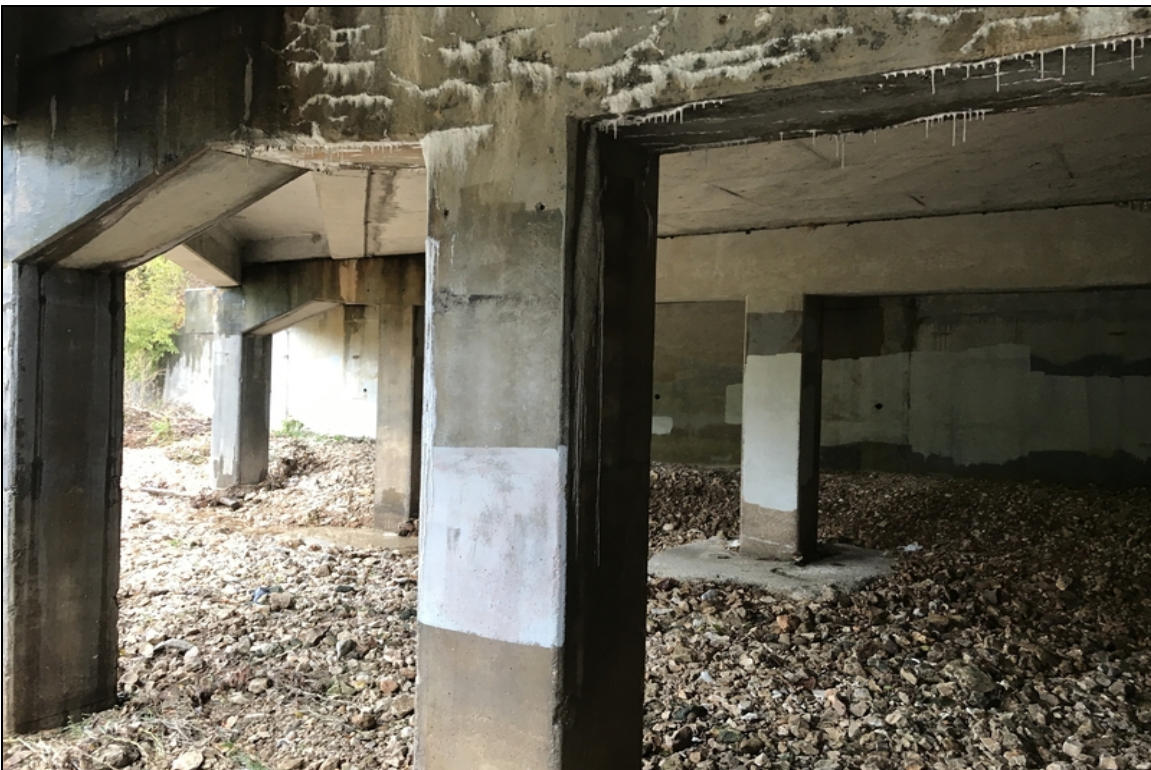
Bent 2 columns 2 & 3 cracking with efflorescence
