**Bridge #01196(Routine)**  
**US 71 B-Washington over Spring Creek**  
**Location: 0.89 MI S OF BENTON CO LN**

**Team Lead: Jacob Turner Inspection Date: September 30, 2021**

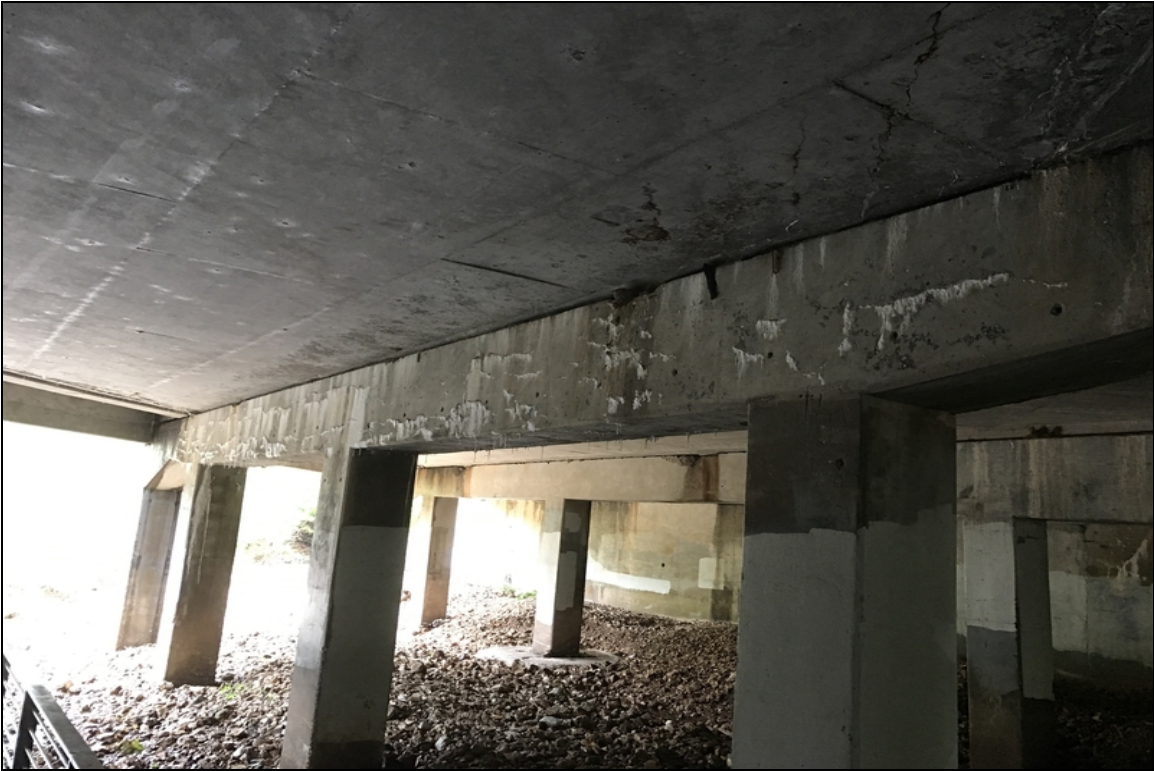
Bent 2 cap cracking with efflorescence (Both sides)

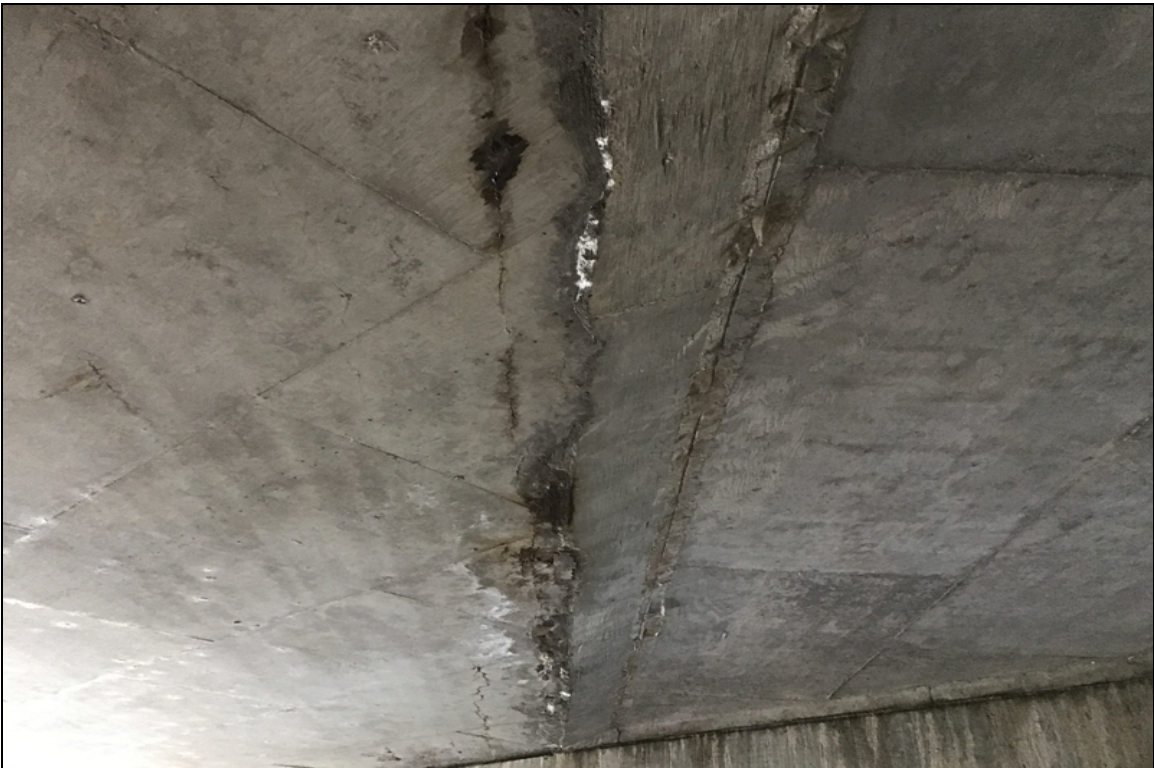
Span 1 slab cracking with efflorescence at construction joint

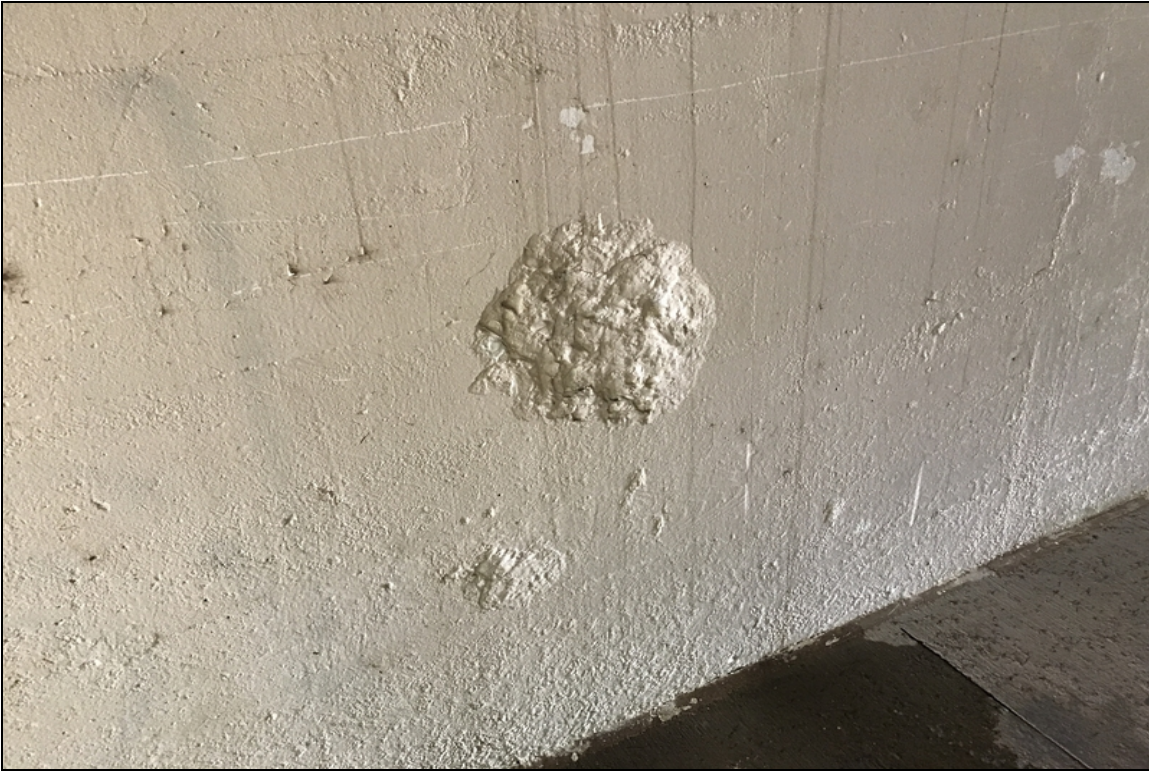
Bent 1 spall

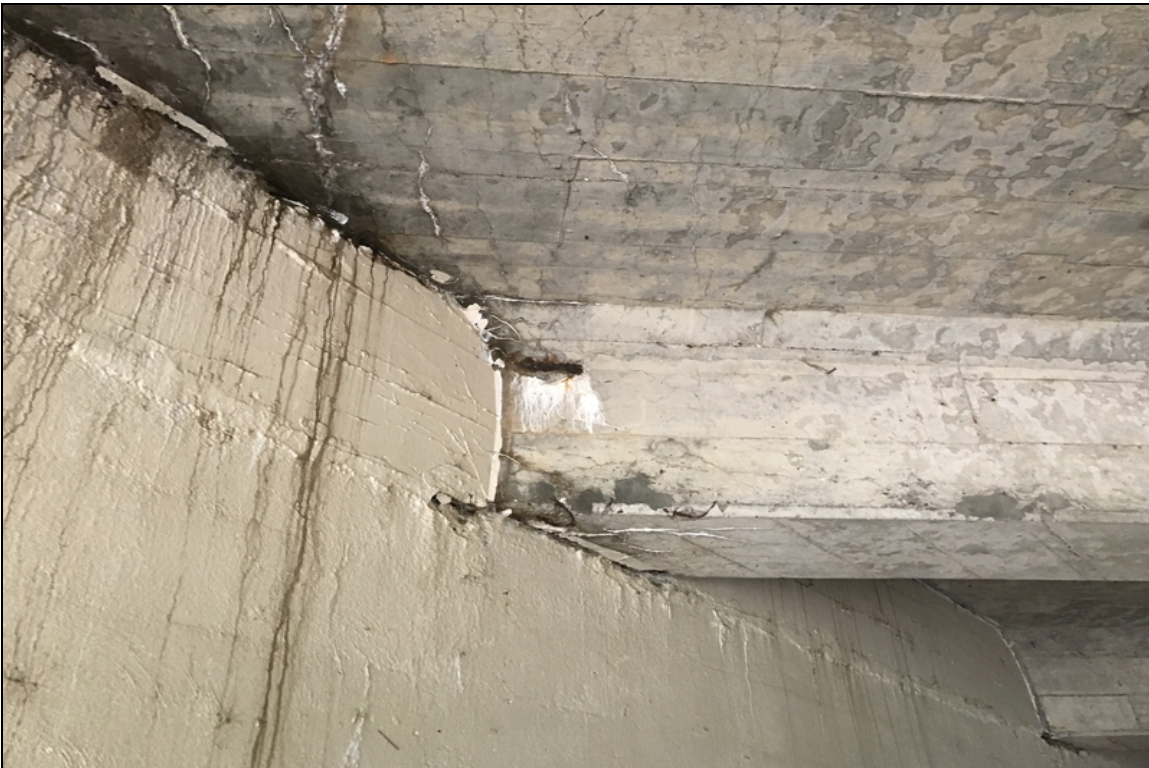
Span 1 bent 1 girder 4 spalling with exposed reinforcing steel

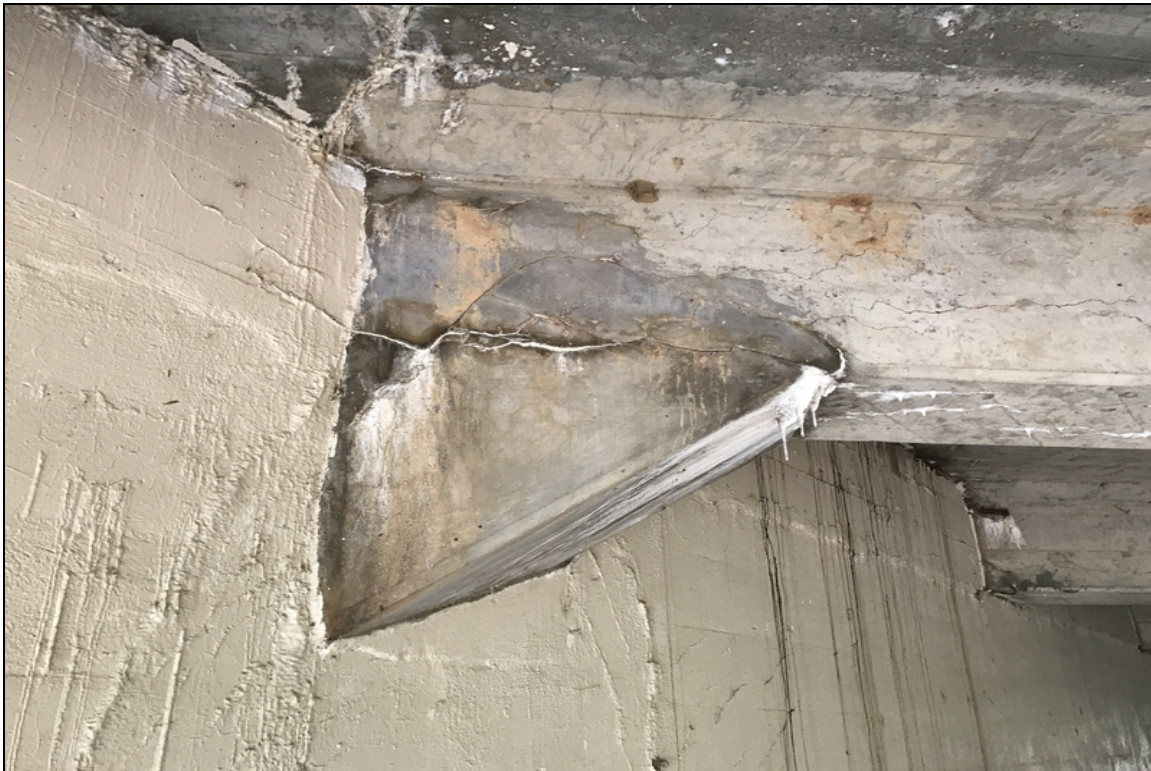
Span 1 bent 1 girder 5 shear type crack

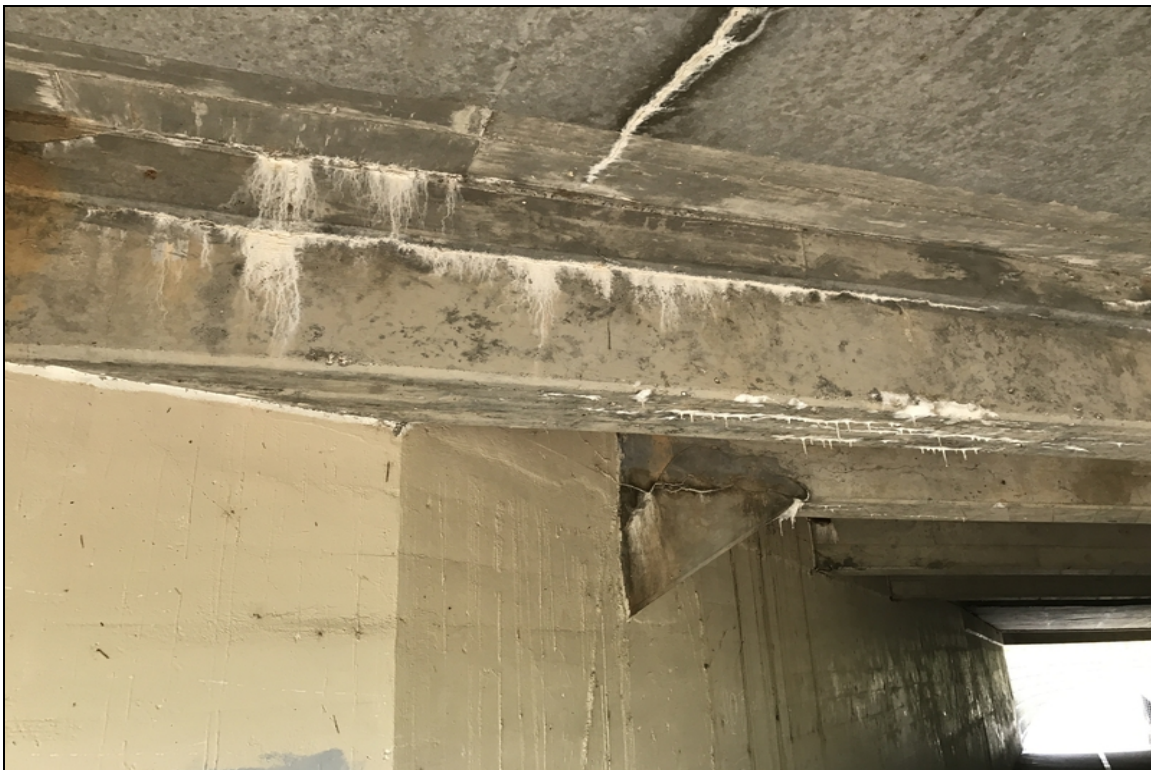
Span 1 girders 5 & 6 cracking with efflorescence

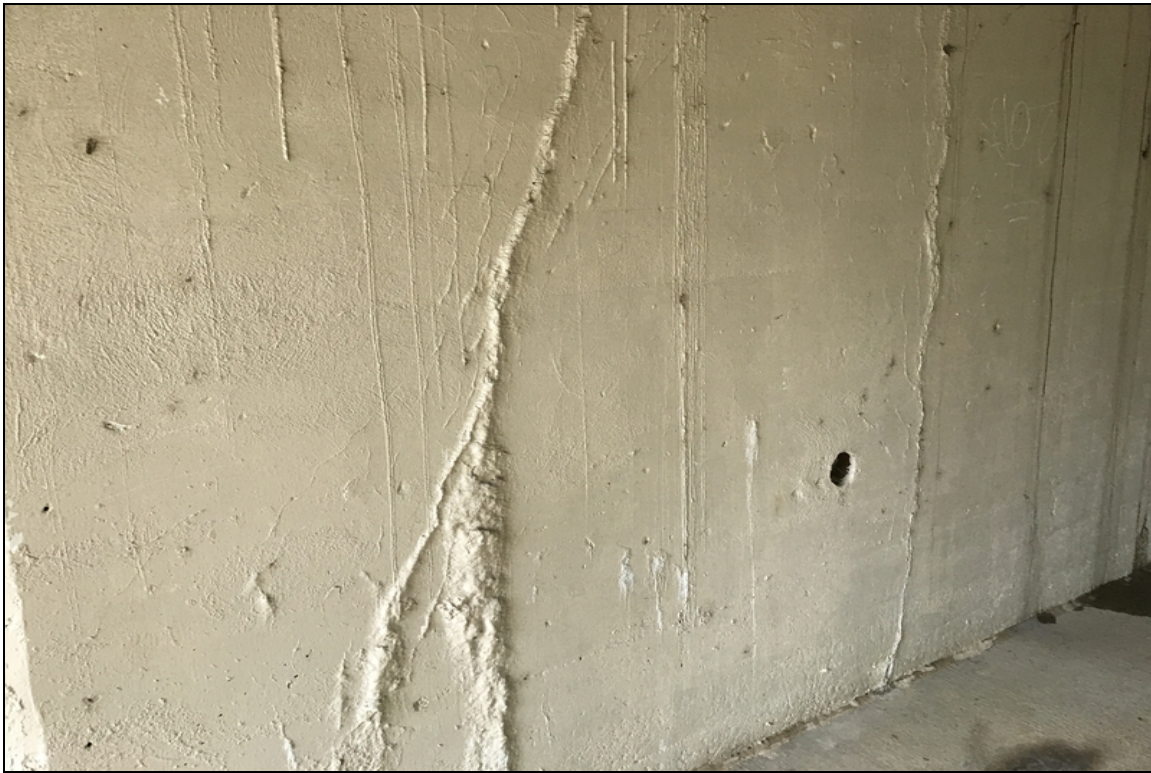
Bent 1 cracking with efflorescence

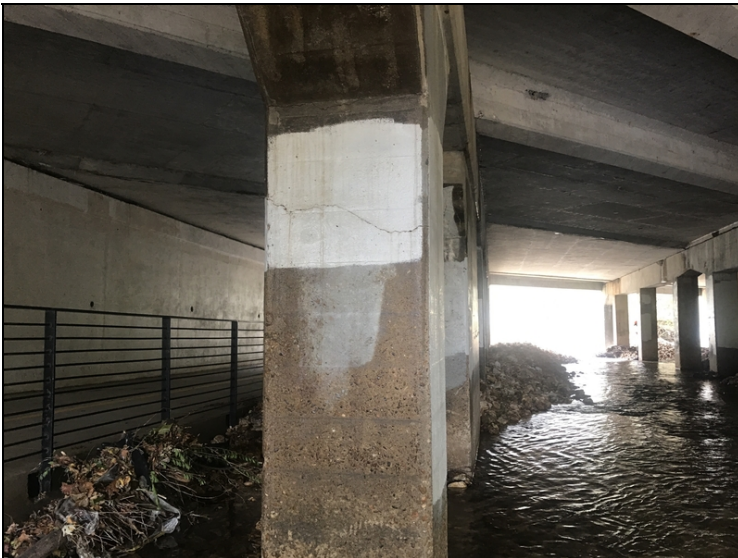
Bent # 2, Column # 7 has a 1/16" wide horizontal crack through the column located approximately 3' below the bottom of the cap.

Crack column # 7. Bent # 2.

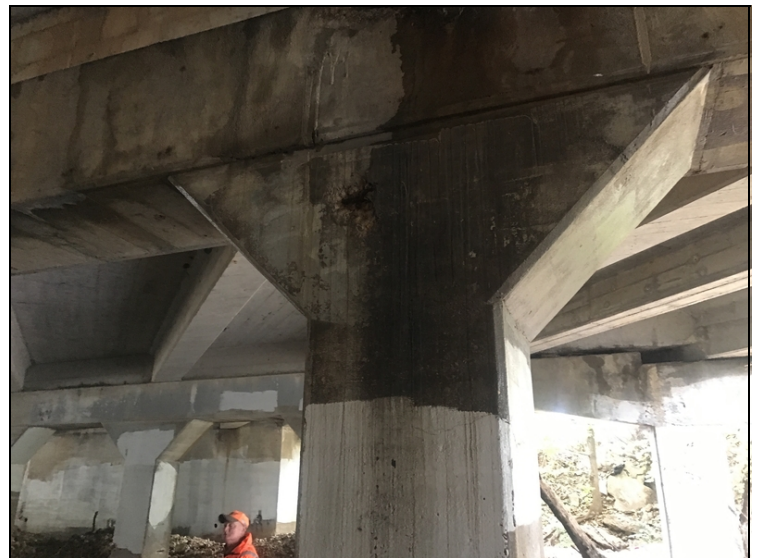
Spall with exposed reinforcing steel. Bent # 2.  
Column # 7.

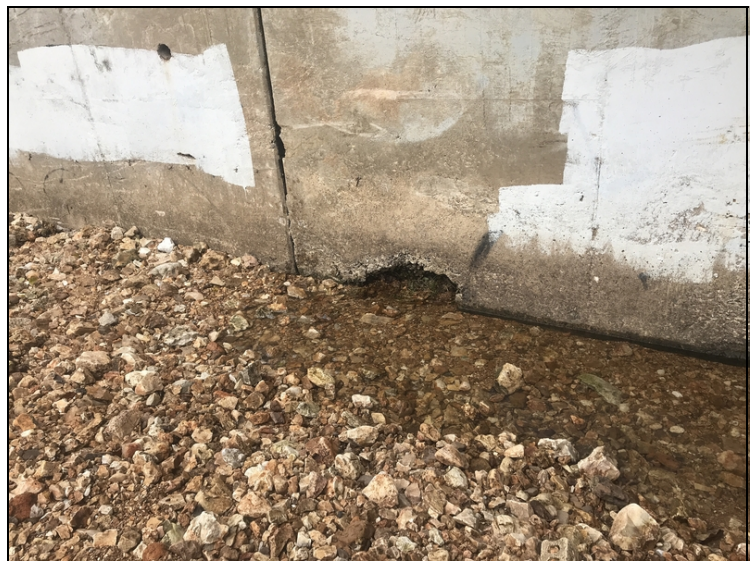
The original portions of the abutments have longitudinal, diagonal, and map cracking with efflorescence. The Left side of Bent # 4 has a 30" area with concrete deterioration located at the water elevation.

Concrete deterioration. Left end of Bent # 4.

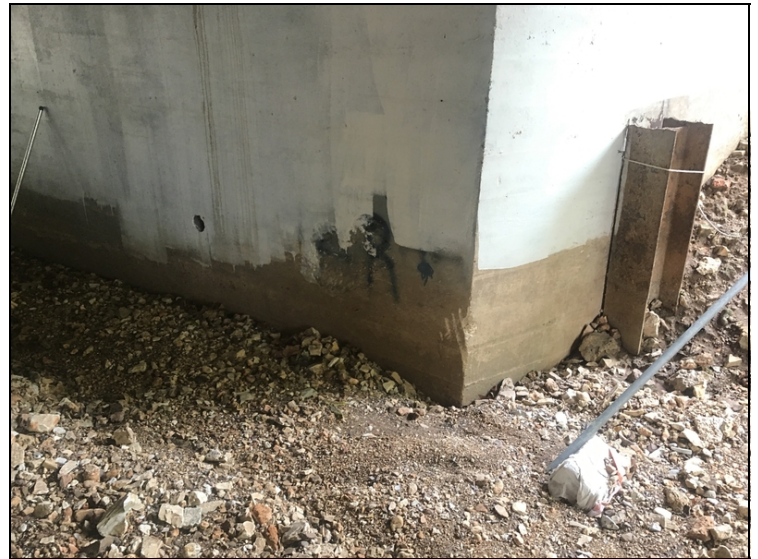
Concrete deterioration. Right end of Bent # 4.

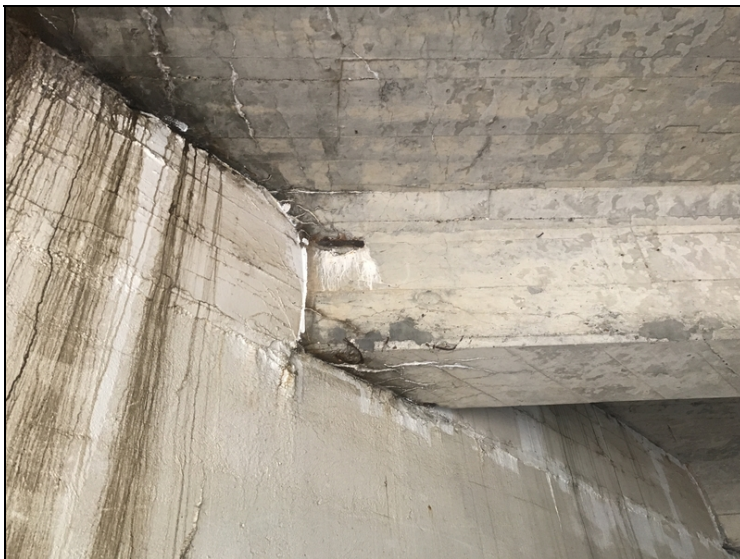
Girder # 3 adjacent to Bent # 1. Map cracking with efflorescence. Spall with exposed reinforcing steel.

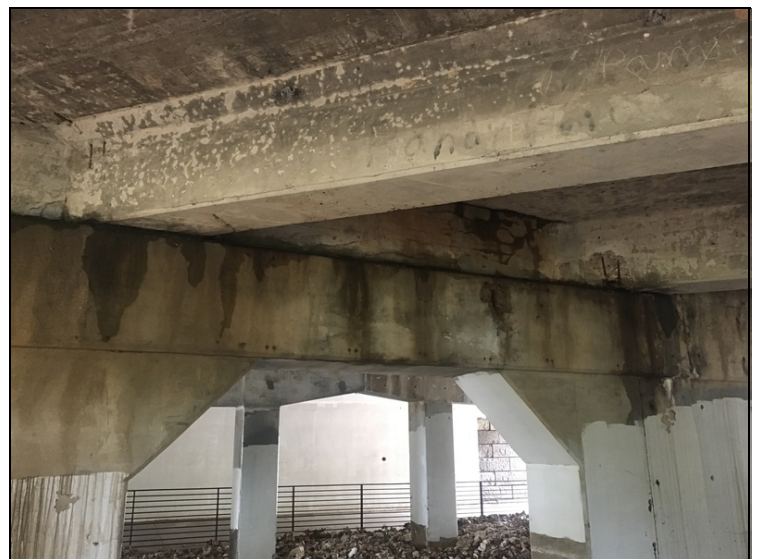
Span # 3. Girders # 3 & 4 over Bent # 3. Spalls with exposed reinforcing steel.

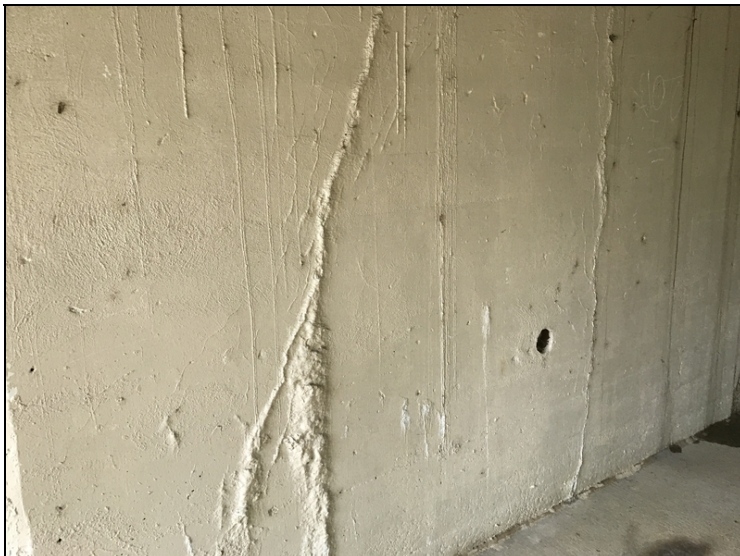
Bent 1 cracking with efflorescence

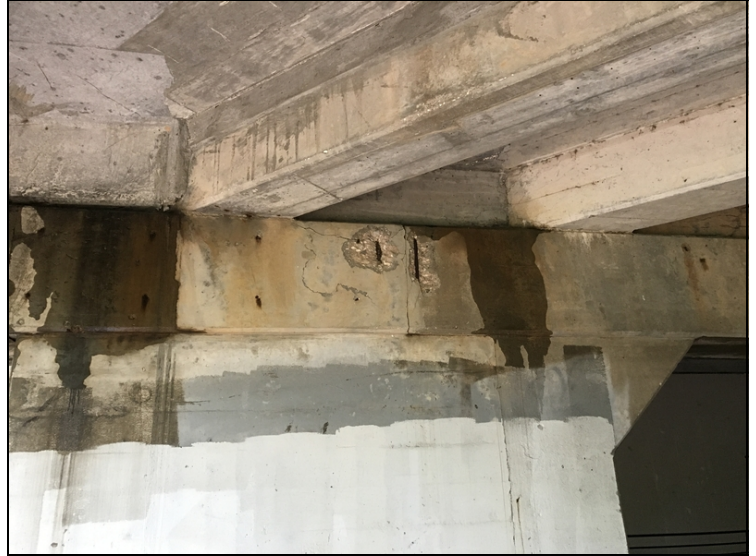
Bent 2 cap (ahd) spalling with exposed reinforcing steel

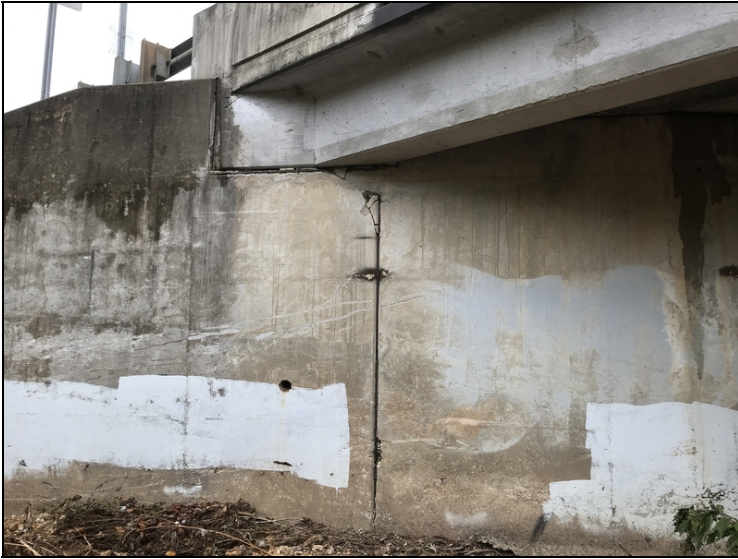
Bent 4 spalling with exposed reinforcing steel at construction joint

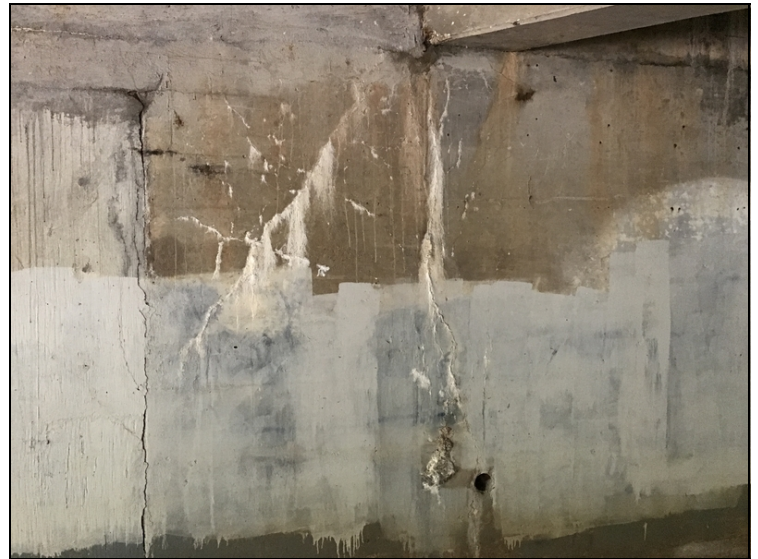
Bent 4 cracking with efflorescence

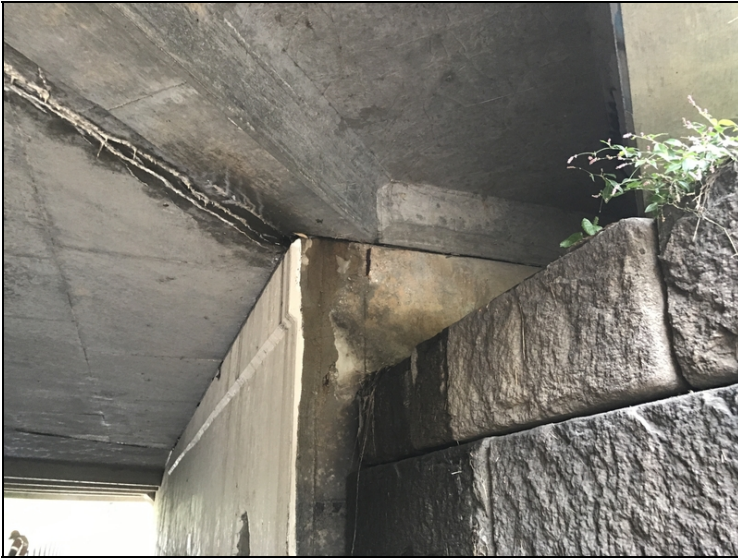
Bent 1 adjacent to girder 2 spalling with exposed reinforcing steel

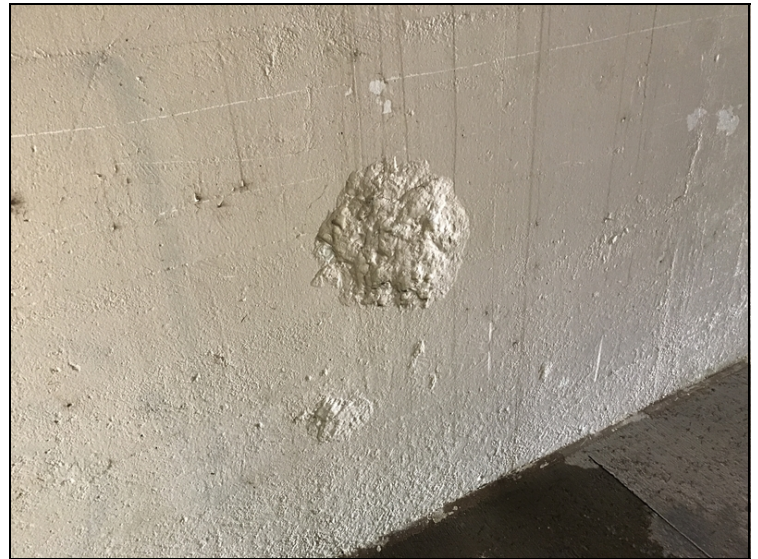
Bent 1 spall

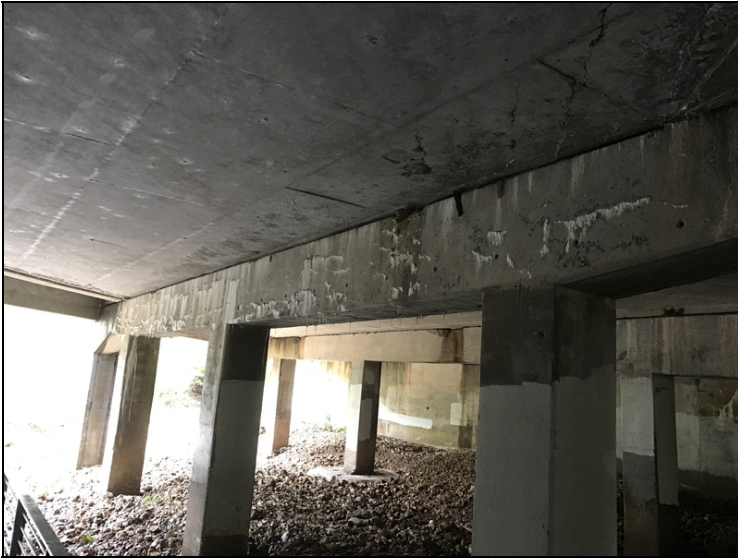
Bent 2 cap cracking with efflorescence (Both sides)

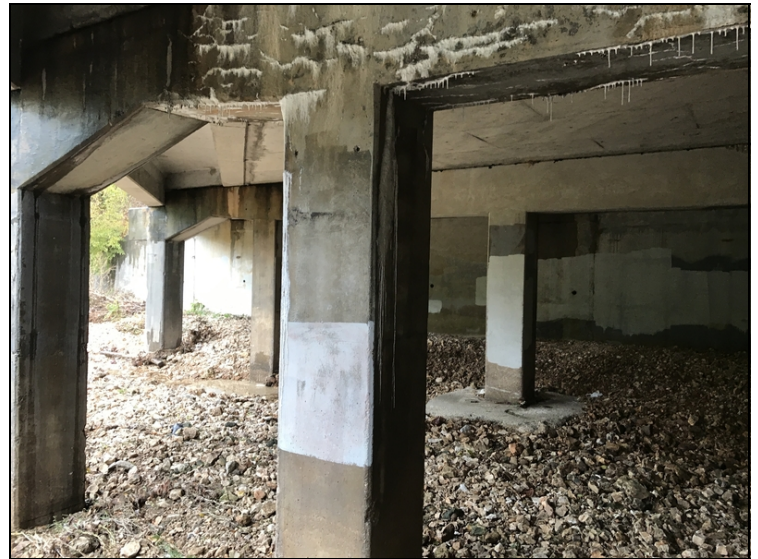
Bent 2 columns 2 & 3 cracking with efflorescence

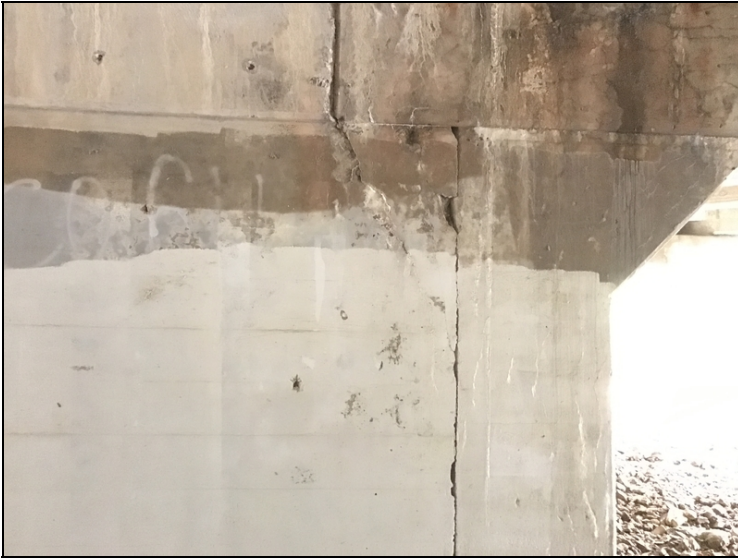
Bent 2 pier wall cracking with efflorescence

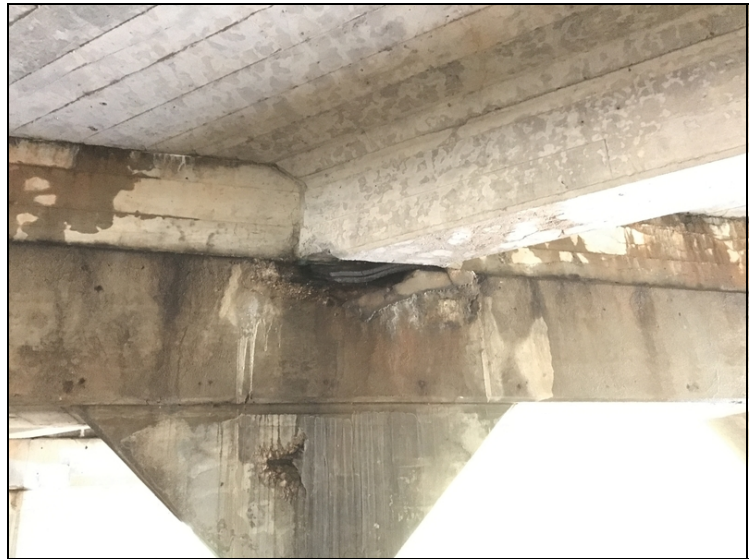
Bent 2 spalling at bearing area adj to girder 4 (Bk)

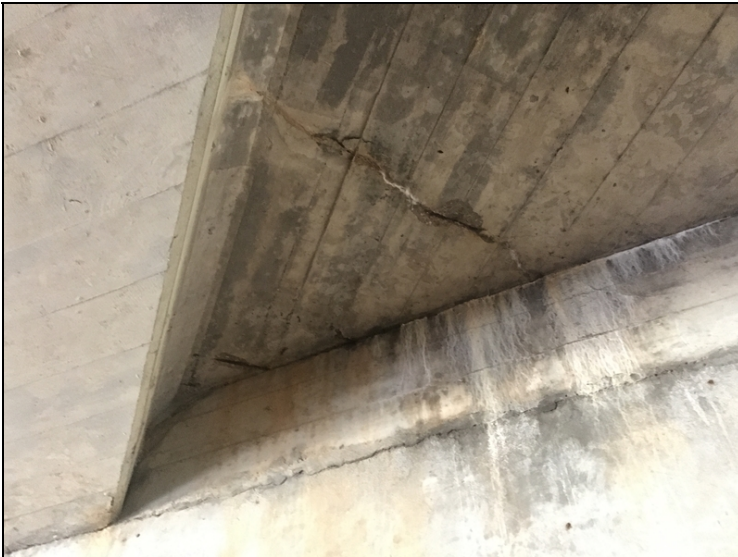
Deck Soffit - Span # 3. Bay # 2. Spalls with exposed reinforcing steel adjacent to Bent # 4.

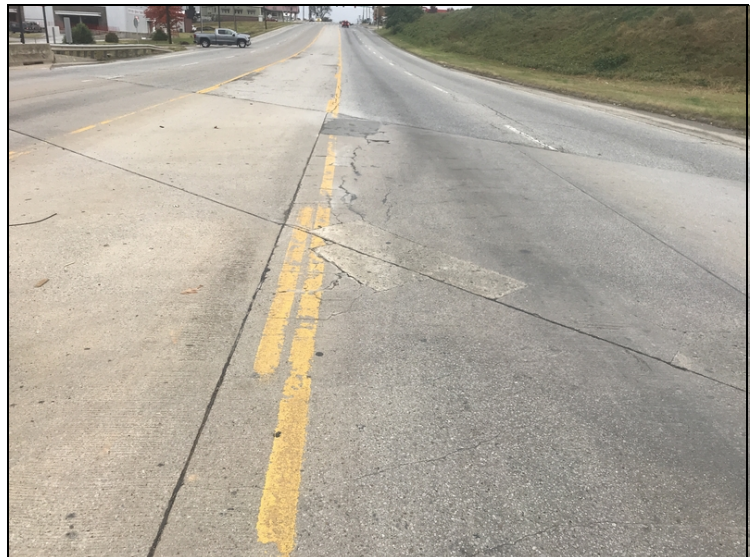
Span # 1. Patched area.

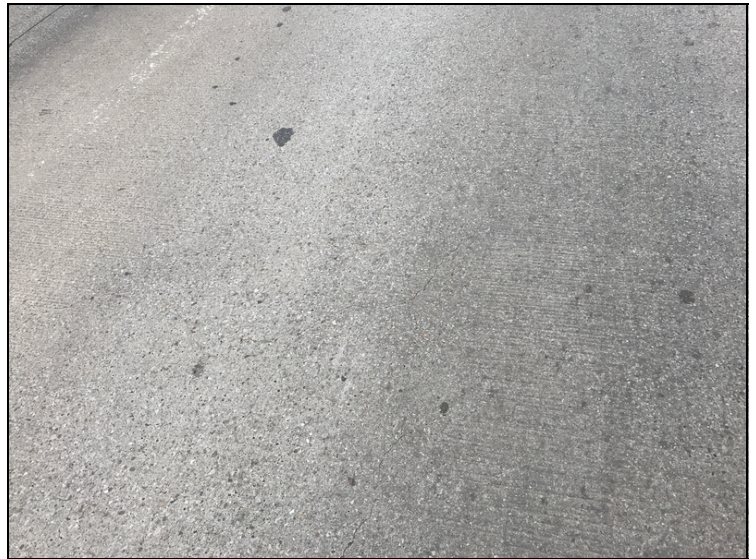
Span # 3 cracking.

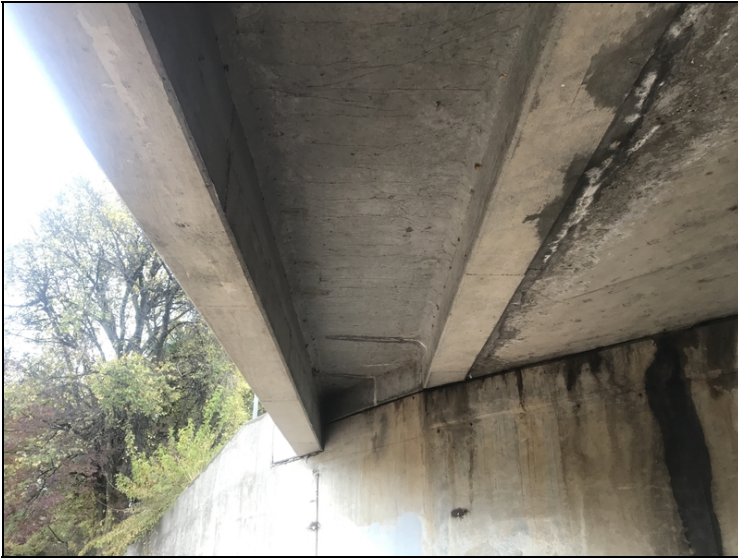
Span # 3. Left. Transverse cracks with efflorescence.

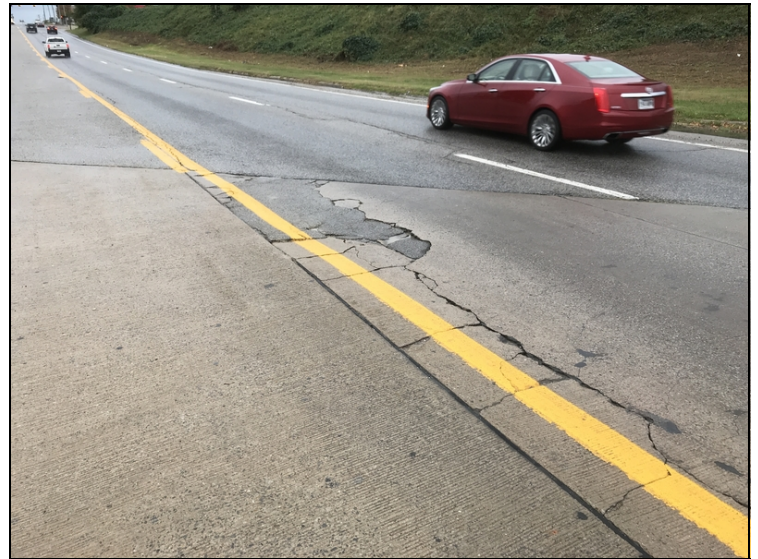
Span 1 spalling in wheel path

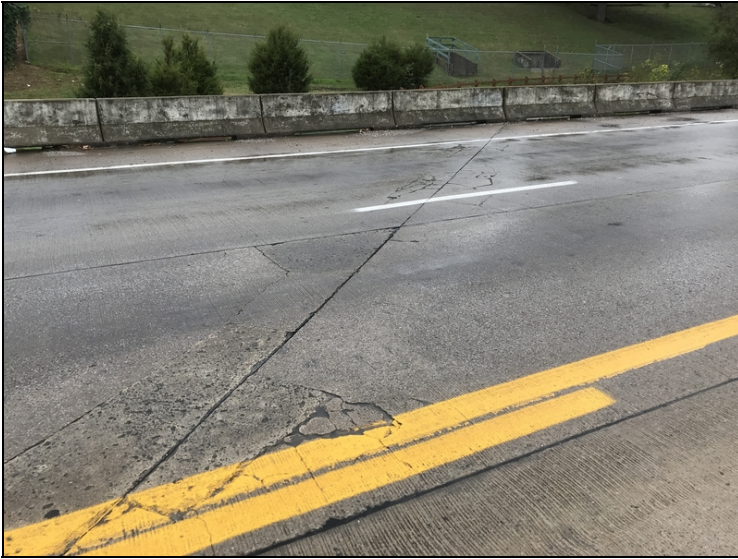
Span 2 spalling in wheel path

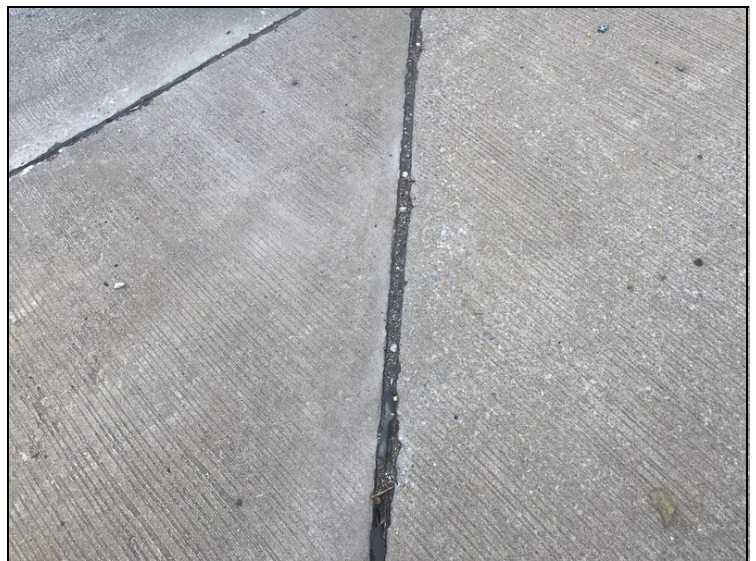
Deck joint material has failed and leaks water and chlorides on the substructure and between the concrete wearing surface and the deck.

Joint Sealant. Deteriorated and missing.

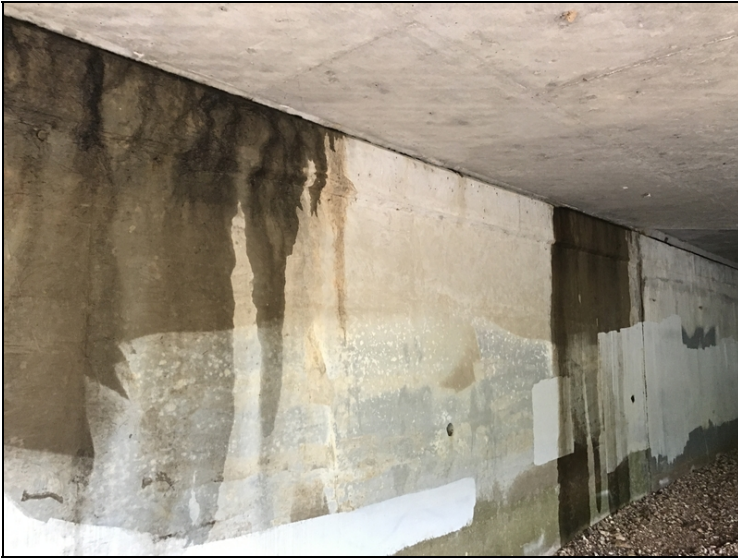
Joints leaking onto substructure

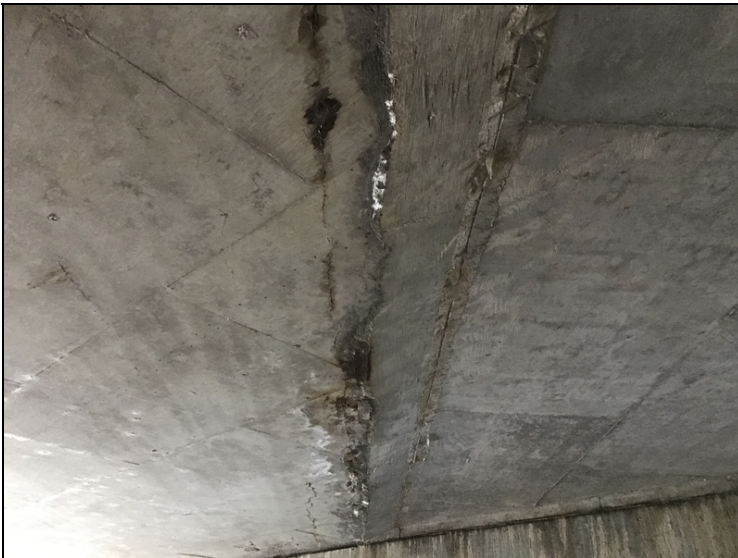
Span 1 slab cracking with efflorescence at construction joint

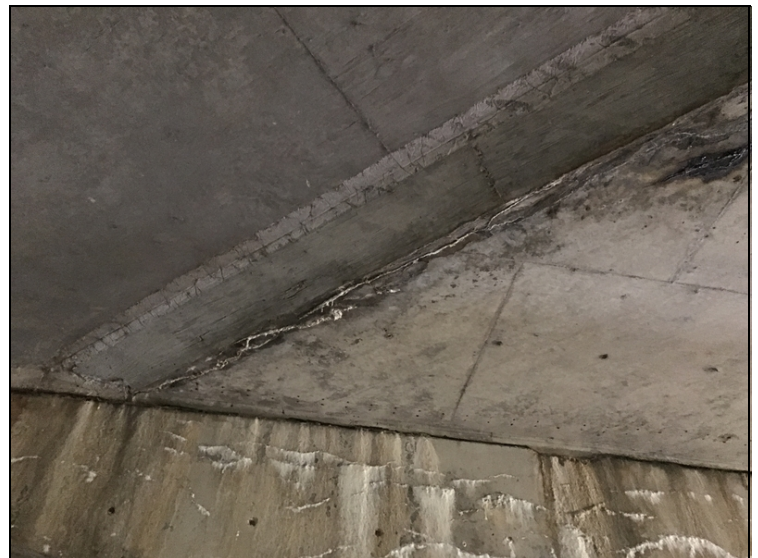
Span 2 slab construction joint cracking with efflorescence
