**Bridge #01408**(Routine, Underwater type 2)

**US 71B-Washington over Dry Branch**

**Team Lead: Jacob Turner Inspection Date: September 30, 2021**

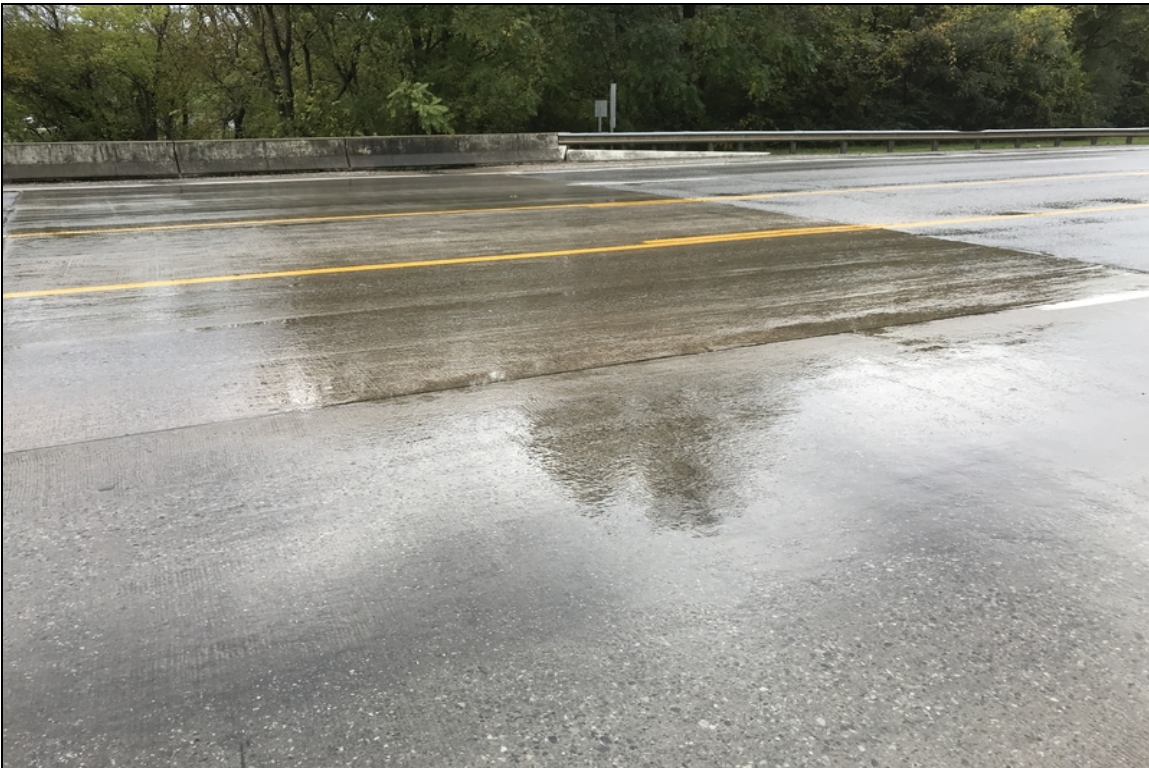
Abrasion in all wheel paths

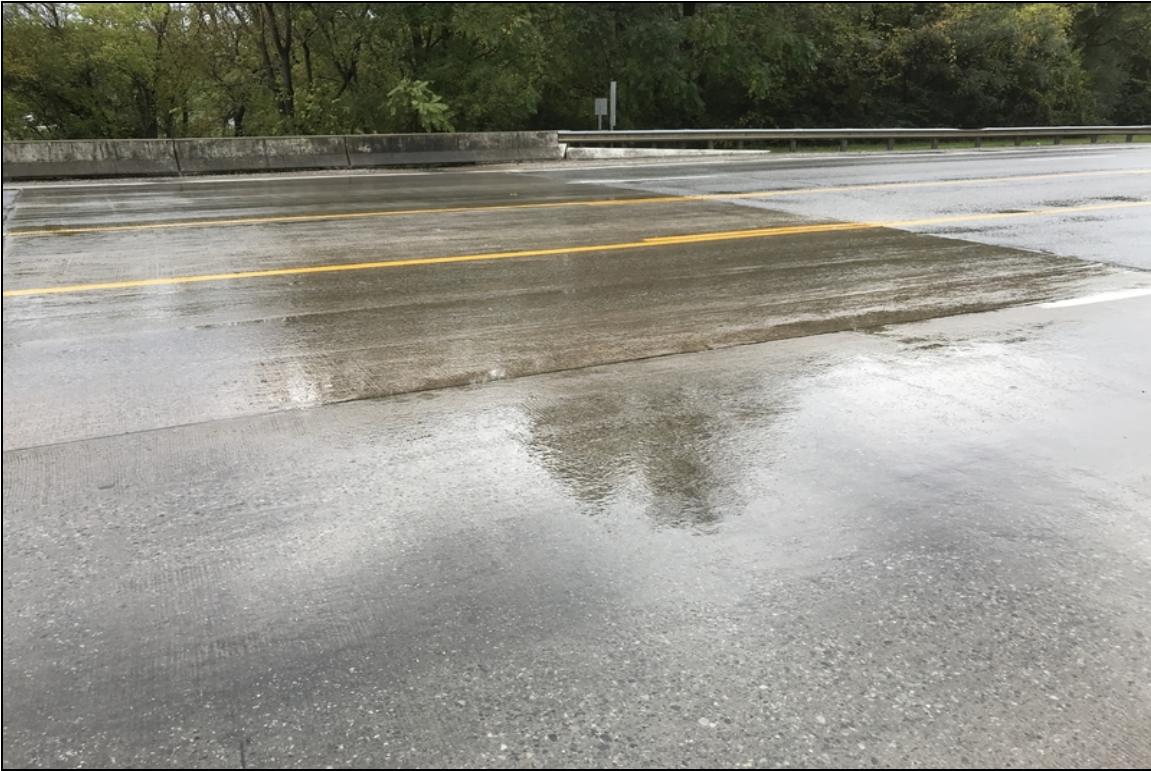
Abrasion in all wheel paths

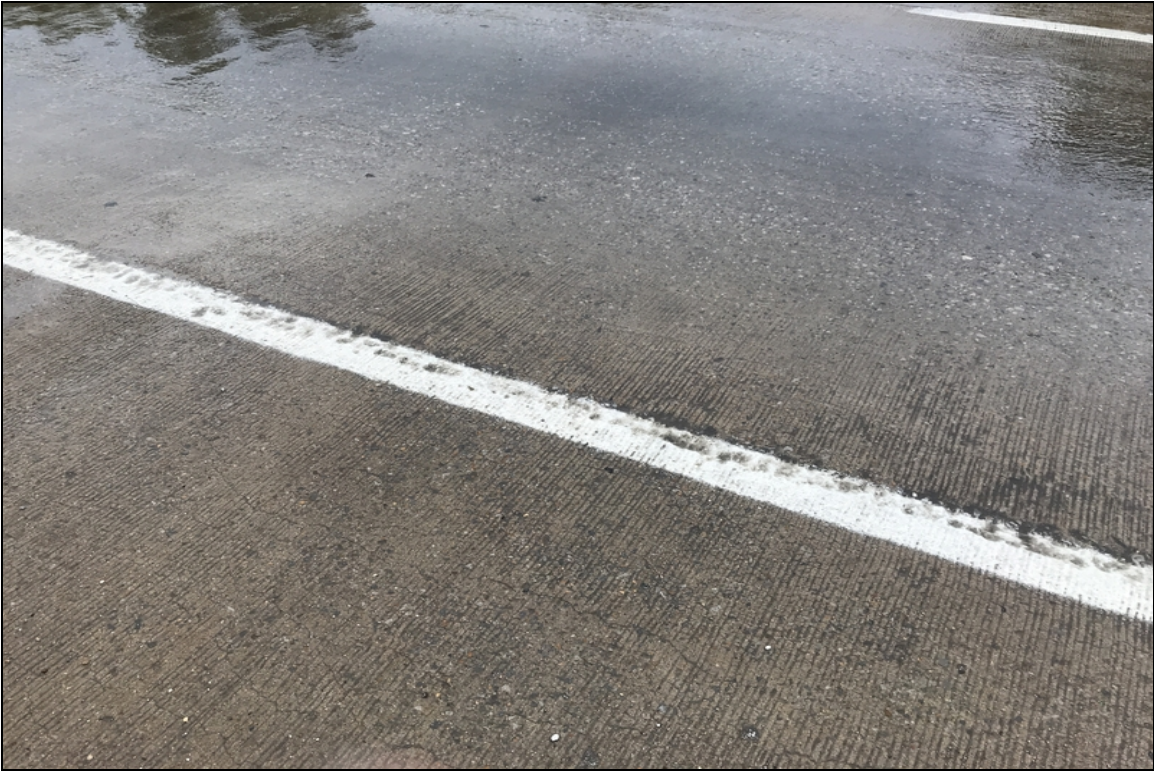
Typical map cracking

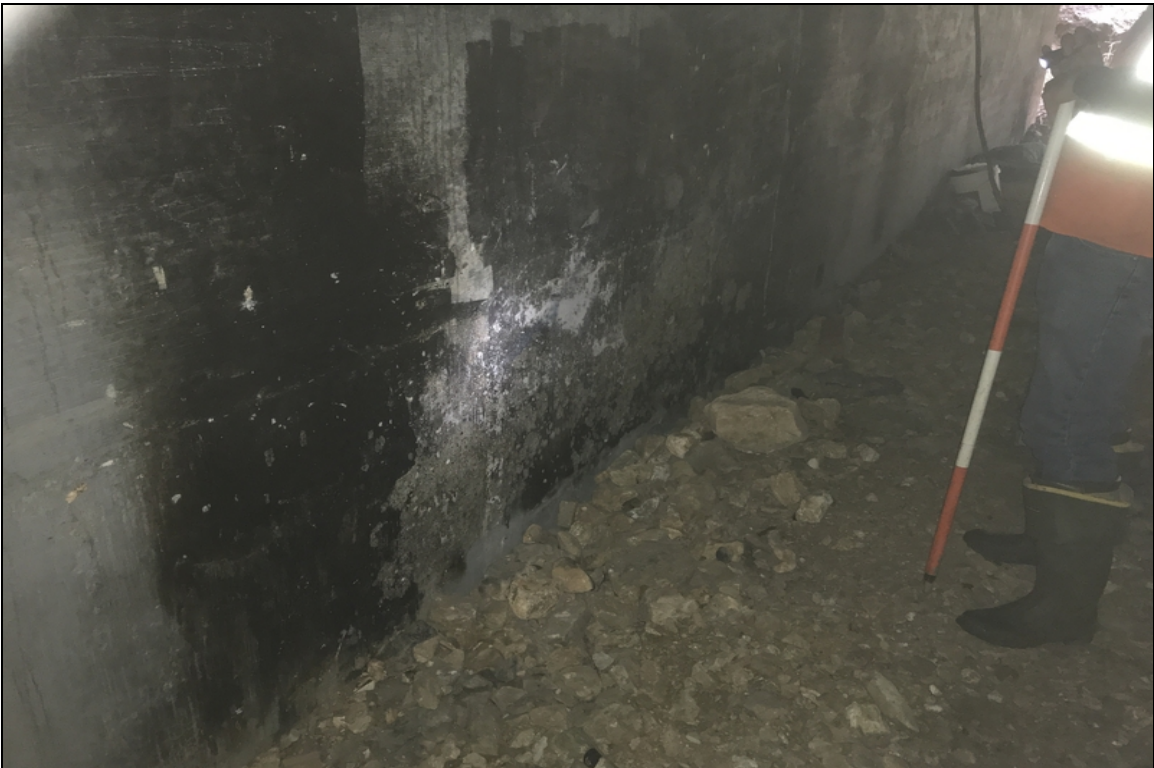
Bent 2 shallow spalling

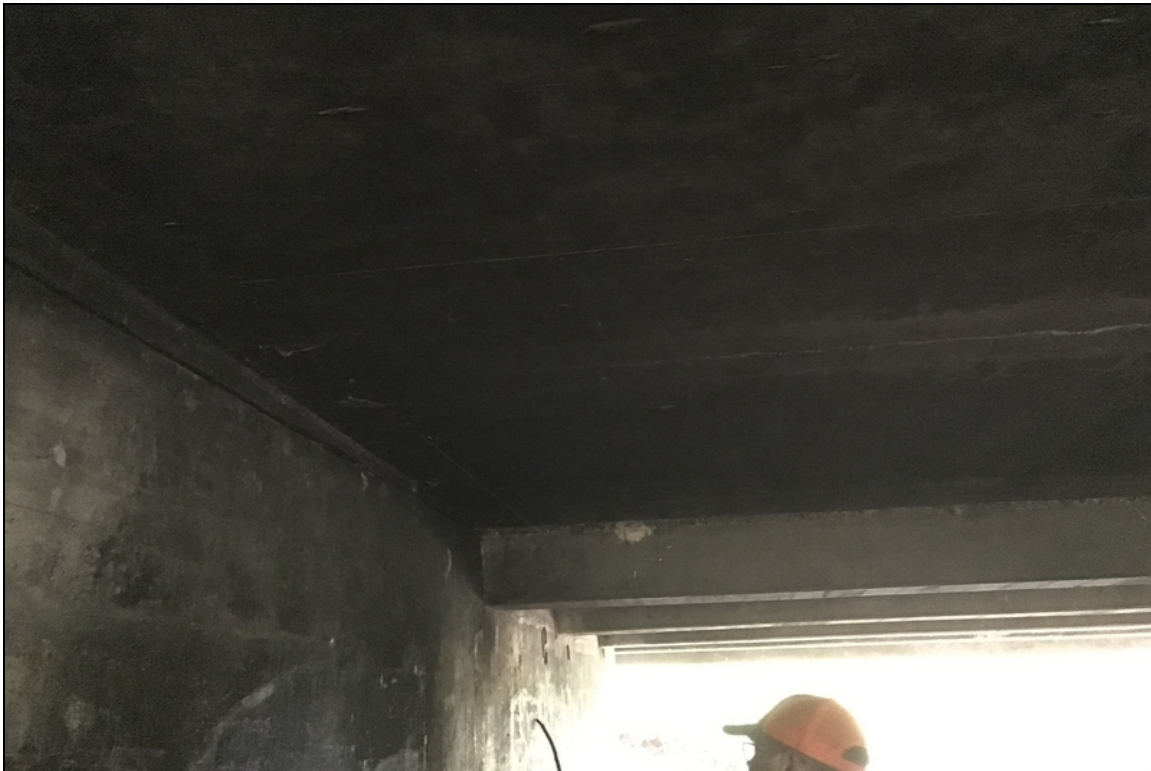
Sud build up on slab unit and bent 2

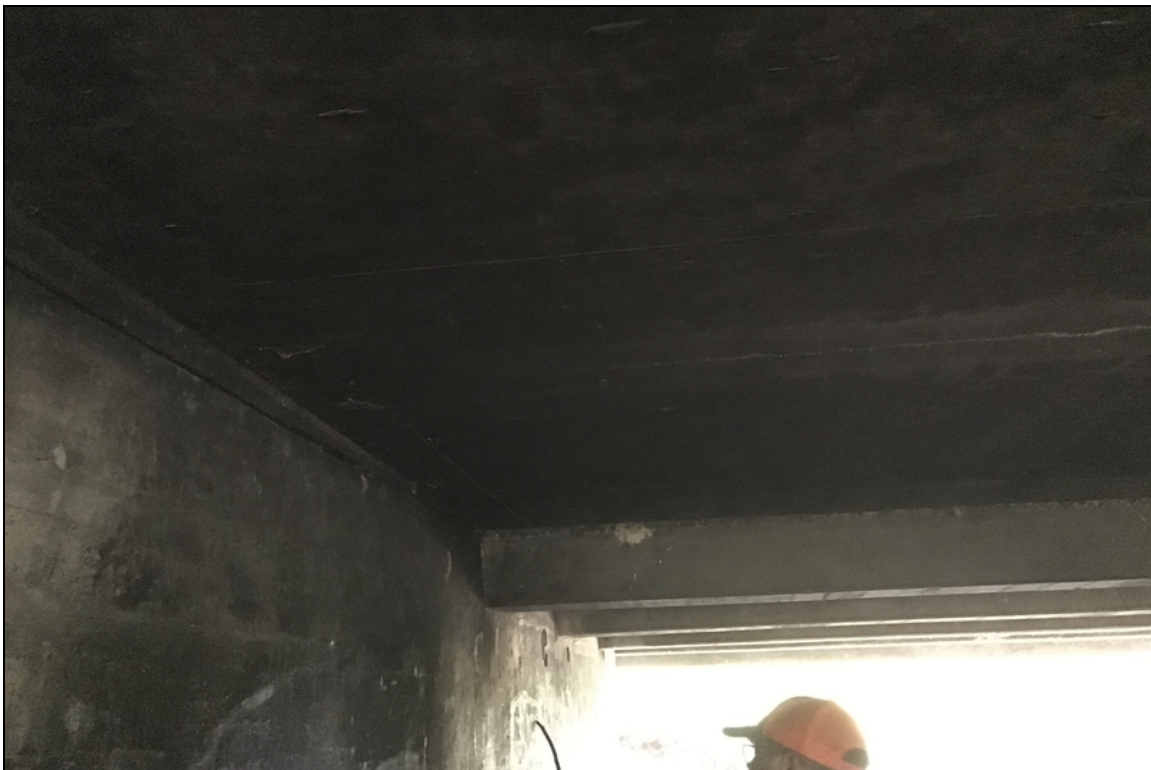
Sud build up on slab unit and bent 2

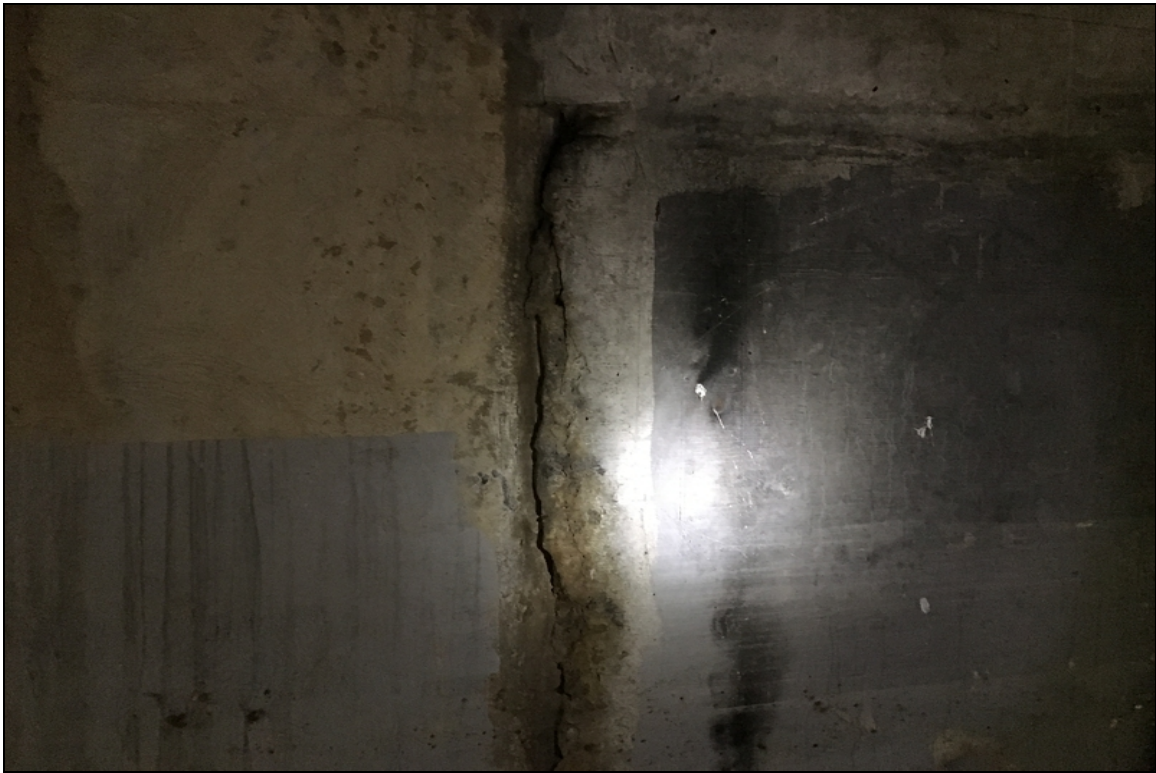
Bent 2 vertical cracking at construction joint

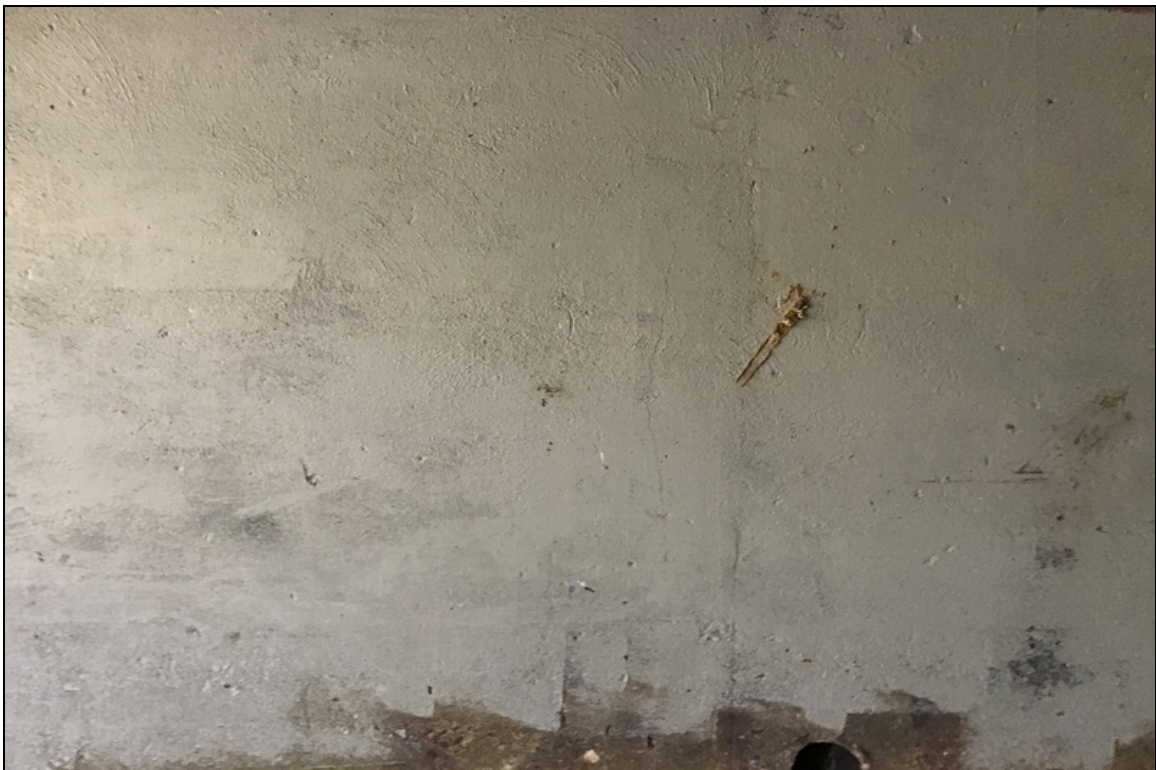
Bent 1 vertical cracking

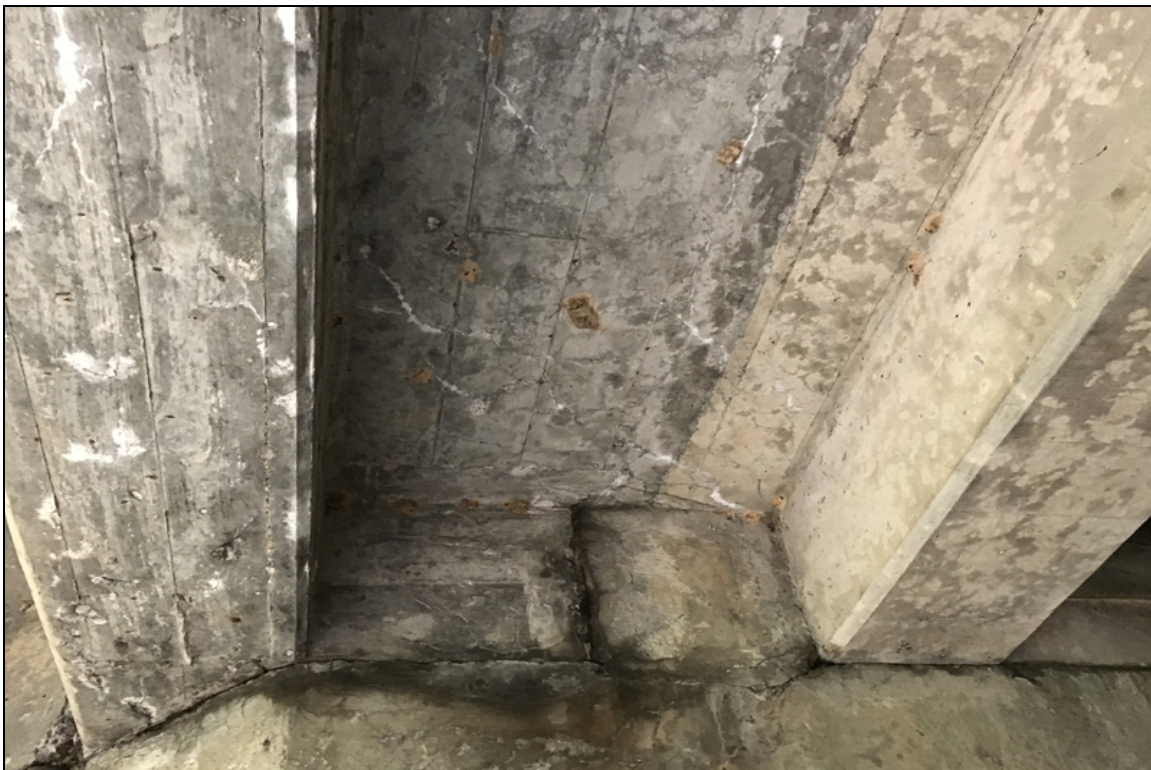
Bay 5 cracking with efflorescence

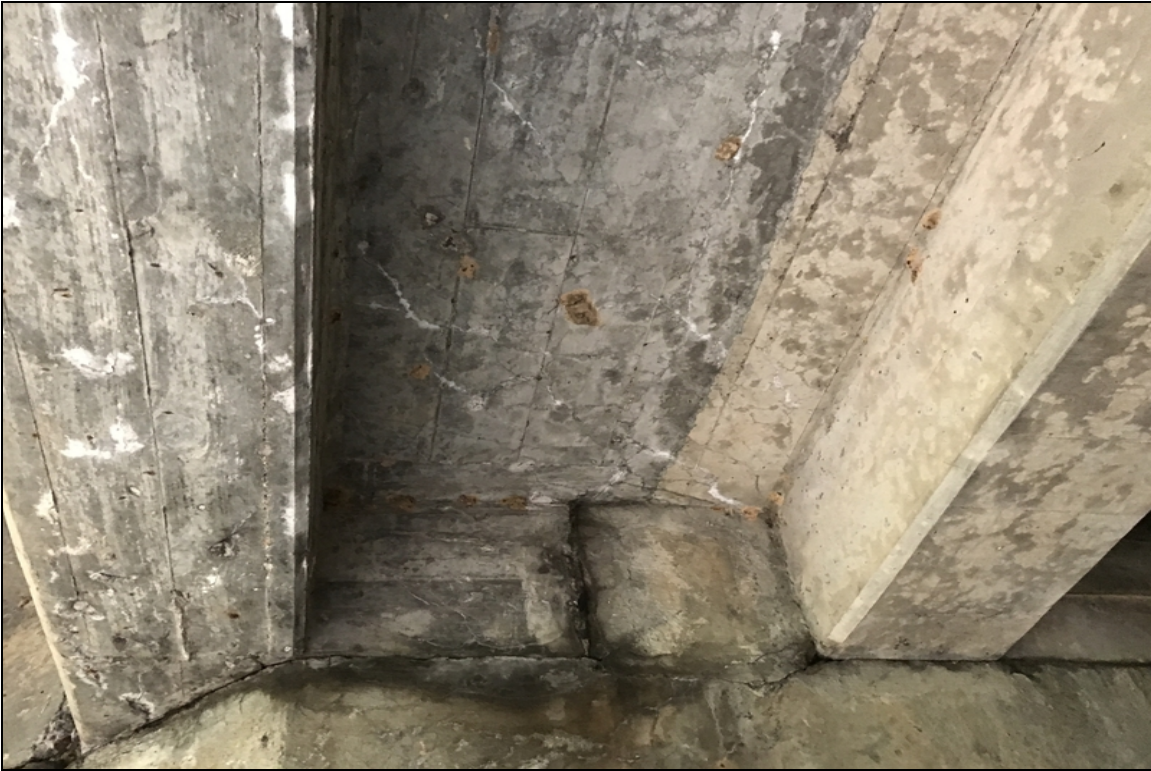
Bay 5 cracking with efflorescence

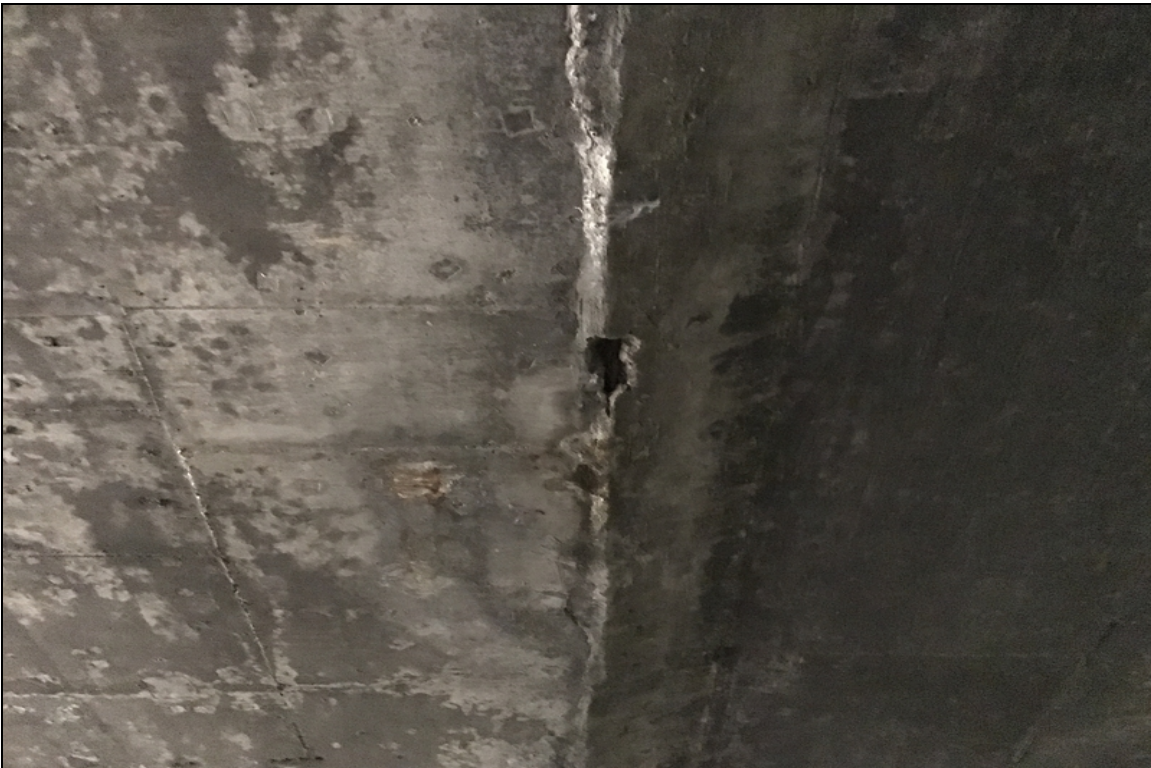
Slab span construction joint cracking with efflorescence and spalling with exposed reinforcing steel

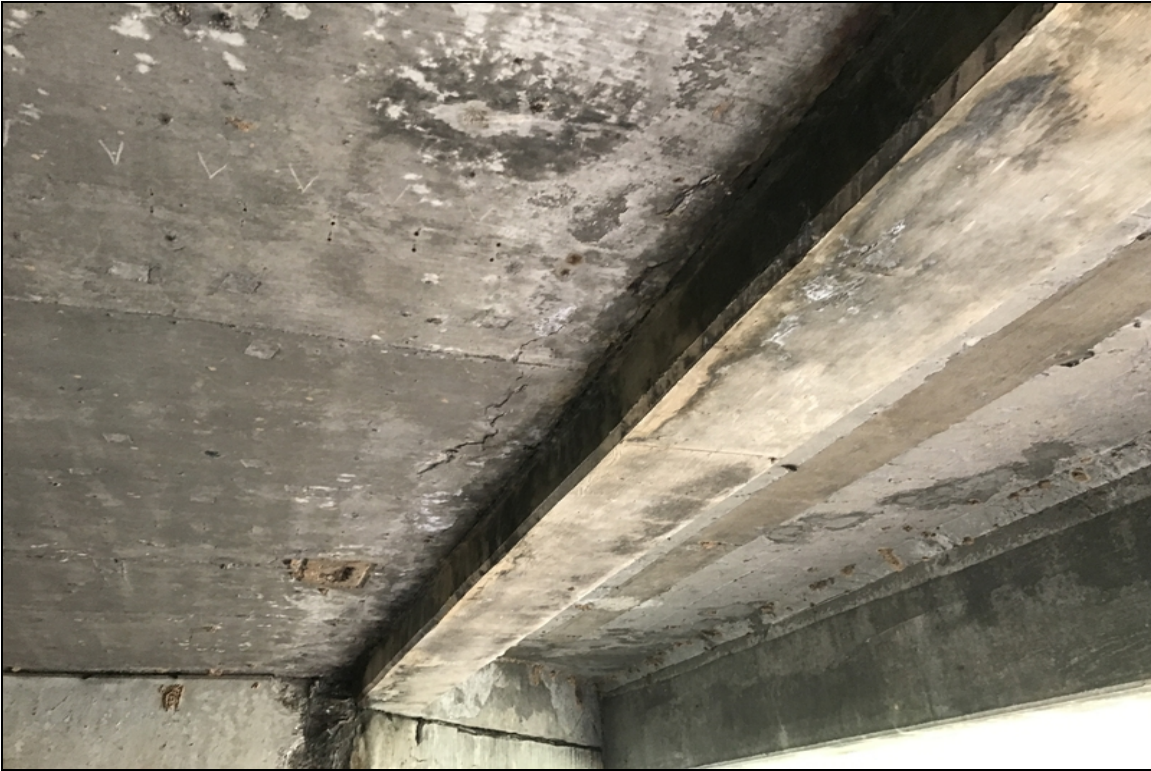
Slab unit adjacent to girder 2 delam

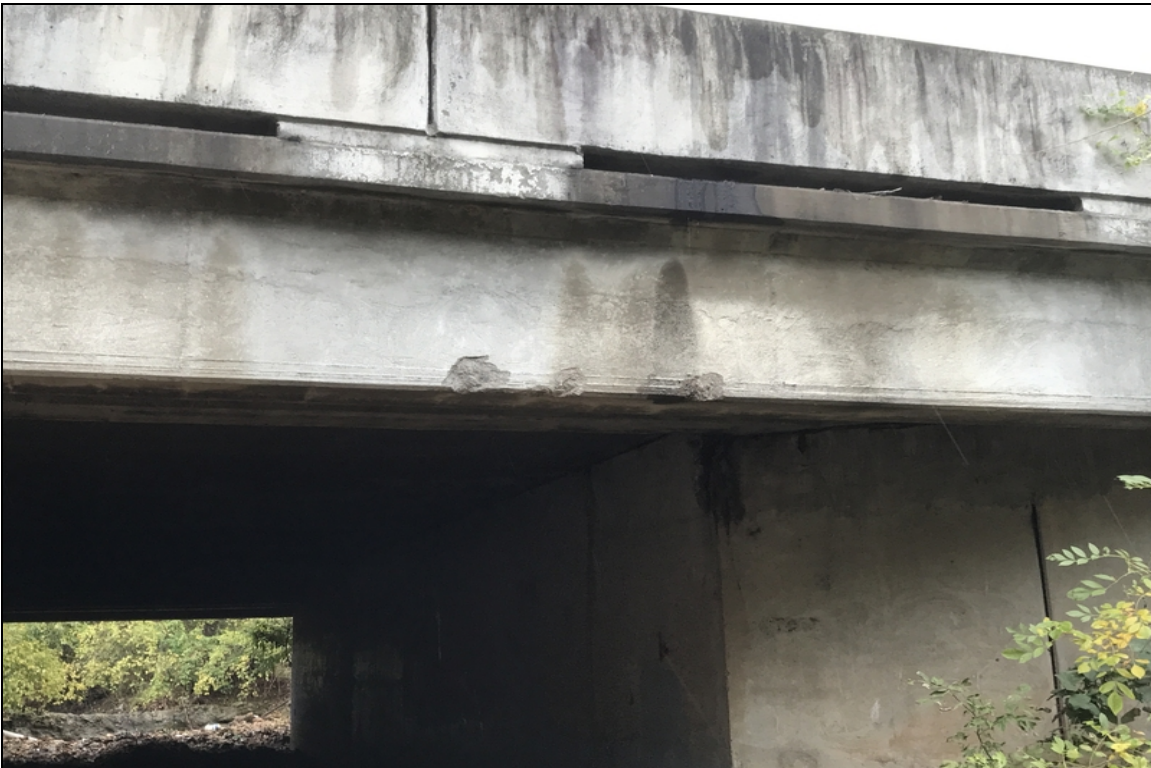
Outside girder 1 spalling

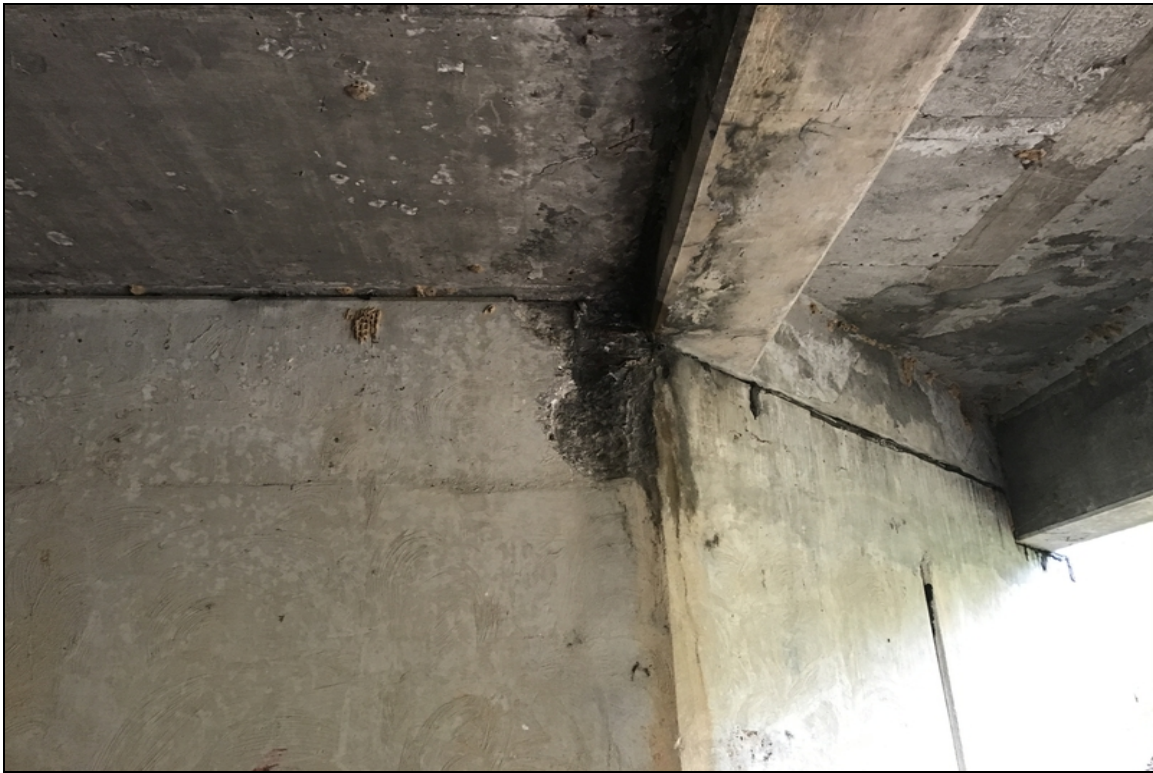
Bent 1 spalling with exposed reinforcing steel adjacent to girder 2 and slab unit

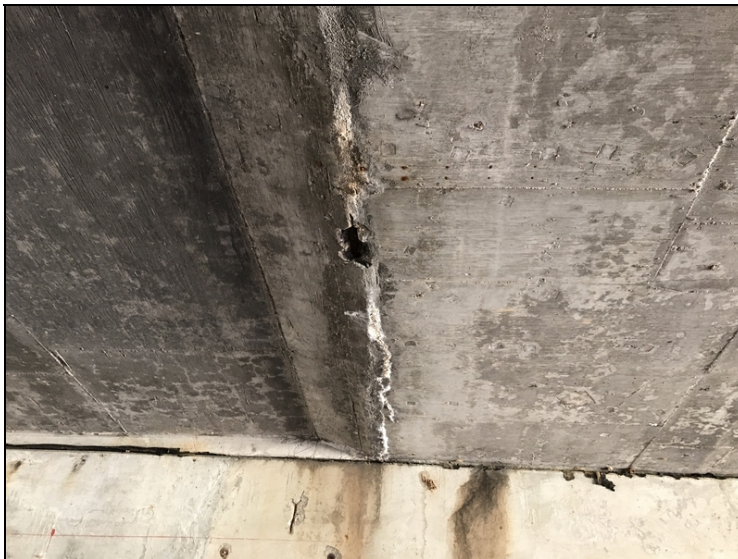
There is a spall with exposed reinforcing steel in the undersurface of the slab at the construction joint near centerline of structure.

Slab soffit construction joint with exposed reinforcing steel.

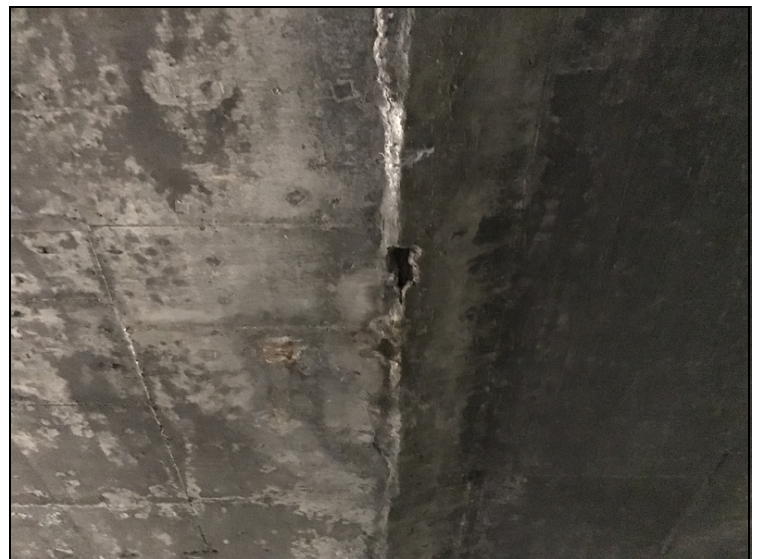
Slab span construction joint cracking with efflorescence and spalling with exposed reinforcing steel

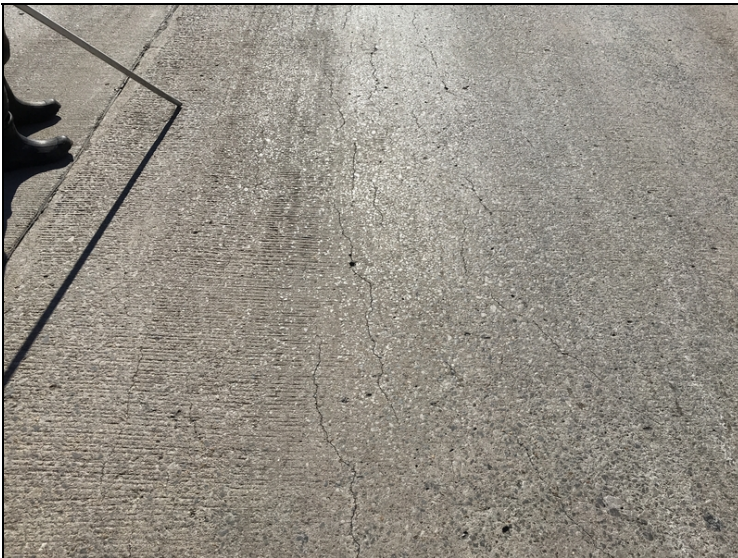
The driving surface of the deck has sealable cracking.

Driving surface of the slab span. Inside Northbound lane.

Type of Work: Repair

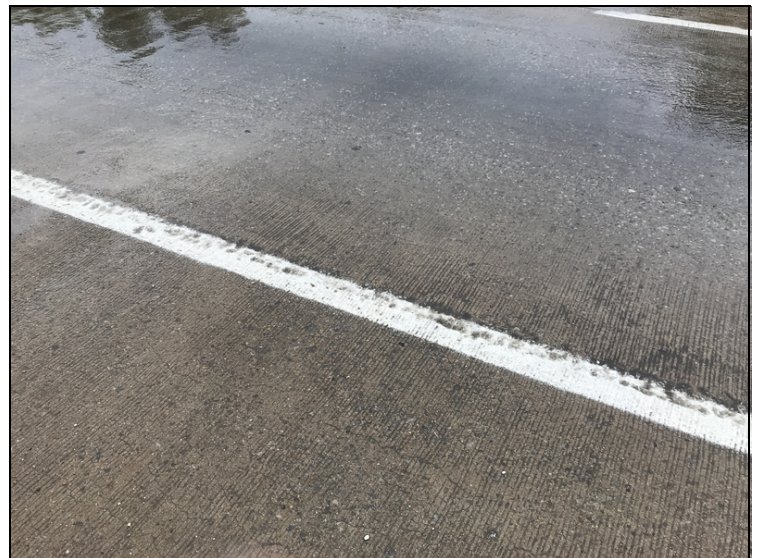
Typical map cracking

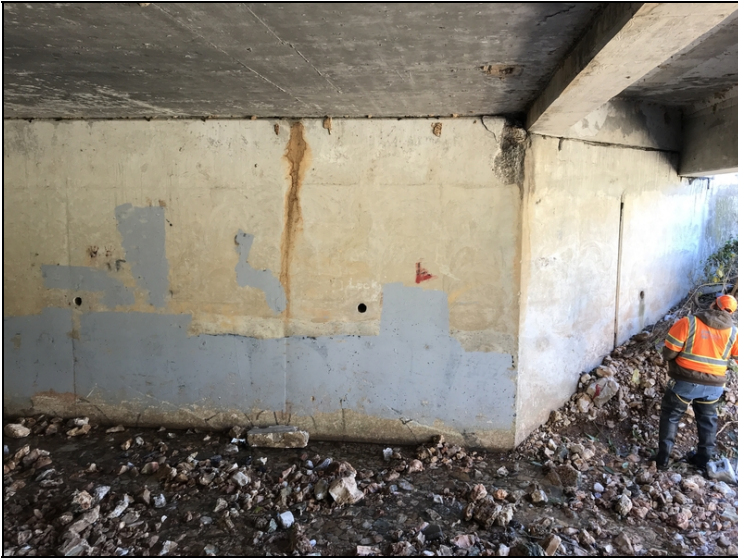
Left end of Bent # 1.

- Bent 1 adjacent to girder 2 has spalling with exposed reinforcing steel

Bent # 1 has a 24" spall with exposed reinforcing steel in the Left side of the bent.

**Type of Work:** Repair

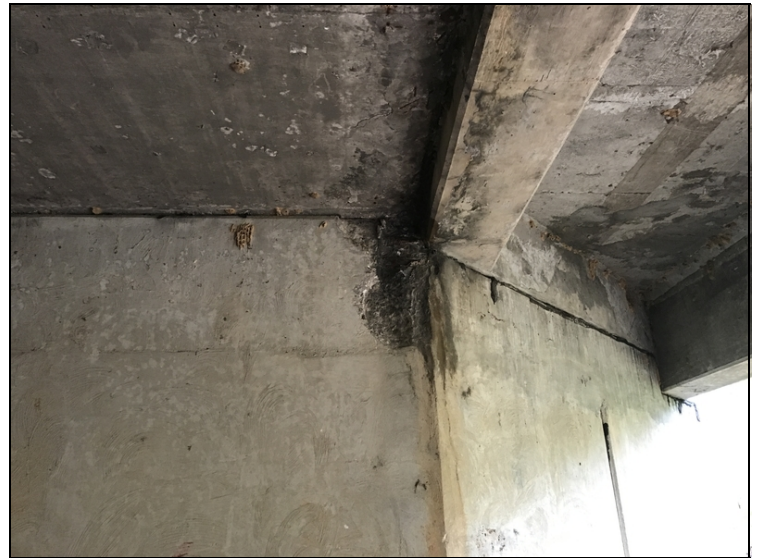
Bent 1 spalling with exposed reinforcing steel adjacent to girder 2 and slab unit
