Bridge #05077(Routine)

US 71 SEC 17B, SB over Mud Creek-Washington

Location: 6.24 MI N JCT US 71 & 62

Team Lead: Bob McEntyre Inspection Date: November 08, 2021

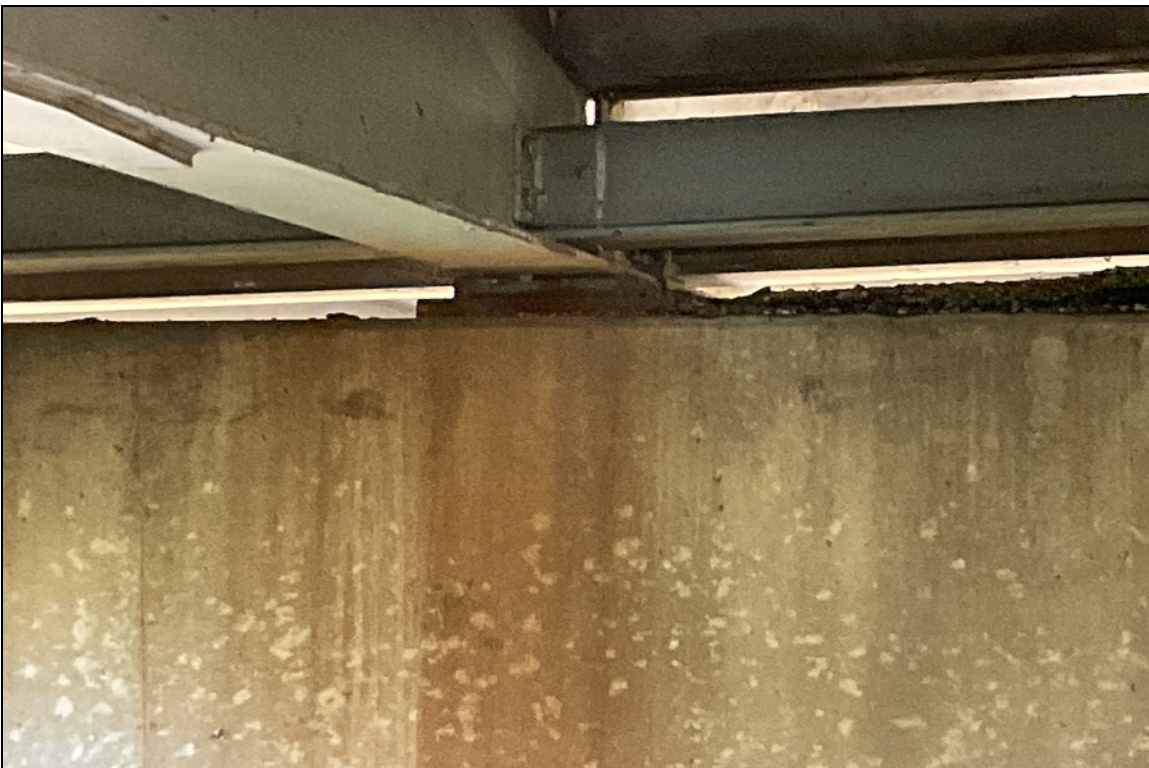
(311)							
-Bearings have active corrosion with layers of rust between the masonry plate and the sole plate. -Some bearings are covered in debris where the deck joints leak. -There are areas of fretting between the sole plates and masonry plates.							
313	Fixed Bearing	EA	28	12	0	15	1
1000	Corrosion	EA	15	0	0	15	0
2210	Movement	EA	1	0	0	0	1
515	Steel Protective Coating	SF	28	13	9	6	0
3440	Effectiveness (Steel Protective Coatings)	SF	15	0	9	6	0

Span 1, bearing 2 over bent 2-Fretting with noise under live load.

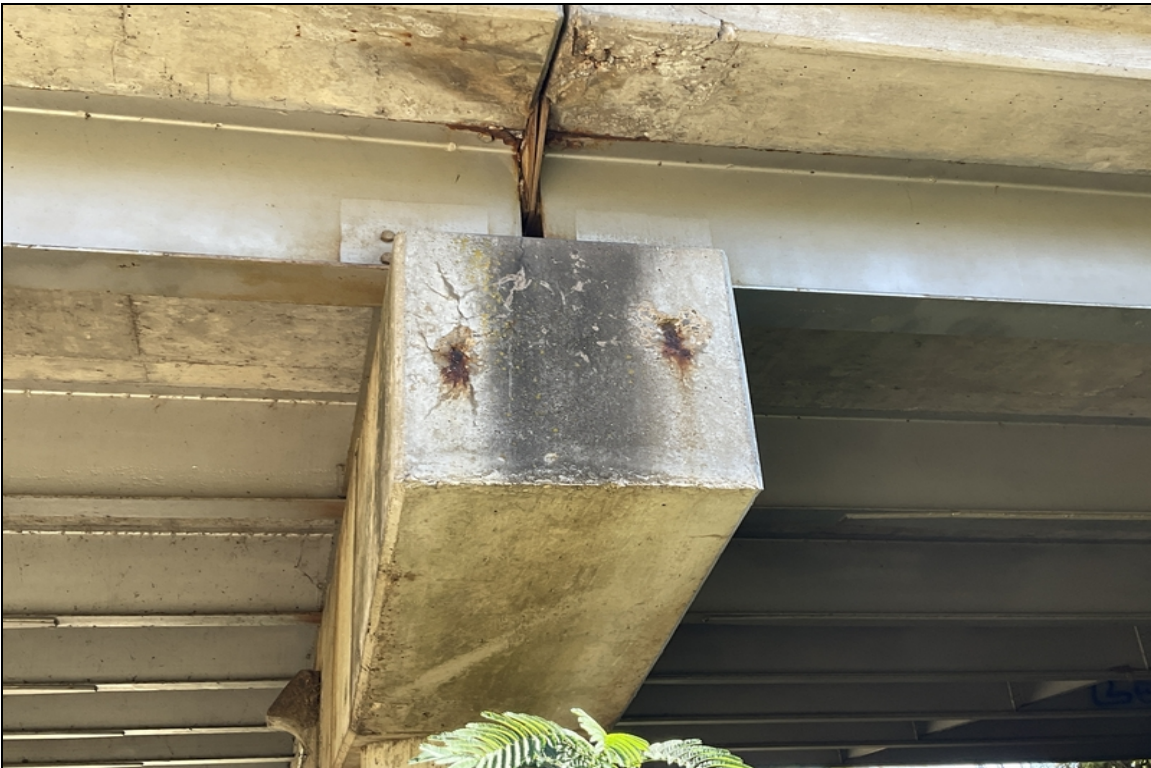
(234)							
-Bent # 2 cap, left end appears to have 2 baseball sized spalls with exposed reinforcing steel. -The right side of bent # 2 has two 3" spalls with exposed reinforcing steel visible from the undersurface of the cap. -The caps at bents # 3 & 4 have minor 3" spalls with exposed reinforcing steel visible from the undersurface of the edges of the caps. -Substructure caps have water stains and debris accumulation where the deck joints leak.							
302	Compression Joint Seal	LF	215	5	32	28	150
2310	Leakage	LF	150	0	0	0	150
2330	Seal Damage	LF	28	0	0	28	0
2360	Adjacent Deck or Header	LF	32	0	32	0	0

Bent 2 cap, left end-Spalls with exposed reinforcing steel.

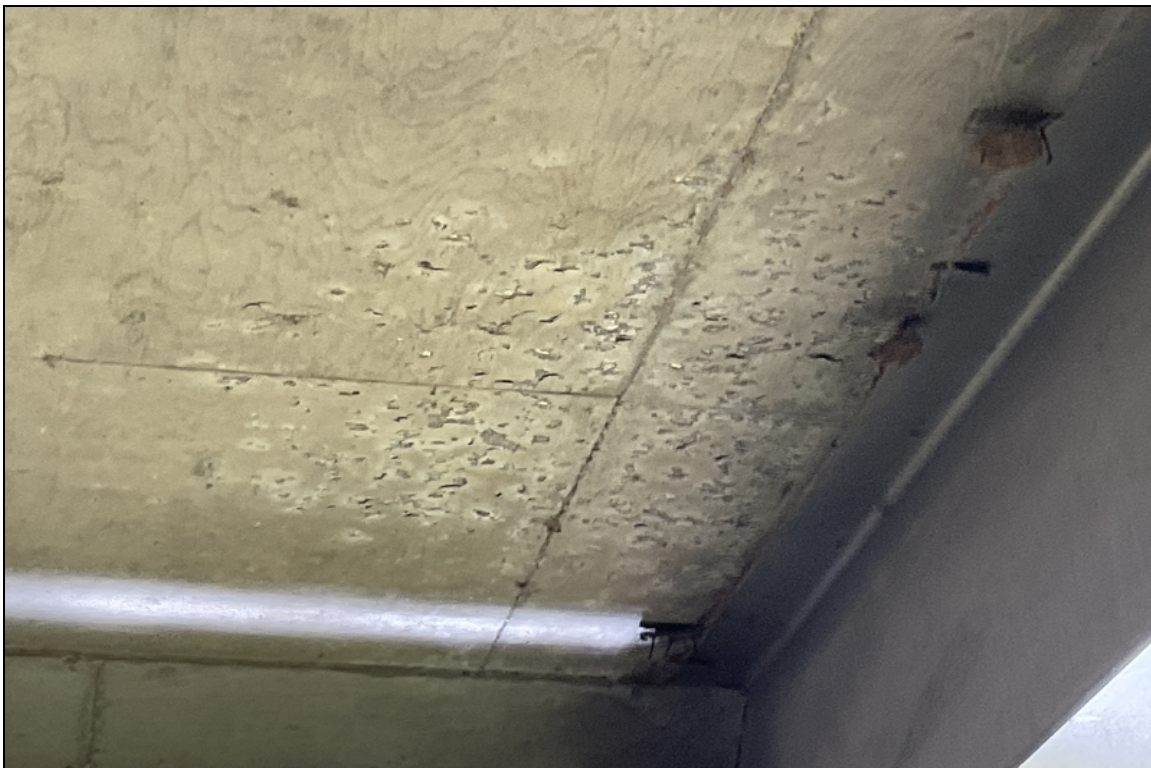
Span #4 bay #1 scaling to the undersurface

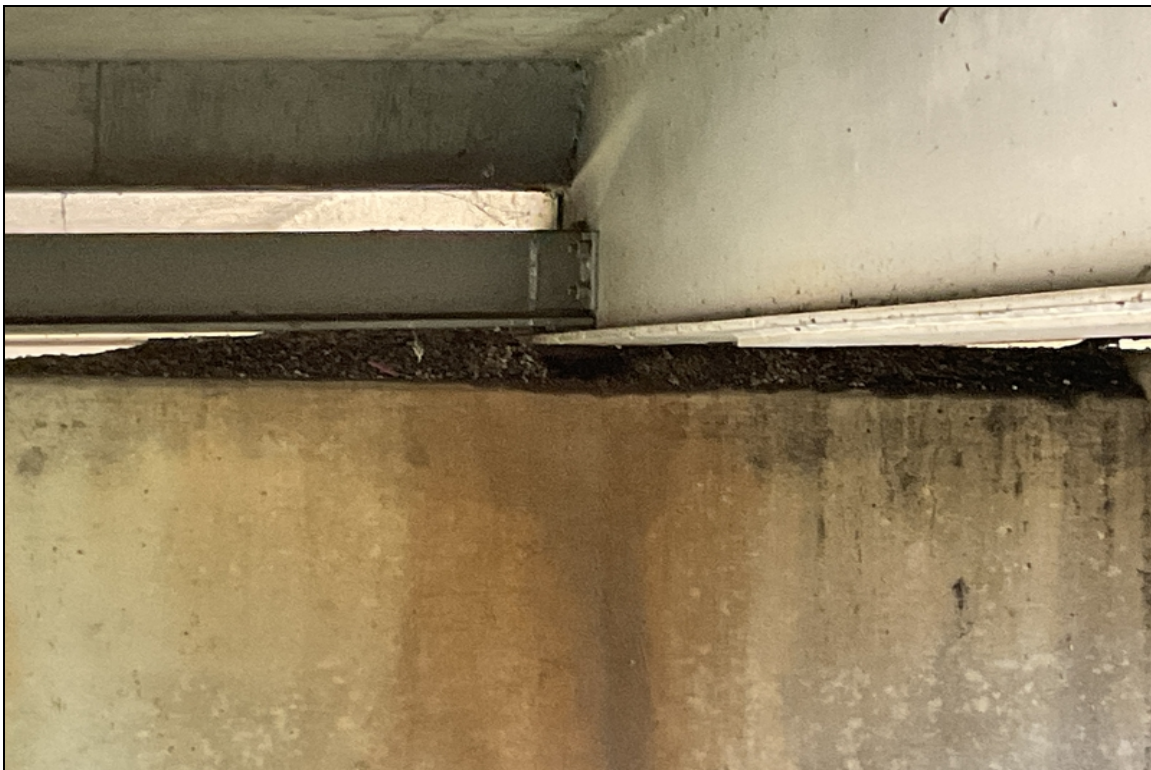
Dirt and debris accumulation on bent 2 cap.

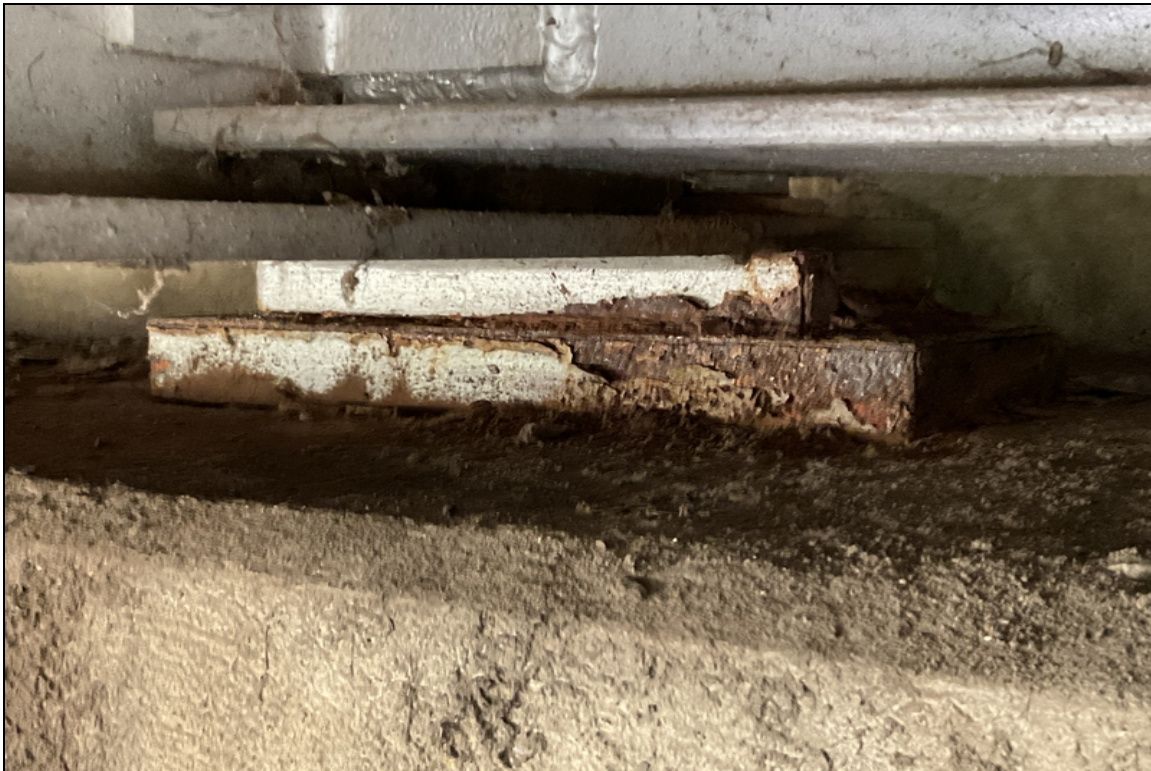
Span 1, bearing 4 at abutment 1-Corrosion.

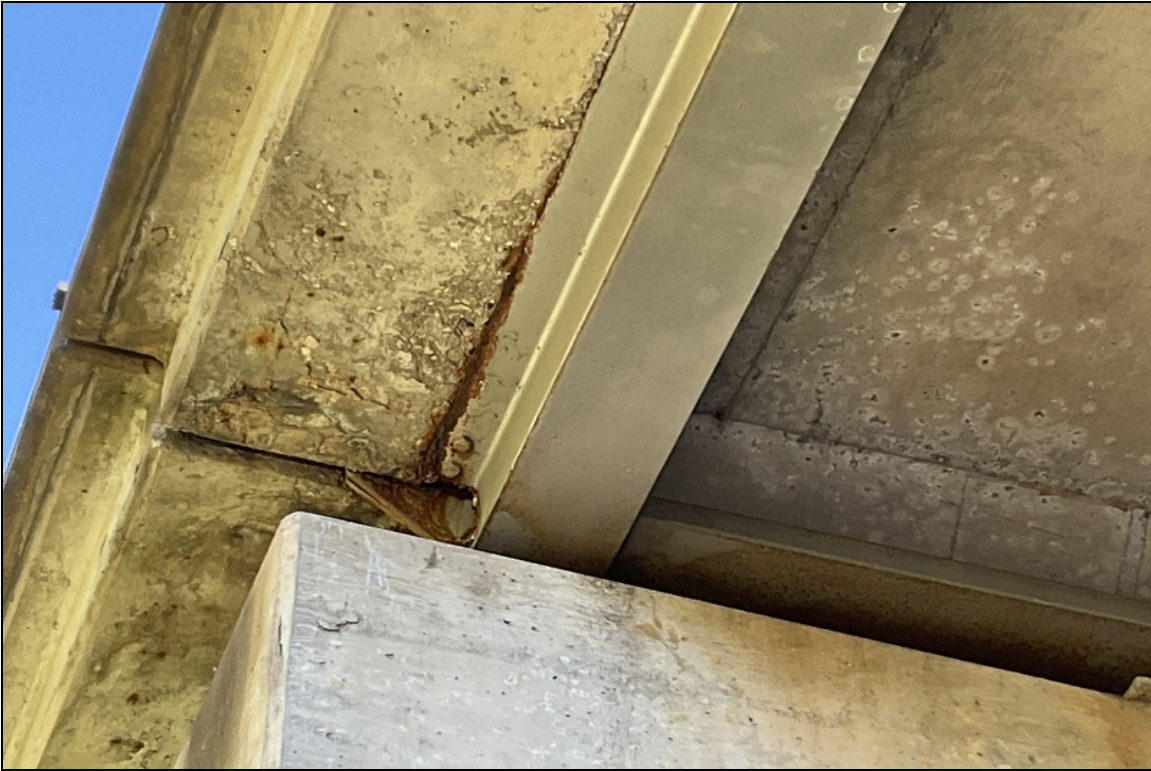
Span 3, beam 7 over bent 4-Corrosion to top flange.

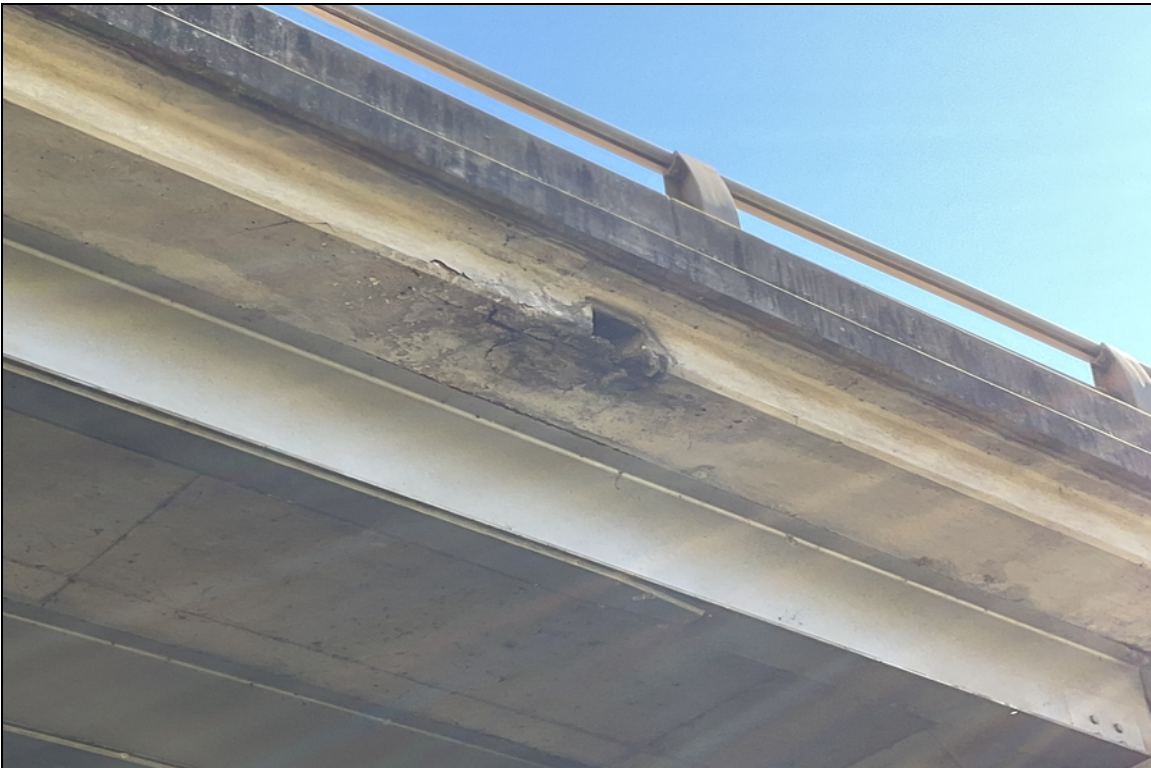
Span 3, left side-Spall / delaminated area adjacent to deck drain.

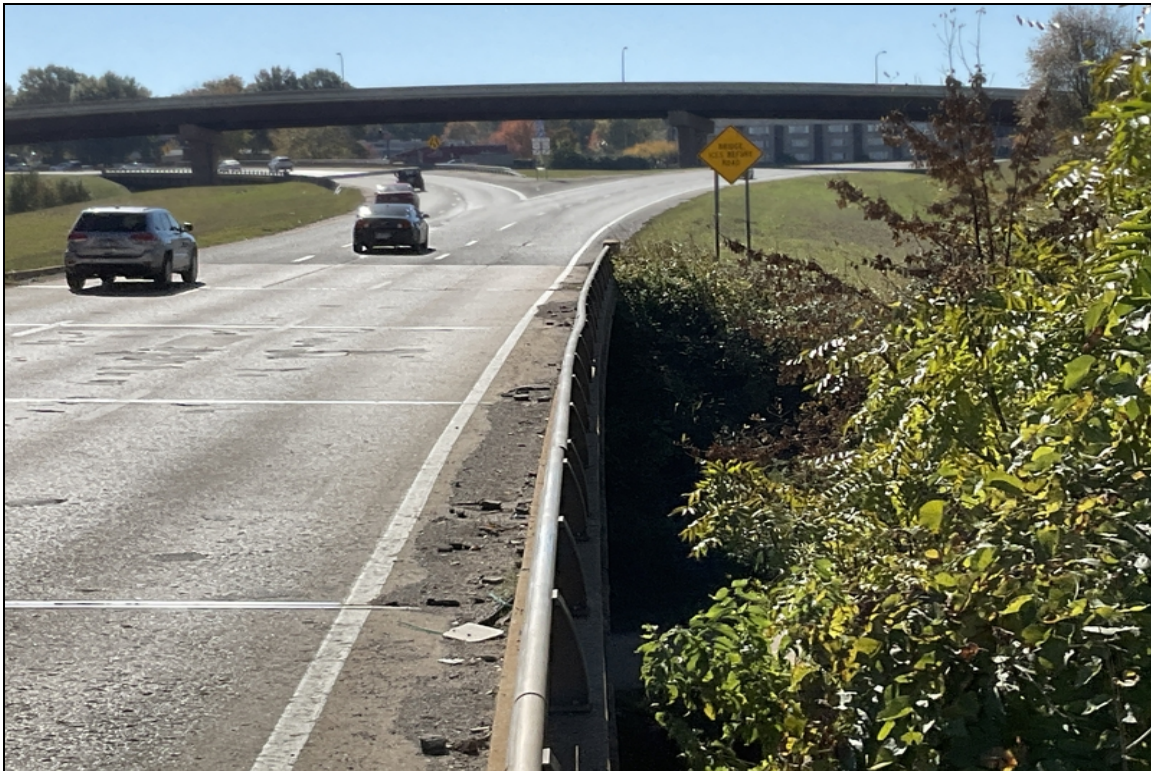
The left bridge railing has minor collision damage at bent # 3.

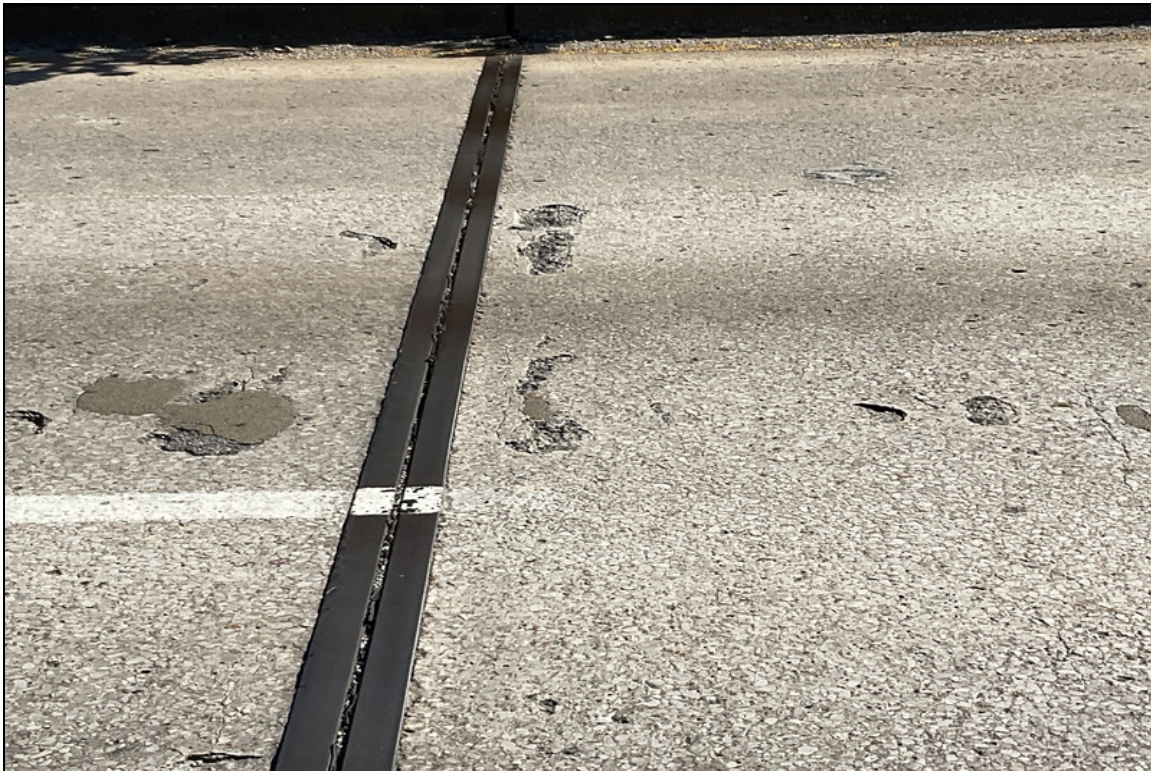
Span # 3 has spalls and delaminated areas adjacent to bent # 4 expansion joint assembly.

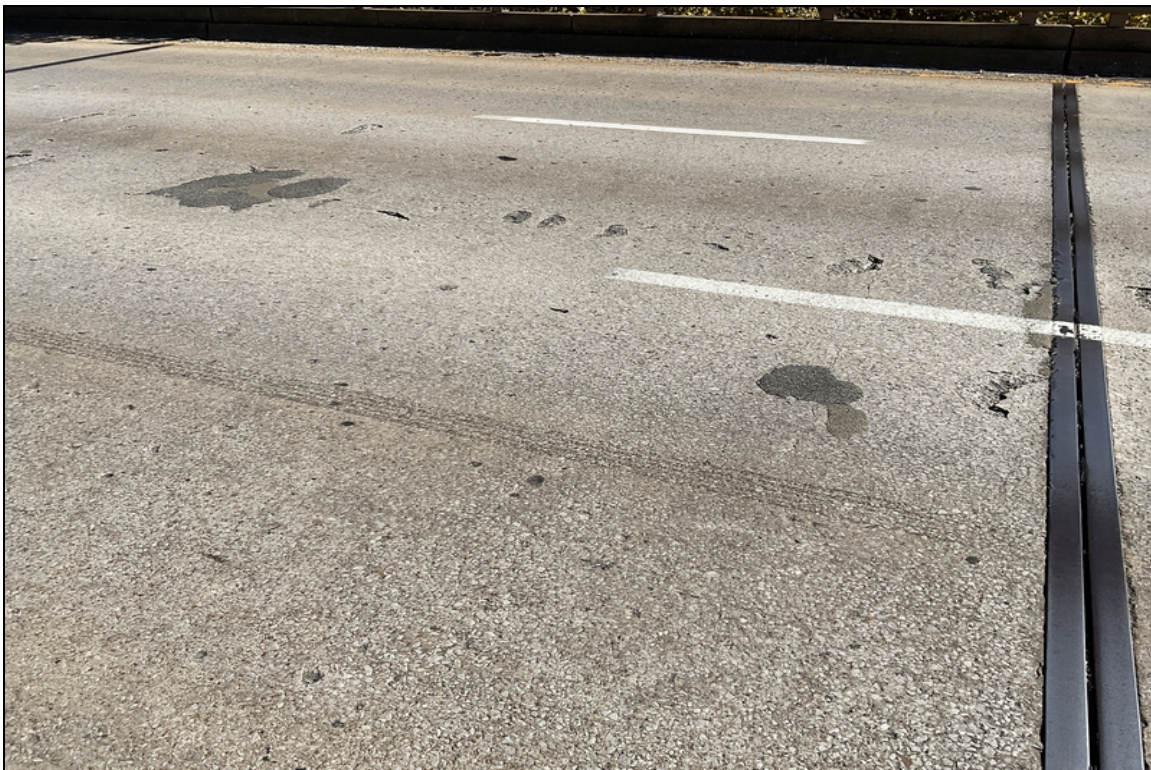
Span 3-Spalls in driving surface.

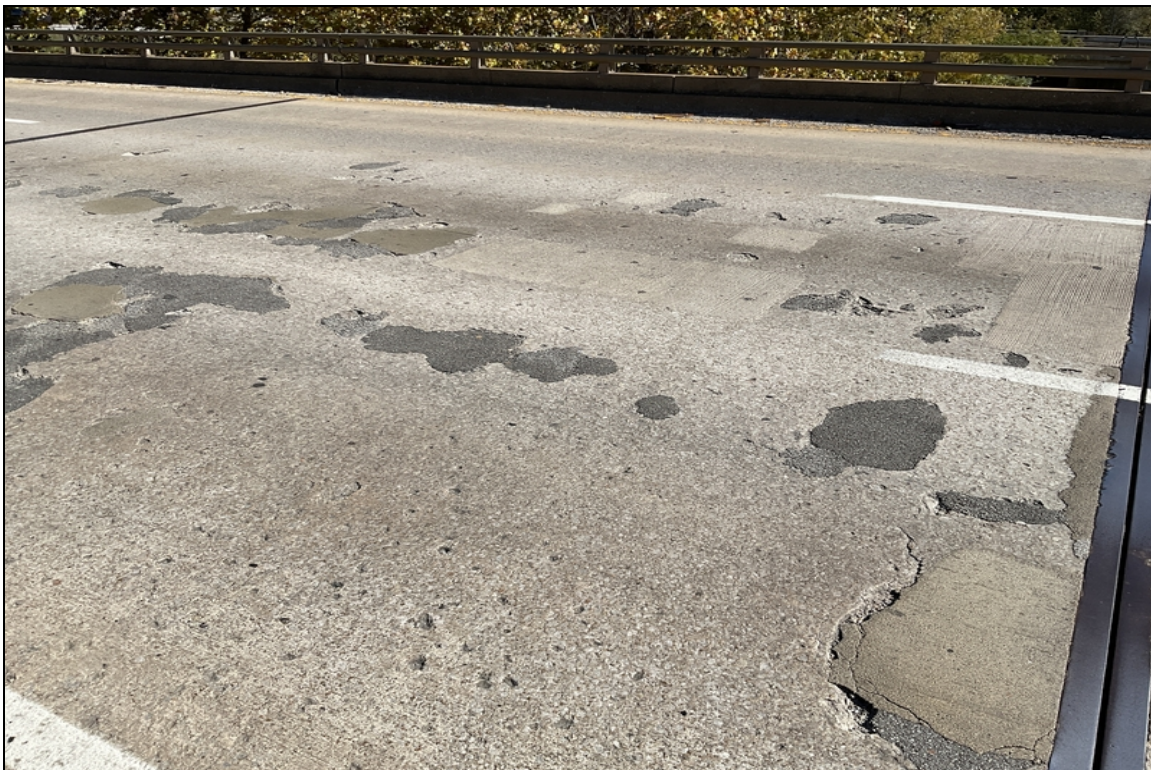
Span 2-Spalls with failing repairs.

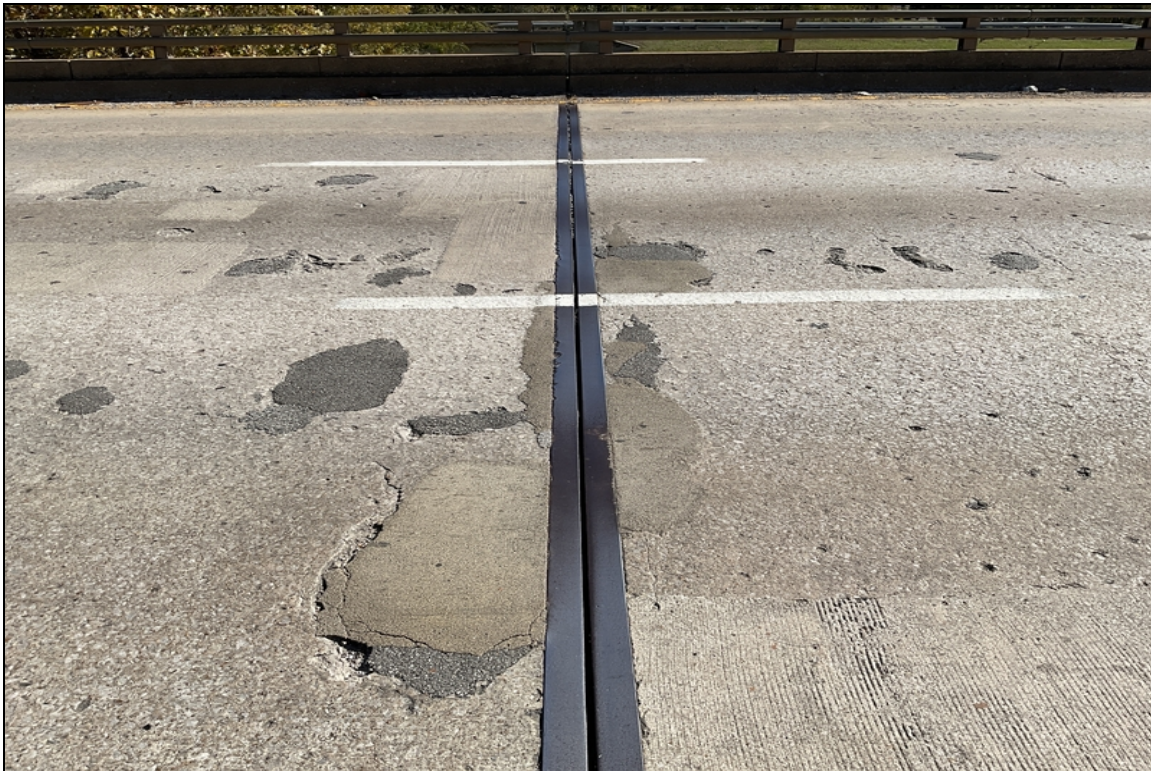
Spans 1 and 2 at bent 2-Spalls and delaminated areas.

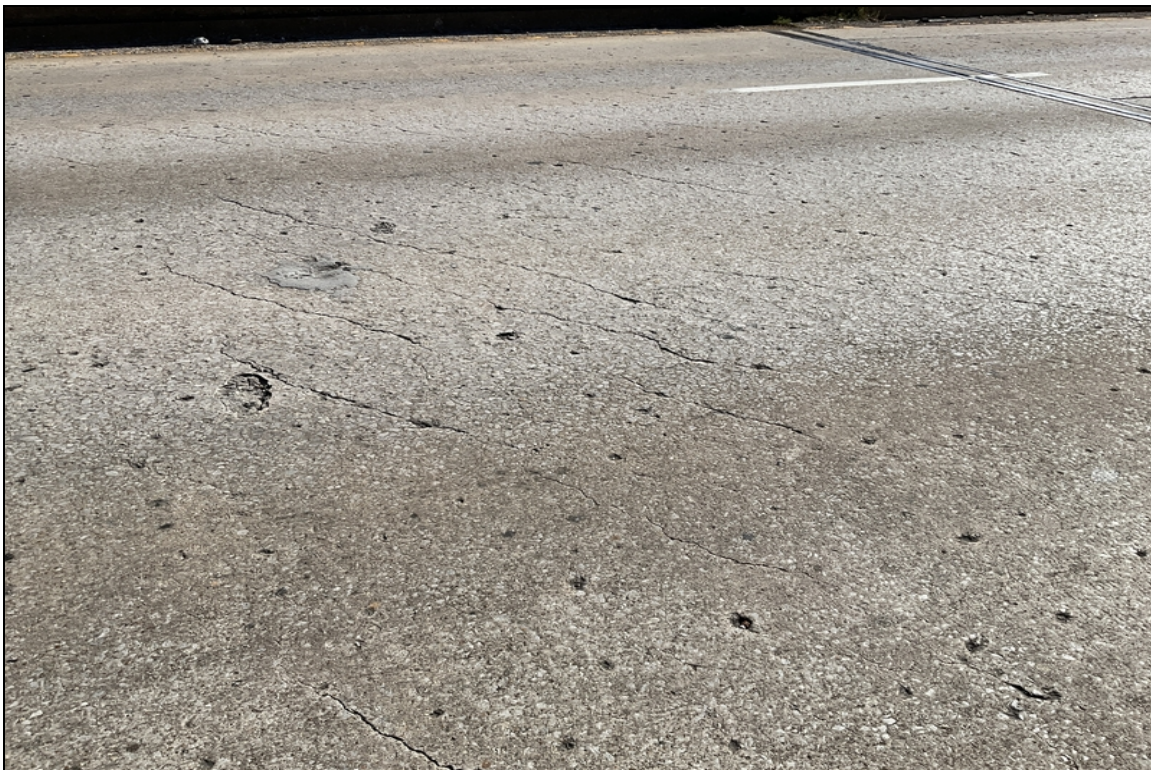
(12)							
-Spans # 1 and # 3 have sealable diagonal cracks on the driving surface of the deck. Span # 1 driving surface is the most notable with numerous moderate width diagonal cracks over the majority of the span. -There are numerous large spalls in the driving surface of all spans that are up to approximately 1 1/2" deep with failing temporary asphalt patches. Span # 2 appears to be the most extreme case at this inspection. -Span # 3 has spalls and delaminated areas adjacent to bent # 4 expansion joint assembly. -There are delaminated areas in the deck. -There is concrete deterioration with delaminated areas visible from the undersurface of the deck overhangs adjacent to the deck drains and the expansion joints in the overhangs. -There are transverse cracks at variable spacing visible from the undersurface of the deck. -The shoulders on the deck and approach roadways have heavy dirt and debris accumulation that restricts the deck drains and the drop inlet at the North approach.

Span 1 diagonal cracks.

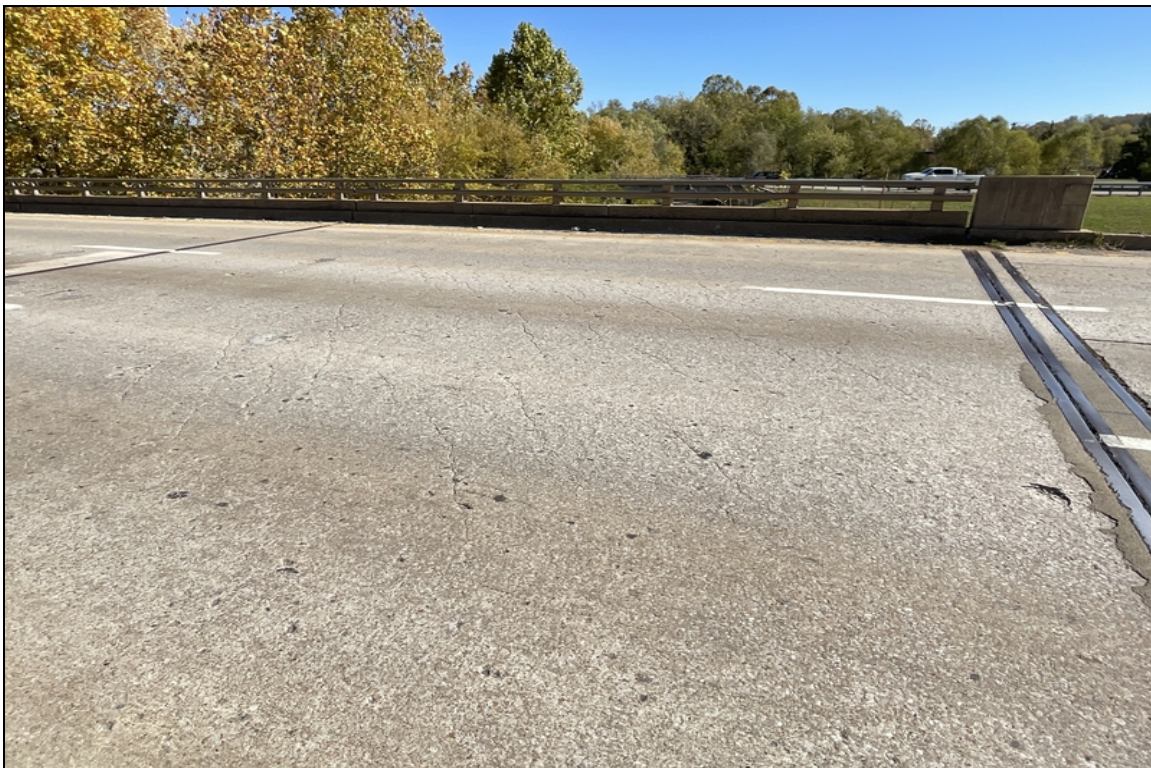
Span # 1 driving surface has numerous moderate width diagonal cracks.

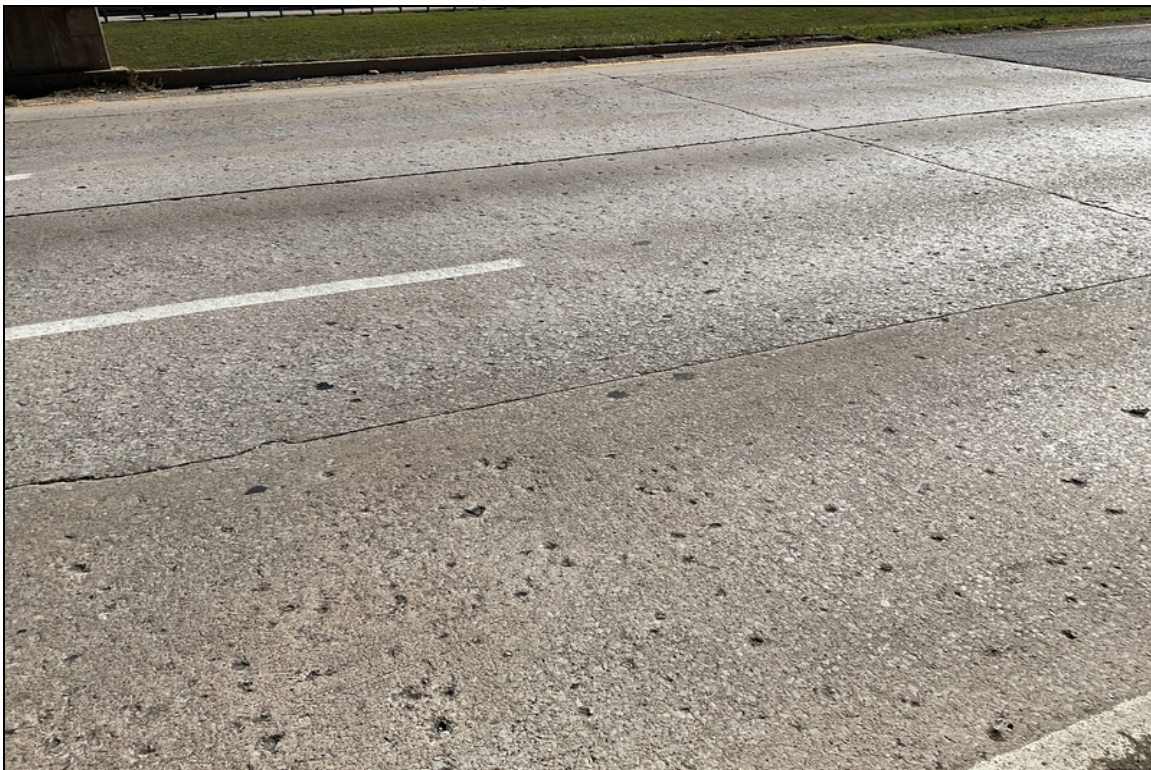
South approach slab-Abrasion with numerous pop outs.

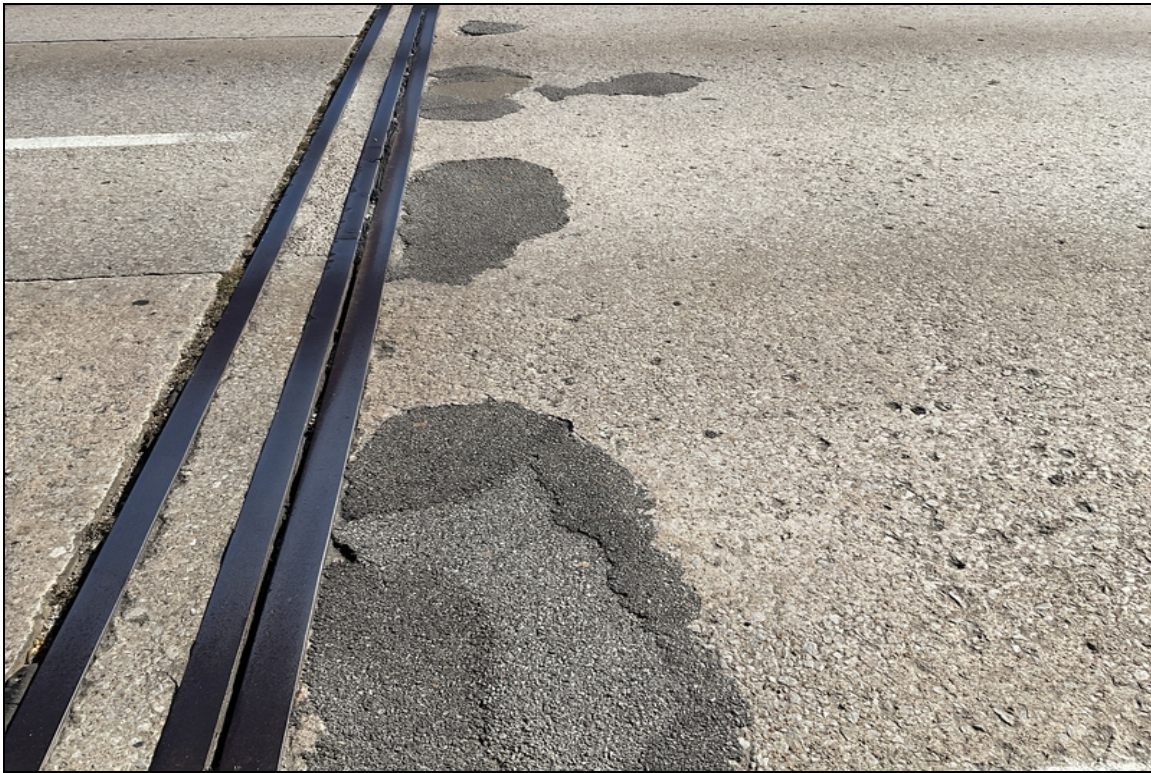
Span 4-Spalls at abutment 2.

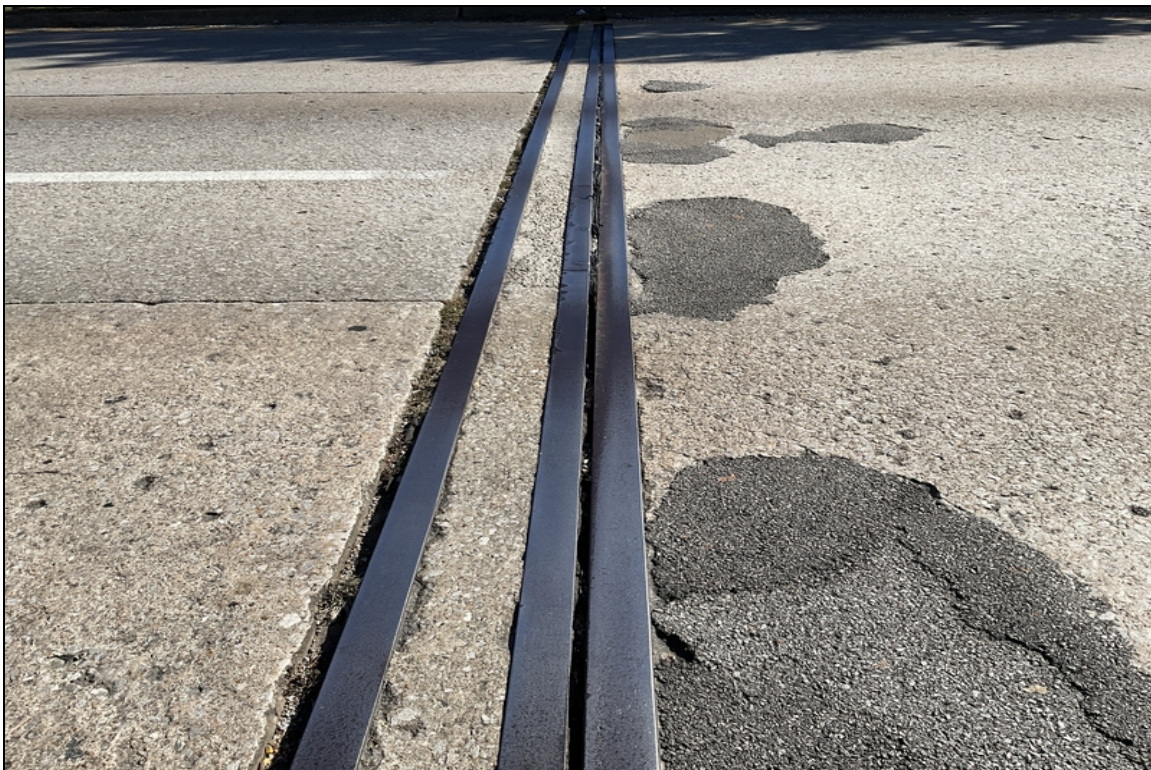
(302)							
-Compression joint seals are torn, deteriorated, and leak water and debris on the substructure caps, bearings, and ends of the beams. -Portions of the deck joint seals are missing during this inspection. -There are numerous patched areas adjacent to the expansion joints.							
311	Movable Bearing	EA	28	13	0	15	0
1000	Corrosion	EA	15	0	0	15	0
515	Steel Protective Coating	SF	28	20	0	0	8
3440	Effectiveness (Steel Protective Coatings)	SF	8	0	0	0	8

Abutment 1 expansion joint-Seal deteriorated.

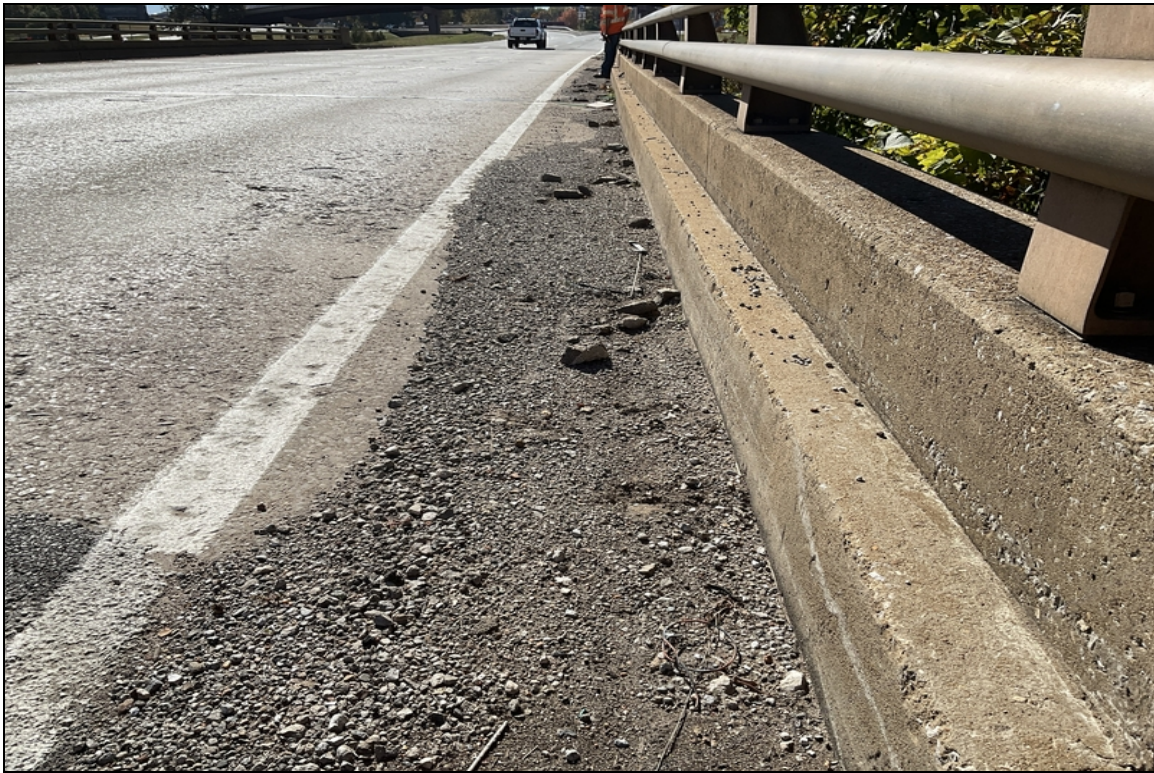
Heavy dirt and debris in gutters.

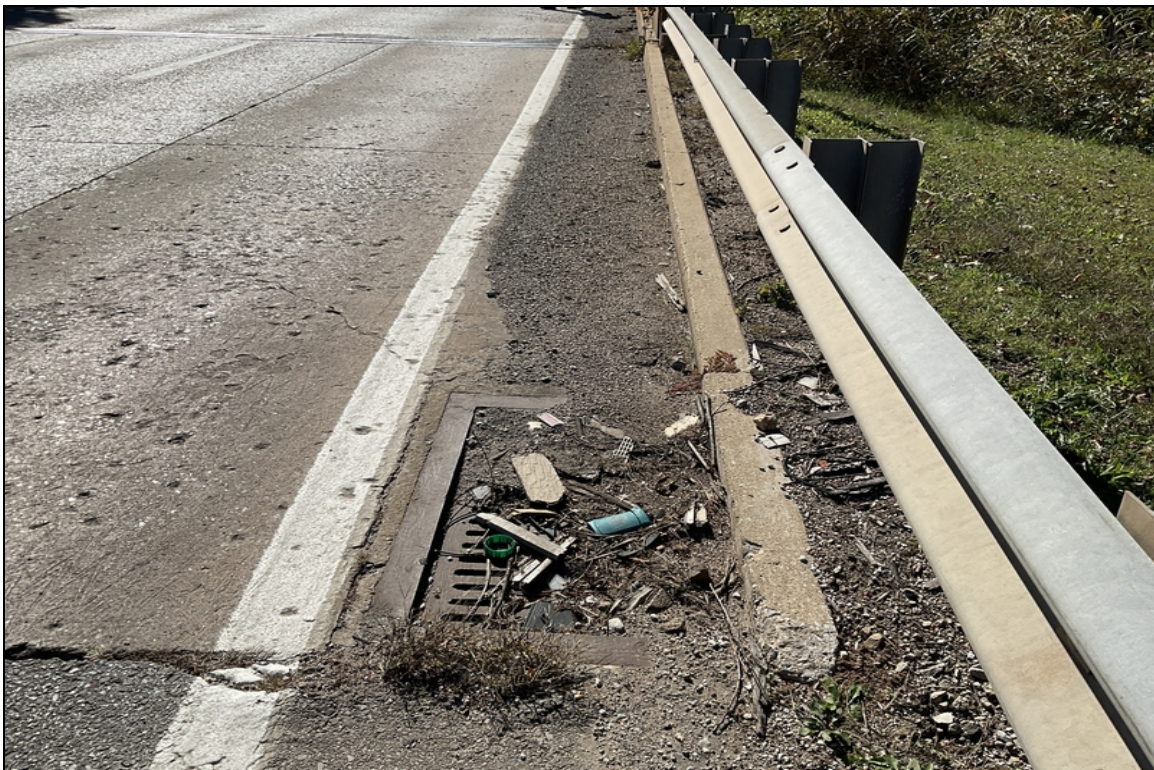
The North approach gutter has heavy dirt and debris accumulation that restricts drop inlet.

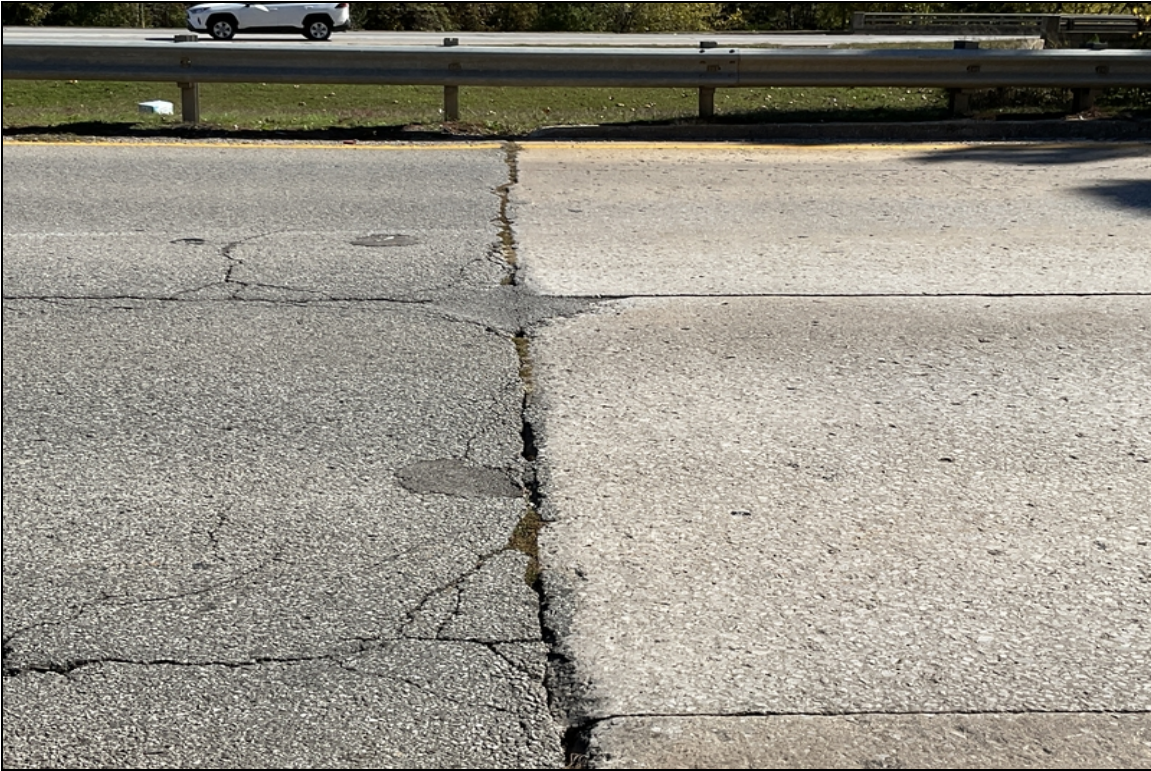
North approach slab-Spall at roadway juncture.

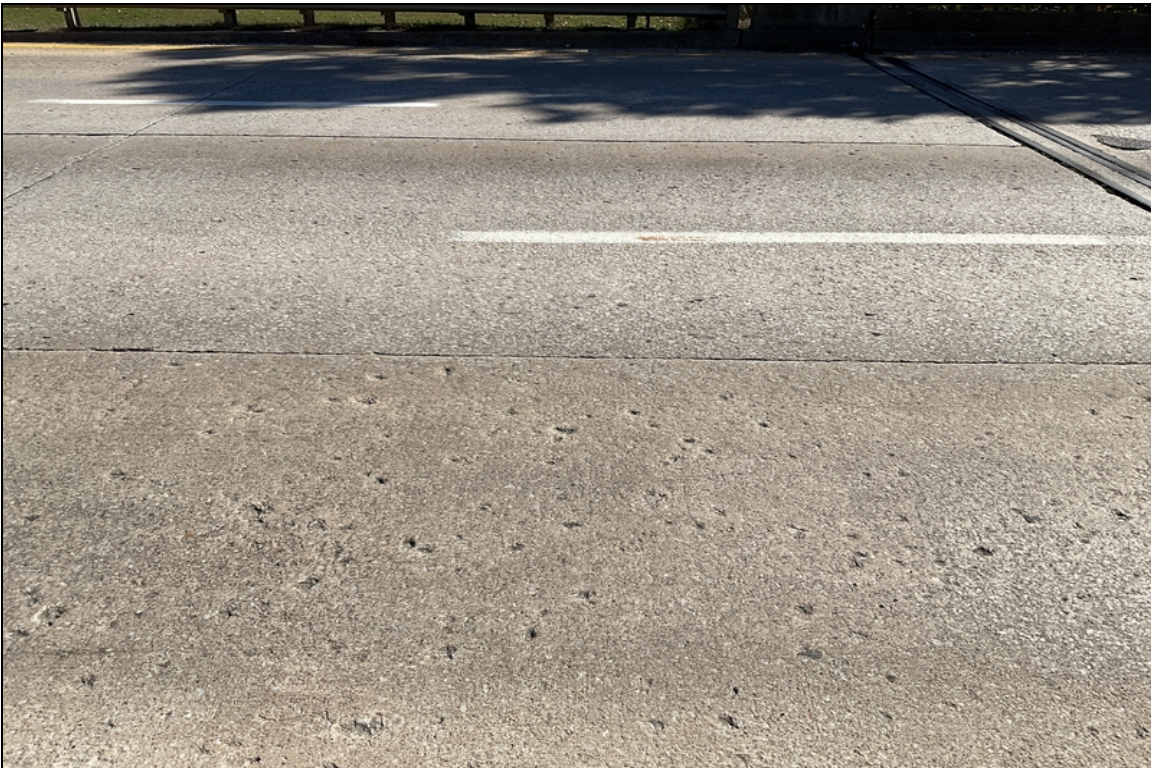
North approach slab-Light abrasion with numerous pop outs.

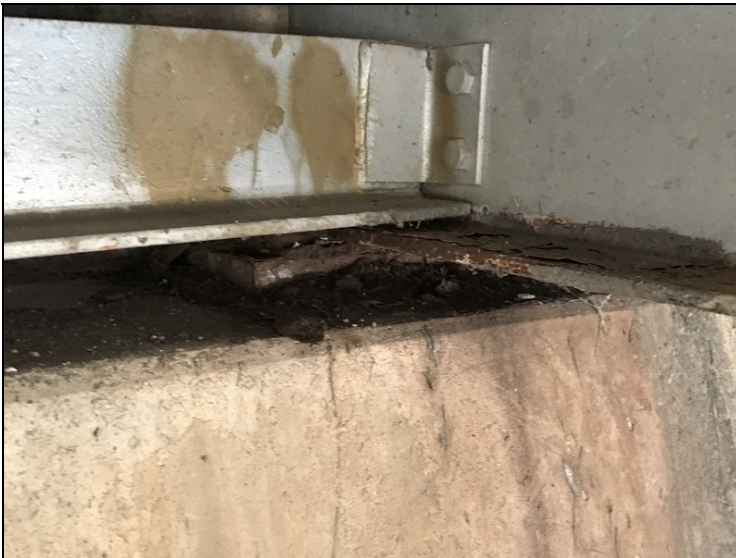
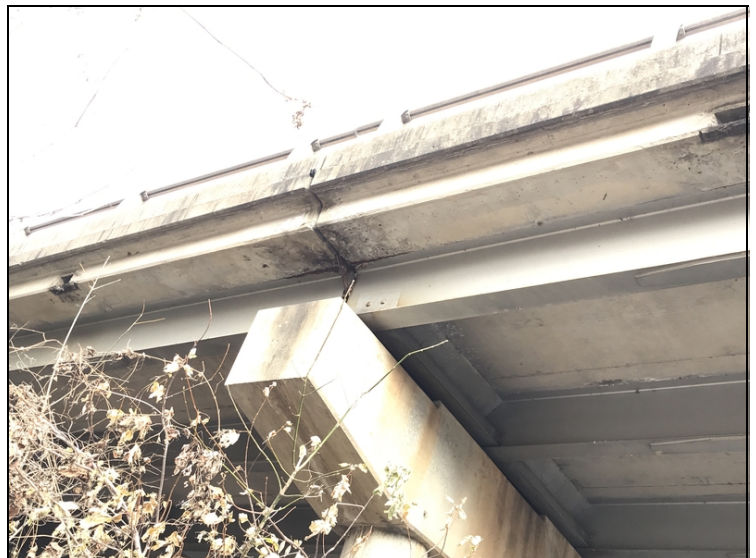
The superstructure has areas of active corrosion in the bottom flanges and the base of webs adjacent to the bearings where the deck joint seals leak water and debris.

Exterior Beams also have active corrosion in the top flange adjacent to the expansion joints.

**Date Reported:** 10/15/2013  
**Priority:** D- Routine  
**Type of Work:** Repair  
**Status:** Monitor  
**Component:** 107 - Steel Open Girder/Beam

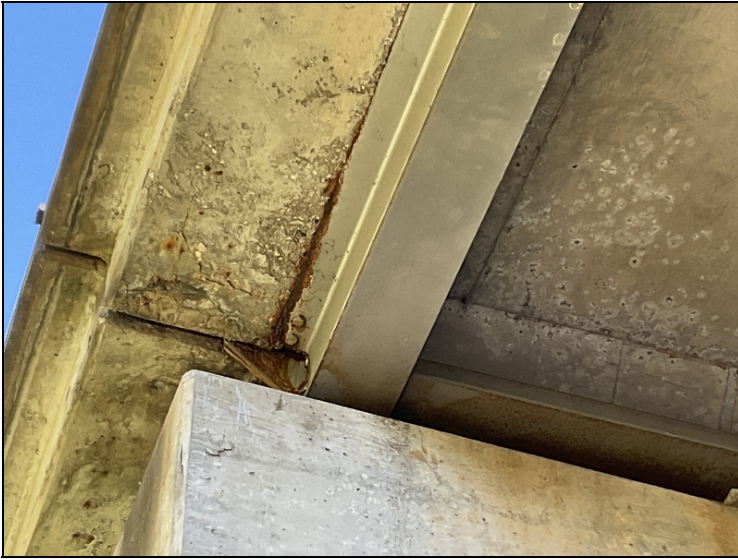
Span # 3, beam # 7 over bent # 4-Corrosion to top flange.

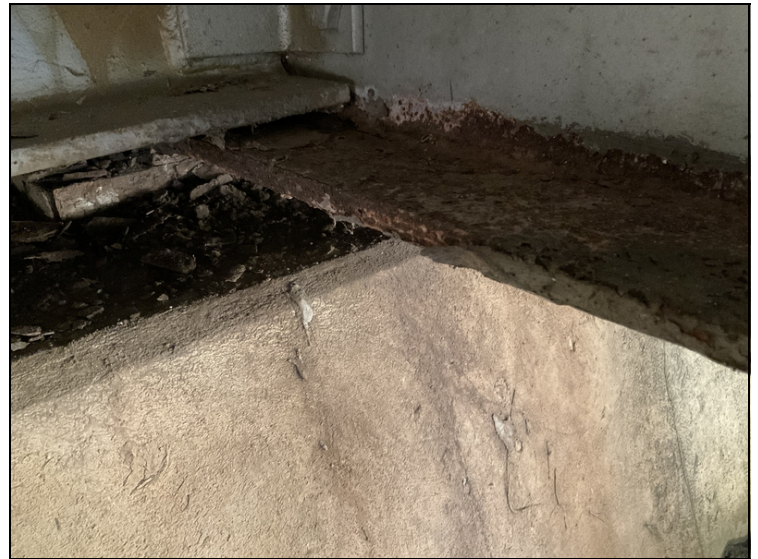
Beam # 3 at abutment # 2-Corrosion to beam end.

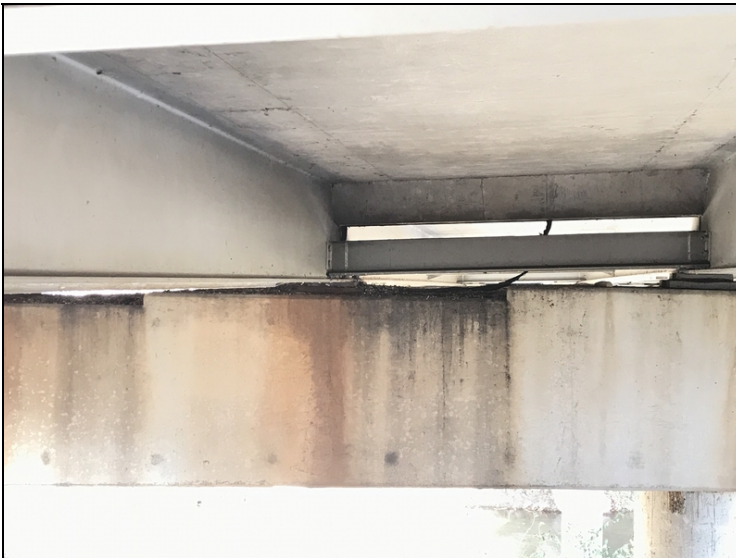
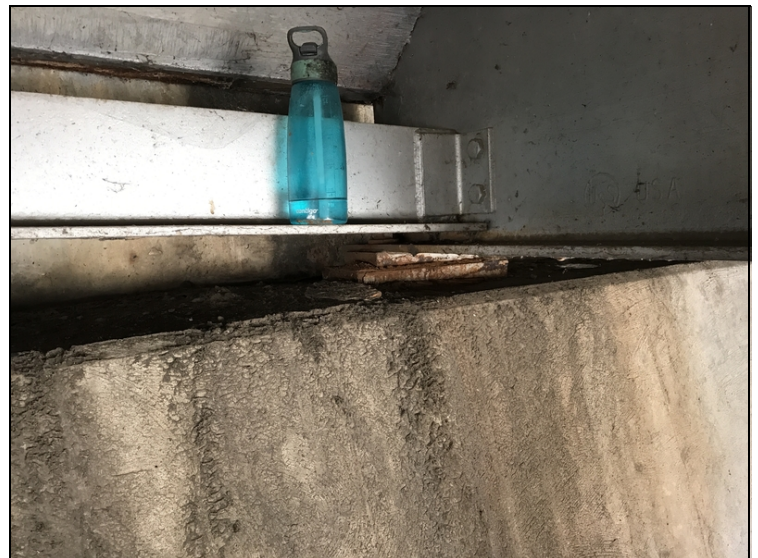
Bearings -  
Bent # 2, Beam # 2 Bearing is noisy with movement during heavy live load impacts.  
Bearings have active corrosion with layers of rust between the masonry plates and the sole plates.  
Some bearings are covered in debris where the deck joints leak.  
There are areas of fretting between the sole plates and masonry plates.

**Date Reported:** 10/15/2013  
**Priority:** C - Important  
**Type of Work:** Repair  
**Status:** Monitor  
**Component:** 311 - Movable Bearing

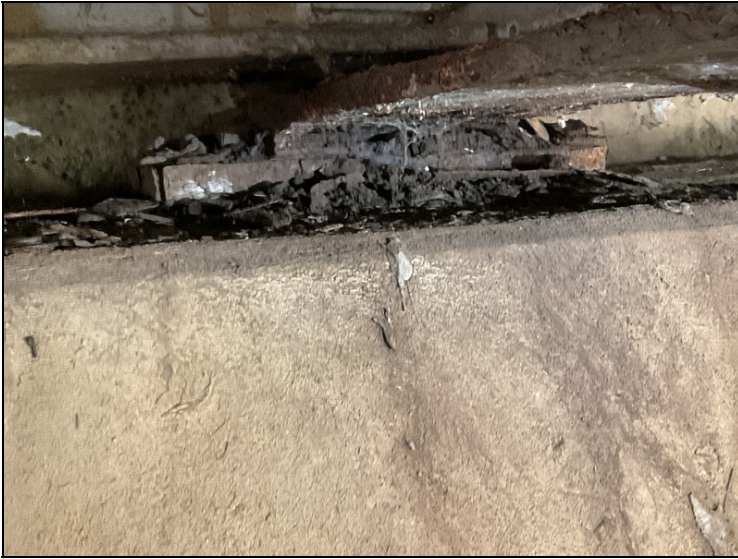
Abutment # 2 bearing # 3-Corrosion.
