Bridge #05077(Routine)

US 71 SEC 17B, SB over Mud Creek-Washington

Location: 6.24 MI N JCT US 71 & 62

Team Lead: Bob McEntyre Inspection Date: November 08, 2021

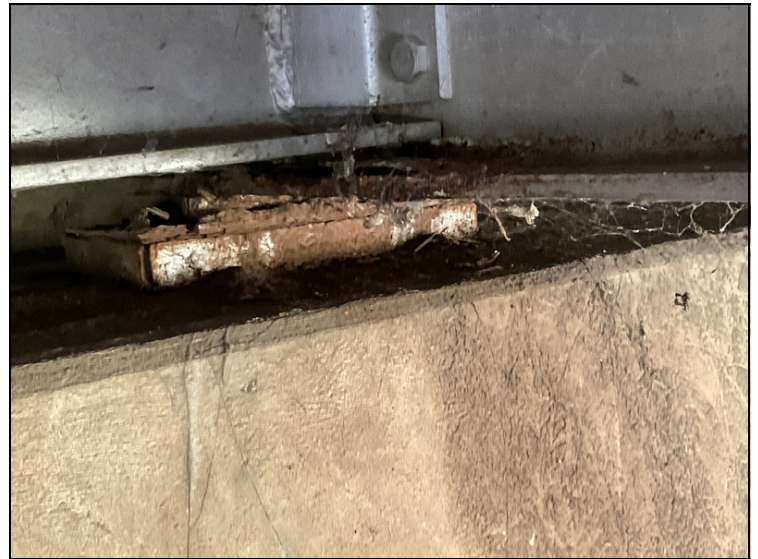
Bearings -  
Bent # 2, Beam # 2 Bearing is noisy with movement during heavy live load impacts.  
Bearings have active corrosion with layers of rust between the masonry plates and the sole plates.  
Some bearings are covered in debris where the deck joints leak.  
There are areas of fretting between the sole plates and masonry plates.

Abutment # 2 bearing #5-Corrosion.

**Date Reported:** 10/15/2013  
**Priority:** C - Important  
**Type of Work:** Repair  
**Status:** Monitor  
**Component:** 311 - Movable Bearing

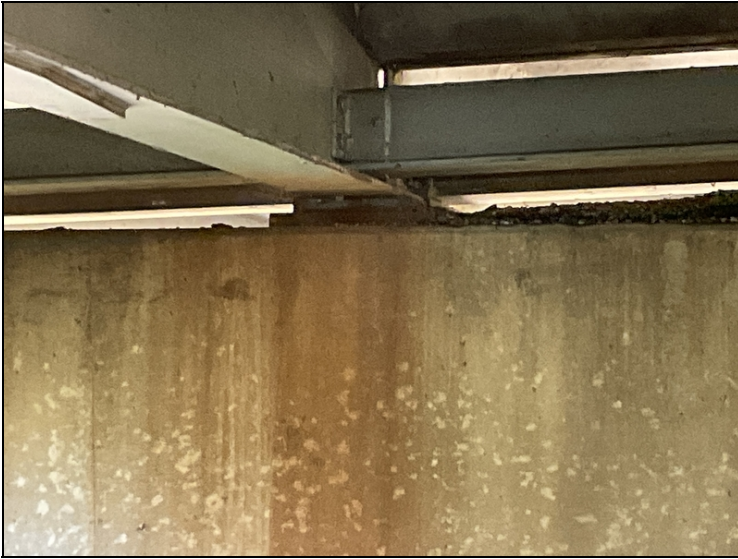
Span # 1, bearing 2 over bent # 2-Fretting with noise under live load.

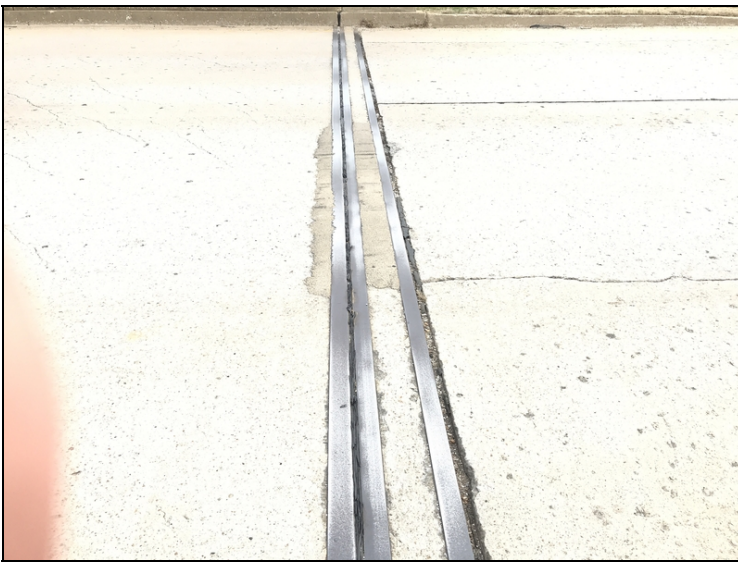
Abutment # 1 expansion joint.

Compression joint seals are torn, deteriorated, and leak water on the substructure caps, bearings, and ends of the beams.

**Date Reported:** 10/15/2013  
**Priority:** D- Routine  
**Type of Work:** Replace  
**Status:** Monitor  
**Component:** 302 - Compression Joint Seal

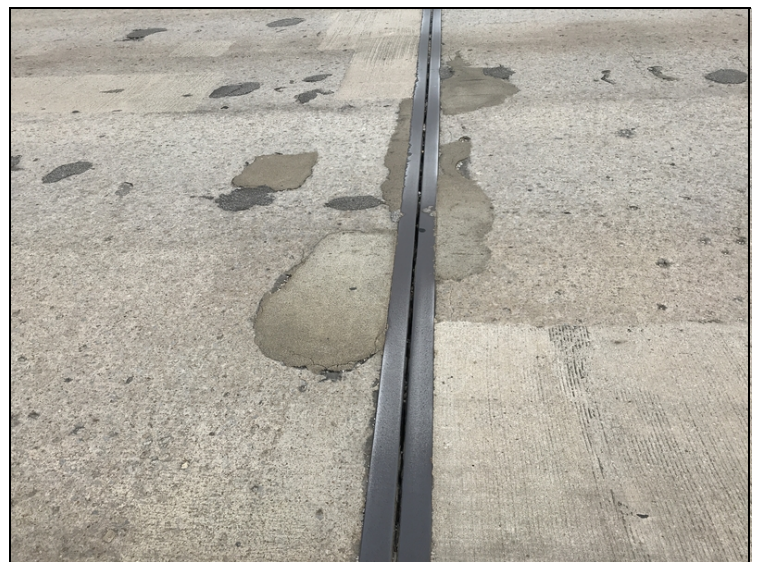
Compression joint seals are torn, deteriorated, and leak water on the substructure caps, bearings, and ends of the beams.

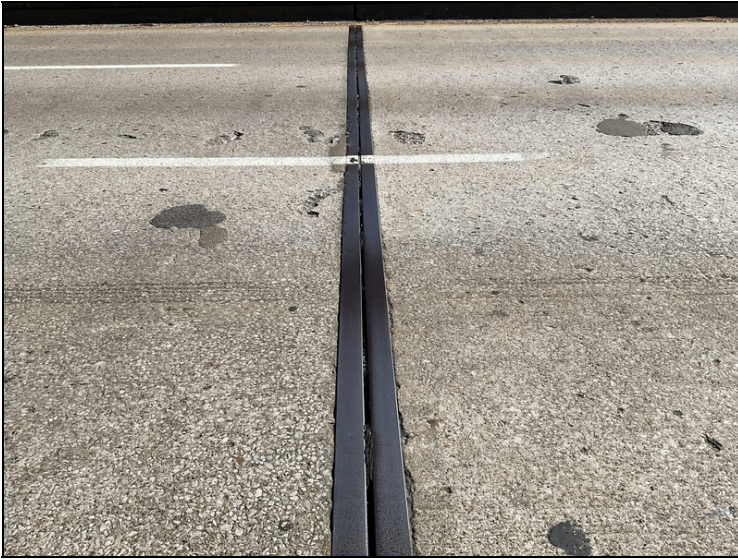
Compression joint seals are torn, deteriorated, and leak water on the substructure caps, bearings, and ends of the beams.

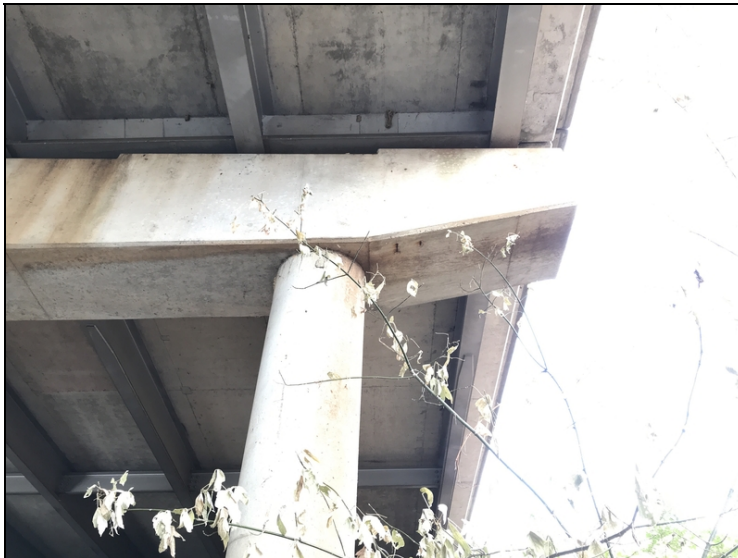
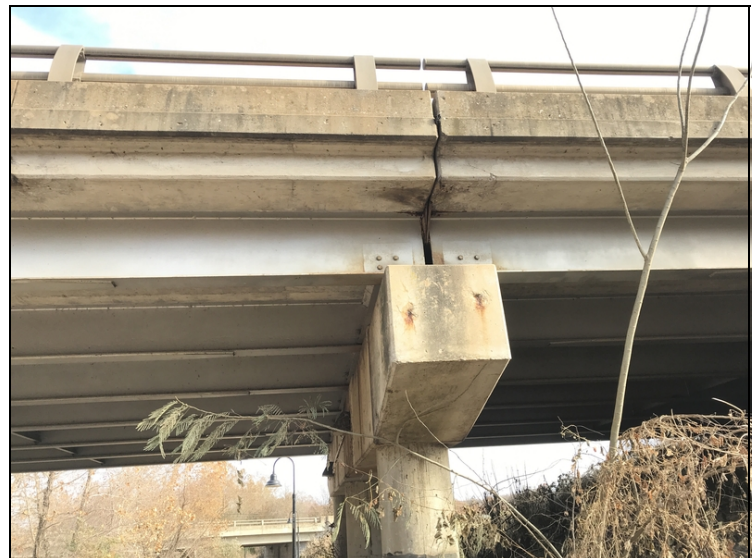
The left end of bent # 2 Cap has 2 5" spalls with exposed reinforcing steel. The right side of bent # 2 cap has two 3" spalls with exposed reinforcing steel visible from the undersurface of the cap. Bents # 3 & 4 have minor 3" spalls with exposed reinforcing steel visible from the undersurface of the edges of the caps. Substructure caps have water stains and debris accumulation where the deck joints leak.

**Date Reported:** 10/15/2013  
**Priority:** D- Routine  
**Type of Work:** Repair  
**Status:** Monitor  
**Component:** 234 - Reinforced Concrete Pier Cap

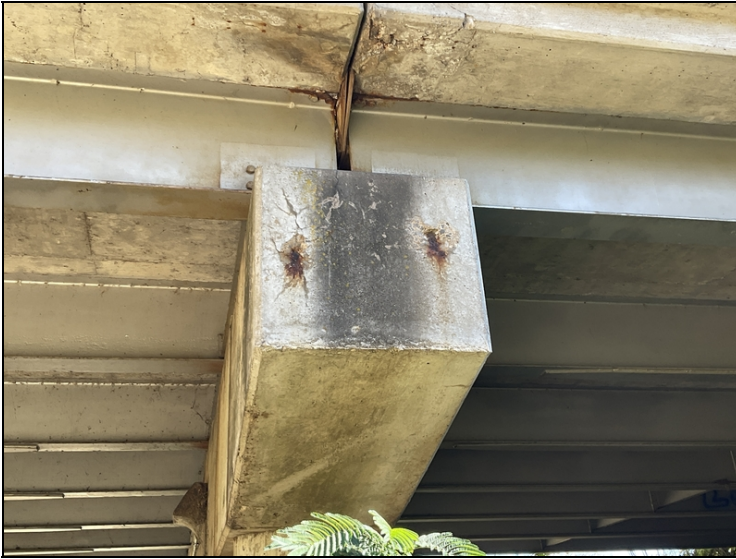
Bent 2 cap, left end-Spalls with exposed reinforcing steel.

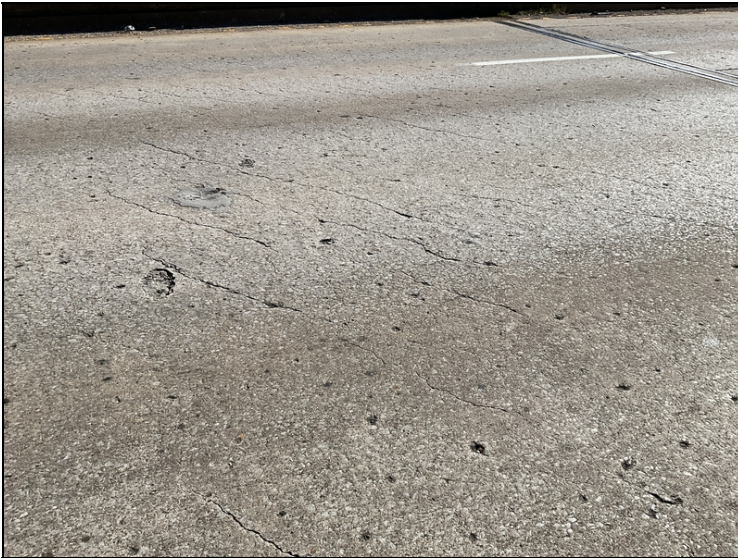
The driving surface of the deck has sealable cracking in all spans. Spans # 1 is the most extreme case with numerous moderate width diagonal cracks in the majority of the driving surface.

Span # 1 numerous moderate width diagonal cracks.

**Date Reported:** 10/13/2015  
**Priority:** D- Routine  
**Type of Work:** Repair  
**Status:** Monitor  
**Component:** 12 - Reinforced Concrete Deck

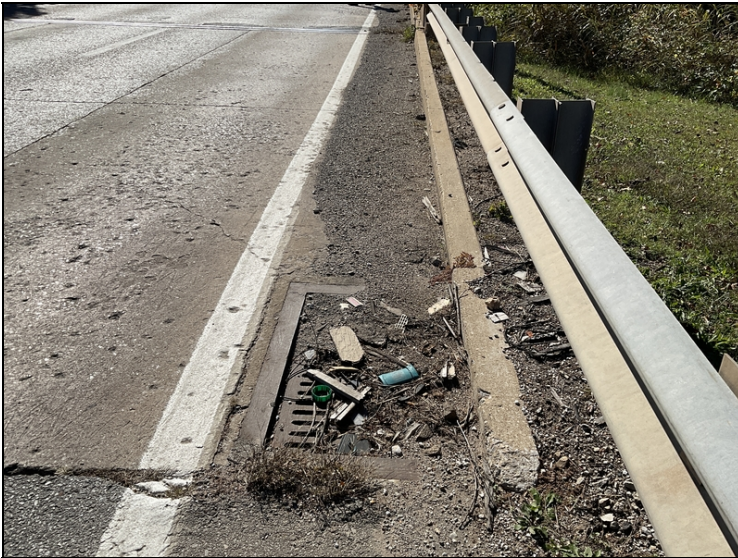
The gutters on the deck and North approach roadway have heavy dirt and debris accumulation. The drop inlet on North approach roadway is restricted by heavy debris accumulation.

The North approach gutter has heavy dirt and debris accumulation that restricts drop inlet.

**Date Reported:** 11/08/2021  
**Priority:** D- Routine  
**Type of Work:** Clean  
**Status:** Open  
**Component:** Approach

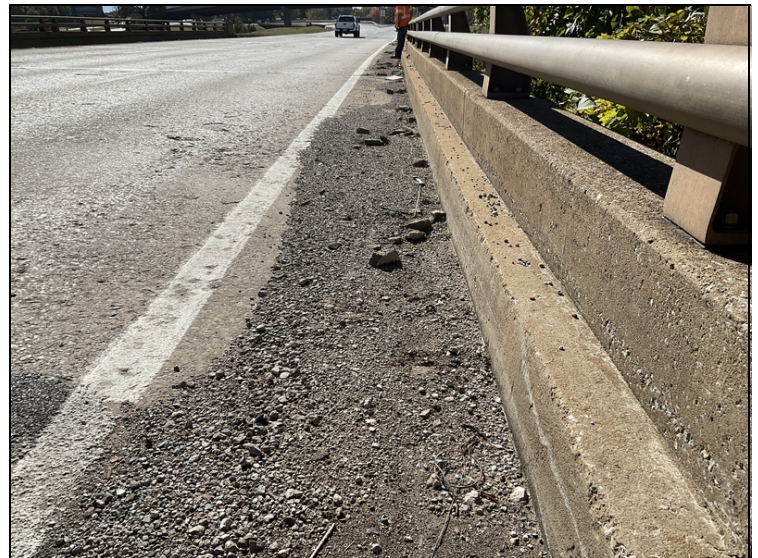
Heavy dirt and debris in gutters.

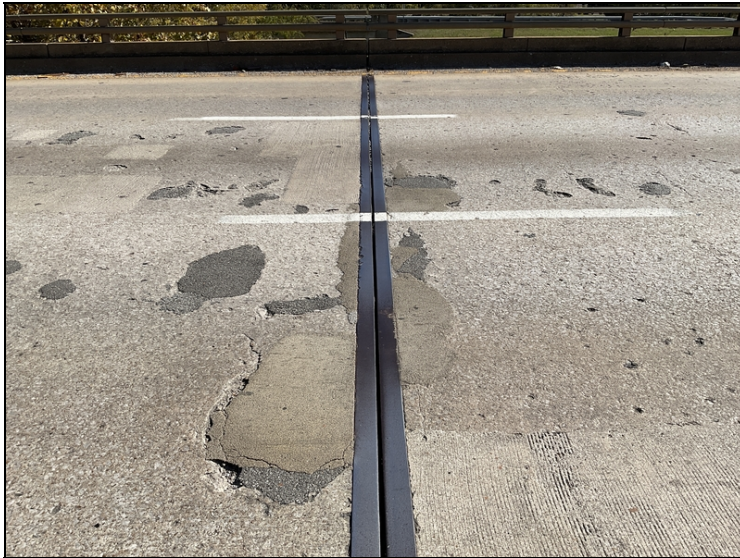
The driving surface of the deck in all spans have large delaminated / spalled areas with asphalt repairs. The asphalt repairs are failing in several locations creating potholes in the driving surface.

Spans 1 and 2 at bent 2-Spalls and delaminated areas.

**Date Reported:** 11/09/2021  
**Priority:** C - Important  
**Type of Work:** Repair  
**Status:** Open  
**Component:** 12 - Reinforced Concrete Deck

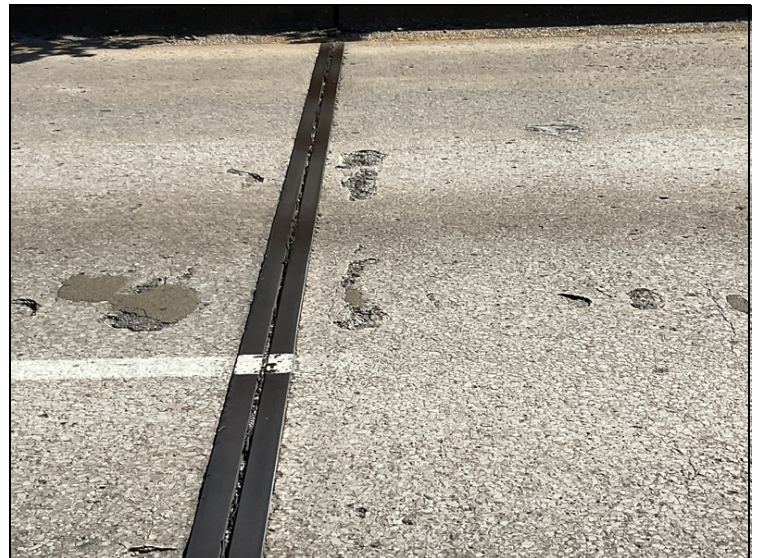
Span # 3 has spalls and delaminated areas adjacent to bent # 4 expansion joint assembly.
