Bridge #A5392(Routine)

US 71 B, SB LNS over Clear Creek- Washington

Location: 5.47 MI S BENTON CO LINE

Team Lead: Bob McEntyre Inspection Date: November 09, 2021

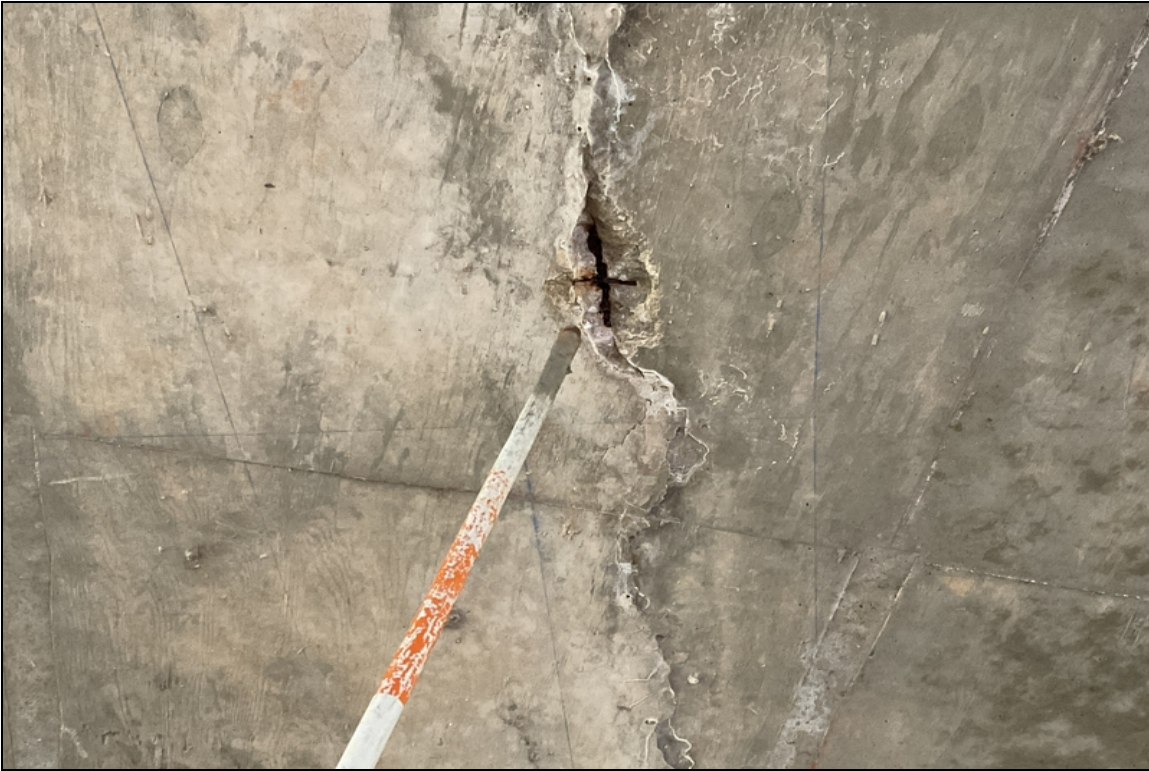
Span # 3-Spall with exposed reinforcing steel in slab undersurface in centerline construction joint.

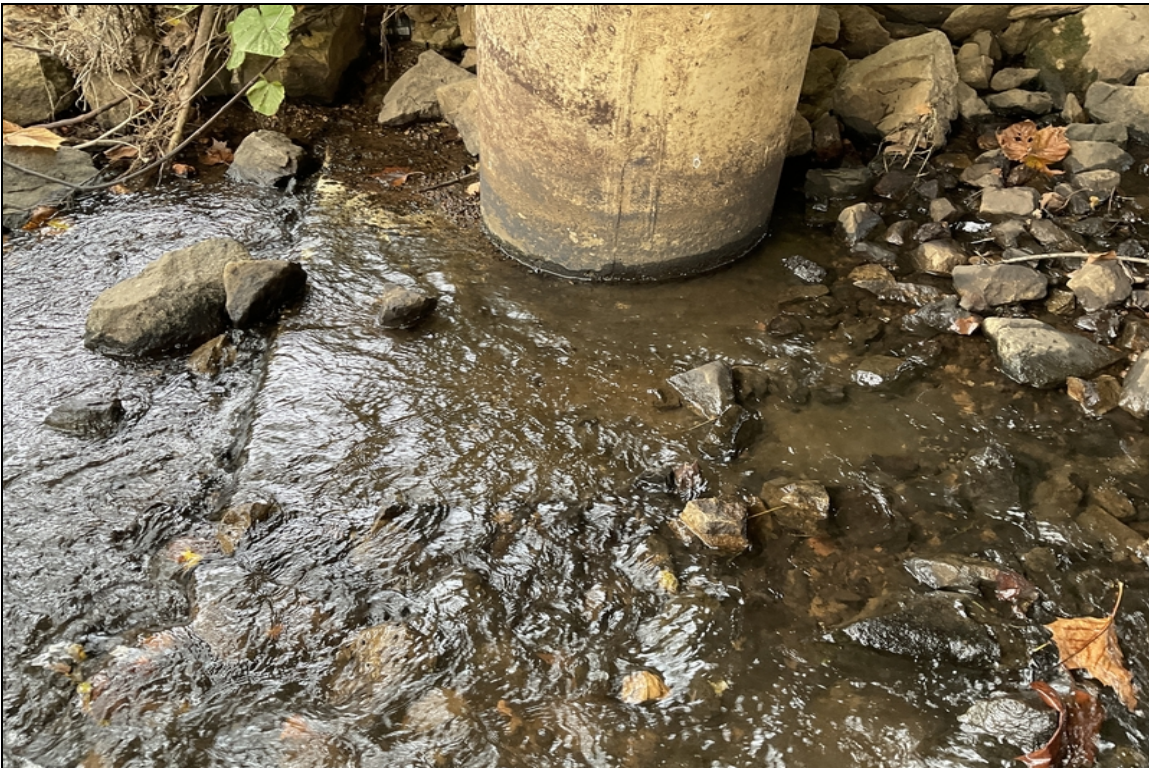
(220)							
-The top of the footings are exposed at bent # 3, columns # 1 and 2. No apparent undermining or scour problems during this inspection.							
234	Reinforced Concrete Pier Cap	LF	100	99	1	0	0
1080	Delamination/Spall/Patched Area	LF	1	0	1	0	0

Bent 3, column 1 footing exposed.

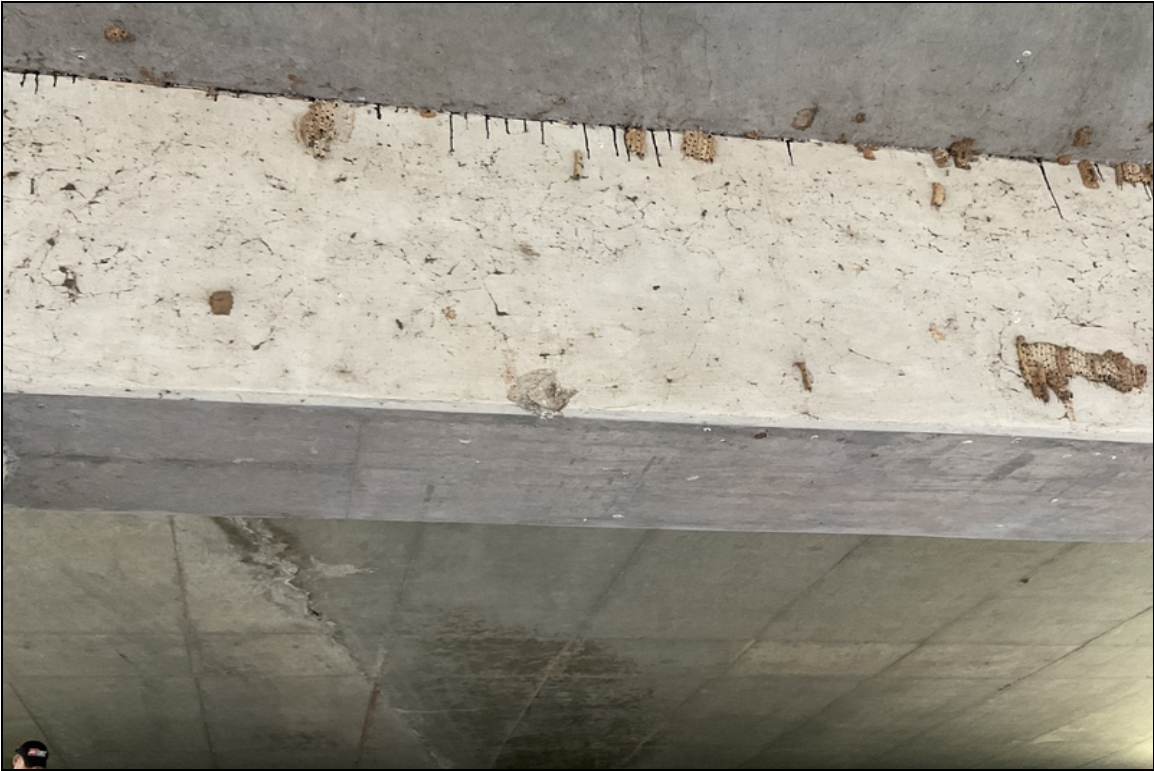
Bent 2 cap-Shallow spall in backface right of centerline.

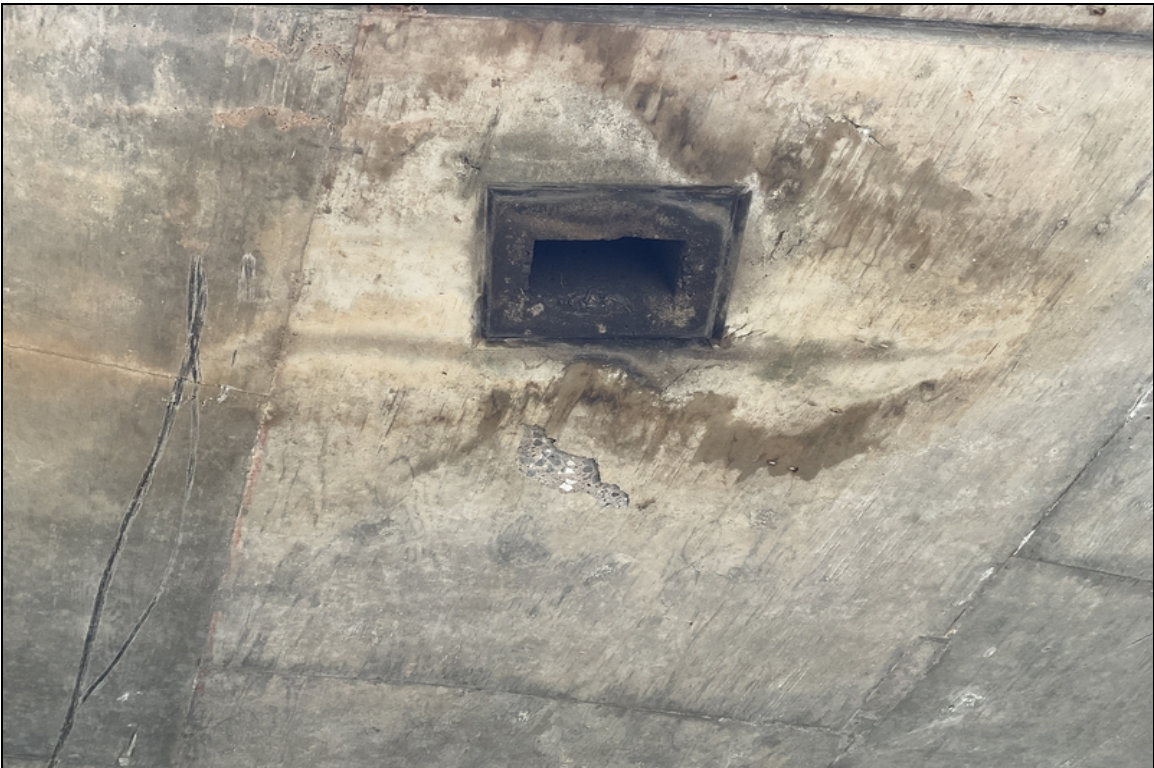
The undersurface of Span # 1 has a shallow spall and delaminated areas adjacent to the deck drain at mid-span.

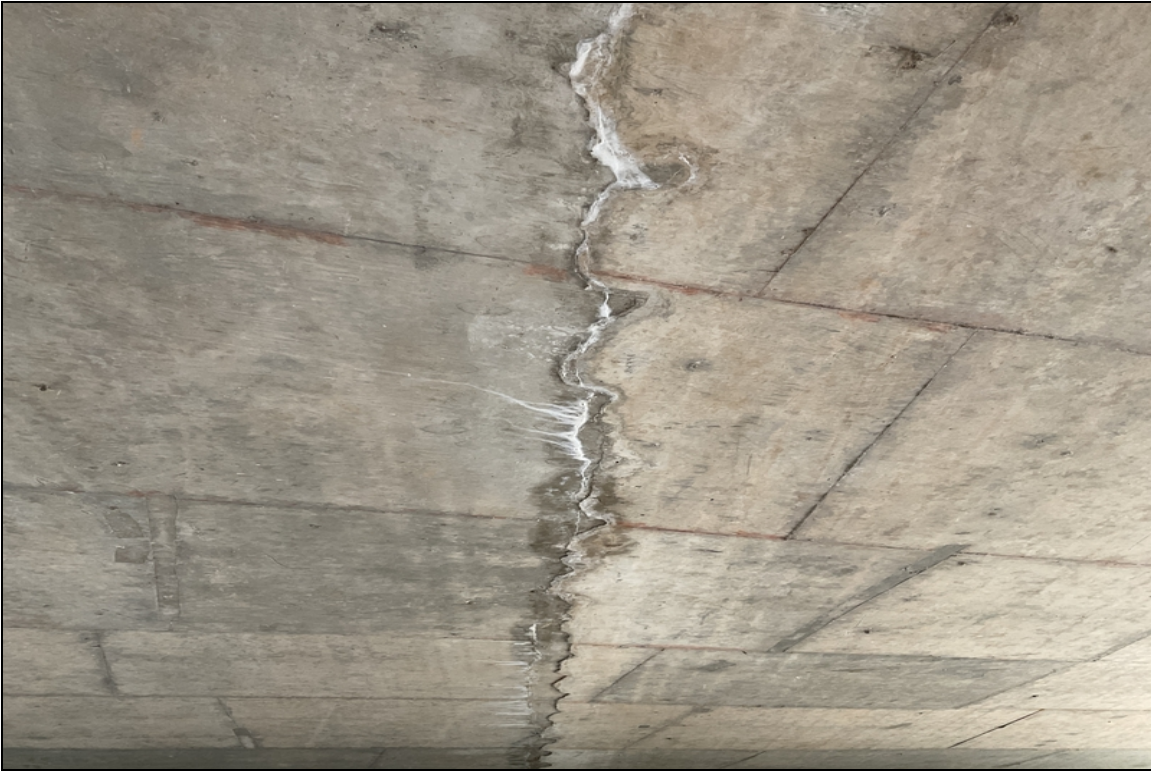
Span 1-Efflorescence at centerline construction joint.

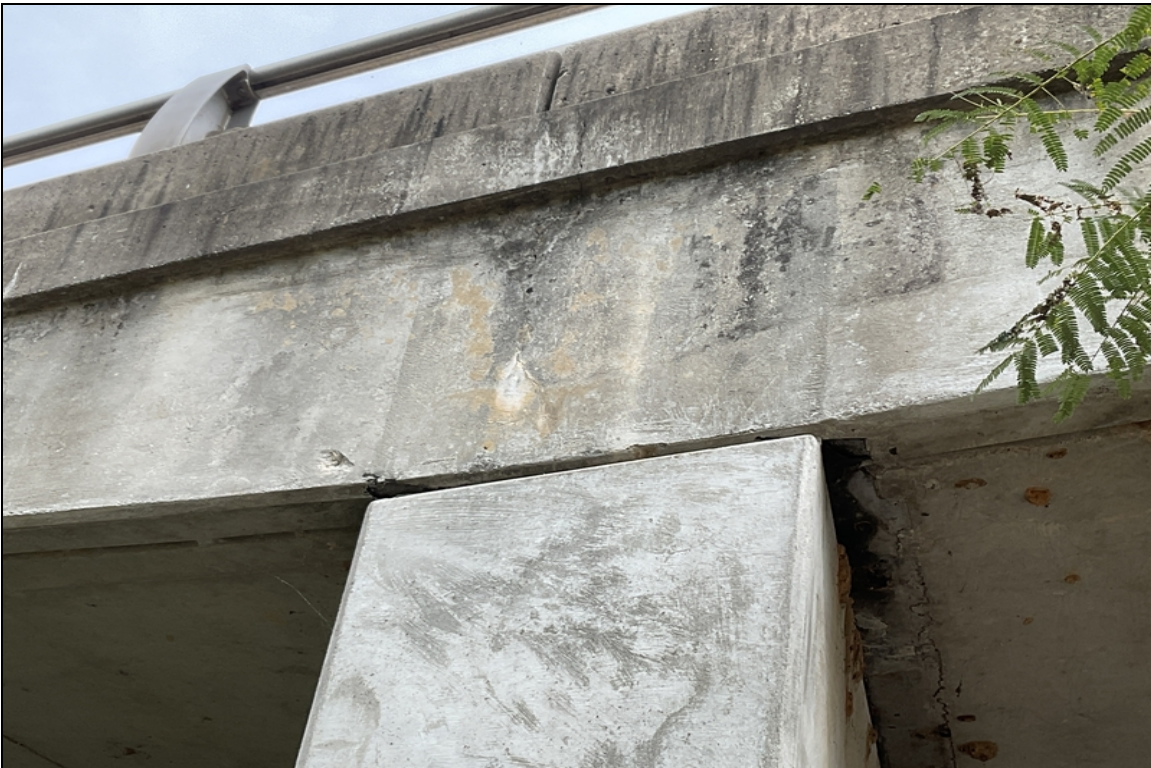
Vertical crack with light efflorescence on exterior side of slab over bent # 2.

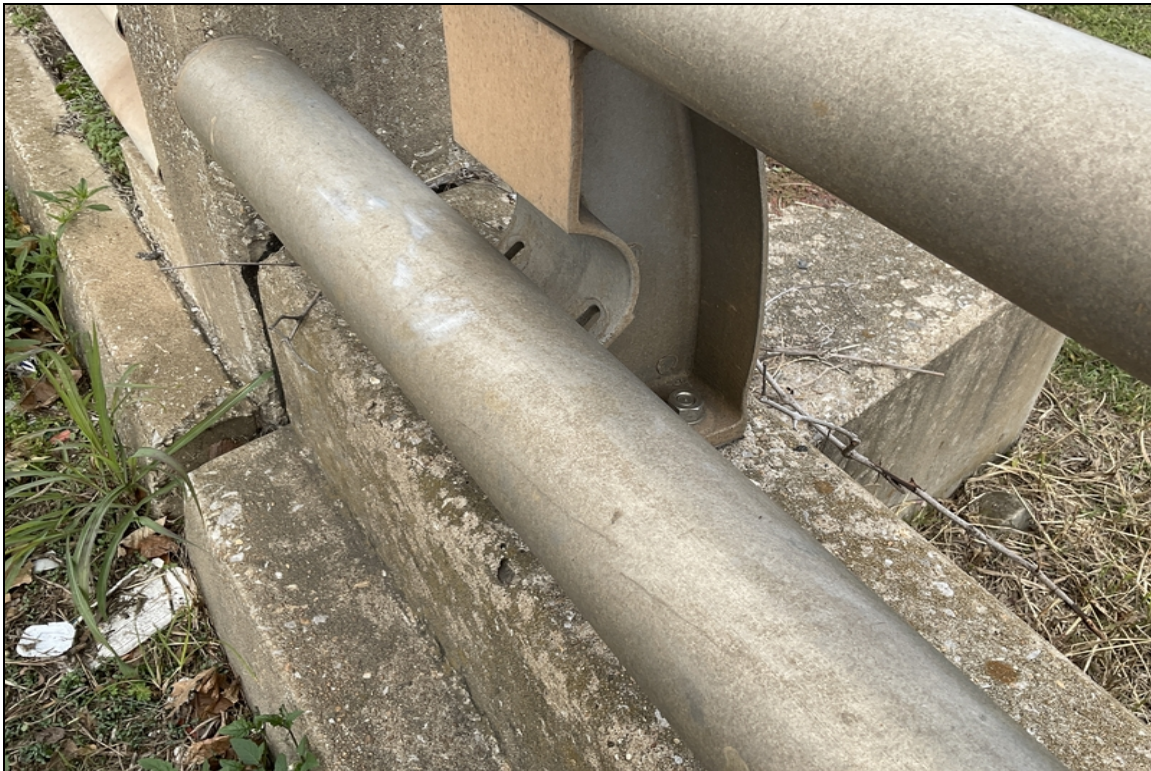
(330)	-The left and right bridge railing in span # 3 has loose and missing bolts that attach the metal railing to the posts.						
331	Reinforced Concrete Bridge Railing	LF	262	240	22	0	0
1130	Cracking (RC and Other)	LF	22	0	22	0	0

Span 3, right side at abutment 2-Missing bolt at post connection.

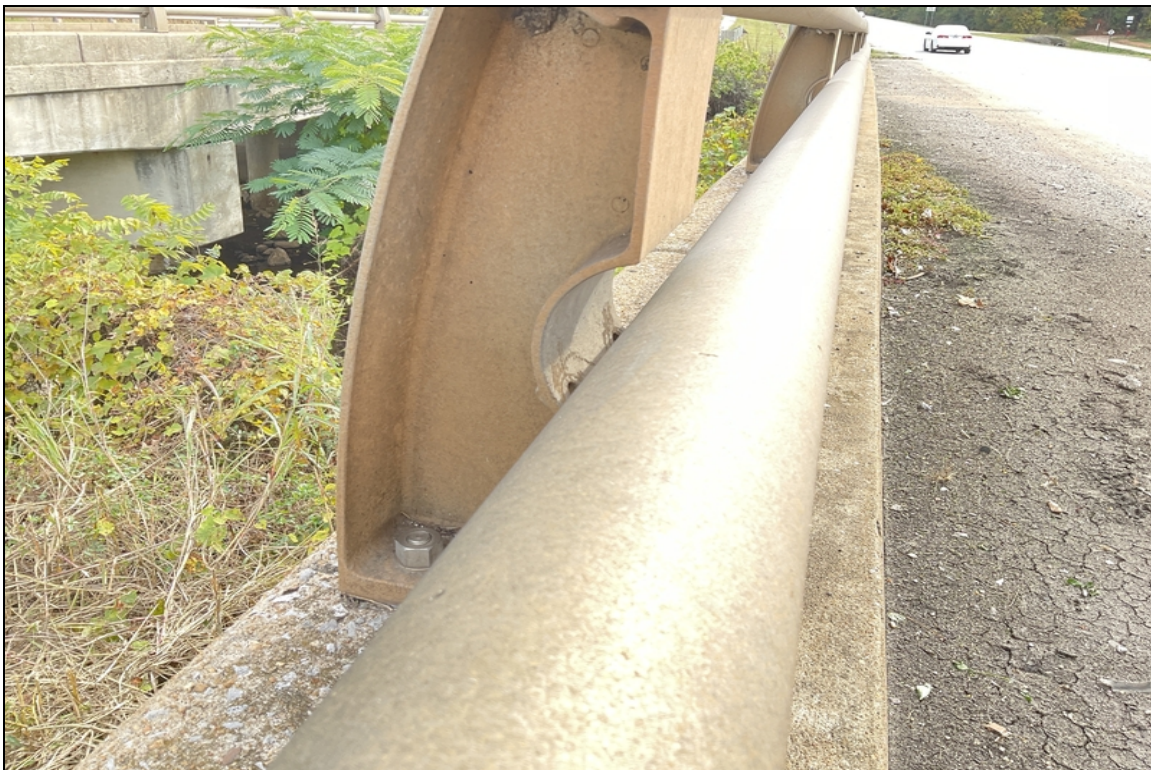
Span 3, right side-Missing bolt at post connection.

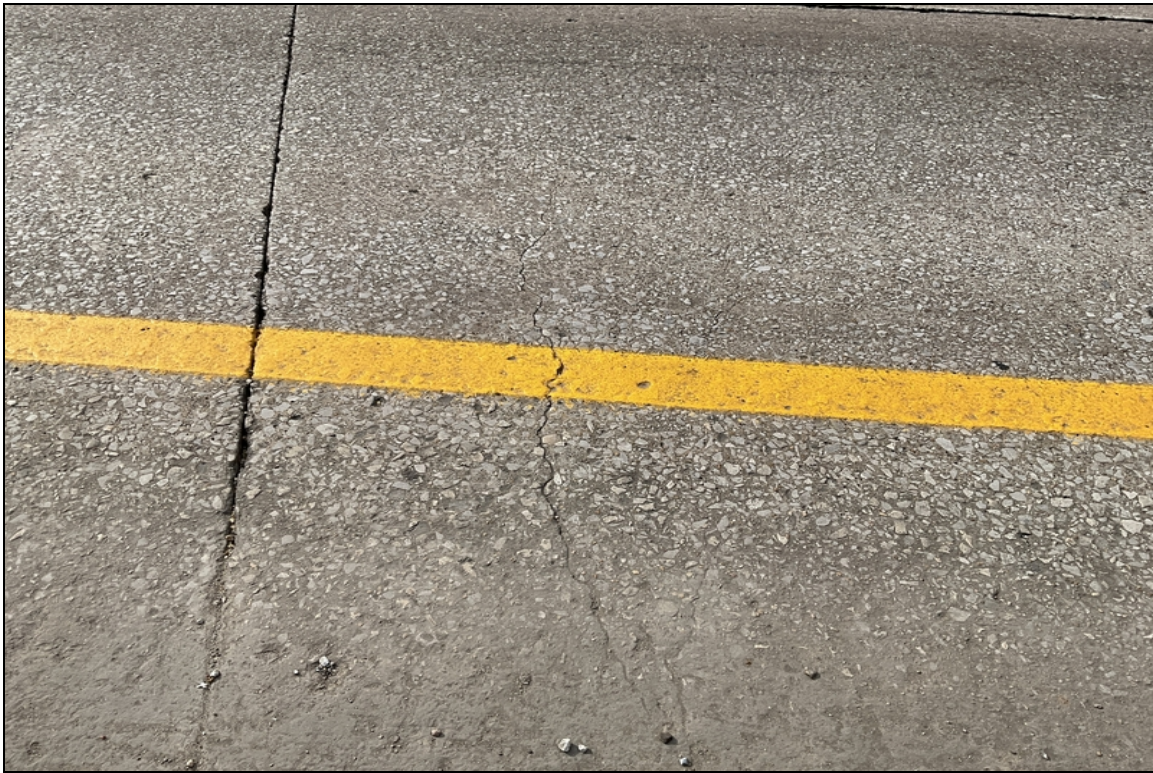
(321)	-The South approach slab has light abrasion and transverse cracks in the driving lanes and medium scale in the right approach gutter.						
330	Metal Bridge Railing	LF	262	254	3	5	0
1020	Connection	LF	8	0	3	5	0

South approach slab-Transverse crack.

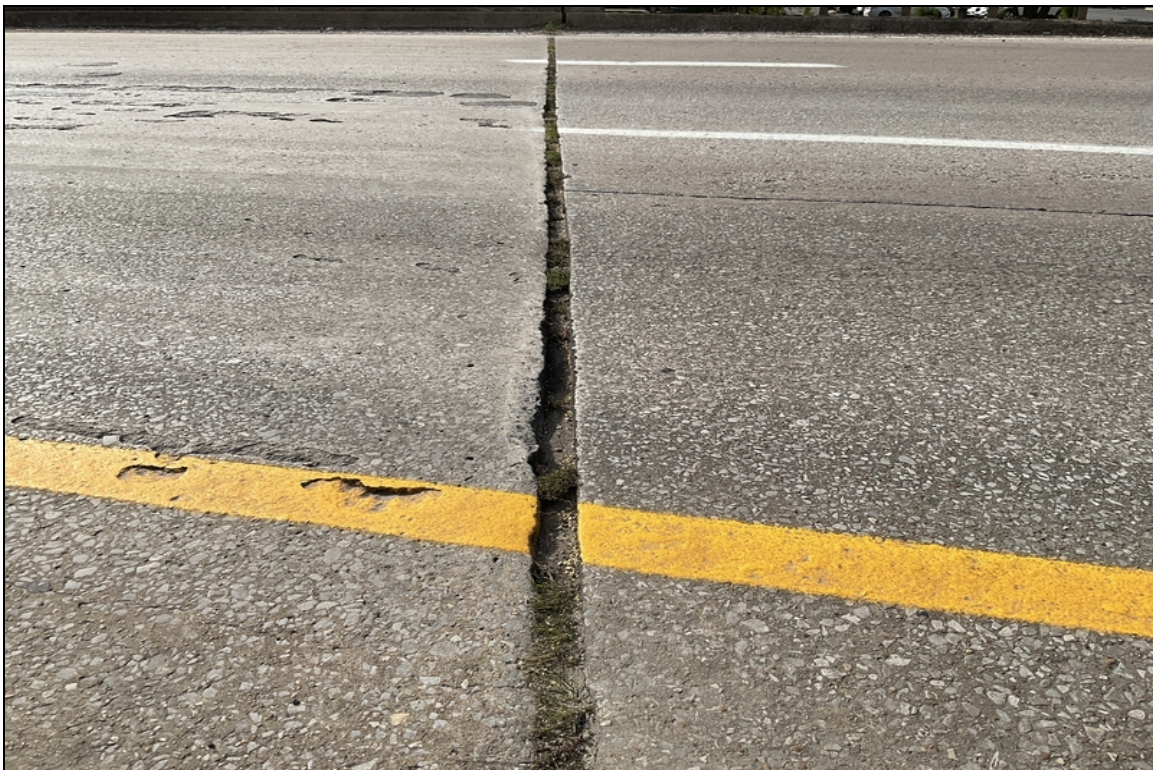
ELEM	DESCRIPTION	UNITS	TOTAL	CS1	CS2	CS3	CS4
301	Pourable Joint Seal	LF	100	0	0	0	100
2350	Debris Impaction	LF	100	0	0	0	100
(301)	-Pourable joint sealant at both bridge ends has failed with the joints full of incompressible material.						
321	Reinforced Concrete Approach Slab	SF	3220	1720	1496	4	0
1130	Cracking (RC and Other)	SF	420	0	416	4	0
1190	Abrasion/Wear (PSC/RC)	SF	1080	0	1080	0	0

Abutment 2 expansion joint-Failing sealant with debris impactation.

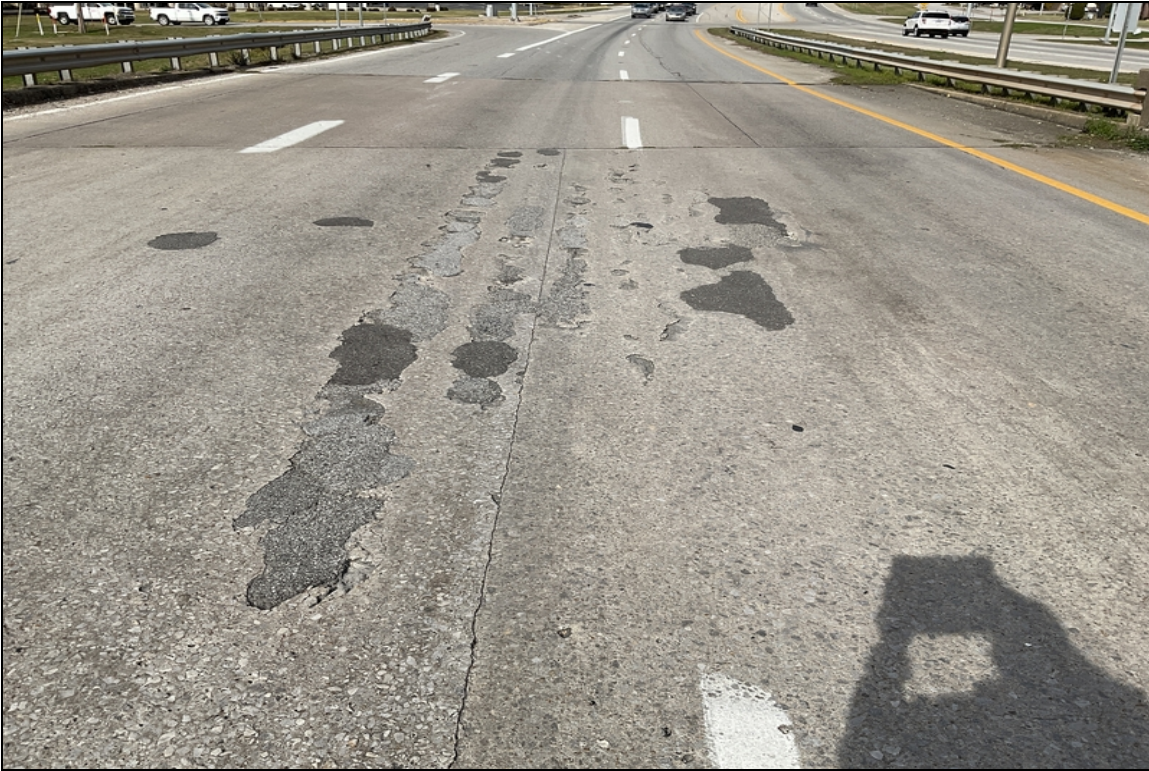
Driving surface of span # 3 has an area of spalling with failing asphalt repairs approximately 30' long x 5' wide located near centerline.

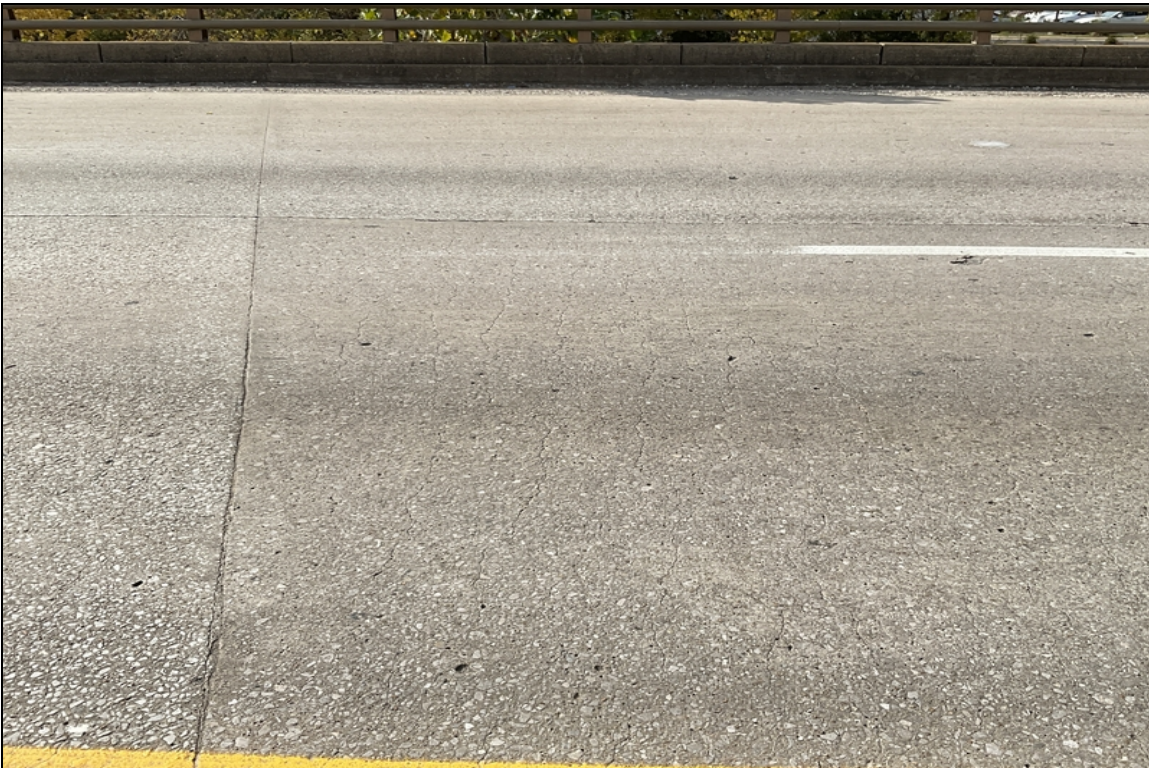
(38)							
-The driving surface has mapcracking in all lanes in the negative moment regions near the intermediate bents. -Span # 1 has two 30" spalls with asphalt patches in the center lane near abutment # 1. -The driving surface has four 5' long x 14" wide spalls with asphalt patches over bent # 2. The repairs are failing with potholes forming in the driving surface. -Spans # 2 and 3 have basket ball sized spalls with exposed reinforcing steel (Exposed reinforcing steel Not visible during this inspection due to asphalt patches). Exposed reinforcing steel has initial section loss during this inspection. -Driving surface of span # 3 has an area of spalling with failing asphalt repairs approximately 30' long x 5' wide located near centerline.  Deck Soffit - -The undersurface of span # 1 has a shallow spall and delaminated areas adjacent to the deck drain at mid-span. -The longitudinal construction joint in span # 3 has a 5" spall with exposed reinforcing steel. -One longitudinal crack with light efflorescence is visible from the undersurface of all 3 spans at the centerline construction joint. -The edges of the deck have one or two vertical hairline cracks with light efflorescence over the intermediate bents. -There are small spalls and scrape marks in the exterior edges of the deck over the pedestrian walk way under span # 1.

Span 2-Mapcracking.

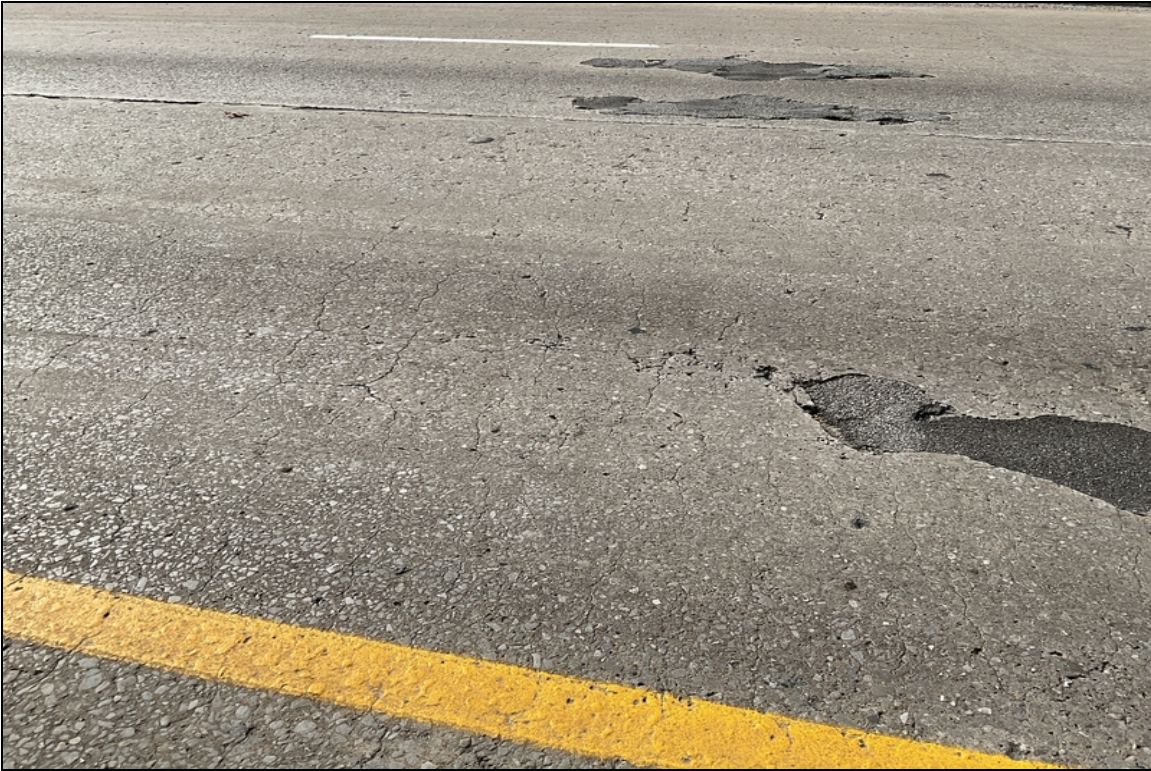
Span -Mapcracking.

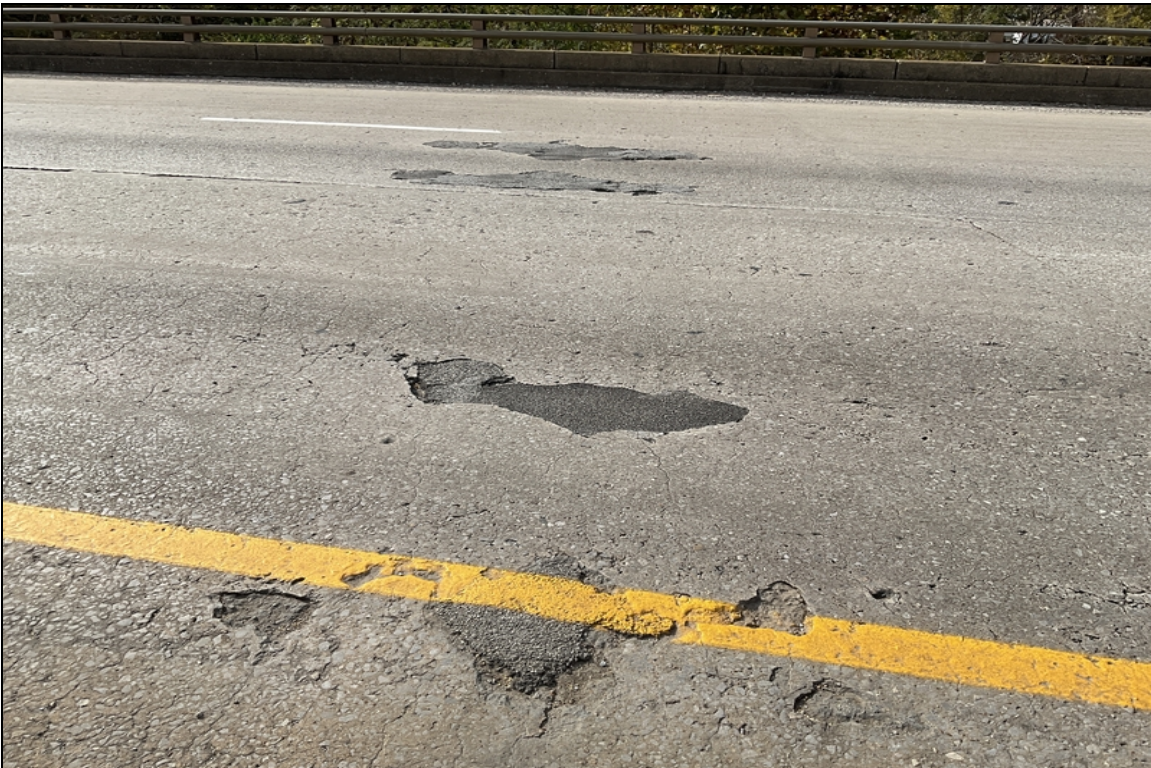
Spalls with asphalt repairs over bent 2.

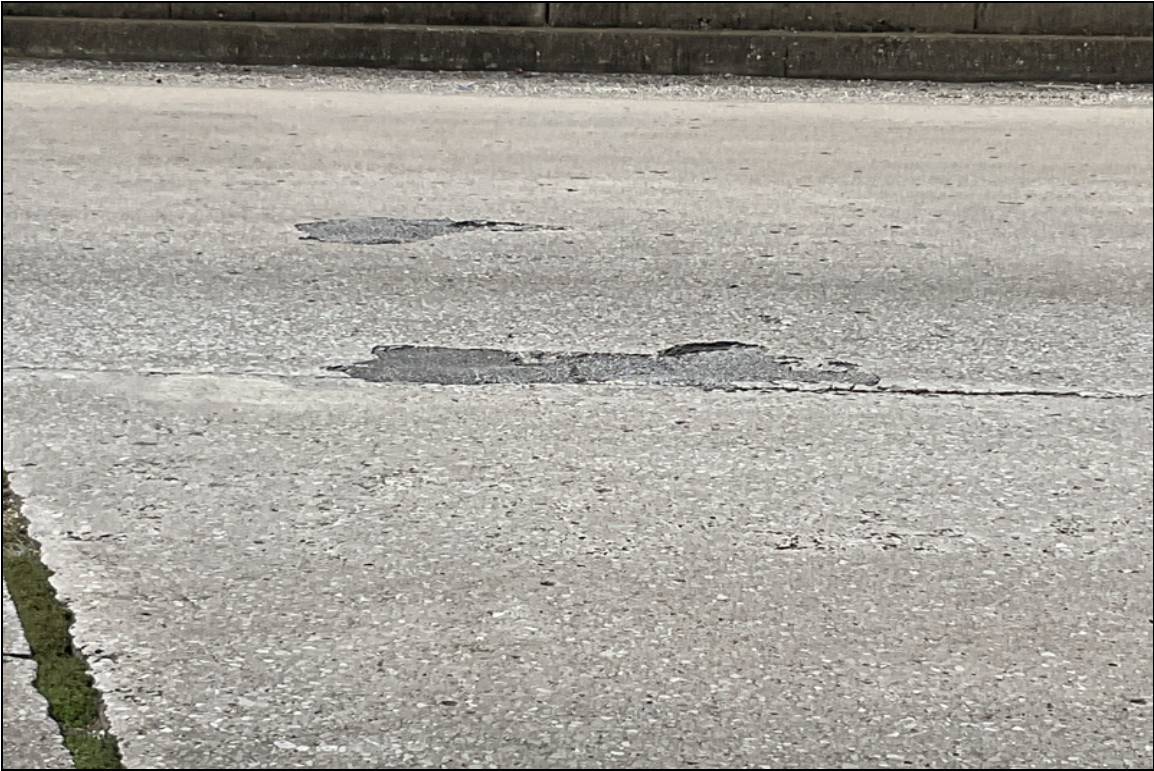
Span 1, center lane-Spalls with asphalt repairs.

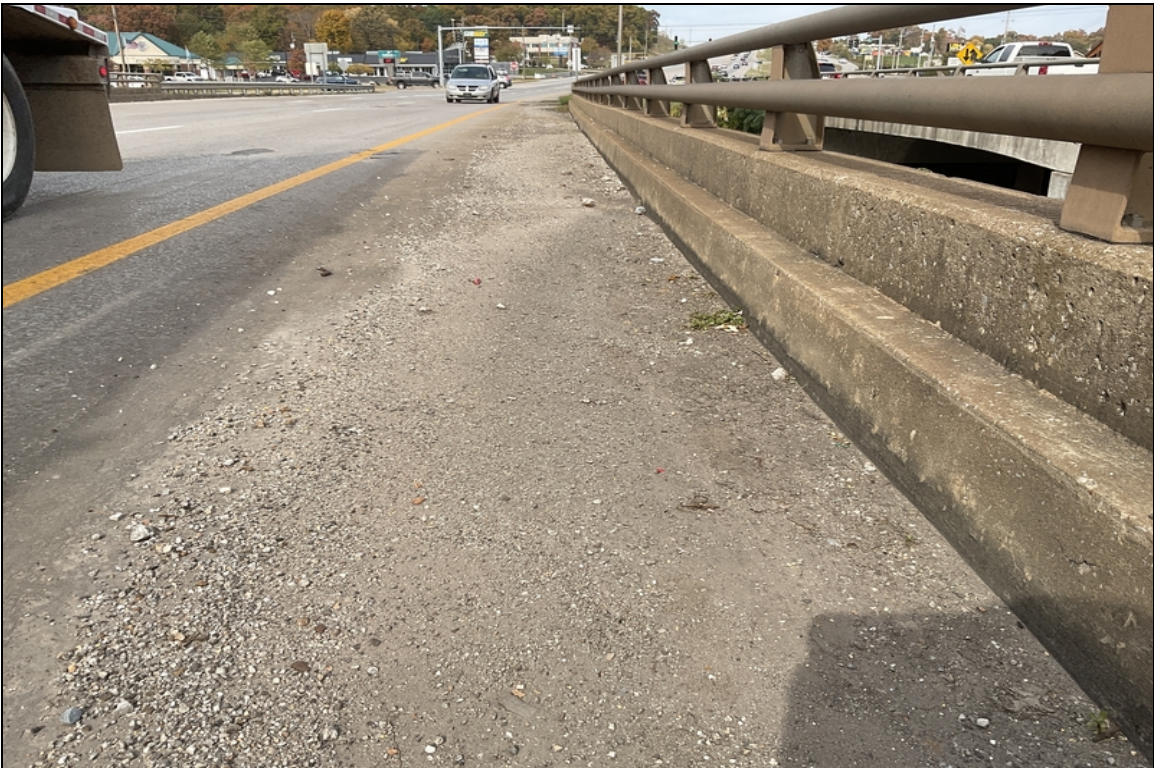
Dirt and debris accumulation in gutters.

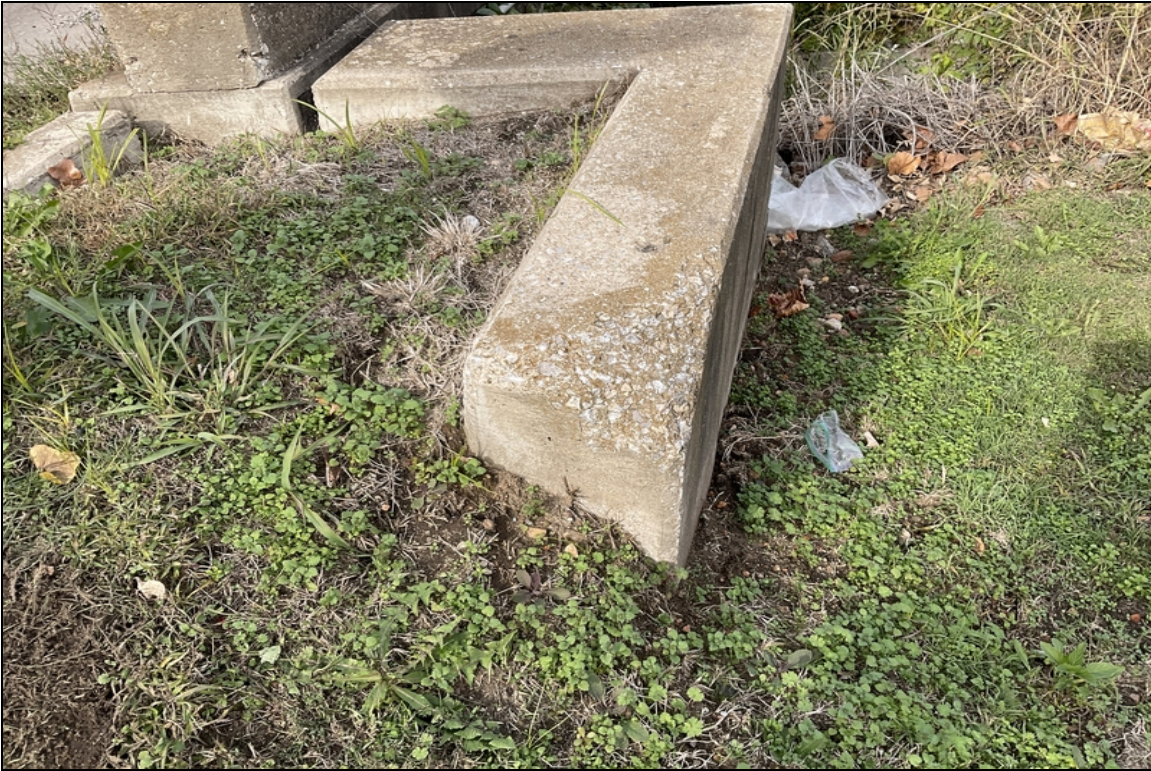
Abutment 1, right side-Spall in turn back portion of abutment.

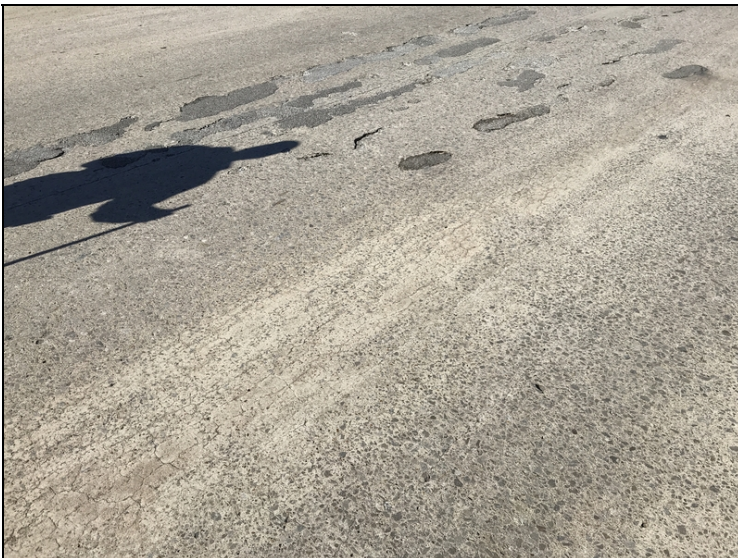
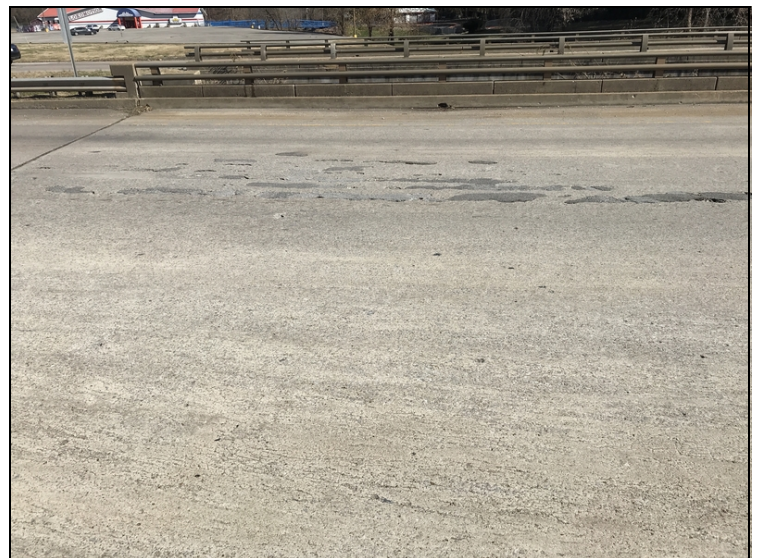
Deck -  
Span # 1 has two 30" spalls with asphalt patches in the center lane near abutment # 1.  
The driving surface has four 5' long x 14" wide spalls with asphalt patches over bent # 2. The repairs are failing with potholes forming in the driving surface.  
Spans # 2 and 3 have basket ball sized spalls with exposed reinforcing steel (Exposed reinforcing steel not visible during this inspection due to asphalt patches). Exposed reinforcing steel is documented as having initial section loss.  
Driving surface of span # 3 has an area of spalling with failing asphalt repairs approximately 30' long x 5' wide located near centerline.  
The undersurface of the slab in span # 3 has a 5" spall with exposed reinforcing steel at the longitudinal construction joint at centerline of structure.

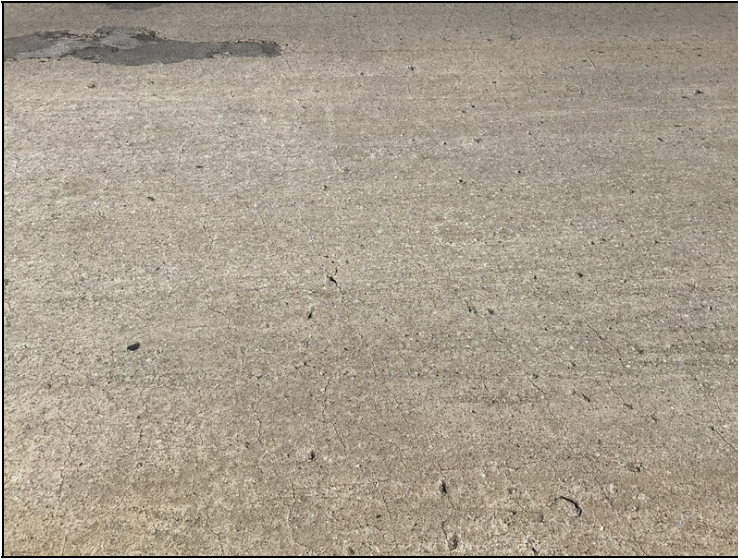
Transverse and map cracking over Bent # 2.

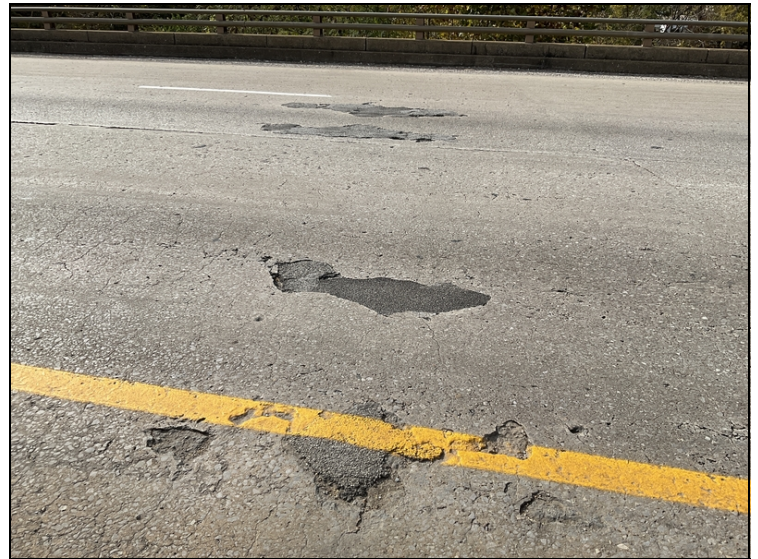
Spalls with asphalt repairs over bent 2.

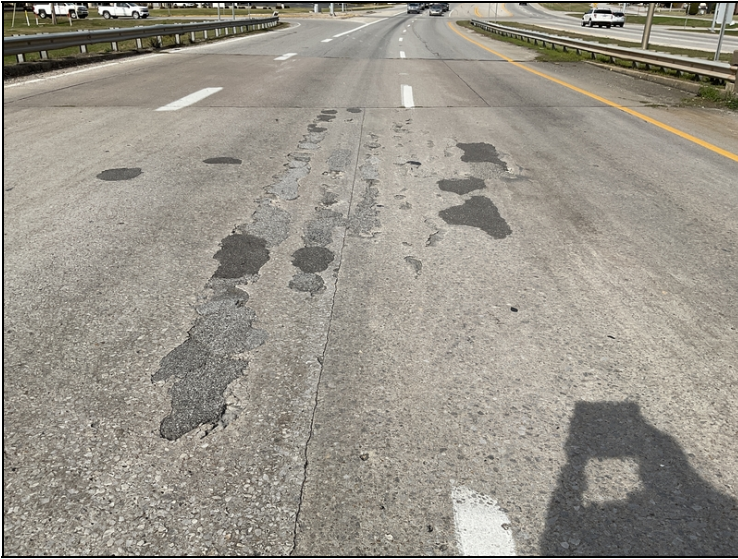
Driving surface of span # 3 has an area of spalling with failing asphalt repairs approximately 30' long x 5' wide located near centerline.

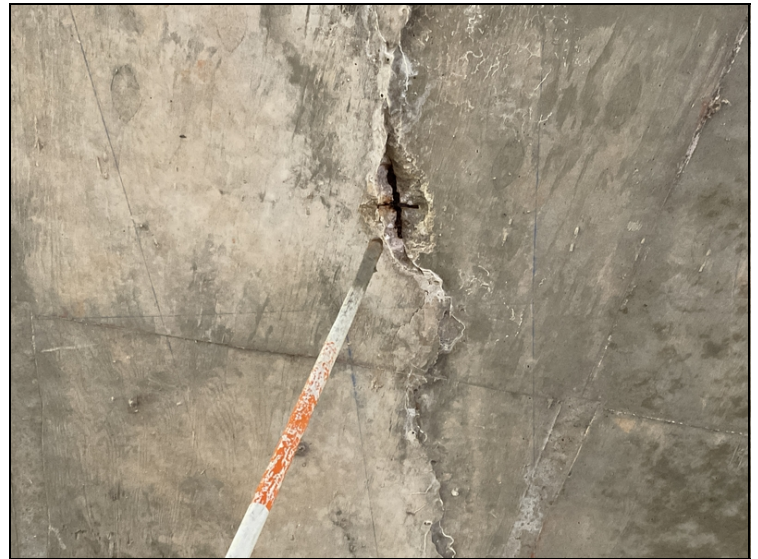
Span # 3-Spall with exposed reinforcing steel in slab undersurface in centerline construction joint.

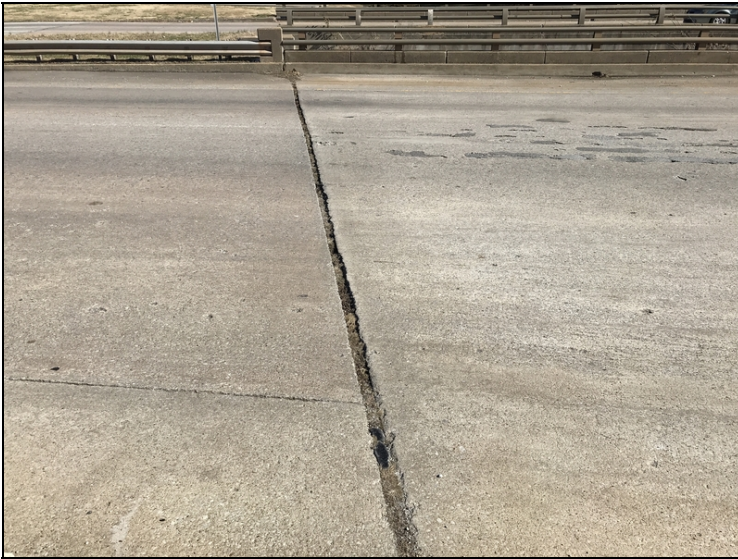
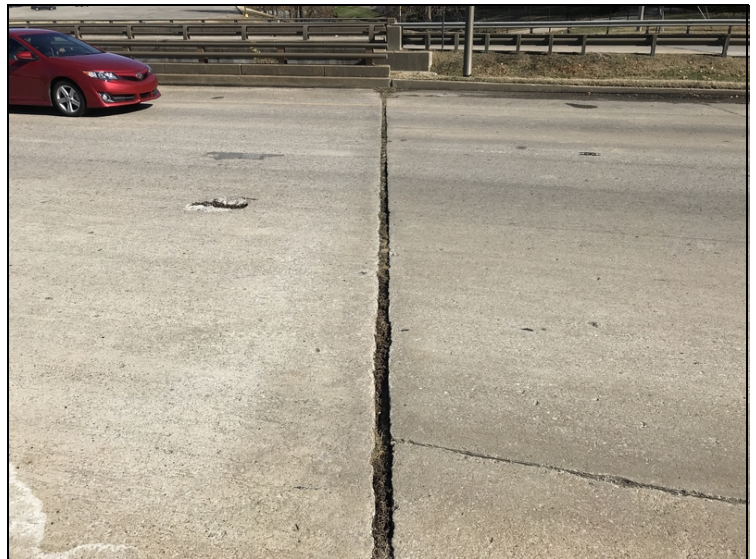
Expansion Joints -  
Expansion joint material has failed and is full of debris at the North and South bridge ends.

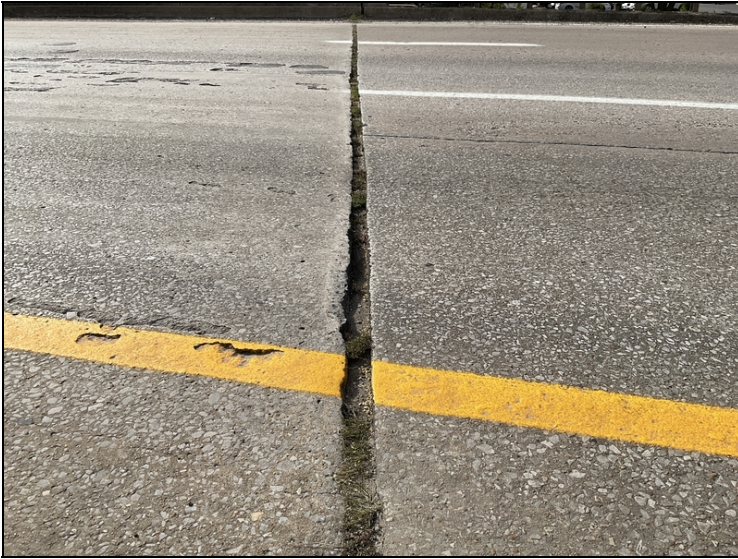
Abutment # 2 expansion joint-Failing sealant with debris impaction.

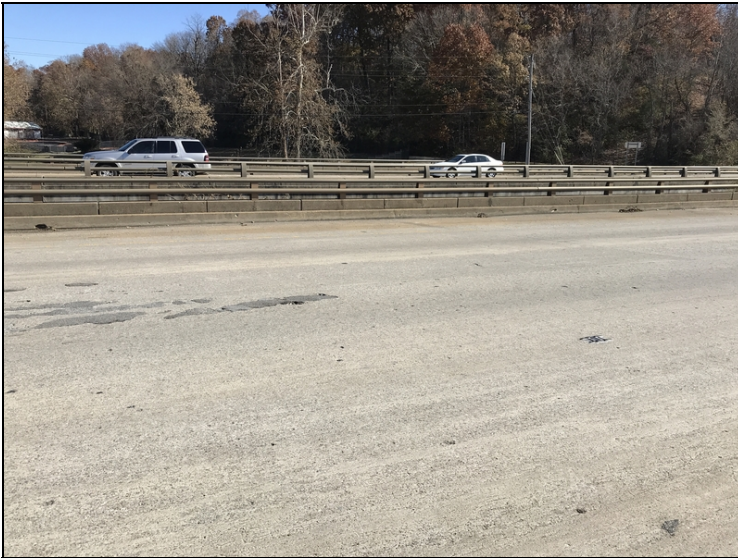
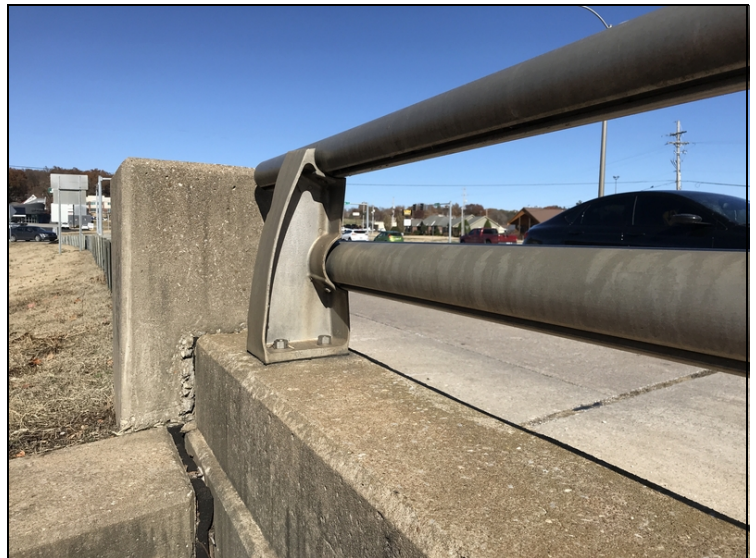
The right and left bridge rails in span # 3 have loose and missing bolts that attach the railing to the posts. The railing has slightly shifted out of position at some of the posts.

Span # 3 loose bridge railing.

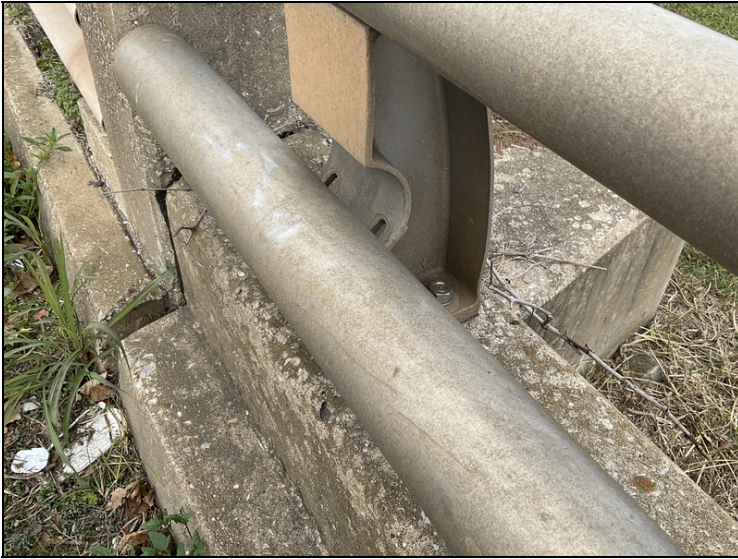
Span 3, right side at abutment 2-Missing bolt at post connection.

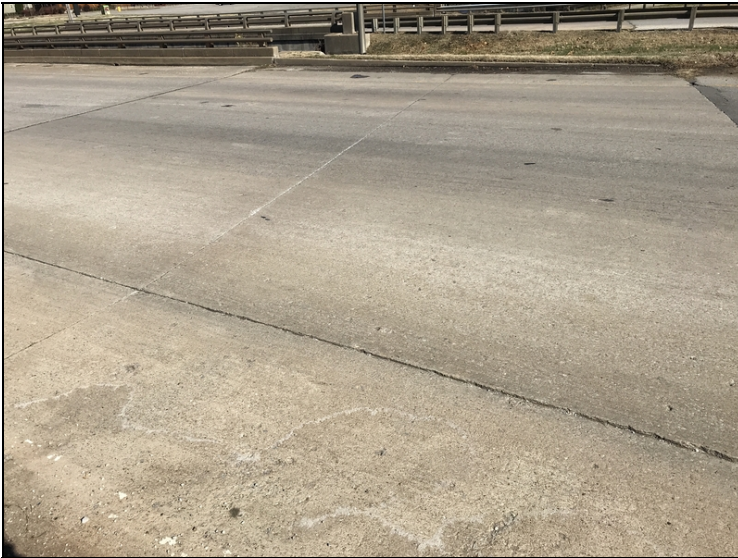
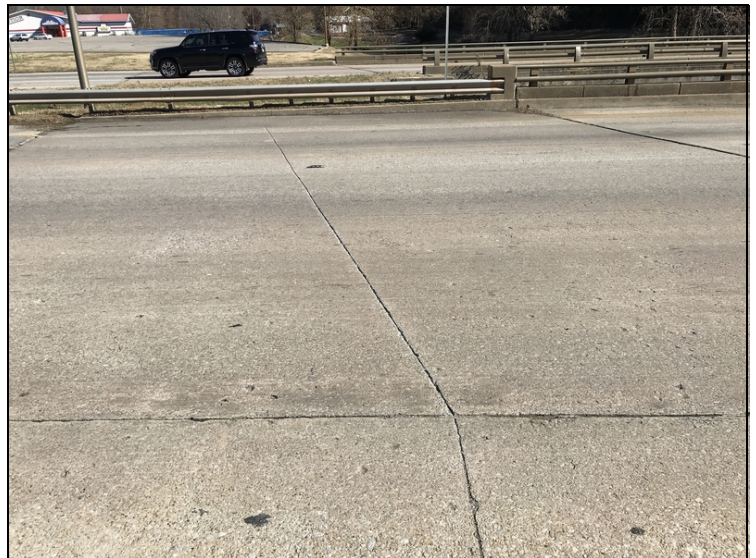
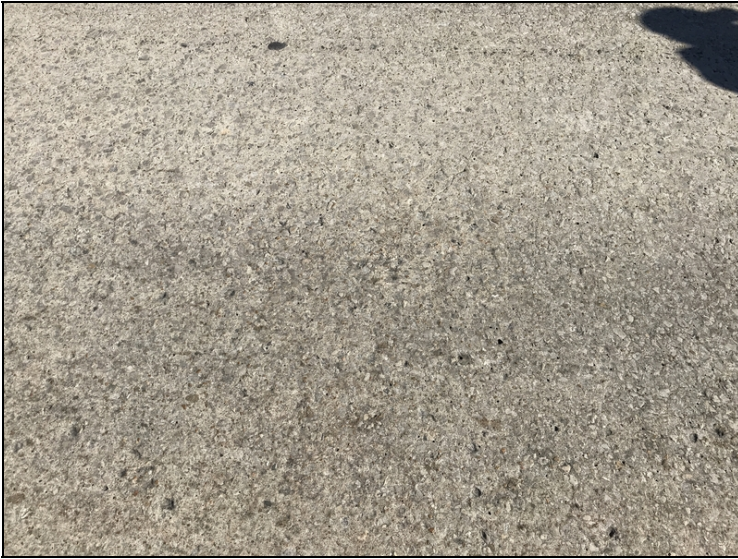
The approach slabs have light abrasion and sealable transverse cracks in the driving lanes and medium scale on the South approach (Right) gutter.

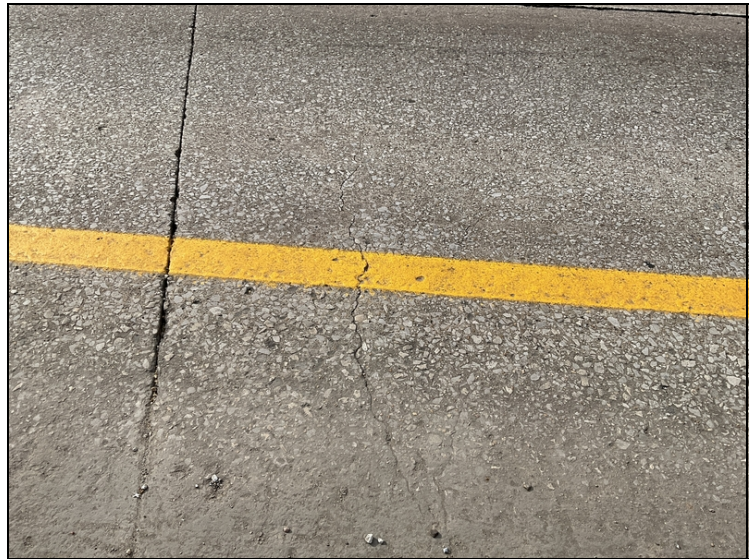
South approach slab-Transverse crack.
