Bridge #A5392(Routine)

US 71 B, SB LNS over Clear Creek- Washington

Location: 5.47 MI S BENTON CO LINE

Team Lead: Bob McEntyre Inspection Date: November 09, 2021

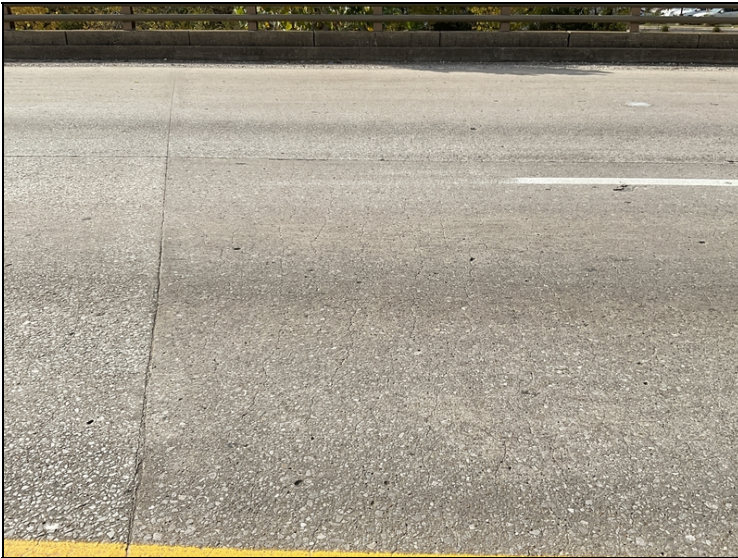
Deck -  
There are sealable cracks in the driving surface of the deck.  
The deck has random surface map cracking visible from the driving surface only.

Span 2-Mapcracking.
