Bridge #B5392(Routine)

US 71 B, NB LNS over Clear Creek-Washington

Location: 5.47 MI SO BENTON CO LINE

Team Lead: Bob McEntyre Inspection Date: November 09, 2021

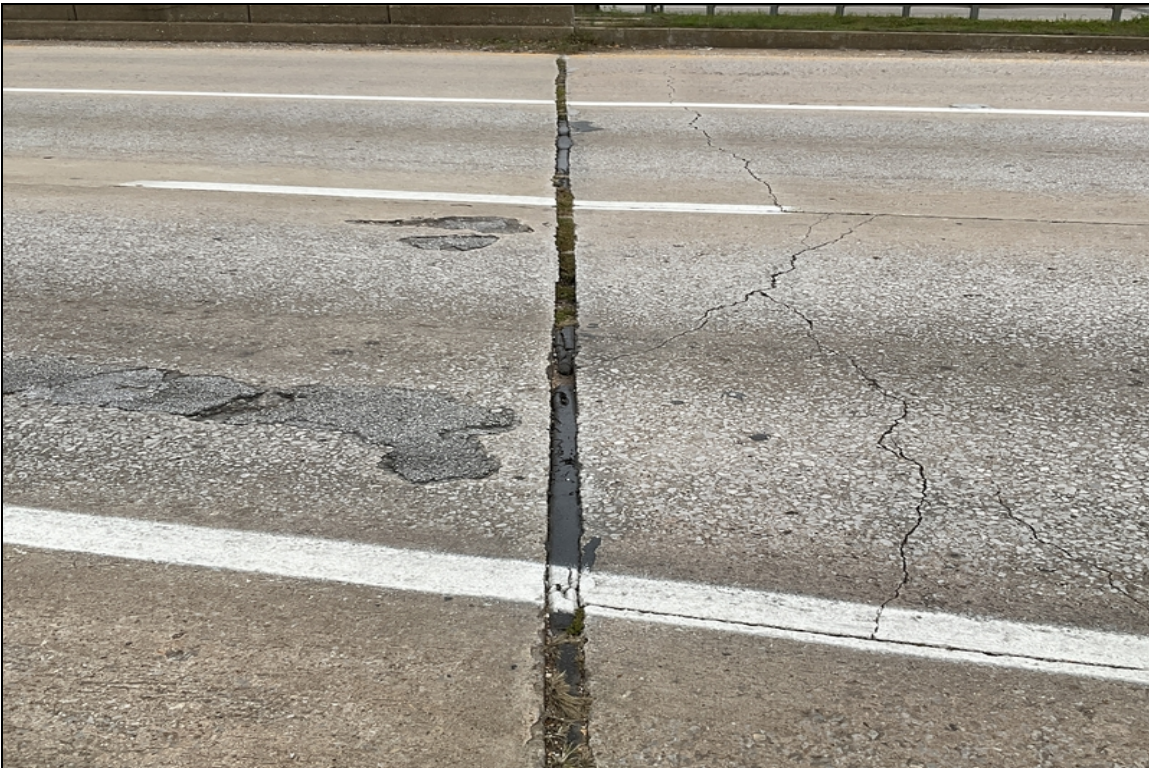
(301)							
-Pourable joint material at both bridge ends leak and are full of incompressible material.							
321	Reinforced Concrete Approach Slab	SF	3500	1286	932	1282	0
1080	Delamination/Spall/Patched Area	SF	0	0	0	0	0
1130	Cracking (RC and Other)	SF	174	0	92	82	0
1190	Abrasion/Wear (PSC/RC)	SF	2040	0	840	1200	0

Abutment # 2 expansion joint sealant has failed with incompressible material in the joint.

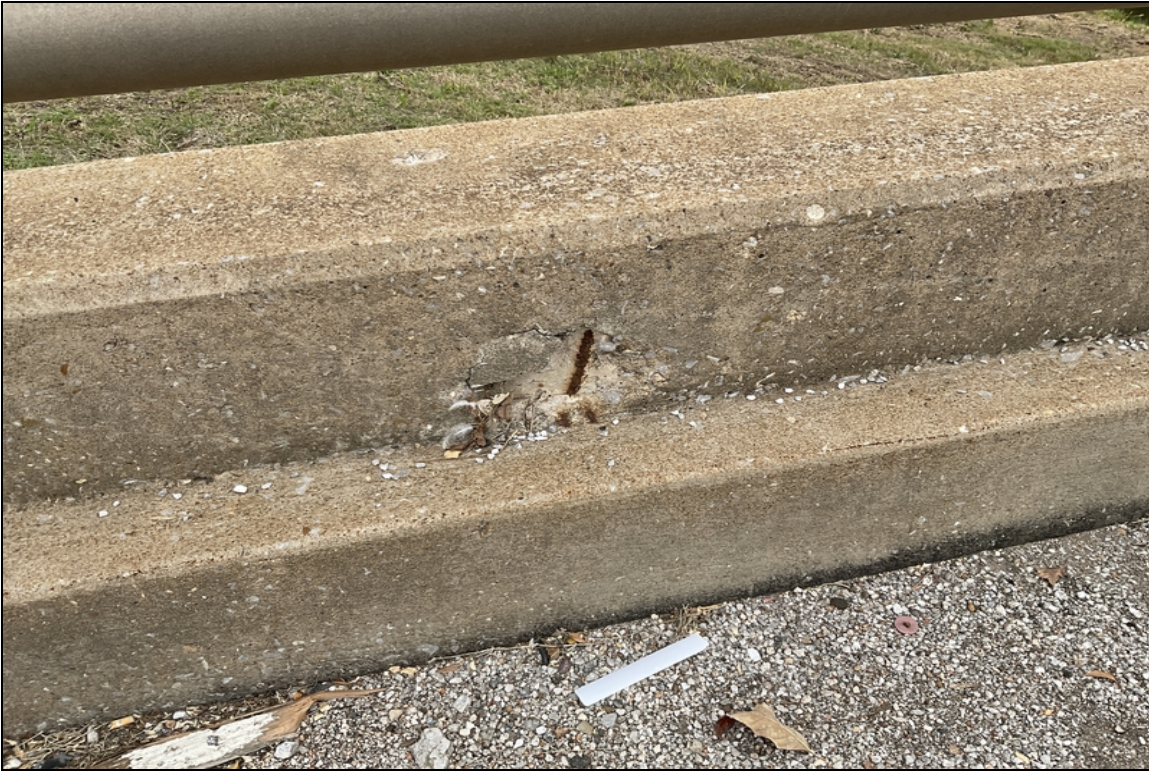
Span 3, right concrete railing at abutment # 2-Spall with exposed reinforcing steel.

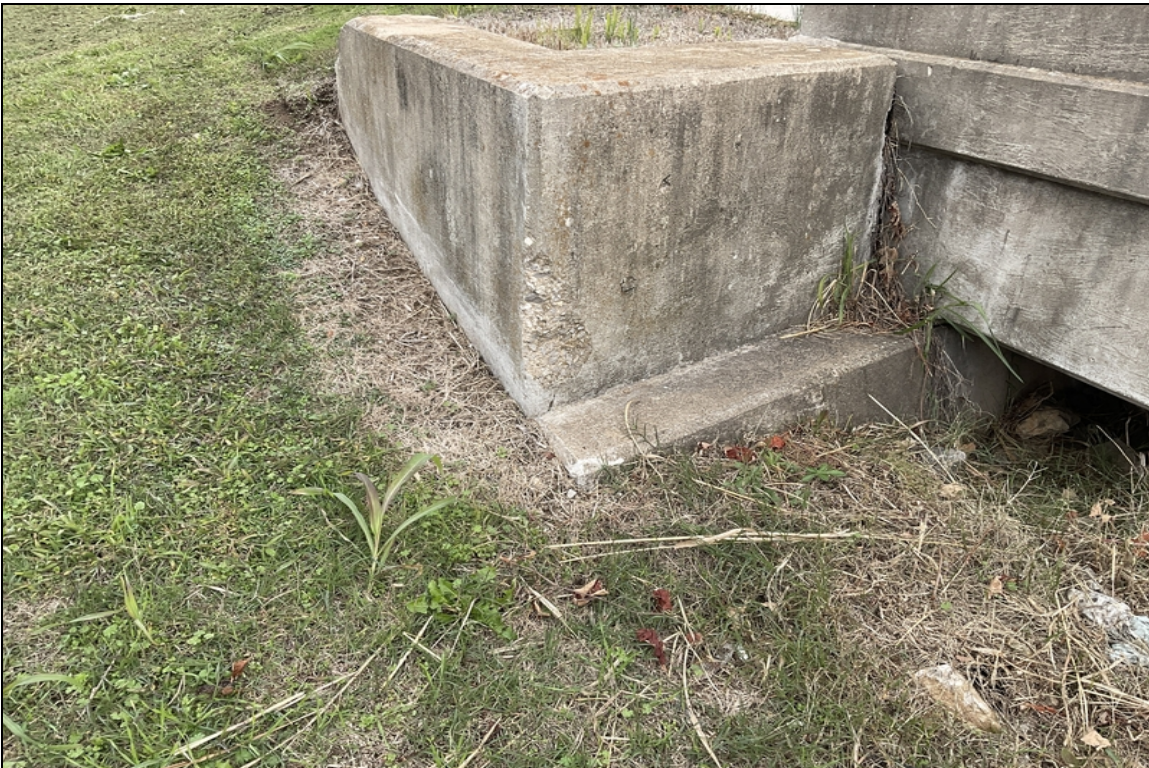
Abutment 2, left side-Shallow spall that appears to be from mowing operations.

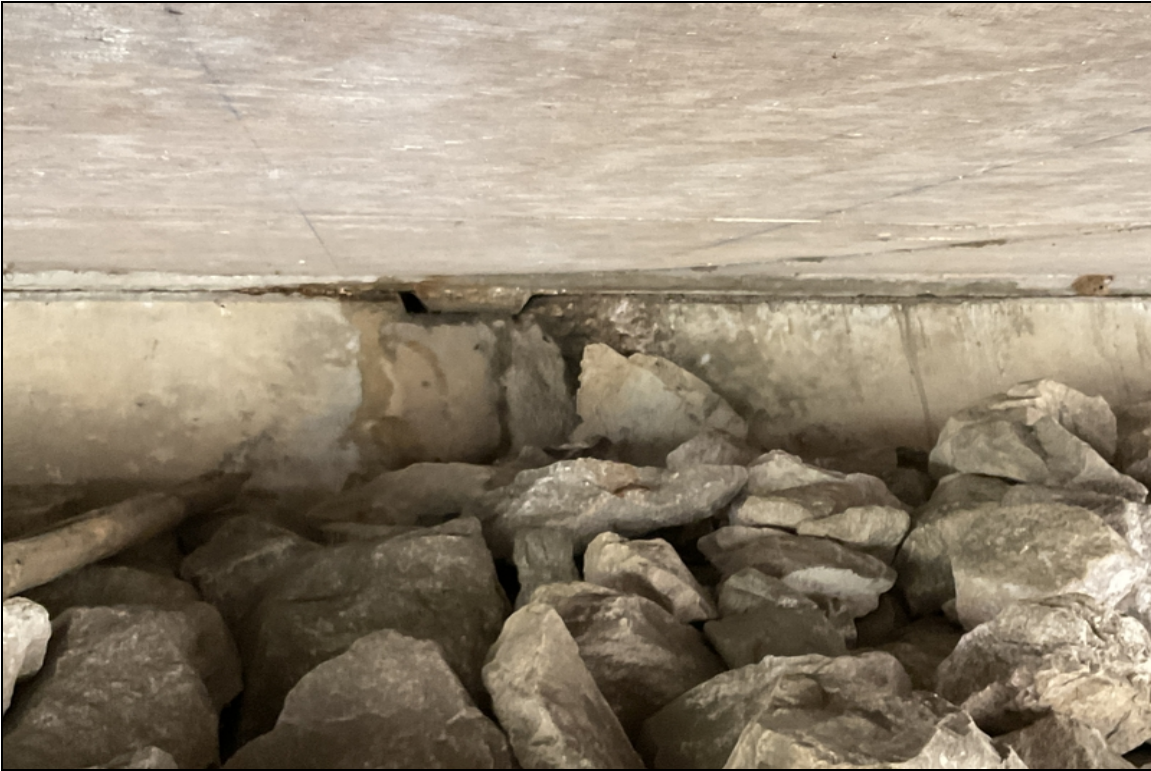
(215)							
-Abutment # 1: -The right turn back portion of abutment # 1 is fractured outside the bearing area.  Abutment # 2: One shallow spall at the left of centerline keyway and left end of cap that does not expose reinforcing steel during this inspection.							
220	Reinforced Concrete Pile Cap/Footing	LF	36	36	0	0	0

Abutment 2-Spall at key way near centerline.

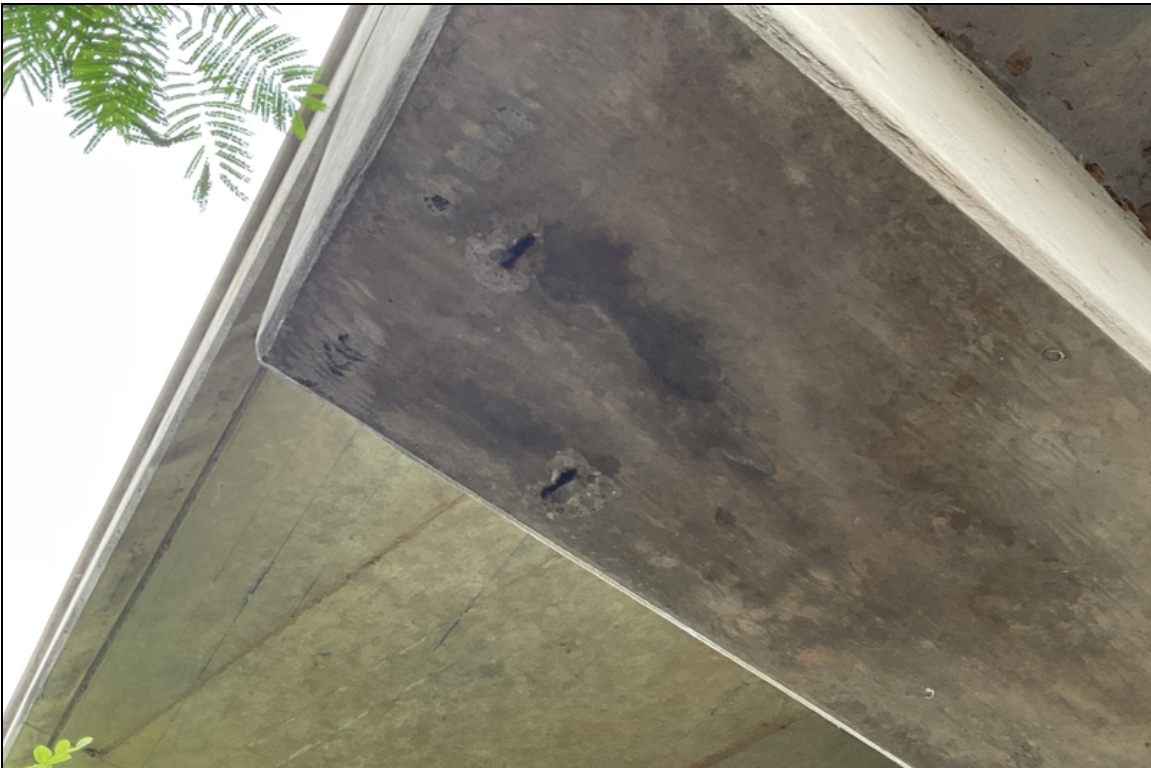
(234)							
-Bent # 2 left has two 4" long shallow spalls with shallow exposed reinforcing steel visible in the bottom of the cap.							
-Bent # 3 left on undersurface of cap has two shallow baseball sized spalls with exposed reinforcing steel with up to initial section loss.							
301	Pourable Joint Seal	LF	108	4	0	0	104
2310	Leakage	LF	100	0	0	0	100
2350	Debris Impaction	LF	4	0	0	0	4

Bent 3 cap, left side-Shallow spalls with exposed reinforcing steel in undersurface.

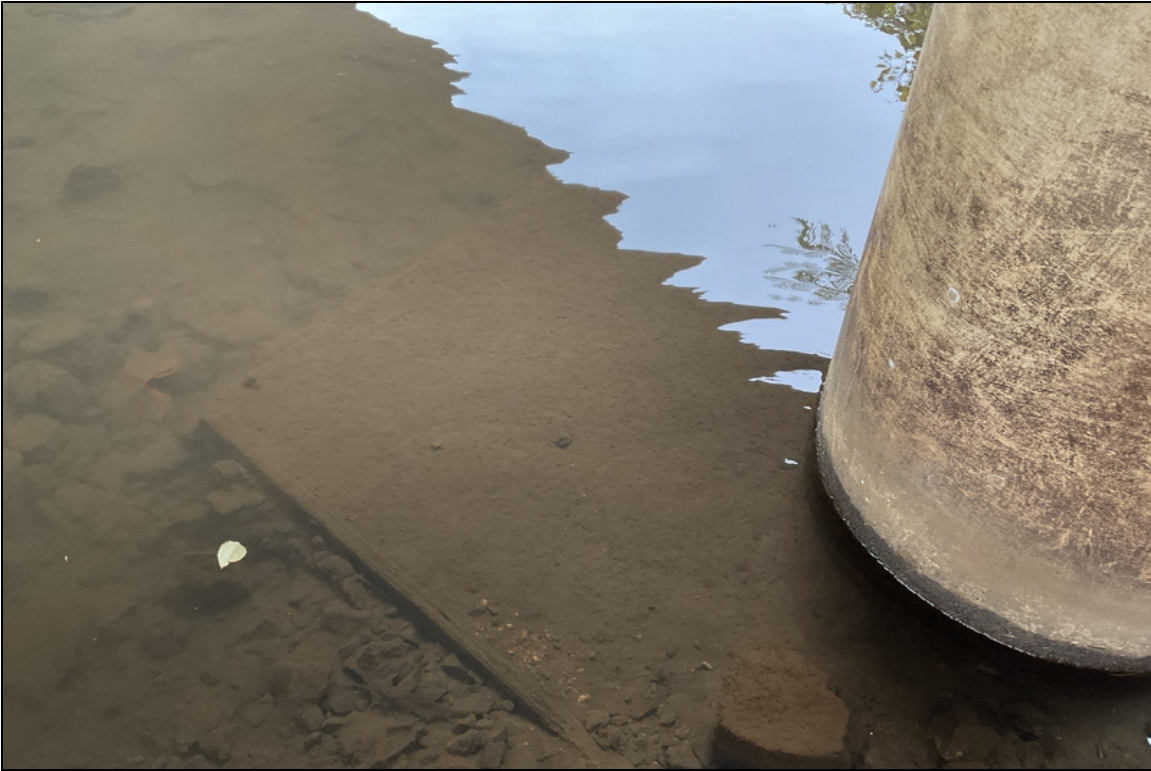
ELEM	DESCRIPTION	UNITS	TOTAL	CS1	CS2	CS3	CS4
(220)							
-The top of bent # 3, columns # 1 and 2 footings are exposed. Footings appear to be keyed into solid lime stone with no apparent scour problems during this inspection.							
11/13/2019 - JCJ & TJL - ArDOT Drawing # 16967 - General notes state that the footings shall be poured directly against excavated surfaces of rock and shall be a minimum of one foot into material designated limestone.							
234	Reinforced Concrete Pier Cap	LF	108	103	5	0	0
1080	Delamination/Spall/Patched Area	LF	2	0	2	0	0
1090	Exposed Rebar	LF	3	0	3	0	0

Bent 3, column 1 footing exposed.

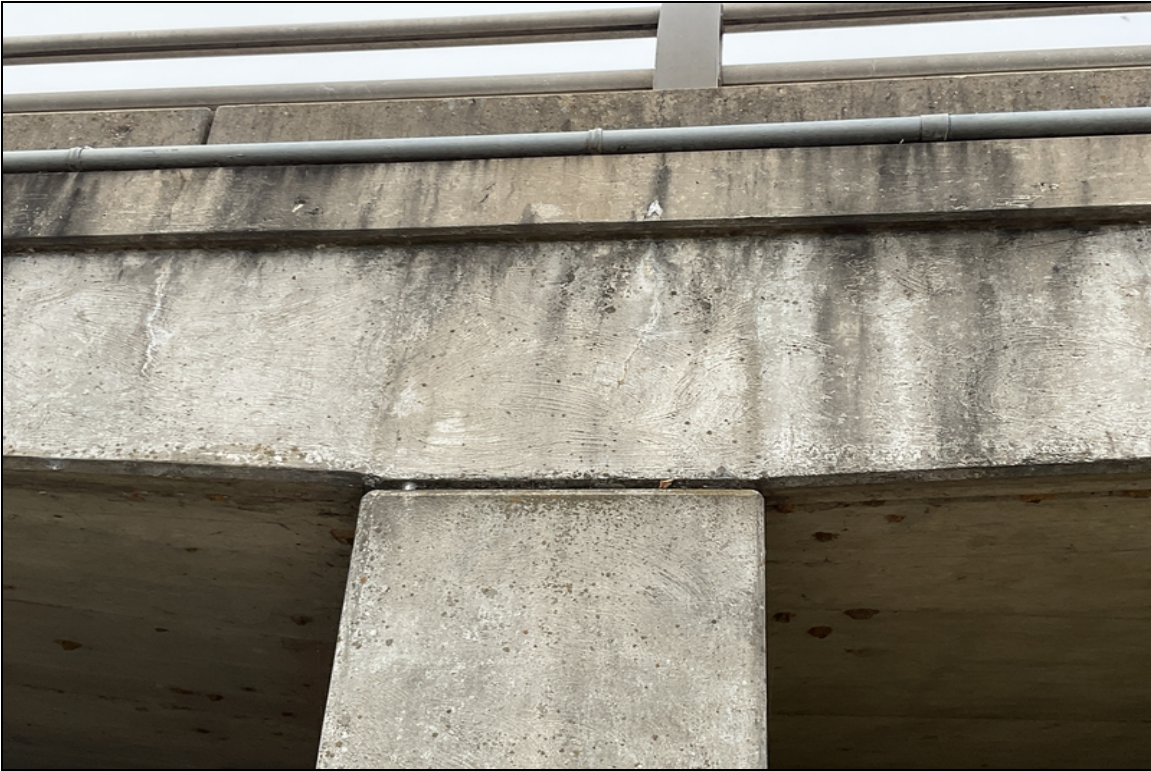
Vertical cracking in slab exterior edge on right side over bent 3.

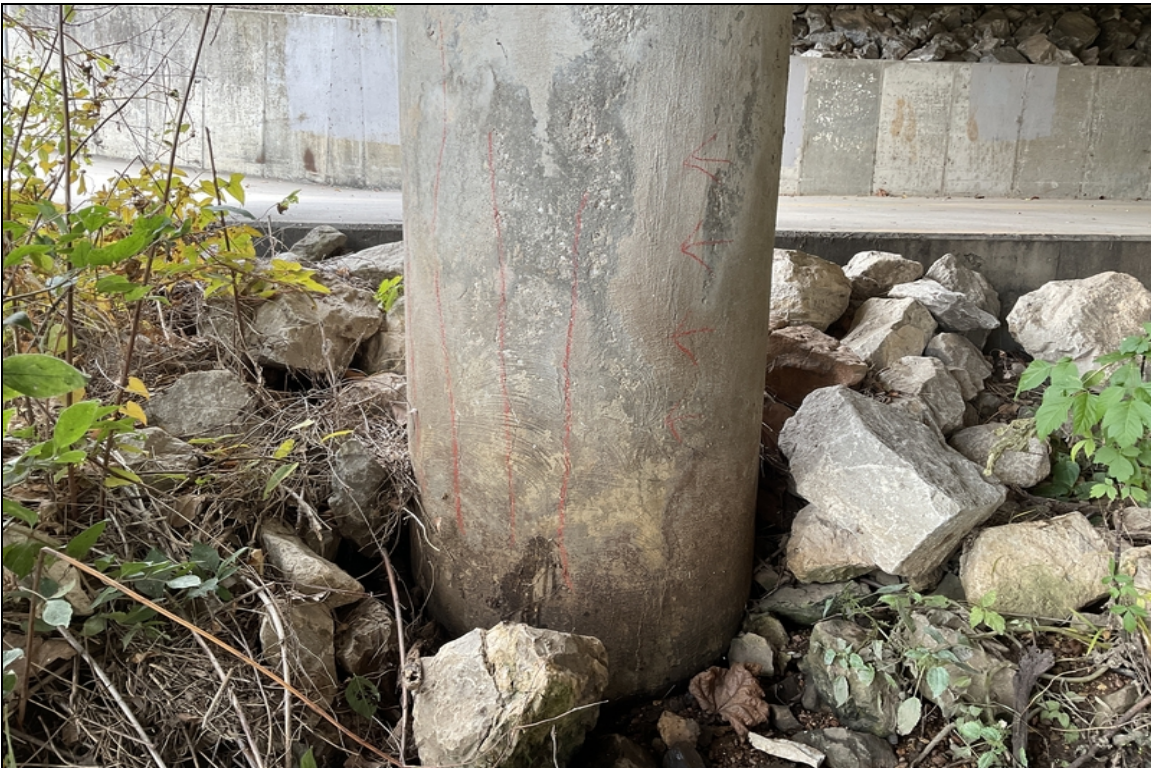
205	Reinforced Concrete Column	EA	6	4	2	0	0
1130	Cracking (RC and Other)	EA	1	0	1	0	0
1190	Abrasion/Wear (PSC/RC)	EA	1	0	1	0	0
(205)							
-Bent # 2, column # 3 has several narrow vertical cracks that propagate from the base of column and extend up the column to approximately 4' in height. There are shallow delaminated areas and scaling along some of the cracks.							
215	Reinforced Concrete Abutment	LF	146	140	5	1	0
1080	Delamination/Spall/Patched Area	LF	4	0	3	1	0
1120	Efflorescence/Rust Staining	LF	1	0	1	0	0
1130	Cracking (RC and Other)	LF	1	0	1	0	0

Bent # 2, column # 3-Numerous vertical cracks on approximately 6" spacing.

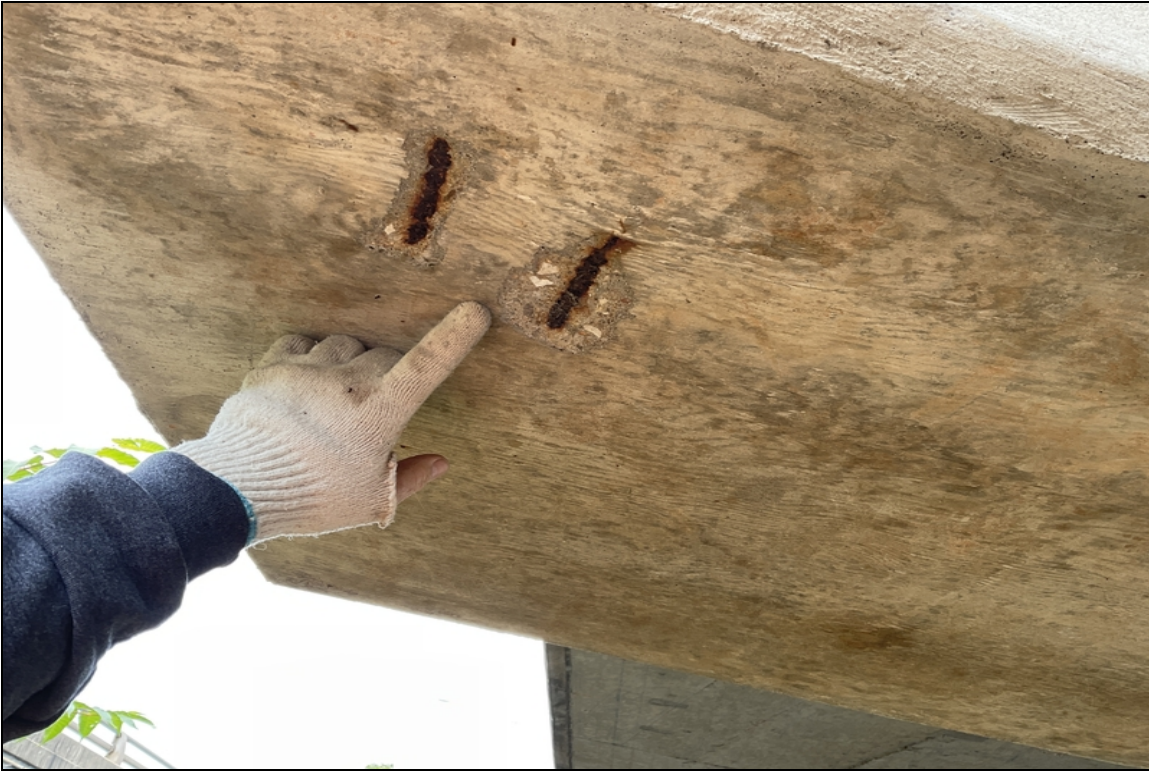
Bent 2 cap, left end-Shallow spalls with exposed reinforcing steel in undersurface.

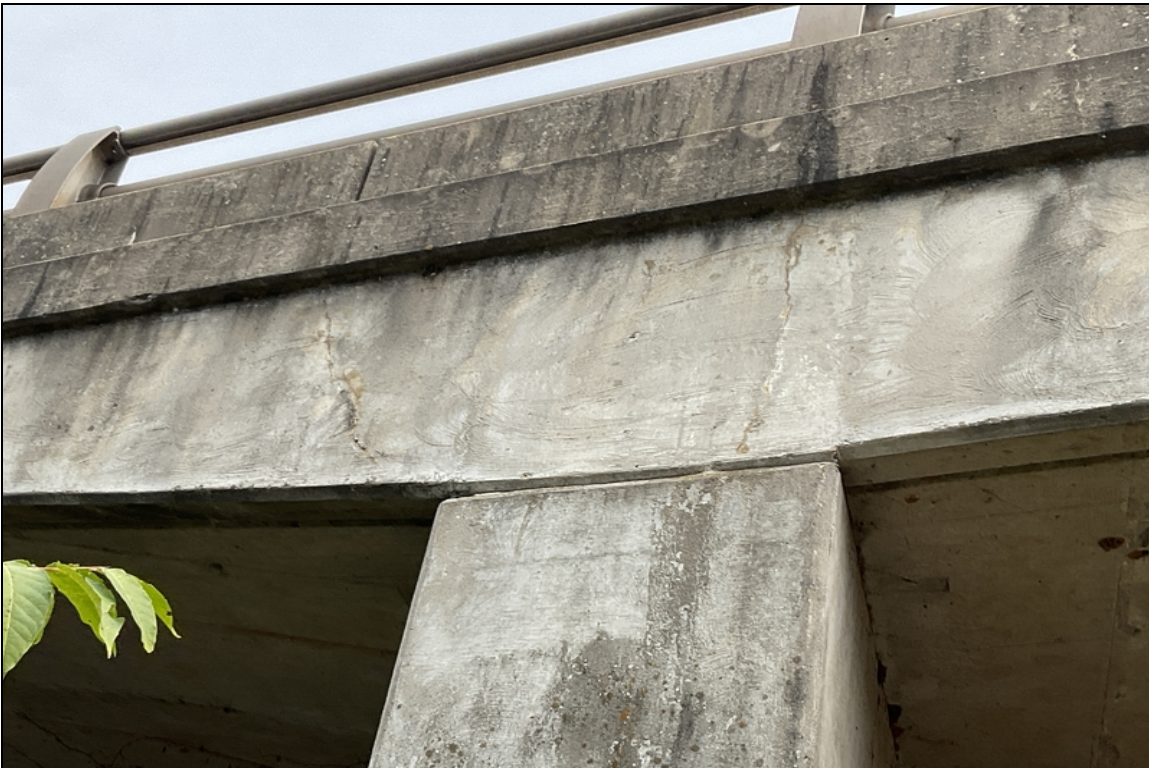
Vertical and diagonal cracking in left exterior side of slab over bent # 2.

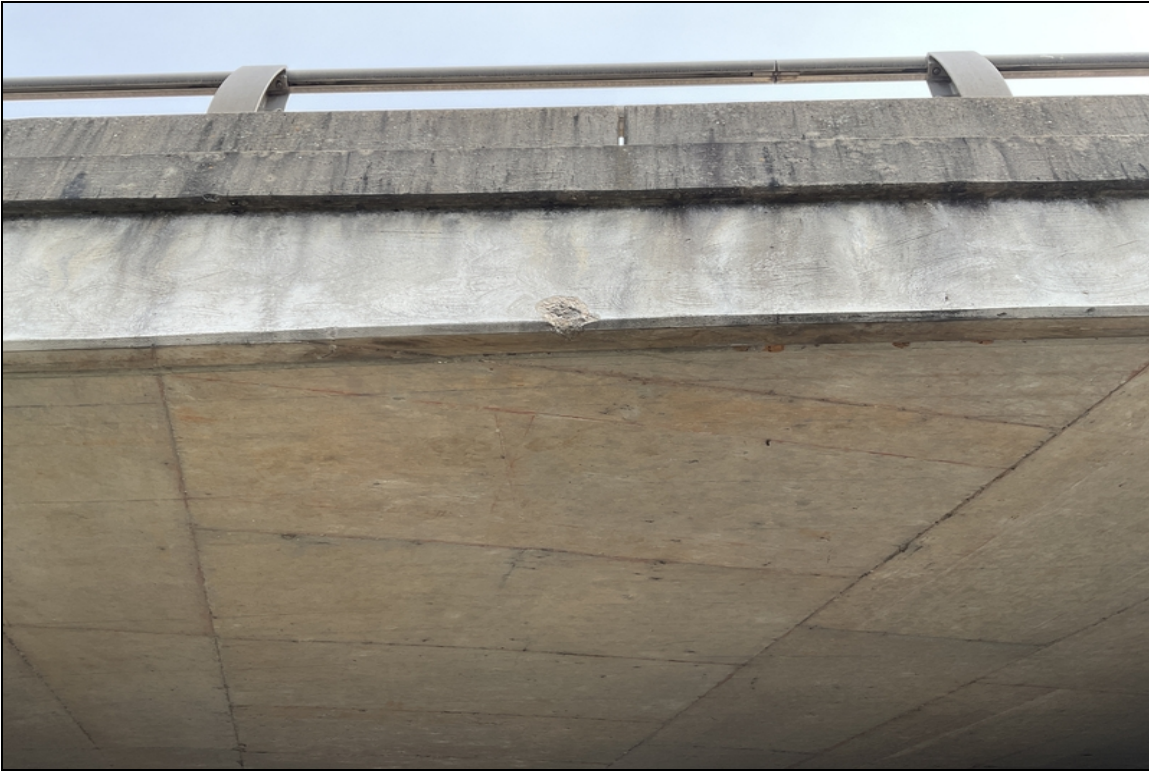
Span 1, left side-Shallow spall over pedestrian trail.

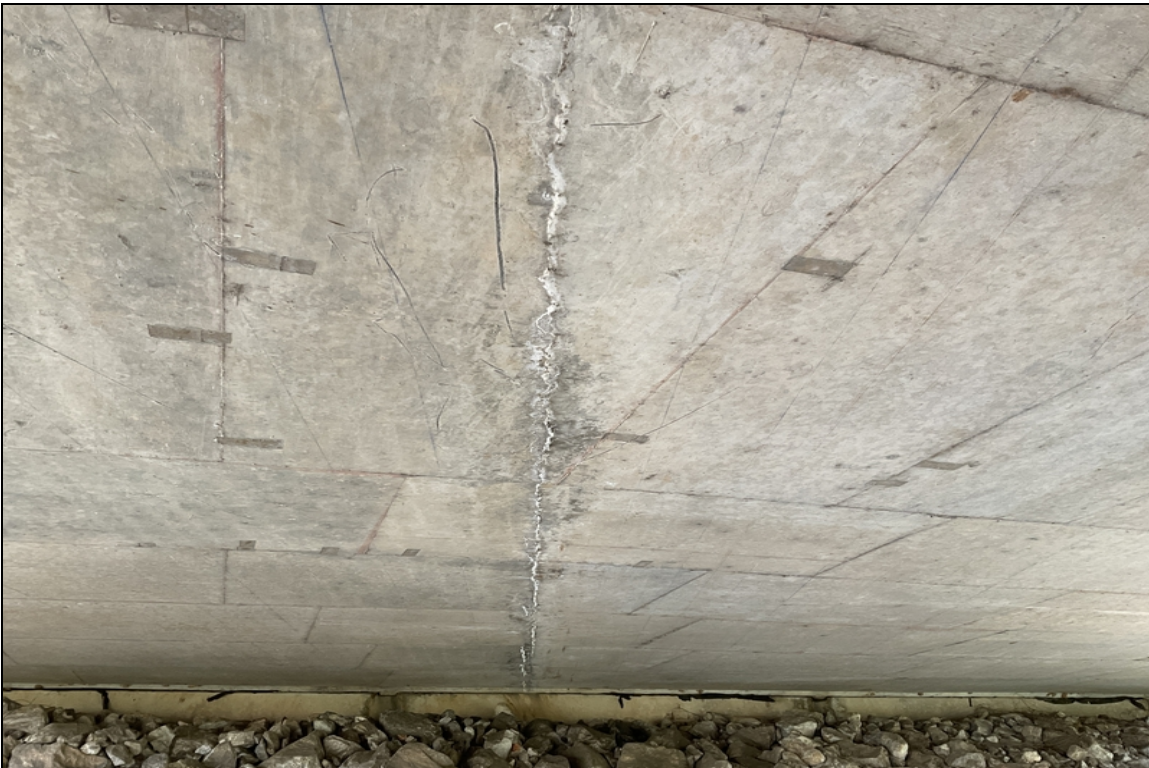
Span 1 undersurface-Efflorescence at construction joint.

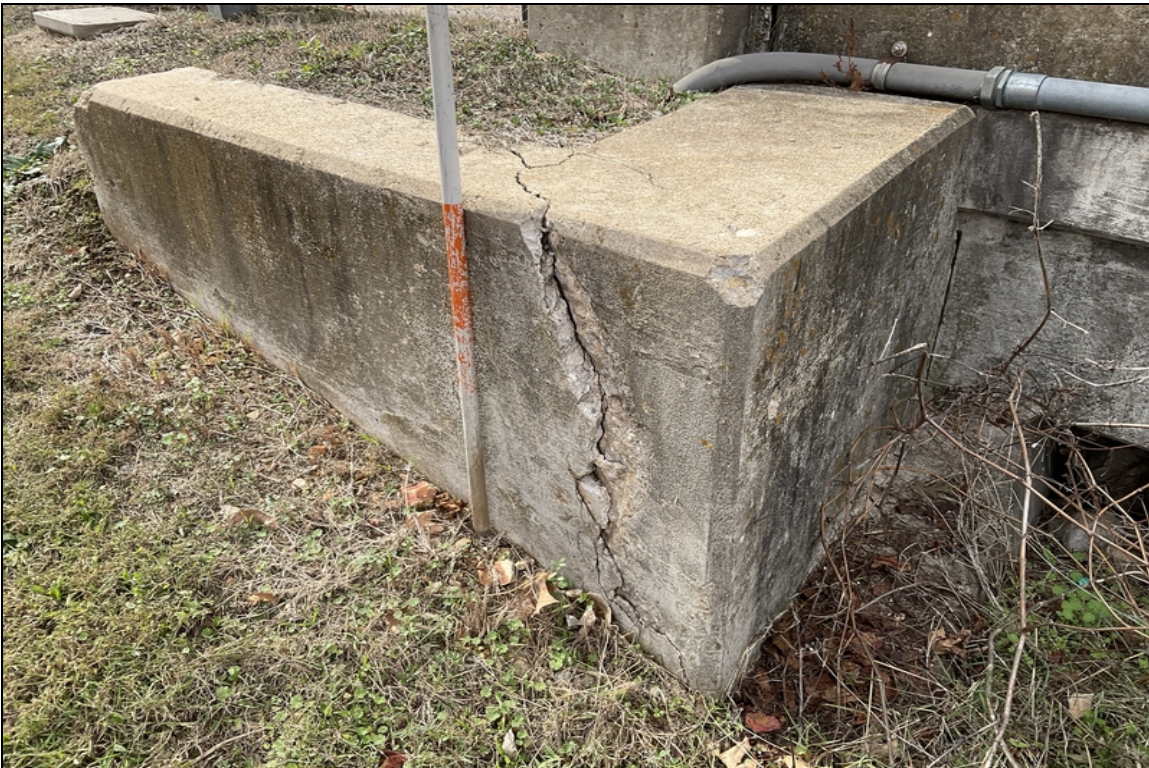
The right turn back portion of abutment # 1 is fractured outside the bearing area.

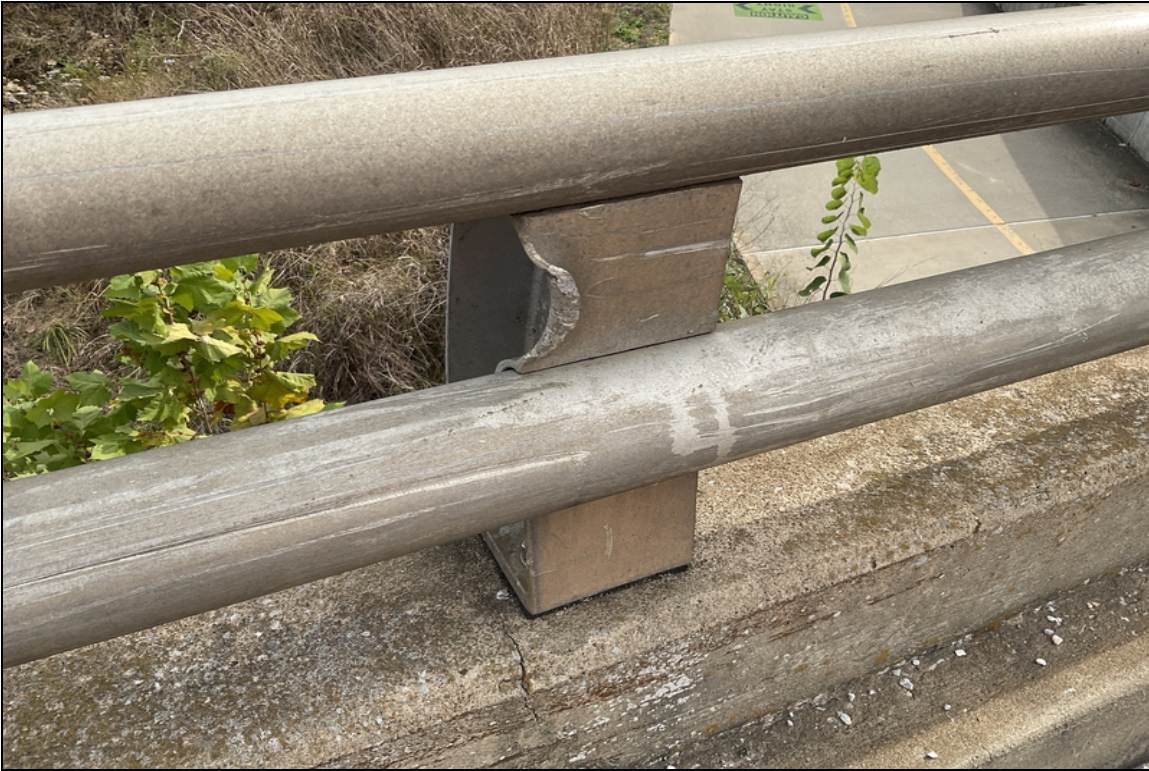
(330)							
-Post # 7 of the right bridge railing has minor collision damage.							
331	Reinforced Concrete Bridge Railing	LF	256	199	57	0	0
1090	Exposed Rebar	LF	1	0	1	0	0
1120	Efflorescence/Rust Staining	LF	7	0	7	0	0

Post # 7 of the right bridge railing has minor collision damage.

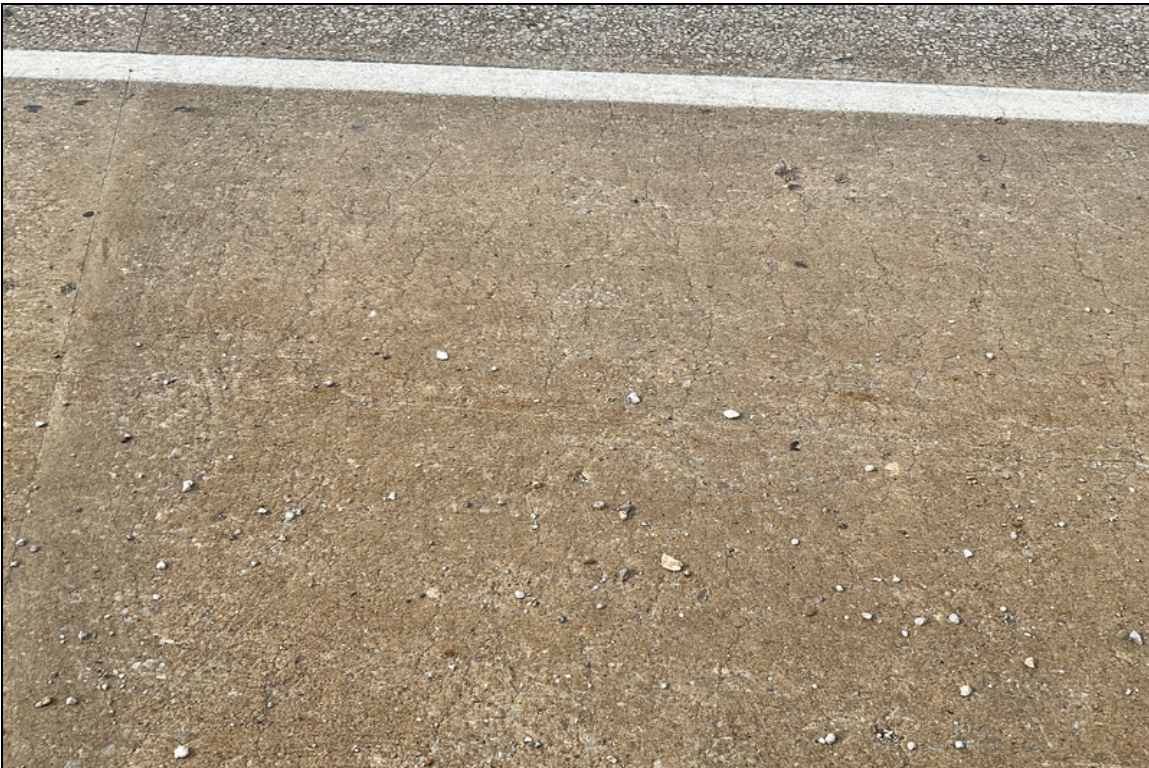
(38)							
-The driving surface of spans # 1 and # 2 have mapcracking in the right shoulder and all three lanes in the negative moment areas near the intermediate bents. -Light to medium abrasion on main lane driving surface. -Minor pop outs in all spans. -Span # 1 has a 5' wide X 26' long area with numerous spalls with exposed reinforcing steel on the driving surface of the deck over the centerline longitudinal construction joint. (Exposed reinforcing steel is covered with temporary asphalt patches during this inspection). Previous inspection notes state that the exposed reinforcing steel has initial section loss during this inspection. -Span # 3 has two basket ball sized spalls on the driving surface of the deck with temporary asphalt patches adjacent to bent # 4. -There are numerous random and transverse cracks visible in the driving surface of deck on all spans. -Delaminated areas along the centerline of bridge deck at the construction joint with light efflorescence. -The vertical face of the slab has narrow vertical cracking over the intermediate bents caps. -There are minor shallow spalls and insignificant scrape marks visible from the undersurface of span # 1 and in the exterior edges of the deck over the pedestrian walk way.

Span # 2, right shoulder-Mapcracking.

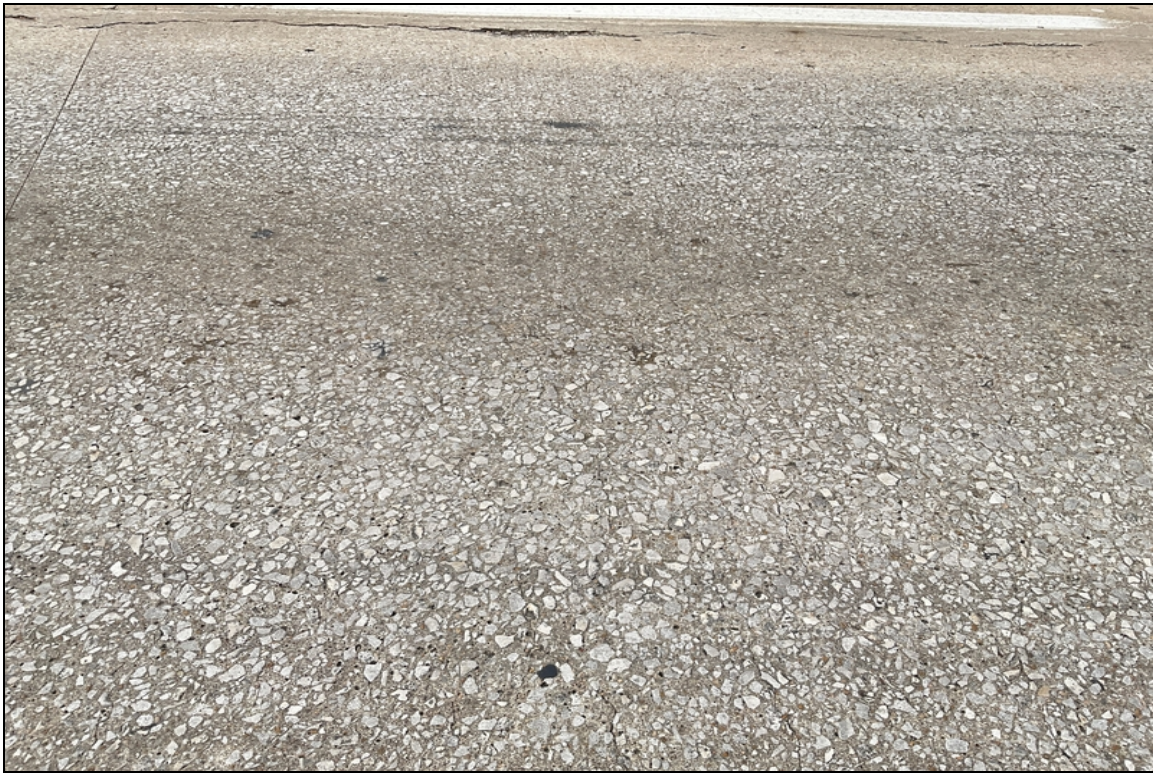
Span # 2, right lane-Mapcracking.

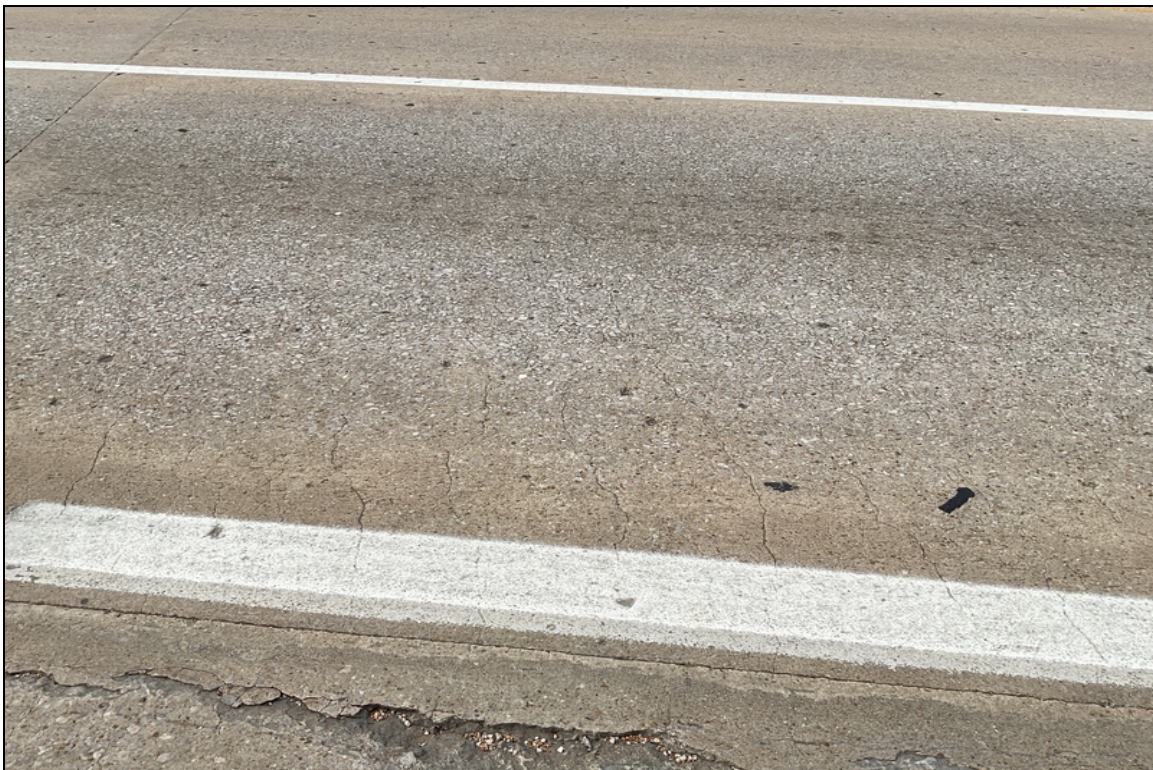
Span 2, center lane-Mapcracking.

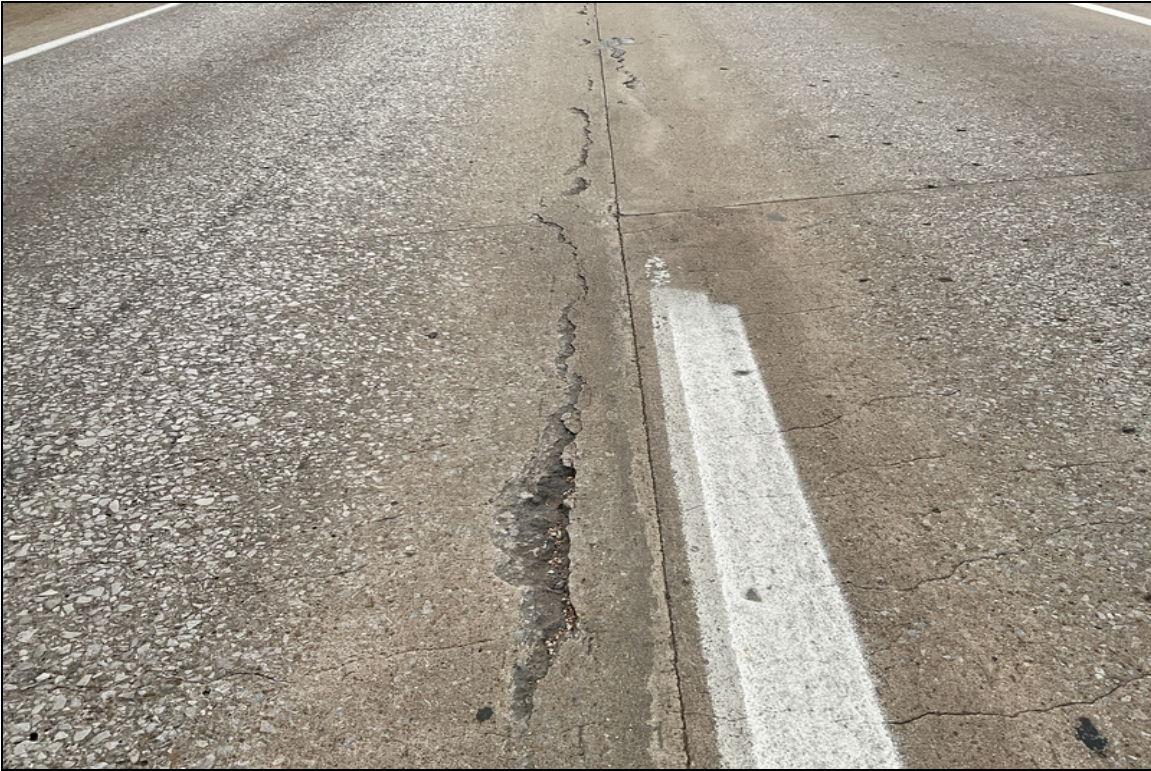
Delaminated areas along centerline.

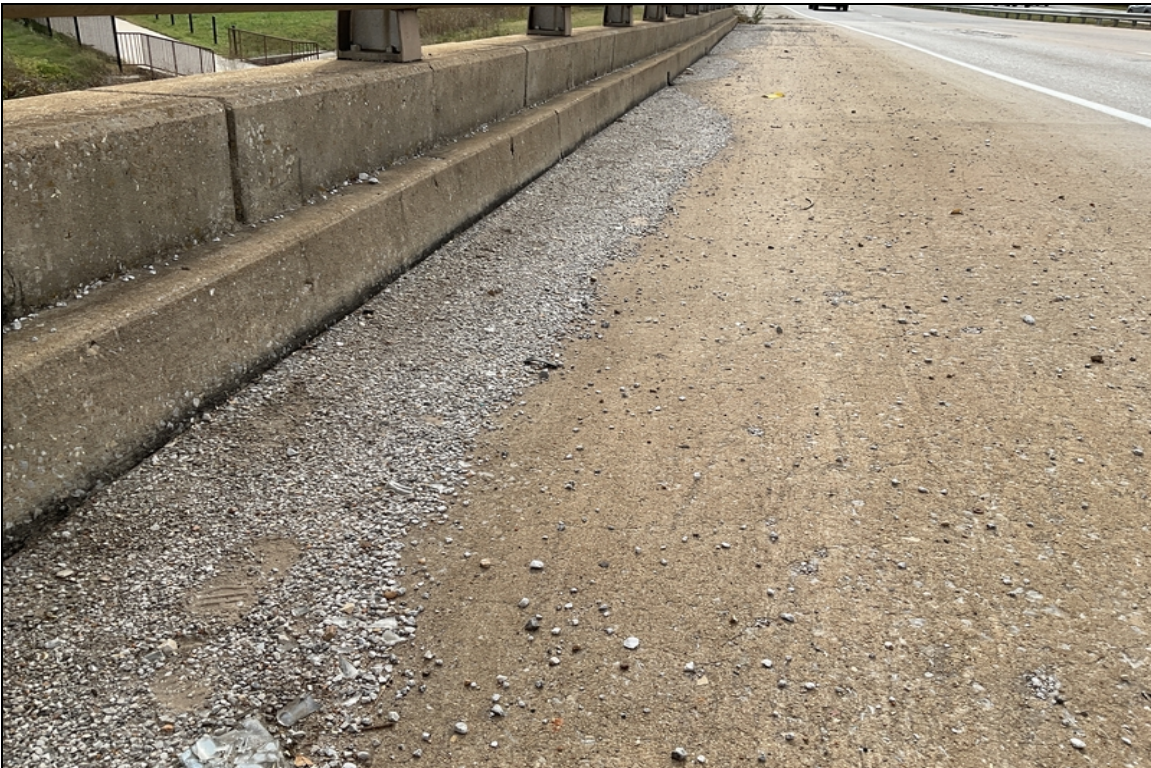
Dirt and debris in gutters.

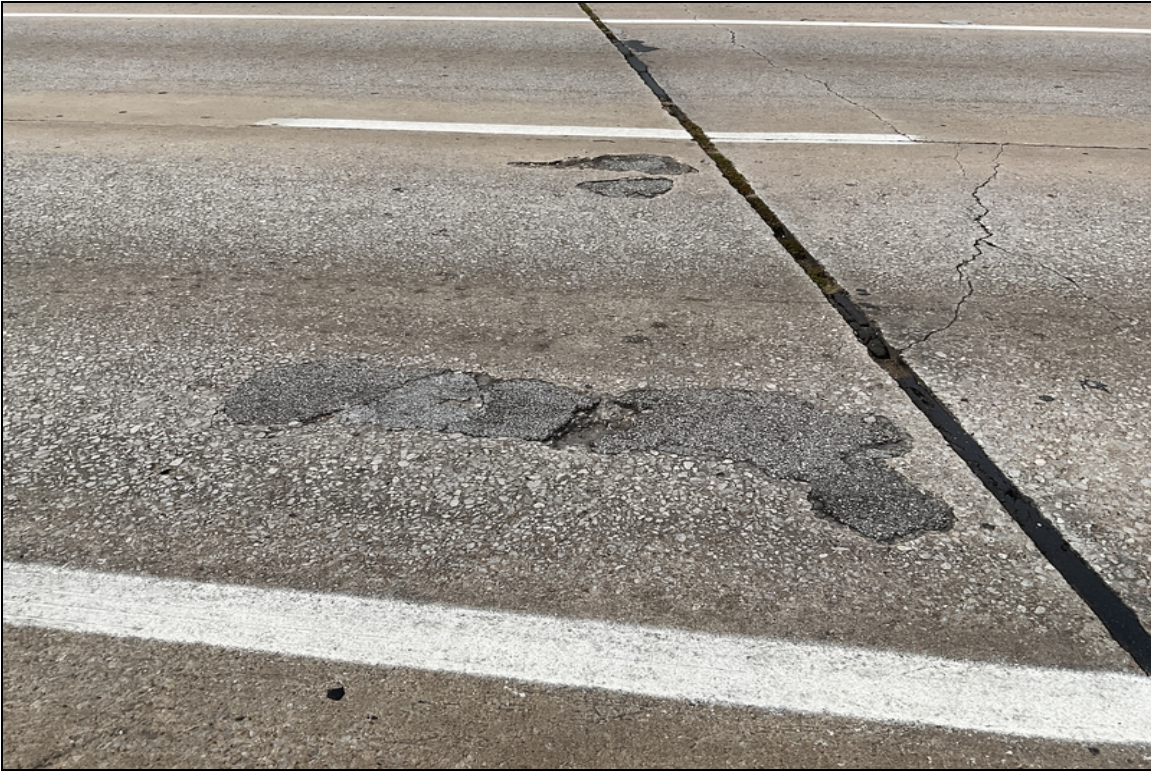
Span 3, right lane-Spalls in driving surface.

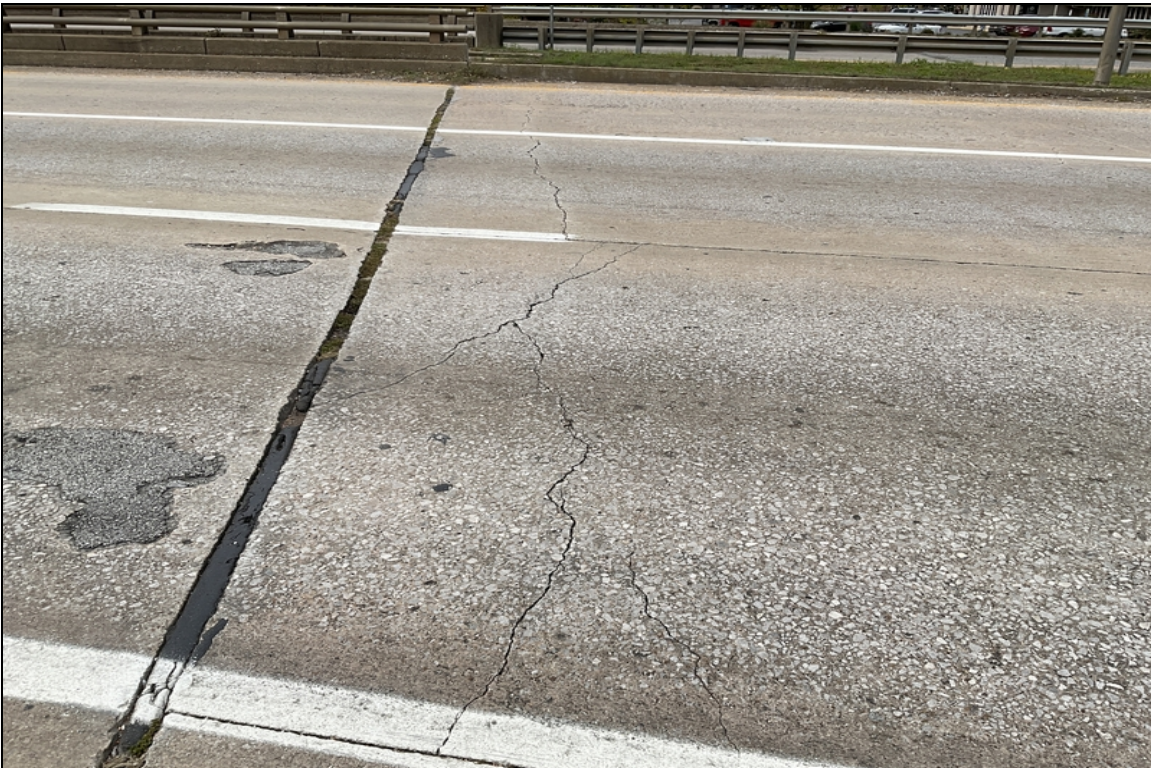
(321)							
-South approach slab has wide sealable cracks.							
-North approach slab has approximately 1/8" wide transverse cracks located approximately 2' from the abutment # 2 expansion joint.							
-The Southeast approach shoulder has medium scaling.							
Approach Roadways:							
-The collision damage to the Southwest approach railing has been repaired since last inspection.							
330	Metal Bridge Railing	LF	256	255	1	0	0
7000	Damage	LF	1	0	1	0	0

North approach slab-Wide transverse cracking.

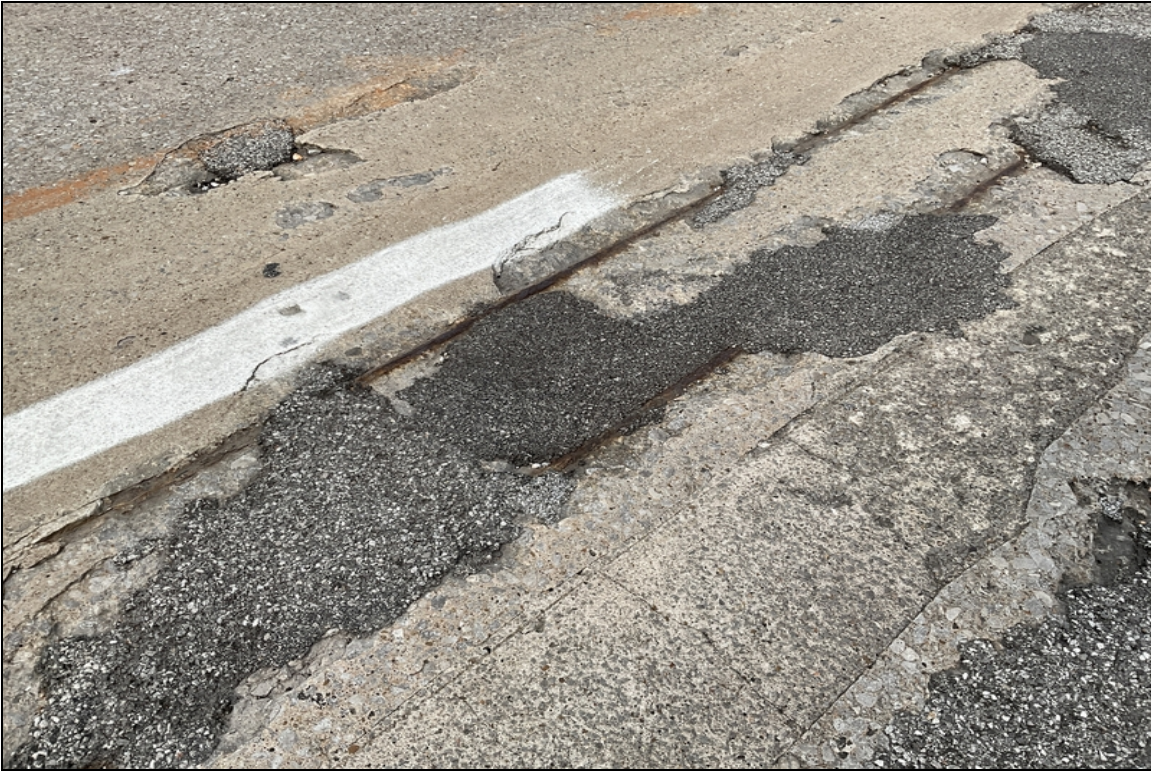
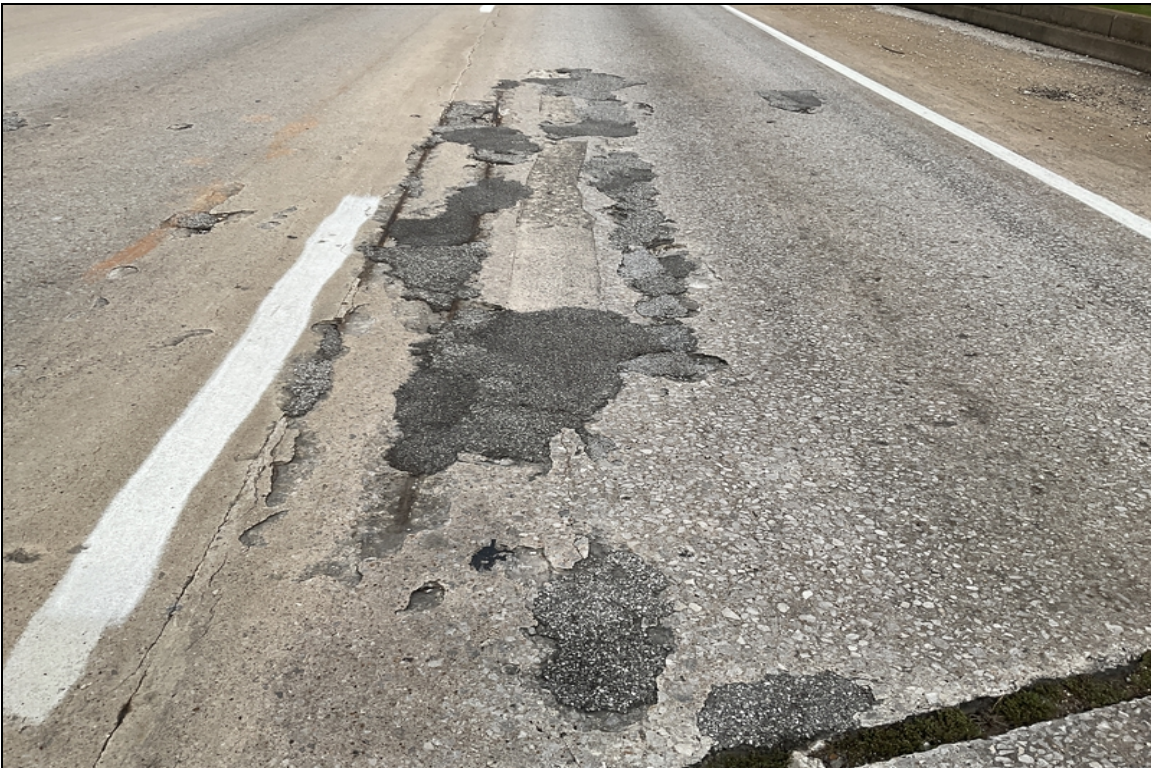
Span 1, right lane-Large area of spalling with exposed reinforcing steel.

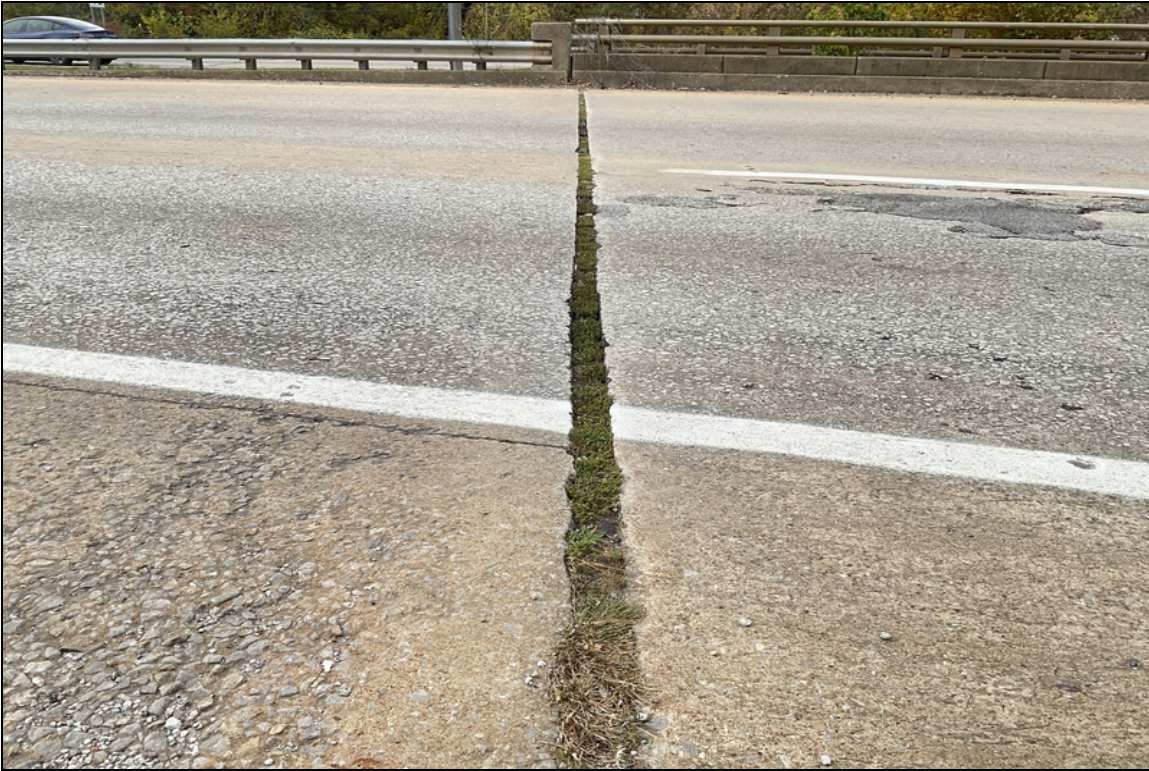
Abutment # 1 expansion joint-Debris impaction.
