Bridge #B5392(Routine)

US 71 B, NB LNS over Clear Creek-Washington

Location: 5.47 MI SO BENTON CO LINE

Team Lead: Bob McEntyre Inspection Date: November 09, 2021

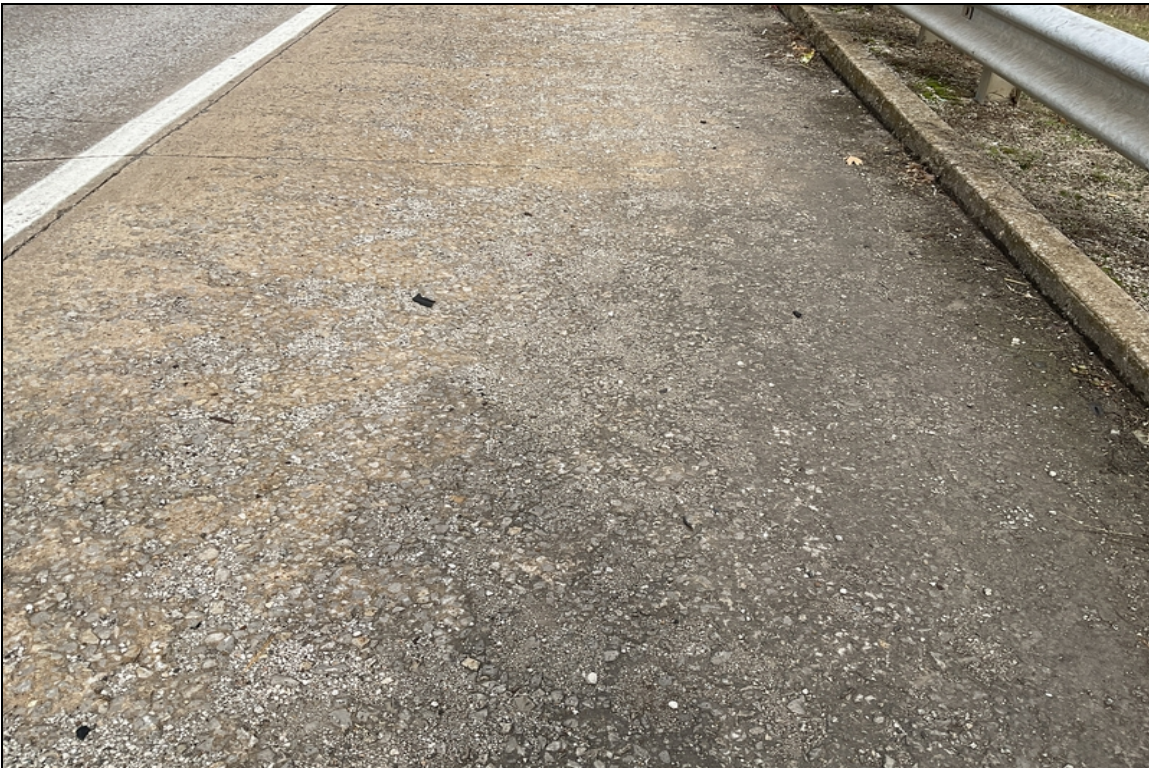
The gutters of the South approach roadway has medium scaling.

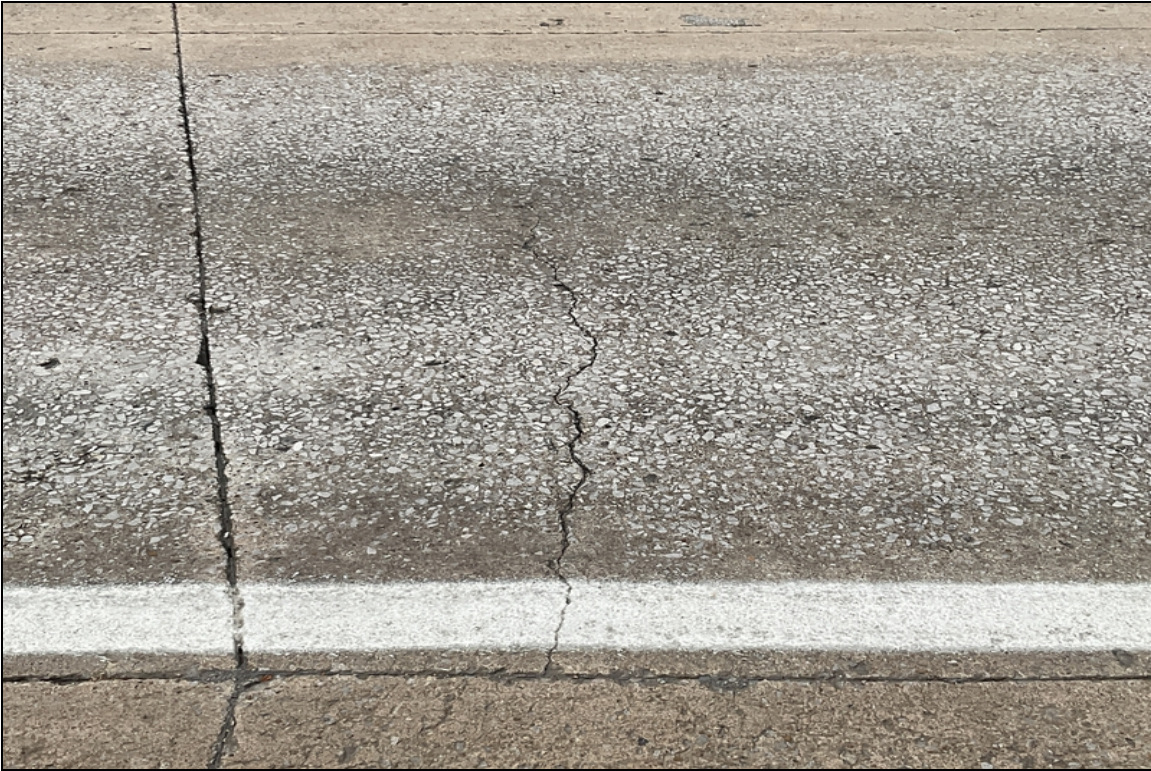
South approach slab, right lane-Moderate width transverse crack.

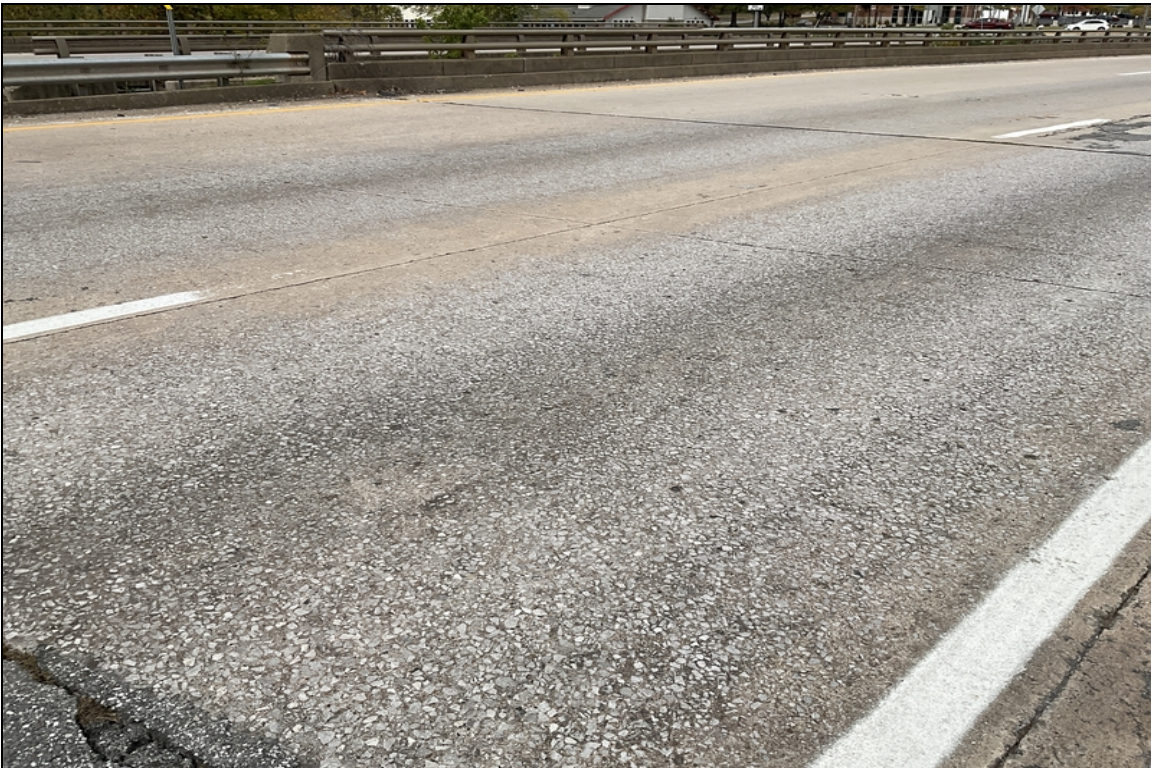
South approach slab-Wear / abrasion.

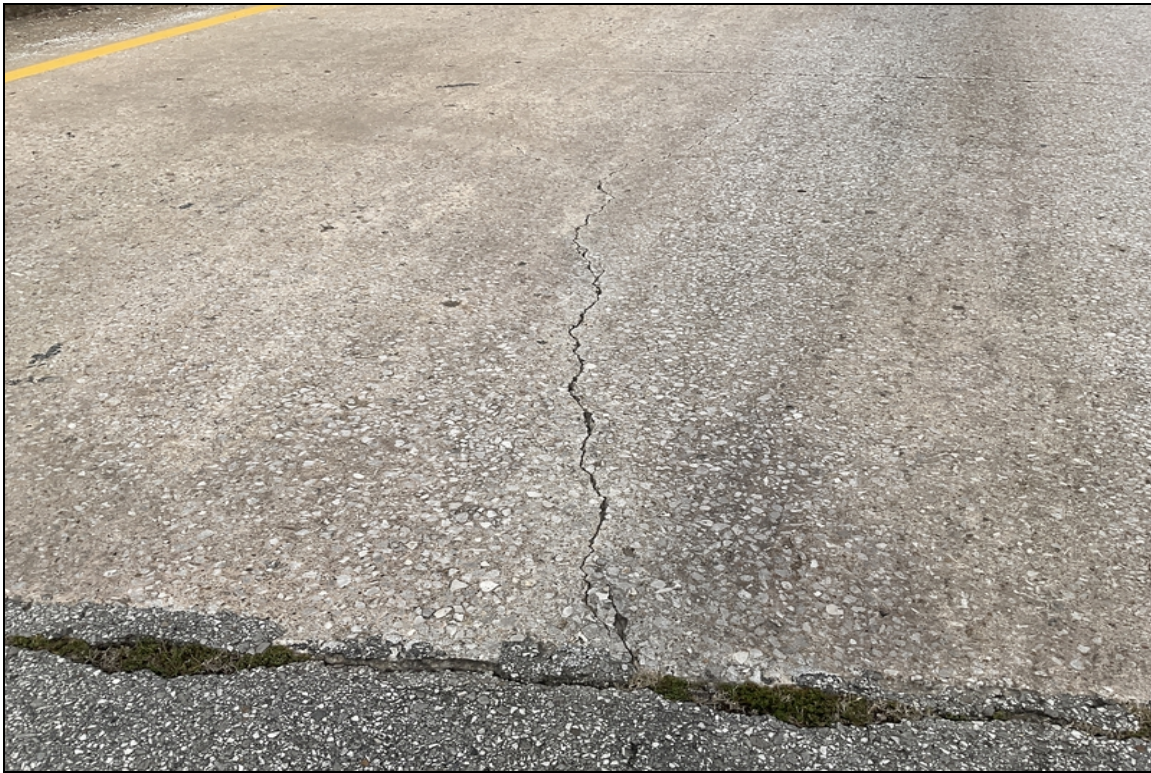
South approach slab, left lane-Wide longitudinal crack.

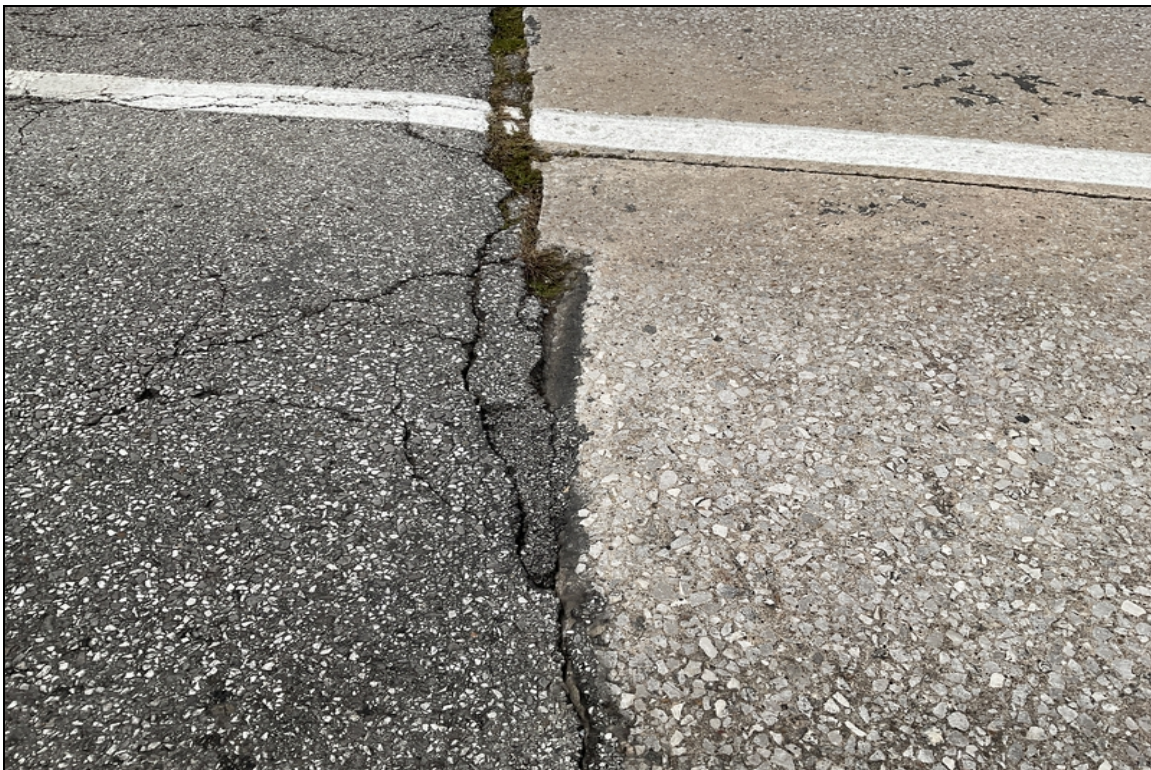
South approach slab-Spall at roadway juncture.

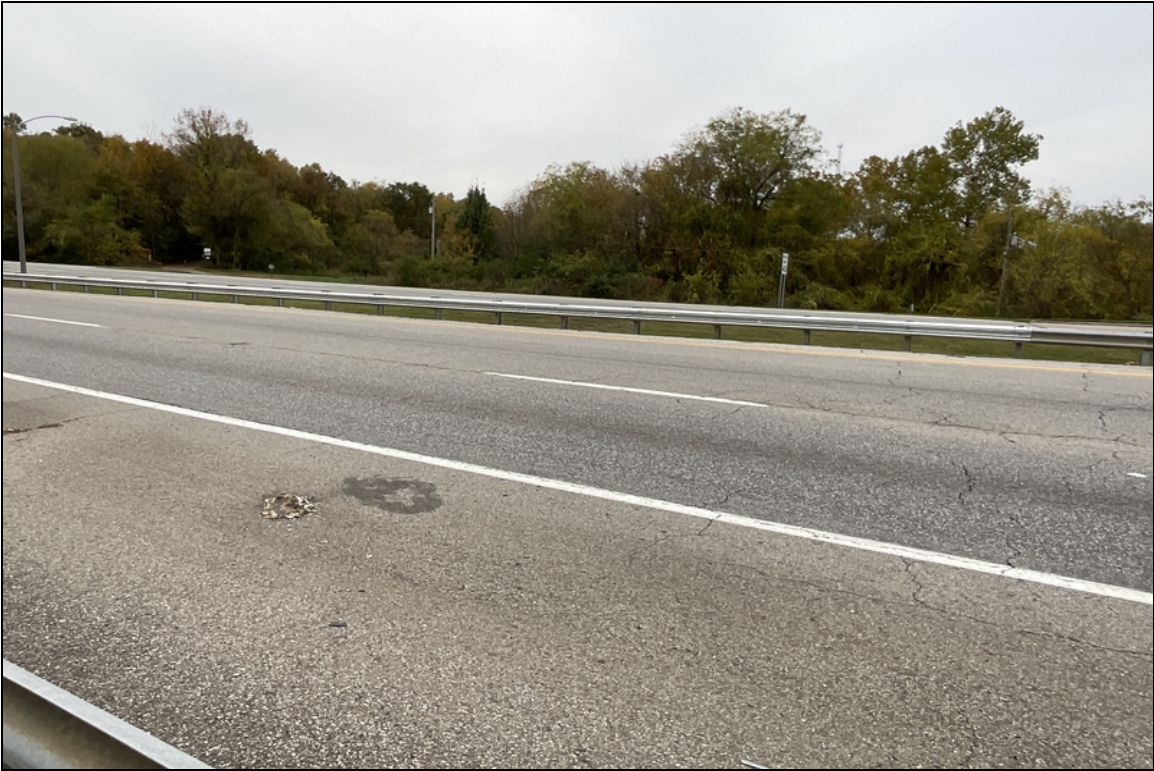
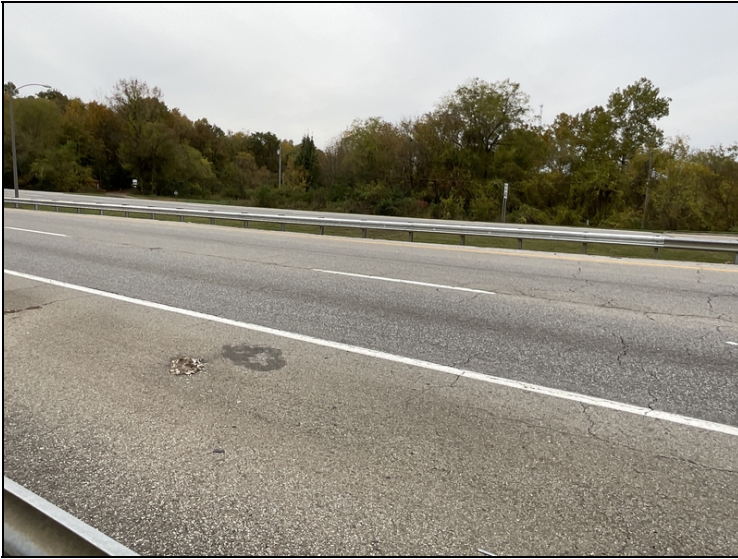
The collision damage to the Southwest approach railing has been repaired since last inspection.

11/09/2021 - RSM - The collision damage to the Southwest approach railing has been repaired since last inspection.

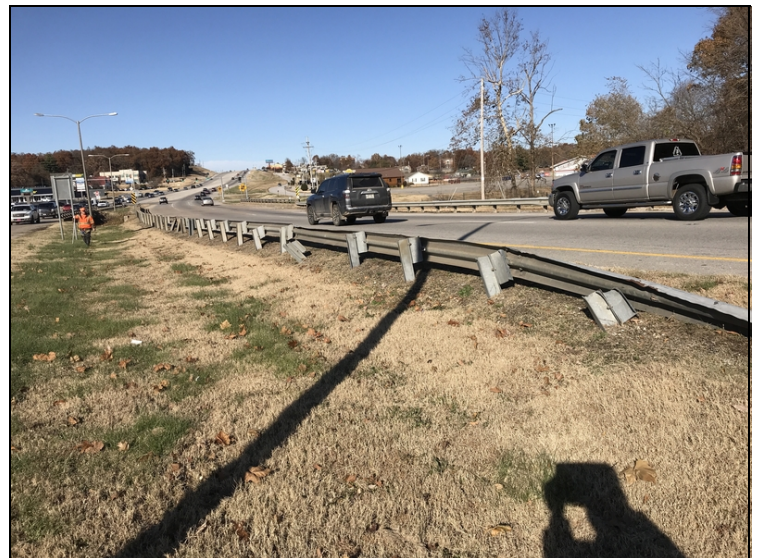
The Southwest approach guardrail has collision damage.

Southwest approach guardrail. Collision damage.

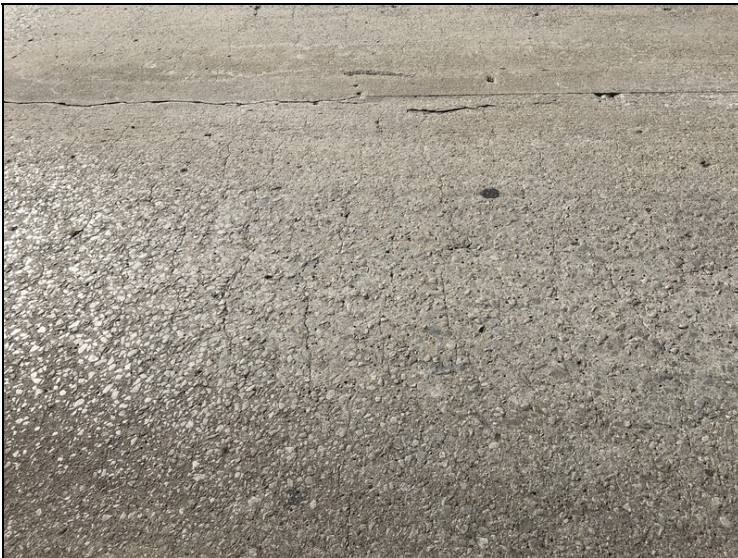
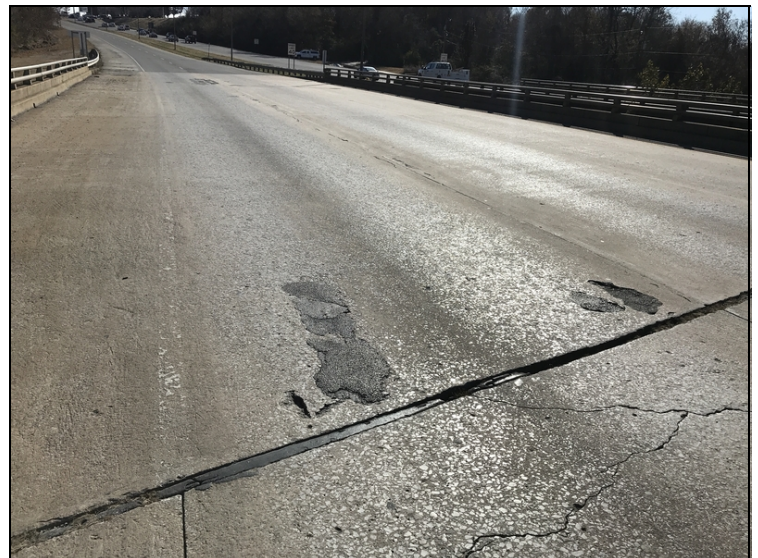
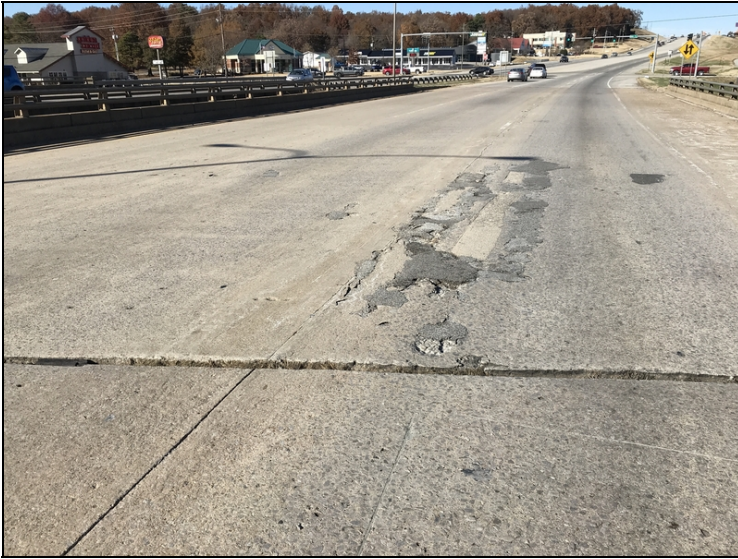
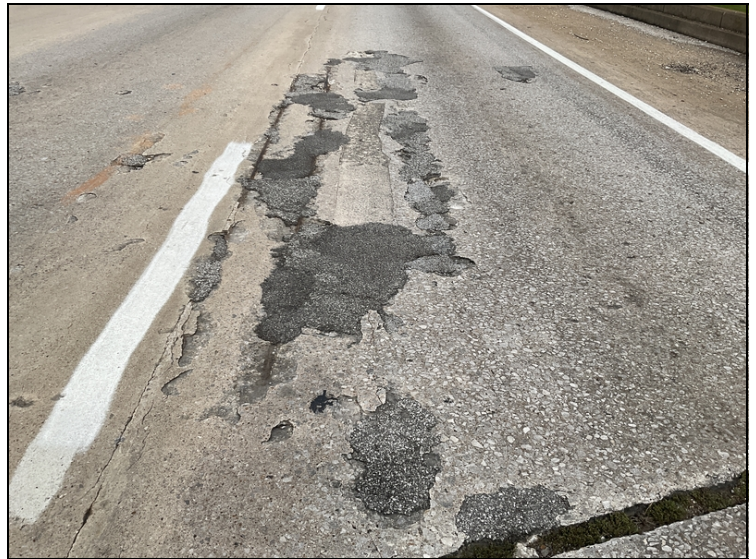
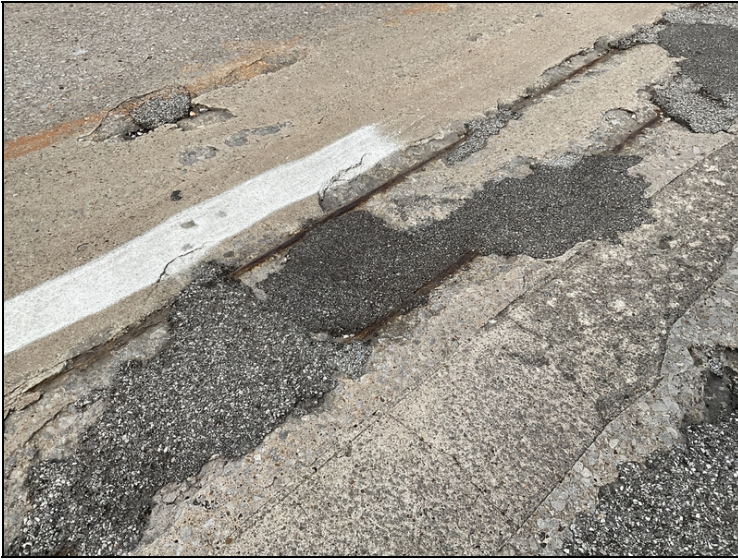
Span # 1 has a 5' X 26' area with numerous spalls with exposed reinforcing steel on the driving surface of the deck over the centerline longitudinal construction joint. Exposed reinforcing steel has initial section loss during this inspection. Span # 3 has two basket ball sized spalls on the driving surface of the deck that have temporary asphalt patches adjacent to Bent # 4.

Span 1, right lane-Large area of spalling with exposed reinforcing steel.

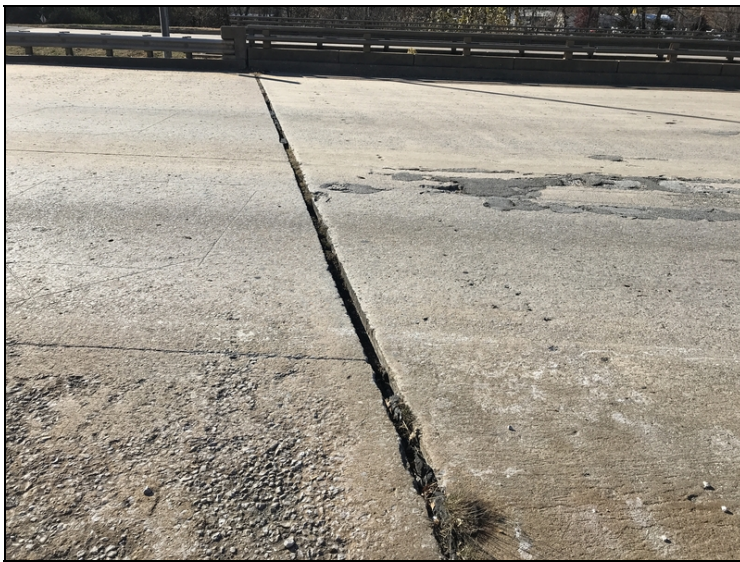
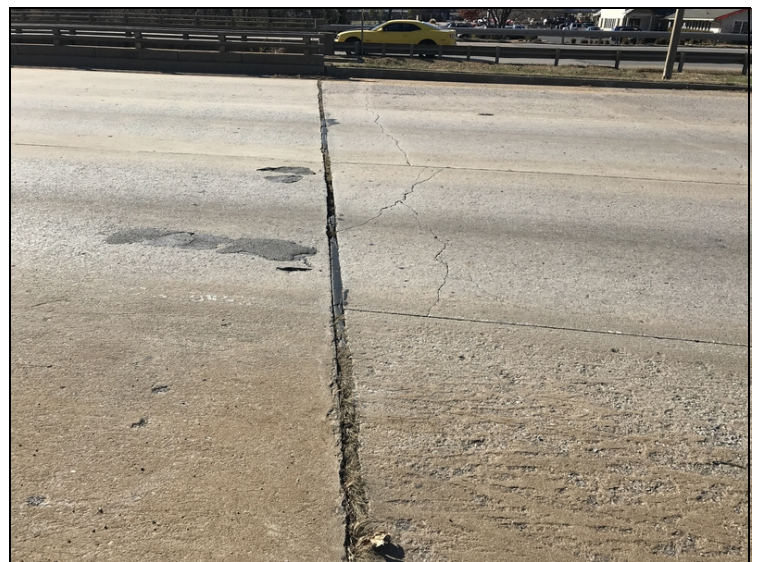
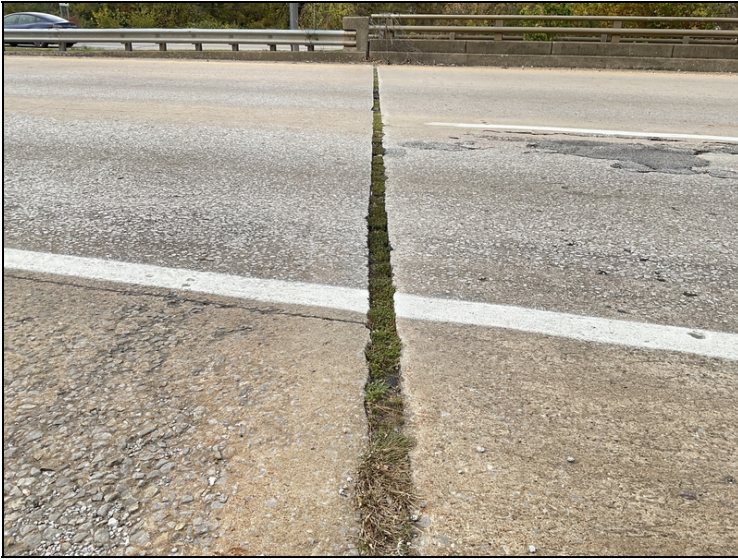
Expansion joints between the abutments and the Approach Slabs -  
The pourable joint sealant is deteriorated and missing with incompressible material in the joint.

Abutment # 1 expansion joint-Debris impaction.

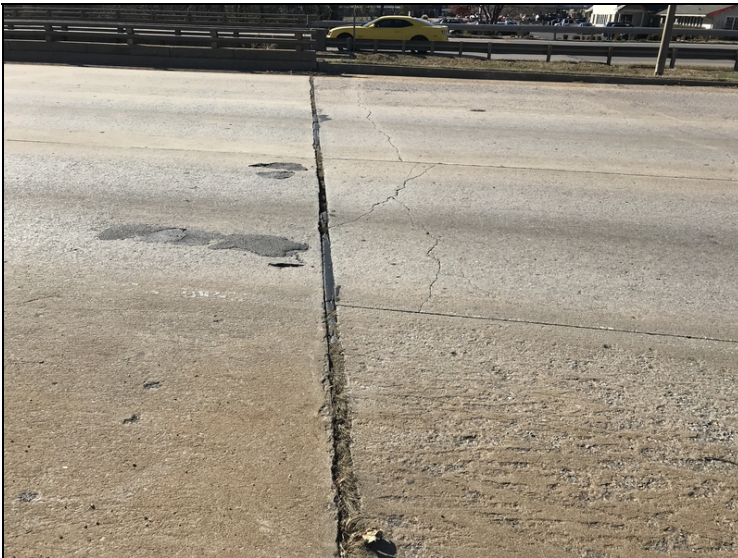
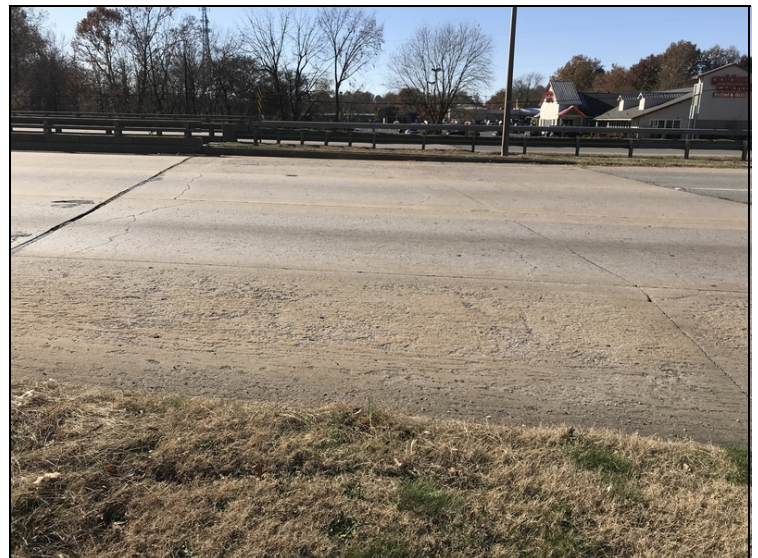
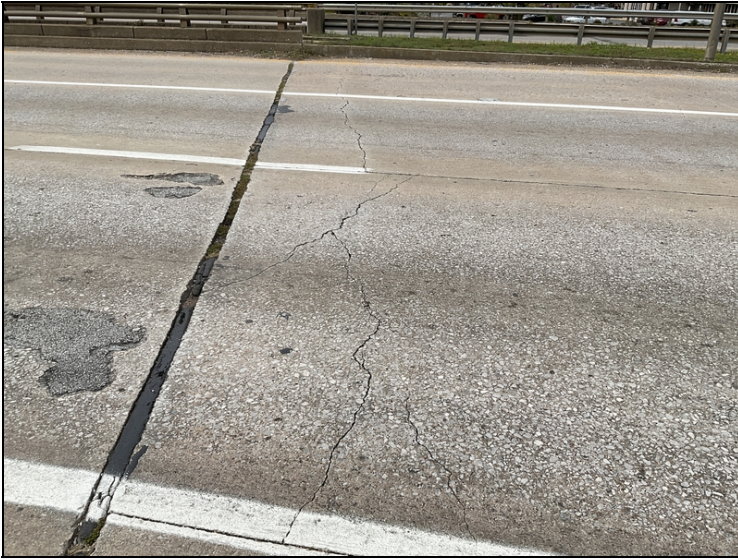
Both approach slabs have sealable cracks.

The North approach slab has sealable transverse cracks near the bridge end approximately 2' from the expansion joint.

North approach slab-Wide transverse cracking.

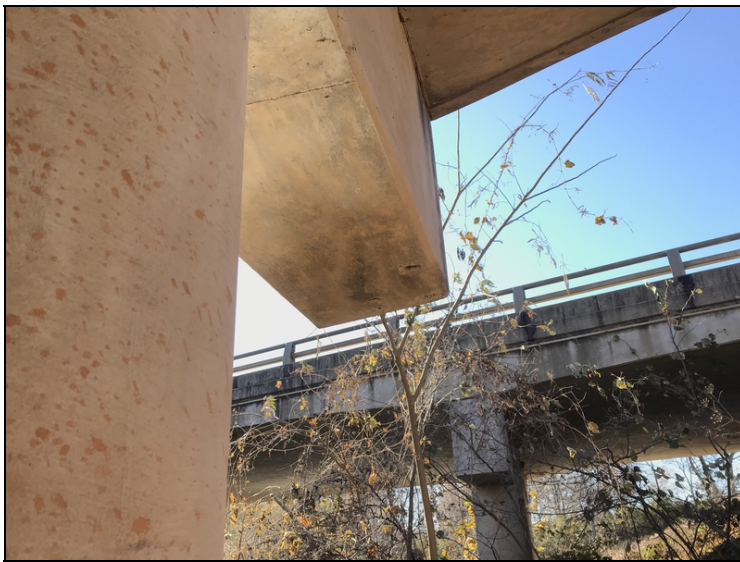
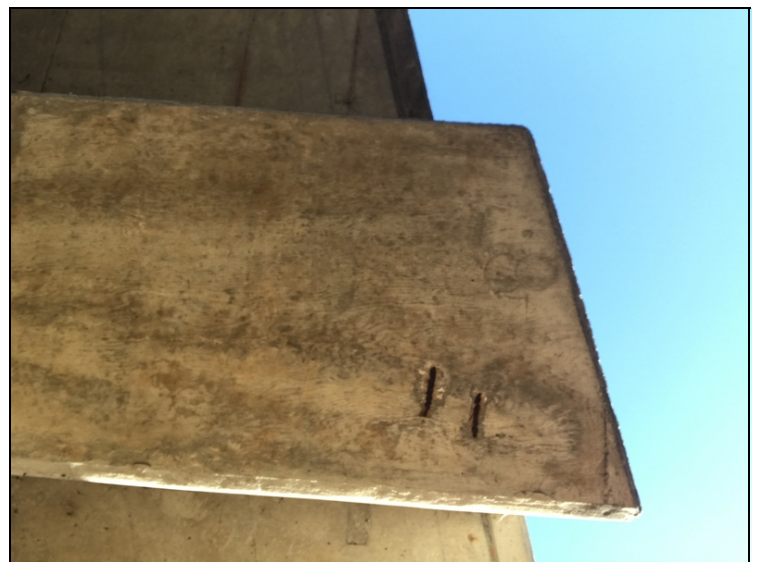
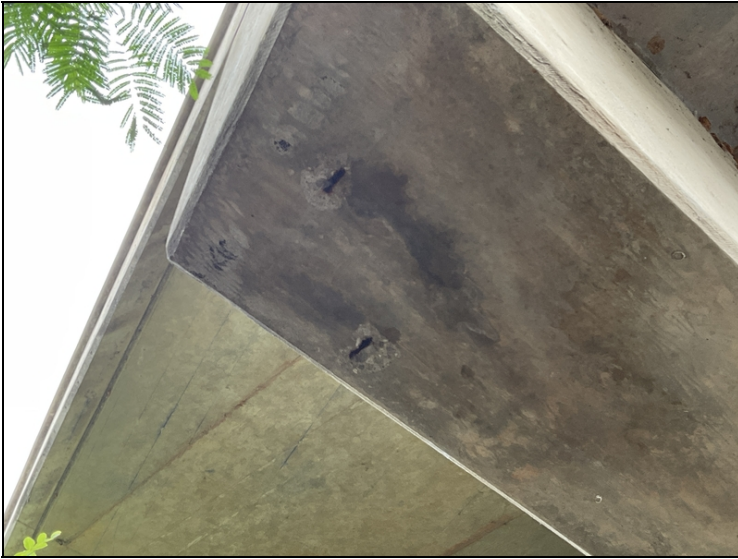
Substructure -  
Shallow spalling with exposed reinforcing steel on the undersurface of Bents # 2 & 3 cap.

Bent 3 cap, left side-Shallow spalls with exposed reinforcing steel in undersurface.

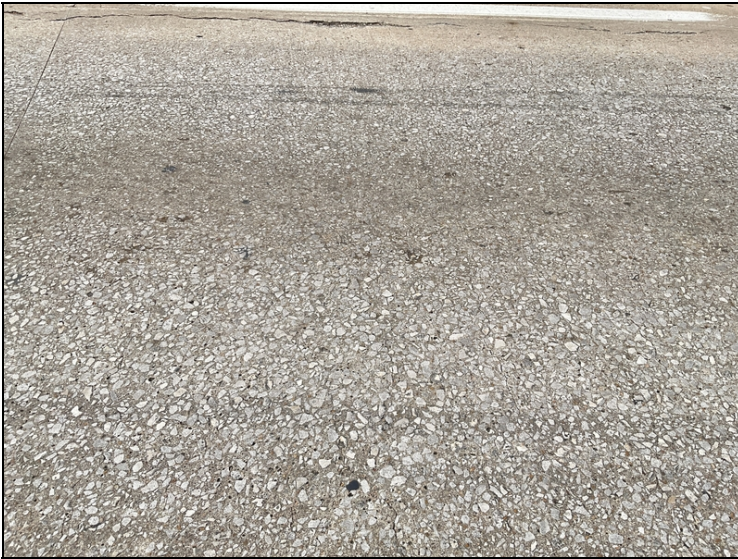
Deck -  
The driving surface of the slab has sealable cracking in all spans.

Span # 2, right lane-Mapcracking.
