Bridge #A5802(Routine)

US 71-SEC 17B, SB over Gregg Ave, A&M RR

Location: 5.21 NO JCT US 62 & 71

Team Lead: Lee Swan Inspection Date: December 01, 2021

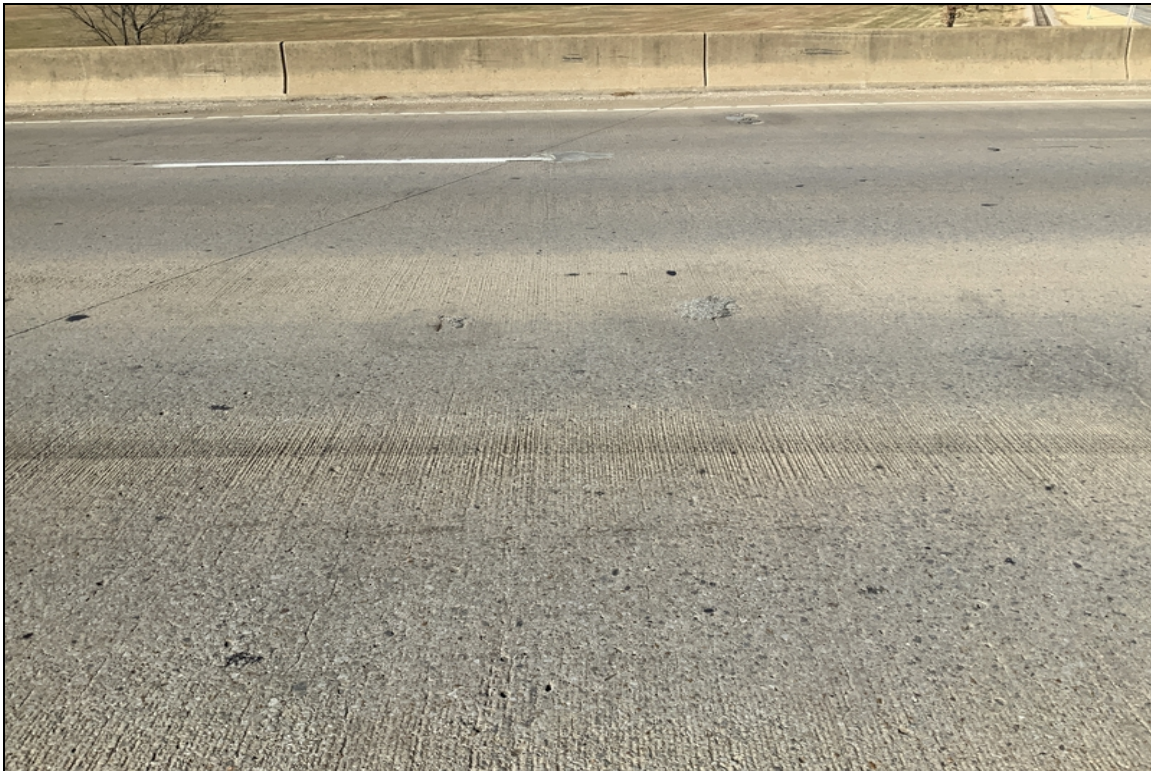
Span 2, transverse cracks and patches.

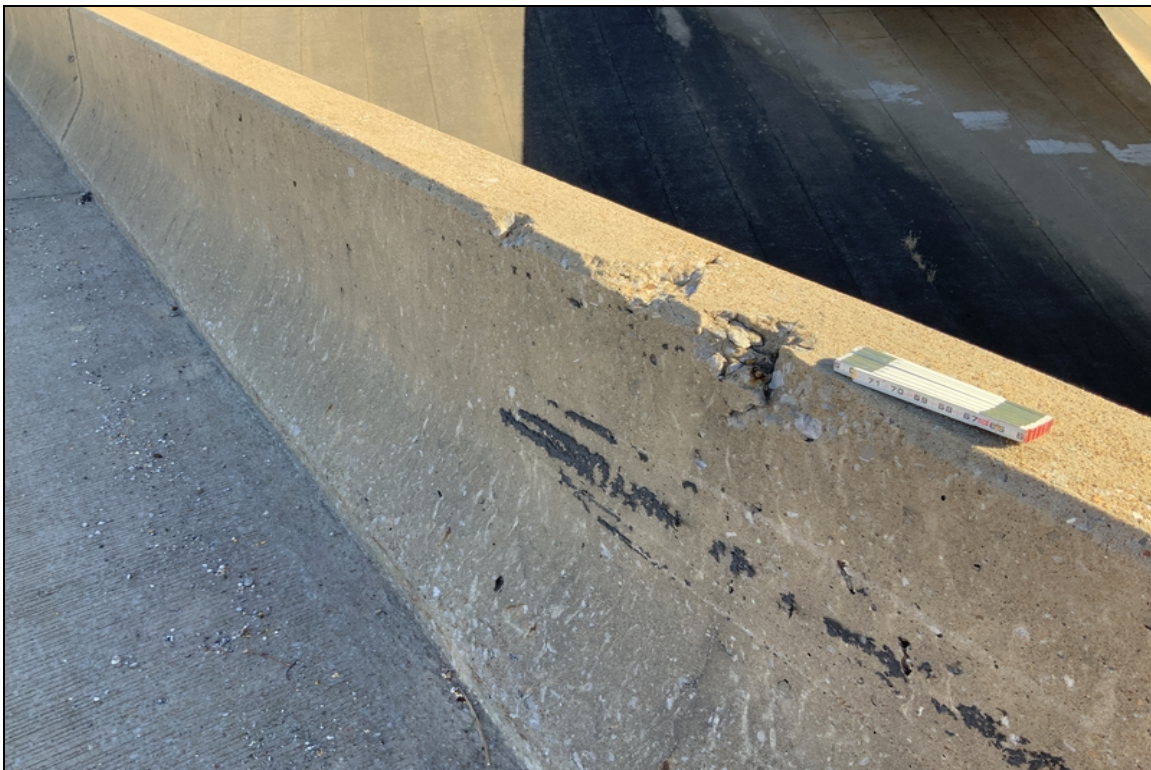
Right bridge rail, small spalls in the top of the rail.

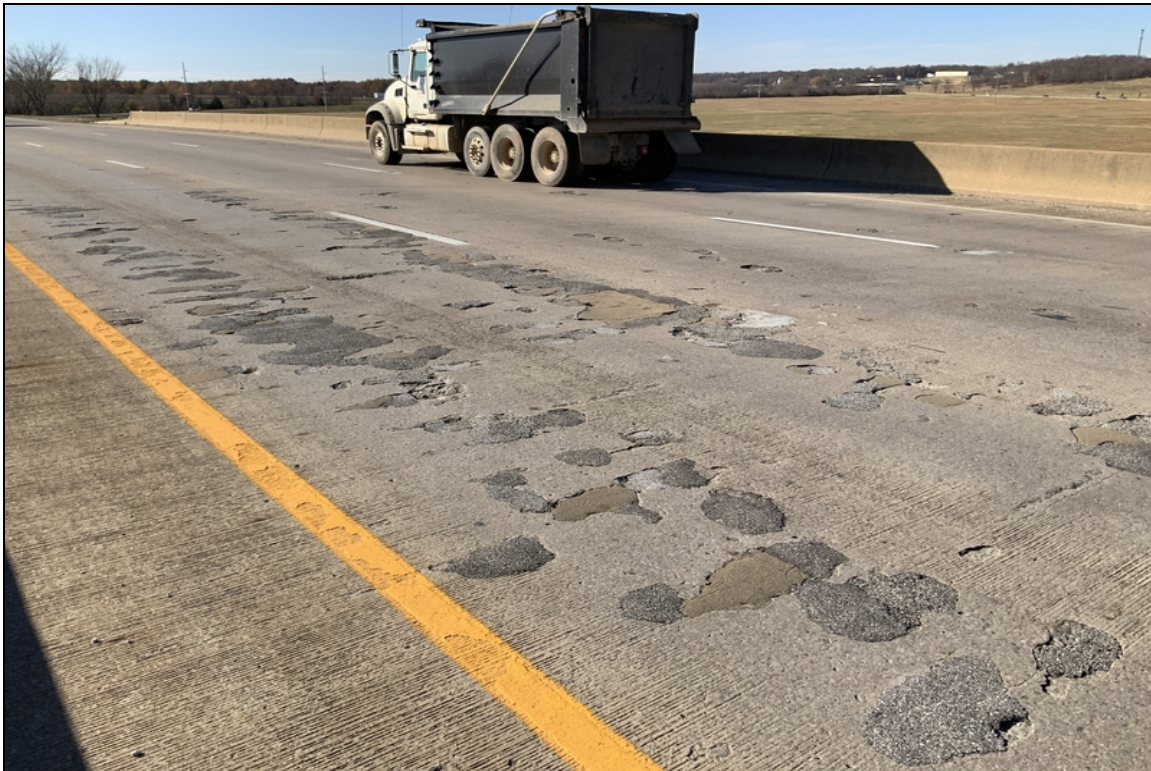
Span 3, several spalls and failing patches.

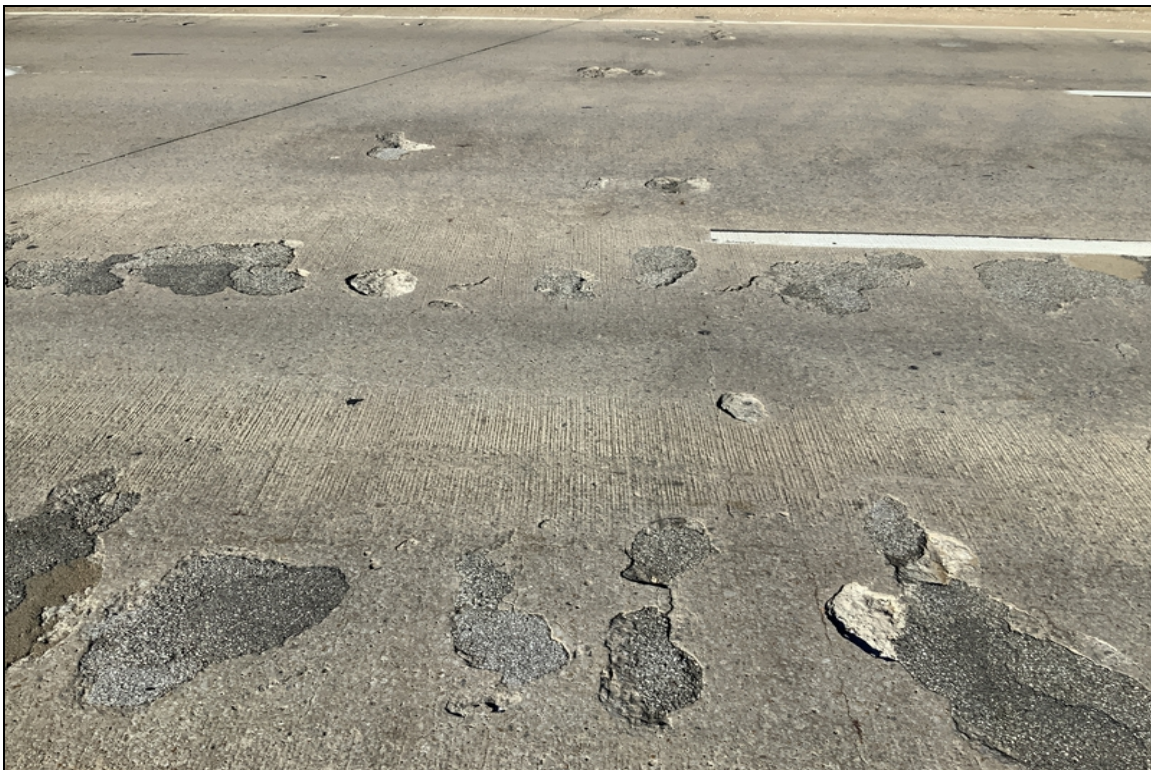
Span 3, spalls and failing patches.

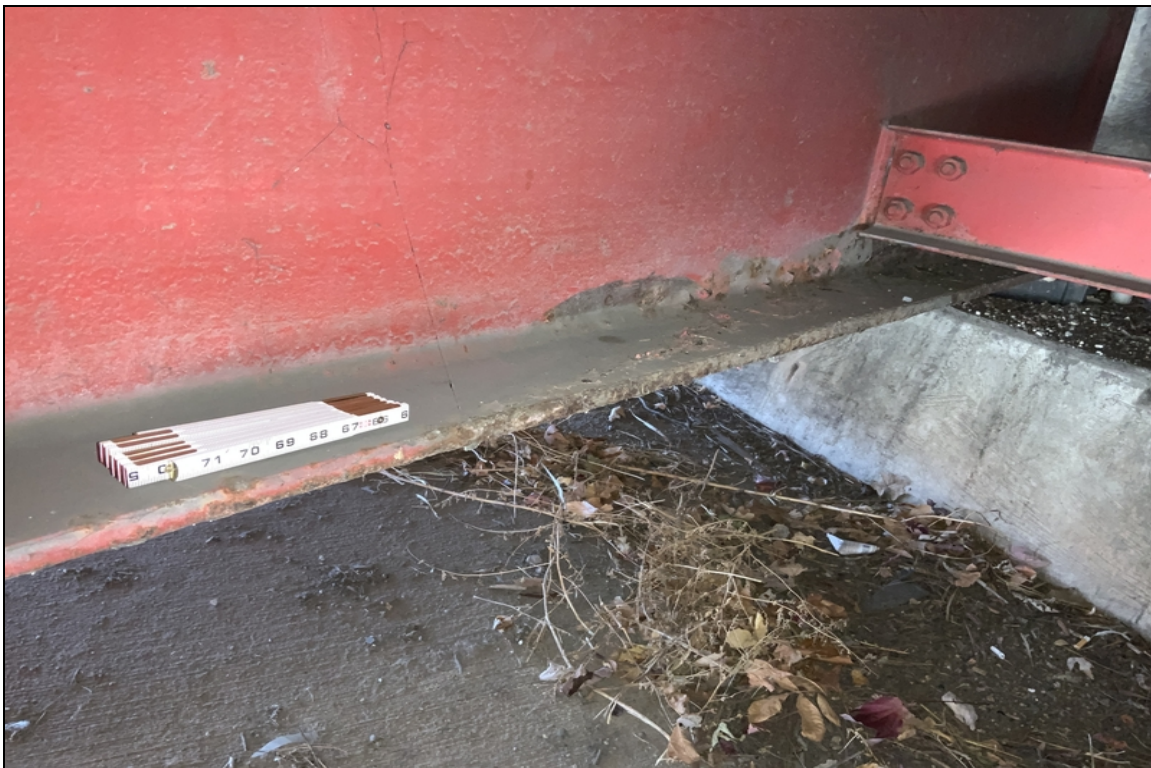
3440	Effectiveness (Steel Protective Coatings)	SF	553	0	511	42	0
(107)	<p>At Bent 1 (West Abutment) and Bent 5 (East Abutment) there is active corrosion along the bottom web juncture and the bottom flanges with flaking rust and pitting due to the compression joint missing and causing water and road debris to accumulate on top of the bridge seat and bottom flanges.</p>						
205	Reinforced Concrete Column	EA	9	6	3	0	0
1130	Cracking (RC and Other)	EA	3	0	3	0	0

Bent 1 girder 5, corrosion

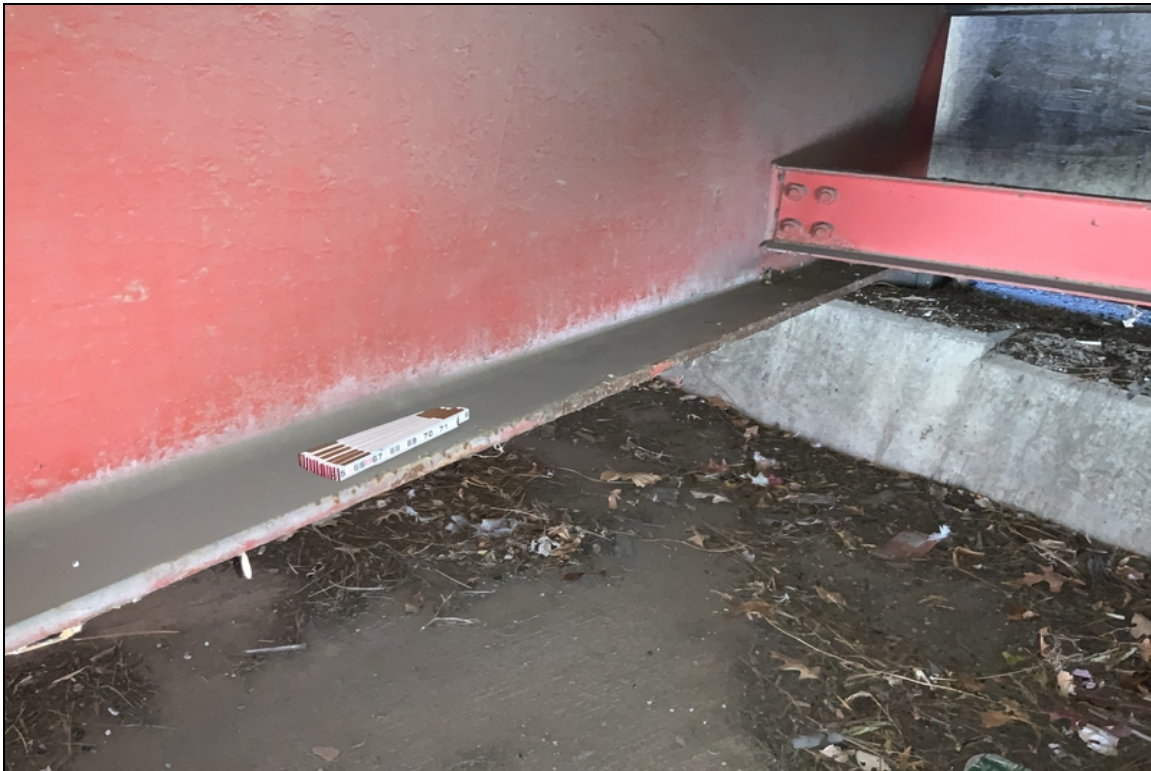
Bent 1 girder 4, corrosion to the bottom flange.

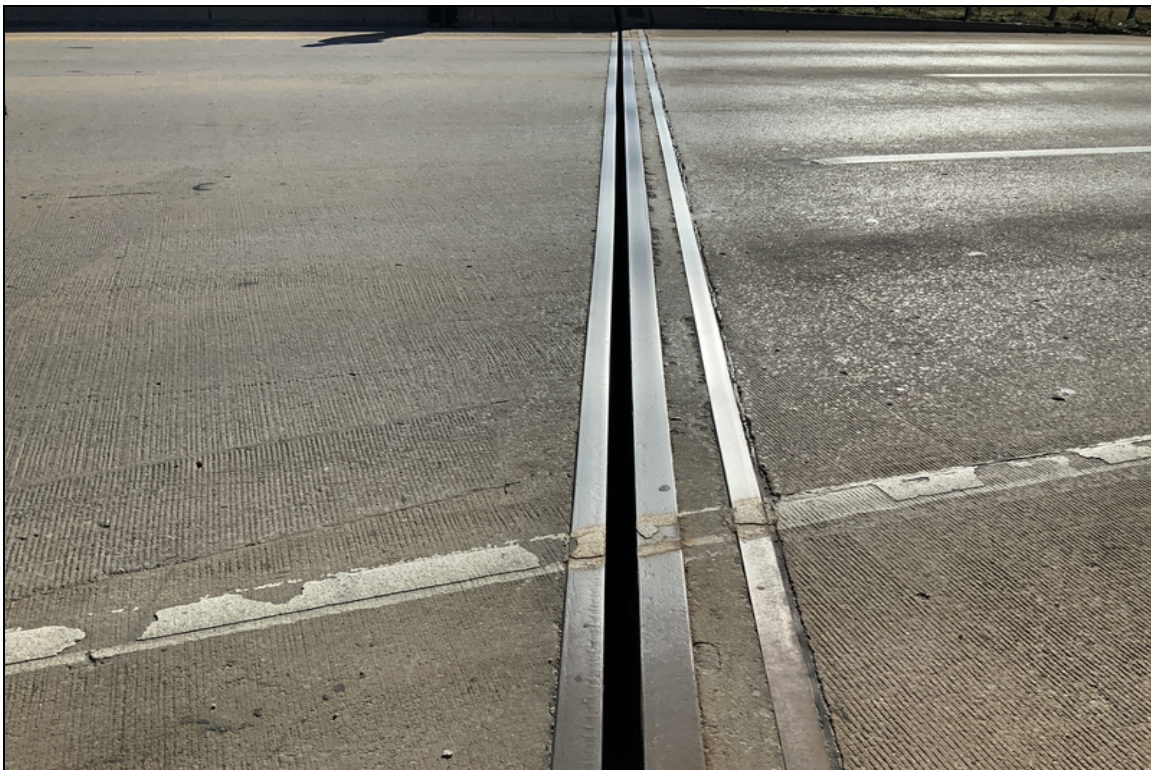
(302)							
Both joint seals are missing.							
310	Elastomeric Bearing	EA	35	21	0	14	0
1000	Corrosion	EA	14	0	0	14	0
515	Steel Protective Coating	SF	35	21	0	7	7
3440	Effectiveness (Steel Protective Coatings)	SF	14	0	0	7	7

Bent 1, joint seal has fallen out.

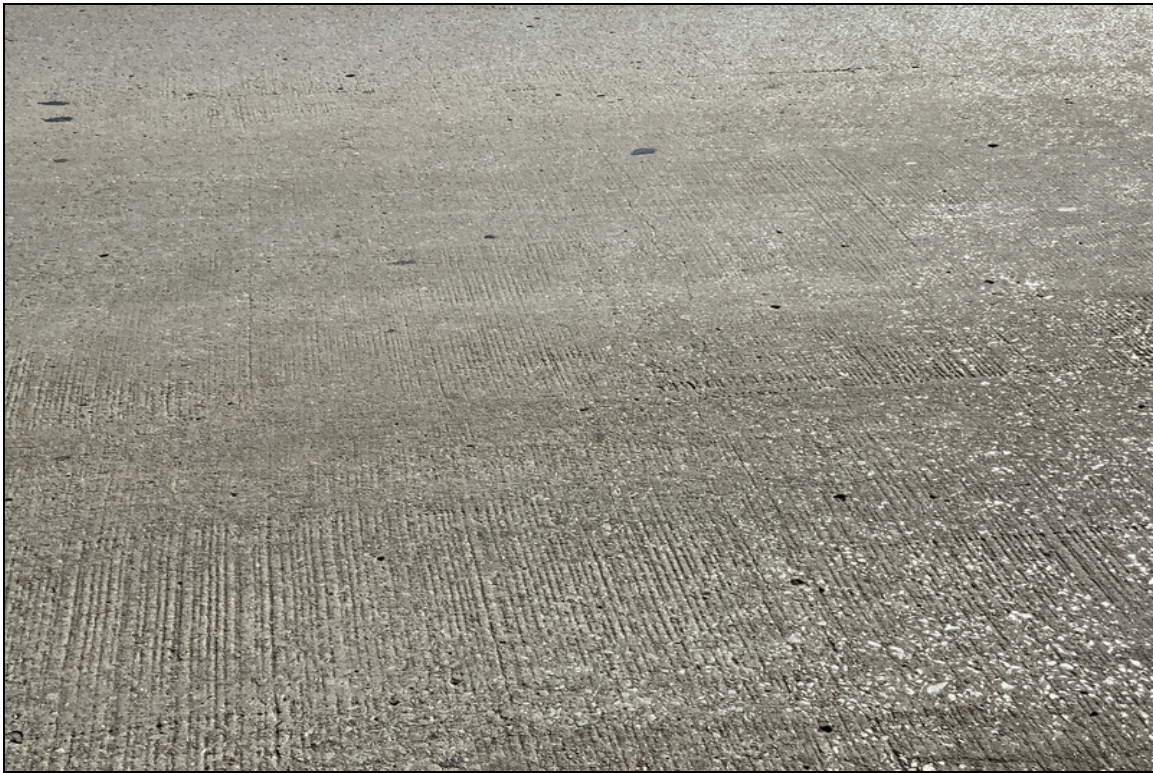
Span 1, transverse cracks.

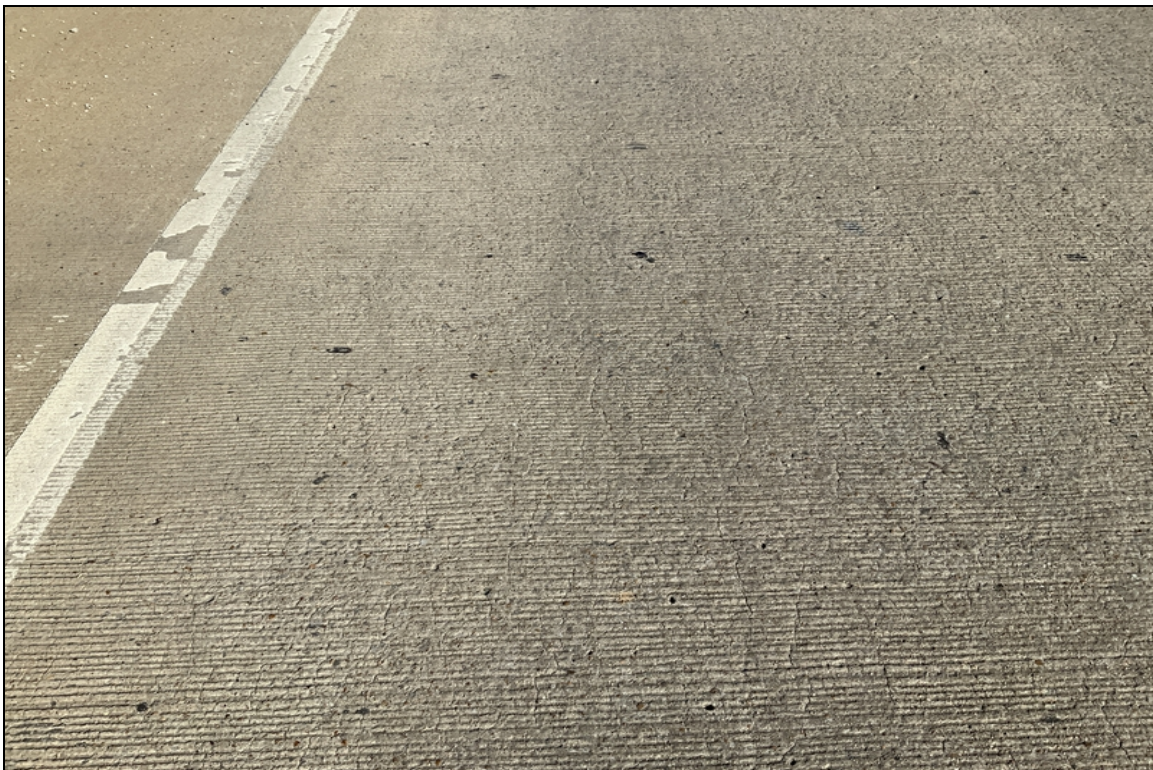
Span 2, longitudinal cracks

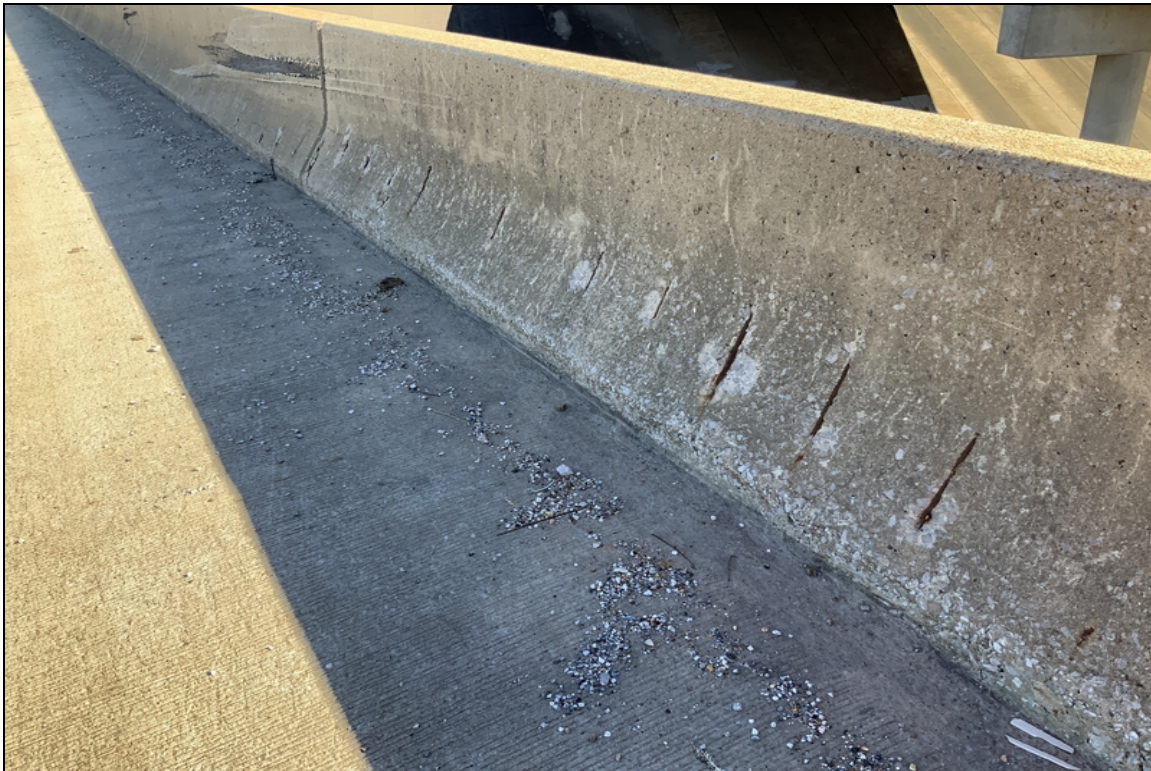
(331)							
Parapet walls on the Rt side of The structure have shallow spalls with exposed reinforcing steel. Exposed reinforcing steel has no apparent section loss with very little concrete cover from the construction process. The left parapet walls has a few shallow spells with exposed reinforcing steel and a few vertical cracks.

Right bridge rail has exposed rebar.

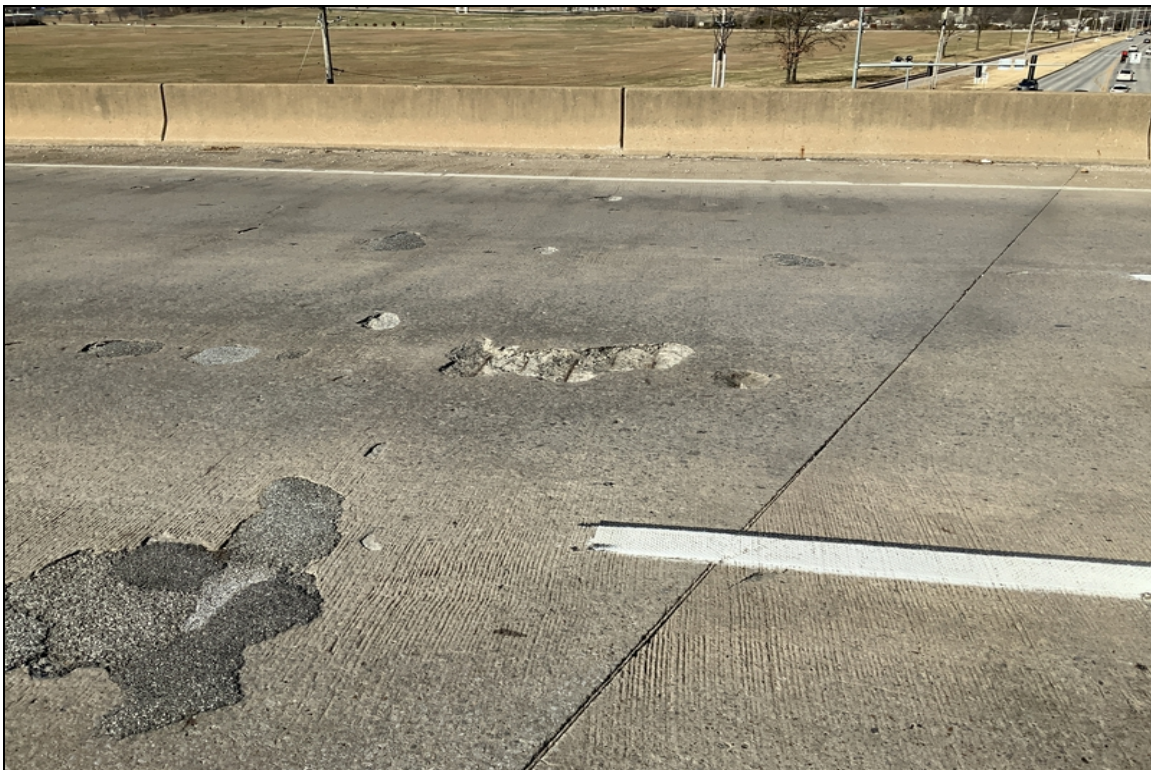
Span 3, large spall with exposed rebar.

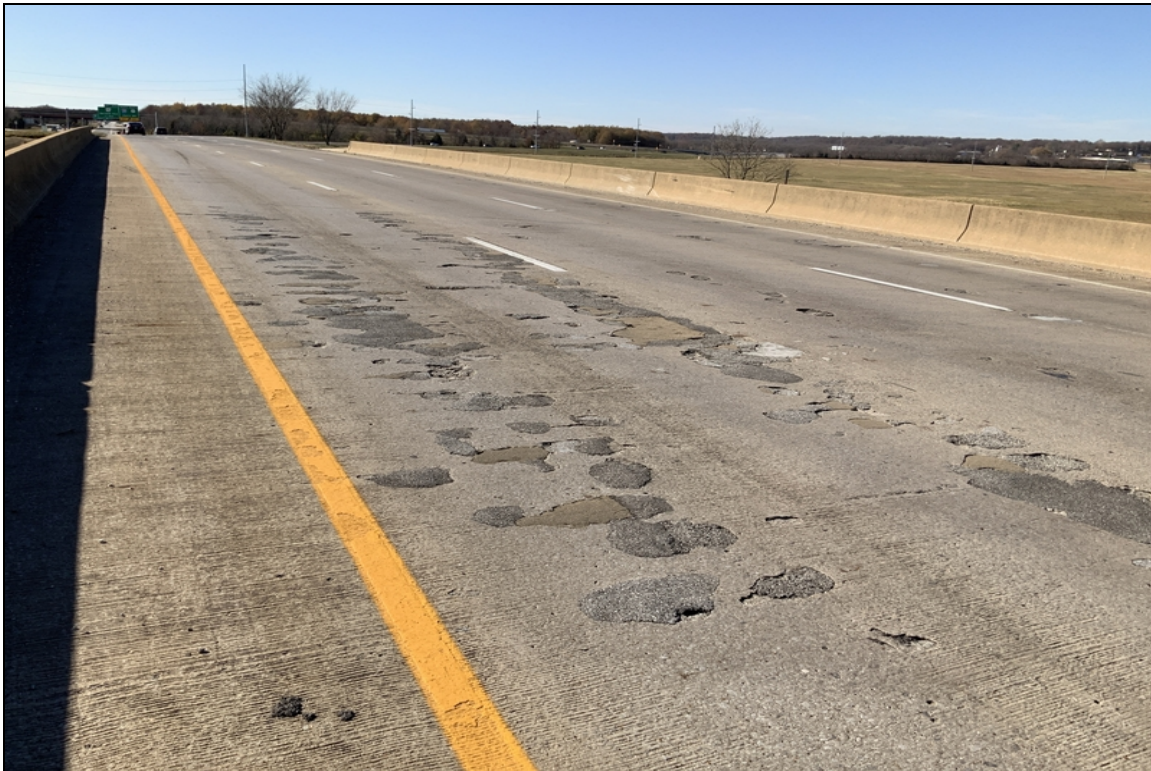
Span 3, several spalls and failing patches.

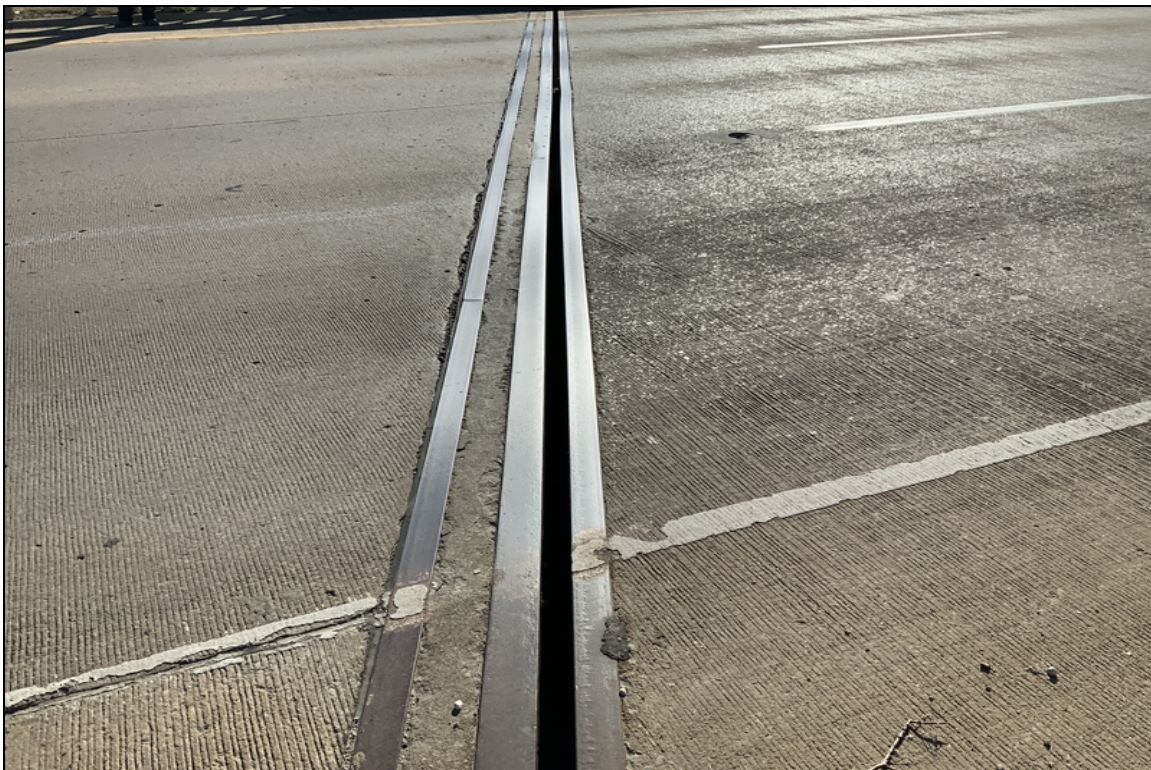
The joint seal at bent 5 has fallen out.

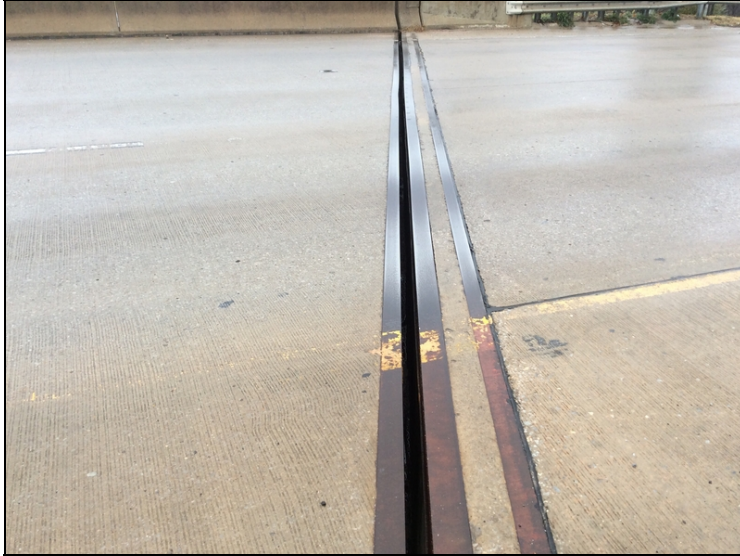
The expansion joint seals at the north and south abutments have failed and are resting on the bridge seat below.

Bent # 5 open expansion joint.

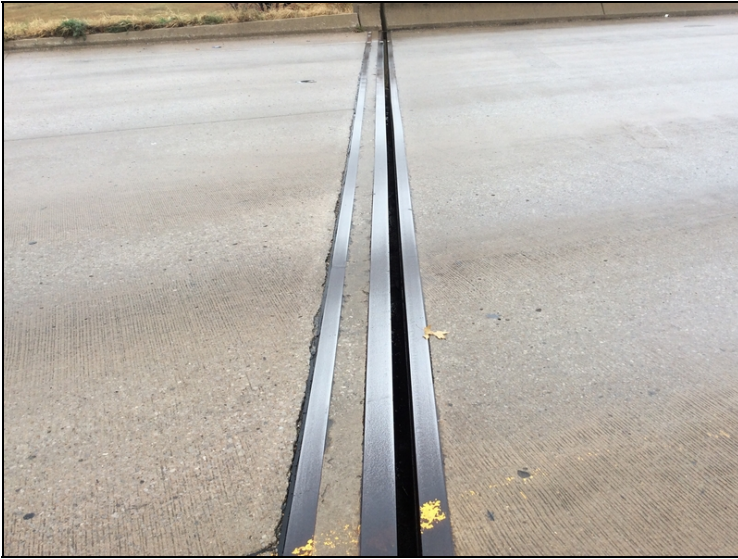
Bent # 1 open expansion joint.

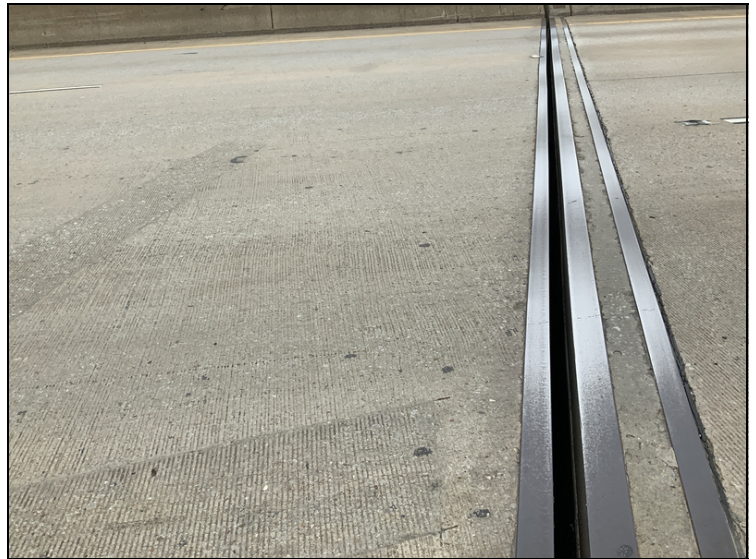
Bent 1 (West Abutment) and Bent 5 (East Abutment) compression joints are both missing and are leaking water along with dumping road debris on top of the bridge set and causing the active corrosion to the girder ends and bearings.

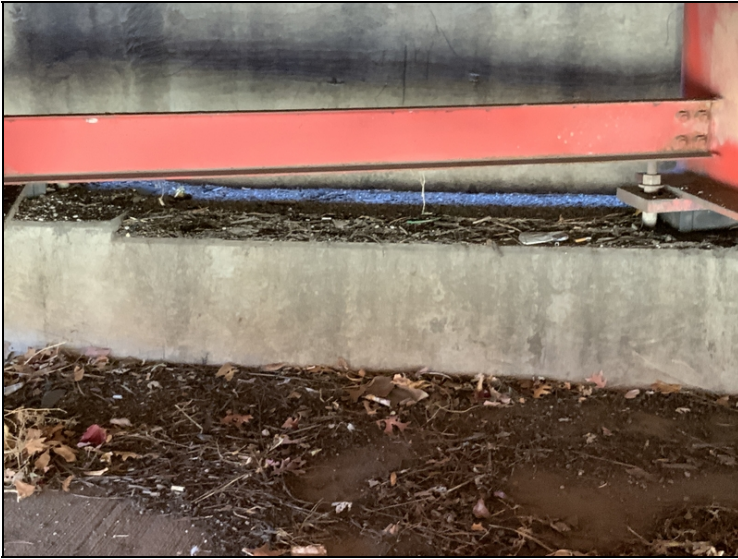
Bent 1 debris on cap

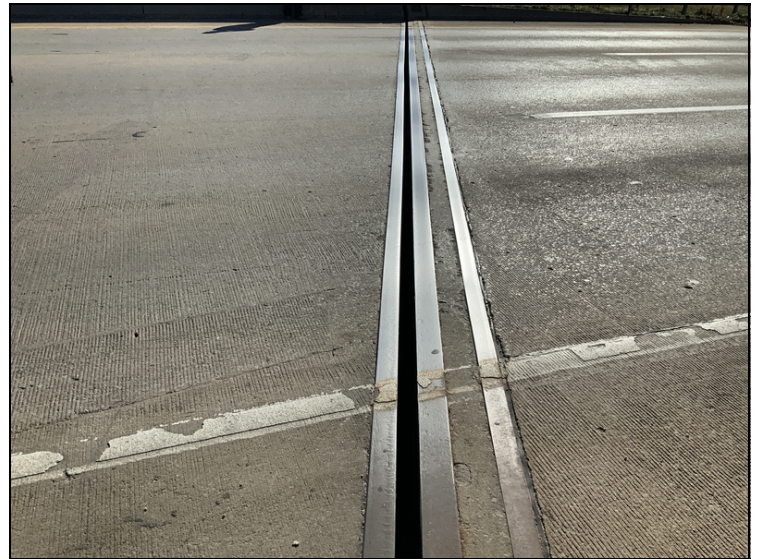
Bent 1, joint seal has fallen out.

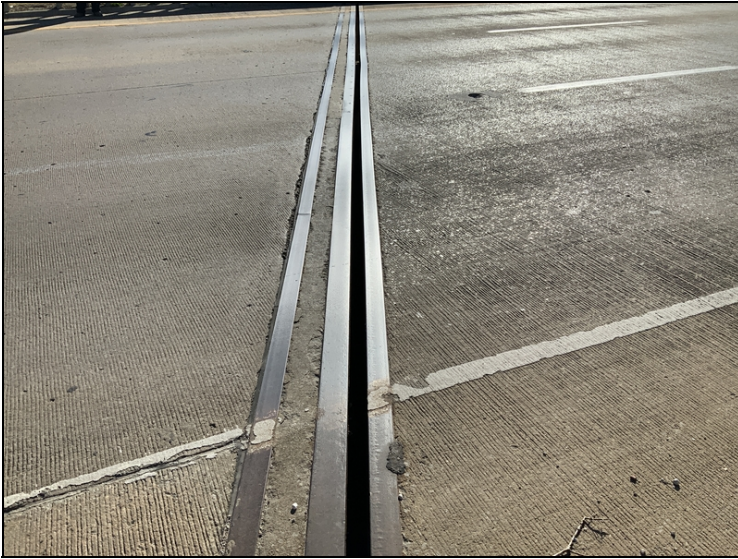
The joint seal at bent 5 has fallen out.

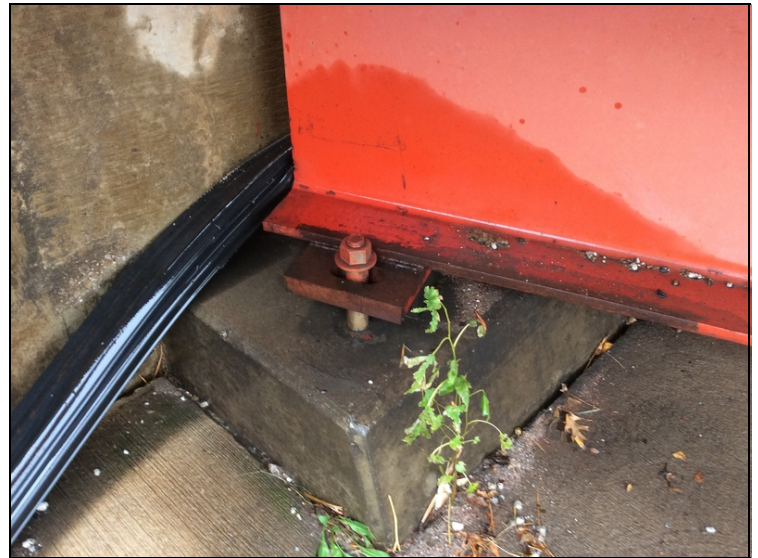
The bearings have a failing paint system with areas of active corrosion.

Corrosion forming on the bearings.

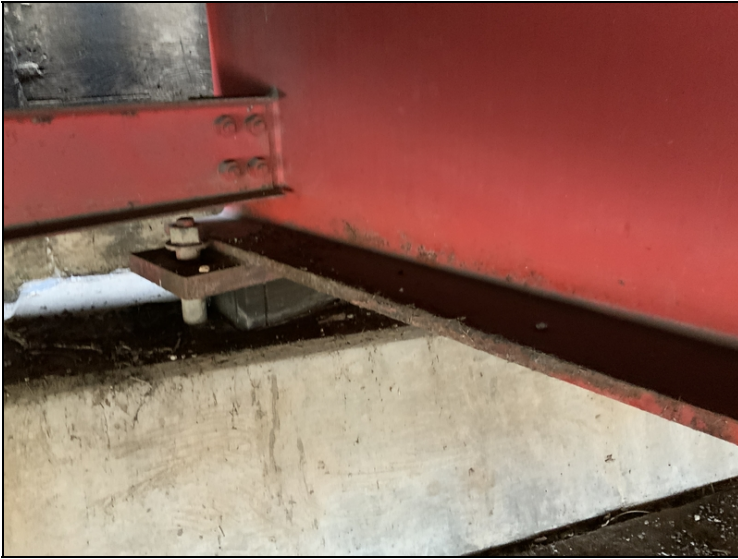
Bent 1 (West Abutment) and Bent 5 (East Abutment) girders 1 - 7 have active corrosion with flaking rust and pitting.

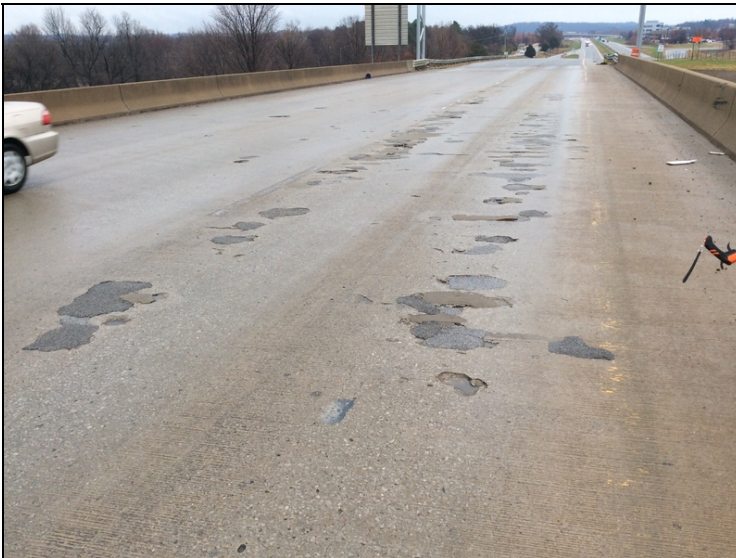
The Right half of Span's # 3 & 4 have numerous delaminated areas and spalls with exposed reinforcing steel on the driving surface.

Span # 3 Right lane delamination's and spalling with exposed reinforcing steel.

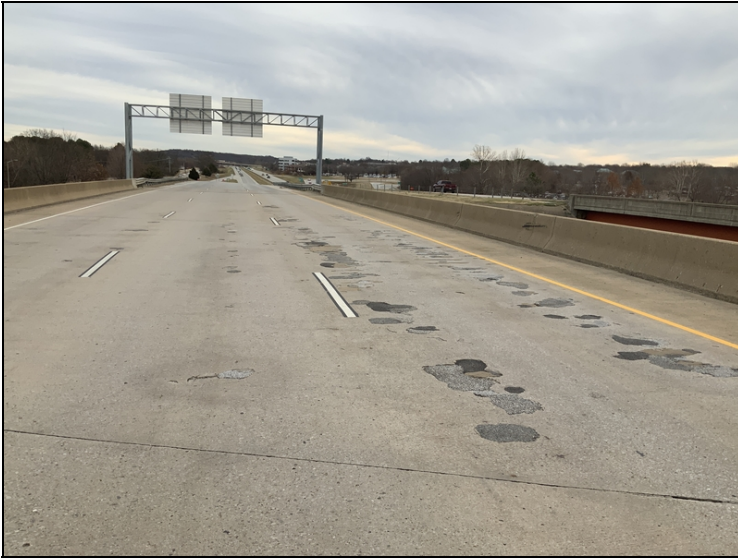
Span 3 has numerous failed asphalt patched areas along with exposed reinforcing steel that has initial section loss.

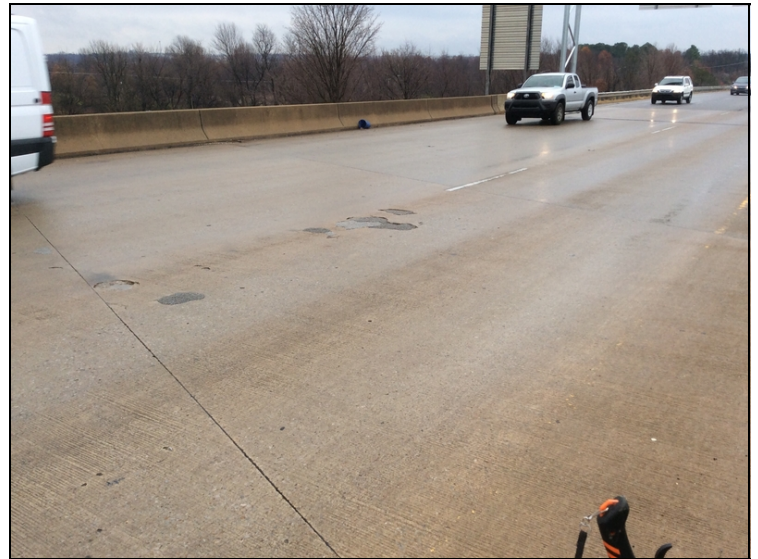
Span # 4 near centerline concrete delamination's and spalls with exposed reinforcing steel.

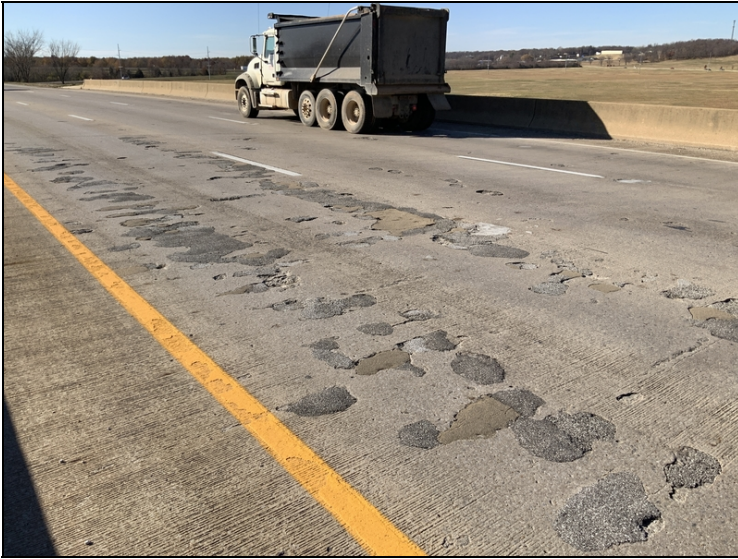
Span 3, several spalls and failing patches.

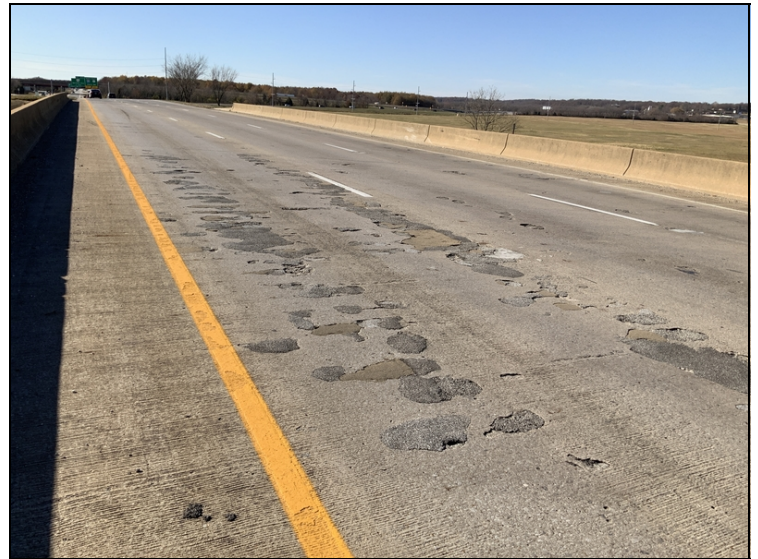
Span 3, several spalls and failing patches.

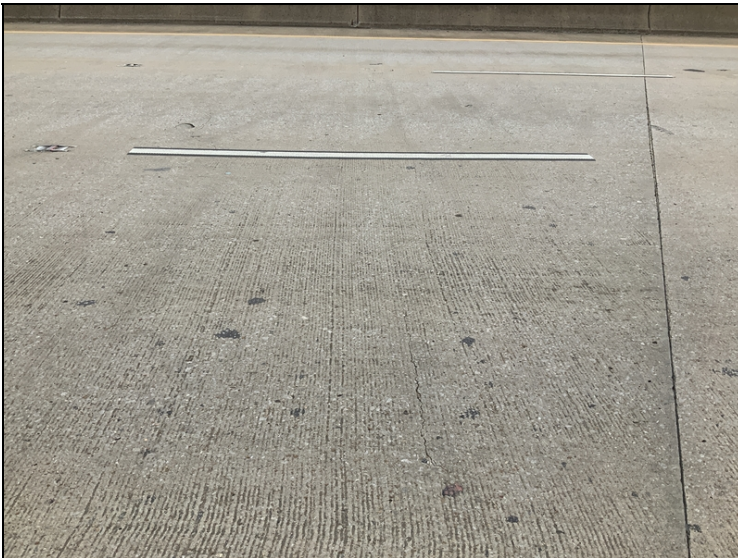
The deck has sealable transverse and longitudinal cracks on the driving surface.

Typical seal-able cracking throughout the driving surface.

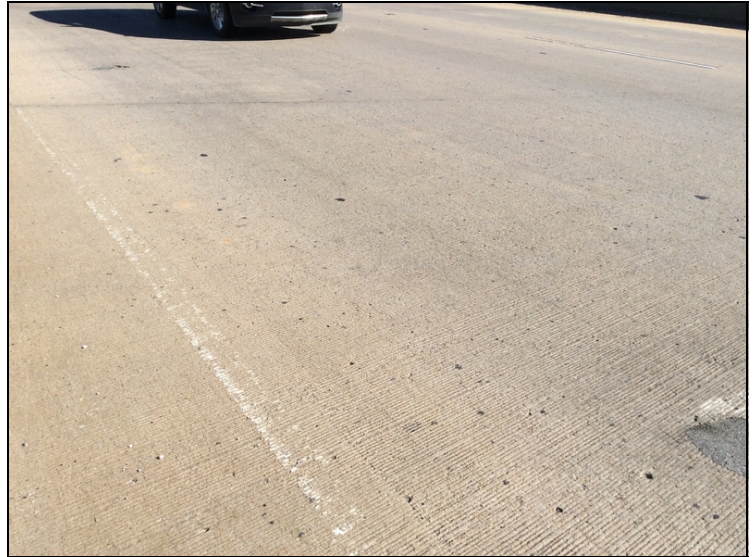
The deck has sealable Transverse and longitudinal
cracks on the driving surface of the deck.

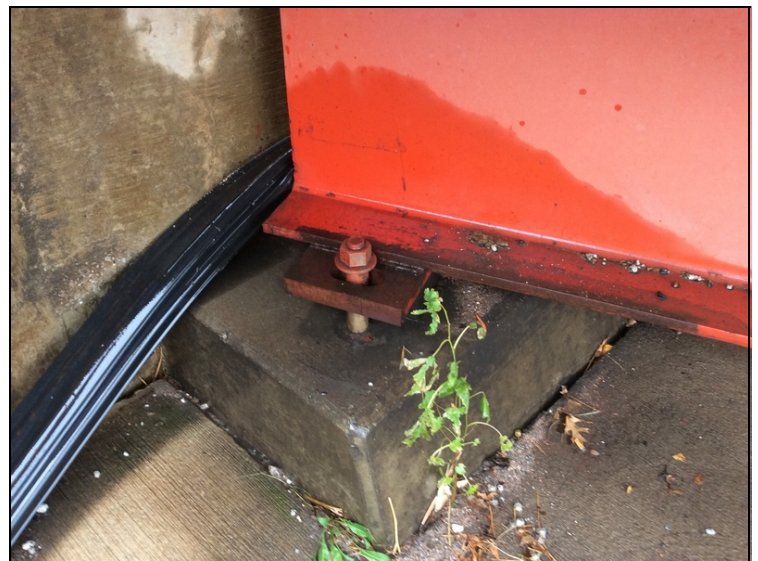
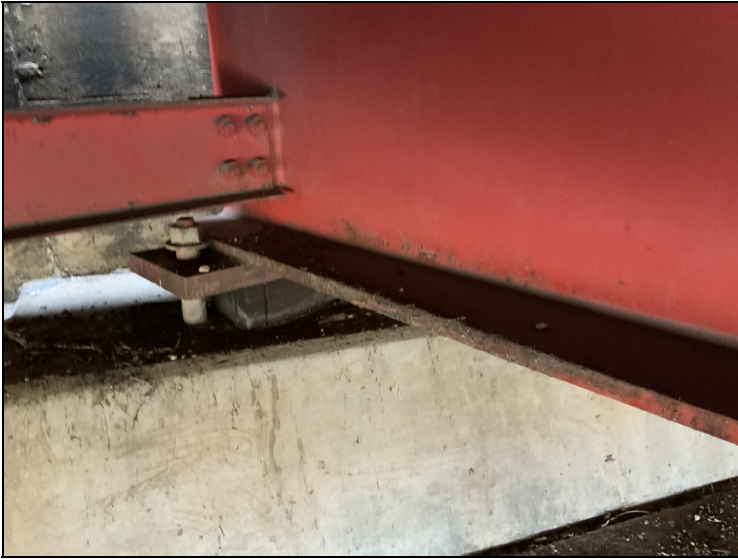
The ends of the beams are developing active corrosion from joint seal leakage at the abutments.

Bent 1 (West Abutment) and Bent 5 (East Abutment) girders 1 - 7 have active corrosion with flaking rust and pitting.

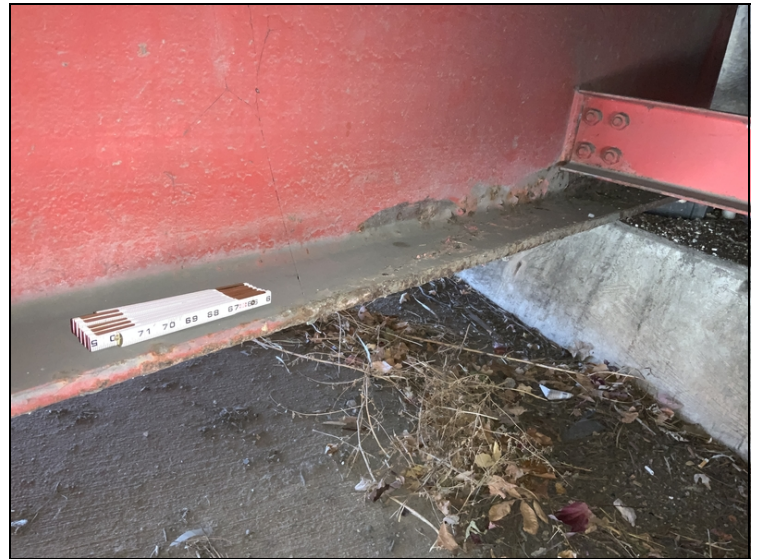
Bent 1 girder 5, corrosion

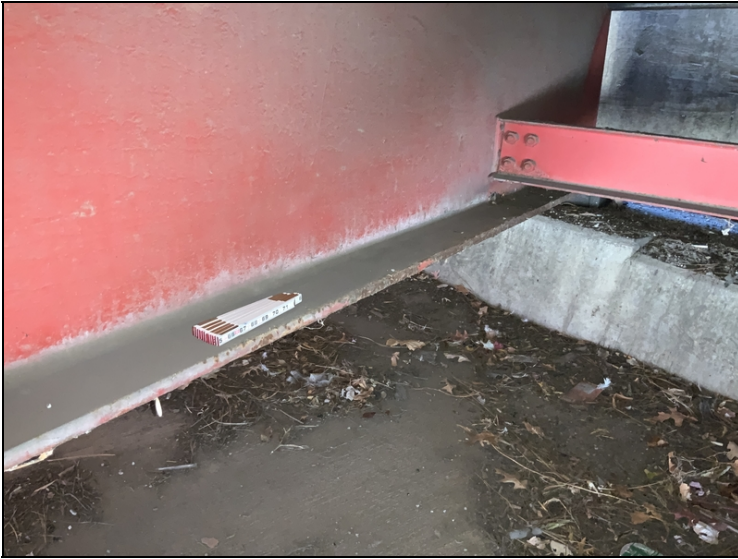
Bent 1 girder 4, corrosion to the bottom flange.

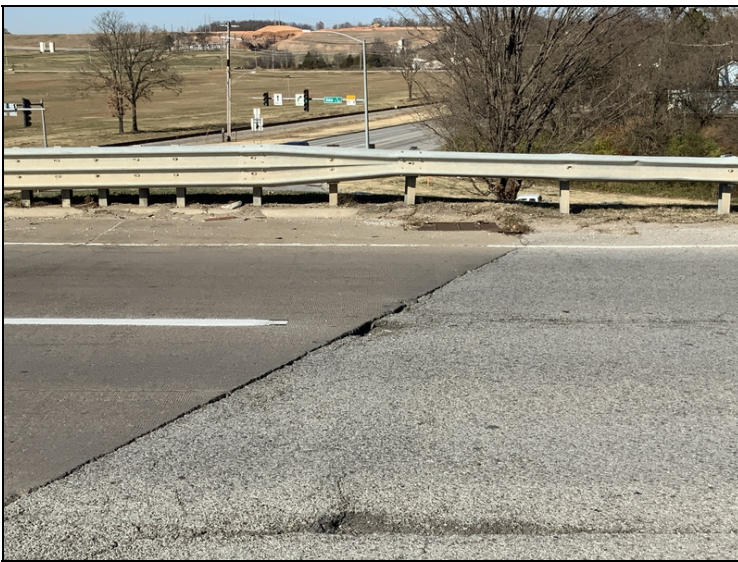
There is a pothole in the approach roadway on the East side of the bridge.

Pothole in approach roadway, East side of bridge.

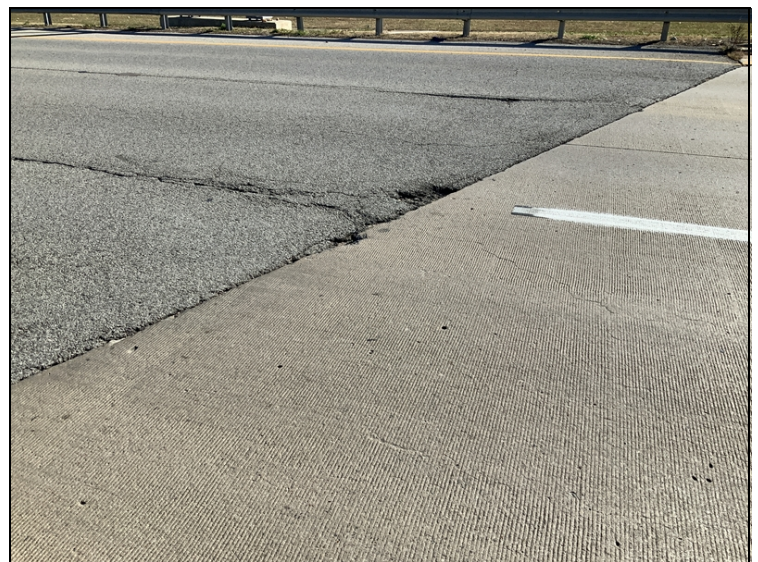
Pothole in approach roadway
