Bridge #B5802(Routine)
US 71-SEC 17B, NB over Gregg Ave., A&M RR.

Location: 5.21 NO JCT US 62 & 71

Team Lead: Lee Swan Inspection Date: December 01, 2021

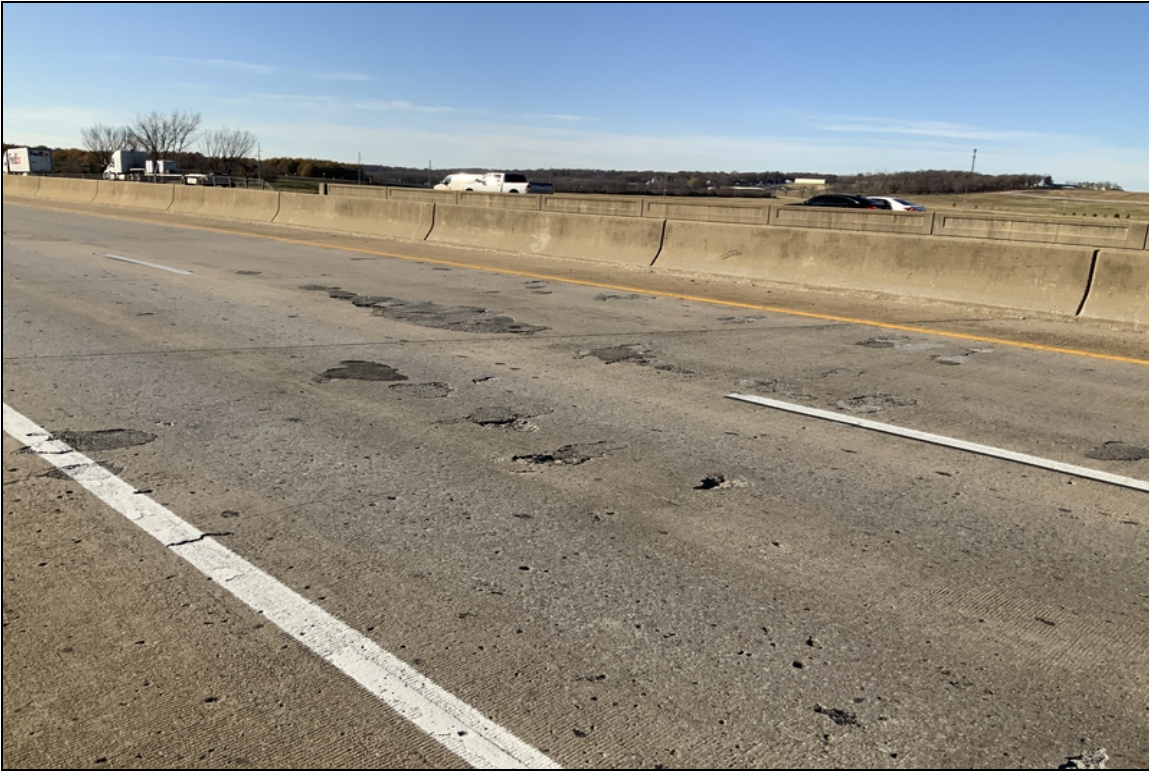
Span 3, spalls and failing patches.

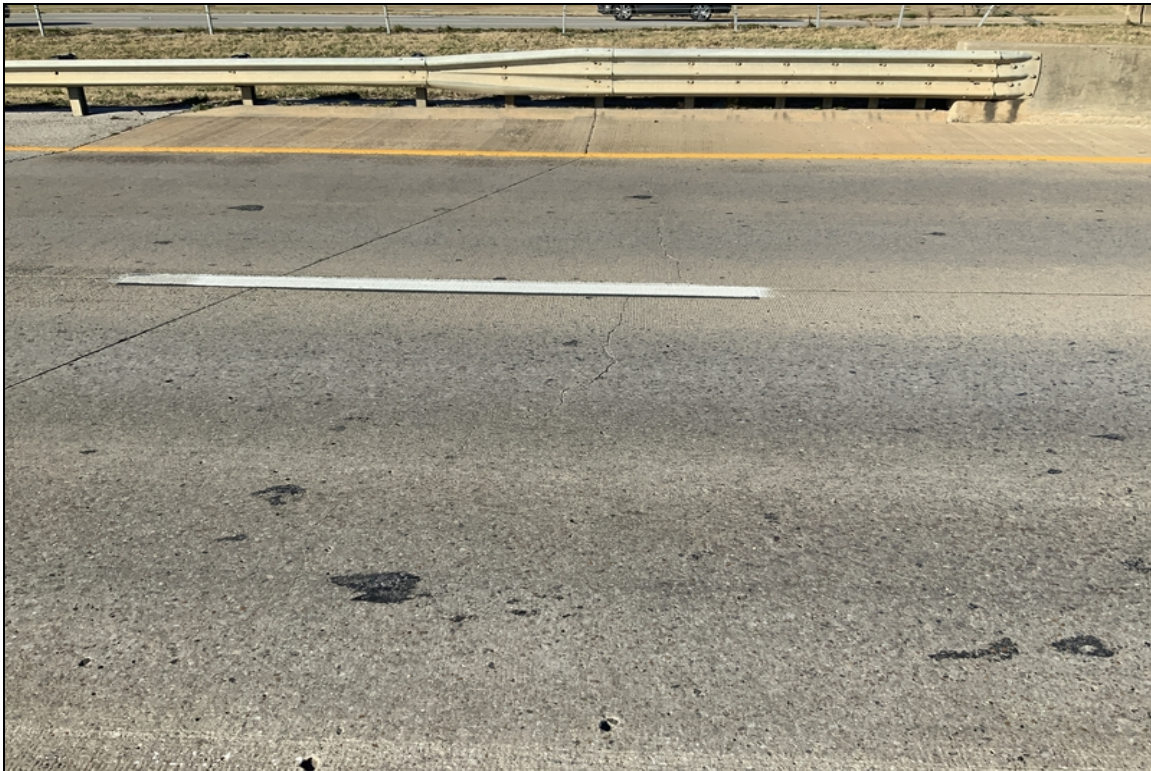
(321)							
The approach slabs have large transverse cracks.							
331	Reinforced Concrete Bridge Railing	LF	646	492	154	0	0
1080	Delamination/Spall/Patched Area	LF	4	0	4	0	0
1090	Exposed Rebar	LF	12	0	12	0	0
1130	Cracking (RC and Other)	LF	138	0	138	0	0

West approach slab, large transverse cracks.

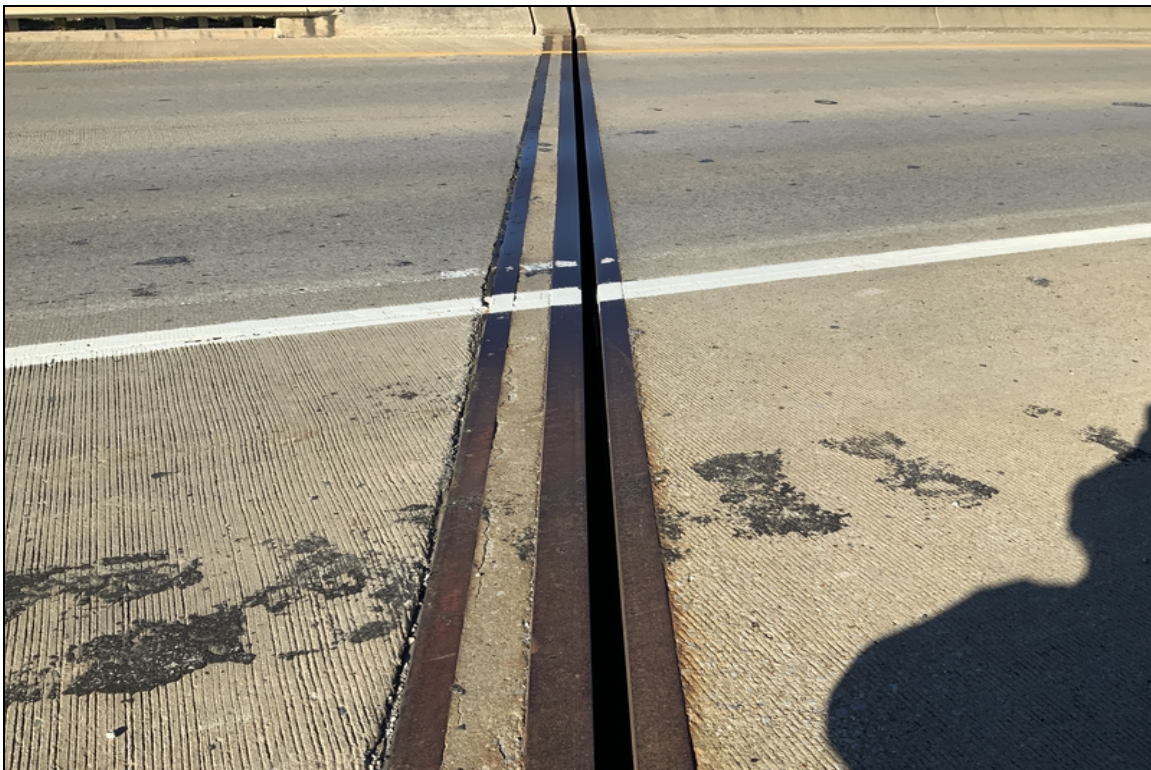
(302)							
Compression joint seal at Bent 1 has fallen out and allowing free flow of water and debris. Compression seal at Bent 5 has partially fallen out with debris impaction. There is a 2' section of steel road iron that has been removed in the Bent 5 Rt lane. Additionally bent # 5 has an area of impact damage from a snow plow that has bent the road iron out of plane.							
310	Elastomeric Bearing	EA	30	0	30	0	0
1000	Corrosion	EA	30	0	30	0	0
515	Steel Protective Coating	SF	30	18	0	6	6
3440	Effectiveness (Steel Protective Coatings)	SF	12	0	0	6	6

Bent 1 joint has fallen out.

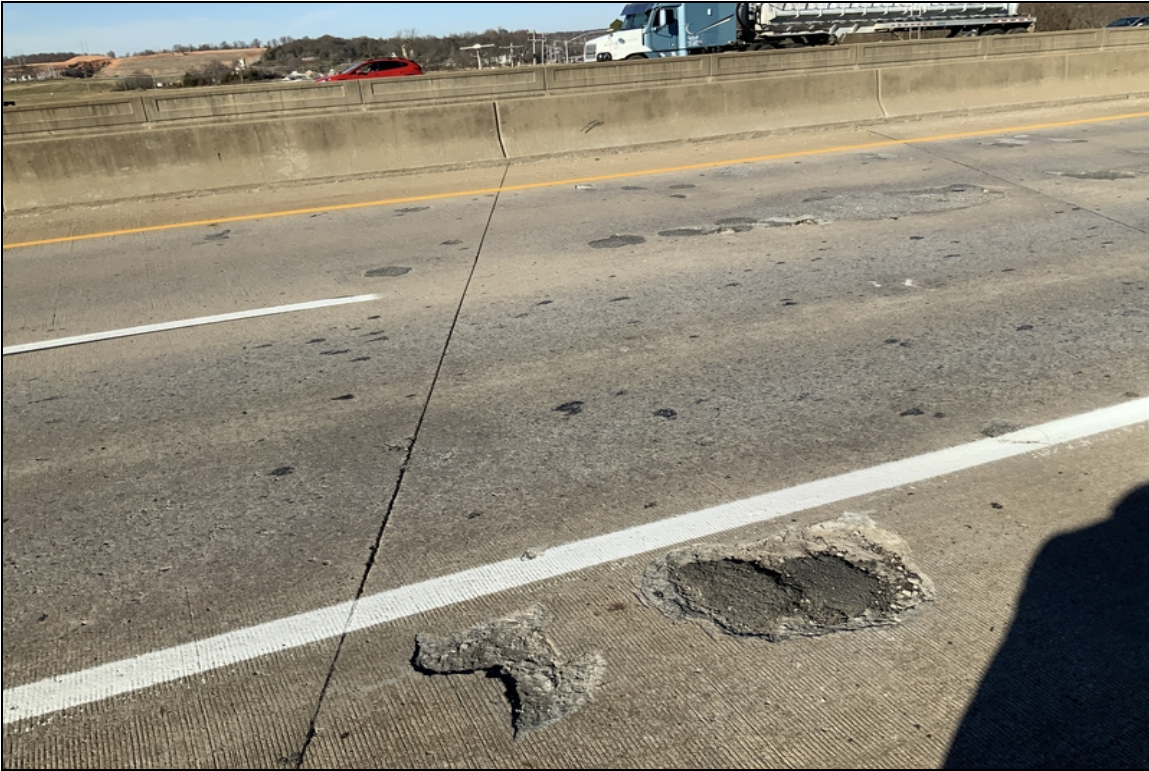
Span 2, spalls and failing patches.

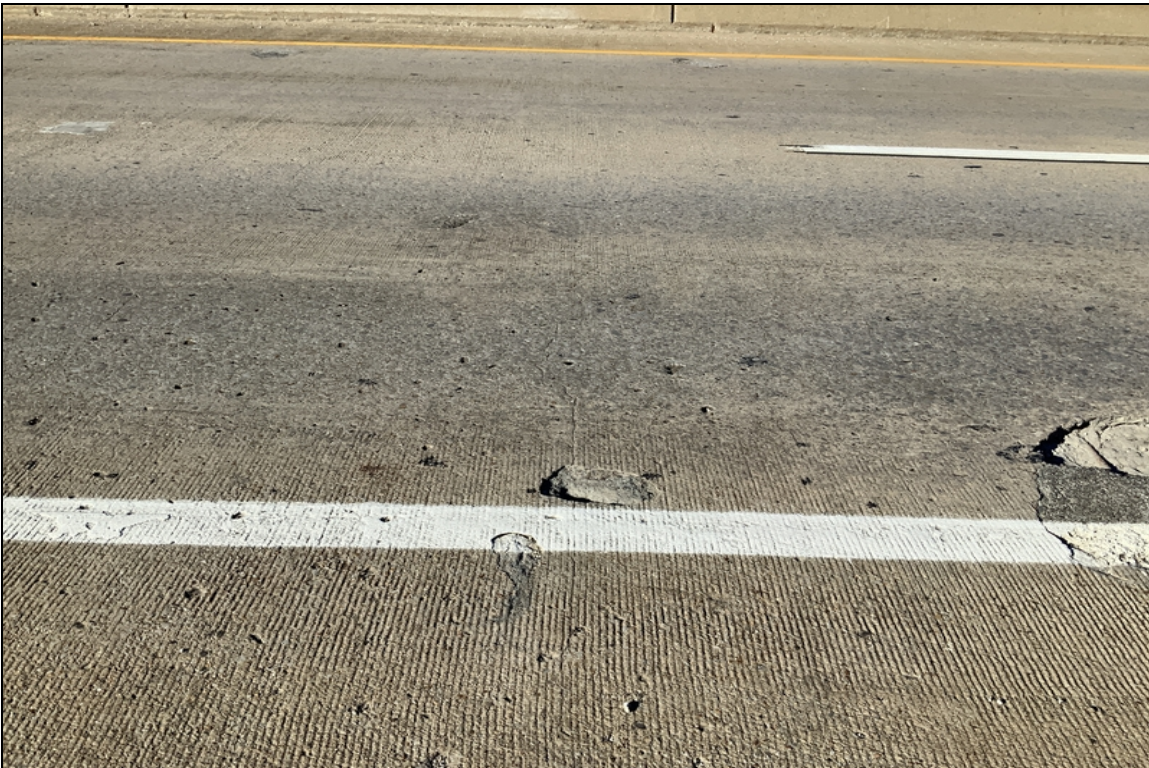
Span 3, spall and abrasion.

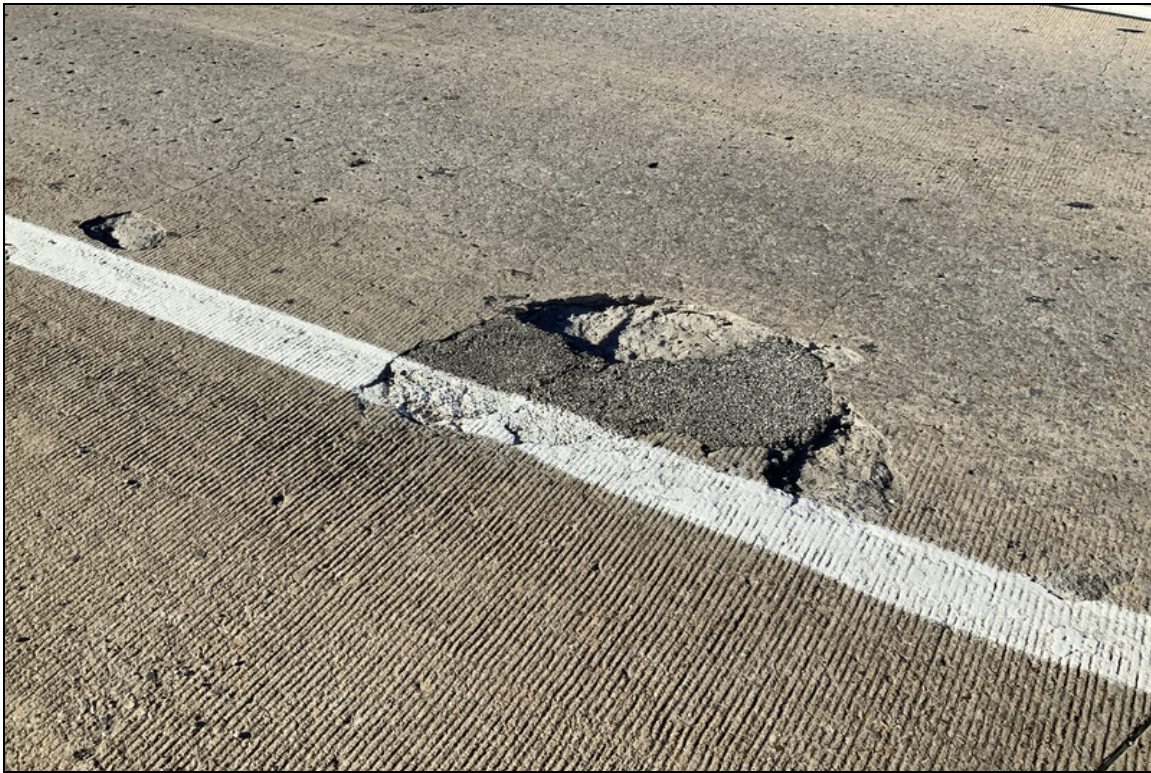
Span 3, spall with exposed rebar

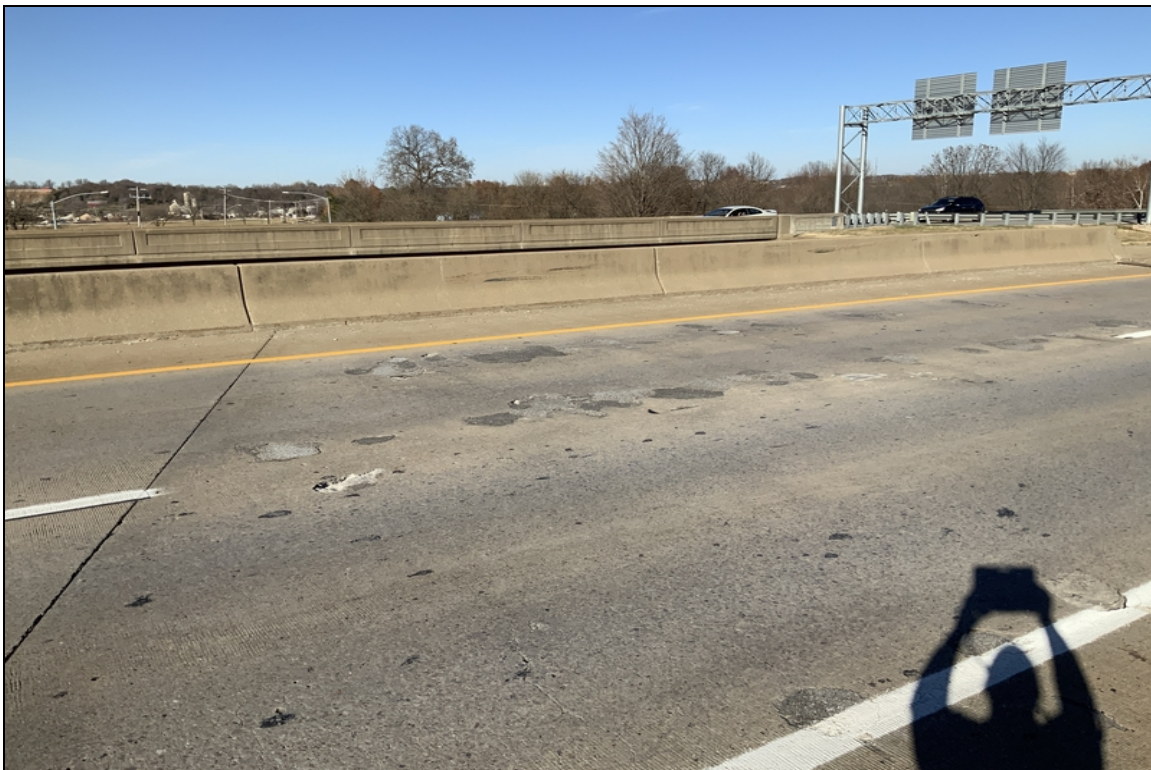
Span 4, large areas of failing patches and spall.

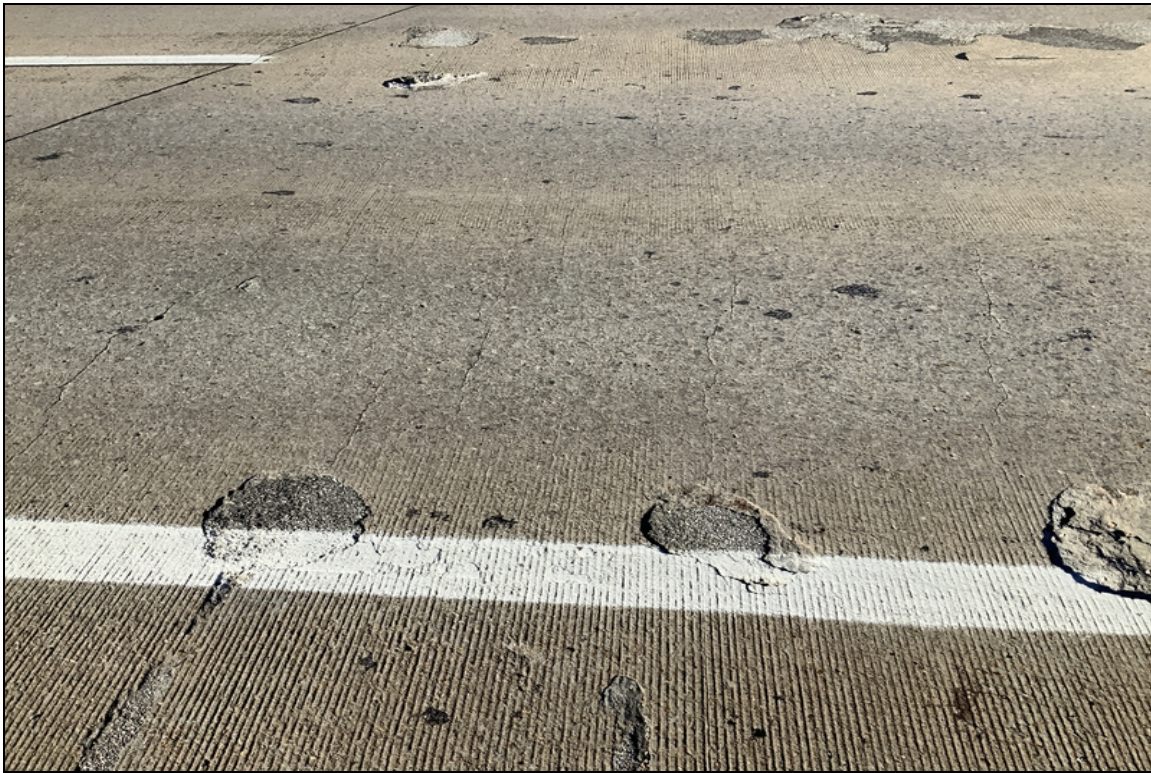
Span 4, transverse cracks and spalls/patches.

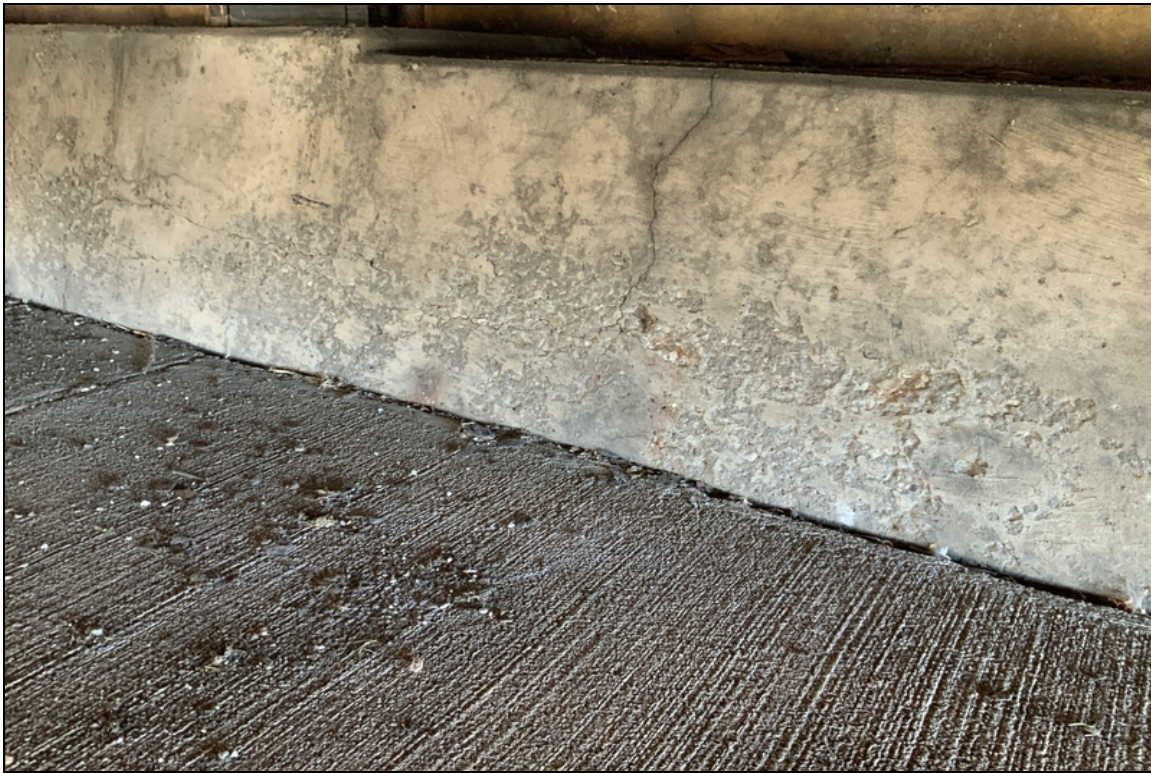
Abrasion and cracks in bent 5.

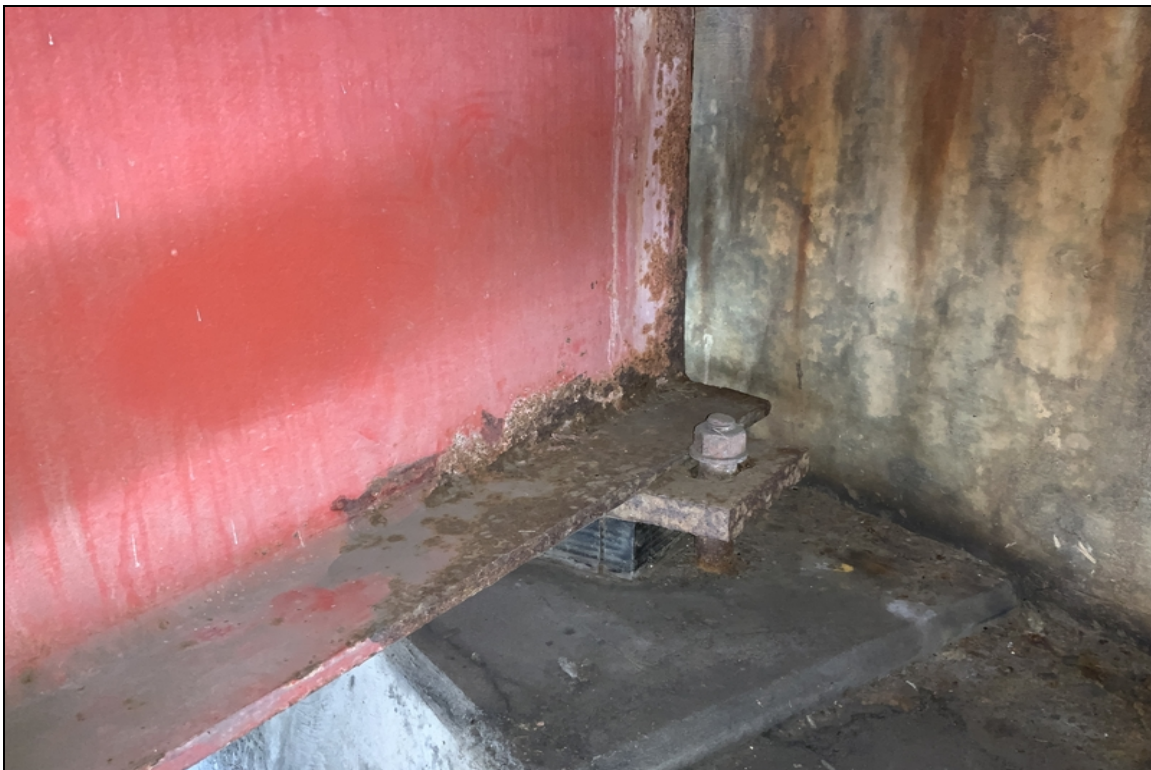
(107)							
Active corrosion on beam ends flanges and webs due to compression seal failure and build up of dirt and debris falling through joint. Superstructure has areas with freckled rust. 12-03-2019 - Girder ends now have flaking rust beginning to form.							
(107-515)							
The paint system has failed on the girder ends where the girders are corroded. Outside girders are chalking.							
205	Reinforced Concrete Column	EA	6	5	1	0	0
1130	Cracking (RC and Other)	EA	1	0	1	0	0

Bent 5 girder 4, corrosion

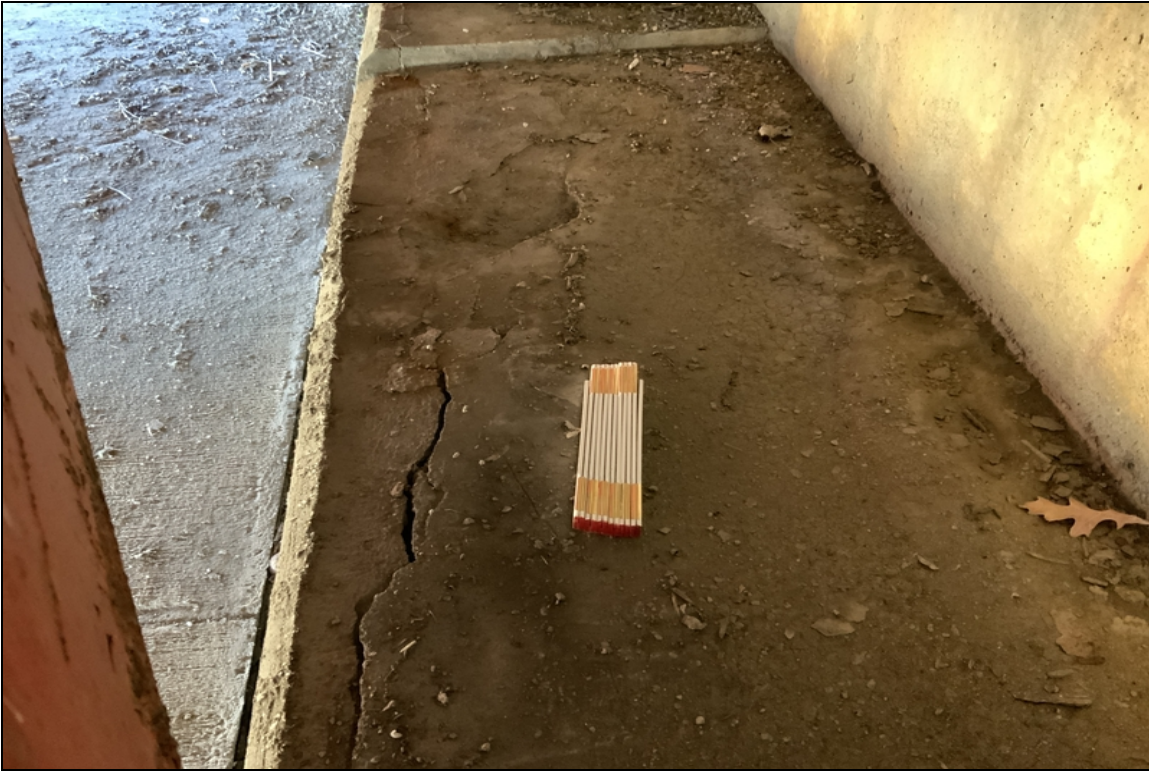
Large crack and delaminating concrete in the beam seat between girders 3 and 4.

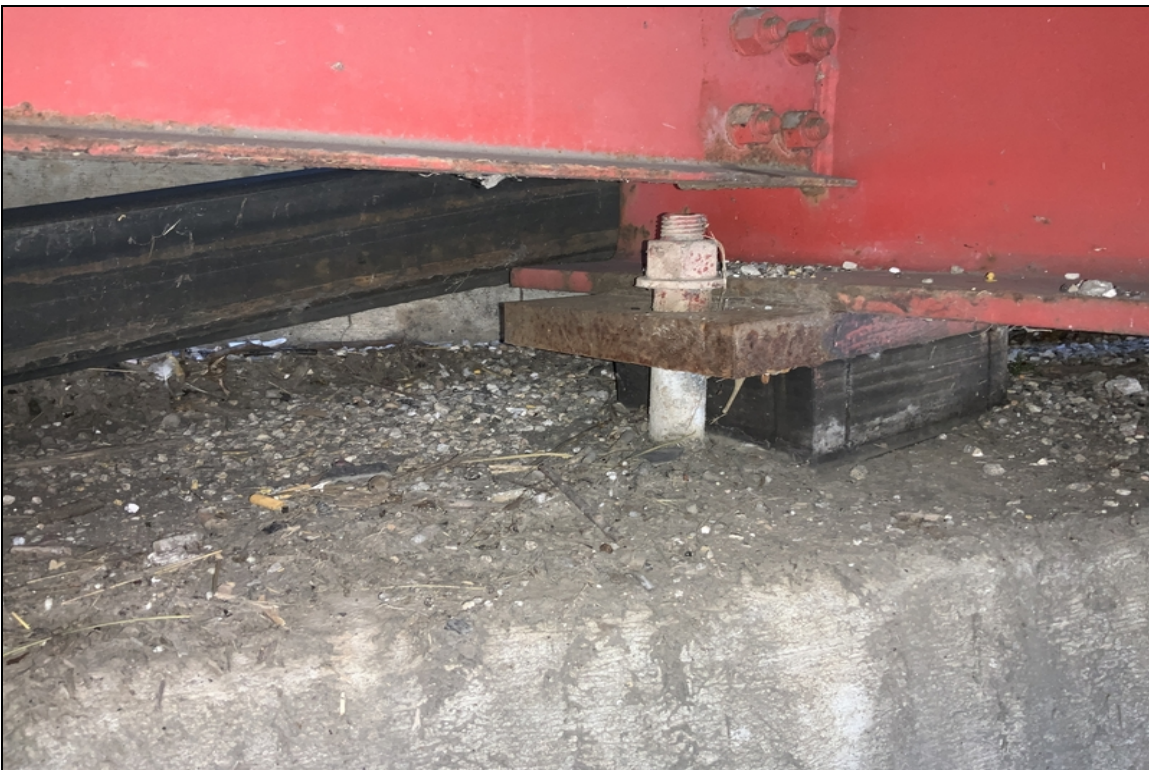
Bent 5 bearing 2, flaking rust,

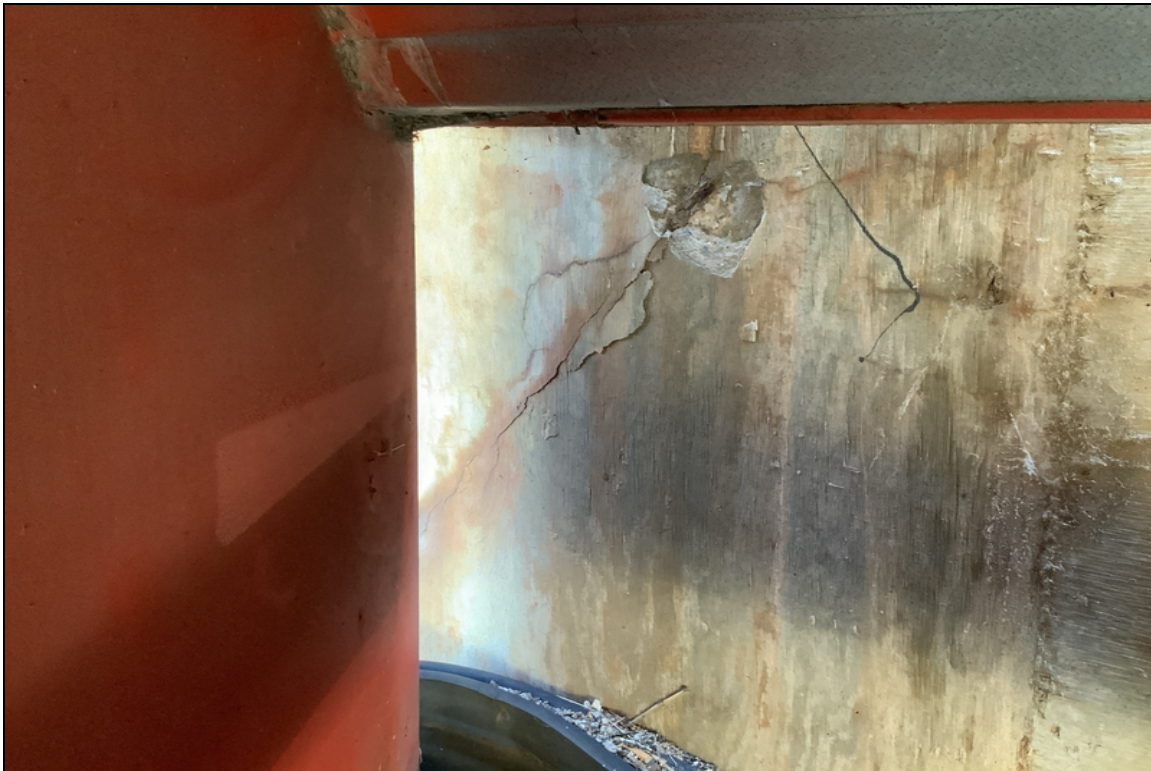
Bent 5 behind girder 1, rebar and crack in back wall.

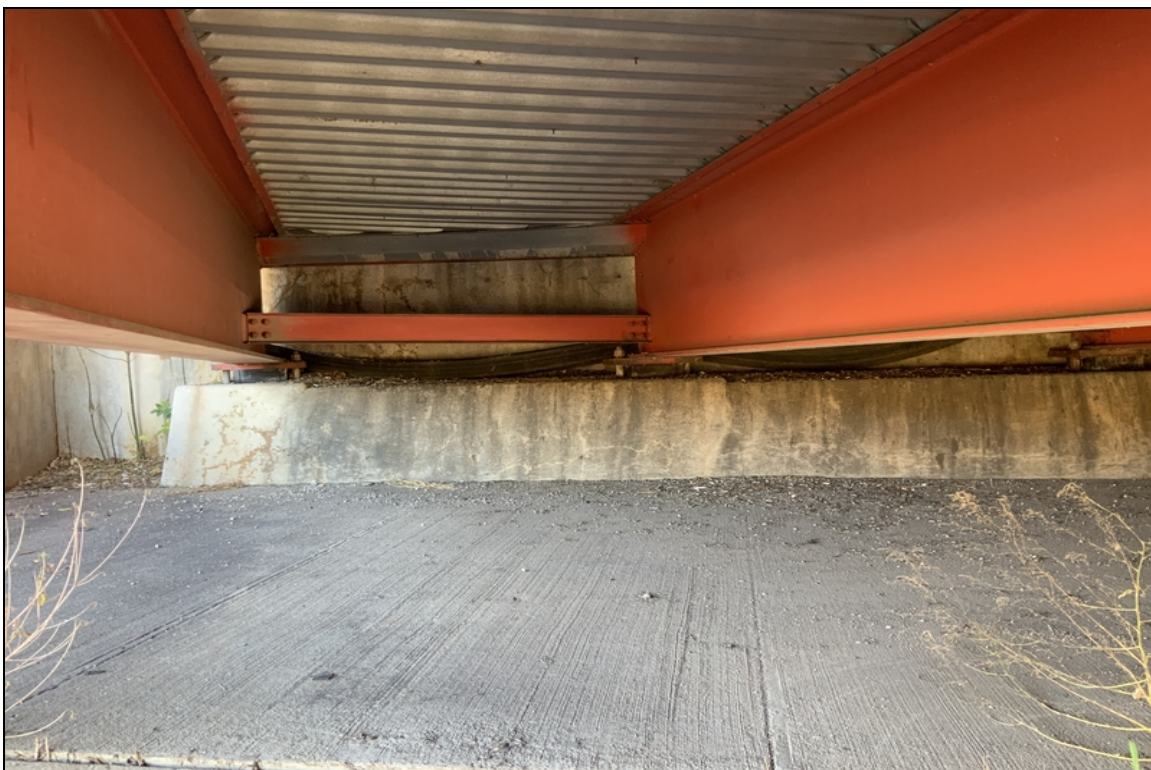
Bent 5, joint laying on cap.

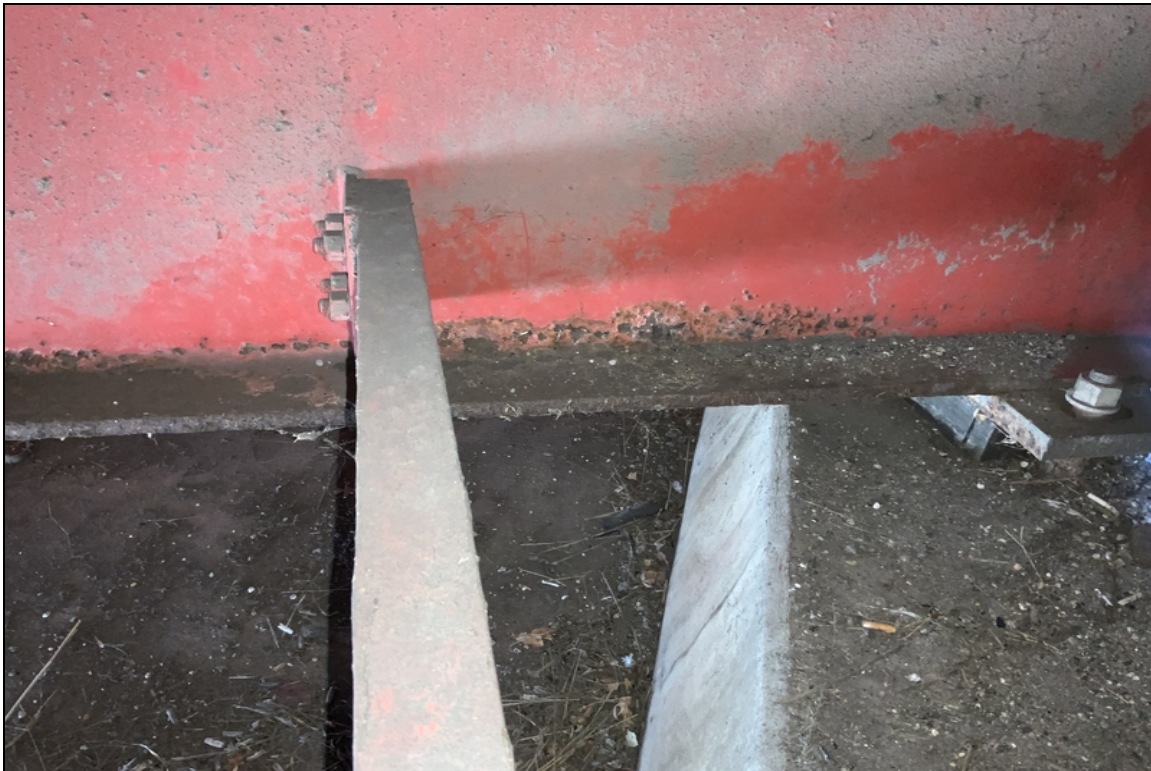
Bent 1 girder 3, corrosion on the bottom flange.

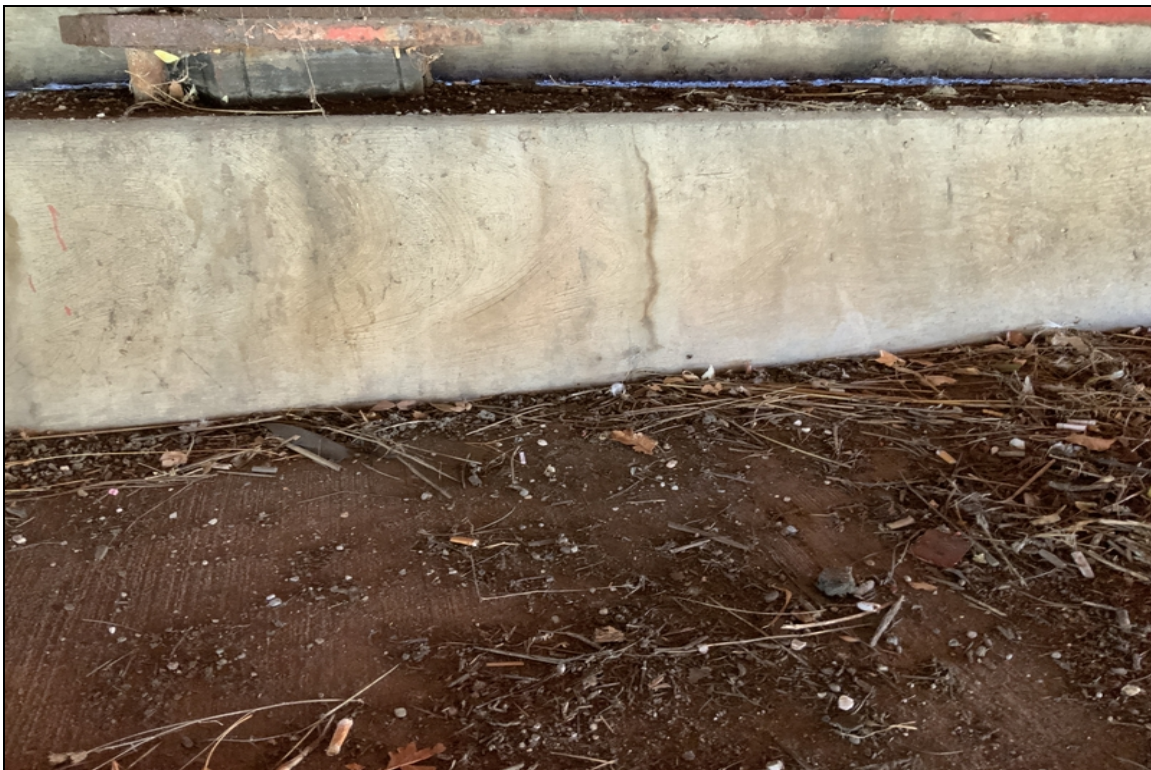
Bent 1, crack in the beam seat.

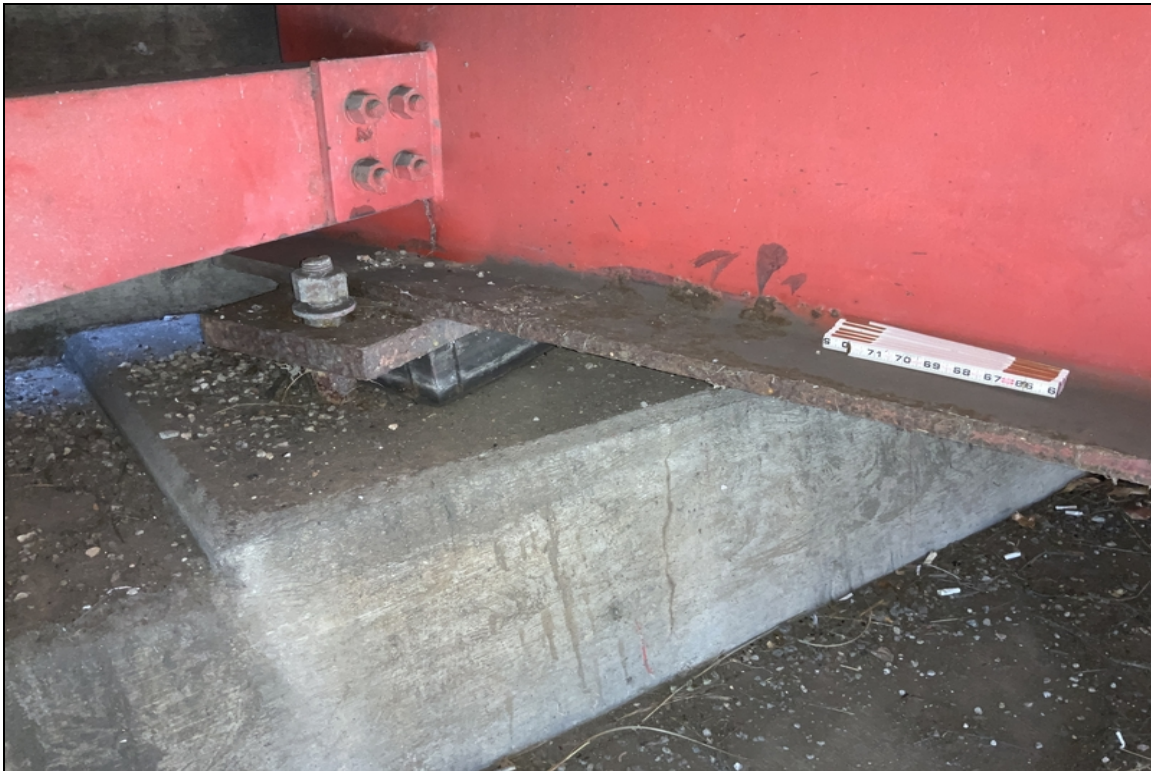
Bent 1 girder 4, corrosion bottom flange.

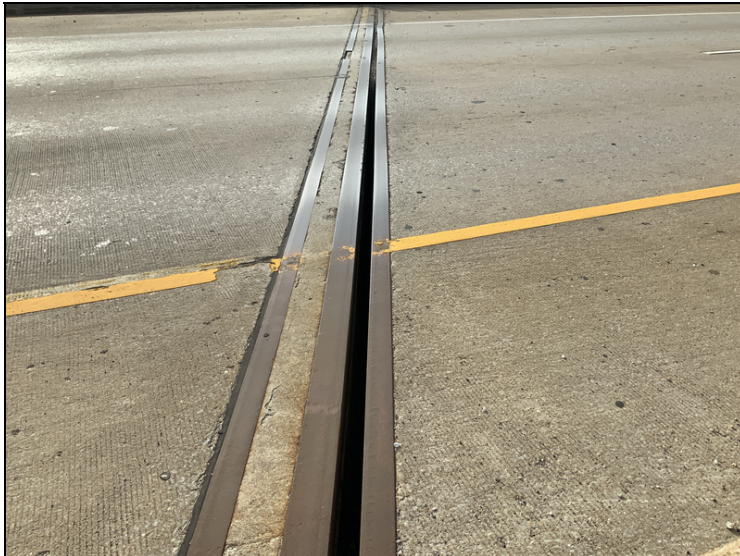
The expansion joint seals have failed and are allowing water to leak on the abutments.

Both bent 1 (West Abutment) and bent 5 (East Abutment) compression joints are missing and are leaking water, plus dumping road debris on top of the bridge seat and the girder ends causing the active corrosion.

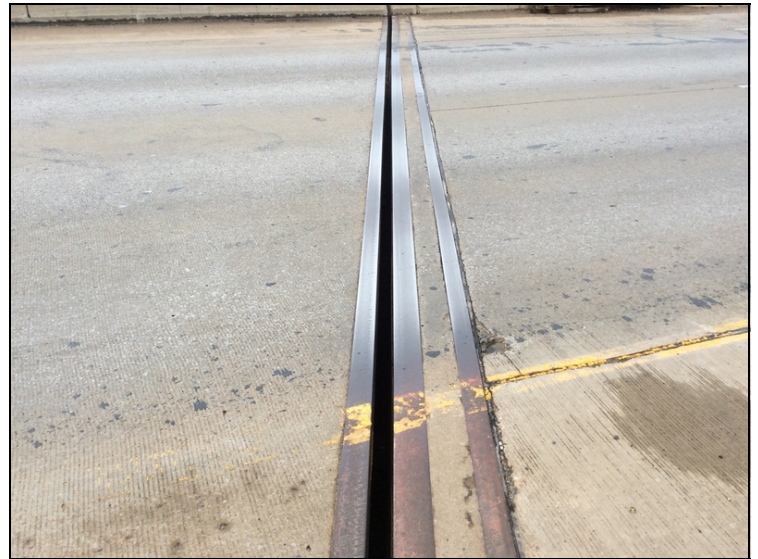
Bent # 1 joint seal missing.

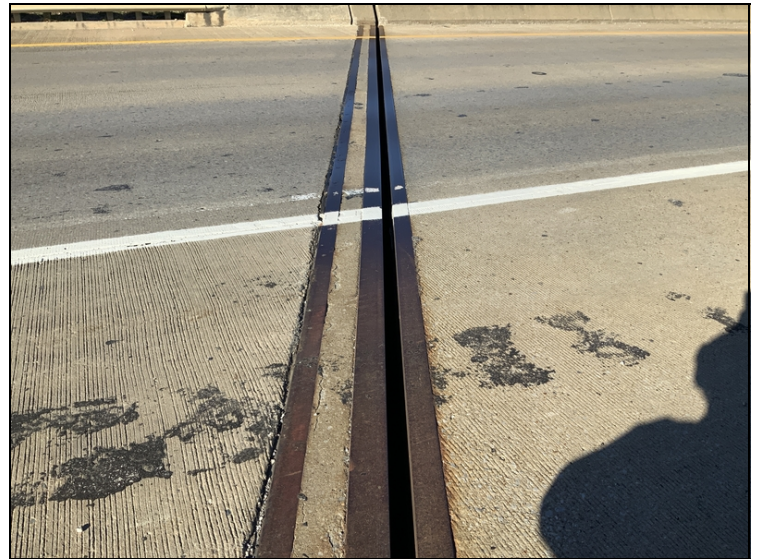
Bent 1 joint has fallen out.

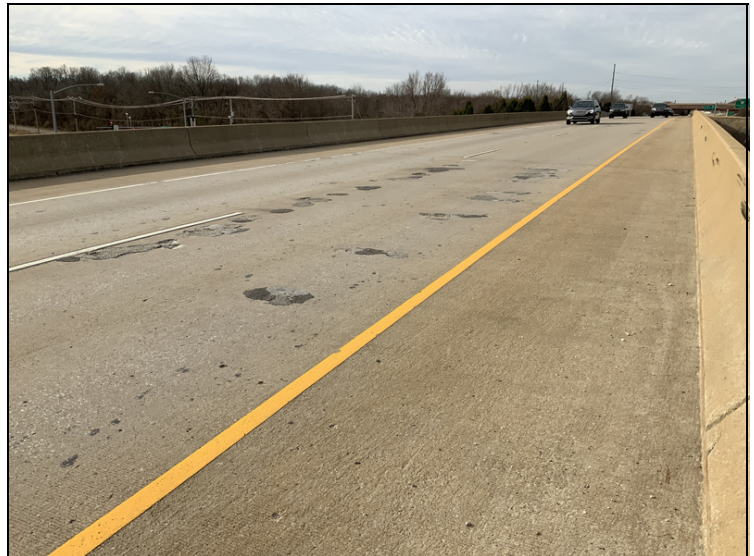
There are numerous spalls with exposed reinforcing steel that are visible on the driving surface of the deck.

Typical spalling with exposed reinforcing steel in spans 3 and 4 (Span 3 being the worst case).

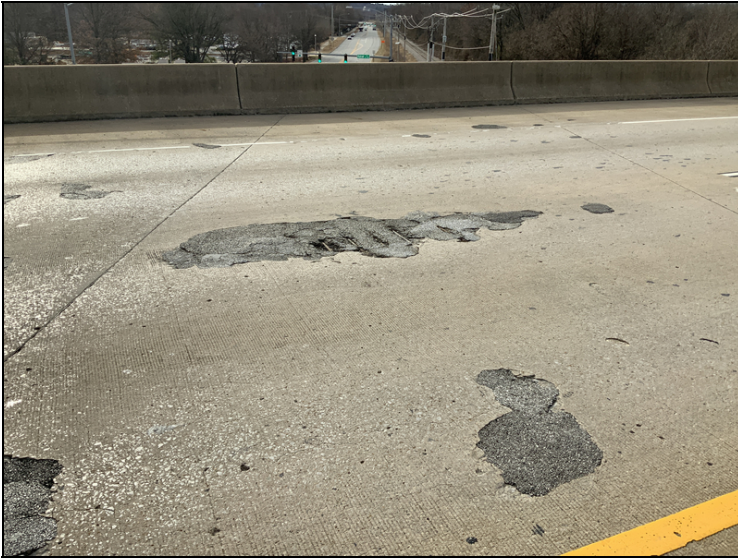
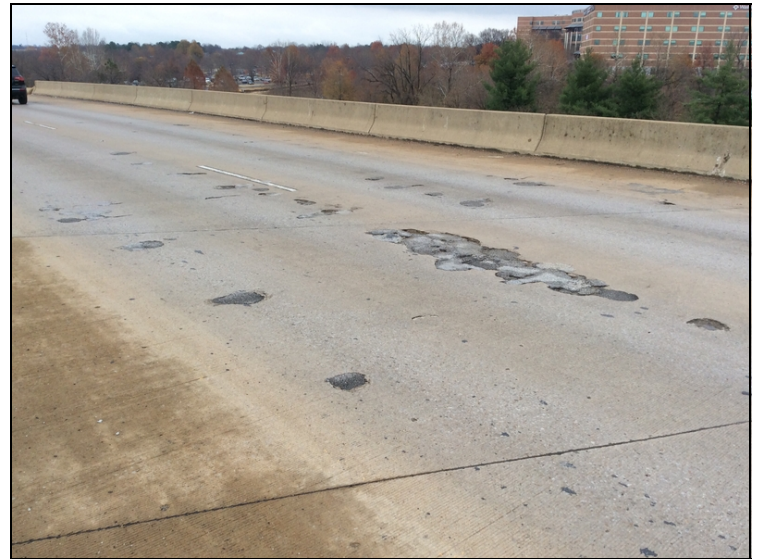
Spans 3 and 4 spalling with exposed reinforcing steel.

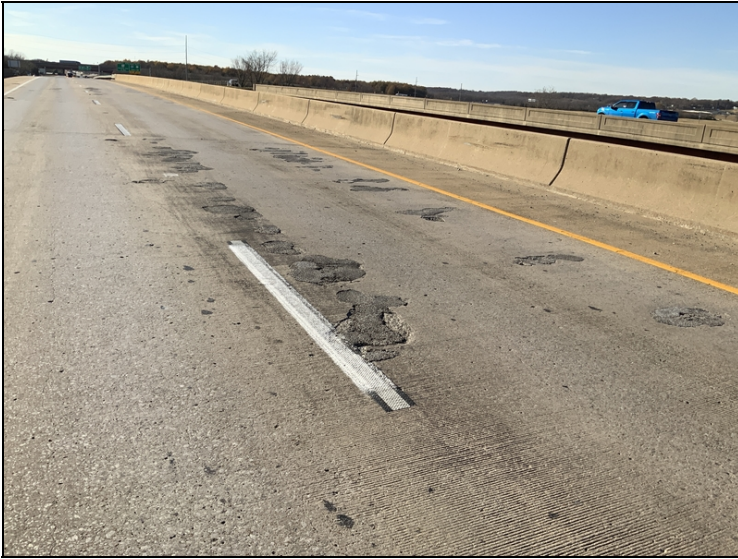
Span 4, several spalls and failing patches.

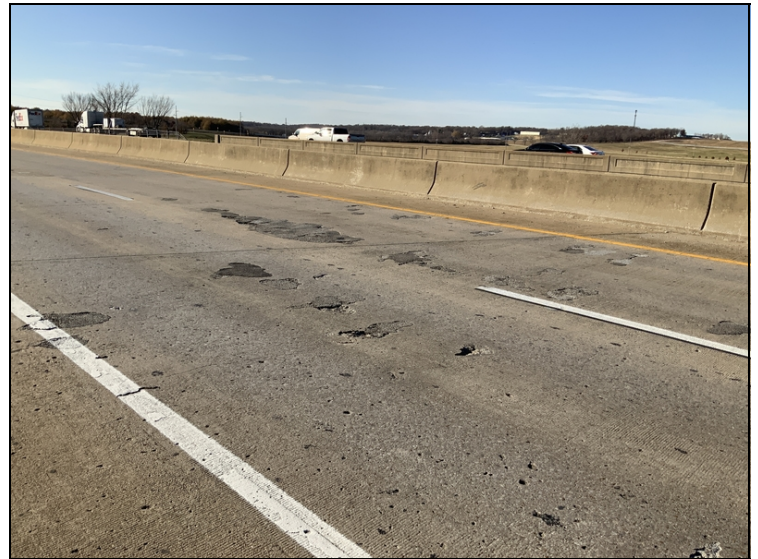
Span 3, spalls and failing patches.

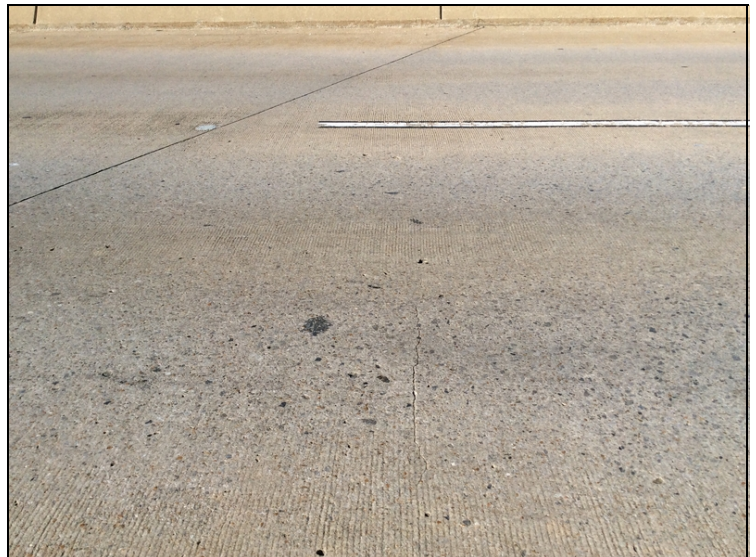
There are sealable transverse, diagonal, and map cracks visible from the driving surface of the deck.

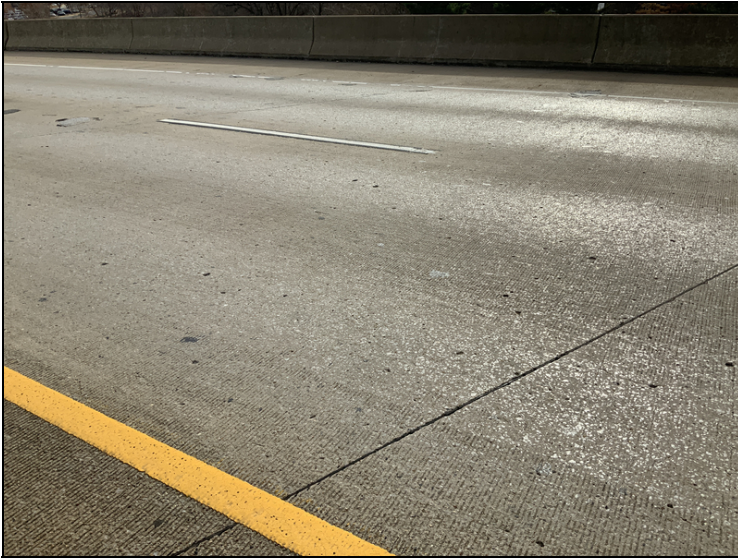
Typical seal-able deck cracking throughout the structure.

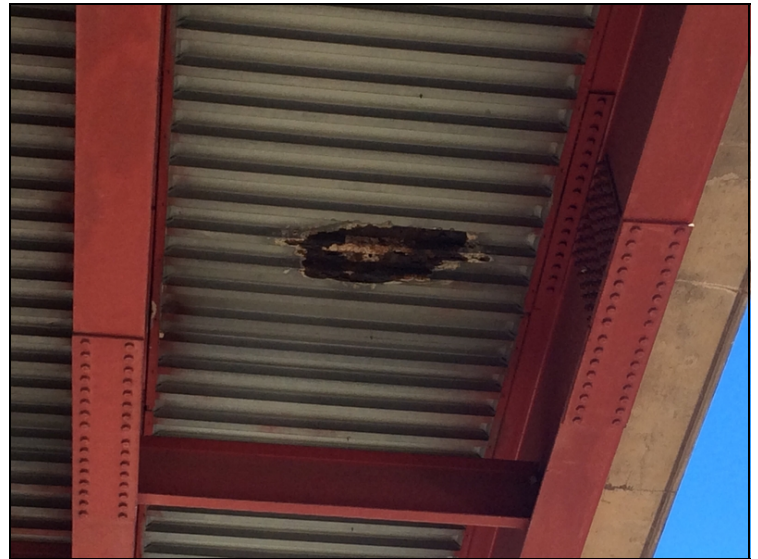
The metal SIP forms have areas with active corrosion at Span 2, Bay 5.

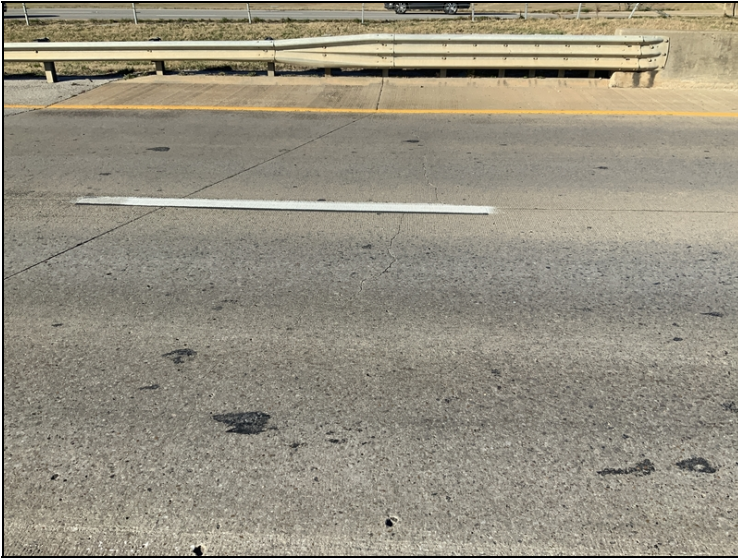
West approach slab, large transverse cracks.
