Bridge #A0698(Routine)

US 71 B, NB LNS over Mud Creek-Washington

Location: 1.98 MI N INT 71 & 71B

Team Lead: Bob McEntyre Inspection Date: November 08, 2021

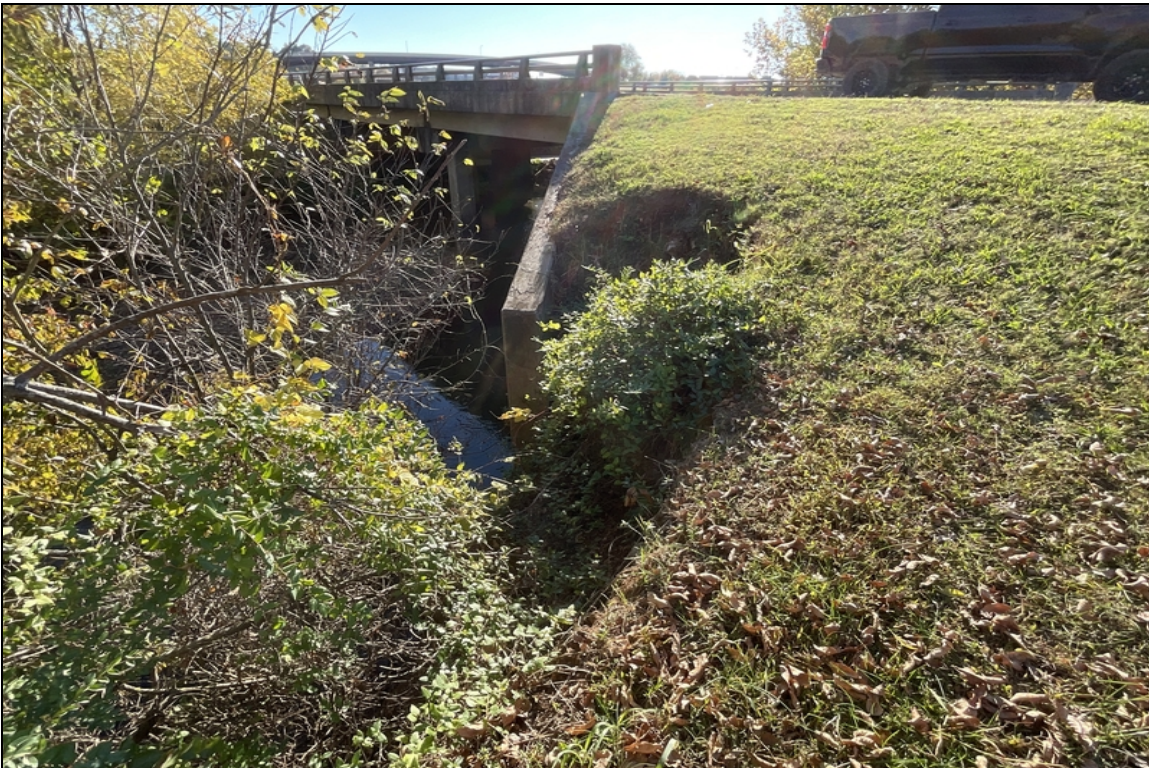
Embankment erosion behind abutment # 2 right wing wall due to lateral stream migration.

Streambed material accumulation in upstream channel appears to be causing lateral stream migration and directing channel flow into abutment # 2 causing scour along the abutment exposing the top and approximately 16" of the vertical face of footing at the inlet end. The Northeast embankment has erosion that has caused loss of embankment material behind the right wing wall at abutment # 2.

11/08/2021 - RSM & SPC: Routine Inspection conducted this date. See element notes for documentation. NBI Condition Rating for item "61" lowered from "7" to "6" due to lateral streambed movement with embankment erosion.

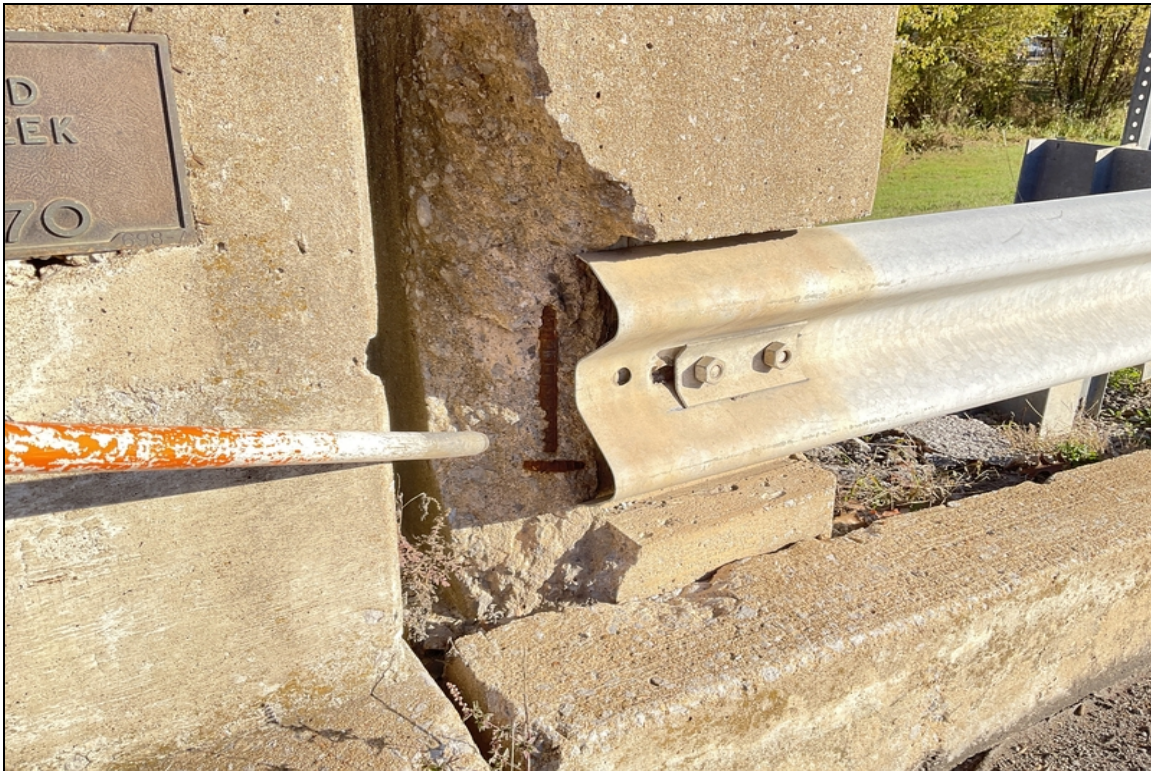
The Southeast approach railing end post on the right side of abutment # 2 has apparent collision damage that has a large spalled area with exposed reinforcing steel.

The Southeast end post has concrete spalling with exposed reinforcing steel at the approach guard railing attachment. No apparent section loss to the exposed reinforcing steel.

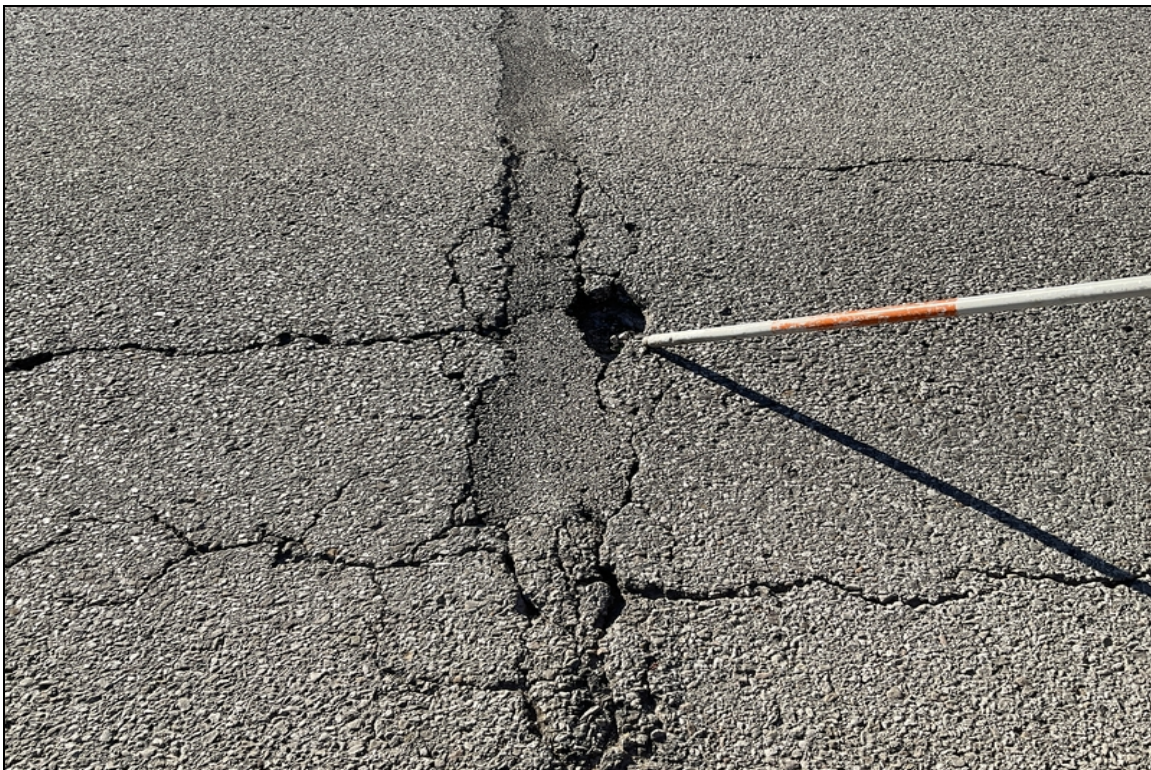
Pothole forming in asphalt driving surface in left lane at abutment # 1.

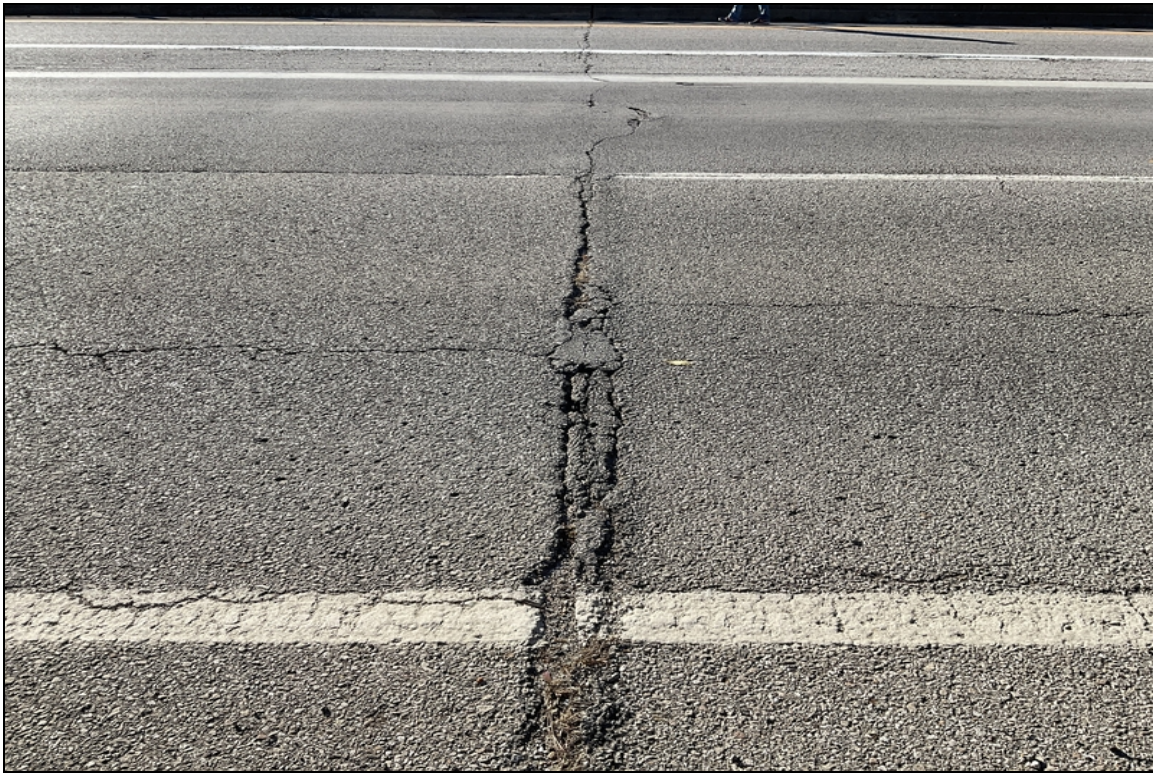
Asphalt cracking over bent 2.

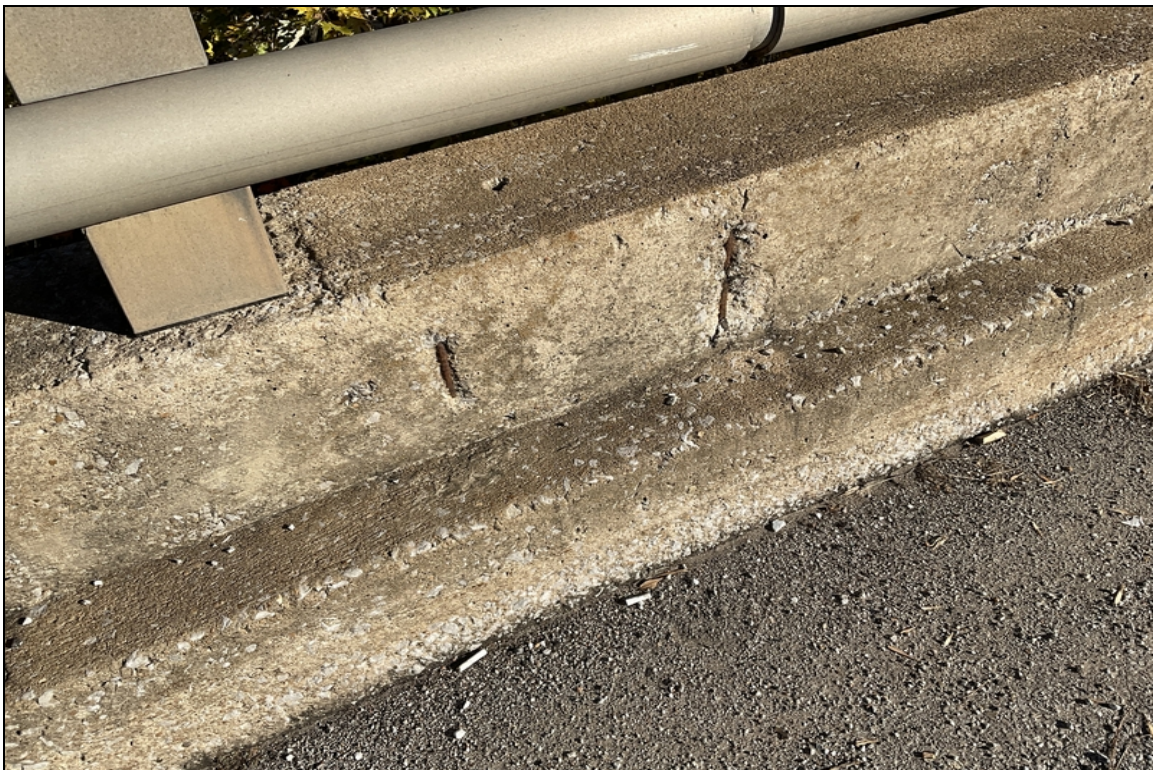
(331) -Numerous shallow spalls with exposed reinforcing steel. -Areas with soft deteriorated concrete in the top of the curb.

Span 2, left railing-Shallow spalls with exposed reinforcing steel.

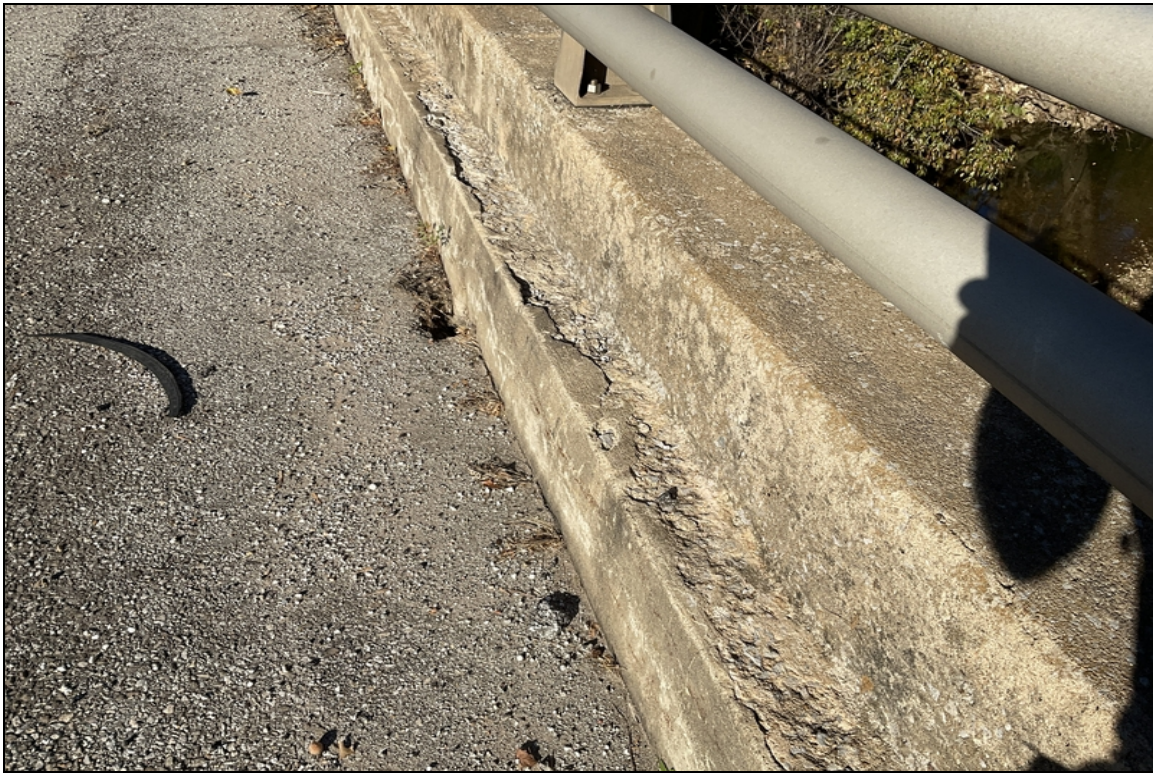
Span 3, left railing-Concrete deterioration.

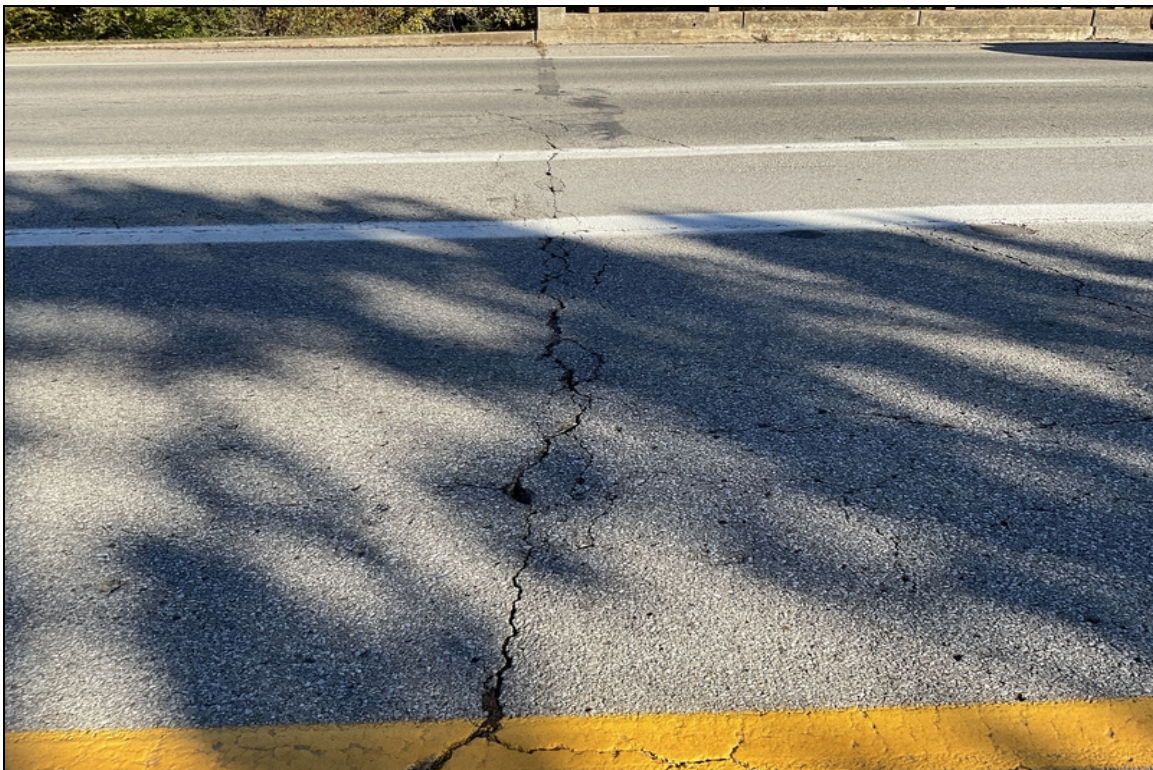
Asphalt cracking over abutment 2.

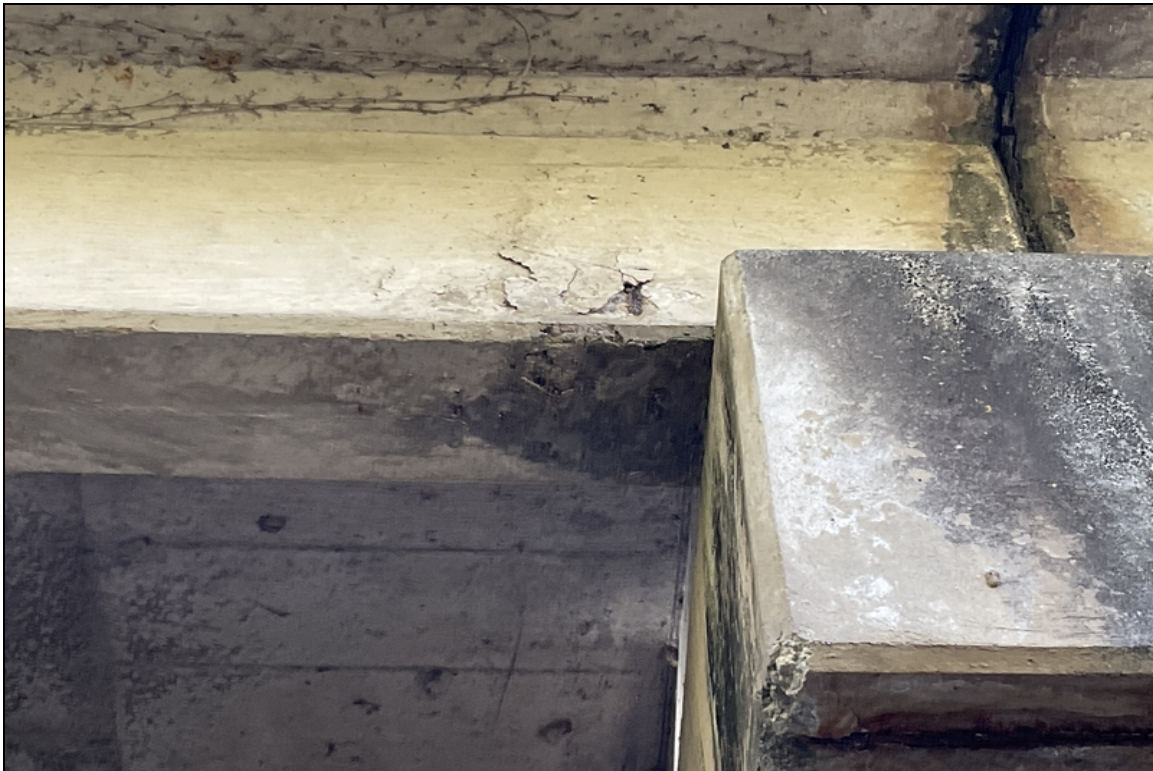
Span 2, girder 10-Spall / Delaminated areas

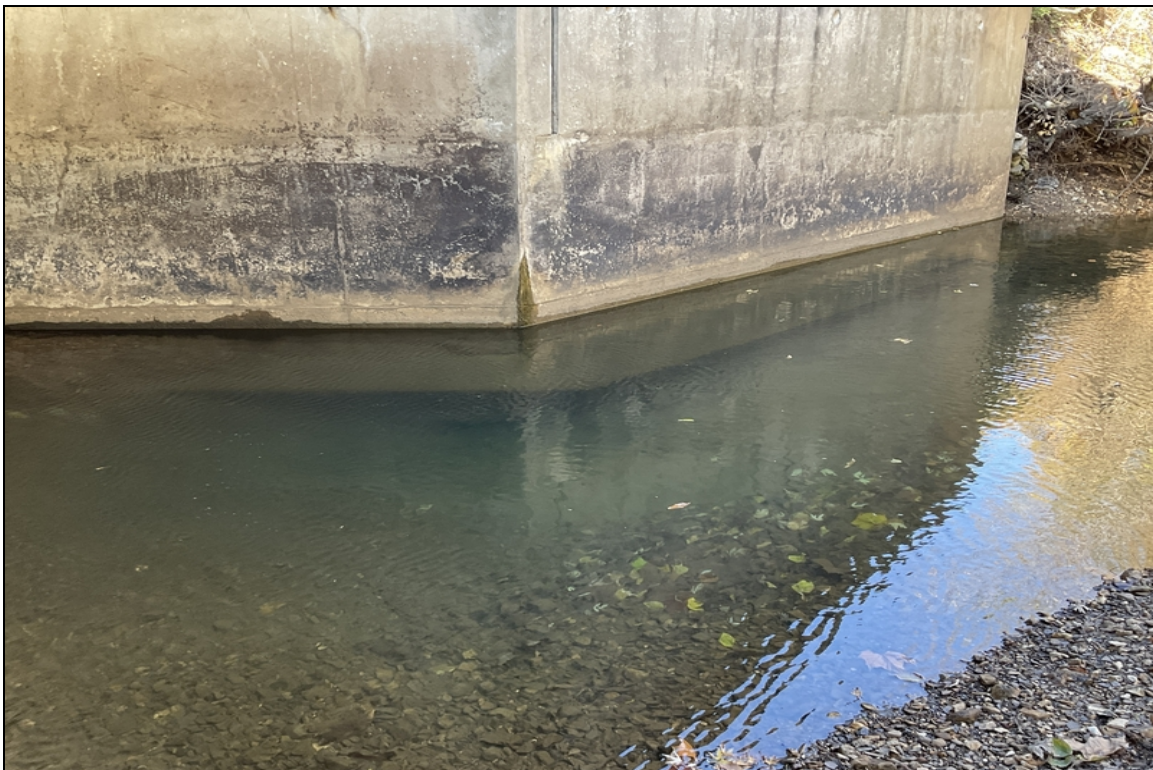
Abutment 2, right side-Footing exposed.

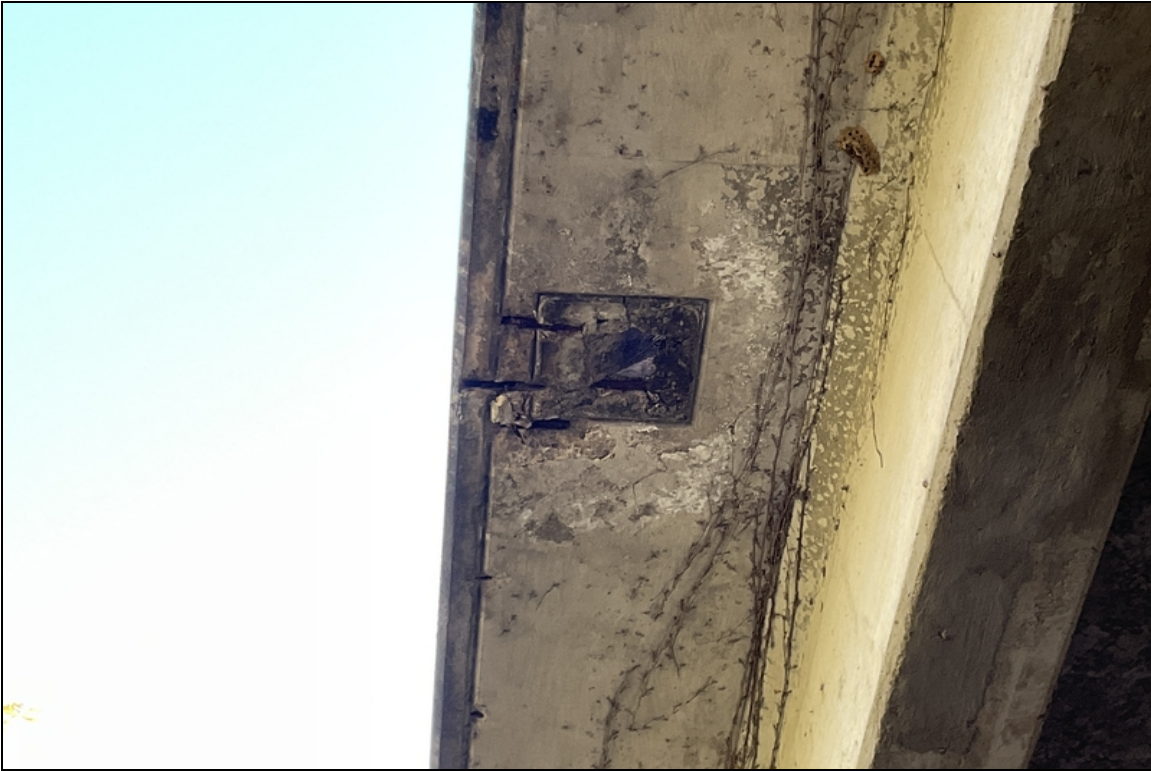
Span 2, right side-Spalling with exposed reinforcing steel adjacent to deck drain.

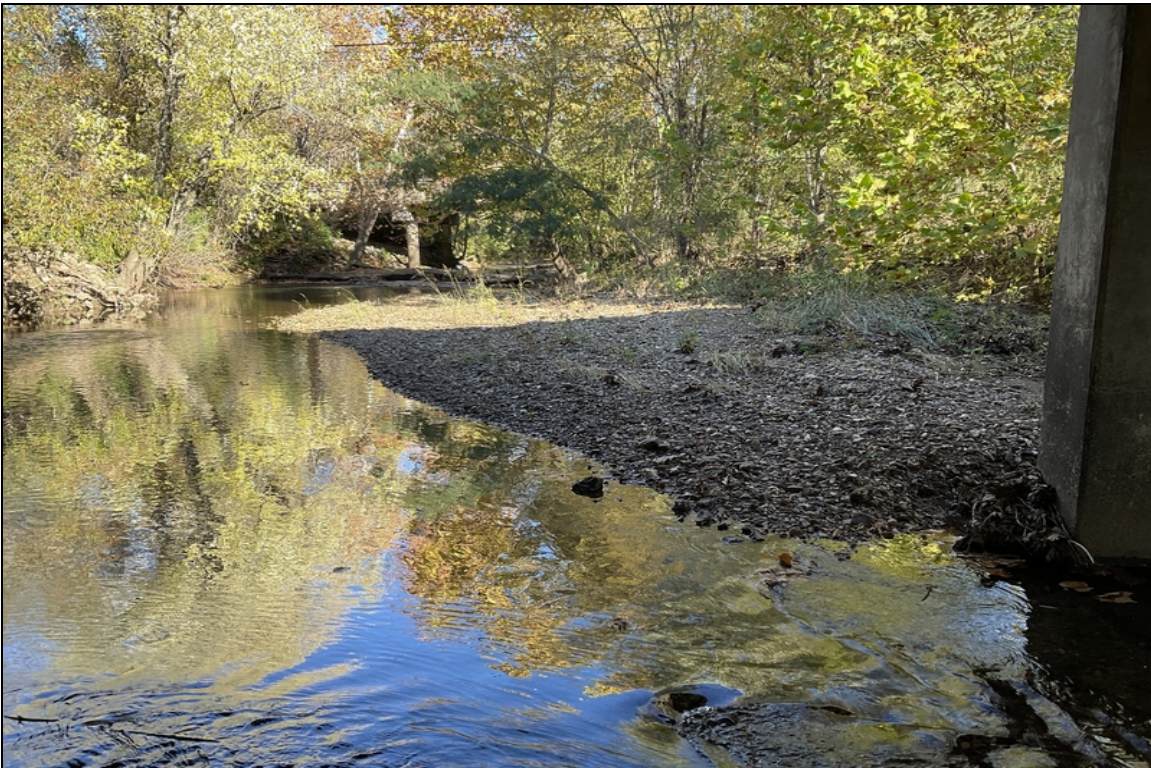
Streambed material accumulation in upstream channel is causing lateral stream migration and directing channel flow into abutment # 2 causing scour along the abutment exposing the top and approximately 16" of the vertical face of footing at the inlet end.

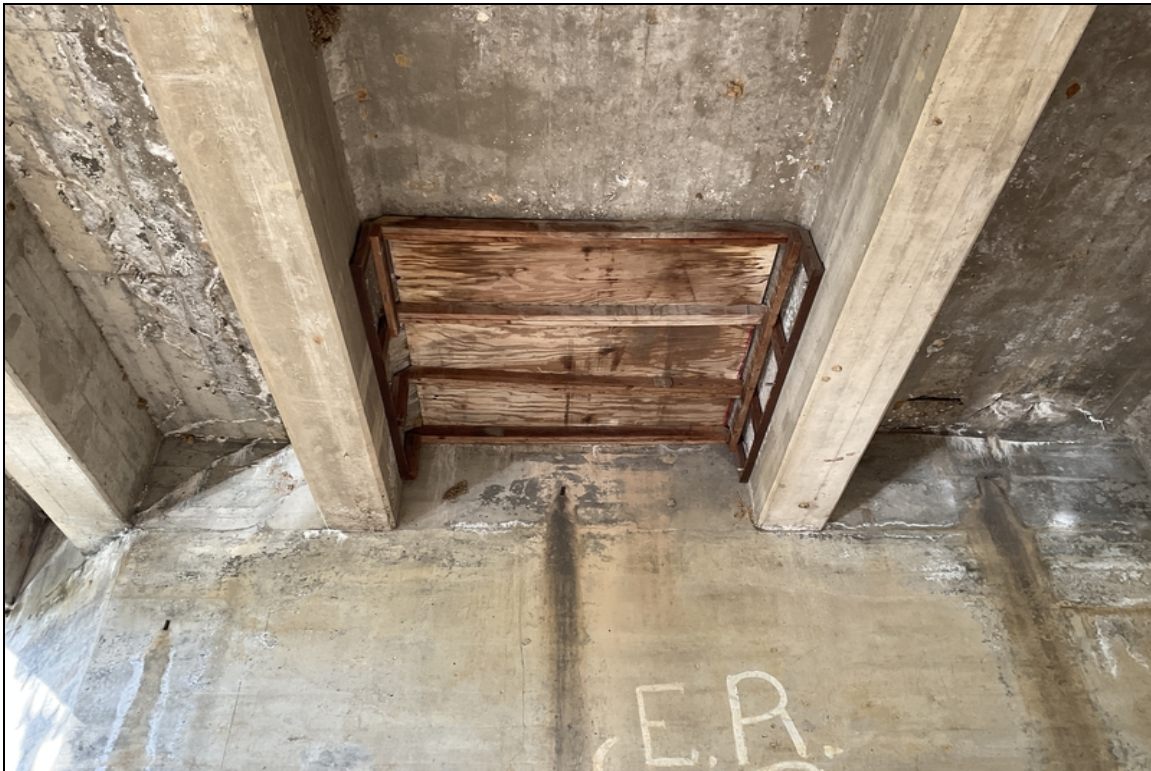
Span 3, bay 3 adjacent to abutment 2-Form work left in place.

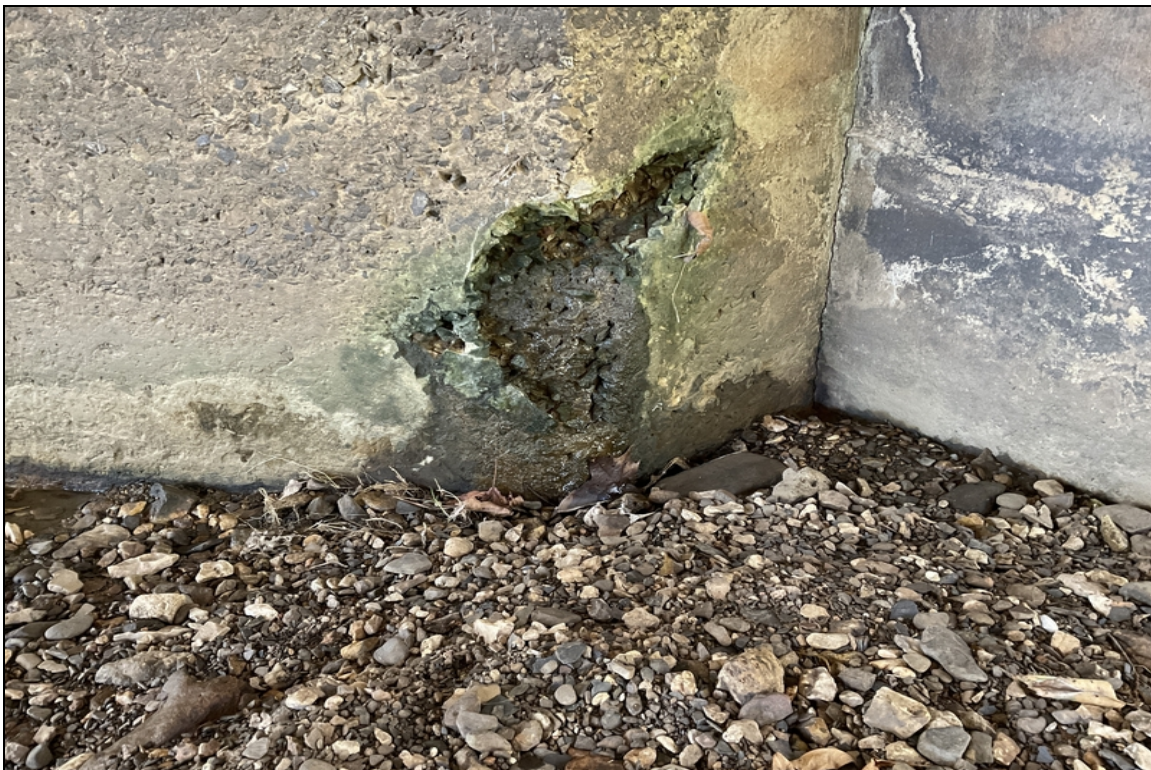
Abutment # 2-Concrete deterioration at base of stem wall near centerline.

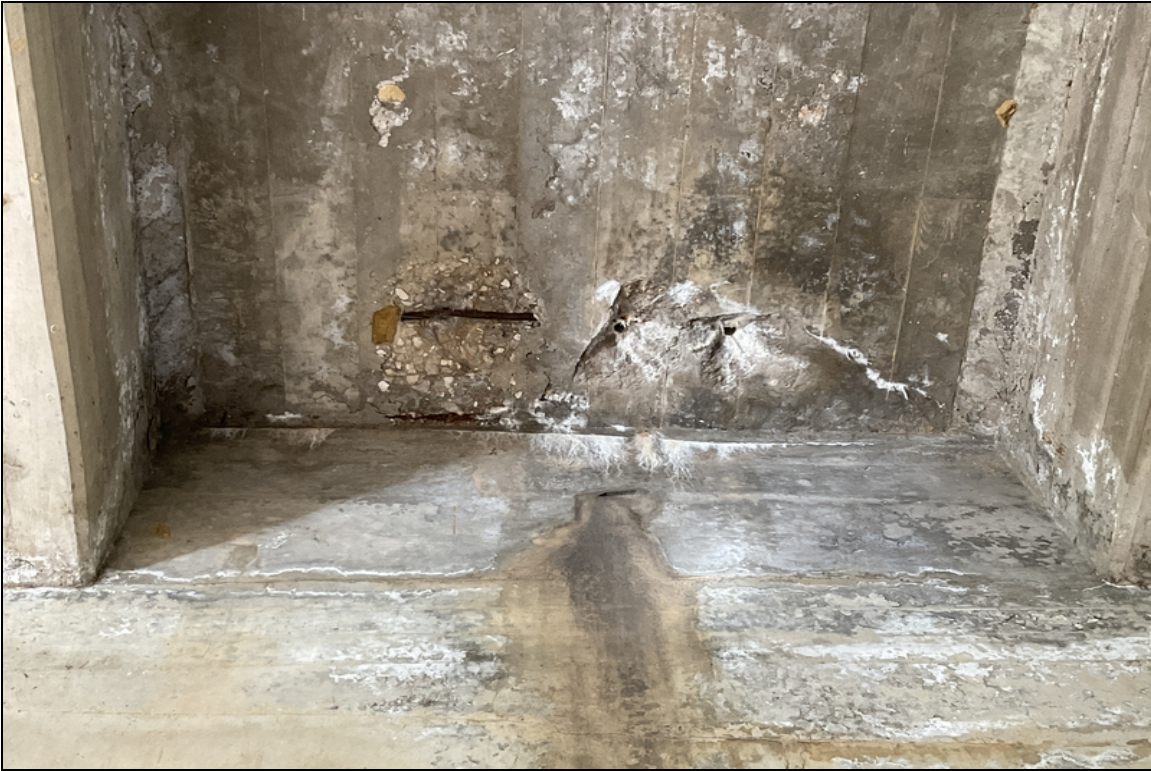
Span # 3, bay # 4 adjacent to abutment # 2-Spalling with exposed reinforcing steel.

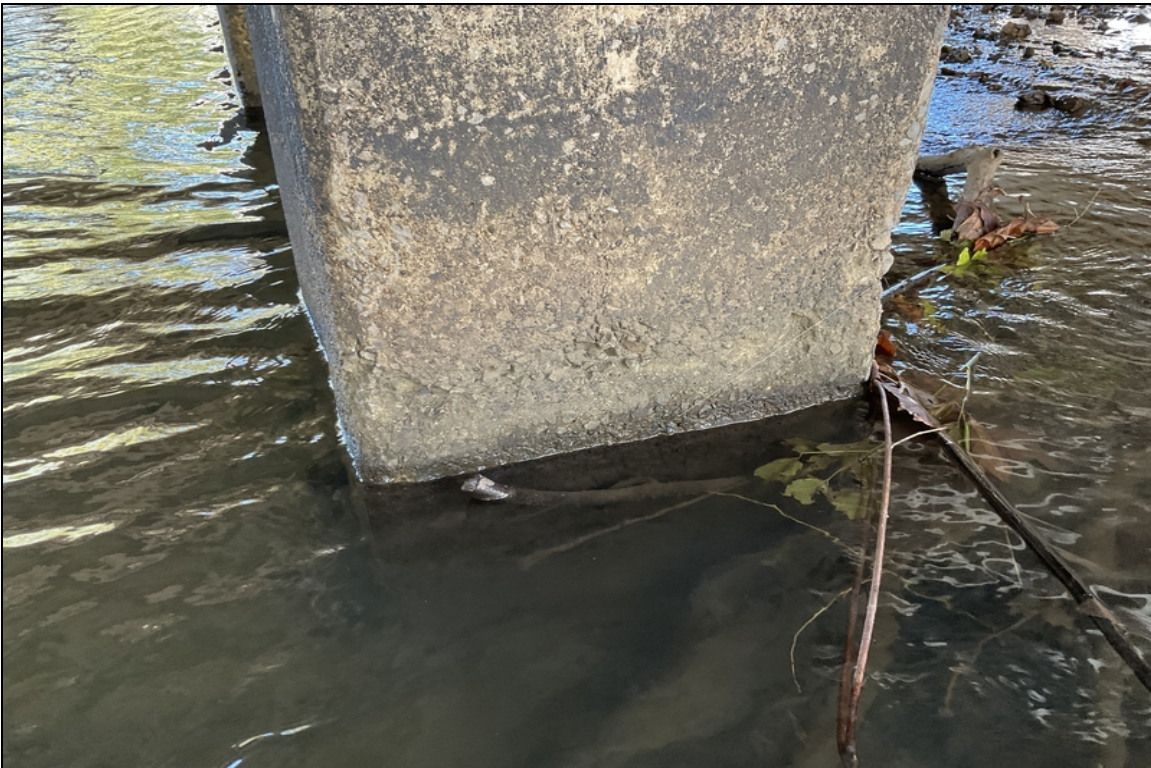
Bent 3, column 3-Abrasion / concrete deterioration.

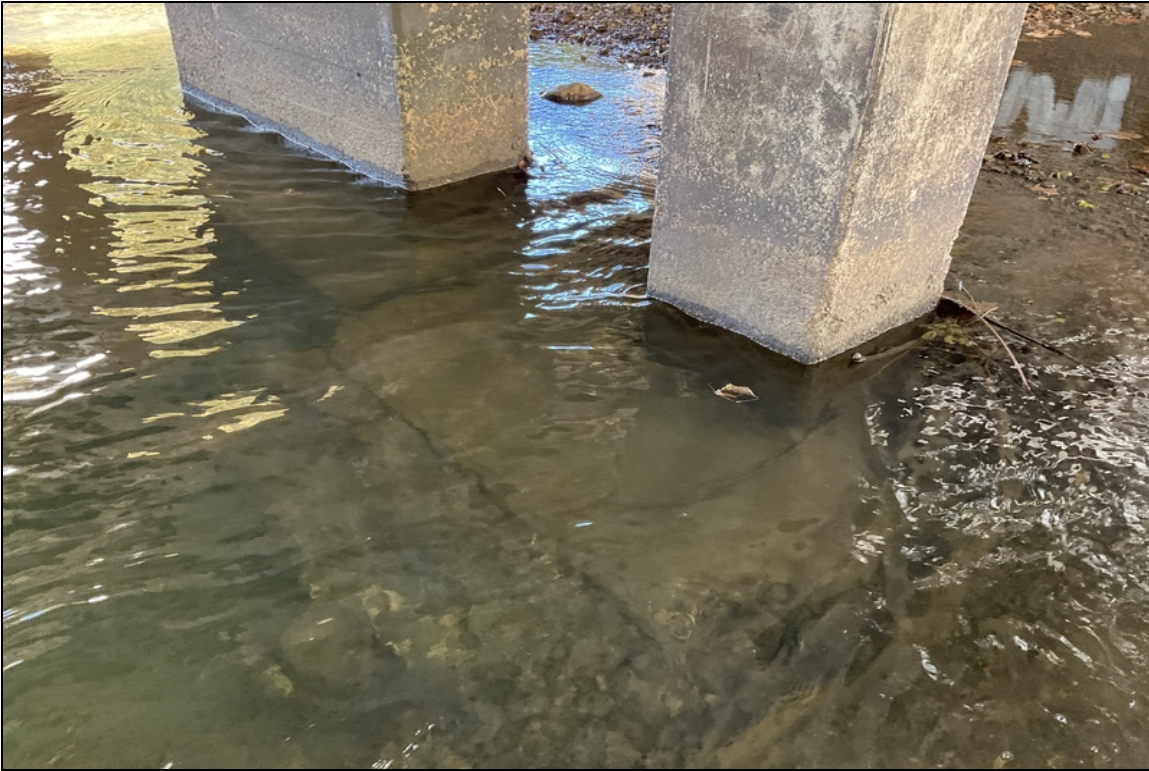
The footings for the portion of bent # 3 pier wall at centerline and column # 3 are exposed with approximately 12" of the vertical face of footings exposed at this inspection.

The top and approximately 12" of the vertical face of bent # 3, column # 3 and pier wall are exposed at this inspection.

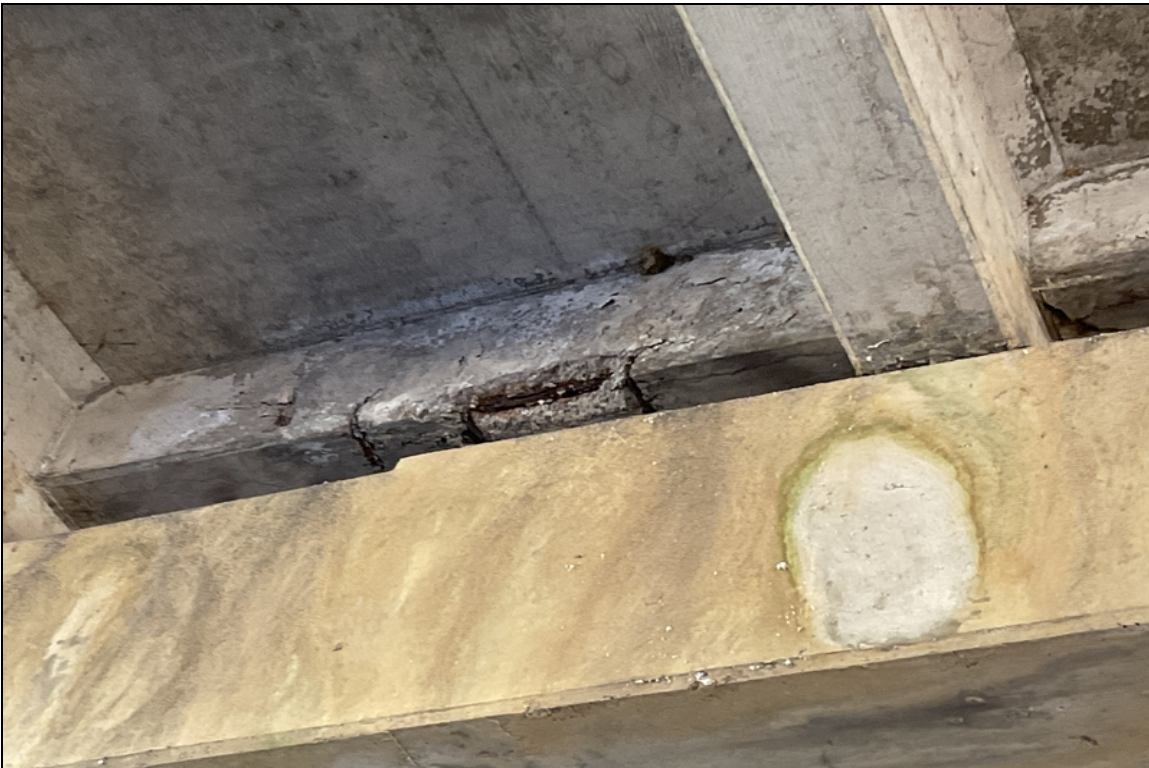
Span 2, bay 8 over bent 2-Spalling with exposed reinforcing steel in expansion dam.

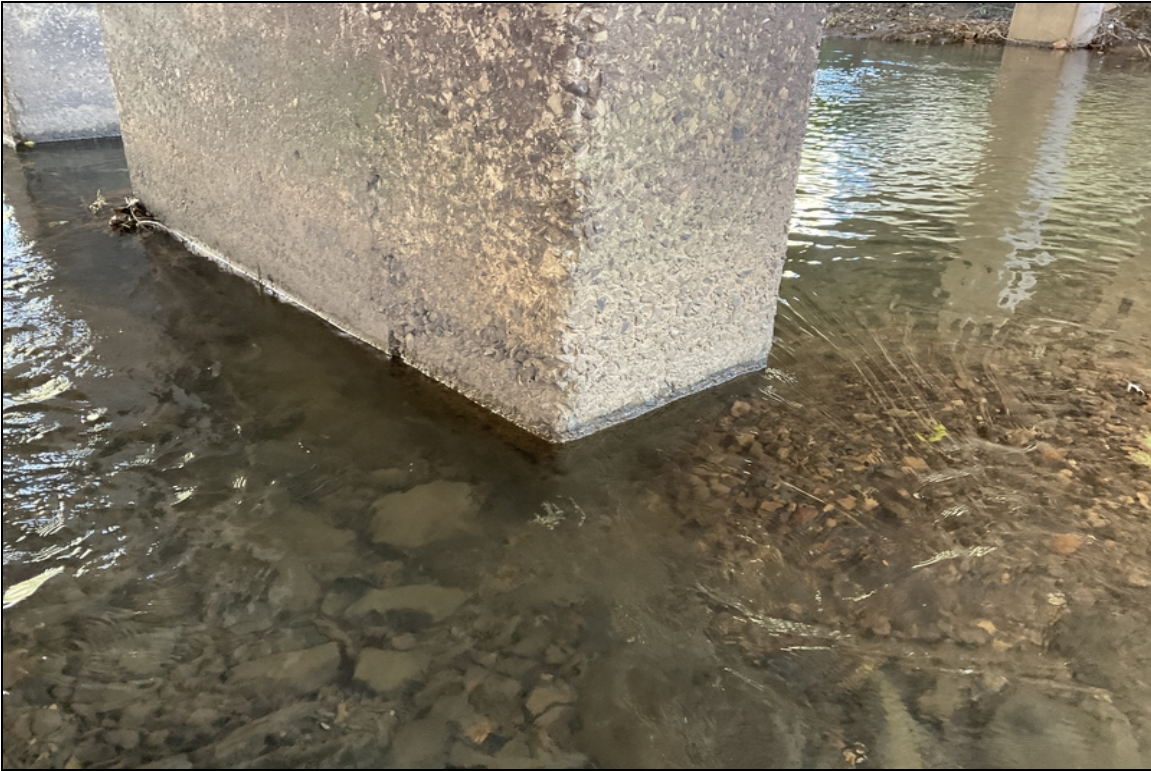
Bent 3, column 2-Abrasion.

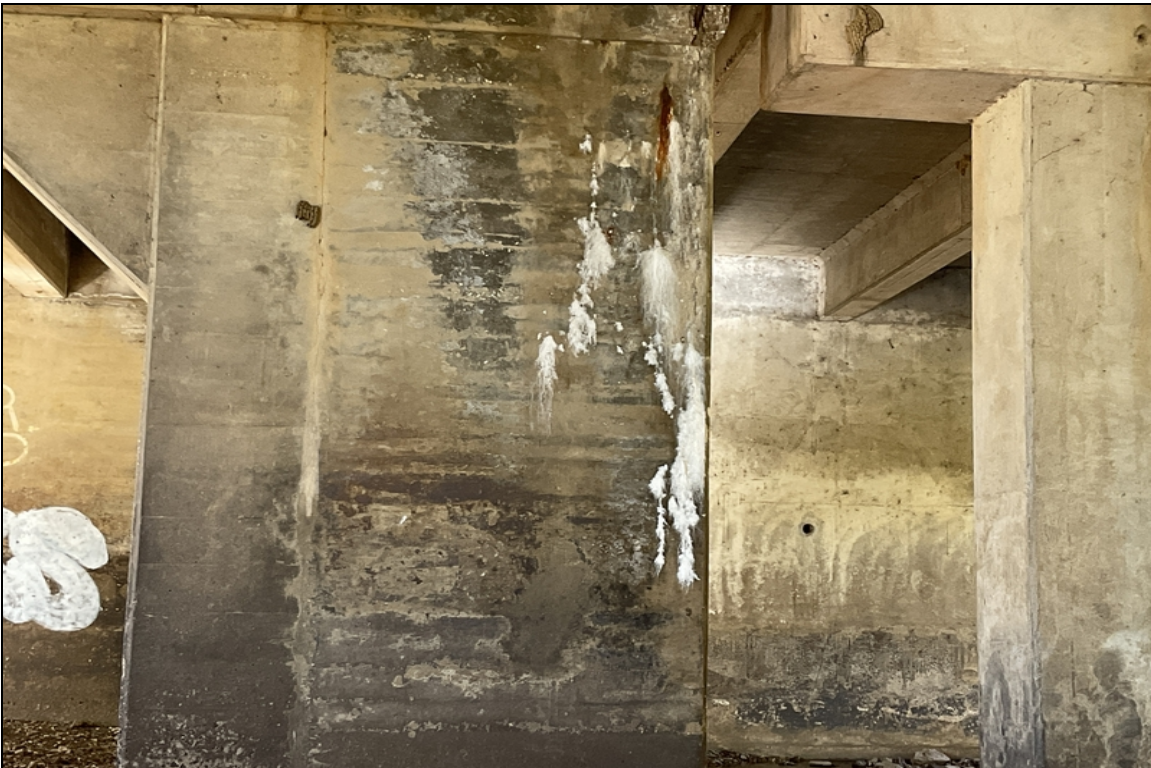
Bent 3 pier wall at centerline-Cracking with efflorescence.

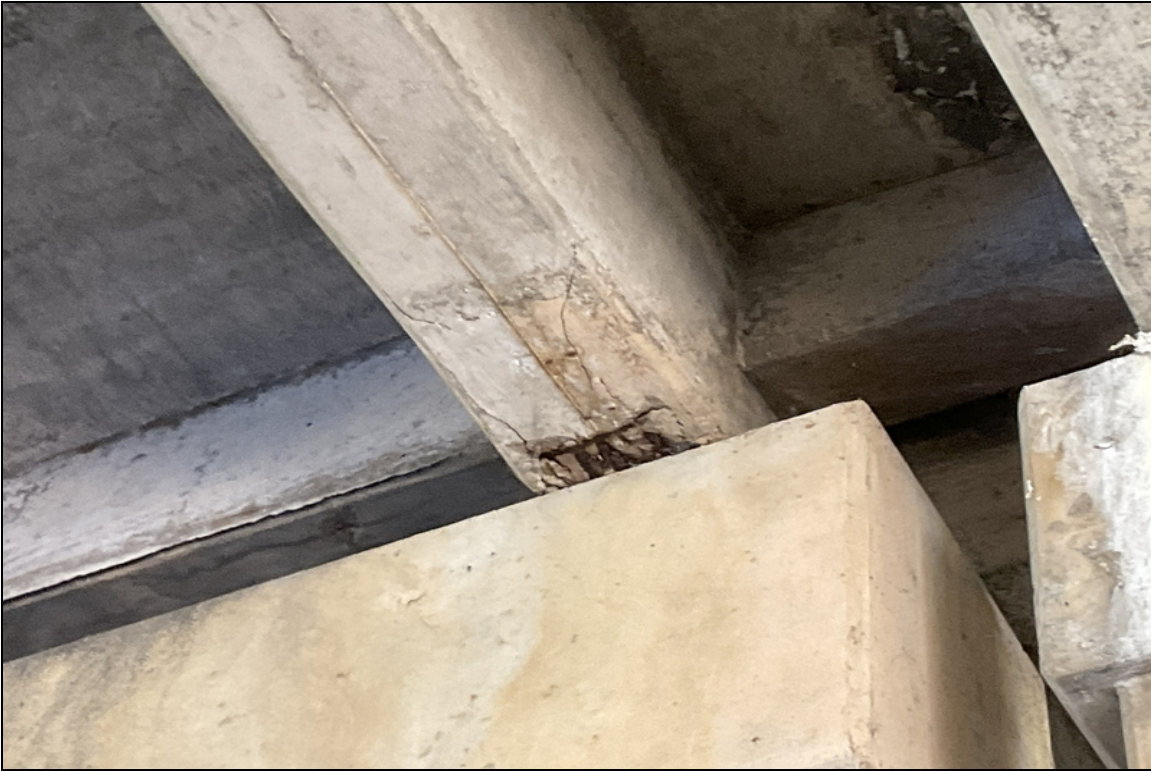
Span # 2, Beam # 7 has an 8" spall with exposed reinforcing steel adjacent to Bent # 2. There is a 10" Delaminated area adjacent to the spall.

Span # 2, Beam # 7 has a softball sized spall with exposed reinforcing steel adjacent to Bent # 2.

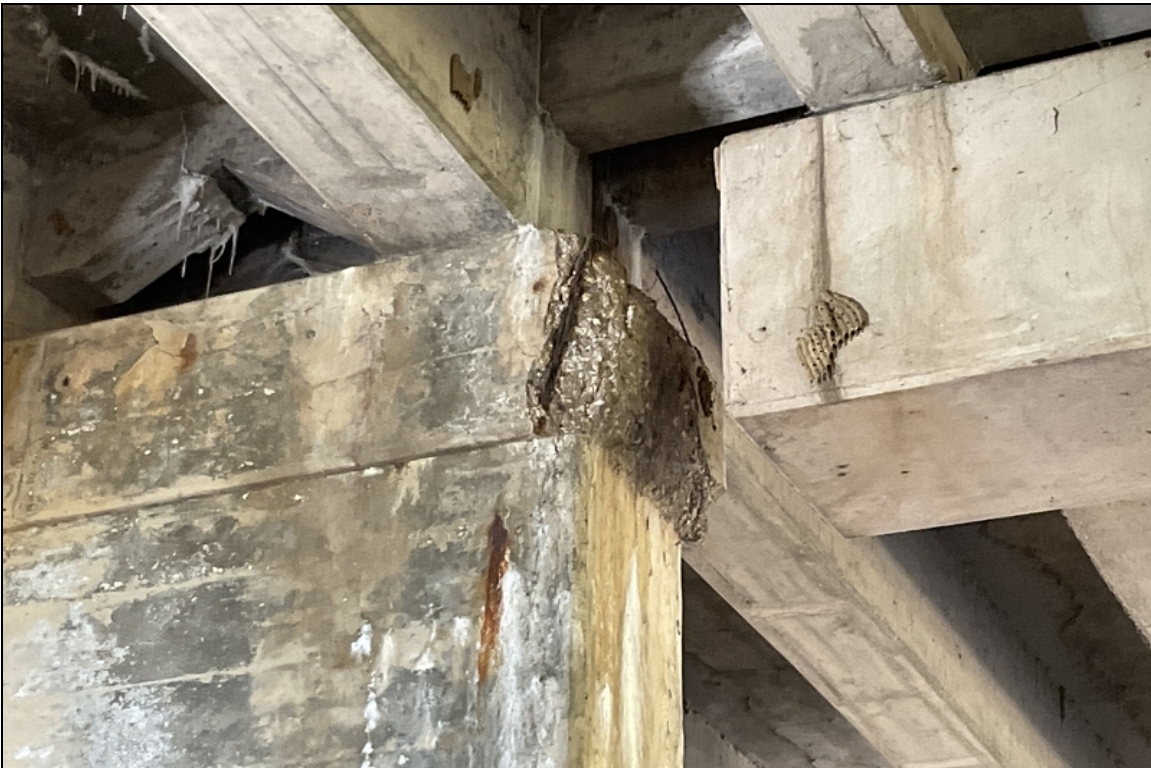
Bent # 3 cap-Spalling with exposed reinforcing steel at centerline.

Bent # 3 cap has soft deteriorated concrete with exposed reinforcing steel near centerline of roadway. Exposed reinforcing steel has active corrosion with flaking rust.

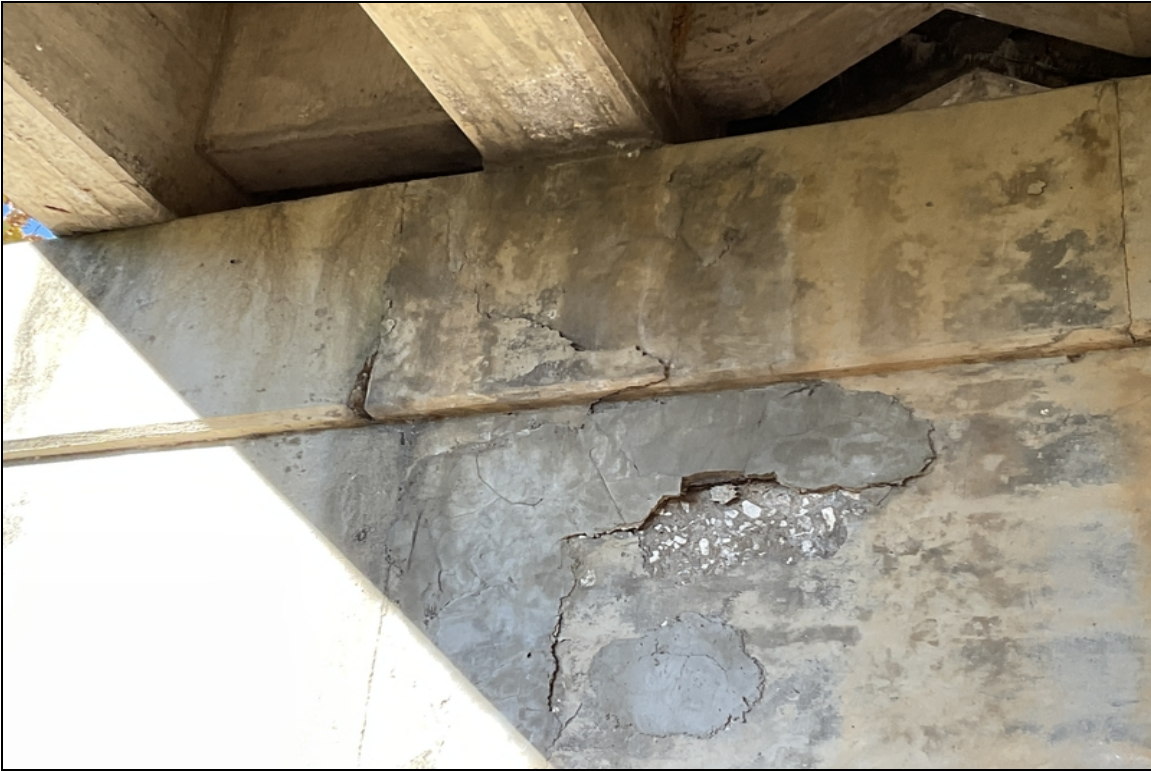
Bent 3, left side-Delaminated area in cap and spalling with failing repairs to pier wall backface.

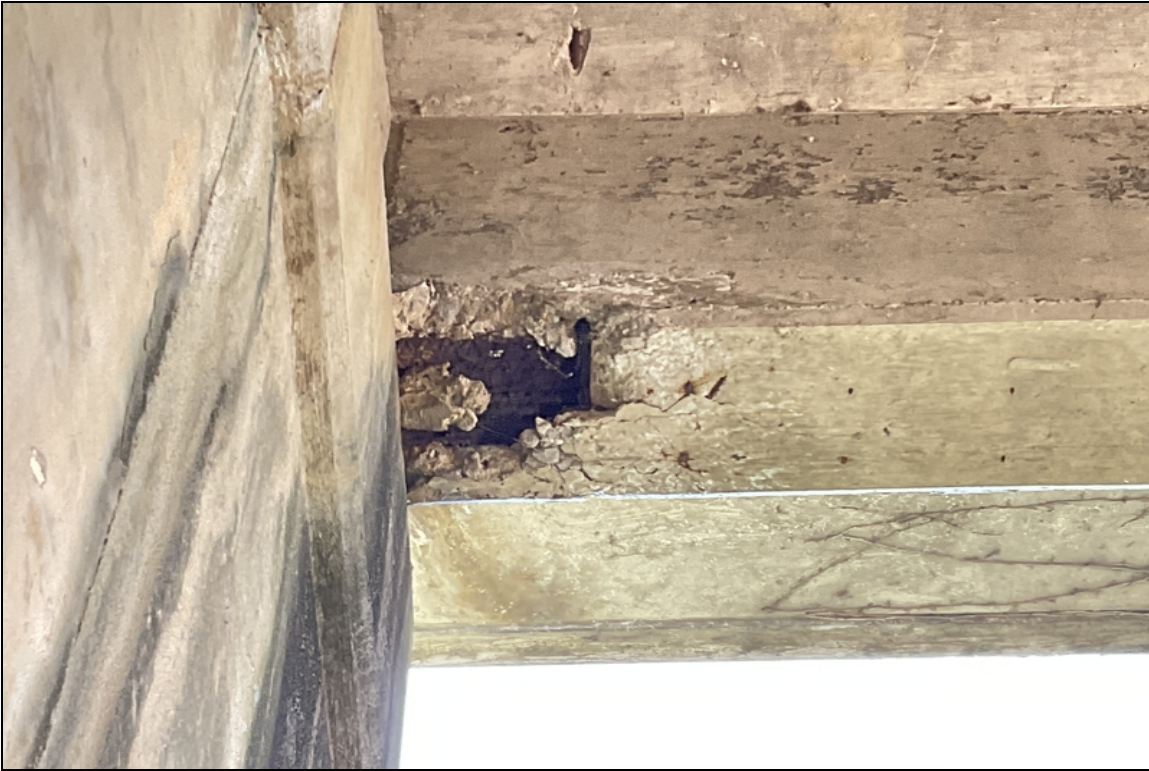
Span 2, girder # 1-Spalling in undersurface that exposes steel loading plate.

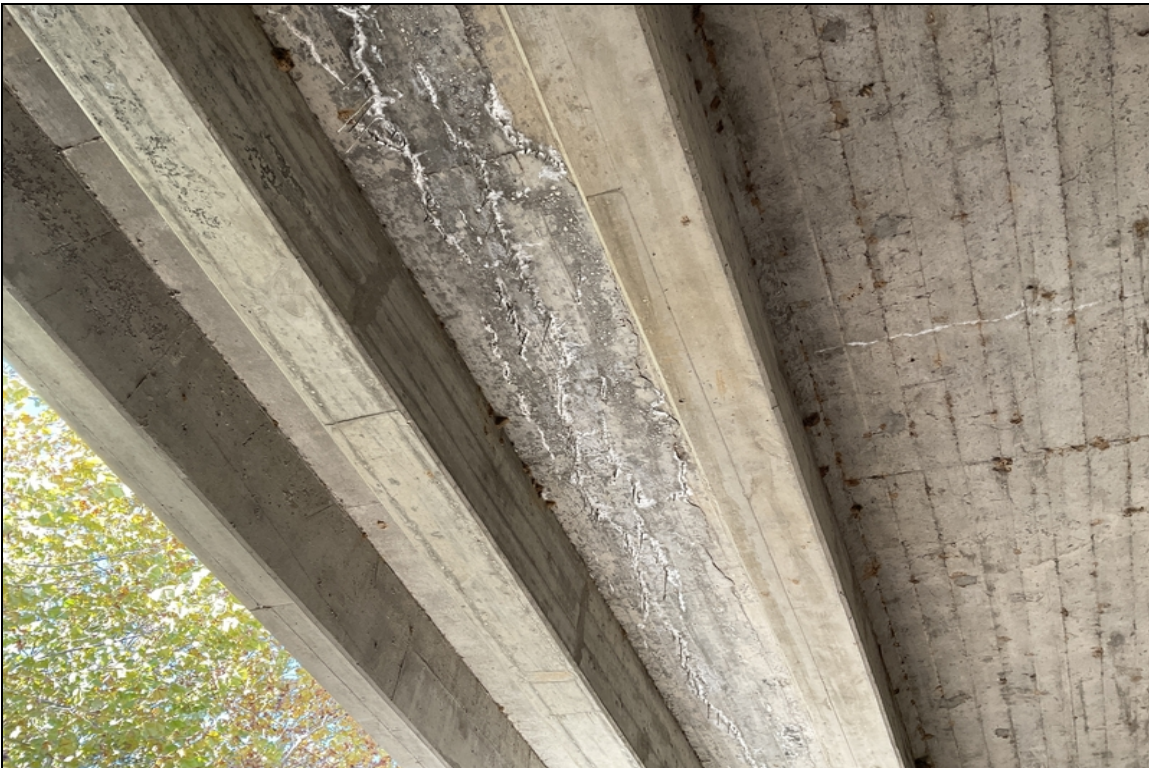
Span 2, bay 2-Cracking with efflorescence.

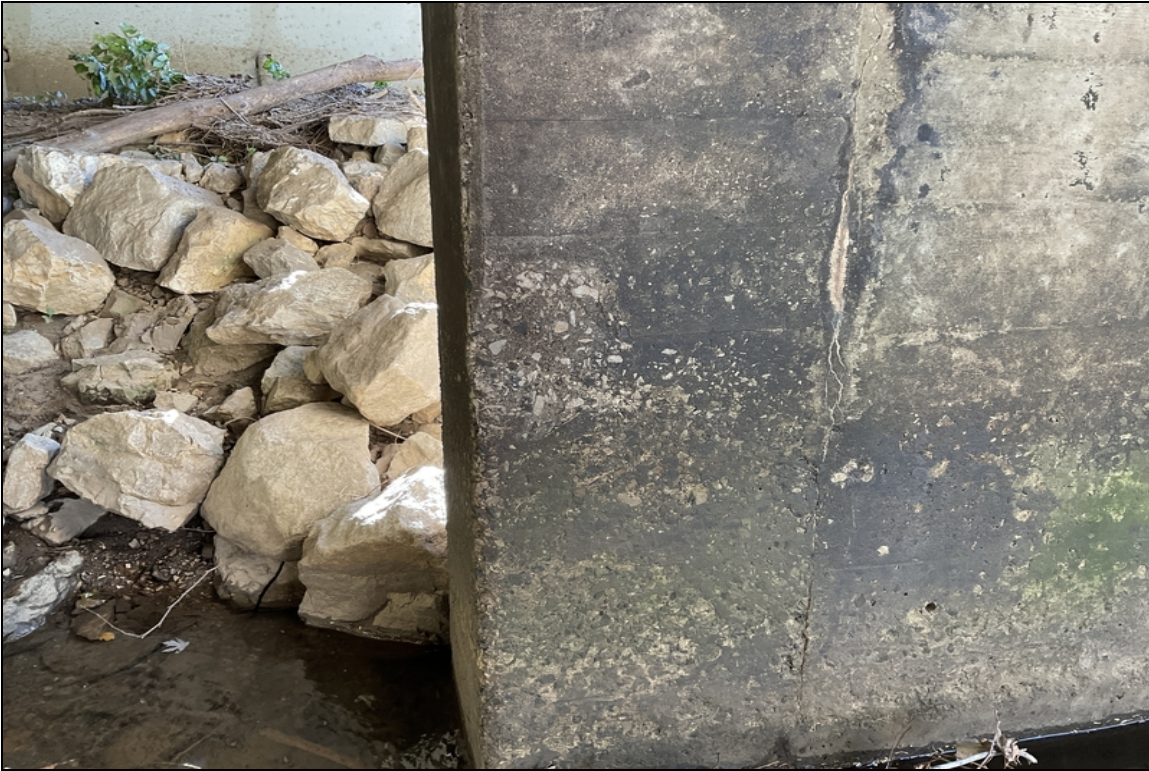
Bent 2, column 1-Shallow spall in ahead face.
