Bridge #A0698(Routine)

US 71 B, NB LNS over Mud Creek-Washington

Location: 1.98 MI N INT 71 & 71B

Team Lead: Bob McEntyre Inspection Date: November 08, 2021

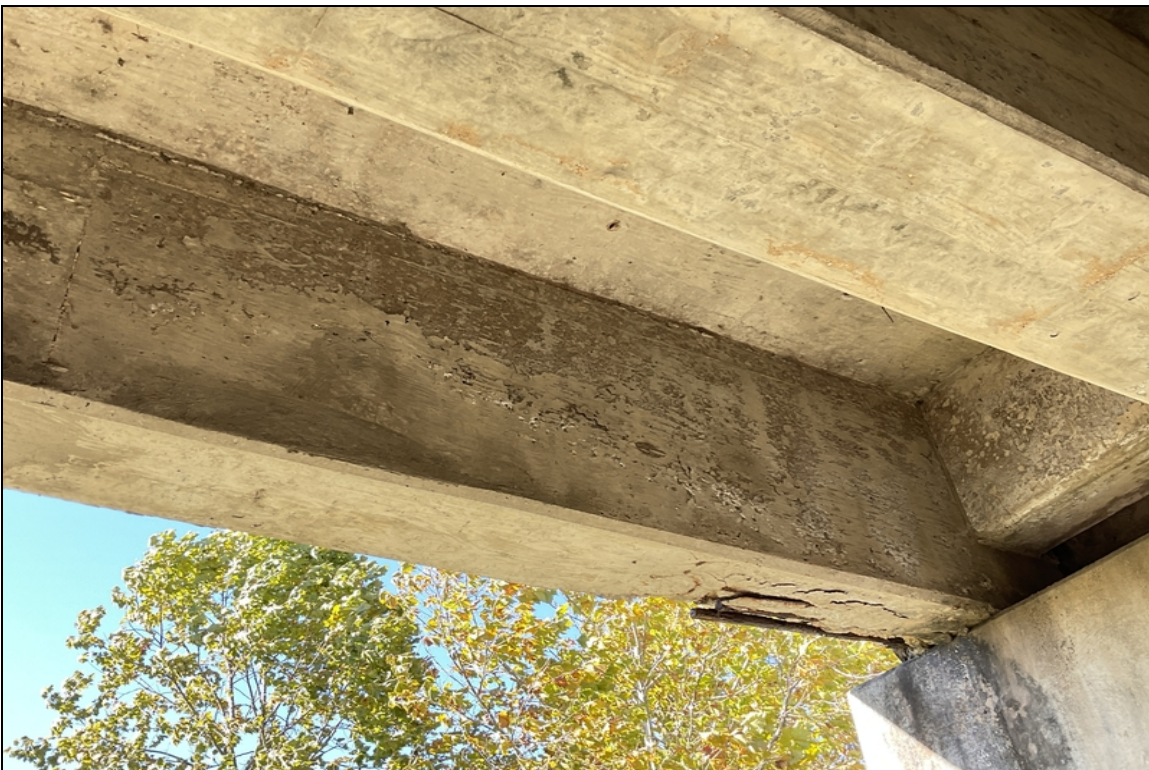
Span # 1, girder # 1 at bent # 2 has light scaling.

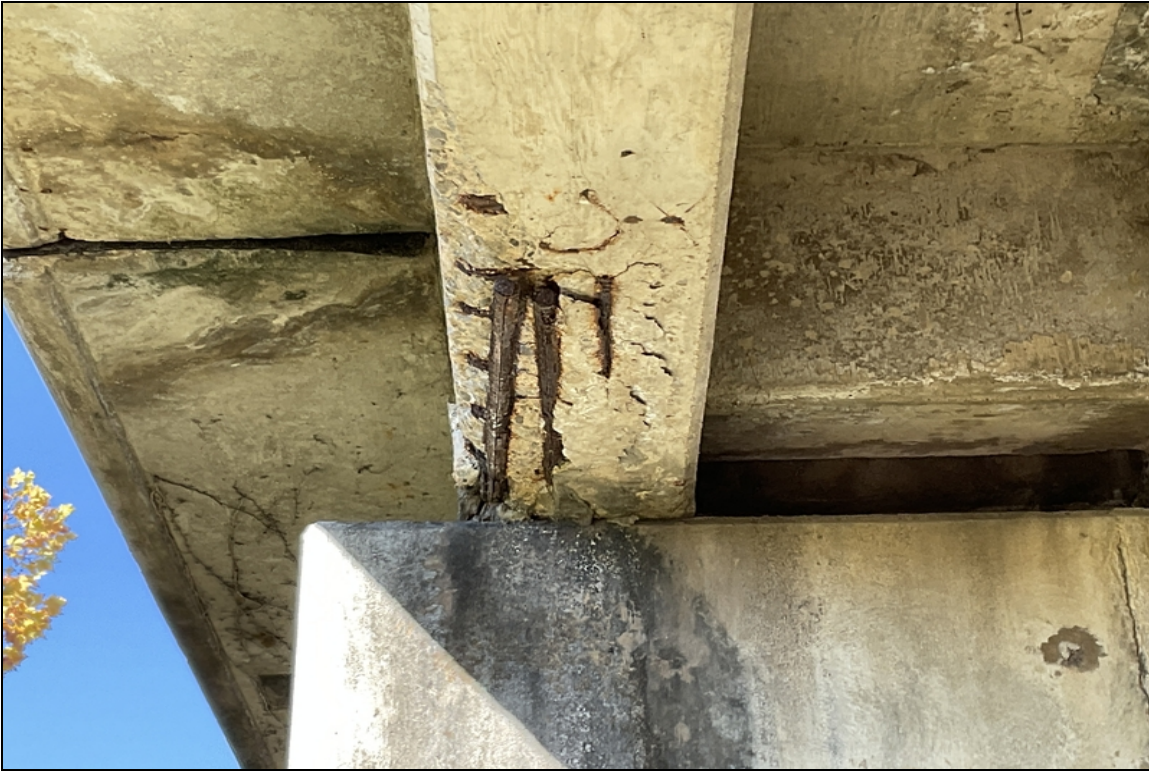
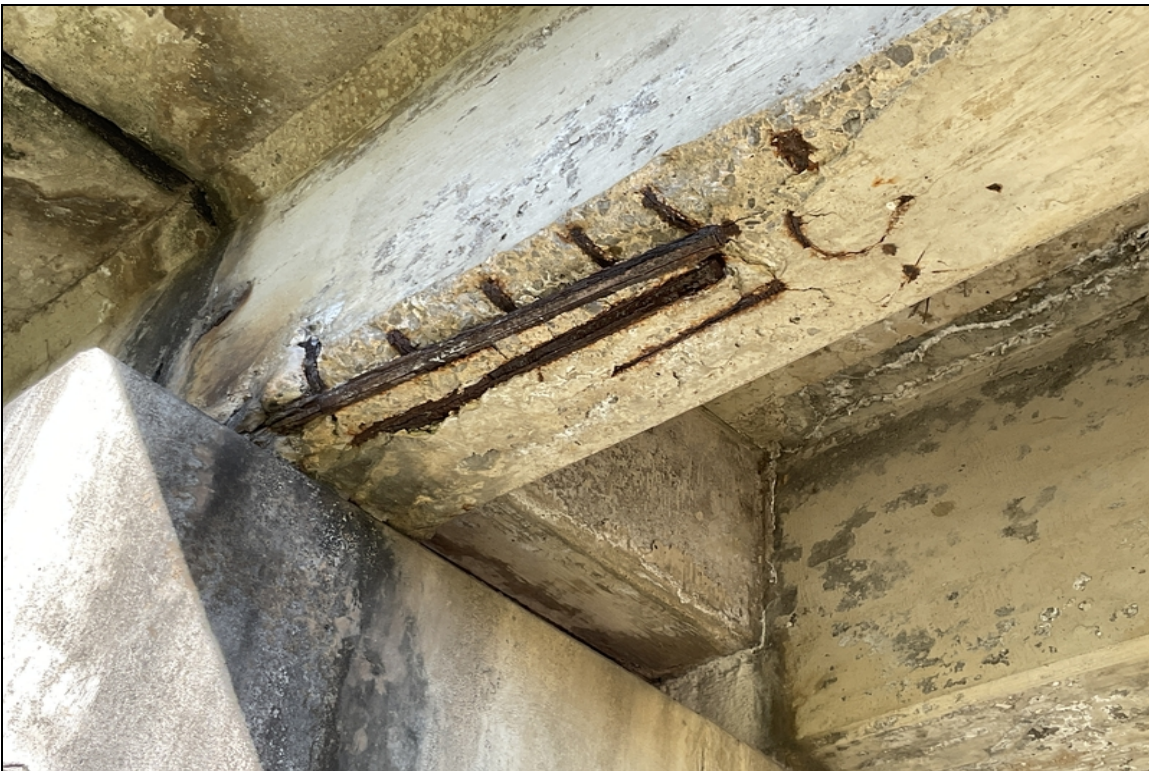
Span # 1, girder # 1 at bent # 2 has an area of spalling in the undersurface of girder that exposes 3 of the primary longitudinal reinforcing bars. The exposed bars appear to be short pieces of reinforcing steel that terminate approximately 30" from the bent. The interior of girder at bent # 2 has light scaling.

Span # 1, girder # 1 at bent # 2 has an area of spalling in the undersurface of girder approximately 30" long that exposes 3 of the longitudinal reinforcing bars that are incorporated into the bent cap for the fixed girder. There is a softball sized spall with exposed reinforcing steel in the exterior edge of Girder # 1 of span # 2 over the bearing area of Bent # 2 that exposes the internal loading plate.

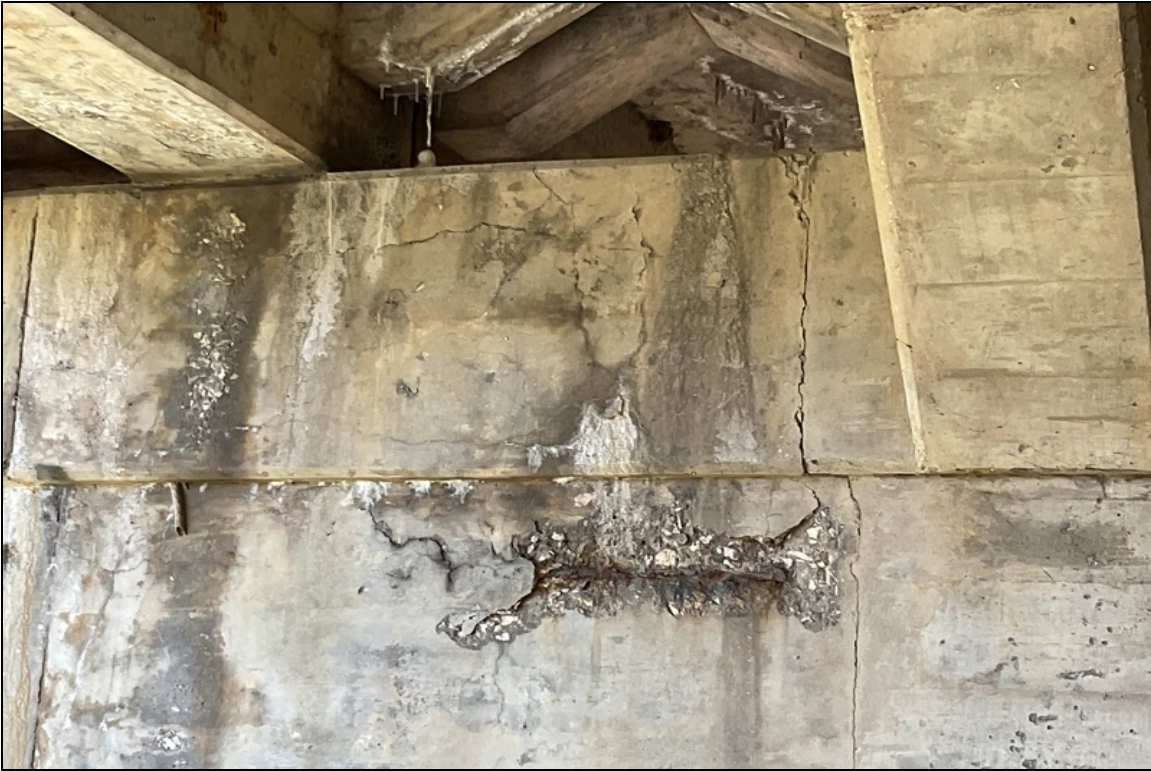
Bent 2, left side-Horizontal cracking in cap with spalling in pier wall.

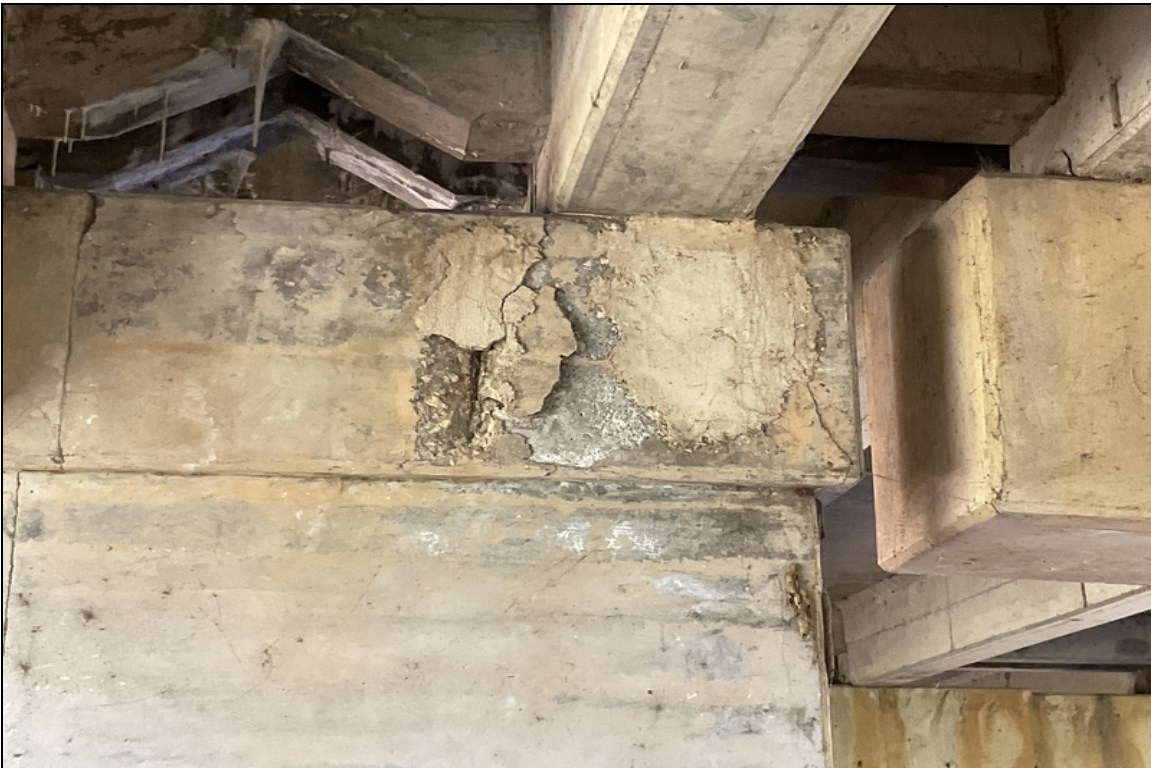
Bent # 2 cap has a 12" x 6" spall with exposed reinforcing steel in the backface under girder # 6 where a previous repair has failed.

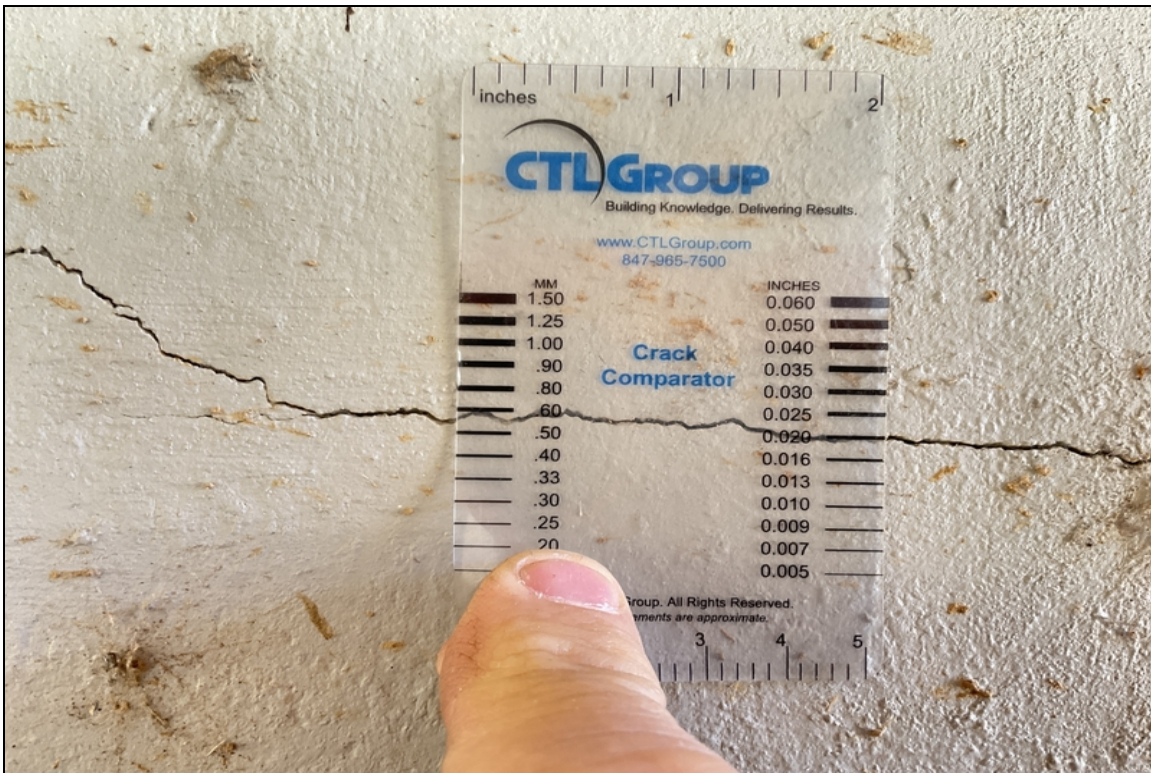
(215)	-The original portion of abutment # 1 left has a horizontal crack that measures 0.020" located approximately 7' above the ground elevation. -There is minor hairline map cracking in the exterior edges of the abutments. Abutment # 2: -The base of abutment # 2 has a 2' area with soft deteriorated concrete with up to 4" of concrete section loss located near the right side of the original portion of the abutment at centerline. -The base of abutment # 2 stem wall has light abrasion. -Streambed material accumulation in upstream channel appears to be causing lateral stream migration and directing channel flow into abutment # 2 causing scour along the abutment exposing the top and approximately 16" of the vertical face of footing at the inlet end. The Northeast embankment has erosion that has caused loss of embankment material behind the right wing wall at abutment # 2.						
220	Reinforced Concrete Pile Cap/Footing	LF	66	35	31	0	0

Abutment 1, left side-Horizontal crack.

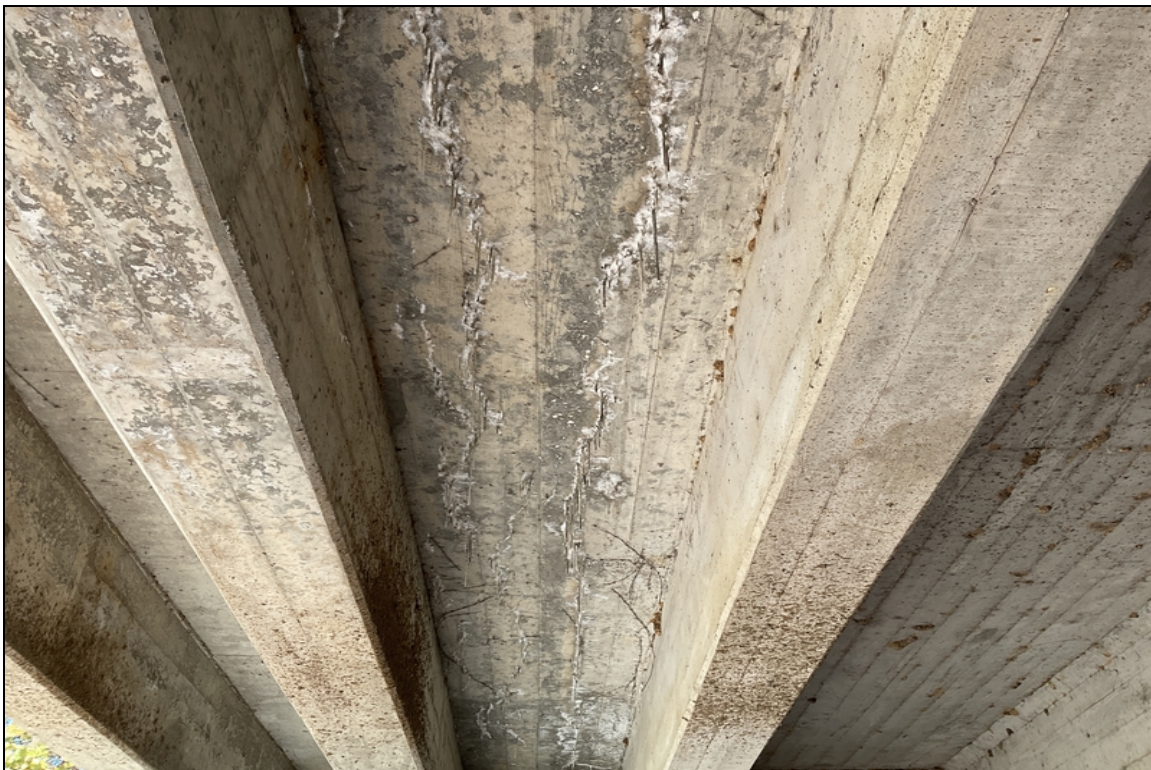
Span 1, bay 2-Efflorescence.

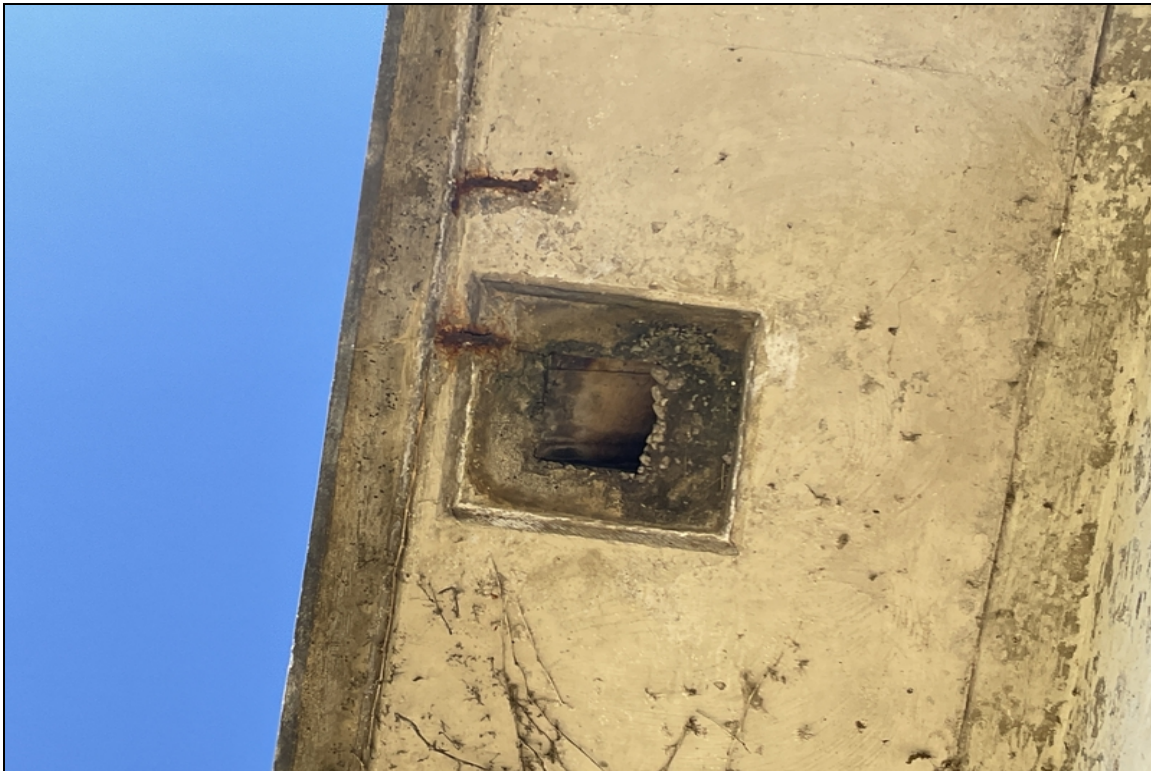
Span 1, left side-Spalling in deck overhang adjacent deck drain.

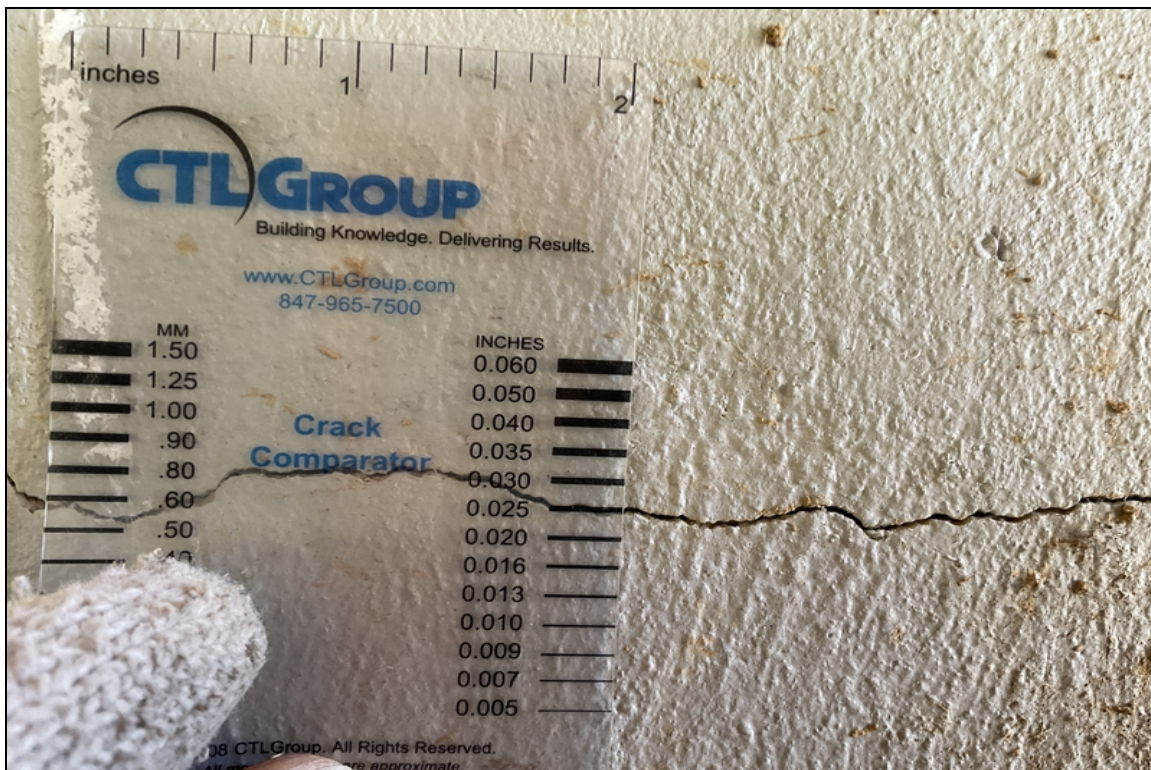
Horizontal crack on left side of abutment 1.

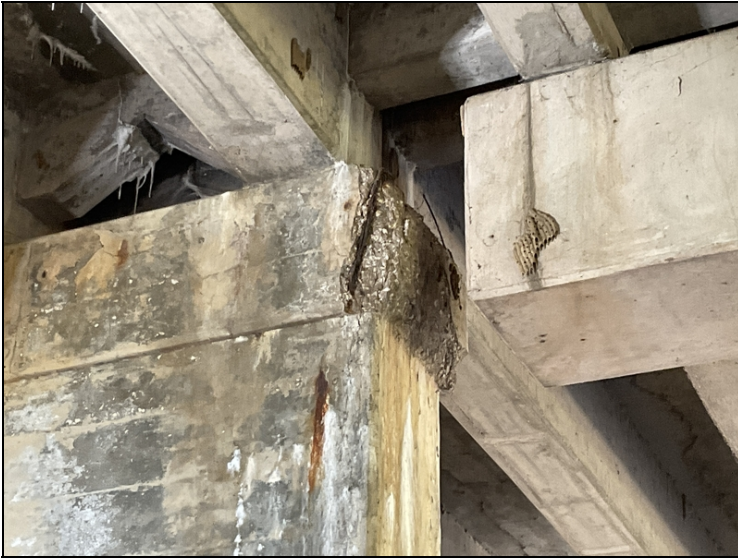
Bent # 3 cap has soft deteriorated concrete with exposed reinforcing steel near centerline of roadway. Exposed reinforcing steel has active corrosion with flaking rust.

Bent # 3 cap-Spalling with exposed reinforcing steel at centerline.

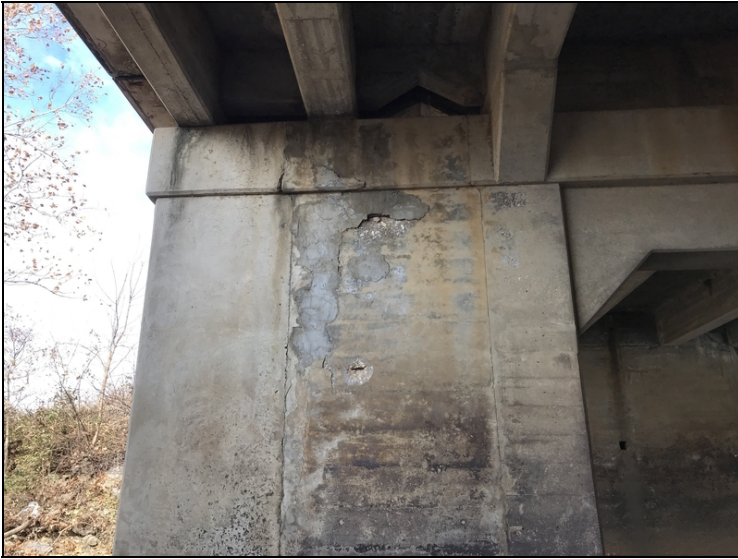
Patched areas are delaminated and sound hollow in the left side of Bent # 3. Spalls with exposed reinforcing steel have active corrosion with up to 1/8" section loss visible during this inspection. The Bent # 3 pier wall under Bay # 5 has light map cracking with efflorescence and discoloration of the concrete where water discharges on the substructure through the leaking deck joint.

Left end of Bent # 3. Delaminated repairs.

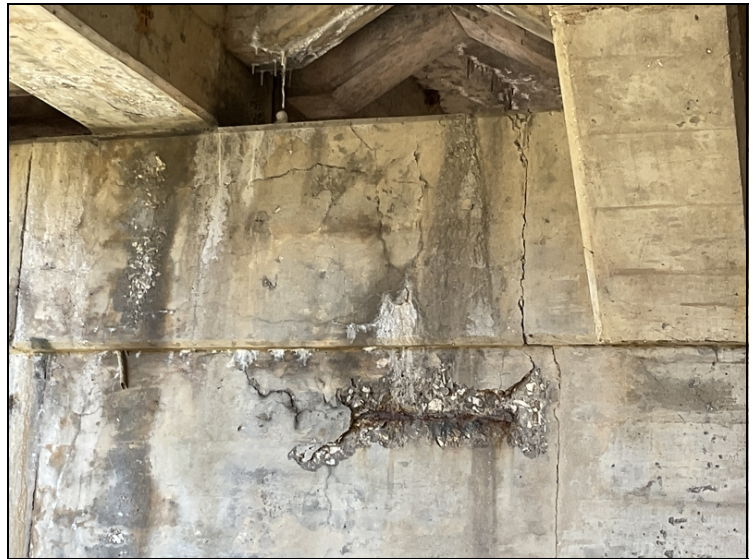
Bent 2, left side-Horizontal cracking in cap with spalling in pier wall.

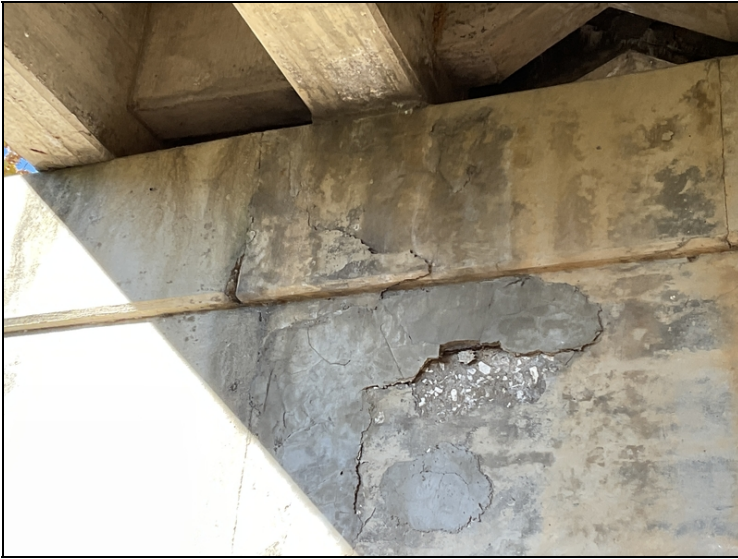
Bent 3, left side-Delaminated area in cap and spalling with failing repairs to pier wall backface.

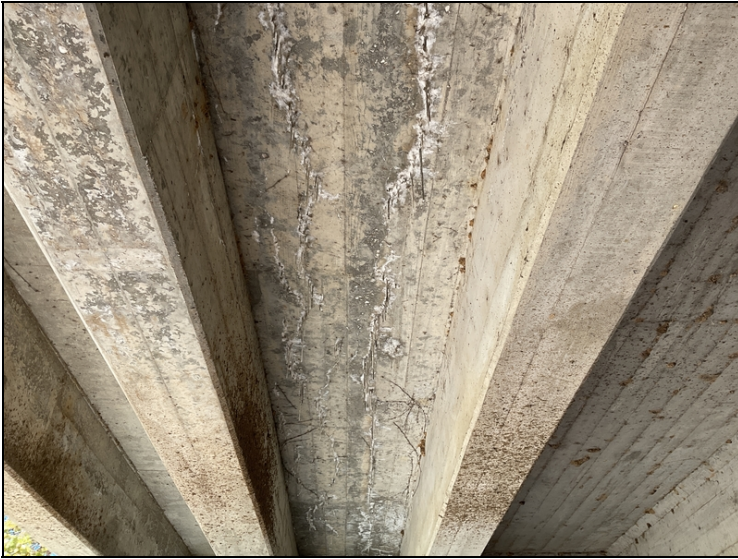
Span # 1, bay # 2-Efflorescence.

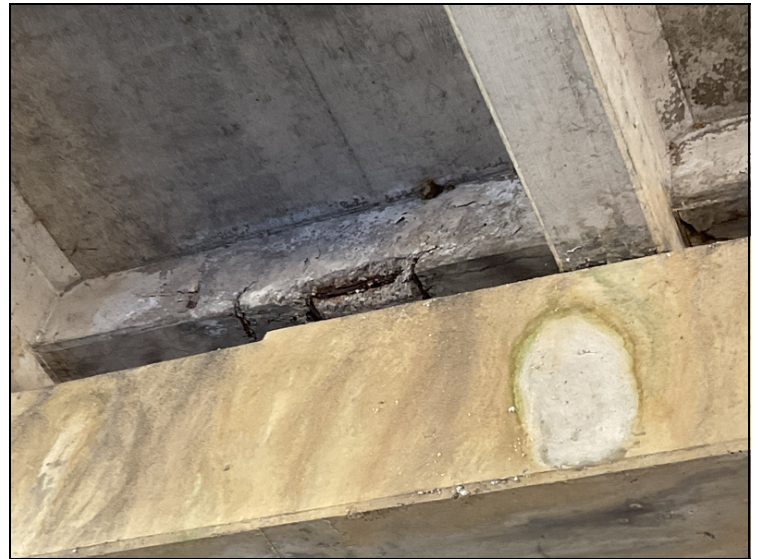
Span # 2, bay # 8 over bent # 2-Spalling with exposed reinforcing steel in expansion dam.

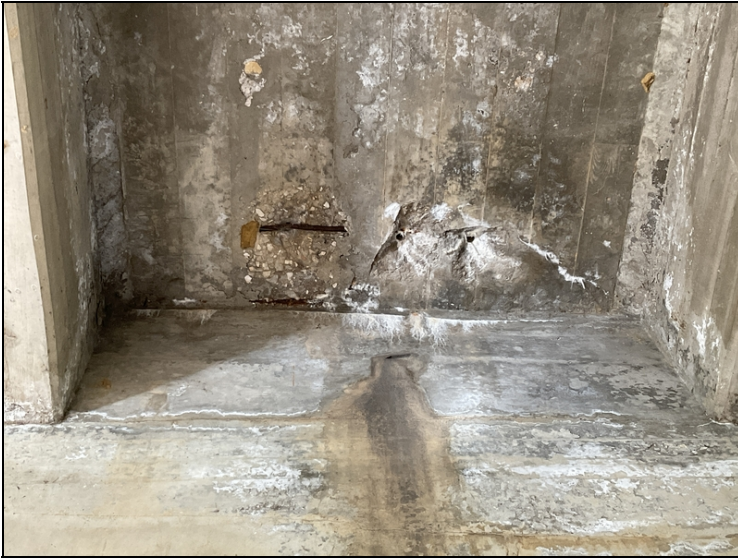
Span # 3, bay # 4 adjacent to abutment # 2-
Spalling with exposed reinforcing steel.

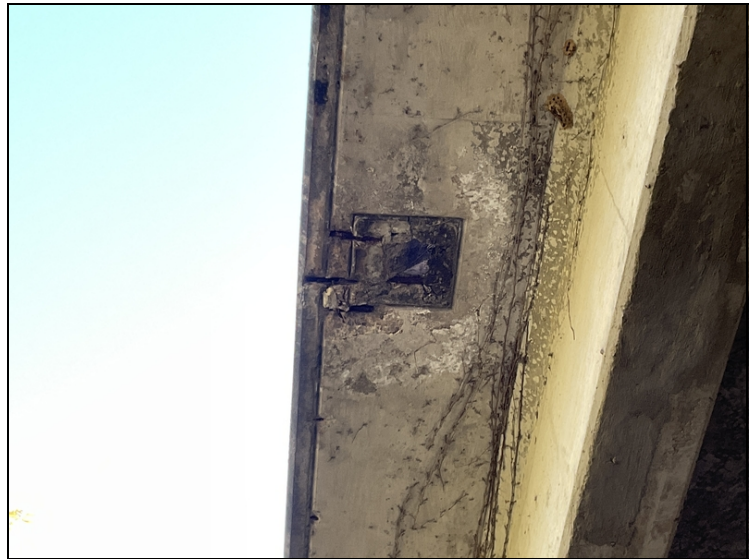
Span # 2, right side-Spalling with exposed
reinforcing steel adjacent to deck drain.

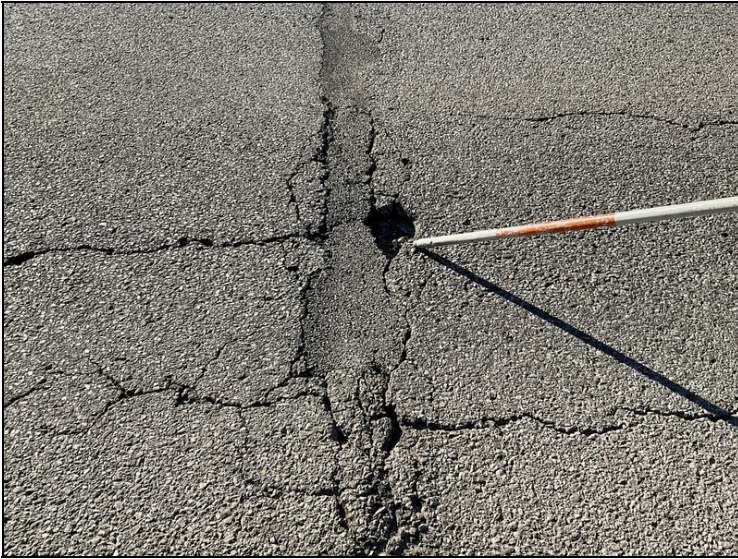
Pothole forming in asphalt driving surface in left lane at abutment # 1.

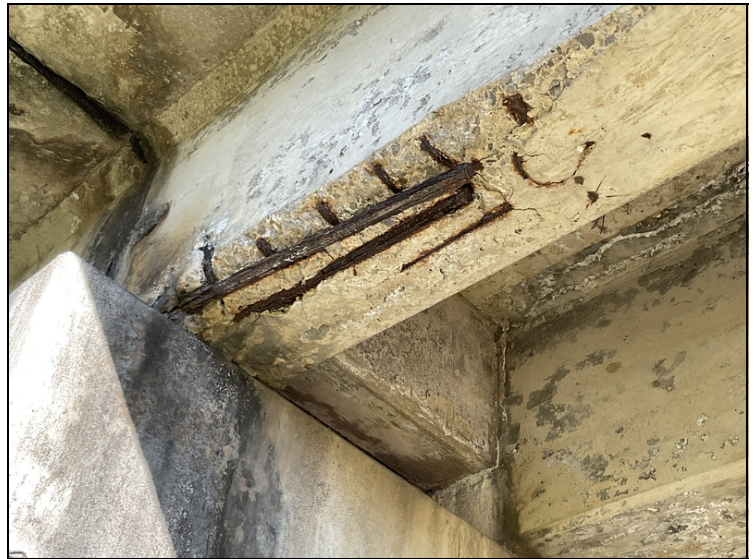
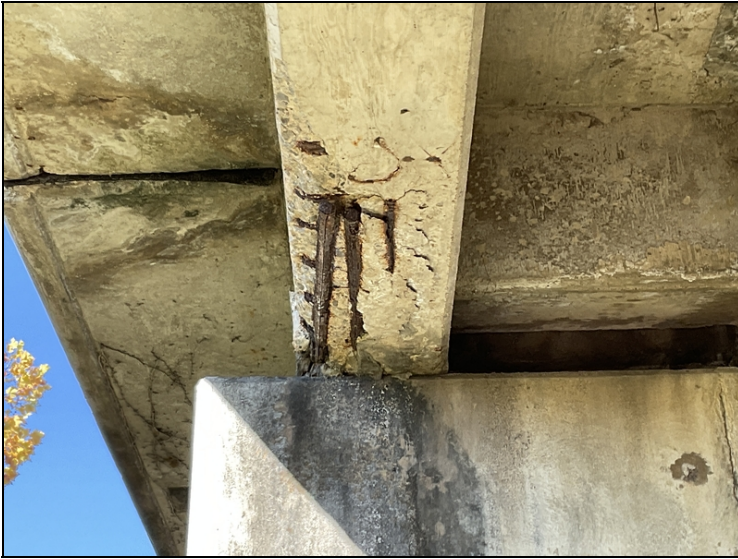
Span # 1, girder # 1 at bent # 2 has an area of spalling in the undersurface of girder that exposes 3 of the primary longitudinal reinforcing bars. The exposed bars appear to be short pieces of reinforcing steel that terminate approximately 30" from the bent. The interior of girder at bent # 2 has light scaling.

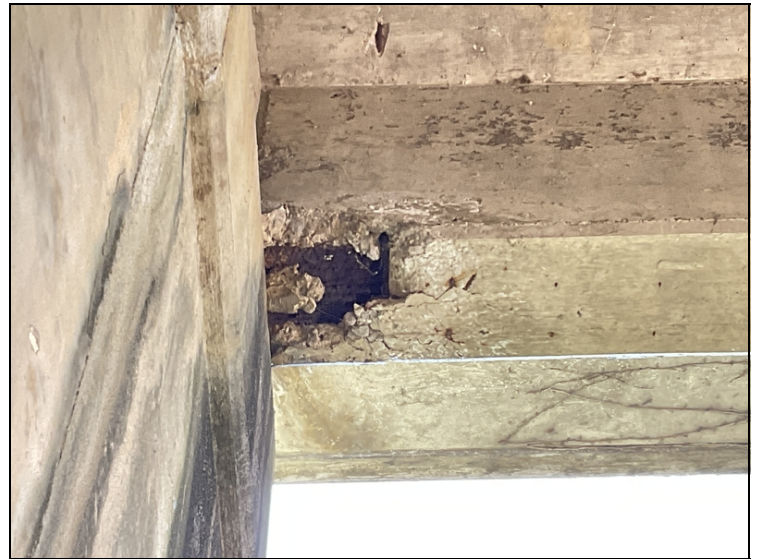
Span 2, girder # 1-Spalling in undersurface that exposes steel loading plate.

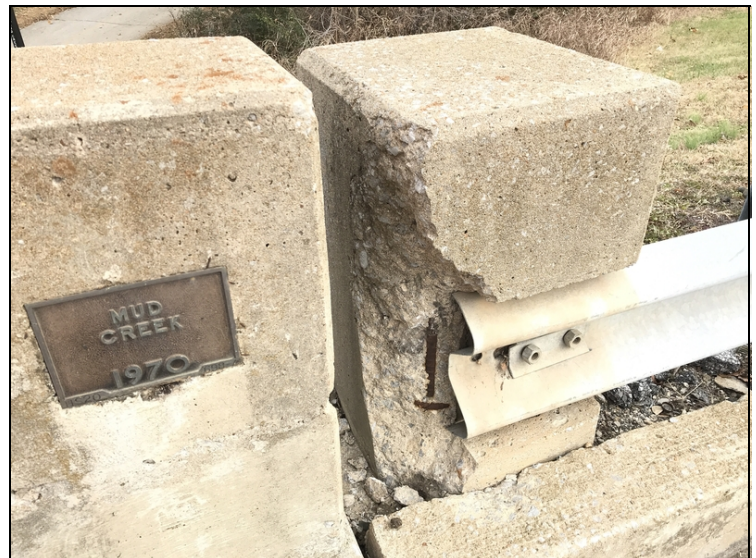
The Southeast end post has concrete spalling with exposed reinforcing steel at the approach guard railing attachment. No apparent section loss to the exposed reinforcing steel.

Collision damage to the Southeast end post.

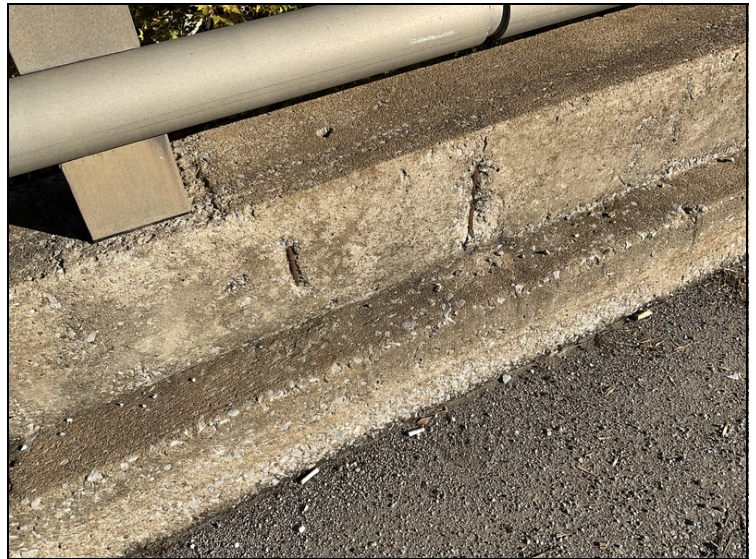
Span # 2, left railing-Shallow spalls with exposed reinforcing steel.

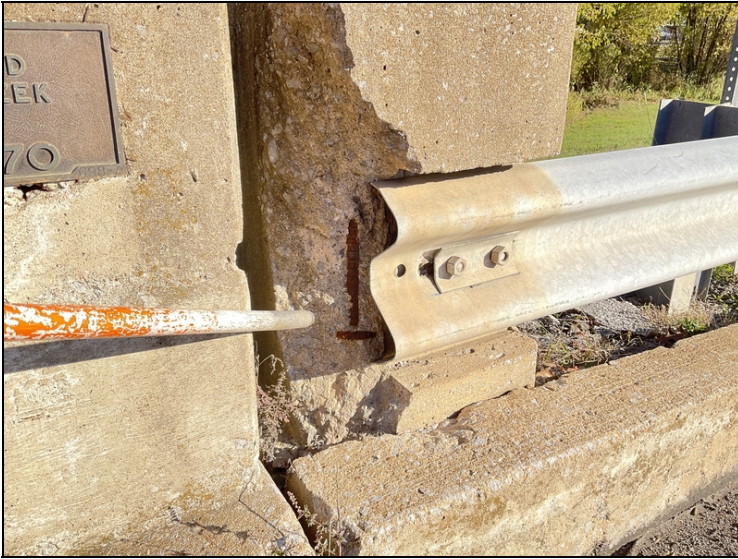
The Southeast approach railing end post on the right side of abutment # 2 has apparent collision damage that has a large spalled area with exposed reinforcing steel.
