Bridge #06109(Routine)

State Highway 80 over Hon Branch-Scott Co.

Location: 0.47 MI SE JCT SH 28

Team Lead: Jeff Jones Inspection Date: October 12, 2021

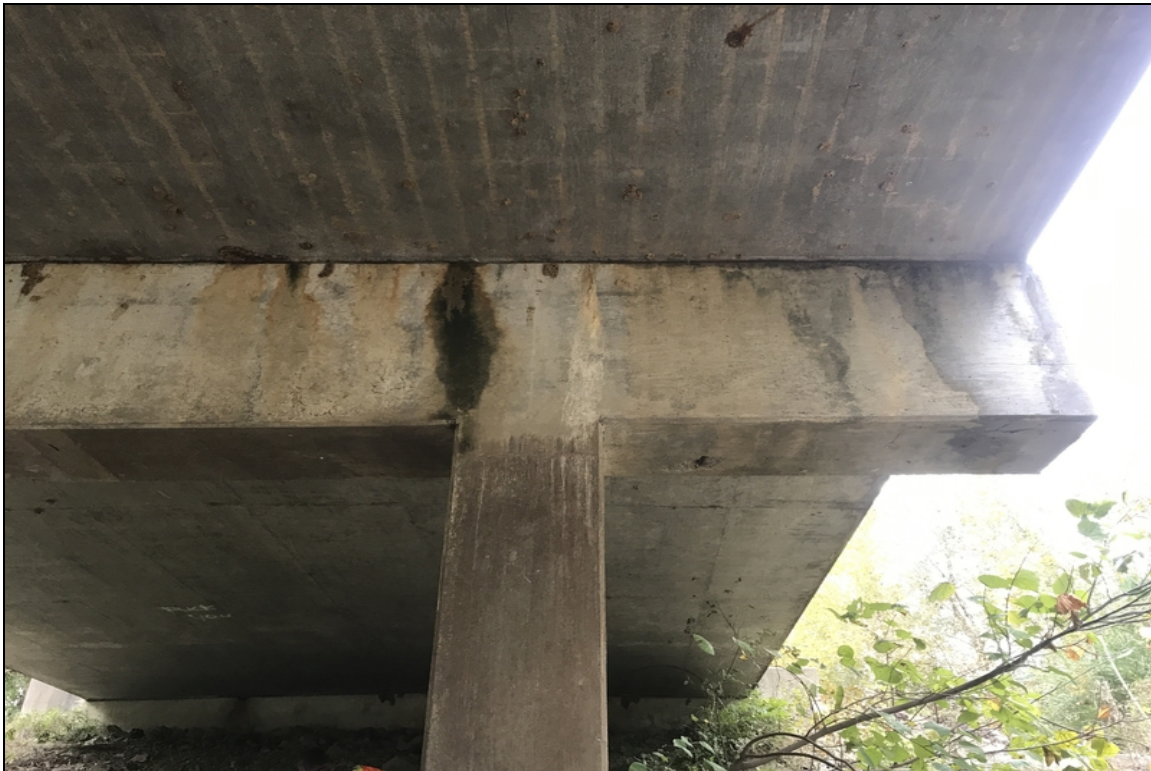
(234)	-There are vertical hairline cracks with light efflorescence over the columns. -There are delaminated areas and spalls with exposed reinforcing steel in the caps. -Exposed reinforcing steel has very little concrete cover from the construction process with up to initial section loss during this inspection. -Stains on the substructure caps indicate water leakage through the failing joint seals.						
301	Pourable Joint Seal	LF	62	0	0	62	0
2310	Leakage	LF	62	0	0	62	0

Typical vertical cracking with light efflorescence buildup over the exterior edge of the columns.

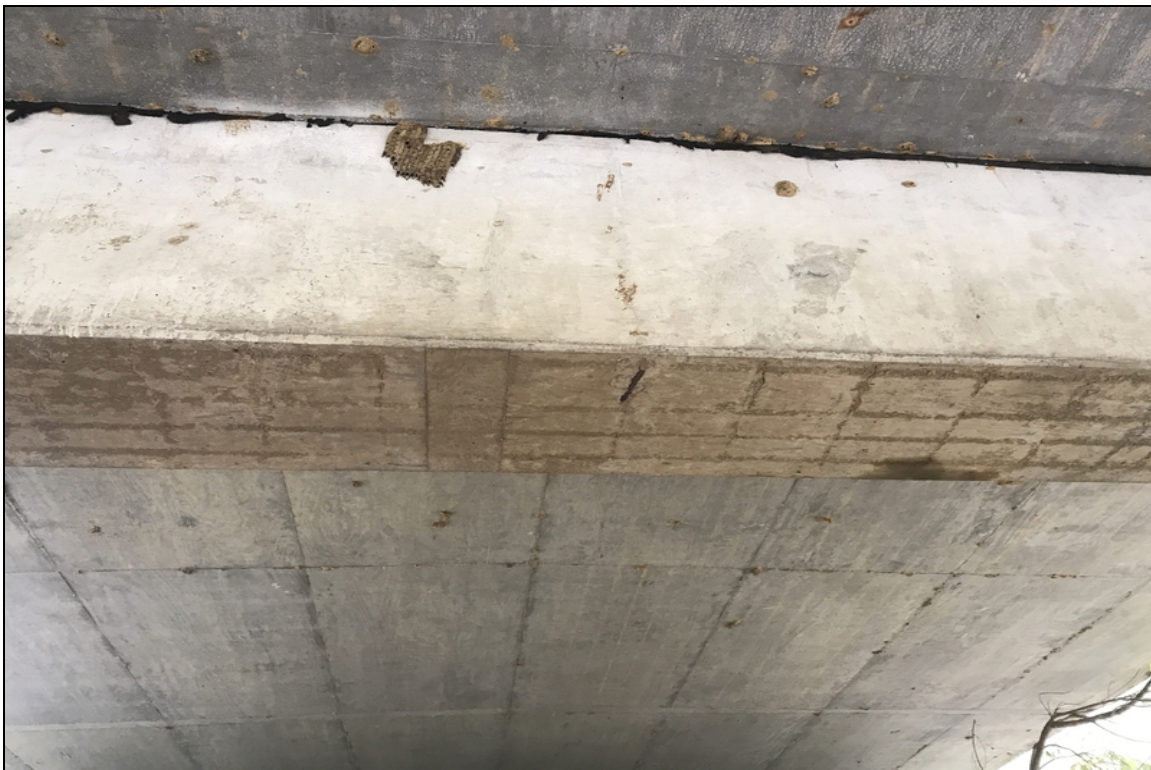
Bent 2 cap undersurface spalling with exposed reinforcing steel.

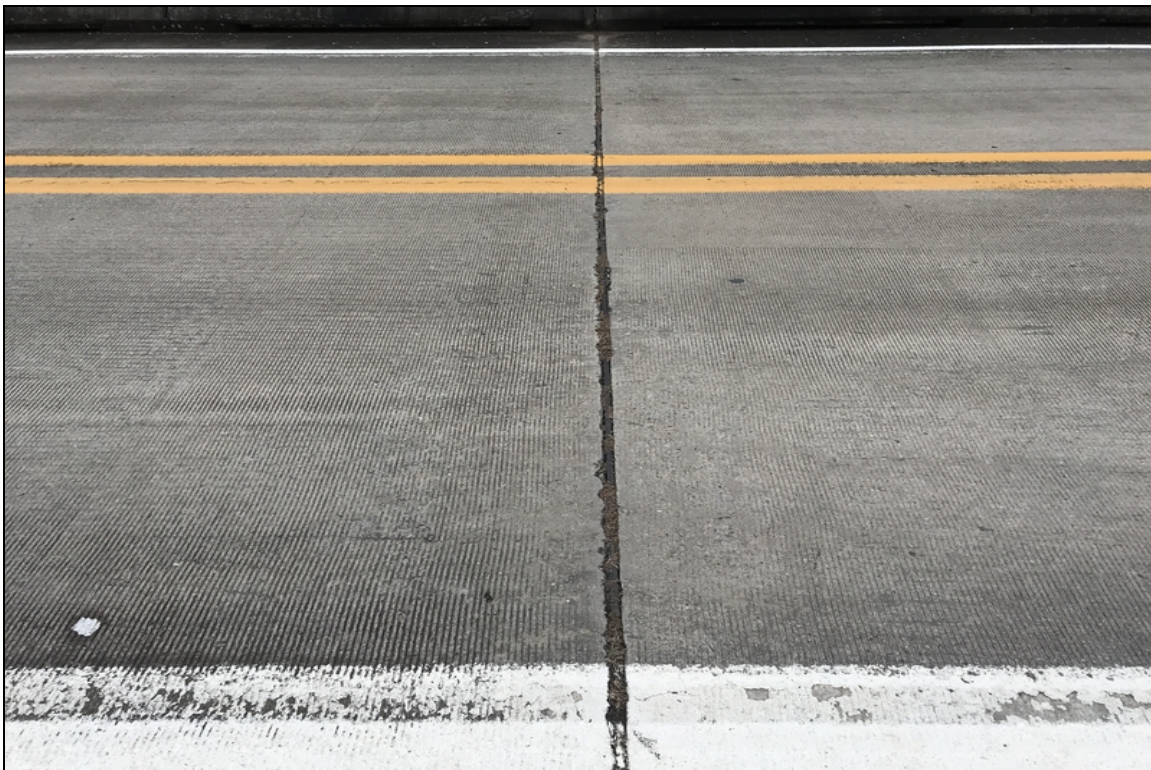
(301)	-Joint sealant between the spans over the intermediate bents have adhesion failure and leak water onto the substructure caps.						
331	Reinforced Concrete Bridge Railing	LF	210	208	2	0	0
1130	Cracking (RC and Other)	LF	2	0	2	0	0

Bent 3 failed joint seal.

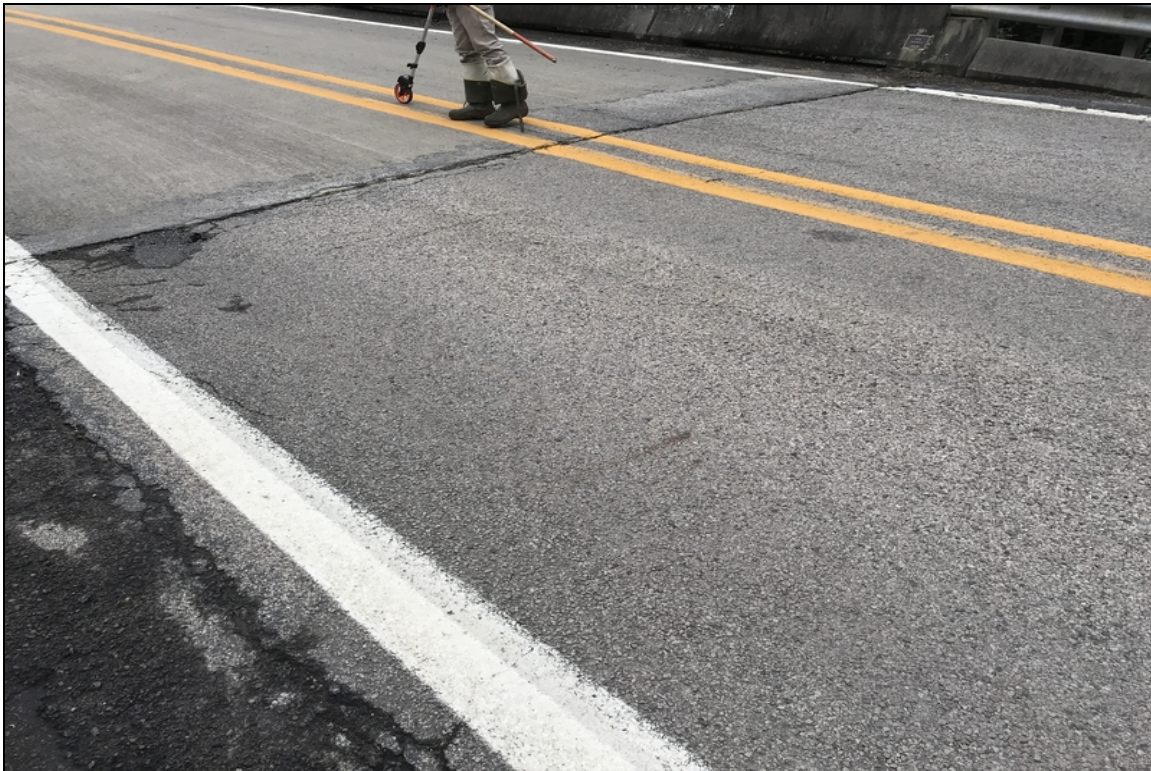
North approach asphalt settlement.

The North approach roadway has cracking with minor settlement.

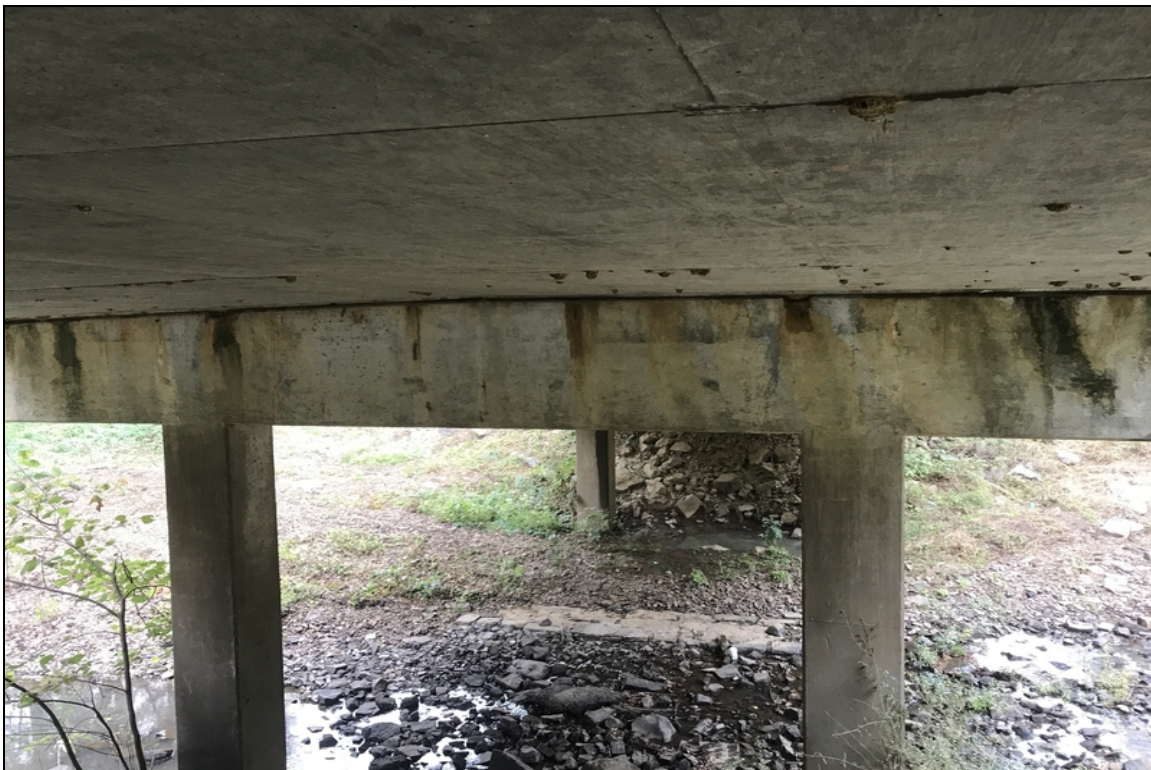
Typical staining from water leakage through the deck joints.

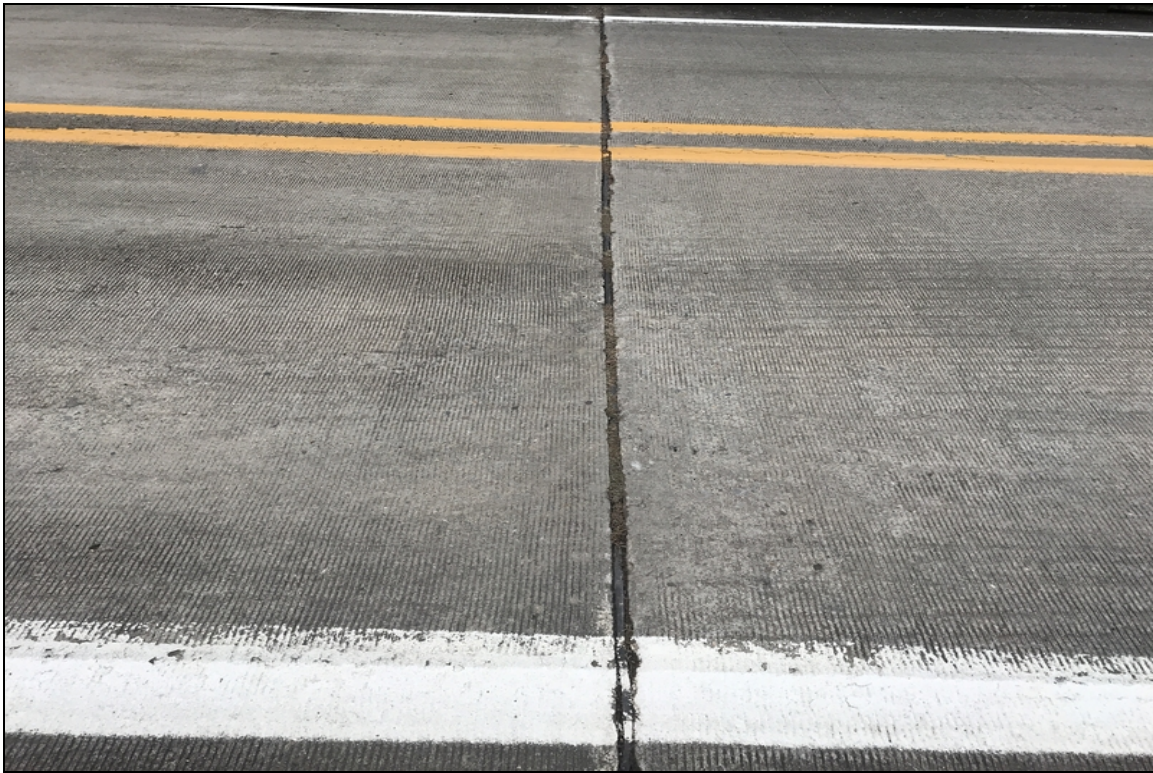
Bent 2 joint seal deterioration.

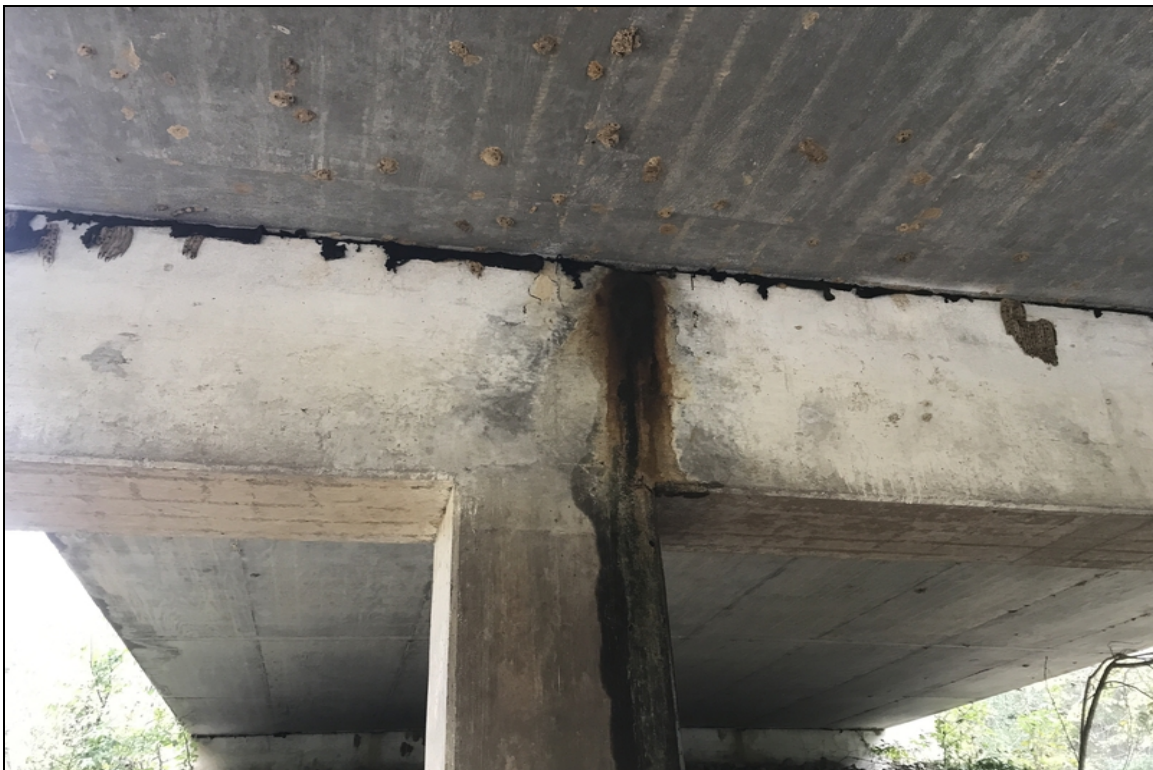
Span 2 Bent 2 Rt delaminated concrete.

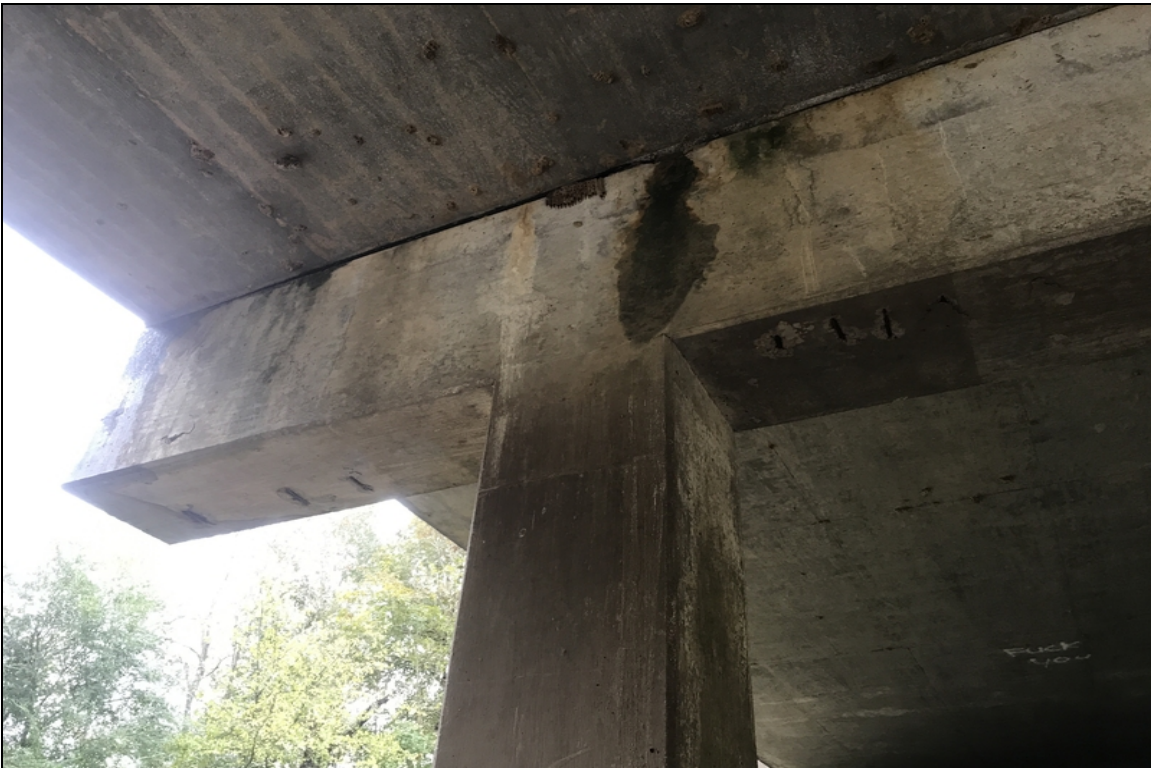
Bent 3 Lt spalling with exposed reinforcing steel.

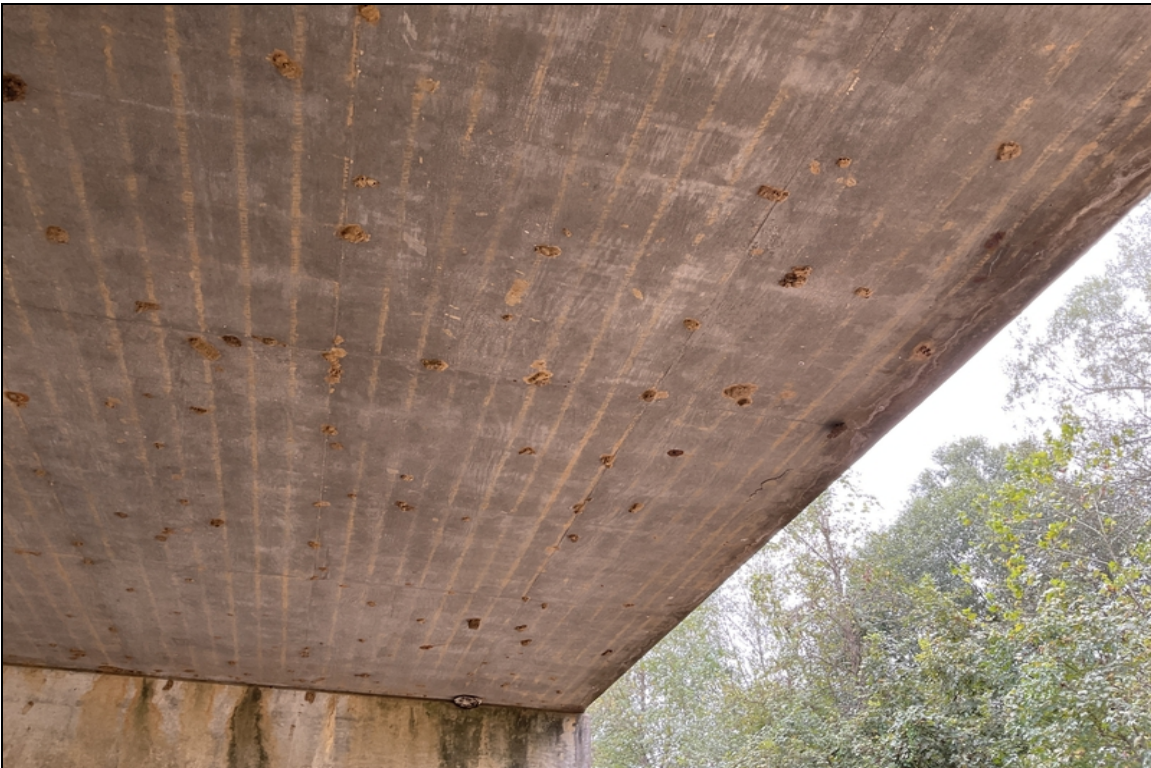
(38)	-Minor vertical hairline cracks visible in the edges of the deck located approximately 1' from the deck joint. -There are diagonal hairline cracks in corners of each span visible from the driving surface of the deck. -Span # 2 Right edge has a delaminated area on the undersurface of the slab.						
205	Reinforced Concrete Column	EA	4	2	2	0	0
1190	Abrasion/Wear (PSC/RC)	EA	2	0	2	0	0

Span # 2. Right. Delaminated area on the undersurface of the slab.

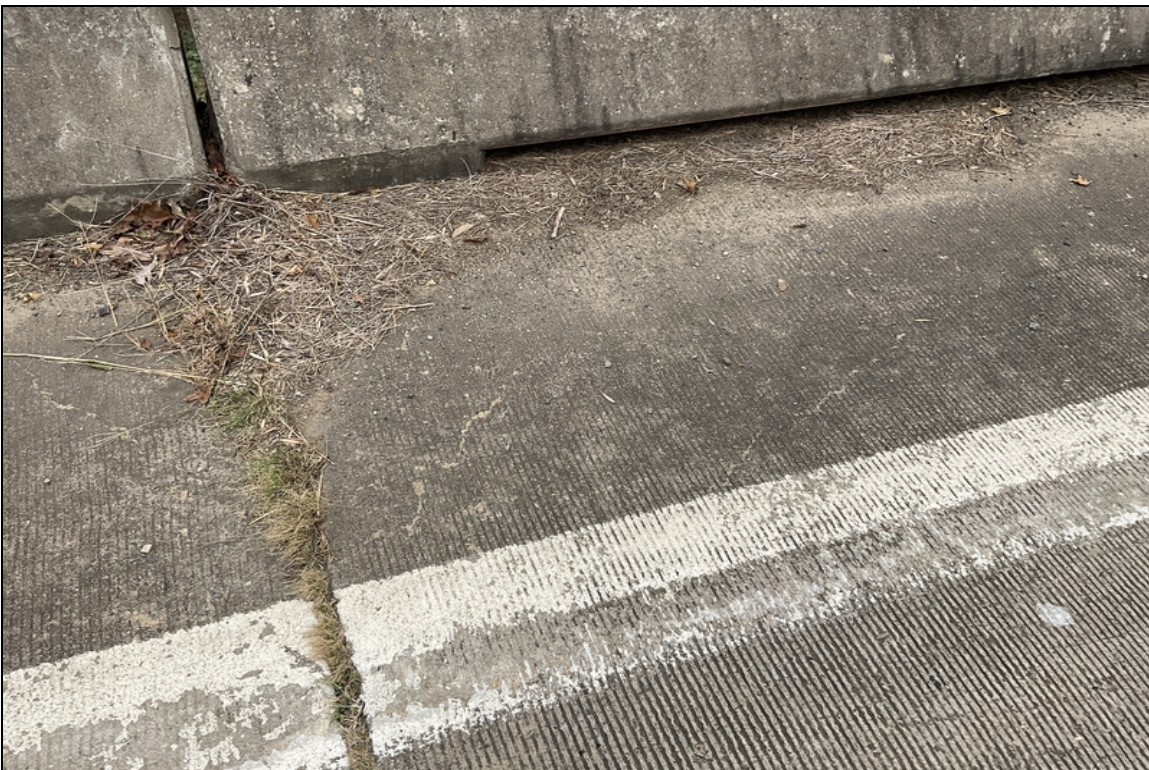
Hairline diagonal cracking in the corners of the slab spans.

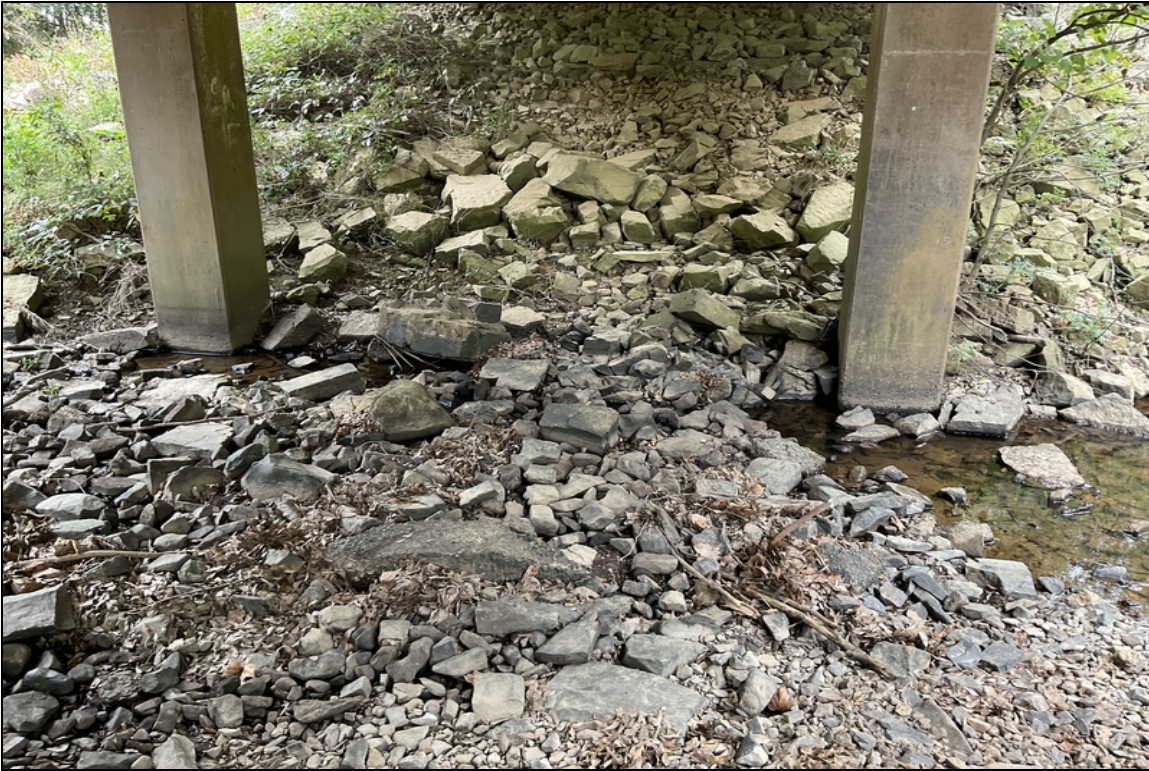
(205)	-There is light abrasion at the base of Bent # 3 columns.						
215	Reinforced Concrete Abutment	LF	98	96	2	0	0
1130	Cracking (RC and Other)	LF	2	0	2	0	0

Bent # 3 columns. Light abrasion.

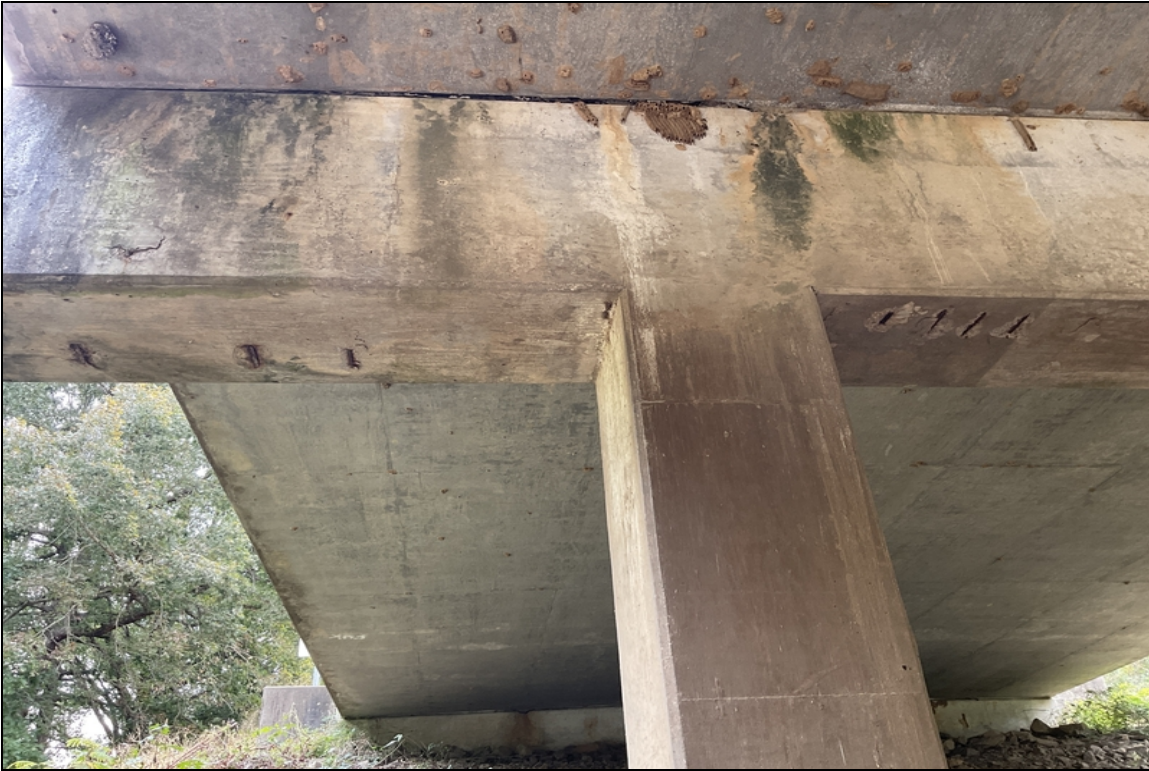
Spalls with exposed reinforcing steel on the undersurface of bent # 3 cap. Exposed reinforcing steel has up to initial section loss during this inspection.

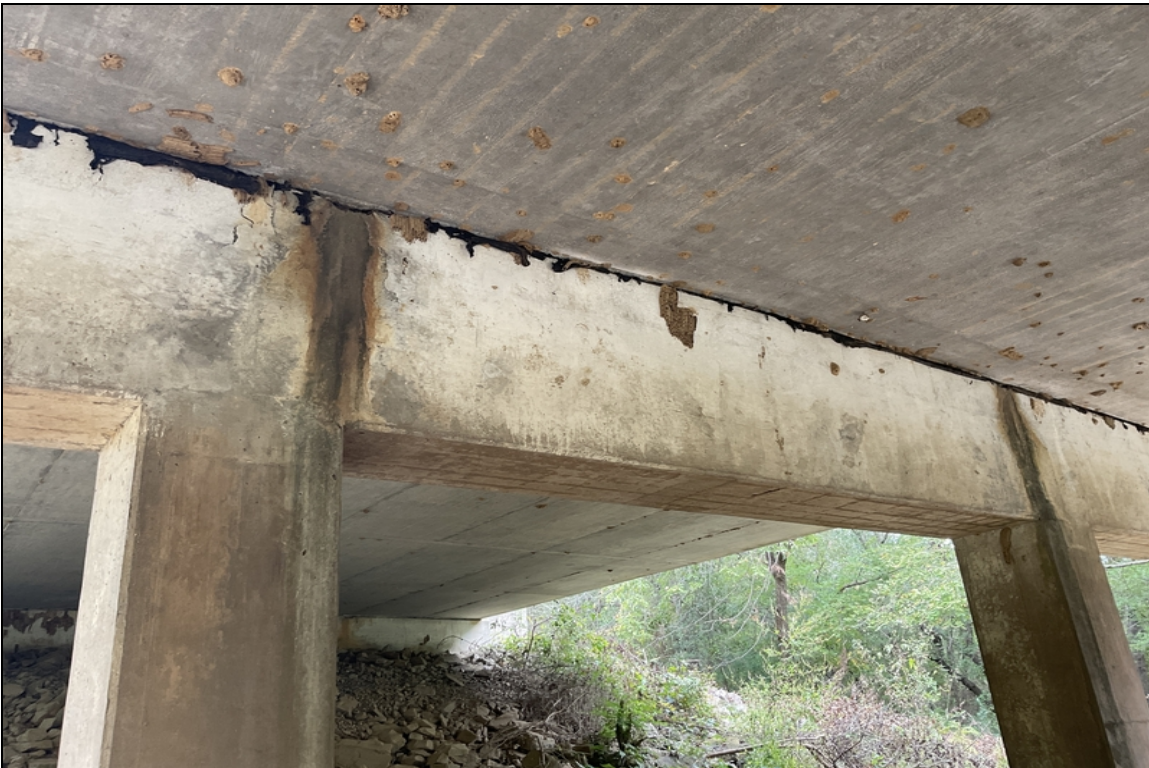
Staining and delaminated areas in the substructure caps from leaking deck joints.

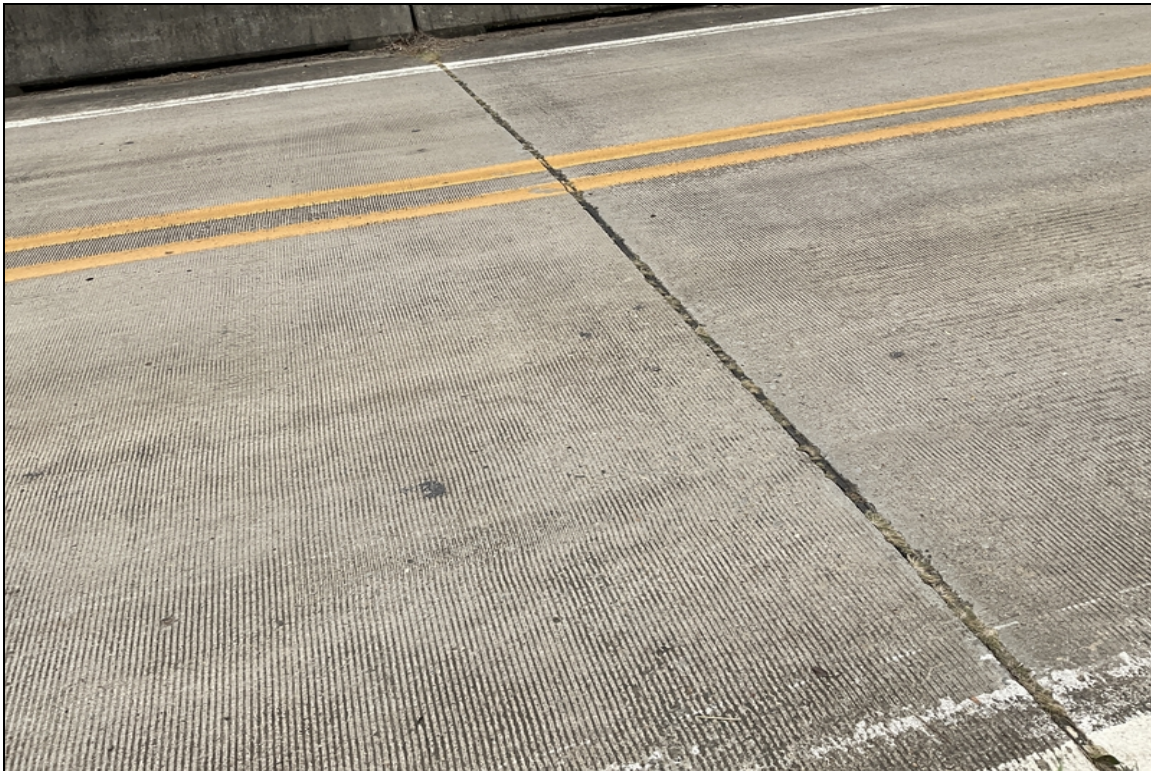
Leaking expansion joint sealant over bent # 3.

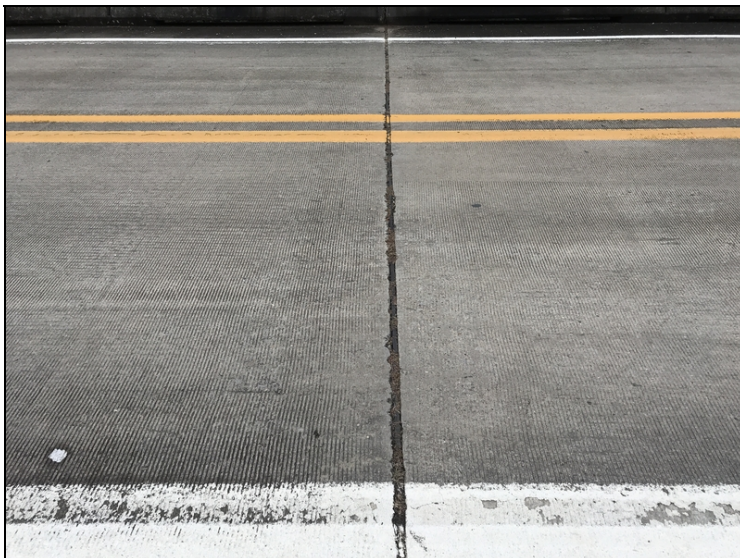
The deck joint sealant over the intermediate bent caps have adhesion failure and leak water. Cap staining indicates the entire length of the joint seals leak and this appears to be contributing to the cracking and spalling in the substructure.

Bent # 3 failed joint seal.

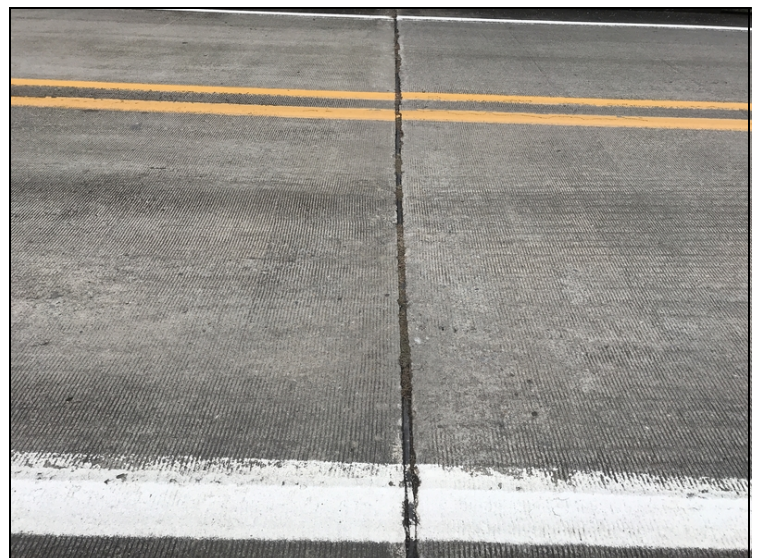
Bent # 2 joint seal deterioration.

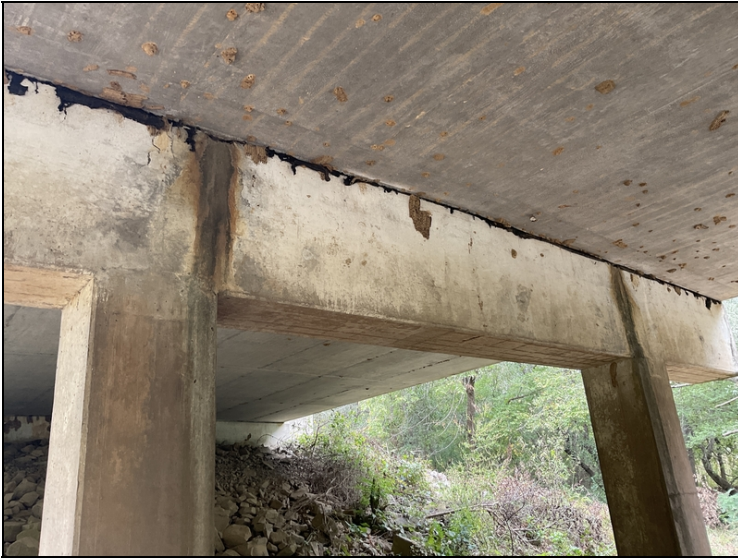
Stains and delaminated areas in Bent # 2 cap from leaking deck joints.

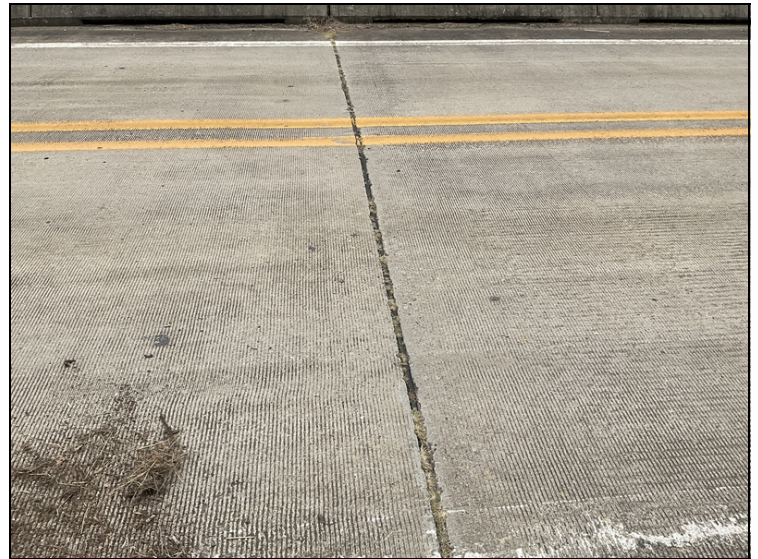
Leaking expansion joint sealant over Bent # 3.

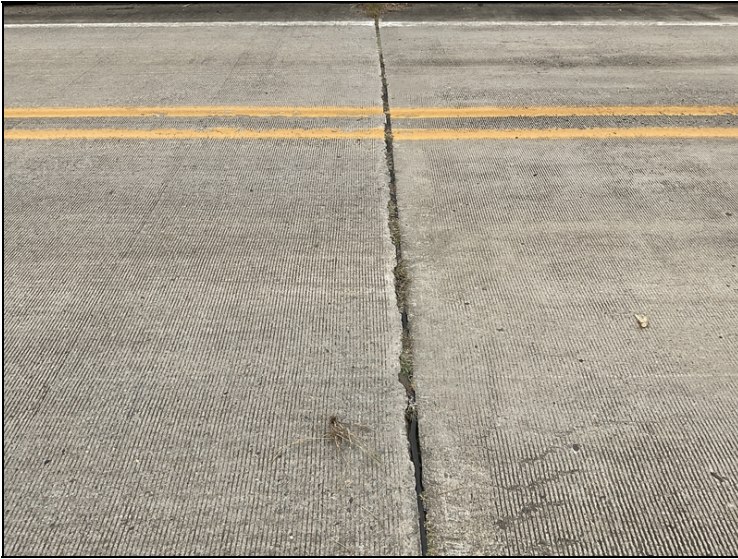
Leaking expansion joint sealant over Bent # 2.

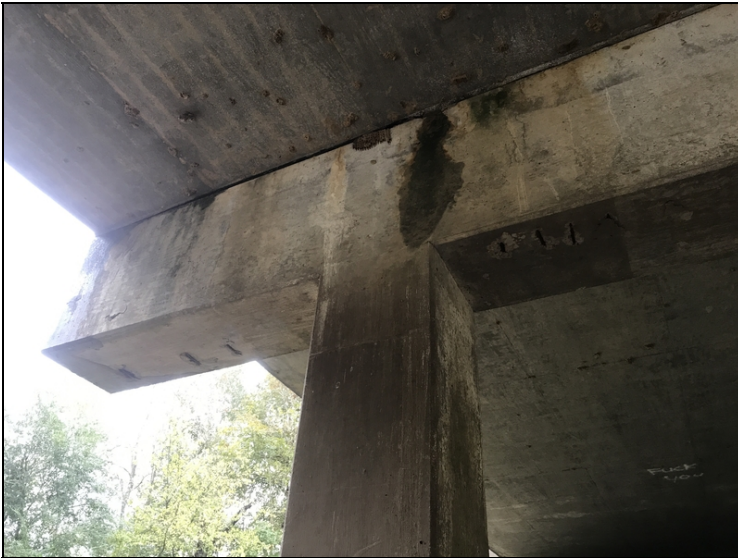
Spalling with exposed reinforcing steel on the undersurface of the intermediate bent caps.

Bent # 3 Lt spalling with exposed reinforcing steel.

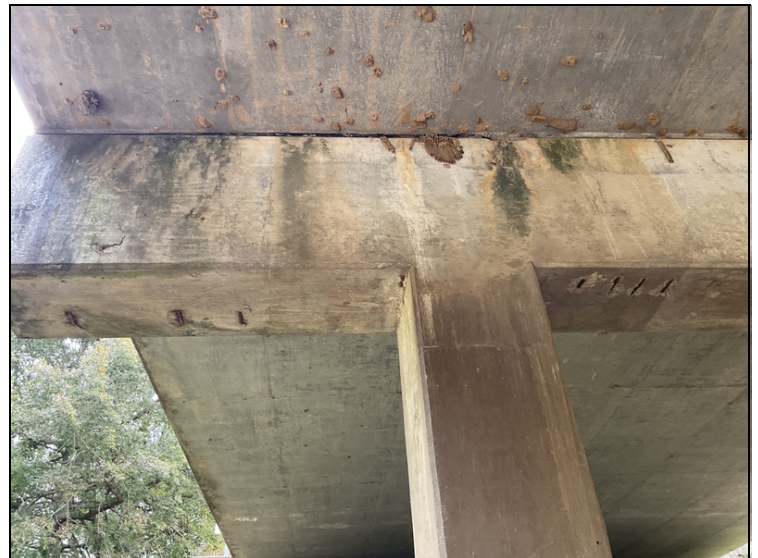
Left end of bent # 3. Spalls with exposed reinforcing steel.

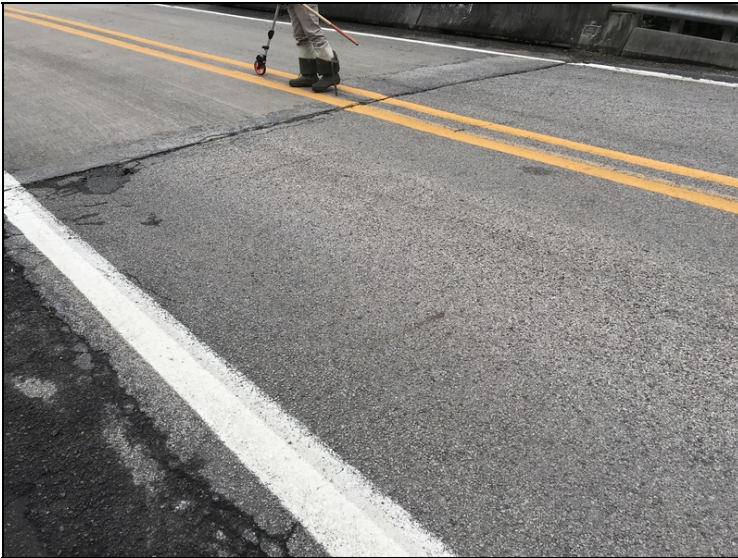
North approach asphalt settlement.

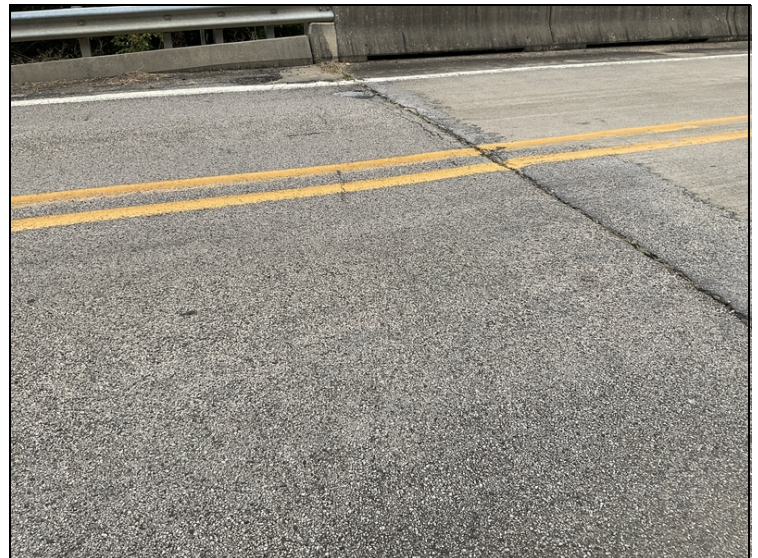
Settlement at the North approach roadway.

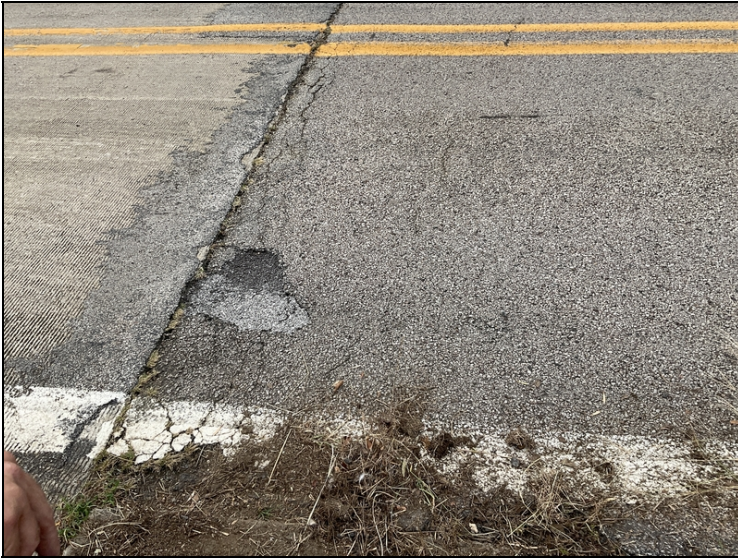
Asphalt settlement at the North approach roadway.

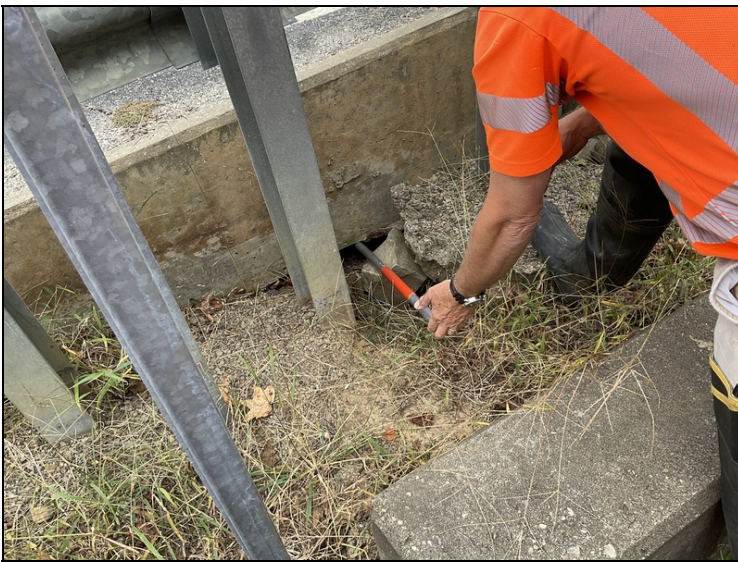
There are voids under the North approach gutter.

Voids under the North approach gutter.
