**Bridge #06110(Routine, Underwater type 2)**

**SH 80 - Scott Co. over Poteau Creek**

**Location: 1.04 MI SE JCT SH 28&80**

**Team Lead: Jeff Jones Inspection Date: September 29, 2021**

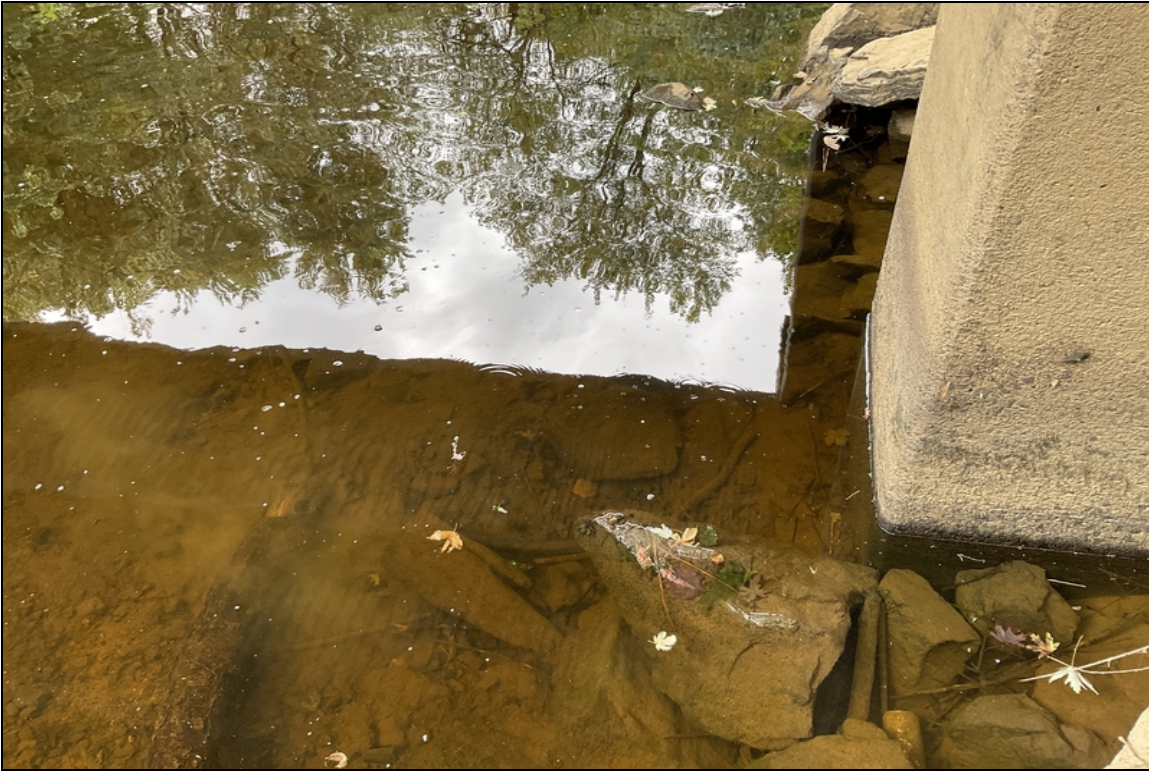
Bent # 2 footings have cover.

Wading and probing along with visual observations during low and clear water conditions indicate that footings have cover with no apparent scour problems during this inspection.

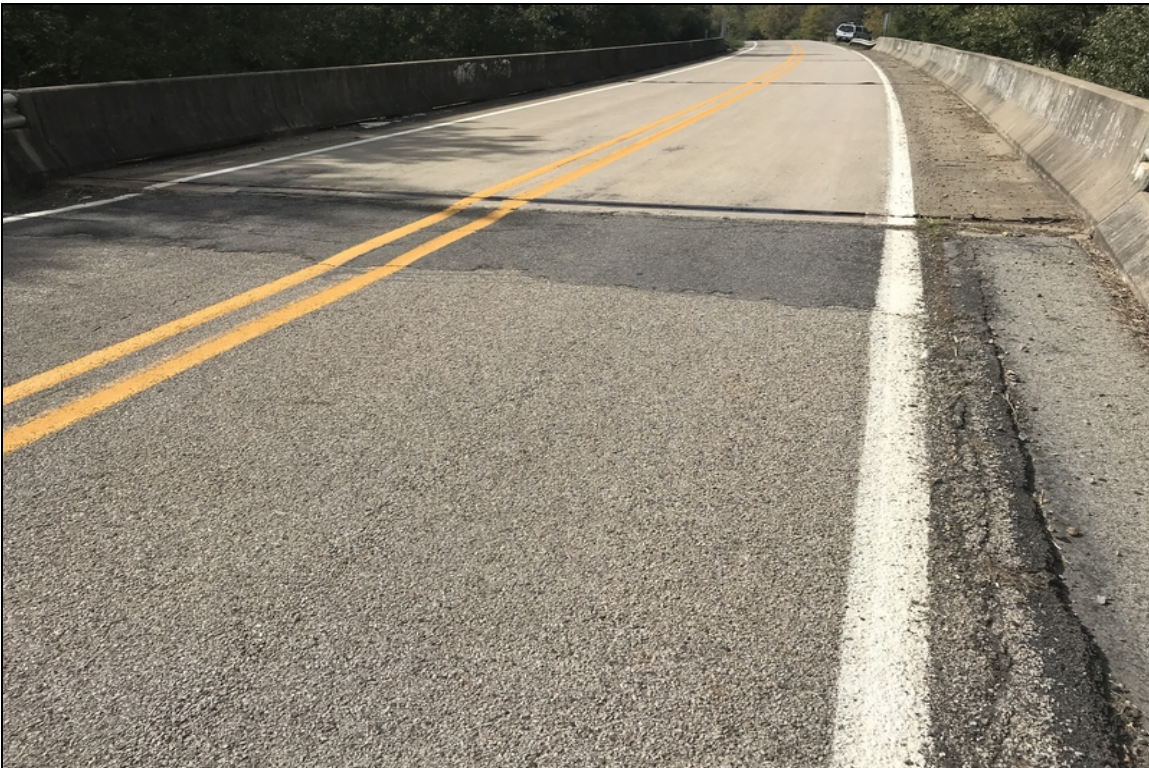
South approach roadway settlement.

There is earth settlement adjacent to the approach gutters and asphalt settlement in the approach roadway adjacent to the abutments.

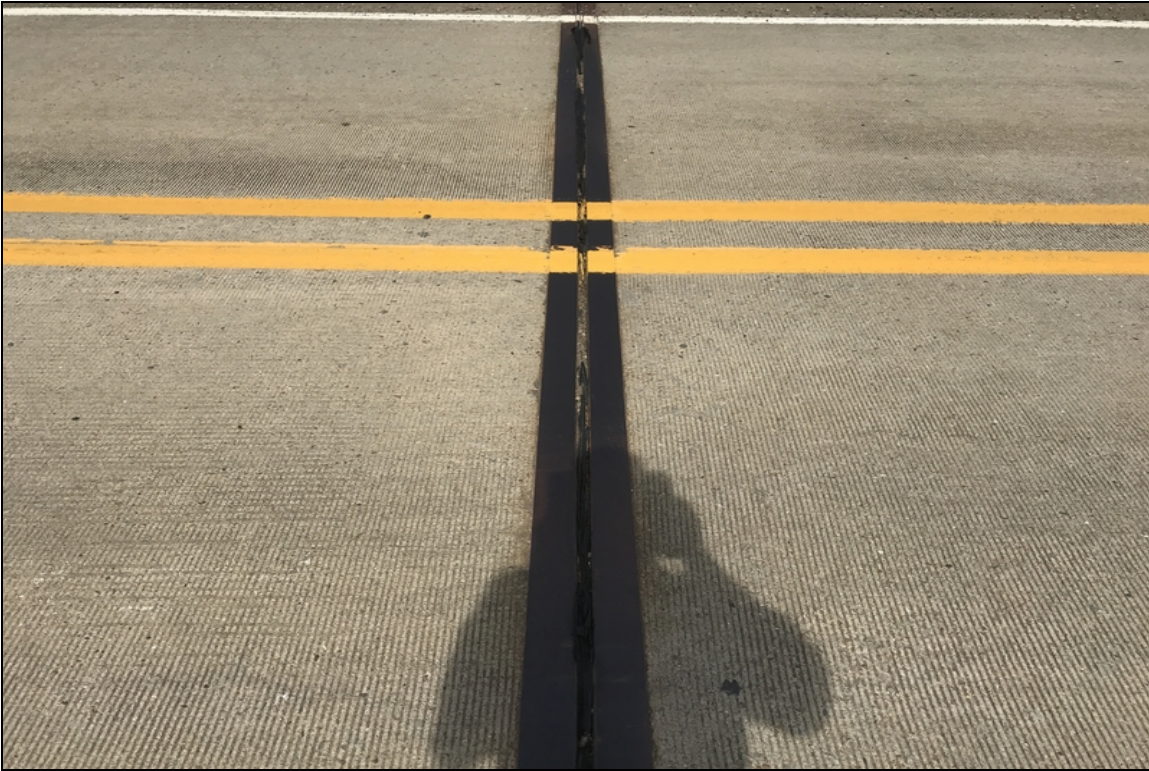
| ELEM | DESCRIPTION | UNITS | TOTAL | CS1 | CS2 | CS3 | CS4 |
|---|---|---|---|---|---|---|---|
| -The tops of the compression joint seals are torn and deteriorated from traffic impacts and snow removal operations.<br>-Joints are leaking water on the superstructure, bearings, and substructure caps. | | | | | | | |

Bent 3 compression joint seal tears and partially missing.

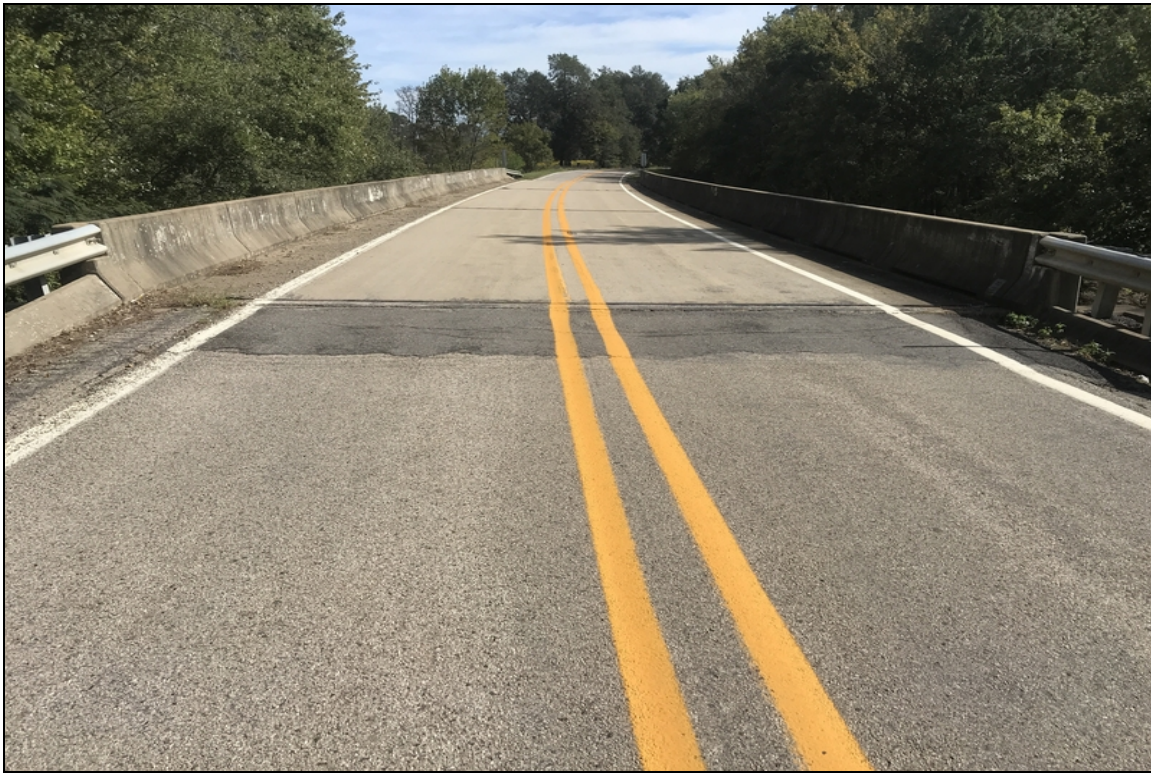
North approach roadway settlement.

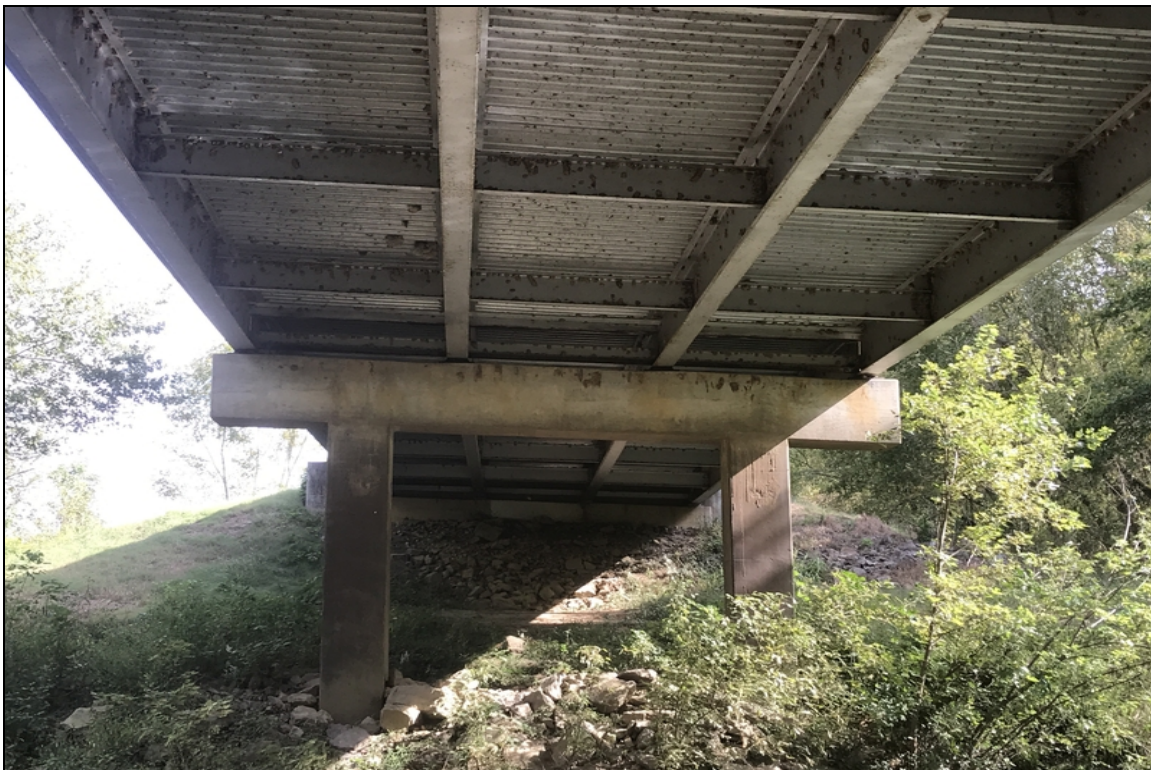
Typical cap staining from water leakage through the deck joints.

The bent caps have spalls with exposed reinforcing steel.  
Stains on the substructure caps indicate leaking deck joint seals.

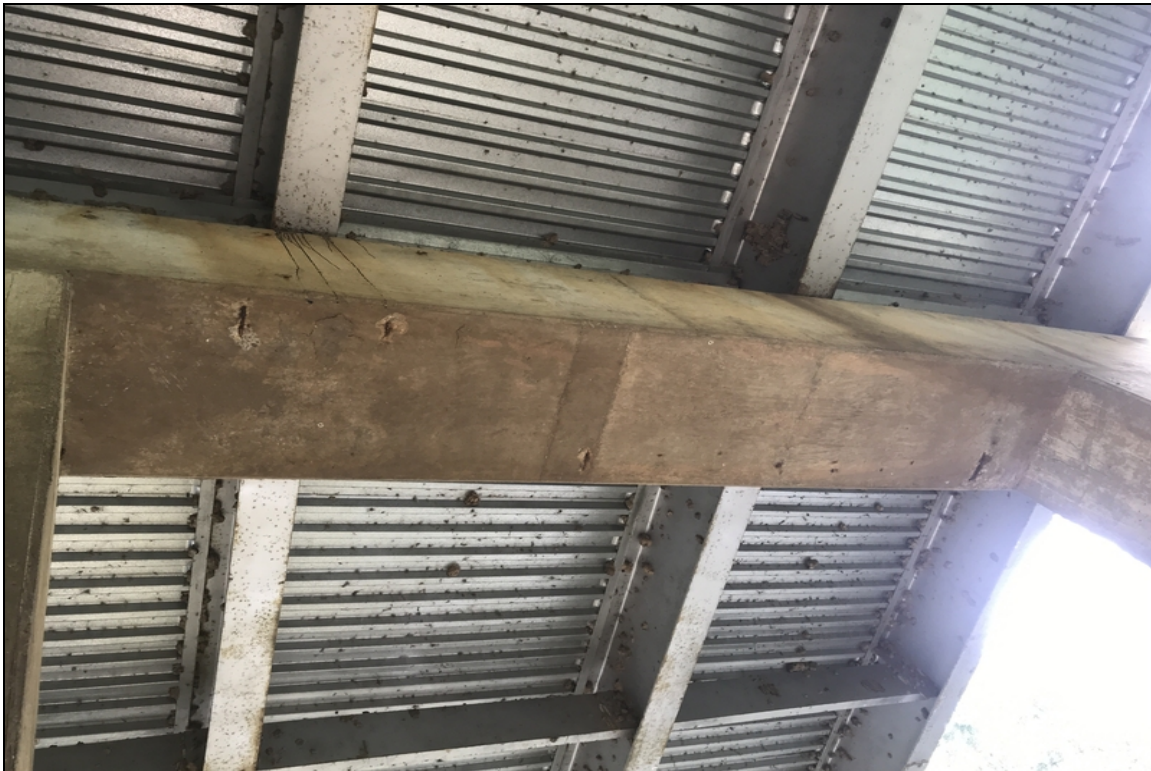
| ELEM | DESCRIPTION | UNITS | TOTAL | CS1 | CS2 | CS3 | CS4 |
|---|---|---|---|---|---|---|---|
| -Intermediate bent caps spalls with exposed reinforcing steel visible from the undersurface of the caps. Exposed reinforcing steel appears to be secondary hoops with initial section loss during this inspection.<br>-There are vertical cracks in the caps over the columns.<br>-There is a horizontal crack in the Ahead face of Bent # 3 cap located over Column # 2. | | | | | | | |

Bent 2 shallow spalling with exposed reinforcing steel on the cap undersurface.

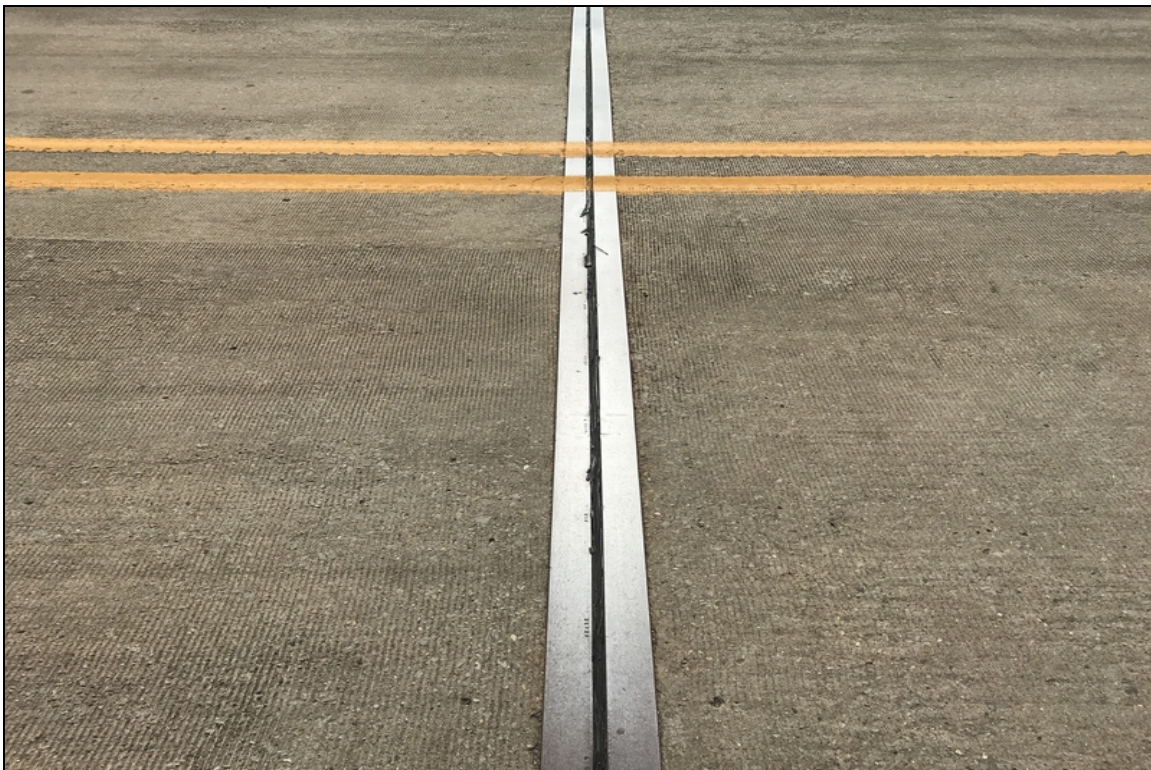
Bent 2 compression joint seal cracking.

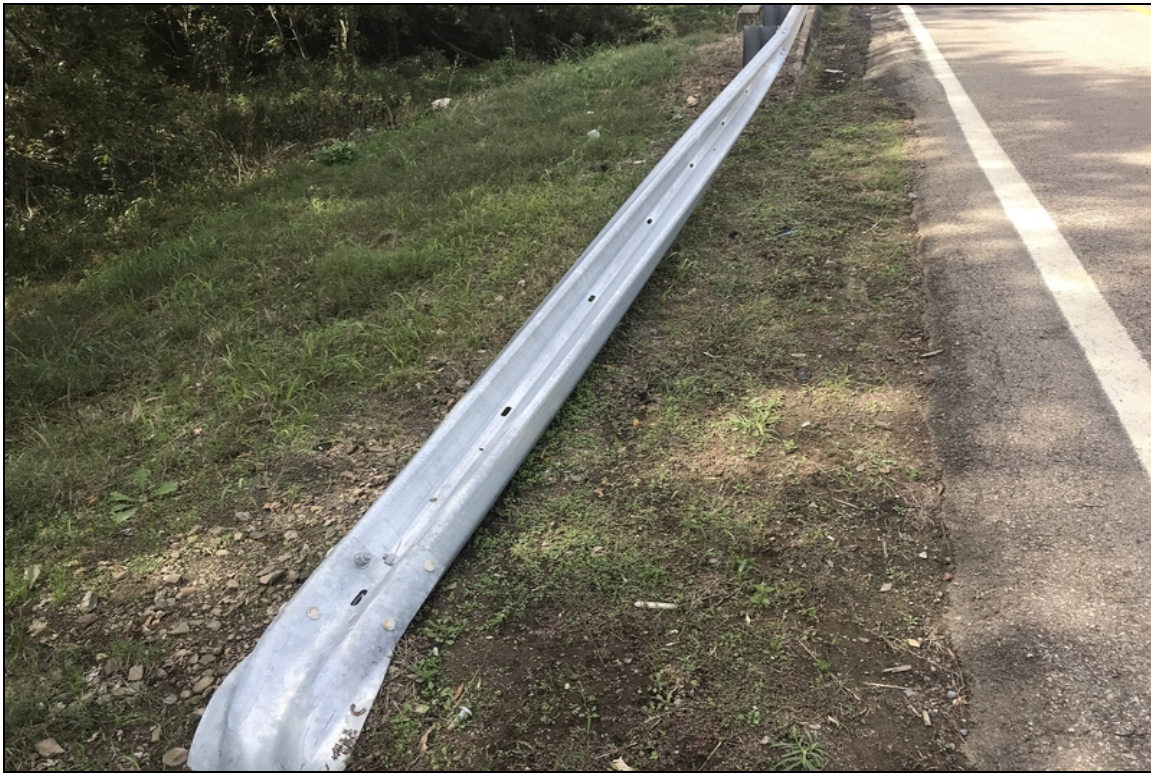
Southwest approach guardrail repair.

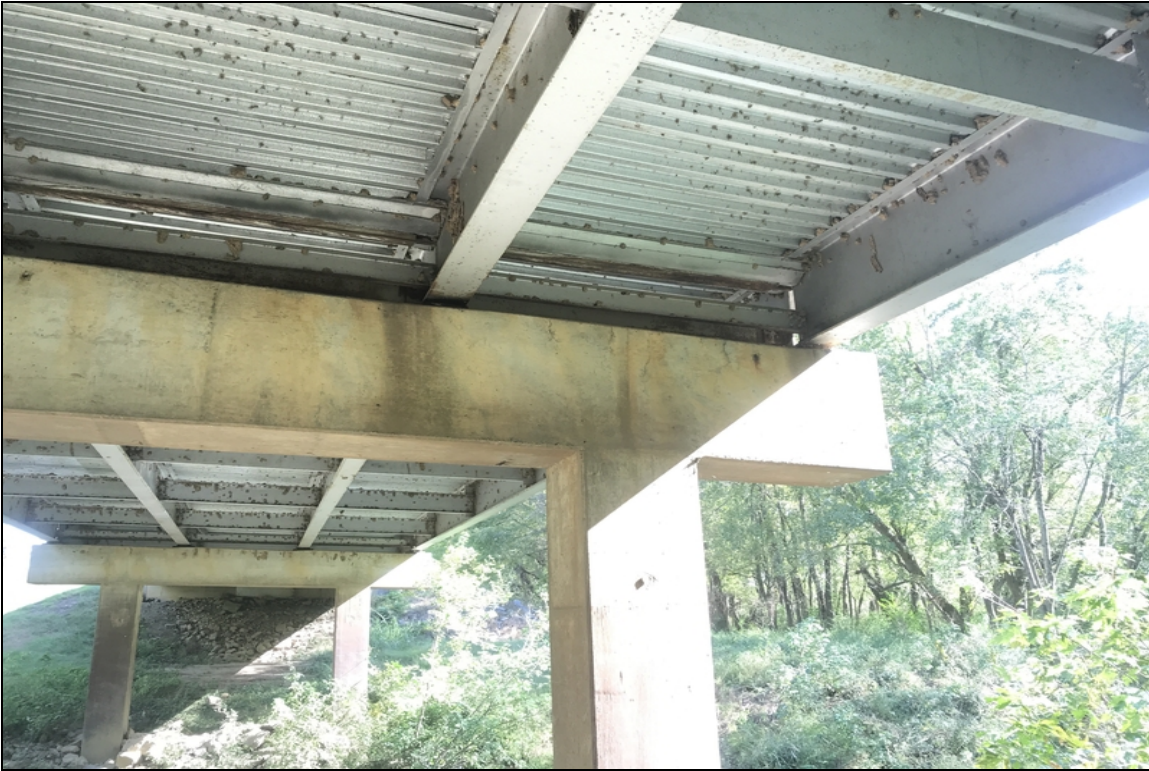
Typical vertical cracking in the caps.

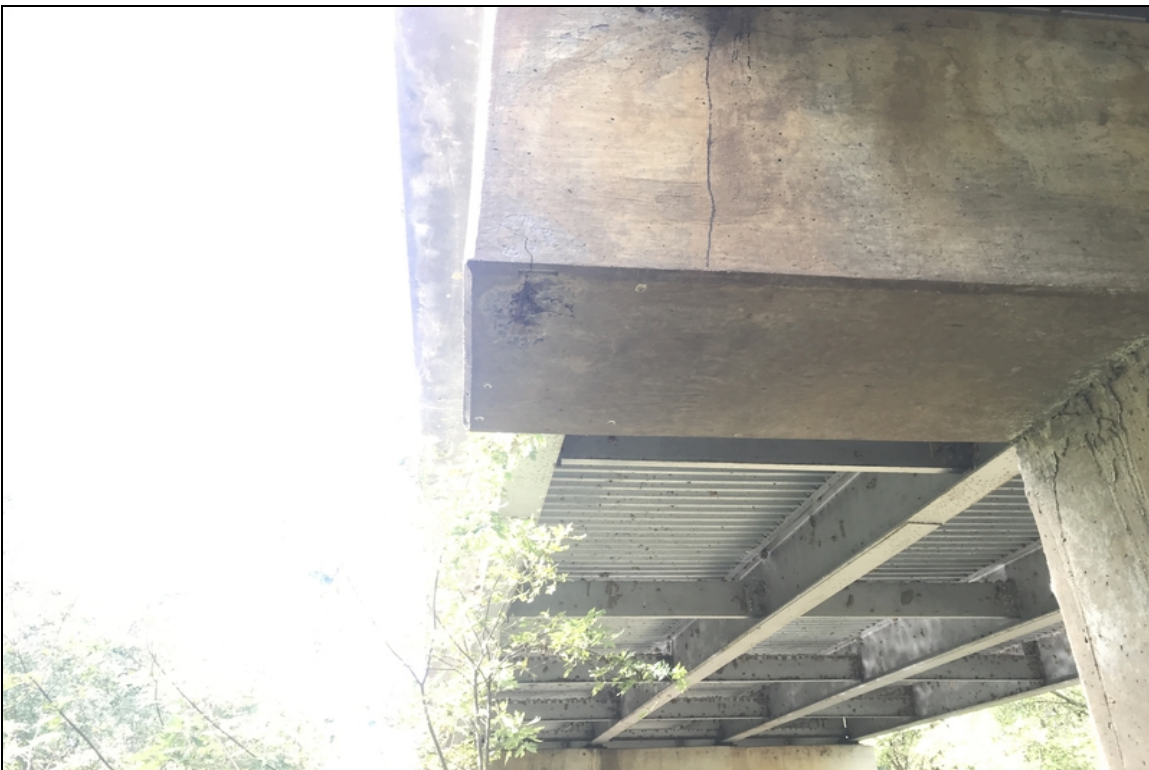
Bent 3 Rt cap undersurface spalling with exposed reinforcing steel.

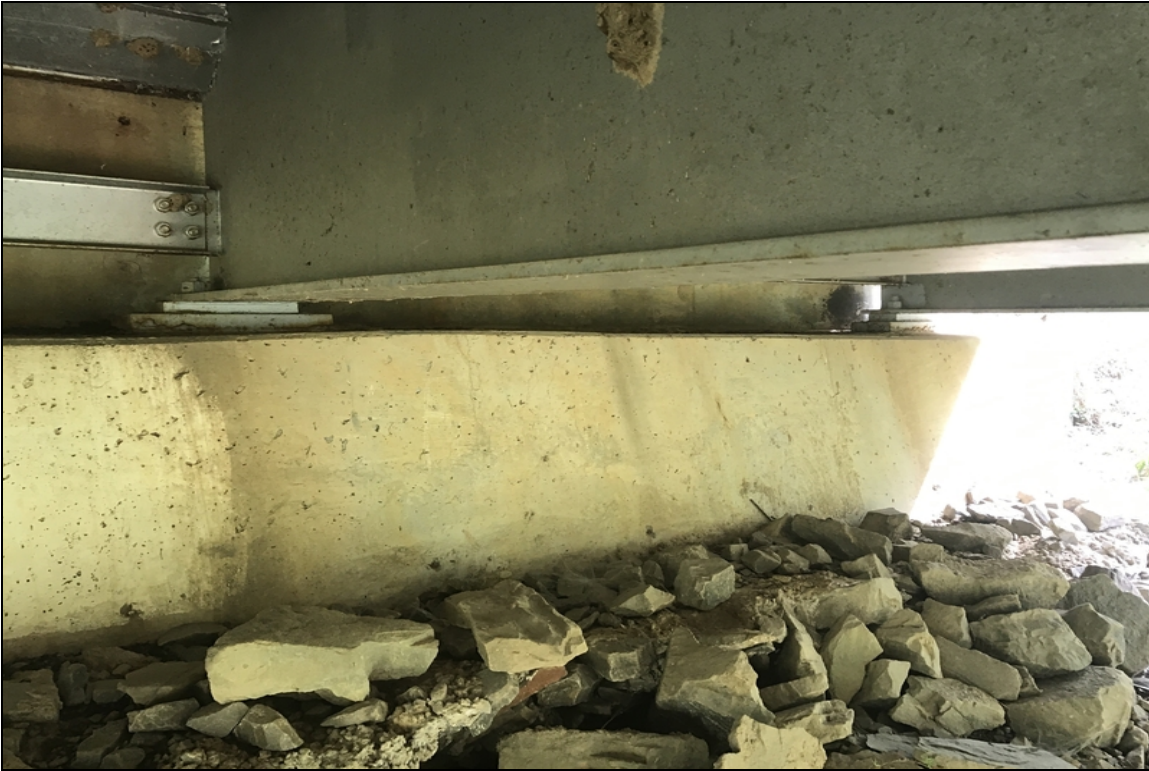
Bent 4 Beams 3 & 4 active corrosion with layers of flaking rust on the masonry plates.

The bearings have active corrosion and layers of flaking rust.

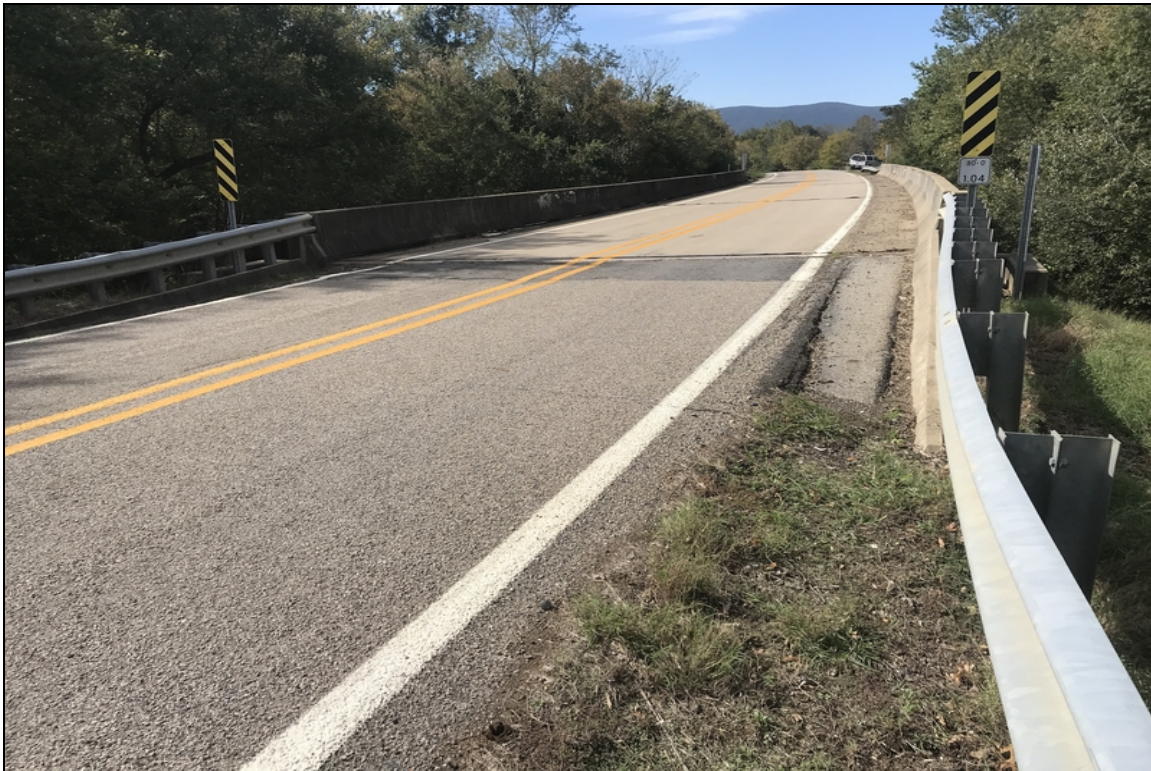
South approach roadway settlement.

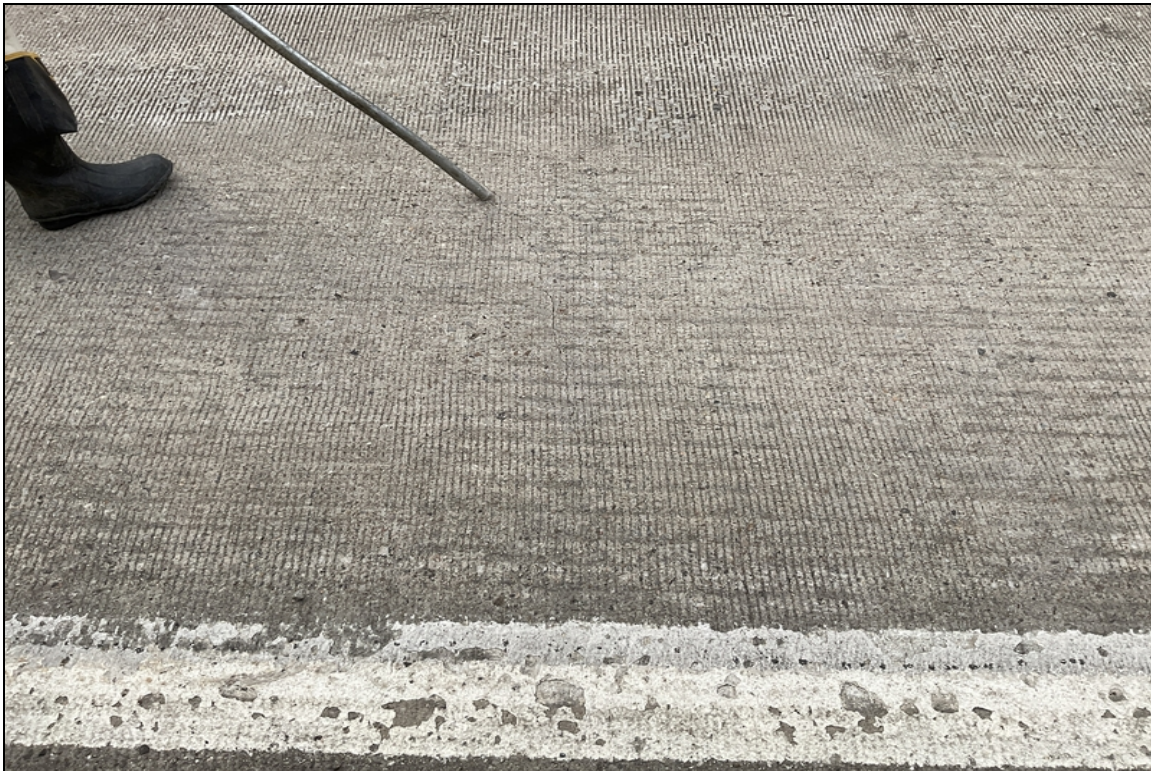
| ELEM | DESCRIPTION | UNITS | TOTAL | CS1 | CS2 | CS3 | CS4 |
|---|---|---|---|---|---|---|---|
| (12) | -There is 1 delaminated area and 1 shallow softball sized spall visible from the undersurface of the overhang under the Right gutter of the structure. Span # 3 Right over Bent # 3.<br>-There are a few transverse hairline cracks with light efflorescence visible from the undersurface of the overhang.<br>-The driving surface has short duration longitudinal and transverse cracking. | | | | | | |

Transverse crack in Span # 1.

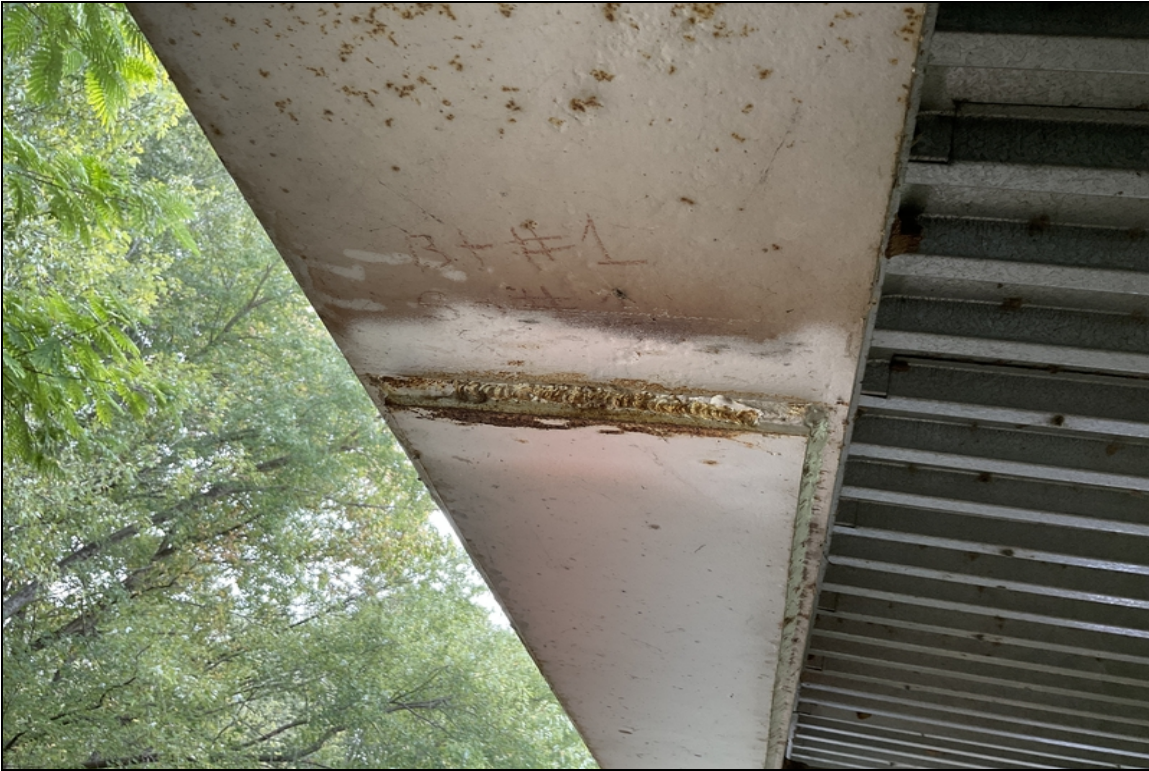
Welded repair to the end of the cover plate at Span # 1, Beam # 1 is still holding during this inspection.

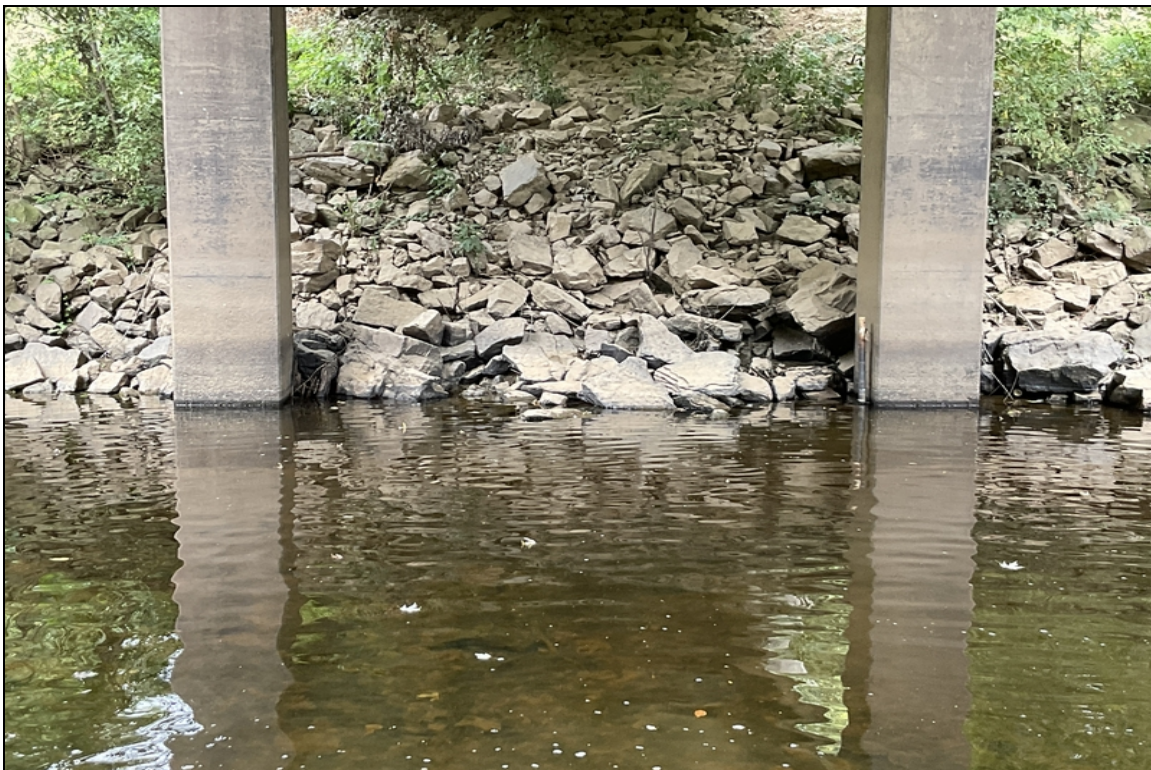
| ELEM | DESCRIPTION | UNITS | TOTAL | CS1 | CS2 | CS3 | CS4 |
|---|---|---|---|---|---|---|---|
| (205) | -The base of Bent # 2 columns have light abrasion at the water elevation.<br>-There is one shallow baseball sized spall with no exposed reinforcing steel in Bent # 2 column # 2. (Appears to be from the construction process). | | | | | | |

Light abrasion at the base of Bent # 2 columns.

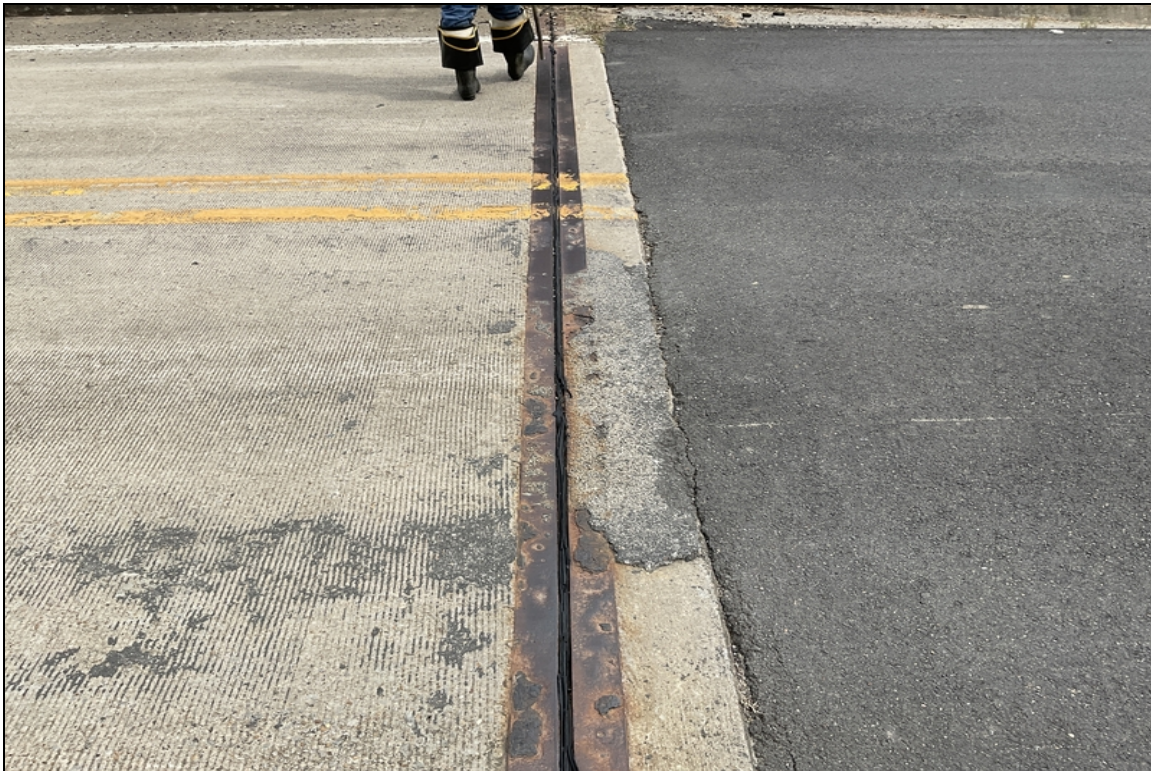
| ELEM | DESCRIPTION | UNITS | TOTAL | CS1 | CS2 | CS3 | CS4 |
|---|---|---|---|---|---|---|---|
| (215) | -Transverse racks typical in the tops of the back walls. (Seal Coat)<br>-The top of Bent # 1 backwall has been covered with a chip and seal coat.<br>-The top of Bent # 4 backwall has been partially covered with a chip and seal coat.<br>There is hairline map cracking in the right end of Bent # 4. | | | | | | |

Top of Bent # 4 backwall. Typical.

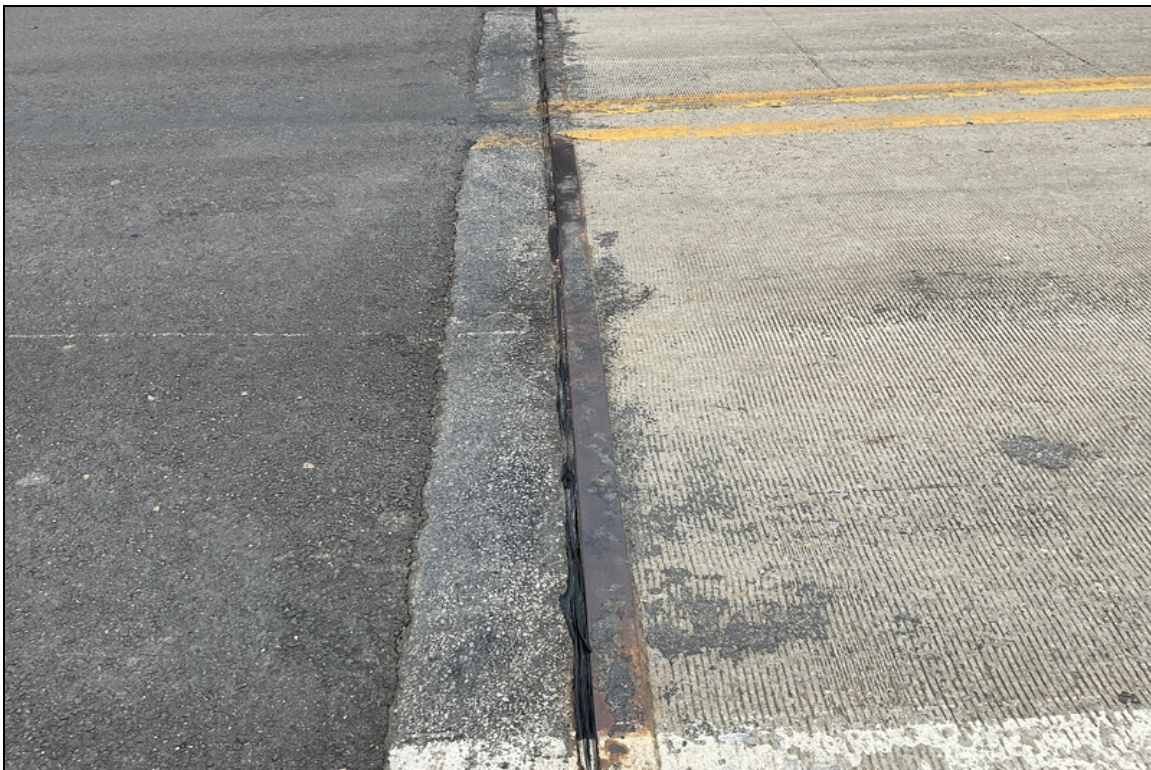
Top of Bent # 1 backwall.

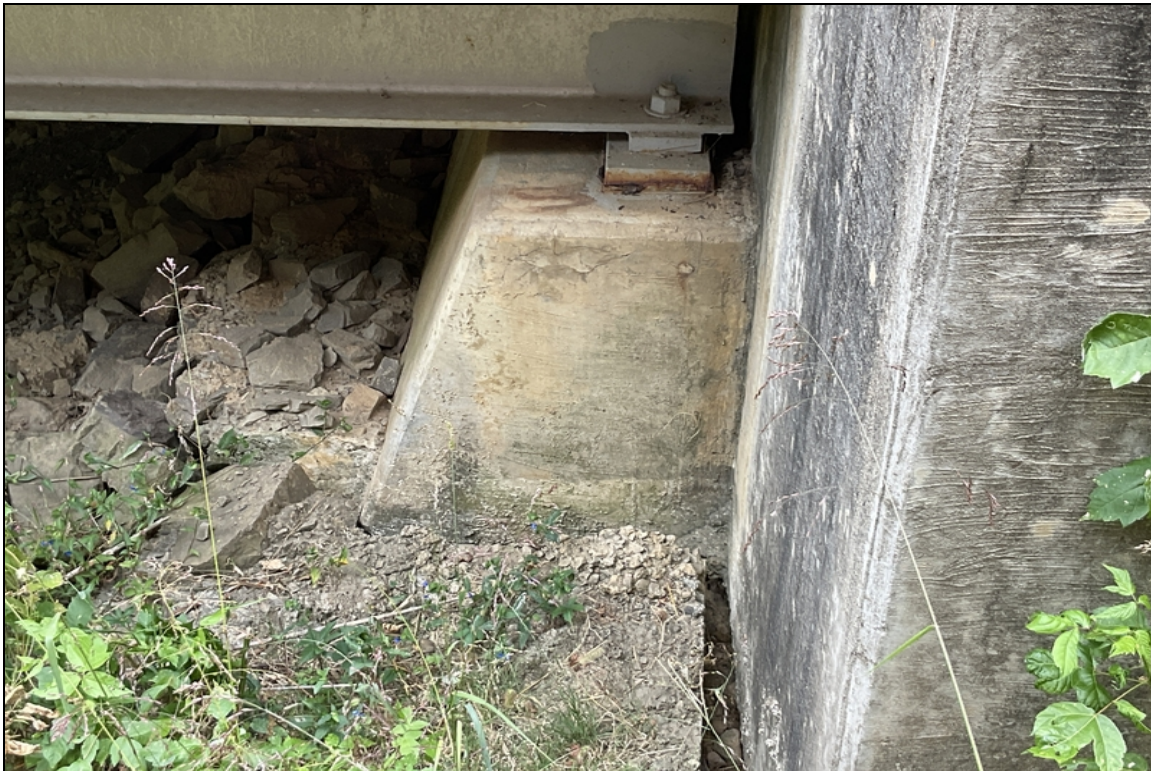
Hairline map cracking in the right end of Bent # 4.

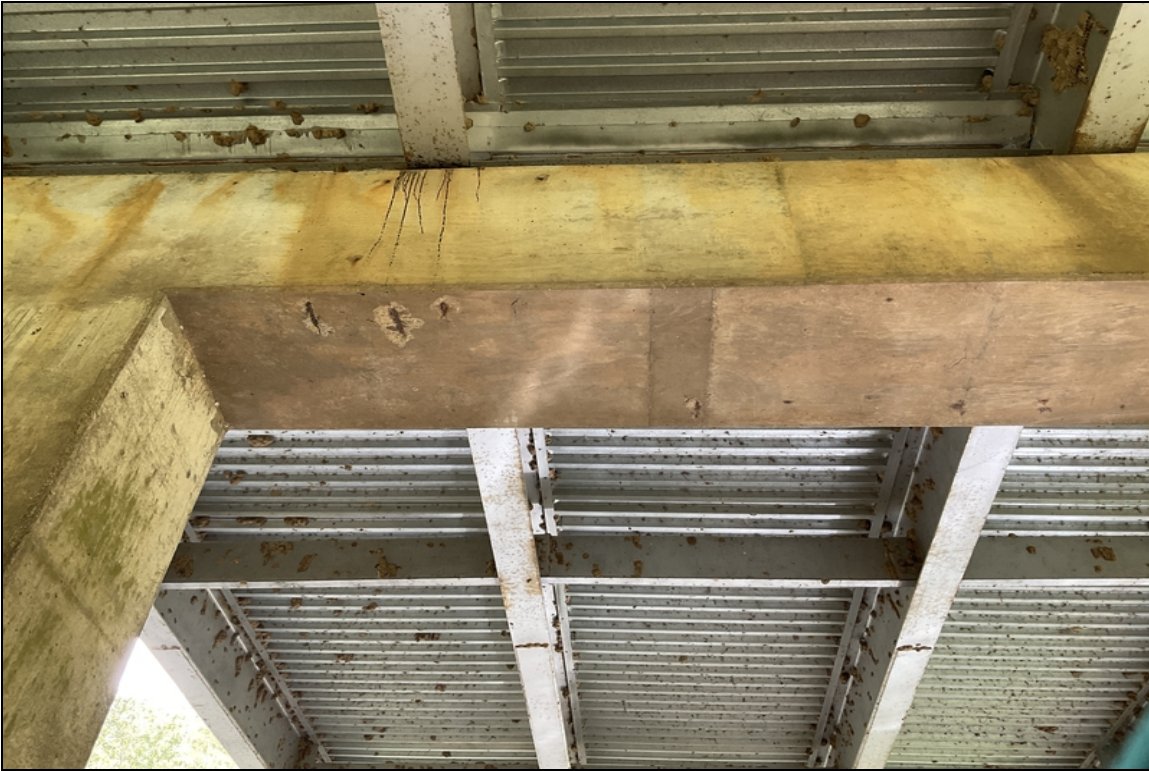
Undersurface of Bent # 2 cap. Spalls with exposed reinforcing steel.

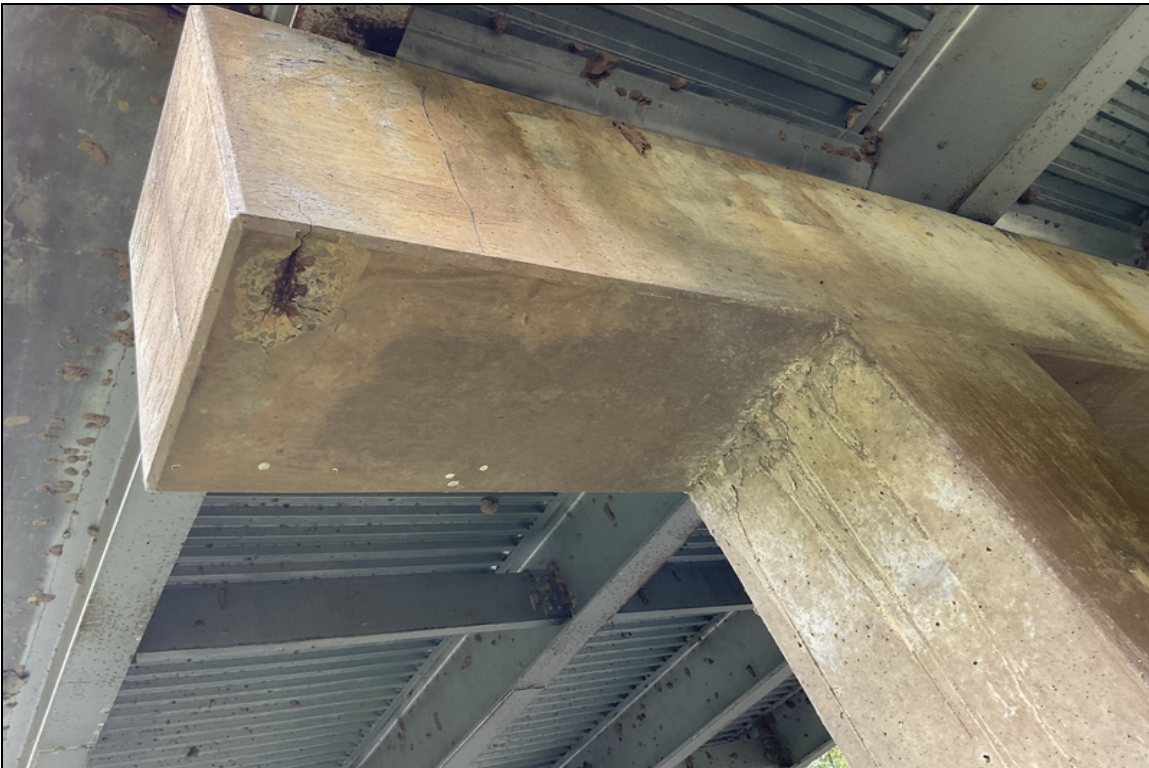
Right end of Bent # 3 cap. Undersurface. Spall with exposed reinforcing steel.

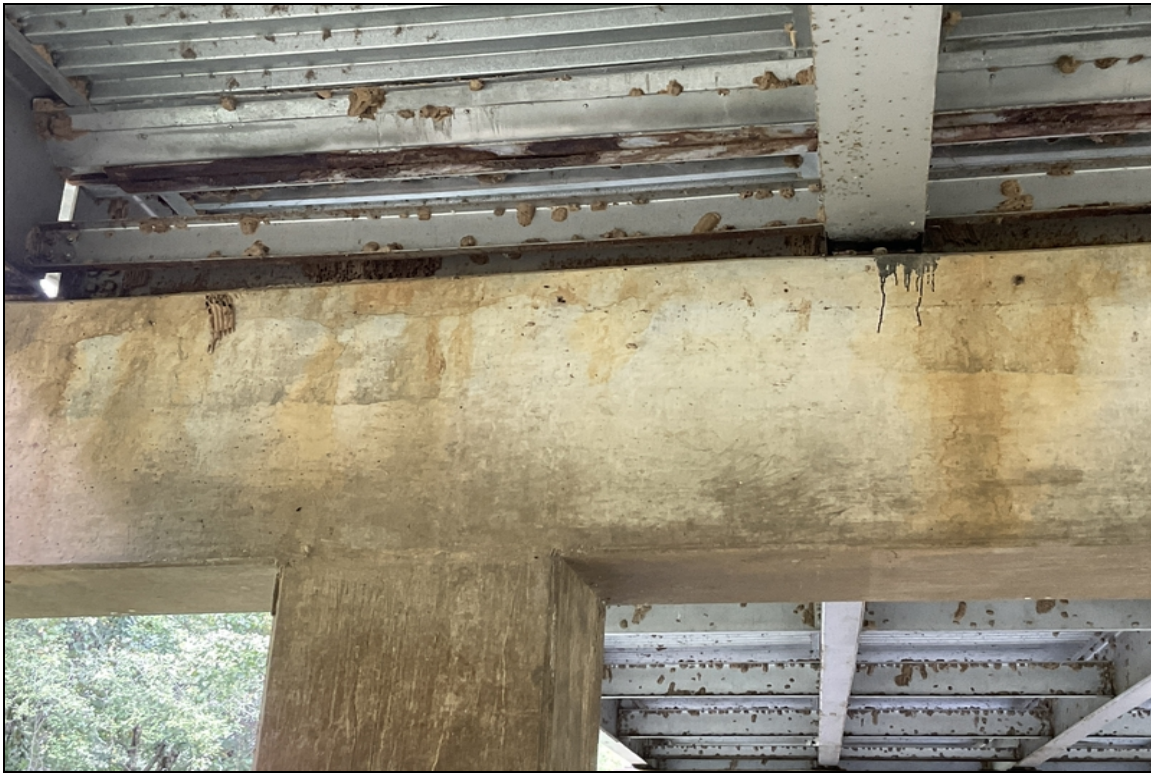
Horizontal crack in the Ahead face of Bent # 3 cap.

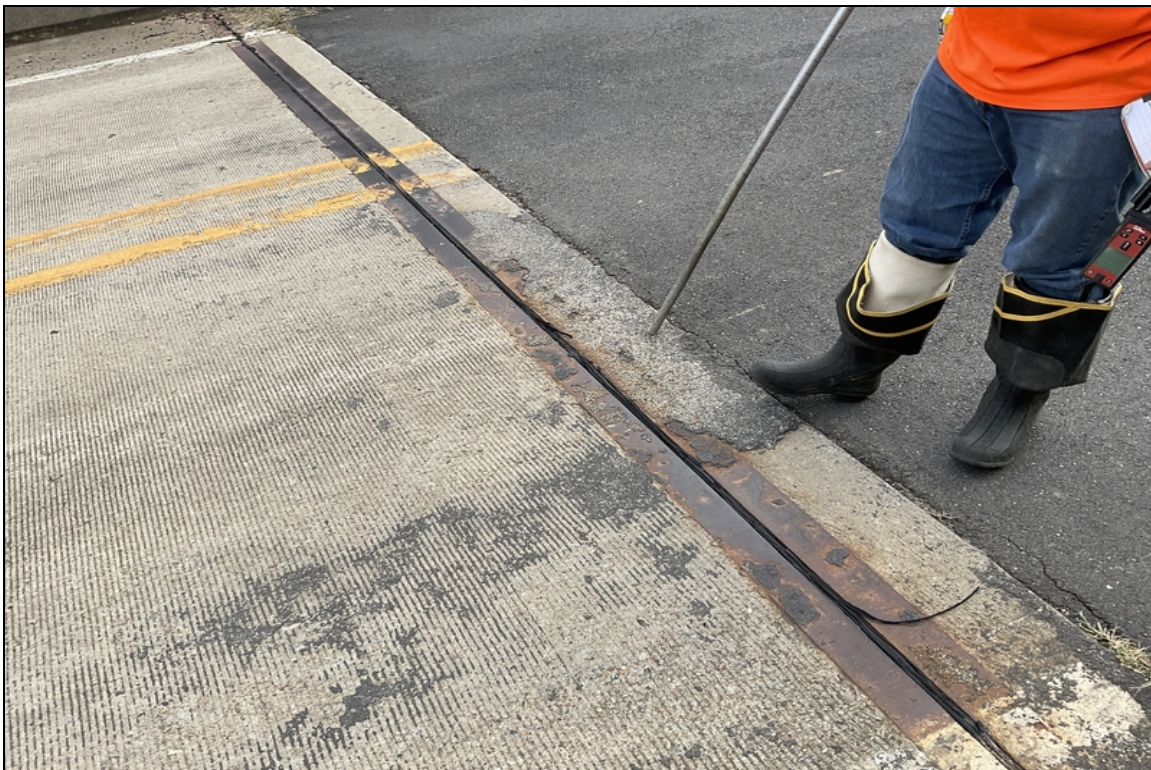
Torn expansion joint seal over Bent # 4.

Bent 4 expansion joint seal. Torn.

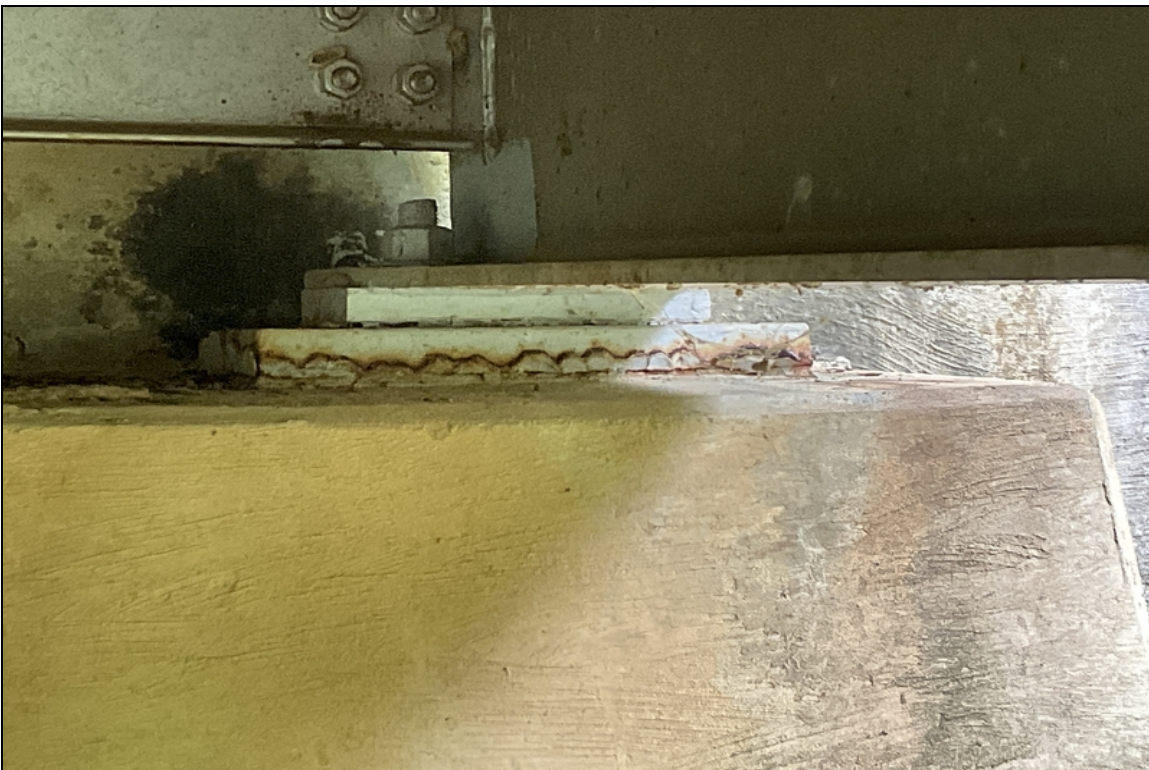
| ELEM | DESCRIPTION | UNITS | TOTAL | CS1 | CS2 | CS3 | CS4 |
|---|---|---|---|---|---|---|---|
| -Ends of beams and bearings have areas of active corrosion that have been covered with "Bridge Mate" rust inhibitor and painted in areas. | | | | | | | |

Bent # 4. Beam # 4 bearing corrosion showing through the paint system.

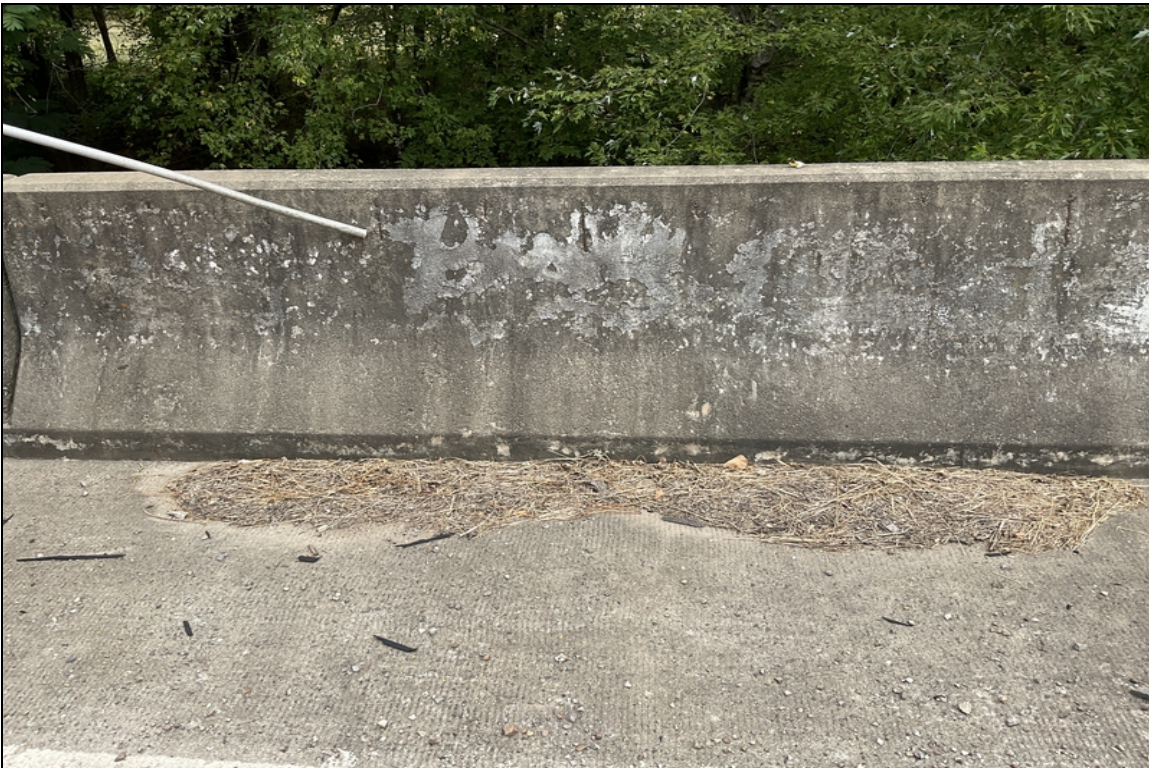
| ELEM | DESCRIPTION | UNITS | TOTAL | CS1 | CS2 | CS3 | CS4 |
|---|---|---|---|---|---|---|---|
| -There are vertical cracks at variable spacing visible in the face of the parapet walls.<br>-The bridge rails have shallow spalls that expose reinforcing steel. | | | | | | | |

Spalls with exposed reinforcing steel in the Left parapet of Span # 1.

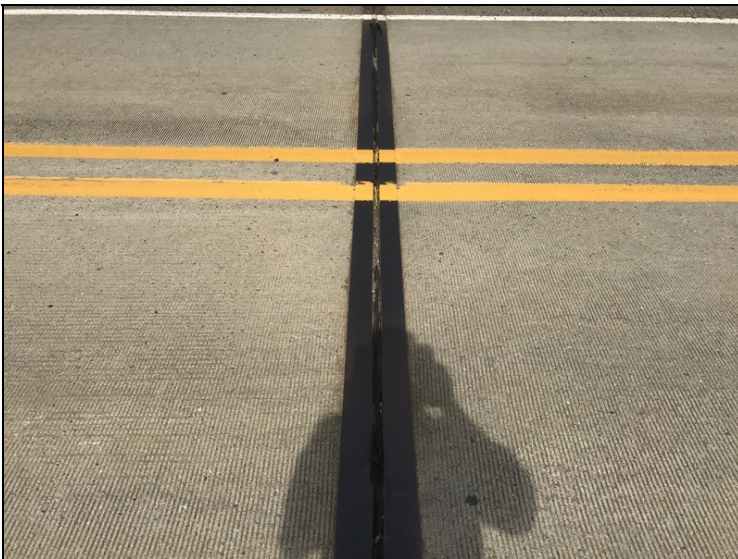
The deck joint seals are ripped, torn, and leak water on the superstructure and substructure.

Bent # 3 compression joint seal tears and partially missing.
