**Bridge #06110(Routine, Underwater type 2)**

**SH 80 - Scott Co. over Poteau Creek**

**Location: 1.04 MI SE JCT SH 28&80**

**Team Lead: Jeff Jones Inspection Date: September 29, 2021**

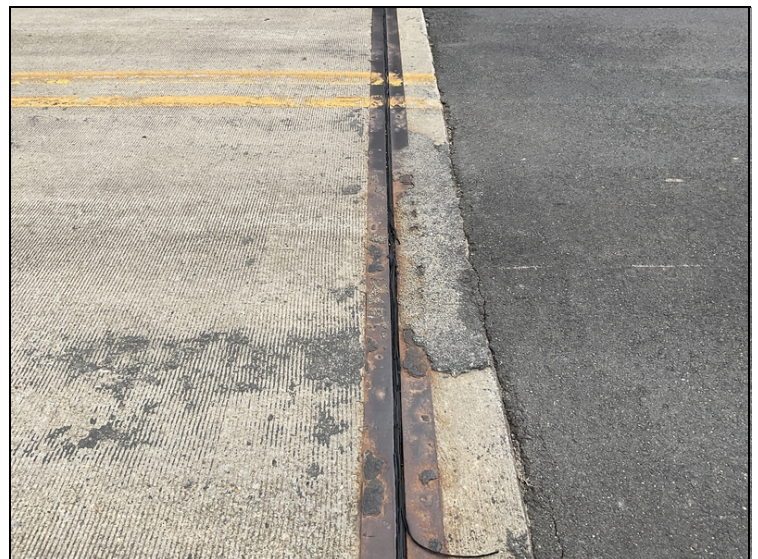
The deck joint seals are ripped, torn, and leak water on the superstructure and substructure.

Bent # 4 compression joint seal tears.

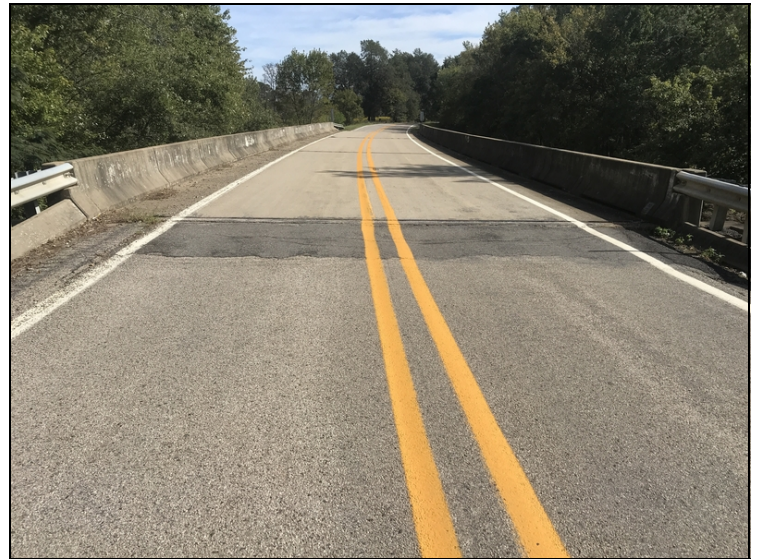
There is earth settlement adjacent to the approach gutters and asphalt settlement in the approach roadway adjacent to the abutments.

North approach roadway settlement.

09/29/2021 - JCJ & TJL - Department Maintenance Forces have constructed a new asphalt leveling course at both approaches. There are still voids under the concrete approach gutters.

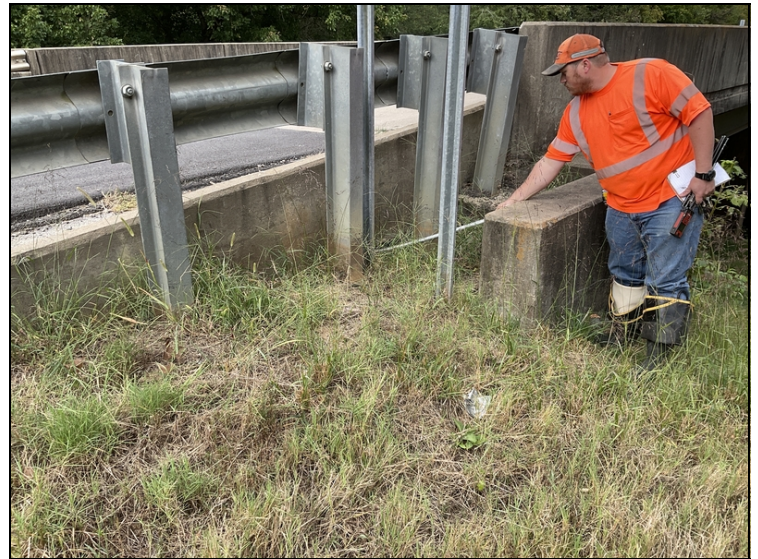
Void under the Northeast approach gutter.

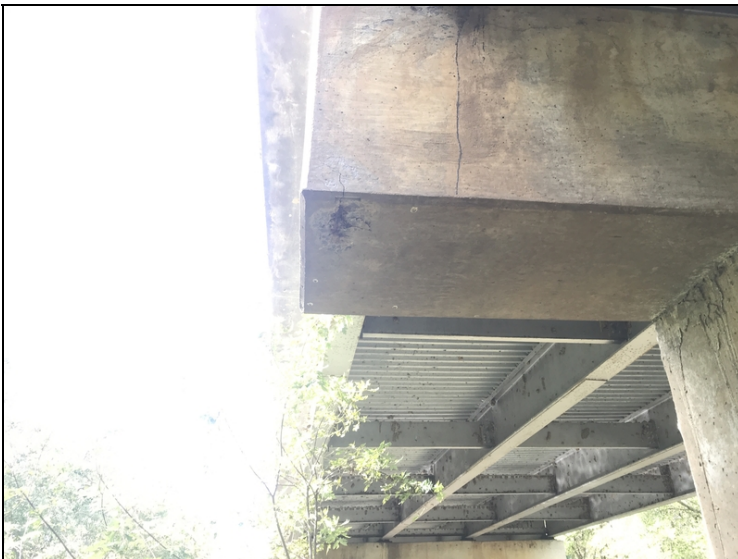
The bent caps have spalls with exposed reinforcing steel.  
Stains on the substructure caps indicate leaking deck joint seals.

Bent # 3 Rt cap undersurface spalling with exposed reinforcing steel.

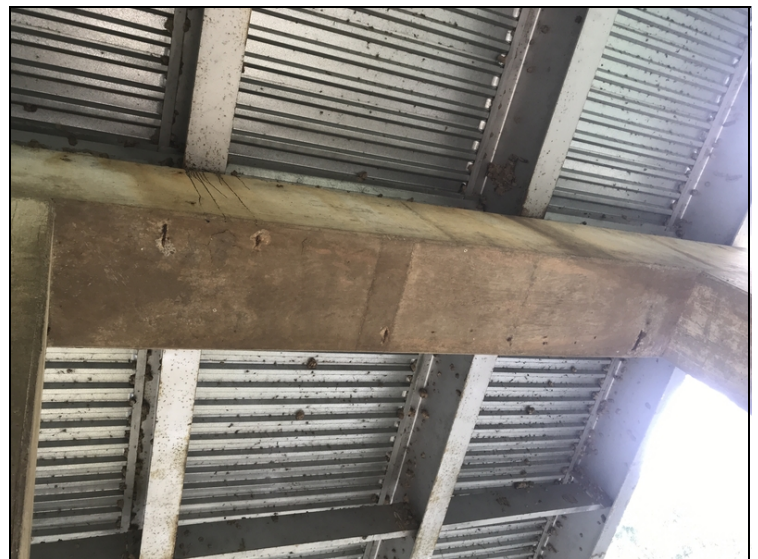
Bent # 2 shallow spalling with exposed reinforcing steel on the cap undersurface.

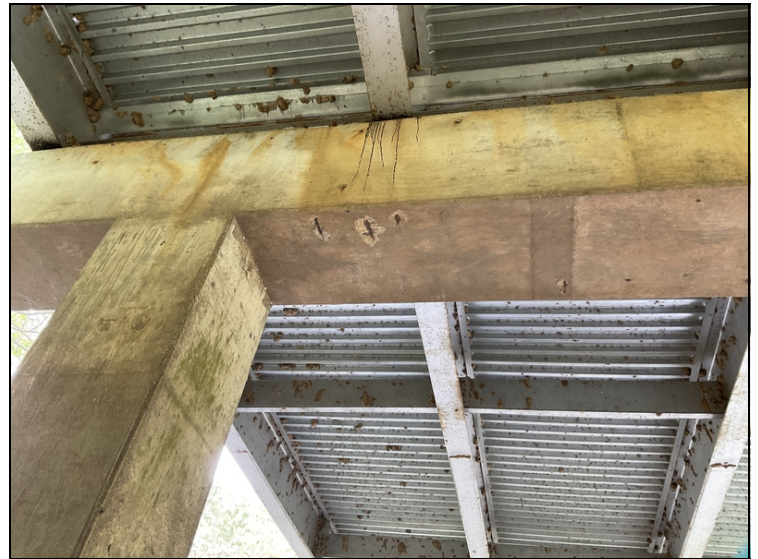
Undersurface of Bent # 2 cap. Spalls with exposed reinforcing steel.

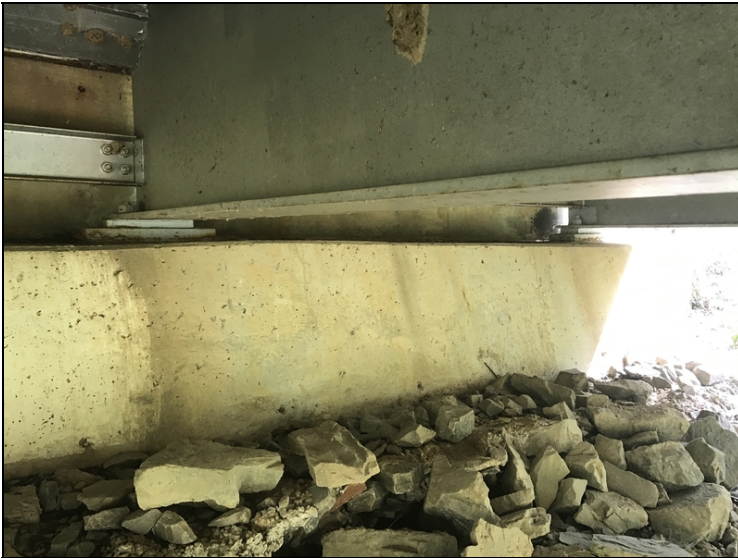
The bearings have active corrosion and layers of flaking rust.

Bent # 4 Beams # 3 & 4 active corrosion with layers of flaking rust on the masonry plates.

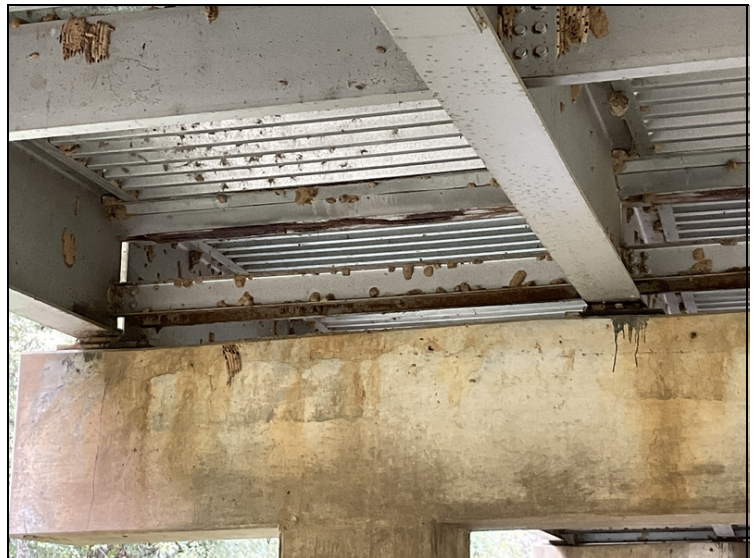
Bent # 3 bearing corrosion.

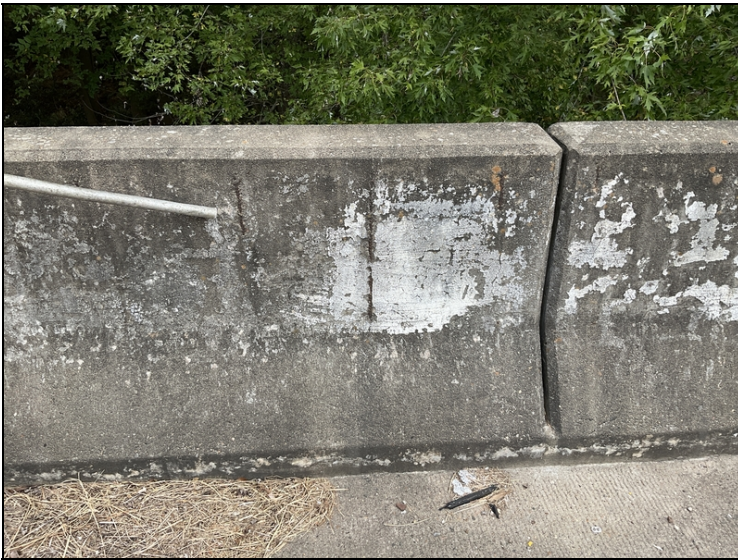
Numerous spalls with exposed reinforcing steel in the face of the parapet walls.

Numerous spalls with exposed reinforcing steel in the face of the parapet wall.
