**Bridge #M1470(Routine)**  
**State Highway 80 over Creek-Scott Co.**  
**Location: 0.9 MI NW US 71**

**Team Lead: Jeff Jones Inspection Date: January 11, 2021**

IDENTIFICATION	
(1) State Names	Arkansas
(8) Structure Number	M1470
(5) Inventory Route	80
(2) Highway Agency District	04
(3) County Code	127-Scott County, Arkansas

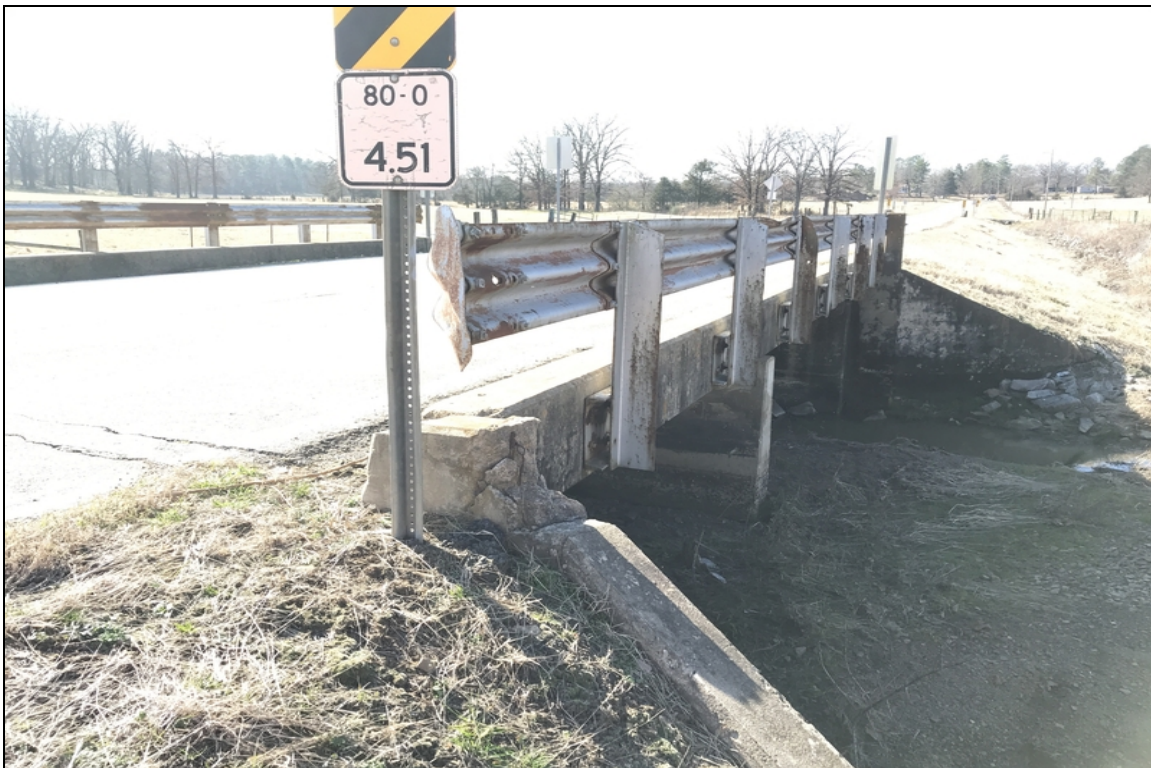
ELEM	DESCRIPTION	UNITS	TOTAL	CS1	CS2	CS3	CS4
1190 (215)	Abrasion/Wear (PSC/RC)	LF	8	0	8	0	0
-There is one 6" spall and two 10" shallow spalls with no exposed reinforcing steel in the bearing areas of Bent # 3 under Beams # 1, 5, and 6. -Random areas of light abrasion on the base of the abutments. -Abutments have isolated vertical cracks.							
301	Pourable Joint Seal	LF	52	52	0	0	0
305 (305)	Assembly Joint without Seal	LF	48	48	0	0	0
The majority of the expansion joints are covered with asphalt. There is active corrosion in the expansion joint that is visible in the gutters.							
330	Metal Bridge Railing	LF	80	78	1	0	1
7000	Damage	LF	2	0	1	0	1
515	Steel Protective Coating	SF	350	349	1	0	0
3440 (330)	Effectiveness (Steel Protective Coatings)	SF	1	0	1	0	0
01/23/2020 - JCJ & TJL - -The metal portions of the bridge railing have a new paint system with isolated areas of minor out of plane bending due to apparent traffic impacts. -The Northeast concrete end post has broken off and has exposed reinforcing steel.

Bent # 3 Lt missing end post.

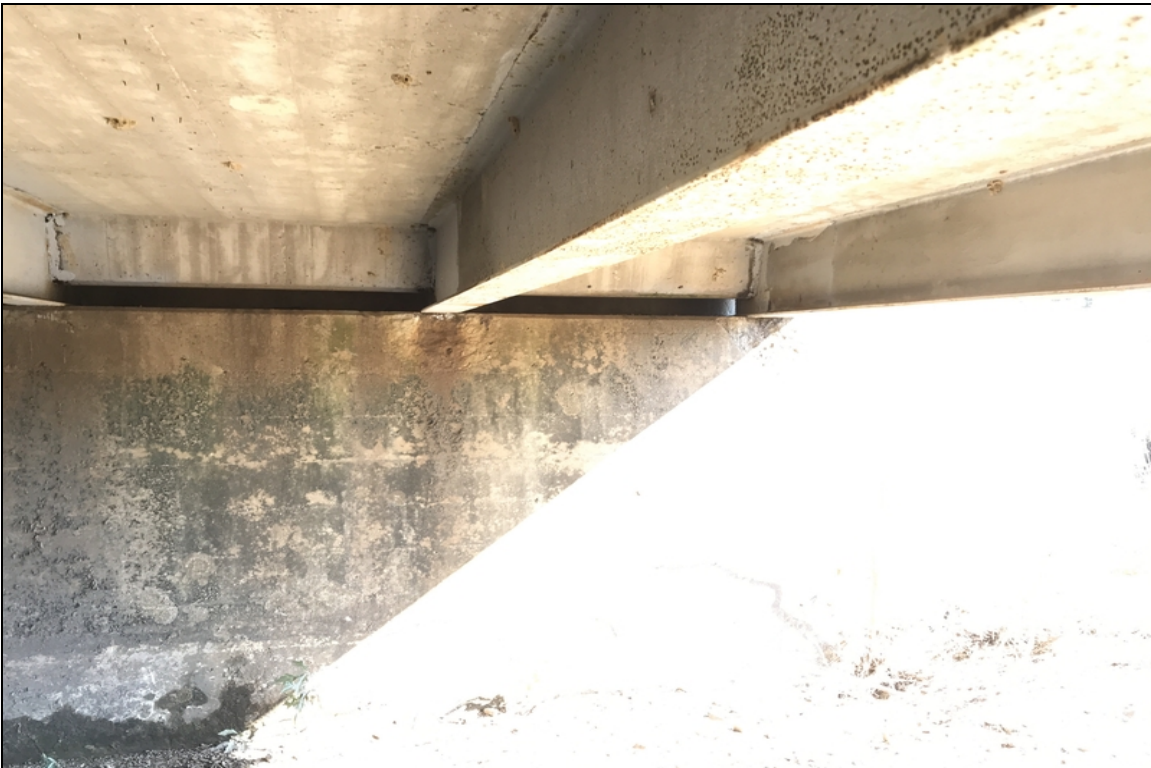
Bent # 3 spalling in the bearing area of beams # 1, 5, & 6.

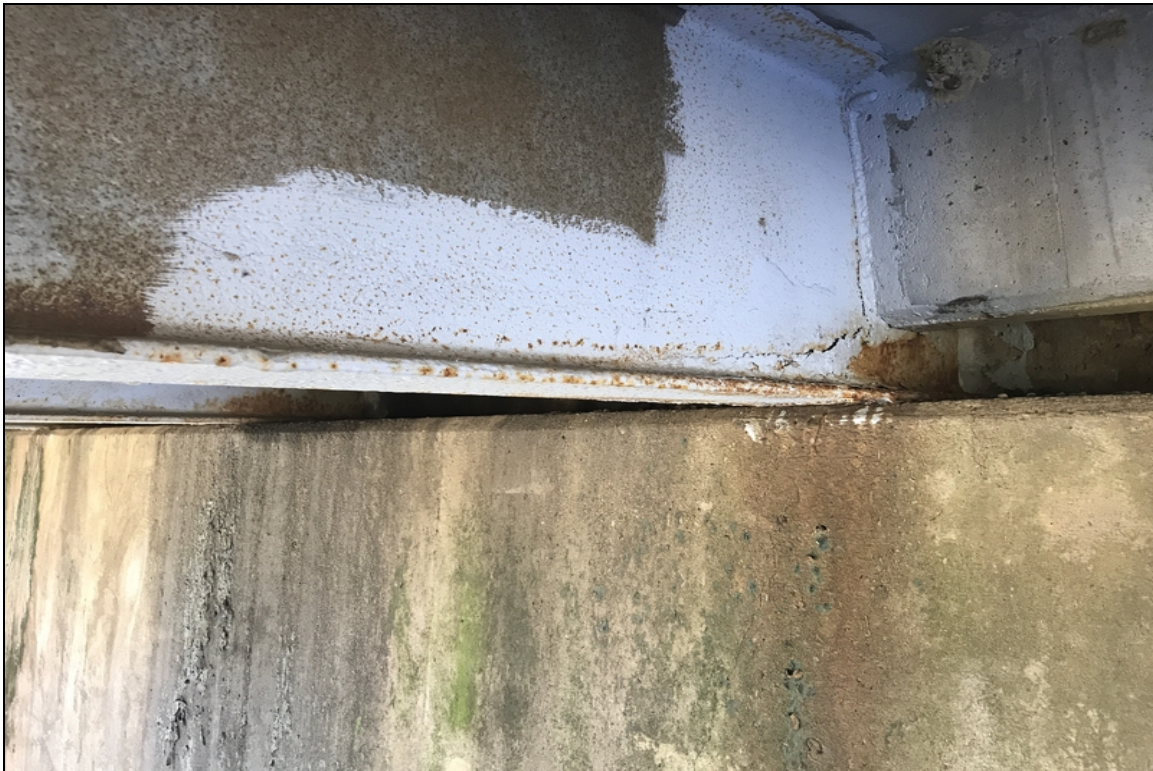
(107)							
-The majority of the superstructure has light freckled rust. -The ends of the beams at the abutments have active corrosion with flaking rust. -Maintenance forces have painted over the active corrosion in the past as a type of repair. -Active corrosion is flaking off the painted repairs in many areas. -Section loss to the ends of the beams at the abutments ranges from heavy pitting up to knife edge section loss to the bottom flanges. -The base of webs in the ends of the beams over the abutments ranges from heavy pitting up to 7/16" section loss at Beam # 5 over Bent # 3. -Beam # 1 over Bent # 2 has an old crack / torch cut that has a welded repair that is cracked. This appears to be in "as built" condition.							
210	Reinforced Concrete Pier Wall	LF	24	0	1	23	0
1130	Cracking (RC and Other)	LF	1	0	1	0	0
1190	Abrasion/Wear (PSC/RC)	LF	23	0	0	23	0

Bent # 1 Beam # 3 active corrosion with layers of flaking rust at the ends of the beams.

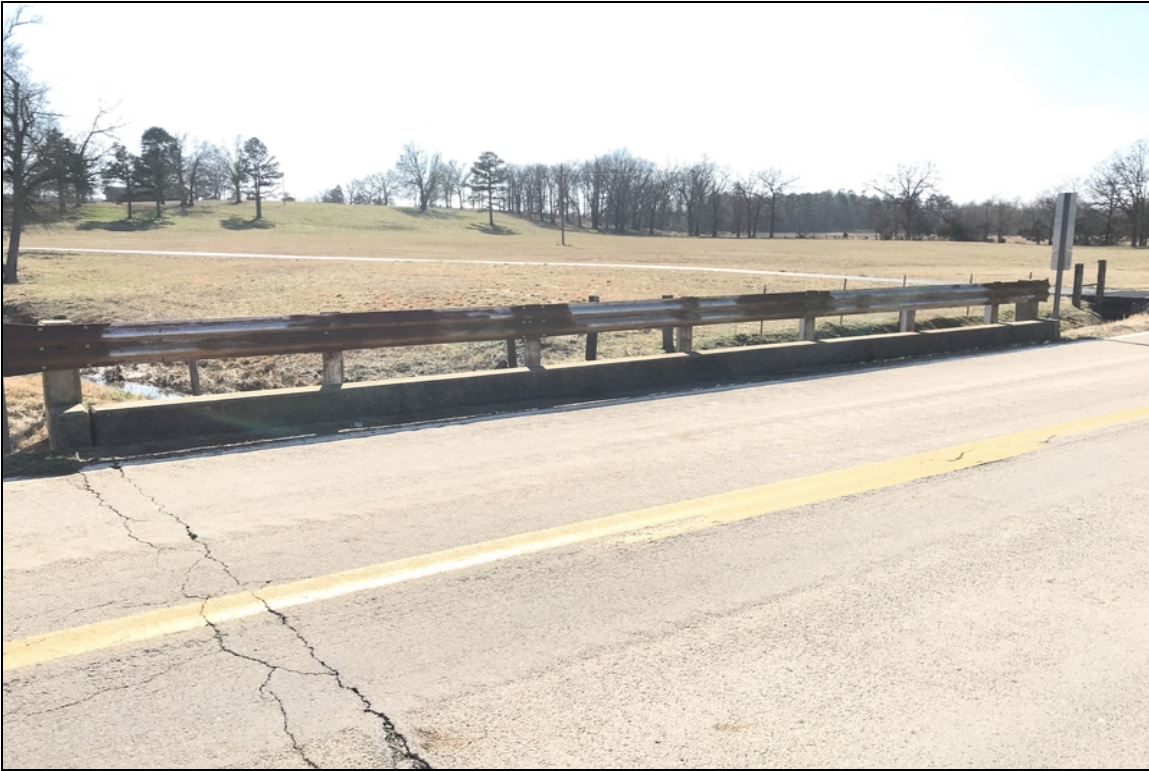
Failing paint system on the bridge rails.

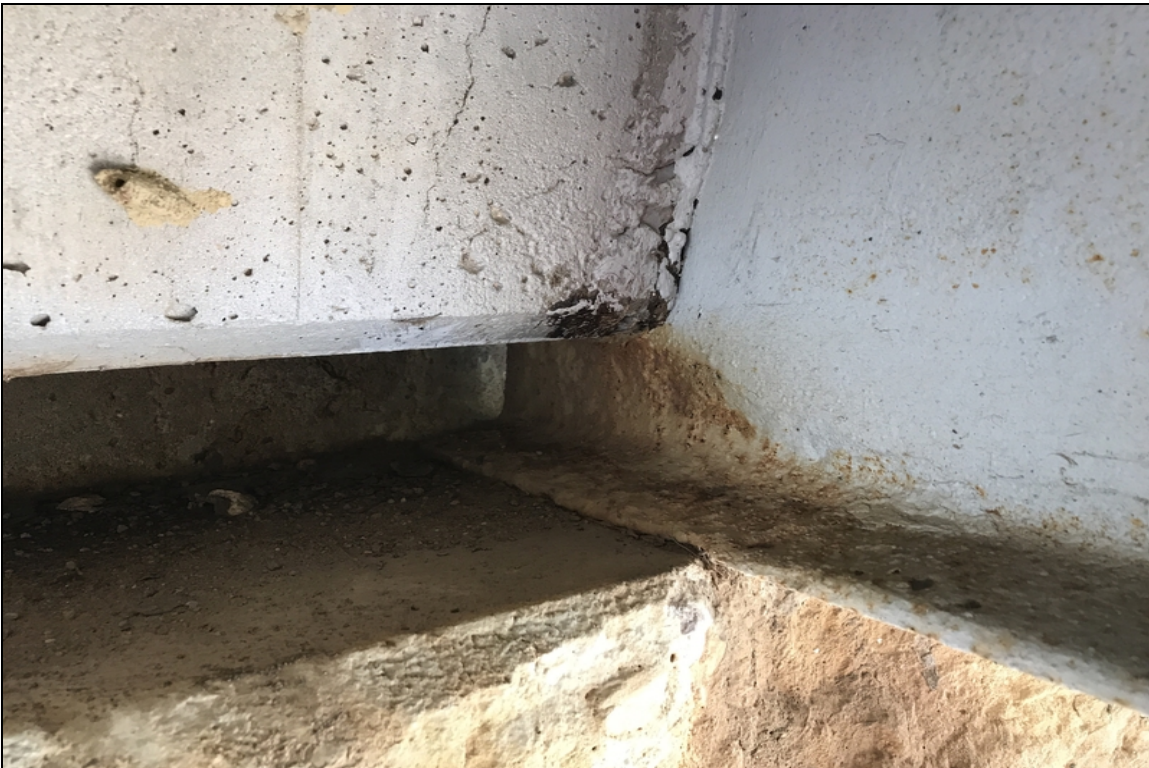
Old section loss scars.

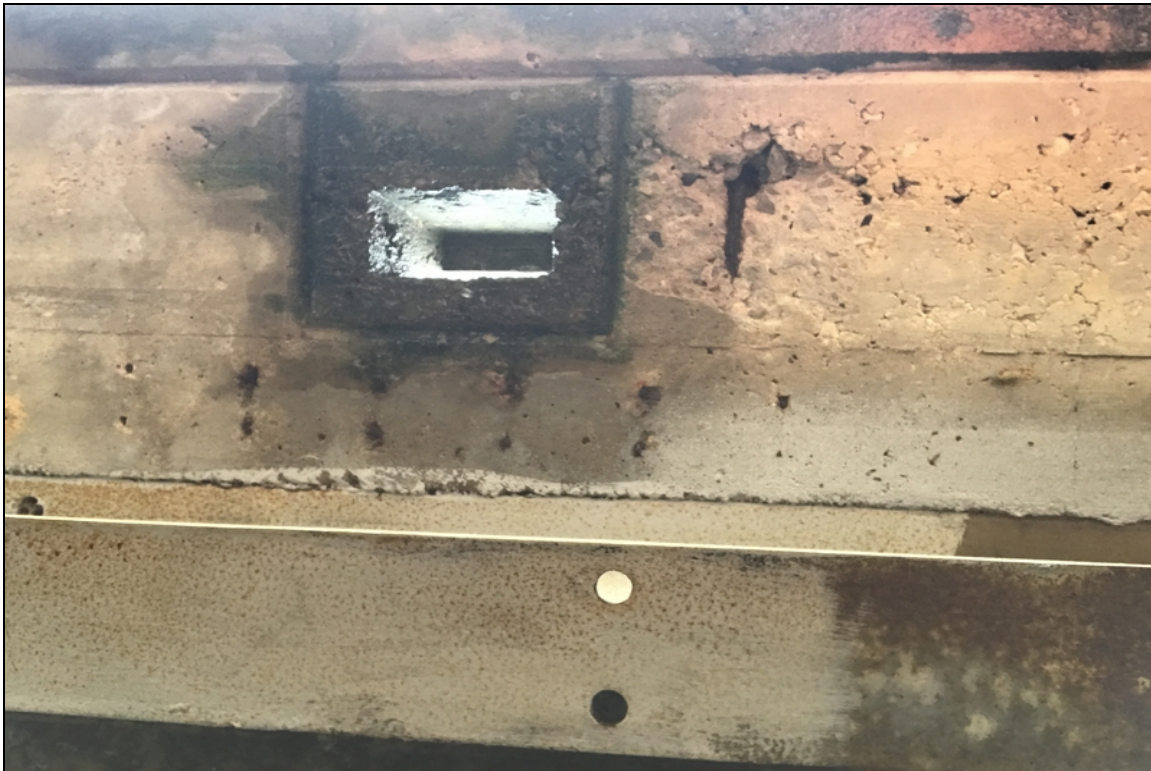
Spall with exposed reinforcing steel adjacent to the deck drains in Span # 2.

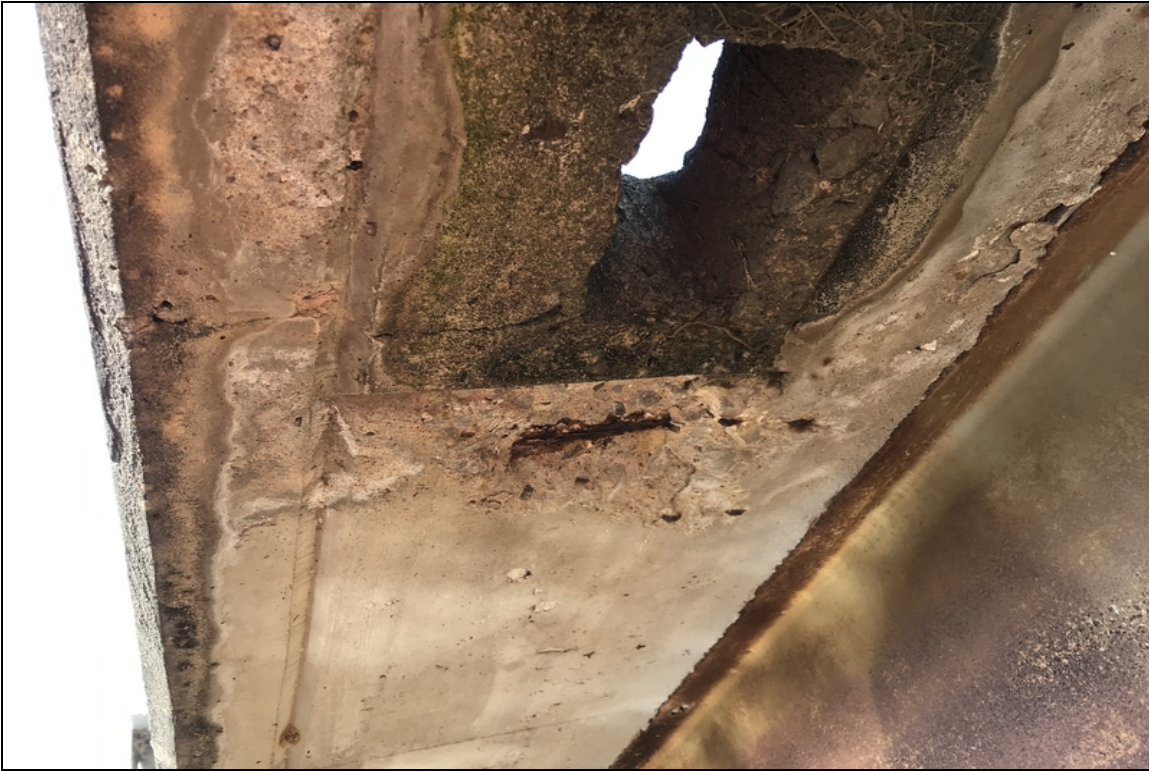
Spall with exposed reinforcing steel adjacent to the Right deck drain in Span # 2.

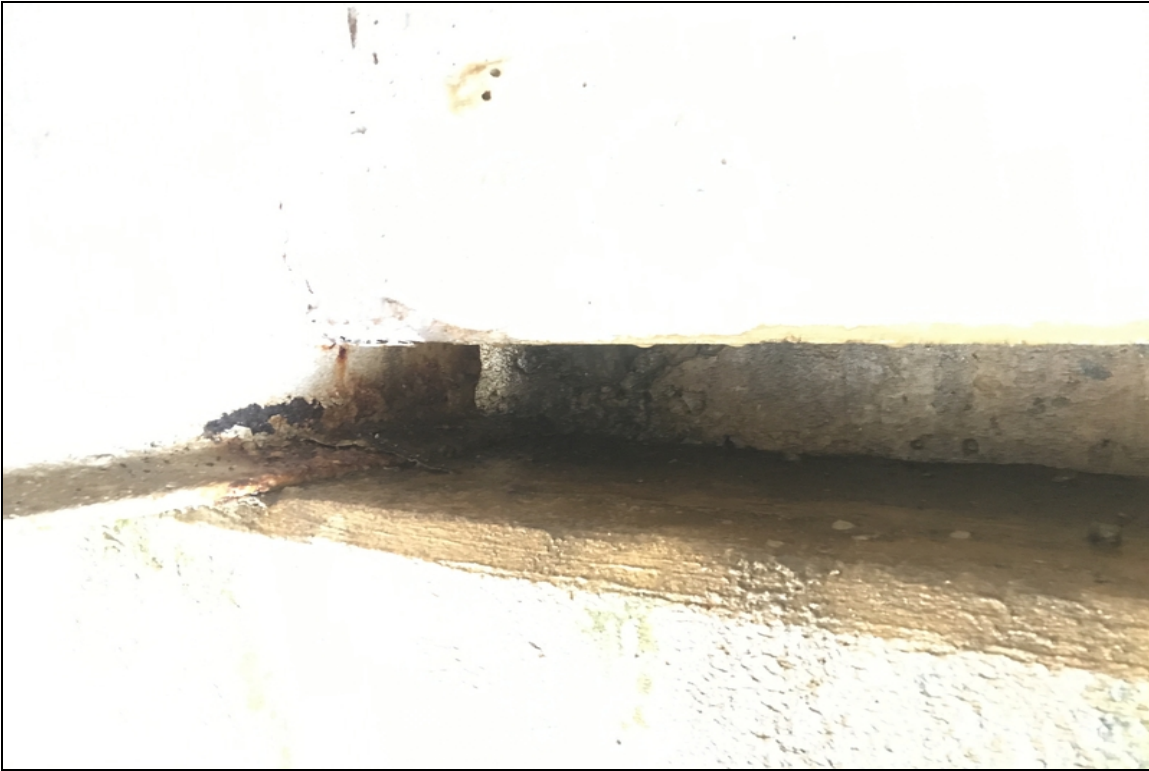
Bent # 1 Beam # 5. Paint system at the end of the beam.

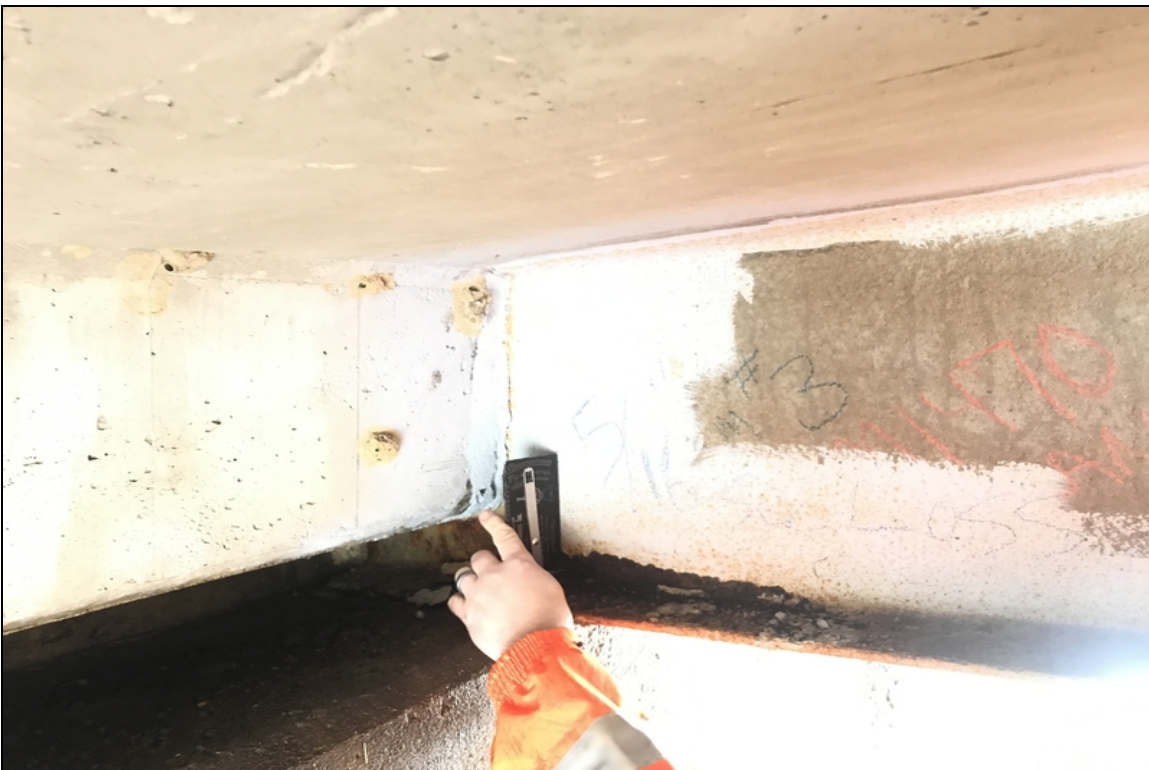
Beam # 3 at Bent # 1 has 5/16" section loss to the base of the web.

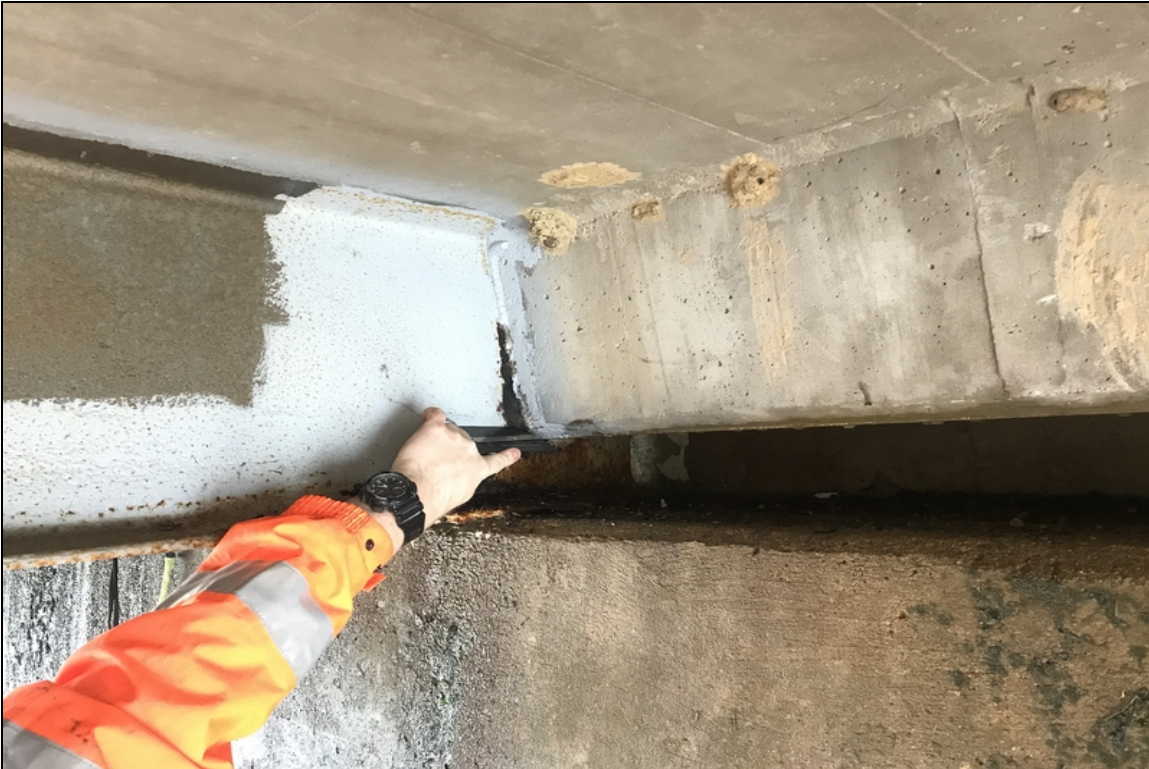
Bent # 1. Beam # 3. There is 1/4" section loss in the vertical face of the web adjacent to the expansion dam.

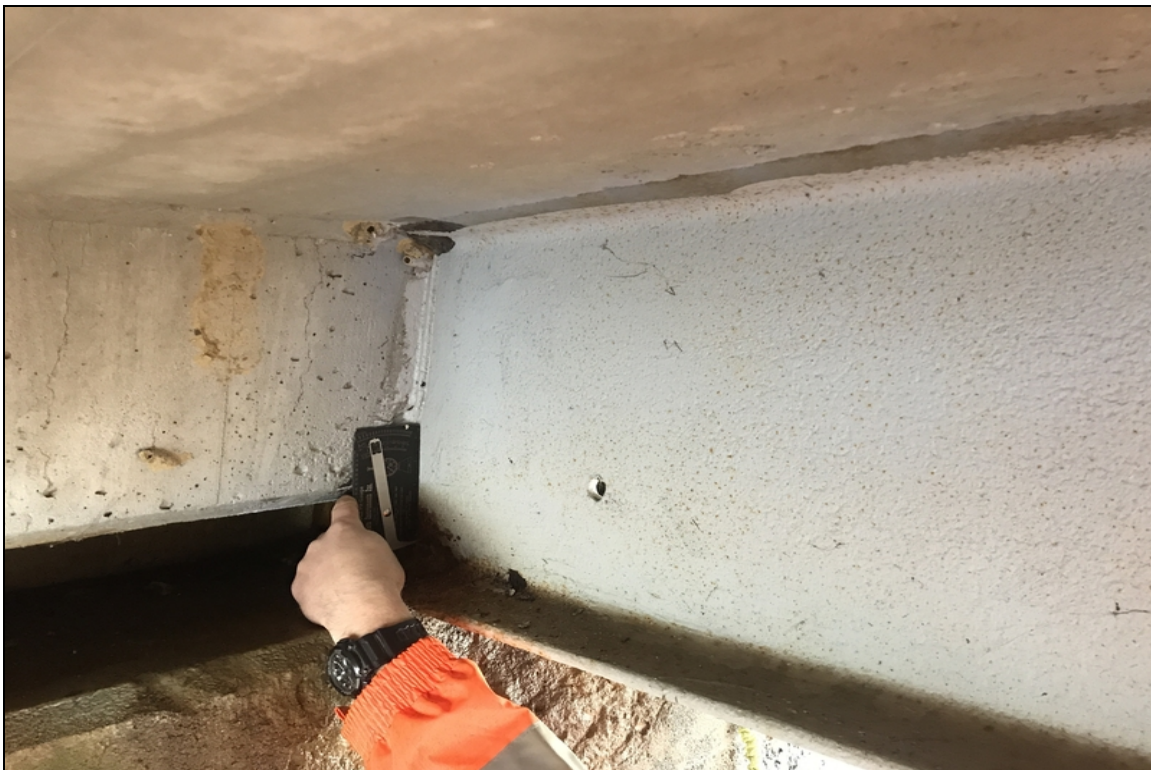
Bent # 3. Beam # 5. Base of web has 7/16" section loss.

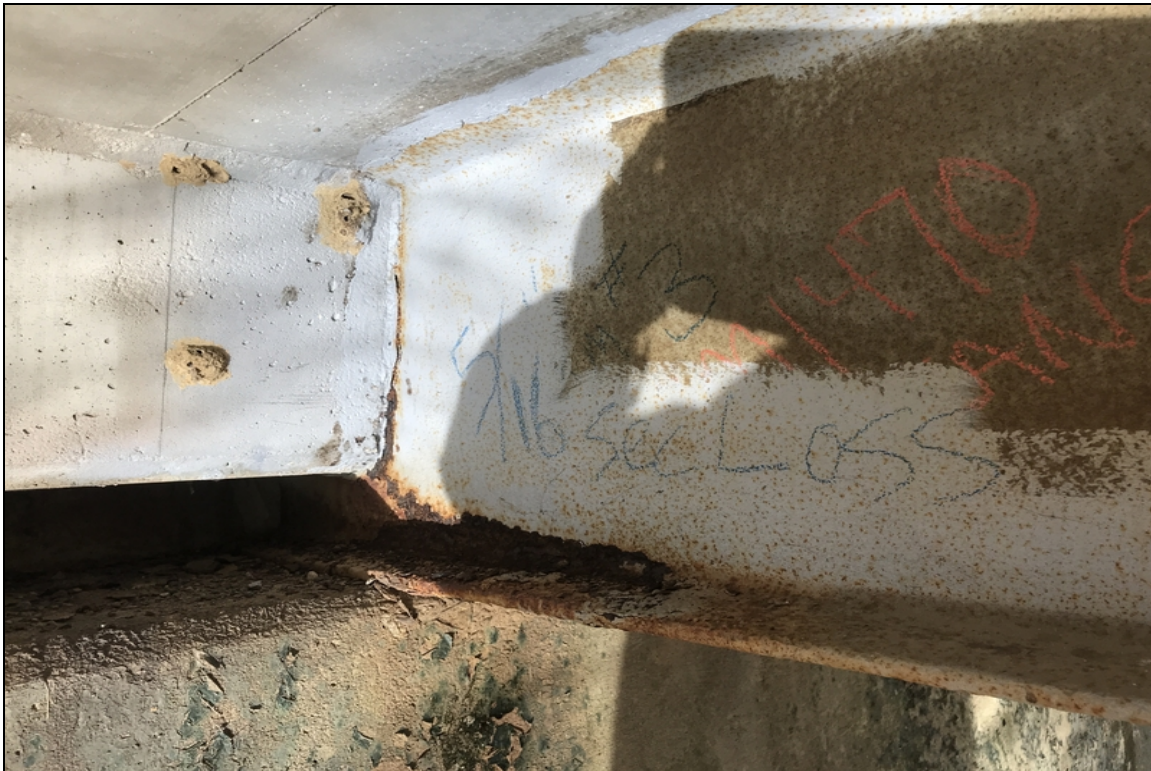
Bent # 1. Beam # 3. Corrosion with section loss.

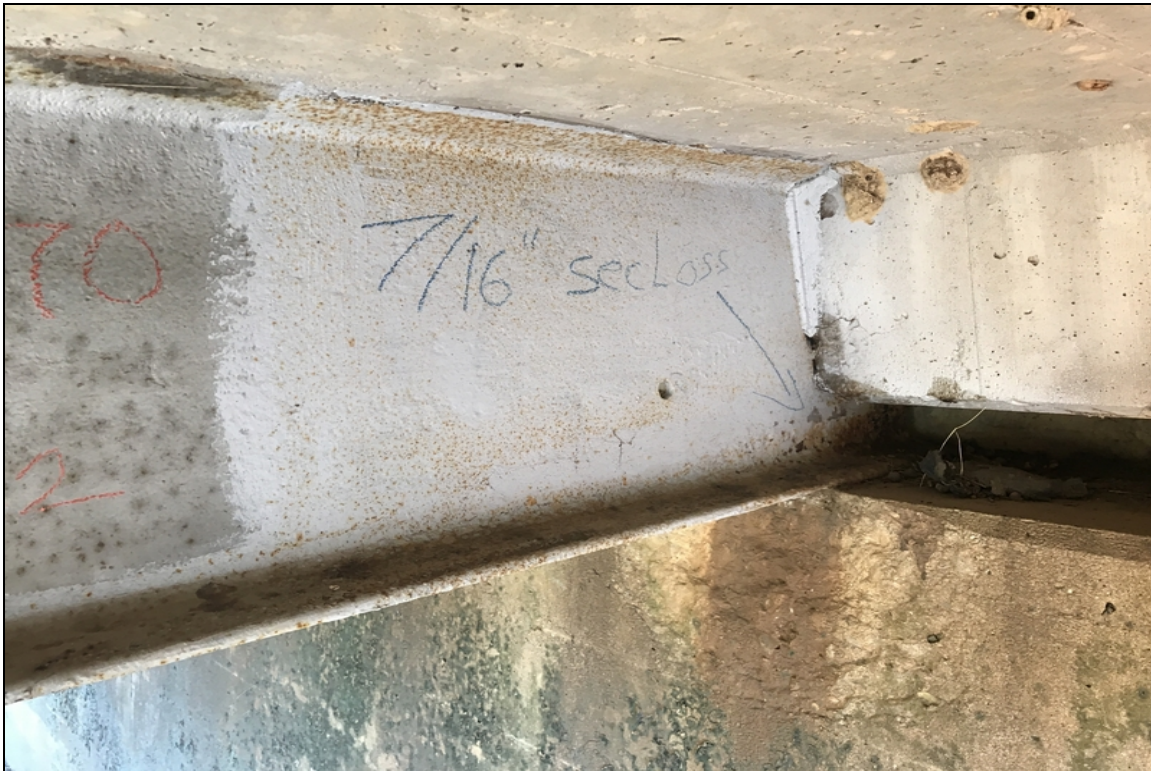
Beam # 5 at Bent # 3. Section loss.

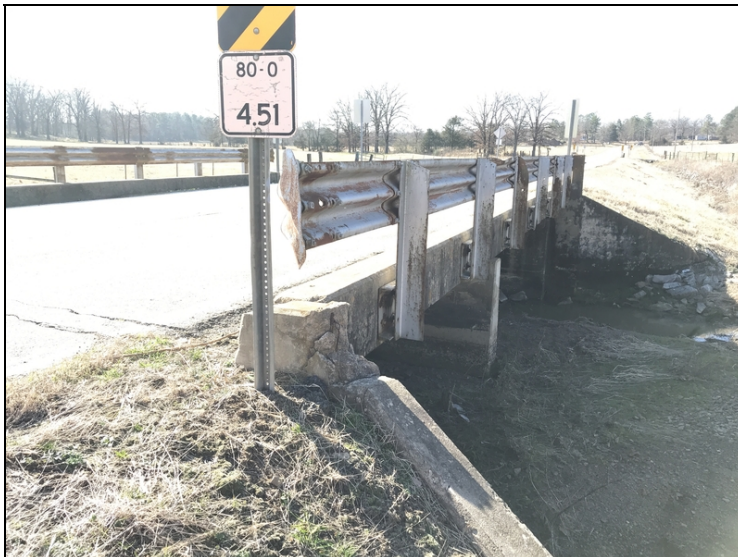
The Northeast concrete end post has broken off and has exposed reinforcing steel.

Bent # 3 Lt missing end post.

**Date Reported:** 02/29/2016  
**Priority:** D- Routine  
**Type of Work:** Repair  
**Status:** Open  
**Component:** 330 - Metal Bridge Railing

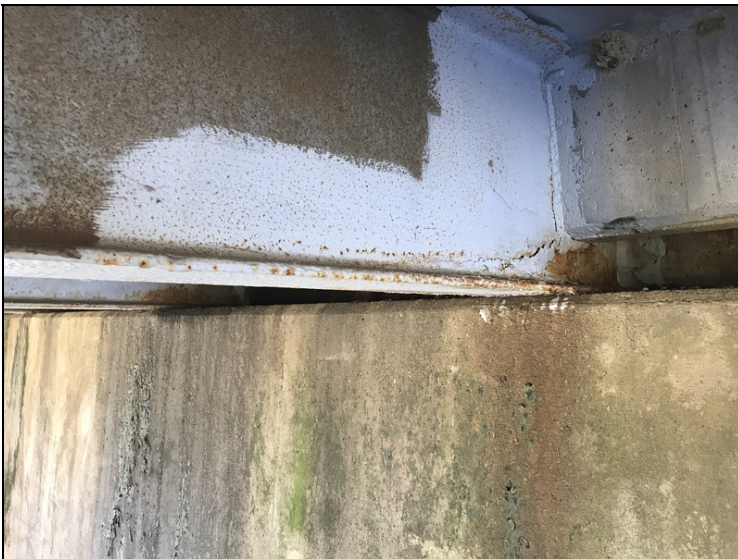
There is active corrosion with flaking rust showing through the paint system at the ends of the beams. Section loss on the ends of the beams to the webs and flanges.

Bent # 1 Beam # 3 active corrosion with layers of flaking rust at the ends of the beams.

**Date Reported:** 02/15/2017  
**Priority:** C - Important  
**Type of Work:** Clean  
**Status:** Open  
**Component:** 107 - Steel Open Girder/Beam

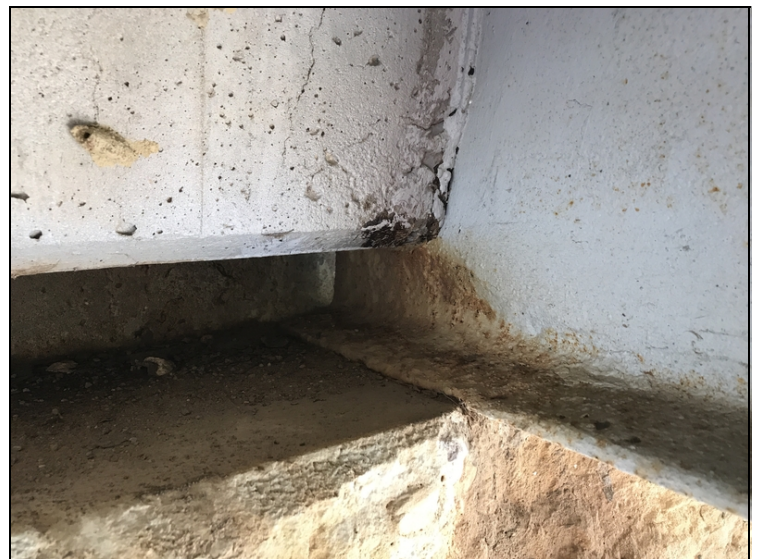
Old section loss scars.

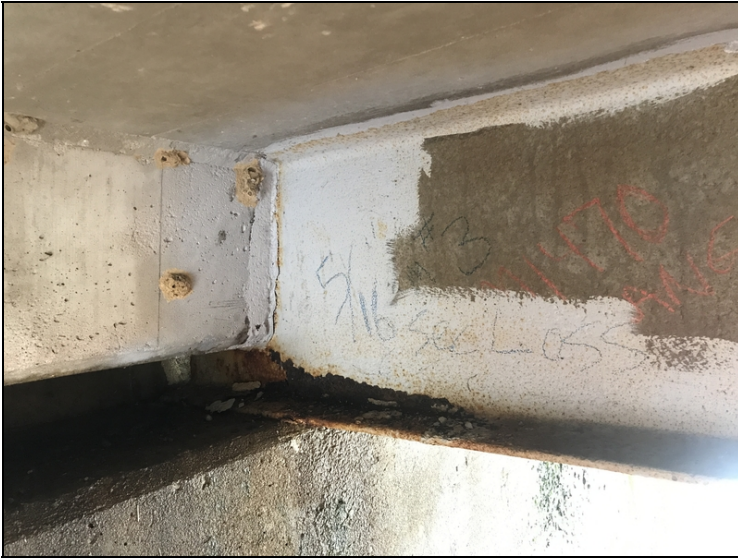
Bent # 1, Beam # 3 has 5/16" section loss to the base of the web.

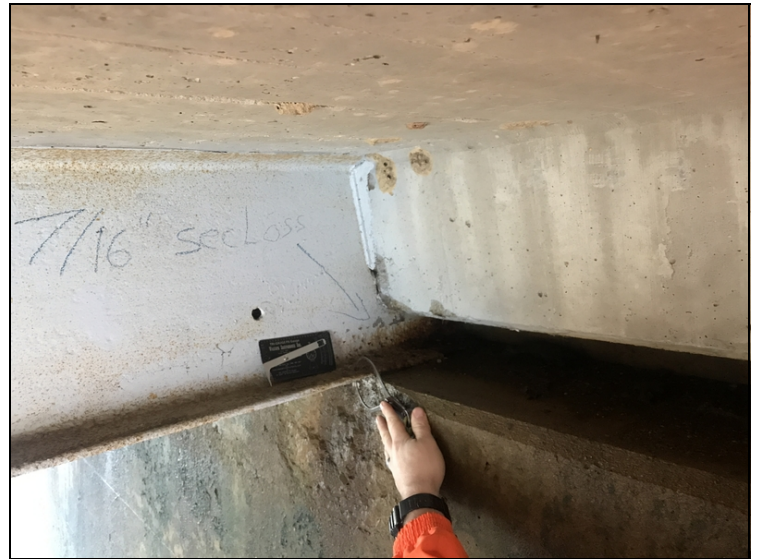
Active corrosion under the paint system has 7/16" section loss to the base of web. The bottom flange is reduced to 3/16".
