Asset #00315(Routine)

US Highway 71 over Carnes Creek-Scott Co.

Location: 0.9 MI NO OF NO BOOTHE

Team Lead: Jeff Jones, Inspection Date: 05/20/2021

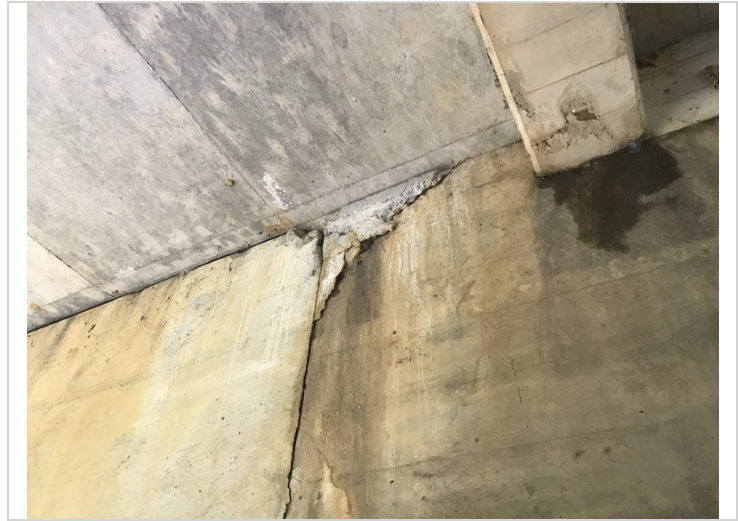
Bent # 2 large concrete delamination adjacent to Girder # 1.

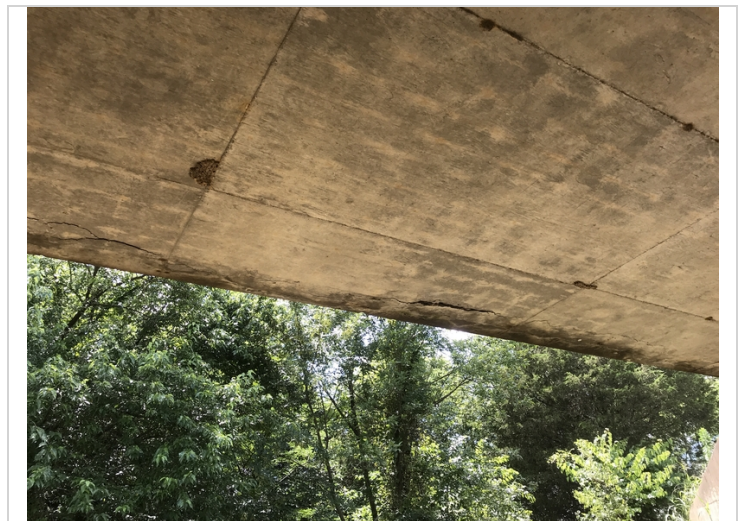
Delaminated concrete on the Lt edge of the slabs
undersurface.

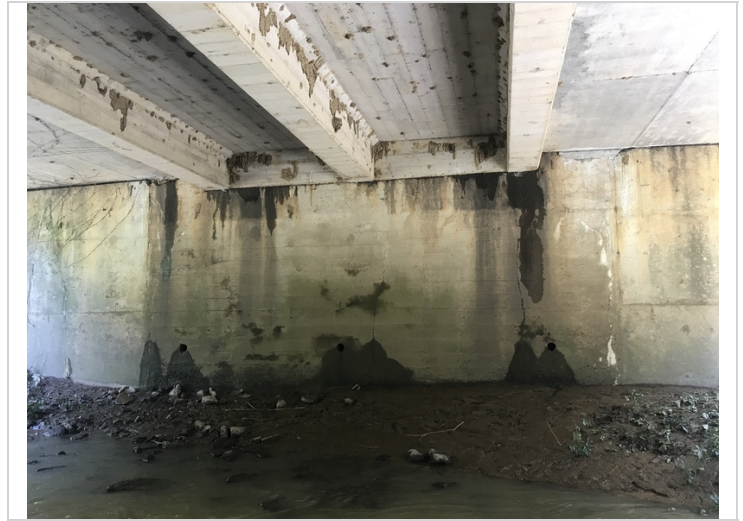
Bent # 1 vertical cracking in the abutment stem.

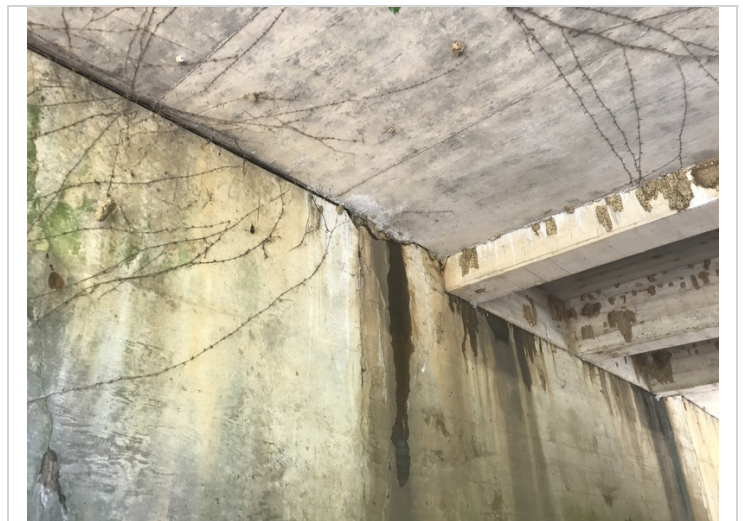
Bent # 1 Rt shallow spalling in the bearing area adjacent to Girder # 3.

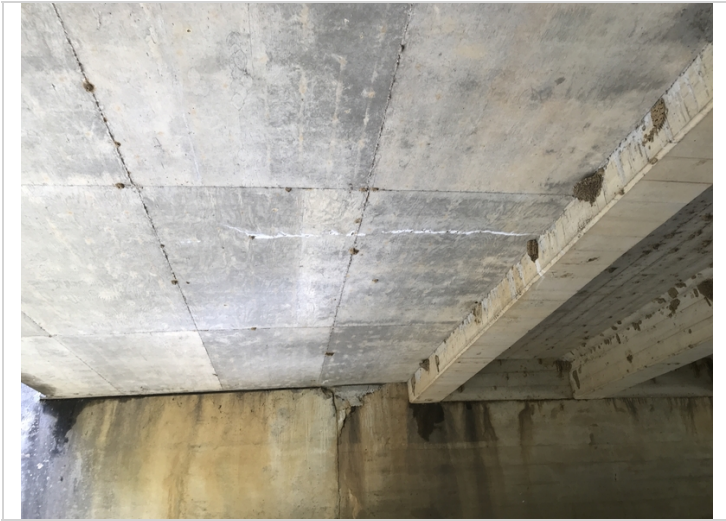
Lt slab crack with efflorescence.

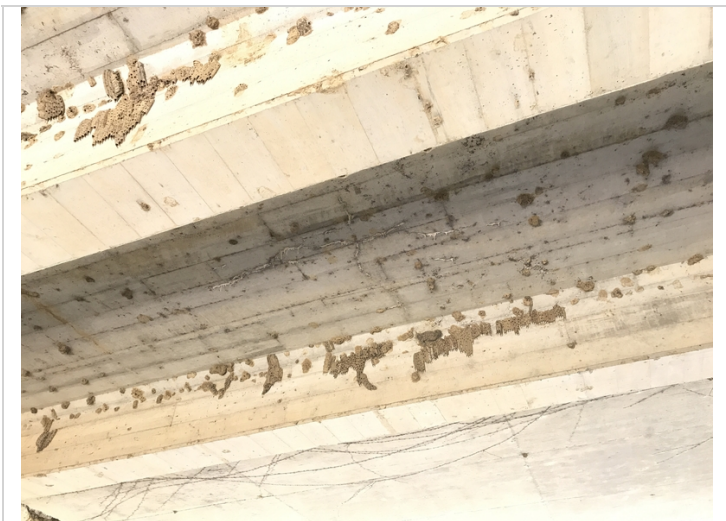
Bay # 2 cracking with efflorescence buildup.

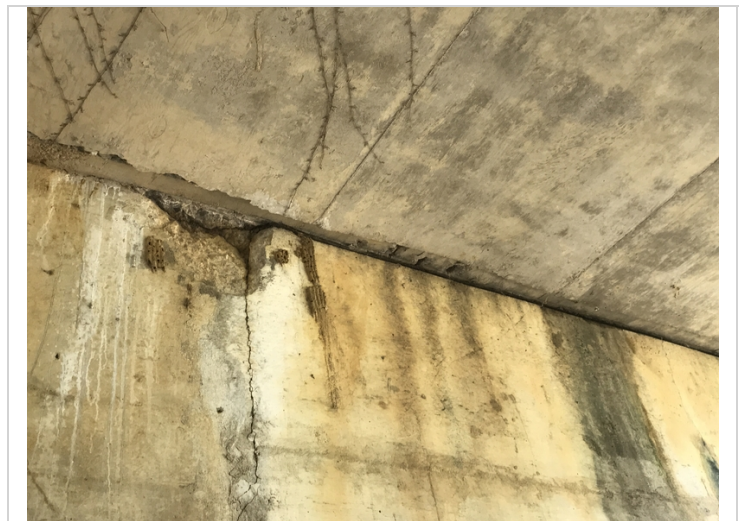
Spalling with exposed reinforcing steel adjacent to Bent # 2 approximately 5' Rt of Girder # 3.

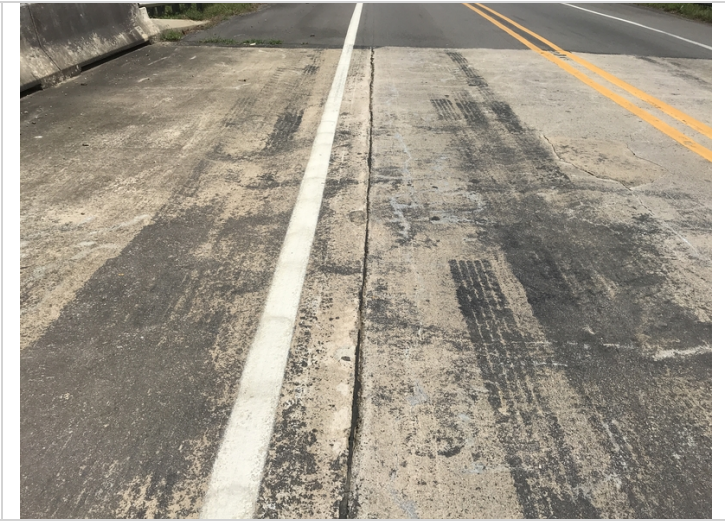
Failing joint sealant between the slab and wearing surface.

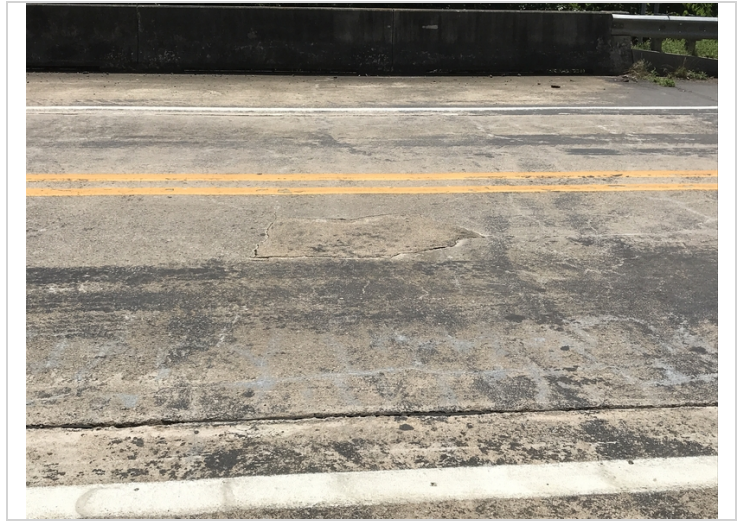
Northbound lane flex patch still solid.

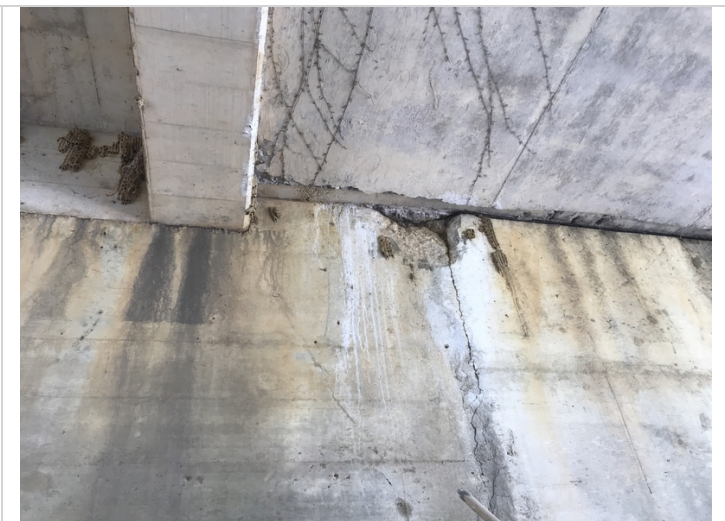
Bent # 2 Rt spalling adjacent to Girder # 3.

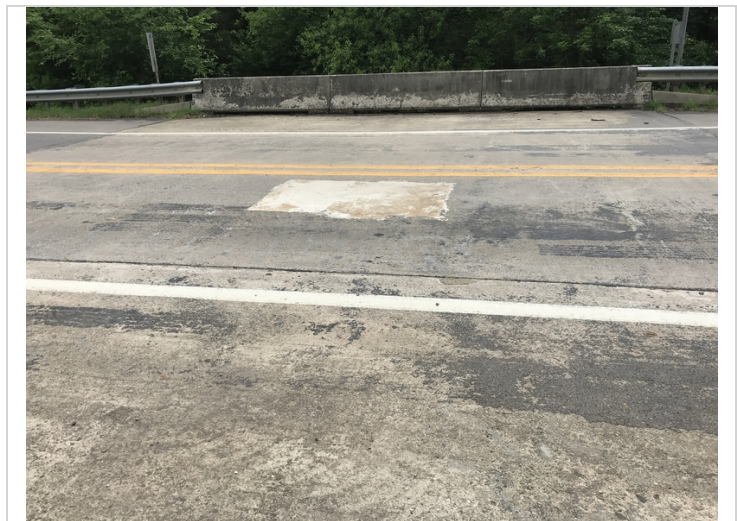
There is a 3' X 5' patched area at mid-span of Northbound lane appears to be holding during this inspection.

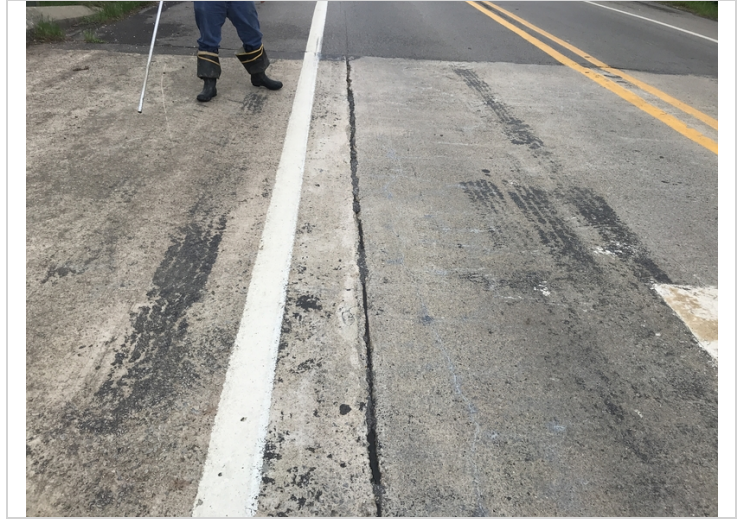
Deteriorated and missing sealant in the longitudinal construction joint.

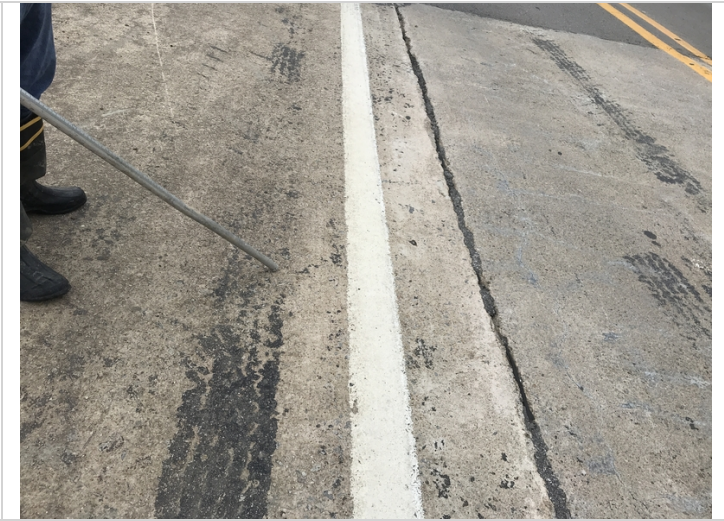
Hairline map cracking with light abrasion along the longitudinal construction joints.

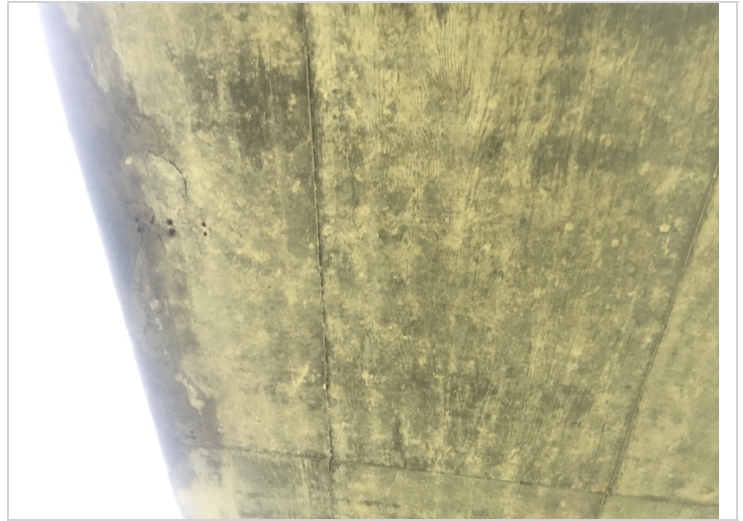
Delaminated area in the Right slab soffit.

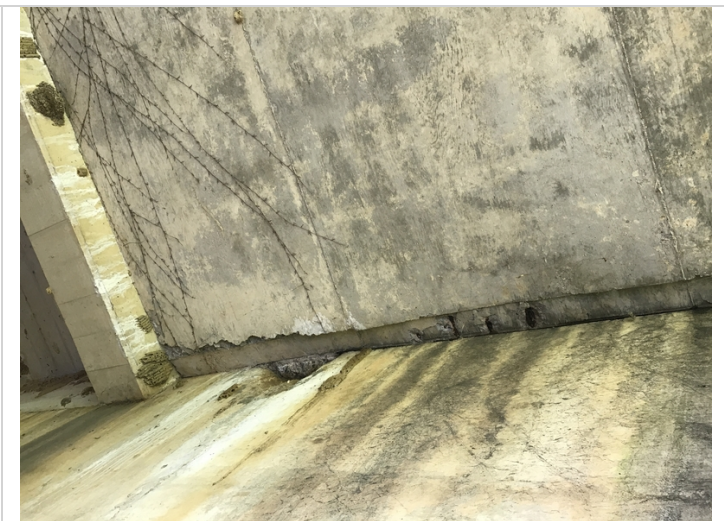
Exposed reinforcing steel in the Right side of the slab span adjacent to Bent # 2.

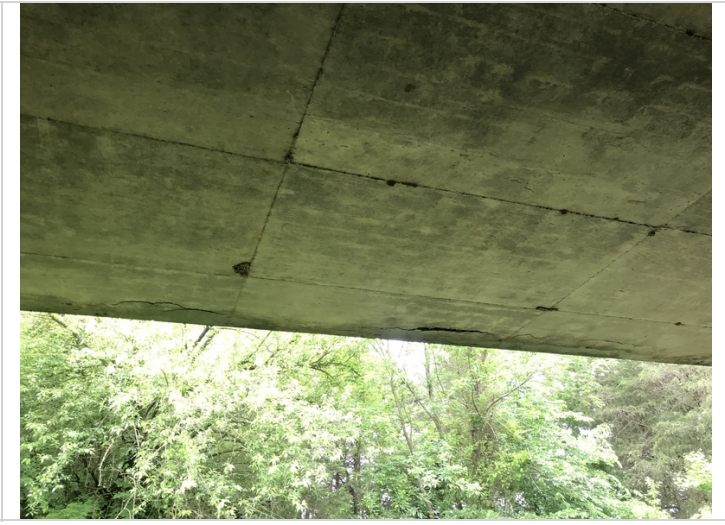
Left edge of slab soffit. Delaminated areas.

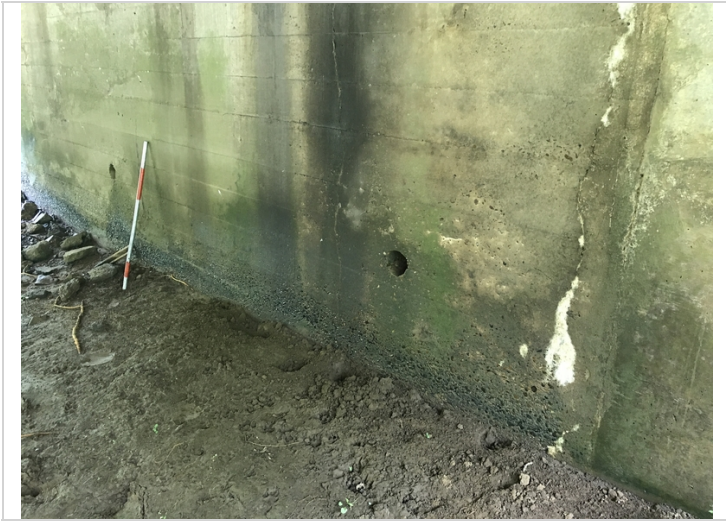
Bent # 1. Light abrasion with vertical cracks that have efflorescence.

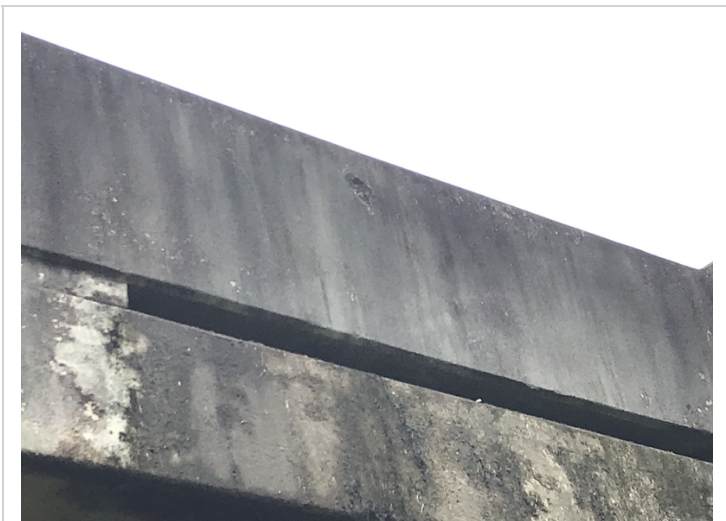
Minor 4" spall with no exposed reinforcing steel in the outside face of the Right parapet located approximately 6' from the North abutment.

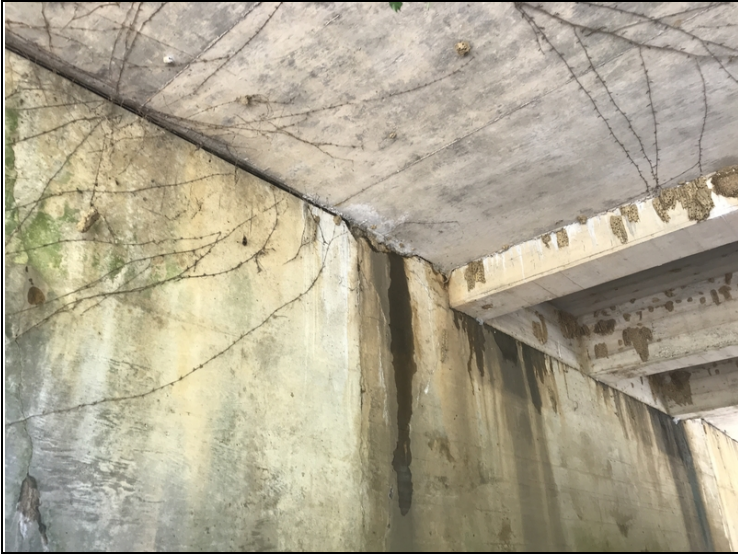
Abutments have minor spalling and delaminated areas in the top of the stem wall adjacent to the exterior girders.

Bent # 1 Right - shallow spalling adjacent to Girder # 3.

Date Reported: 07/02/2015
Priority: D- Routine
Type of Work: Repair (General)
Status: Open
Component: Element

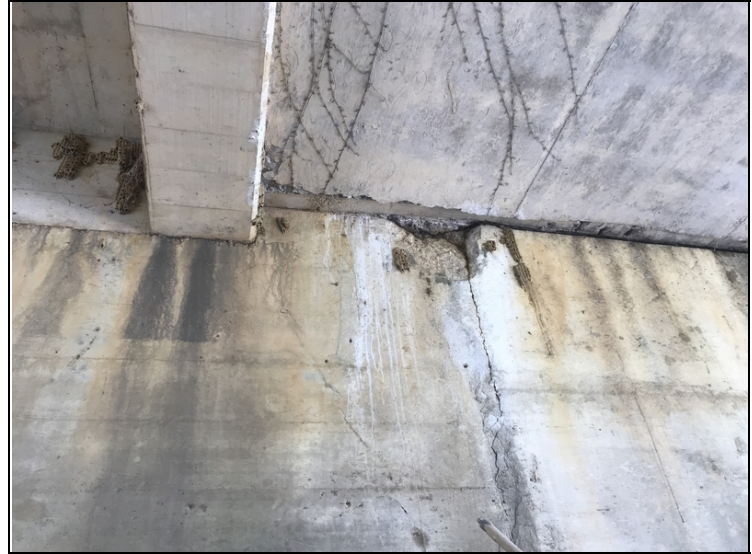
Bent # 2 Right - spalling adjacent to Girder # 3.

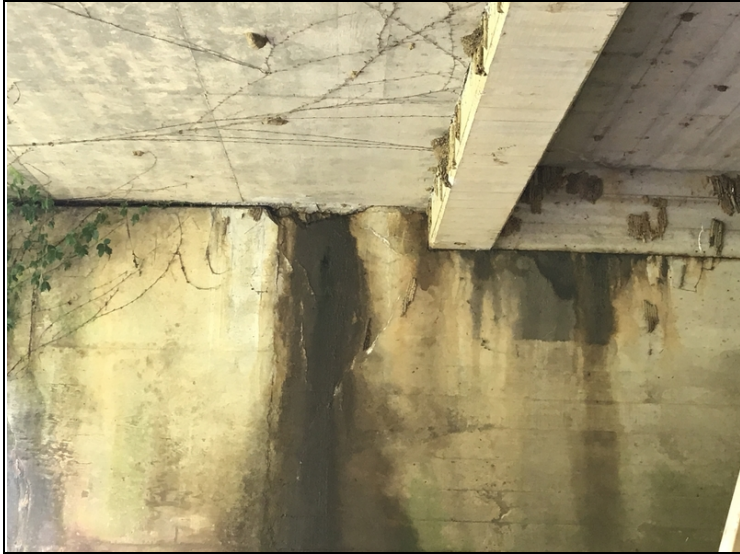
Spalling in the Right side of Bent # 1.

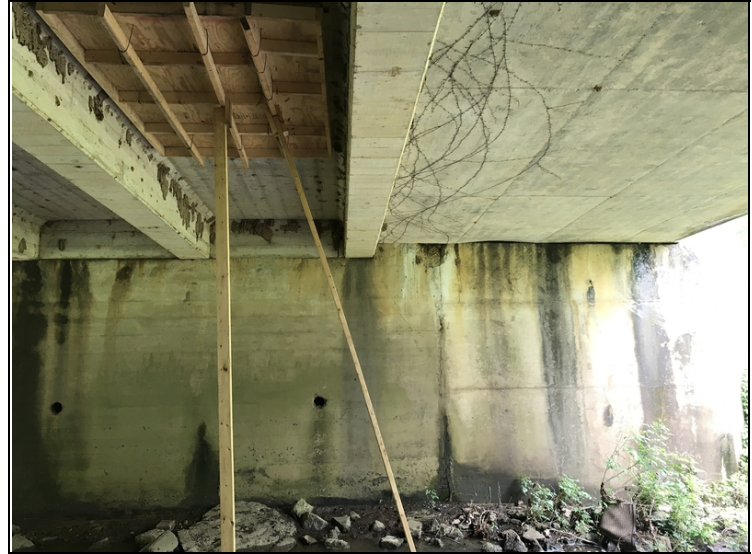
Spalling in the Right side of Bent # 2.

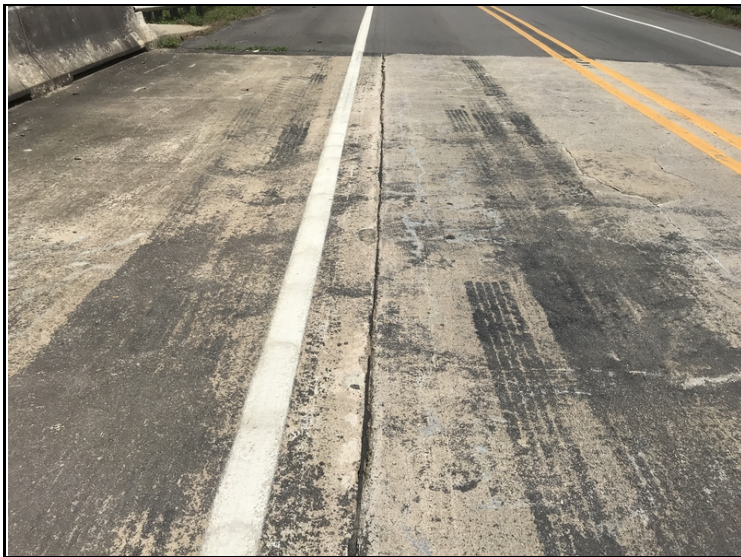
The sealant in the longitudinal construction joints is deteriorated and missing in locations.

Failing joint sealant between the slab and wearing surface.

Date Reported: 07/02/2015
Priority: D- Routine
Type of Work: Repair (General)
Status: Open
Component: Element

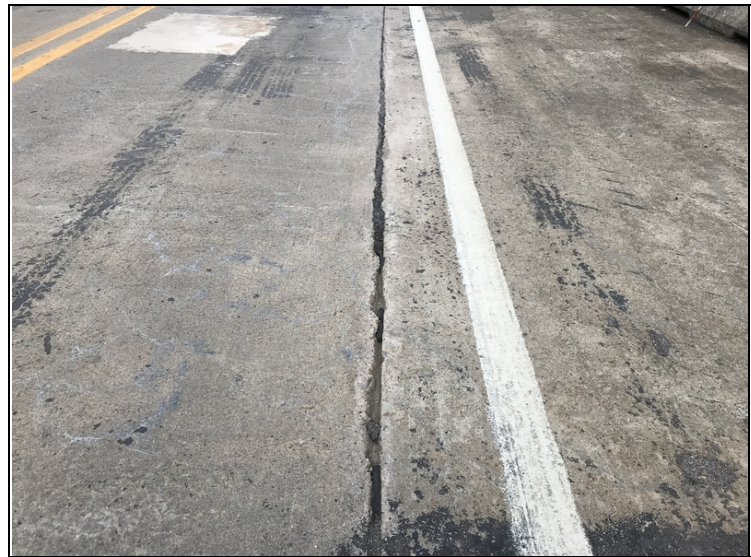
Deteriorated and Missing longitudinal construction joint sealant.

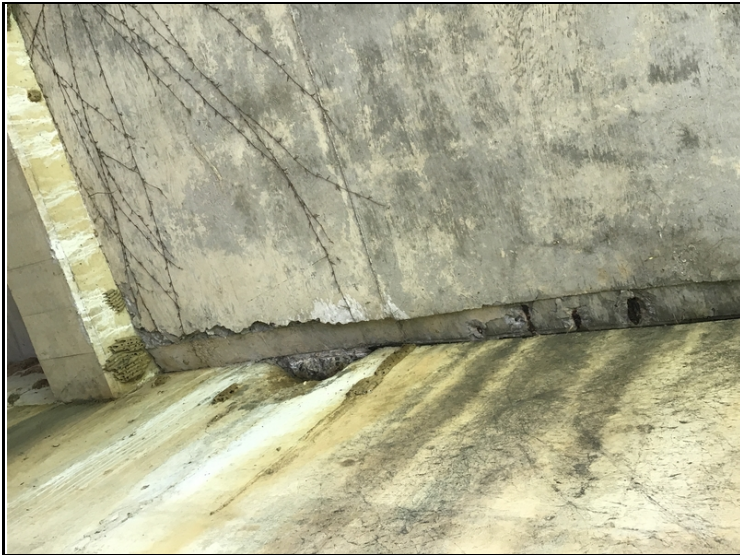
There are spalls with exposed reinforcing steel in the Right slab soffit adjacent to Bent # 2.

Date Reported: 05/21/2021
Priority: D- Routine
Type of Work: Repair (General)
Status: Open
Component: Superstructure

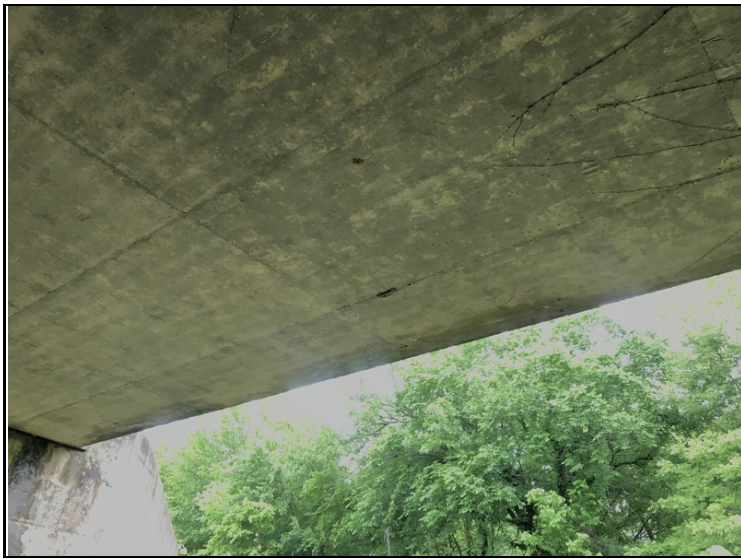
The exterior edges of the slab soffit has longitudinal delaminated areas.

Right slab soffit. Delaminated areas.

Date Reported: 05/21/2021
Priority: D- Routine
Type of Work: Repair (General)
Status: Open
Component: Element

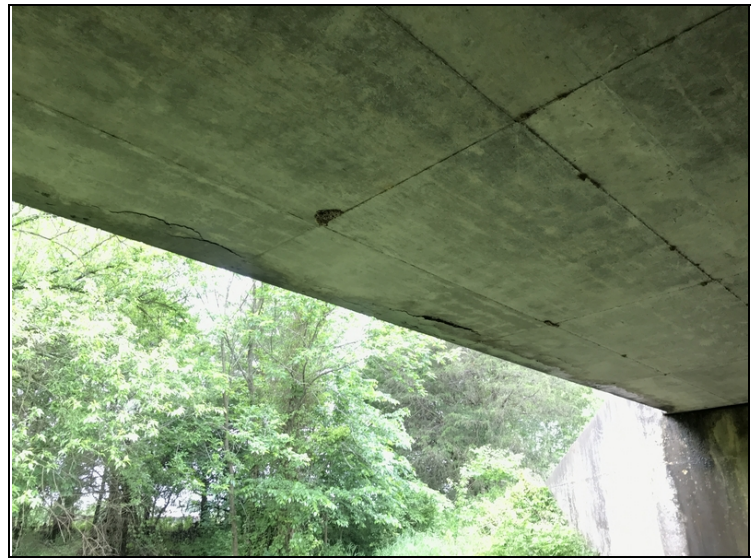
Left slab soffit. Delaminated areas.
