Asset #00316(Routine)

US Highway 71 over Kings Relief - Scott Co.

Location: 0.40 MI N OF JCT SH 23&71

Team Lead: Jeff Jones, Inspection Date: 05/19/2021

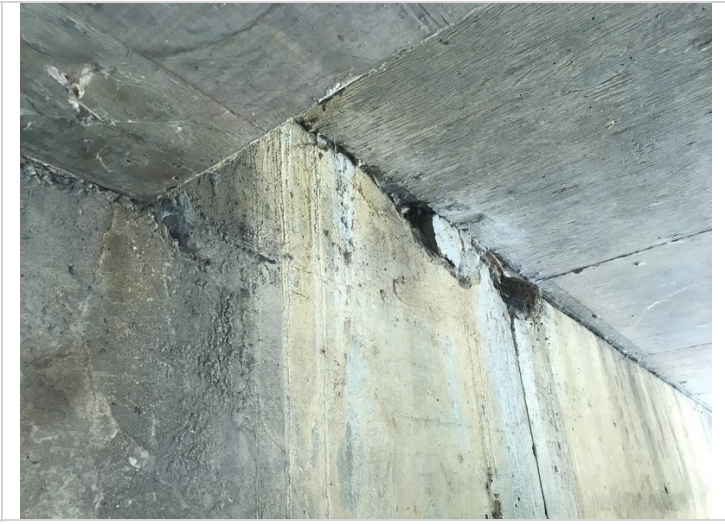
Bent # 1 spalling with exposed reinforcing steel.

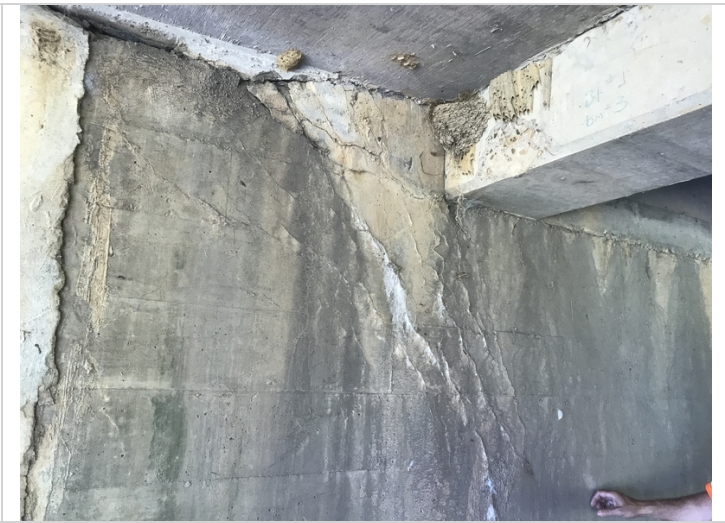
Bent # 1 Rt cracking with efflorescence buildup.

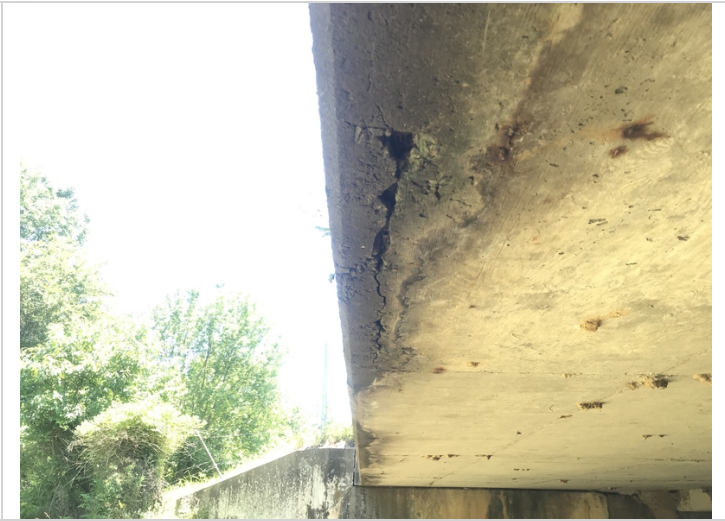
Spalling with exposed reinforcing steel and delaminated concrete along the right side.

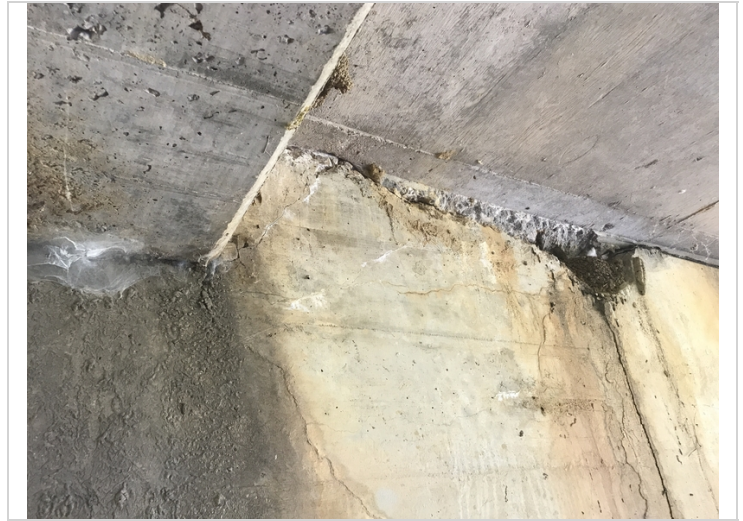
Bent # 2 Lt cracking with efflorescence.

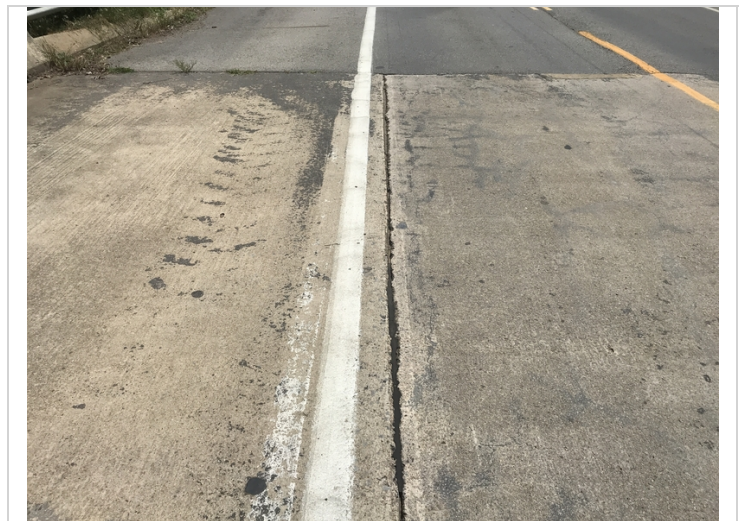
Missing joint sealant.

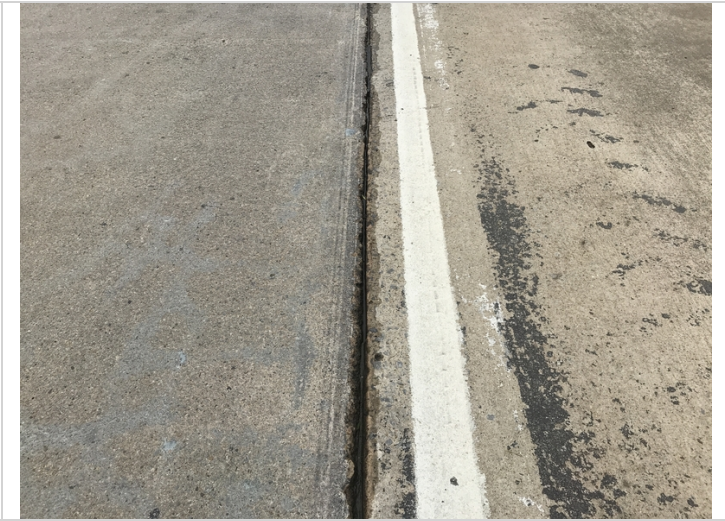
Longitudinal construction joint with missing sealant.

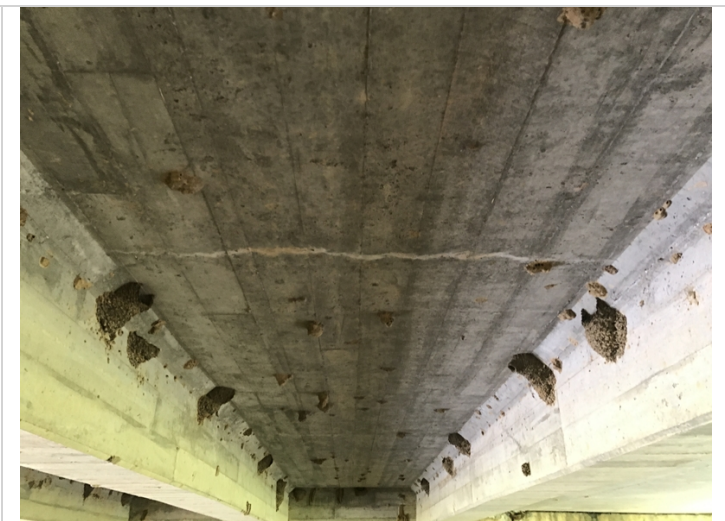
Transverse hairline crack in the deck soffit.

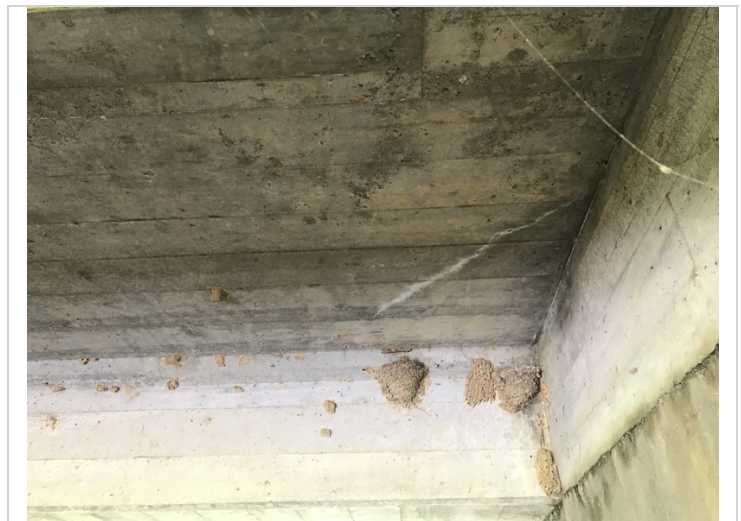
Diagonal hairline crack with light efflorescence in the deck soffit adjacent to Girder # 1 at Bent # 2.

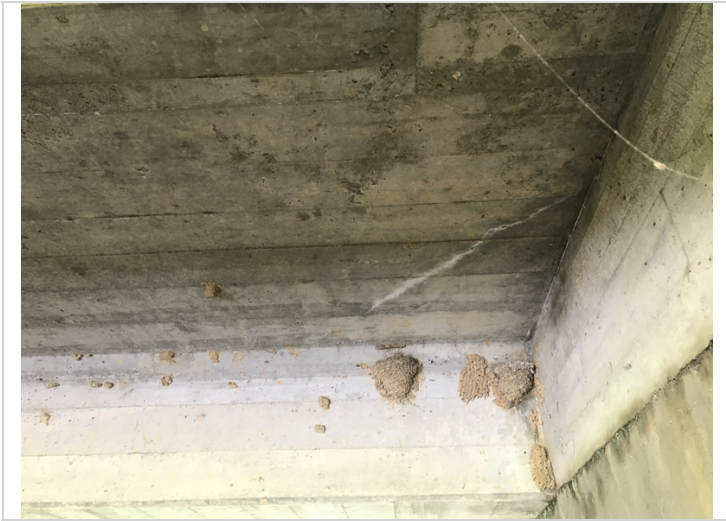
Diagonal hairline crack with light efflorescence in the deck soffit adjacent to Girder # 1 at Bent # 2.

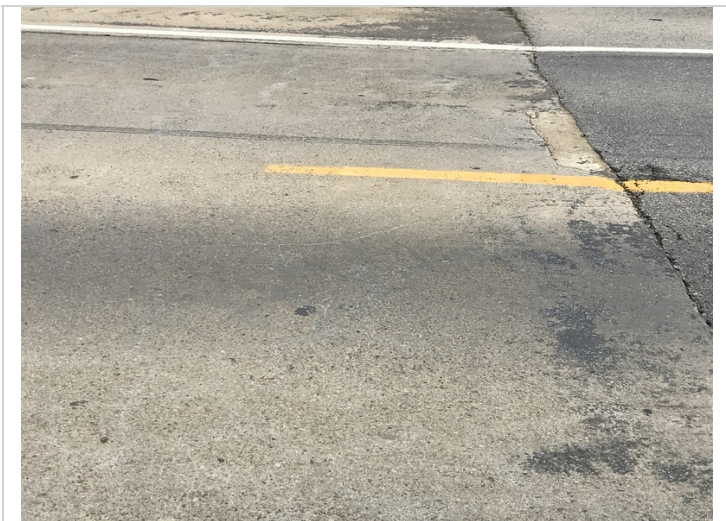
Patched area in the wearing surface of the deck located in the Right lane over Bent # 1.

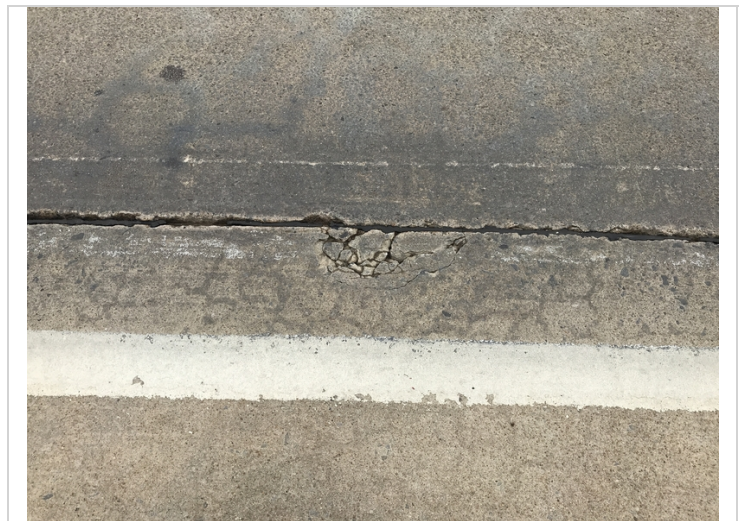
There is a 12" area that is breaking apart along the Left longitudinal construction joint.

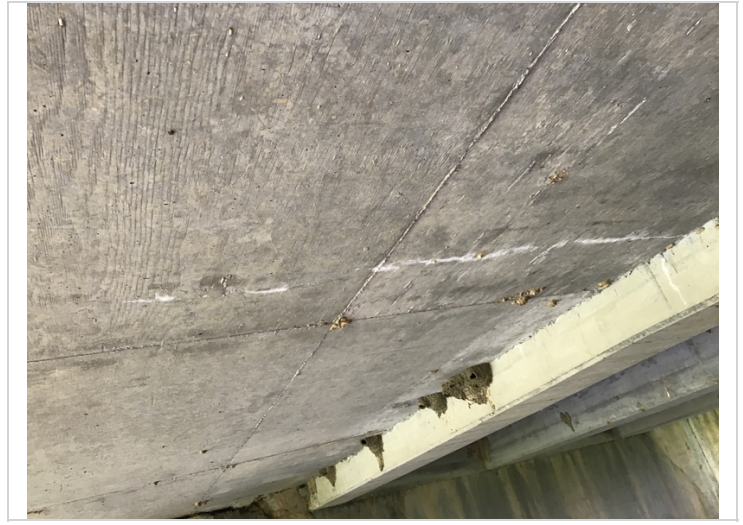
Transverse hairline crack with light efflorescence in the Right slab soffit.

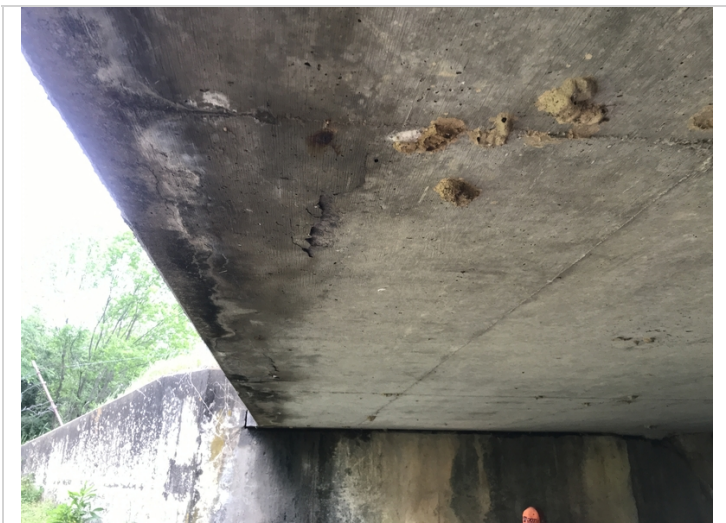
Delaminated area in the Right slab soffit.

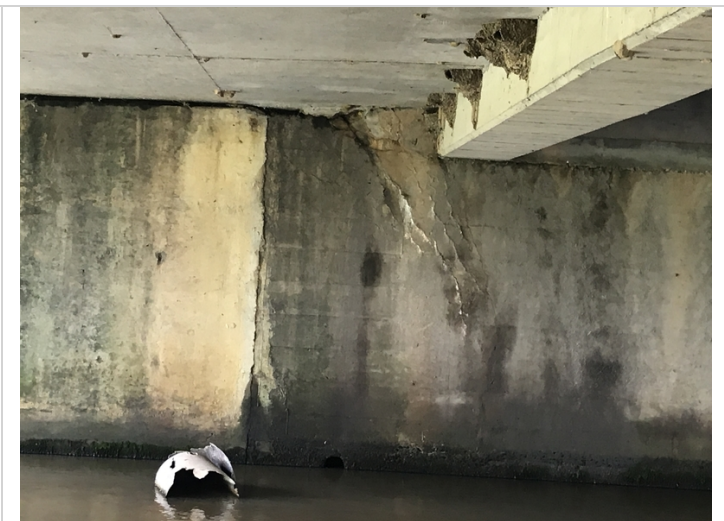
Spalling with diagonal cracking with efflorescence in the Right side of Bent # 1 adjacent to Girder # 3.

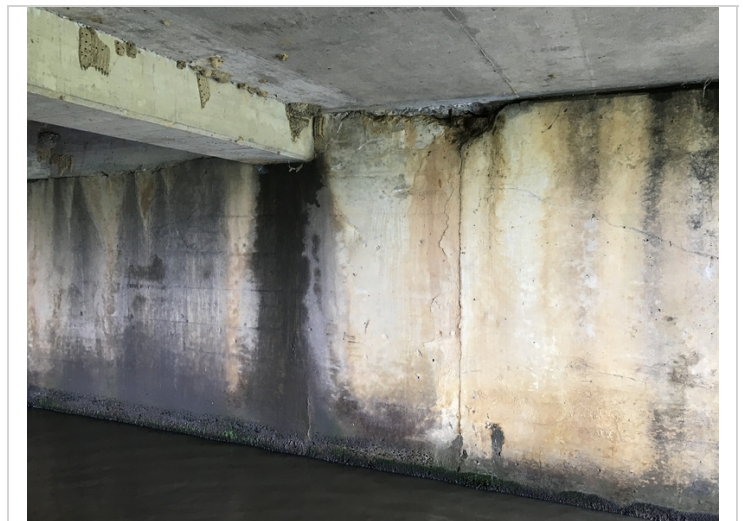
Spalling with exposed reinforcing steel in the Right side of Bent # 2 adjacent to Girder # 3.

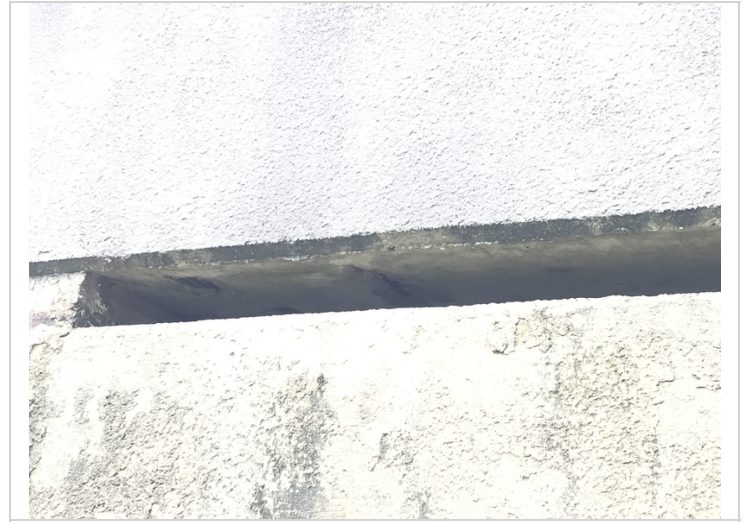
Spalls with exposed reinforcing steel inside the drain openings of the parapet walls.

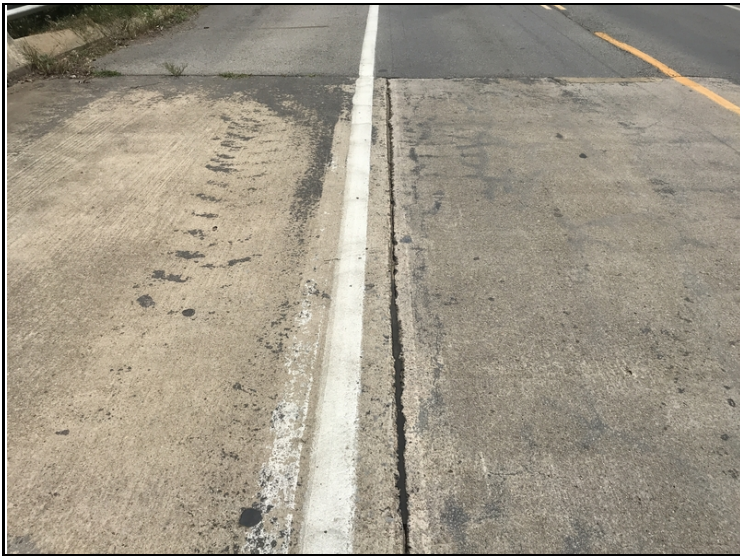
The longitudinal construction joint sealant in the deck is deteriorated and missing in locations.

Missing joint sealant.

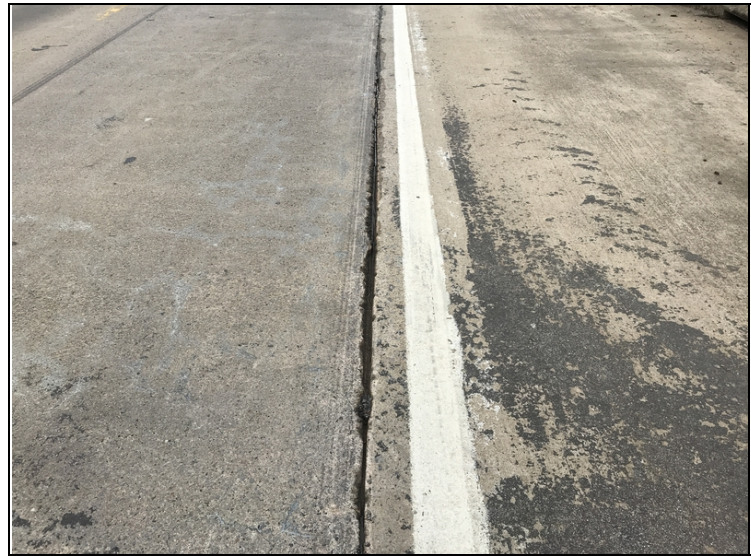
Missing sealant in the longitudinal construction joint.

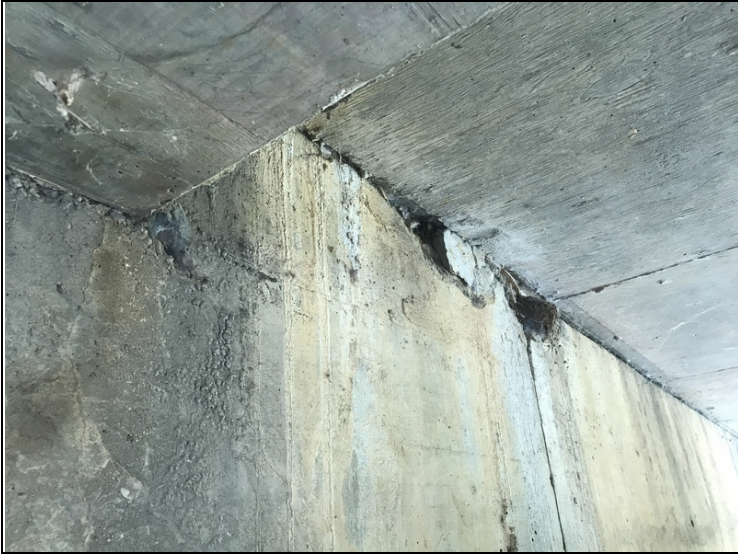
The abutments have concrete delaminations and spalling with exposed reinforcing steel.

Bent # 1 spalling with exposed reinforcing steel.

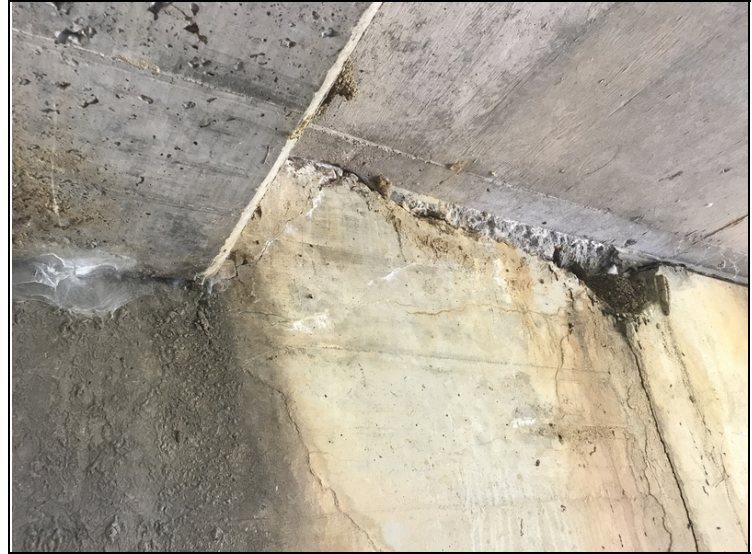
Bent # 2 Lt cracking with efflorescence.

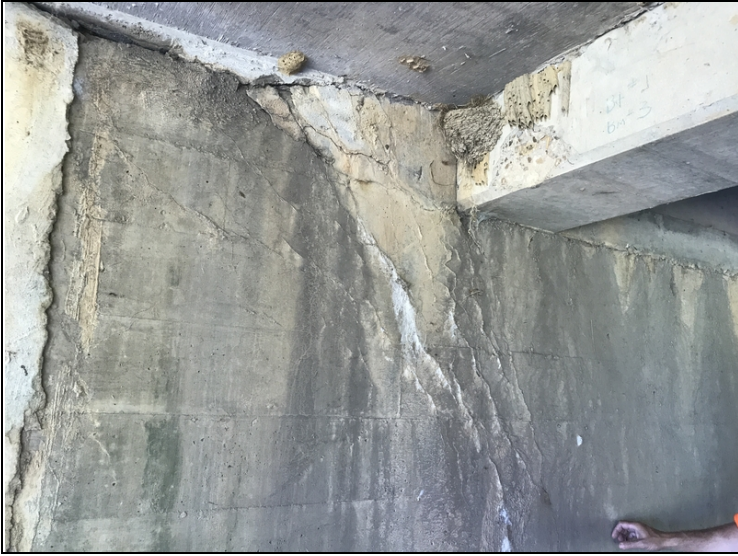
Bent # 1 Rt cracking with efflorescence buildup.

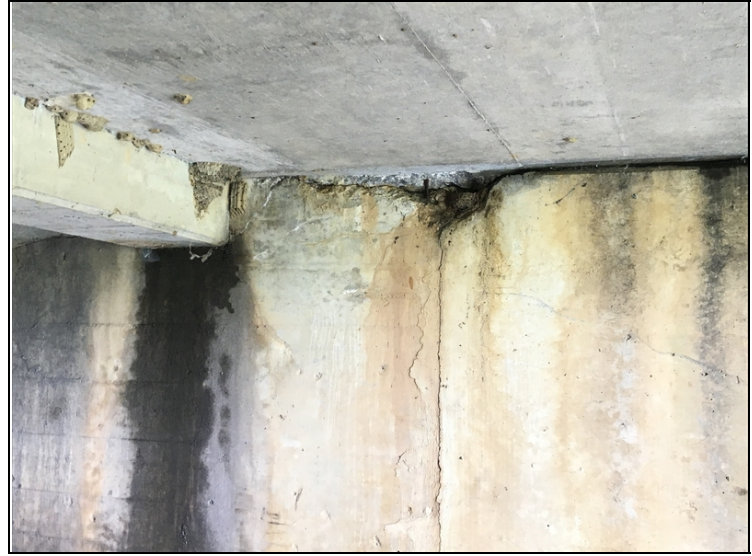
Bent # 2 adjacent to Girder # 3. Spall with exposed reinforcing steel.

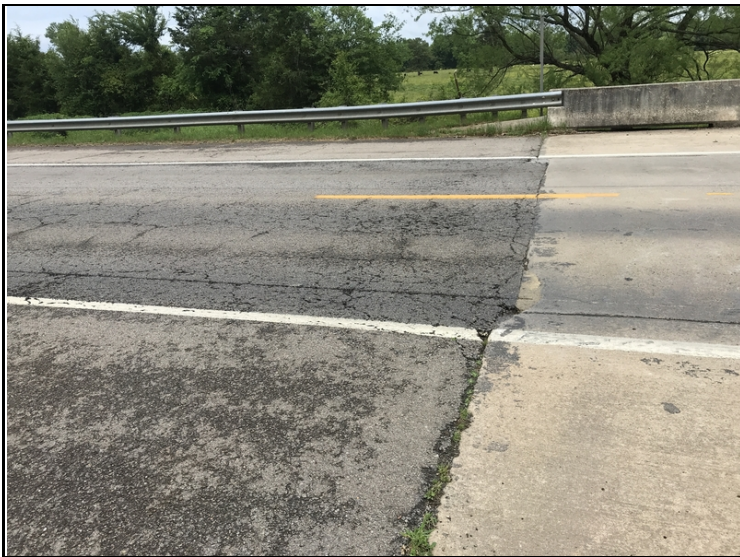
The approach roadway asphalt is breaking apart at the North bridge end.

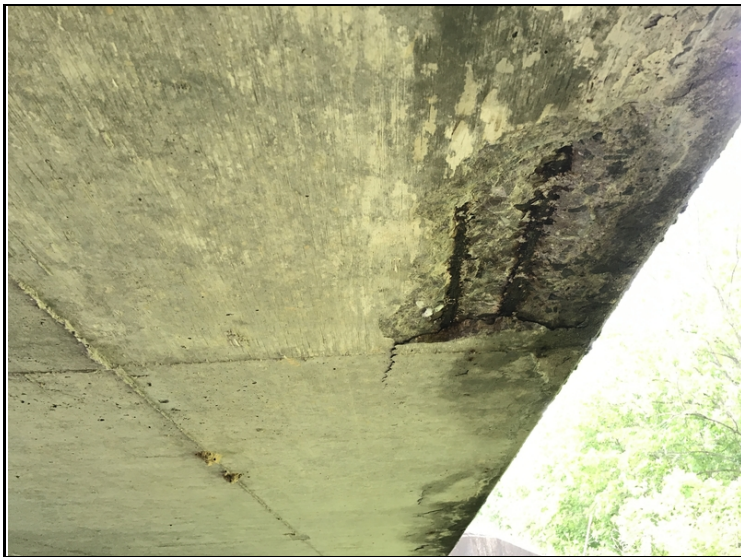
The undersurface of the exterior edges of the deck have delaminated areas and spalls with exposed reinforcing steel.

Left deck soffit. Spall with exposed reinforcing steel.

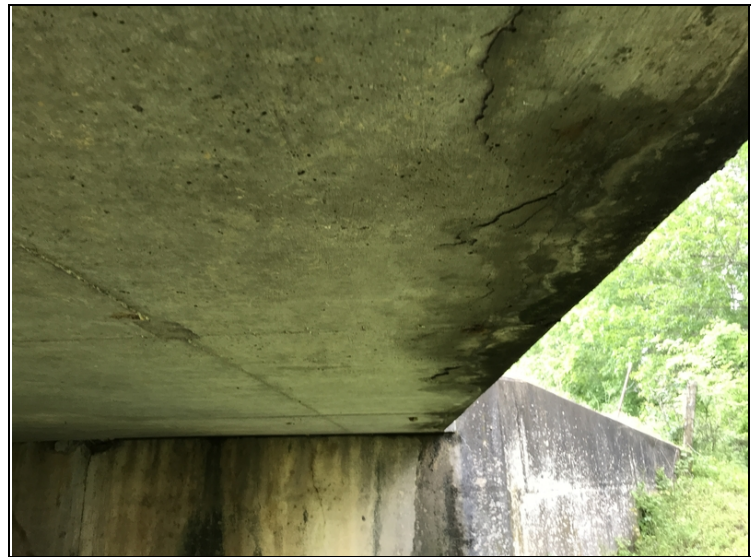
Left edge of deck soffit. Delaminated areas. Typical along both edges of the structure.
