Asset #00317(Routine)

US Highway 71 over Kings Creek - Scott Co.

Location: 0.3 MI N SH 23&71

Team Lead: Jeff Jones, Inspection Date: 05/24/2021

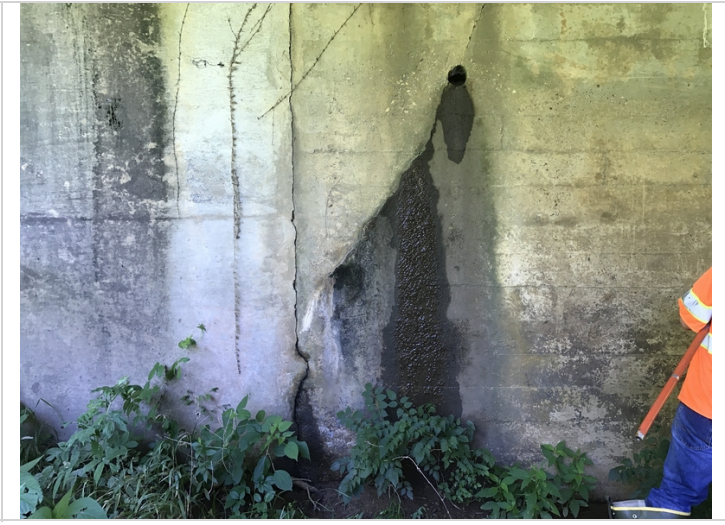
Bent # 4 Lt diagonal crack with efflorescence and rust stains.

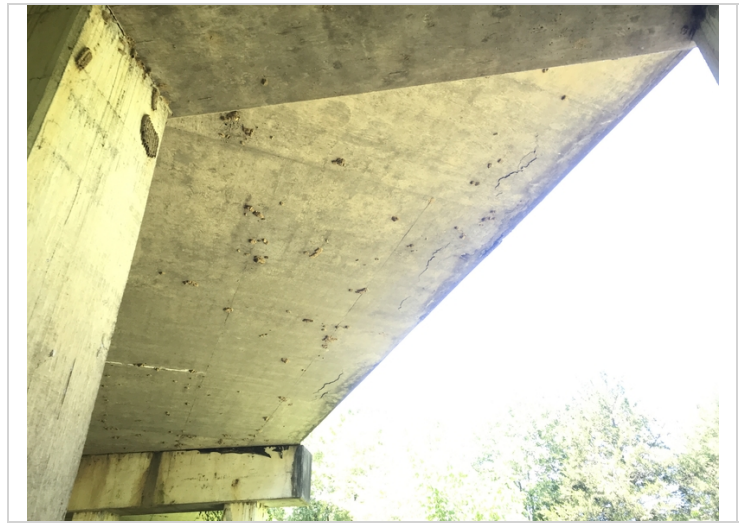
Span # 2 concrete delamination along the Left edge.

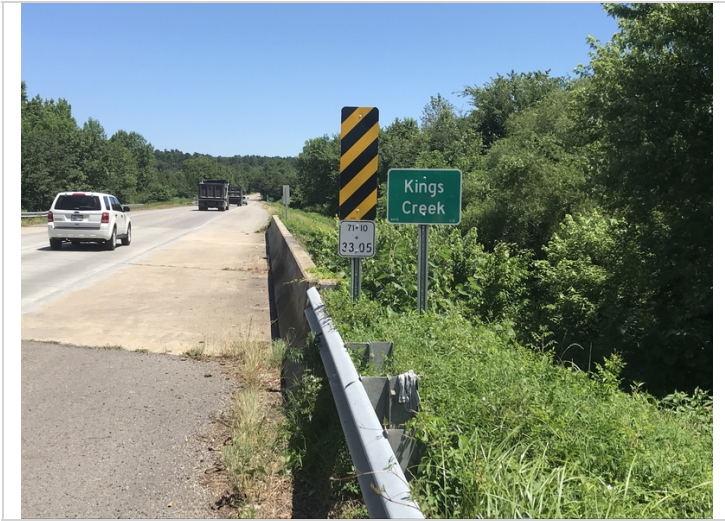
Log mile sign is incorrect.

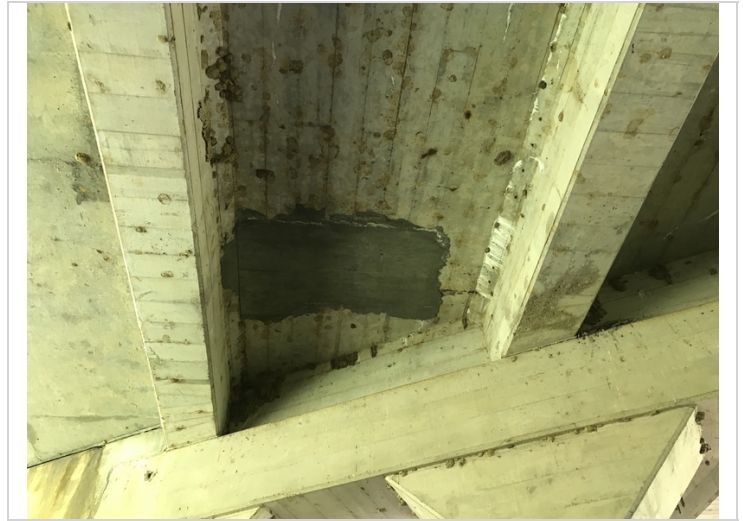
Span # 3 Bay # 2 deck repair.

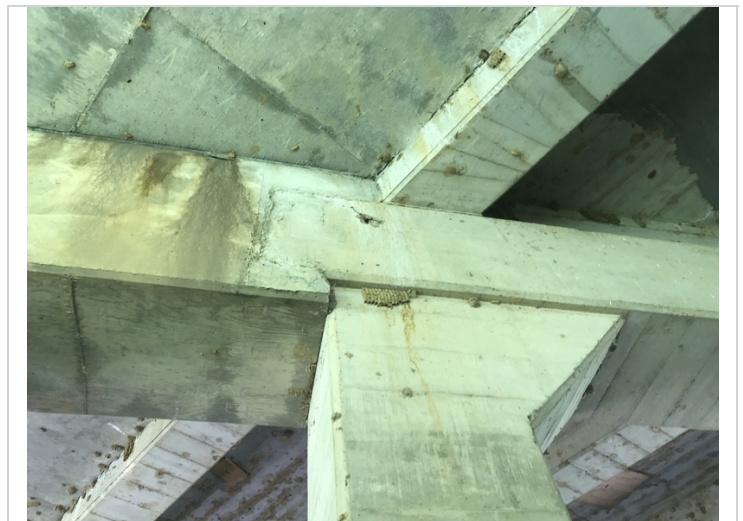
Bent # 3 over Col # 5 spalling with exposed reinforcing steel.

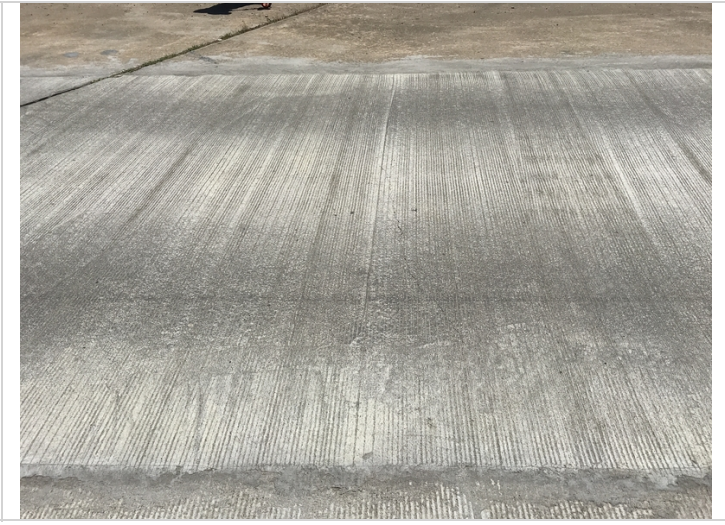
Sealable cracking on the new driving surface of the deck.

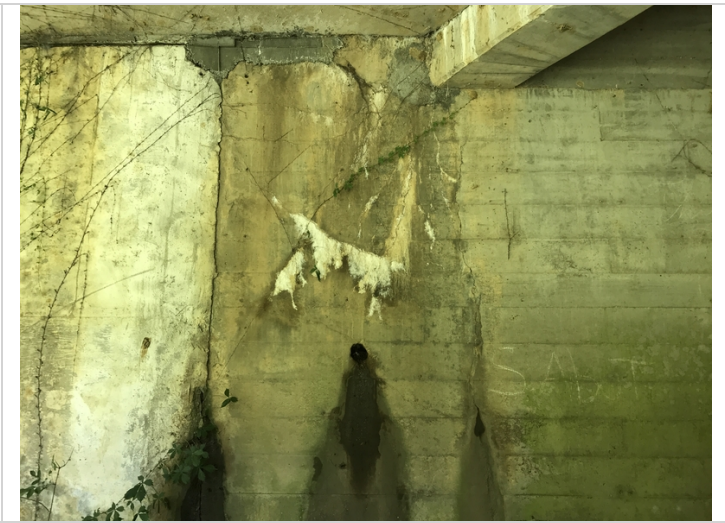
Bent # 1 Rt at Girder # 3 cracking with efflorescence and repairs.

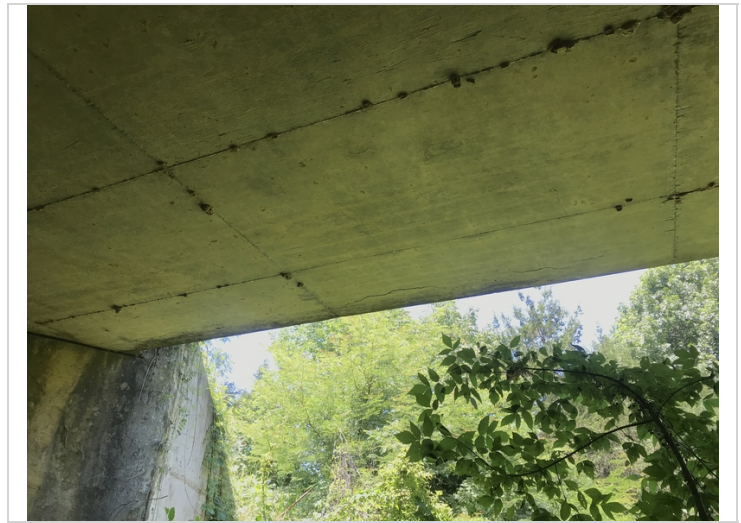
Span # 1 Lt concrete delamination along the slab edge.

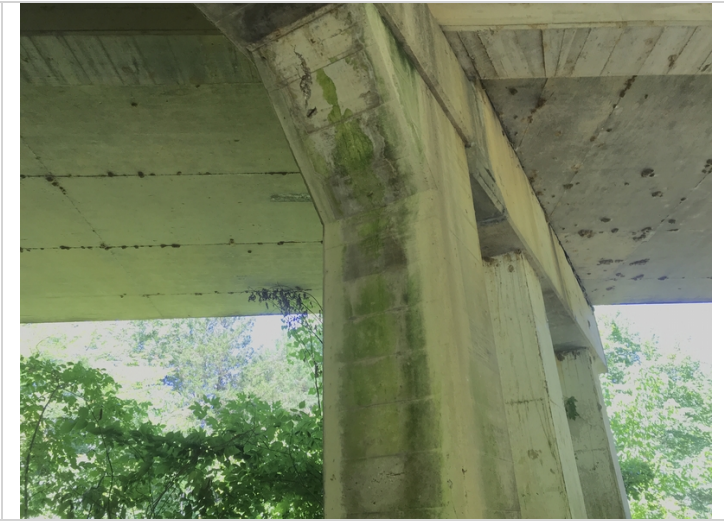
Bent # 2 column # 3 vertical cracking and concrete delamination's.

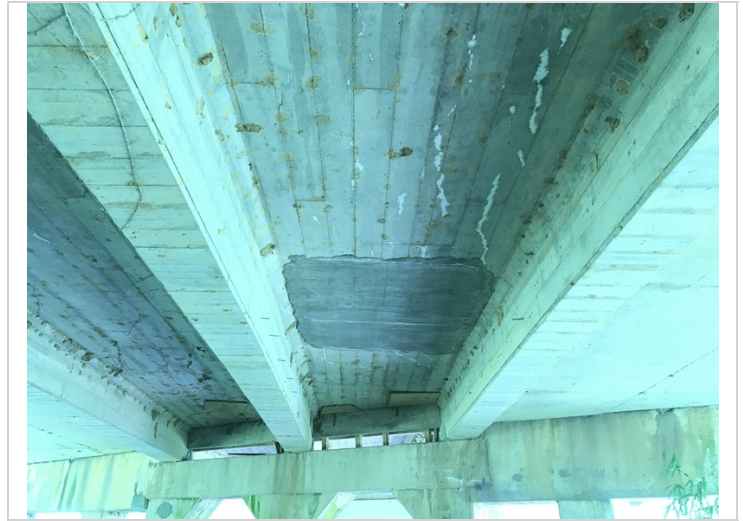
Span # 1 Bay # 3 deck repair.

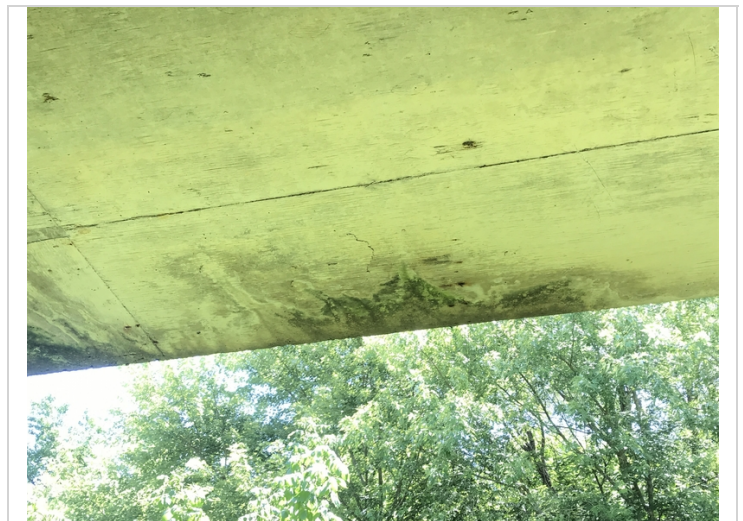
Span # 1 Rt small concrete delamination's along the edge.

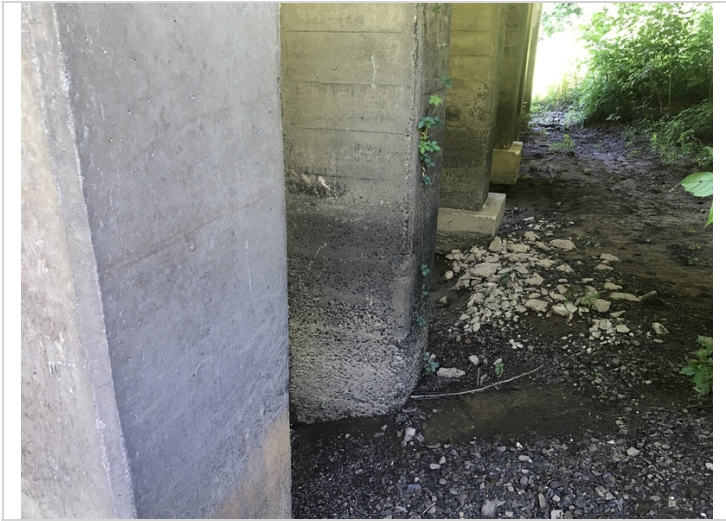
Bent # 3 column with medium abrasion.

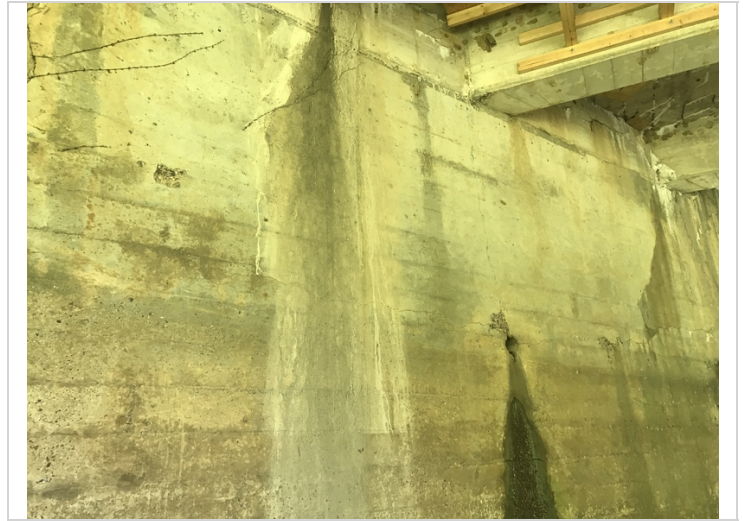
Bent # 4 Vertical and horizontal cracking.

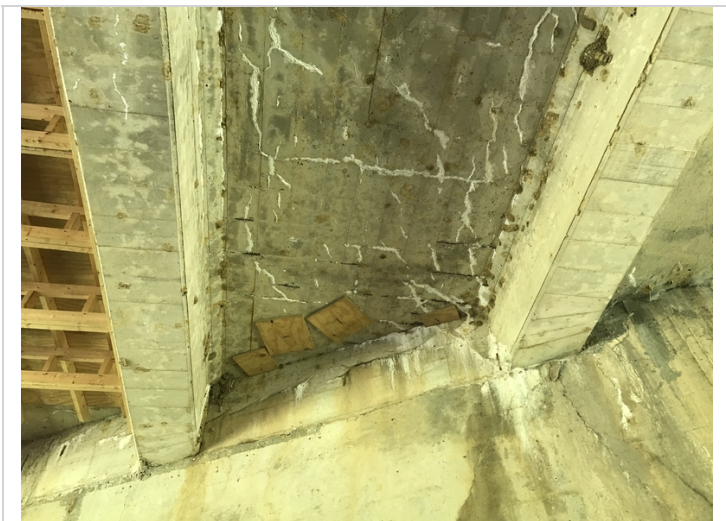
Span # 3 Bay # 2 exposed reinforcing steel.

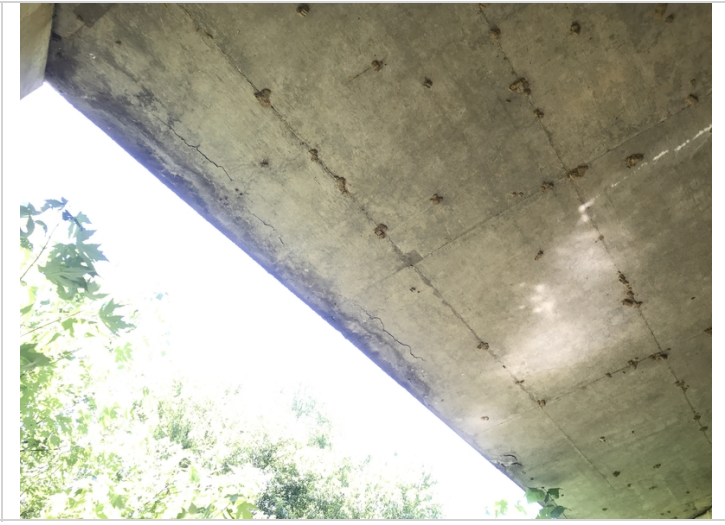
Span # 2 Rt concrete delamination's along the edge of the slab.

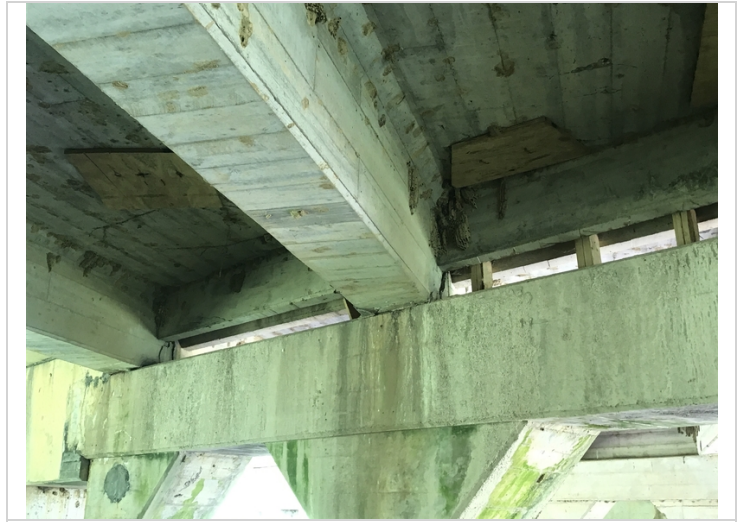
Span # 1 Bent # 2 spalling at the ends of the girders.

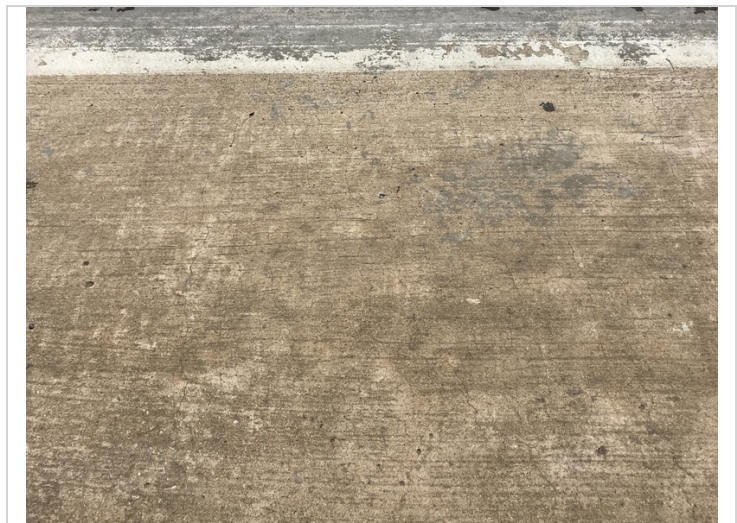
Typical map cracking on the concrete slab spans.

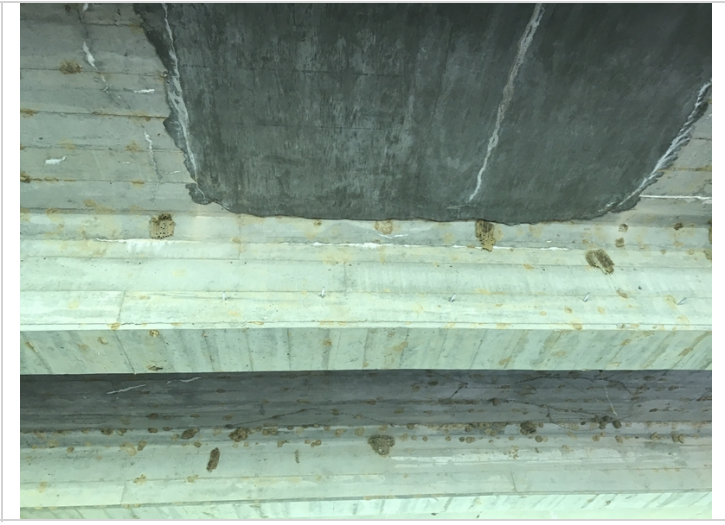
Span # 1 Girder # 2 longitudinal cracking near mid span with efflorescence.

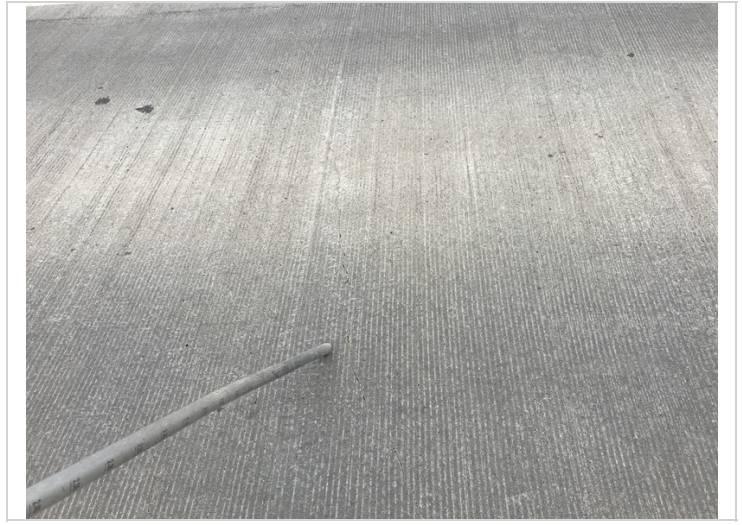
Transverse crack in the wearing surface of the deck.

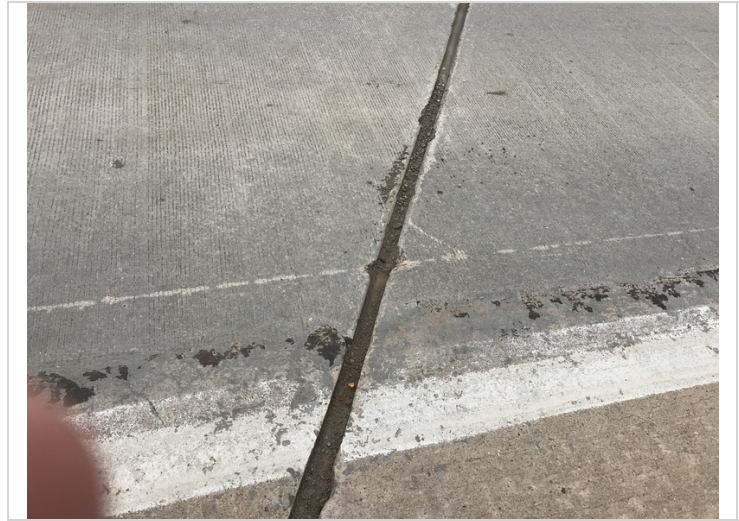
There are scrape marks in the edge of the Left Lane with shallow spalls at the expansion joints.

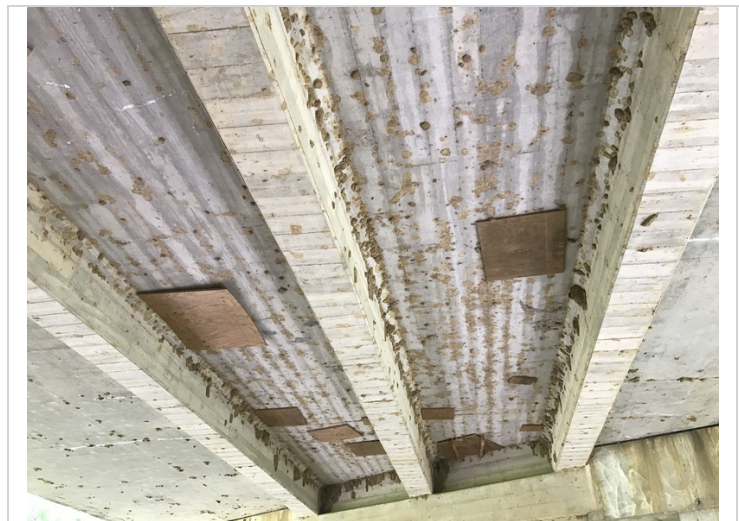
Deck soffit span # 2. Several full depth repairs with temporary form work left in place.

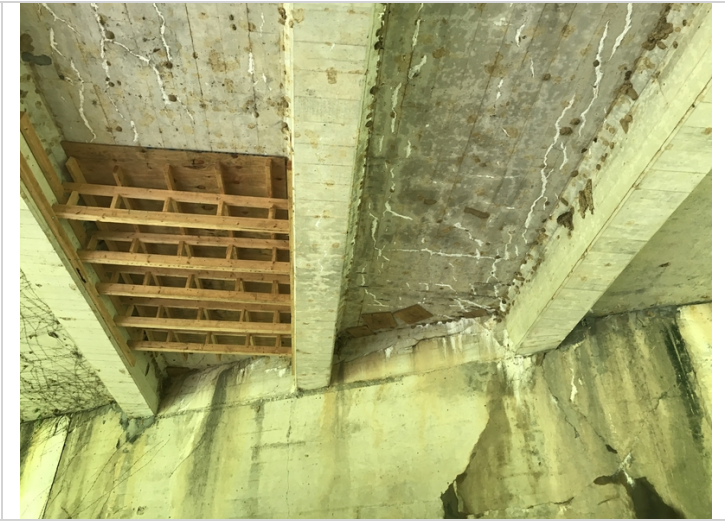
Span # 3. Adjacent to Bent # 4. Spalls with exposed reinforcing steel and full depth repairs with temporary form work left in place.

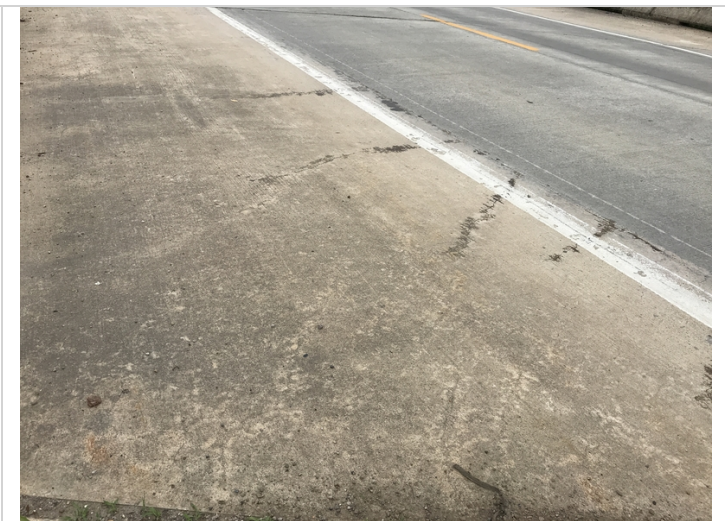
Left side of Span # 2. Transverse cracks.

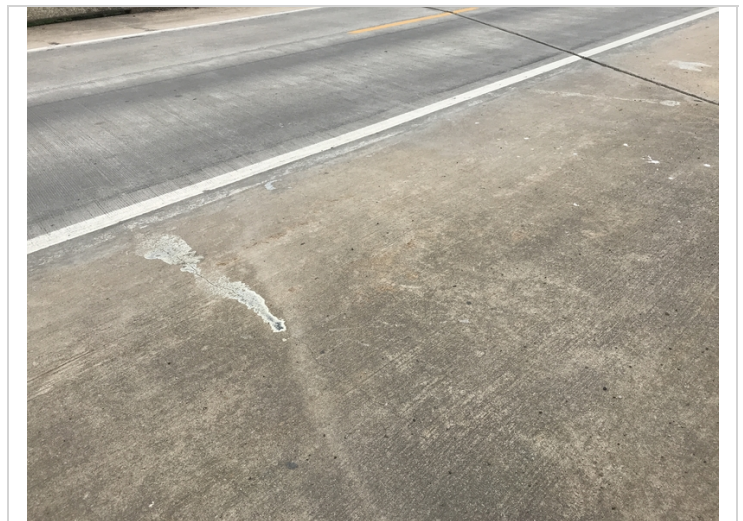
Transverse crack. Right side of Span # 2.

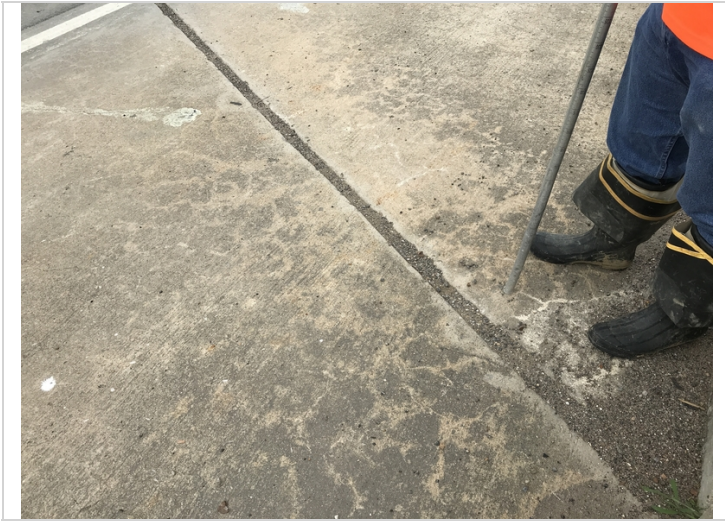
Hairline map cracking in the gutters.

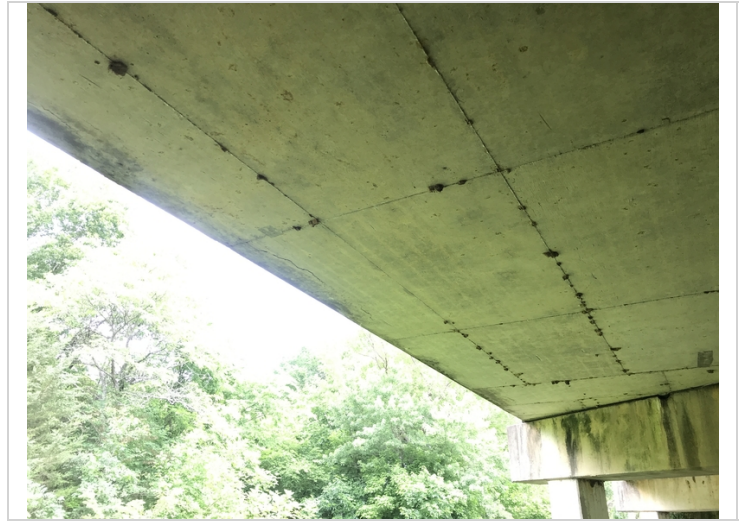
Left slab soffit. Span # 1. Delaminated areas.

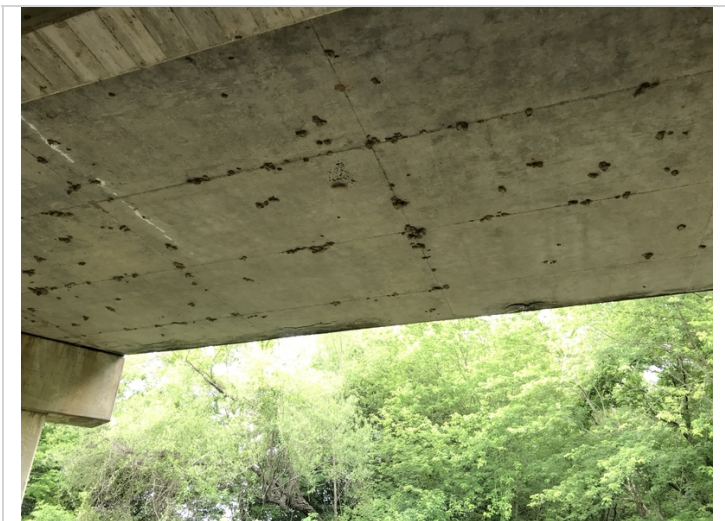
Right slab soffit. Span # 2. Delaminated areas along edge of slab.

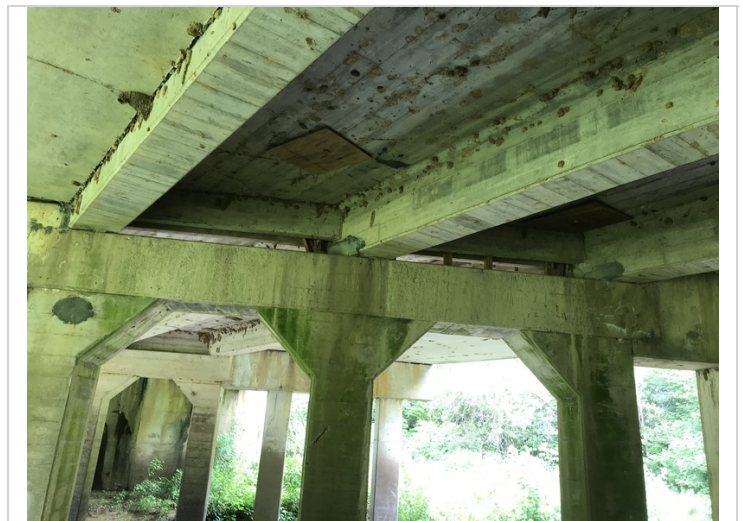
Grouted repairs in Span # 1 girders over Bent # 2.

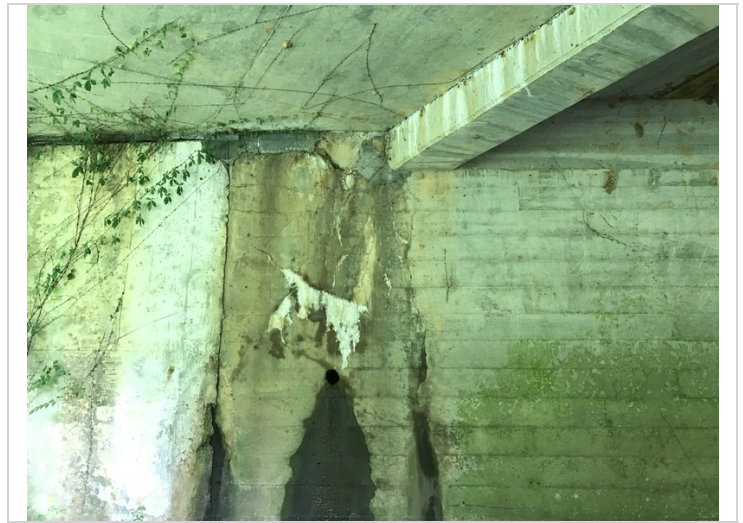
(215) -Bent # 1 has diagonal and map cracking with efflorescence under Girders # 1 and 3 in the original portions of the abutment. -There are grouted repairs adjacent to Girder # 3 in Bent # 1. -One full height vertical crack under Girder # 2. -Bent # 4 has diagonal cracking with efflorescence under Girders # 1 and 3 in the original portions of the abutment. -One full height vertical crack under Girder # 2. -Bent # 4 has a horizontal crack that appears to propagate from the weep holes in the original portion of the abutment.							
234	Reinforced Concrete Pier Cap	LF	95	78	16	1	0
1080	Delamination/Spall/Patched Area	LF	5	0	5	0	0
1090	Exposed Rebar	LF	2	0	1	1	0
1120	Efflorescence/Rust Staining	LF	5	0	5	0	0
1130	Cracking (RC and Other)	LF	5	0	5	0	0

Diagonal and map cracking with efflorescence and grouted repairs adjacent to girder # 3 in Bent # 1.

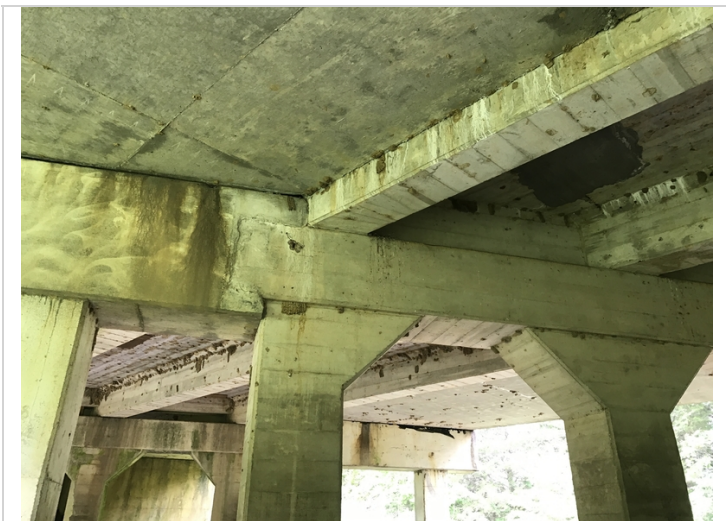
(234) -Cracking with efflorescence at Bent # 2 where the original substructure was widened and in the bearing area of girders. -Maintenance forces have patched some areas in the past. -There is one shallow spall with exposed reinforcing reinforcing in the Span # 3 side of Bent # 3 under Girder # 3.							
301	Pourable Joint Seal	LF	109	55	54	0	0
2350	Debris Impaction	LF	54	0	54	0	0

Spall with exposed reinforcing steel in span # 3 side of Bent # 3 under Girder # 3.

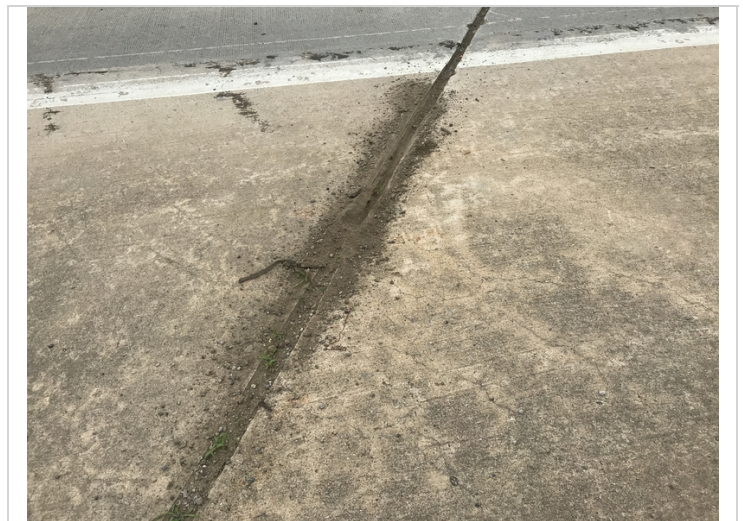
(301) -Poured joint seals placed between the new wearing surfaces. -There is dirt accumulation in the slab span portions of the joints.							
331	Reinforced Concrete Bridge Railing	LF	210	198	3	9	0
1090	Exposed Rebar	LF	9	0	0	9	0
1130	Cracking (RC and Other)	LF	3	0	3	0	0

There is dirt accumulation in the slab span portions of the joints.

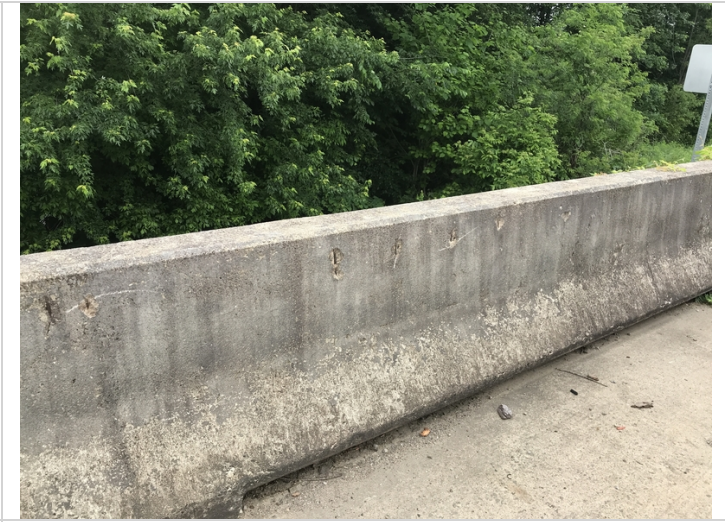
ELEMENTS	DESCRIPTION	UNITS	TOTAL	CS1	CS2	CS3	CS4
	(331) -There is light scale at the base of the Right parapet wall. -Several spalls with exposed reinforcing steel in the Left parapet of Span # 3.

Several Spalls with exposed reinforcing steel in the Left parapet of Span # 3.

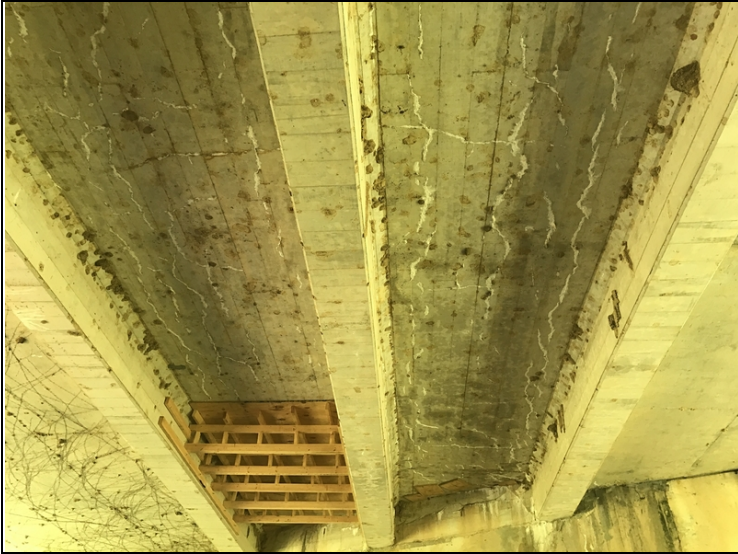
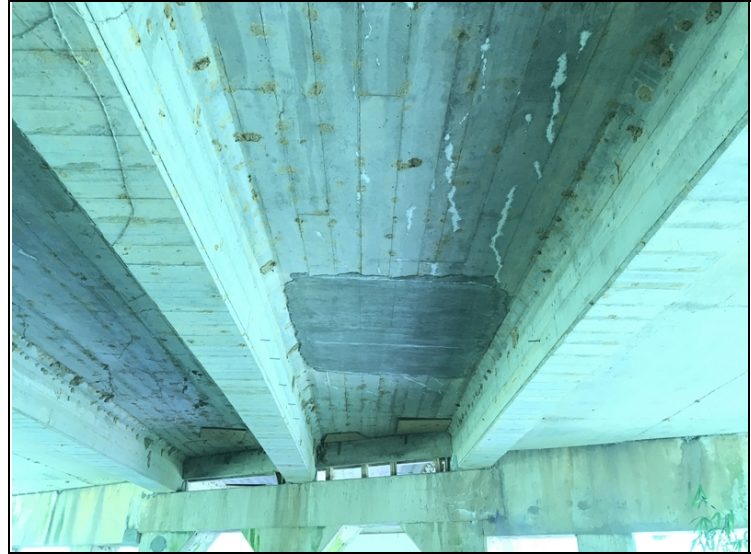
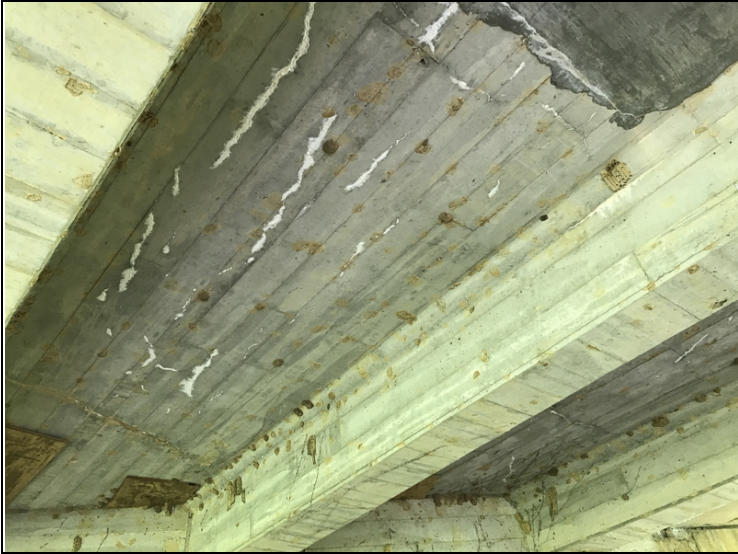
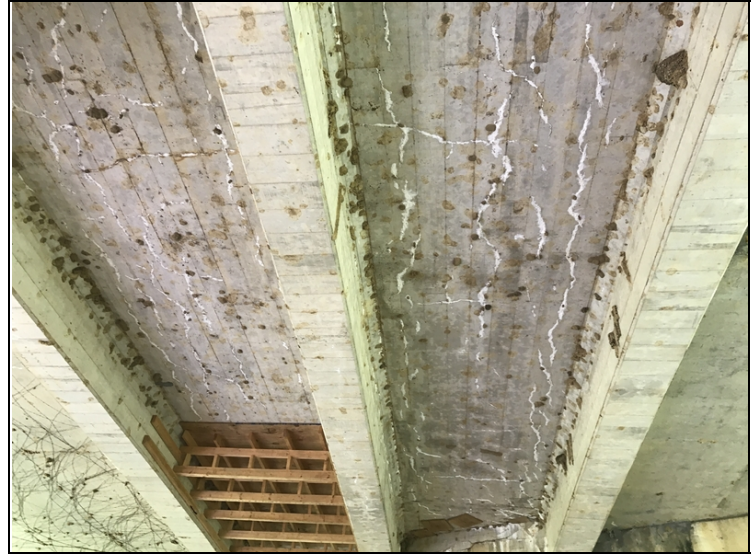
Map cracking with efflorescence is visible from the undersurface of Spans # 1 and # 3.

Span # 1 Bay # 3 cracking with efflorescence.

Map cracking with efflorescence in deck soffit of
Span # 1.

Map cracking with efflorescence in the deck soffit of
Span # 3.

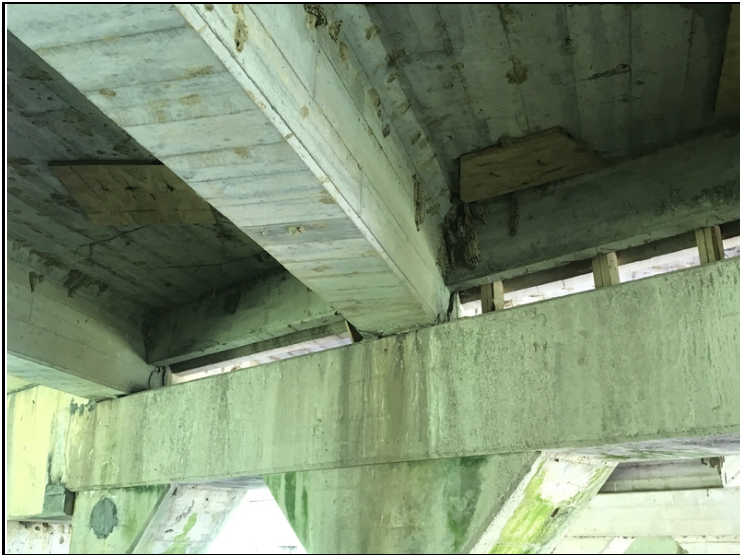
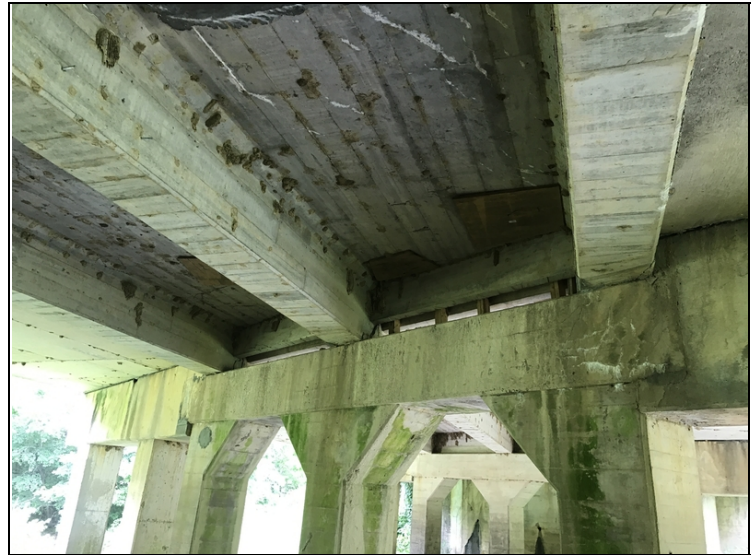
Girder # 1, 2, & 3 of Span # 1 have delaminated areas adjacent to Bent # 2.

Span # 1 Bent # 2 spalling at the ends of the girders.

Delaminated areas in Span # 1 Girders over Bent # 2.

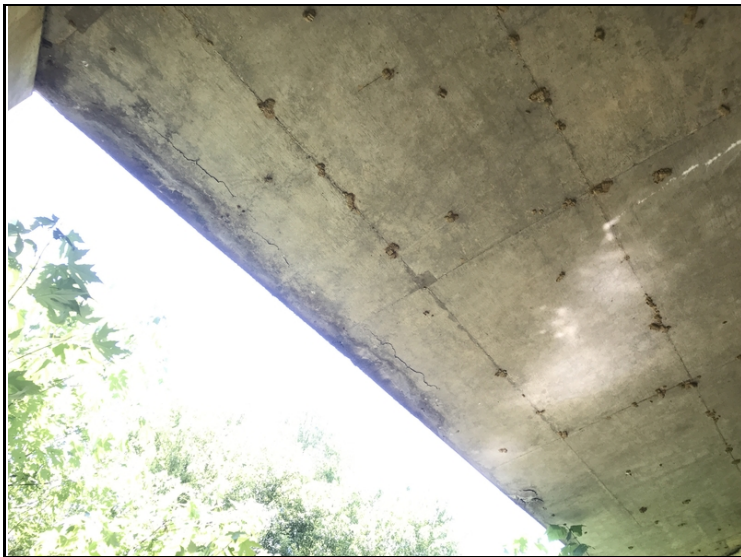
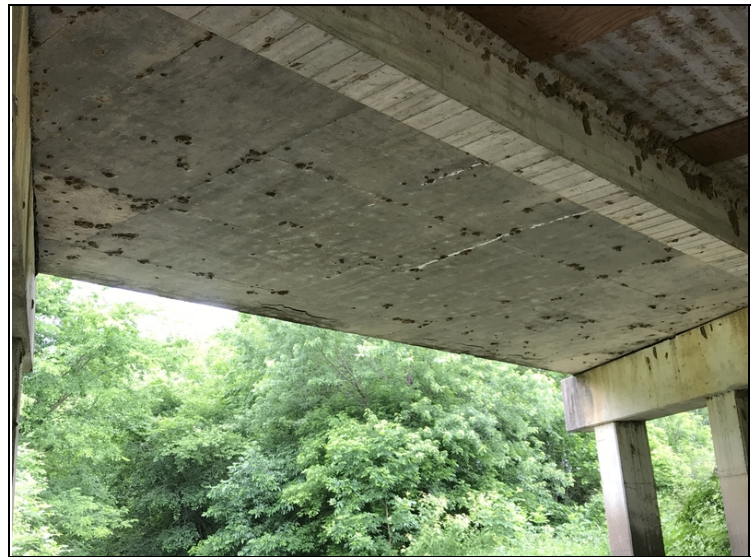
The undersurface of the slab spans have areas that are delaminated and spalled along the exterior edges.

Span # 2 Rt concrete delaminations along the edge of the slab.

Left slab soffit of Span # 2. Delaminated areas along edge of slab.

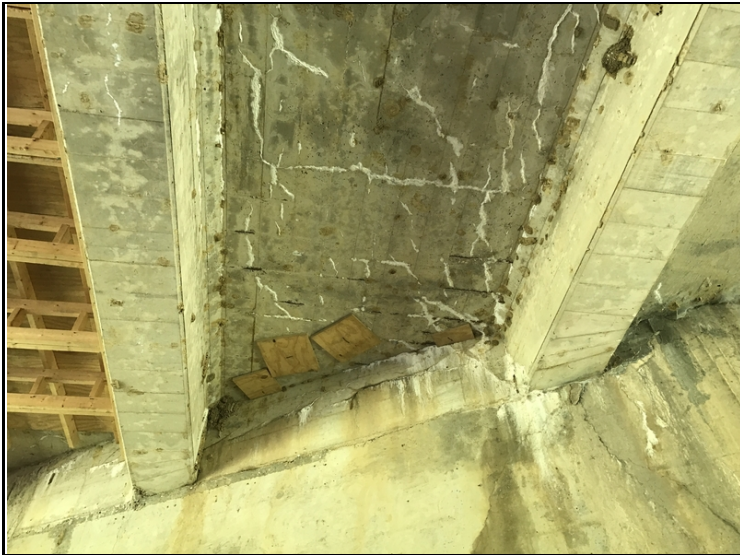
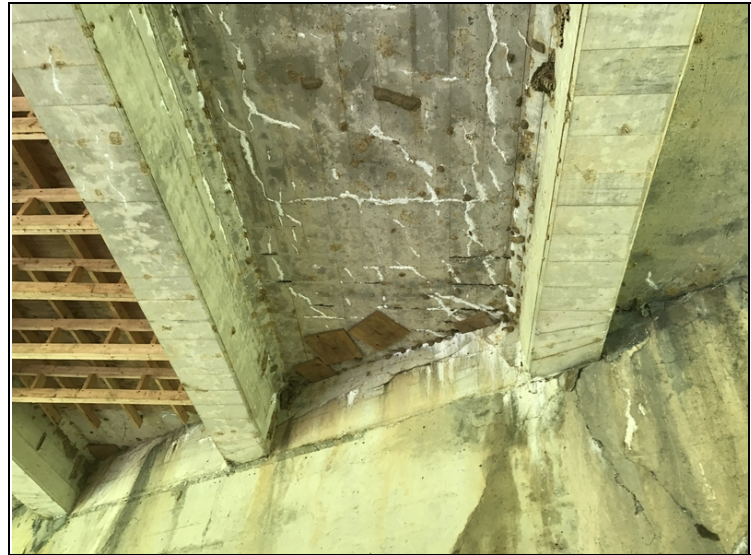
Spalling with exposed reinforcing steel visible from the undersurface of the deck adjacent to bent # 4.

Span # 3 Bay # 2 exposed reinforcing steel.

Span # 3 bay # 2. Spalls with exposed reinforcing steel adjacent to bent # 4.

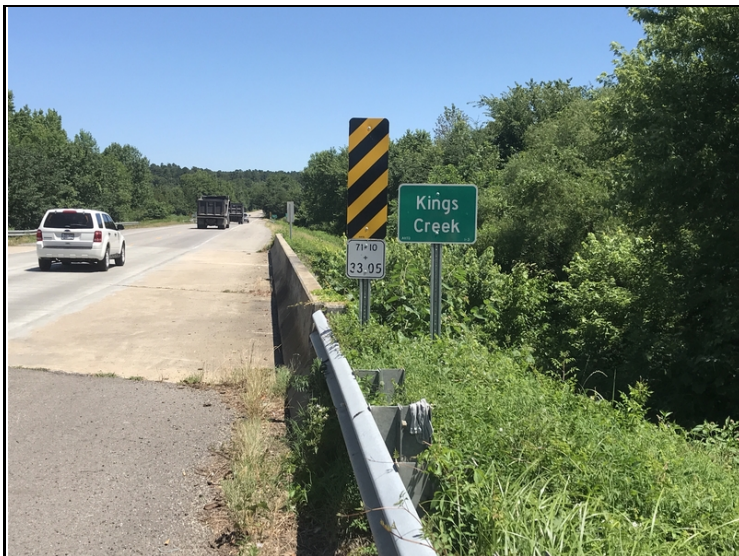
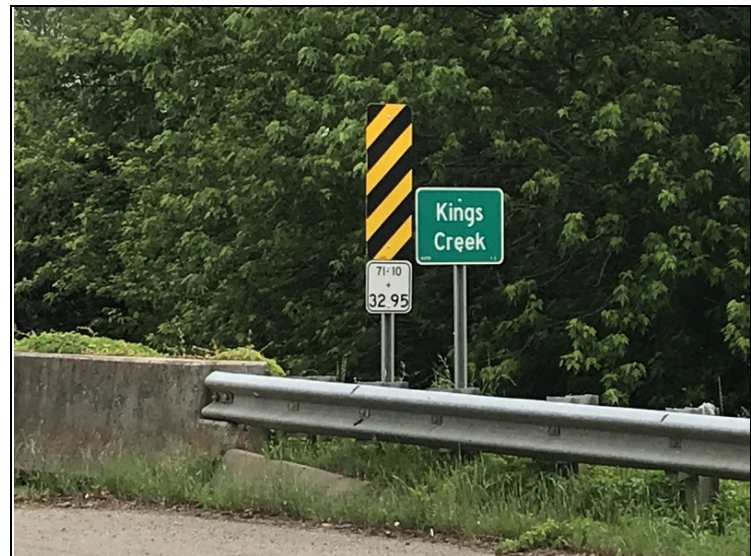
The log mile signs posted at the structure are incorrect.

Log mile sign is incorrect.

05/24/2021 - JCJ & TJL - Log Mile Sign is correct during this inspection.

Log mile posting should be 32.95.

Replaced incorrect sign with corrected Log Mile Sign

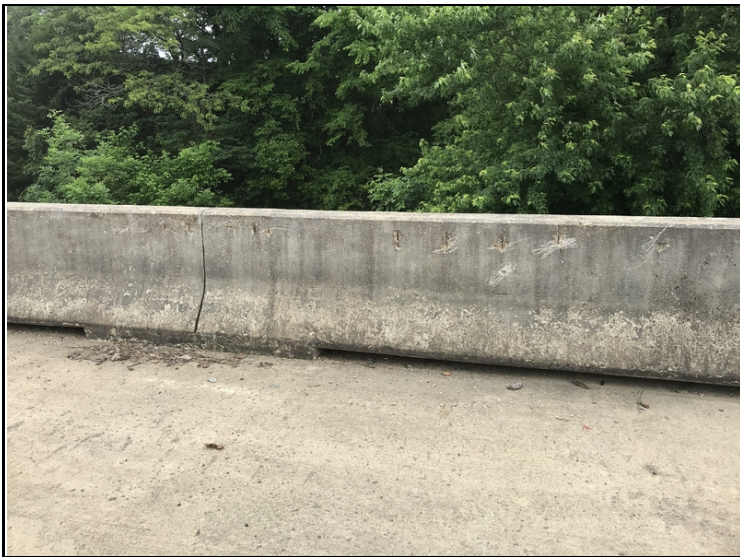
The Left parapet of Span # 3 has shallow spalls with exposed reinforcing steel.
