Asset #00319(Routine)

US Highway 71 over Brushy Creek - Scott Co.

Location: 6.48 MI NO OF JCT SH 28

Team Lead: Jeff Jones, Inspection Date: 05/24/2021

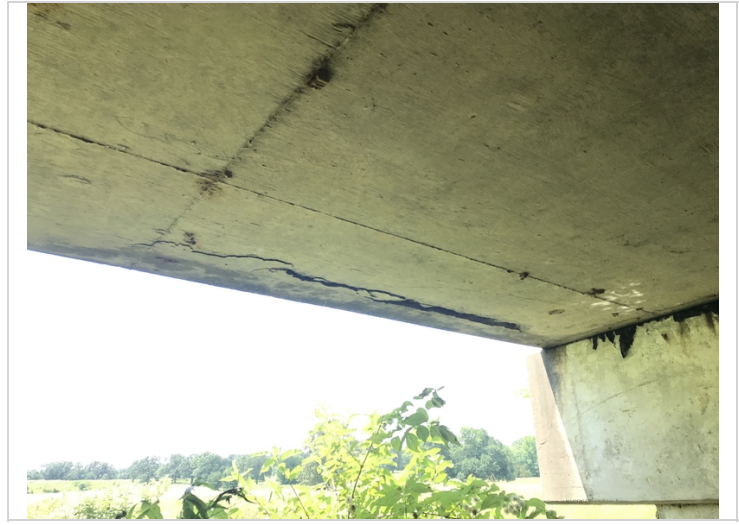
Span 1 Bent 2 concrete delamination and spalling with exposed reinforcing steel.

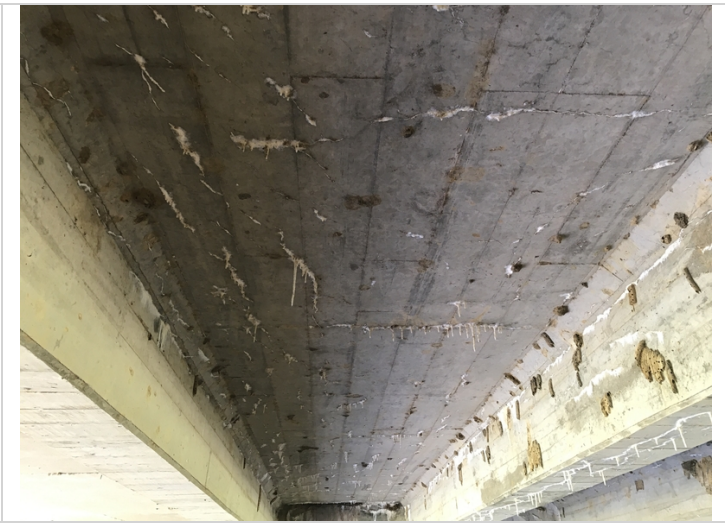
Span 2 Bay 1 cracks with efflorescence.

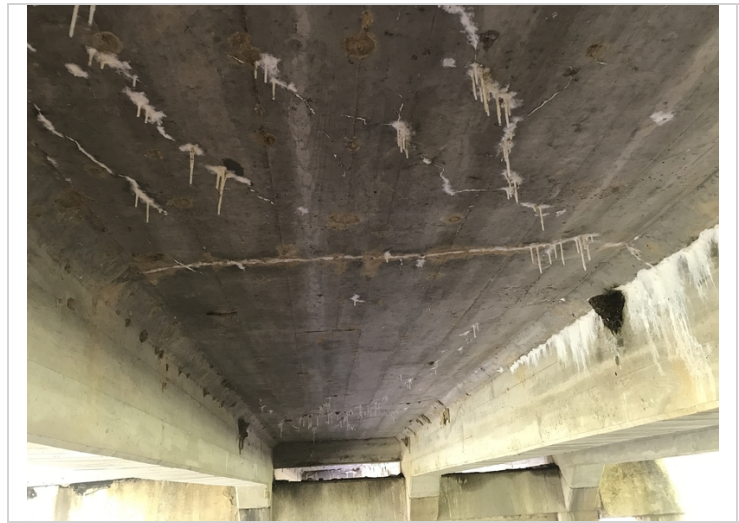
Span # 1 Bay # 1 cracking with efflorescence buildup.

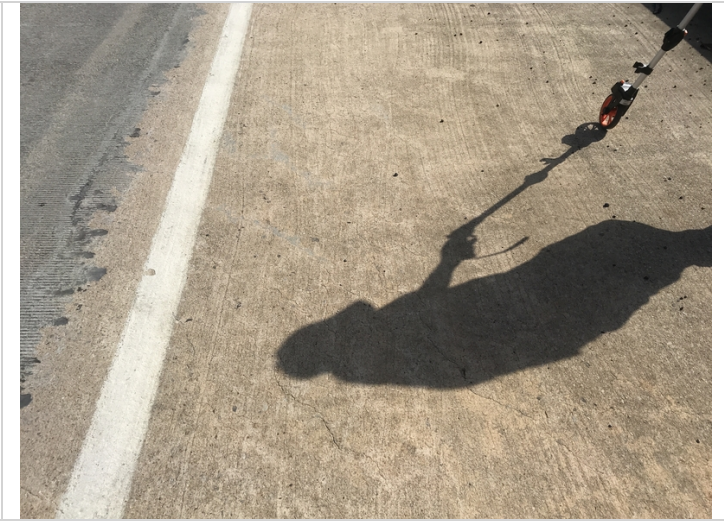
Map cracking on the slabs.

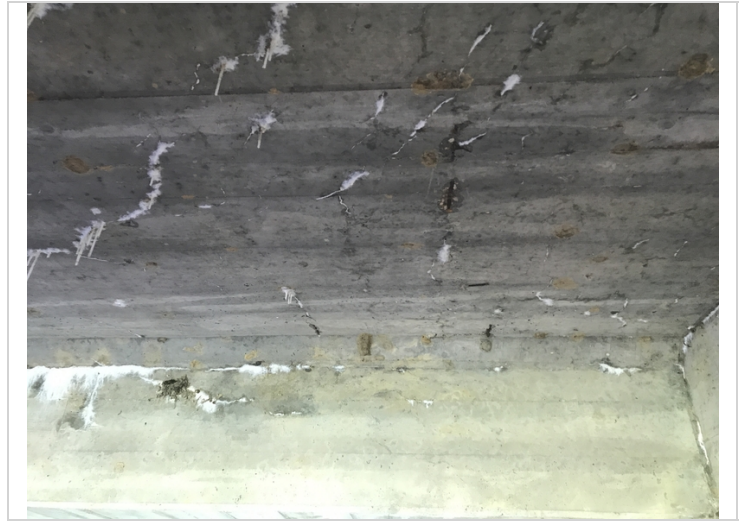
Span 1 Bay 1 spalling with exposed reinforcing steel adjacent to Bent 1.

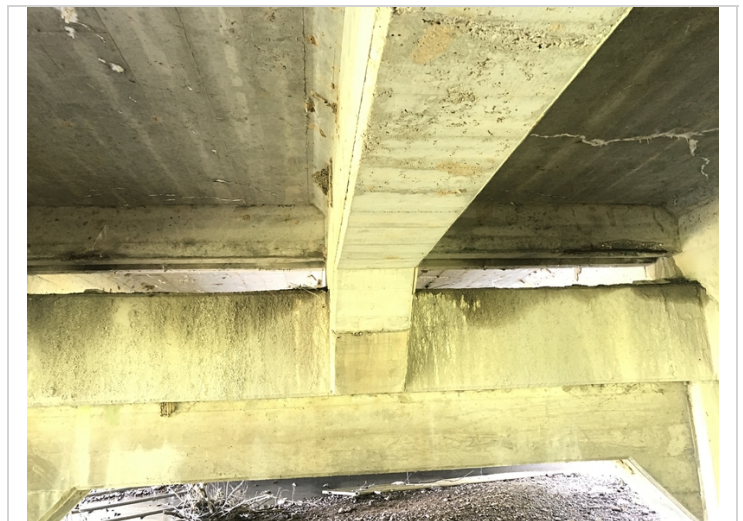
Span 1 spalling with exposed reinforcing steel in the deck expansion dam.

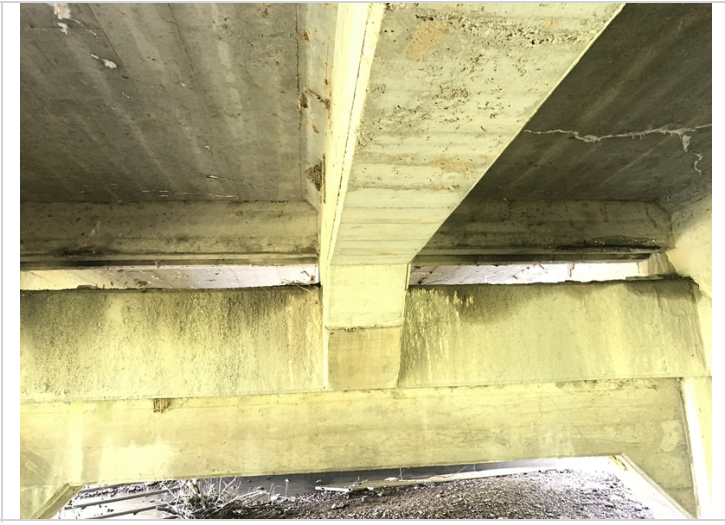
Span # 1 spalling with exposed reinforcing steel in the deck expansion dam.

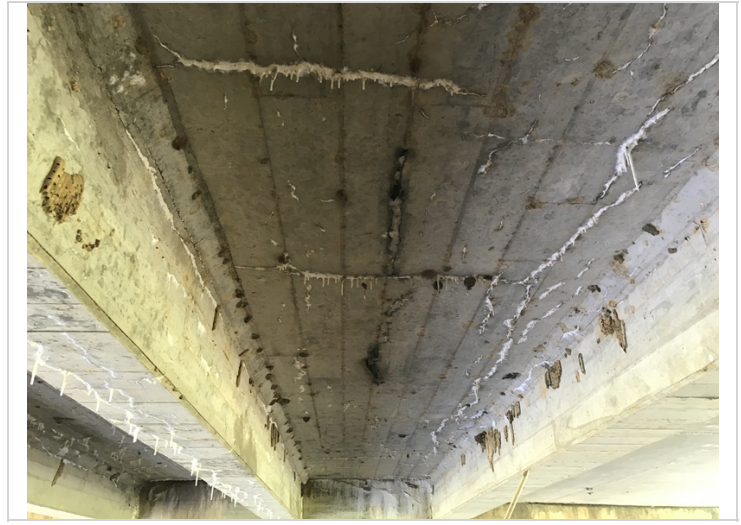
Span 2 Bay 2 cracking with efflorescence on the undersurface.

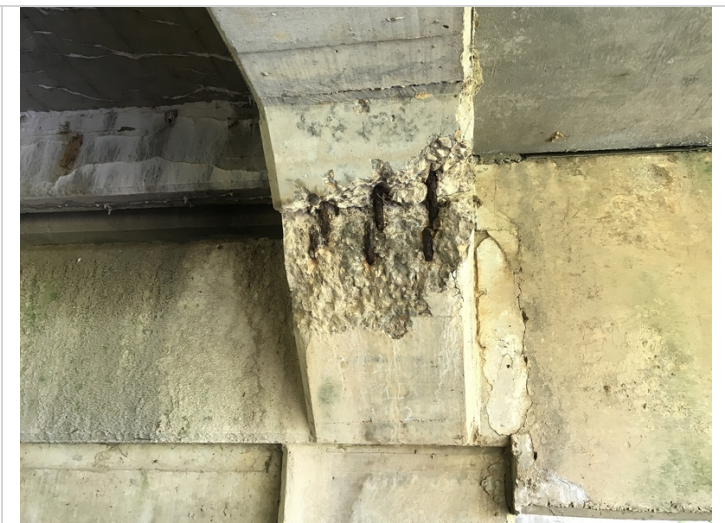
Span 2 Bent 2 Girder 1 spalling with exposed reinforcing steel.

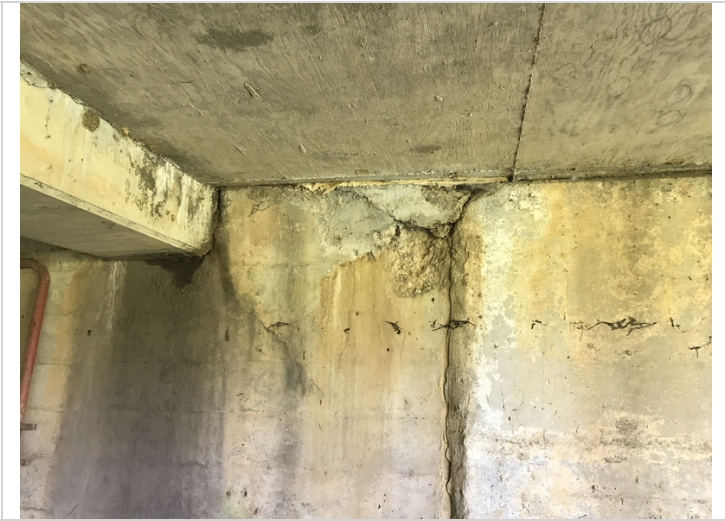
Bent 1 Lt spalling with exposed reinforcing steel adjacent to Girder 1.

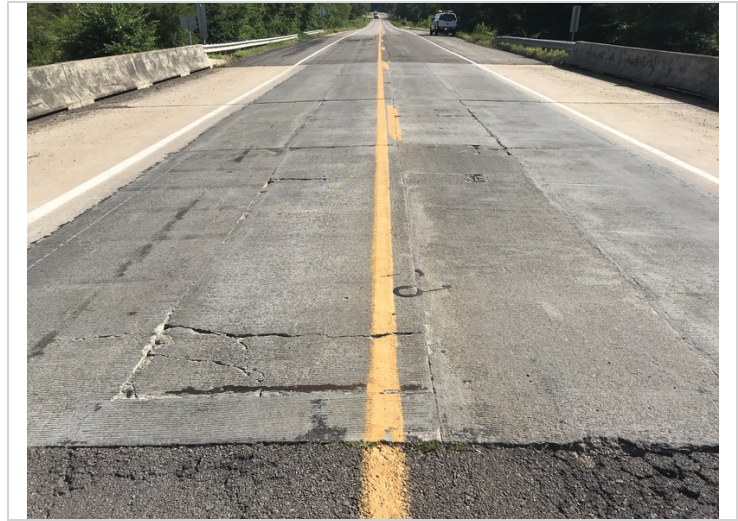
Span # 1 wearing surface breaking apart.

The rigid overlay driving surface of the deck has de-bonded and broken apart in areas and is audible when impacted by traffic.

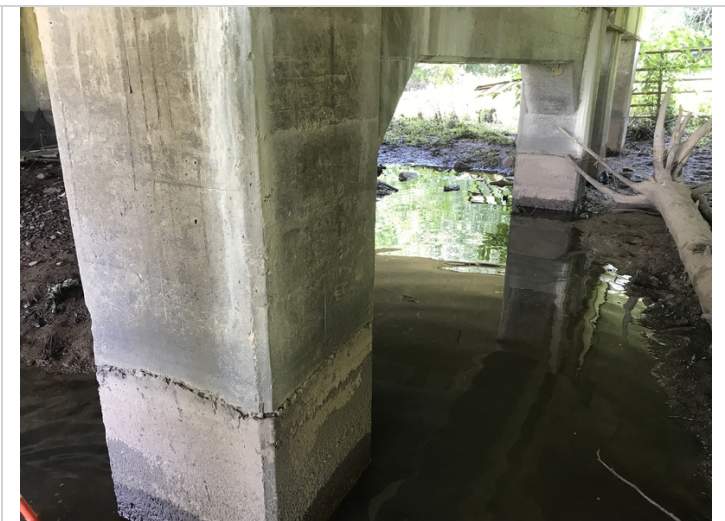
(205) -Columns # 3 & 4 have minor concrete deterioration at the construction joint. -There is light abrasion at the base of the columns.							
215	Reinforced Concrete Abutment	LF	101	16	82	3	0
1080	Delamination/Spall/Patched Area	LF	6	0	6	0	0
1090	Exposed Rebar	LF	1	0	0	1	0
1120	Efflorescence/Rust Staining	LF	27	0	25	2	0
1130	Cracking (RC and Other)	LF	11	0	11	0	0
1190	Abrasion/Wear (PSC/RC)	LF	40	0	40	0	0

Bent 2 columns 3 & 4 abrasion and concrete deterioration.

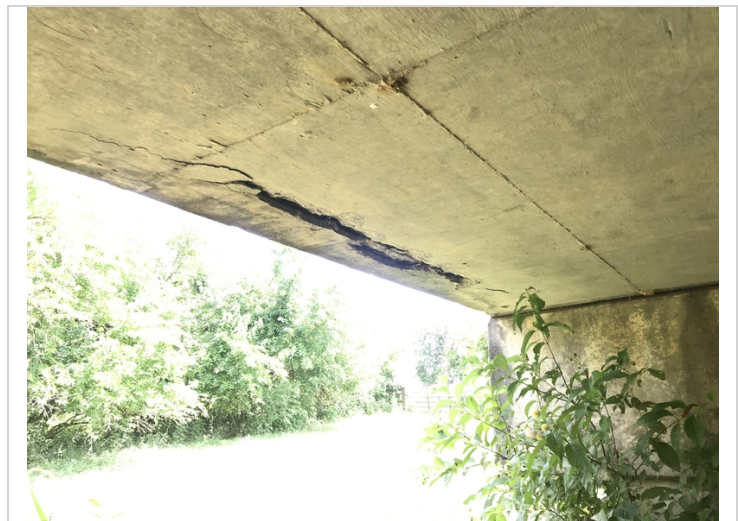
Span 2 Rt spalling with exposed reinforcing steel.

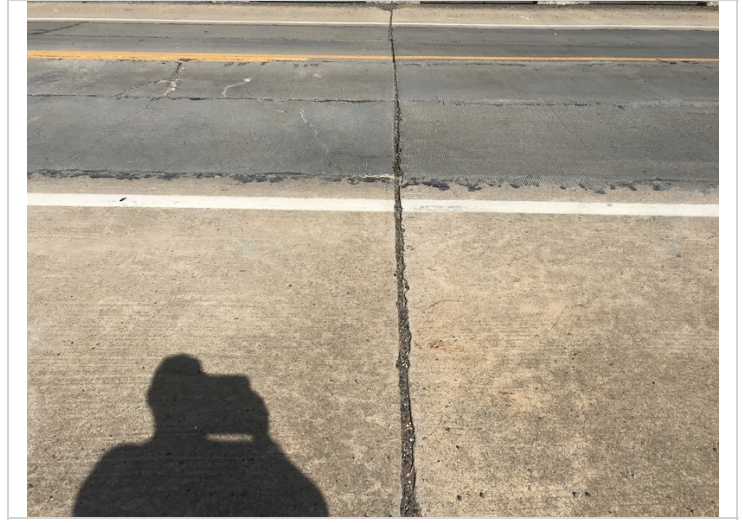
Typical joint seal deterioration.

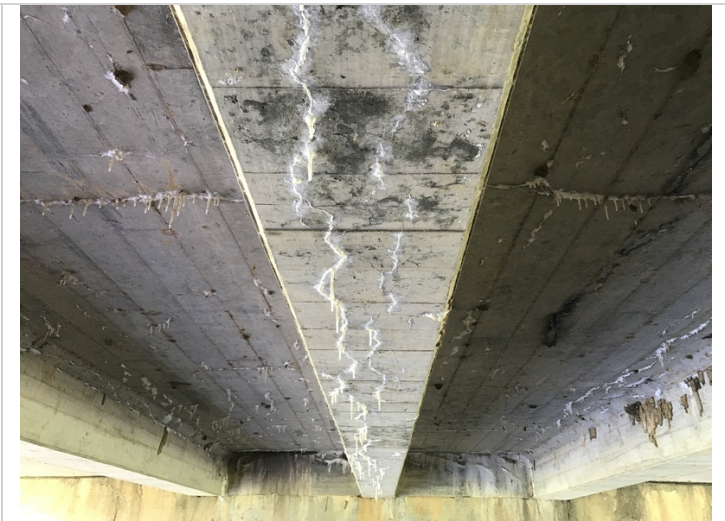
Span 2 Girder 2 cracking with efflorescence.

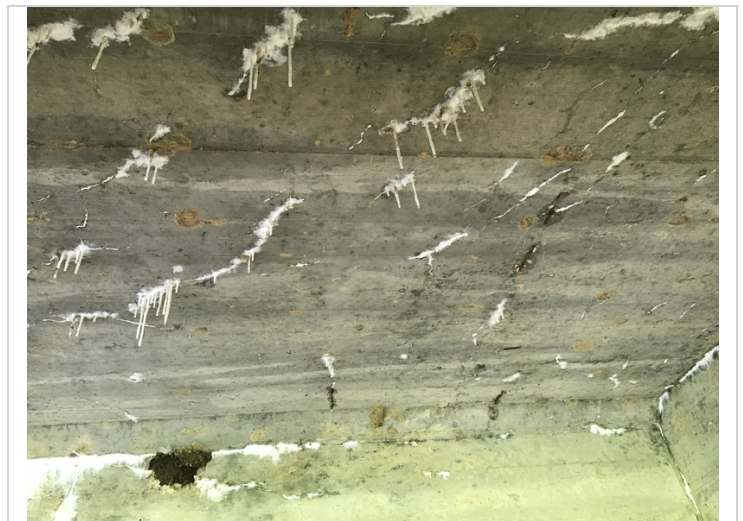
Span # 1, Bay # 1. Spalls with exposed reinforcing steel in proximity to Bent # 1.

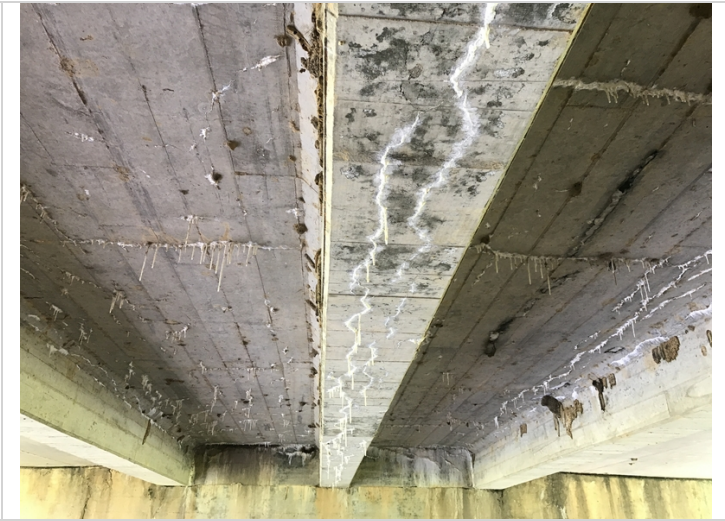
Span # 2 deck soffit. Map cracking and transverse cracking with efflorescence.

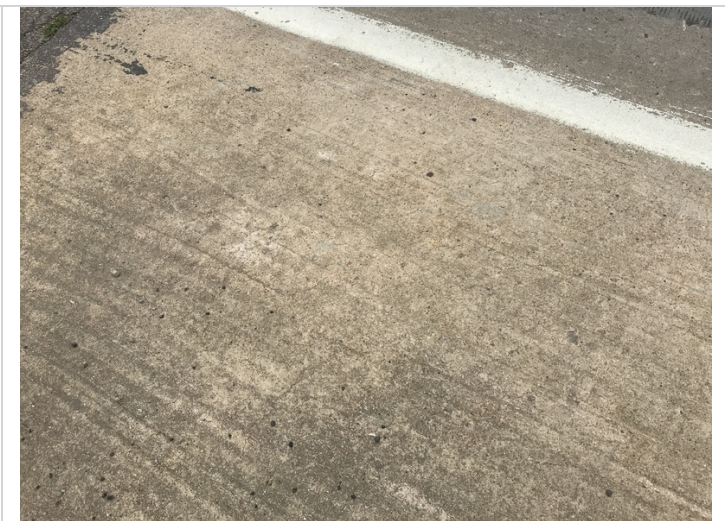
Minor map cracks. Span # 2. Left side of slab.

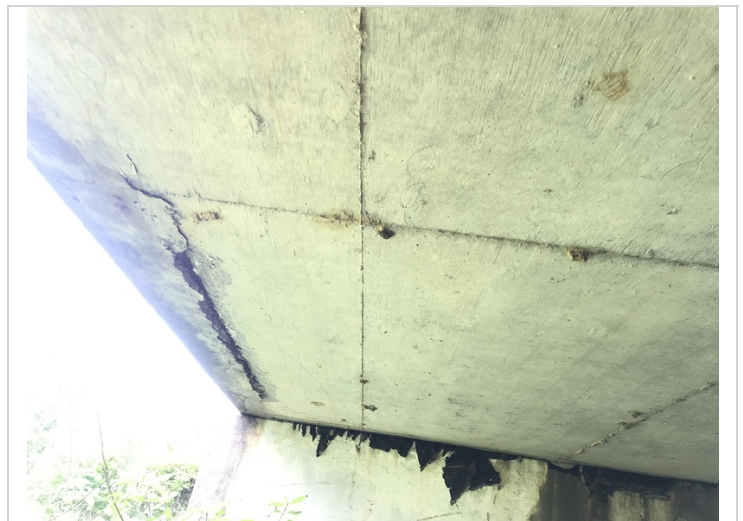
Span # 1. Left slab soffit. Spalling with exposed reinforcing steel.

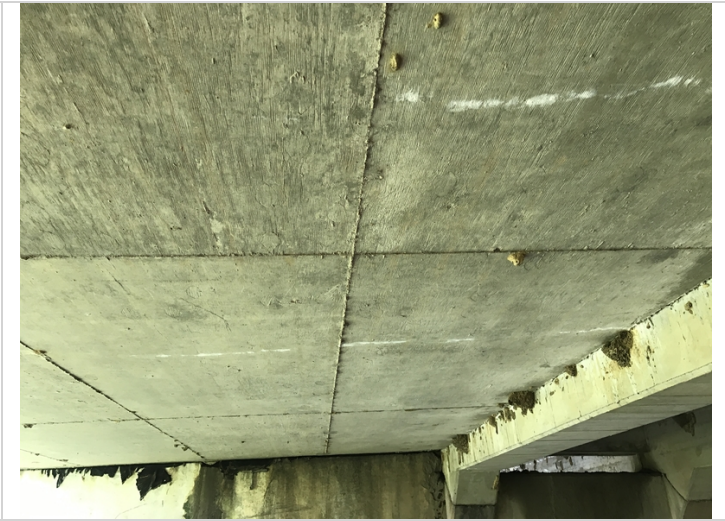
Transverse hairline cracks in the Left side of Span # 1.

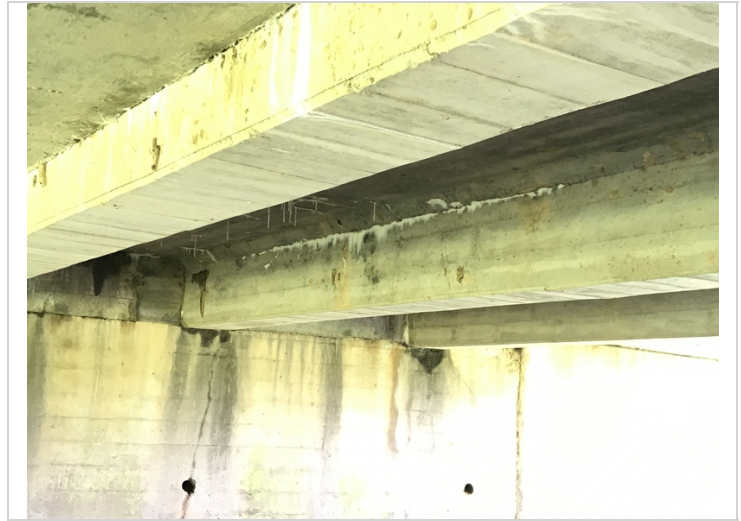
Span # 1. Girder # 2. Horizontal crack with efflorescence.

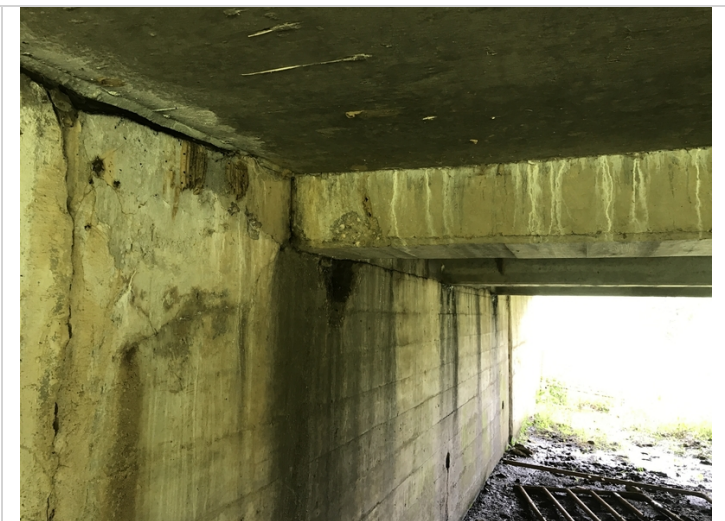
Girder # 3 at Bent # 1. No change.

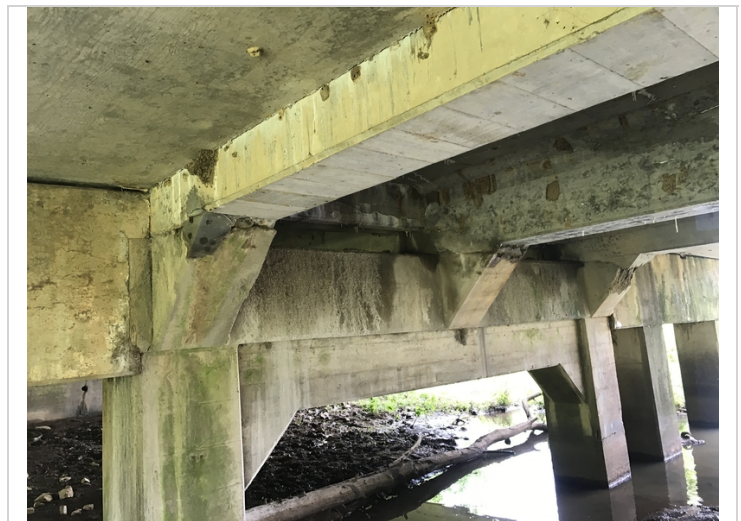
(234) -Bent # 2, Span # 1 side has a spalled area adjacent to Beam # 1 at the construction joint. -Bent # 2, Span # 2 at Girder # 1 has a concrete spall in the haunch under the beam. -Bent # 2 Girder # 3 has a 10" spall with exposed reinforcing steel with initial section loss. Repair to the haunch has failed and has exposed the reinforcing steel.

Repair still holding. Span # 2 Bent # 2 Girder # 3.

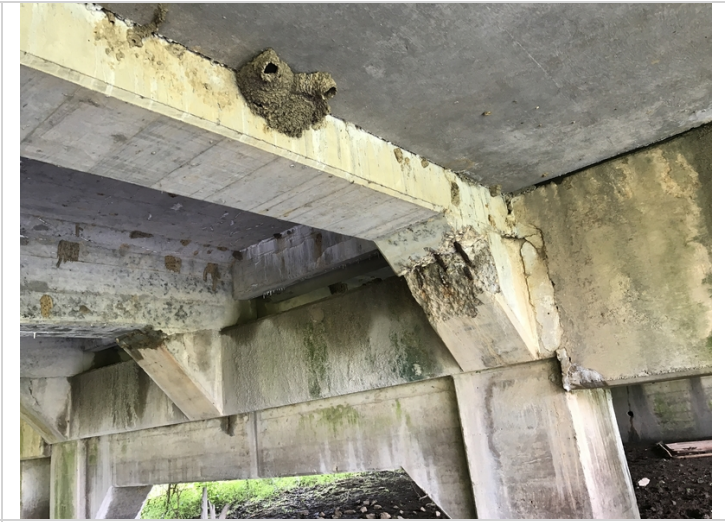
Span # 2, Girder # 1 at Bent # 2. Spalling with exposed reinforcing steel at the cap haunch.

The concrete haunch for Girder # 1 Span # 2 at Bent # 2 has spalling with exposed reinforcing steel.

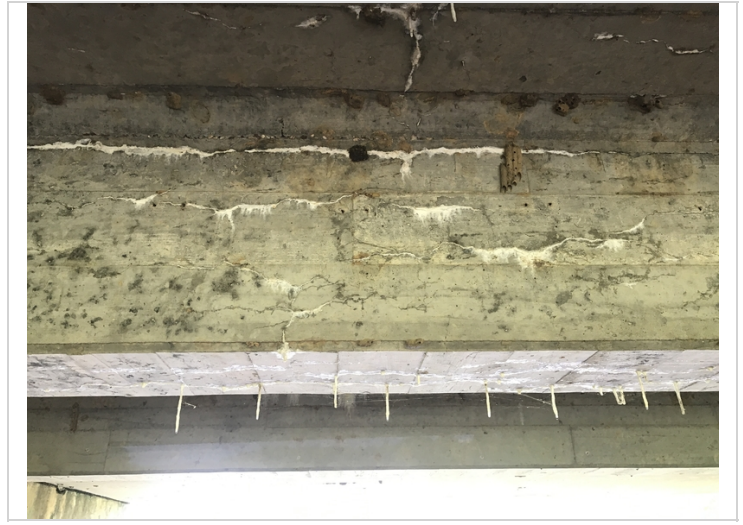
Cracking in Span # 2, Girder # 2. Typical.

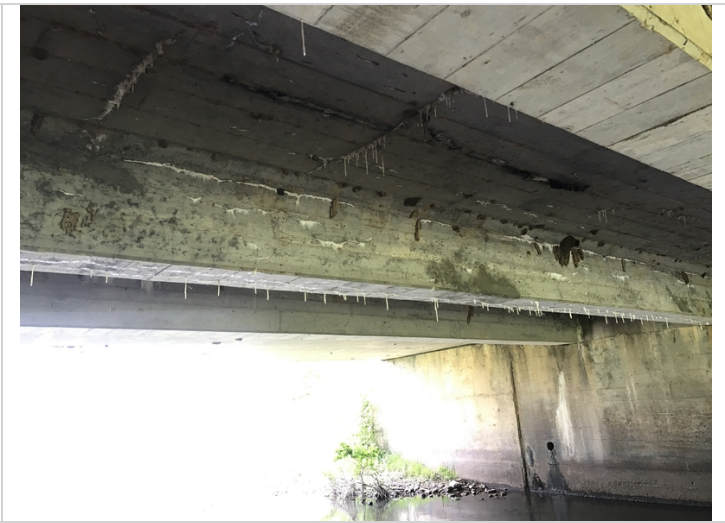
Span # 2, Girder # 2. Cracks with efflorescence.

Span # 2 Girder # 2 has map cracking with efflorescence.

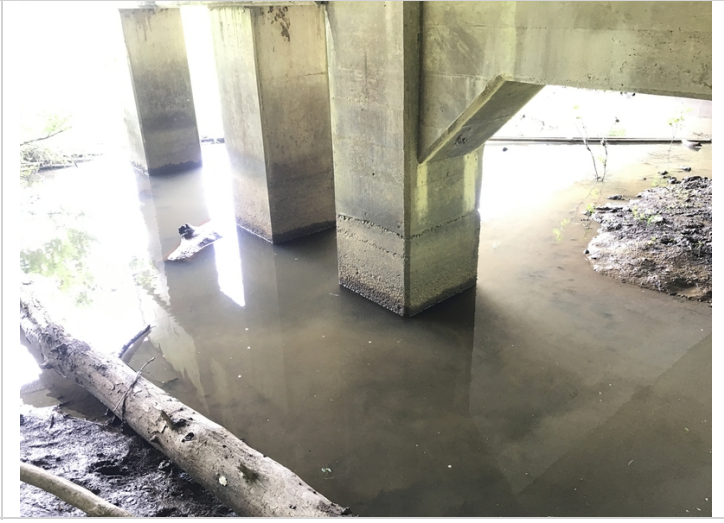
Bent # 2, Column # 3 construction joint.

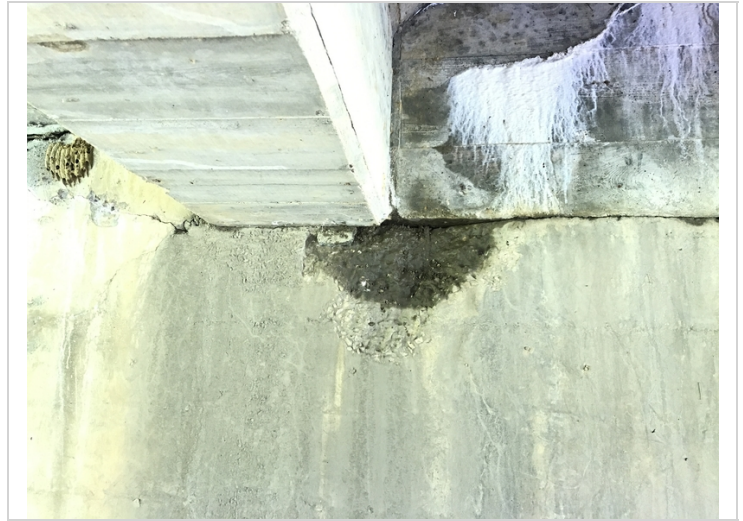
Bent # 1 has a 12" spalled area with exposed reinforcing steel under Girder # 3.

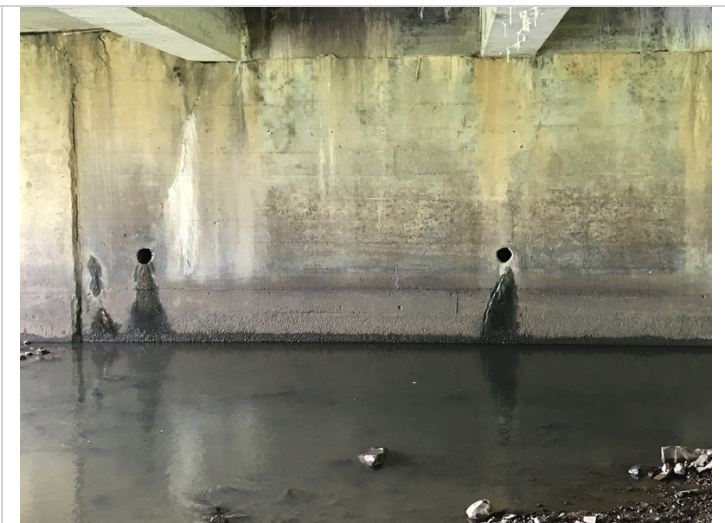
Light abrasion at the base of Bent # 3.

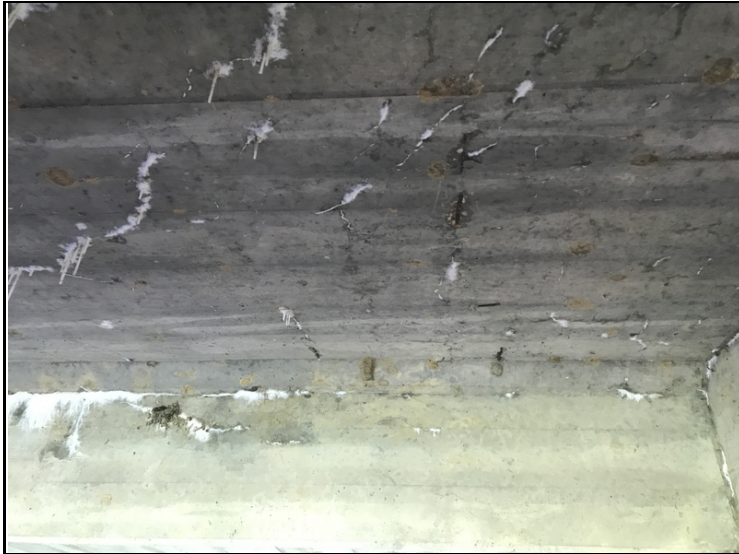
Span # 1 Bay # 1 spalling with exposed reinforcing steel adjacent to Bent # 1.

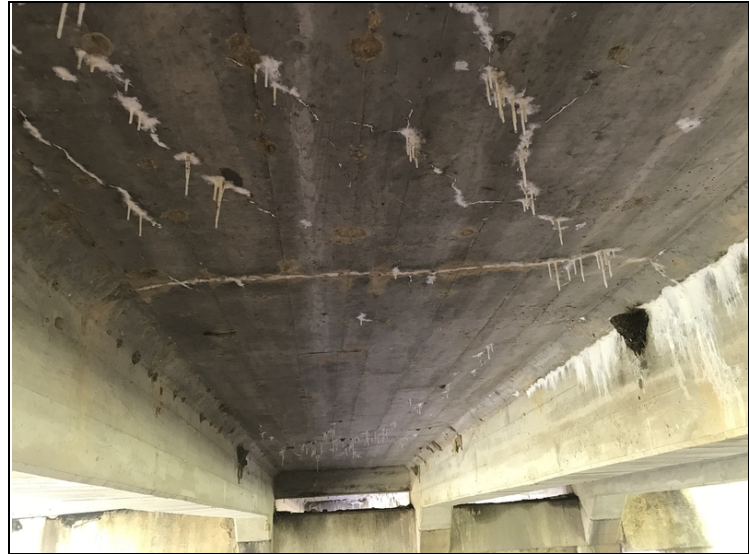
Span # 1 Bay # 1 cracking with efflorescence buildup.

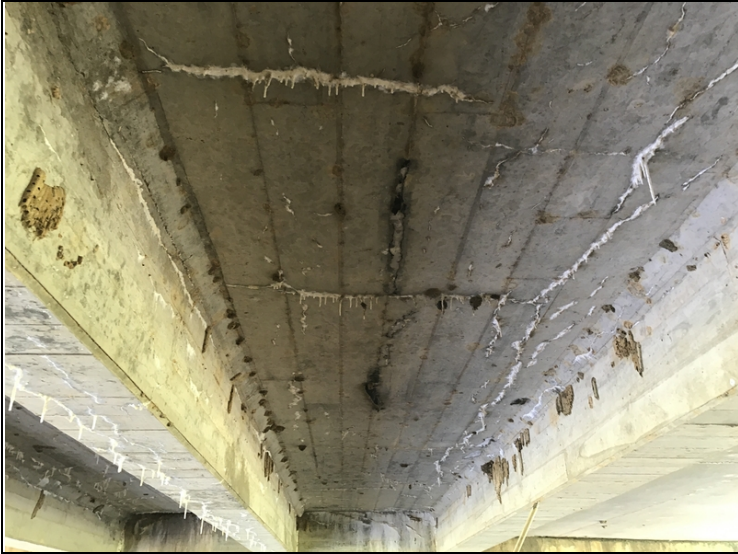
Span # 2 Bay # 2 cracking with efflorescence on the undersurface.

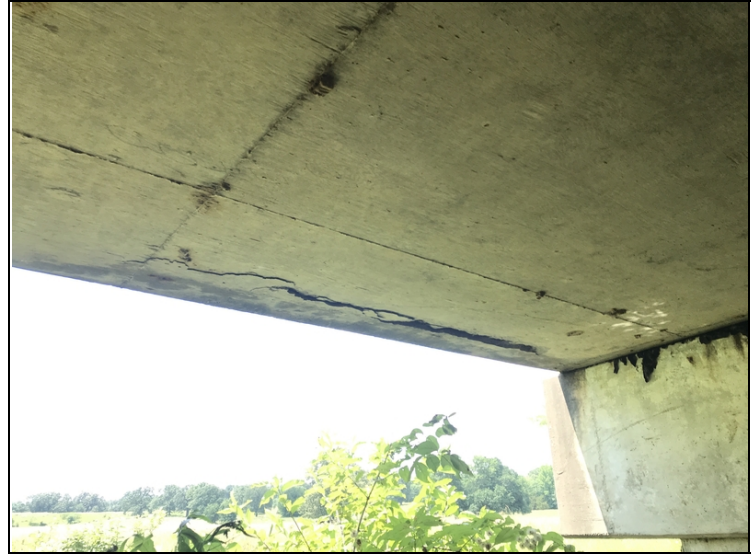
Span # 1 Bent # 2 concrete delamination and spalling with exposed reinforcing steel.

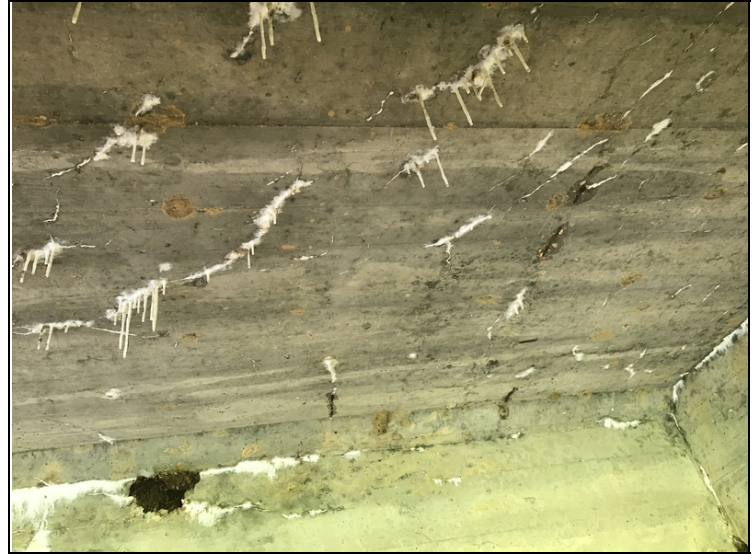
Span # 1 spalls with exposed reinforcing steel.

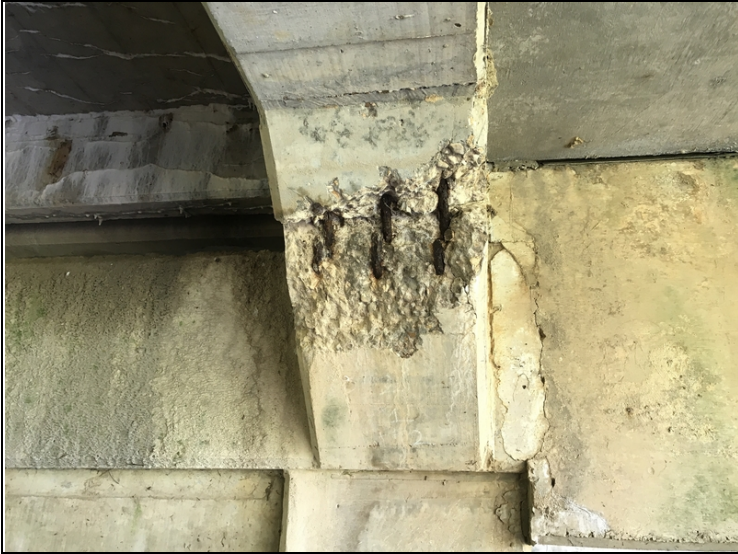
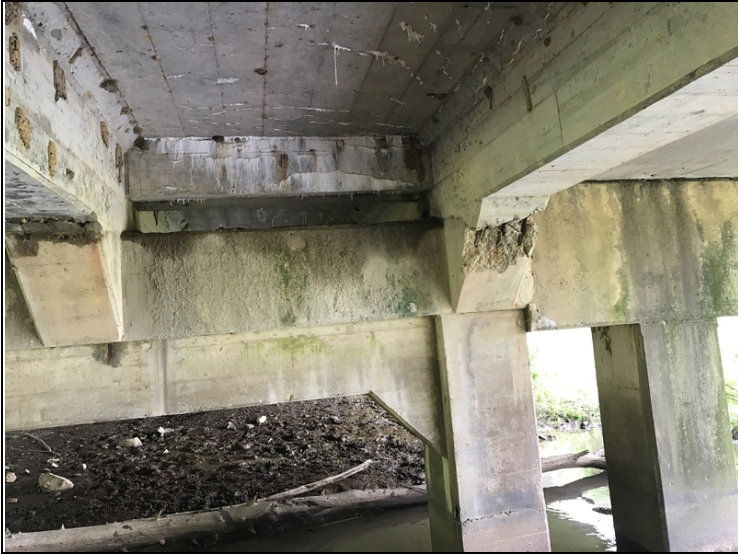
Span # 2 Bent # 2 Girder # 1 spalling with exposed reinforcing steel.

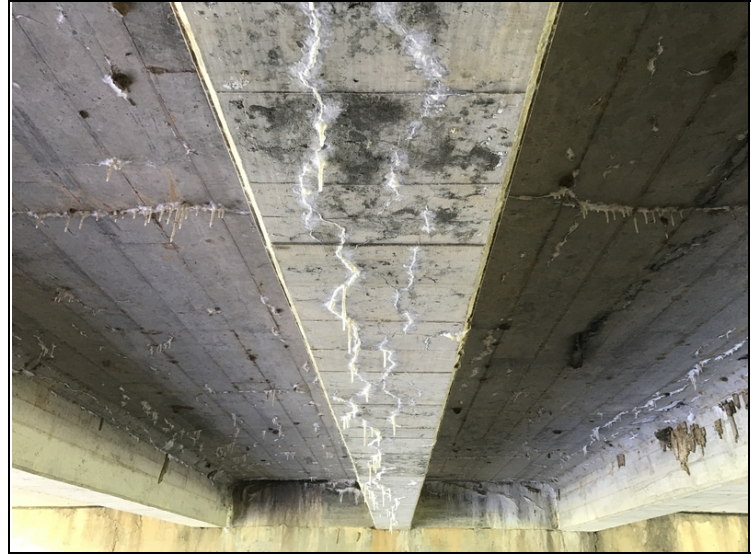
Span # 2 Girder # 2 cracking with efflorescence.

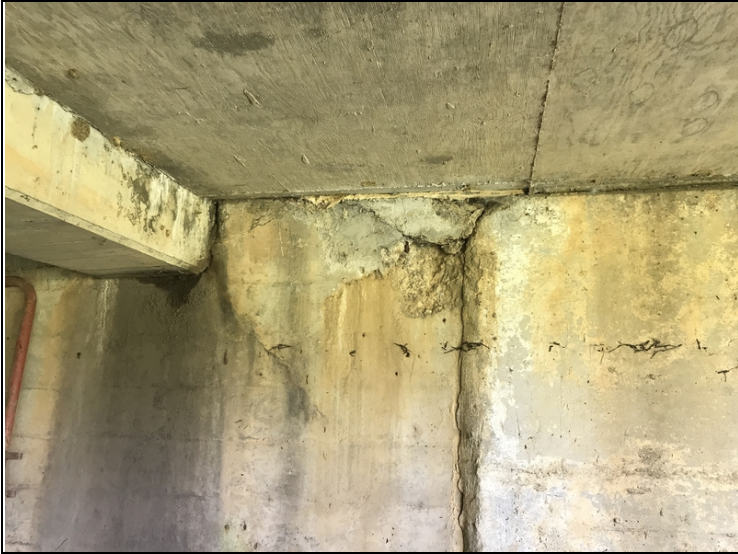
The south abutment has spalling in the top of the stem wall.

Bent # 1 Lt spalling with exposed reinforcing steel adjacent to Girder # 1.

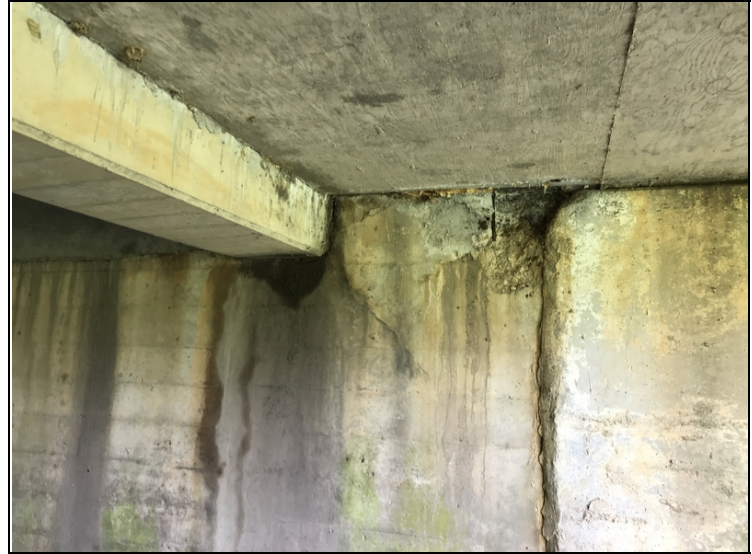
Bent # 1 Left. Spall with exposed reinforcing steel.

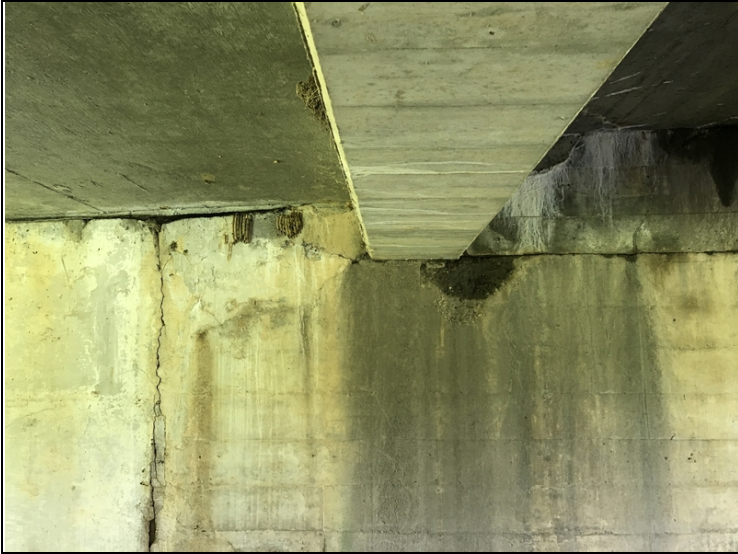
Bent # 1 Right. Spall with exposed reinforcing steel.

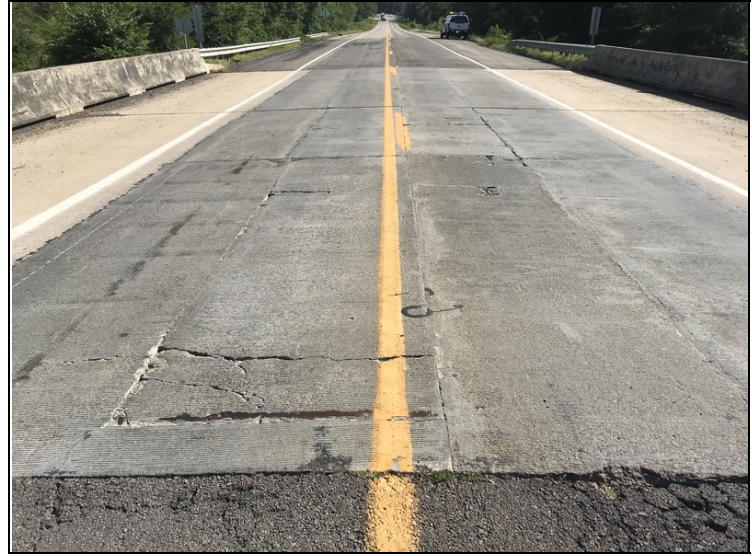
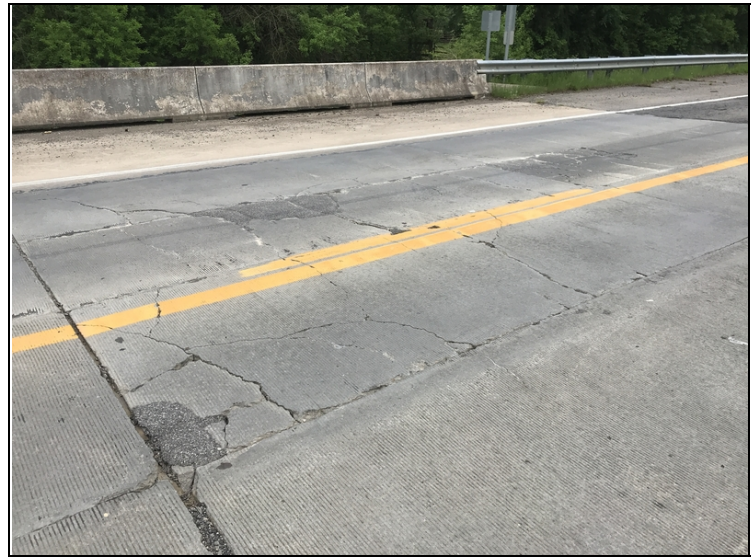
-Differential elevation in the wearing surface indicate possible reduction in section of the deck due to abrasion between the wearing surface and the original deck.

Span # 1 wearing surface breaking apart.

Span # 1 wearing surface is breaking apart.

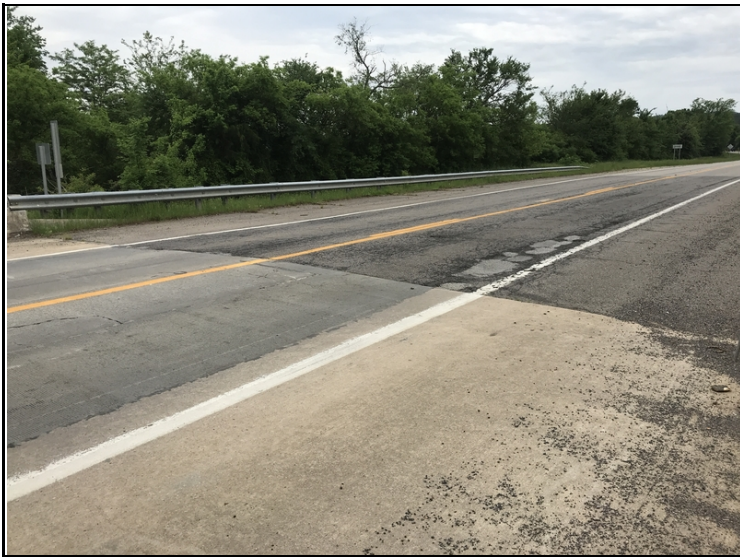
South approach.

Asphalt approach roadway -
The asphalt at both approaches is breaking apart with several patches.
