Asset #00320(Routine)

US Highway 71 over Old Freedom Cr- Scott Co

Location: 5.69 MI NO OF JCT SH 28

Team Lead: Jeff Jones, Inspection Date: 05/24/2021

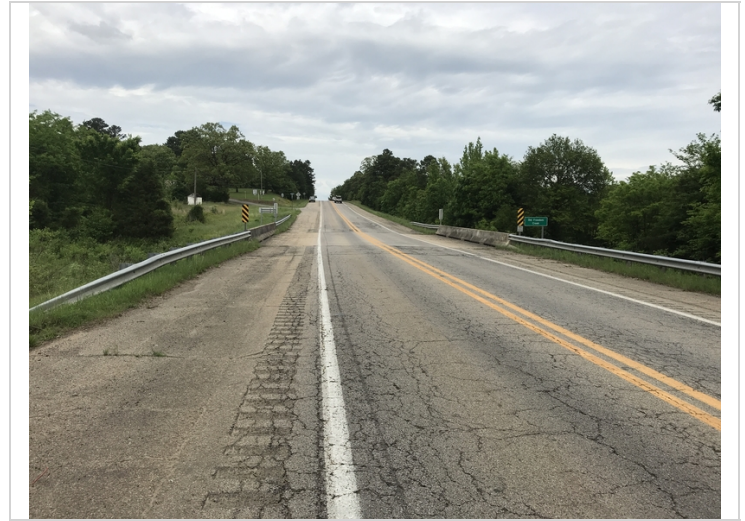
Approach roadway facing North.

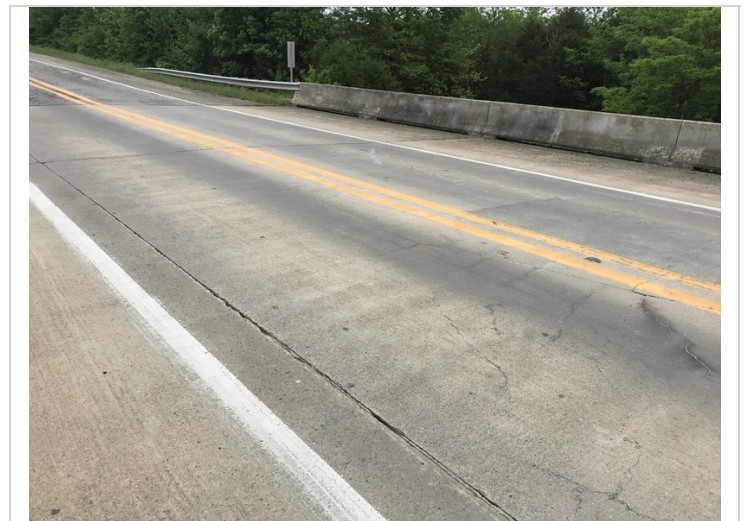
Driving surface of the deck. Typical.

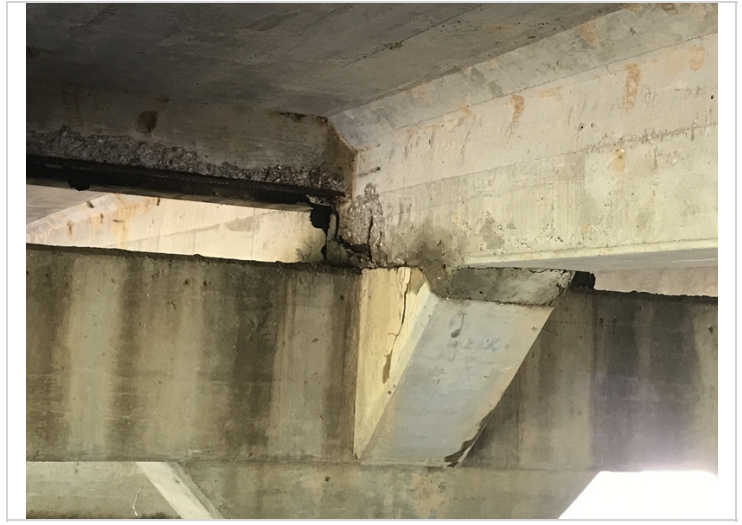
Span # 2 Bent # 2 Girder # 2 spalling with exposed reinforcing steel.

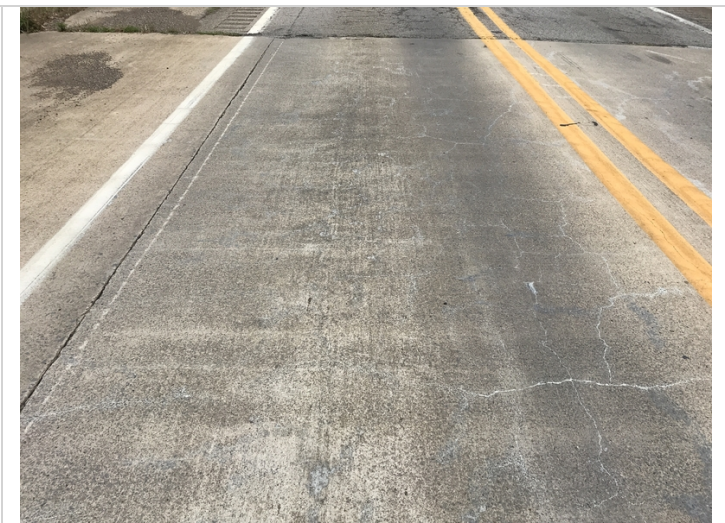
Typical cracking on the wearing surface of the deck.

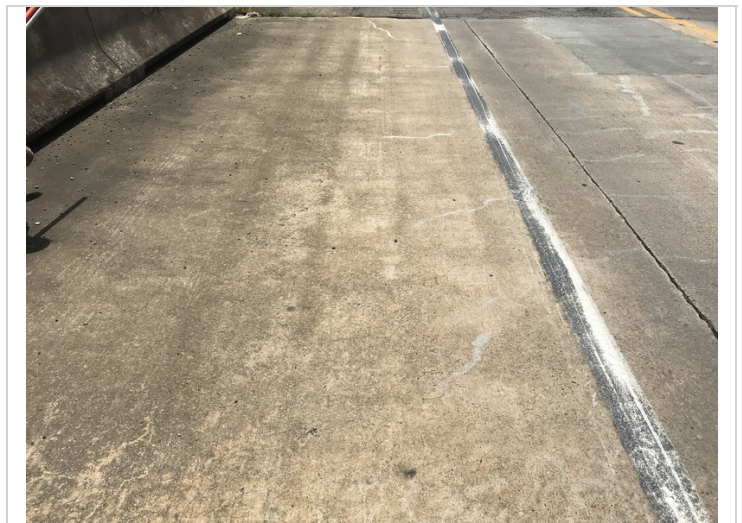
Span # 1 Rt has light map cracking.

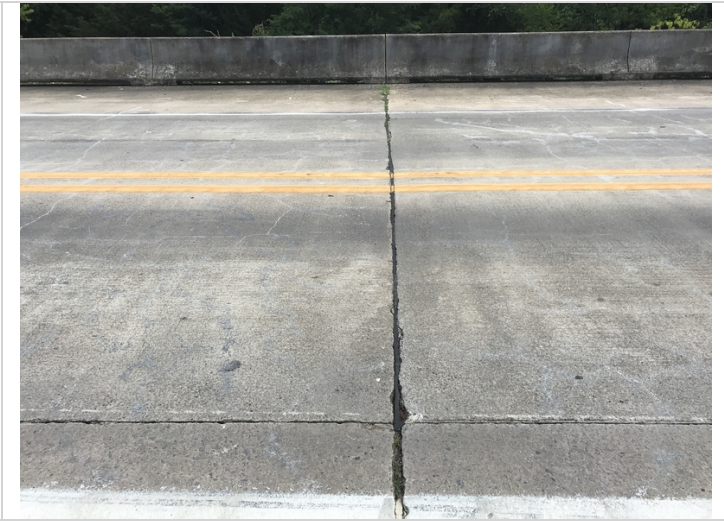
Bent # 2 joint seal adhesion failure.

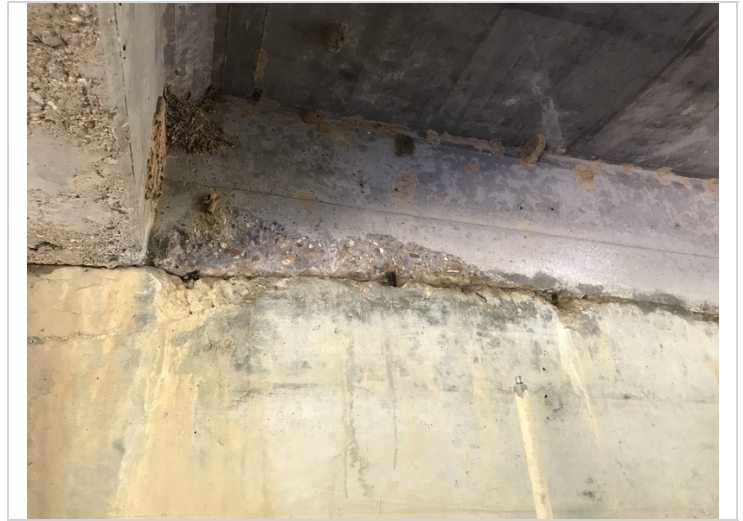
Bent # 3 Bay # 1 small spalls with exposed reinforcing steel.

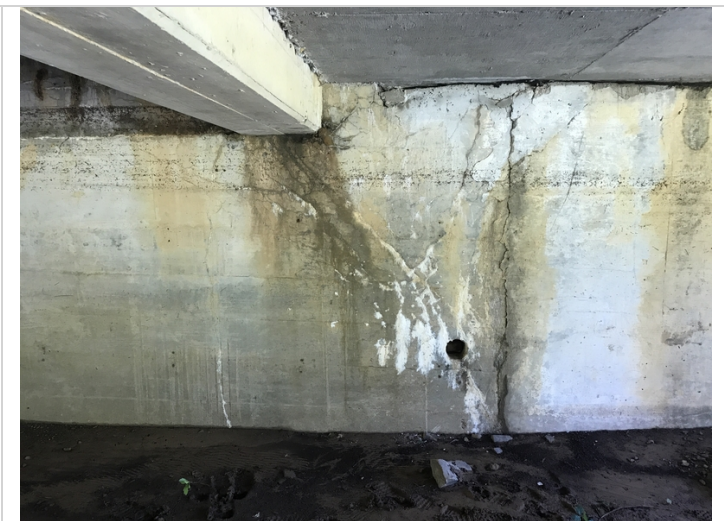
Bent # 1 Lt with cracking with efflorescence , concrete delamination's and shallow spalling.

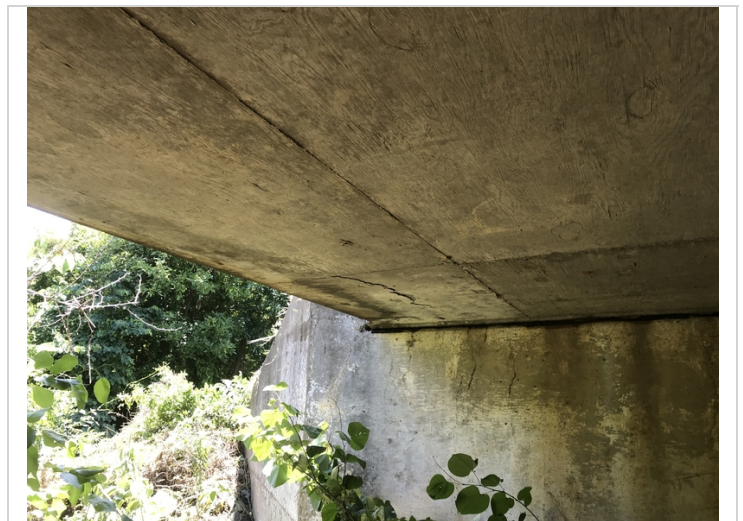
Span # 1 Bent # 1 Rt concrete delamination.

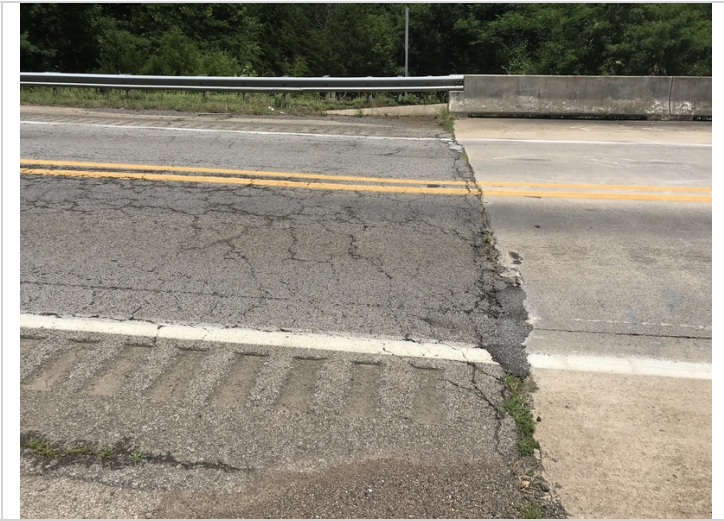
North approach roadway deterioration.

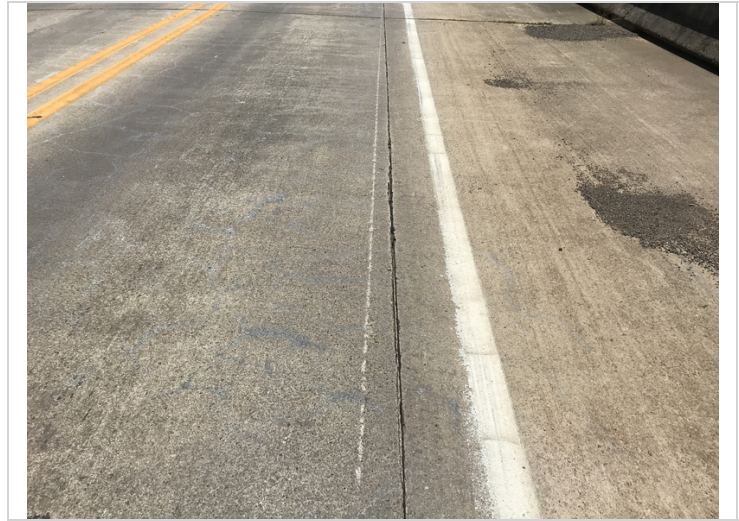
Missing sealant at the longitudinal construction joint.

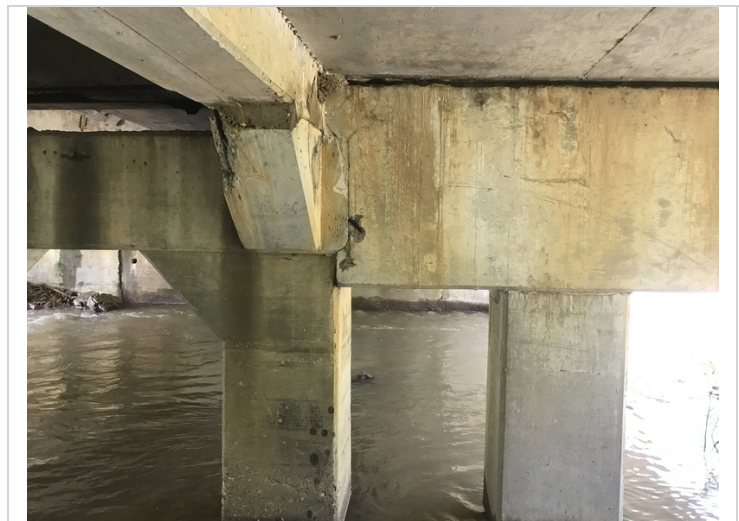
Bent # 2 Rt spalling with exposed reinforcing steel.

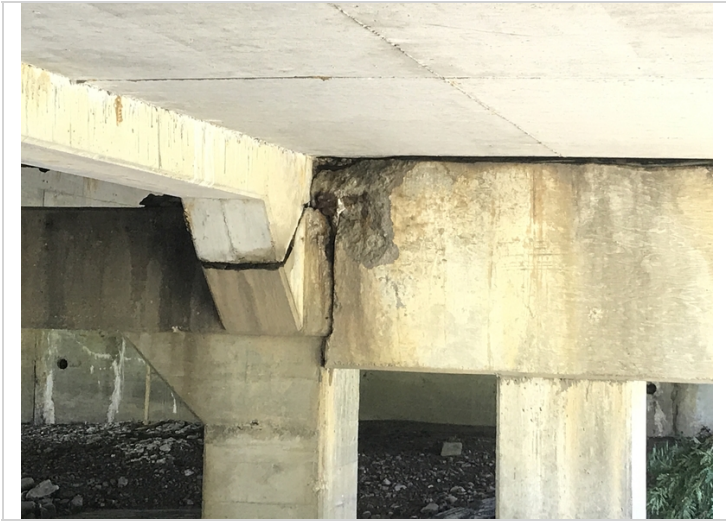
Span # 2 Column # 3 spalling with exposed reinforcing steel.

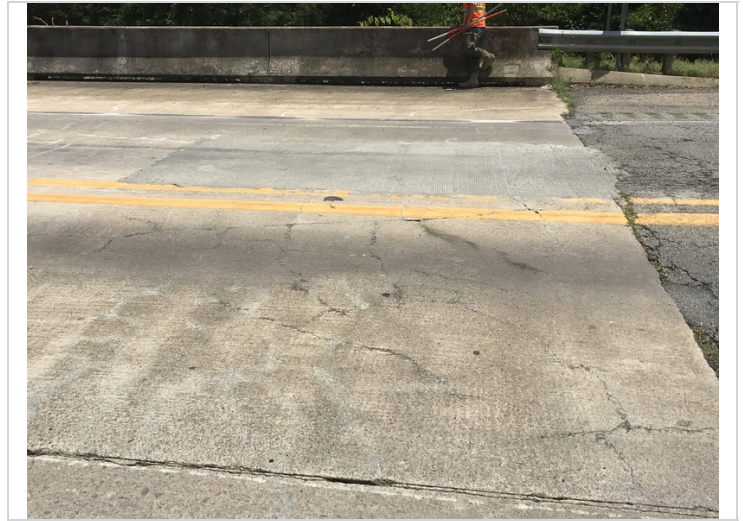
Span # 1 northbound repair.

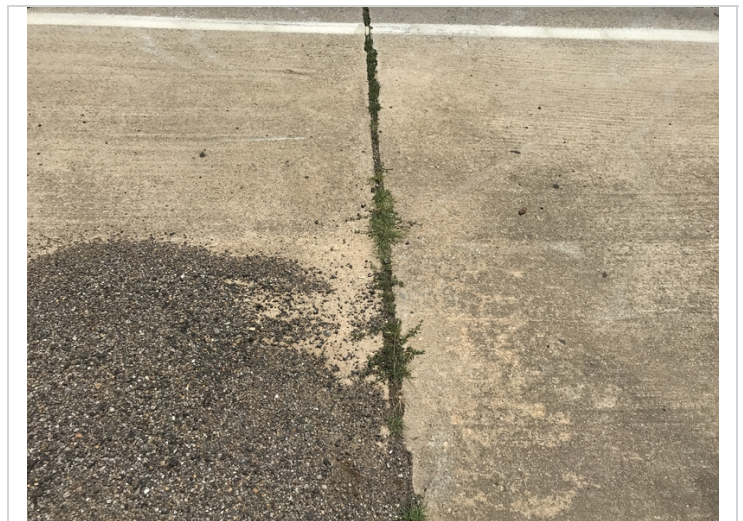
Dirt and debris accumulation in the deck joints.

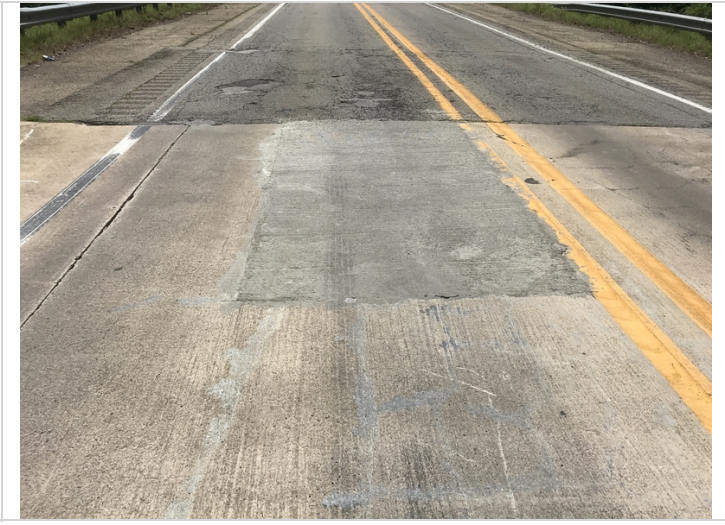
Span # 1 concrete repair.

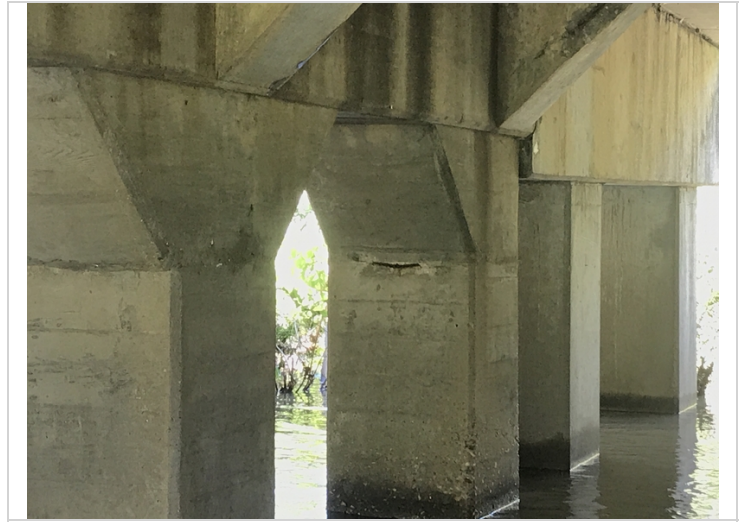
Bent # 2 Column # 5 spalling with exposed reinforcing steel.

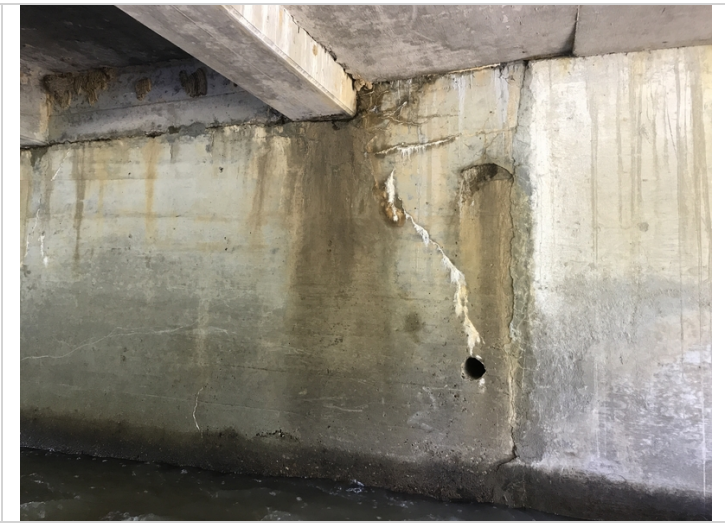
Bent # 3 at Girder # 3 cracking with efflorescence.

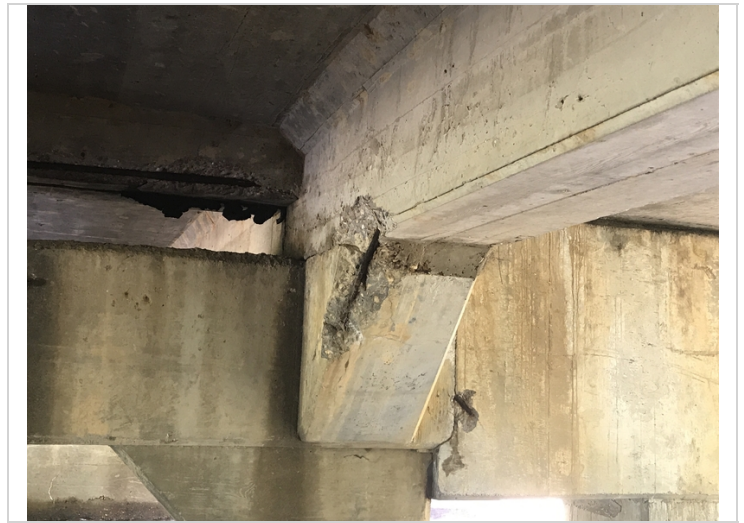
Span # 1 Girder # 3 spalling with exposed reinforcing steel.

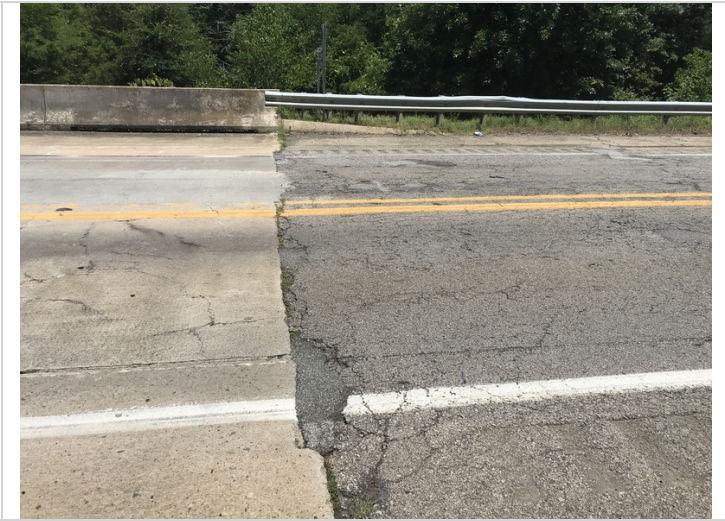
South approach rutting and achm breaking apart.

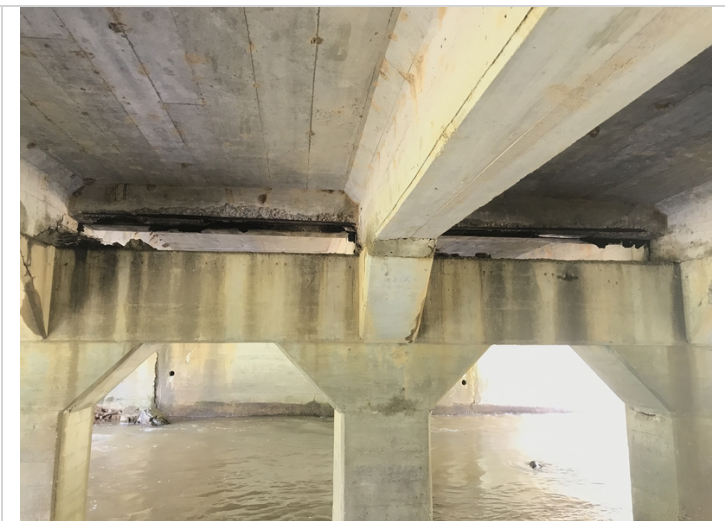
Bent # 2 deck haunch spalling with exposed reinforcing steel.

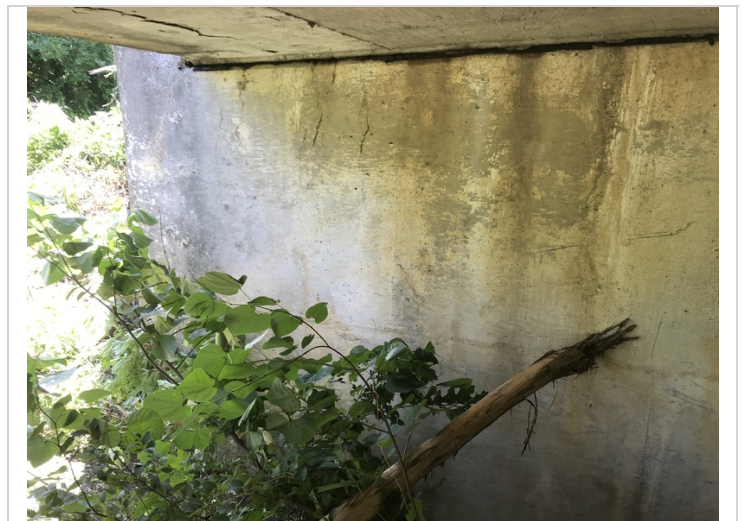
Bent # 1 Rt vertical cracks in the abutment stem.

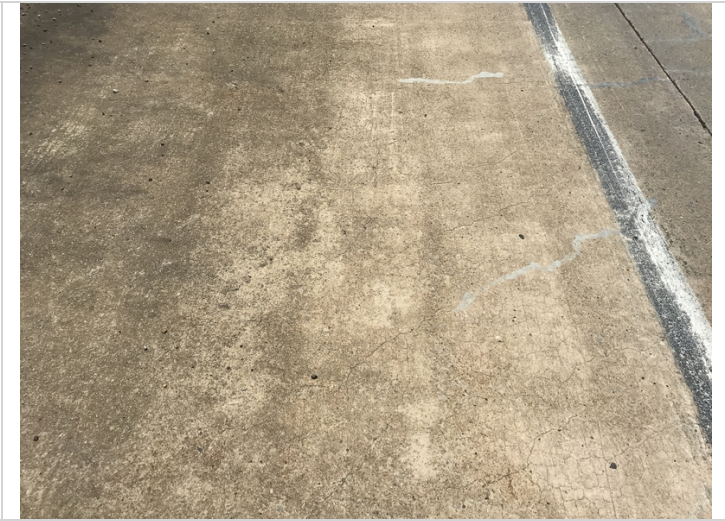
Span # 1 Rt sealable cracking on the slab span.

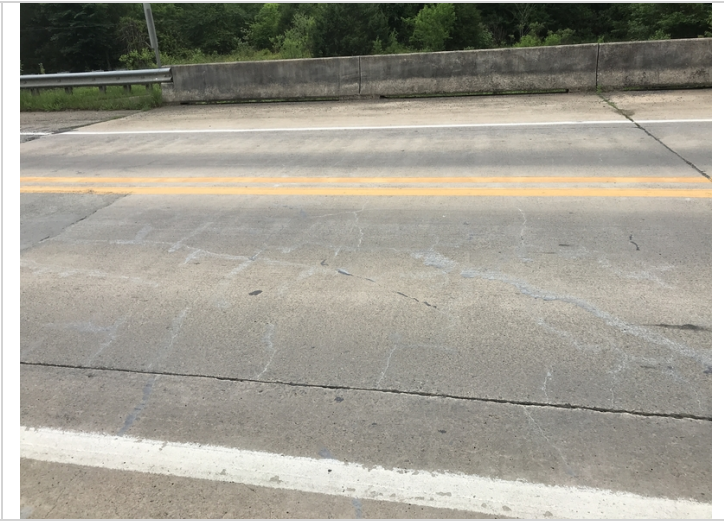
Map cracking in the wearing surface.

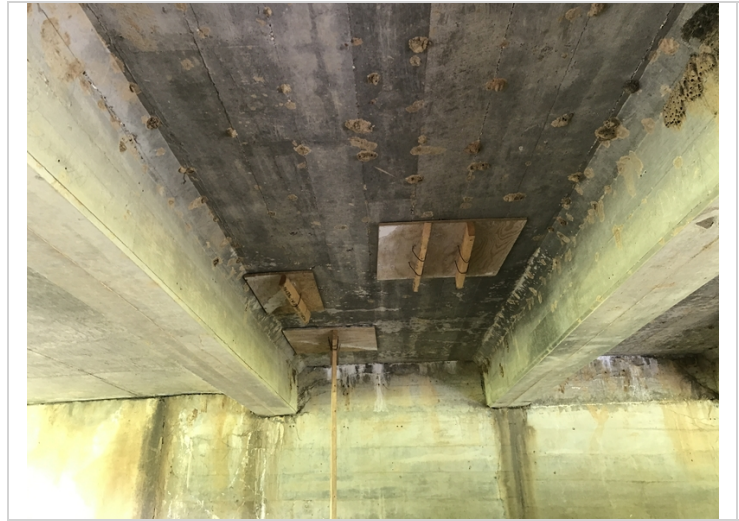
Full depth repairs in Span # 1. Bay # 2. Temporary form work left in place.

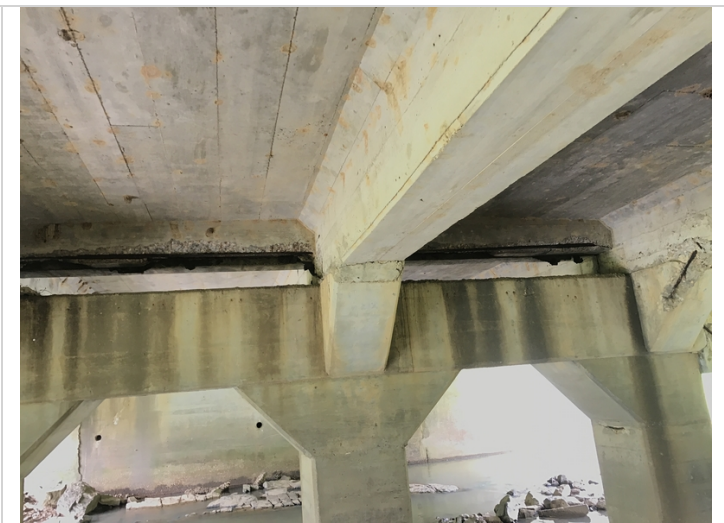
Spalling with exposed reinforcing steel in the deck haunches over Bent # 2. Span # 1.

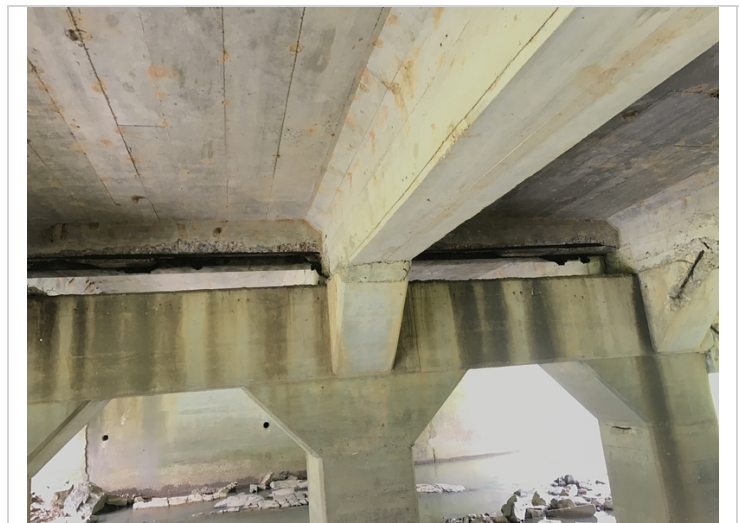
Spalling with exposed reinforcing steel in the deck haunches over Bent # 2. Span # 1.

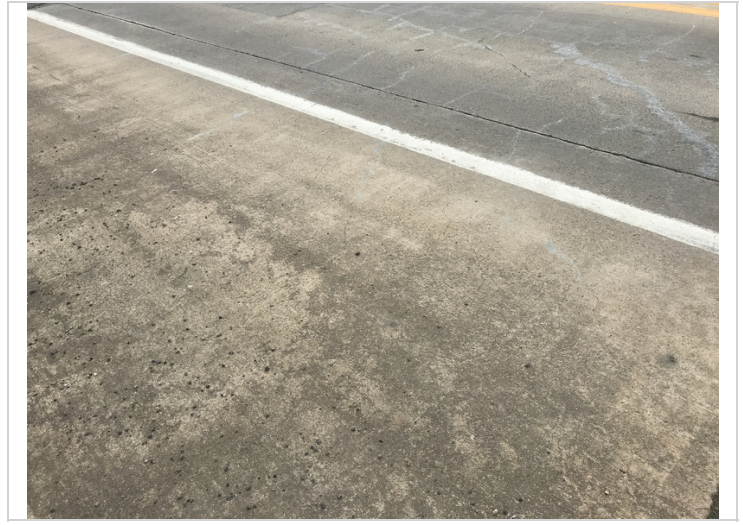
Map cracking in the driving surface of the right shoulder.

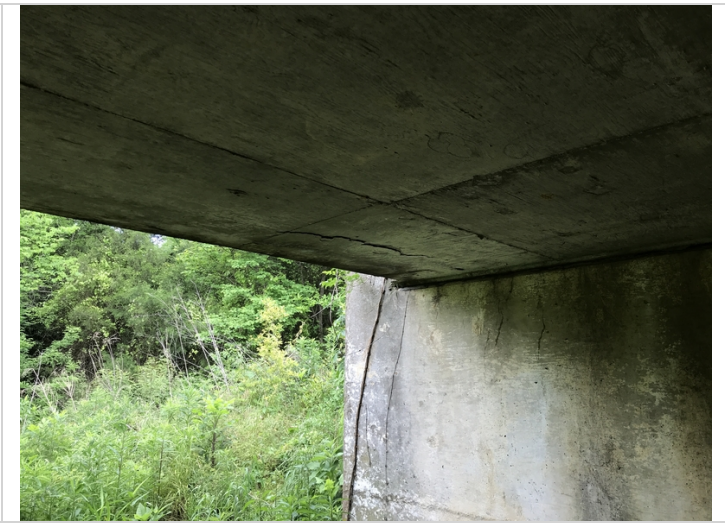
Delaminated area in undersurface of right slab. Span # 1.

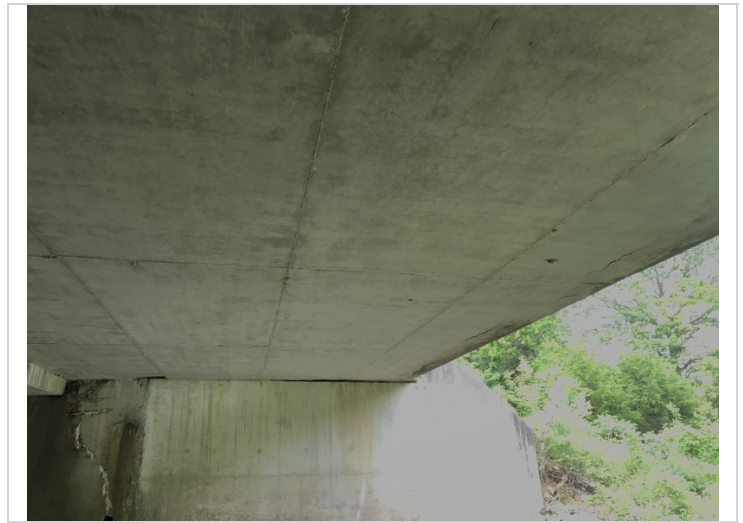
Right slab soffit. Span # 2. Delaminated areas in edge of deck.

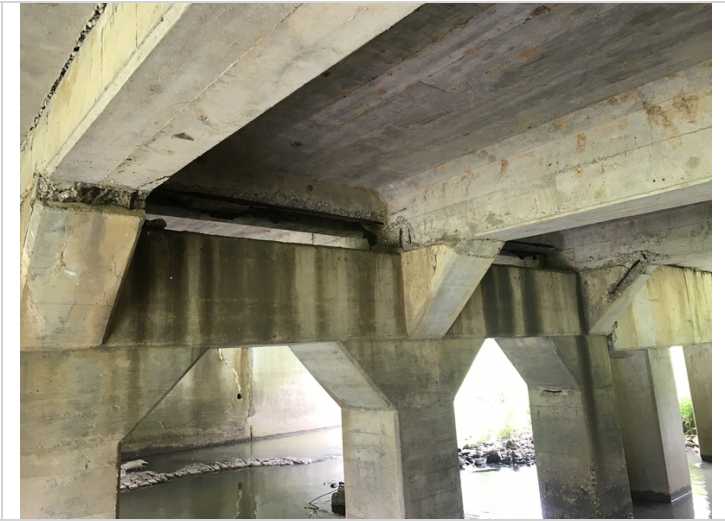
Spalling with exposed reinforcing steel in span # 1 concrete girders over bent # 2.

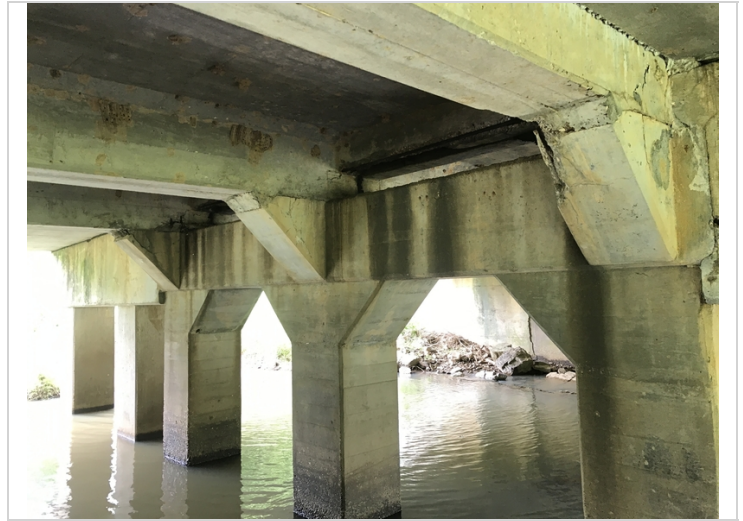
Spalling with exposed reinforcing steel in span # 1 concrete girders over bent # 2.

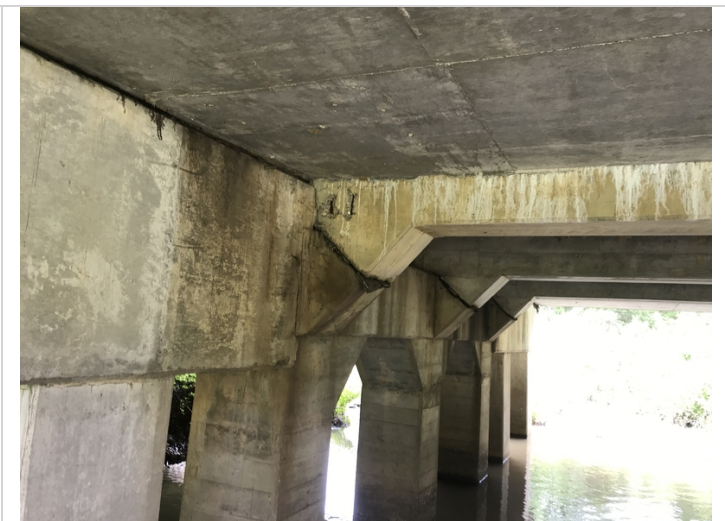
Span # 2. Girder # 3 over bent # 2. Spalls with exposed reinforcing steel.

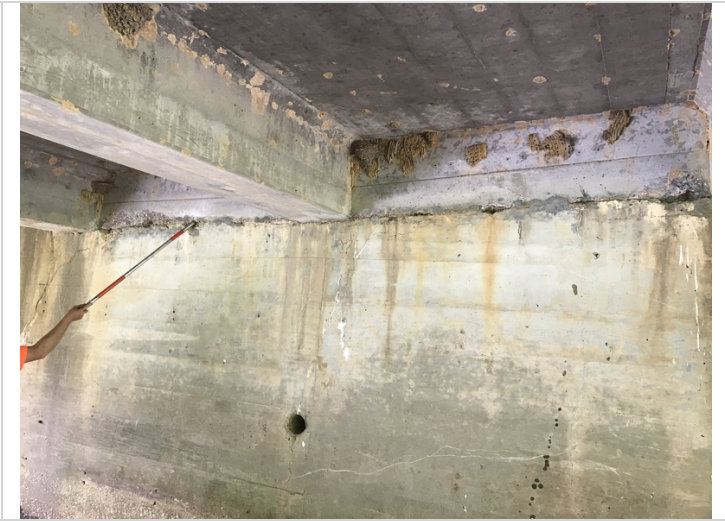
Shallow spalls with exposed reinforcing steel in the original portion of Bent # 3.

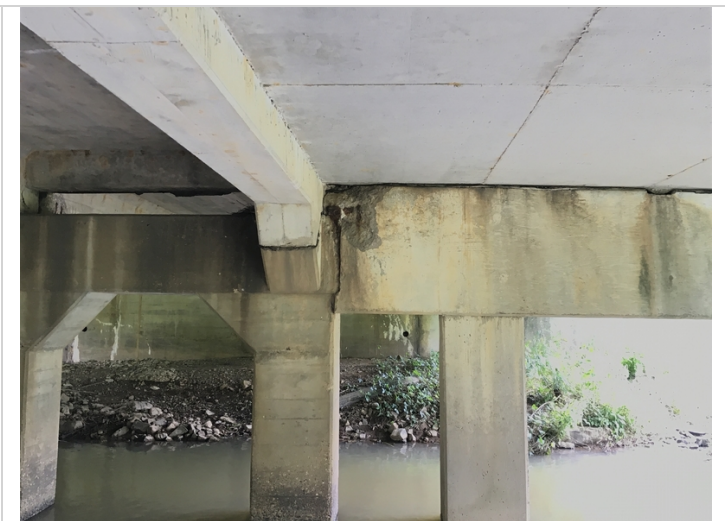
Span # 2. Spall with exposed reinforcing steel adjacent to girder # 1.

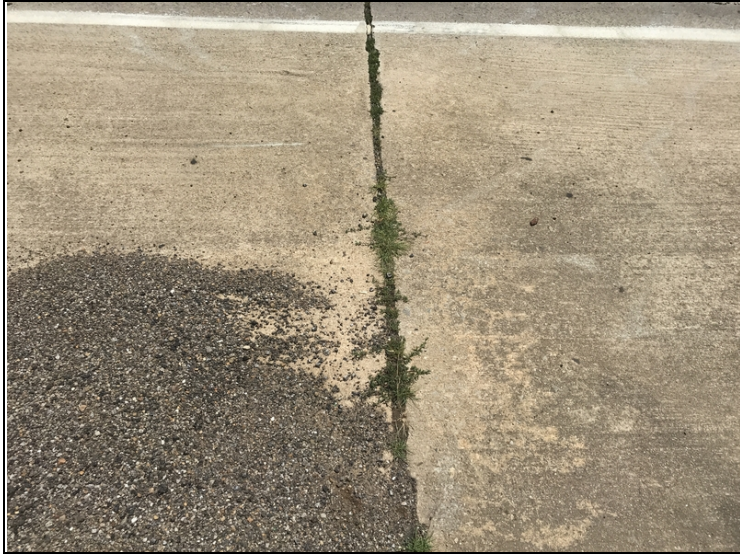
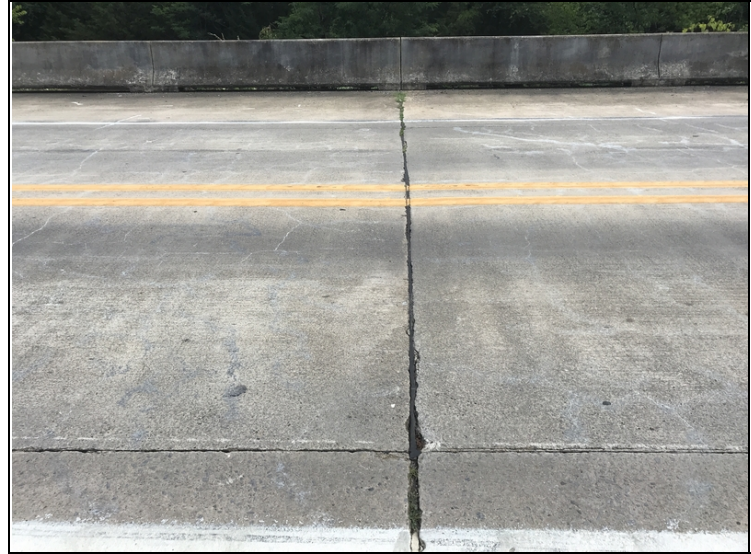
Deck joint sealant is deteriorating and missing in locations.

Dirt and debris accumulation in the deck joints.

Bent # 2 joint seal adhesion failure.

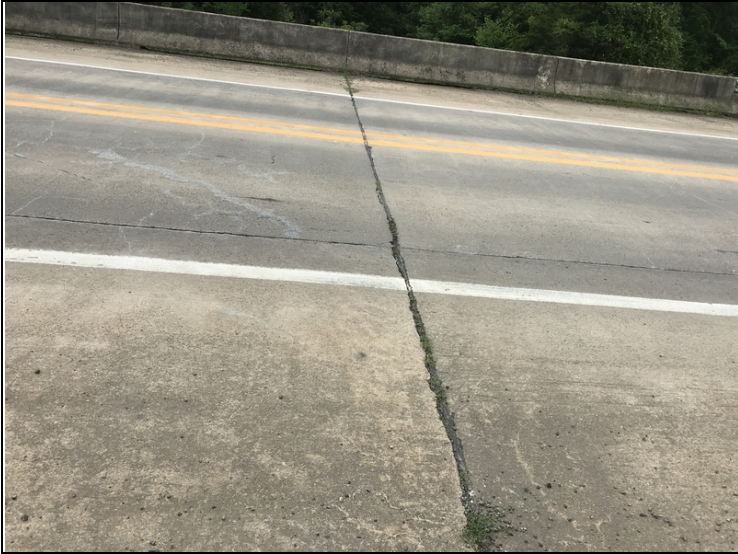
Expansion joint seal is deteriorated and missing in locations.

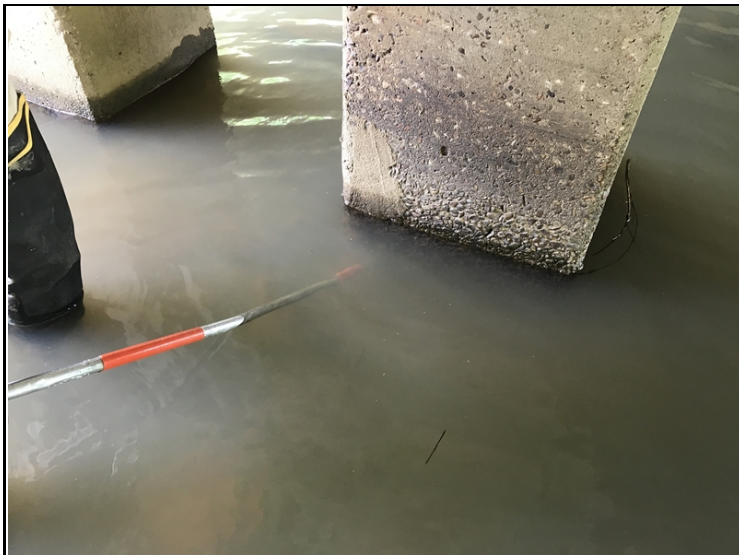
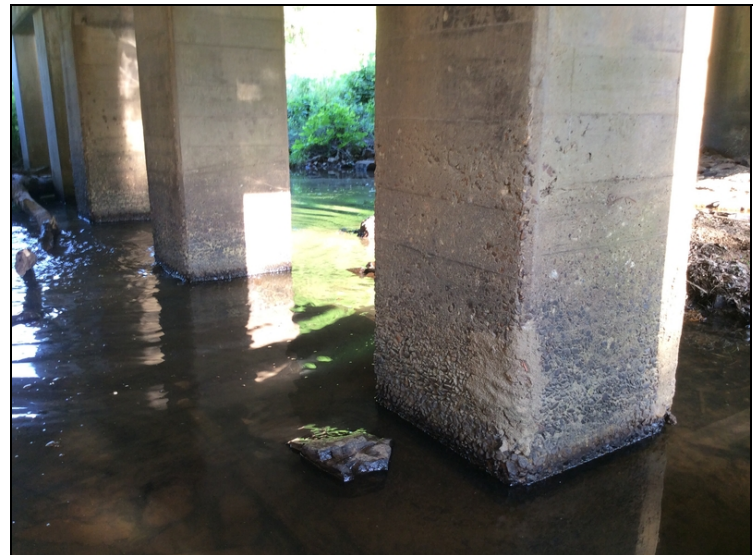
Base of Bent # 2 columns have medium to heavy abrasion with concrete deterioration at the footing juncture.

Concrete section loss in columns at bent # 2.

Concrete deterioration at the base of columns at Bent # 2 with up to 2" of concrete section loss at the base of columns that has been grouted since the last inspection.

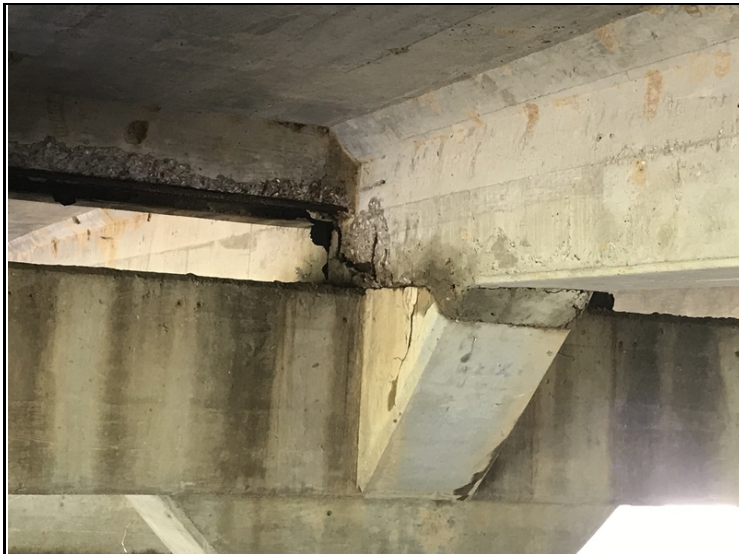
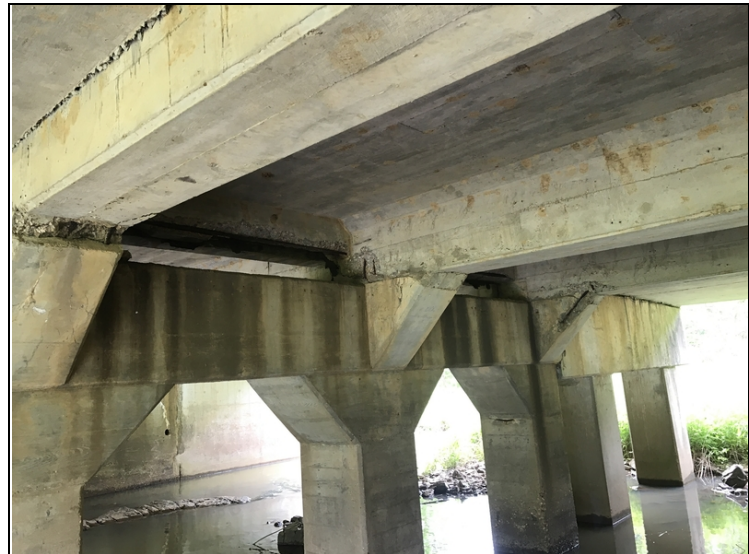
Reinforced concrete superstructure have isolated areas of concrete spalling that exposes reinforcing steel. Exposed reinforcing steel has active corrosion.

Span # 2 Bent # 2 Girder # 2 spalling with exposed reinforcing steel.

Spalling with exposed reinforcing steel in the concrete girders. Span # 1.

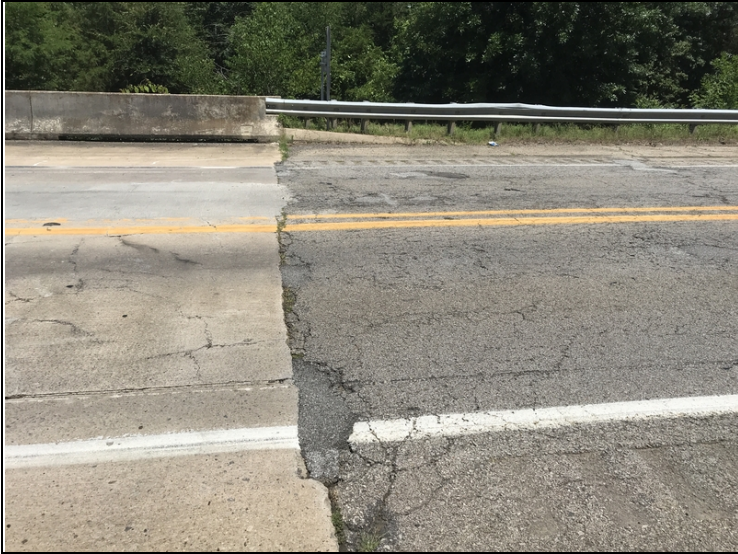
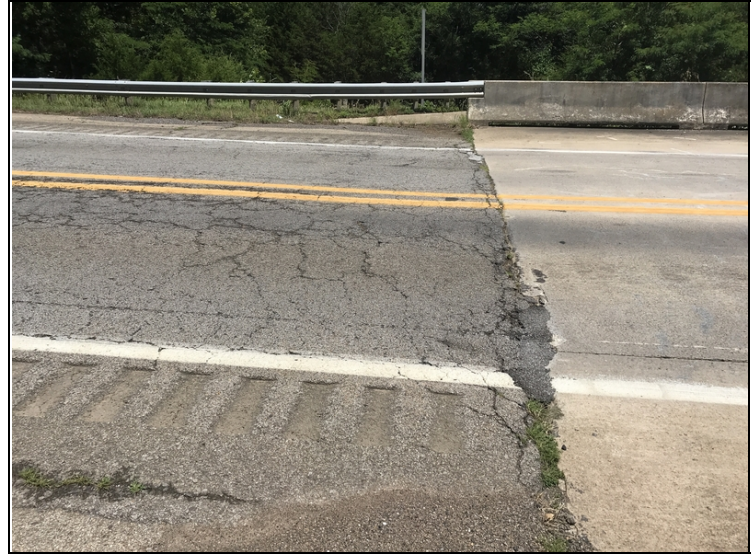
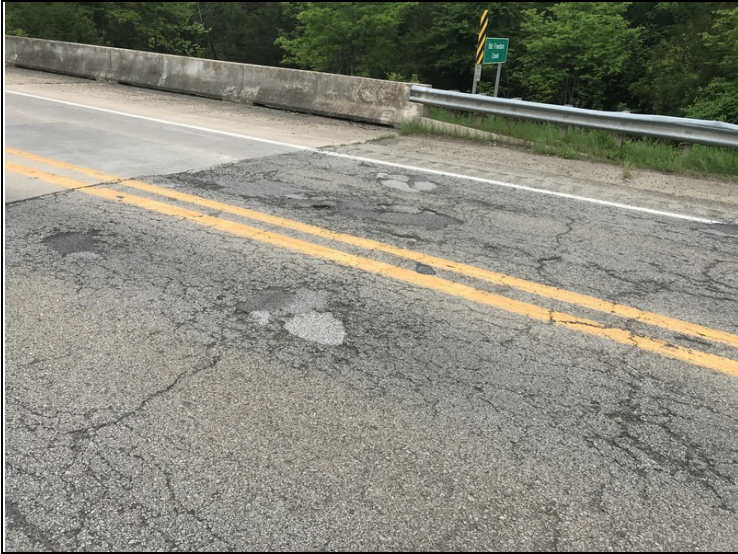
The asphalt is deteriorated and breaking apart at the approaches.

South approach rutting and achm breaking apart.

North approach roadway deterioration.

South approach roadway is breaking apart.

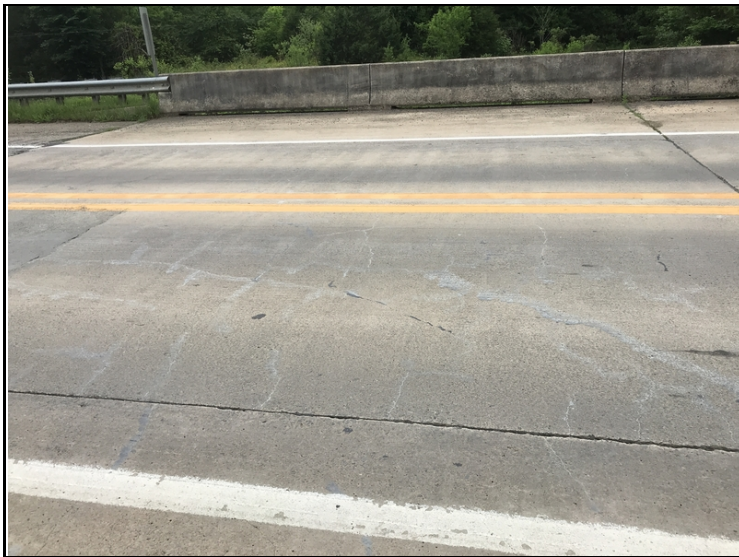
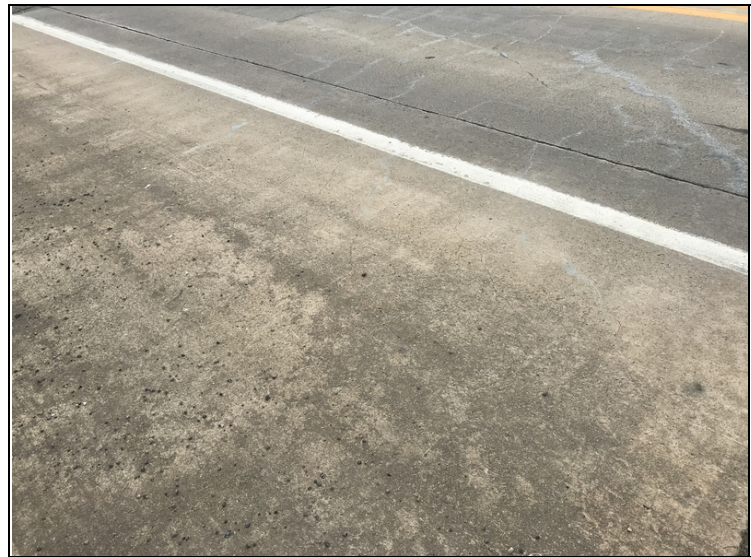
There is map cracking in the rigid concrete overlay.

Map cracking in the wearing surface.

Map cracking in the driving surface of the right shoulder.

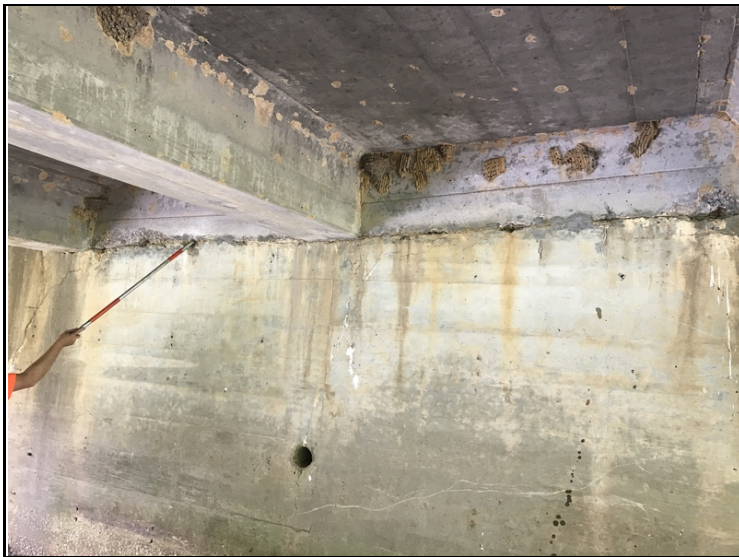
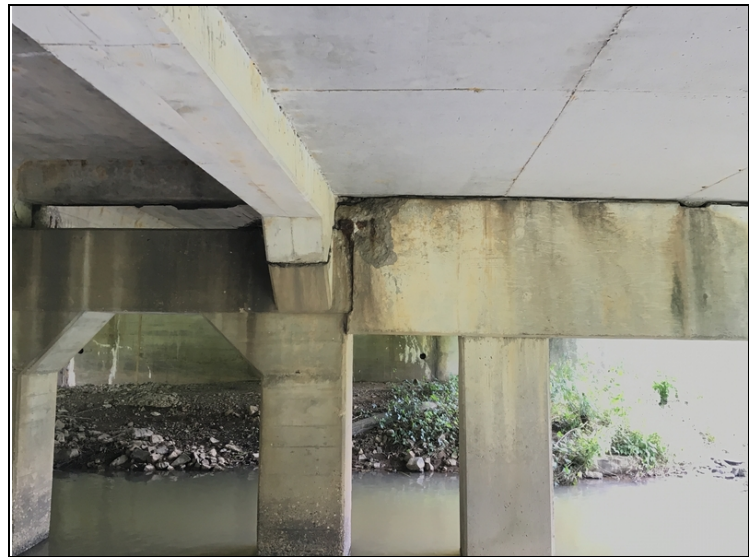
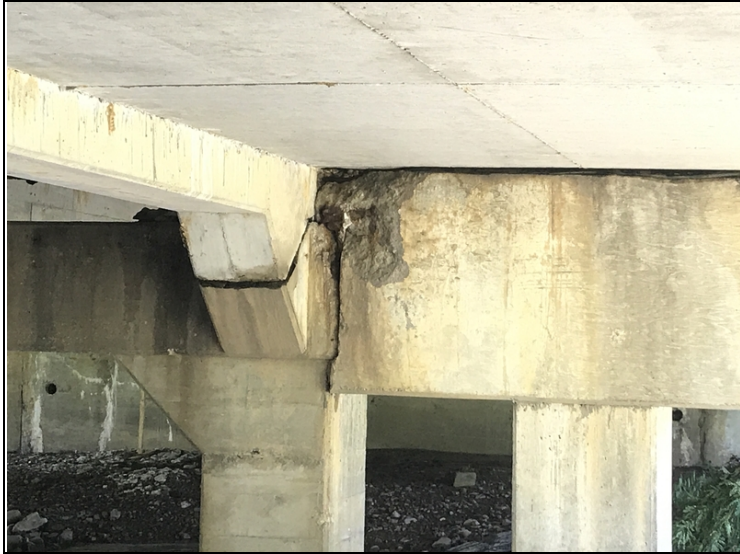
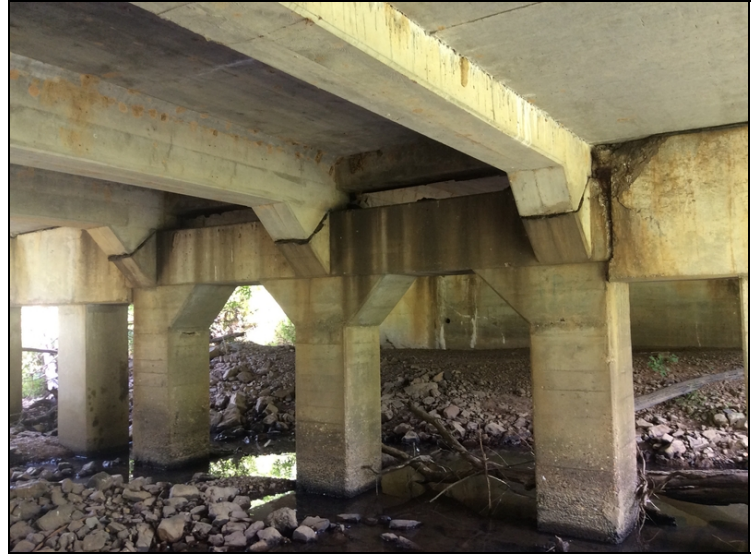
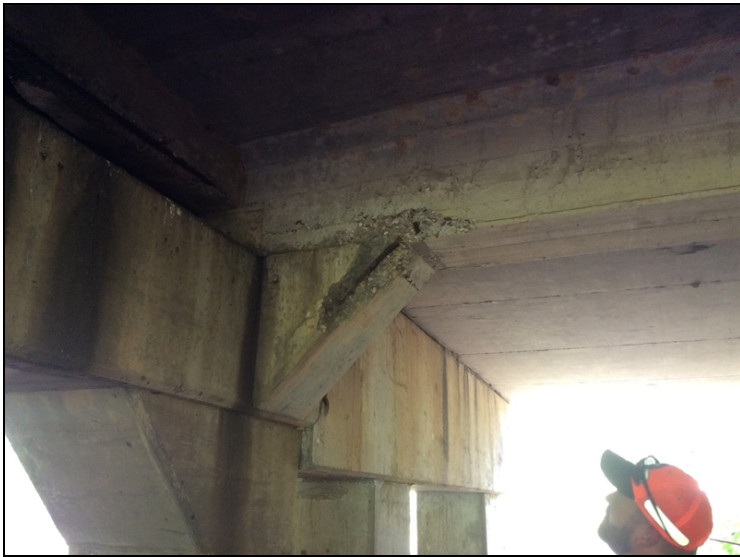
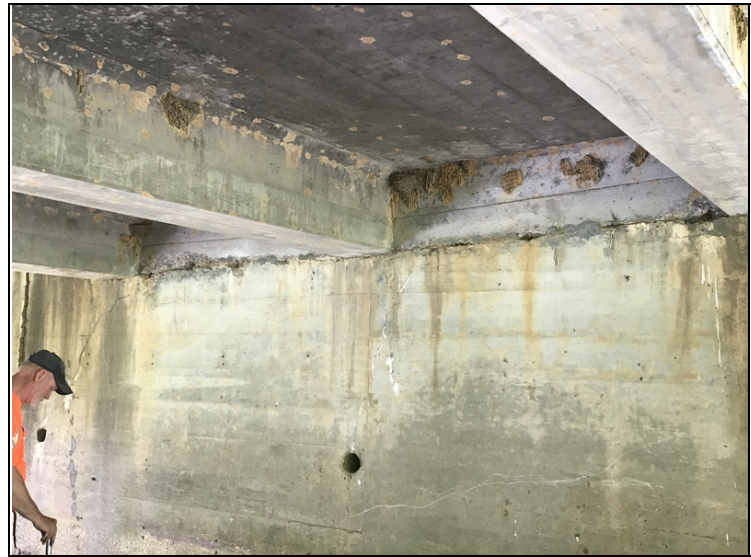
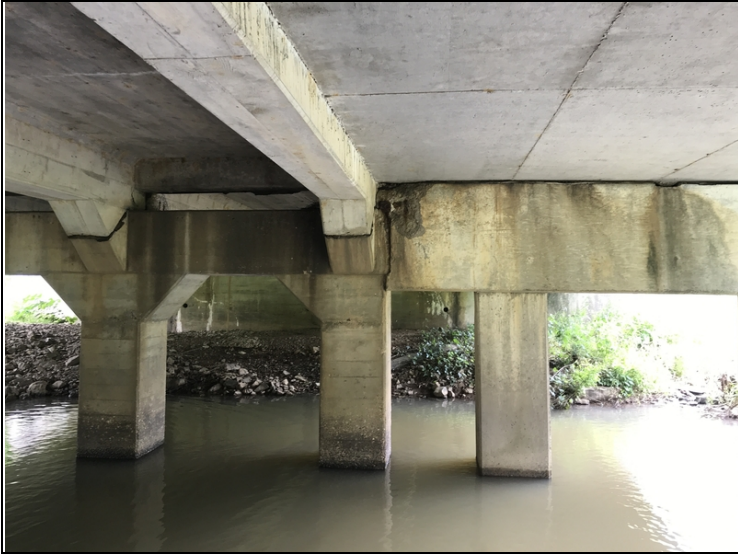
There is spalling with exposed reinforcing steel in the substructure cap adjacent to Girder # 3.
There is shallow spalling with exposed reinforcing steel in the top of the Bent # 3 stem wall.
There is spalling with exposed reinforcing steel in Columns # 3 & 5.

Shallow spalls with exposed reinforcing steel in the original portion of Bent # 3.

Span # 2. Spall with exposed reinforcing steel adjacent to girder # 1.

Bent # 2 Cap Span # 2 Column # 3 spalling with exposed reinforcing steel.

Span # 2, Bent # 2.

Spall Span # 1, Girder # 3, Bent # 2.

Original portion of bent # 3 has shallow spalls with exposed reinforcing steel at top of stem wall.

Span # 2 bent # 2. Spall with exposed reinforcing steel adjacent to girder # 1.

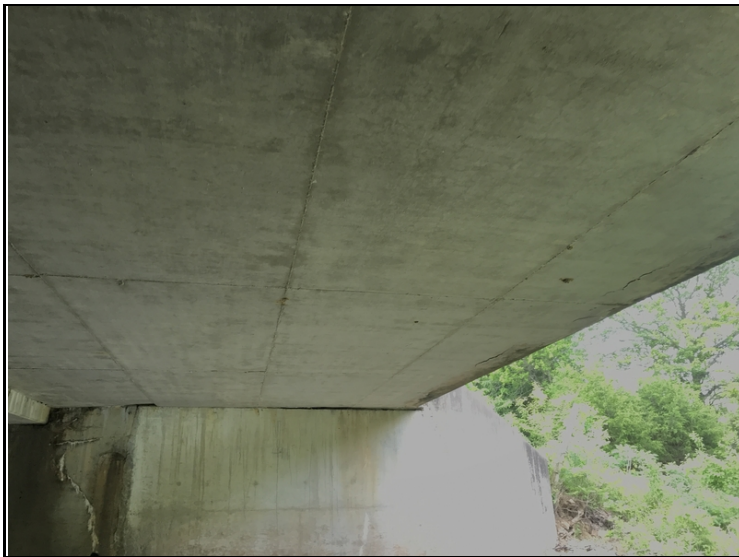
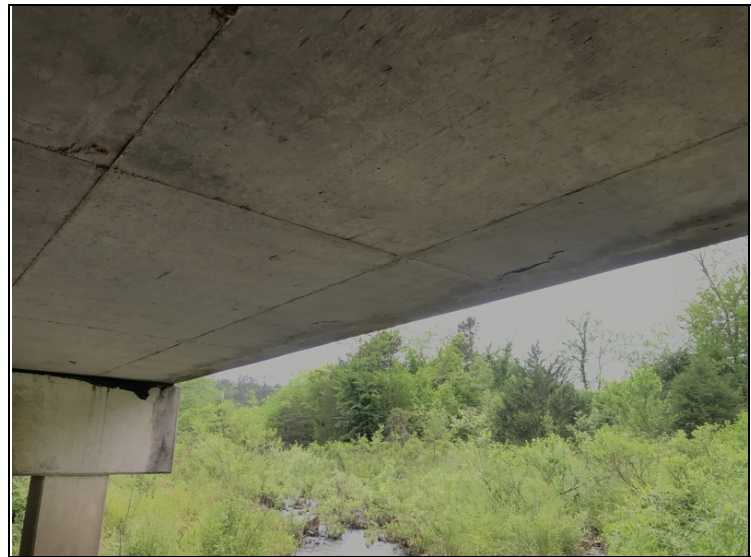
The edges of the slab soffit have longitudinal cracking with delaminated areas.

Right slab soffit. Span # 2. Delaminated areas in edge of deck.

Left edge of span # 2 slab soffit. Delaminated areas.
