Asset #00321(Routine)

US Highway 71 over Clear Cr. - Scott Co.

Location: 4.56 MI N OF JCT SH 28

Team Lead: Jeff Jones, Inspection Date: 07/07/2021

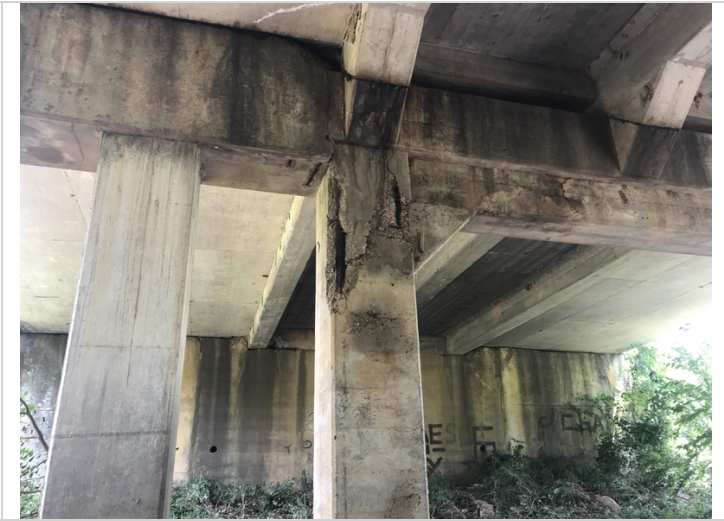
(205) -The Span # 2 side of Bent # 2, Column # 4 has concrete deterioration with exposed primary reinforcing steel in the top 3' of column. The exposed reinforcing steel has active corrosion with approximately 1/8" of section loss. -The base of Bent # 2, Columns # 3 & 4 have medium abrasion and concrete section loss. -Bent # 2 Column # 3 has vertical cracking along the edge.							
215	Reinforced Concrete Abutment	LF	154	128	14	12	0
1080	Delamination/Spall/Patched Area	LF	7	0	4	3	0
1090	Exposed Rebar	LF	6	0	0	6	0
1120	Efflorescence/Rust Staining	LF	4	0	4	0	0
1130	Cracking (RC and Other)	LF	9	0	6	3	0

Bent # 2 Span # 2 Column # 4 spalling with exposed reinforcing steel.

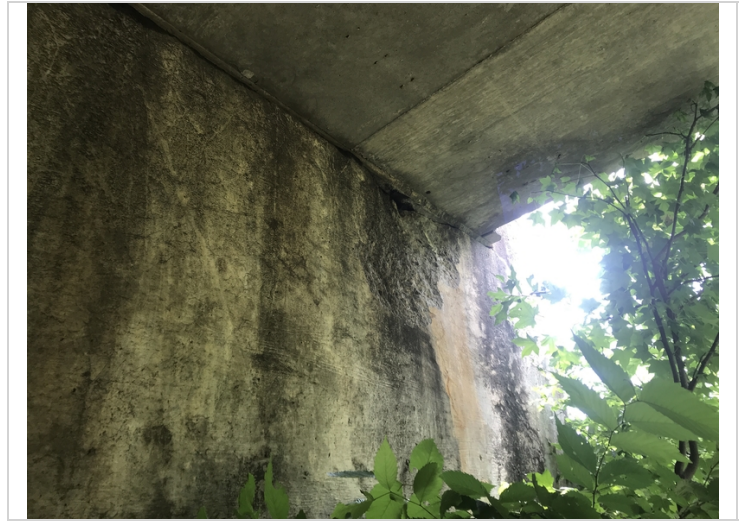
(215) -Bent # 1 has map and diagonal cracks, spalls with exposed reinforcing steel, and delaminated areas adjacent to the exterior girders. There is up to 1/8" section loss to the exposed reinforcing steel. -Bent # 1 has a full height vertical crack at center line under Girder # 2. -There is One 2' x 1' x 6" deep spall with exposed reinforcing steel at the top of abutment, left of Girder # 1. -There is One 2' x 1' x 3" deep spall with exposed reinforcing steel at the top of abutment, right of Girder # 3. -Bent # 4 has vertical cracking on the left side of abutment at the construction joint. (Original wing wall juncture) -Bent # 4 has horizontal crack approximately 10" below the top of the breast wall. -Bent # 4 has one vertical crack located approximately 2' right of centerline.							
220	Reinforced Concrete Pile Cap/Footing	LF	218	218	0	0	0

Bent # 1 Lt spalling in the bearing area.

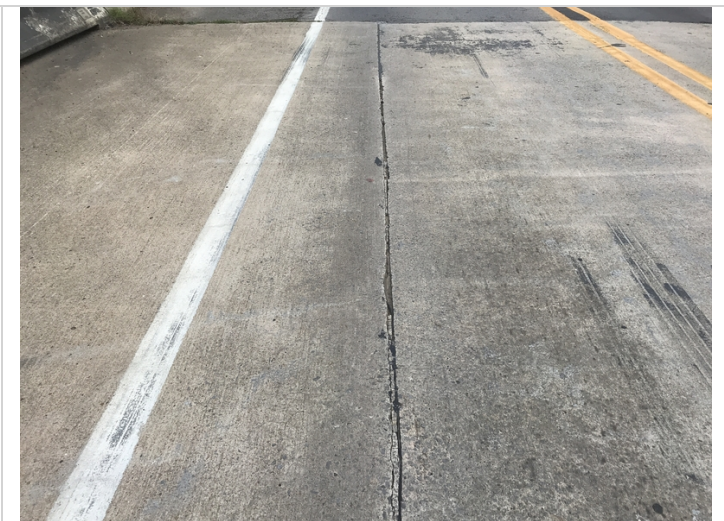
Span # 1 Rt longitudinal construction joint missing sealant.

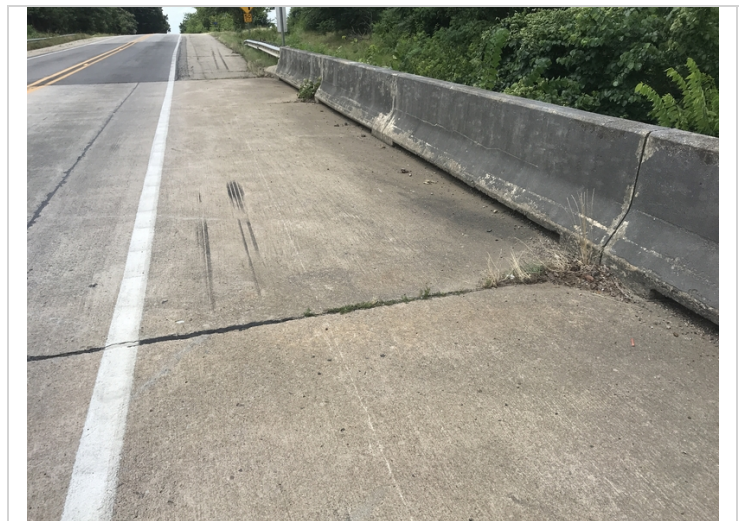
(301) -Dirt and vegetation growing in the joints along the shoulders.							
331	Reinforced Concrete Bridge Railing	LF	160	152	8	0	0
1130	Cracking (RC and Other)	LF	8	0	8	0	0

Dirt and vegetation in the deck joints along the gutters.

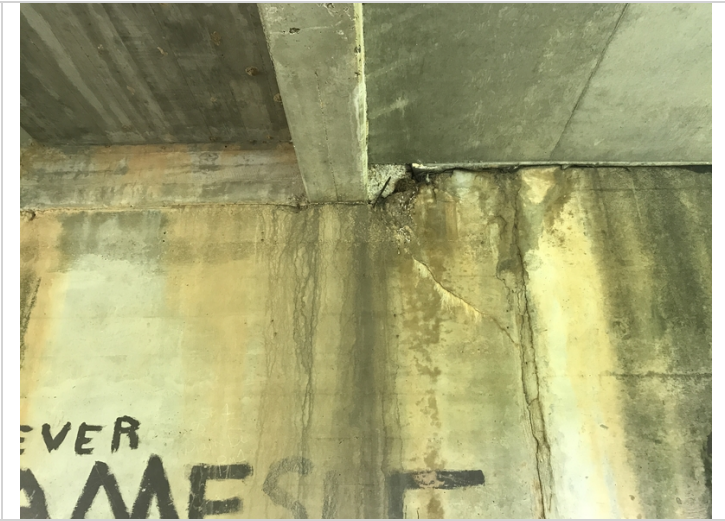
Bent # 1 at Girder # 1 spalling with exposed reinforcing steel in the bearing area.

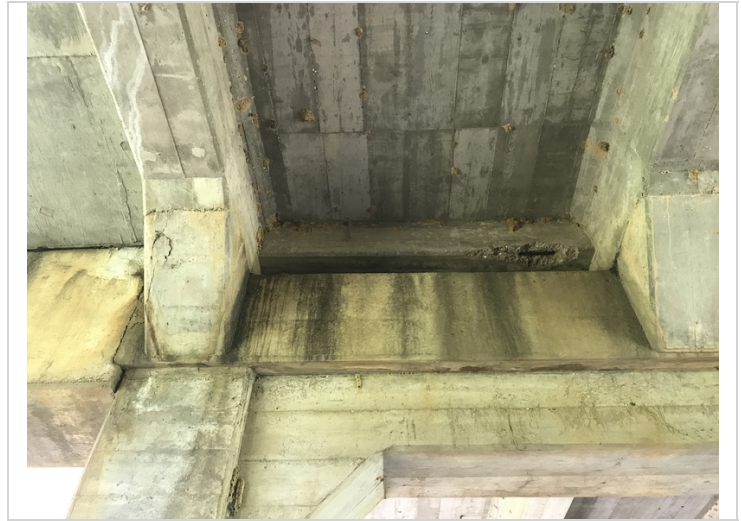
Span # 1 Girder # 1 at Bent # 2 cracking in the cap haunch and Bay # 1 spalling in the deck haunch with exposed reinforcing steel.

The deck haunch in span # 1 at bent # 2 between beams # 1 and # 2 has spalling with exposed reinforcing steel.

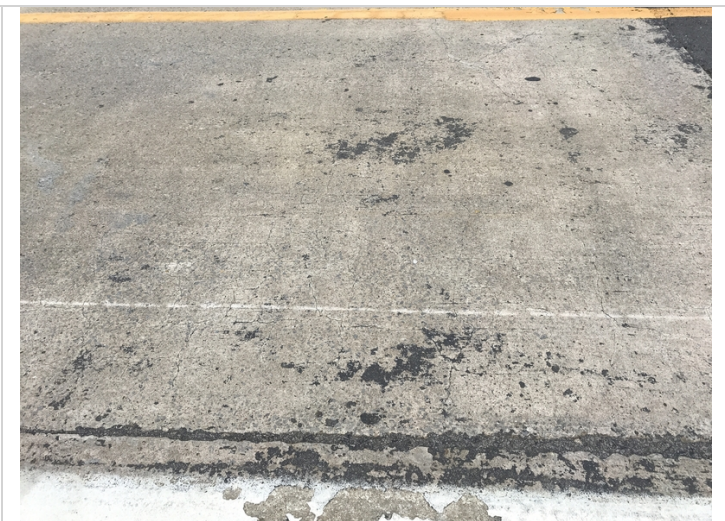
Span # 1 map cracks.

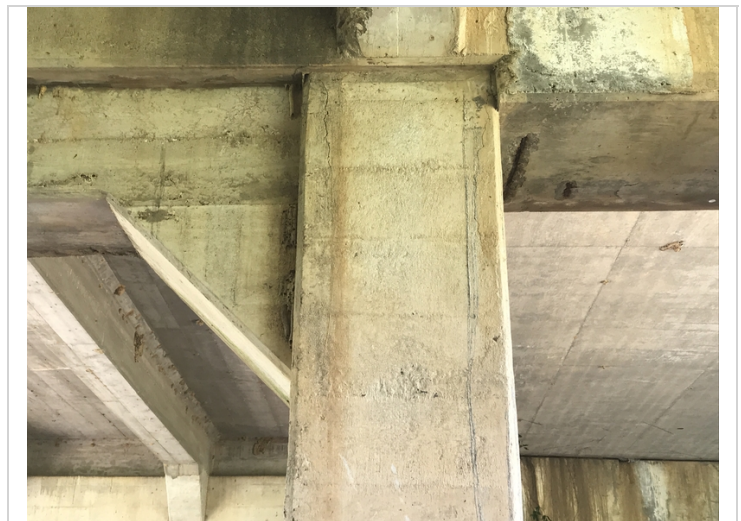
Bent # 2 Column # 4 vertical cracking at the cap juncture.

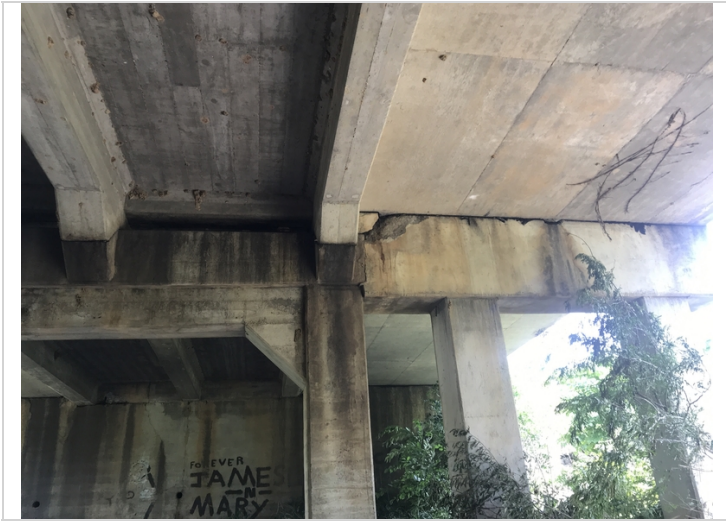
Bent # 2 Span # 2 adjacent to Girder # 1 spalling.

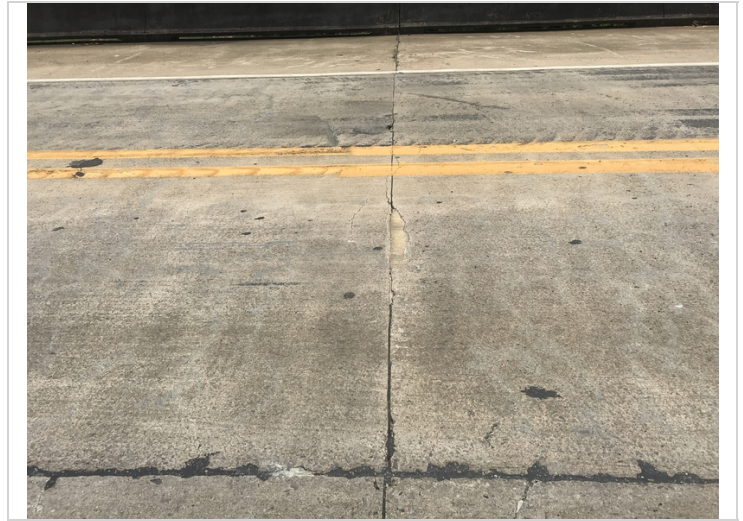
(16) Deck wearing surface- -The original portions of the deck have a rigid concrete overlay. -Driving surface of the deck has map cracking. State maintenance forces have sealed the cracks in the driving surface with epoxy in the past. -There are additional cracks in the driving surface of the deck that are not sealed. -There is a 3' previously repaired area in the Northwest corner of the deck that is breaking apart. -The transverse construction joint over Bent # 2 has deteriorated sealant with vegetation growing in the gutters. Deck Soffit- -There are a few transverse and diagonal cracks at variable spacing that are visible from the undersurface of the deck. Some minor efflorescence is visible from the undersurface of the deck. -Span # 1, Bay # 1, Bent # 2 expansion dam haunch is spalled with exposed reinforcing steel. (510-16) Wearing surface is breaking apart over Bents # 3 and 4.

Spalling in the wearing surface over Bent # 3.

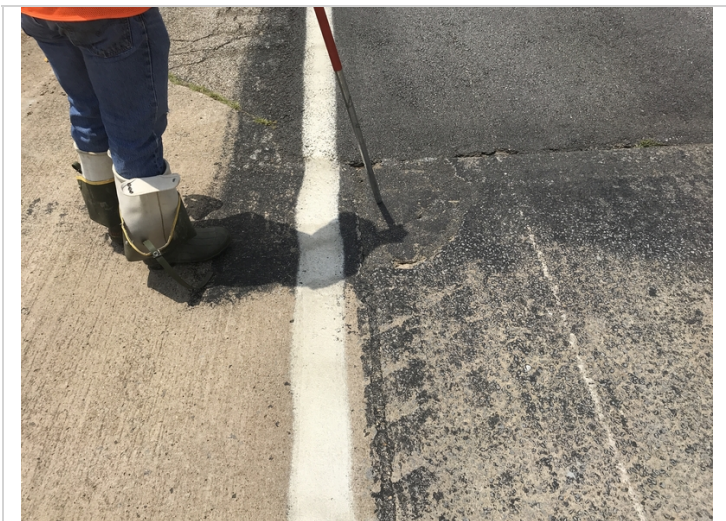
Bent # 4 Lt failing repair.

A repair is breaking apart in the Northwest corner of the deck.
Wearing surface breaking apart over Bent # 3.

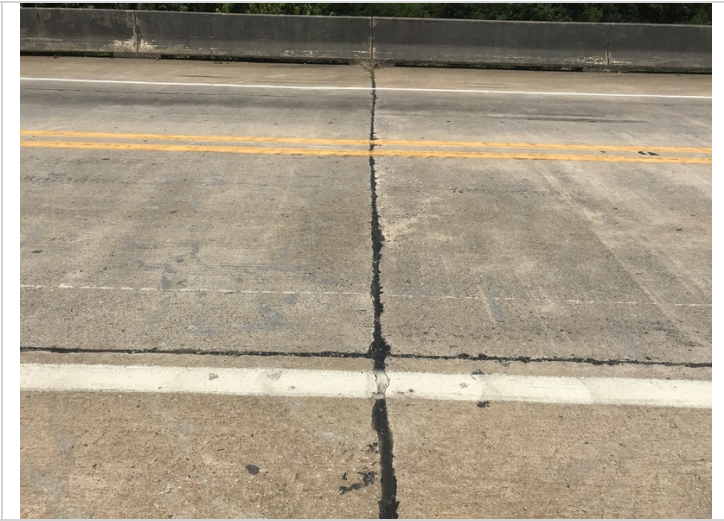
Bent # 2 joint seal.

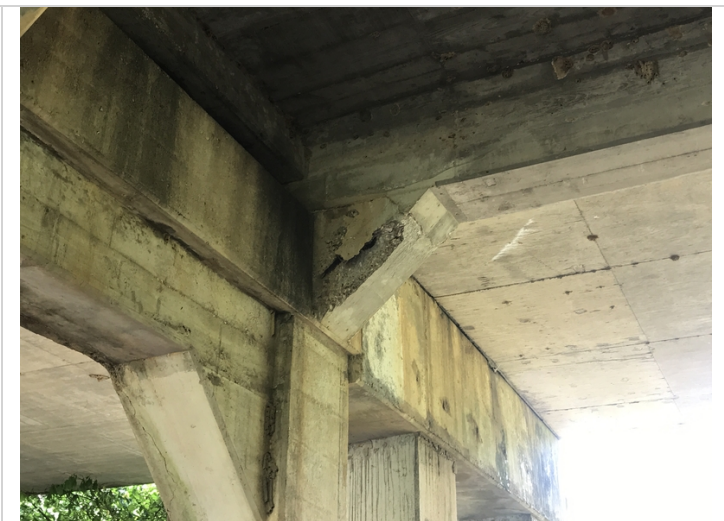
Bent # 2 Girder # 3 spalling with exposed reinforcing steel in the cap haunch.

Beam # 3 haunch in Span # 1 at Bent # 2 has spalling with exposed reinforcing steel on the interior vertical face of haunch.

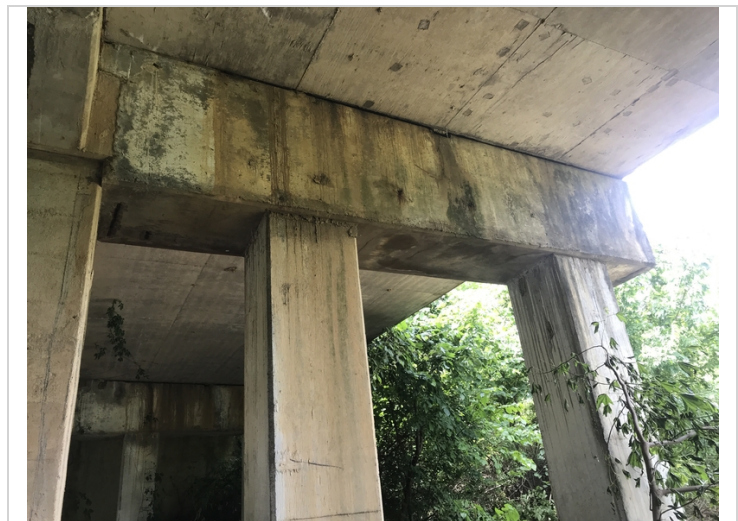
(234) -Bents # 2 and 3 have shallow spalls with exposed reinforcing steel (stirrups) at the undersurface of the caps. Reinforcing steel appears to have initial section loss and has very little concrete cover from the construction process. -Bent # 2 has one 12" spalled area in the haunch under Girder # 3. -Girder haunch spall with exposed reinforcing steel in Span # 1 side of Girder # 3 in Bent # 2 cap. -Bent # 2 has a basketball sized spalled area adjacent to the exterior edges of Girder # 3 on the Span # 2 side, a 36" long delamination/spall adjacent to Girder # 1 and a 12" delamination adjacent to Girder # 1 Span # 1. Bent # 3 has staining in the right side of the cap and cracking in proximity to the construction joint where the structure was widened.

Bent # 2 Rt widened portion of cap with spalling that exposes reinforcing steel on the cap under surface at both ends.

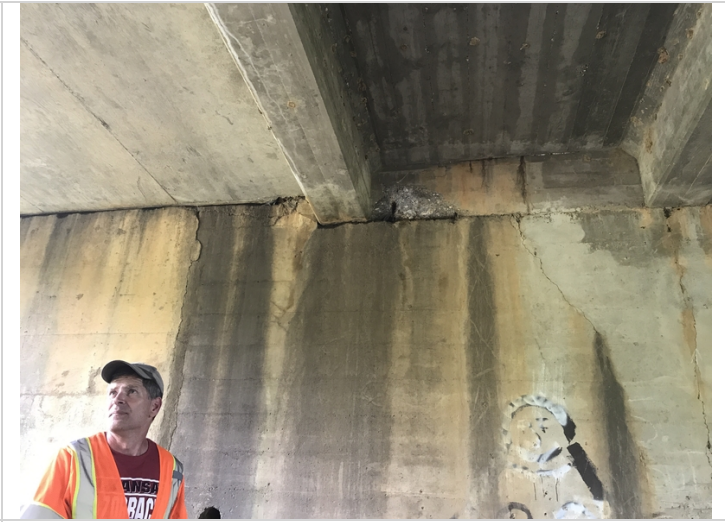
Bent # 1 adjacent to Girder # 3 spalling with exposed reinforcing steel.

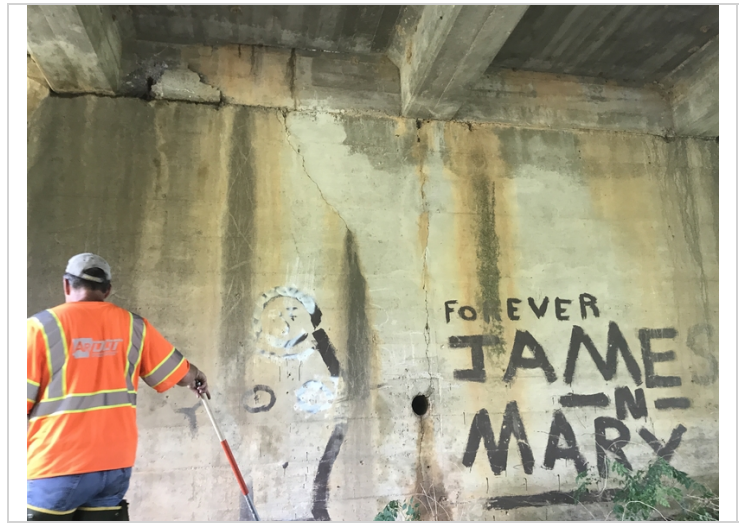
Bent # 1 vertical cracking at the centerline.

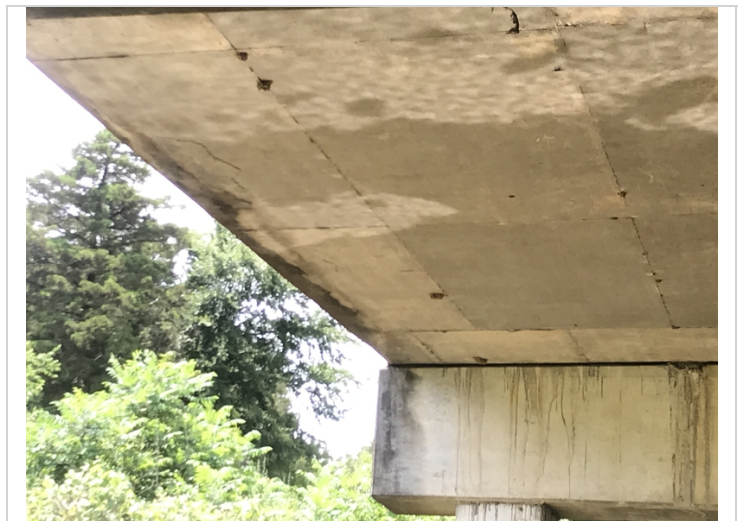
(38) -Minor cracking on the driving surface of the slabs. -Some cracking has been sealed by maintenance forces in the past. Slab Soffit- -The undersurface of the deck along the exterior edges have delaminated areas in the widened slab span portions of the deck.							
110	Reinforced Concrete Open Girder/Beam	LF	180	160	20	0	0
1120	Efflorescence/Rust Staining	LF	12	0	12	0	0
1130	Cracking (RC and Other)	LF	8	0	8	0	0

Span # 3 slab soffit. Delaminated area.

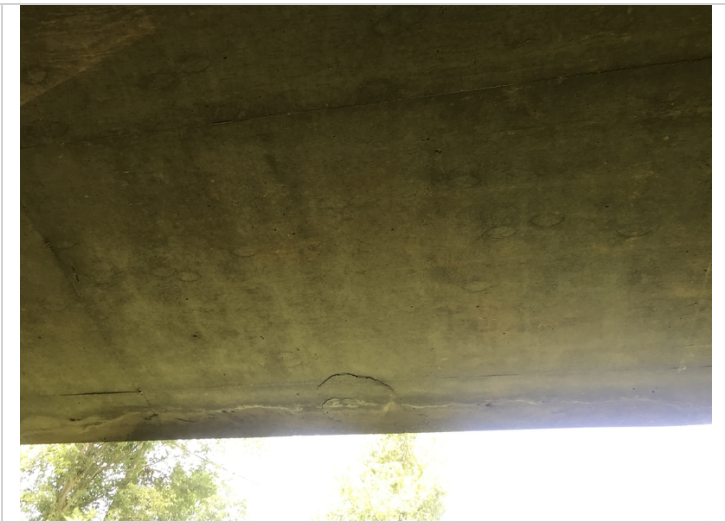
Delaminated area. Right side of Span # 3 slab soffit.

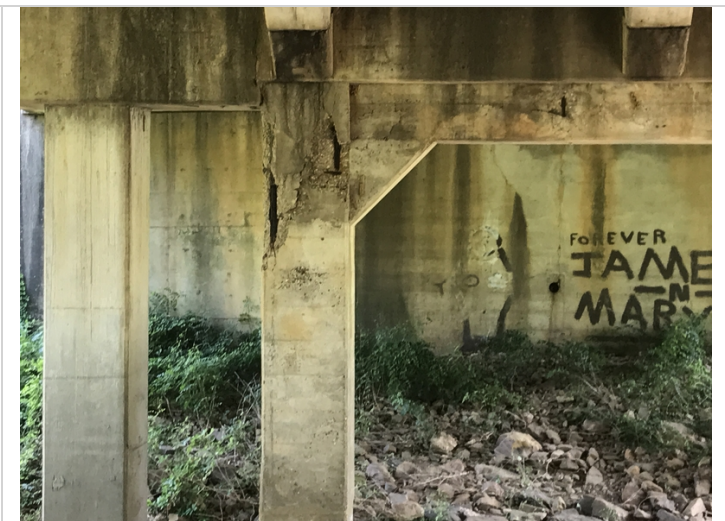
Bent # 2. Column # 4. Ahead face. Spalling with exposed reinforcing steel.

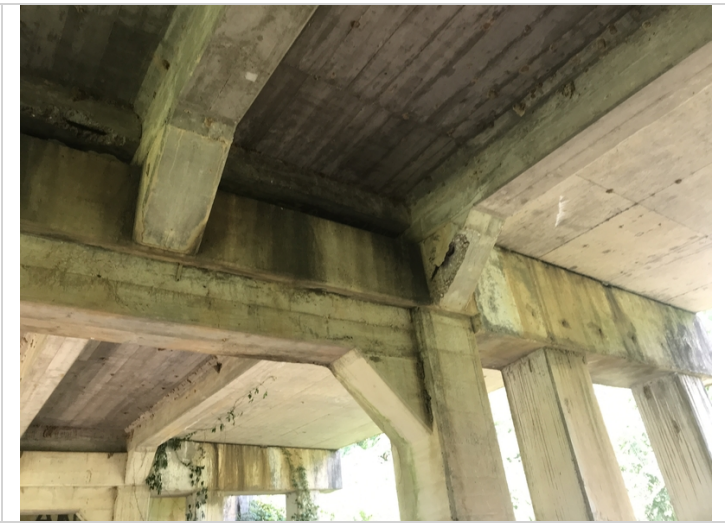
Bent # 2. Back face. Girder # 3 spall in haunch.

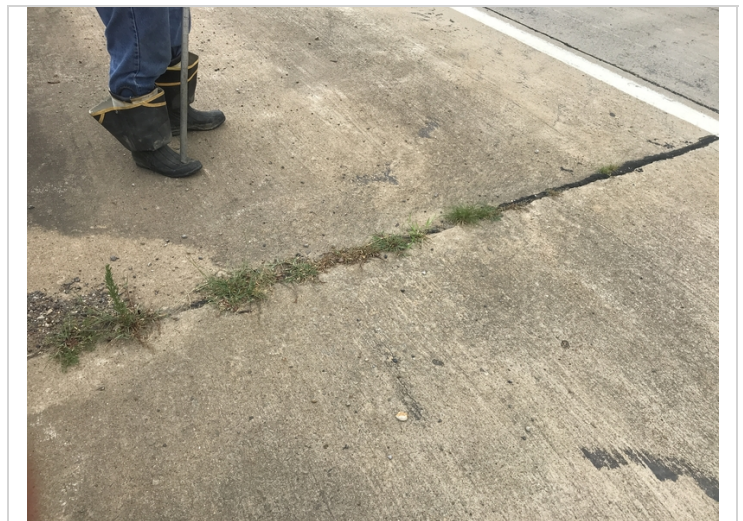
Expansion joint over Bent # 2. Vegetation growing in the joint.

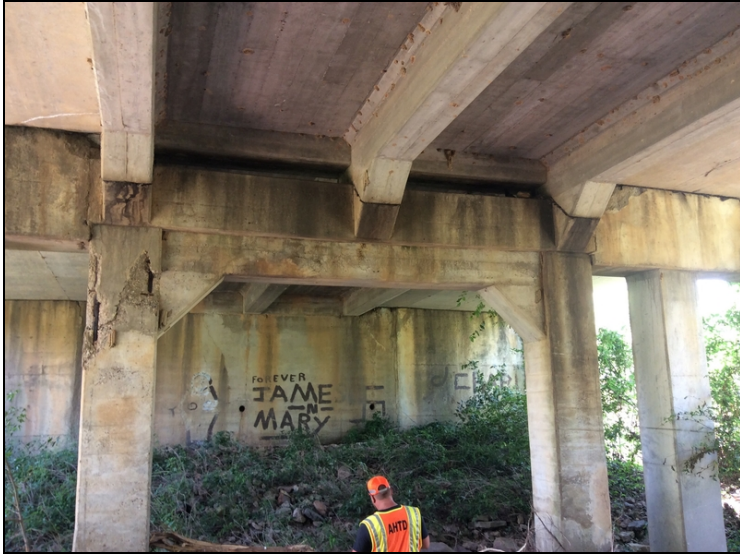
The substructure has numerous areas of spalling with exposed reinforcing steel. The most extreme case is Bent # 2 Column # 4 which has concrete spalling in the upper 3' portion of the column with exposed primary reinforcing steel. Exposed reinforcing steel has active corrosion and approximately 1/8" section loss.

Bent # 2. Cap, span # 2 side. Spall in Column # 4.

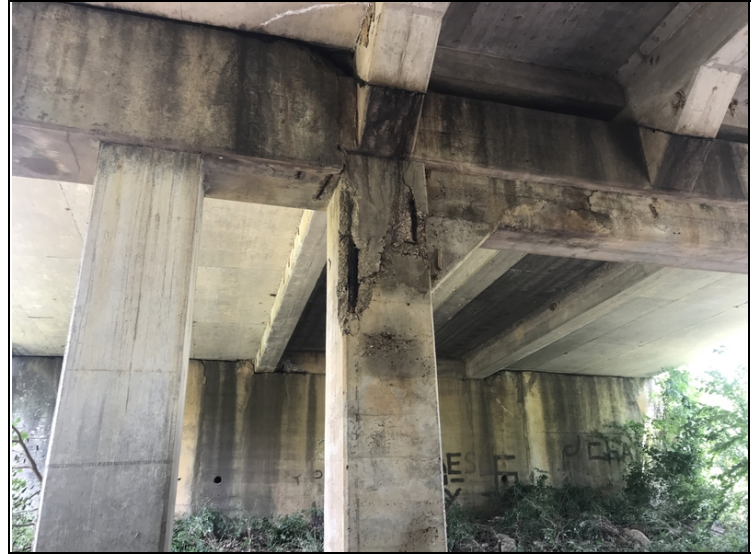
Bent # 2 Span # 2 Column # 4 spalling with exposed reinforcing steel.

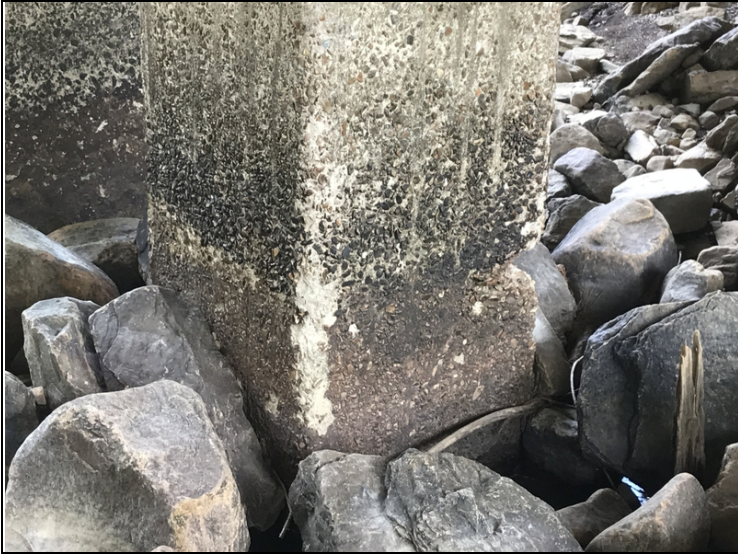
Bent # 2. Column # 4 concrete section loss.

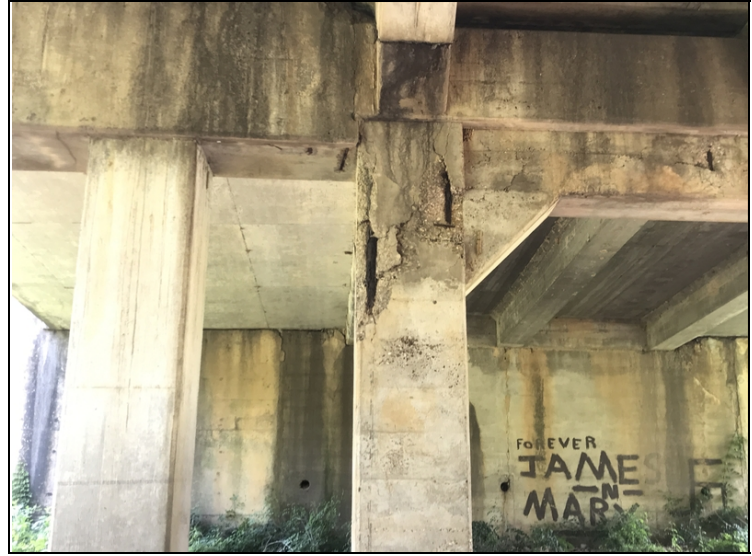
Bent # 2. Column # 4. Exposed reinforcing steel.

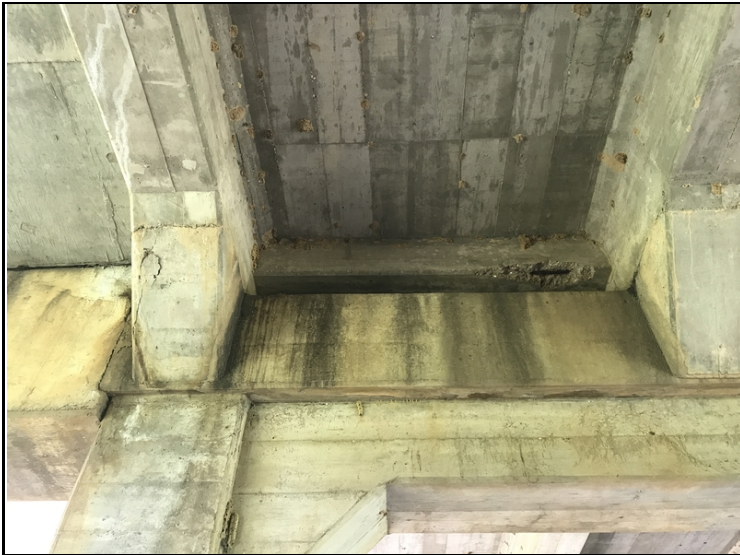
Span # 1 Girder # 1 at Bent # 2 cracking in the cap haunch and Bay # 1 spalling in the deck haunch with exposed reinforcing steel.

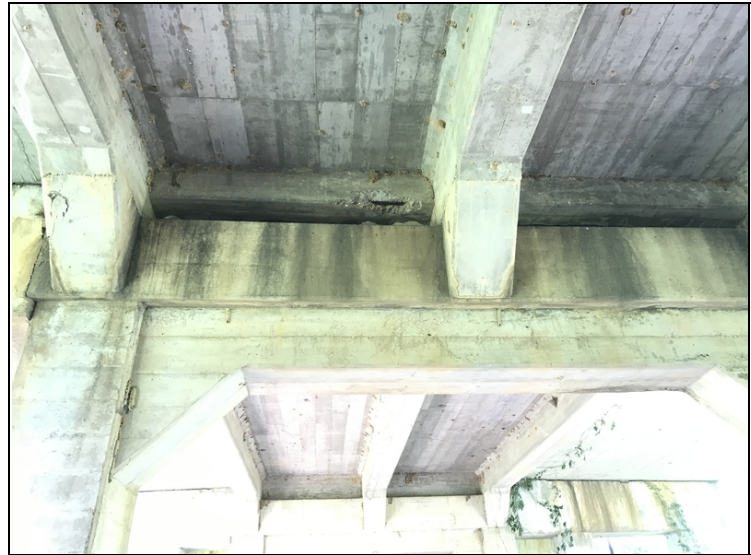
Span # 1 expansion dam over Bent # 2. Spall with exposed reinforcing steel.

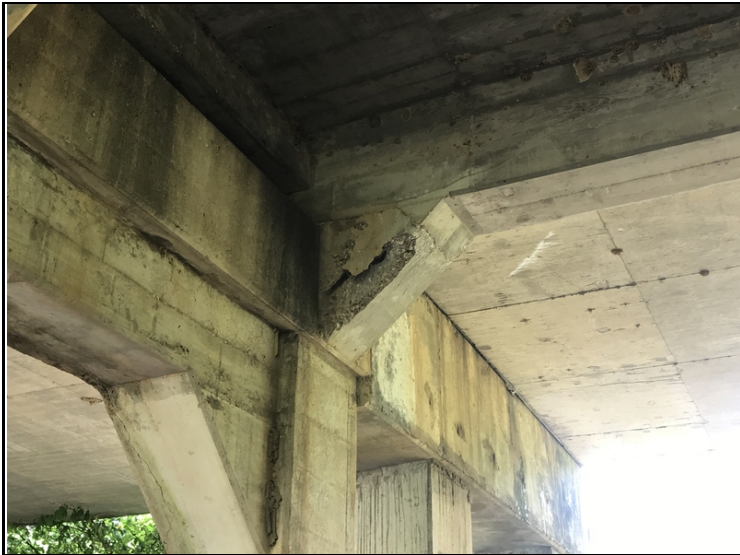
Bent # 2 Girder # 3 spalling with exposed reinforcing steel in the cap haunch.

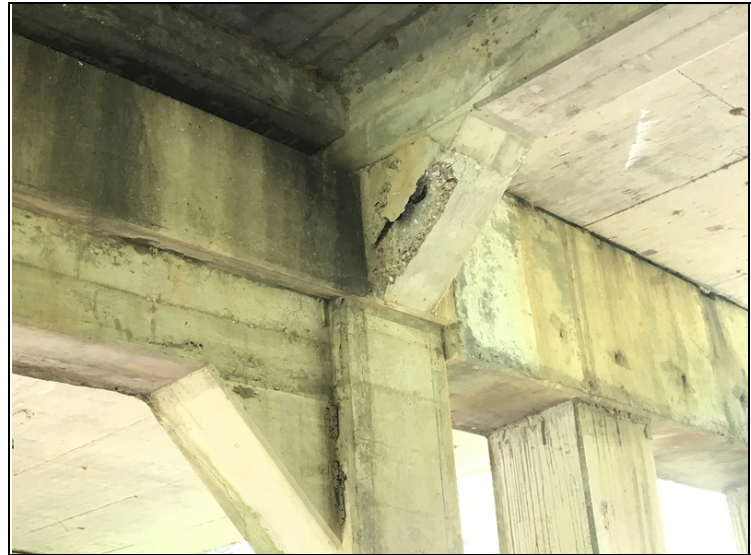
Bent # 2. Span # 1 Girder # 3 haunch. Spall with exposed reinforcing steel.

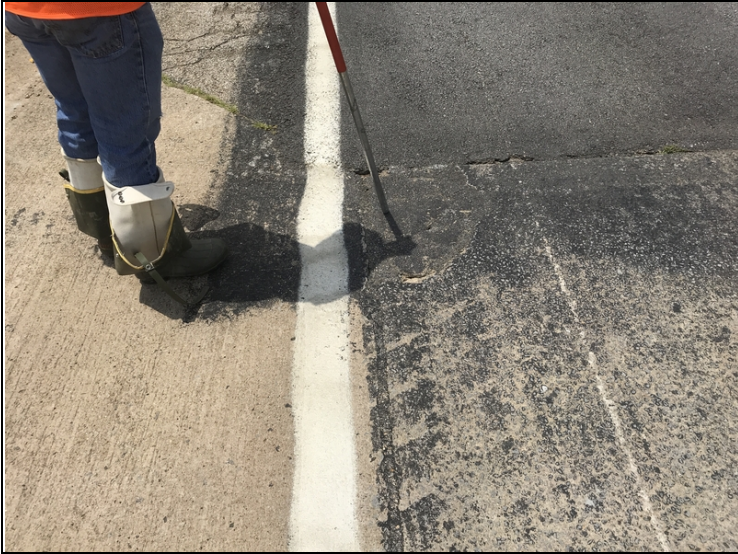
Bent # 4 Lt failing repair.

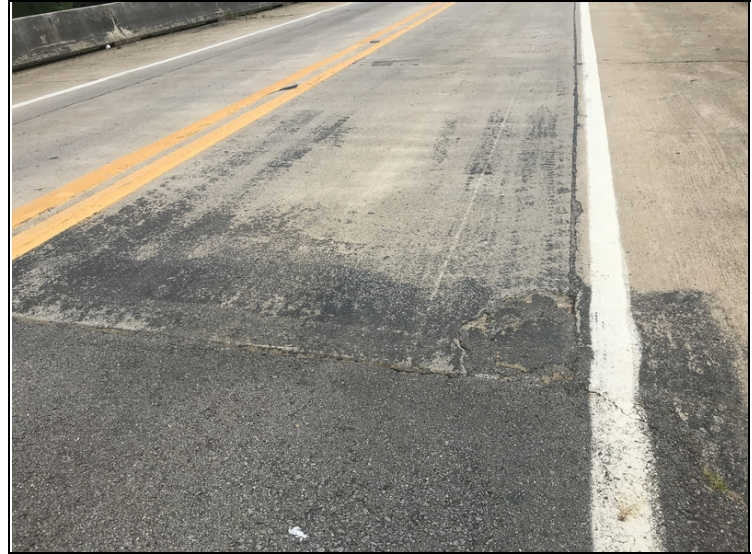
Driving surface of Span # 3 Northwest corner.

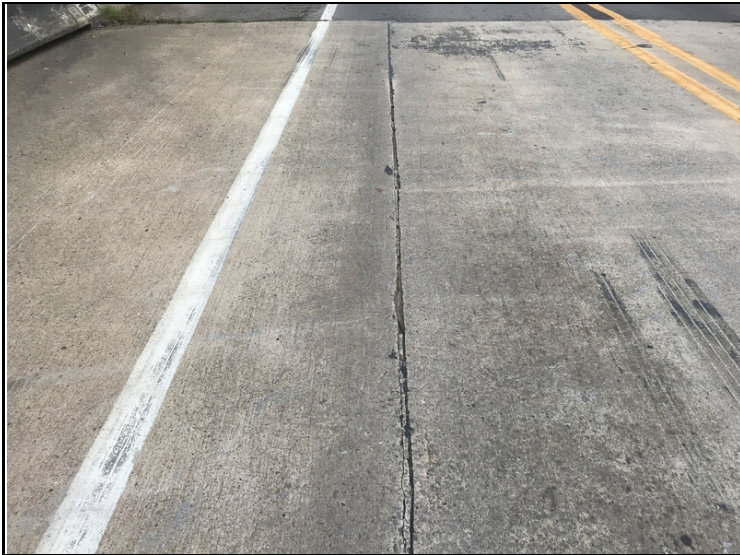
The poured joint sealant is deteriorated and missing in areas.

Span # 1 Rt longitudinal construction joint missing sealant.
