Asset #00322(Routine)

US Highway 71 over Sq. Rock Cr. - Scott Co.

Location: 1.60 MI NO OF JCT SH 28

Team Lead: Jeff Jones, Inspection Date: 07/07/2021

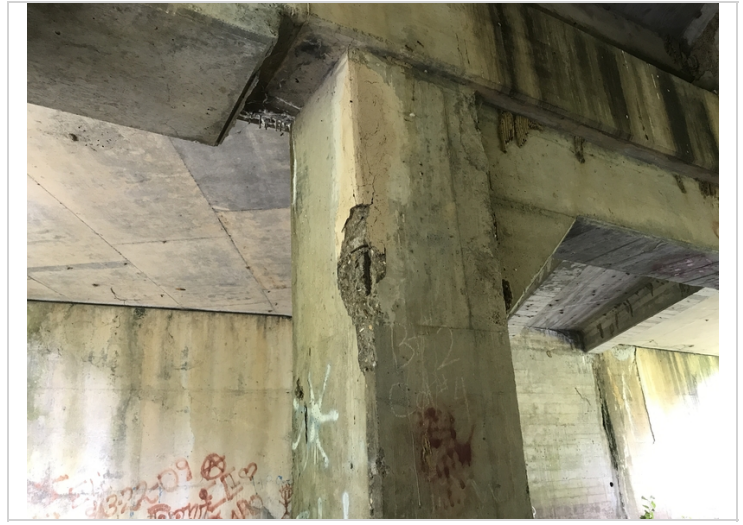
(205) -Bent # 2, Column # 4 has a 20" spall with exposed reinforcing steel with a 36" delaminated area above the spall. -Bent # 2, Column # 4 has vertical cracking with a delaminated area on the the Span # 1 side approximately half way up the column. -There is light to medium abrasion at the base of the original columns.							
215	Reinforced Concrete Abutment	LF	216	163	44	9	0
1080	Delamination/Spall/Patched Area	LF	4	0	3	1	0
1090	Exposed Rebar	LF	3	0	0	3	0
1120	Efflorescence/Rust Staining	LF	16	0	12	4	0
1130	Cracking (RC and Other)	LF	27	0	26	1	0
1190	Abrasion/Wear (PSC/RC)	LF	3	0	3	0	0

Bent 2 Column 4 spalling with exposed reinforcing steel.

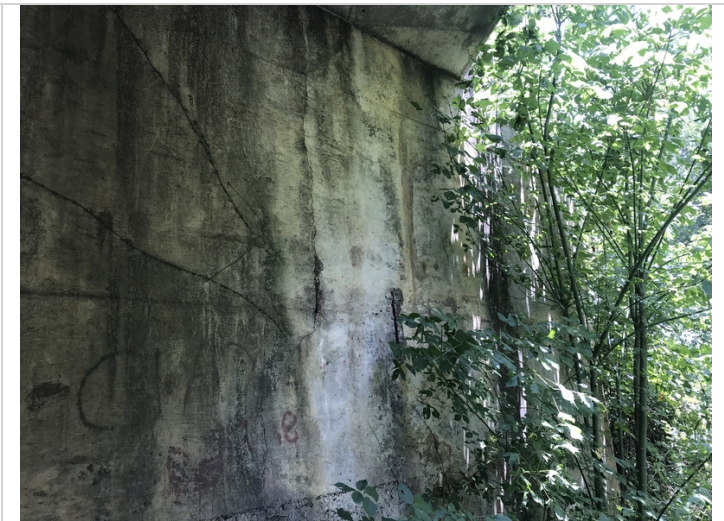
Bent 3 Rt spalling with exposed reinforcing steel.

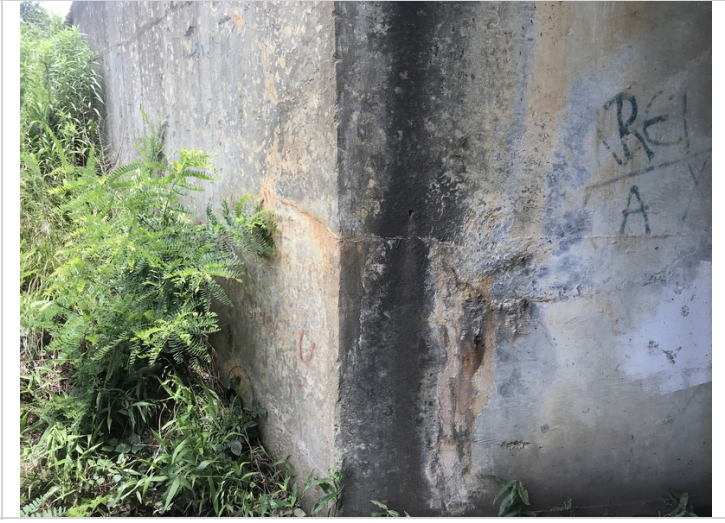
Bent # 3 Lt cracking with efflorescence.

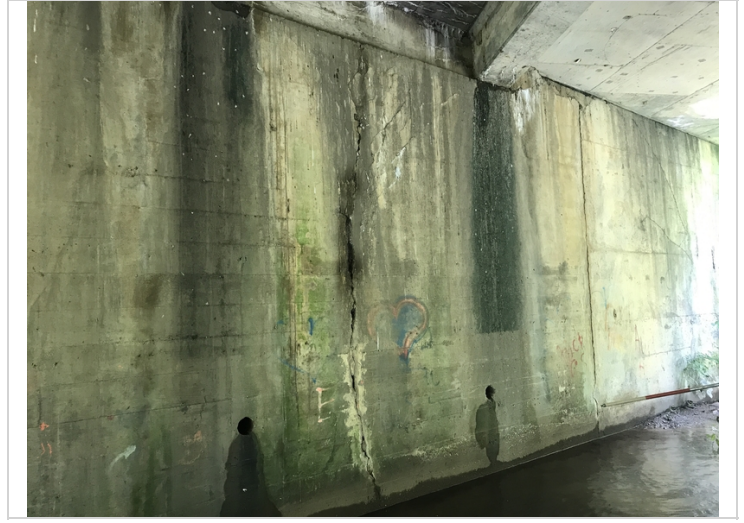
Bent 3 vertical crack.

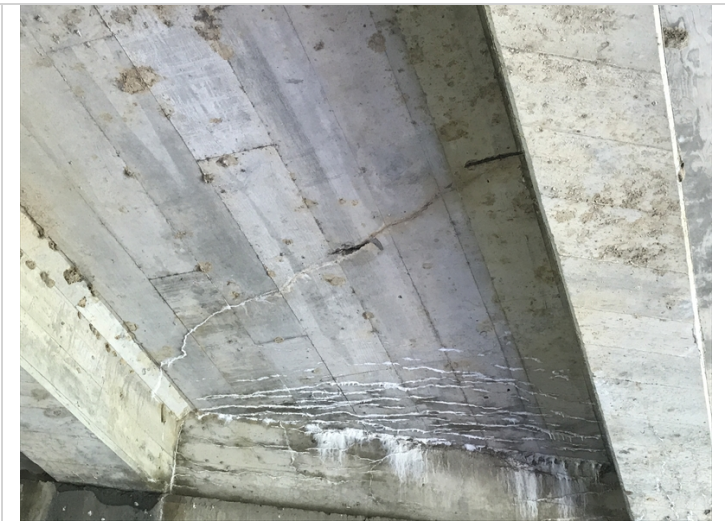
Span 2 Bay 2 spalling with exposed reinforcing steel.

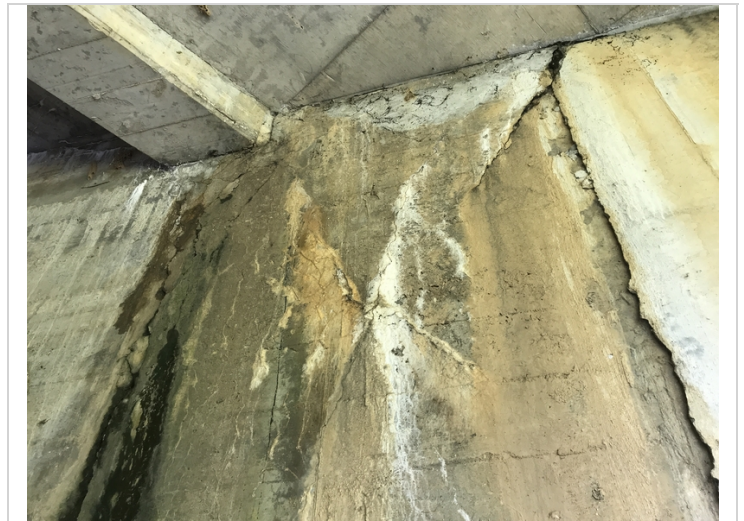
Bent 1 Lt cracking with efflorescence.

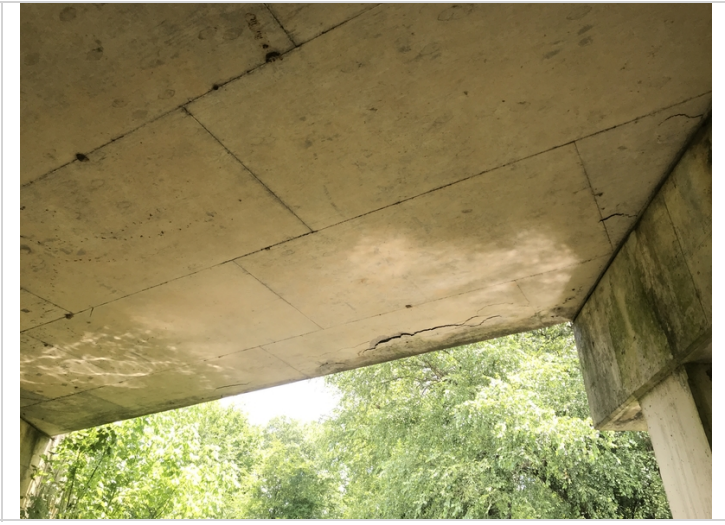
Span 2 Rt concrete delamination along the edge of the slab span.

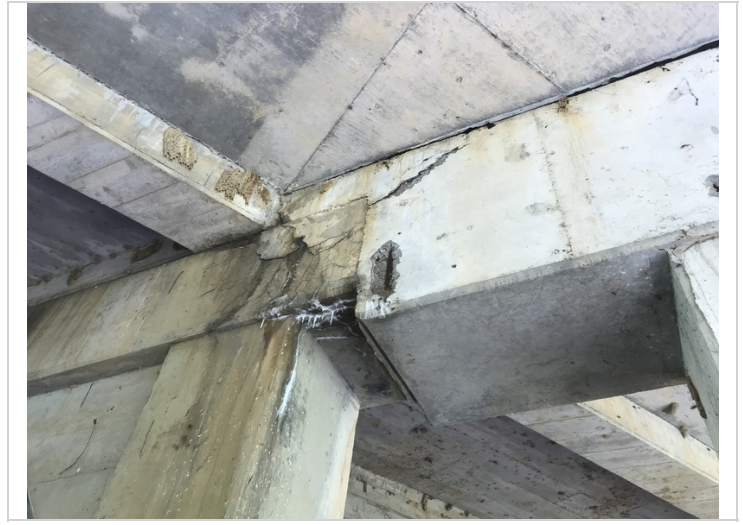
Bent 2 over Col 4 concrete delamination and exposed reinforcing steel.

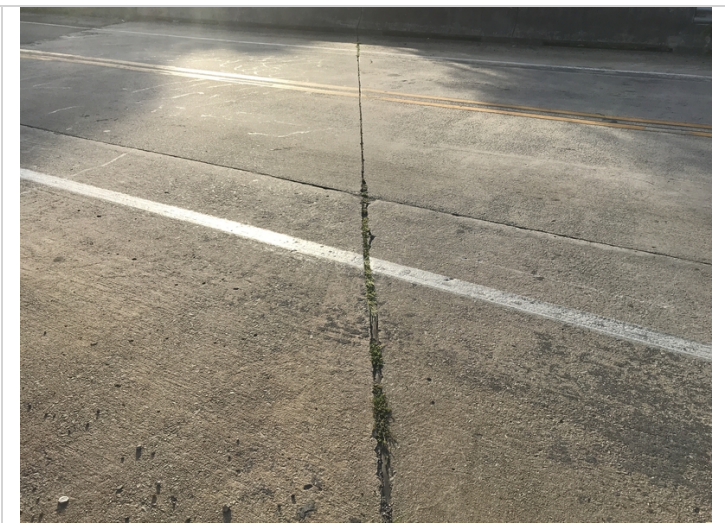
Failing joint sealant.

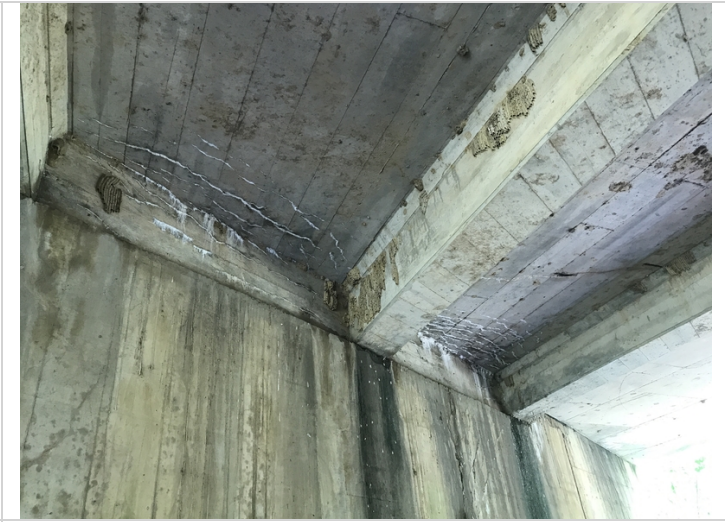
Span 2 cracking with efflorescence buildup.

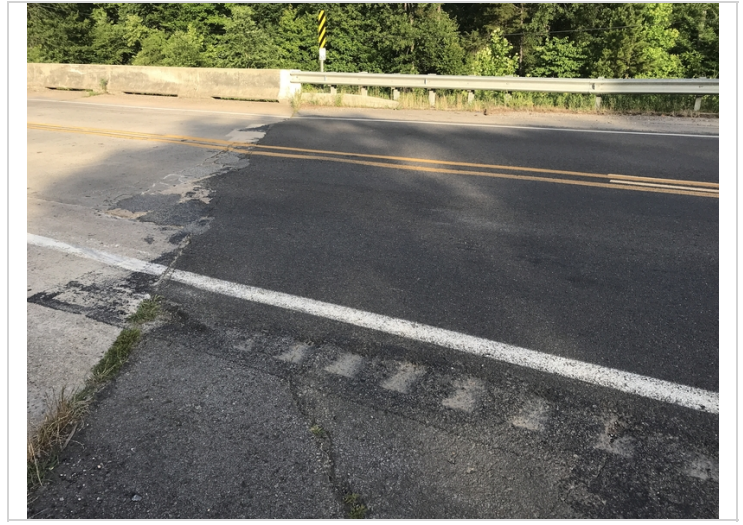
North approach asphalt repair.

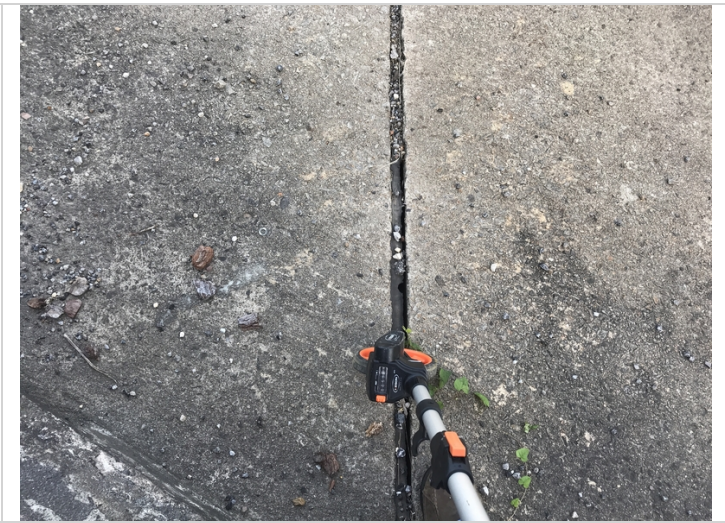
Seal adhesion failure.

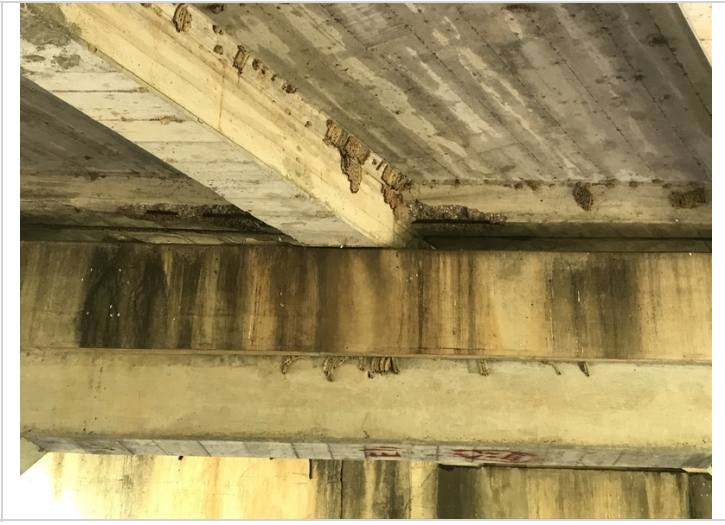
Bent 2 deck haunch spalling with exposed reinforcing steel.

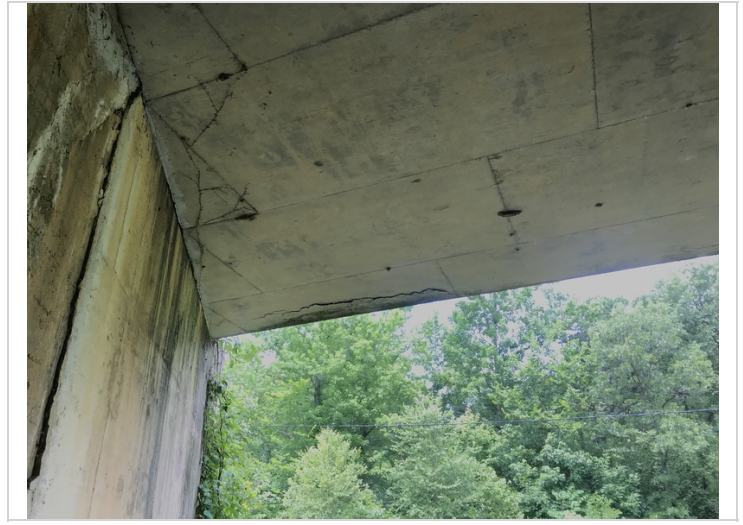
Span 1 Lt concrete delamination.

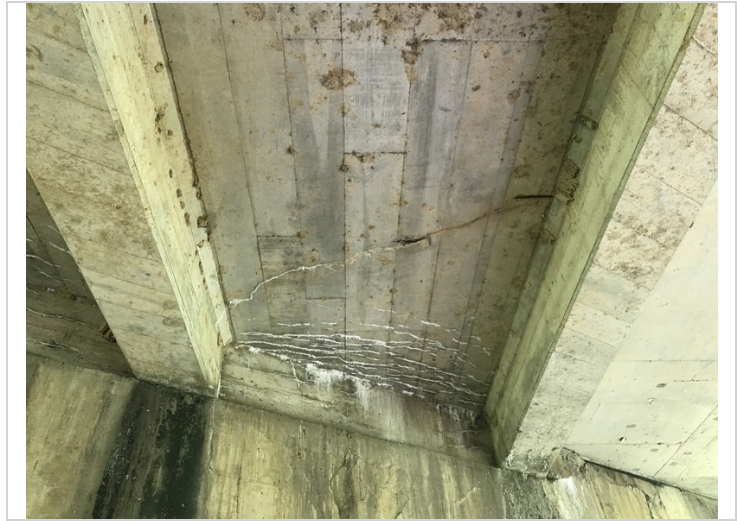
Span # 1 Deck soffit. Spall with exposed reinforcing steel in Bay # 2 adjacent to Bent # 3.

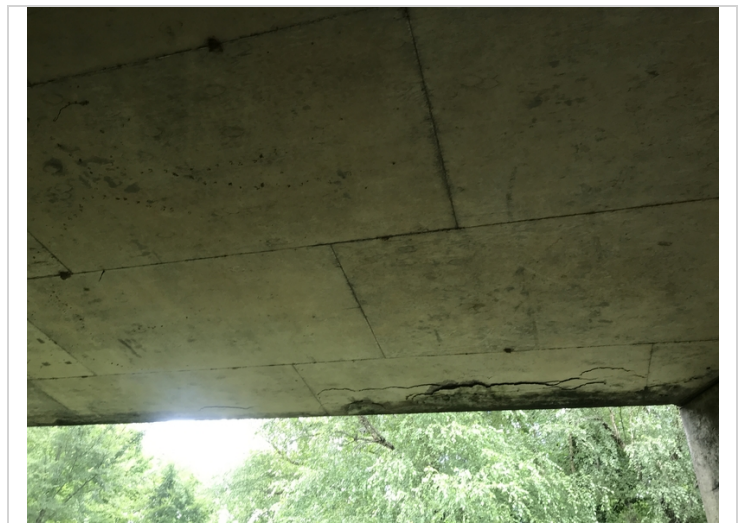
Slab soffit. Right side of Span # 2. Delaminated areas.

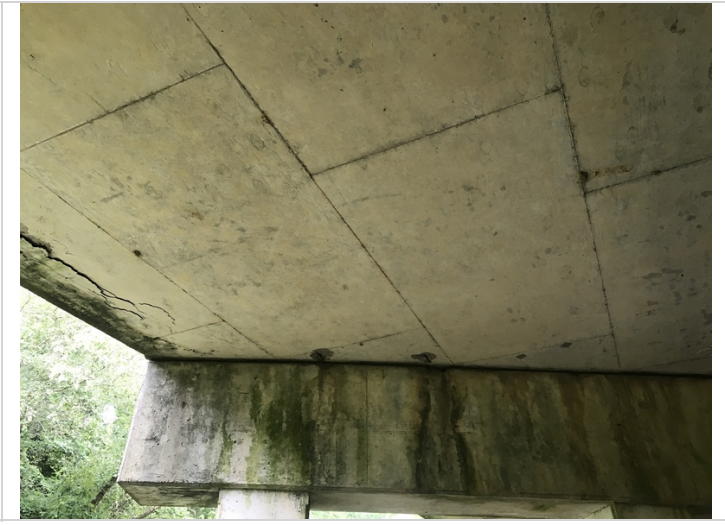
Span # 2 slab soffit adjacent to Bent # 2. Spall with exposed reinforcing steel and delaminated areas.

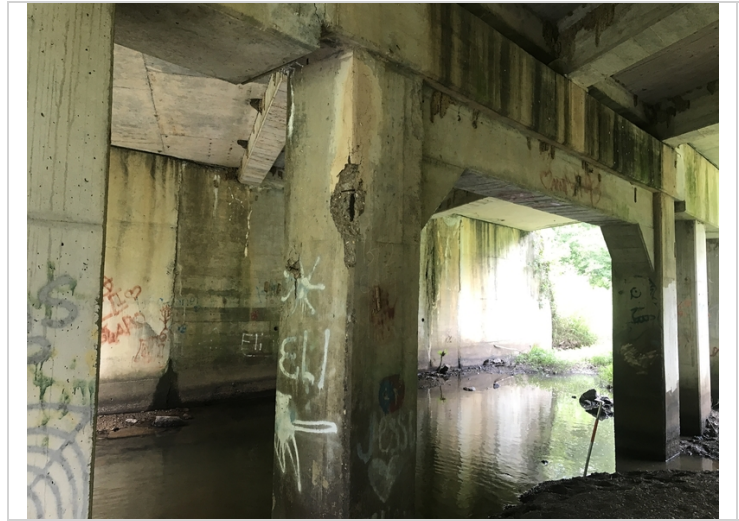
Bent # 2. Column # 4. Spall with exposed reinforcing steel.

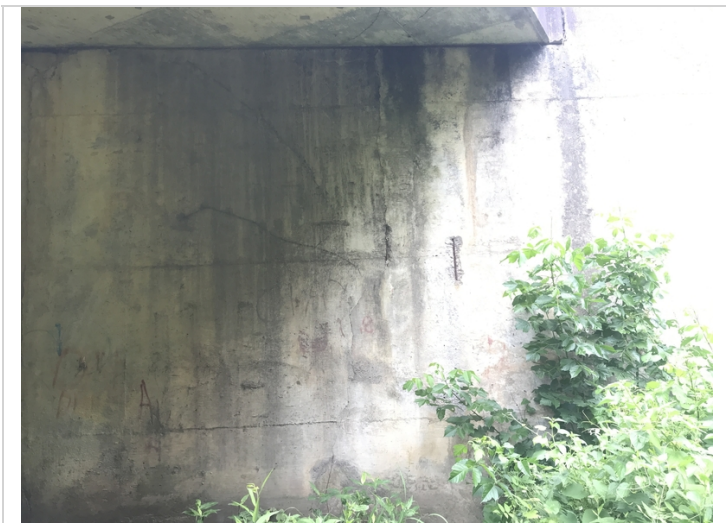
There is a vertical crack with two 2" X 10" areas of spalling with exposed reinforcing steel on the Right side of Bent # 3.

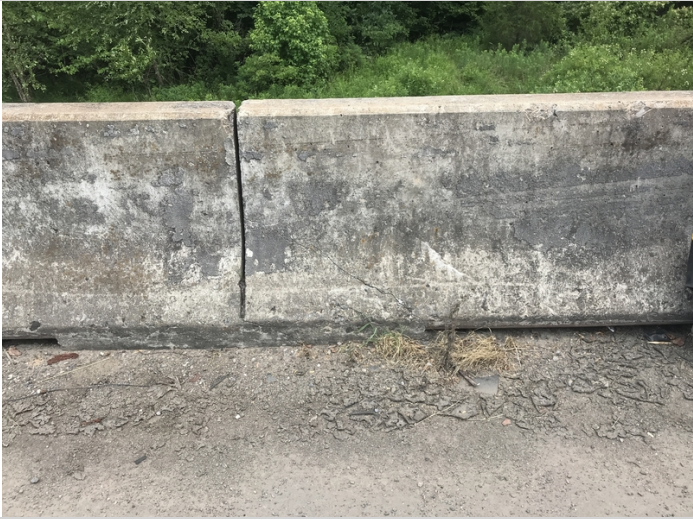
Diagonal cracking in the Left parapet of Span # 1.

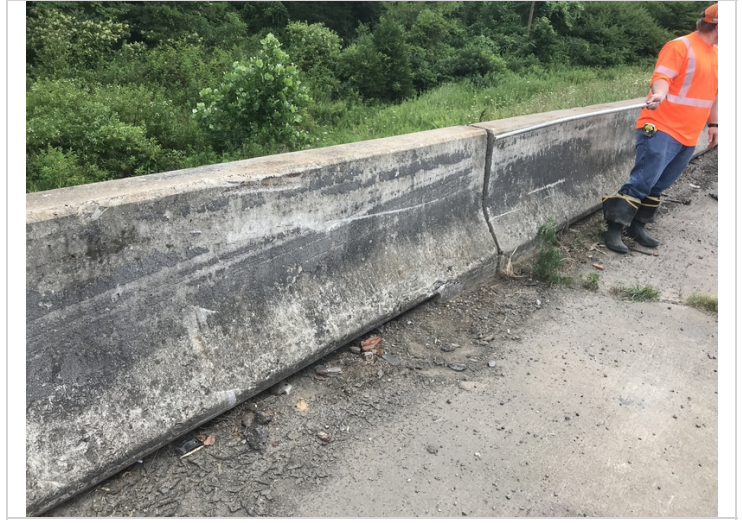
Left bridge railing in Span # 1 over Bent # 2 has collision damage. Base of wall is fractured at the deck juncture and the top is leaning out of alignment 1 1/2".

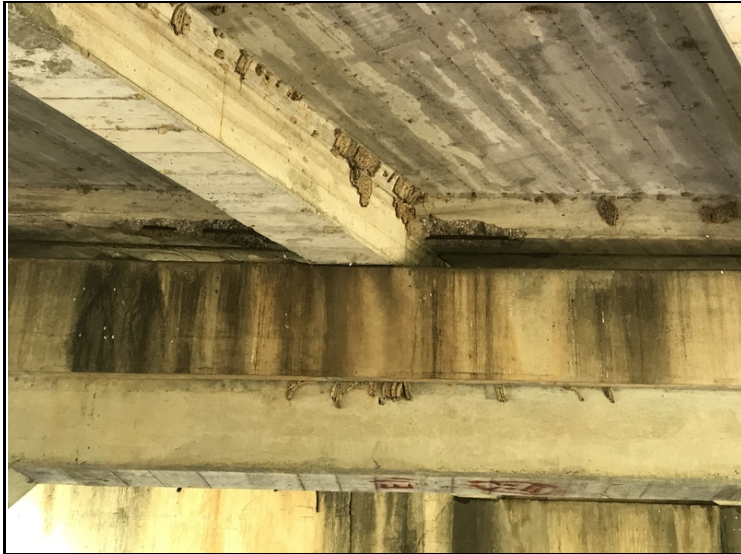
Driving surface of the deck is breaking apart.
Deck joint sealant is deteriorated.
The deck haunches over Bent # 2 have spalling with exposed reinforcing steel.
The concrete wearing surface is audible and abrades on the bridge deck under traffic.

Bent # 2 deck haunch spalling with exposed reinforcing steel.

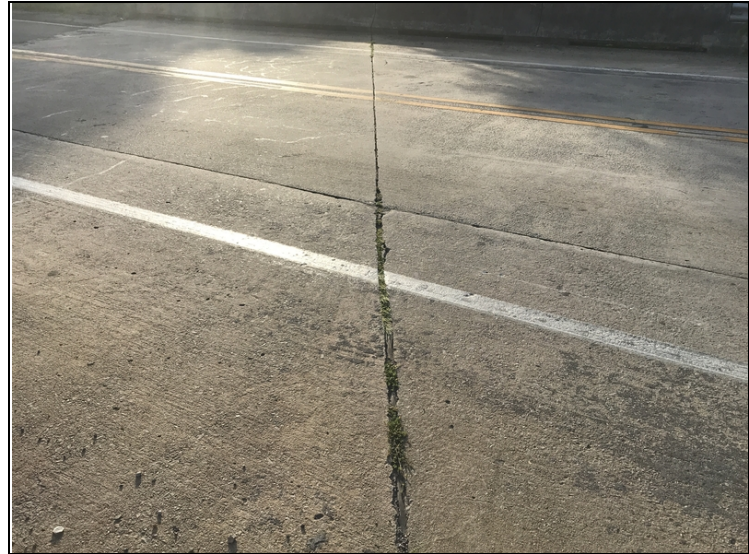
Failing joint sealant.

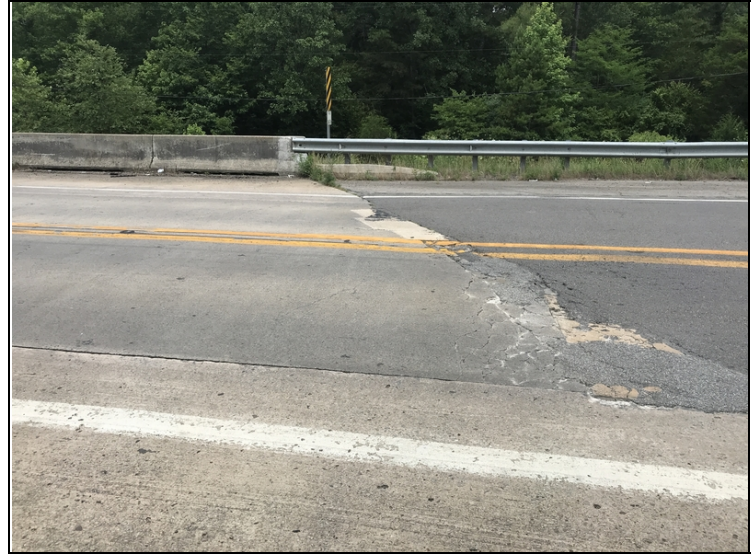
North end of Bridge deck wearing surface.

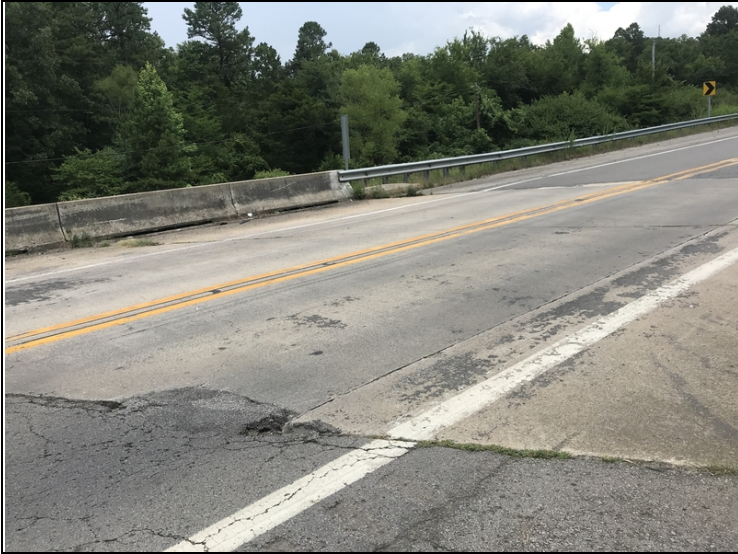
South end of bridge deck wearing surface.

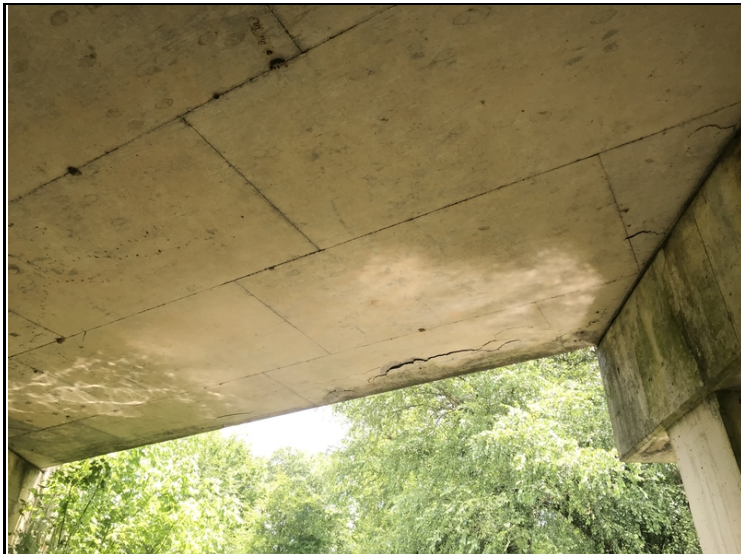
The exterior edges of the deck undersurface have large delaminated areas.

Span # 2 Right concrete delamination along the edge of the slab span.

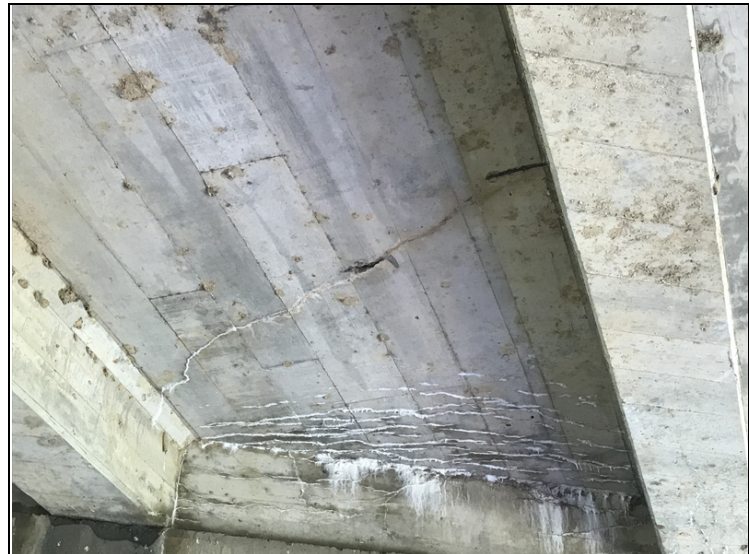
There are a few isolated areas with shallow spalling with exposed reinforcing steel on the undersurface between the girders over Bent # 2 and in Span # 2, Bay # 2.

Span # 2 Bay # 2 spalling with exposed reinforcing steel.

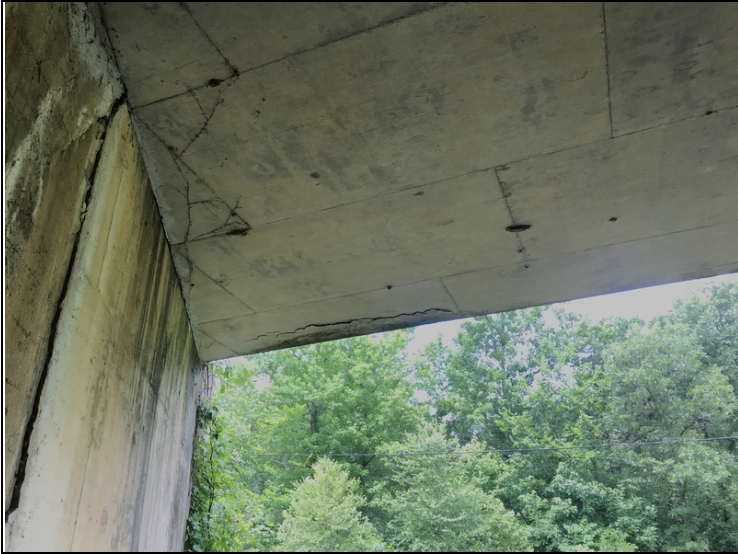
Span # 1 Left concrete delamination.

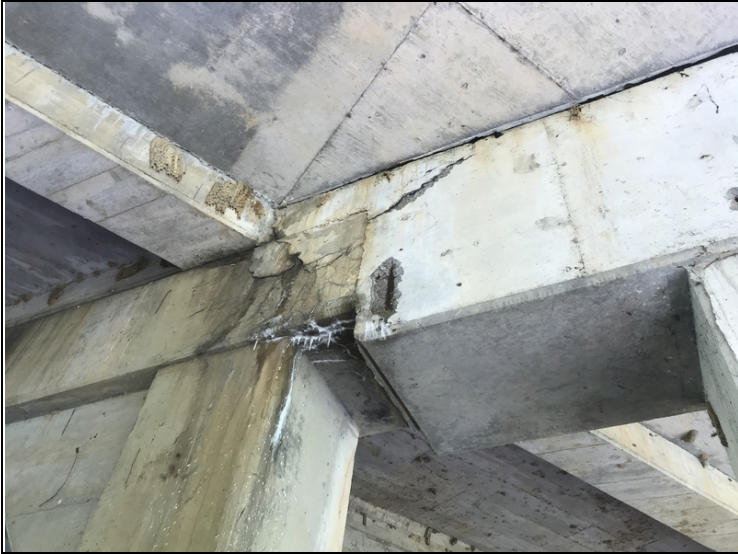
Bent # 2, Column # 4 has a 12" spall with exposed reinforcing steel.
Bent # 2 Cap has a 24" delaminated area adjacent to Girder # 3.

Bent # 2 over Column # 4 concrete delamination and exposed reinforcing steel.

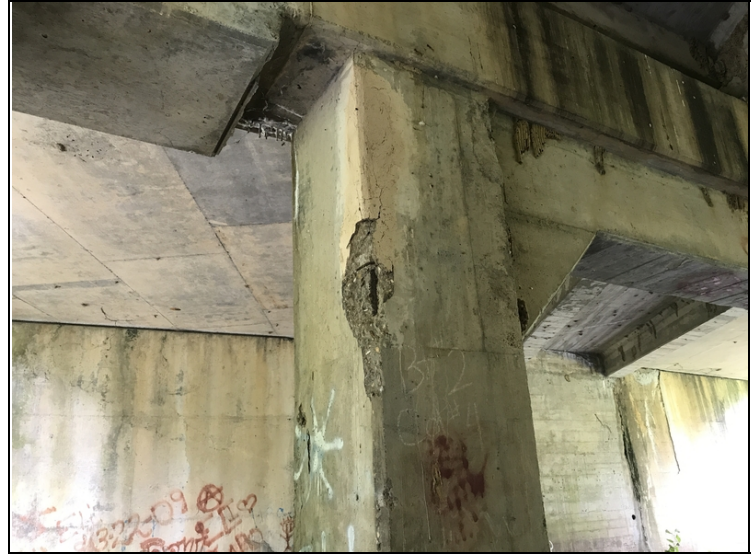
Bent # 2 Column # 4 spalling with exposed reinforcing steel.

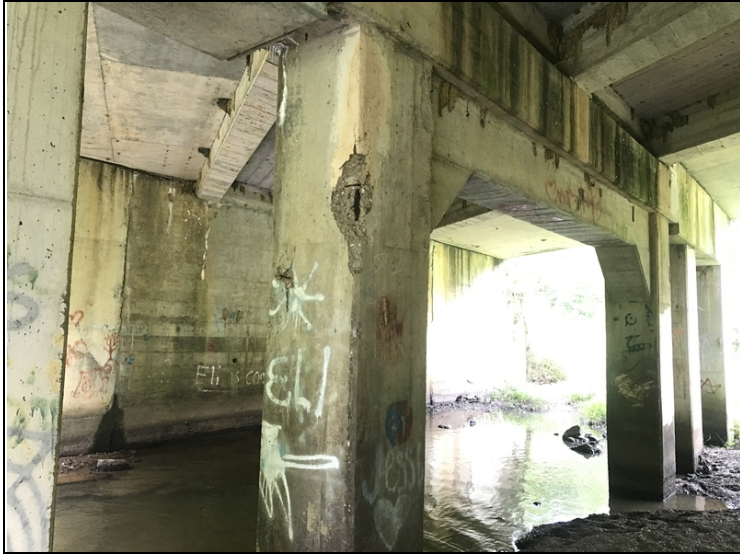
Bent # 2 column # 4. Spall with exposed reinforcing steel.

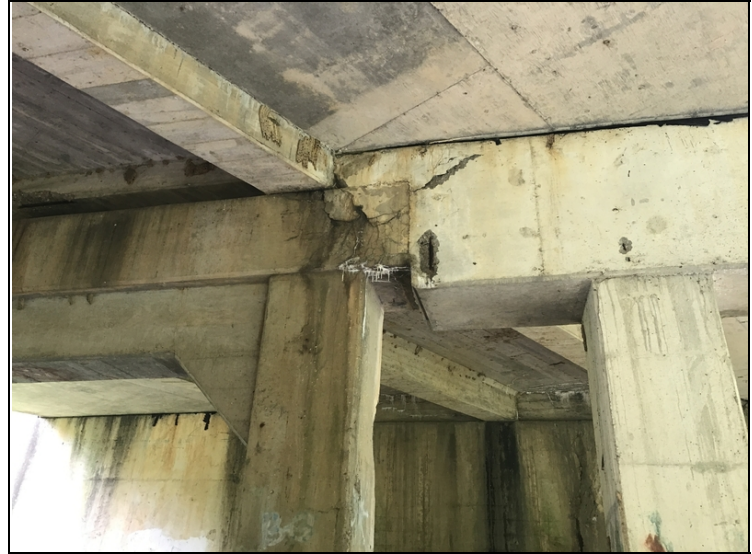
(234) -The Span # 1 side of Bent # 2 there is a 3' delaminated area in the Right side of the cap adjacent to Girder # 3. -The Span # 1 side of Bent # 2 there is a 8" tall spall with exposed reinforcing steel on the Right side of the cap adjacent to the old section of the cap. -There is map cracking with efflorescence adjacent to the construction joints where the cap was widened.

Span # 1 side of Bent # 2 cap. Spall with exposed reinforcing steel and delaminated areas.

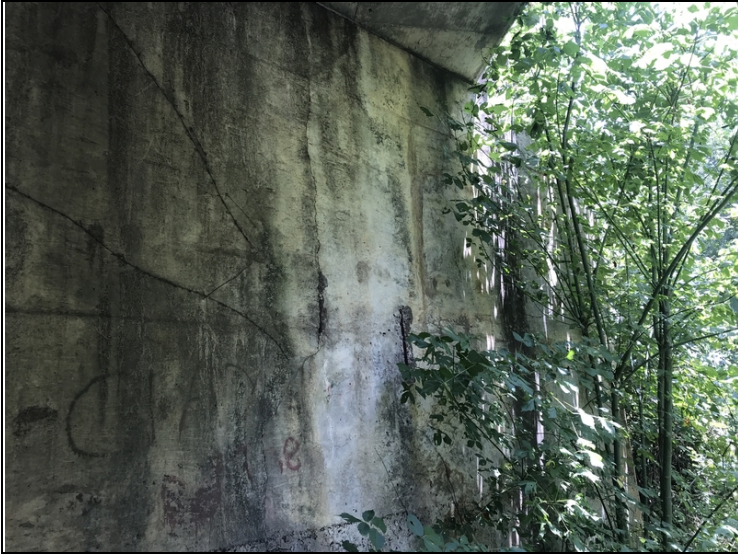
The abutments have wide vertical cracks and spalling with exposed reinforcing steel.

Bent # 3 Rt spalling with exposed reinforcing steel.

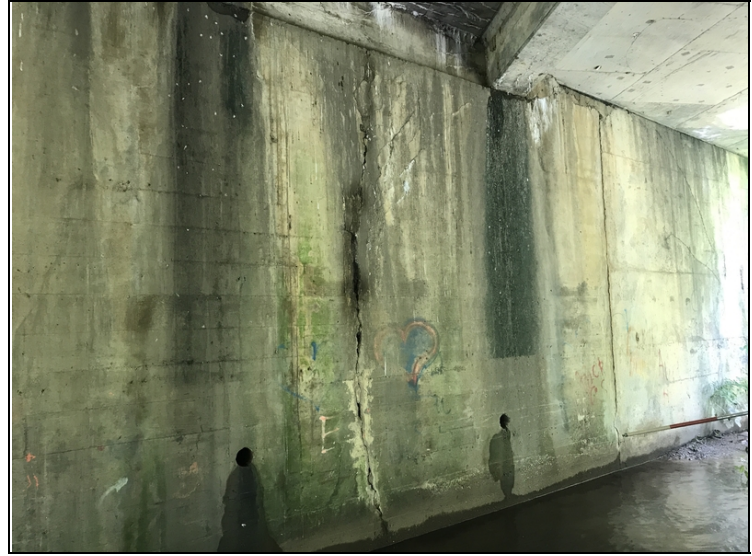
Bent # 3 vertical crack.

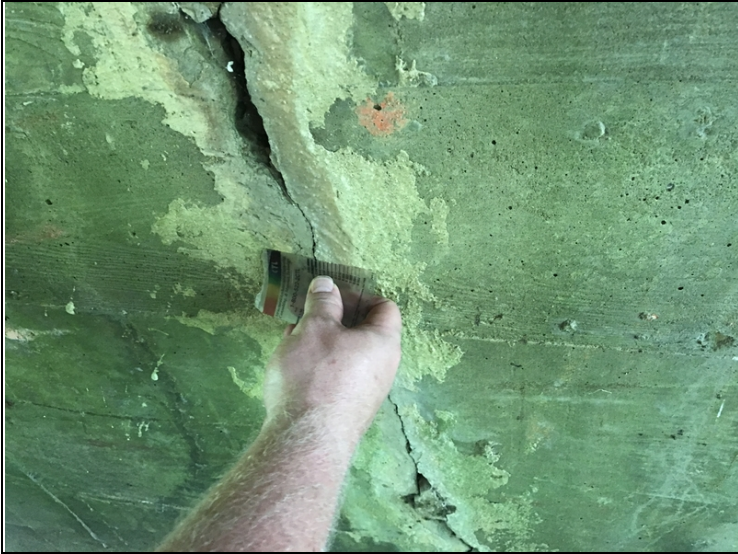
Bent # 3 abutment crack measured 0.040" during this inspection.

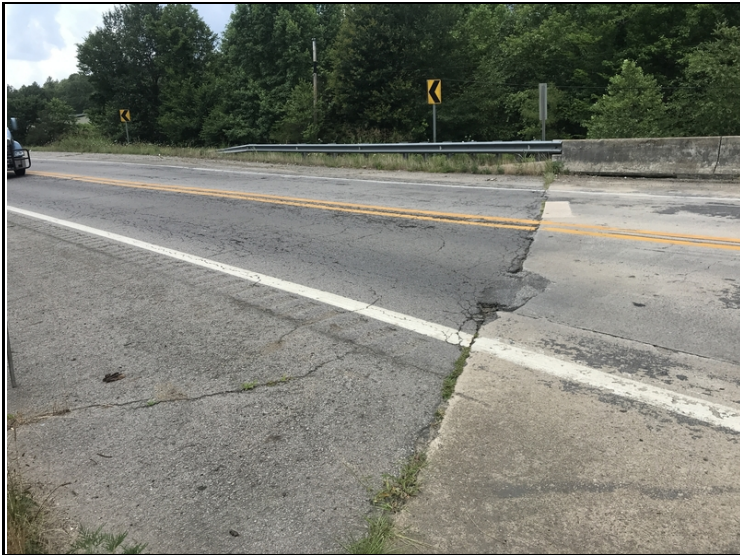
South approach roadway.

The asphalt is breaking apart at the South bridge end.

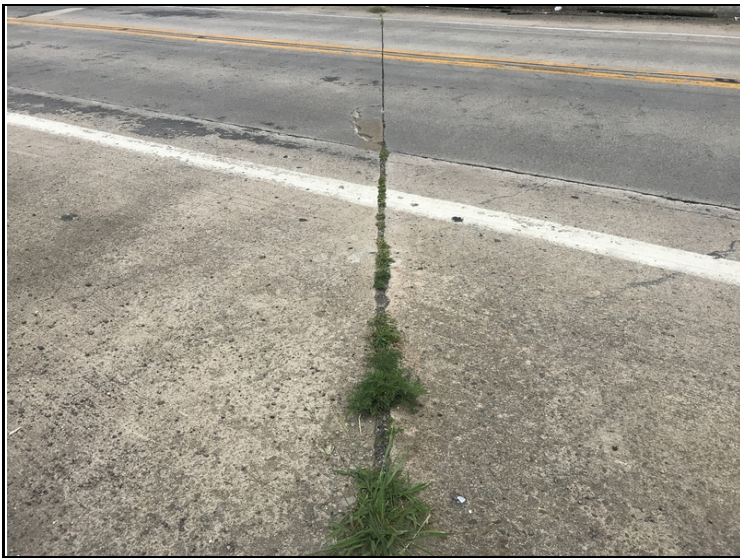
Joint sealant is deteriorated with debris accumulation in the joints.

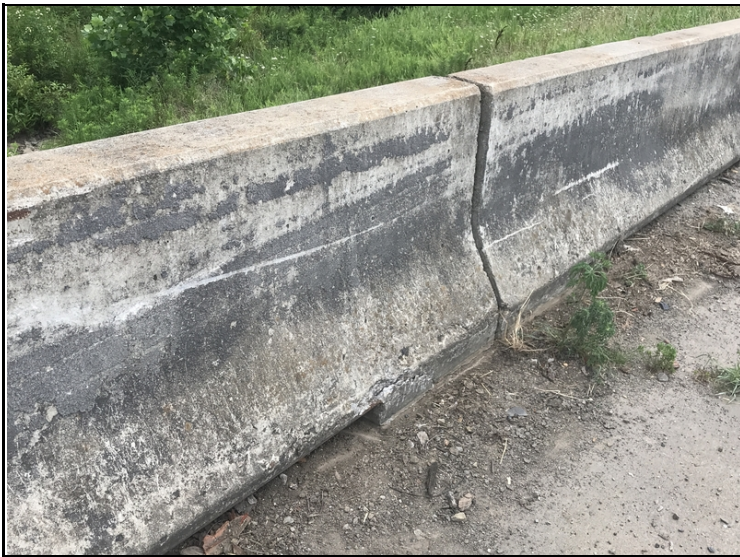
Left bridge railing in Span # 1 over Bent # 2 has collision damage. Base of wall is fractured at the deck juncture and the top is leaning out of alignment 1 1/2".

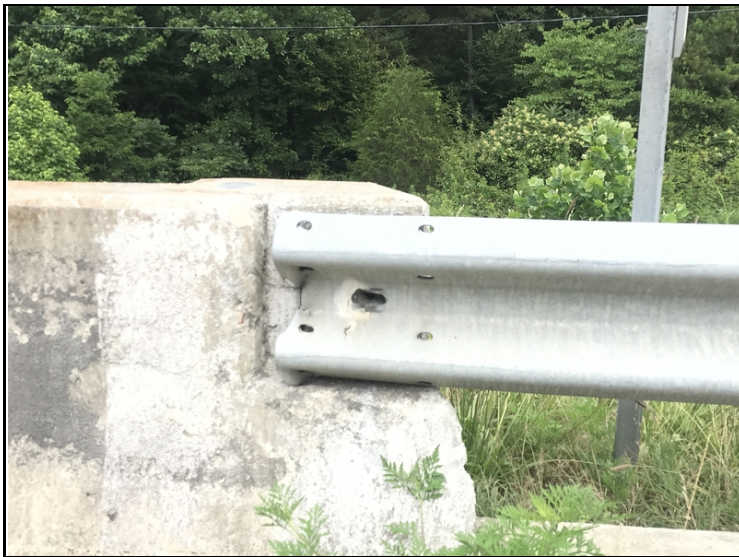
The Northwest approach guardrail is not attached to the Bridge parapet wall.
