Asset #05864(Routine)

# US HWY 71-Logan Co over Little Petit Jean River

Location: 0.65 MI N. OF Scott, Co

Team Lead: Bob McEntyre, Inspection Date: 08/17/2022

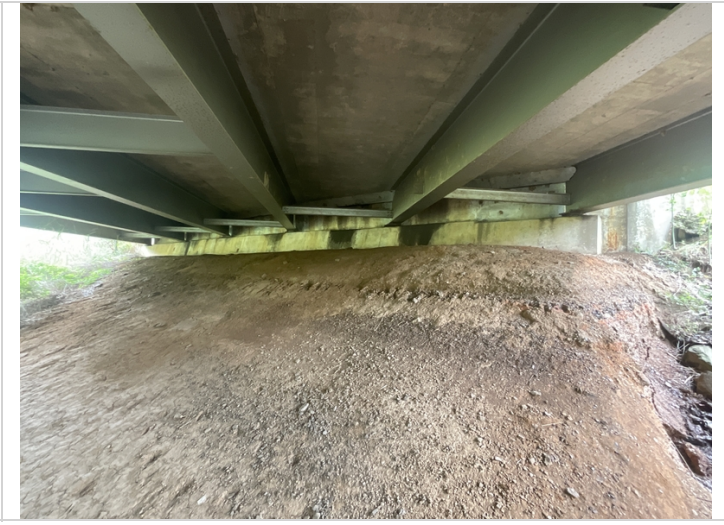
Abutment 2, bearing 6-Corrosion with pack rust between bearing plates

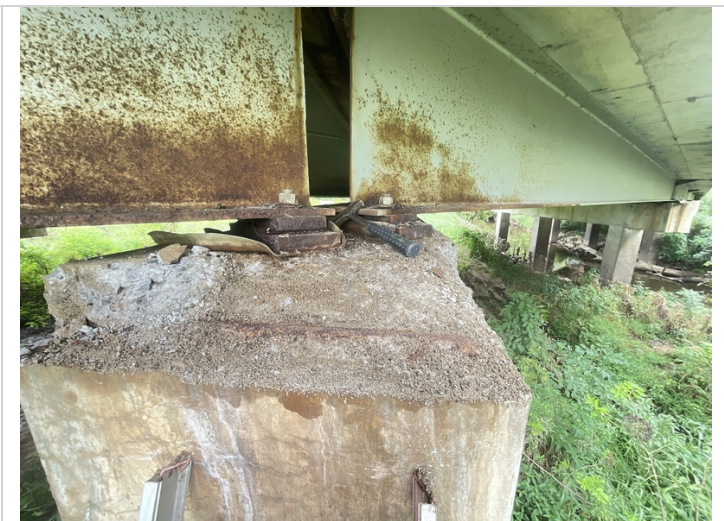
Bent # 5 cap, left end has soft and deteriorated concrete with spalling.

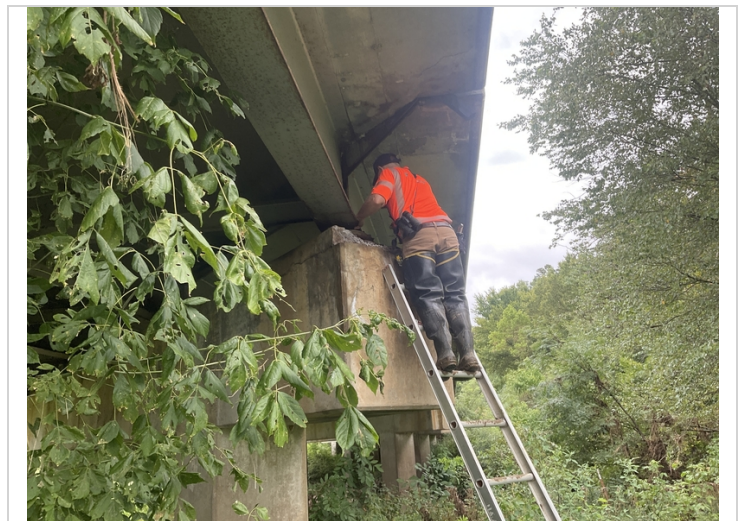
Bent # 5 cap, left end has soft and deteriorated concrete with spalling.

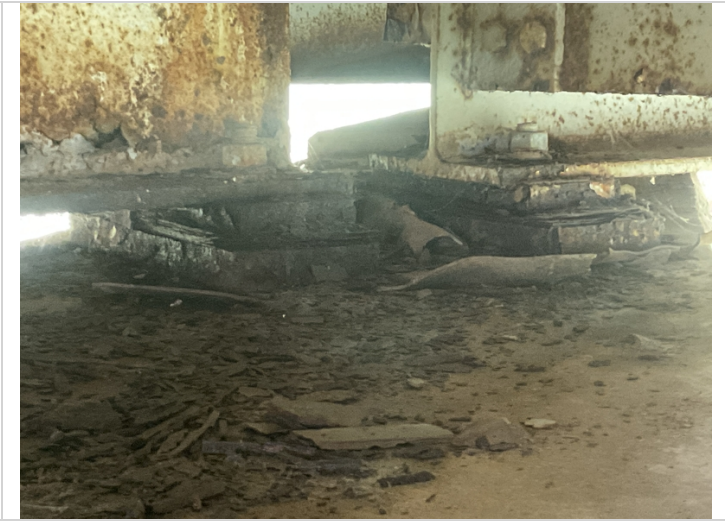
Bent # 6 cap backface, left side has 9' long delaminated area in the top and face of cap. The delaminated area appears to extend under bearing # 1 of span # 5

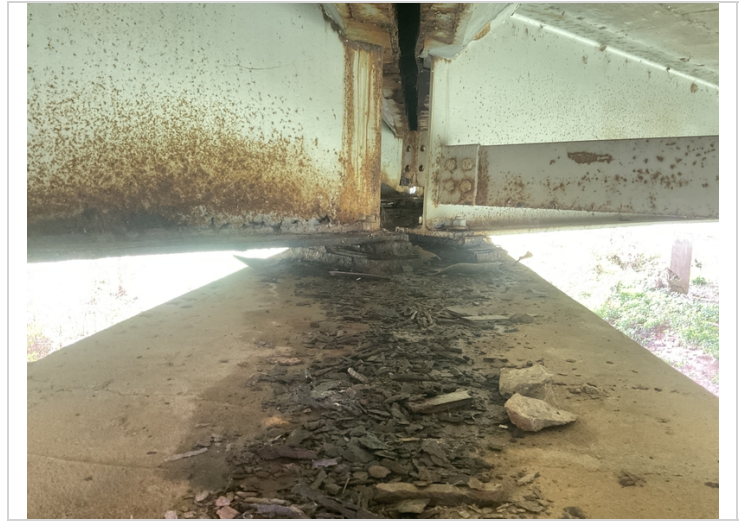
Bent 6-Heavy corrosion to bearing devices

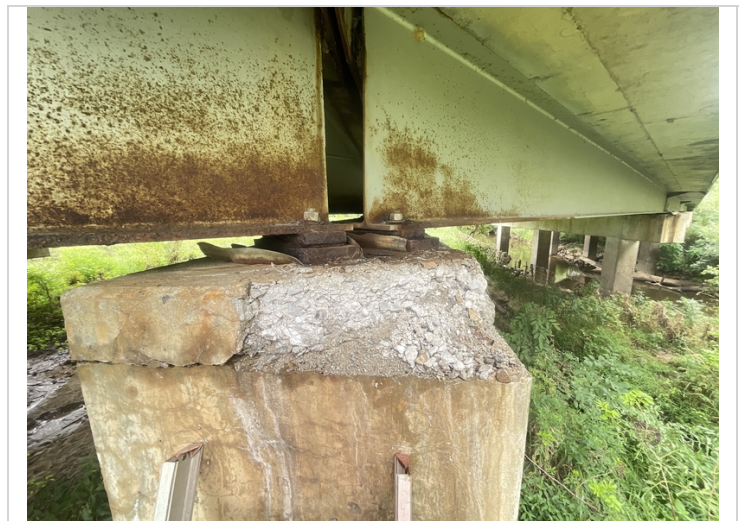
Bent # 5 cap, left end has soft and deteriorated concrete with spalling.

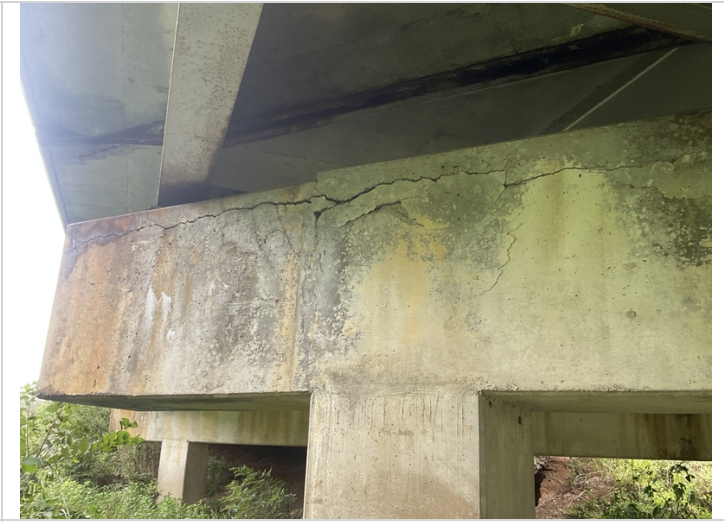
Bent # 5 cap, left end has soft and deteriorated concrete with spalling.

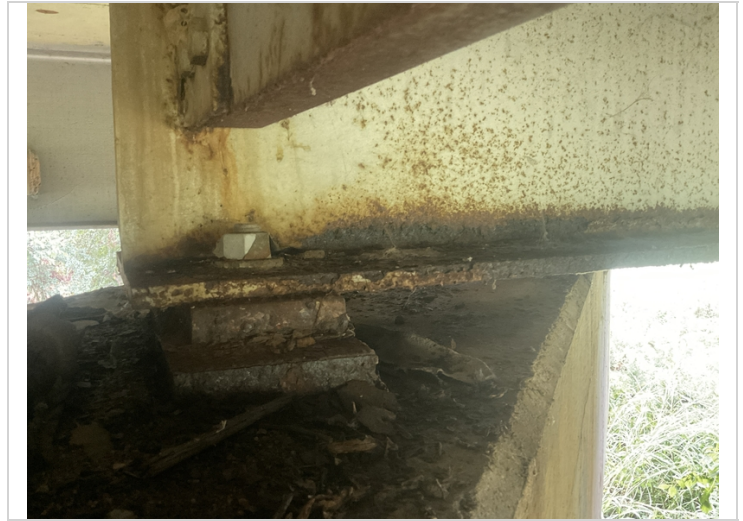
Span 5, beam 2 at bent 5-Corrosion to web at expansion dam

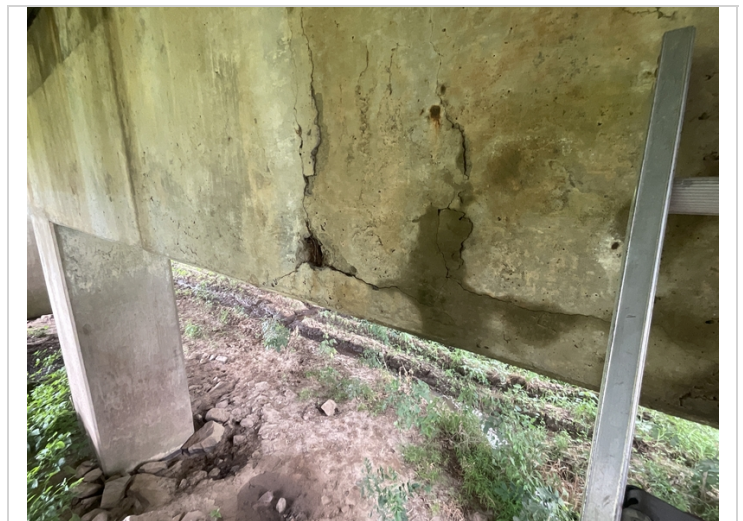
Bent 5 bearing area

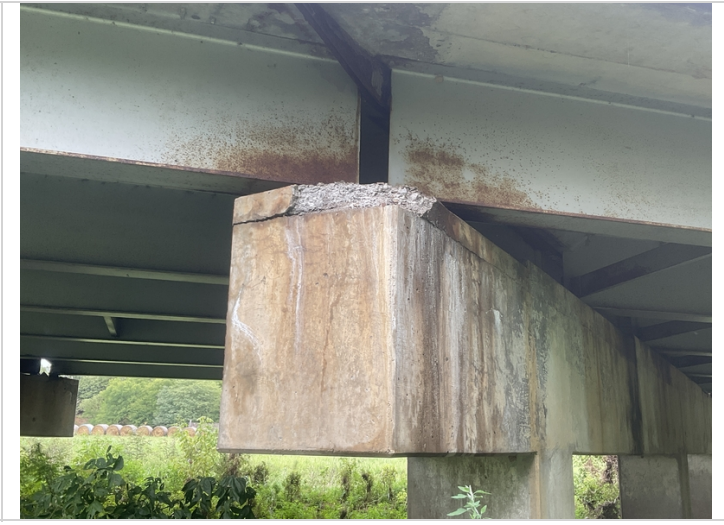
Bent 5 aheadface between columns 1 and 2-Spalling with exposed reinforcing steel

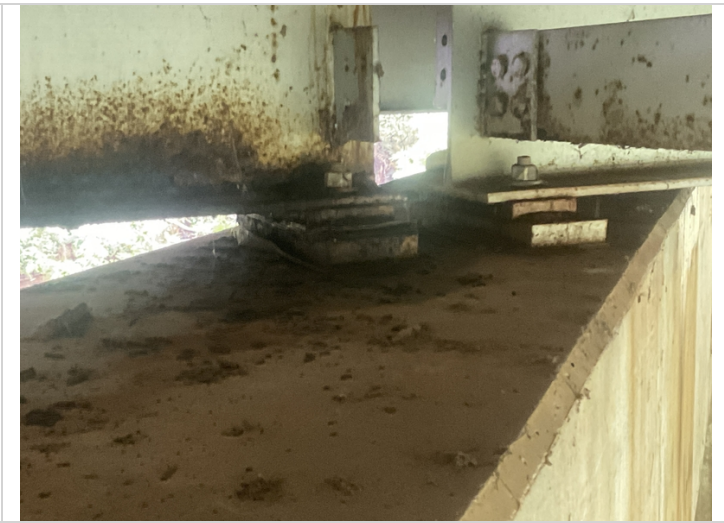
Bent # 2

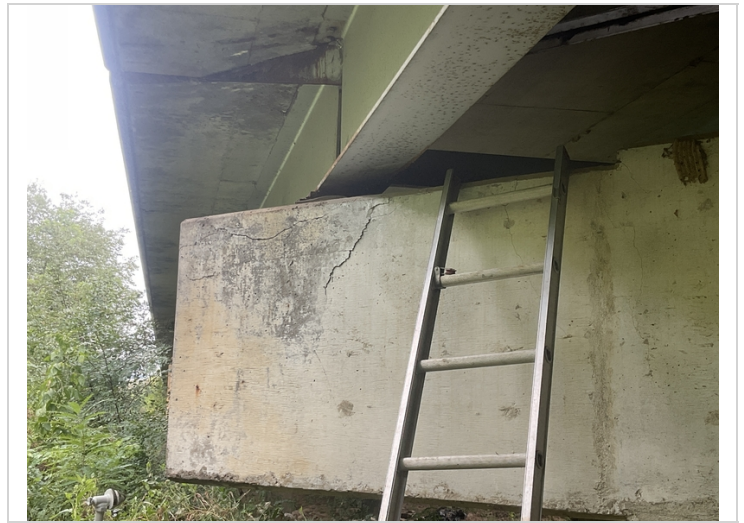
Span 2, beam 3 at bent 2-Corrosion

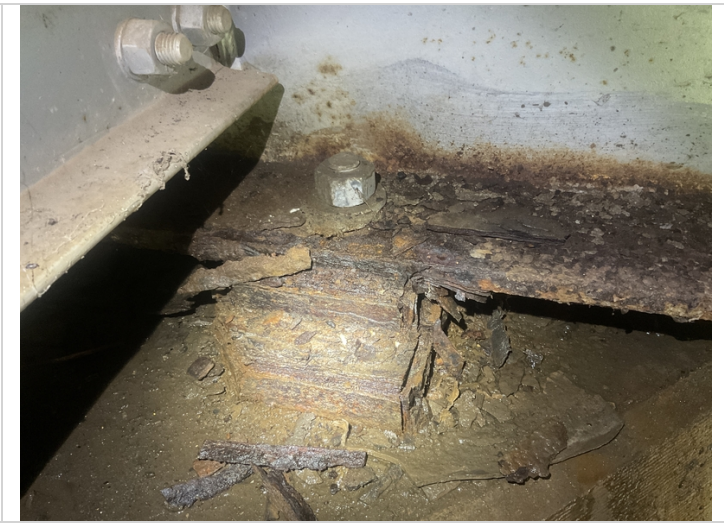
Abutment 1, bearing 1-Corrosion

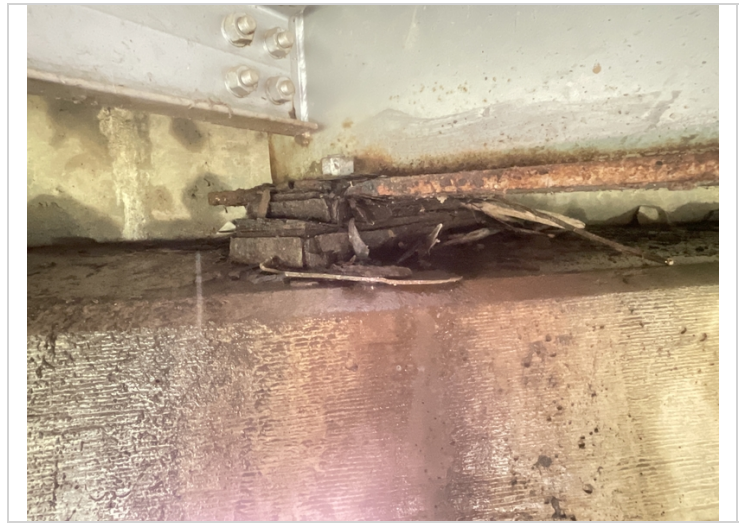
Abutment 1, beam 3-Corrosion

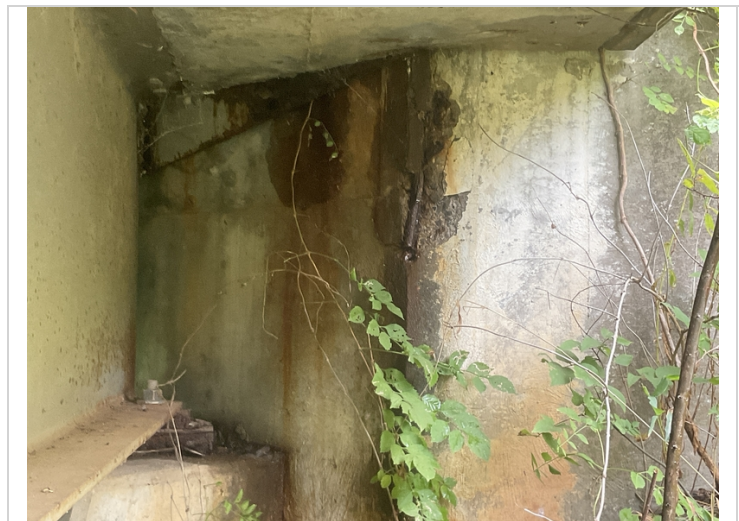
Abutment # 1 backwall left side has a 14" spall with exposed reinforcing steel at the wing wall juncture.

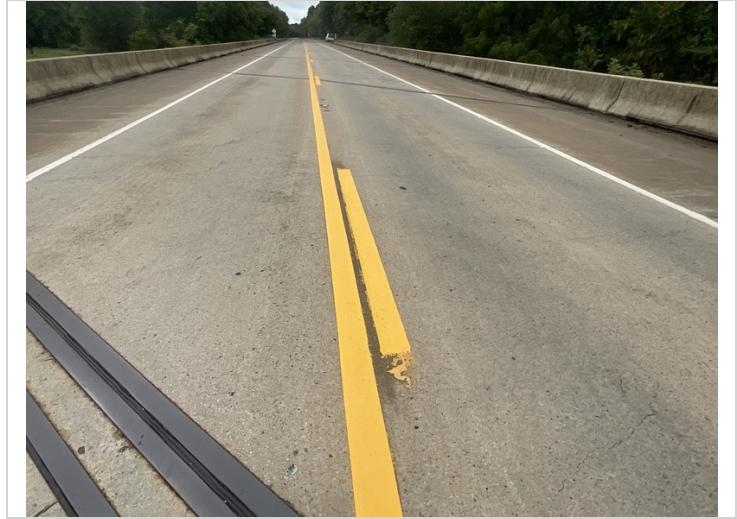
Span # 4 has several moderate sized spalls with temporary asphalt repairs.

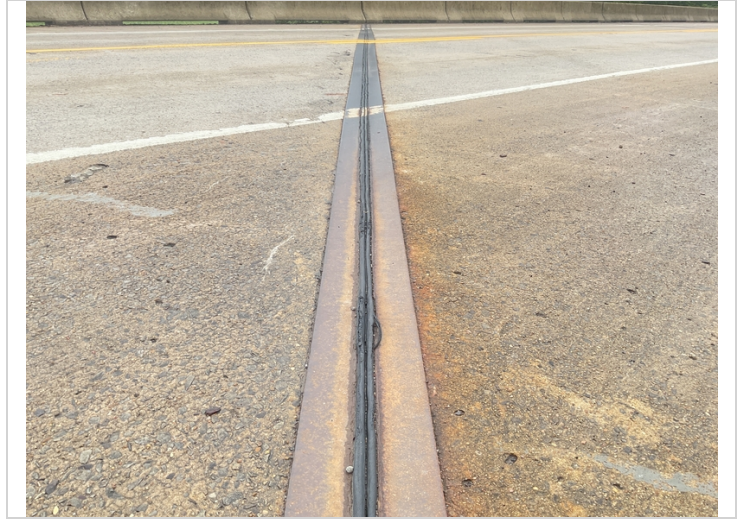
Bent 4 expansion joint-Seal deterioration

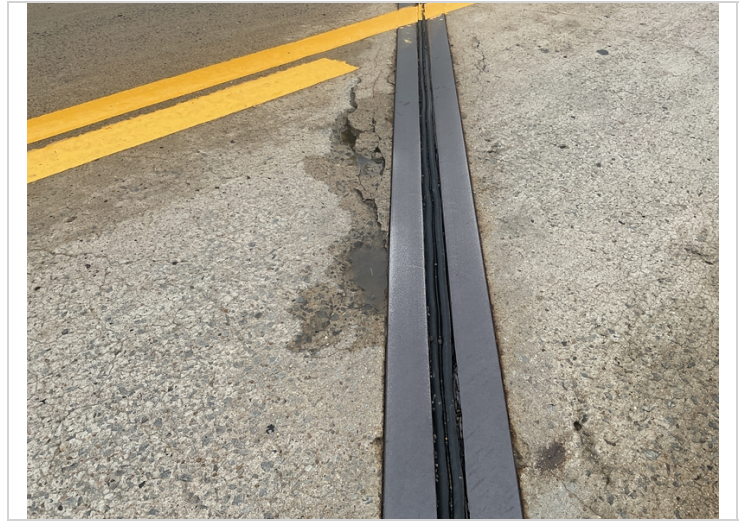
Span 3, left lane-Spalling adjacent to expansion joint assembly

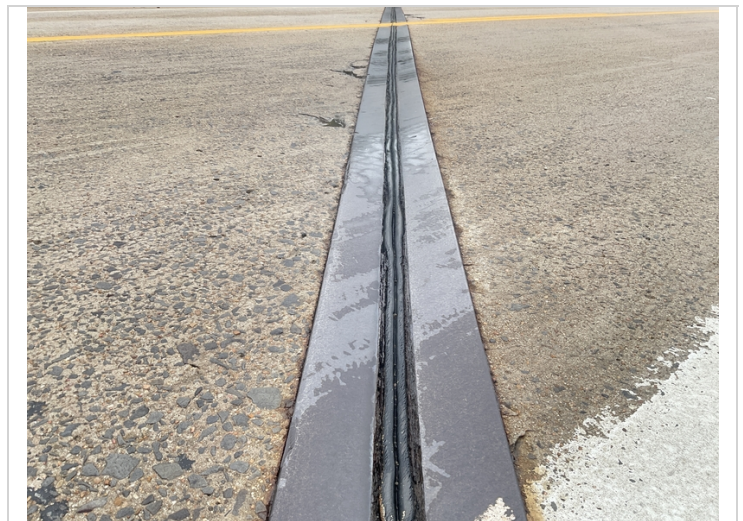
Bent 3 expansion joint-Seal deterioration

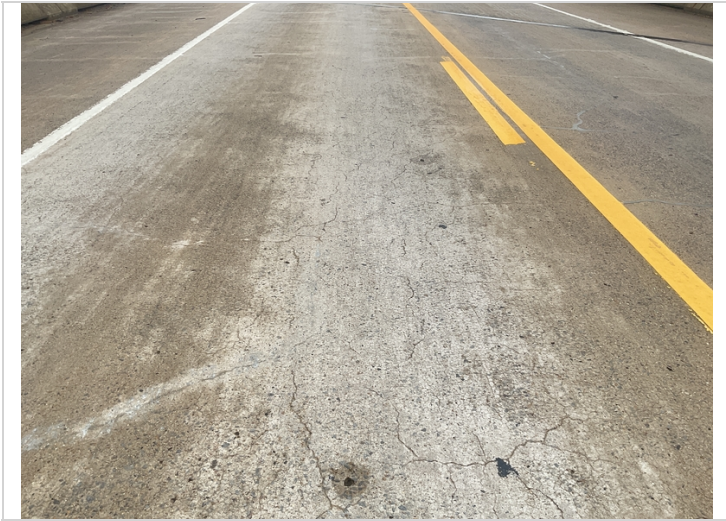
Span 1, left lane-Mapcracking

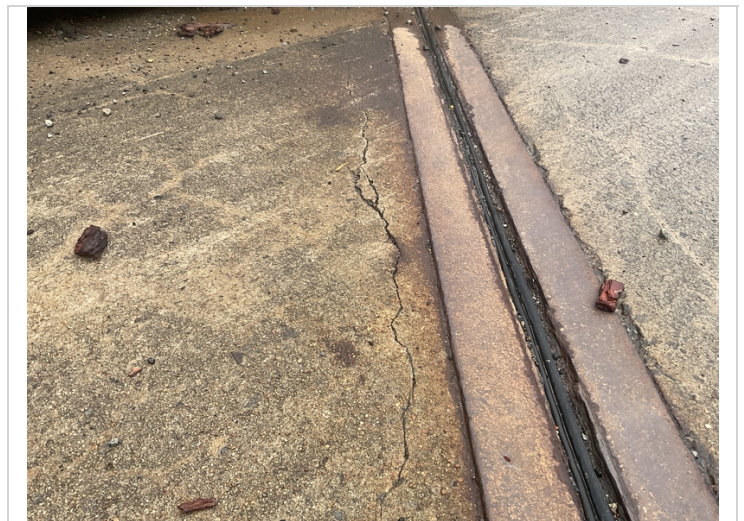
Cracking / delaminated area in left shoulder adjacent to bent expansion joint assembly

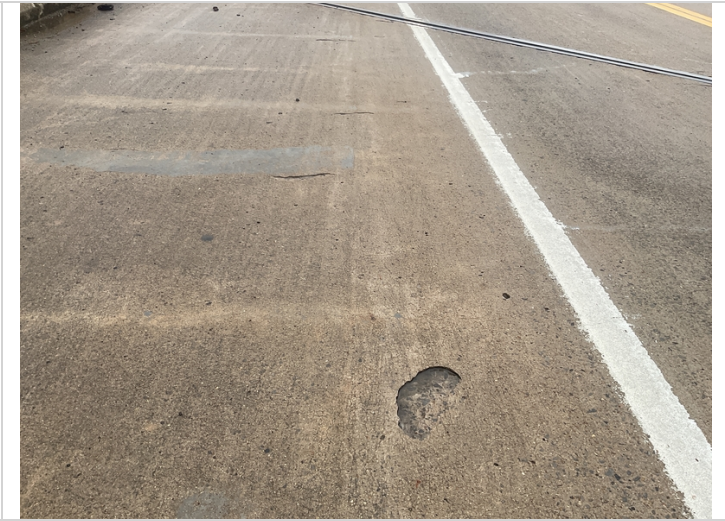
Span 1, left shoulder-Shallow delaminated areas

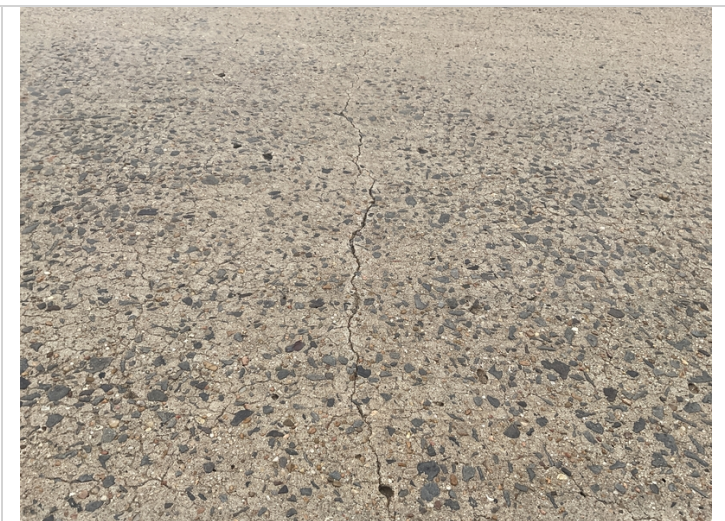
Span 1, left lane-Transverse cracking

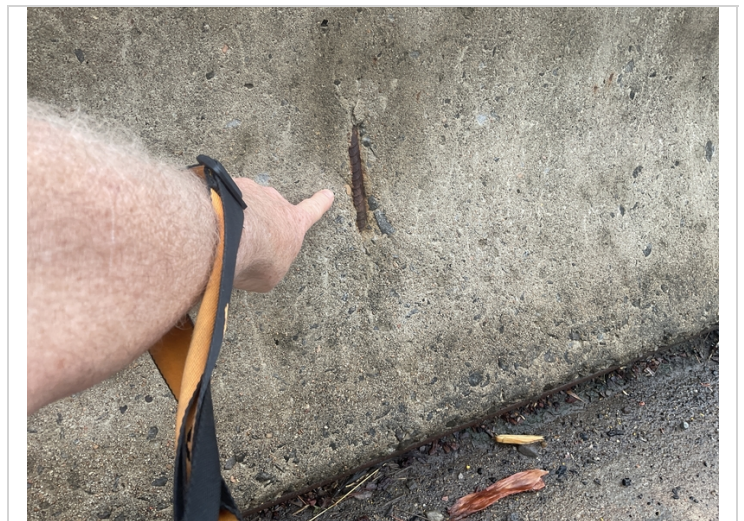
Span 1, left parapet-Shallow spall with exposed reinforcing steel

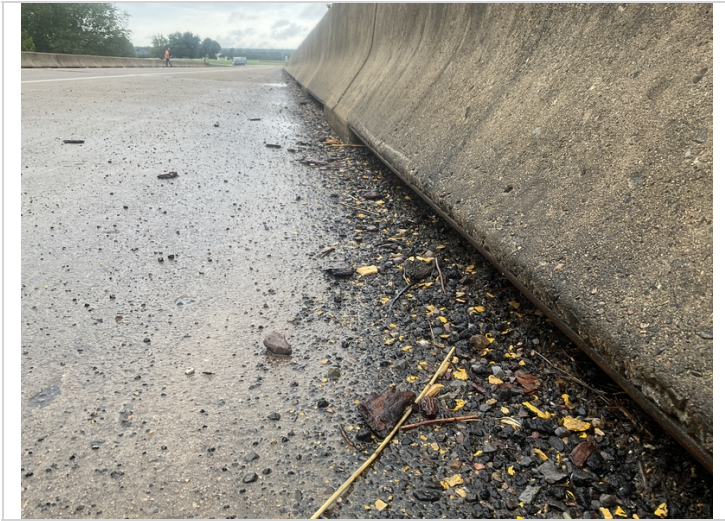
The shoulders have dirt and debris accumulation that restricts the deck drains in the parapets.

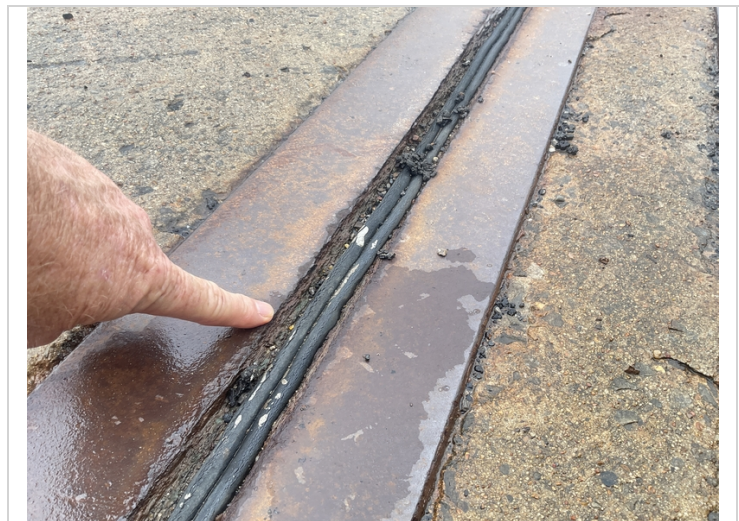
Abutment 1 expansion joint-Deterioration

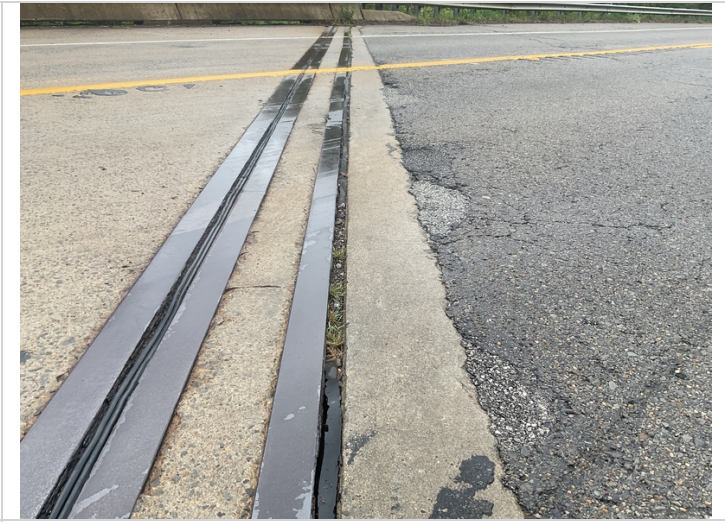
Expansion joint assemblies have corrosion with pack rust causing seal adhesion failure. Abutment 1 expansion joint pictured

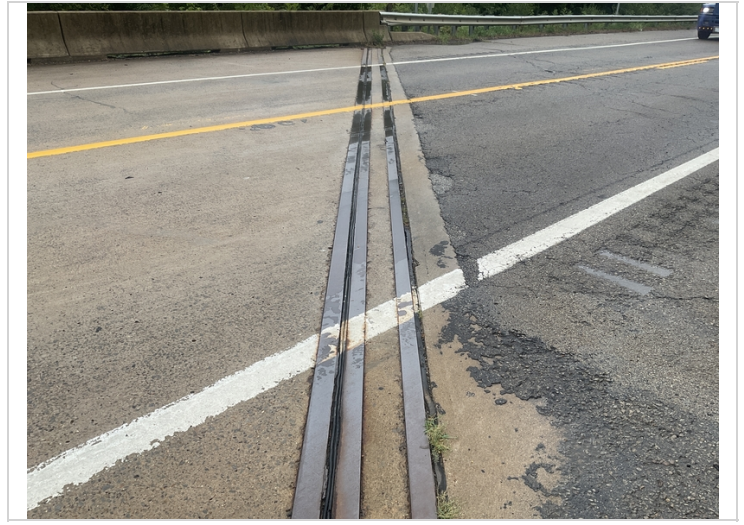
Joint sealant deteriorated and missing in locations between abutment # 1 expansion joint assembly and South approach roadway.

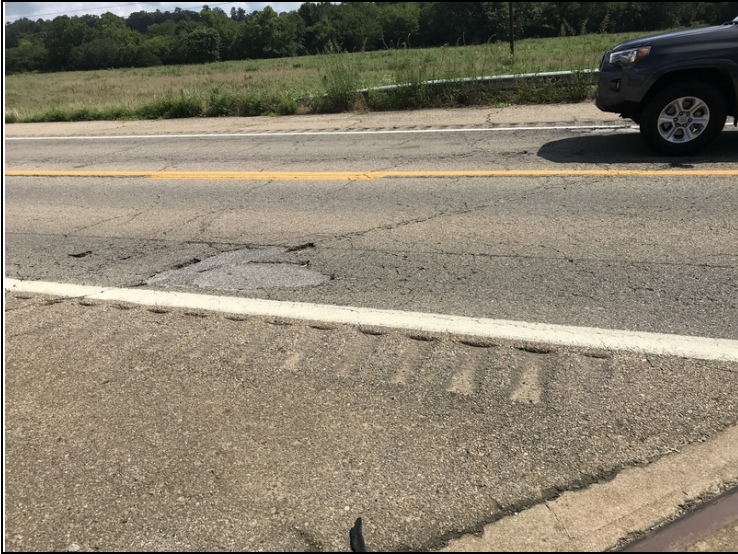
Asphalt driving surface of the North approach roadway is breaking apart with potholes forming.

The asphalt driving surface of the North approach roadway is breaking apart with potholes forming.

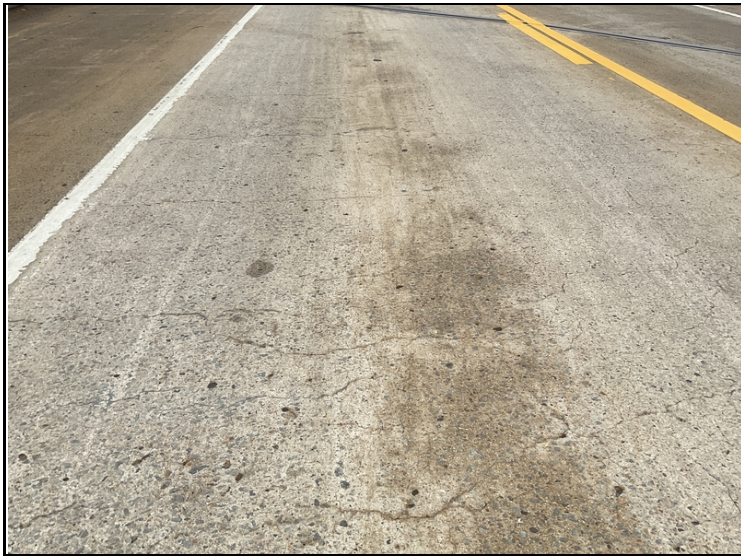
Span # 3, left lane-Mapcracking.

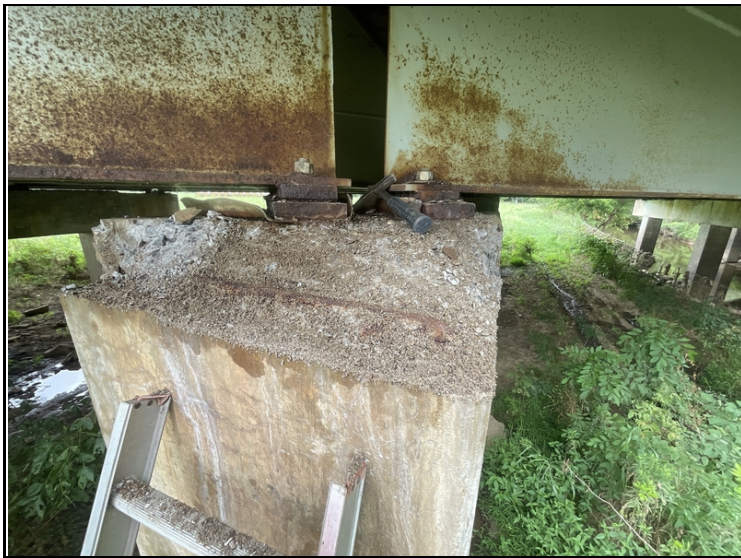
Substructure caps have concrete spalls, delaminated areas and horizontal cracks that appear to have been caused by water leakage through the expansion joints. The horizontal cracks are located approximately 4" to 6" below the top of caps. Bent # 5 cap, left end has soft and deteriorated concrete with the top of the cap spalled off outside the bearing area. The spalled area reaches the bearings but no loss of bearing area apparent at this inspection.

07/08/2020 - JCJ & TJL - Substructure deterioration continues. Bent # 6 horizontal cracking is 1/2" in width. Raised to C Priority.

Bent # 5 cap, left end has soft and deteriorated concrete with the top of the cap spalled off outside the bearing area. The spalled area reaches the bearings but no loss of bearing area apparent at this inspection.

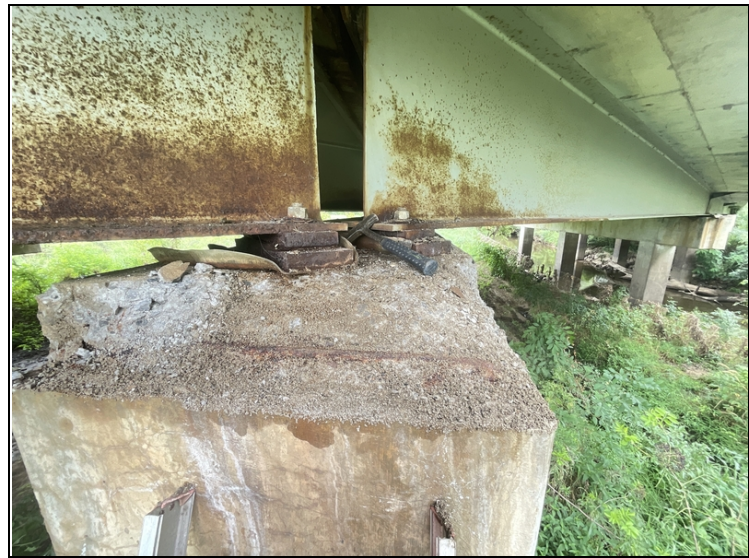
Bent # 5 cap, left end has soft and deteriorated concrete with the top of the cap spalled off outside the bearing area. The spalled area reaches the bearings but no loss of bearing area apparent at this inspection.

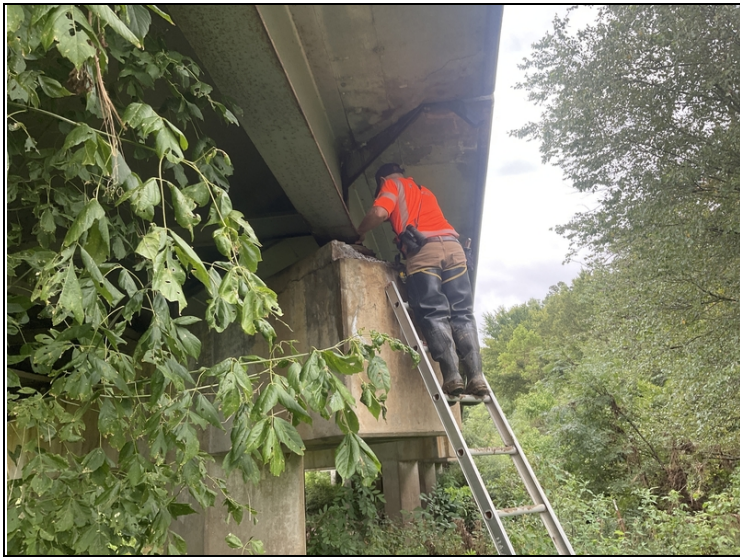
Bent # 5 cap, left end has soft and deteriorated concrete with the top of the cap spalled off outside the bearing area. The spalled area reaches the bearings but no loss of bearing area apparent at this inspection.

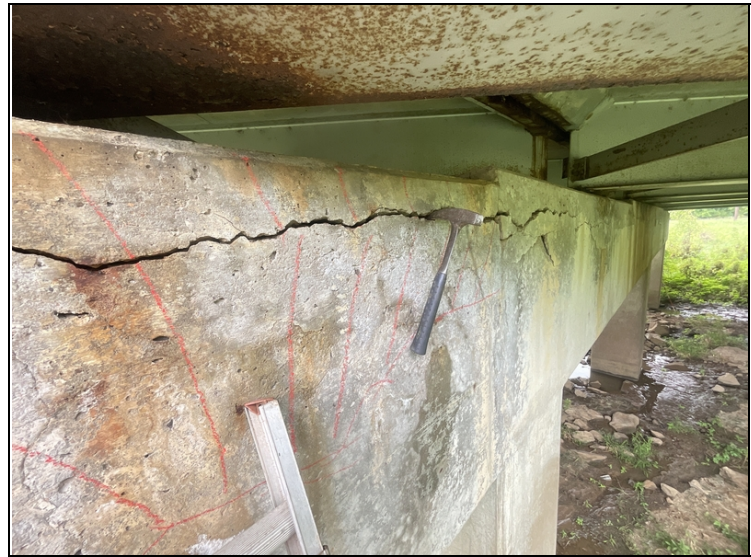
Bent # 6 cap backface between columns # 2 and # 3 has map cracking and delaminated areas. The left side of cap has a 9' long delaminated area in the top and face of cap. The delaminated area appears to extend under bearing # 1 of span # 5.

Bent # 6 cap backface, left side has 9' long delaminated area in the top and face of cap. The delaminated area appears to extend under bearing # 1 of span # 5

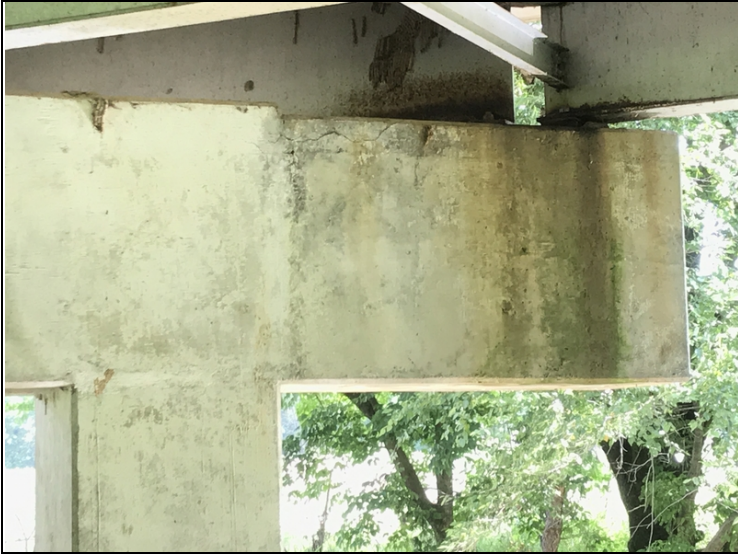
Horizontal cracking in the a right side of bent # 3.  
Back face.

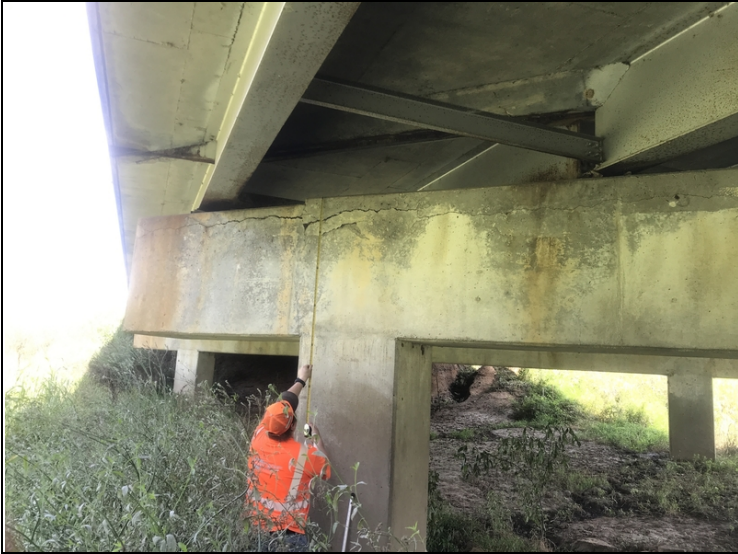
Left end of bent # 6 cap. Back face. 1/2" wide crack.

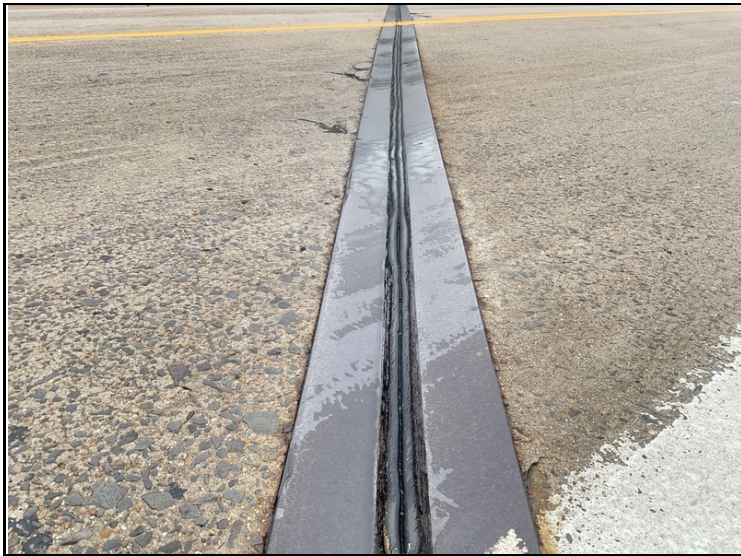
Expansion joint seals are deteriorated with cracking, rips and tears visible in the seals. Expansion joint assemblies have corrosion with pack rust separating the seals from the assemblies.

Bent # 3 expansion joint-Seal deterioration.

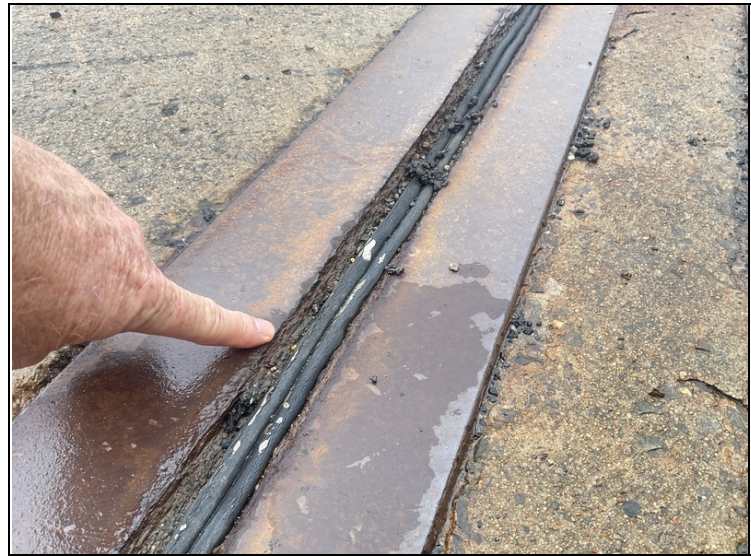
Expansion joint assemblies have corrosion with pack rust separating the seals from the assemblies. Abutment # 1 expansion joint pictured.

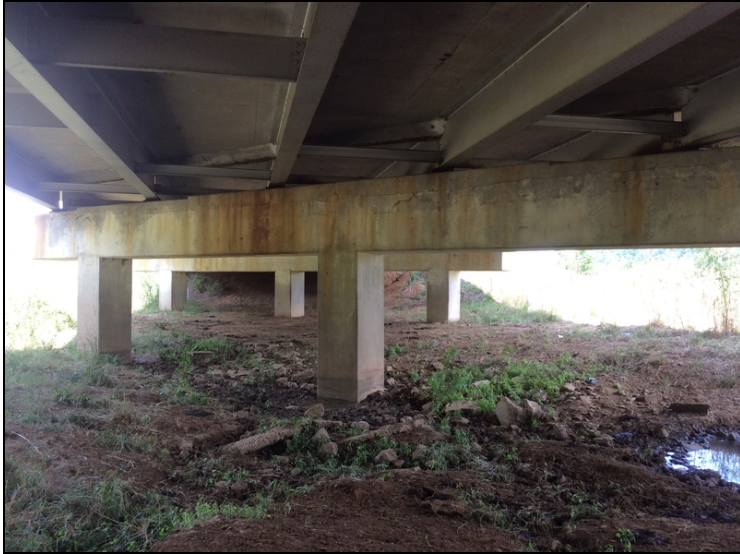
Water stains and significant deterioration of the bent caps indicate that the deck joint seals are leaking.

Water stains in the intermediate bents from water leakage through the deck joints.

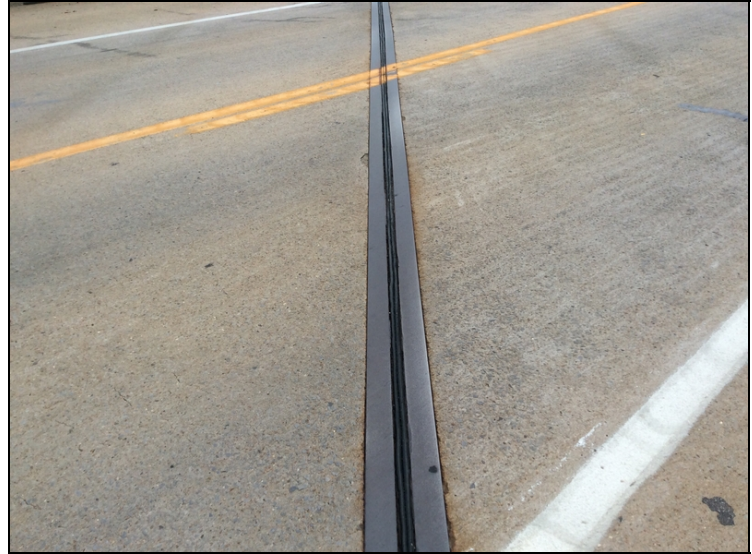
Bent # 7 joint seal condition.

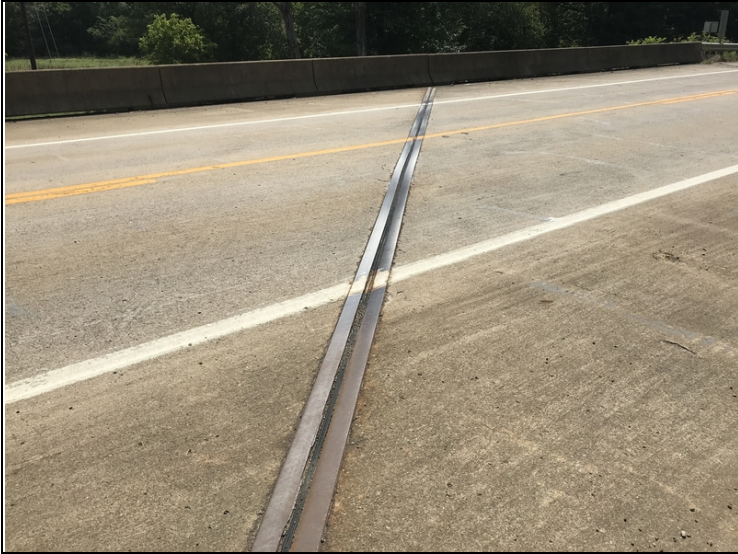
Span # 2 expansion joint seal. Typical.

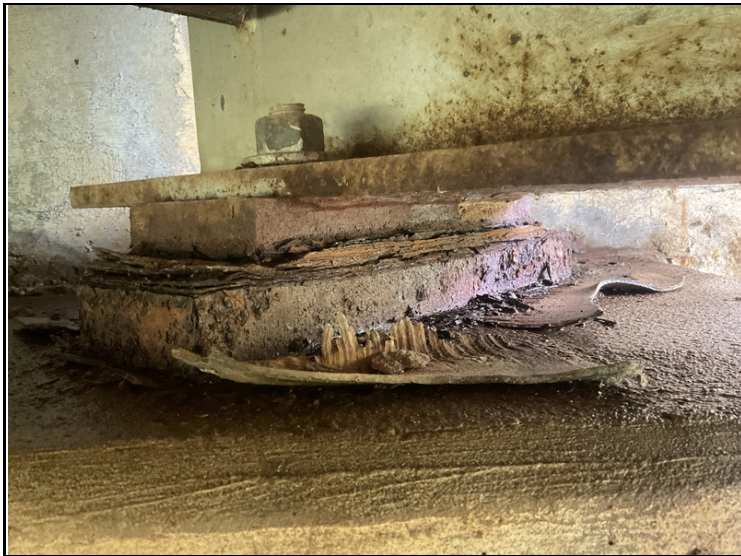
08/17/2022 - RSM - Changed priority from "D" to "C" due to continued deterioration with pack rust restricting bearing movement.

Abutment # 2, bearing # 6-Corrosion with pack rust between bearing plates.

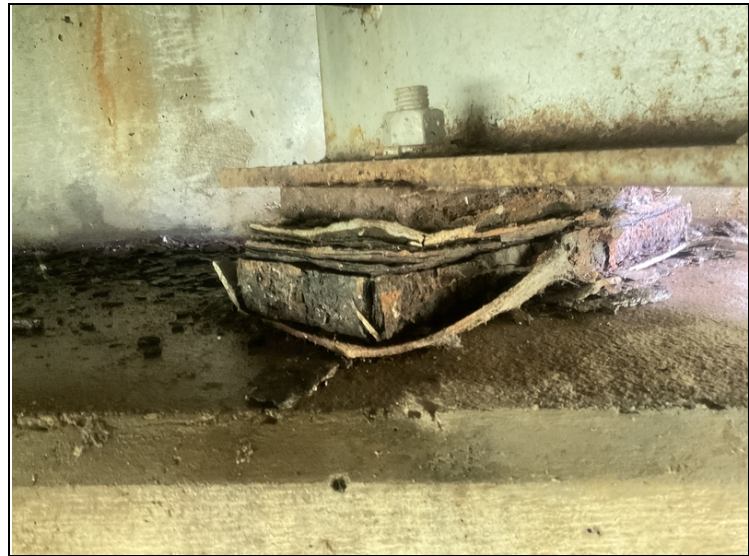
Abutment # 1, bearing # 1-Corrosion.

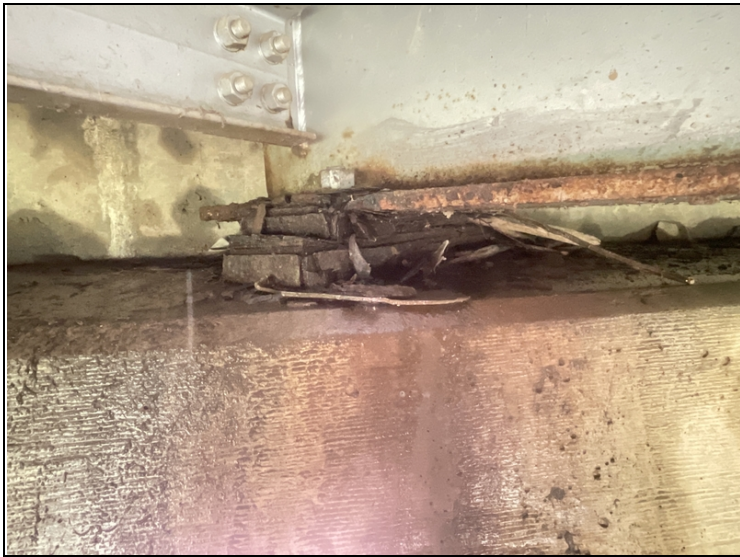
Abutment # 1, bearing # 3-Corrosion.

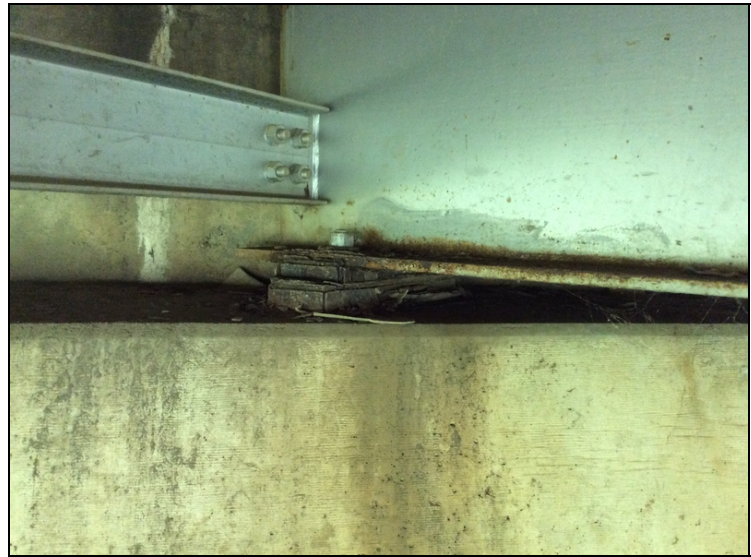
Bearings have active corrosion with flaking rust and heavy pack rust between the sole and masonry plates.

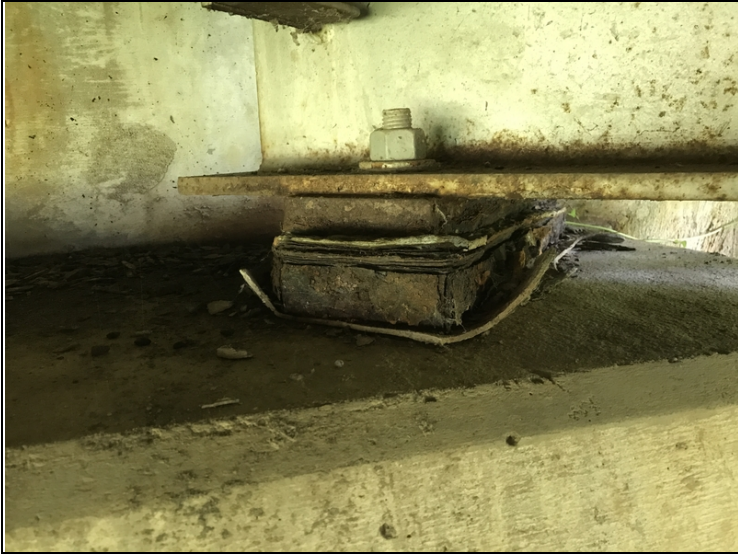
Bearings have active corrosion with flaking rust and heavy pack rust between the sole and masonry plates.

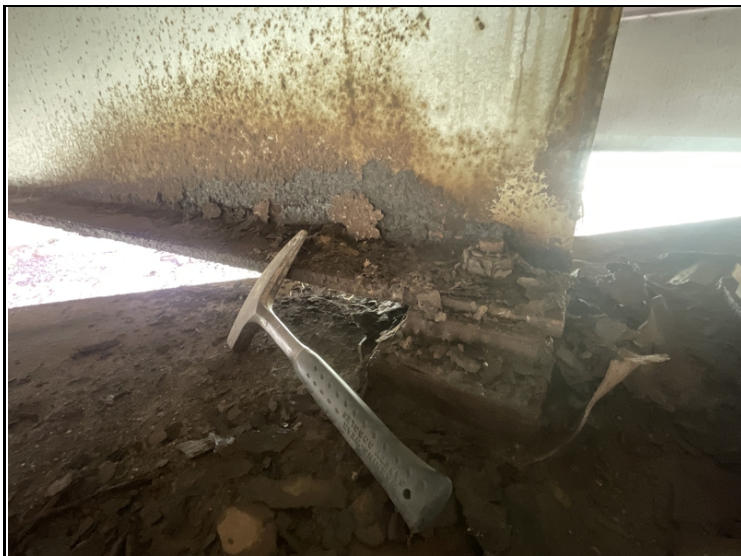
Beams have areas of active corrosion with flaking rust at the ends of beams where the expansion joint seals leak water on the superstructure. There is up to approximately 1/8" section loss to the base of webs and bottom flanges. The paint system is developing light freckled rust in numerous areas.

Span # 6, beam # 3 at bent # 6-Corrosion/section loss.

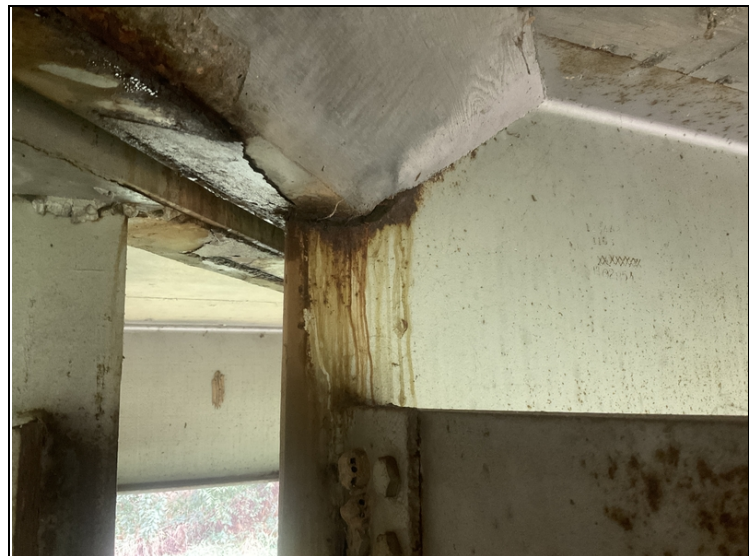
Span # 5, beam # 2 at bent # 5-Corrosion to web at expansion dam.

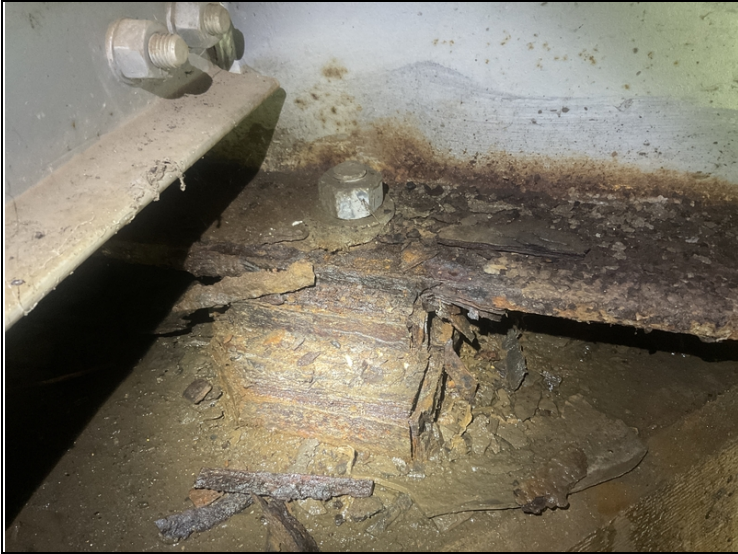
Abutment # 1, beam # 3-Corrosion.

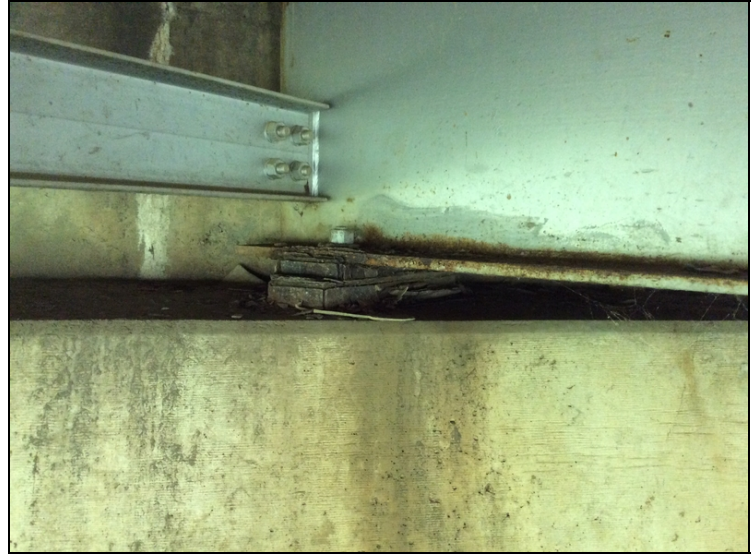
Active corrosion at the beam ends from water leakage through the expansion joints.

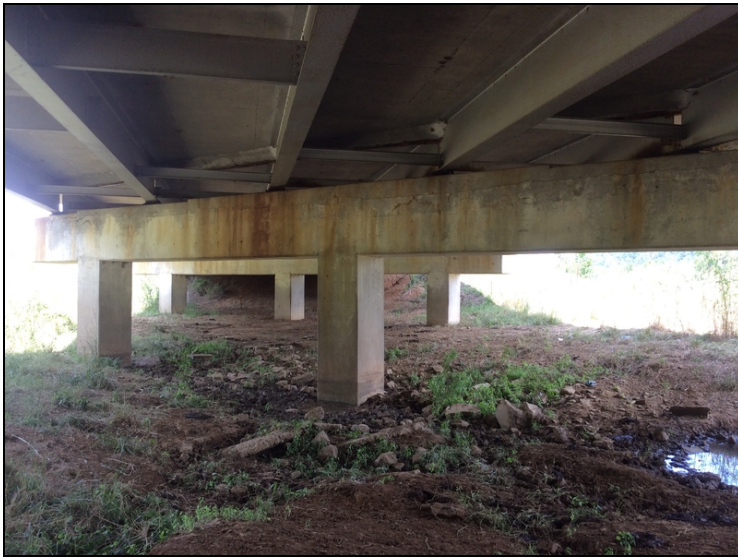
Freckled rust typical on the paint system.

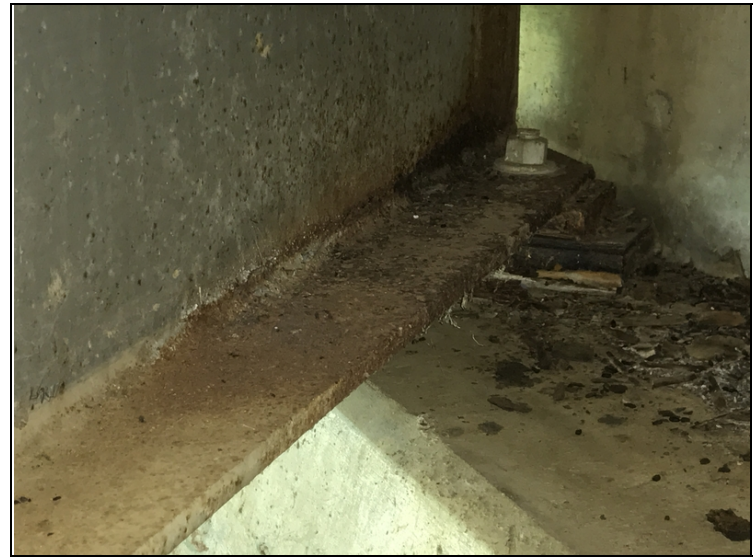
Beams have areas of active corrosion with flaking rust at the ends of beams where the expansion joint seals leak water on the superstructure. There is up to approximately 1/8" section loss to the base of webs and bottom flanges.

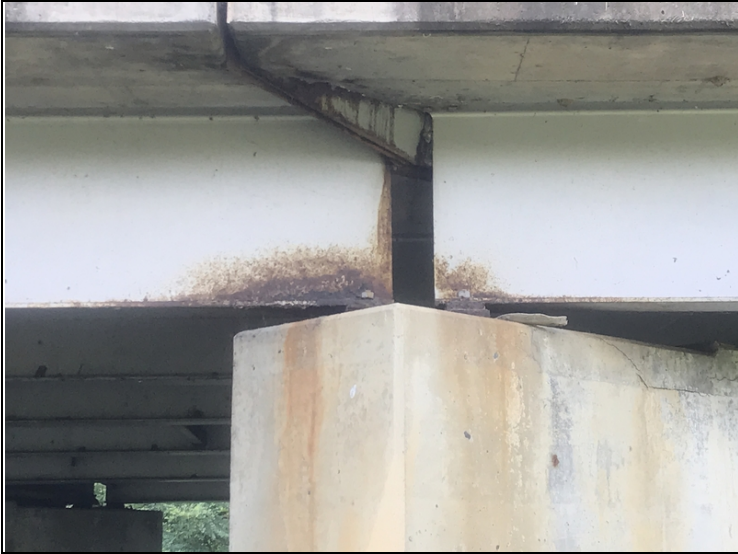
Beams have areas of active corrosion with flaking rust at the ends of beams where the expansion joint seals leak water on the superstructure. There is up to approximately 1/8" section loss to the base of webs and bottom flanges.

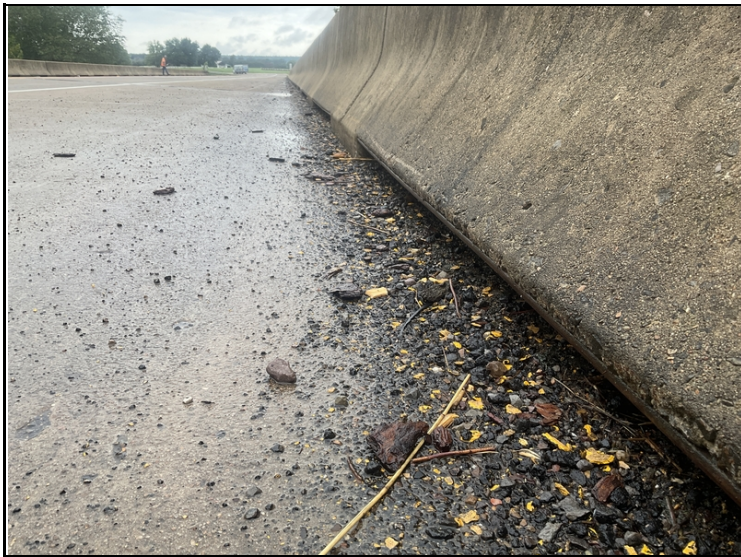
The shoulders have dirt and debris accumulation that restricts the deck drains in the parapets.
