Asset #05864(Routine)

# US HWY 71-Logan Co over Little Petit Jean River

Location: 0.65 MI N. OF Scott, Co

Team Lead: Bob McEntyre, Inspection Date: 08/17/2022

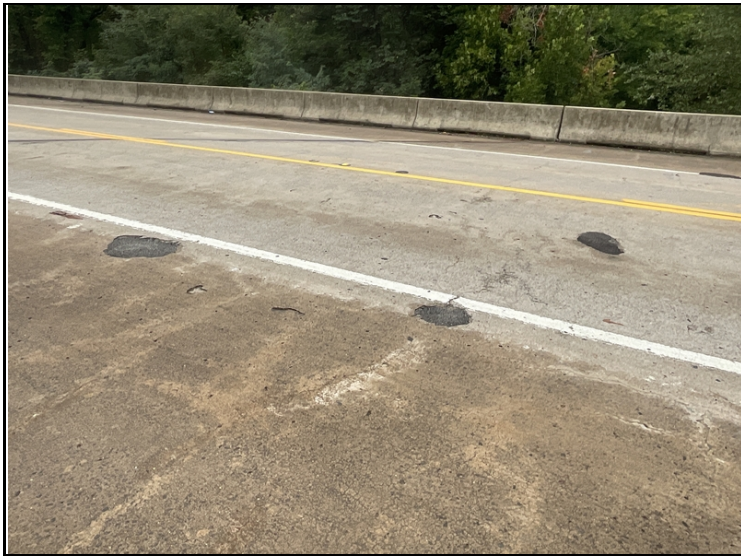
Span # 4 has several moderate sized spalls in the driving lanes with temporary asphalt repairs.

Span # 4 has several moderate sized spalls with temporary asphalt repairs.

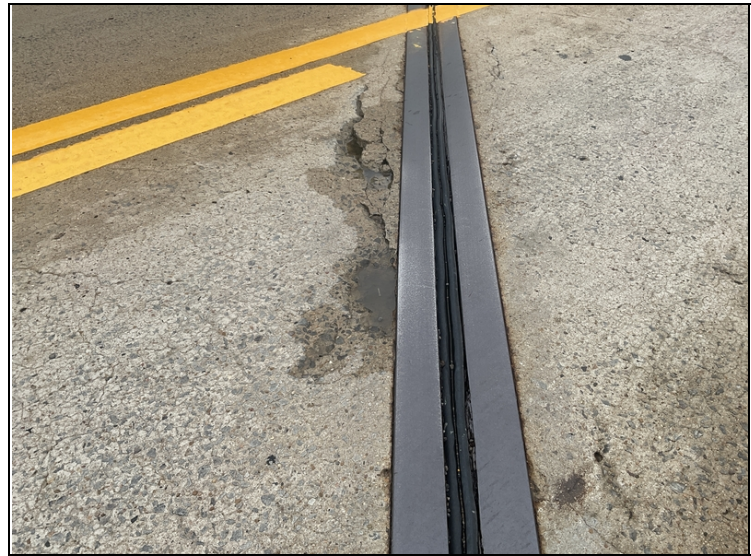
Span # 3, left lane-Spalling adjacent to expansion joint assembly.

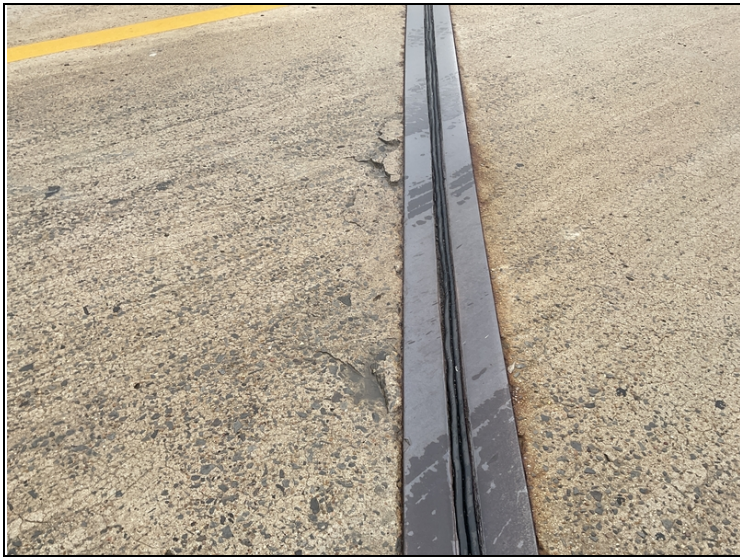
Span # 2, right lane at bent # 3-  
Delaminated/spalled area adjacent to expansion  
joint assembly.

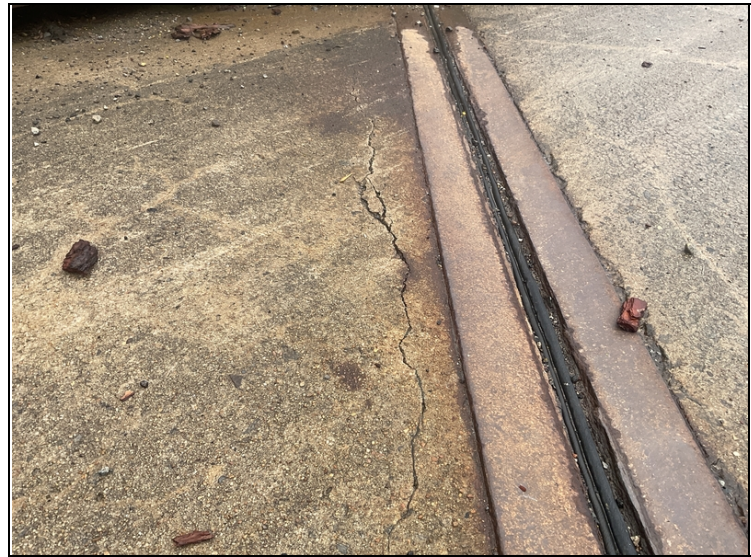
Cracking / delaminated area in left shoulder  
adjacent to bent # 2 expansion joint assembly.
