Asset #05999(Routine)

# US Highway 71 over Ross Creek-Scott Co.

Location: 9.53 MI NO JCT 270

Team Lead: Jeff Jones, Inspection Date: 04/12/2021

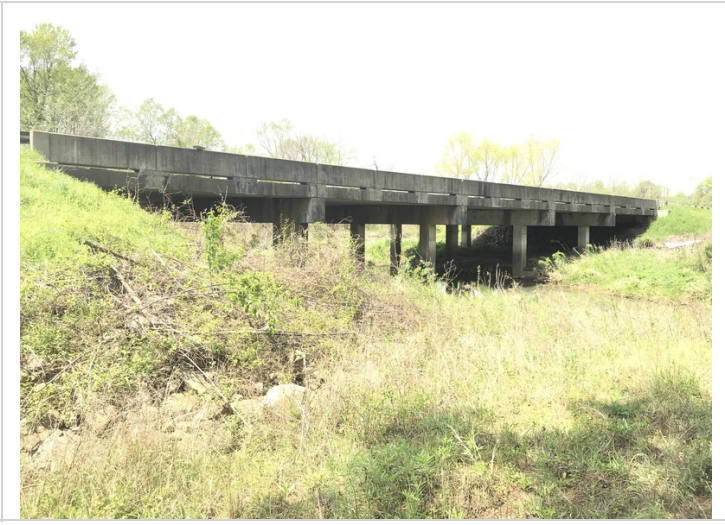
Elevation. East side of structure.

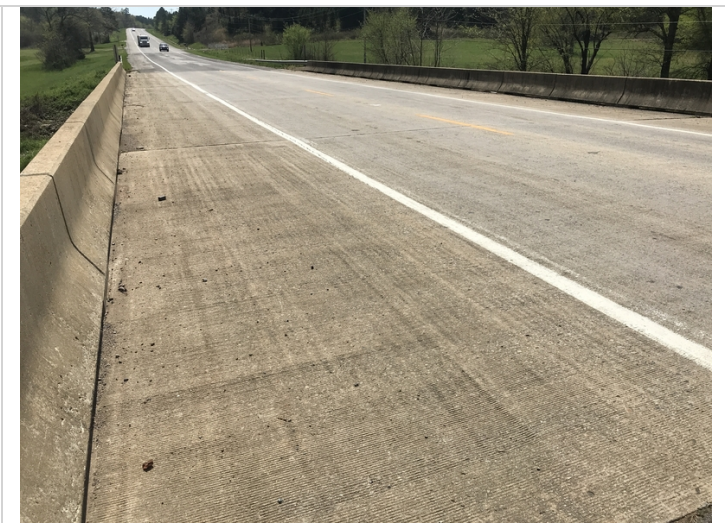
Driving surface of the deck. Typical.

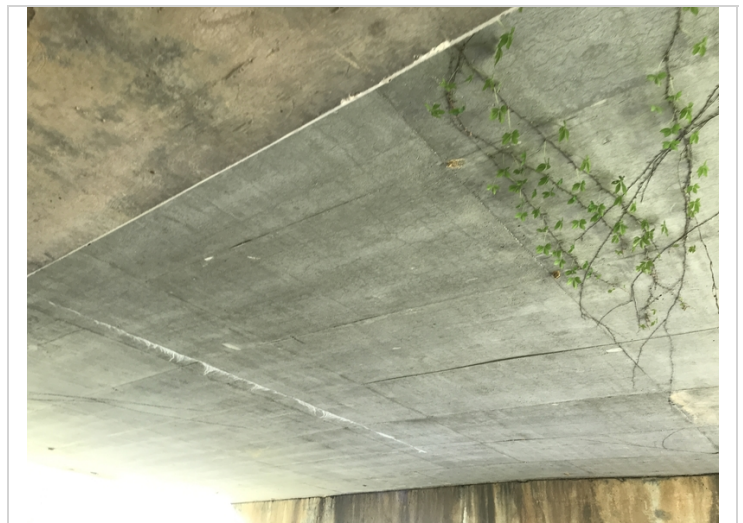
Slab soffit. Typical.

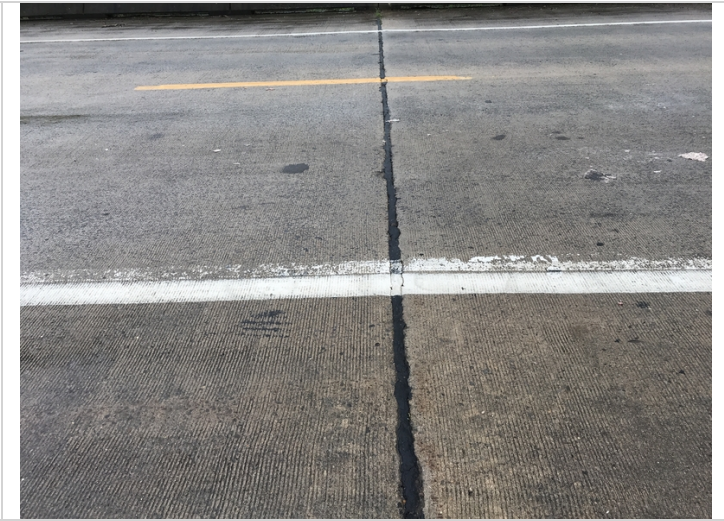
Typical joint seal.

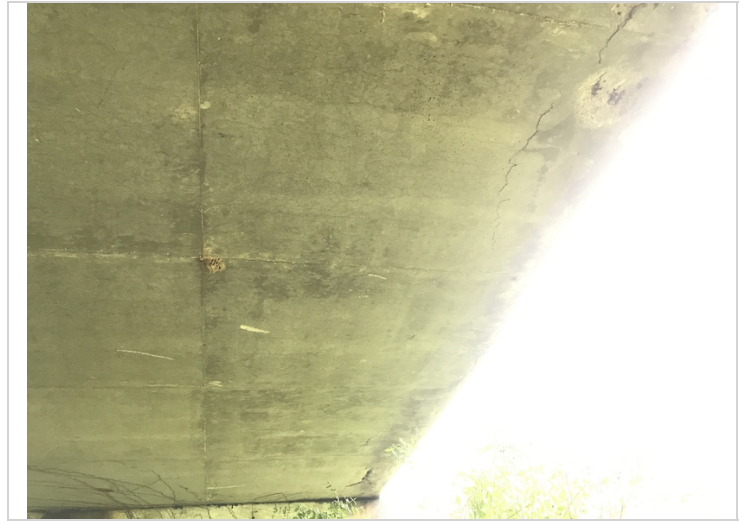
Span # 2 Lt spalling with exposed reinforcing steel.

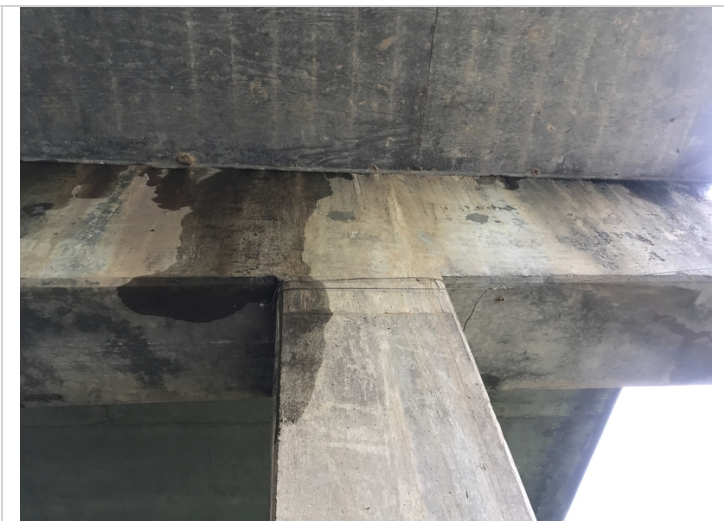
Bent # 3 Lt cap crack with efflorescence buildup.

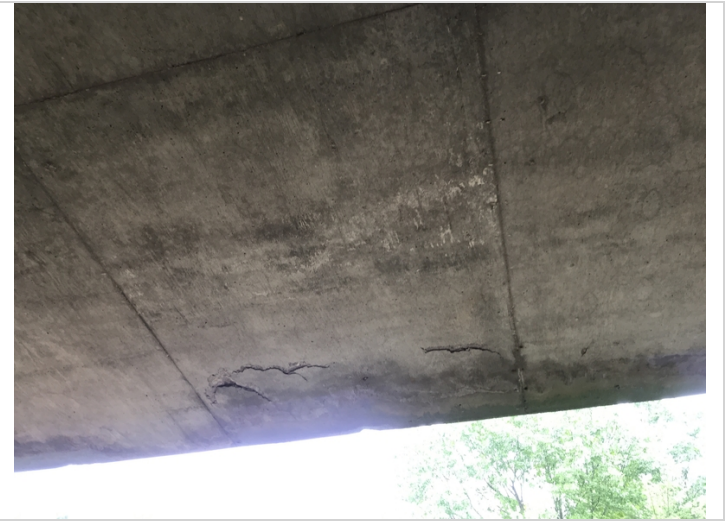
Span # 5 Rt concrete delamination along the edge of the slab.

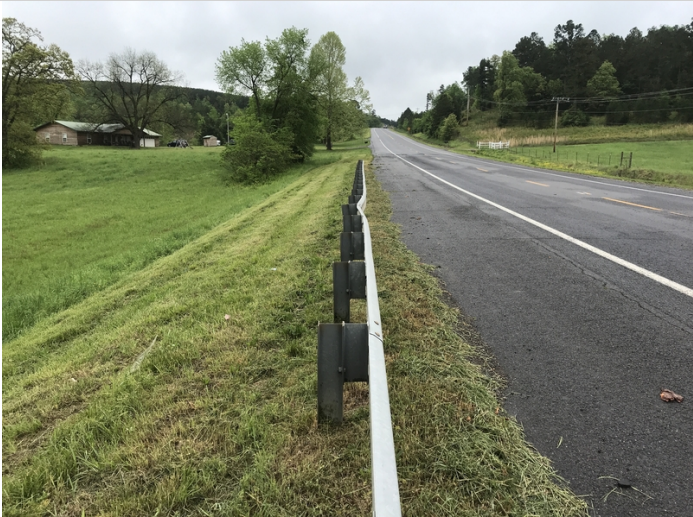
Southeast approach rail damage.

The southeast approach railing has light collision damage.

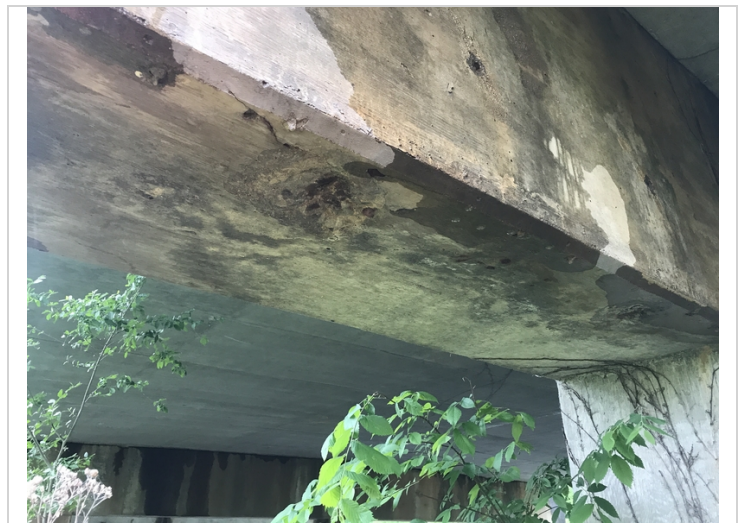
Bent # 2 Lt spalling with exposed reinforcing steel on the undersurface of the slab.

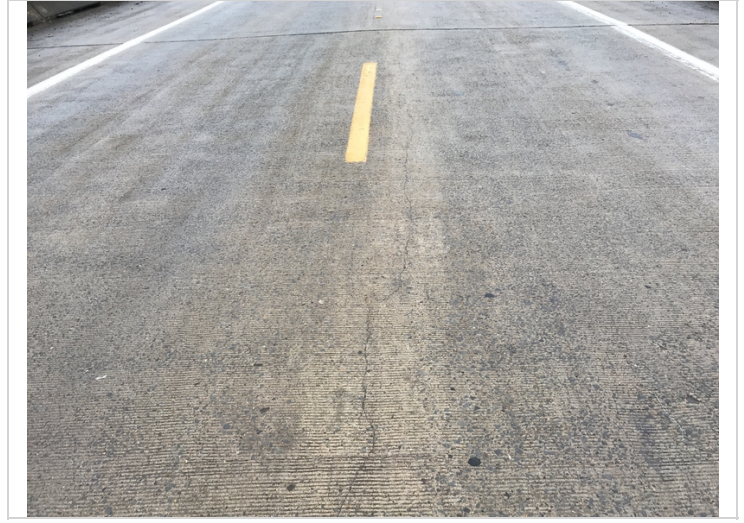
Longitudinal cracks on the driving surface of the slab.

The driving surface of the slab span has sealable cracking in all spans.

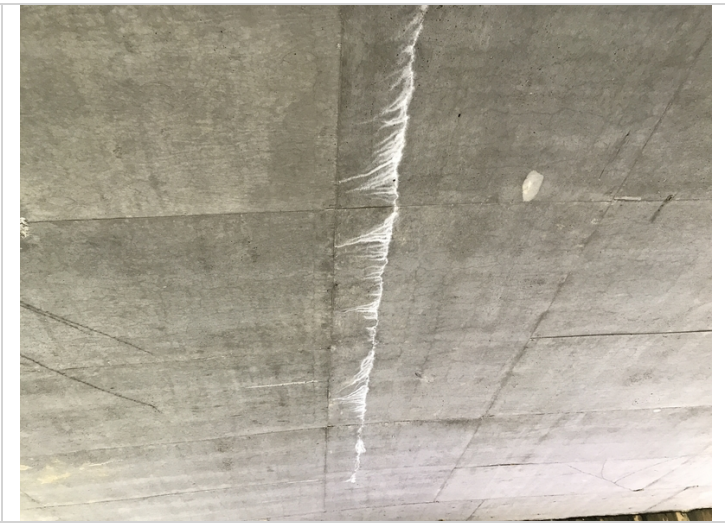
Span # 2 cracking with efflorescence on the undersurface.

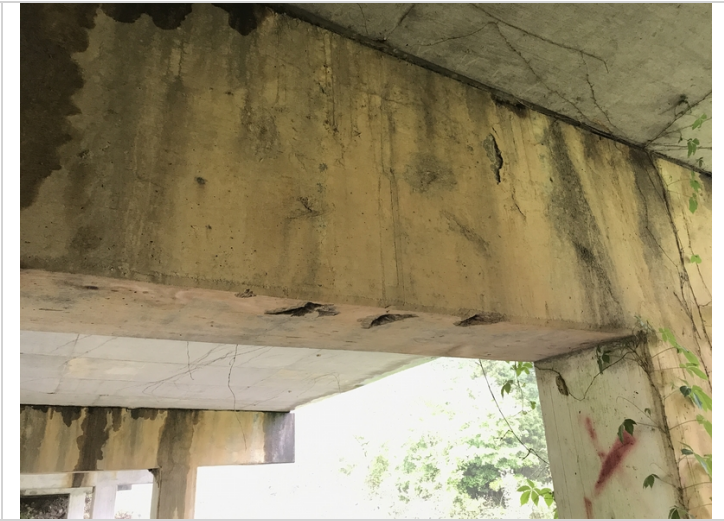
Bent # 2 spalling with exposed reinforcing steel.

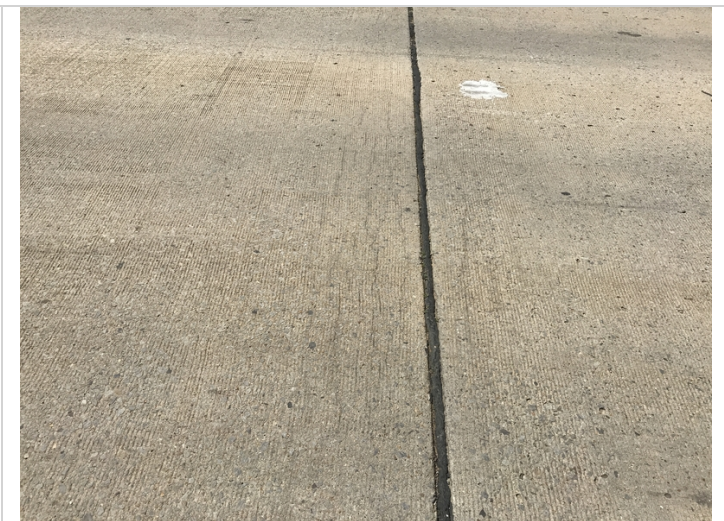
Transverse cracking in Span # 2 adjacent to Bent # 3.

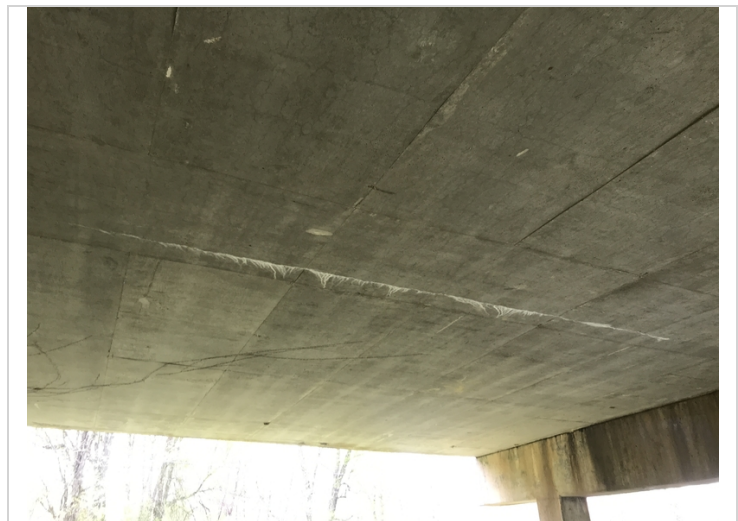
Longitudinal cracking with efflorescence in Span # 2.

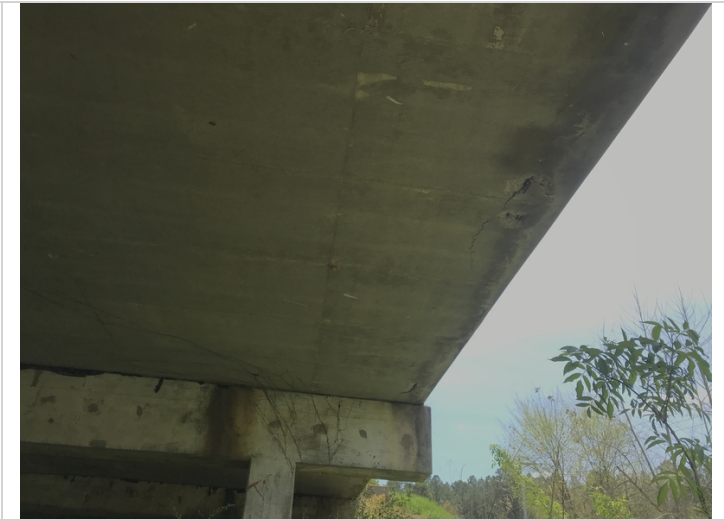
Spalls with exposed reinforcing steel in the Left edge of Span # 2.

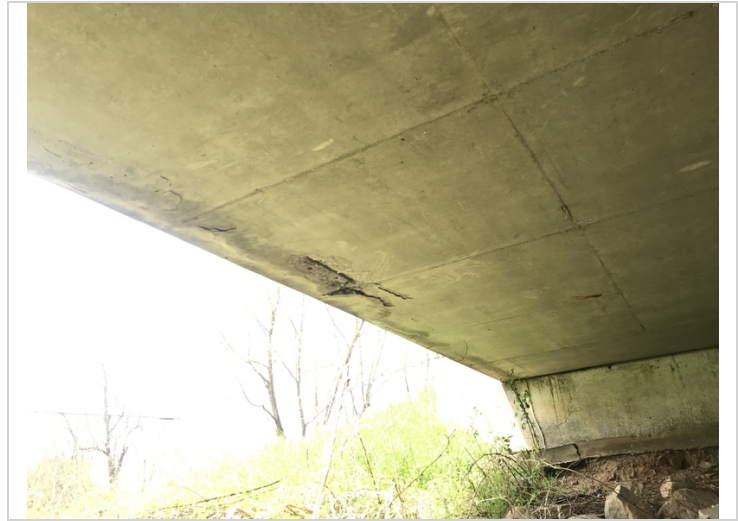
Left edge of Span # 5. Spalling with exposed reinforcing steel.

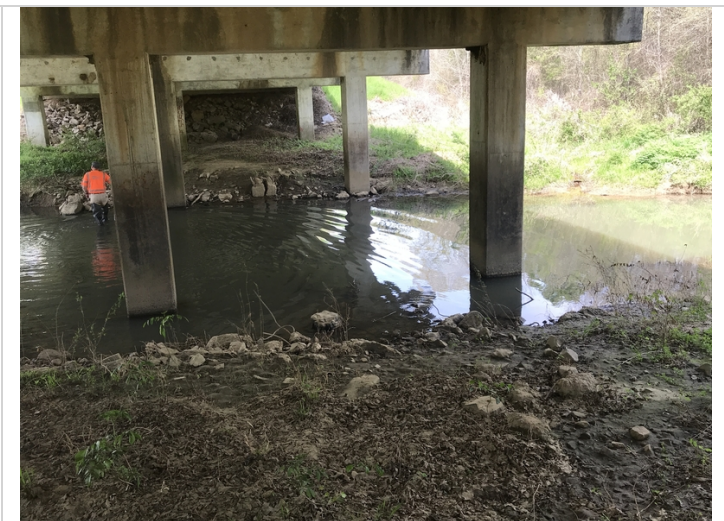
(205) -Light abrasion at the base of columns in the channel.							
215	Reinforced Concrete Abutment	LF	128	128	0	0	0
(215) -No apparent problems with the abutments during this inspection.  -Concrete mud sill placed in front of the abutment caps have minor erosion with cracks and settlement along the edges.							
220	Reinforced Concrete Pile Cap/Footing	LF	60	60	0	0	0

Light abrasion at the base of columns in the channel.

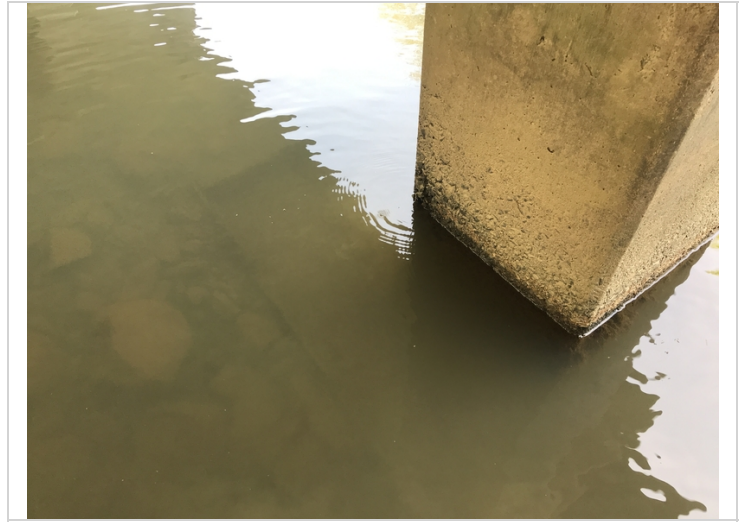
(220) -Bent # 3, Right and Left columns and Bent # 4 Left column have the top of footings exposed with no apparent scour problems during this inspection.							
234	Reinforced Concrete Pier Cap	LF	190	145	34	11	0
1080	Delamination/Spall/Patched Area	LF	25	0	22	3	0
1090	Exposed Rebar	LF	6	0	0	6	0
1120	Efflorescence/Rust Staining	LF	5	0	3	2	0
1130	Cracking (RC and Other)	LF	9	0	9	0	0

Top of footing is exposed at Bent # 3. Right column.

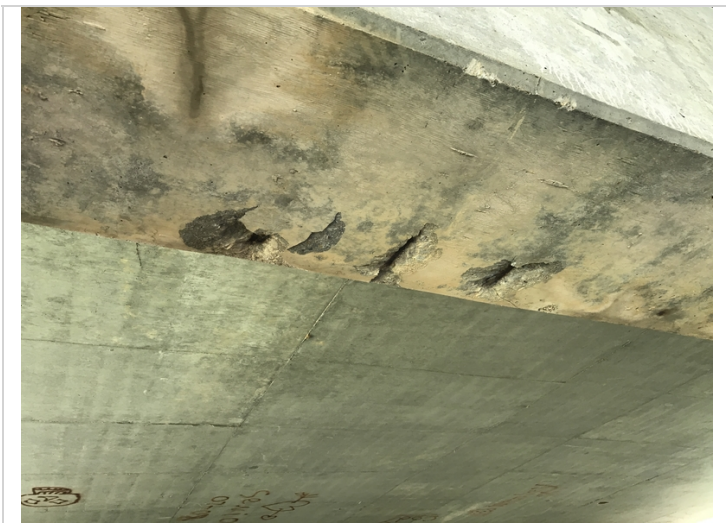
Spalls with exposed reinforcing in the undersurface of bent #  
2.

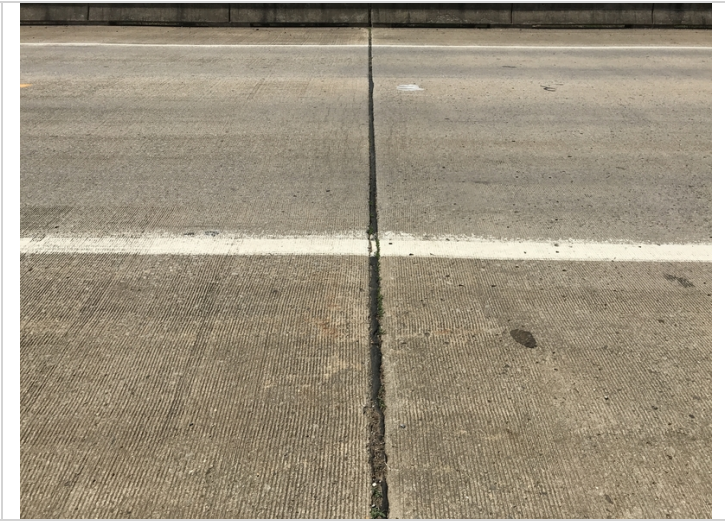
Deck joint sealant over bent # 3.

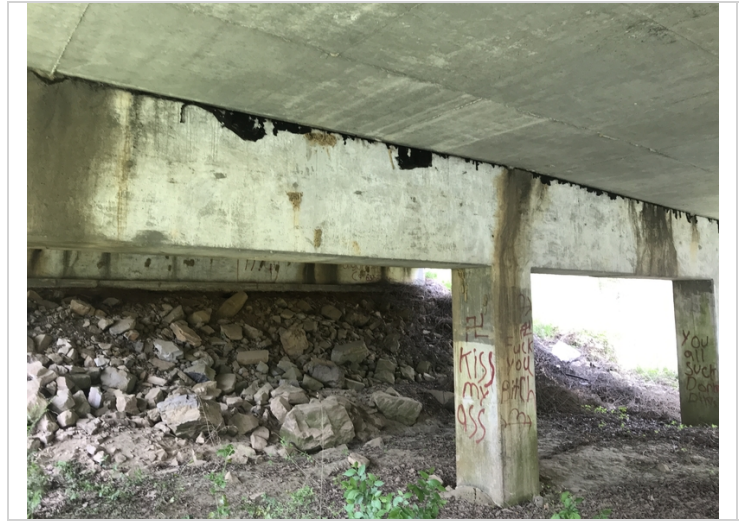
Staining in the intermediate caps from leaking joints.

Deck joint sealant is deteriorated and leaks water on the bent caps.

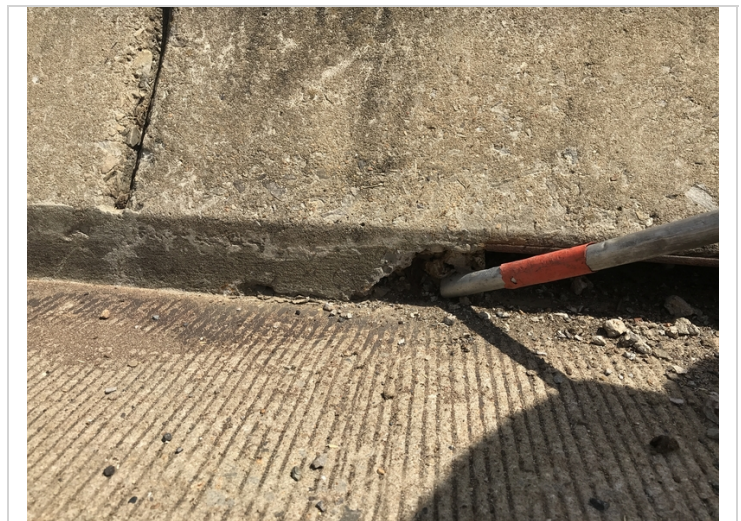
Spall with exposed reinforcing steel at the base of parapet.  
Span # 4. Right.

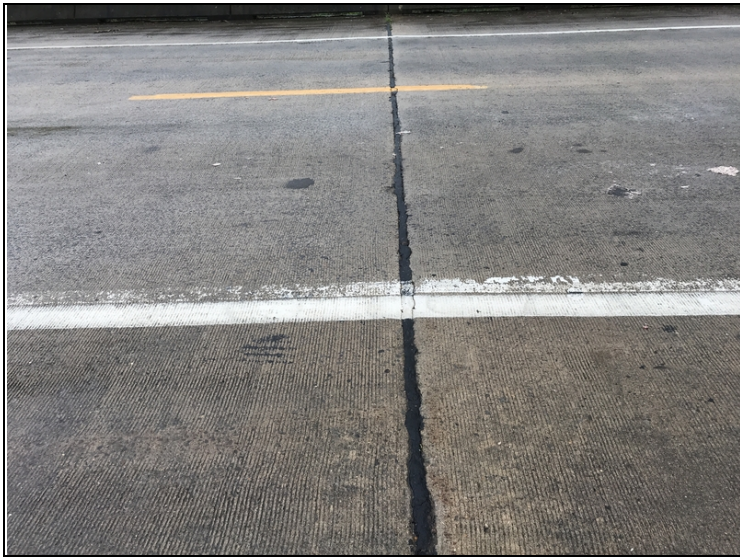
Typical joint seal.

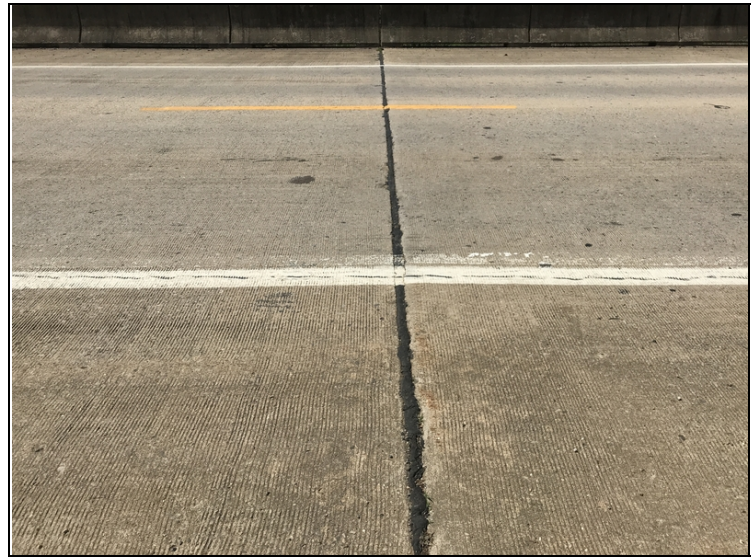
Deck joint sealant over bent # 5.

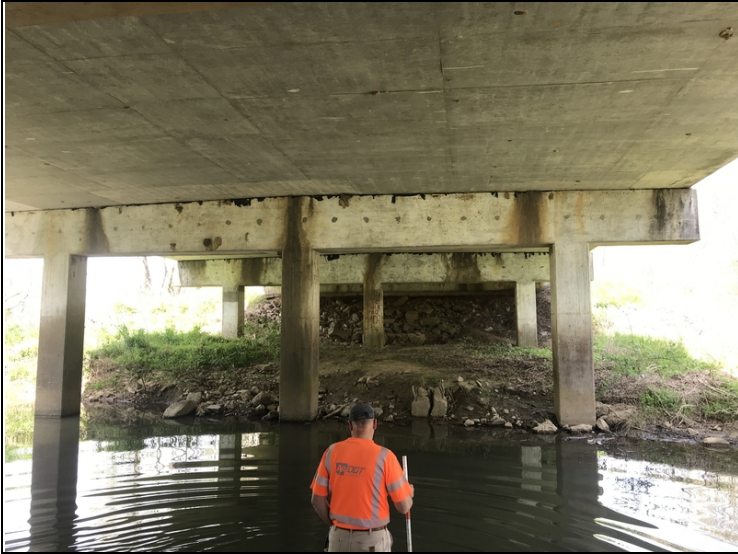
Staining on intermediate bent caps from leaking joint sealant.

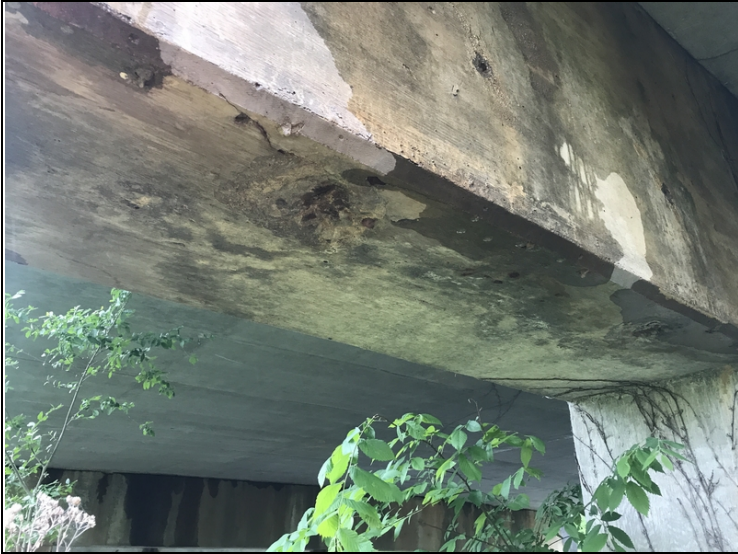
The intermediate bent caps have delaminated areas and shallow spalling with exposed reinforcing steel from apparent joint leakage.

Bent # 2 Left spalling with exposed reinforcing steel on the undersurface of the slab.

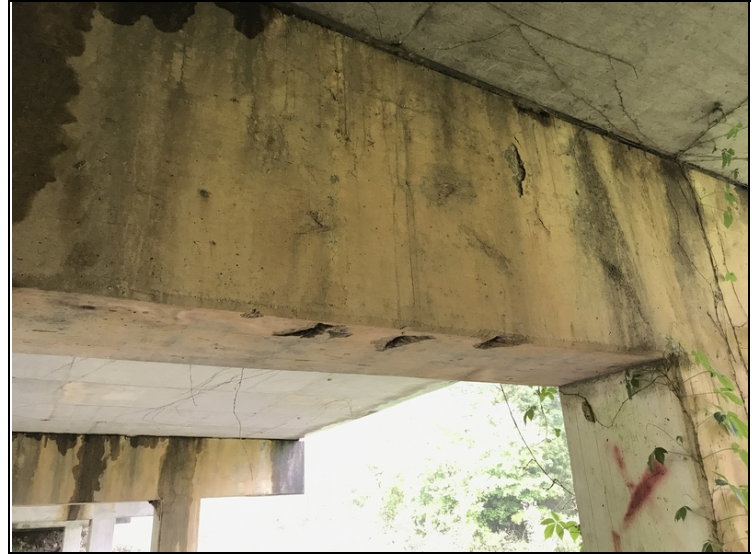
Bent # 2 spalling with exposed reinforcing steel.

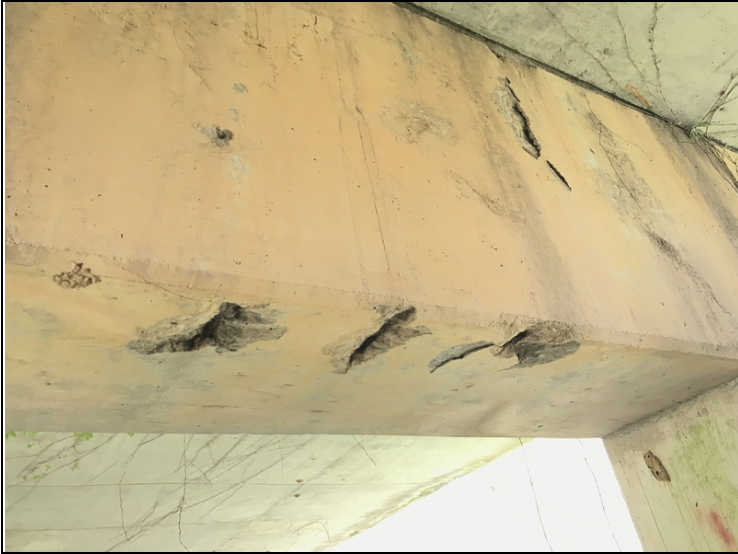
Spalls with exposed reinforcing steel in bent # 2 cap.

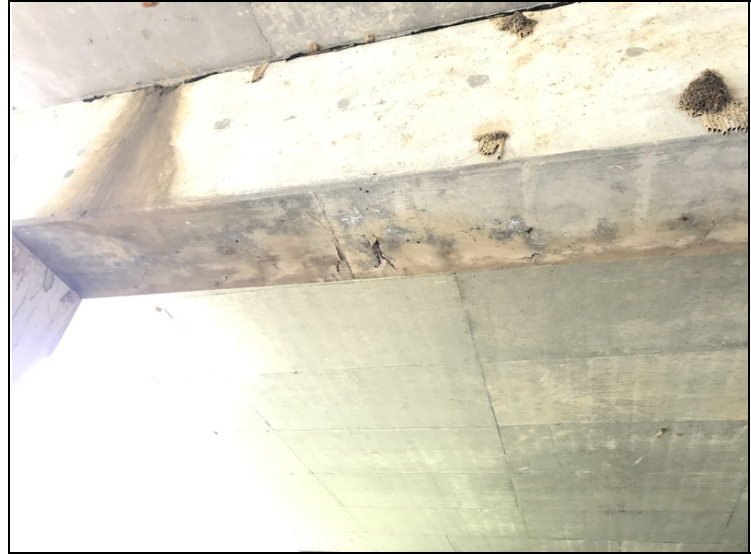
Spalls with exposed reinforcing steel in bent # 4. Left.

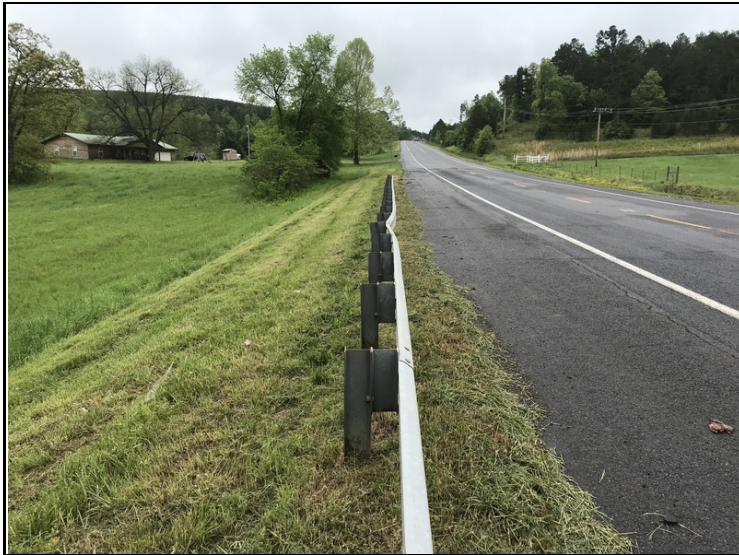
Southeast approach rail damage.

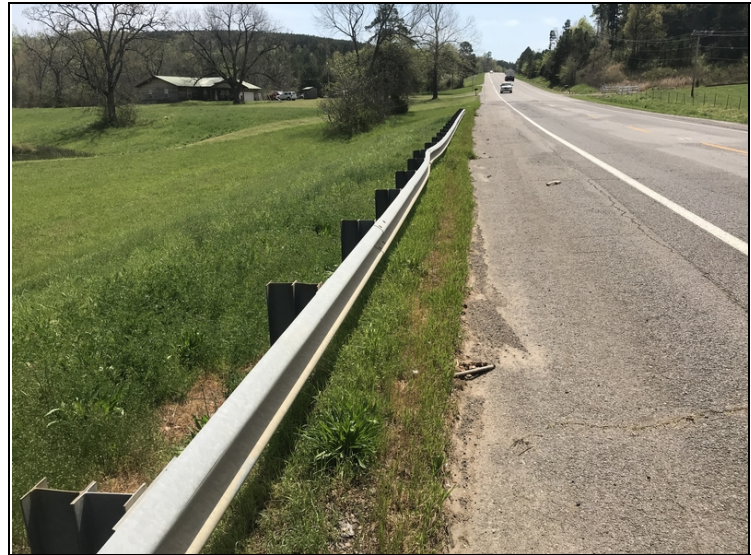
Collision damage in the southeast approach railing.

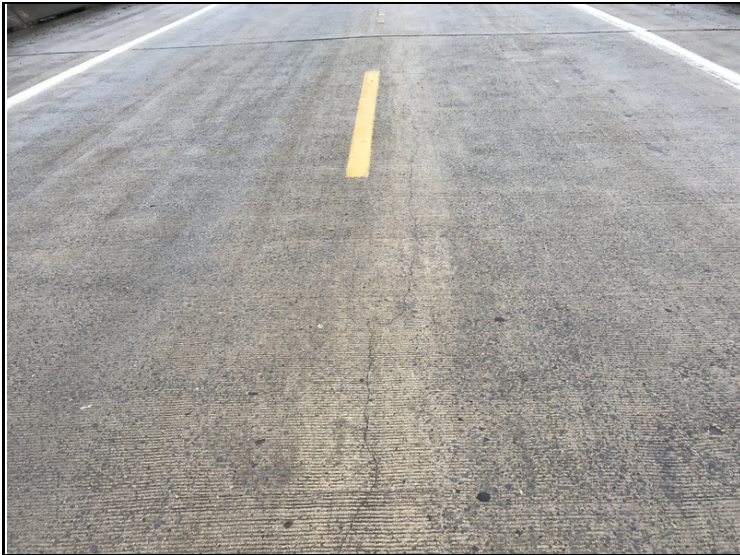
Longitudinal cracks on the driving surface of the slab.

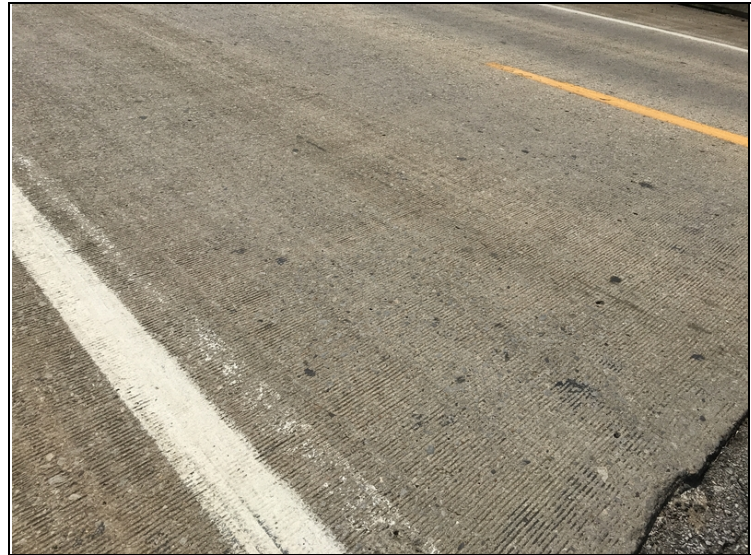
Sealable longitudinal cracking in the deck.

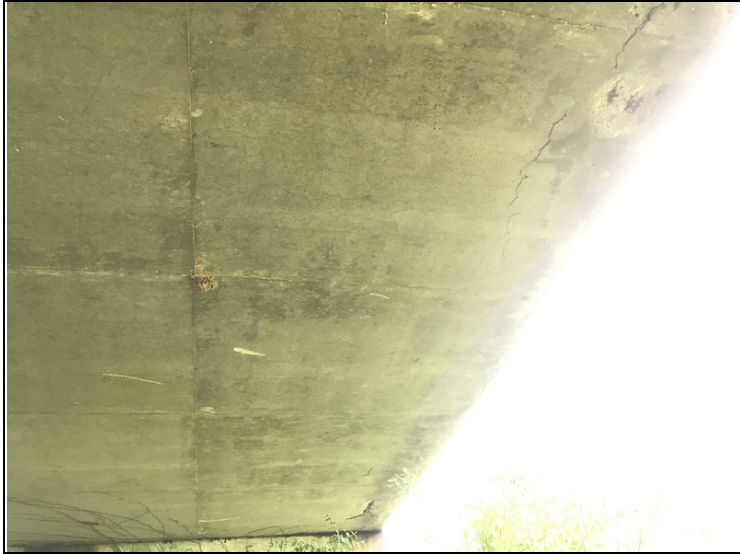
The undersurface of the slab on both exterior edges has cracks, delaminated areas, and spalls with exposed reinforcing steel.

Span # 2 Left has spalling with exposed reinforcing steel.

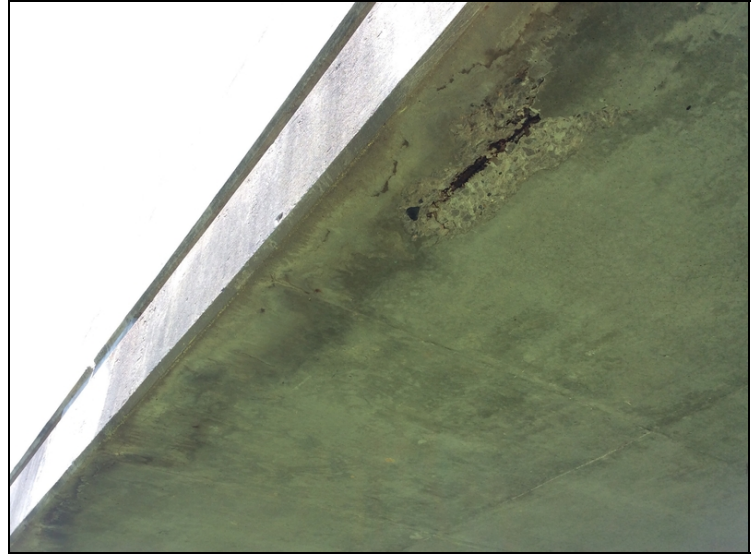
Longitudinal cracks with stains, delaminated areas, and softball sized spalls with exposed reinforcing steel visible from the undersurface of the deck, located approximately 1' from both edges of the deck. Span # 2 Left pictured.

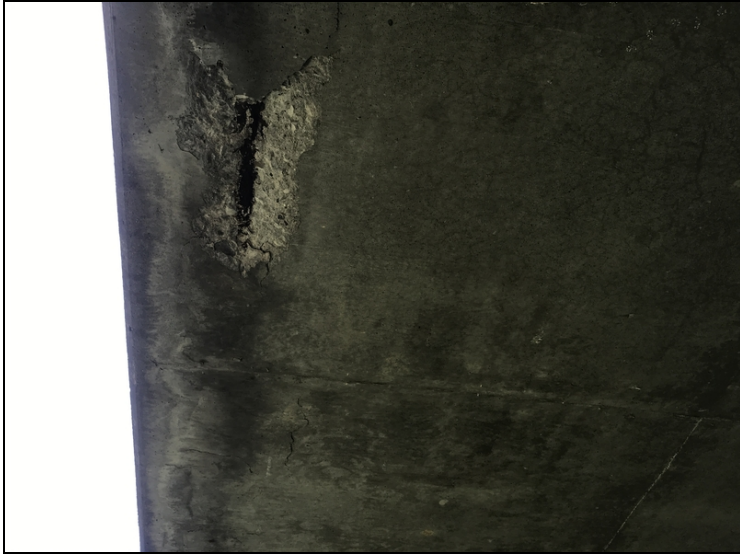
Left edge of deck soffit. Spalls with exposed reinforcing steel.

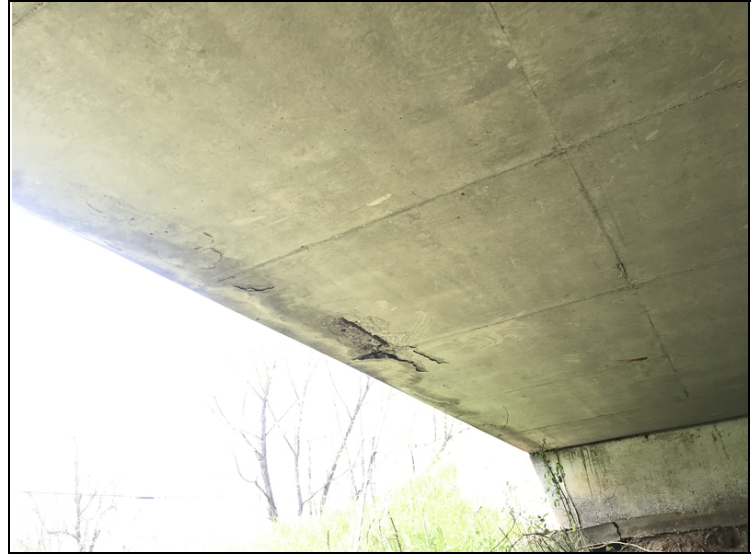
Left edge of Span # 5. Slab soffit has spalling with exposed reinforcing steel.
