Bridge #00331(Routine)

SH 10 Spur over Hester Creek-Seb. Co.

Location: 2.31 MI E OF JCT US 71

Team Lead: Eric West Inspection Date: December 20, 2021

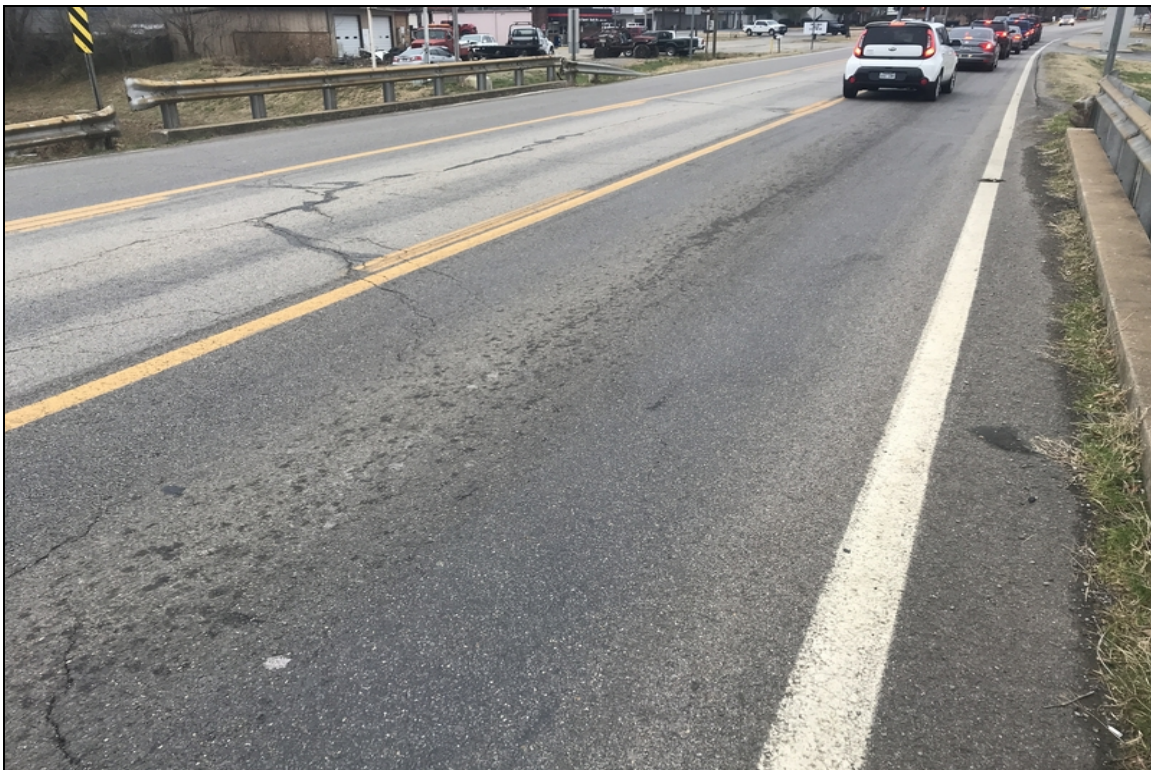
(16) -The asphalt driving surface of the deck has isolated cracks with transverse cracks at the bridge ends. The asphalt driving surface has a full length longitudinal crack at centerline that has been partially sealed in the past. -There are transverse cracks (Perpendicular to the centerline of roadway) between deck girders near the abutments visible from the undersurface of deck. -Longitudinal construction joints where the deck was widened has minor efflorescence. Approach roadways: -The West approach roadway has approximately 2" of settlement at roadway centerline.							
(16-510) -Minor cracking on the asphalt wearing surface.							
110	Reinforced Concrete Open Girder/Beam	LF	294	222	71	1	0
1120	Efflorescence/Rust Staining	LF	1	0	0	1	0
1130	Cracking (RC and Other)	LF	71	0	71	0	0

Typical driving surface of the deck.

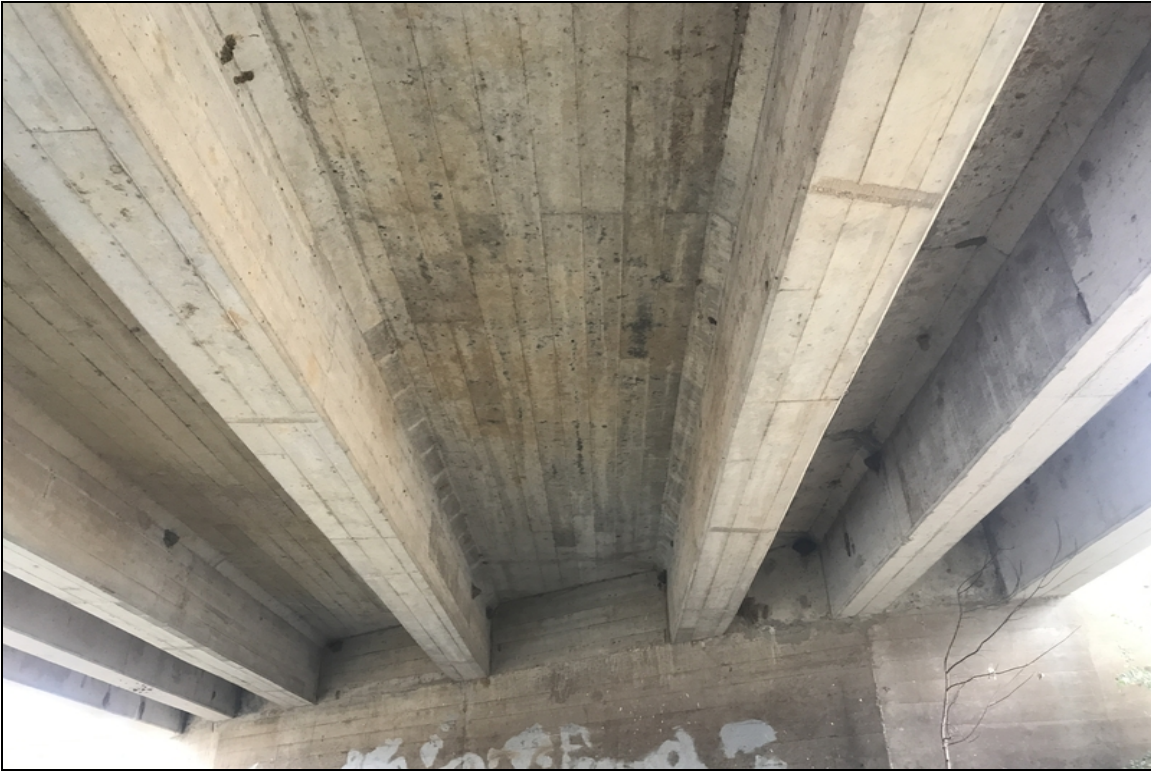
Typical undersurface of the deck.

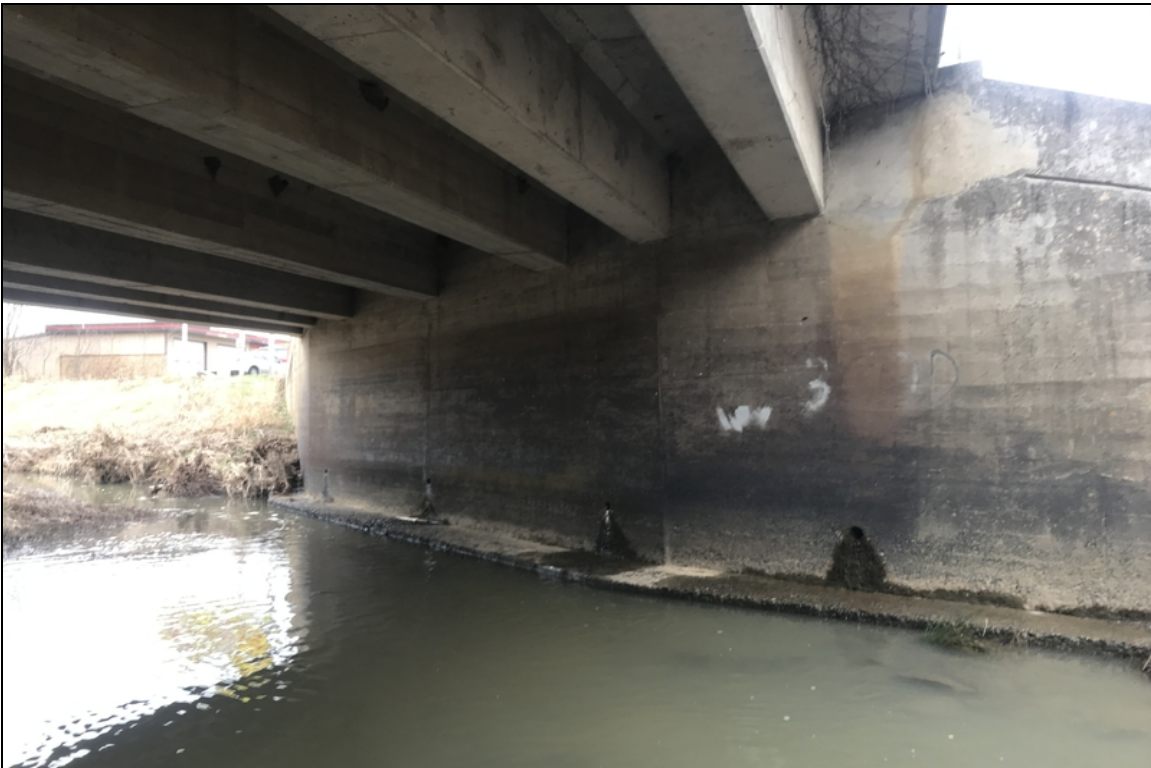
(215) -Abutment # 1 Rt. has a full height moderate width crack at the juncture of the monolithic wing wall. -Abutment # 1 footing is exposed with no apparent undermining at this inspection. -Abutment # 2 stem wall has a full height moderate width crack under girder # 2. The stem wall has a horizontal crack located approximately 4' below the girders under bays # 2 & 5. -There are a few isolated vertical cracks in each abutment. -The abutment stem walls have vertical and diagonal cracking adjacent to the exterior girders. -The base of the abutments have light to medium abrasion.							
220	Reinforced Concrete Pile Cap/Footing	LF	45	0	0	45	0

ELEM	DESCRIPTION	UNITS	TOTAL	CS1	CS2	CS3	CS4
1190 (220)	Abrasion/Wear (PSC/RC)	LF	45	0	0	45	0
-The footing at abutment # 1 is exposed. Probing indicated no apparent undermining or scour problems at this inspection. -The exposed footing has medium / heavy abrasion along the edge and below the water elevation.							
330	Metal Bridge Railing	LF	84	0	84	0	0
1000	Corrosion	LF	84	0	84	0	0
515	Steel Protective Coating	SF	444	0	0	393	51
3440	Effectiveness (Steel Protective Coatings)	SF	444	0	0	393	51
(330) -The bridge railing protective coating is failing in several locations with rust forming on the railing. Approach railing: -Northeast approach bridge rail has recently been replaced.							
(330-515)							
-Bridge rails have a failing paint system.

Abutment #1 typical.

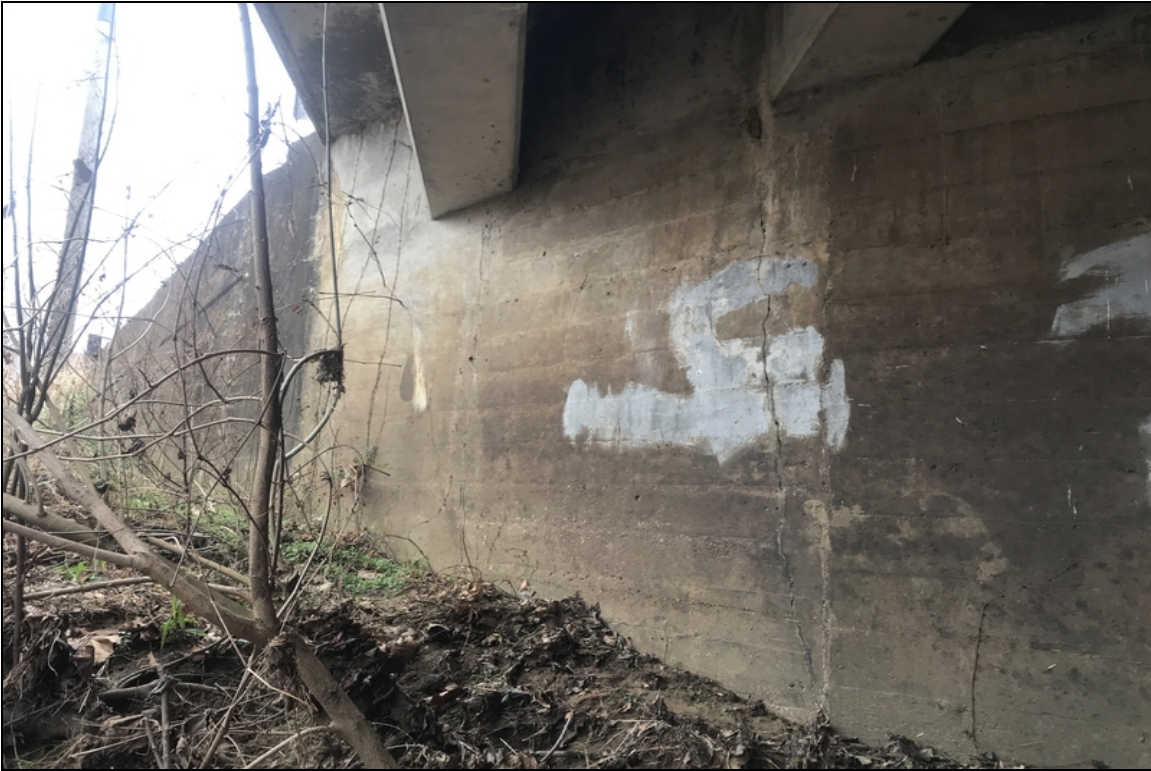
Abutment #2 Lt moderate width vertical cracking and cracking with efflorescence buildup.

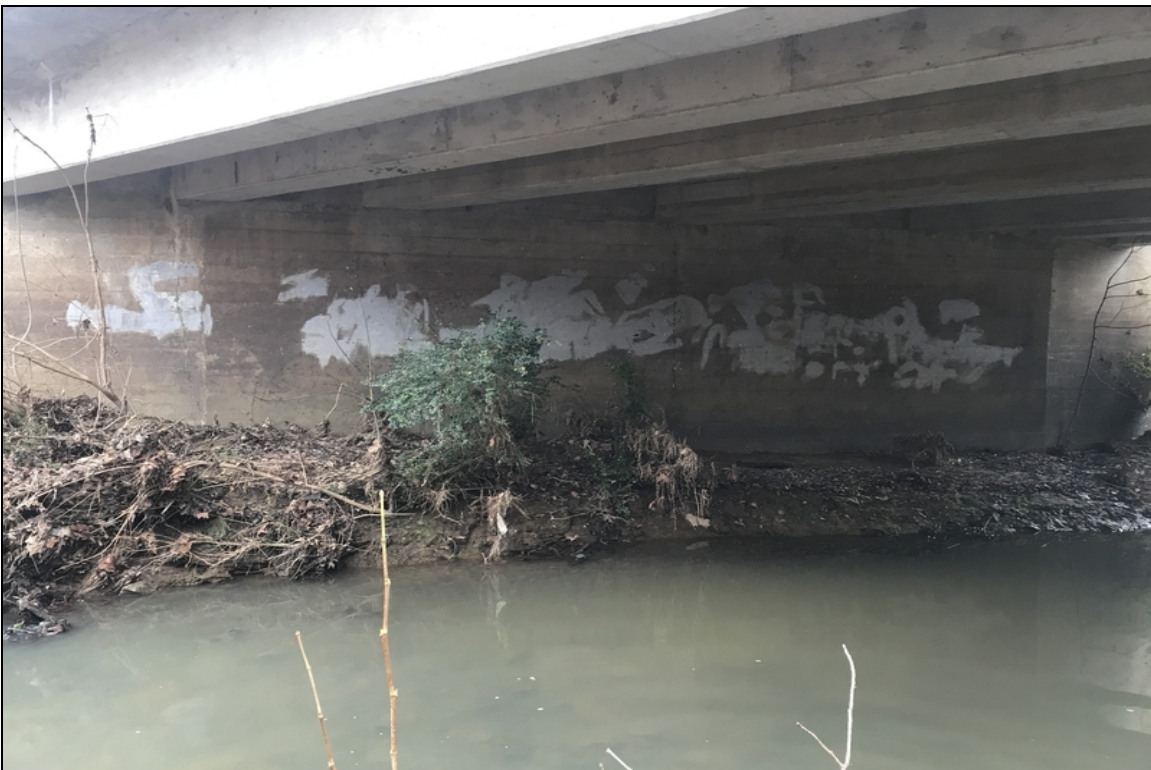
Abutment #2 typical.

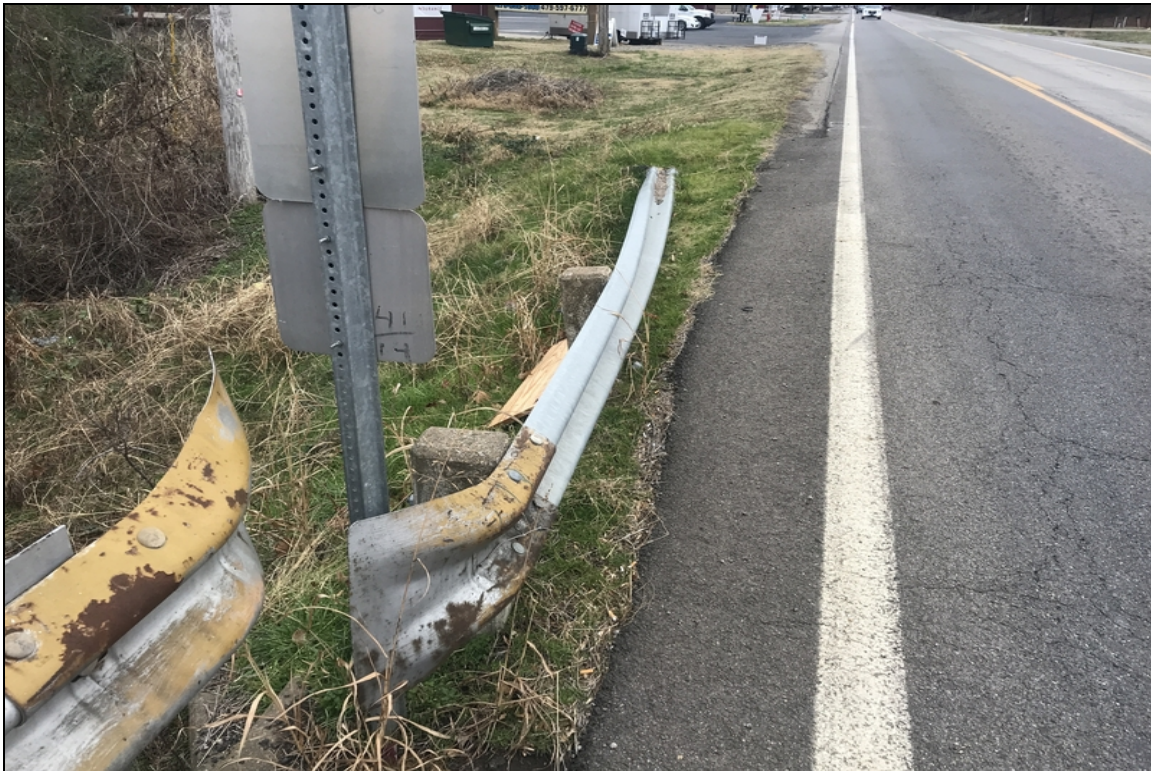
Northeast approach guardrail replaced.

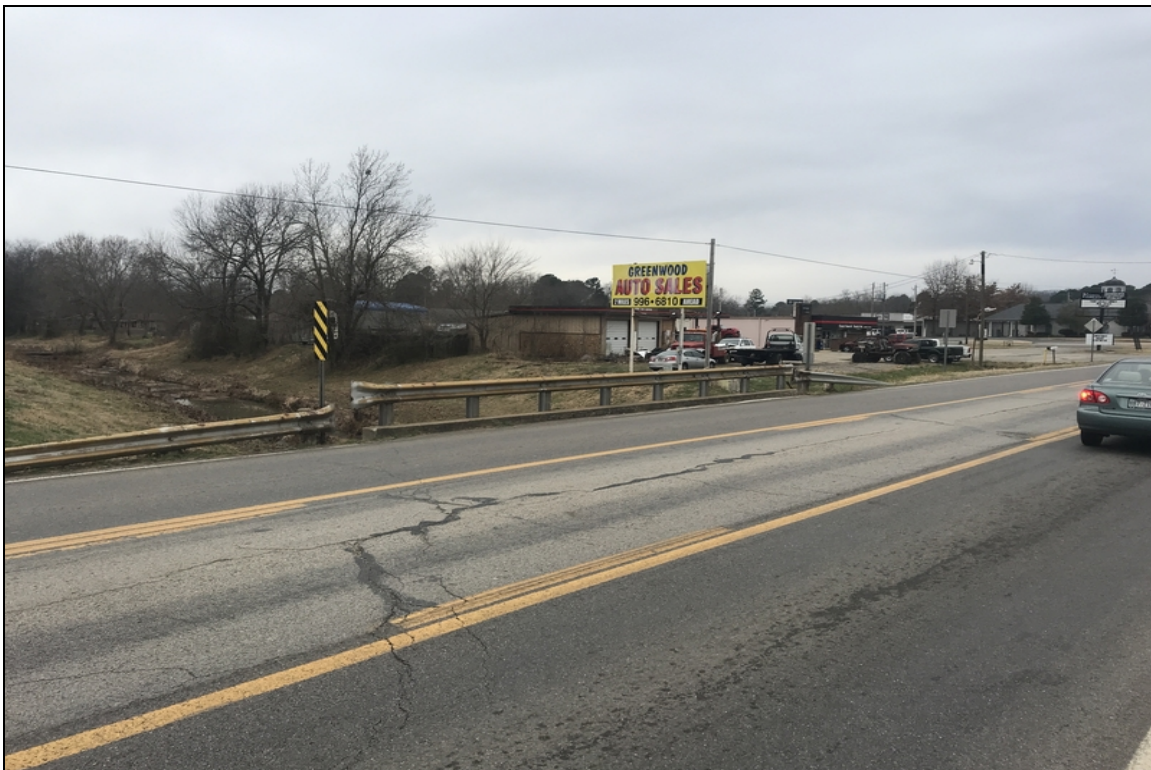
Rt bridge rail.
