Bridge #00332(Routine)

SH 10 Spur over Heartsill Creek-Seb. Co.

Team Lead: Eric West Inspection Date: January 06, 2022

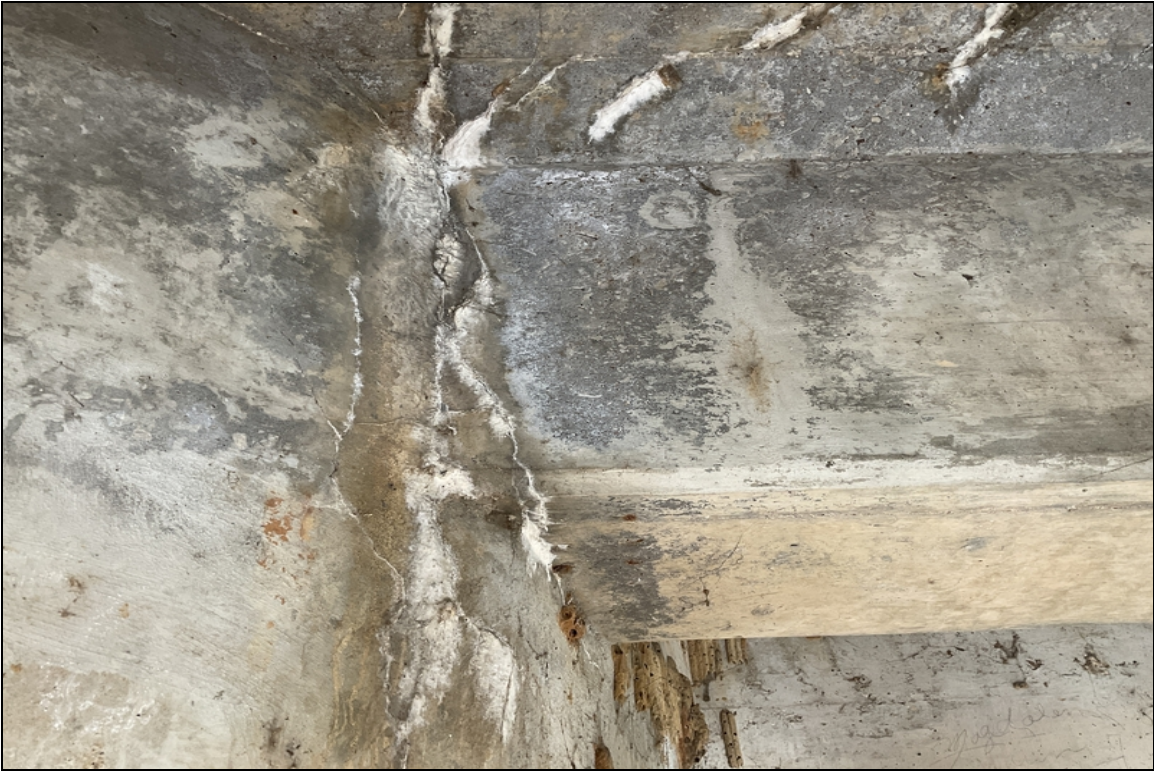
(110)							
-Beam #4 bottom edge has a softball sized spall with no exposed reinforcing steel located approximately 2' from abutment # 1. -Tee beams have vertical hairline cracks that are on approximately 2' centers near mid-span. -Beam #6 has a vertical crack with efflorescence buildup adjacent to abutment #1. -Beam #7 adjacent to abutment # 1 has an area of light scaling to interior and exterior sides that is approximately 9' in length with two full height hairline cracks with efflorescence. The cracks propagate into the slab undersurface. The area of scaling is captured in the Delamination/Spall/Patched Area defect.							
215	Reinforced Concrete Abutment	LF	130	15	112	3	0
1120	Efflorescence/Rust Staining	LF	4	0	2	2	0
1130	Cracking (RC and Other)	LF	22	0	22	0	0
1190	Abrasion/Wear (PSC/RC)	LF	89	0	88	1	0

Abutment #1 beam #1 vertical crack with efflorescence buildup.

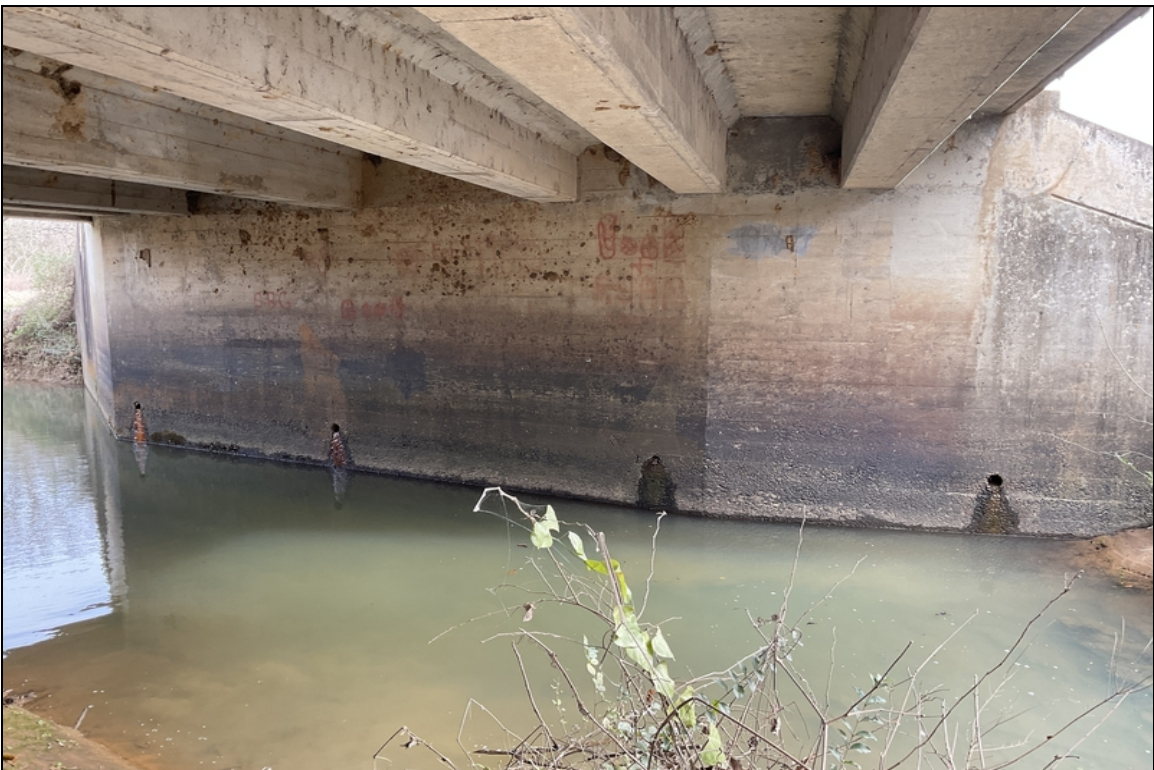
(215)							
-Abutment # 1 cracks have moderate efflorescence. -Abutment # 1 Rt and monolithic Southwest wing wall has a few diagonal and vertical cracks. The cracks have staining and efflorescence in locations. -Abutment #2 cracks have light efflorescence. -The base of abutments # 1 and # 2 have light abrasion.							
330	Metal Bridge Railing	LF	70	46	24	0	0
1000	Corrosion	LF	24	0	24	0	0
515	Steel Protective Coating	SF	282	211	28	28	15
3440	Effectiveness (Steel Protective Coatings)	SF	71	0	28	28	15

Abutment #2 typical.

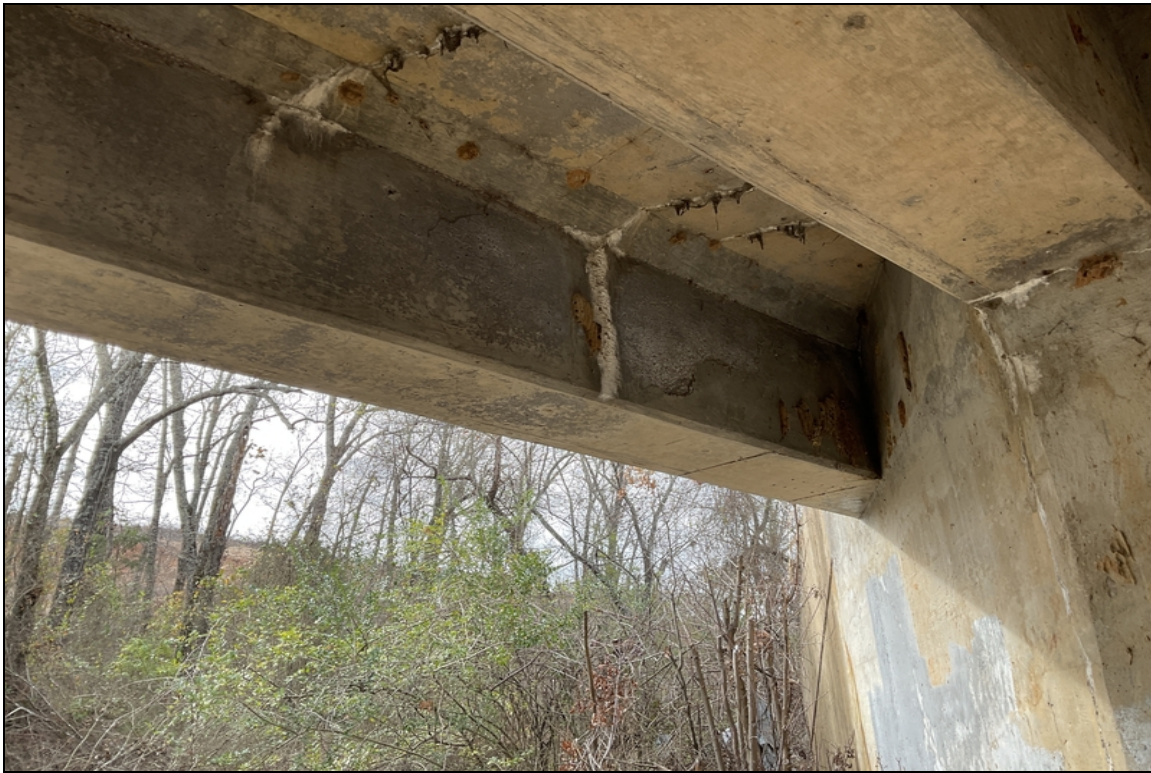
Beam #7 scaling and cracking.

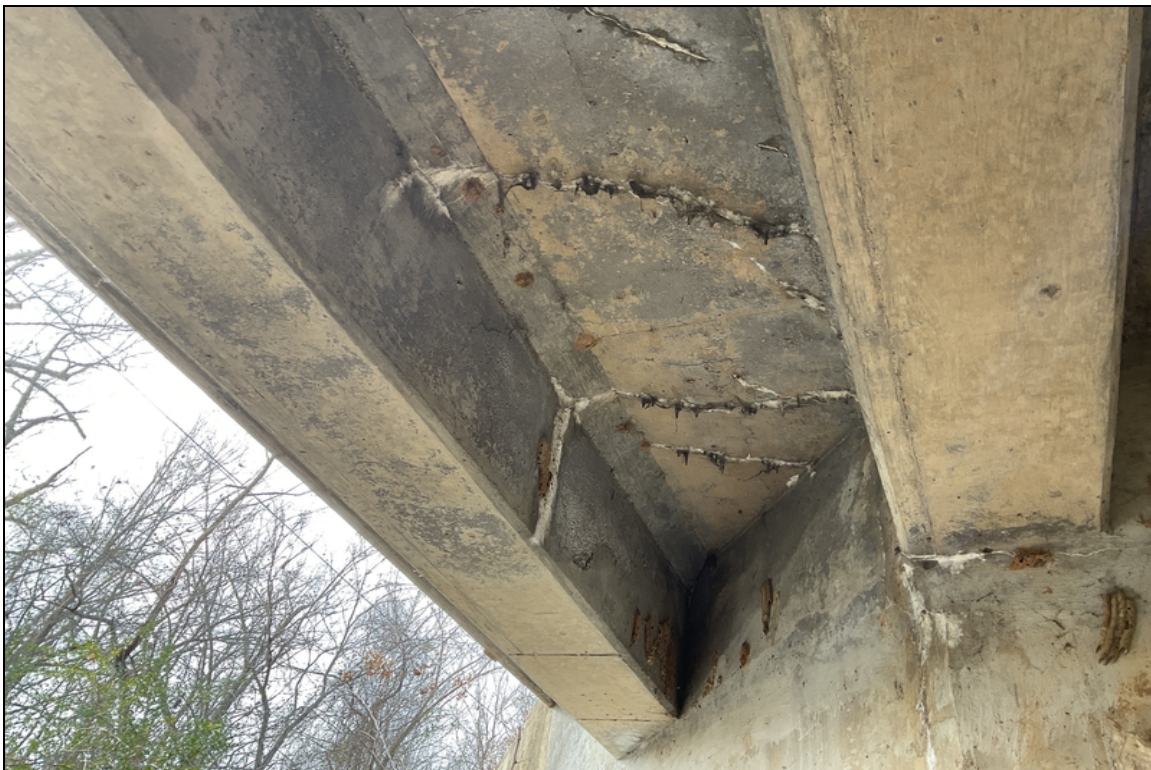
Bay #6 cracking with efflorescence buildup.

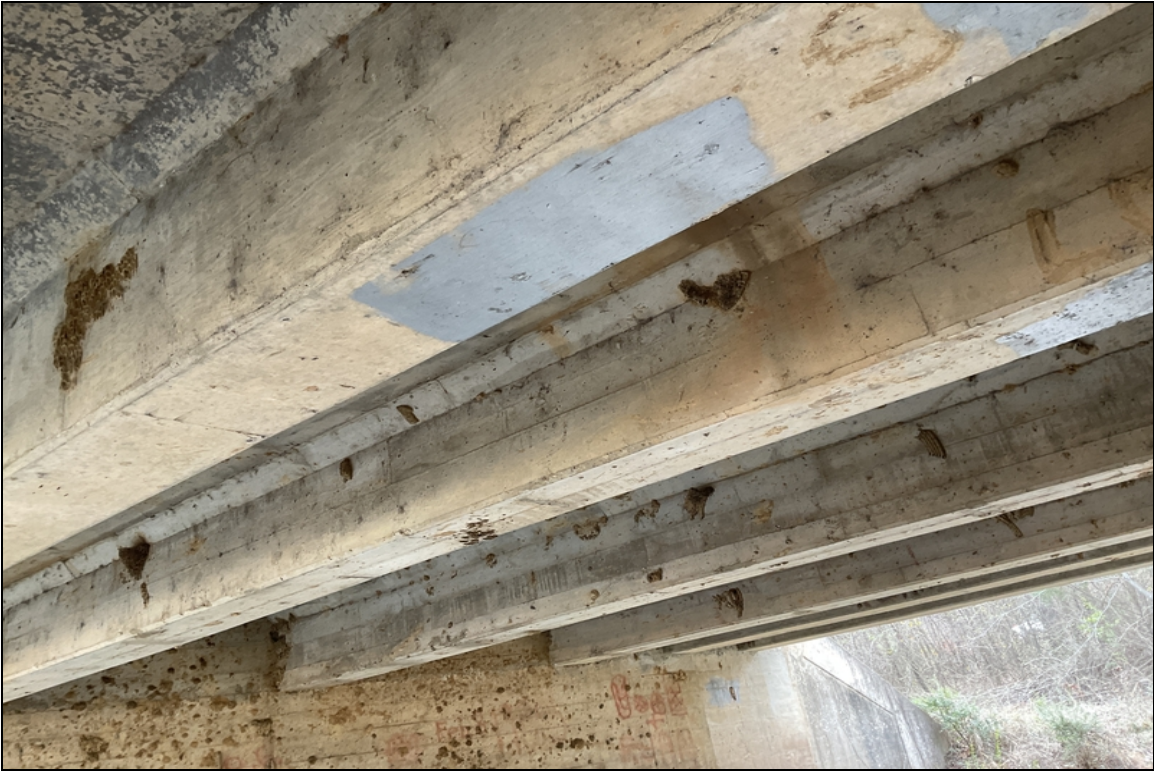
Typical undersurface of the deck.

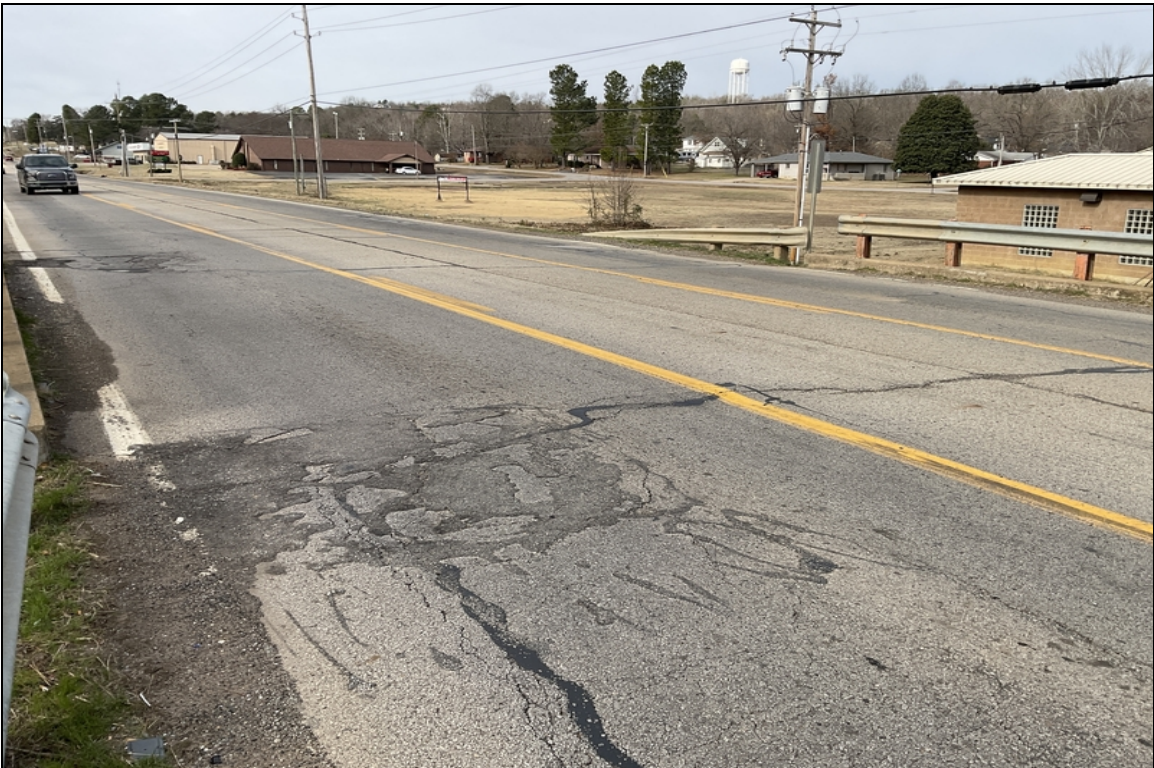
Typical driving surface of the deck.

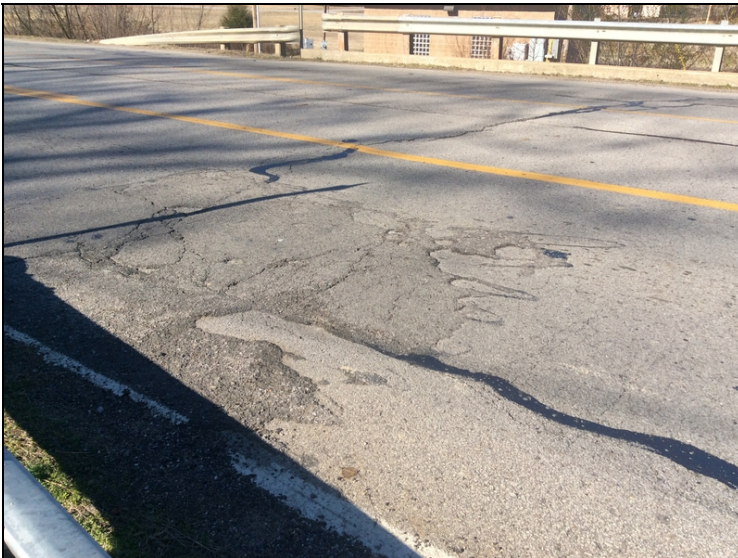
There is minor asphalt settlement adjacent to the bridge ends with failing asphalt repairs.

Asphalt settlement at the approaches

Date Reported: 03/05/2012
Priority: D- Routine
Type of Work: Repair
Status: Monitor
Inspection Direction W to E
Component: Approach

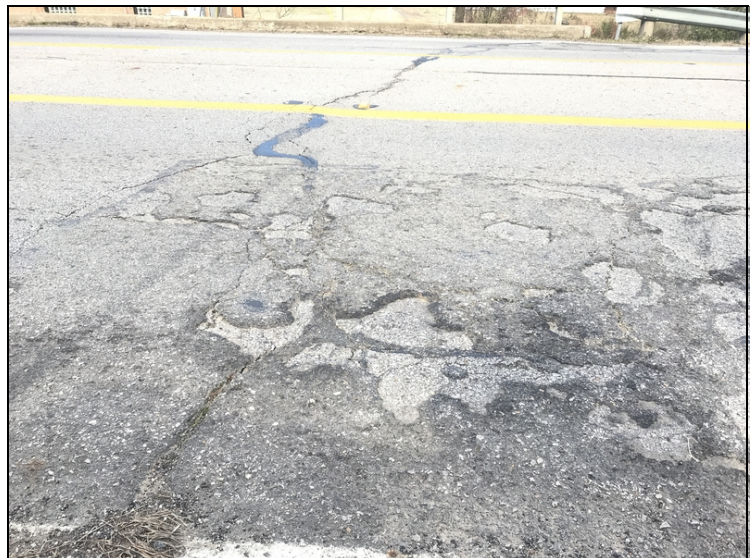
The East and West approach roadways have settlement with failing asphalt repairs at the bridge ends. East approach pictured.

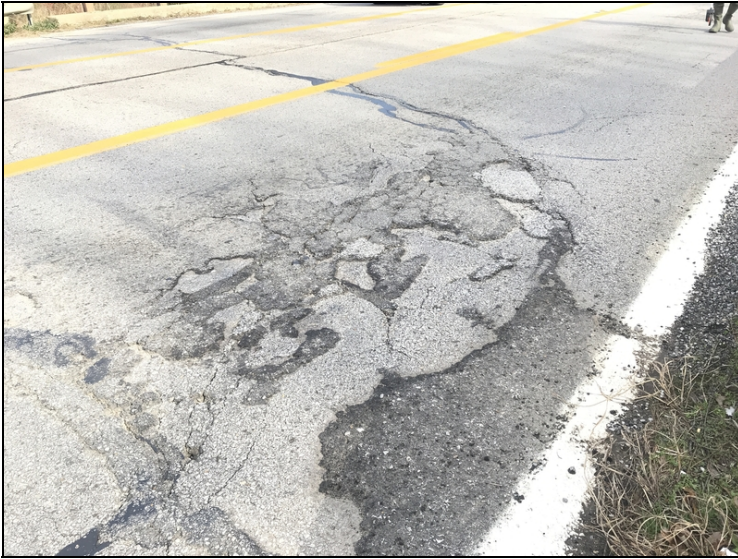
The East and West approach roadways have settlement with failing asphalt repairs at the bridge ends. West approach pictured.

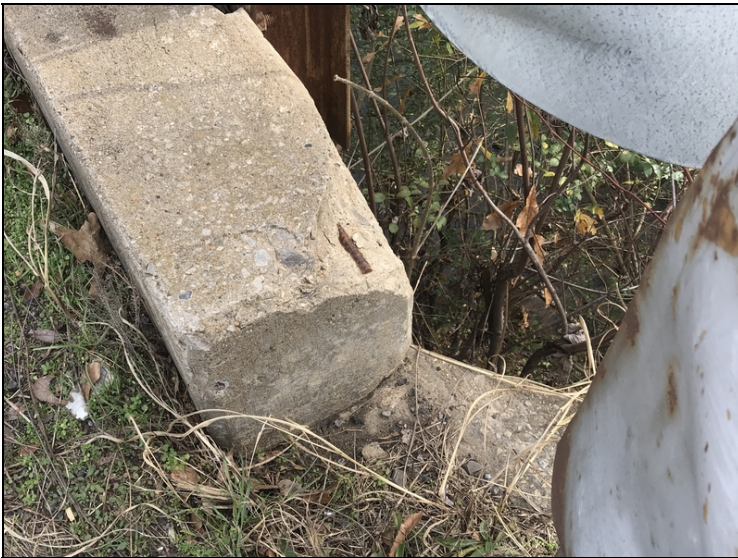
The right concrete curb has a softball sized spall with exposed reinforcing steel at abutment # 1.

The left concrete curb has areas of concrete deterioration / spalling adjacent to bridge railing posts # 1 and # 2.

The right concrete curb has a softball sized spall with exposed reinforcing steel. The left concrete curb has areas of concrete deterioration / spalling adjacent to bridge railing posts # 1 and # 2.

Date Reported: 12/04/2019
Priority: G - General/ Preventive maintenance
Type of Work: Repair
Status: Monitor
Inspection Direction W to E
Component: 330 - Metal Bridge Railing
