Bridge #06166(Routine, Underwater type 2)

State Highway 10 over Heartsill Creek-Seb. Co

Location: 0.04 MI E OF SH 10 SPUR

Team Lead: Eric West Inspection Date: August 30, 2021

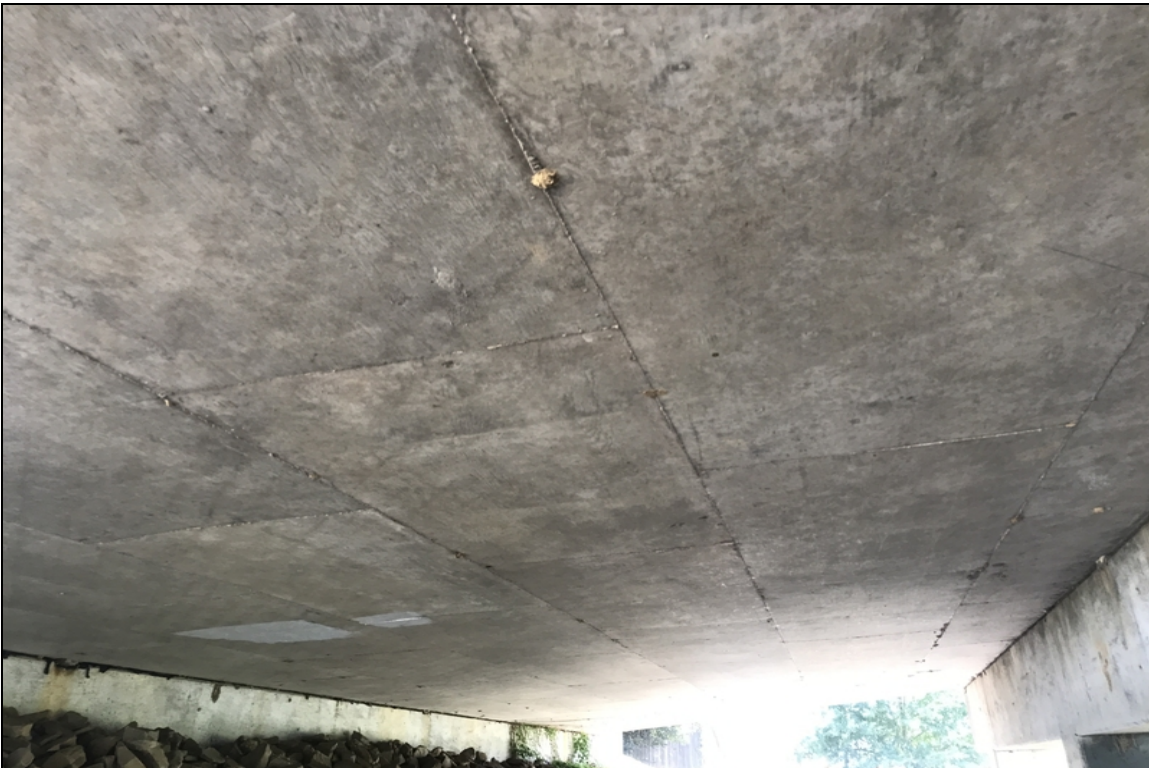
Typical undersurface of the slab.

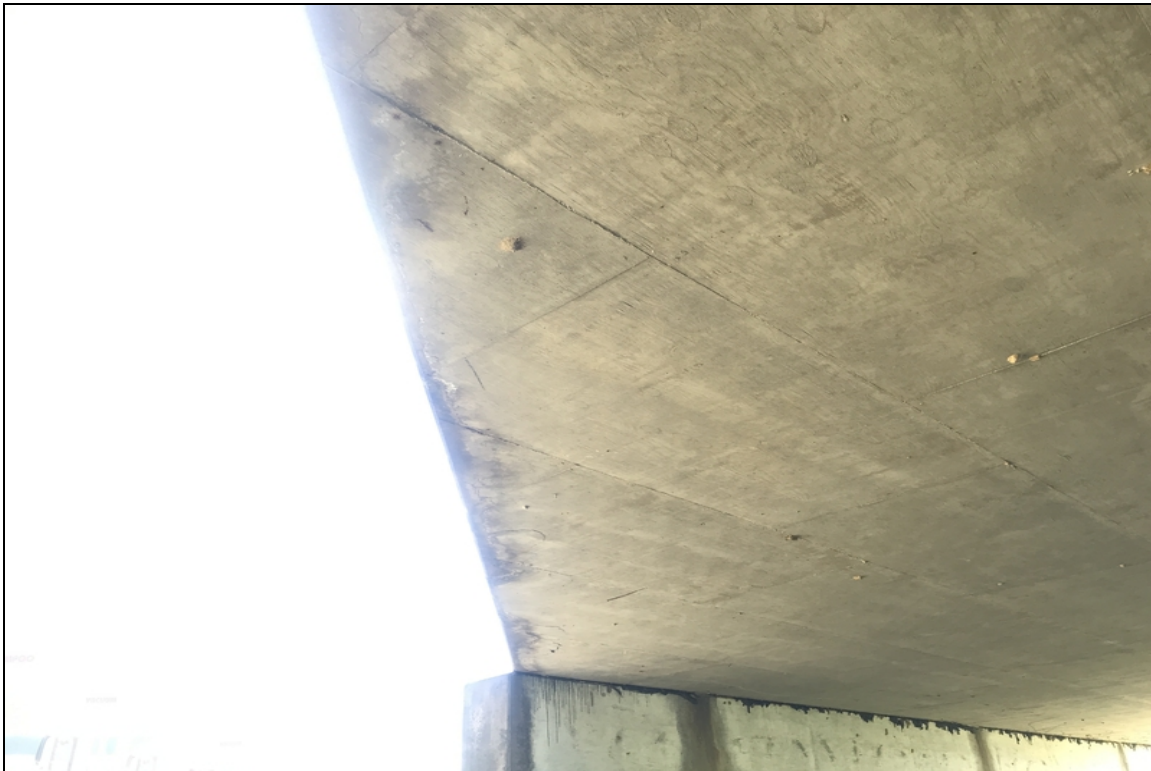
(38)	<p>-Driving surface of the deck has numerous sealable cracks. The majority of the cracks are perpendicular to the skew angle. The cracks are moderate width in several locations.</p> <p>-The driving lanes have light wear and areas of map cracking in the exterior travel lanes.</p> <p>-The left edge of span #2 has a 2' delaminated area.</p> <p>Undersurface:</p> <p>-The undersurface of the slab has cracking that is perpendicular to the substructure with light efflorescence.</p> <p>-Span #1 undersurface has moderate width longitudinal cracking along the centerline.</p> <p>-Span #2 undersurface has moderate width longitudinal cracking along the centerline and concrete delamination at midspan on the Lt undersurface.</p> <p>-Span #3 undersurface has an area of honeycombing with exposed reinforcing steel in the left side near mid-span. The undersurface has a moderate width longitudinal crack adjacent to the centerline near midspan.</p> <p>-Span #4 undersurface has longitudinal moderate width cracking Rt of the centerline. The Lt undersurface has several concrete delamination's on the undersurface.</p>

Span #4 Lt concrete delamination along the edge of the slab undersurface.

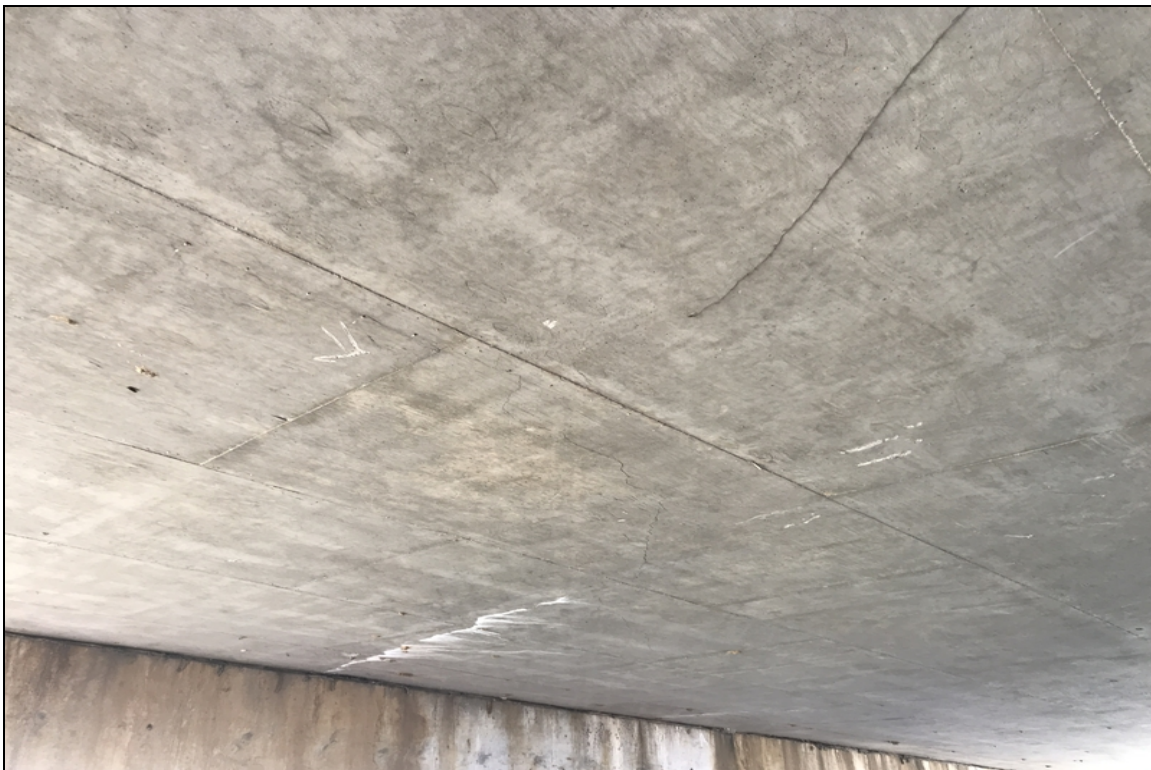
Span #4 moderate width longitudinal cracking along with cracking with efflorescence buildup.

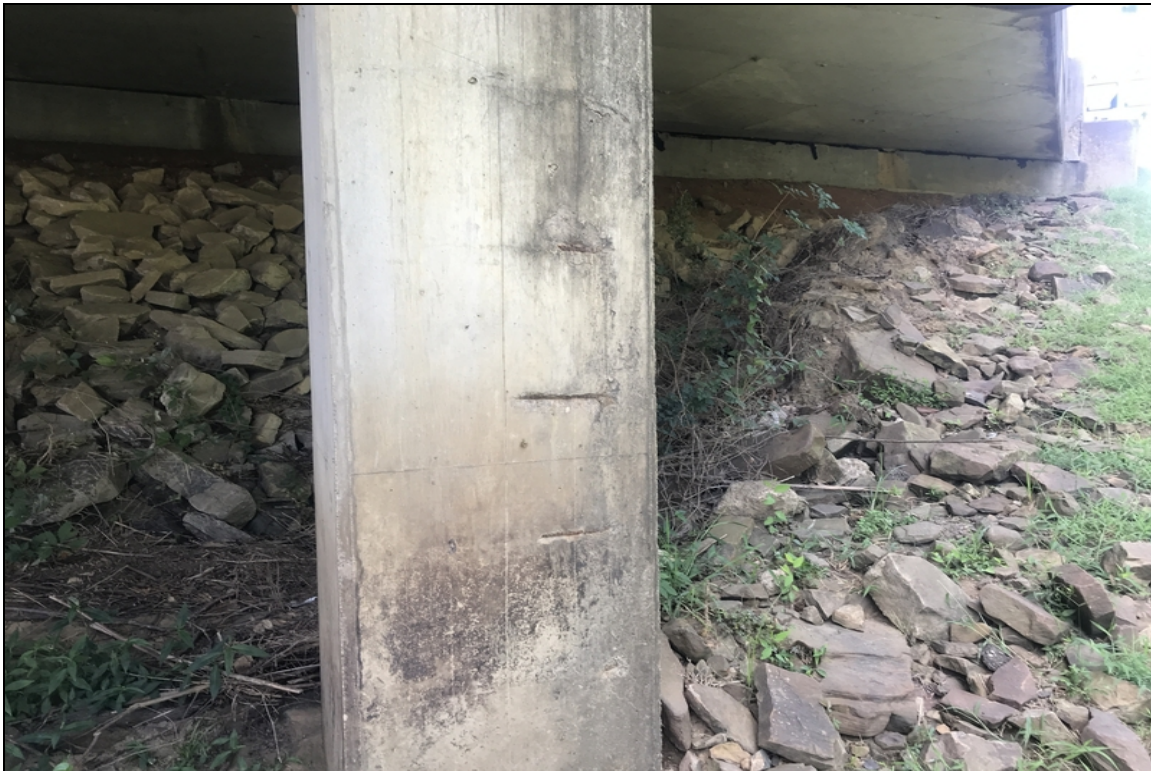
(205)	<p>-Bent #2, column #1 has numerous areas of shallow spalling with exposed reinforcing steel approximately 8" long located in the ahead face of column.</p> <p>-The bases of the columns at bents #3 and #4 have light abrasion near the normal water elevation.</p> <p>-There are grouted repairs at the base of the columns in random areas. Repairs appear to be holding at this inspection.</p> <p>-Bent #5, column #1 has delaminated concrete at the cap juncture. Column #4 has horizontal cracking at the cap juncture.</p>						
215	Reinforced Concrete Abutment	LF	124	121	3	0	0
1080	Delamination/Spall/Patched Area	LF	1	0	1	0	0
1130	Cracking (RC and Other)	LF	2	0	2	0	0

Bent #2 column #1 spalling with exposed reinforcing steel.

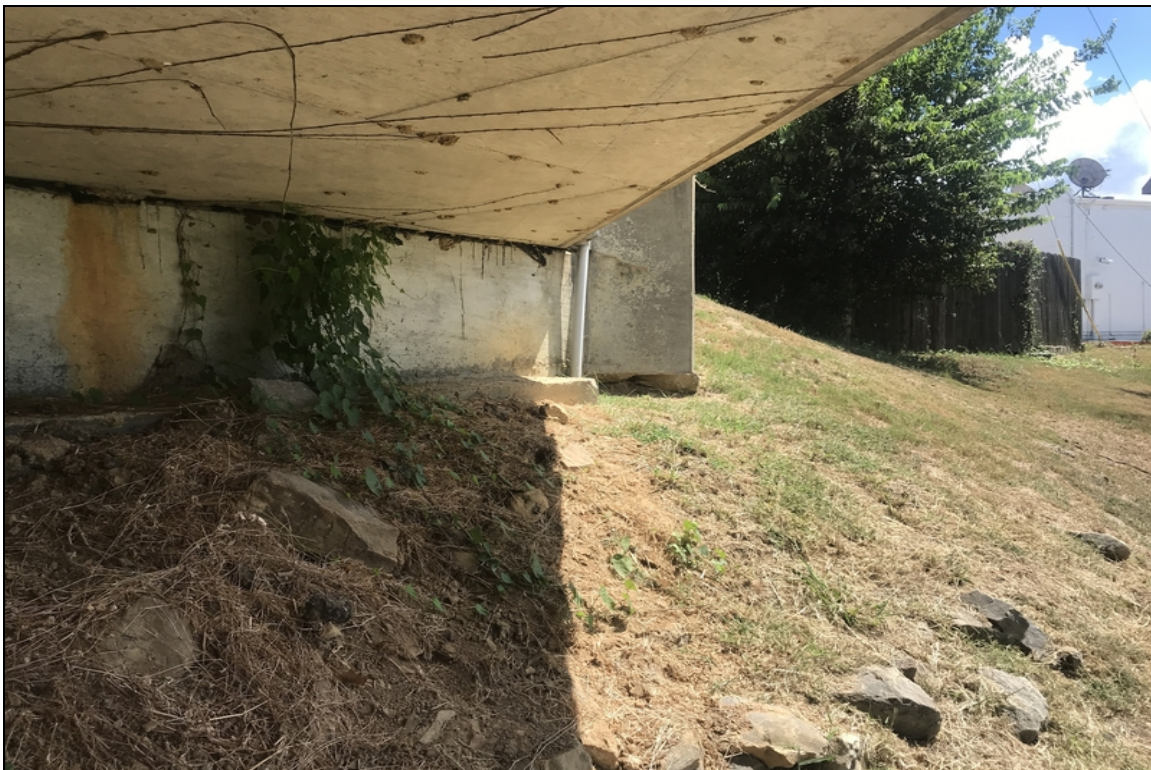
Abutment #2 Rt undermining.

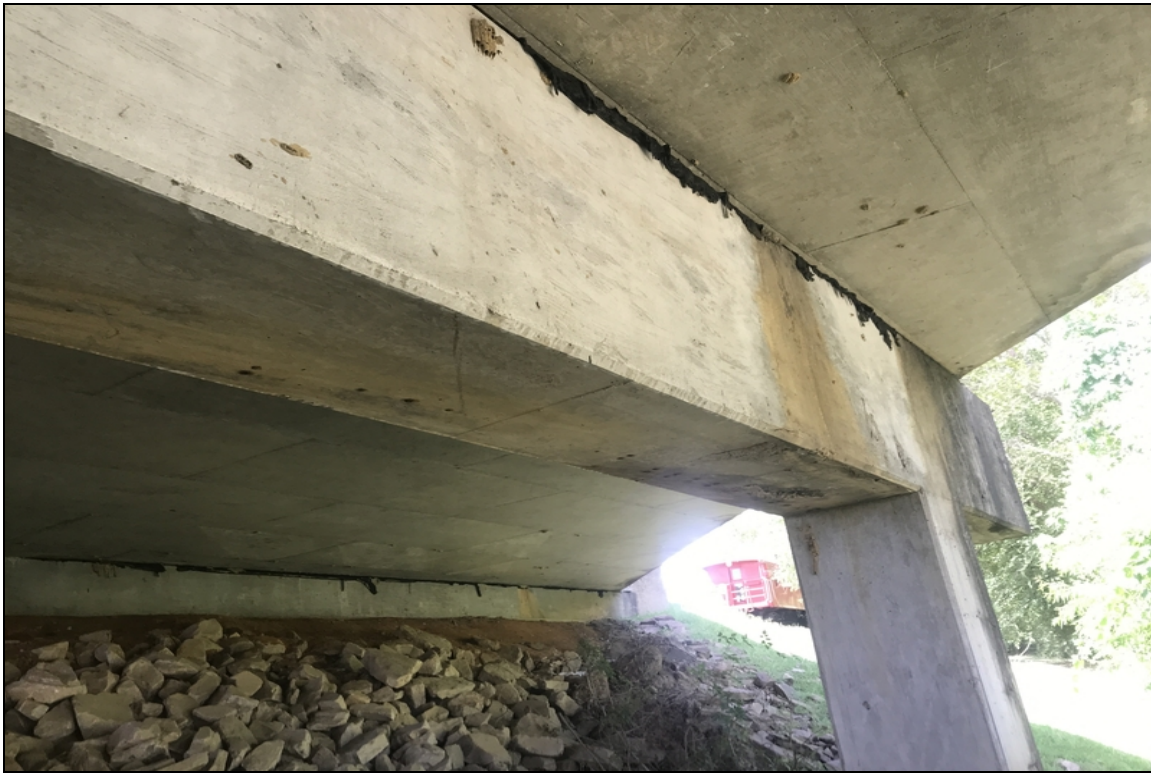
ELEM	DESCRIPTION	UNITS	TOTAL	CS1	CS2	CS3	CS4
1090	Exposed Rebar	LF	10	0	1	9	0
1130	Cracking (RC and Other)	LF	8	0	8	0	0
(234)							
-Substructure caps have water stains indicating that the deck joint seals are leaking. -One shallow basketball sized spall in the center keyway of bents # 2 & 3 with exposed reinforcing steel. -Bent #2 has a 24" spall with exposed reinforcing steel with up to 2" of concrete section loss at the centerline. There is a 24" delaminated area adjacent to the spall. The exposed reinforcing steel has active corrosion with up to approximately 1/8" section loss. The left side of bent #2 cap has delaminated concrete along the bottom edge and in the undersurface along with spalls that expose reinforcing steel in the vertical face adjacent to column #1 that extends toward mid-span approximately 4'. The cap has delaminated areas adjacent to column #2. -Bent # 3 left edge of the cap has a 10" spall that has exposed reinforcing steel. Exposed reinforcing steel has active corrosion with up to initial section loss at this inspection. The undersurface of Bent #3 cap has a 6' delaminated area between columns # 1 & 2 and a 10' long delaminated area between columns # 2 & 3. The undersurface of the caps have several small delaminated areas and short duration cracks that correspond with areas that appear to have large amounts of water leakage through the deck joint seals. -Bent #4 has shallow spalling near the centerline with exposed reinforcing steel and delaminated concrete. The Rt half of the cap has several concrete delamination's -Bent #5 has concrete delamination's on the undersurface of the cap between columns 1-3.

Bent #2 cap spalling and delaminated concrete.

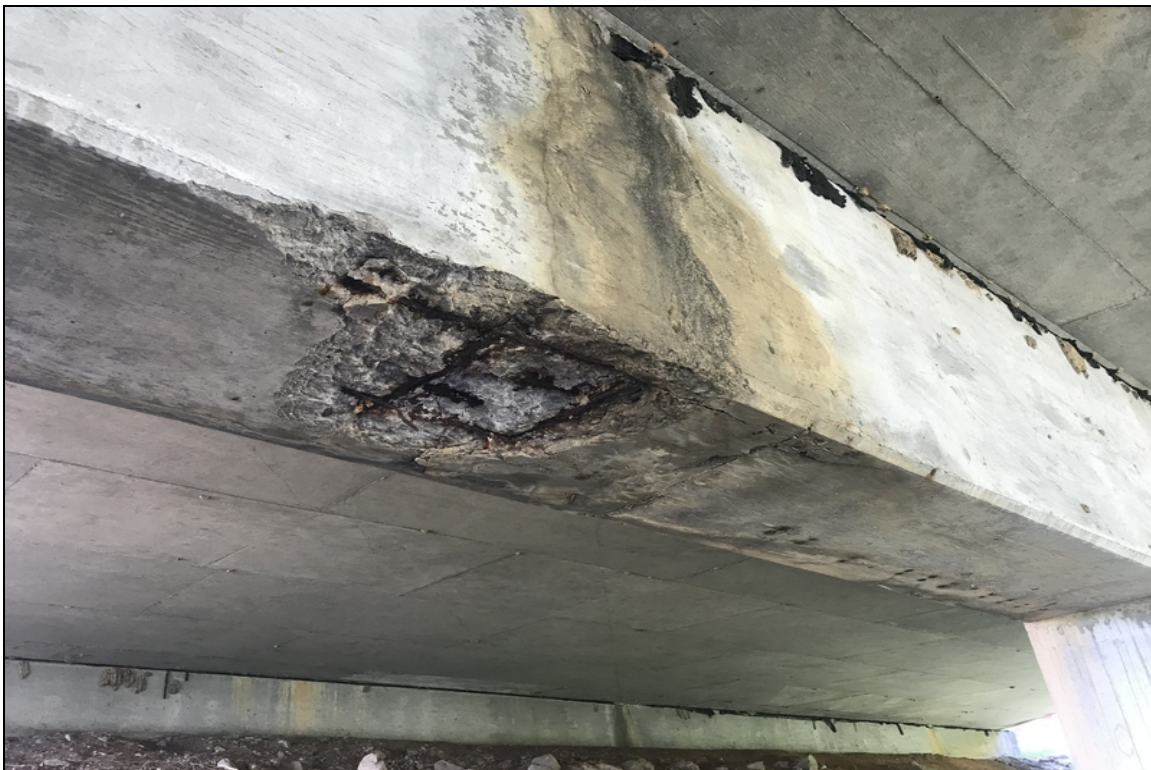
Bent #2 cap spalling with exposed reinforcing steel at centerline.

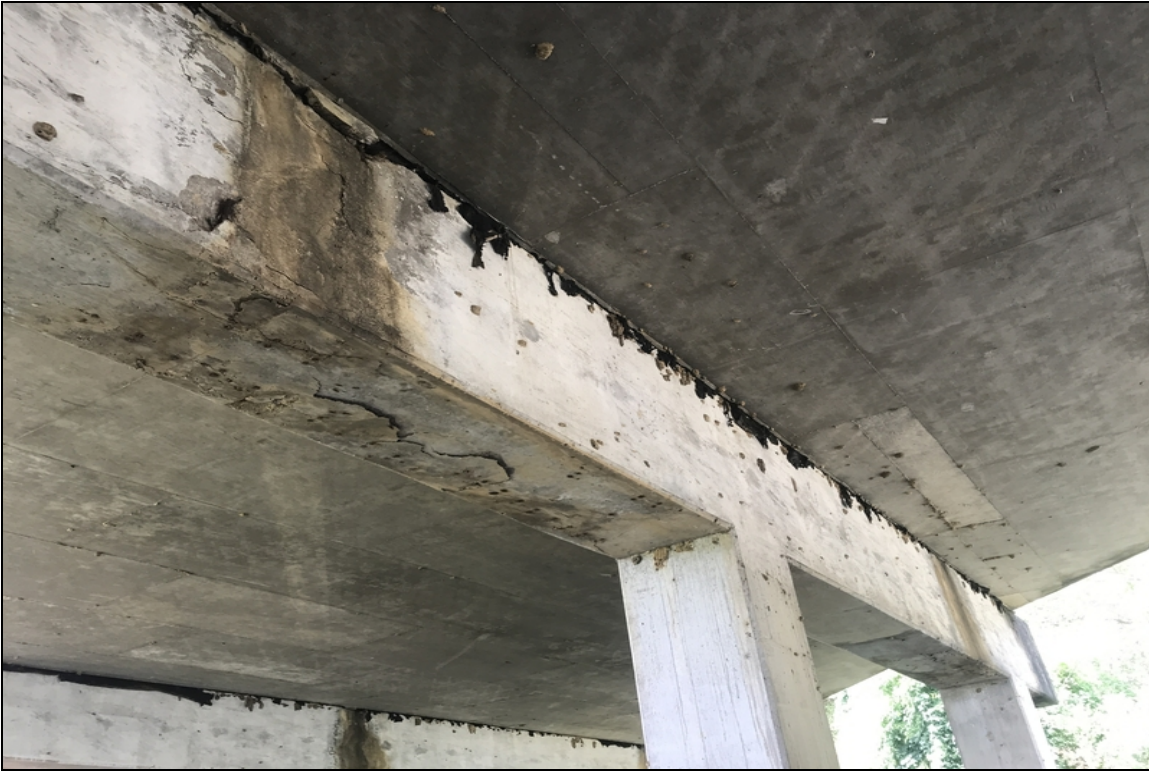
Bent #3 concrete deterioration with spalling that exposes reinforcing steel large delaminated areas on the undersurface of the cap.

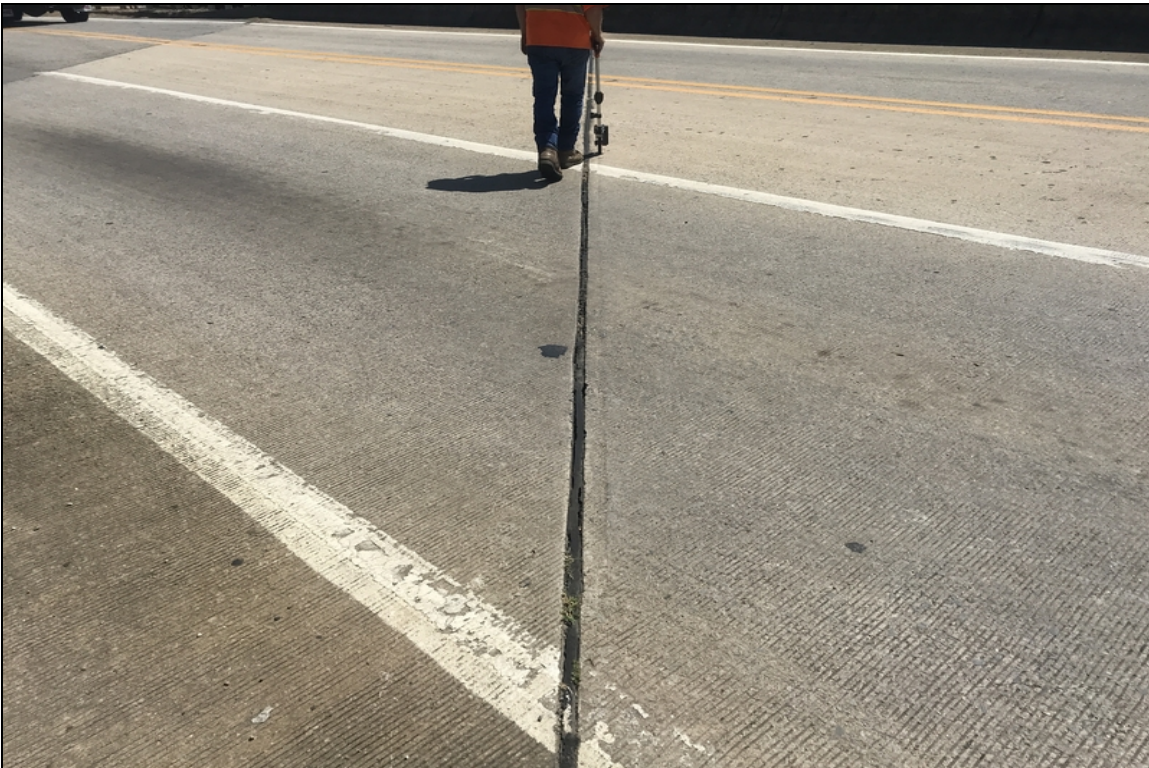
302	Compression Joint Seal	LF	228	0	212	16	0
2310	Leakage	LF	228	0	212	16	0
(302)							
-The compression joint seals are deteriorating and have numerous areas of adhesion failure and leak water. -Areas of the seals are missing and allowing incompressible materials to fill the joints. -No apparent recent repairs to the joints seals.							
331	Reinforced Concrete Bridge Railing	LF	350	327	22	1	0
1080	Delamination/Spall/Patched Area	LF	1	0	0	1	0
1130	Cracking (RC and Other)	LF	22	0	22	0	0

Bent #5 failing compression joint.

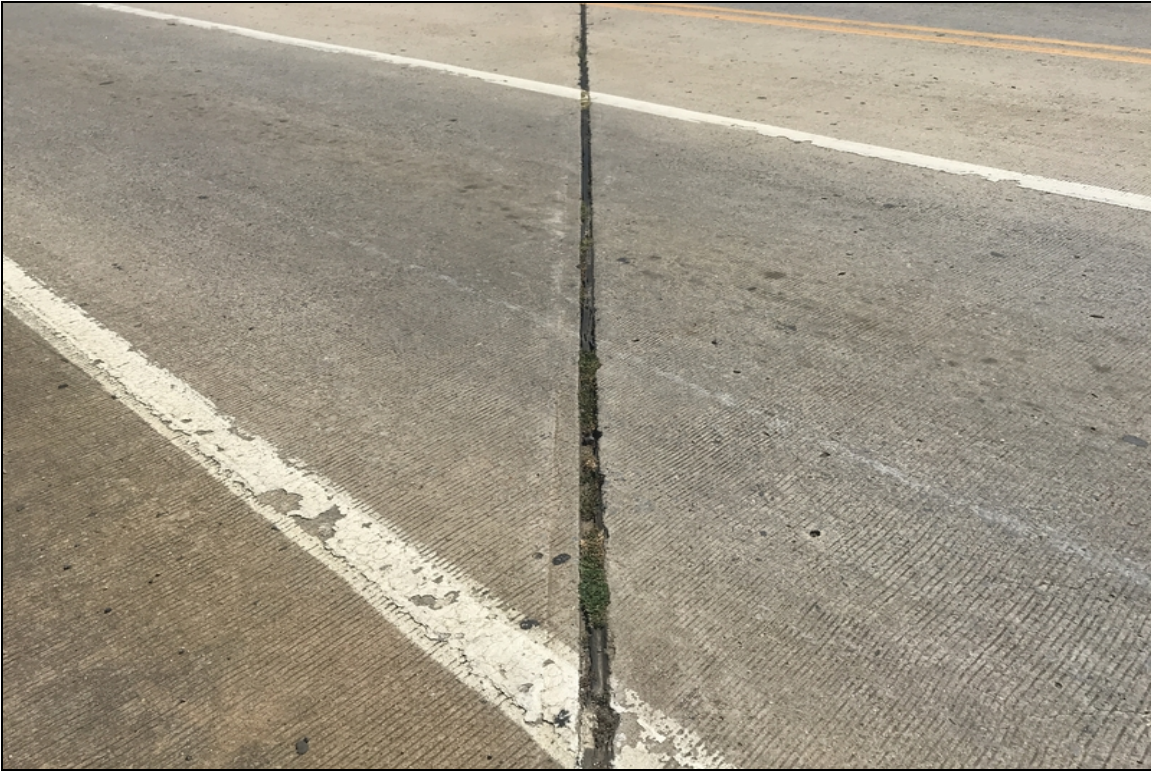
Bent #4 failing compression joint seal.

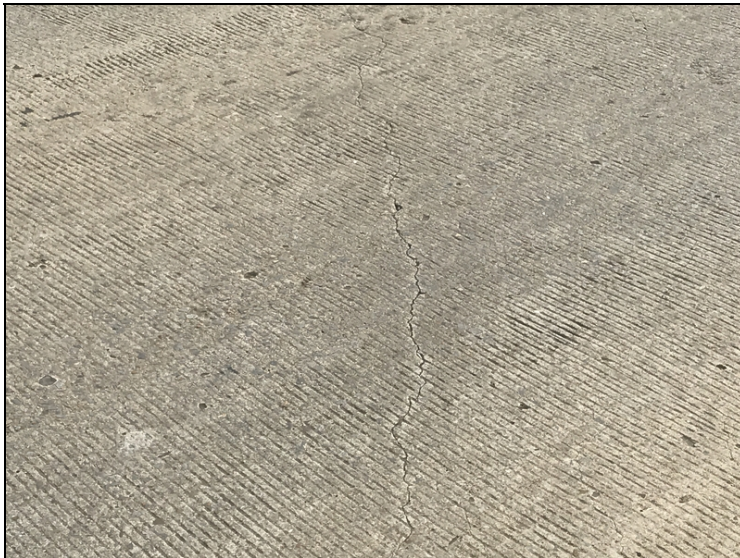
Deck -
The driving surface of the deck has numerous sealable cracks in all spans.

Span #3, right lane-Cracking.

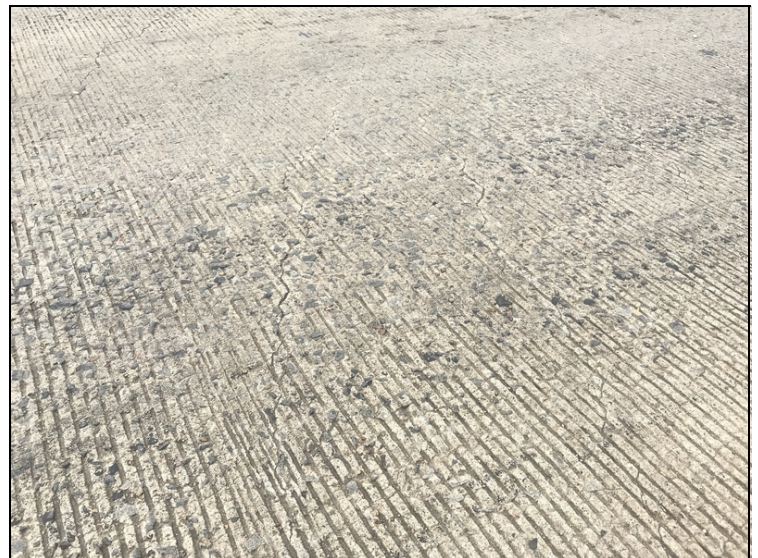
Span #4-Deck cracking perpendicular to skew angle.

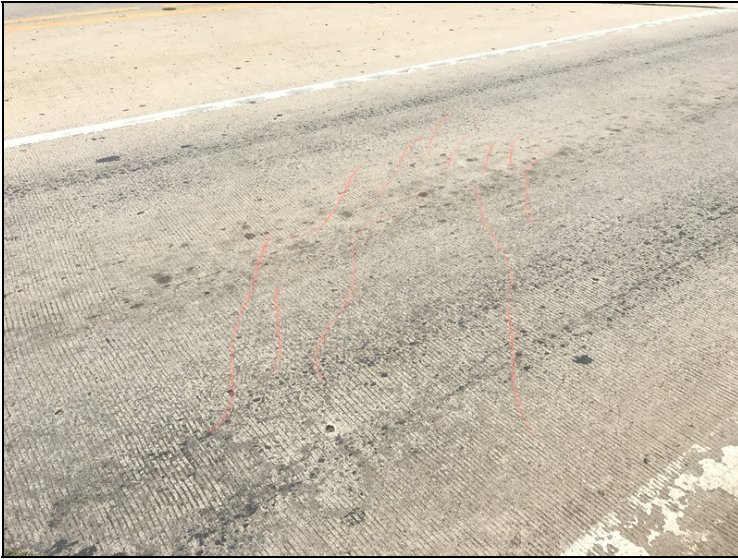
Span #3-Diagonal cracking.

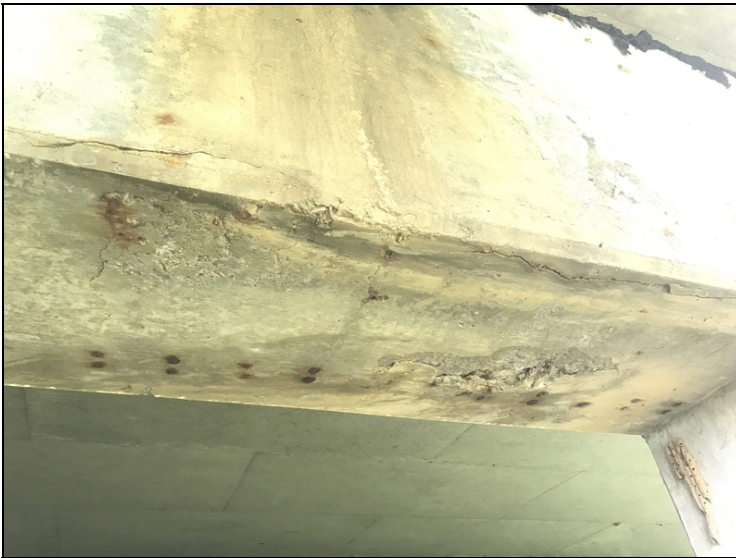
Bents #2 and #3 caps have delaminated areas and large spalls with exposed reinforcing steel where the deck joint seals leak water on the substructure caps.

Bent #2 cap, left side-Spalling with exposed reinforcing steel with delaminated areas.

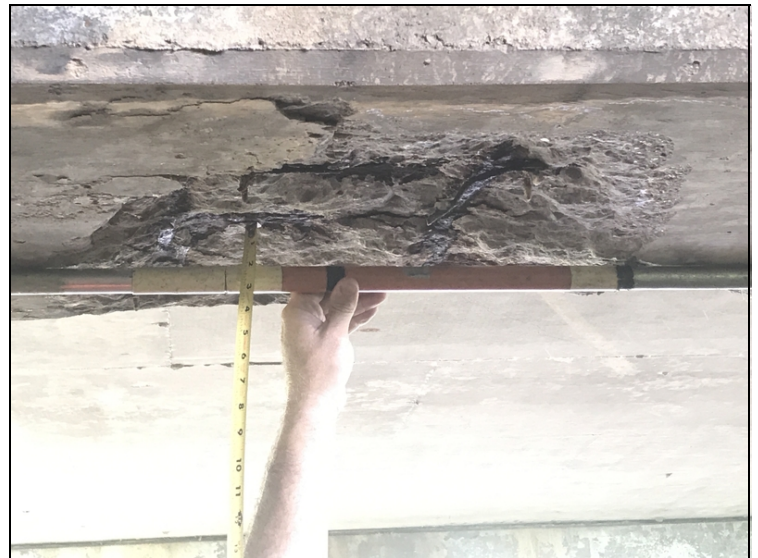
Bent #2 cap at mid-span-Spalling with exposed reinforcing steel with up to 2" of concrete section loss.

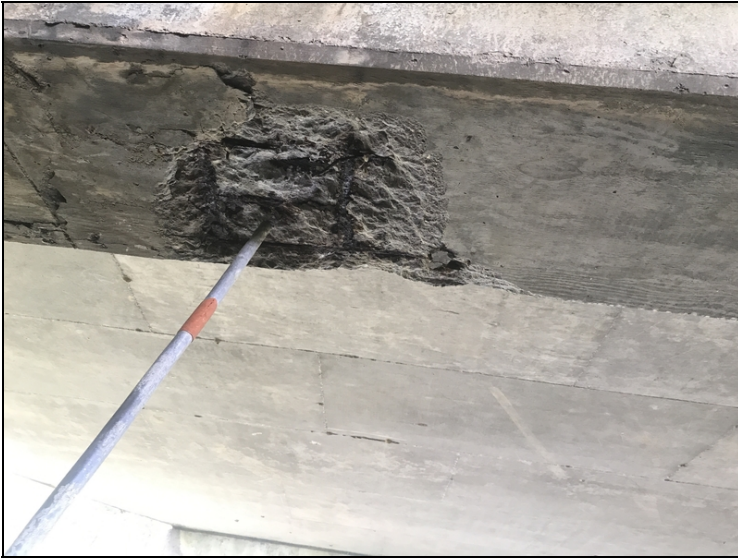
Bent #2 cap at mid-span-Spalling with exposed reinforcing steel with up to 2" of concrete section loss.

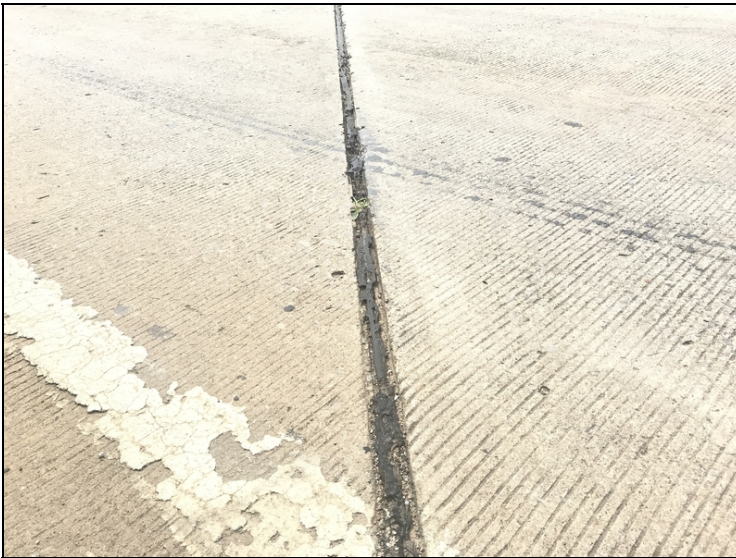
Expansion joint sealant is deteriorated and allowing incompressible materials in the deck joint. There are water stains on the substructure caps from apparent water leakage through the deck joint seals.

Bent #3-Adhesion failure / deteriorated joint seal.

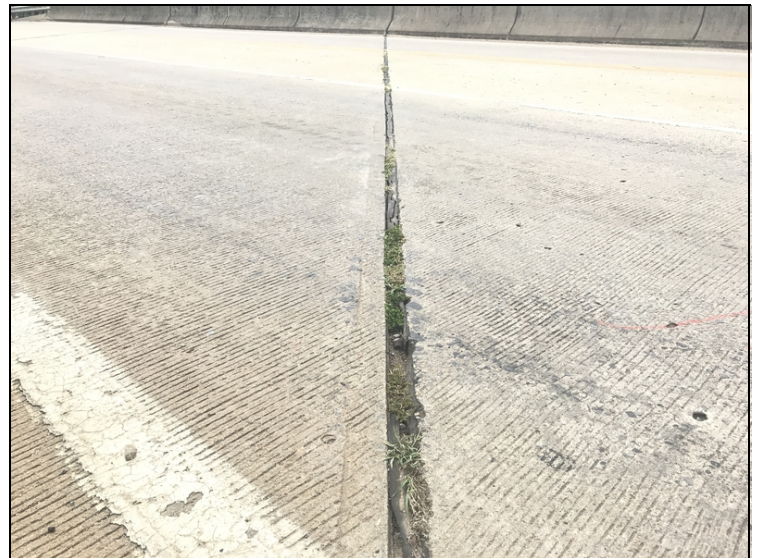
Bent #4 expansion joint seal-Adhesion failure.

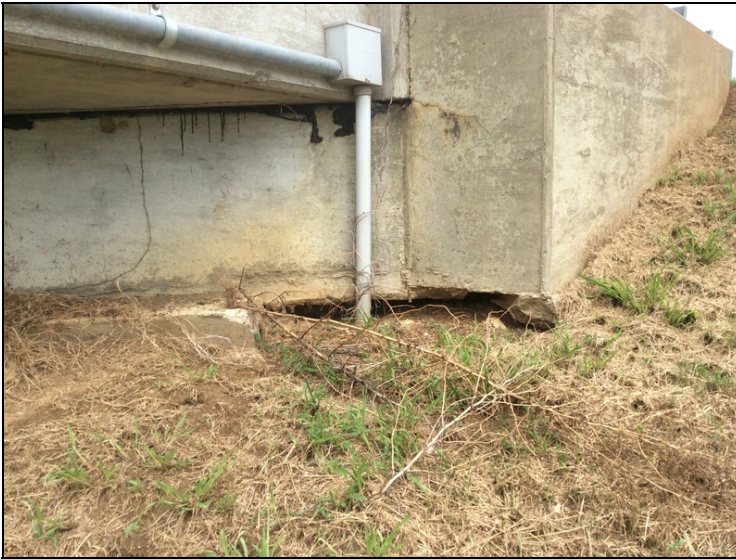
Bent # 6 Right minor settlement

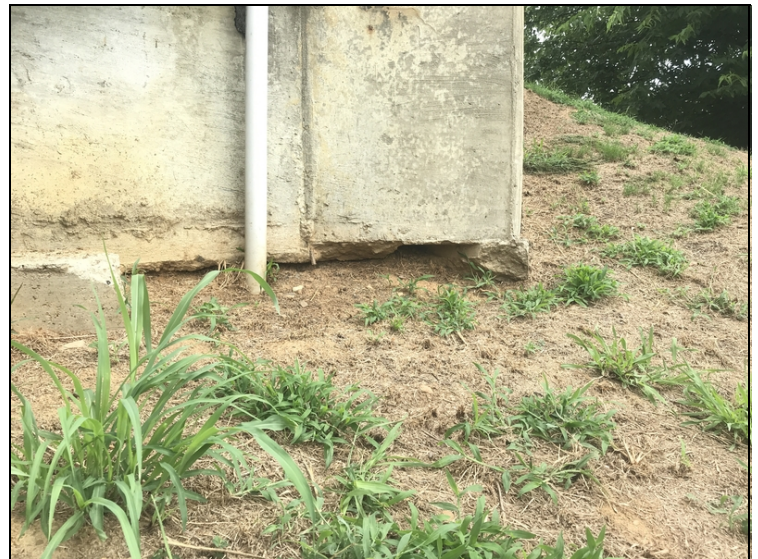
The right side of abutment #2 has minor erosion / earth settlement at the end of the abutment near the wing wall juncture.

Abutment #2, right side-Minor erosion.

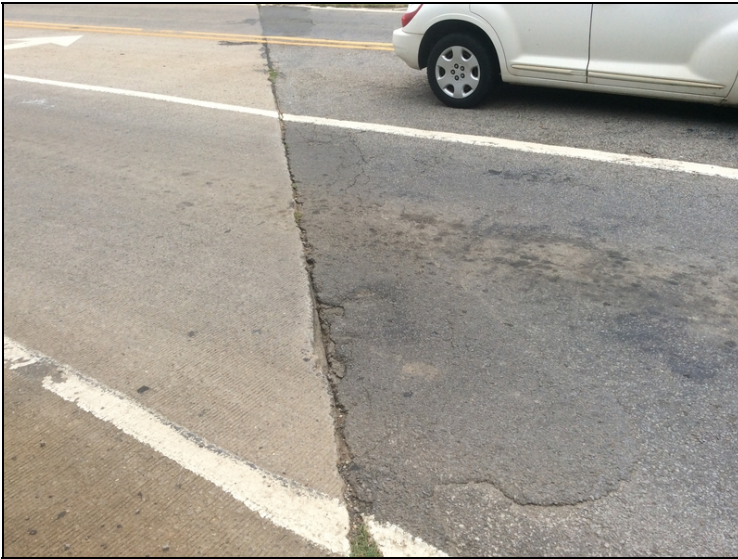
West approach roadway -
The West approach roadway at abutment #1 has minor asphalt settlement.

Bent # 1 Asphalt settlement at the approach

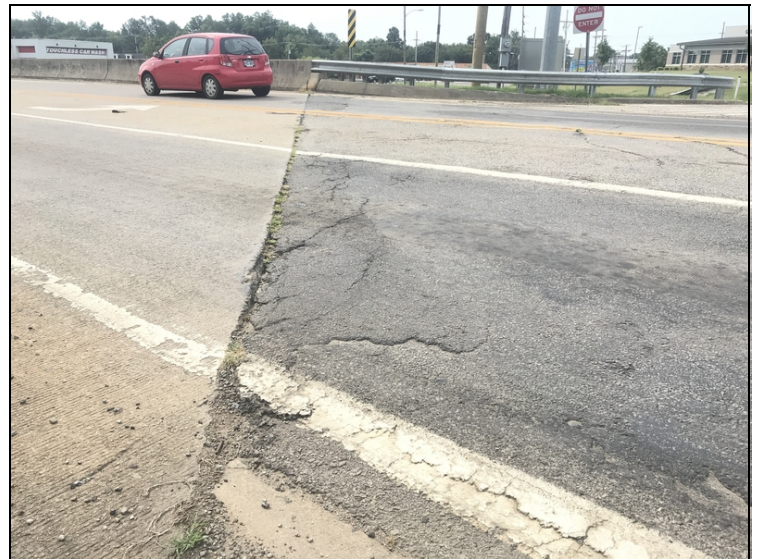
West approach-Settlement.

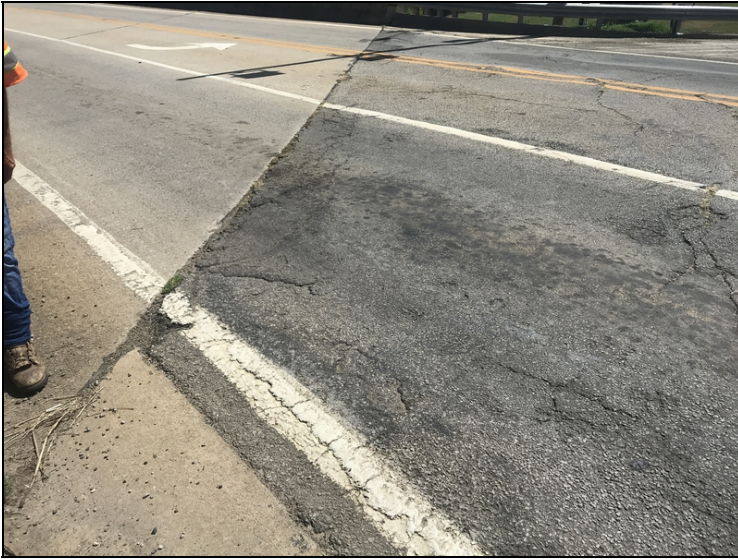
West approach asphalt breaking apart and settlement.
