Asset #A0704(Routine)

## State Highway 10 over Greasy Creek - Logan Co.

Location: 5.50 MI E SEBASTIAN CO LI

Team Lead: Bob McEntyre, Inspection Date: 07/19/2022

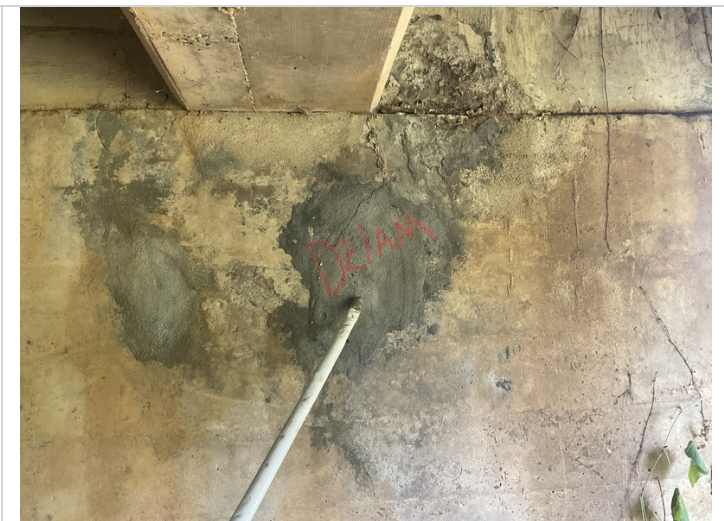
(215) -Abutment # 1 under beam # 2 has a large 36 inch delaminated area under the beam. Maintenance Forces have grouted over a portion of the delaminated area in the past. The grouted repair has failed and is delaminated. -Maintenance forces have made a few grouted patches in both abutments. -Abutment stem walls have a few vertical full height cracks. -Abutment # 2 left monolithic wing wall has a moderate width vertical crack in upper portion of wall adjacent at the abutment juncture. The right wing wall has vertical and diagonal cracking and concrete deterioration below the weep hole. -Concrete deterioration is visible between the weep holes in abutment # 2 stem wall.							
220	Reinforced Concrete Pile Cap/Footing	LF	45	0	0	45	0
1190	Abrasion/Wear (PSC/RC)	LF	45	0	0	45	0

Abutment 1, left side-Delaminated repair

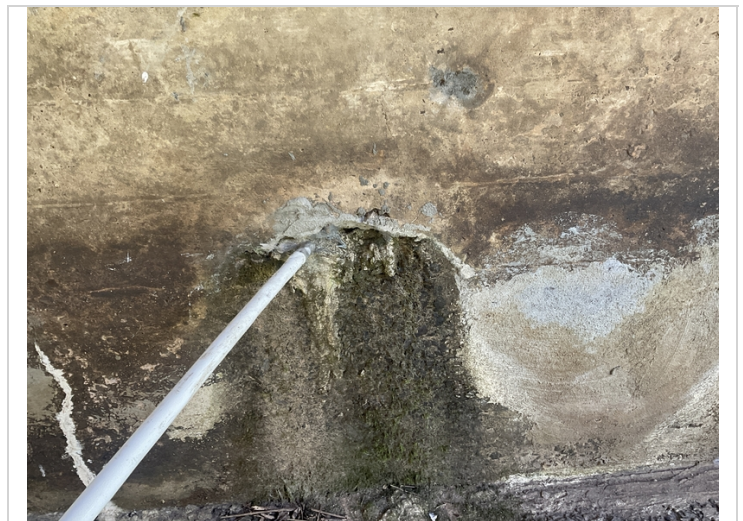
Abutment 2 stem wall-Concrete deterioration

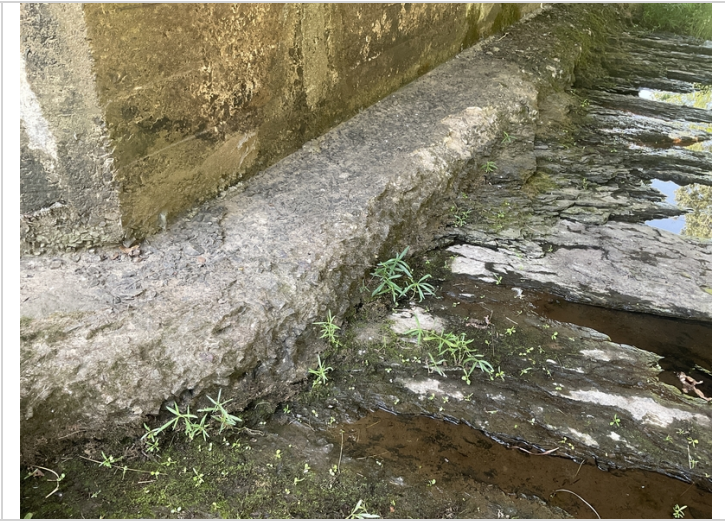
(220) -The top of abutment # 2 footing is exposed during this inspection. The footing has soft deteriorated concrete with up to 2" of section loss around the edges. No exposed reinforcing steel or apparent scour problems at this inspection.							
234	Reinforced Concrete Pier Cap	LF	95	62	29	4	0
1080	Delamination/Spall/Patched Area	LF	16	0	16	0	0
1090	Exposed Rebar	LF	1	0	0	1	0
1120	Efflorescence/Rust Staining	LF	3	0	0	3	0
1130	Cracking (RC and Other)	LF	13	0	13	0	0

Abutment 2 footing-Concrete deterioration

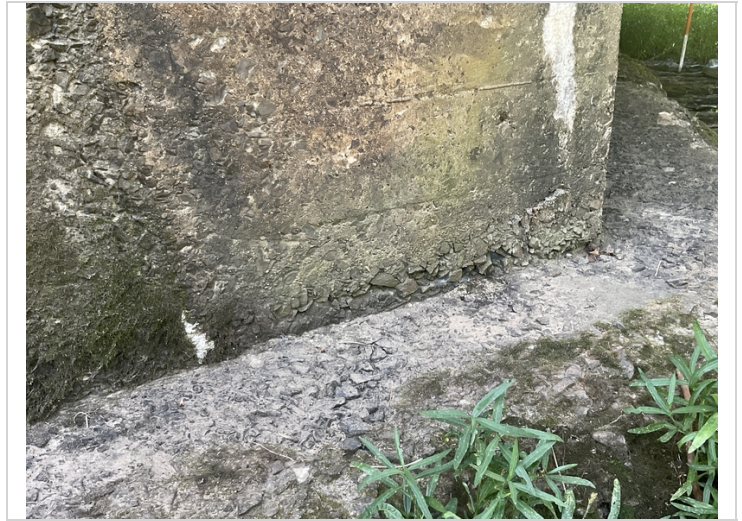
Abutment 2, right wing wall-Abrasion

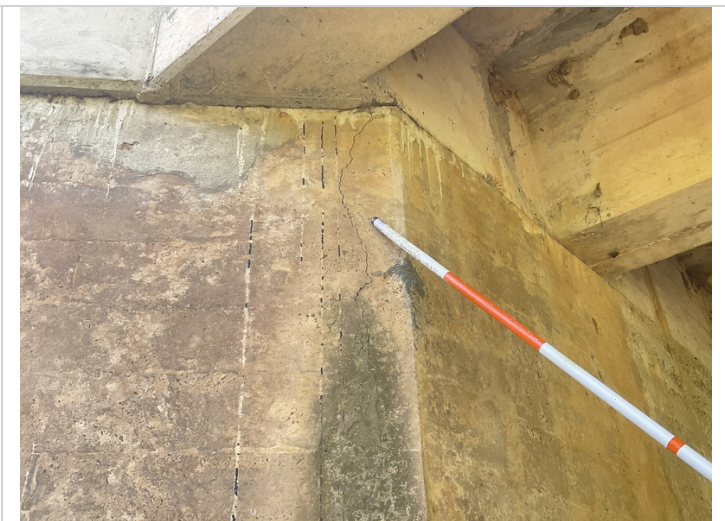
Abutment # 2 right monolithic wing wall has a moderate width vertical crack in upper portion of wall adjacent to abutment stem wall.

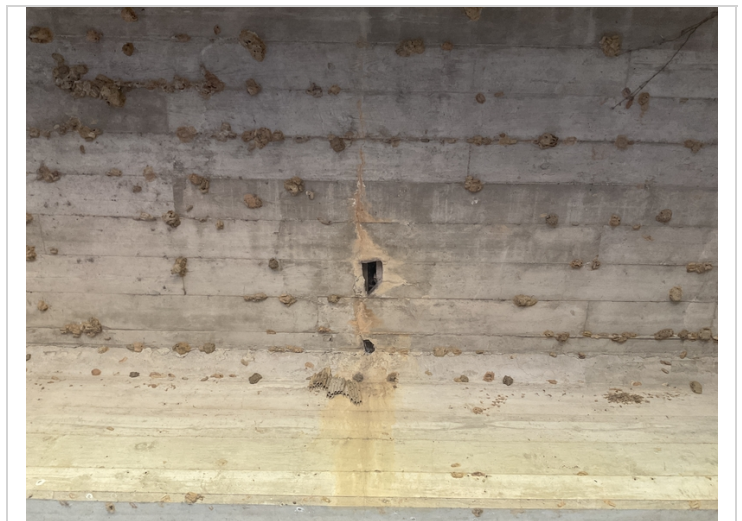
Span 2, bay 2-Void in deck undersurface

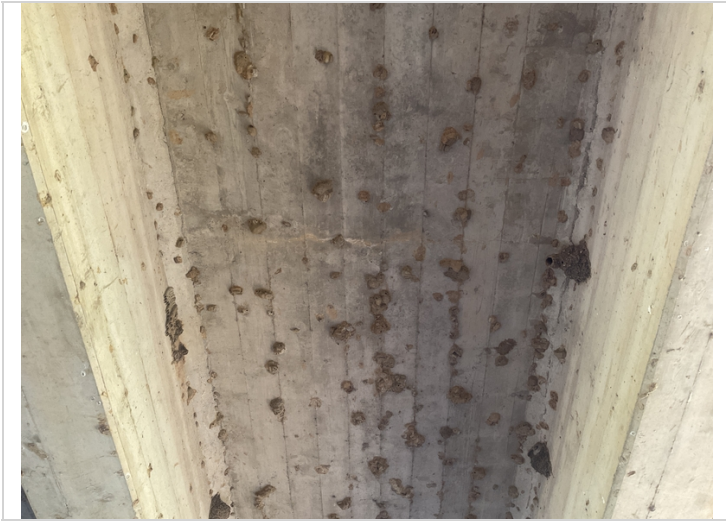
Span 2, bay 2-Transverse crack with light efflorescence

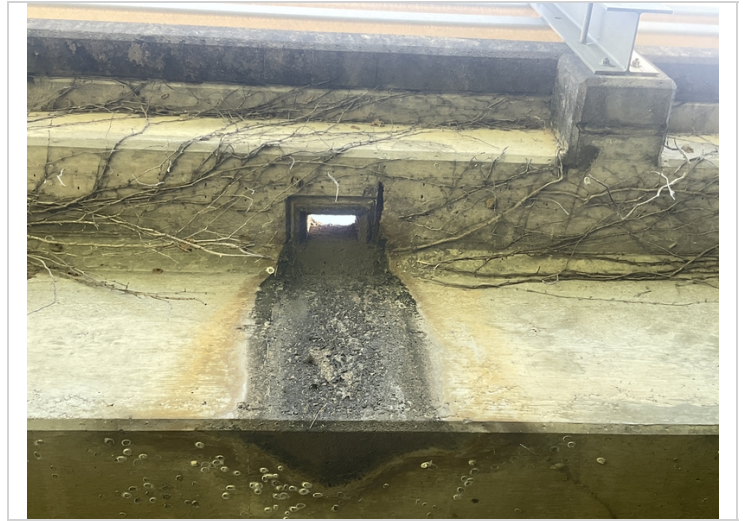
Span # 2, right deck overhang has a shallow spall with exposed reinforcing steel adjacent to the deck drain. Initial section loss to the reinforcing steel.

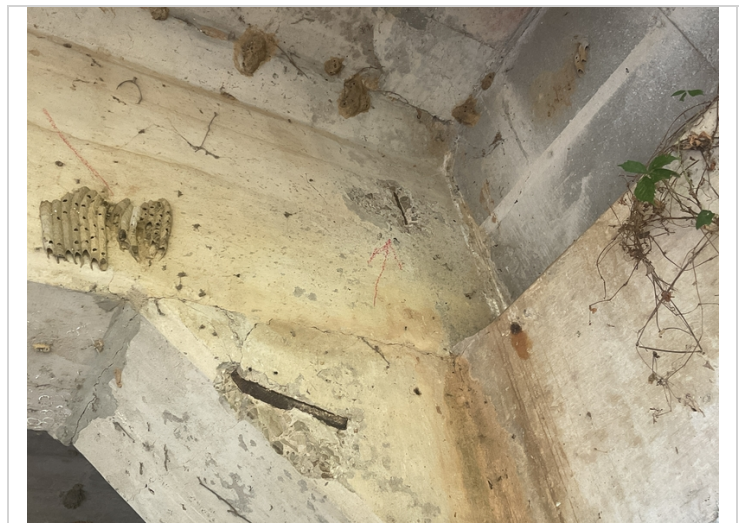
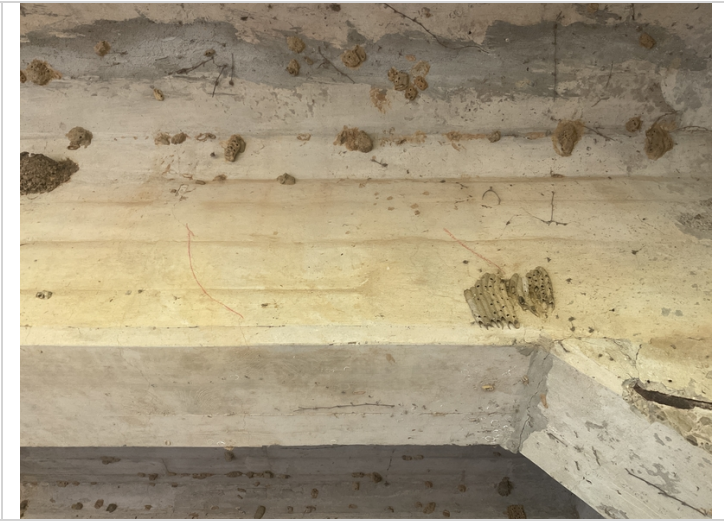
Span # 2 girder # 2 has a hairline shear type crack and spalling with exposed reinforcing steel in the beam over bent # 2.

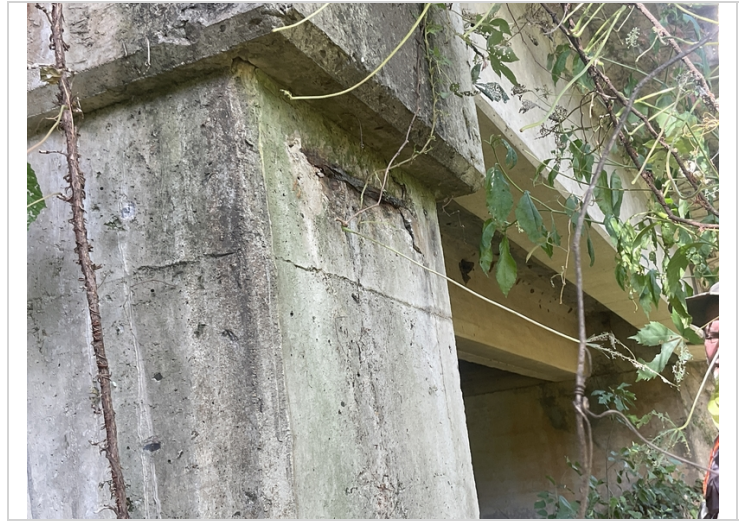
Bent 2, column 1-Spall with exposed reinforcing steel

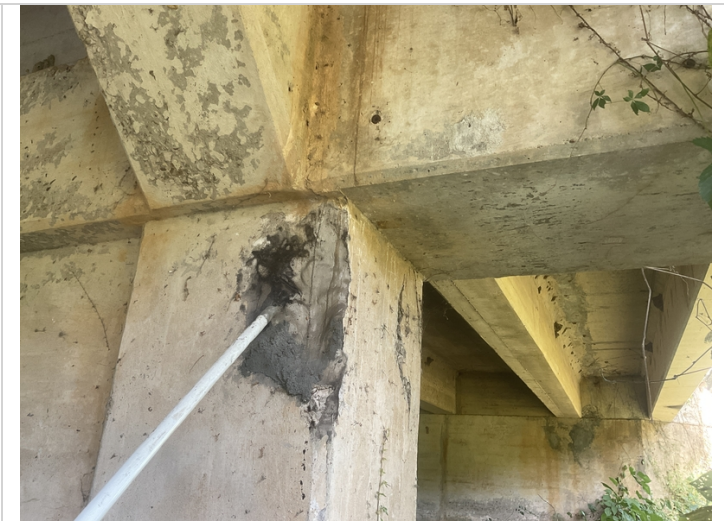
Bent 2, column 2-Repaired area

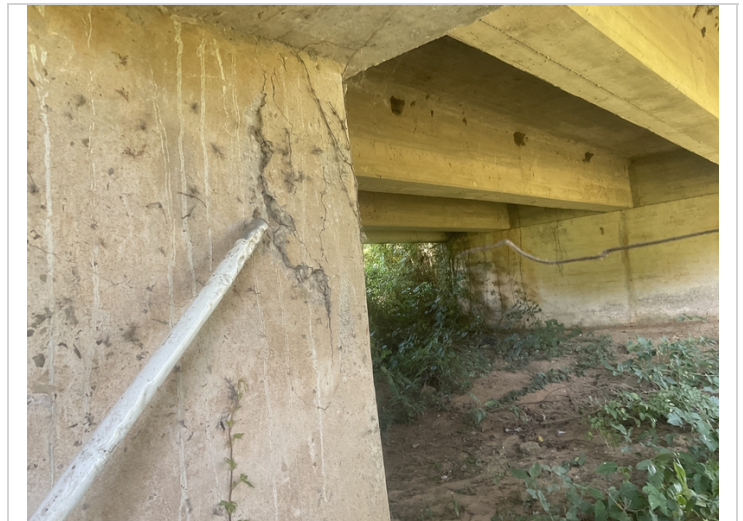
Bent # 2, column # 2 left exterior face has an 18" delaminated area at the cap juncture.

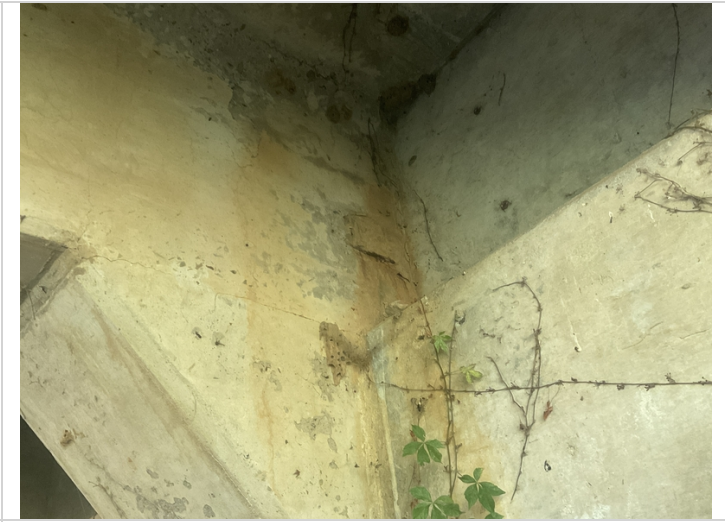
Span # 1, girder # 4 at bent # 2 has a 6" spall with exposed reinforcing steel.

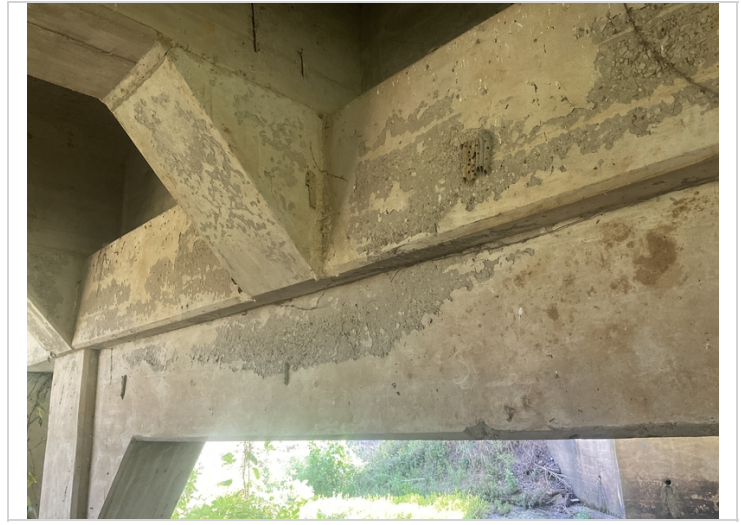
(234) -Bent # 2 cap has shallow spalling with exposed reinforcing steel in the beam # 2 haunch. -Bent # 2 cap has light scale due to leaking deck joint.

Scaling in bent 2 cap backface

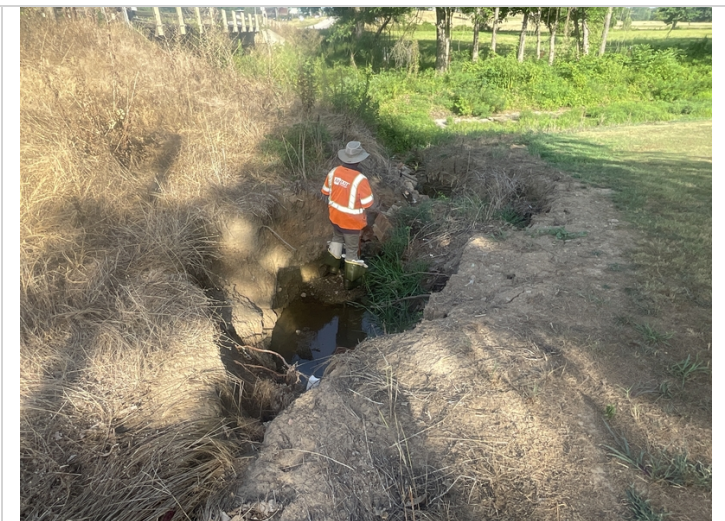
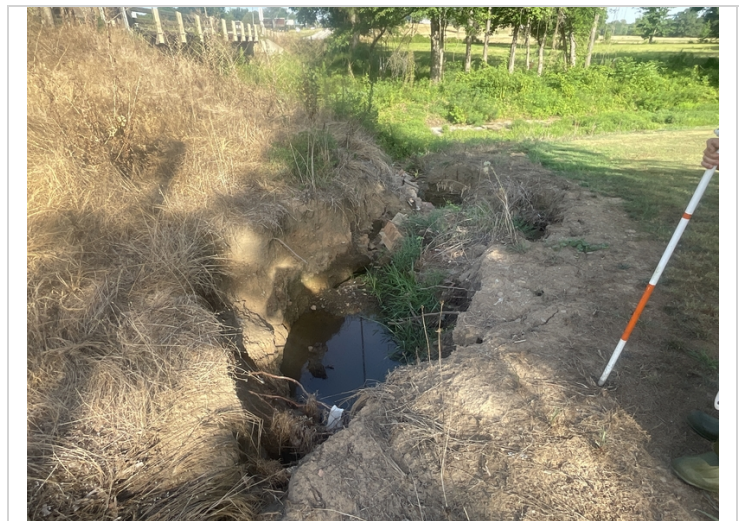
The drainage ditch on the left embankment at the East bridge end has erosion that has eroding the adjacent private property.

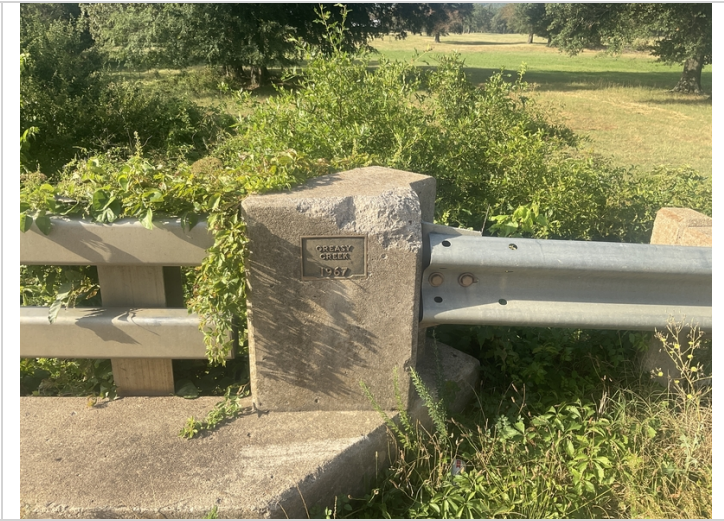
Left end post at abutment # 1 has shallow spalling to the top of post.

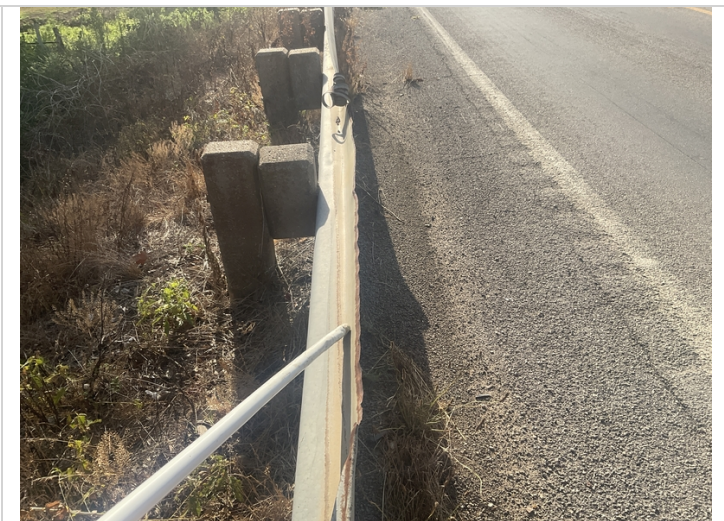
The left approach railing at abutment # 1 has collision damage that has created sharp jagged edges along the top.

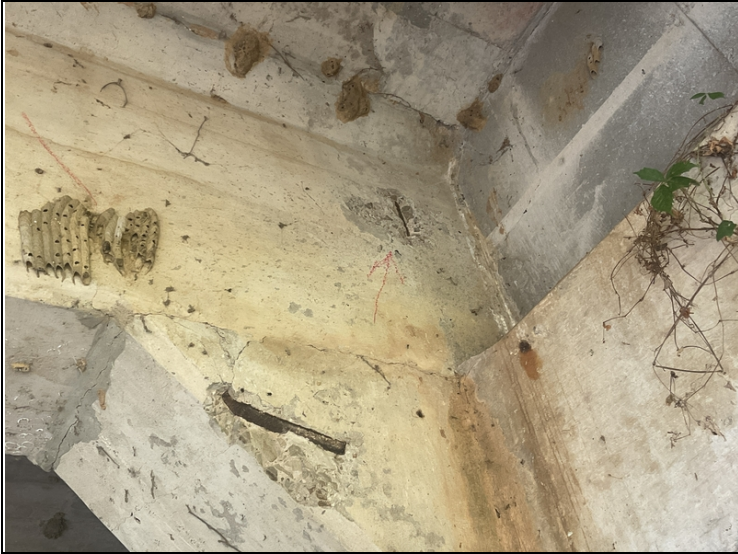
Superstructure -  
Span # 1, girders # 3 and 4 have shallow concrete spalls with exposed reinforcing steel adjacent to bent # 2.  
Span # 2, girder # 2 has a shallow 6" spall with exposed reinforcing steel over bent # 2.

Span # 2, girder # 2 has a shallow 6" spall with exposed reinforcing steel over bent # 2.

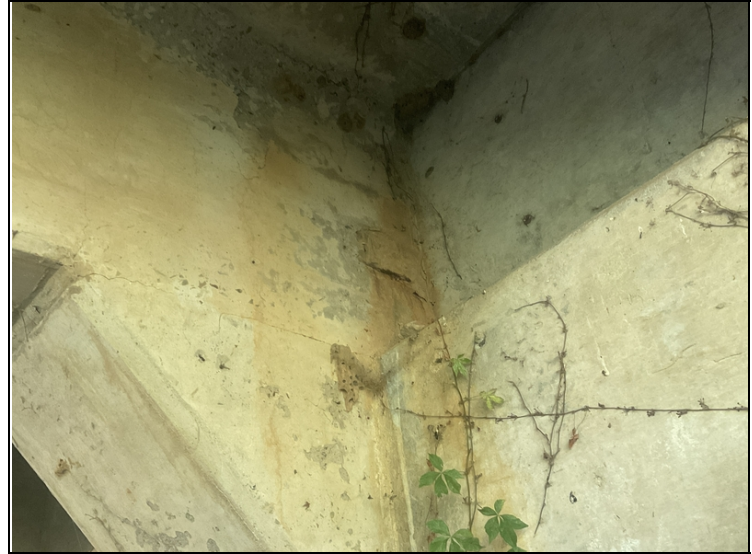
Span # 1, girder # 4 at bent # 2 has a 6" spall with exposed reinforcing steel.

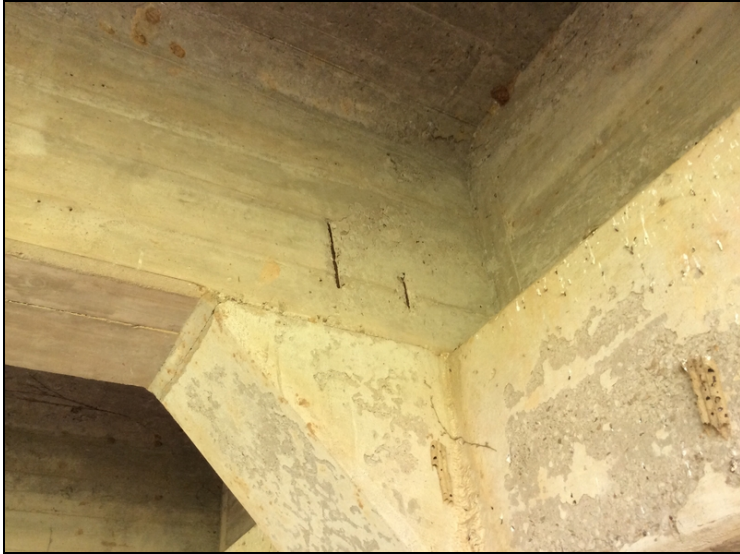
Span # 1, beam # 3-Spalling with exposed reinforcing steel over bent # 2.

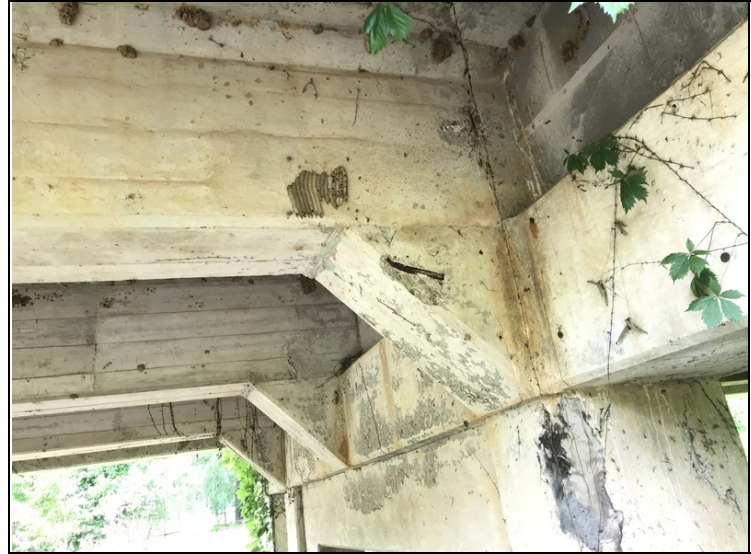
Span # 1, girders # 3 and 4 have shallow concrete spalls with exposed reinforcing steel adjacent to bent # 2.

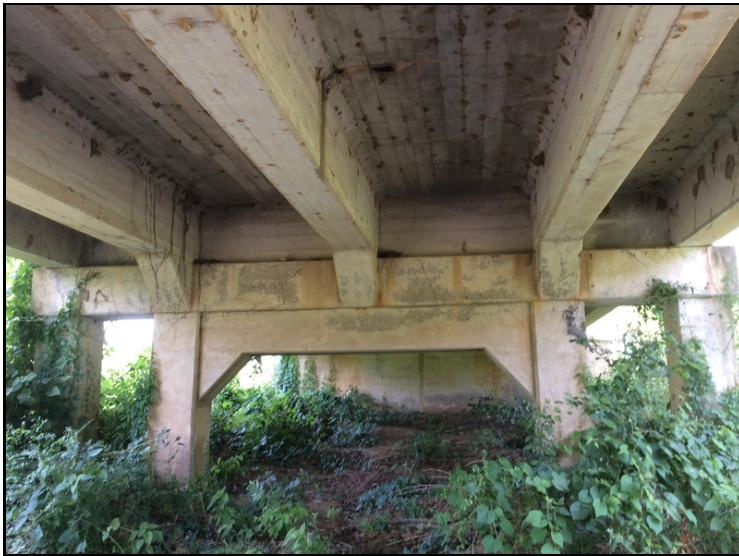
Bent 2 column 1 has a 16" spall with exposed reinforcing steel.  
Bent # 2 Cap has light scale with water stains.

Bent # 2 staining from apparent water leakage through the deck joints.

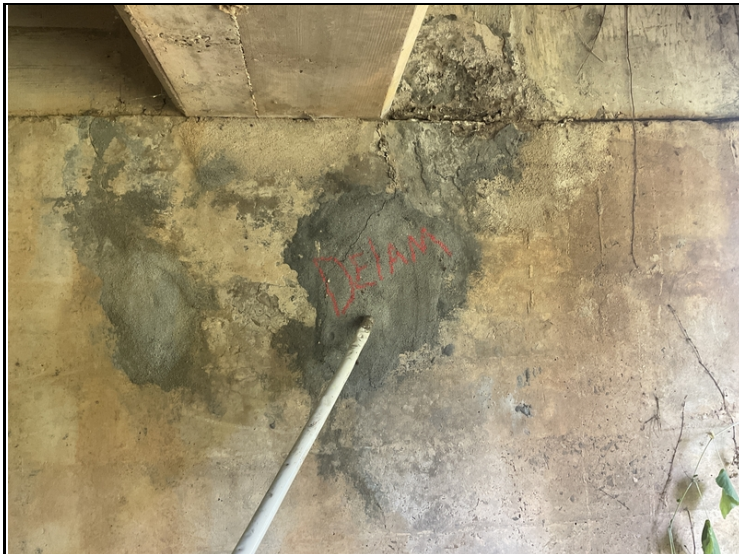
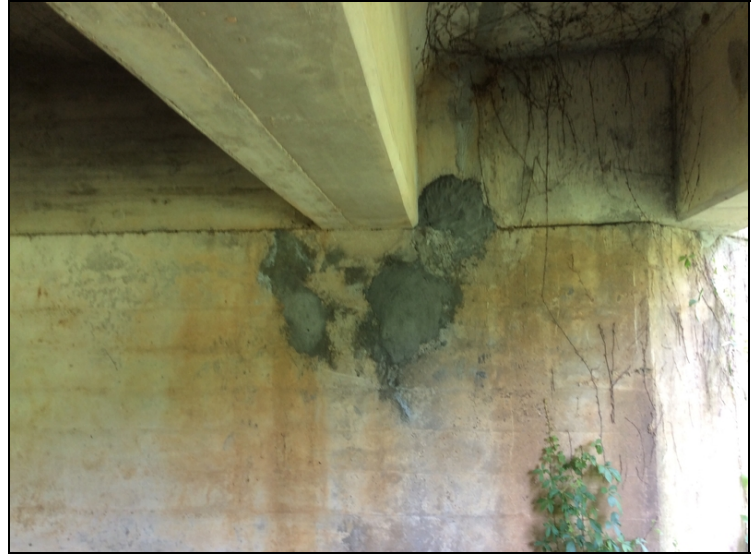
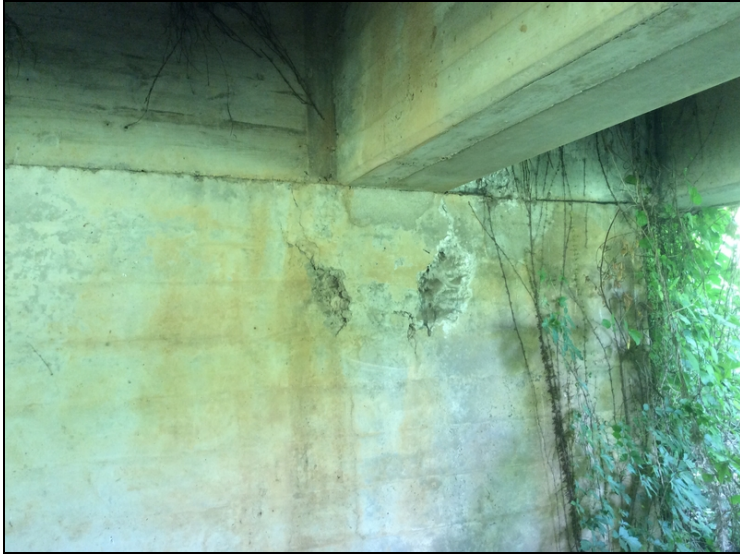
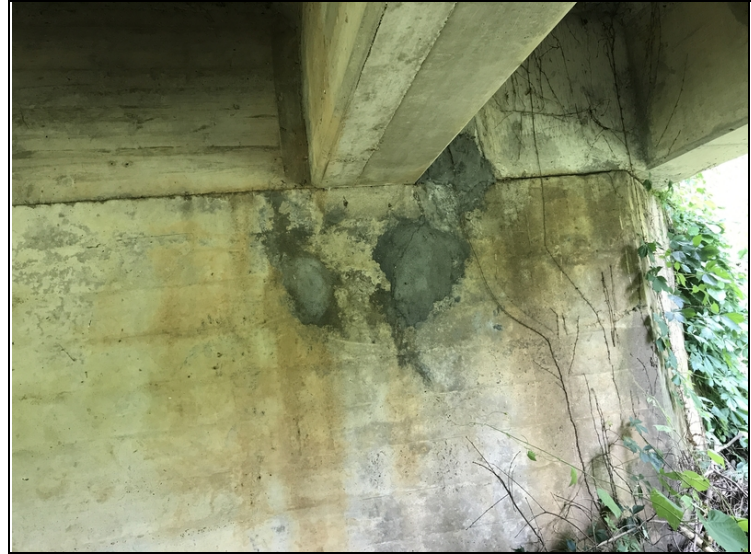
Abutment # 1 has a 30" delaminated area under girder # 2. The grouted repairs to the delaminated area have failed and sound delaminated when sounded with a geologist hammer.

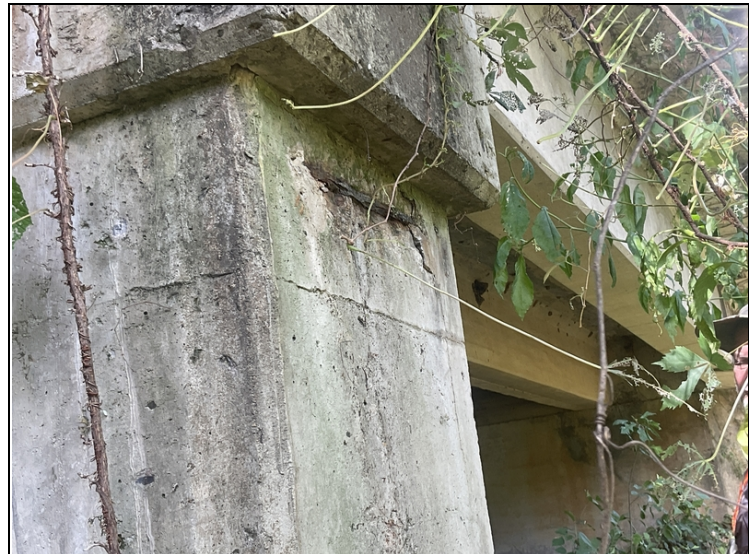
Bent # 2, column # 1 has a 16" spall with exposed reinforcing steel.

Bent # 2, column # 1-Spall with exposed reinforcing steel.

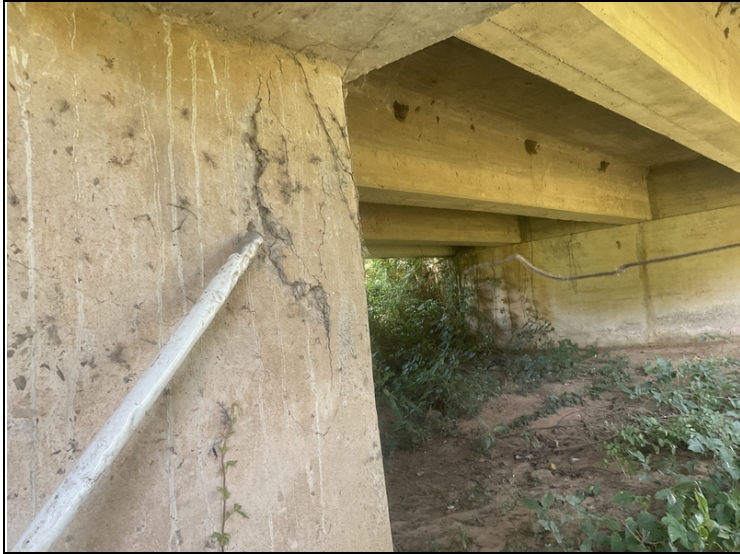
Bent # 2, column # 2 left exterior face has an 18" delaminated area at the cap juncture.

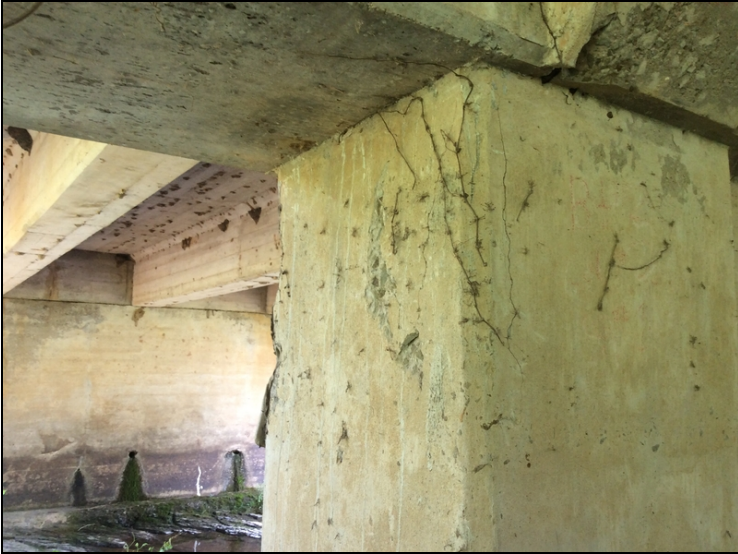
One basketball size delaminated area next to the repaired spall in Bent # 2, Column # 2.

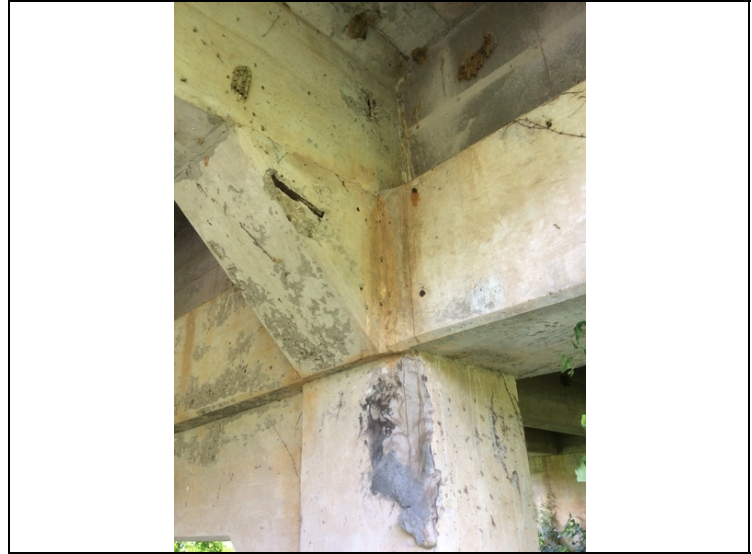
The ahead face of bent # 2 cap haunch has a spall with exposed reinforcing steel under girder # 2.

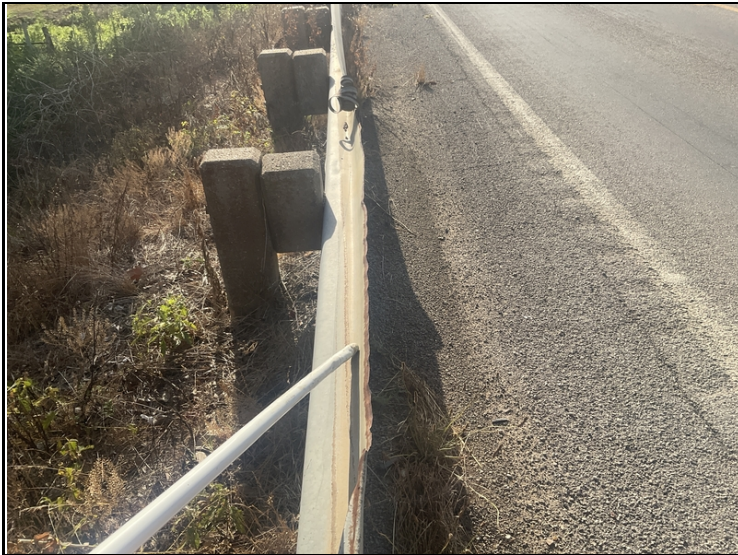
The left approach railing at abutment # 1 has collision damage that has created sharp jagged edges along the top of railing.

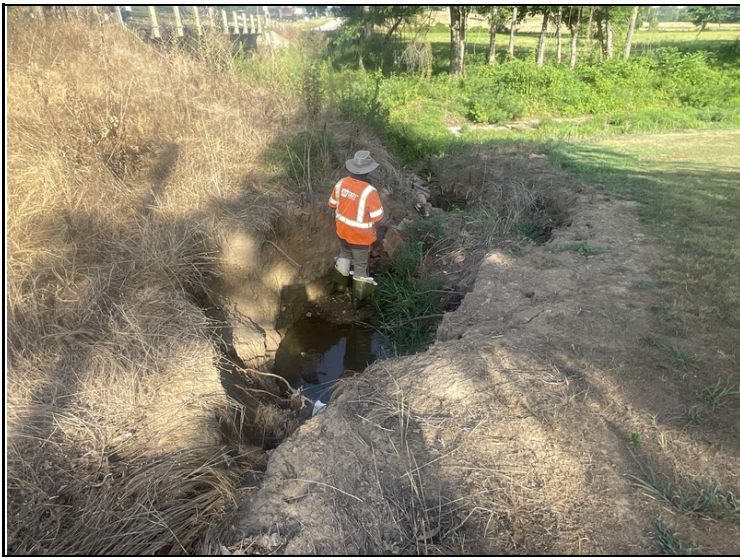
Northeast Embankment -  
The drainage ditch on the Northeast embankment has significant erosion.

The drainage ditch on the Northeast embankment  
has significant erosion.
