Asset #A1273(Routine)

State Highway 10 over Scott Creek-Logan Co.

Team Lead: Bob McEntyre, Inspection Date: 08/04/2022

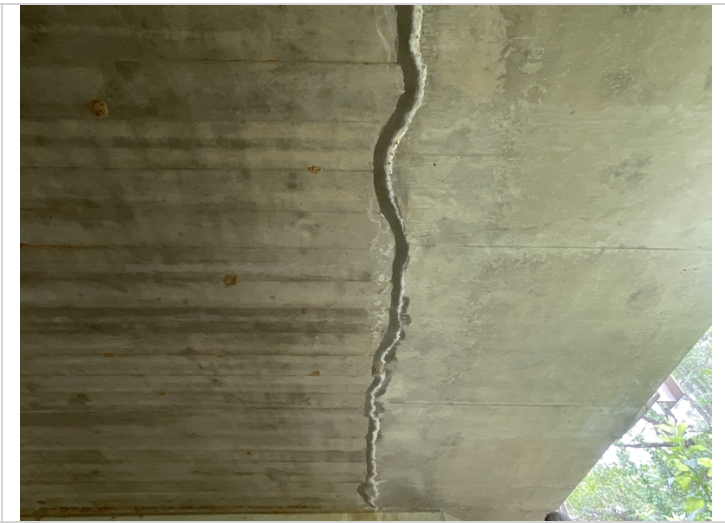
(38) Slab Span:							
-Span # 4 has a shallow 4" spall with no exposed reinforcing steel in the undersurface of the slab at centerline near mid-span.							
-Span # 4 concrete slab has longitudinal cracking with efflorescence and staining near mid-span and at the construction joints where the structure was widened.							
-Vertical hairline cracks at variable spacing are visible in the edge of the deck.							
-Light scale along the edges of the slab is visible from the undersurface.							
110	Reinforced Concrete Open Girder/Beam	LF	600	351	245	4	0
1080	Delamination/Spall/Patched Area	LF	2	0	2	0	0
1090	Exposed Rebar	LF	5	0	1	4	0
1120	Efflorescence/Rust Staining	LF	2	0	2	0	0
1130	Cracking (RC and Other)	LF	240	0	240	0	0

Span 4, right side-Efflorescence along construction joint

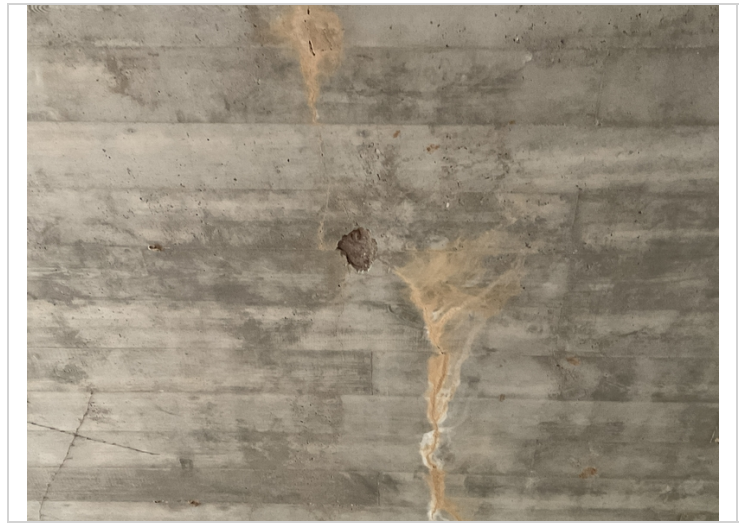
Span 3-Scaling near centerline at mid-span

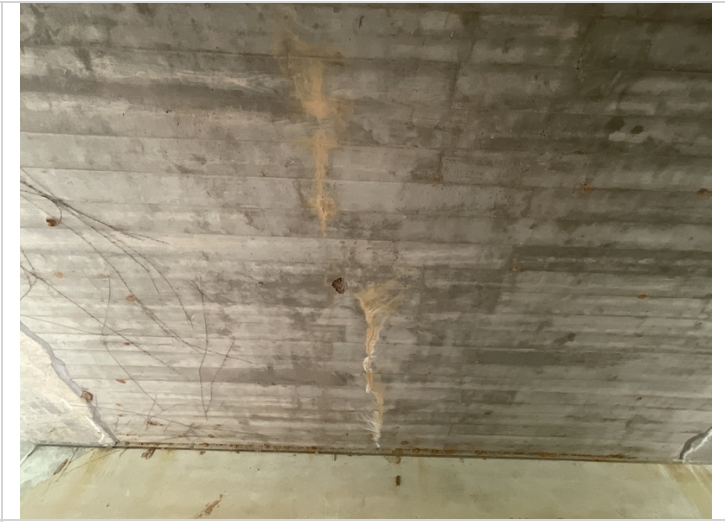
Span 4, longitudinal crack with efflorescence and staining at centerline

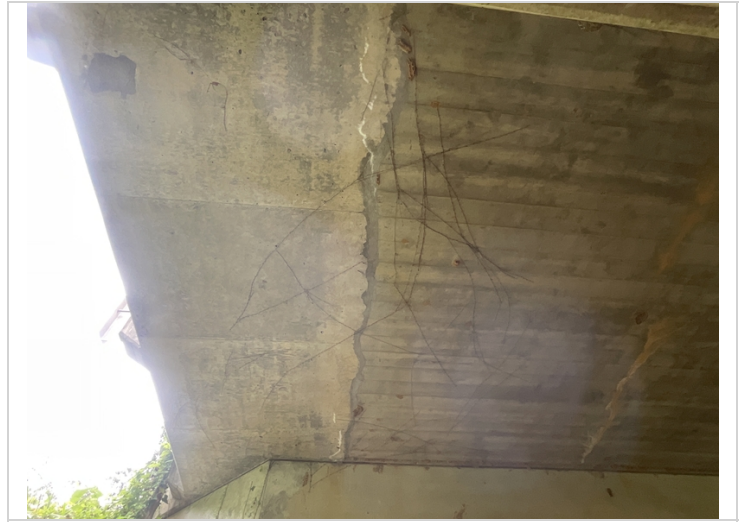
Span 4, left side-Longitudinal cracking with efflorescence along construction joint

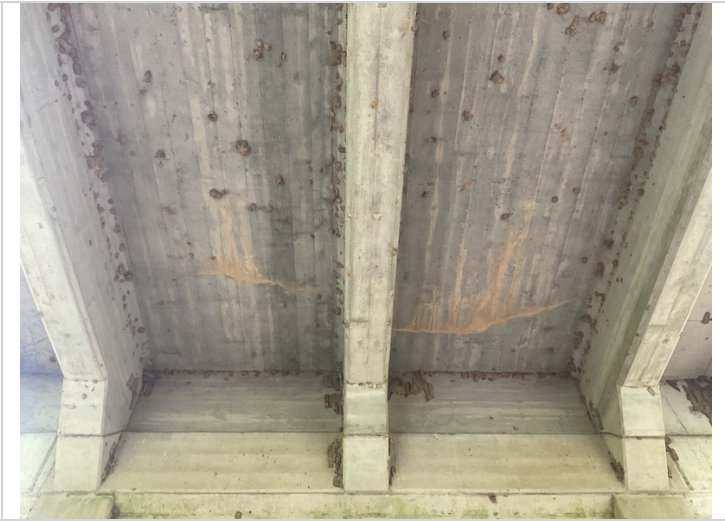
Span 3-Transverse cracking with staining

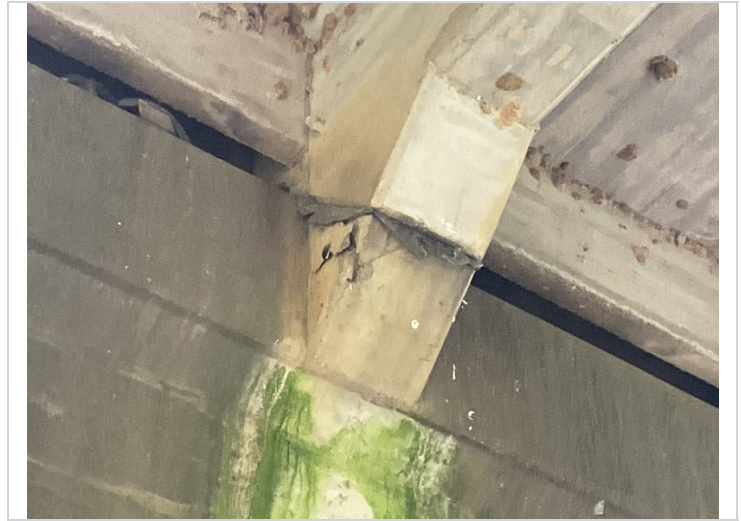
Bent 3 cap aheadface under girder 3-Spalling with exposed reinforcing steel

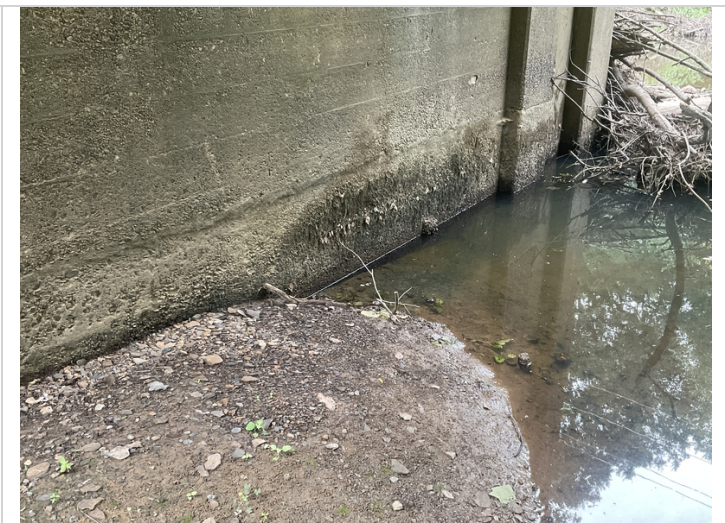
Bent 3-Abrasion

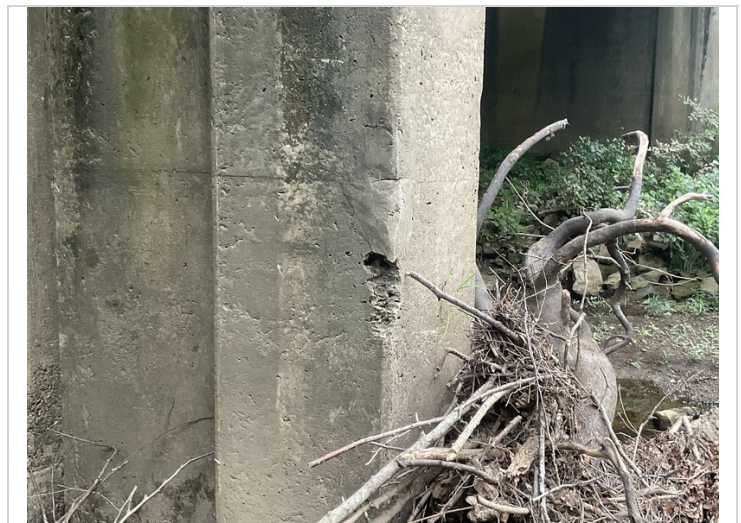
Bent 3, column 1-Concrete deterioration

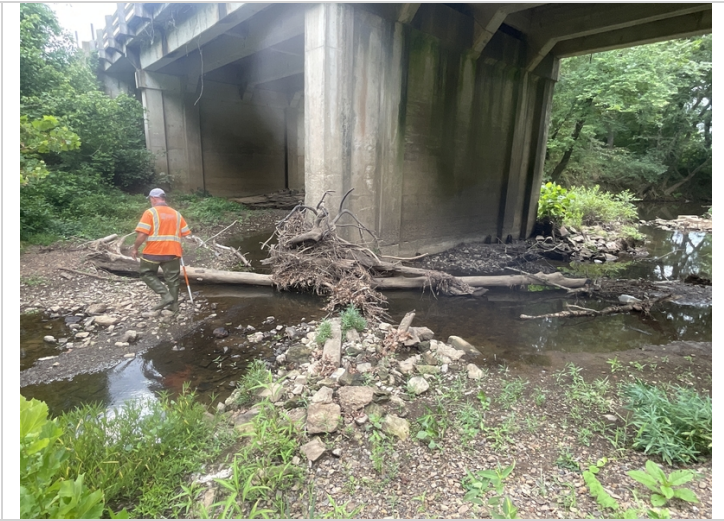
Drift accumulation at bent 3

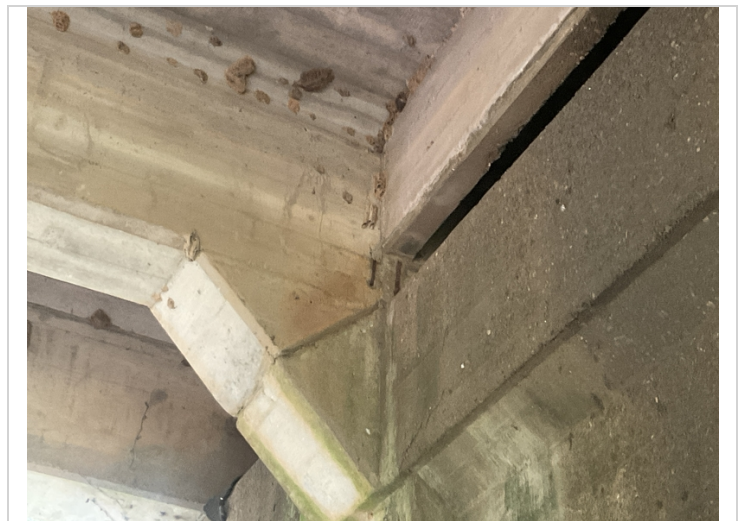
Span 2, girder 4 at bent 2-Shallow spall with exposed reinforcing steel

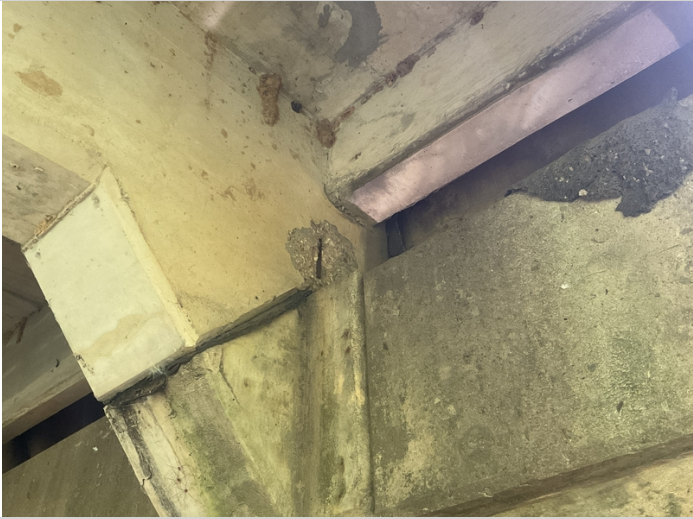
Span 1, girder 4 over bent 2-Spall with exposed reinforcing steel

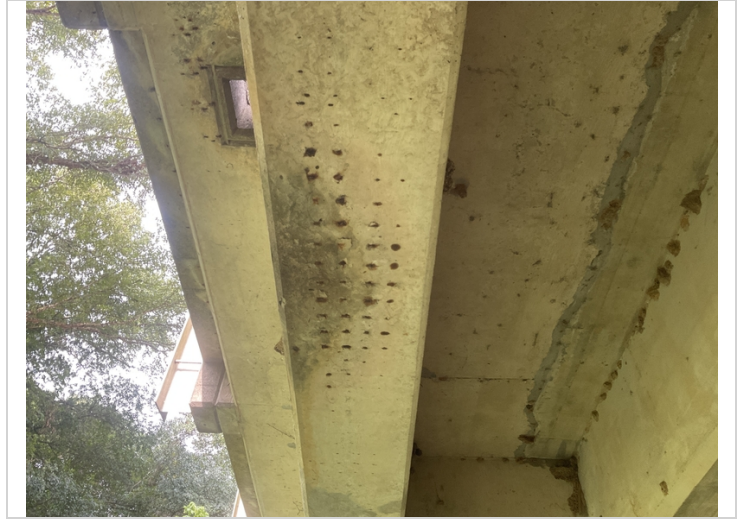
Span 1, girder 5-Exposed slab bolsters

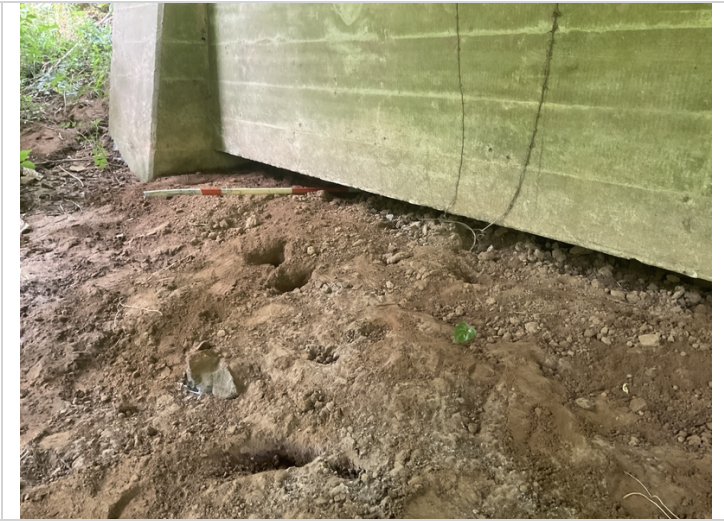
(210) -Abutment # 1 web wall has earth settlement with voids that penetrate up to approximately 16" under the web wall. -Abutment # 1 has patched areas over the widened portions of the structure between the girders. -Bent # 2 web wall has a vertical crack and a 5" spall with exposed reinforcing steel at center line. -Span # 2 side of bent # 3 web wall has medium abrasion at the water elevation with 2" deep concrete deterioration adjacent to column # 2 at the cold / construction joints. -Abutment # 2 web wall has a couple of vertical hairline cracks propagating from the weep holes and at the centerline of bent. -Abutment # 2 has light scaling in the turn back portion (original wing wall) of stem wall. -Abutment # 2 web wall has a vertical hairline crack near the center of bent and one that propagates from the right weep hole.							
220	Reinforced Concrete Pile Cap/Footing	LF	4	4	0	0	0

Abutment 1-Earth settlement

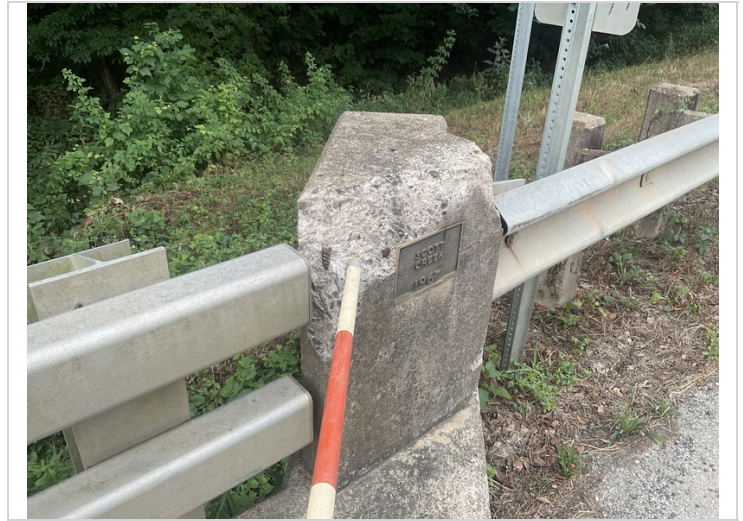
Abutment 1, right end post-Spalling with exposed reinforcing steel

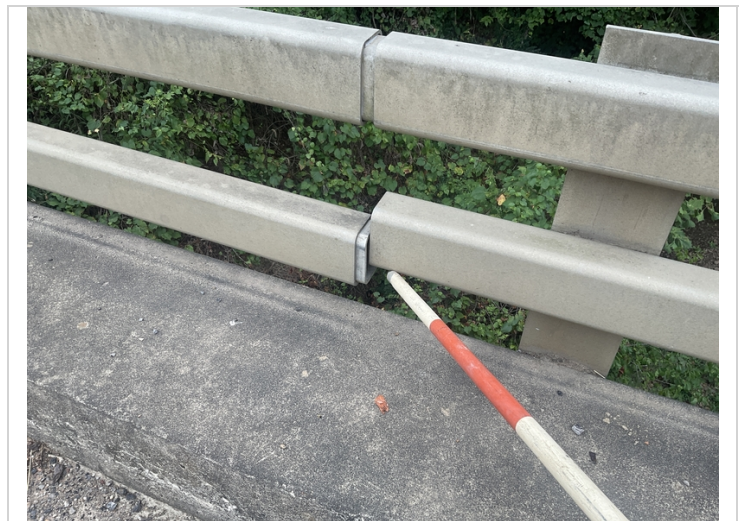
Span 3, right railing-Failed connection

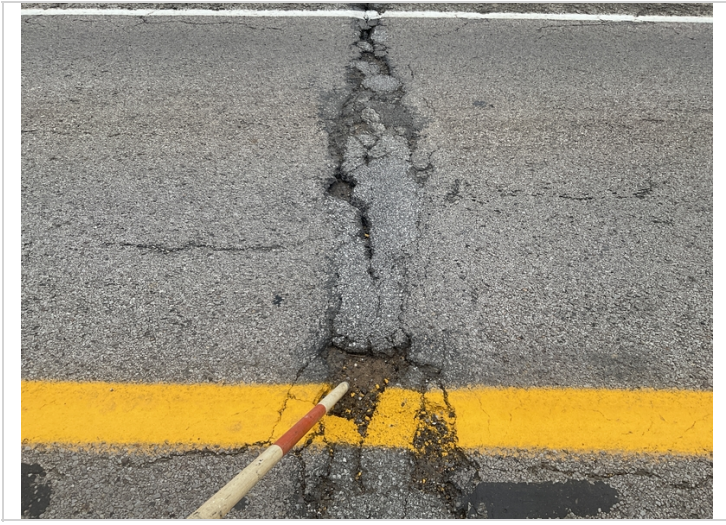
Asphalt breaking apart over bent 3

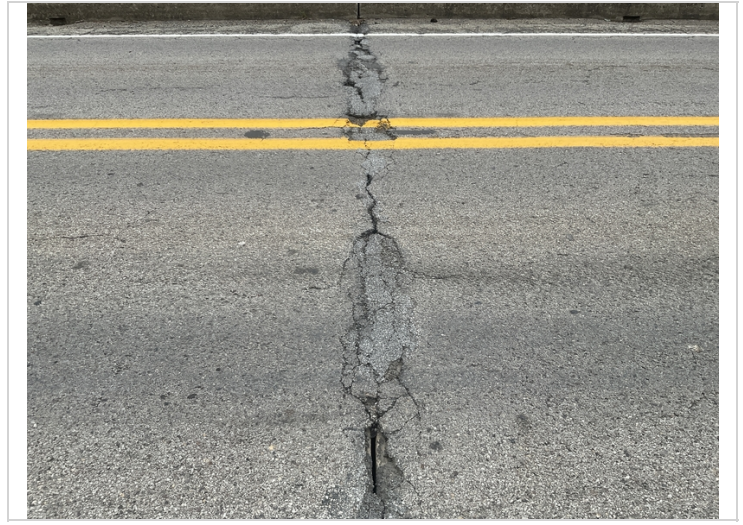
Asphalt breaking apart over bent 3

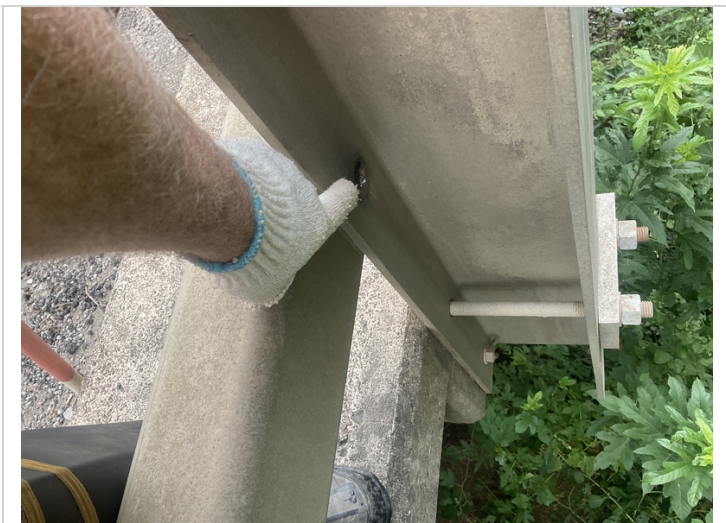
Span 1, right at bent 2-Missing bolt for bottom railing

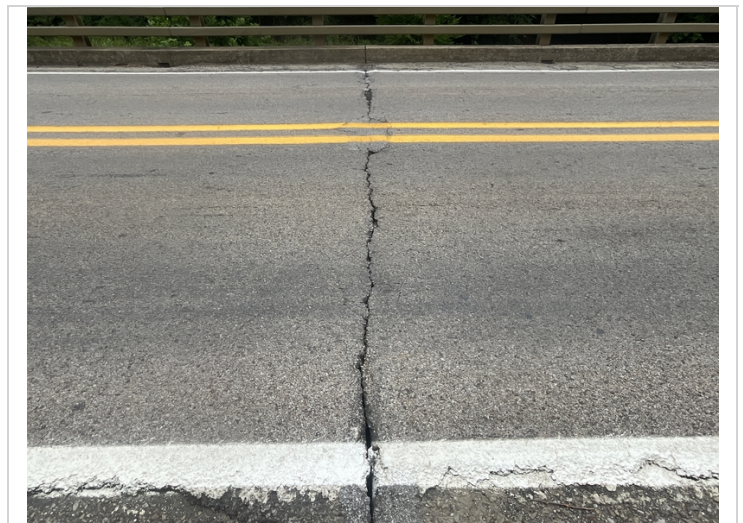
Asphalt cracked over bent 2

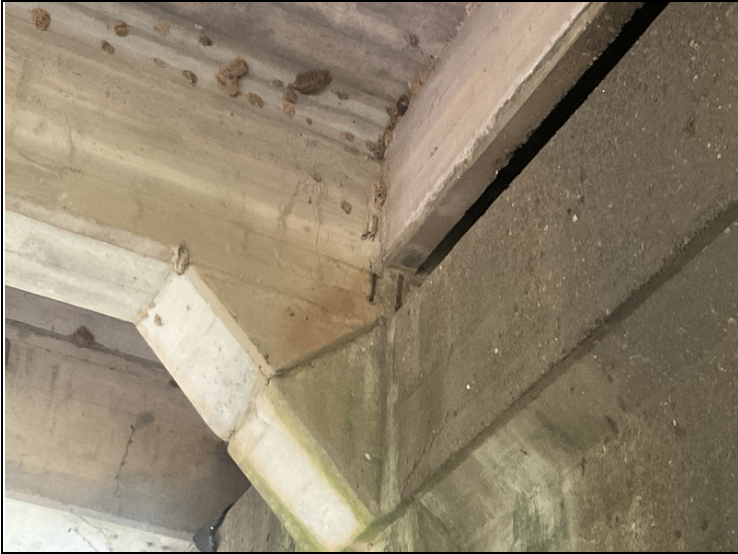
Superstructure -  
Concrete deck girders have spalls with exposed reinforcing steel.

Span # 2, girder # 4 at bent # 2-Shallow spall with exposed reinforcing steel.

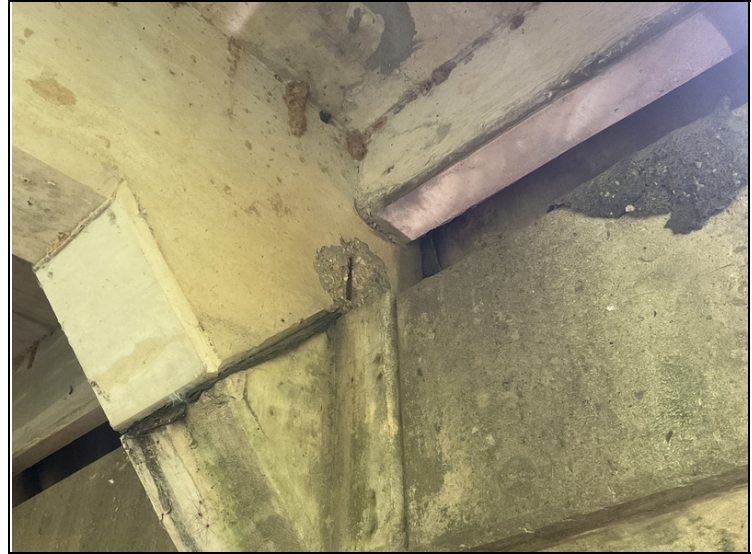
Span # 1, girder # 4 over bent # 2-Spall with exposed reinforcing steel.

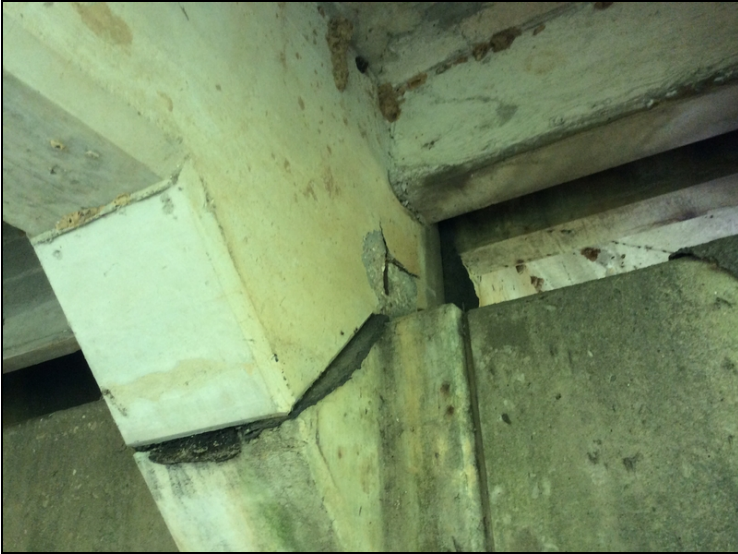
Span # 1, girder # 4 at bent # 2-Spalling with  
exposed reinforcing steel.

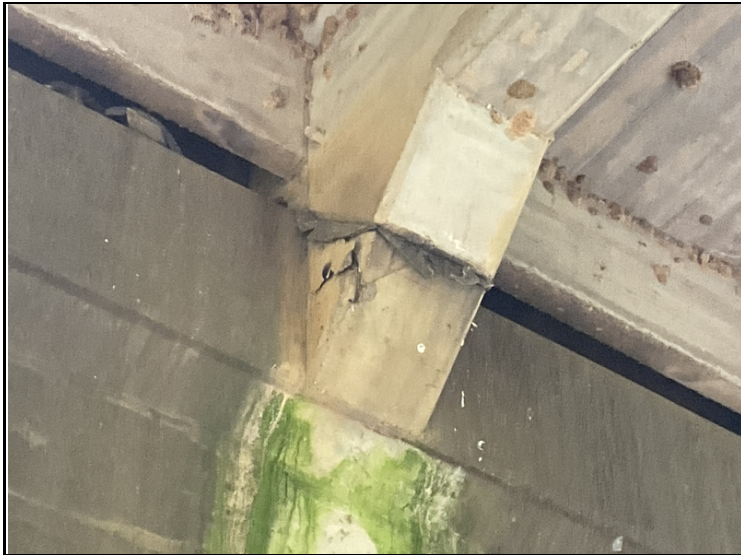
Substructure cap haunches and stem walls have spalls with exposed reinforcing steel. There is minor concrete deterioration in bent # 3 columns.

Bent # 3 cap aheadface under girder # 3-Spalling with exposed reinforcing steel.

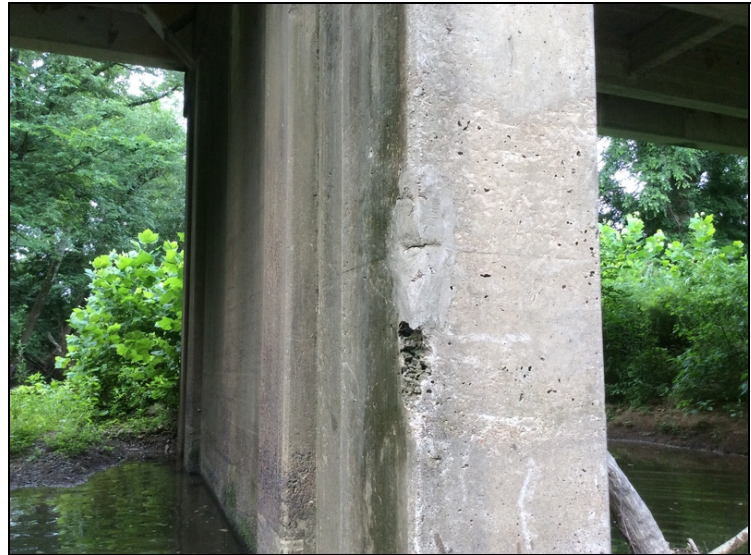
Bent # 3, column # 1 has an area of concrete section loss that is 3 inches deep and 12 inches tall near the base of column with an adjacent repair.

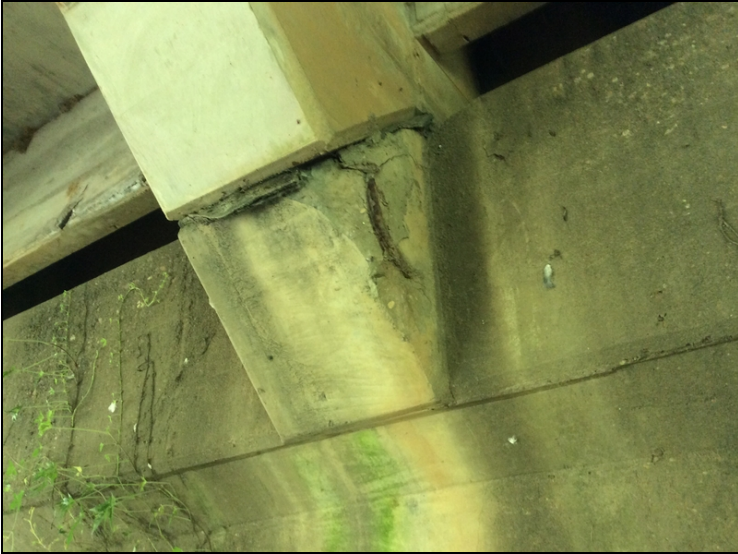
Bent # 2-Spalling with exposed reinforcing steel in cap haunch.

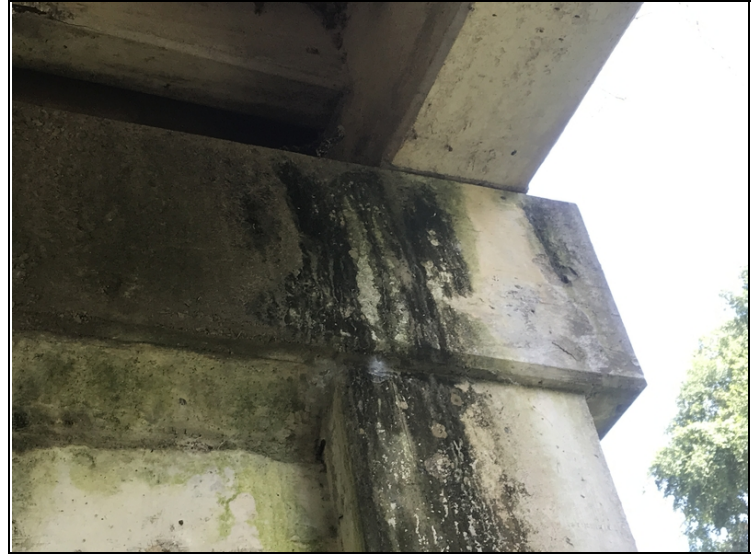
Spall with exposed reinforcing steel in the left side of bent # 2 cap.

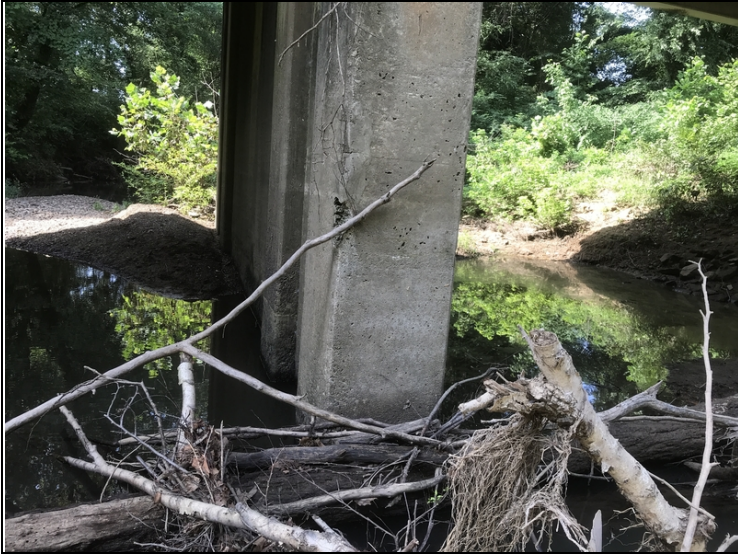
Bent # 3, Column # 1-Concrete deterioration.

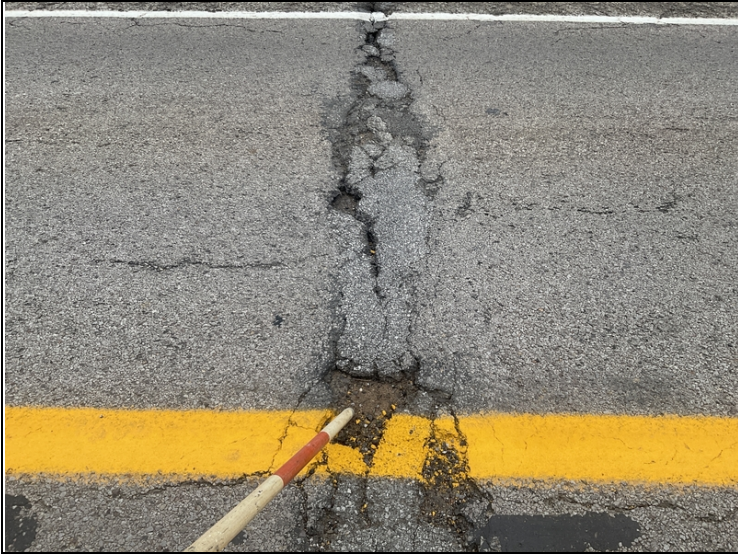
Expansion Joints -  
Asphalt is breaking apart over the expansion joints with potholes forming in the driving surface. The expansion joints leak water and debris on the substructure caps.

Asphalt breaking apart over bent # 3.

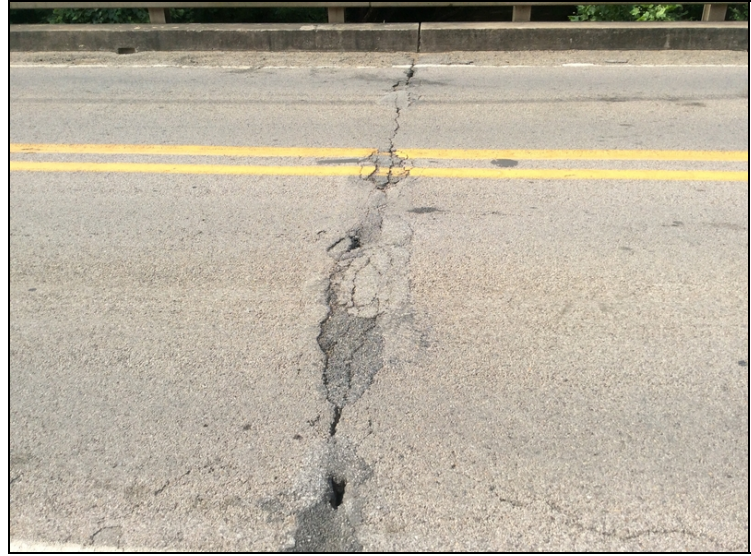
Bent # 3 asphalt deterioration over the joint.

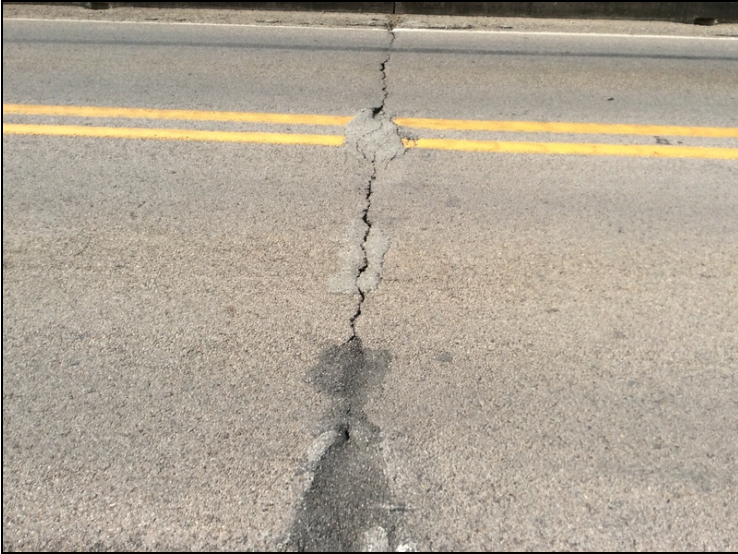
Bent # 2 asphalt deterioration over the deck joint.

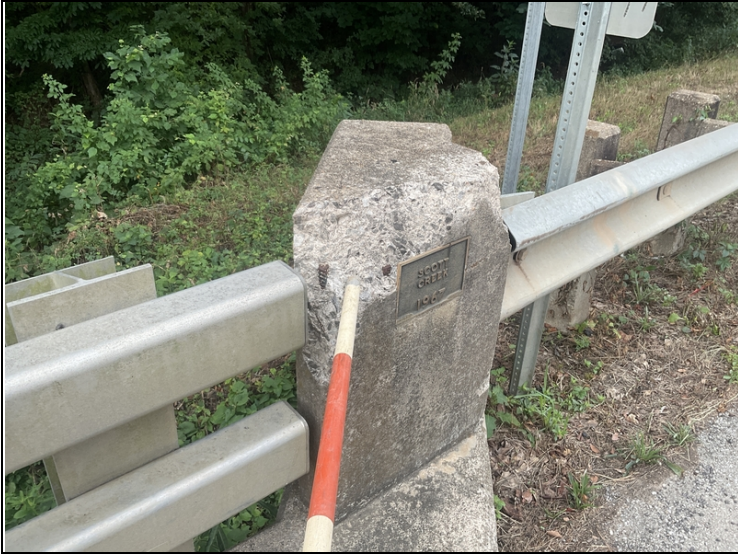
Bridge Railing -  
Right bridge railing in span # 3 has missing bolts in the connection. The left and right bridge railing has loose bolted connections in some locations.  
The right end post at abutment # 1 has collision damage with spalling that exposes reinforcing steel.

Abutment # 1, right end post-Spalling with exposed reinforcing steel.

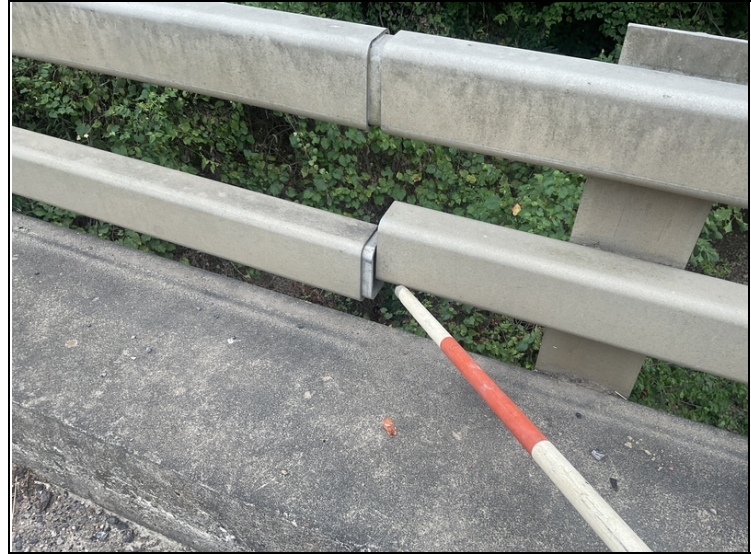
Span # 3, right railing-Failed connection.

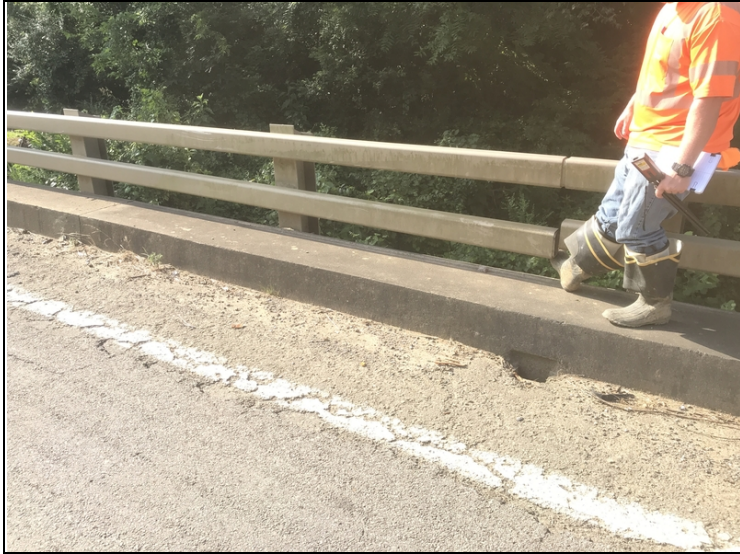
Connection is missing bolts in the right side of  
Span # 3.

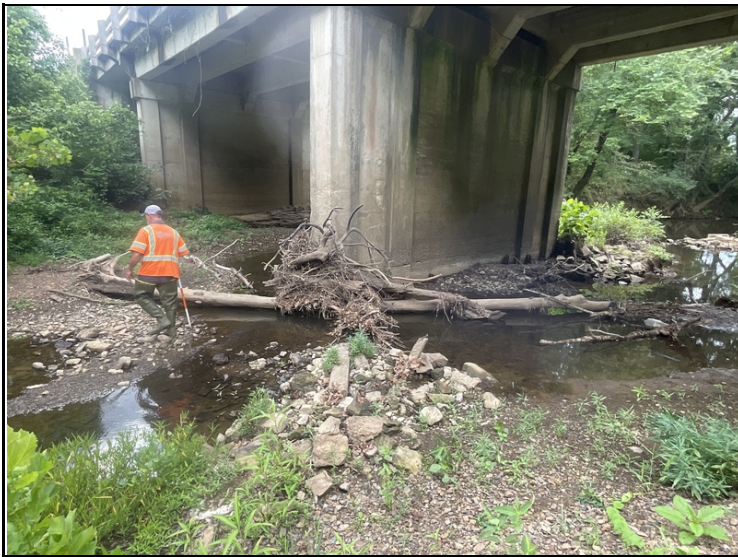
The channel has drift accumulation at bent # 3 causing localized scour at the base of column # 1.
