Asset #00348(Routine, Underwater type 2)

State Highway 22 over Big Creek Seb. Co.

Location: 0.10 MI E OF BLOOMER, ARK

Team Lead: Jeff Jones, Inspection Date: 08/01/2022

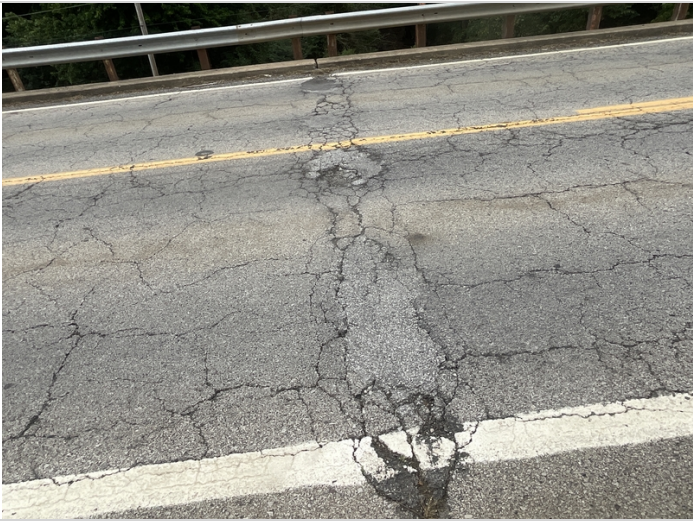
Asphalt wearing surface is breaking apart over Bent # 4.

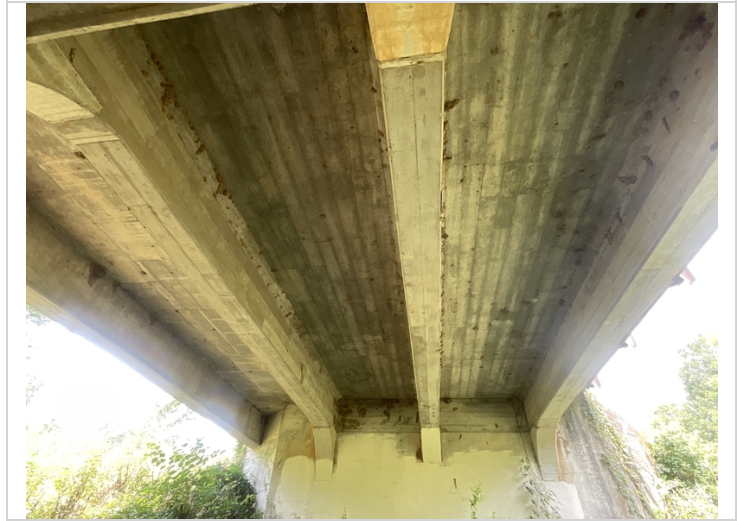
Span # 1 deck soffit. Typical.

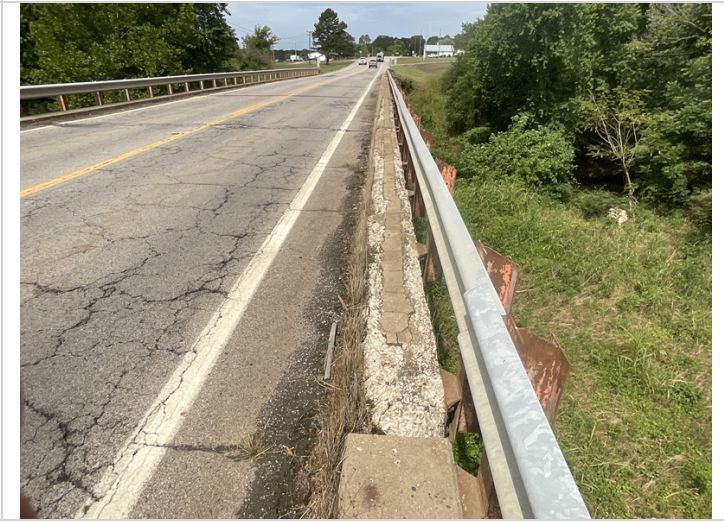
Soft and deteriorated concrete in the Left gutter.

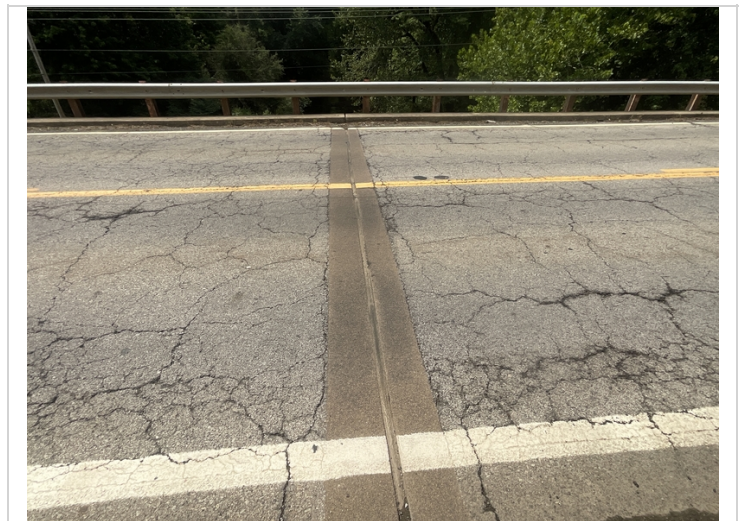
Expansion joint with previous repair on the deck over Span #
2.

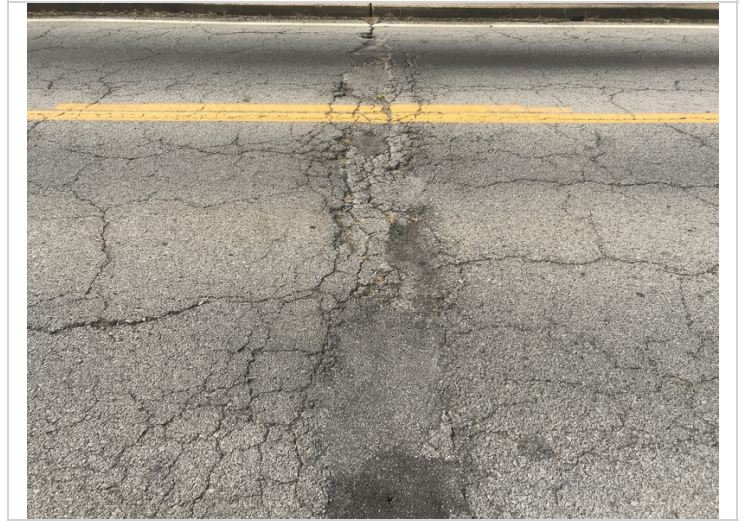
Concrete deterioration over the intermediate bents.

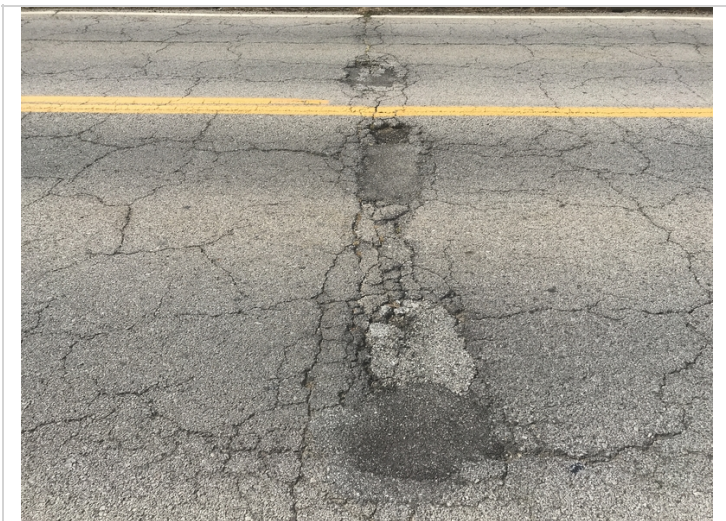
Potholes over the deck joints over the intermediate bents.

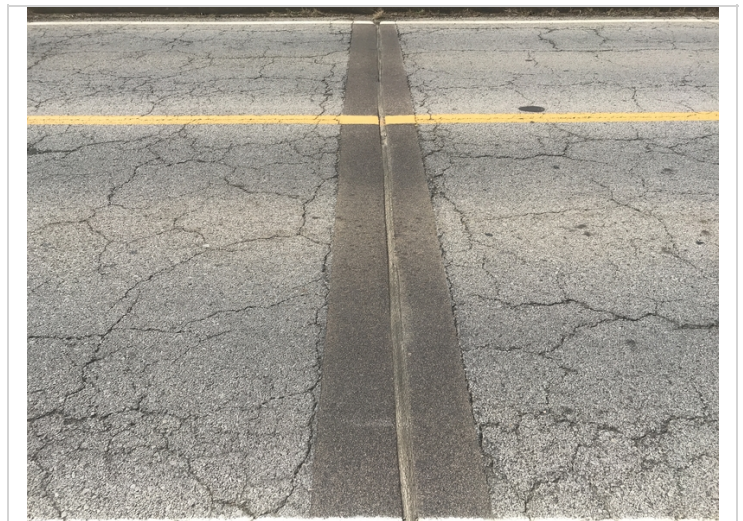
Bent # 3 joint repair.

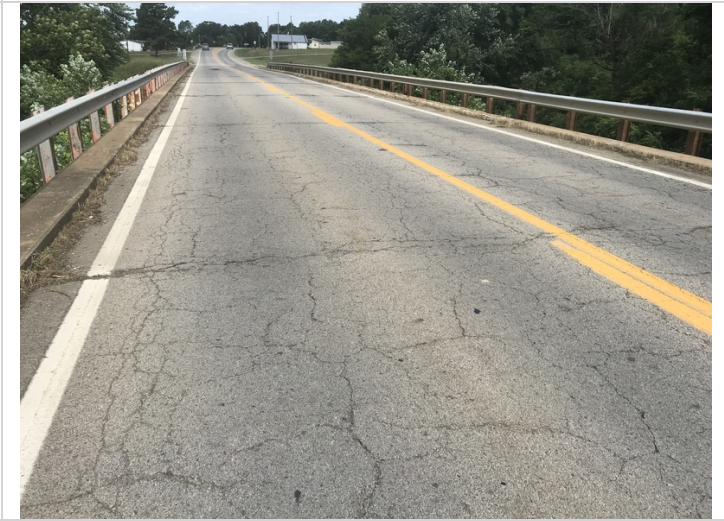
Driving surface cracking.

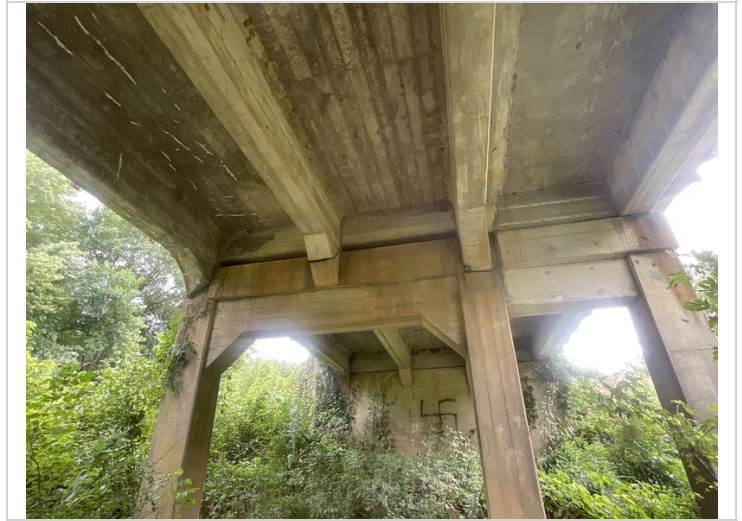
Span # 5 at Bent # 6. Spalls in the girder haunches adjacent to Bent # 6. Photo of Girder # 1 on the Left.

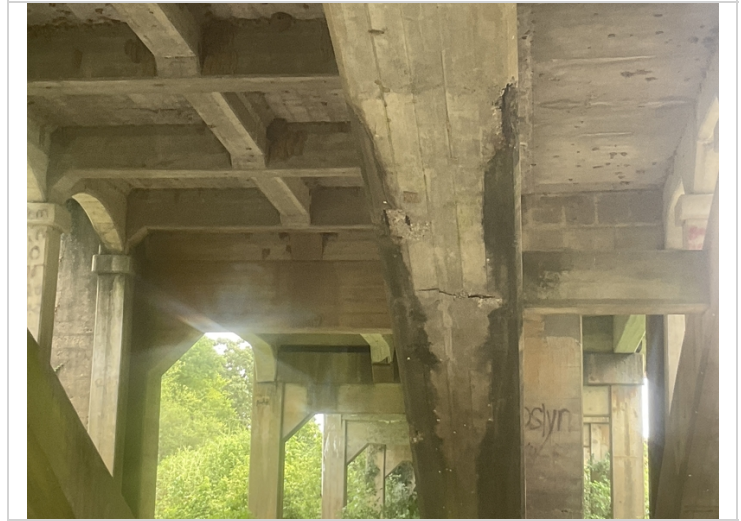
Spalls with exposed reinforcing steel in Arch Rib # 2.

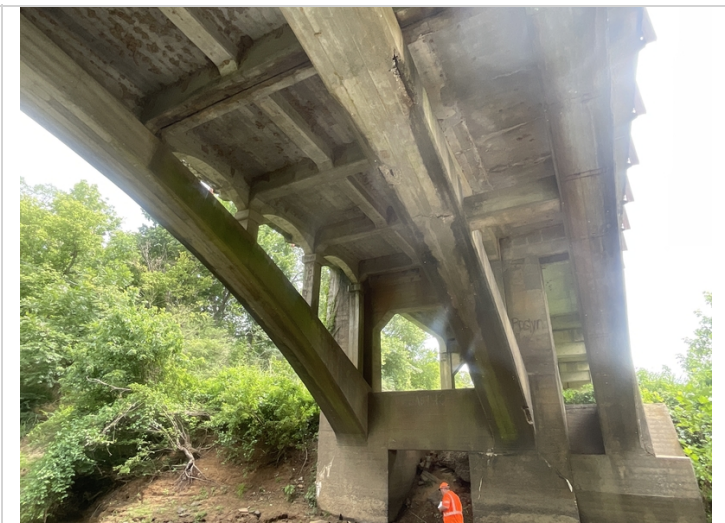
Arch Rib # 2 in proximity to Bent # 3. Spalls with exposed reinforcing steel.

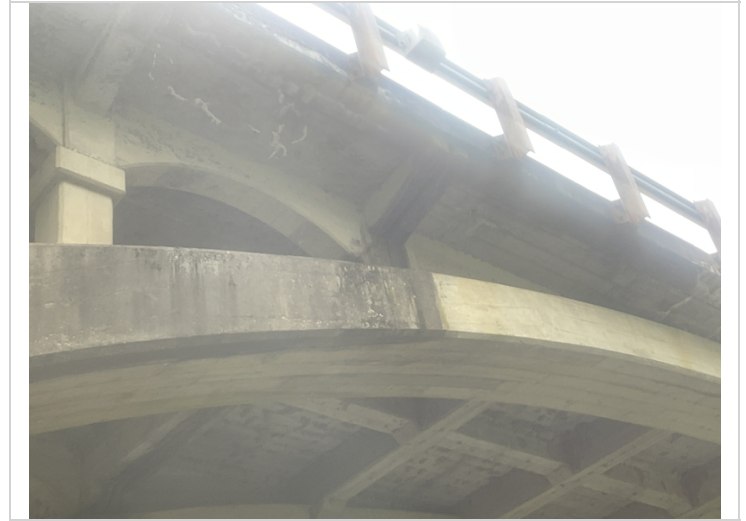
Arch Rib # 1, Column # 9 at the floor beam juncture.
Diagonal crack.

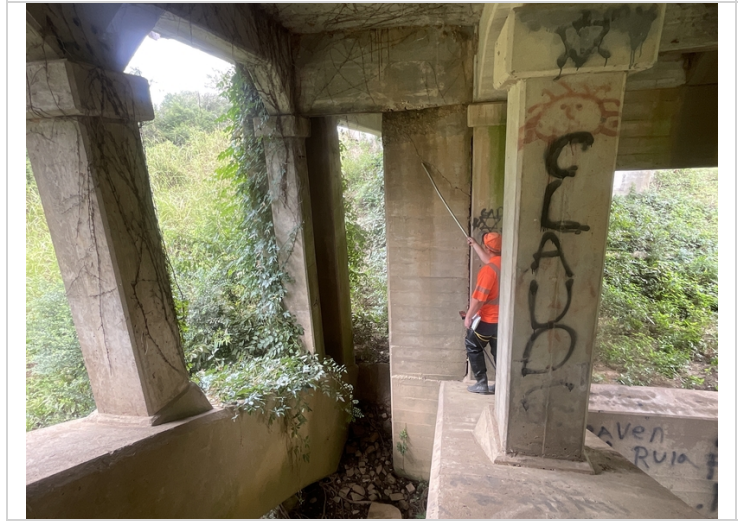
Column # 2. Bent # 2. Span # 2 ahead face. Diagonal crack with spalling at the cap juncture where the structure was widened.

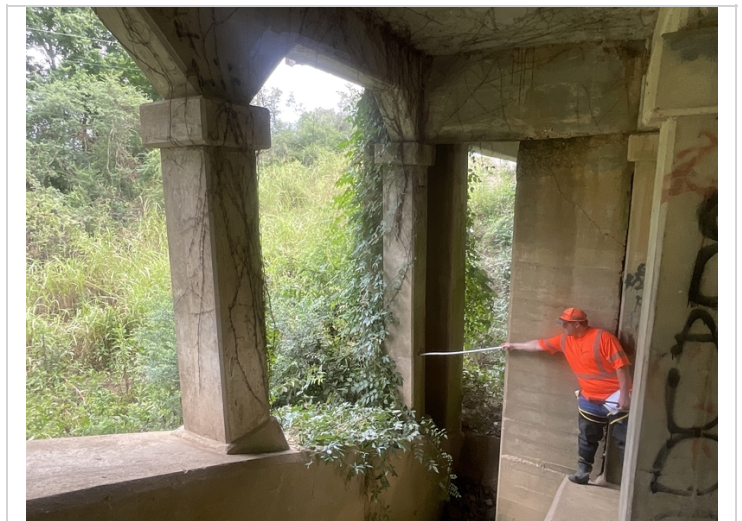
Bent # 2 ahead face of Column # 3. Spalls with exposed reinforcing steel.

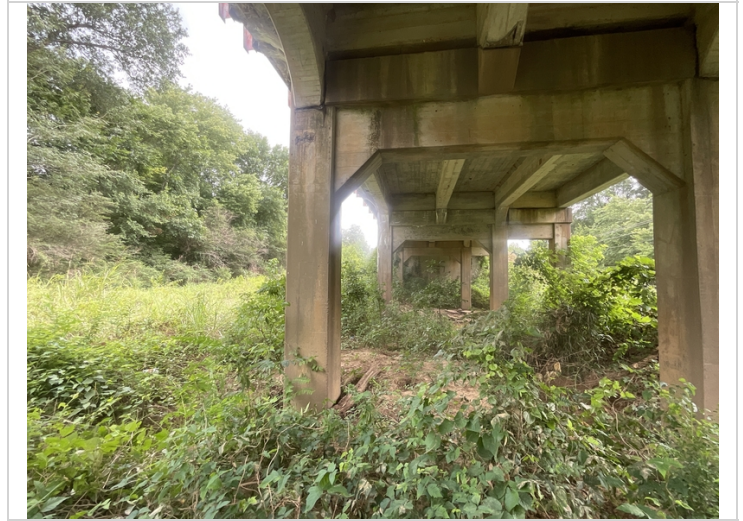
Bent # 4. Column # 1. Back face. Spall with exposed reinforcing steel.

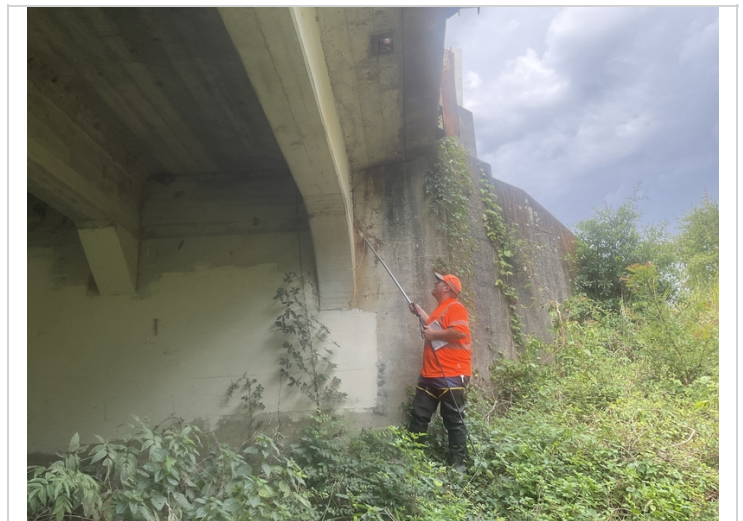
There is a diagonal crack with efflorescence on the Left side of Bent # 1 outside the bearing area.

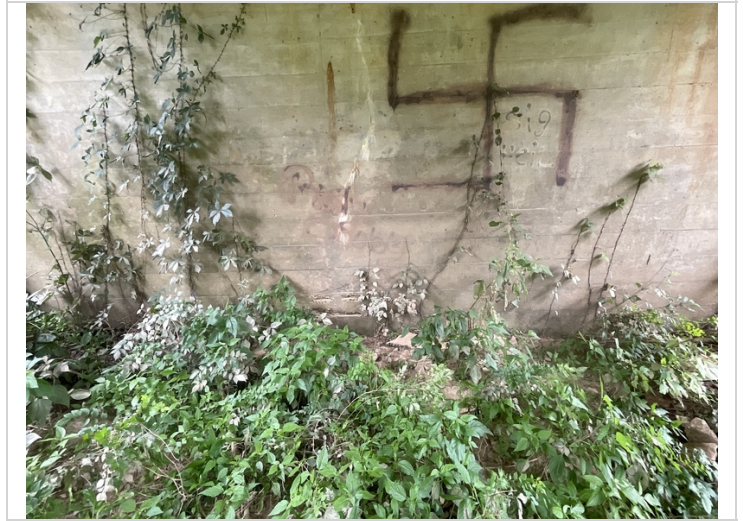
Spalls with exposed reinforcing steel in the base of the East abutment.

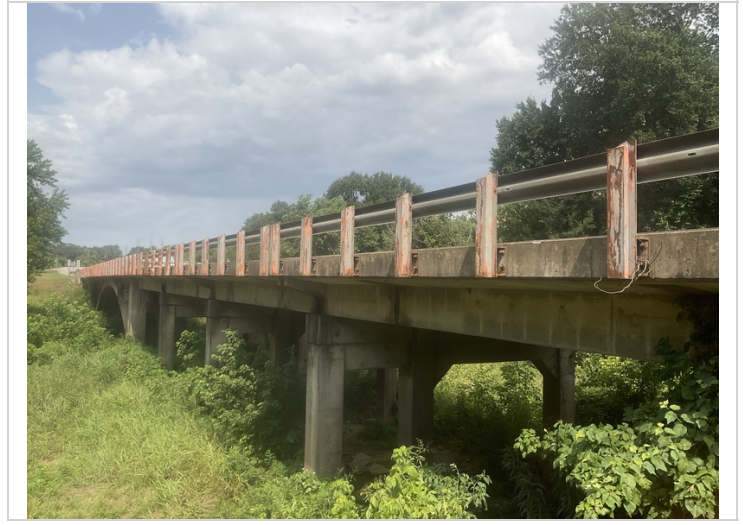
Bridge railing posts with a deteriorated paint system.

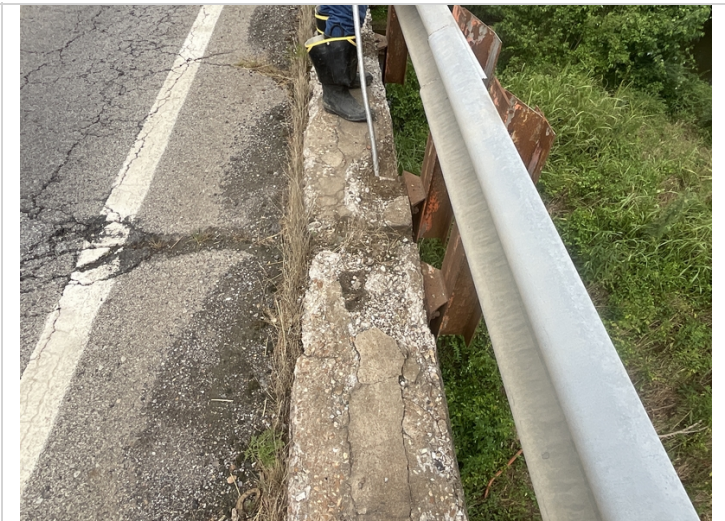
Concrete deterioration and concrete section loss in the Left curb have deterioration that exposes several of the anchors of the bridge railing posts. Photo taken from the Left side of Bent # 4.

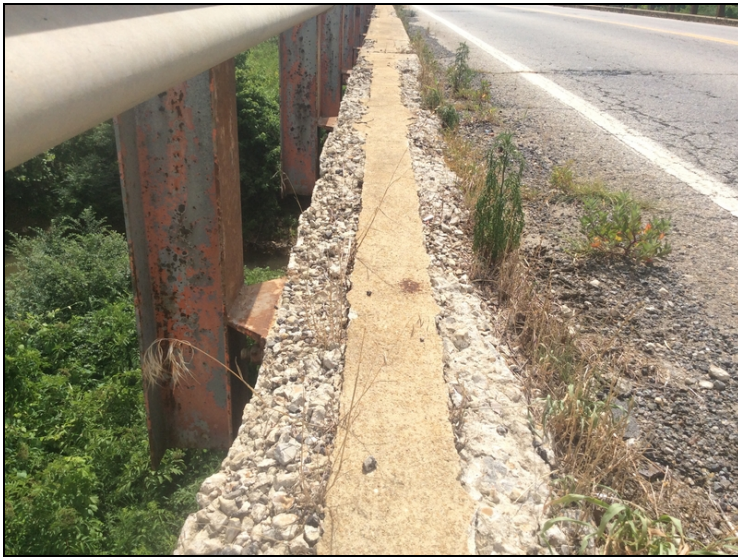
Concrete curbs on Left side of structure -
The curbs along the left side of the structure have soft deteriorated concrete and concrete section loss.

Span #2 Left-Concrete deterioration / spalling to curbs.

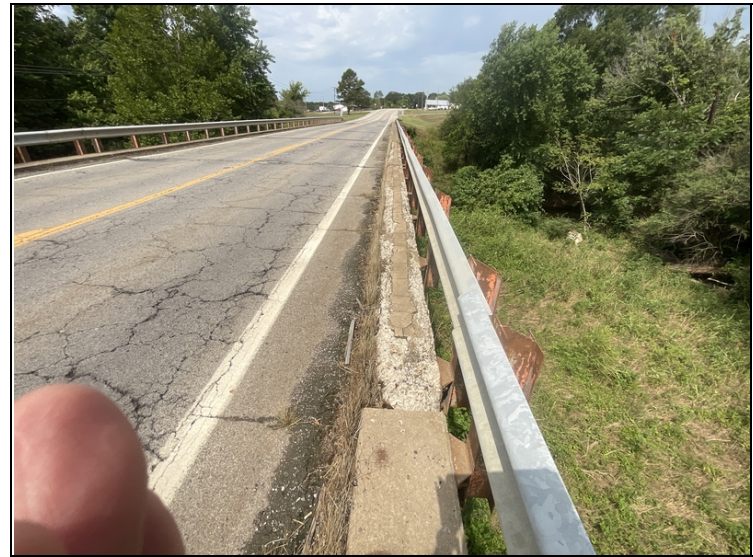
Soft deteriorated concrete in the Left curb.

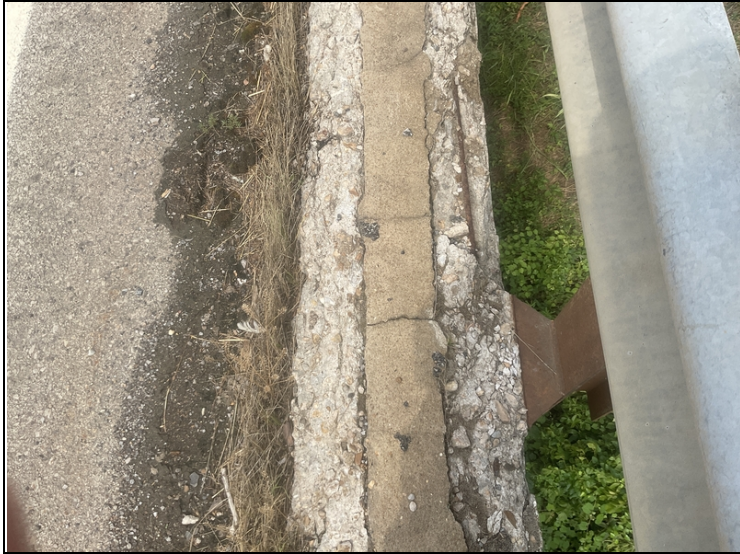
Exposed reinforcing steel in the curb - Left side of structure.

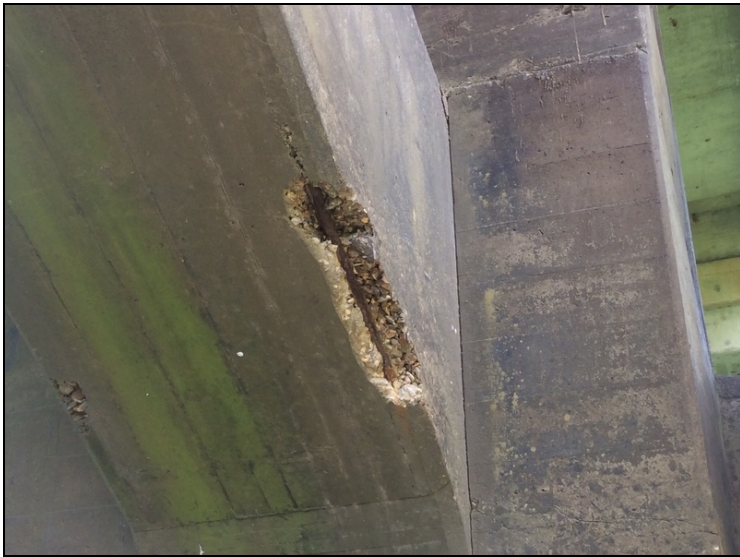
Concrete Arch Rib # 2 -
Concrete Arch Rib # 2 has areas of spalling with exposed reinforcing steel. The exposed reinforcing steel has active corrosion.

Sp #2, arch #2-Spalling with exposed reinforcing steel at bent #3.

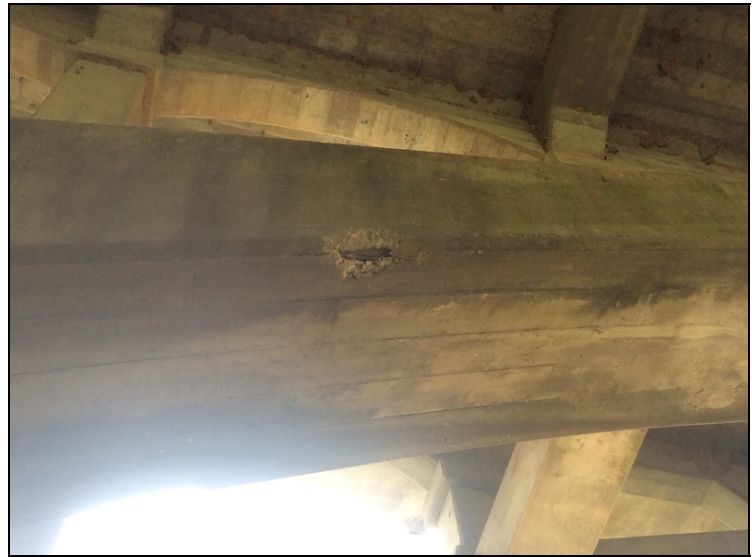
Sp #2, arch #2-Spalling in arch rib in bay #11.

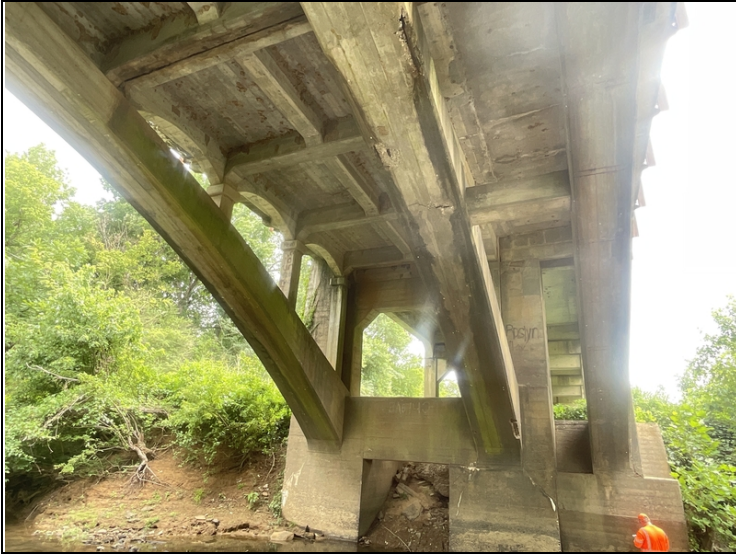
Arch Rib # 2. Spalls with exposed reinforcing steel
in proximity to Bent # 3.

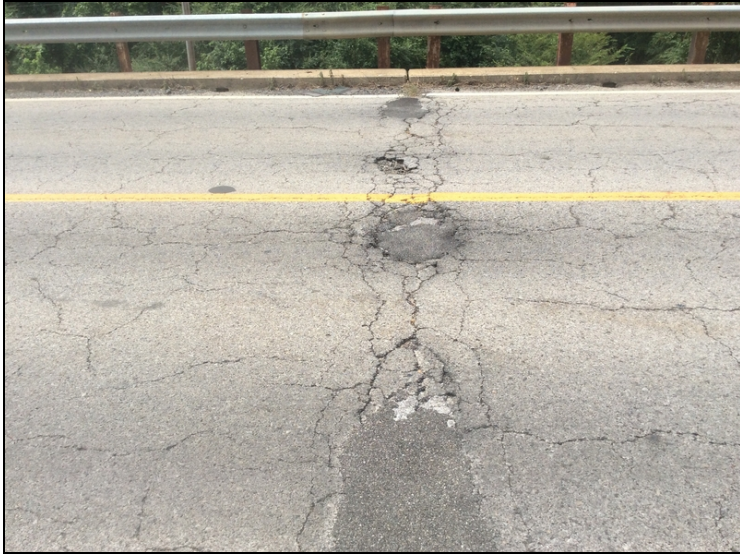
The asphalt driving surface is breaking up over the deck joints allowing potholes to form in the driving surface.

Bent #4 expansion joint-Potholes forming in driving surface.

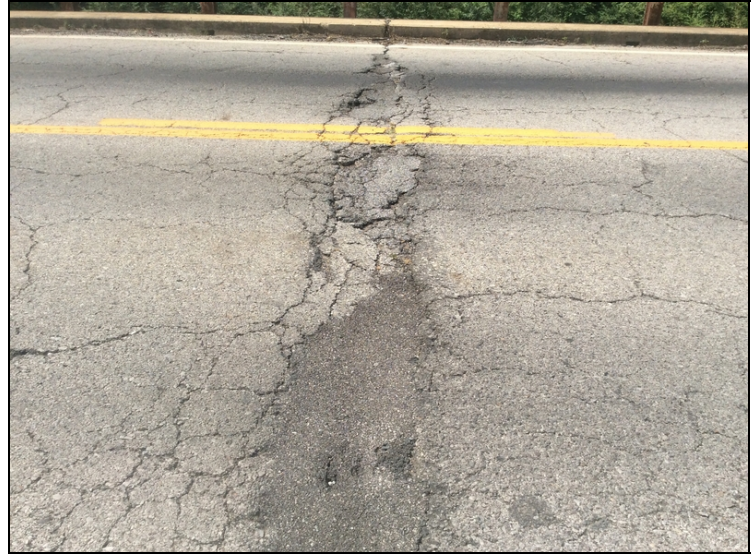
Bent #2 expansion joint-Spalling in driving surface.

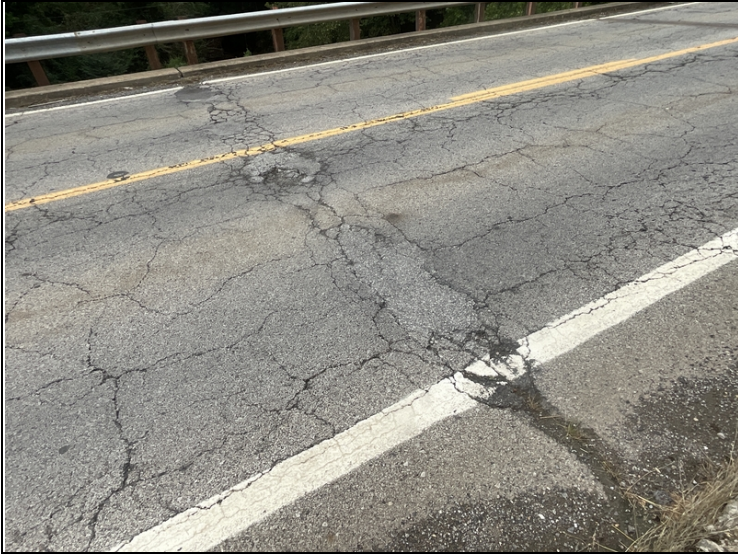
Asphalt wearing surface is breaking apart over
Bent # 4.

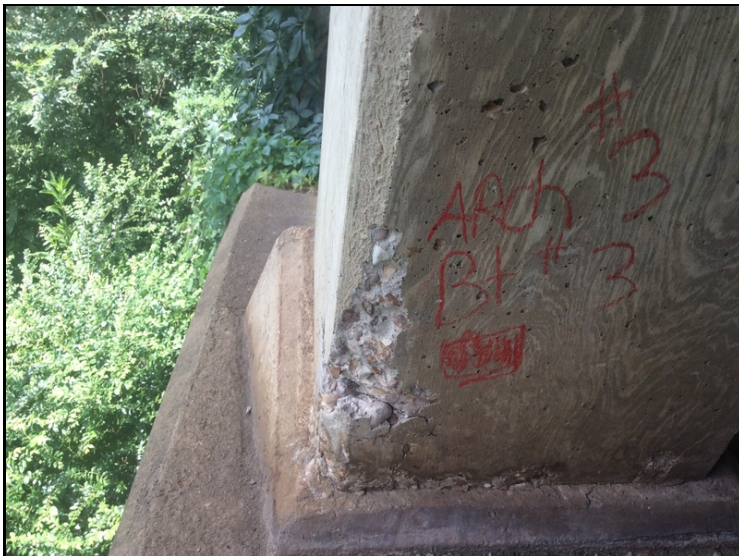
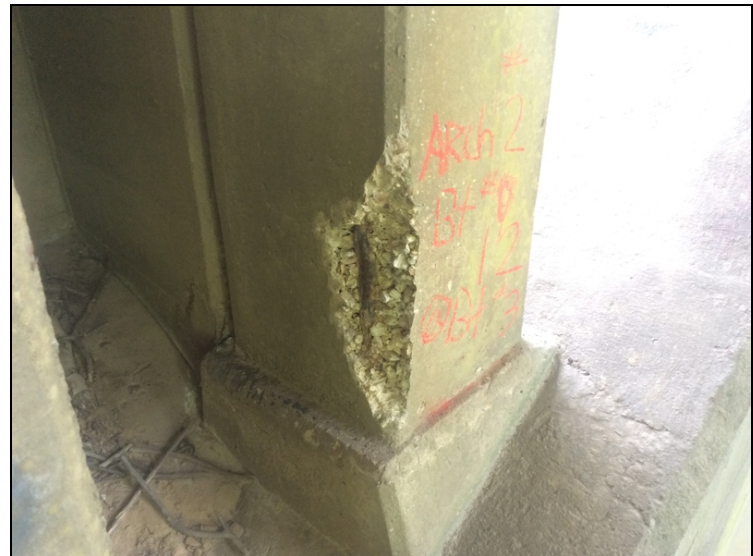
Spandrel column # 12 on Arch Rib # 2 at Bent # 3 has a 5" x 16" spall with exposed rebar at base of the column.

Arch #2 bent #12-Spalling with exposed reinforcing steel in column.

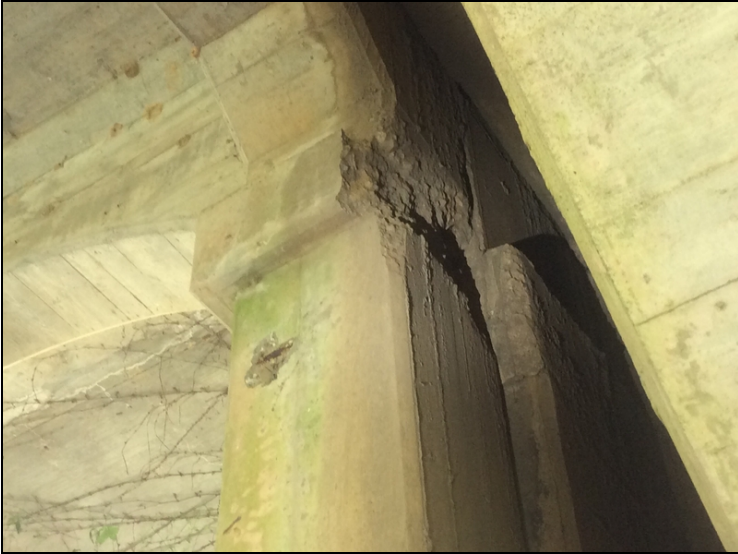
Arch rib #2, column #1-Spalling at cap juncture.

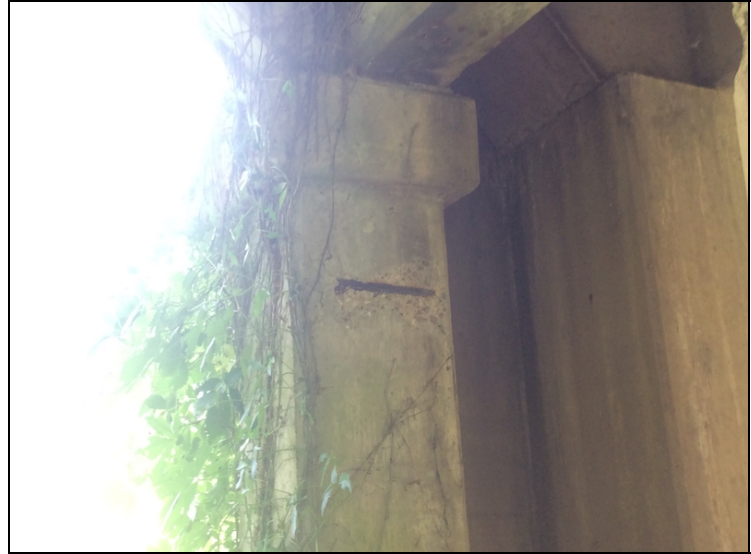
Spandrel column # 1 on Arch Rib # 3 has a 12" long horizontal spall with exposed rebar near the top of the column.

Arch #3, spandrel column #1-Spall with exposed reinforcing steel in column.

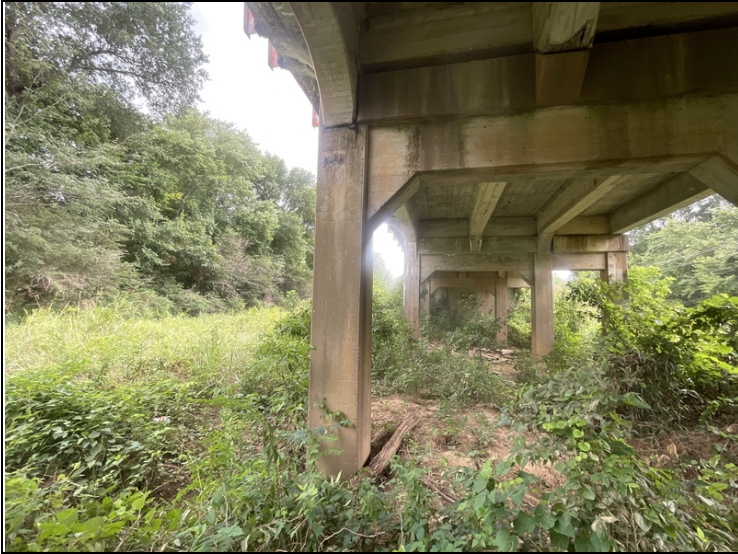
Bent # 4. Column # 1. Back face. Spall with exposed reinforcing steel.

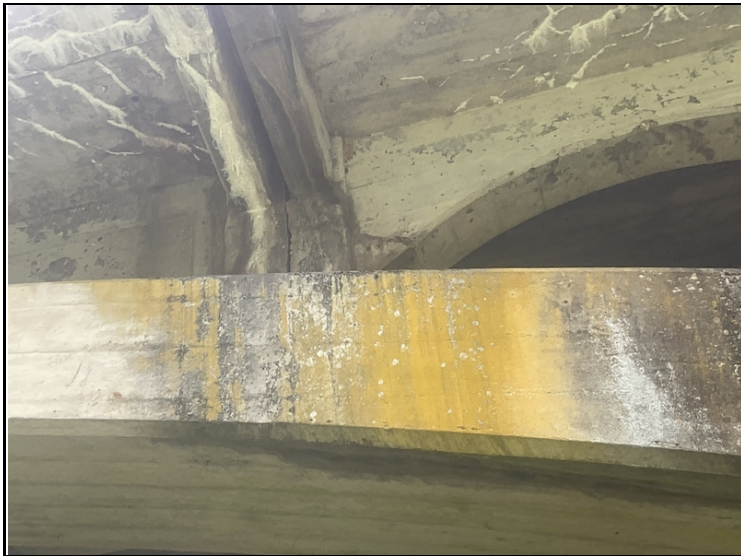
The concrete fascia beams located at spandrel column # 4 and column # 9 on arch rib # 1 have fractures and spalling at the bases of the beams with cracking that propagates diagonally across the exterior vertical faces of the beams and the ends of the monolithic floor beams.

Arch Rib # 1, Column # 4 at the floor beam juncture. Diagonal crack.

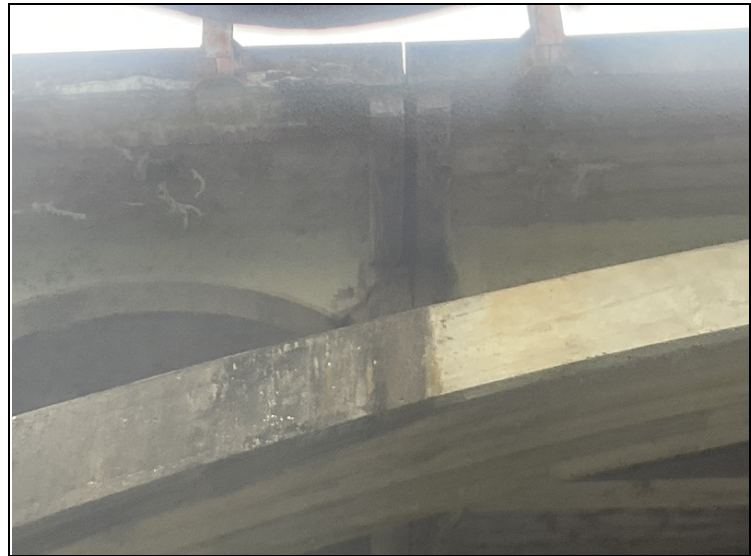
Arch Rib # 1, Column # 9 at the floor beam juncture. Diagonal crack.

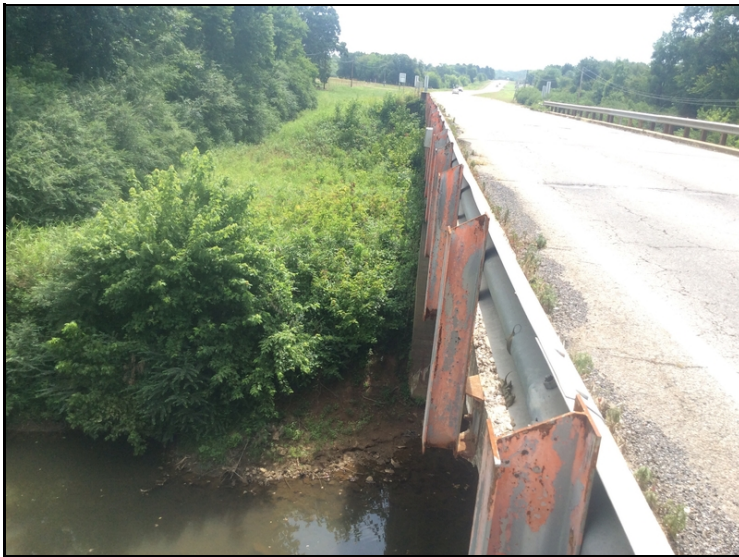
Bridge railing posts -
The bridge railing posts have a failing paint system with rust forming.

Bridge railing Post has paint failure.

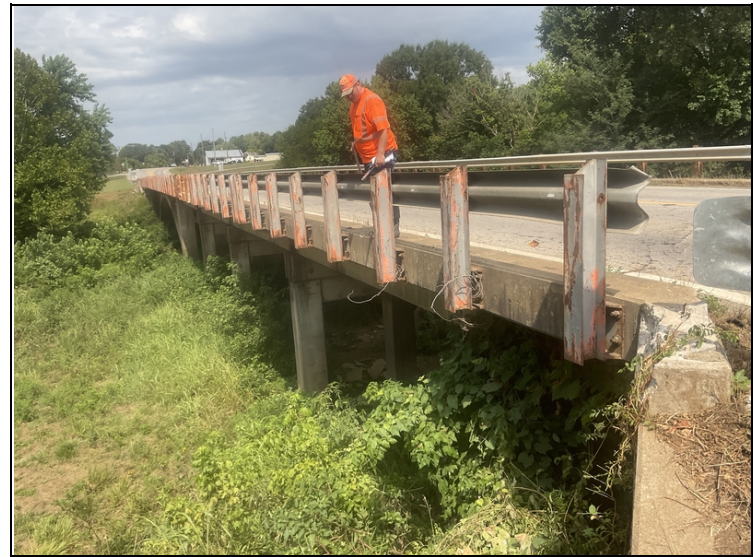
Bridge railing post on the Right side of structure.
Deteriorated paint system. Typical.

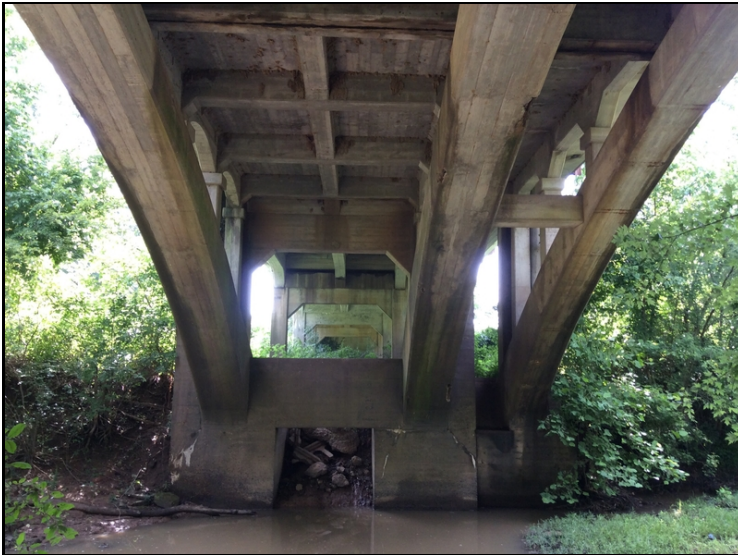
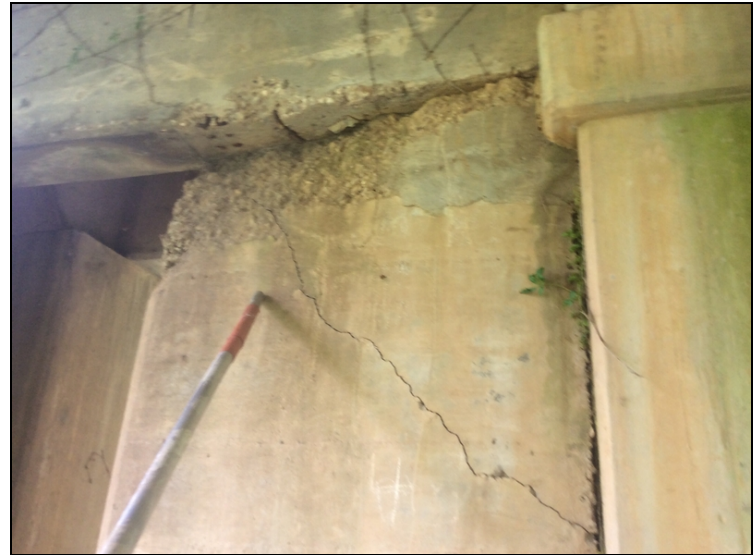
Spandrel columns founded on the skewback have cracking and spalling at the base and upper portion of columns. The most extreme case is located on the Right side of Bent # 2 at Arch rib # 2 at the widened portion of the structure where there is some loss of bearing area at the top of the spandrel column.

Bent # 2, column # 2-Spalling cracking on ahead face.

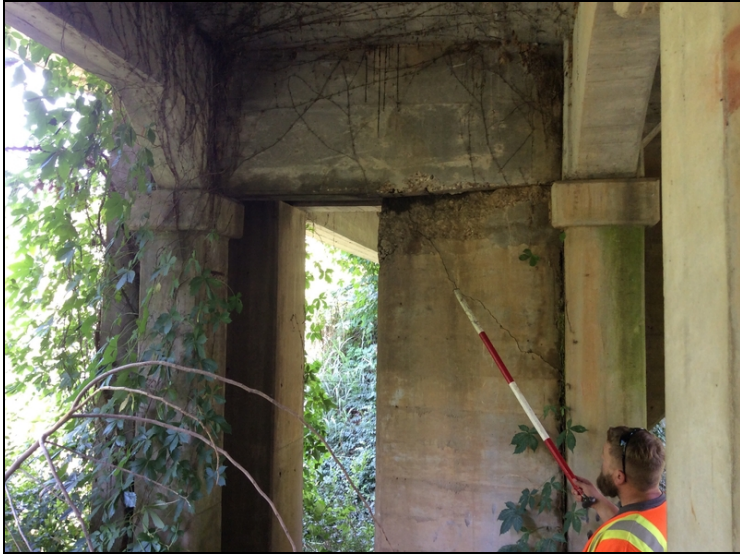
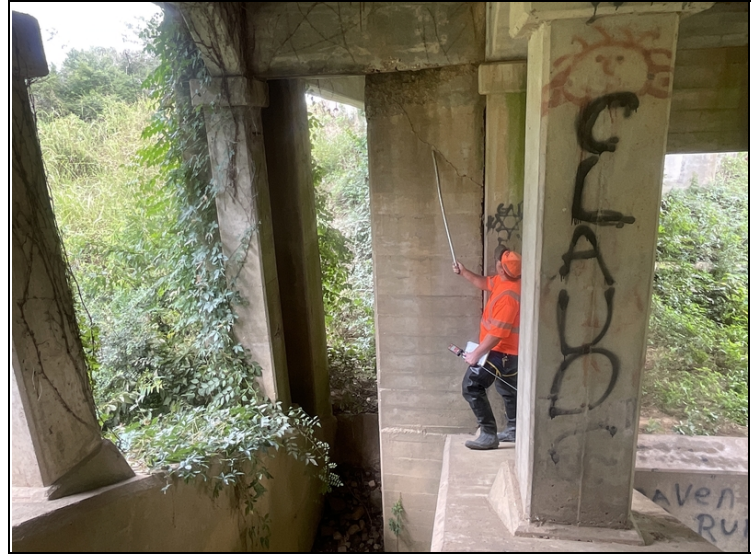
Column # 2. Bent # 2. Span # 2 ahead face.
Diagonal crack with spalling at the cap juncture
where the structure was widened.

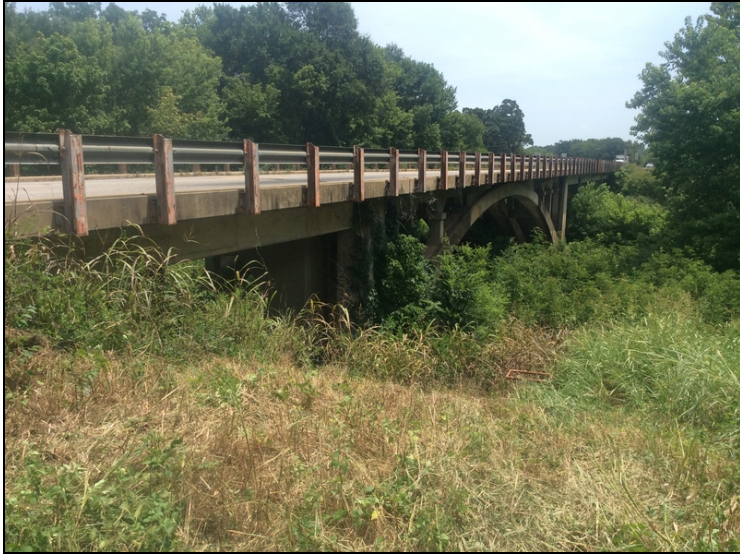
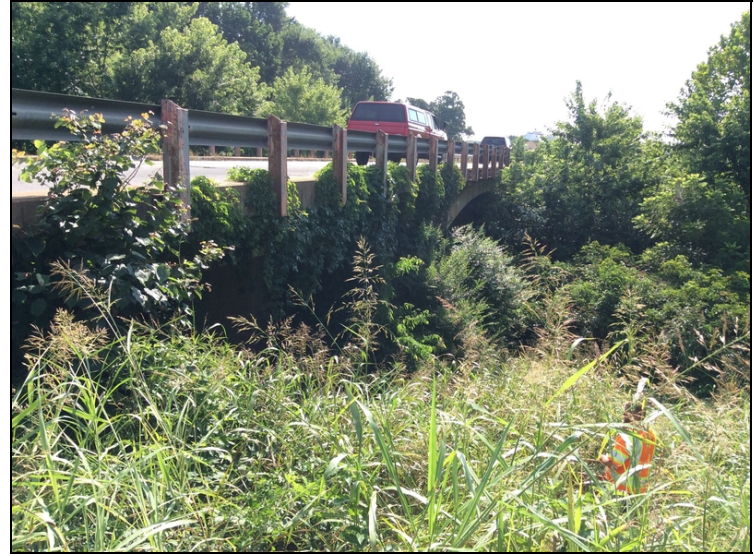
Channel - The channel has heavy vegetation that inhibits inspection efforts. Vegetation covers portions of the substructure.

Heavy vegetation inhibits inspection efforts.

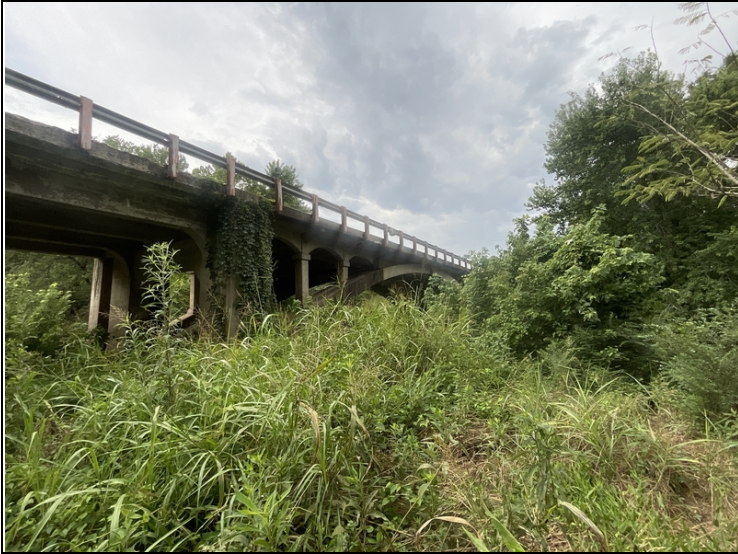
Vegetation.

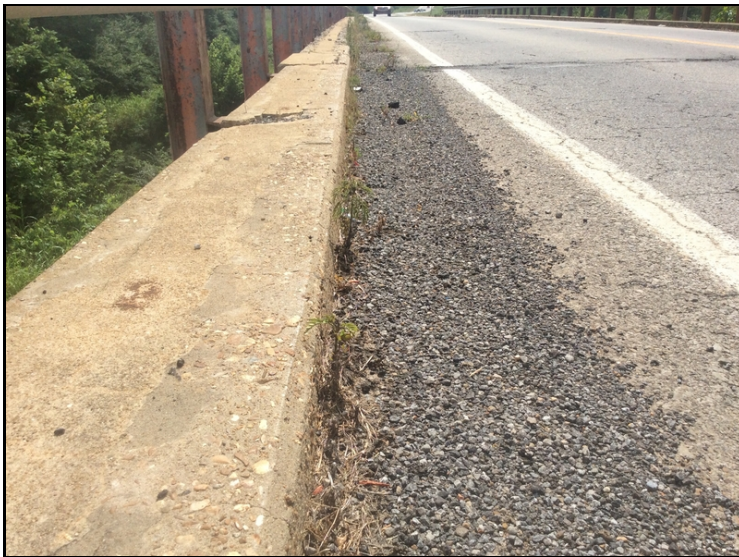
Deck - The gutters have moderate dirt and debris accumulation.

Dirt and debris in gutters.

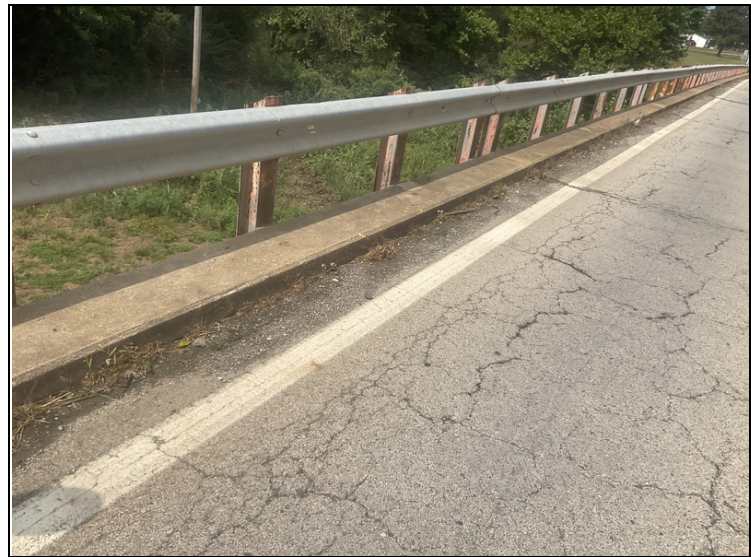
Debris accumulation in the Right gutter. Typical.

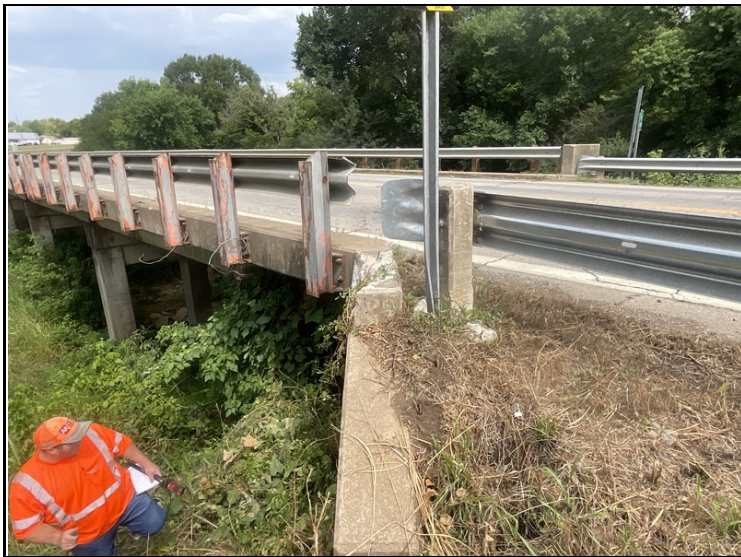
The Southeast end post has been knocked off the structure.

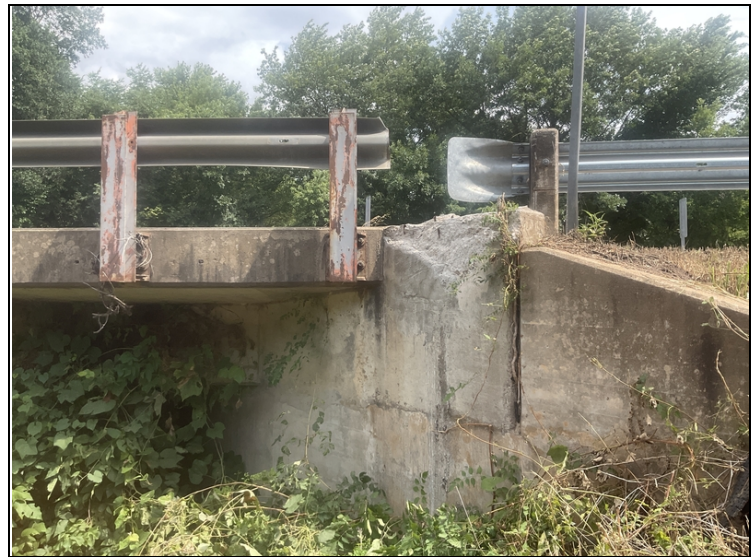
The Southeast end post has been knocked off the structure.

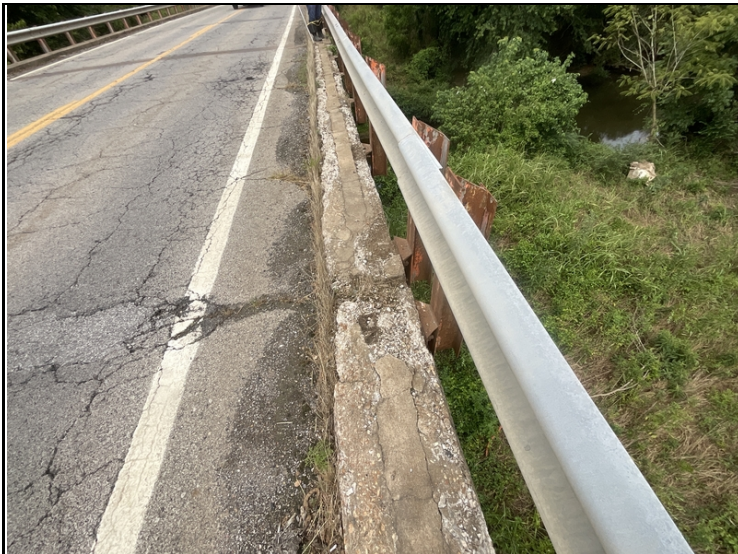
Photo taken of the Left side of Bent # 4.

Anchorage for the bridge railing posts is set in deteriorated concrete.

Concrete deterioration and concrete section loss in the Left curb have deterioration that exposes several of the anchors of the bridge railing posts.
