Asset #06085(Routine)

SH 59-Crawford Co. over Webber Creek

Location: 8.3 MI N IR 40

Team Lead: Jeff Jones, Inspection Date: 03/15/2021

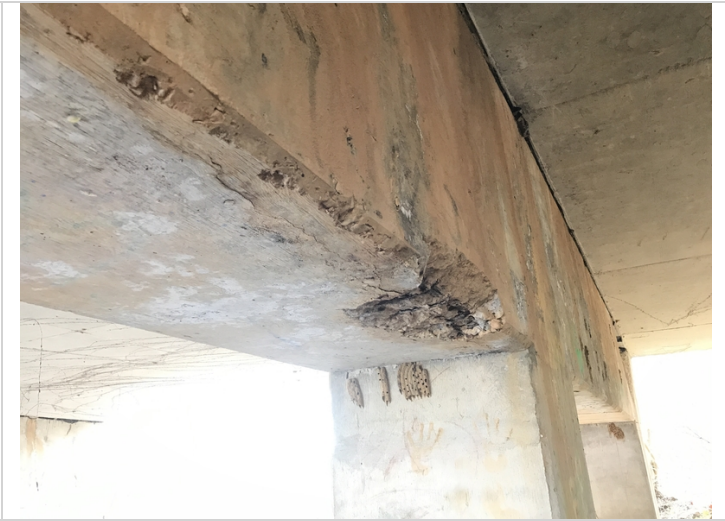
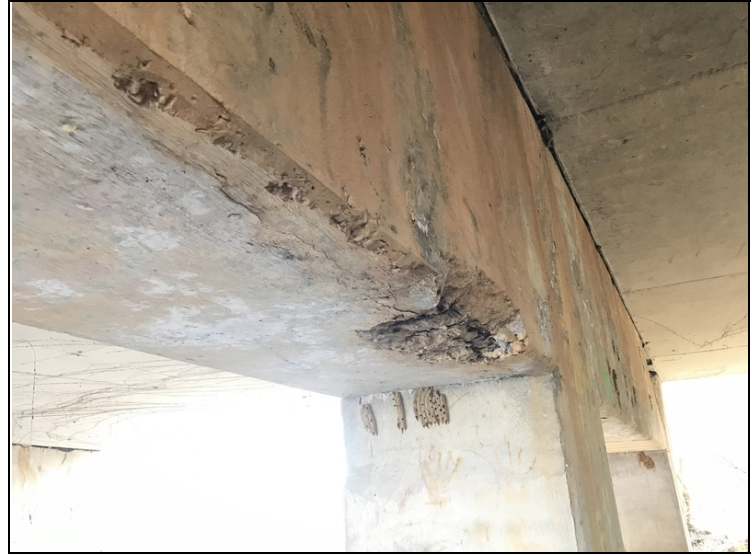
Bent # 2 cracking and spalling with exposed reinforcing steel.

Bent # 2 reinforced concrete cap has numerous areas of spalling at the key-ways. The right side of Bent # 2 in Span # 1 has a 6'L x 3'T x 6" deep area of concrete spalling that has exposed the reinforcing steel. Exposed reinforcing steel has active corrosion with initial section loss.

Both caps have concrete delaminations and spalls, the undersurface of the caps has cracking with delaminated concrete that is deteriorated. These deficiencies appear to have been caused by water leakage through the deck joints.

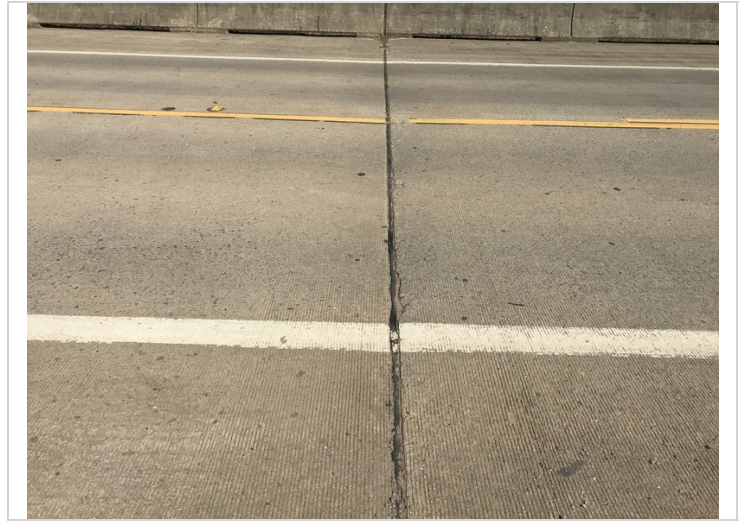
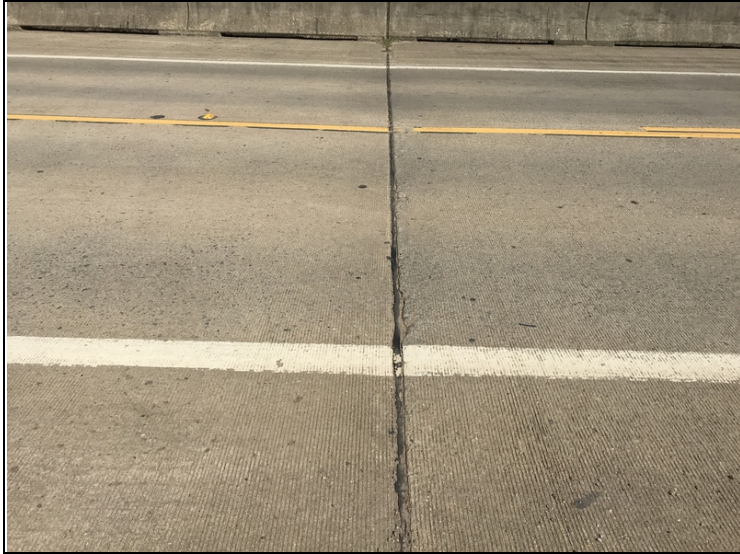
Bent # 3 joint seal debris impaction.

Deck joint sealant is deteriorated and leaks water on the substructure caps and allows incompressible material to accumulate between the concrete slabs.

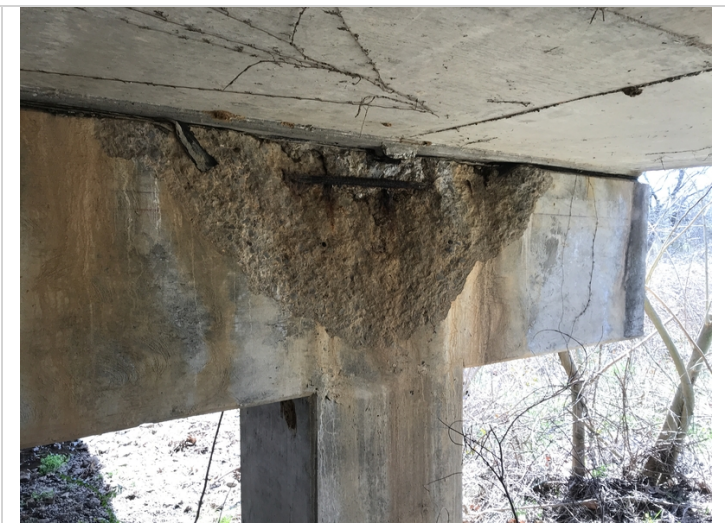
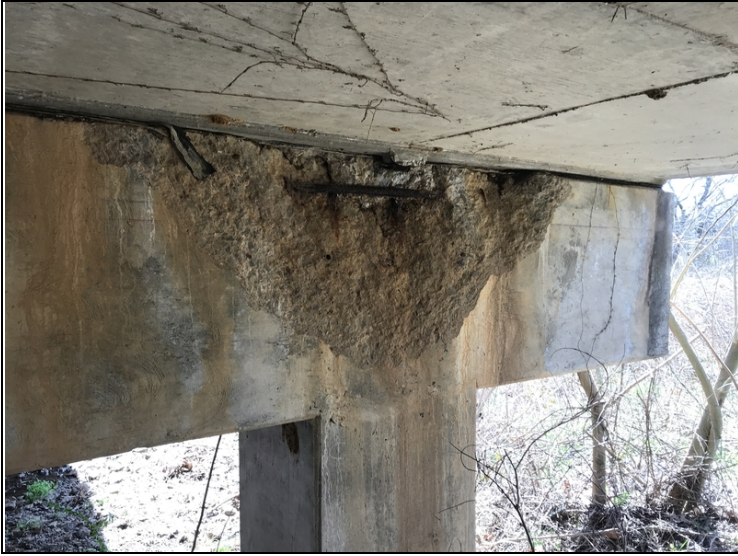
Span # 1 Bent # 2 Rt spalling with exposed reinforcing steel.

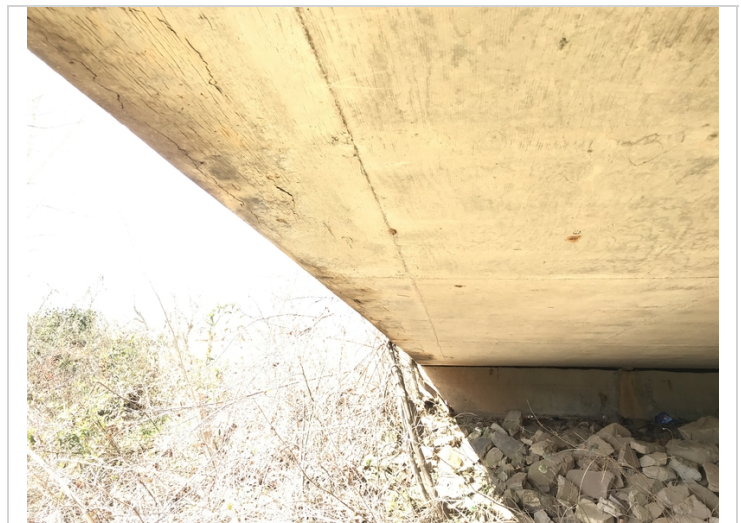
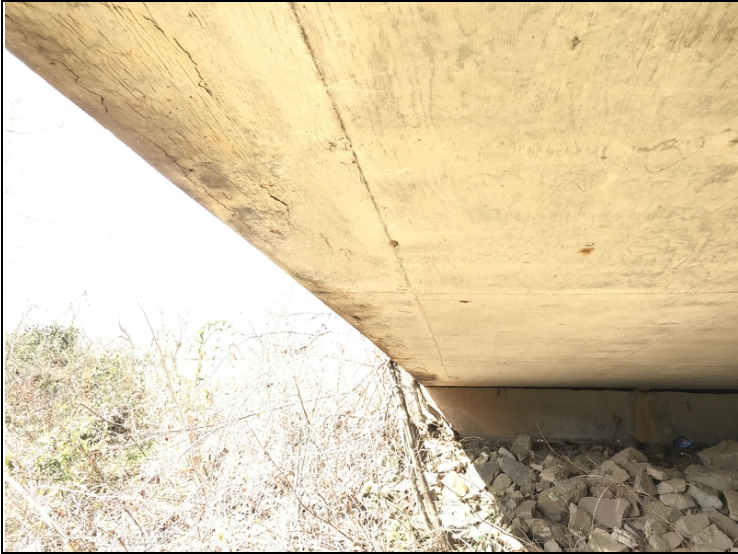
Span # 1 Rt concrete delamination along the Right edge of the slab.

The undersurface edges of the concrete slabs have large areas of delaminated concrete.

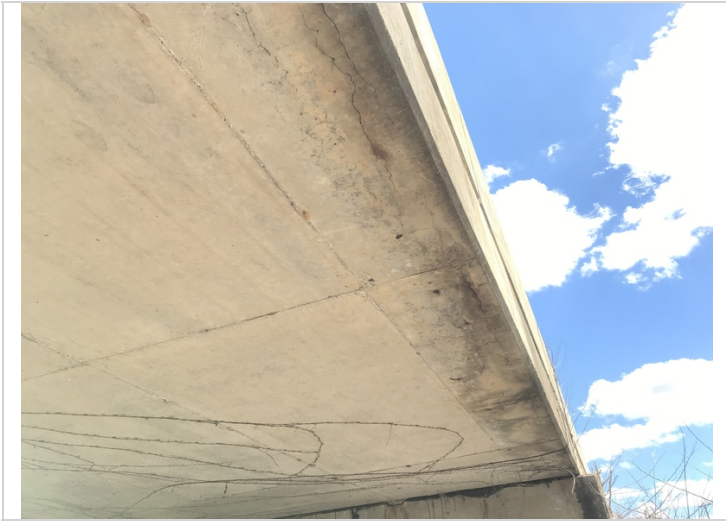
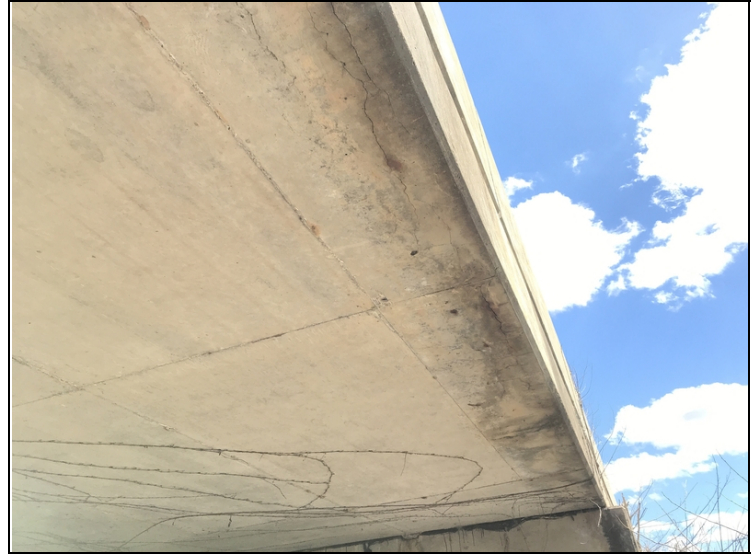
Span # 2 Rt delaminated concrete along the edge of the slab.

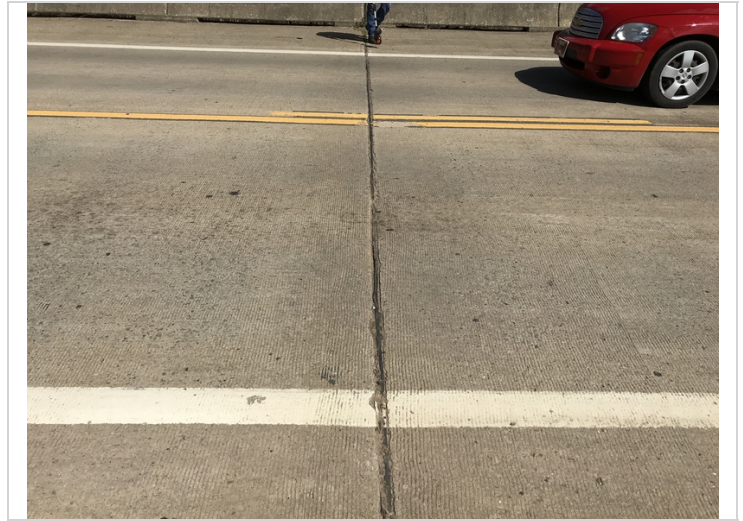
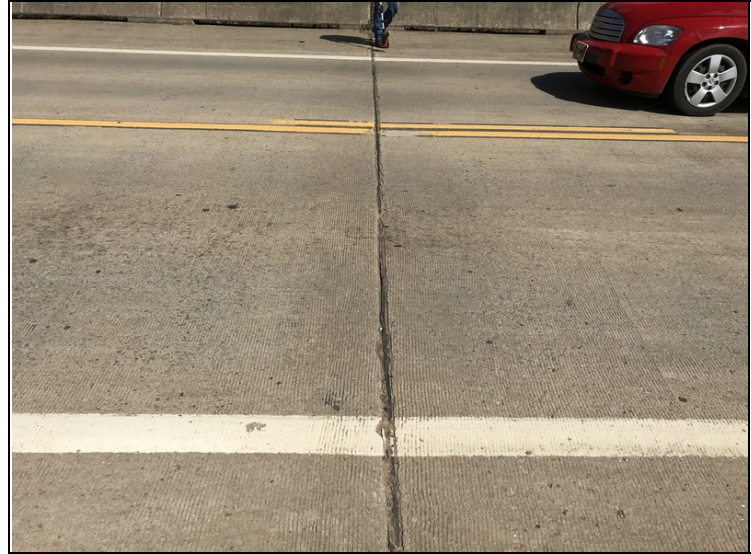
Bent # 2 joint seal deterioration with debris impactation.

Bent # 2 joint seal deterioration with debris impaction.

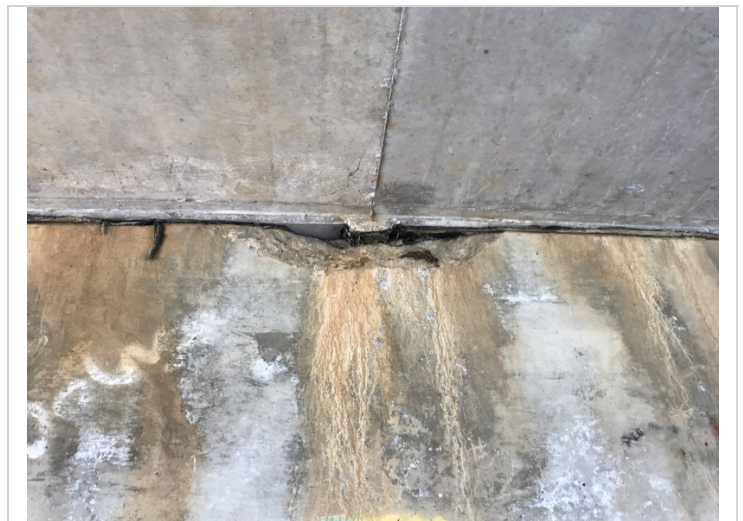
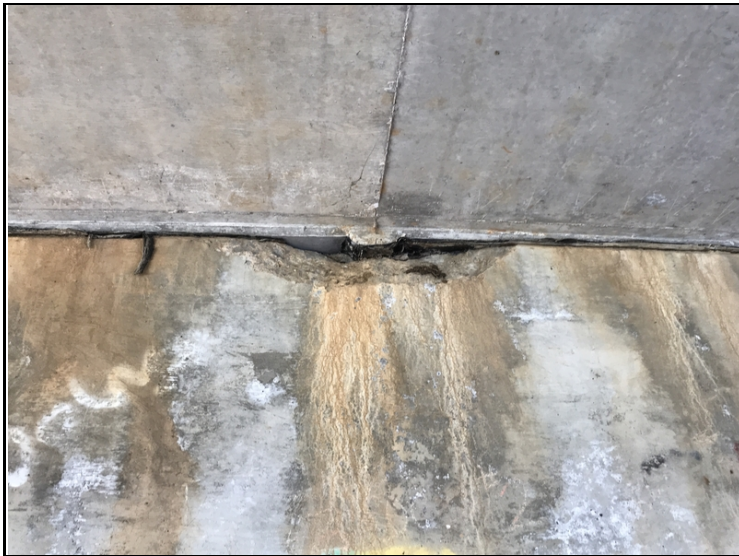
Bent # 2 Span # 2 spalling at the centerline of the Bent.

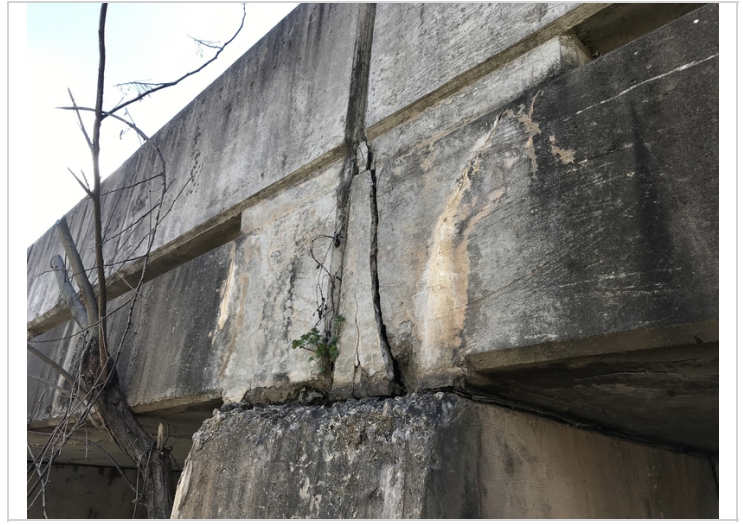
Bent # 2 Lt edge of the slab spalling with efflorescence.

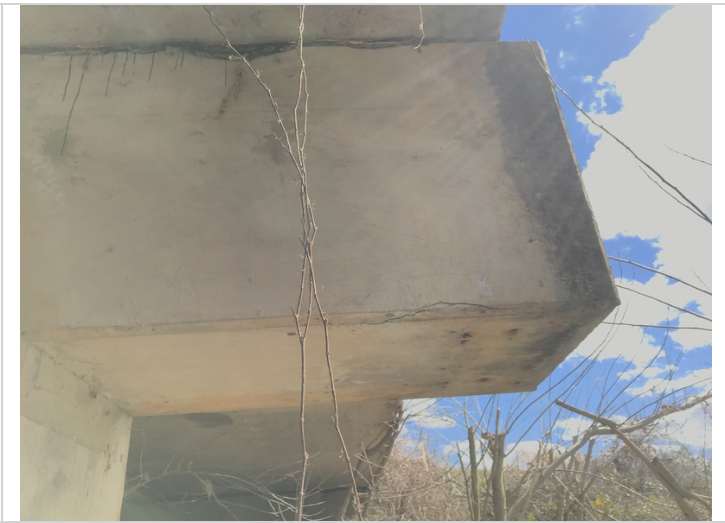
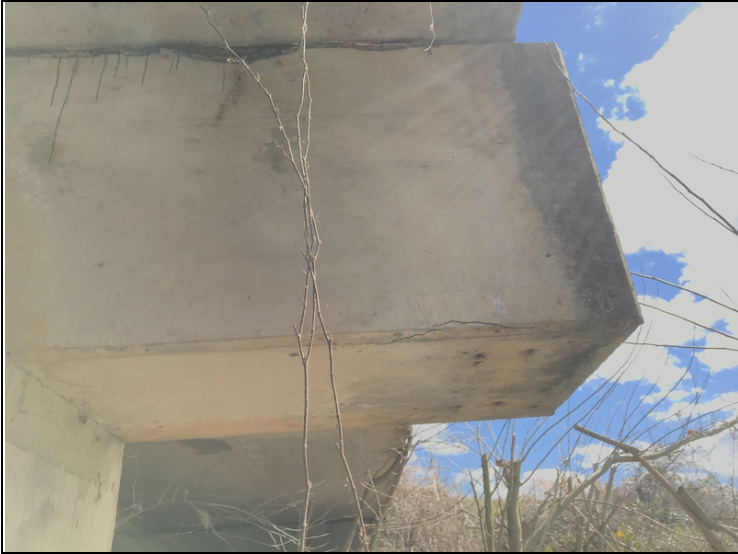
Bent # 3 Rt concrete delamination.

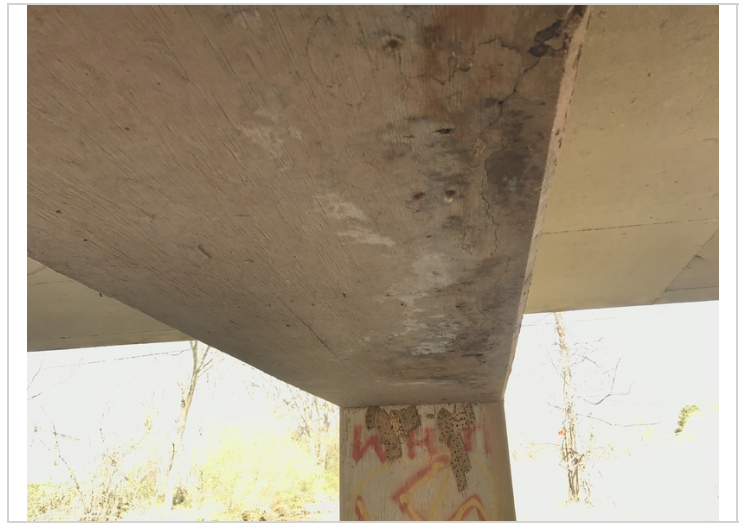
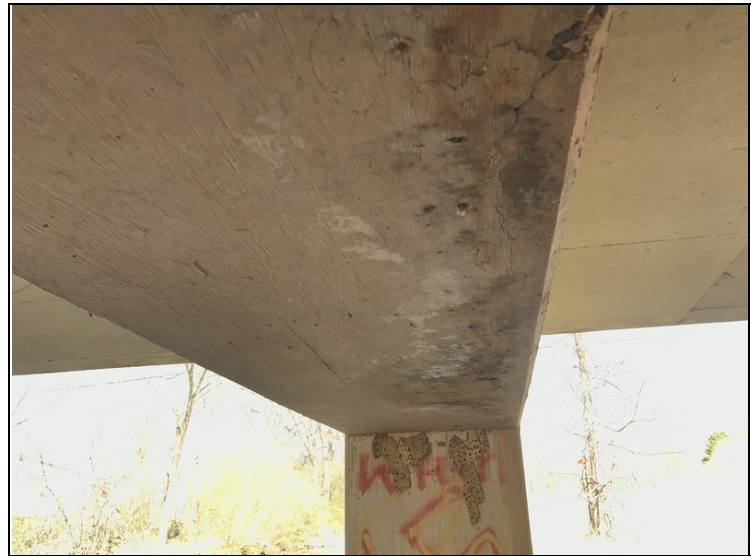
Bent # 3 cracking on the undersurface of the cap.

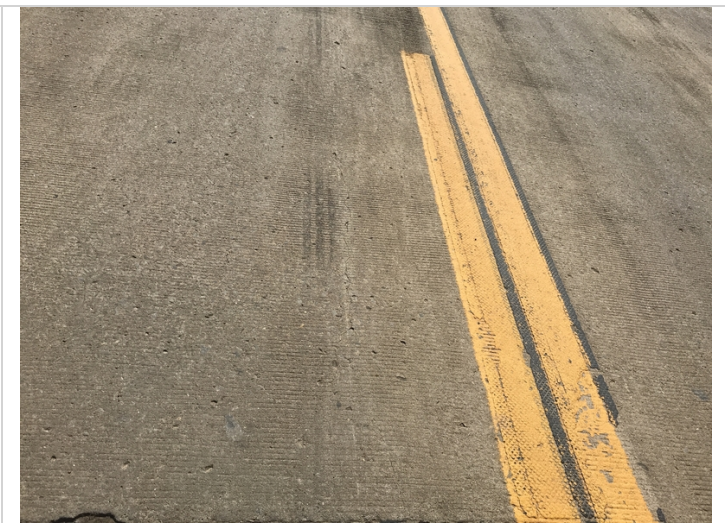
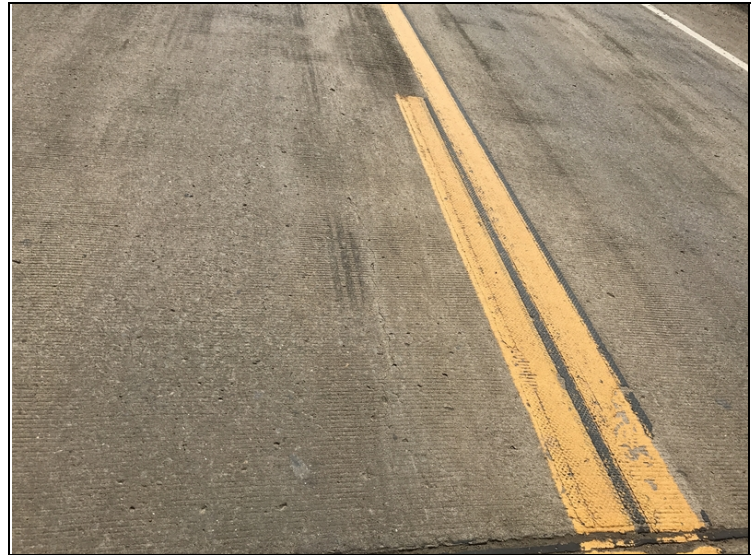
Longitudinal crack in Span # 2.

The driving surface of the deck has sealable cracking in all spans.

Sealable longitudinal crack in Span # 2.

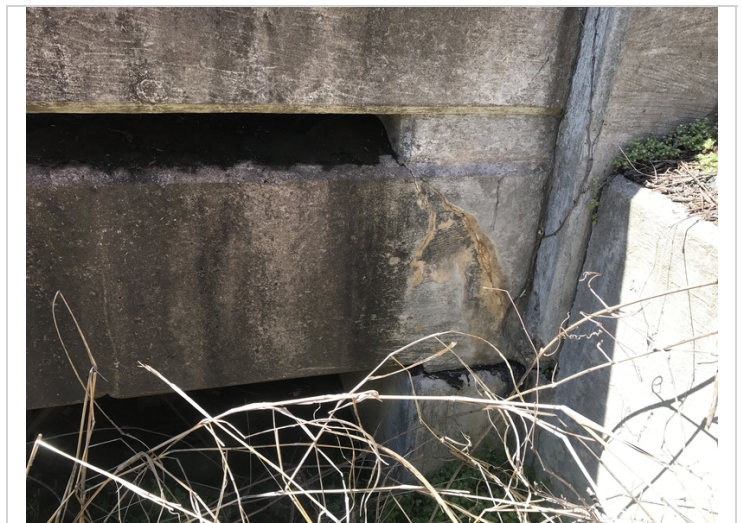
Diagonal cracking in the Left edge of Span # 1 adjacent to Bent # 1.

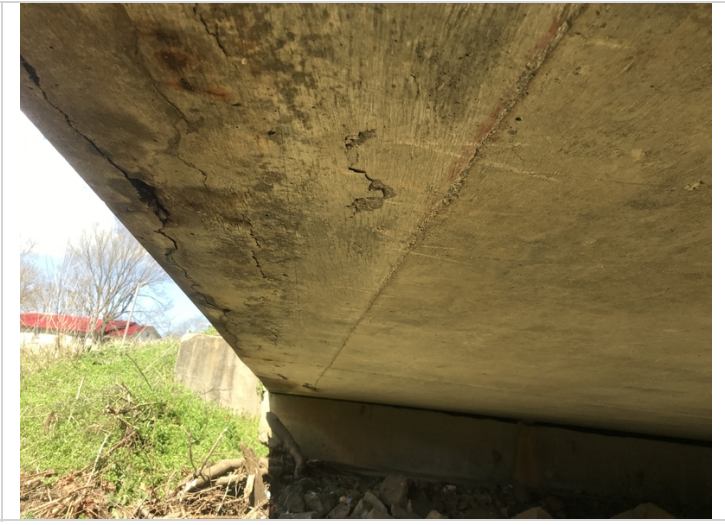
Delaminated area in the Right soffit of Span # 1.

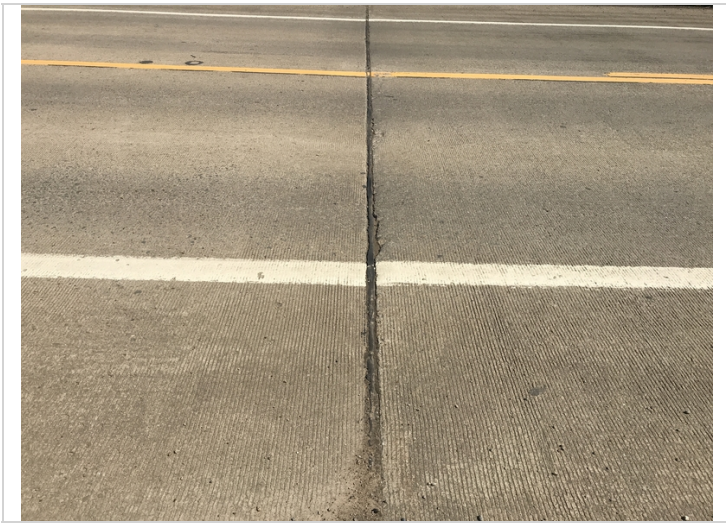
Debris accumulation in the joints. Joint over Bent # 3.

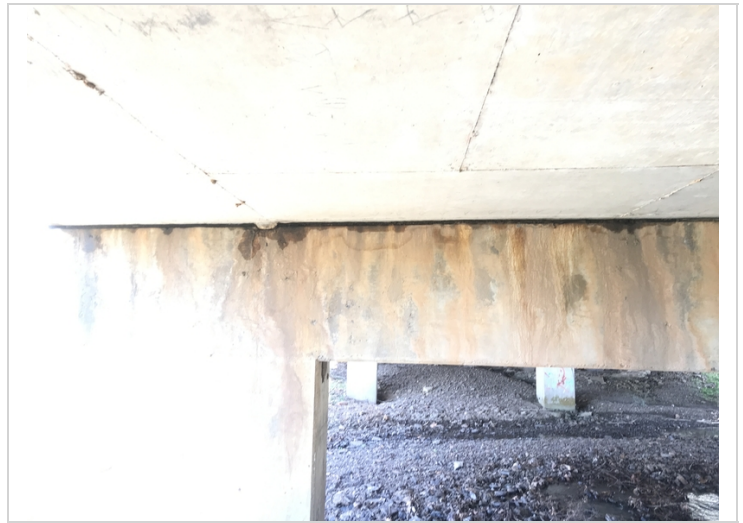
Water drains on the cap due to joint leakage.

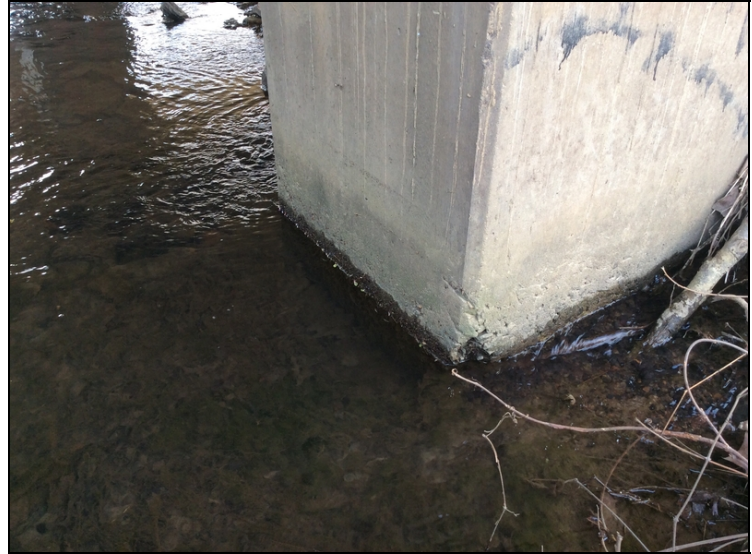
Bent # 3 column # 1 has an area of honeycomb that has created an area of concrete section loss approximately 6 inches high and 2 inches deep at the base of the column.

Bent # 3, Column # 1 has an area of honeycomb at the base on the Span # 3 side.

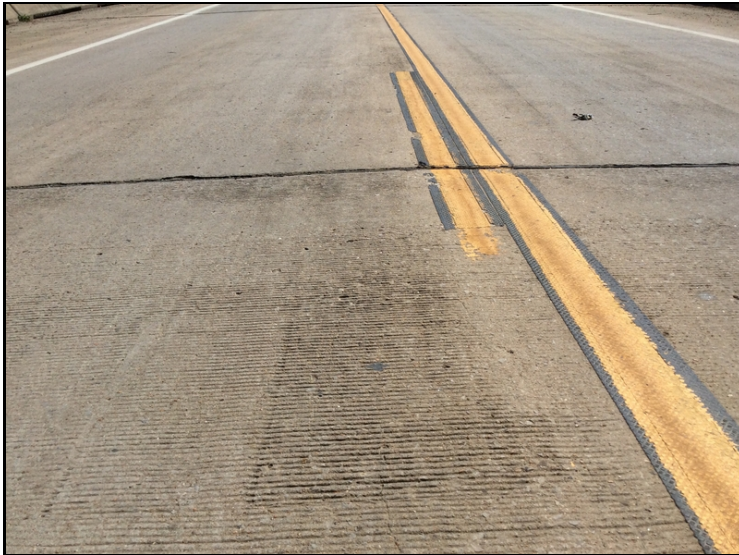
One longitudinal crack near centerline of Spans # 1, 2, and 3.

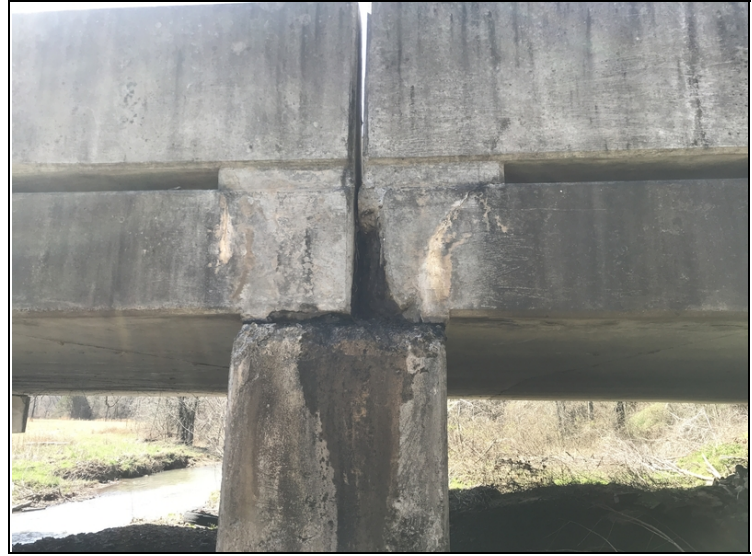
Left edge of deck over Bent # 2.

There are cracks and spalls in the edges of the deck over the intermediate bent caps.
